Teck Highland Valley Copper Partnership

2017 Dam Safety Inspection Report

Highland Tailings Storage Facility

March 2018

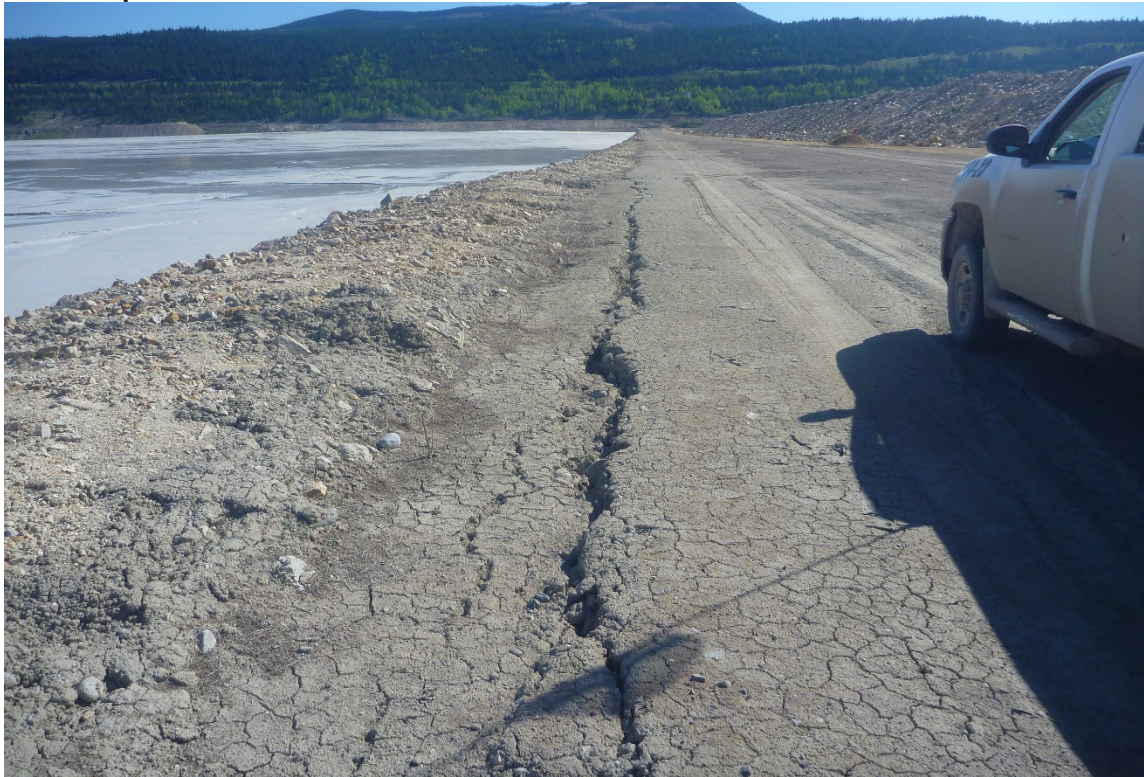
Photo 1 – Cracking at the seam between RF1 and U/S RF2 at approx. Sta. 0+800

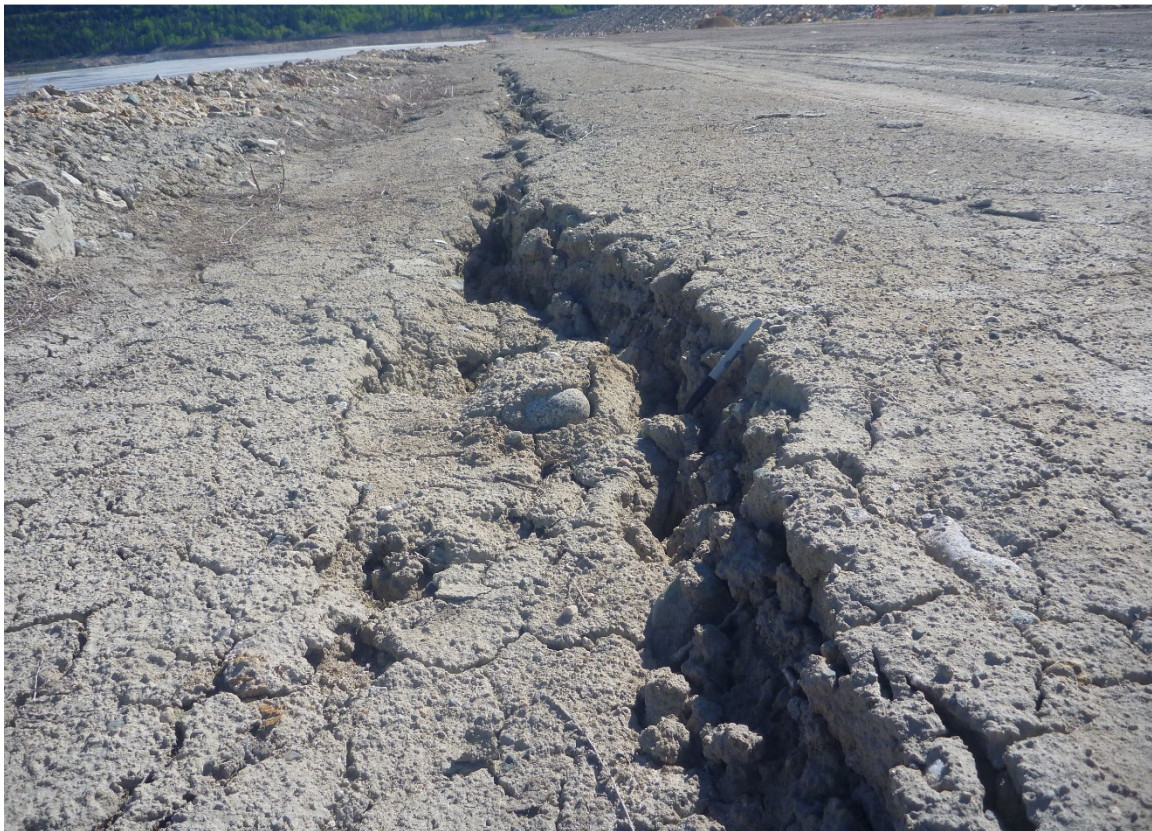
Photo 2 - Cracking at the seam between RF1 and U/S RF2 at approx. Sta. 0+800

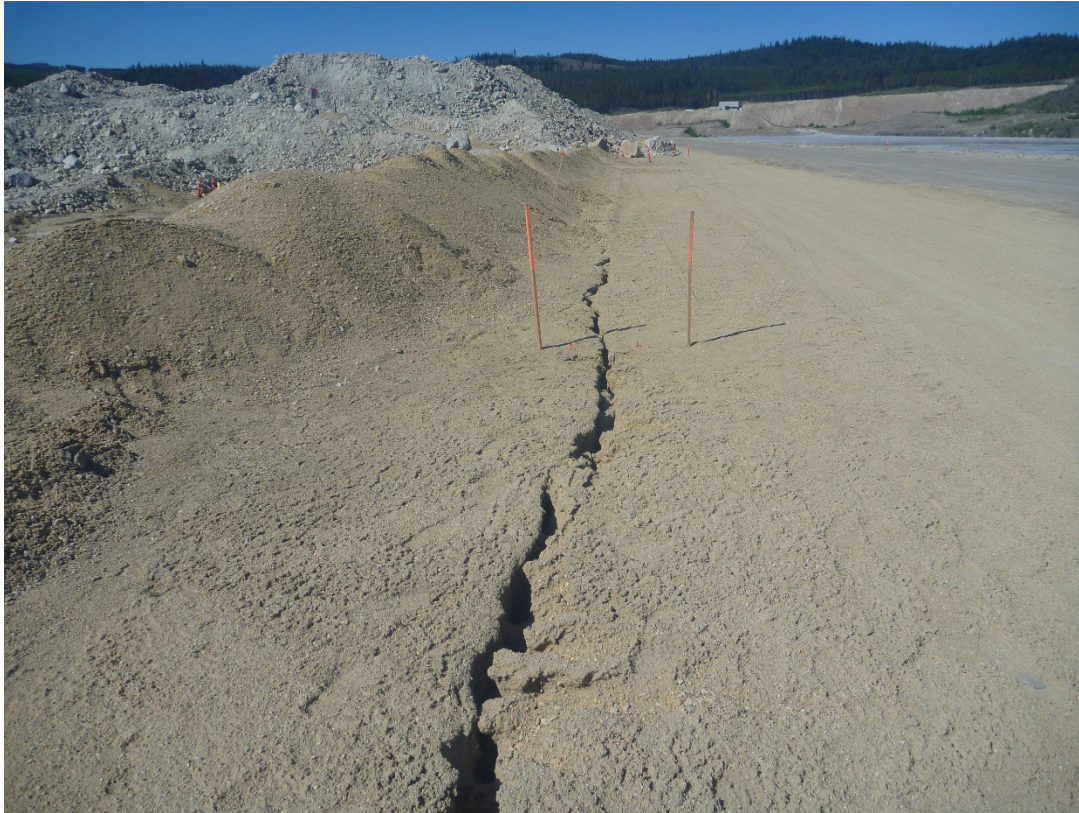
Photo 3 – Cracking on the u/s edge of SG2 zone at approx. Sta. 1+550 (facing west)

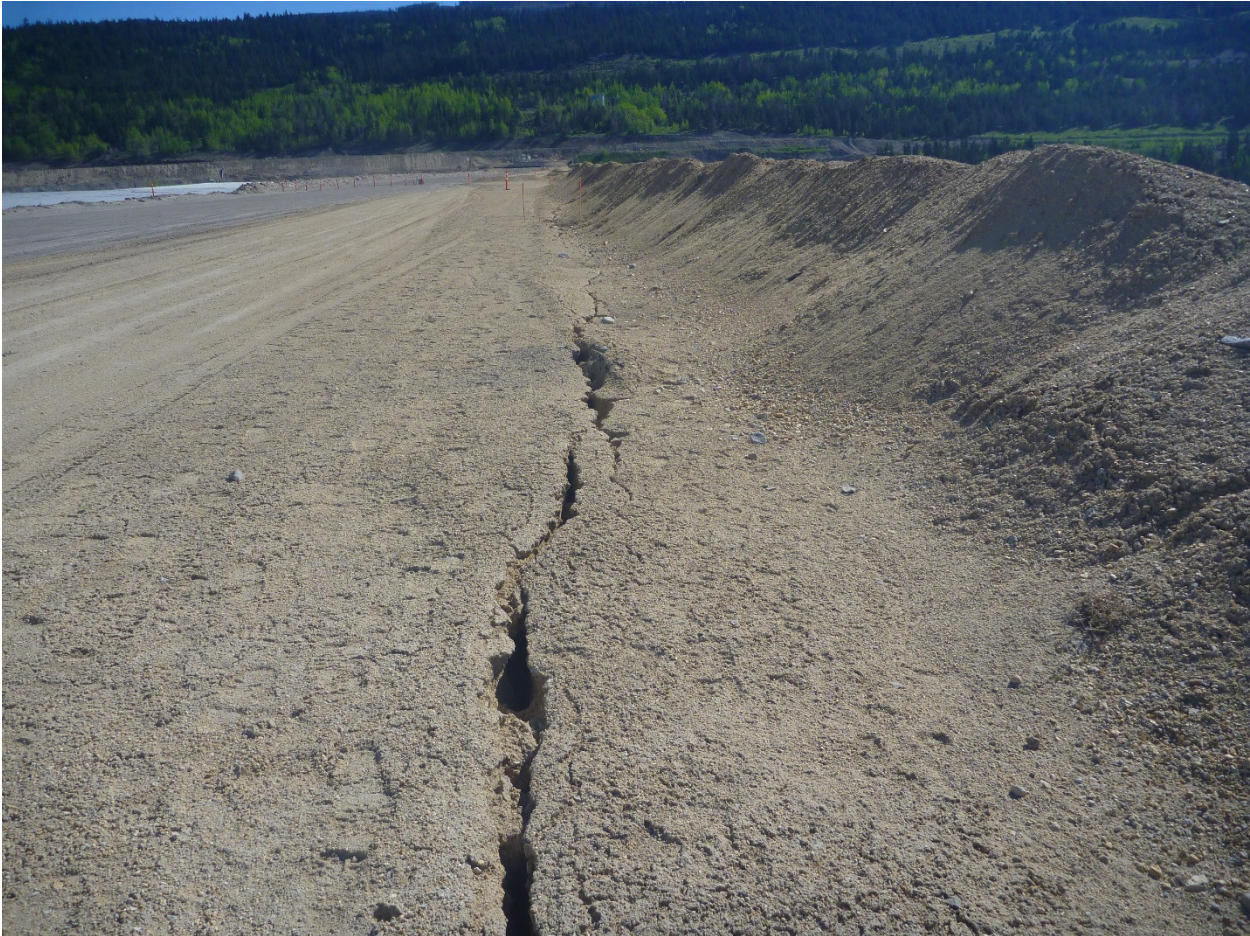
Photo 4 – Cracking on the u/s edge of SG2 zone at approx. Sta. 1+550

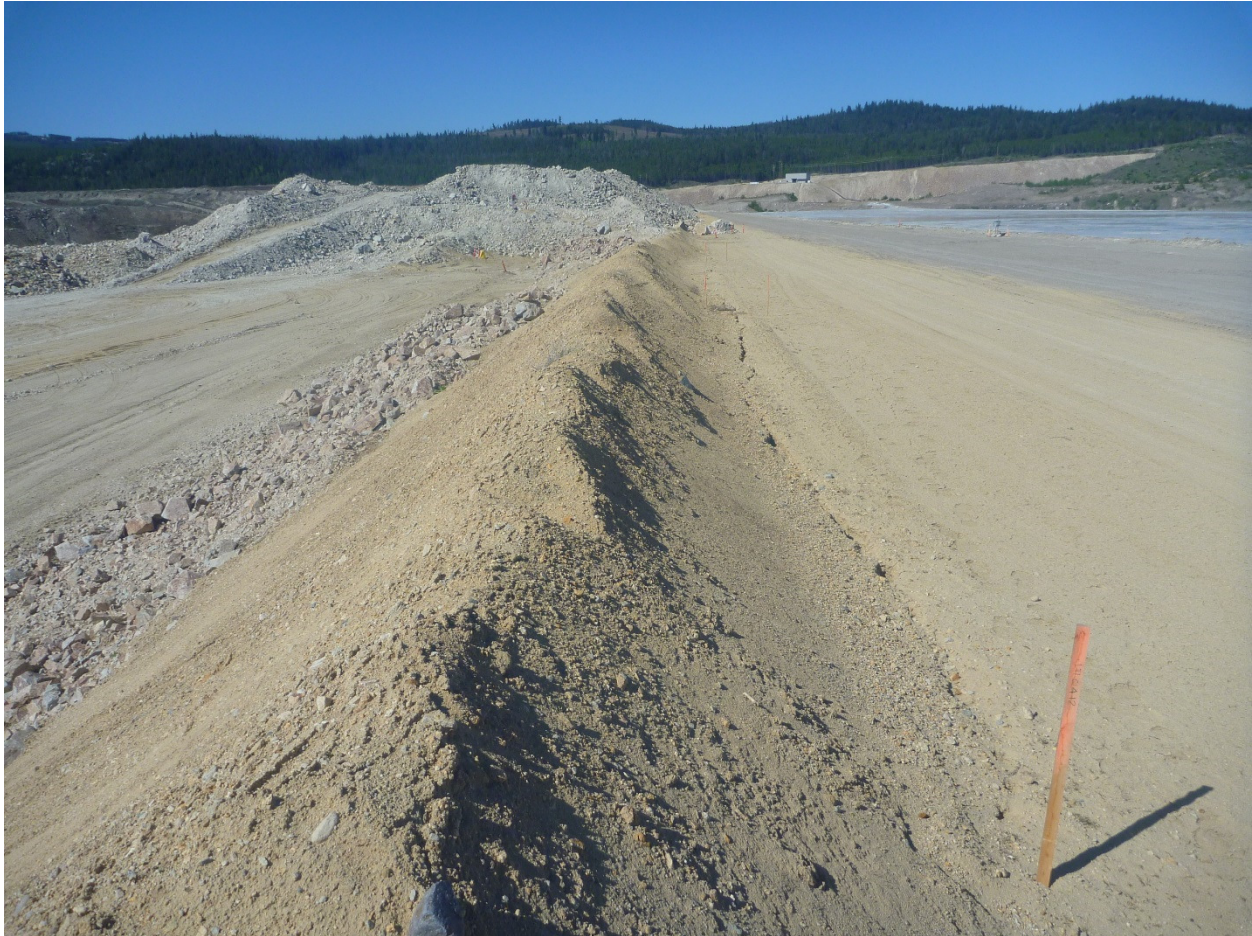
Photo 5 – Overview of cracking area on the u/s edge of SG2 zone showing height of loose safety berm (~ 4m)

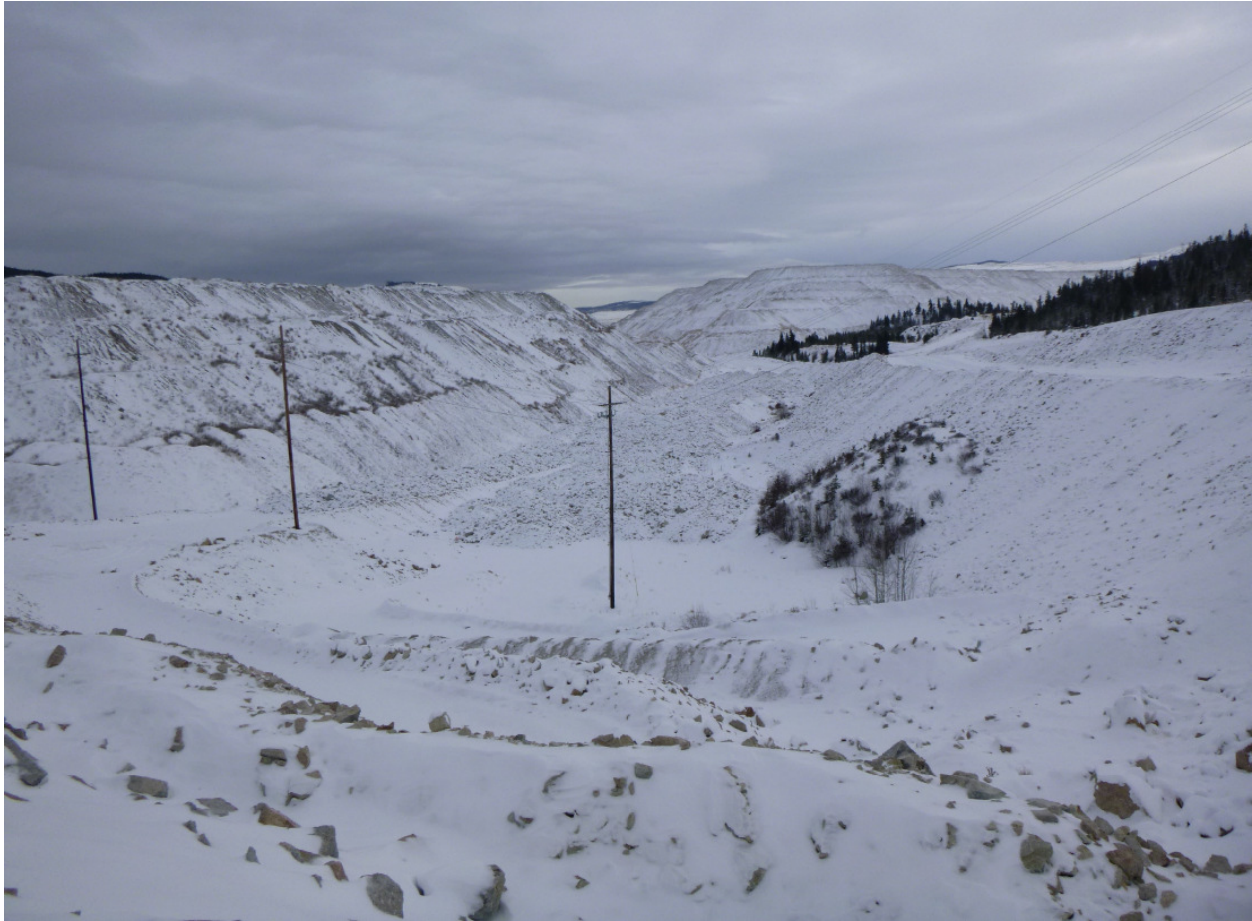
Photo 4 – Recently dumped d/s RF2 material observed between west side of I-9 waste dump and the west access road on the dam (looking southeast).

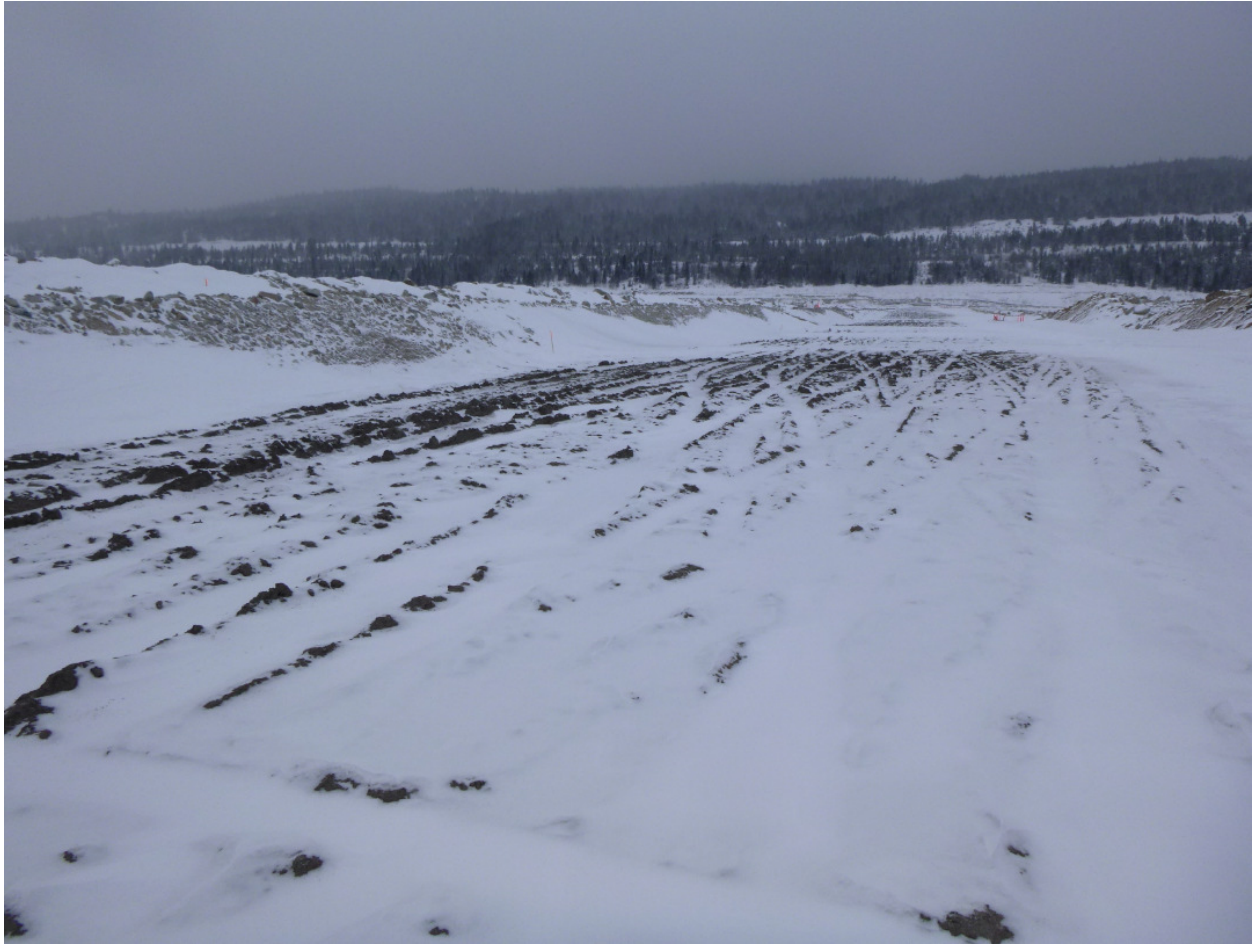
Photo 5 – Sections of the till core zone were heavily rutted (looking northeast).

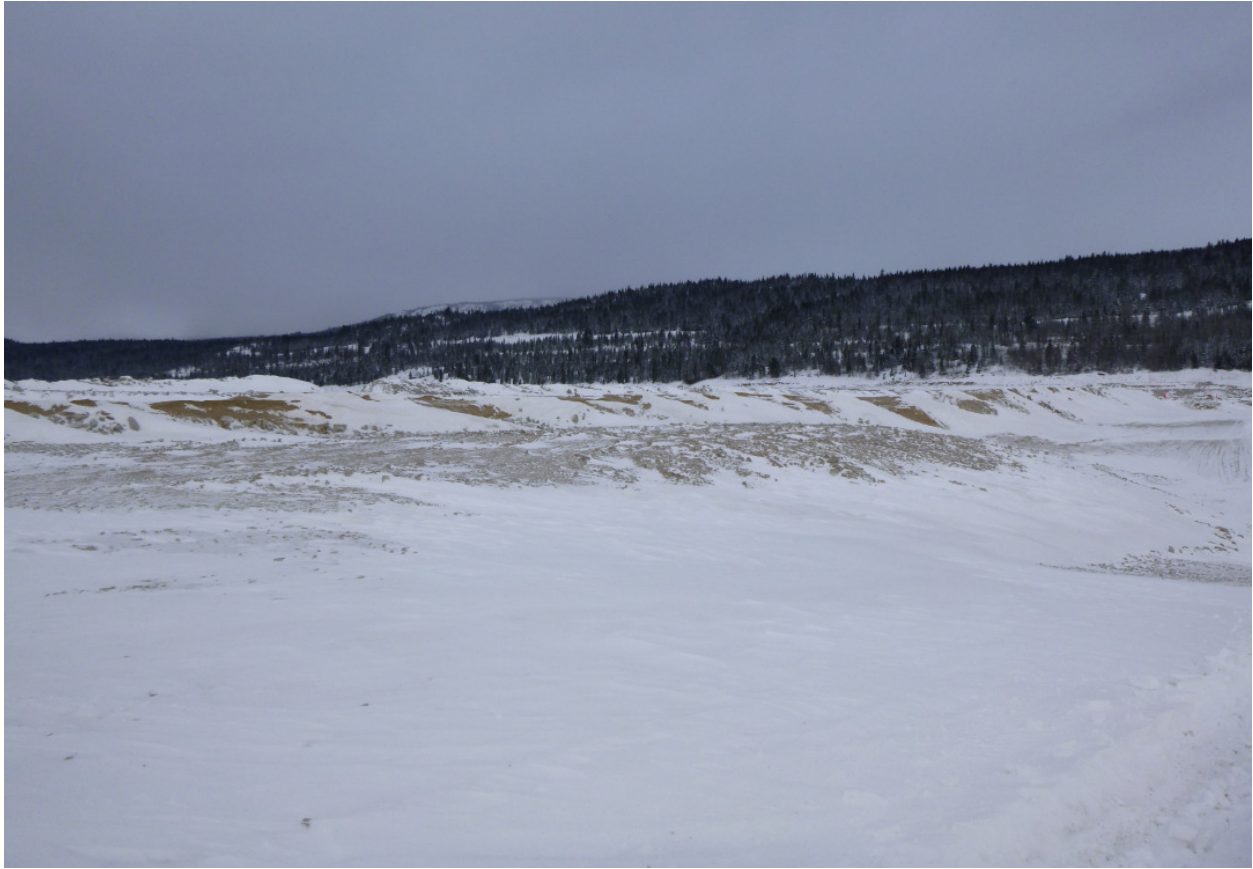
Photo 6 – Area where THVCP Mine Ops hauled, dumped and wheel packed d/s RF2 material from December 8 to 10, 2017. The material was placed between ~Sta. 1+475 to ~Sta. 1+625 to ~El. 1268 m to support and buttress the SG2 where cracking had previously occurred (refer to MRM-2017-004) (looking north).

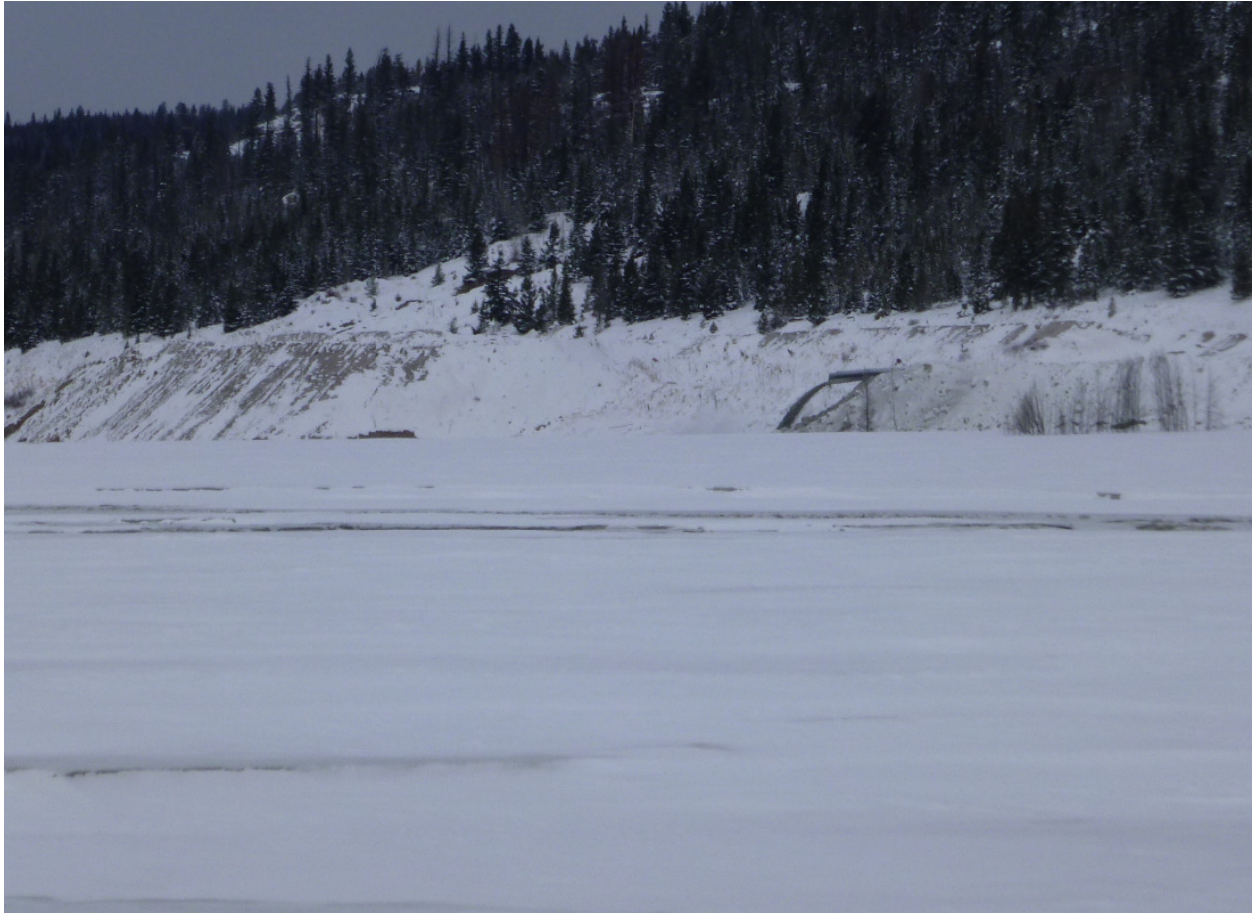
Photo 7 – Tailings discharging northwest of the east abutment (looking northeast).

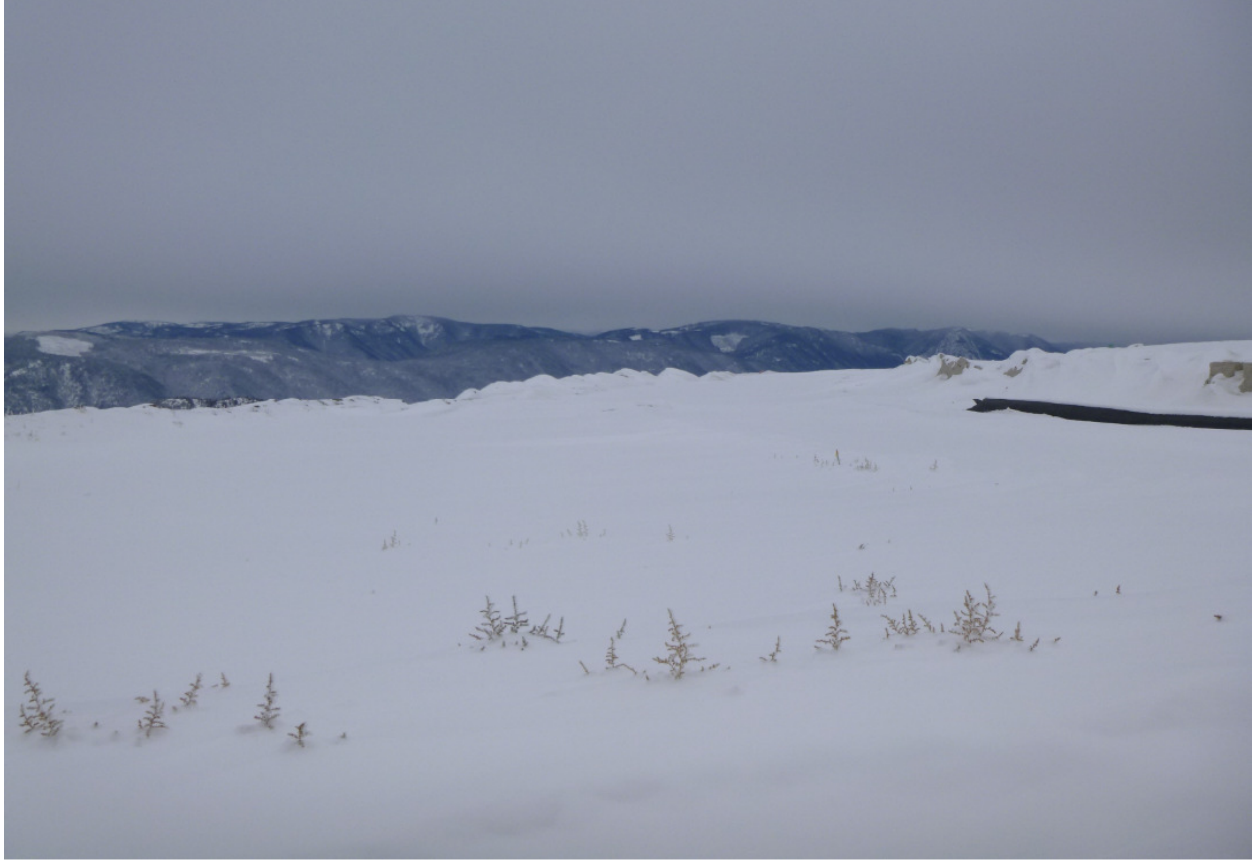
Photo 2 – Minor vegetation observed through the snow on the till core zone at the South Dam (looking northwest).

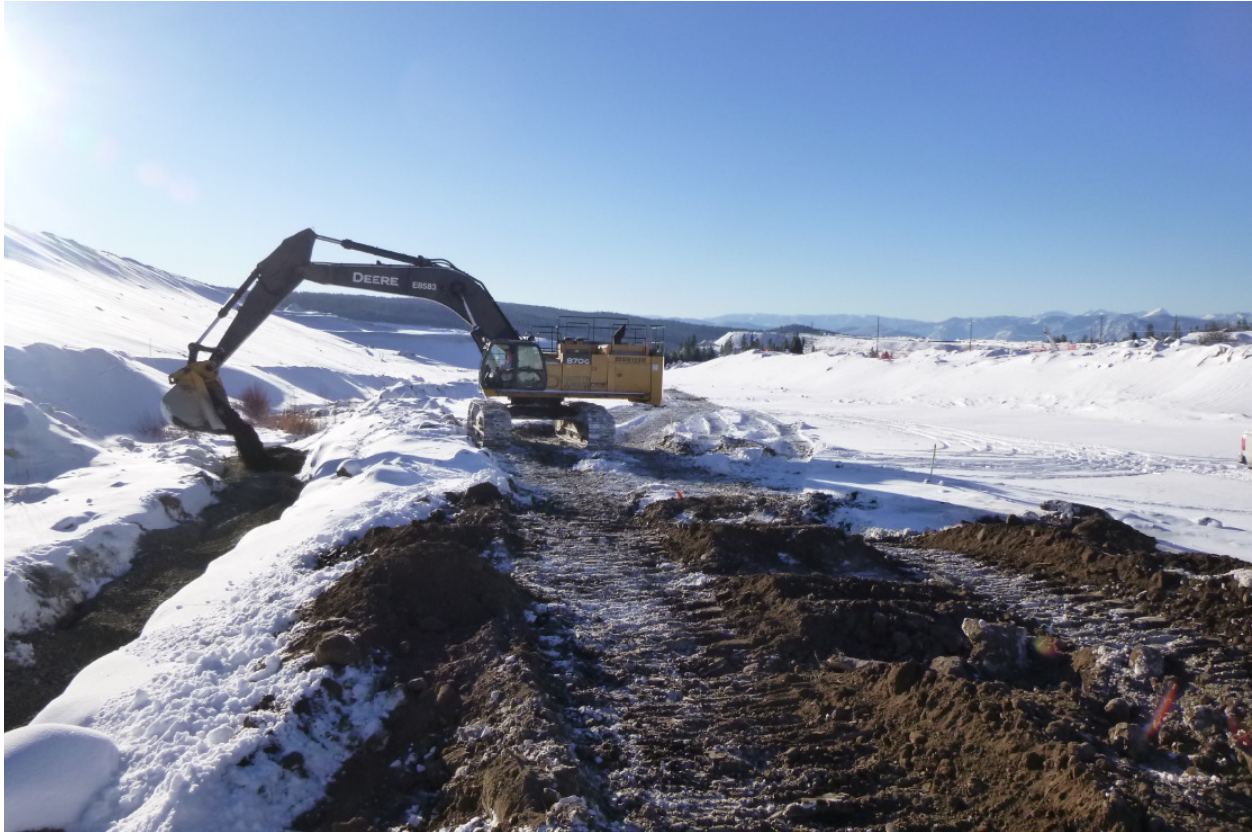
Photo 3 – Temporary ditch dug during foundation preparation works at the North Abutment (from Sta. 3+500 to ~3+570) backfilled on 17-12-20 (looking south).

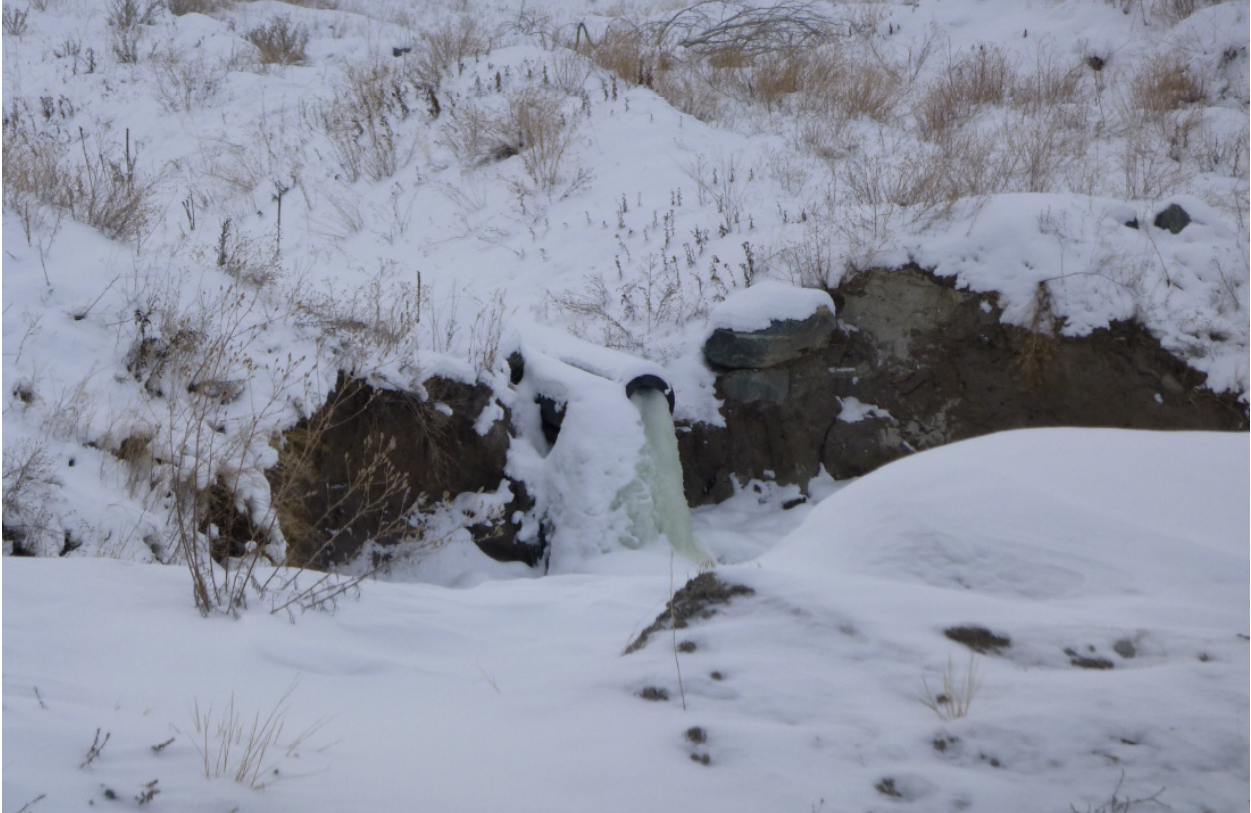
Photo 4 – No flow from Jim Black Lake reporting to Point B weir (Photo 4).

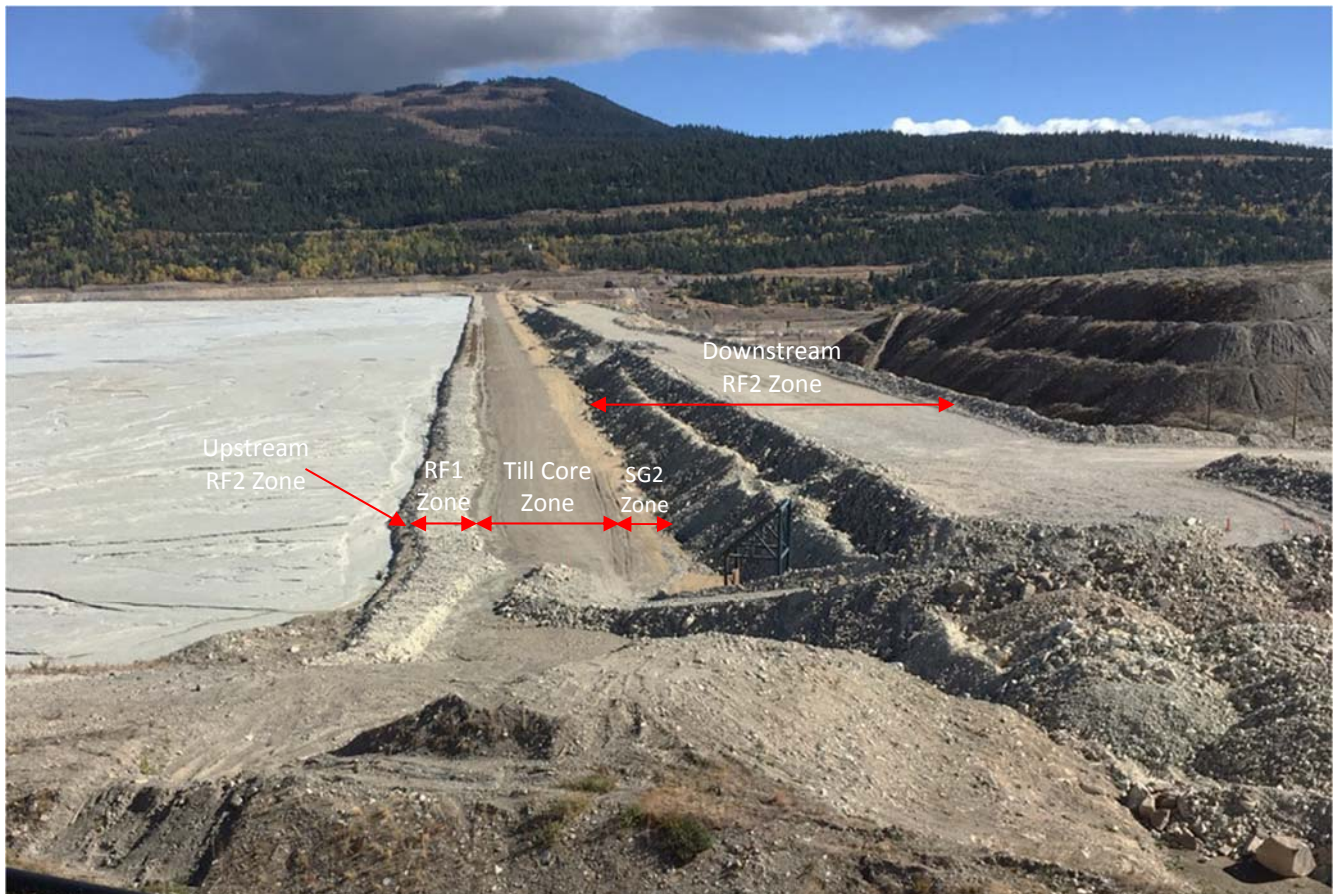
Photo II-B-2 Overview of Dam from East Abutment and Exposed Bedrock from 2015 Abutment Foundation Preparation Works (HH-2017-09)

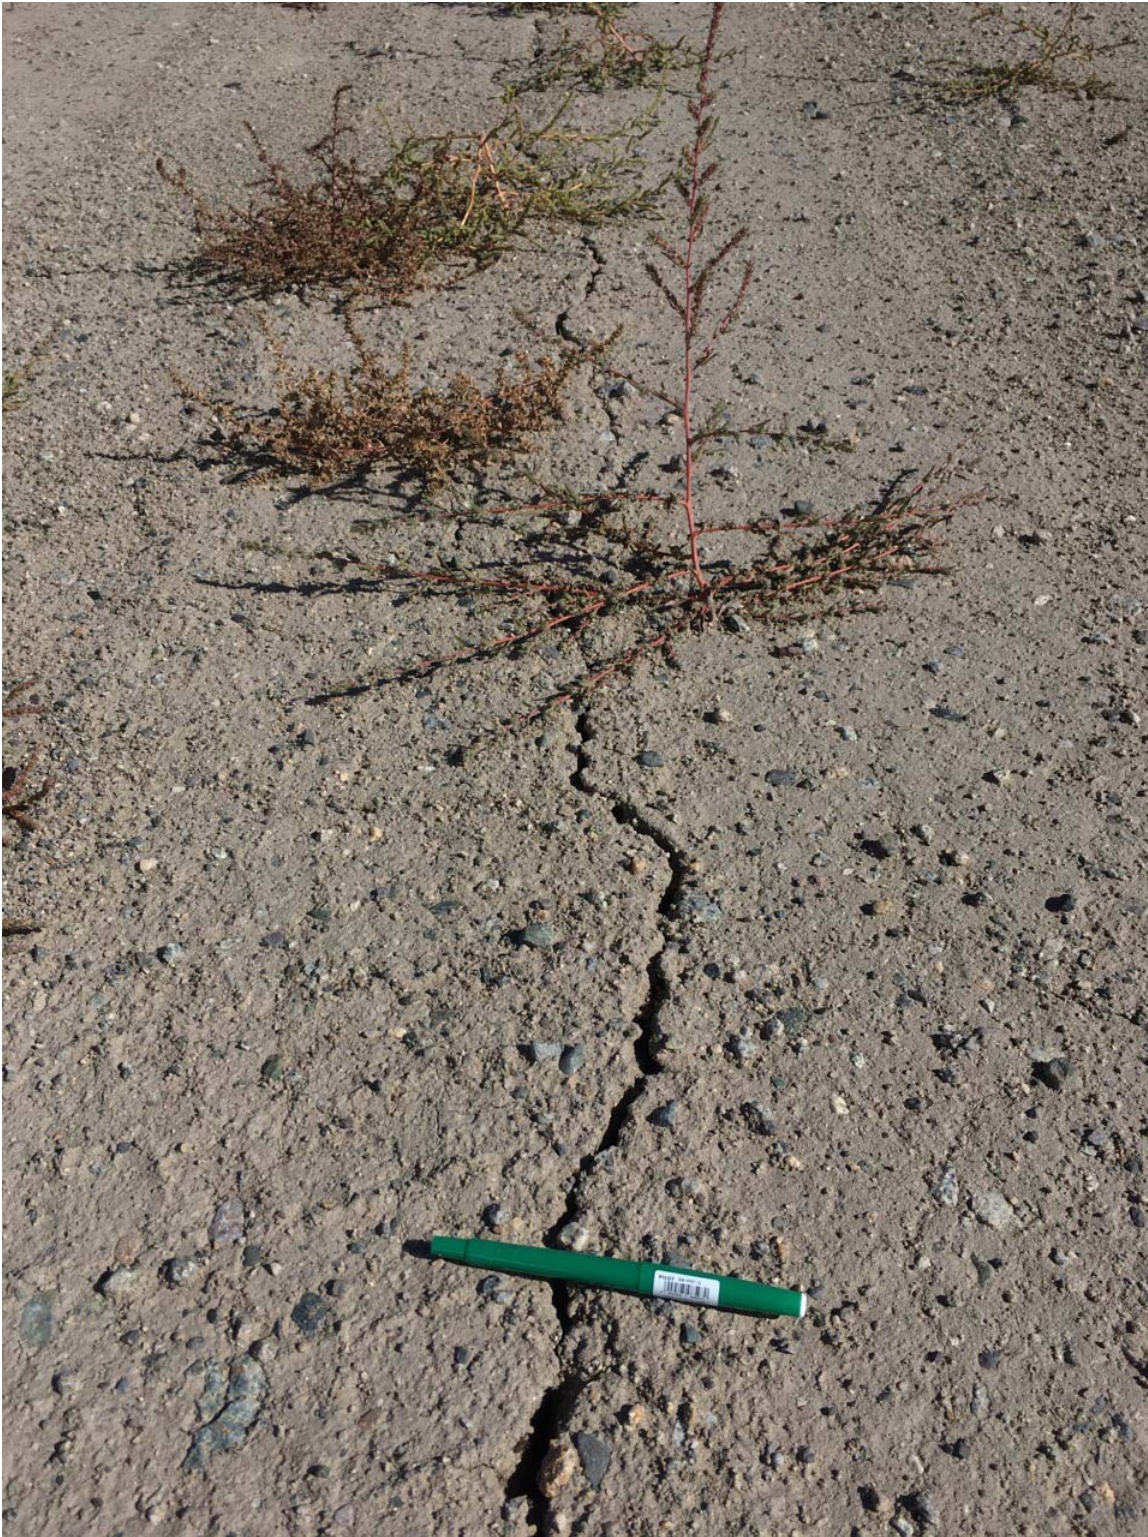
Photo II-B-6 Existing longitudinal crack on downstream edge of SG2 fill zone, with no signs of fresh movement or vertical displacement across crack; crack is >30 cm deep and up to 20 cm wide; hairline crack approx. 1 m upstream of the main crack (HH-2017-07)

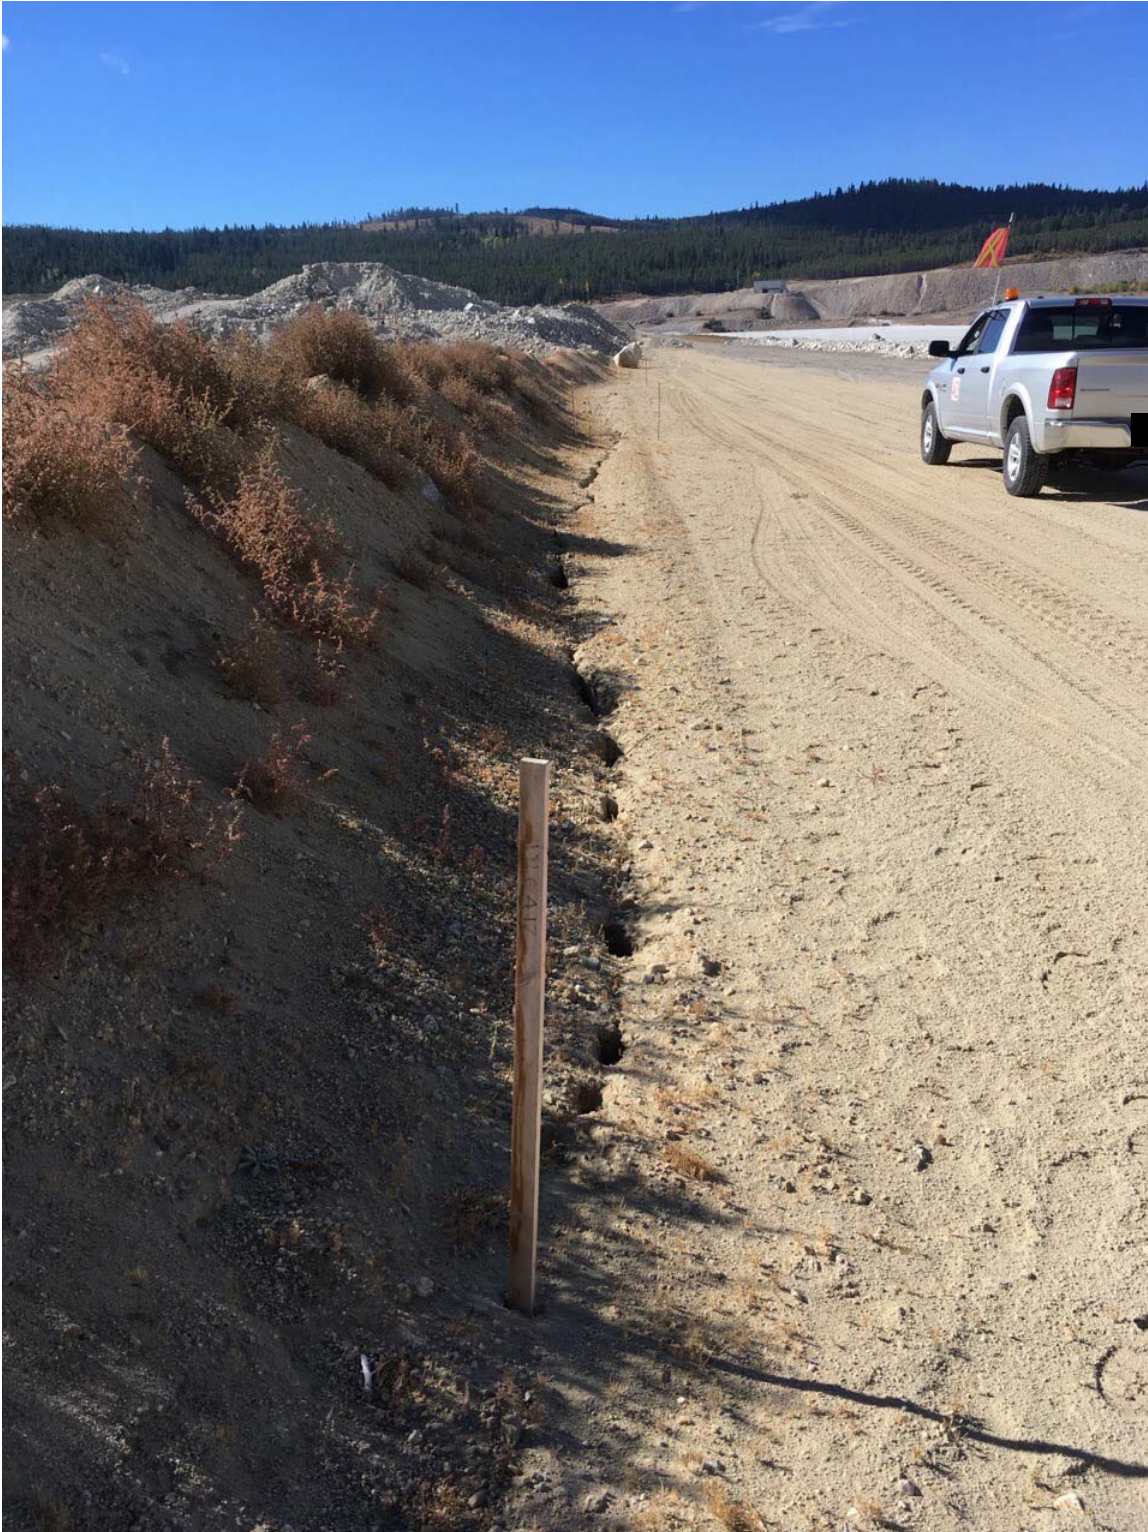
Photo II-B-7 Existing longitudinal crack on downstream edge of SG2 fill zone, with no signs of fresh movement or vertical displacement across crack; crack is >30 cm deep and up to 20 cm wide; hairline crack approx. 1 m upstream of the main crack (HH-2017-07)

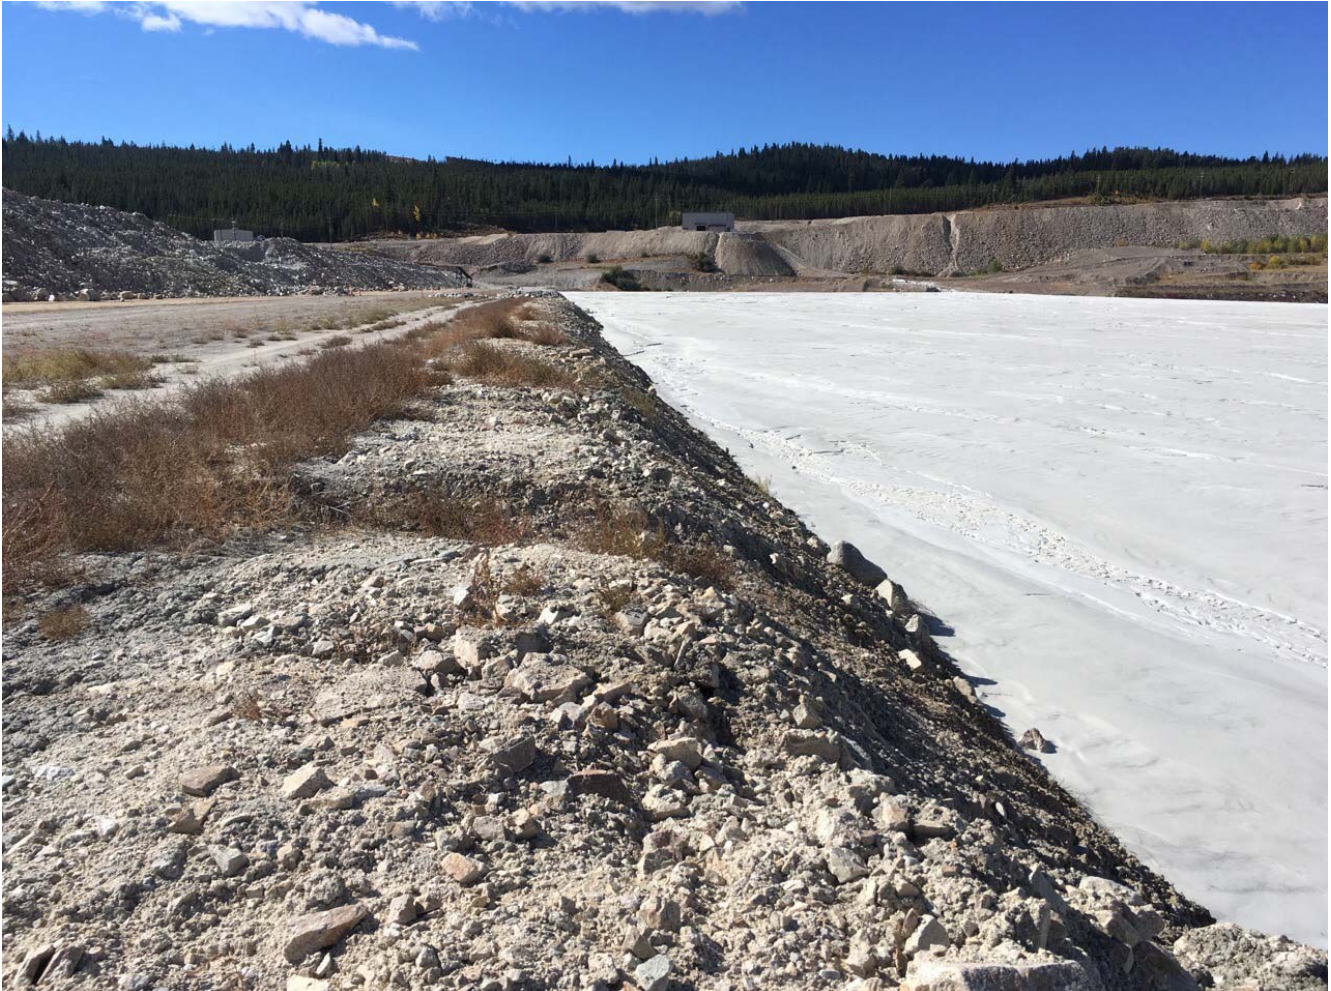
Photo II-B-8 Upstream Face of Dam - Facing Northeast; RF2/RF1 buffer zone on the upstream edge of dam crest, approx. 1 m high; available buffer is approx. 0.5 m (HH-2017-08)

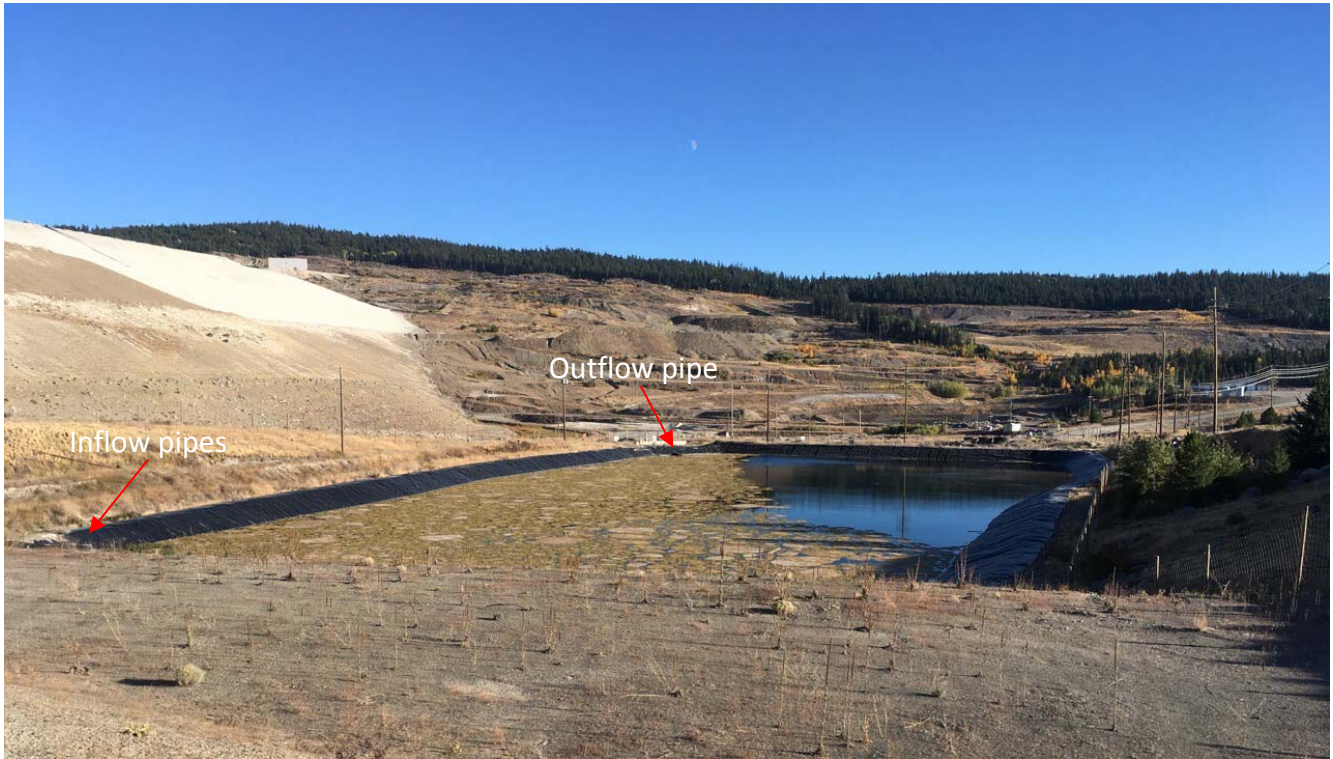
Photo II-C-10 Seepage Pond 2 Outflow Pipe – Facing West; Outlet not yet repaired (SS-2017-08)

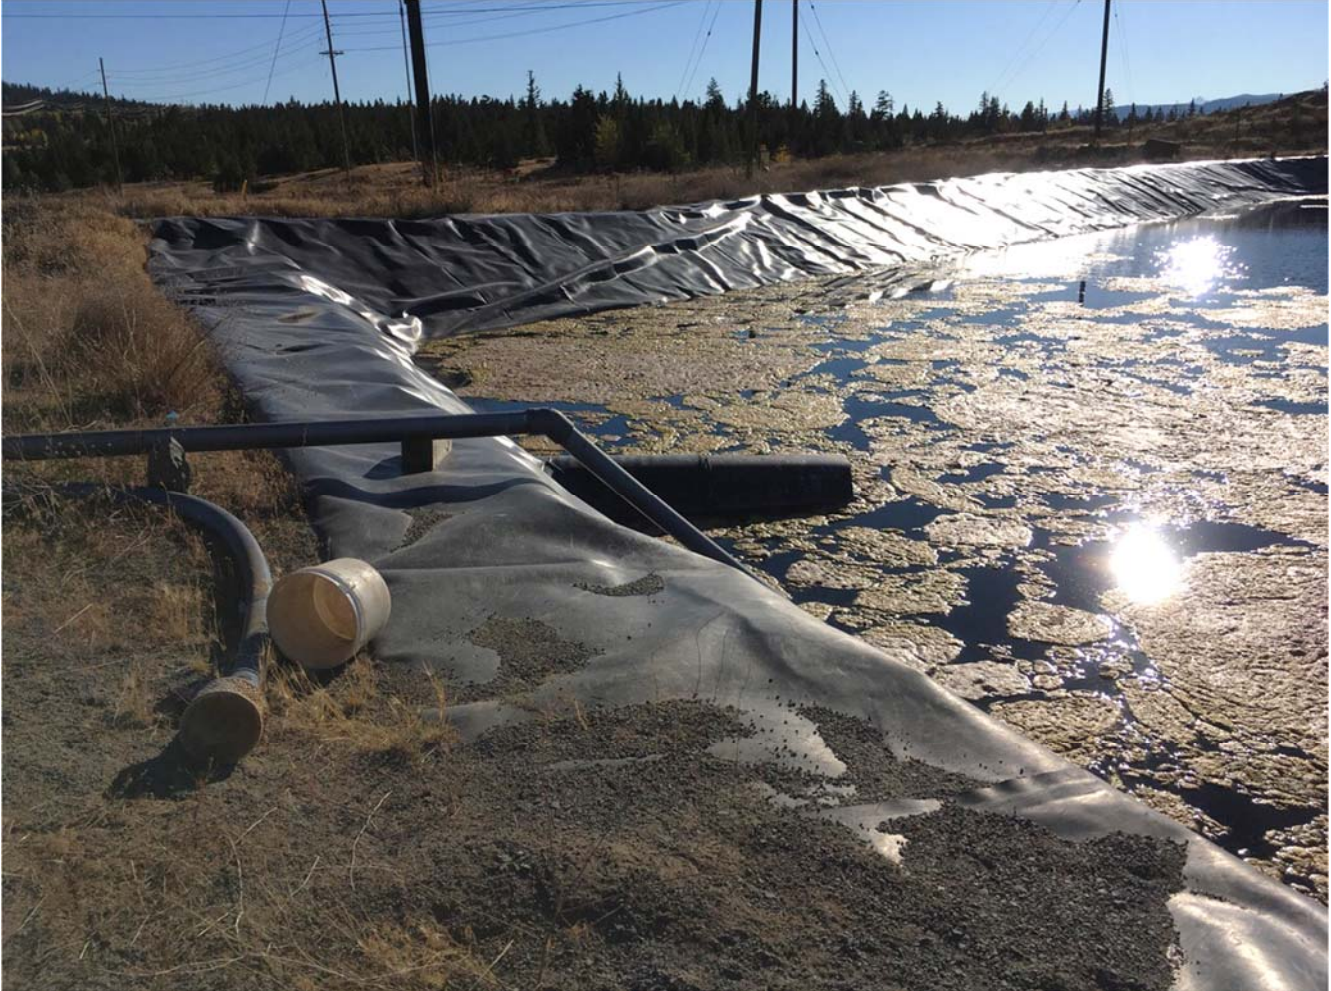
Photo II-C-11 Seepage Pond 2 Tear in Liner Repaired in 2017 – On east side of pond (SS-2017-08)

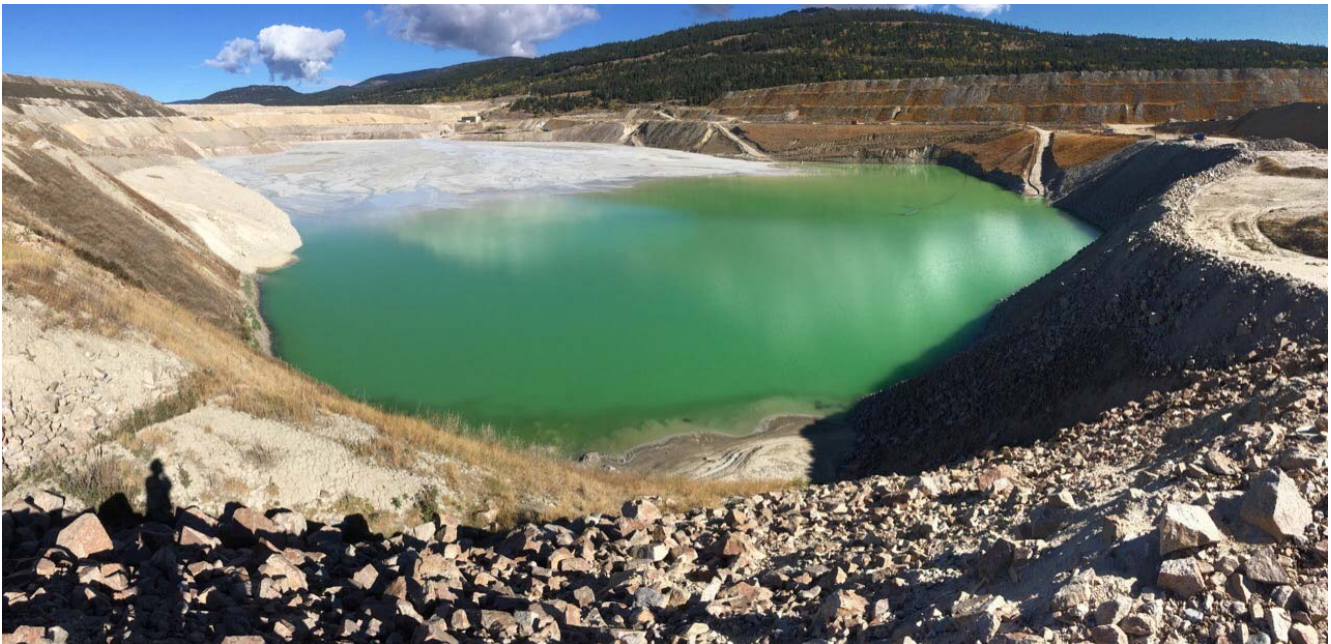
Photo II-D-2 West side of Lake; multiple erosion gullies observed (ML-2017-01)
