**TECK WASHINGTON INCORPORATED
PEND OREILLE MINE – TAILINGS DISPOSAL FACILITY # 3**

2017 ANNUAL INSPECTION REPORT

VA101-18/22-1
Rev 0
February 2, 2018

**2017 ANNUAL INSPECTION REPORT
VA101-18/22-1**

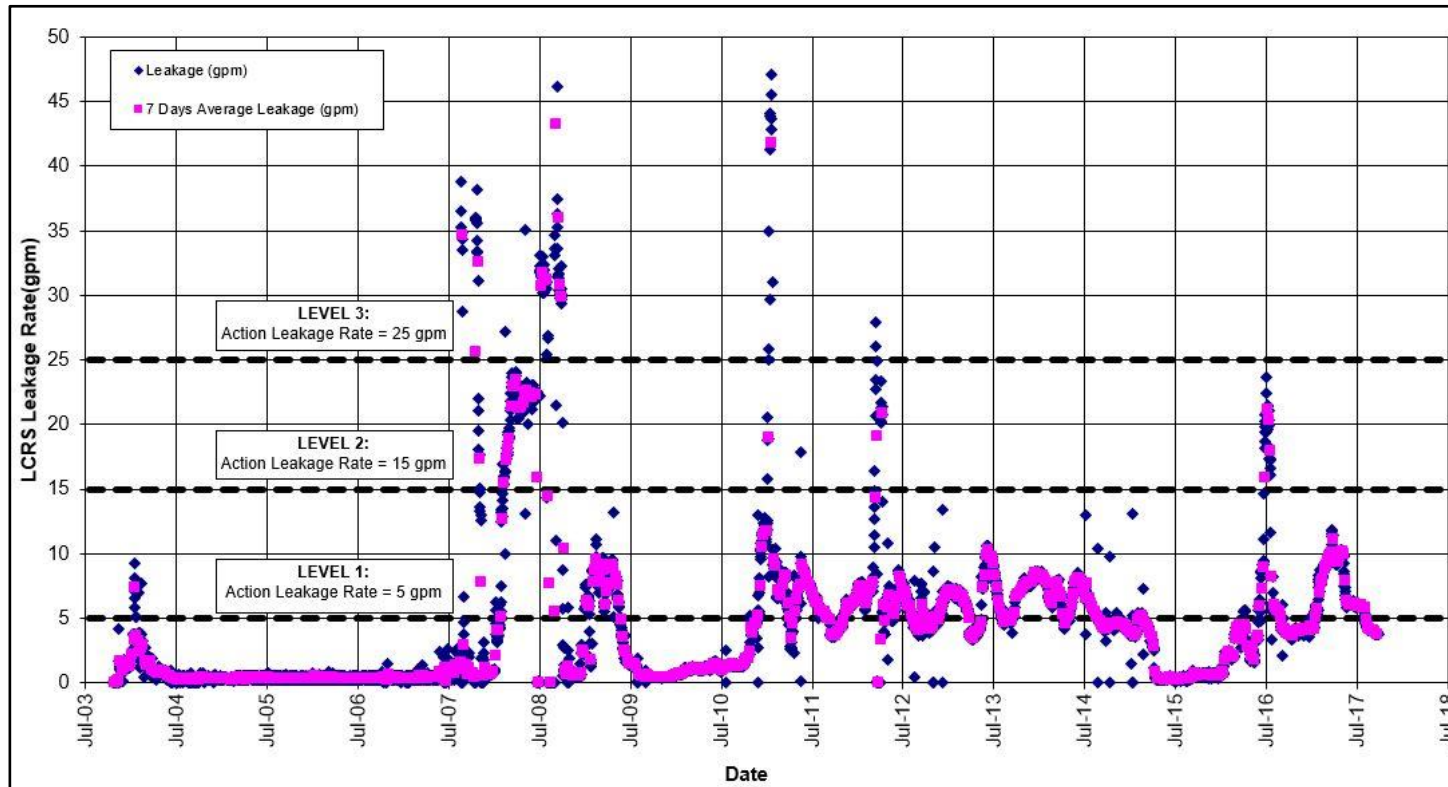
Figure 2.3 Tailings Disposal Facility #3 – LCRS Leakage Rate vs. Time

Water reporting to the LCRS is pumped out via the LCRS riser pipes and the flow volume is measured. The daily and 7-day average leakage flow rates from the LCRS are provided on Figure 2.3. The LCRS flow rates fluctuated above and below the Level 1 Action Leakage Rate of 5 gpm from September 2014 to March 2015, then dropped below the Level 1 Action Leakage Rate in March 2015 and stabilized in the range of 0 to 2.5 gpm. The drop to historical LCRS leakage rates (July 2004 to July 2009) was expected once active tailings deposition resumed around the facility via the spigot points.

Leakage rates remained at historical levels from March 2015 to February 2016. The LCRS flow rates fluctuated above and below the Level 1 Action Leakage Rate from February 2016 to June 2016. Leakage rates peaked at 23 gpm in July 2016, just below the Level 3 Action Leakage Rate and two liner leaks were suspected: one near the barge area and one near the LCRS area. Tailings discharge and sand bag placement were focused in suspected leak areas and leakage rates decreased to the range of 2 to 4 gpm below the Level 1 Action Leakage Rate of 5 gpm.

In January 2017, the leakage rate again exceeded the Level 1 Action Leakage Rate peaking in May 2017 at approximately 10 gpm. Suspected liner leaks were sealed and the leakage rate was reduced to below the Level 1 Action Leakage Rate in August 2017. TWI continues to monitor leakage rates and uses acoustic sounding methods to detect leaks as necessary.

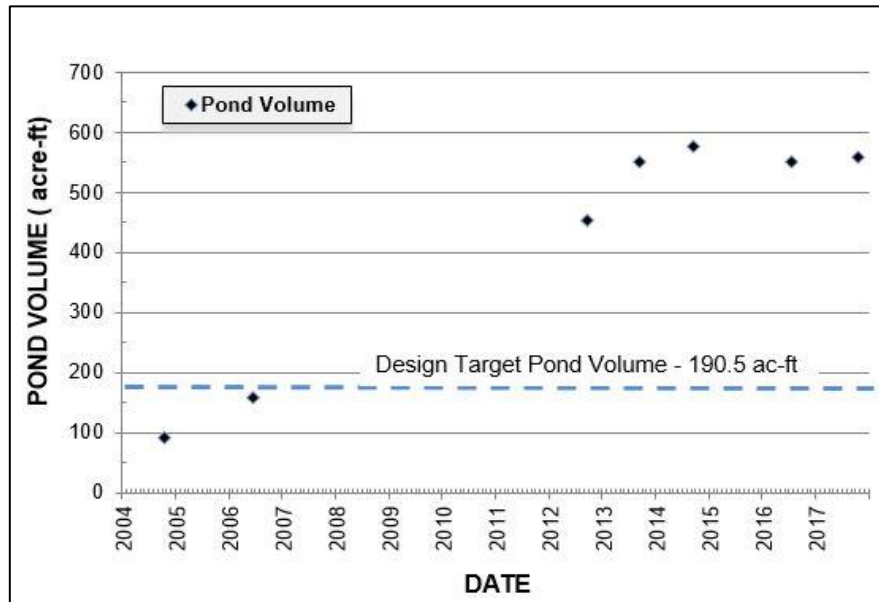
Figure 2.4 Tailings Disposal Facility #3 – Pond Volume versus Time

A volumetric survey conducted in October 2017 provided an updated pond volume estimate. The pond volumes previously estimated and reported in the annual inspection reports were reviewed and compiled into a graph summarizing the pond volume versus time as shown on Figure 2.4.

The targeted operational design pond volume of 190.5 acre-feet is included on the plot. The pond volume increased substantially during the care and maintenance period as expected. The implementation of the evaporative program combined with tailings void losses during ongoing tailings deposition has halted the upward trend.

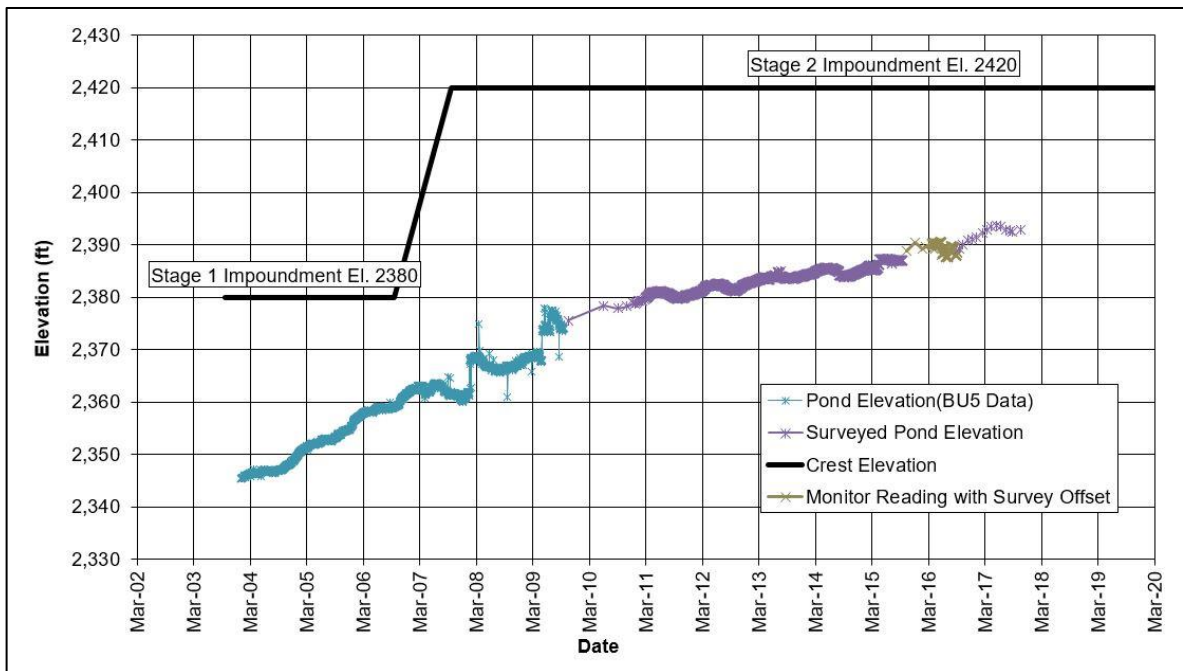
Figure 2.5 Tailings Disposal Facility #3 – Filling Curve

Tailings deposition resumed in December 2014. There is sufficient capacity remaining in the facility for tailings solids and storm water storage based on the updated filling curve on Figure 2.5. Survey measurements have recently been the most reliable source for determining pond elevation.

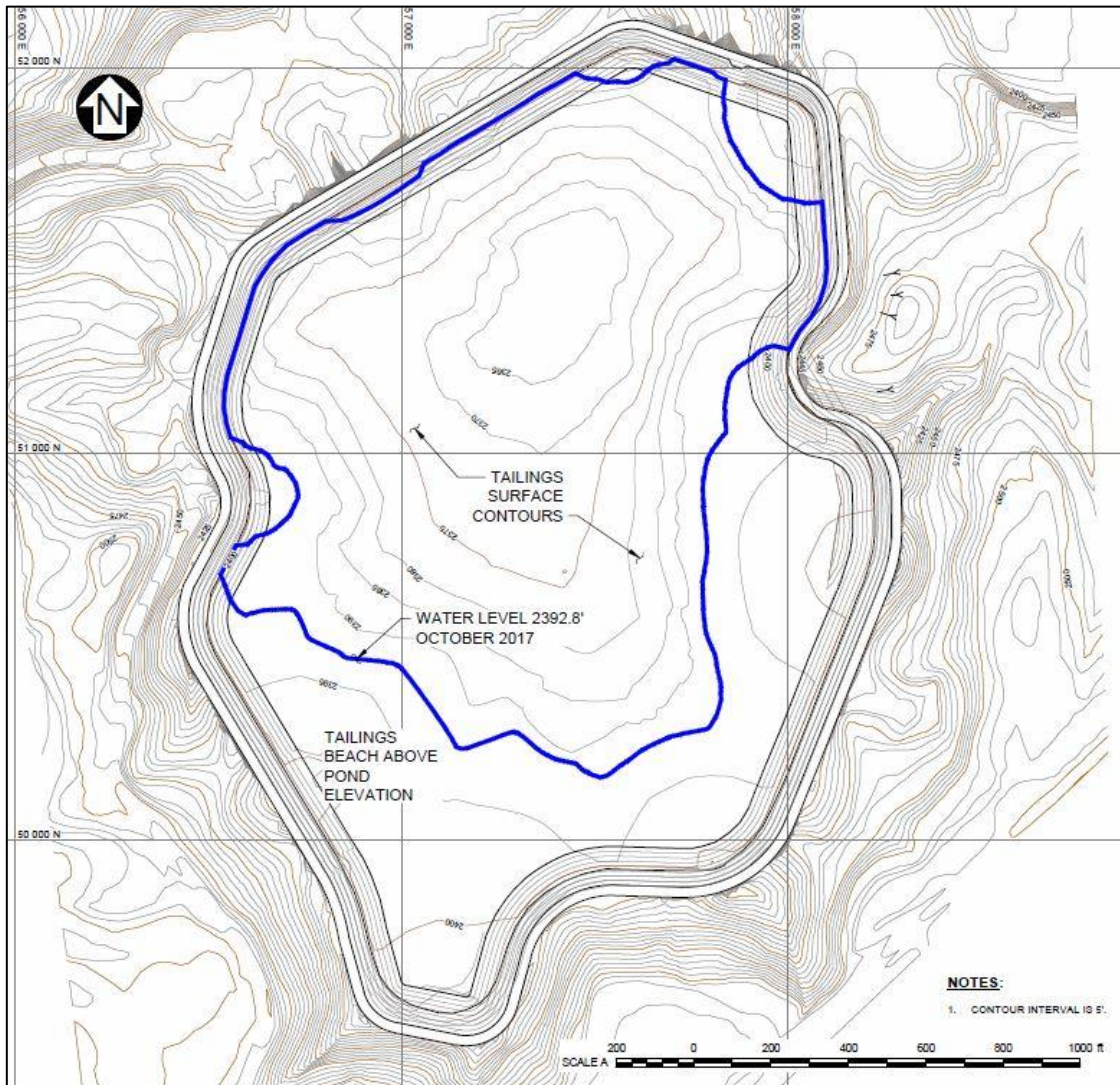
Figure 2.6 Tailings Disposal Facility #3 – Bathymetric Survey Plan

TWI completed a bathymetric survey in 2017 and the volumes for tailings solids and pond water were updated. The tailings solids volume is approximately 84,600,000 ft³ and the water volume is approximately 24,300,000 ft³.

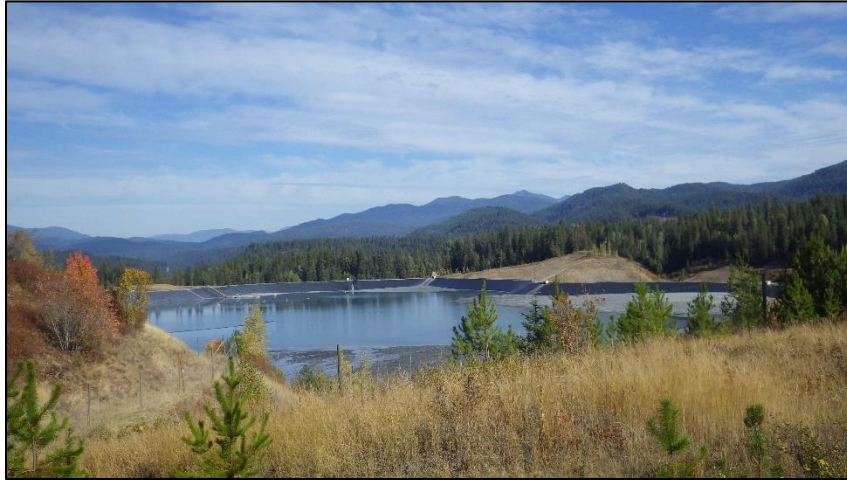
The general location and extent of the supernatant pond is shown on Photo 1 (Appendix A). TWI has continued with a program of enhanced evaporation to control the amount of water retained in the facility. Large floating fan forced evaporators were operated in 2017. The Goldsim water balance model was updated throughout the year in compliance with the corporate guidance document.

PHOTO 1 – View of tailings basin from the south.

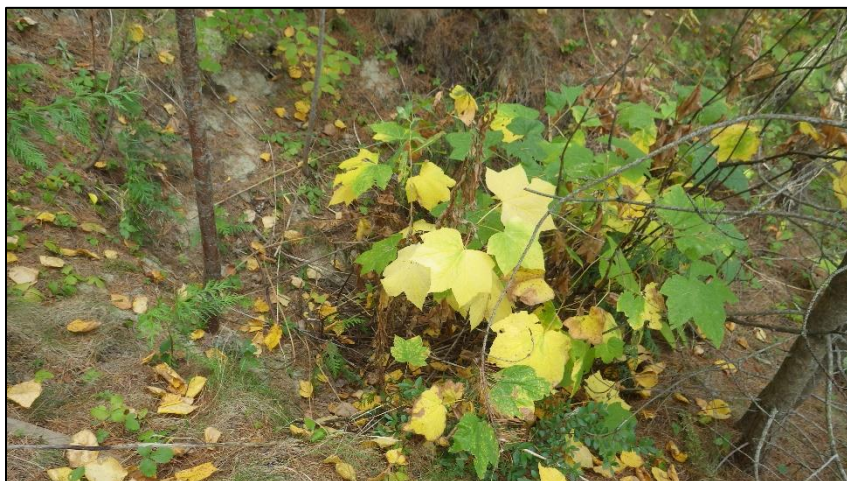
PHOTO 24 – “Sink hole” location upstream of TDF#3 basin.

- The “sink hole” inspection requirement can be reduced to an annual inspection by the Geotechnical Engineer. Mine site visual inspections can be suspended, and
- Conduct annual pond bathymetry surveys to verify pond size and confirm evaporation efficiency.

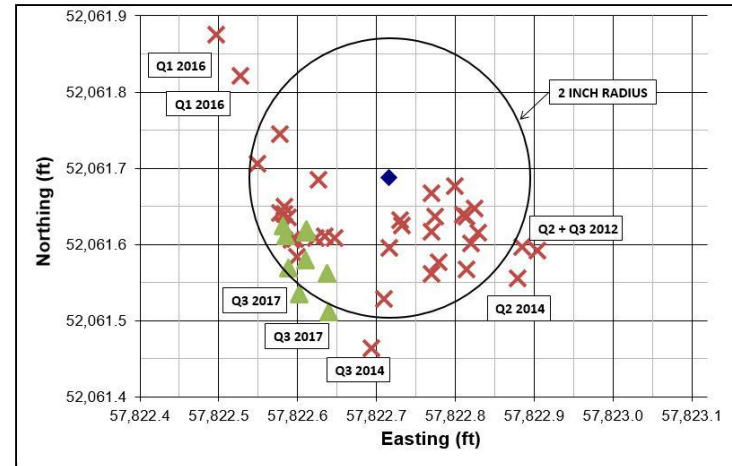
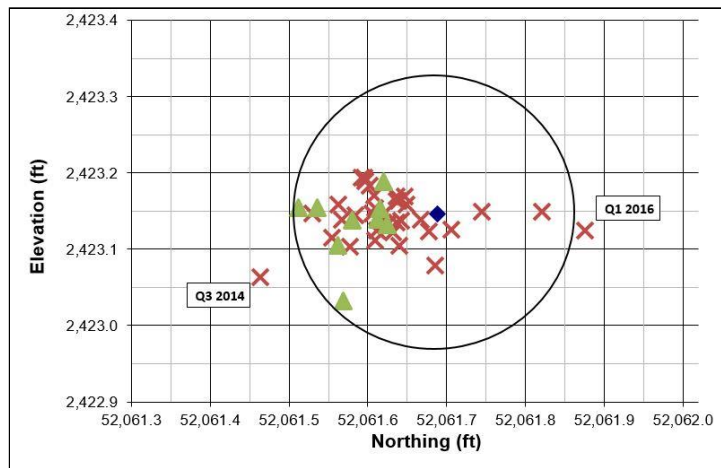
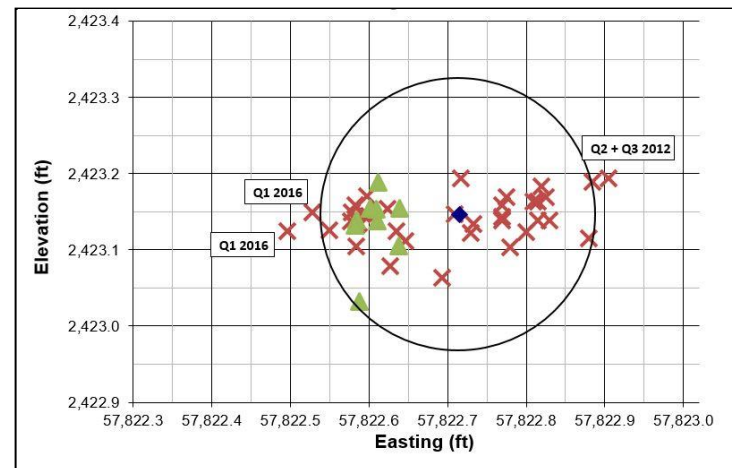
M6 Plan View

Generally, the survey movement monitoring in 2017 was within the tolerances specified in the O&M Manual. Measured deflection in Q3 of 2017 at M6 was outside the 2 inch tolerance. This deflection does not appear to be consistent with any of the other greater than 2 inch deflection seen at this monument. Further monitoring is necessary before any potential movement trends can be established.
