Teck Highland Valley Copper Partnership

2017 Dam Safety Inspection Report

7-Day Pond

March 2018

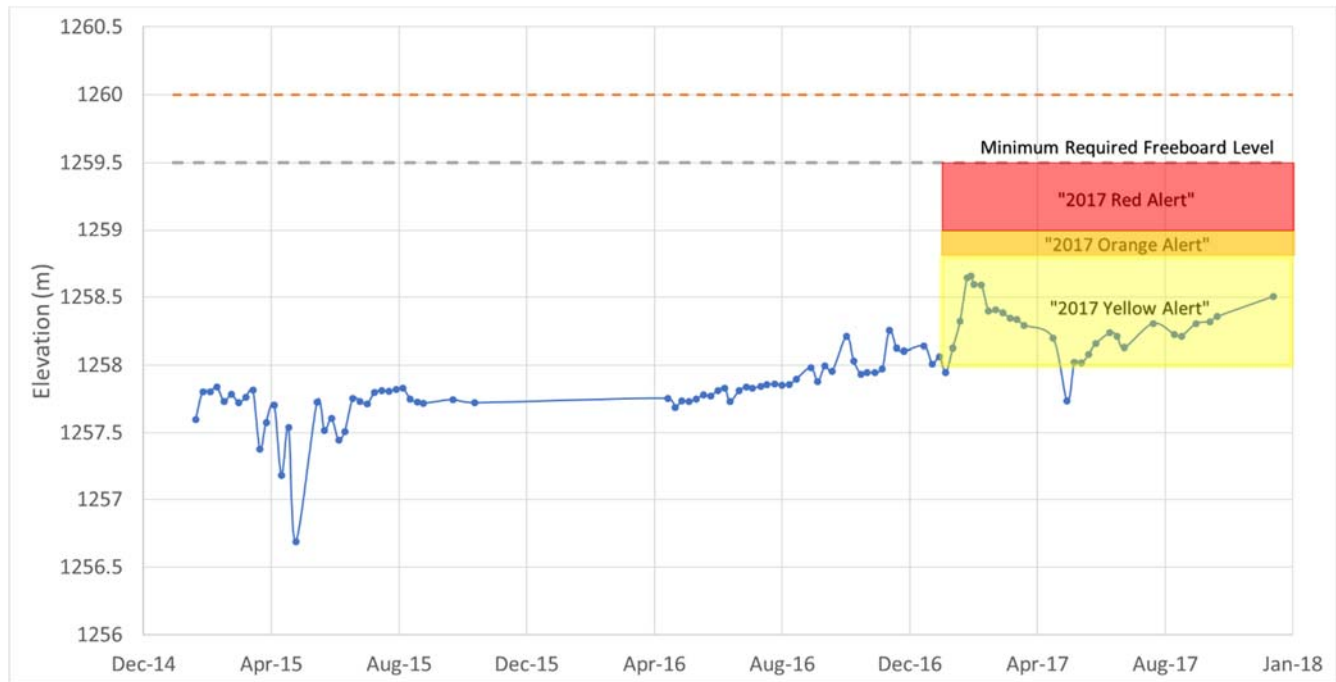
Figure 5.1 7-Day Pond 2017 Reservoir Level

Quarterly visual inspections were completed by THVCP. The pond level within the yellow alert range for most of the year because approximately 27,000 m³ of tailings were discharged into the facility over than period. Revised pond alert levels have been defined form 2018 based on the latest bathymetry. There are no geotechnical instruments at 7-Day Pond and none are recommended for the existing condition.

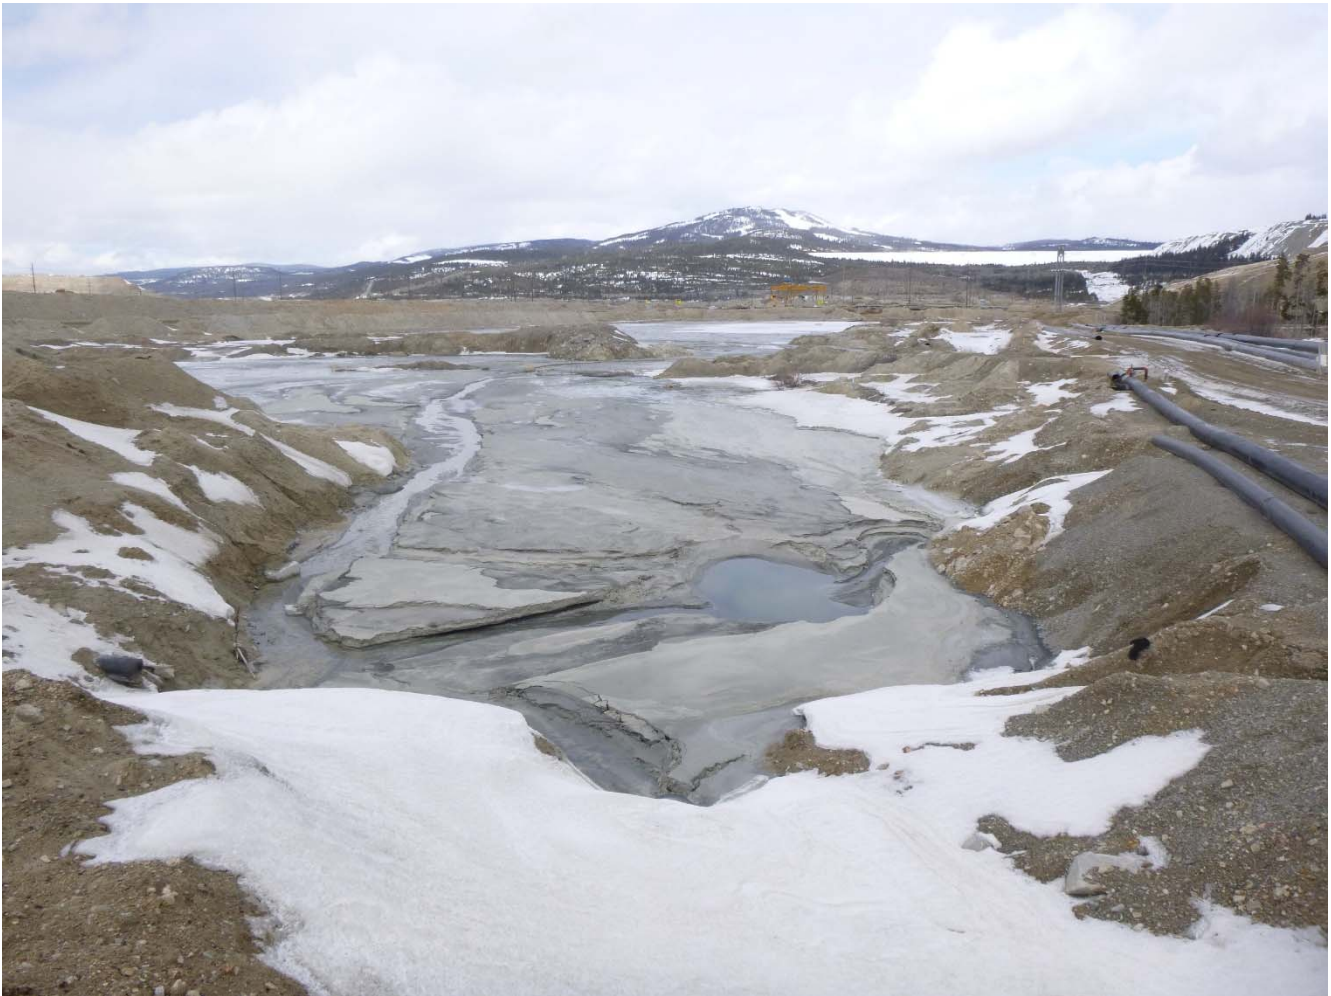
Photo II-1 Overview of pond looking northwest (SDP-2017-01)

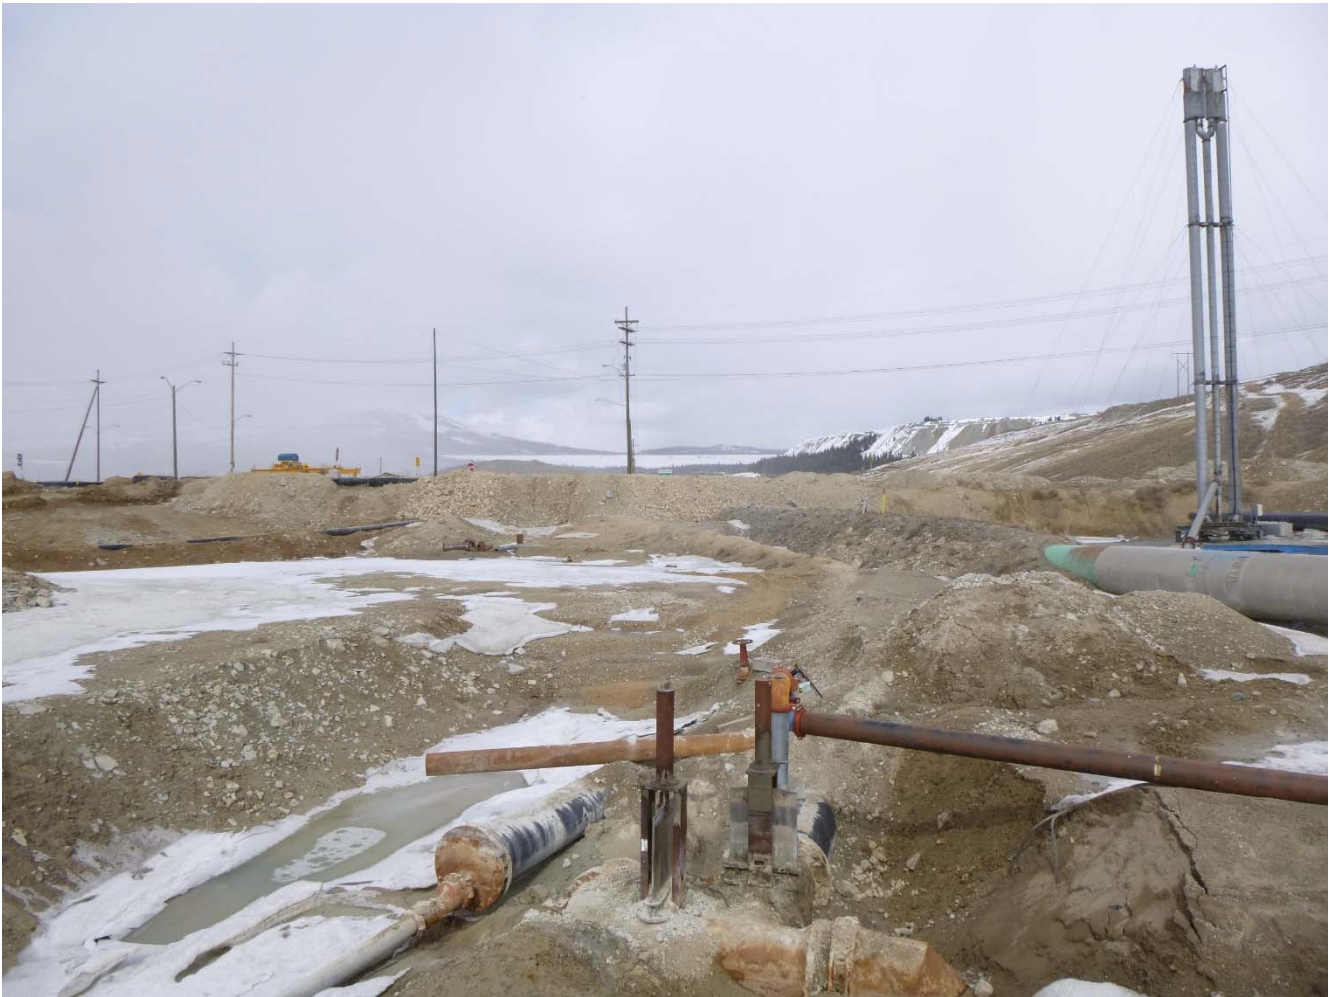
Photo II-2 Standing on east bench looking northwest at upstream slope of north embankment (SDP-2017-08)

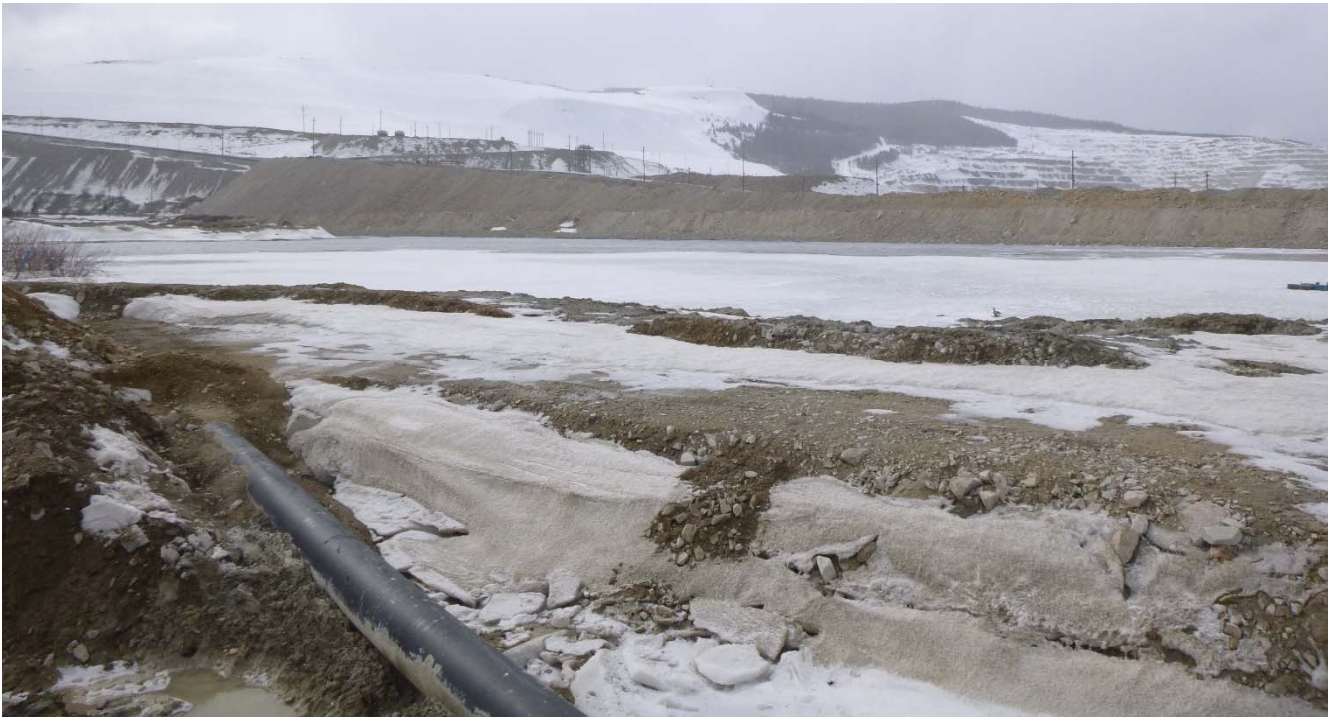
Photo II-3 Overview of pond looking southwest (SDP-2017-08)

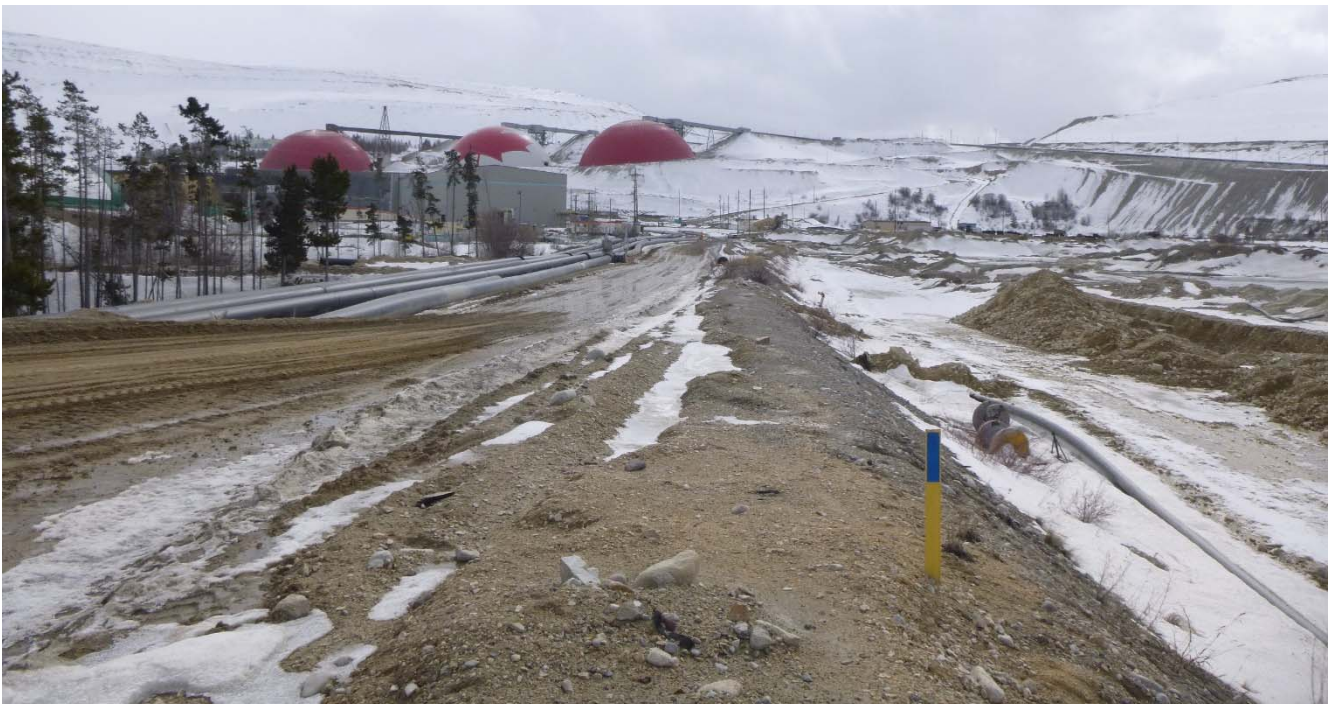
- **Crest:** The haul road which forms the crest of the dam around 7-Day Pond was in good physical condition. No indicators of significant concern were observed (e.g. cracking, slumping).

Photo II-4 Haul road crest and upstream slope of east embankment looking southeast (SDP-2017-07)

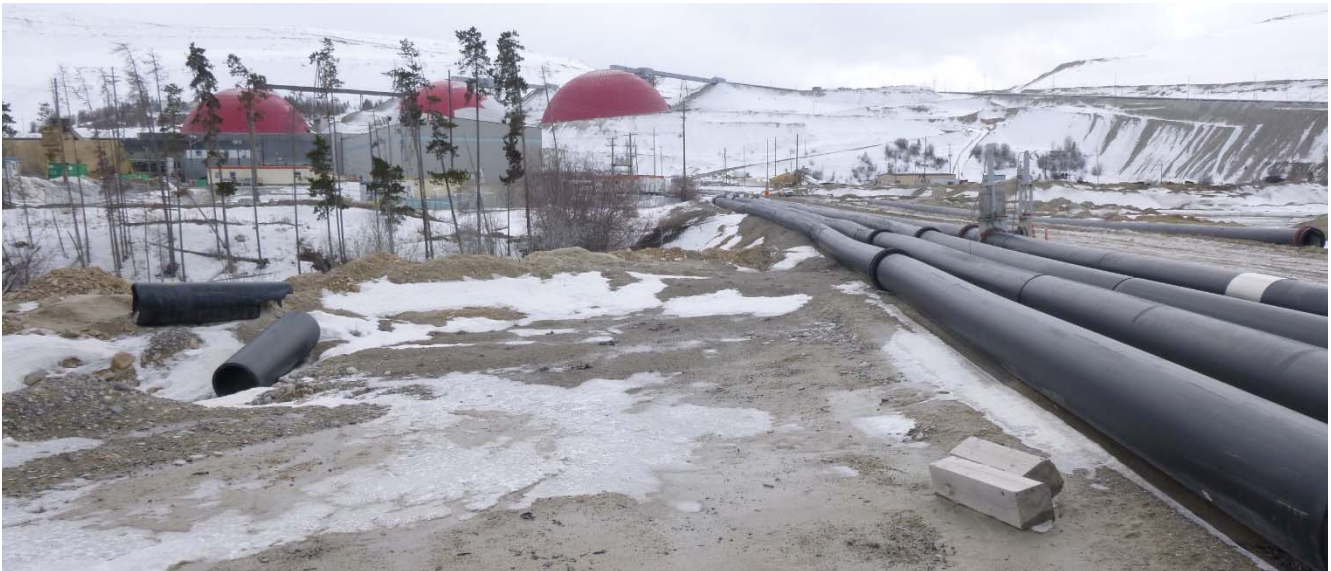
Photo II-5 Divider road between treed areas downstream of east embankment (SDP-2017-06)

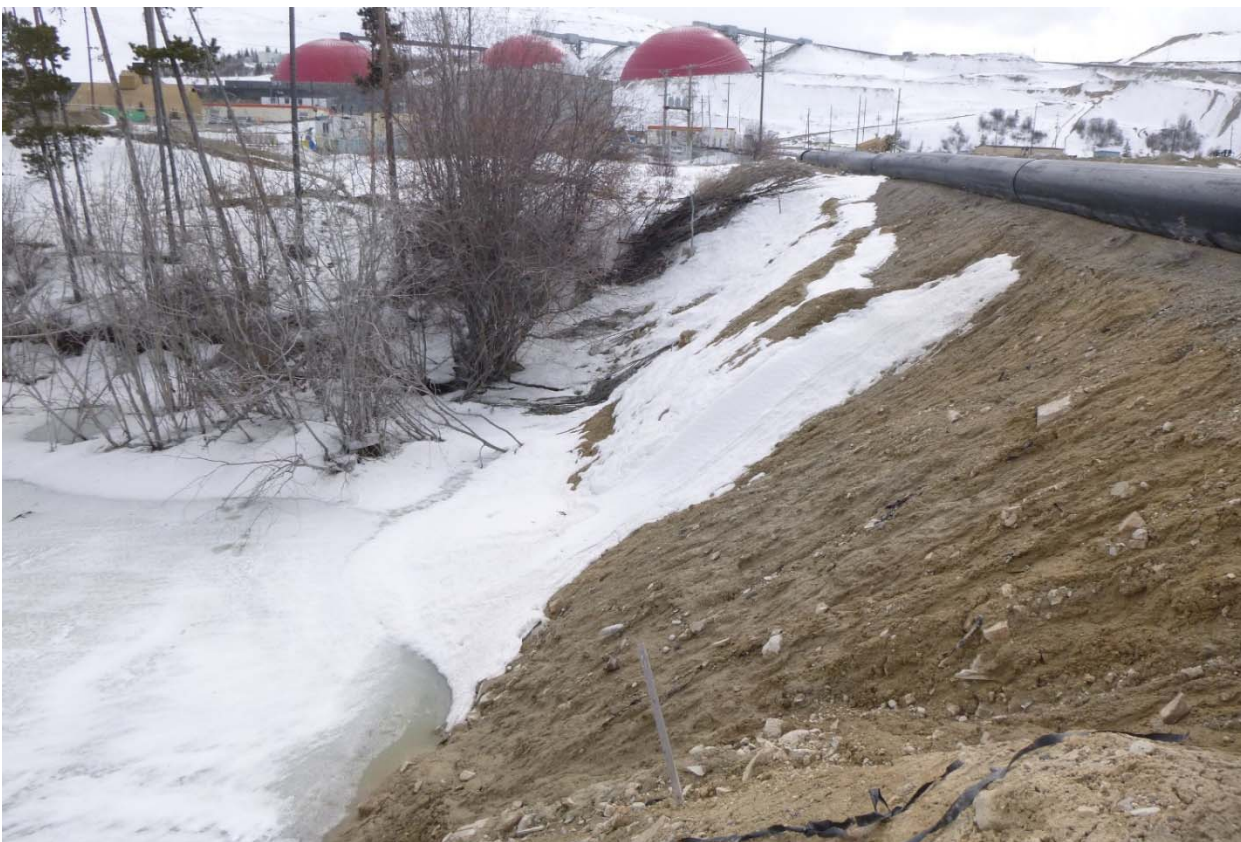
- **Upstream and Downstream Slopes:** Upstream slopes were in good physical. The upstream slopes were not vegetated, but no indicators of significant concern were observed (e.g. animal activity, cracking, slumping, surface erosion features). The visible parts of the downstream slope of the haul road forming the eastern containment of the impoundment was in good physical condition. Ponding was observed in the two adjacent treed areas, i.e. at the downstream toe of the eastern embankment.

Photo II-6 Downstream slope of east embankment looking at southern treed area with ponding at toe (SDP-2017-05)

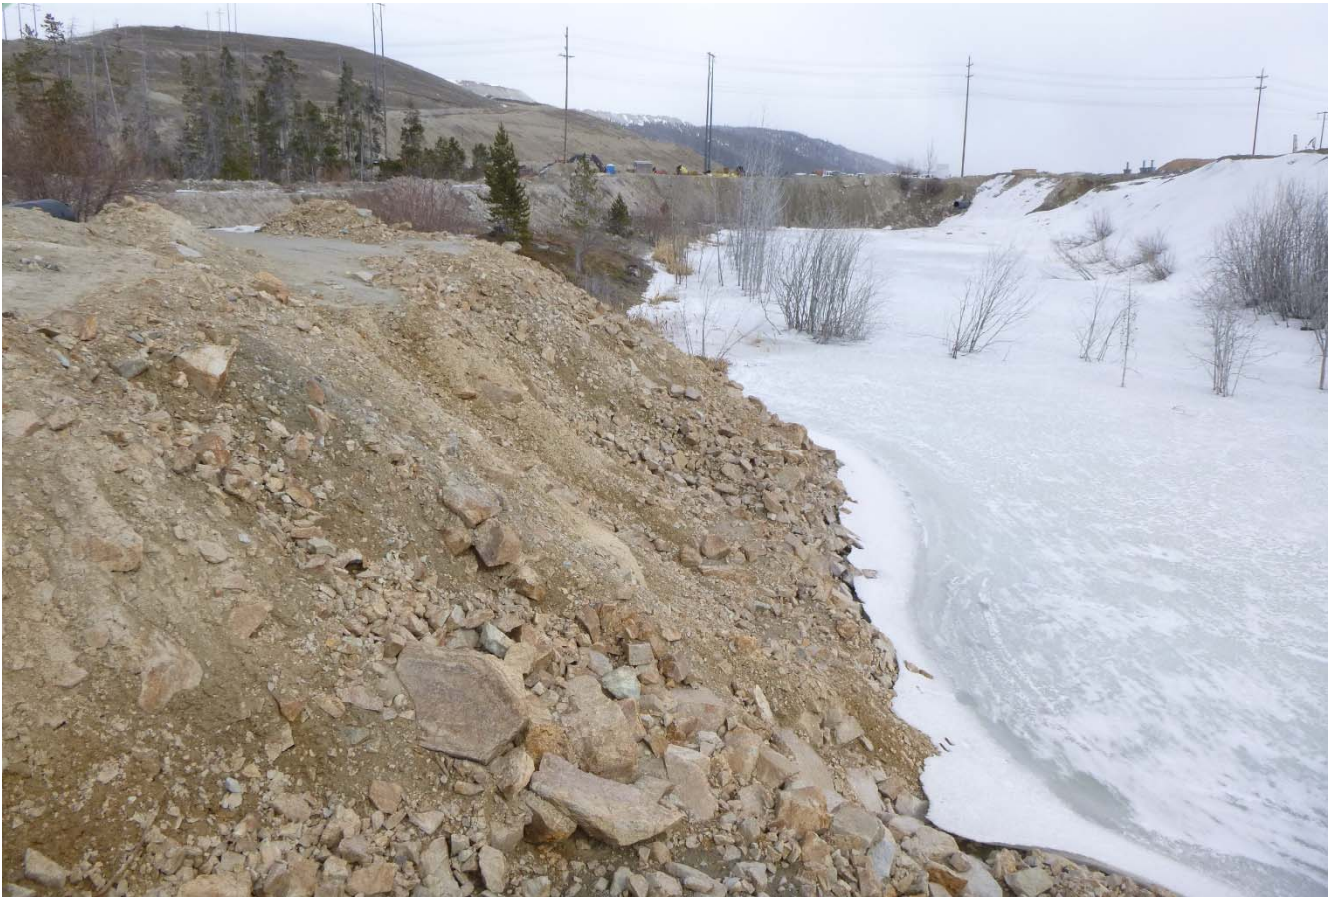
Photo II-7 Ponding in southern treed area looking west (SDP-2017-05)

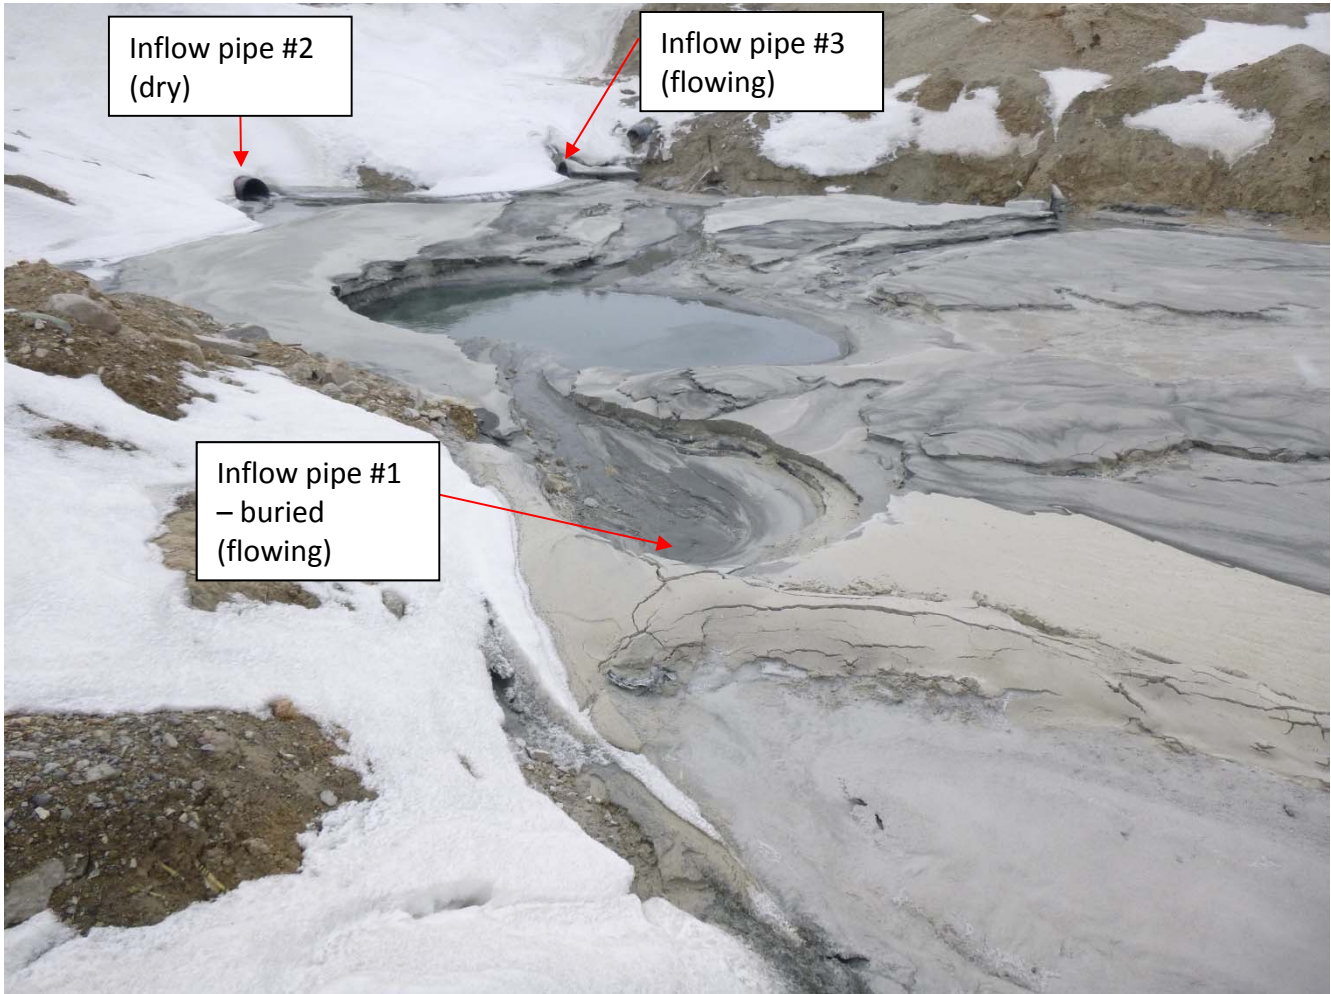
- 1) The inflow pipe in the northwest corner of the pond was not flowing at time of inspection.
- 2) Inflow pipes #1 and #3 at the southern end of pond were flowing at time of inspection. Flow rates were not measured. Inflow pipe #2 was not flowing at time of inspection.
- 3) Inflow pipe #1 is buried by tailings.
- 4) No outflow was noted at time of inspection. Inflows were either seeping out of the pond or accumulating in the pond.

Photo II-8 Inflow pipes with one (right) flowing at time of inspection (SDP-2017-02)

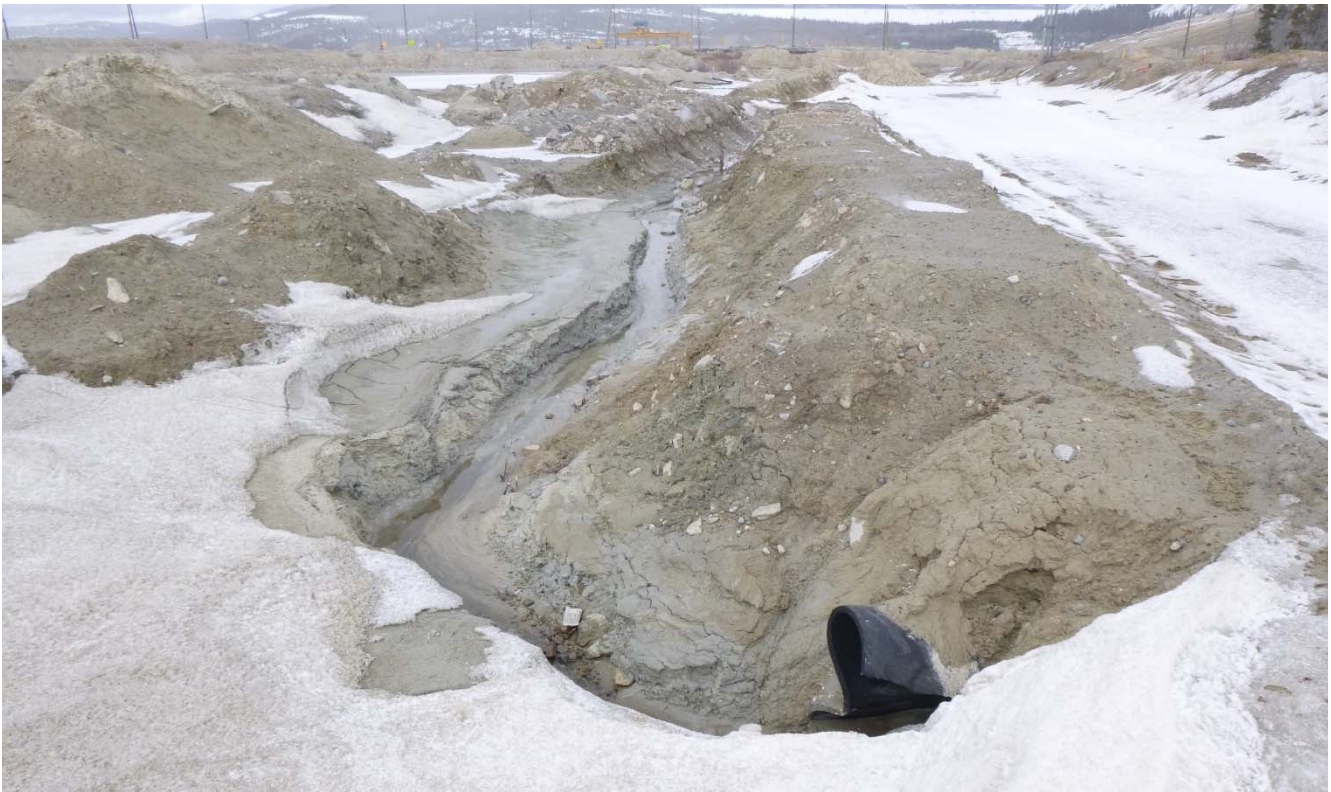
Photo II-9 Minor inflow from pipe along east embankment. Photo taken looking north (SDP-2017-03)

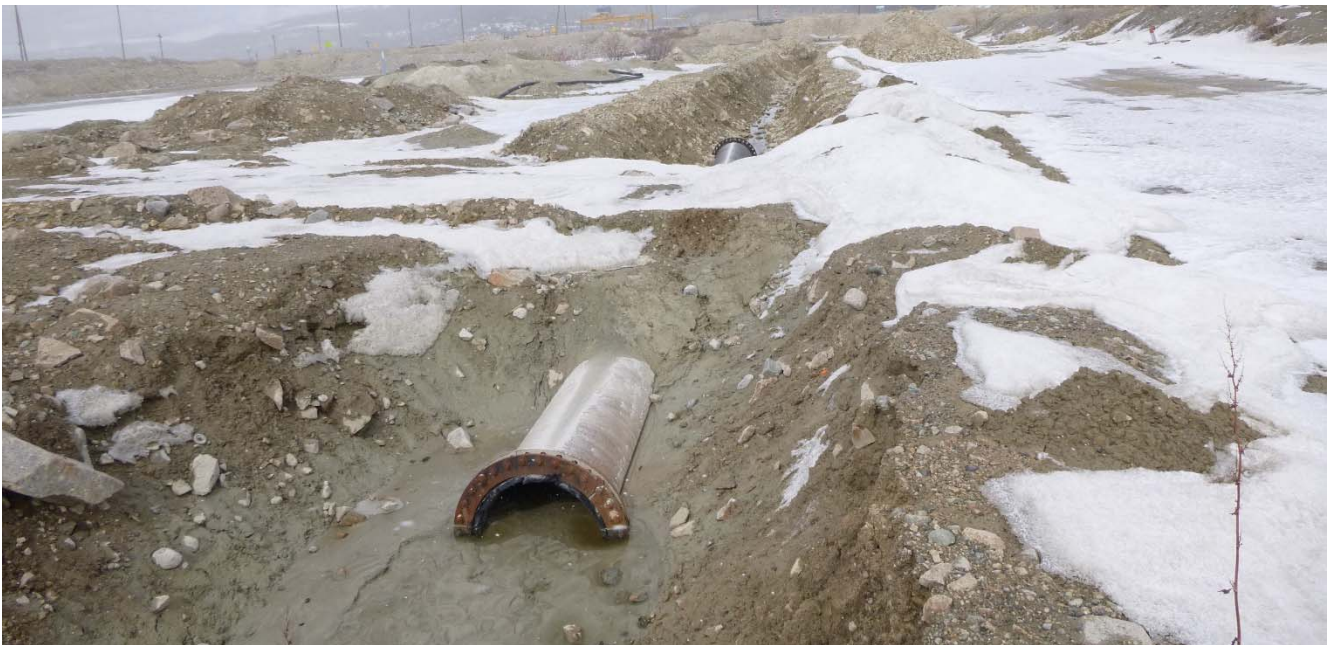
Photo II-10 Disconnected segment of pipe, partially buried along eastern embankment. Photo taken looking northwest (SDP-2017-04)

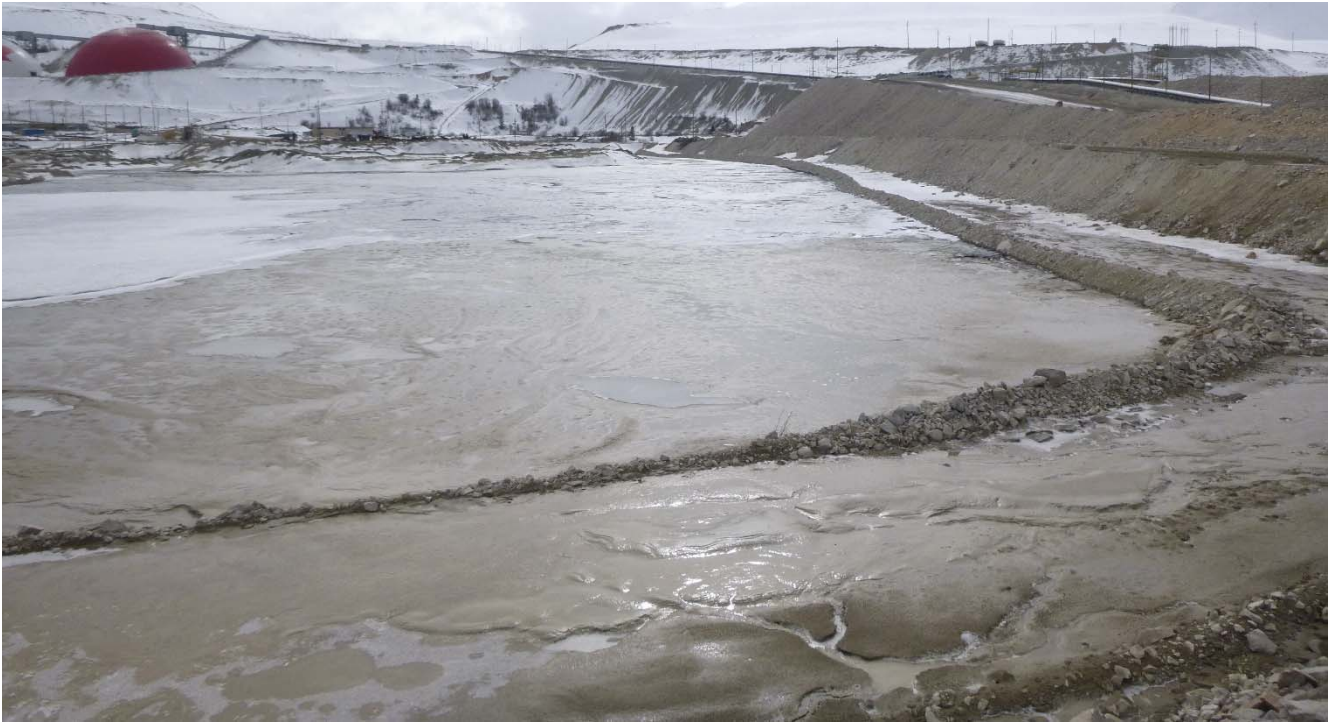
Photo II-11 Pond overview and upstream slope of west embankment looking south (SDP-2016-09)

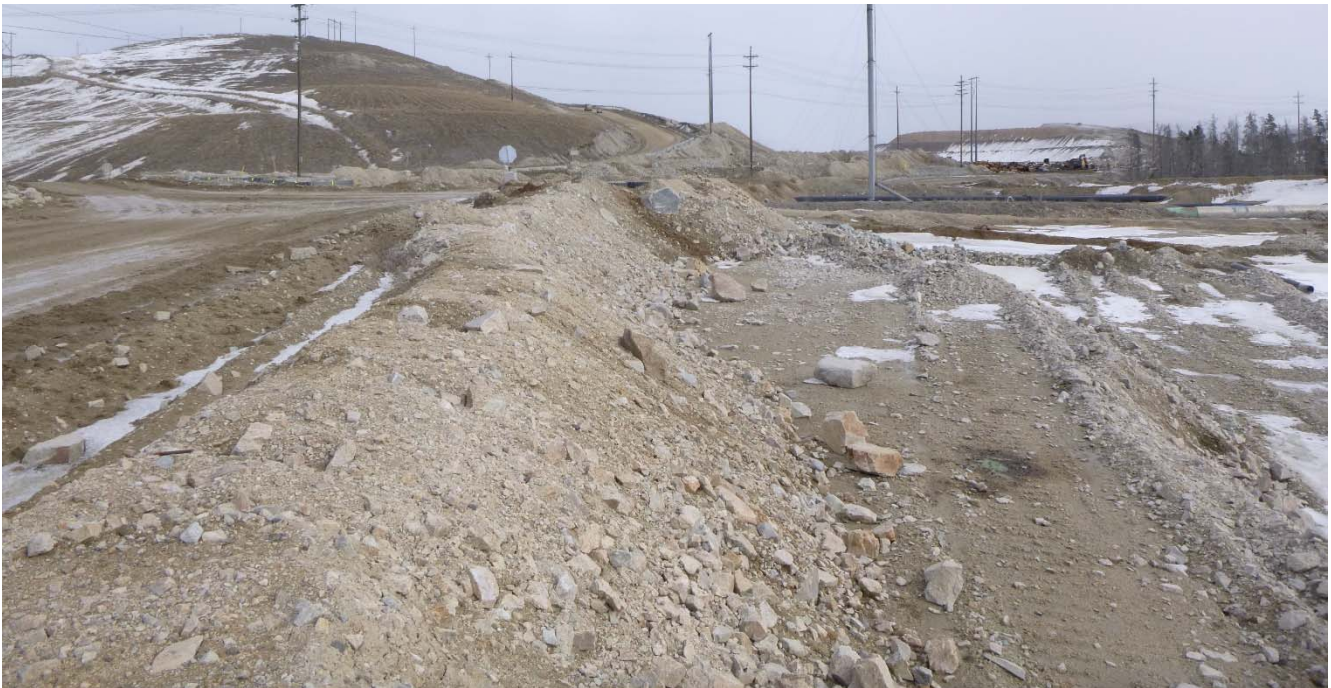
Photo II-12 Haul road crest and upstream slope of north embankment looking east (SDP-2016-09)

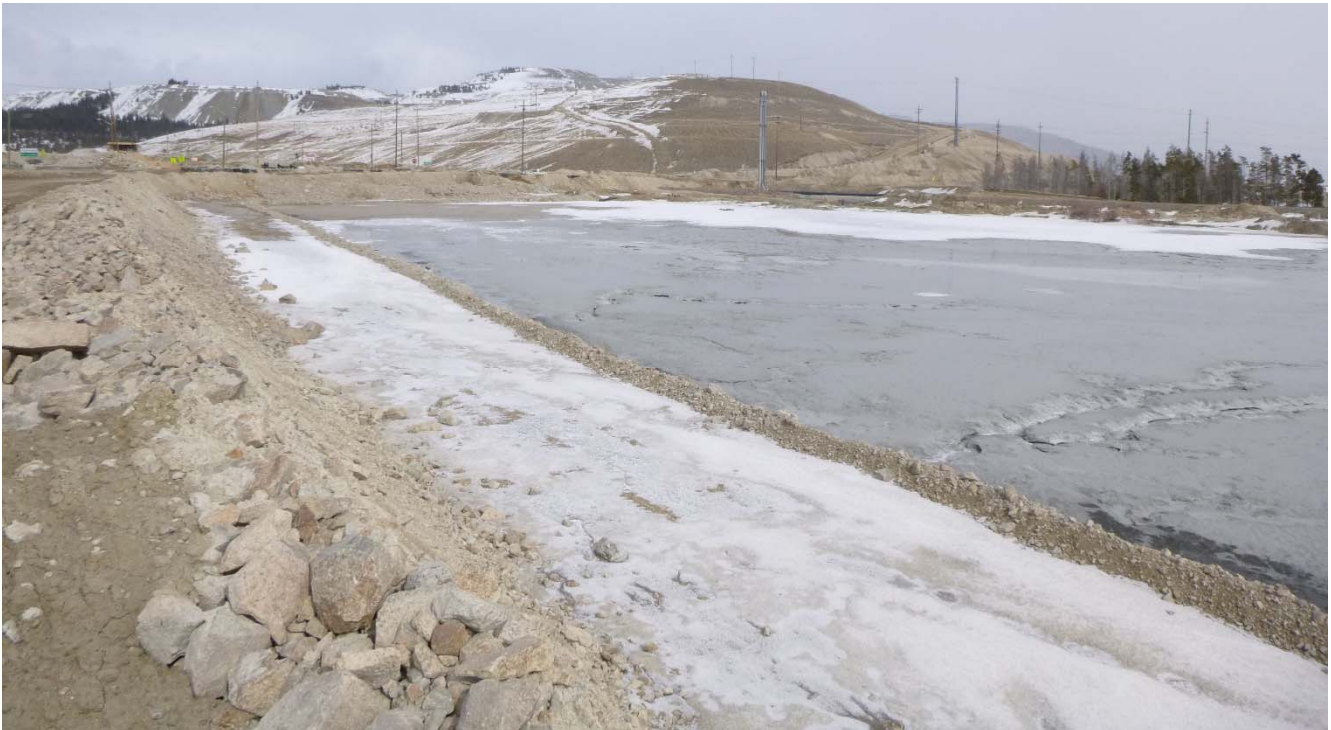
Photo II-13 Upstream slope of west embankment looking northeast (SDP-2016-10)

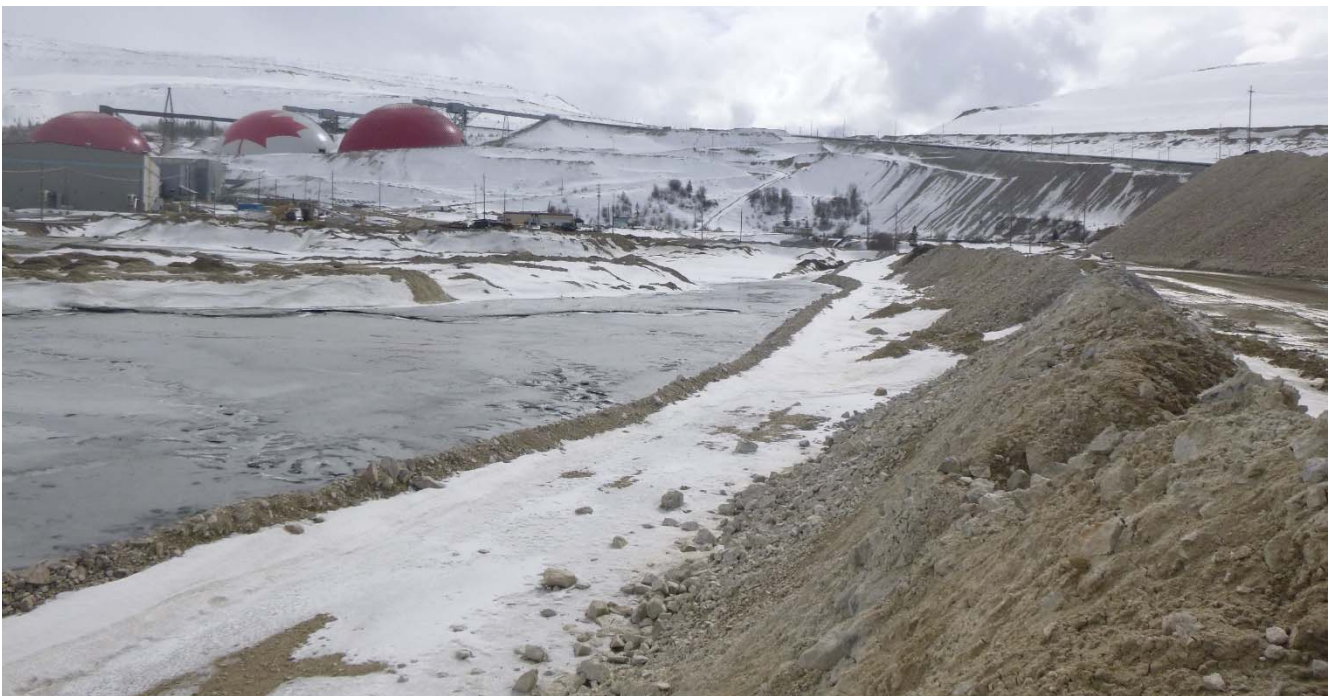
Photo II-14 Upstream slope of west embankment looking southwest (SDP-2016-10)

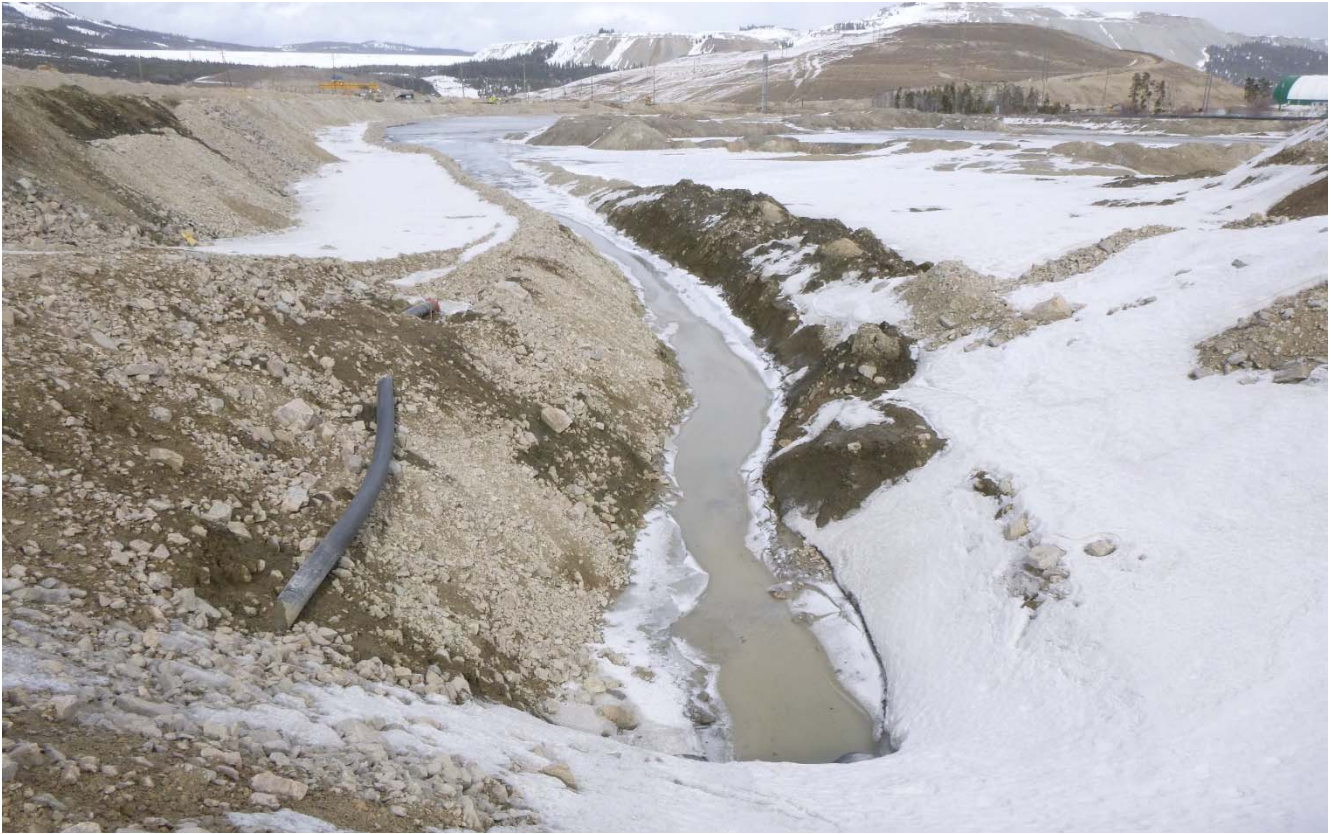
Photo II-15 Inflow pipes at southwest corner of pond. No flow from pipes. Photo taken looking northeast (SDP-2017-11)
