Teck Highland Valley Copper Partnership

2017 Dam Safety Inspection Report

Bethlehem No. 1 Tailings Storage Facility

March 2018

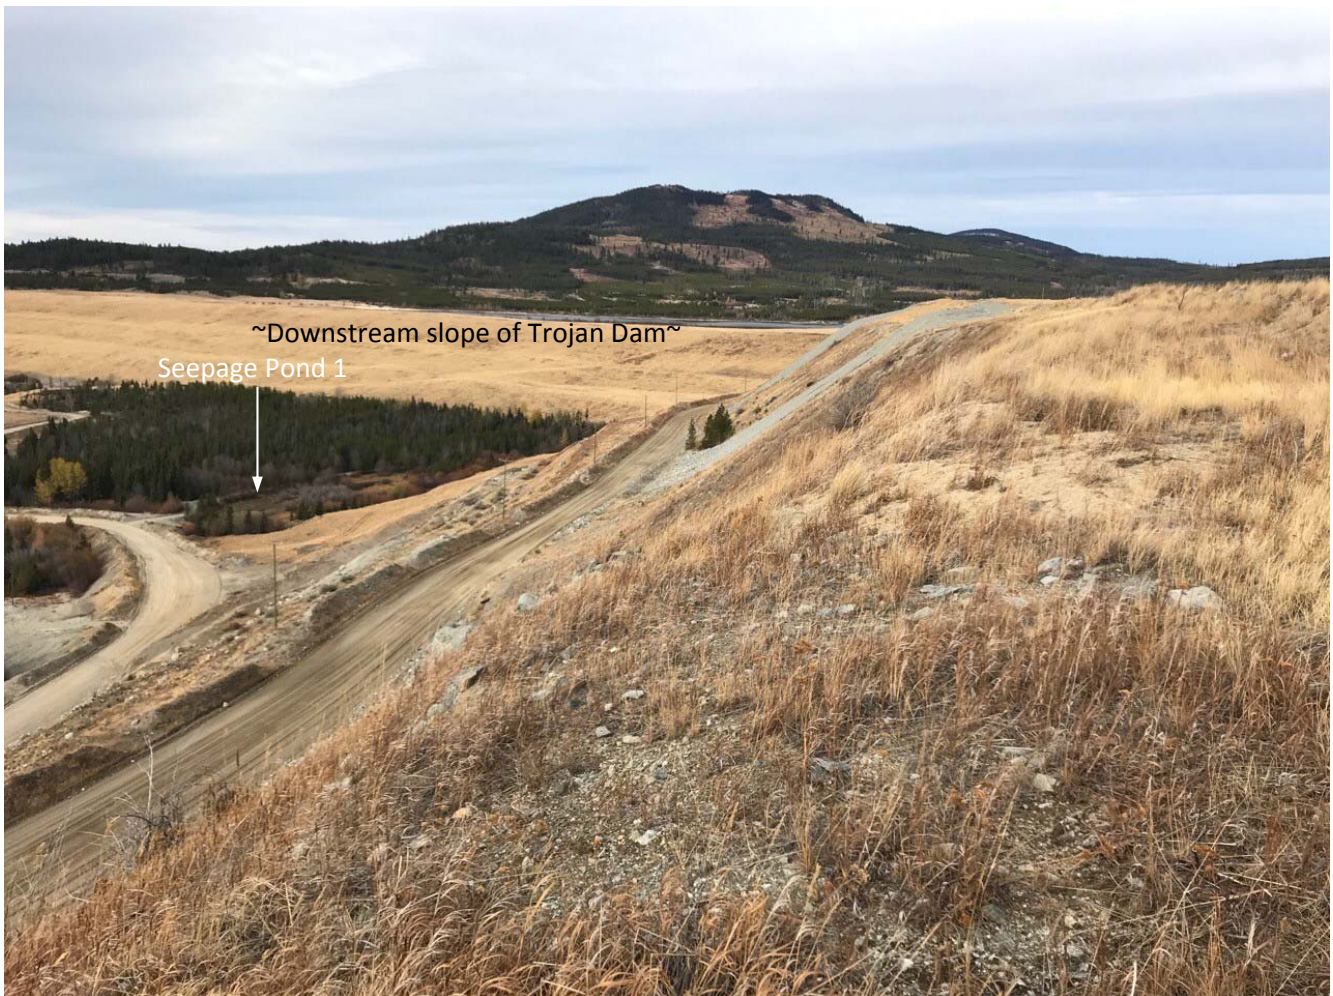
Photo II-A-2 Crack from September 2015 rockfill placement (repair of erosion gully). Area marked and monitored by THVCP, no visible change from 2016 report, crack width ~35mm (BTH-2017-03)

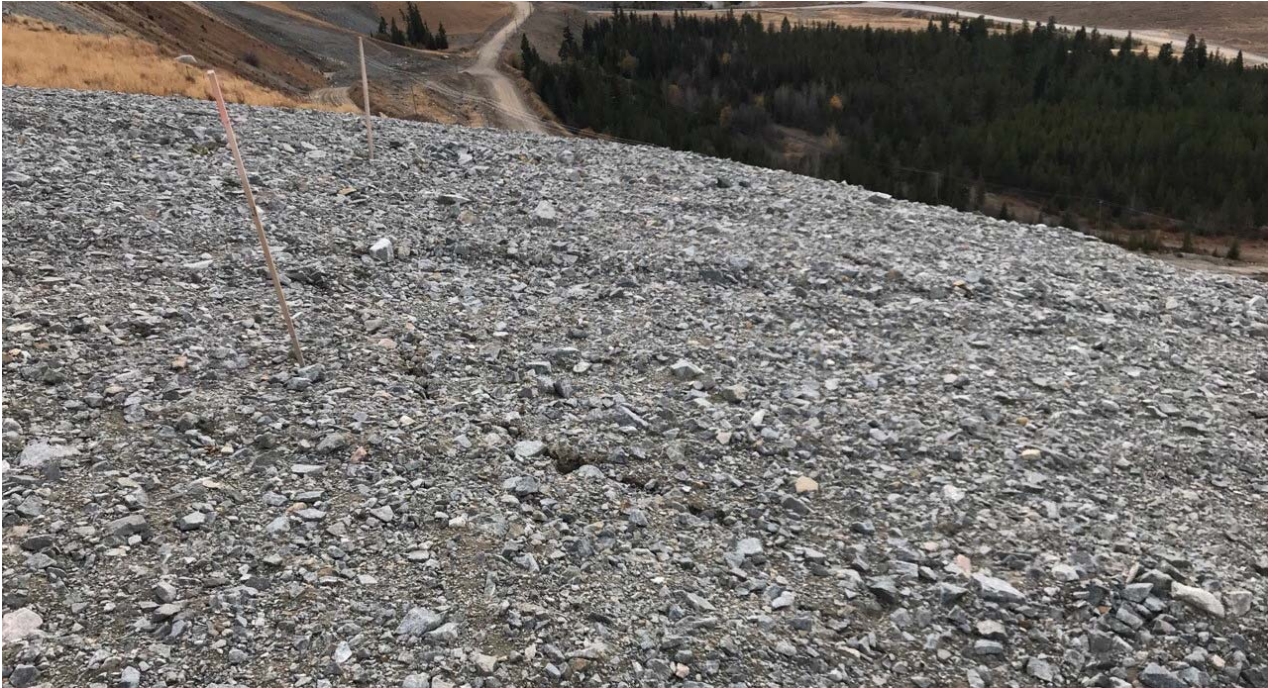
Photo II-A-3 Downstream slope of dam, historic repair of slope scar, no new signs of erosion or scouring. View towards left abutment (BTH-2017-02)

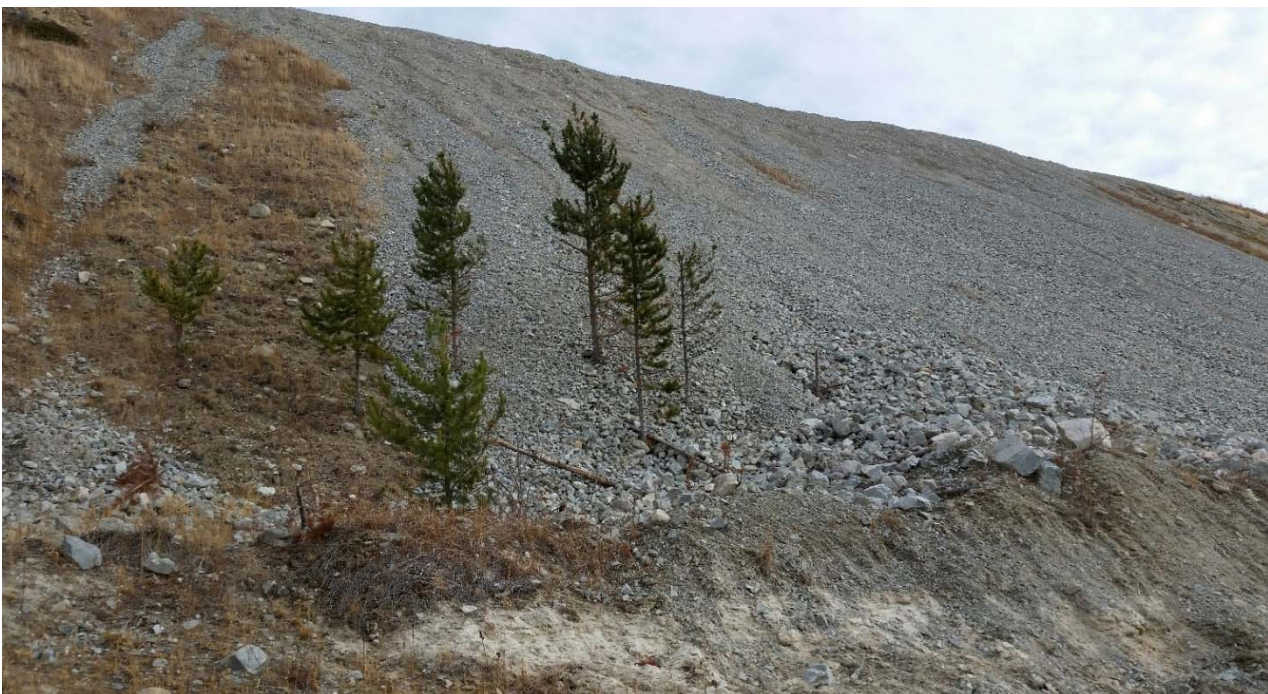
Photo II-A-4 Downstream slope of dam, historic repair of slope scar, no new signs of erosion or scouring. View towards left abutment lower down (BTH-2017-02)

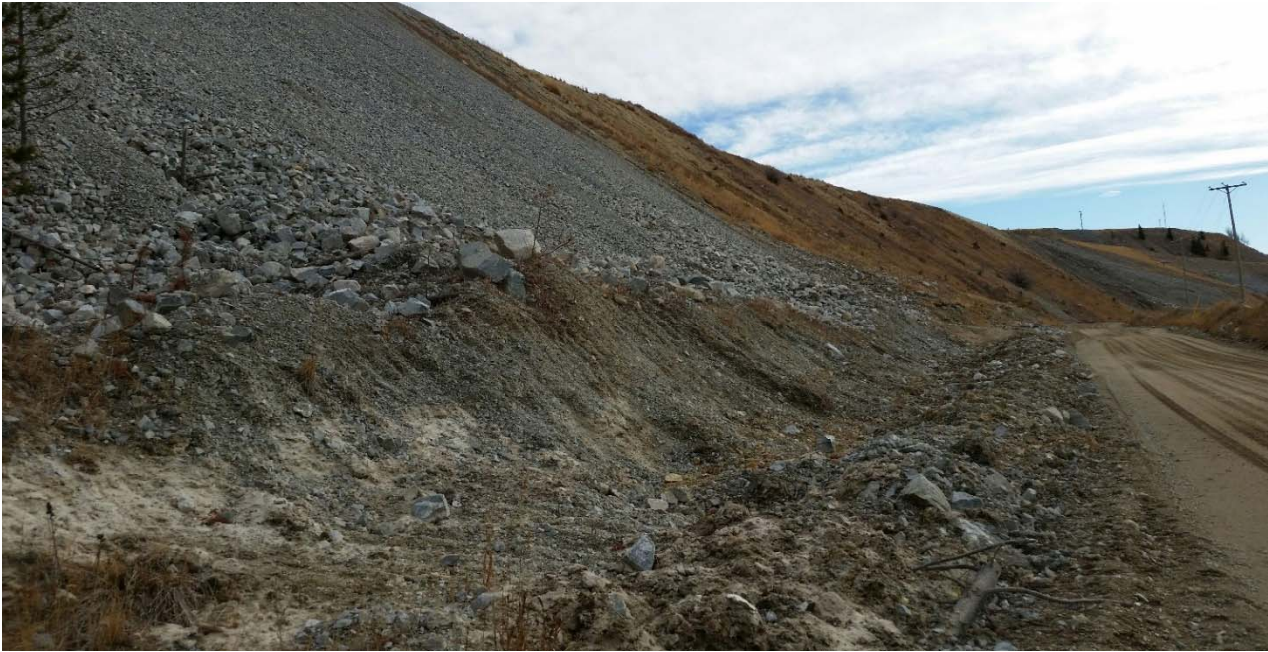
Photo II-A-5 Downstream slope of dam, historic repair of slope scar, no signs of erosion or scouring. View towards right abutment (BTH-2017-02)

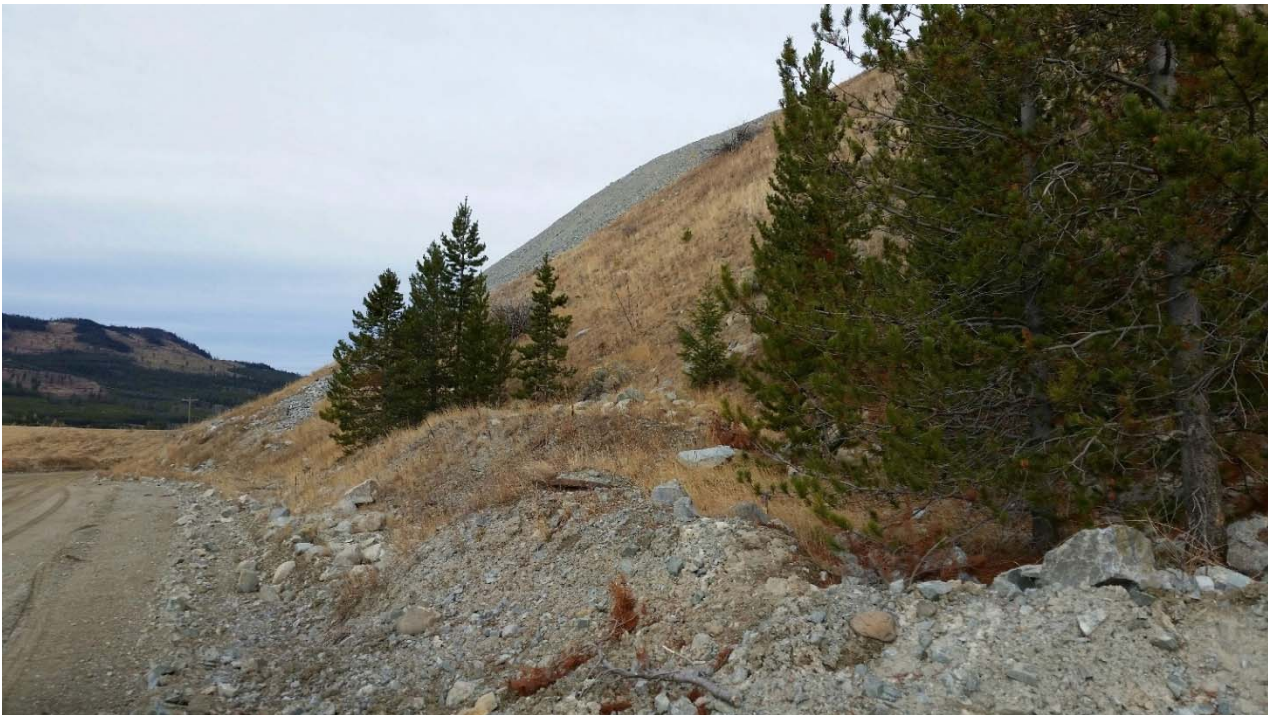
Photo II-A-6 Downstream slope of dam, view looking south (BTH-2017-05)

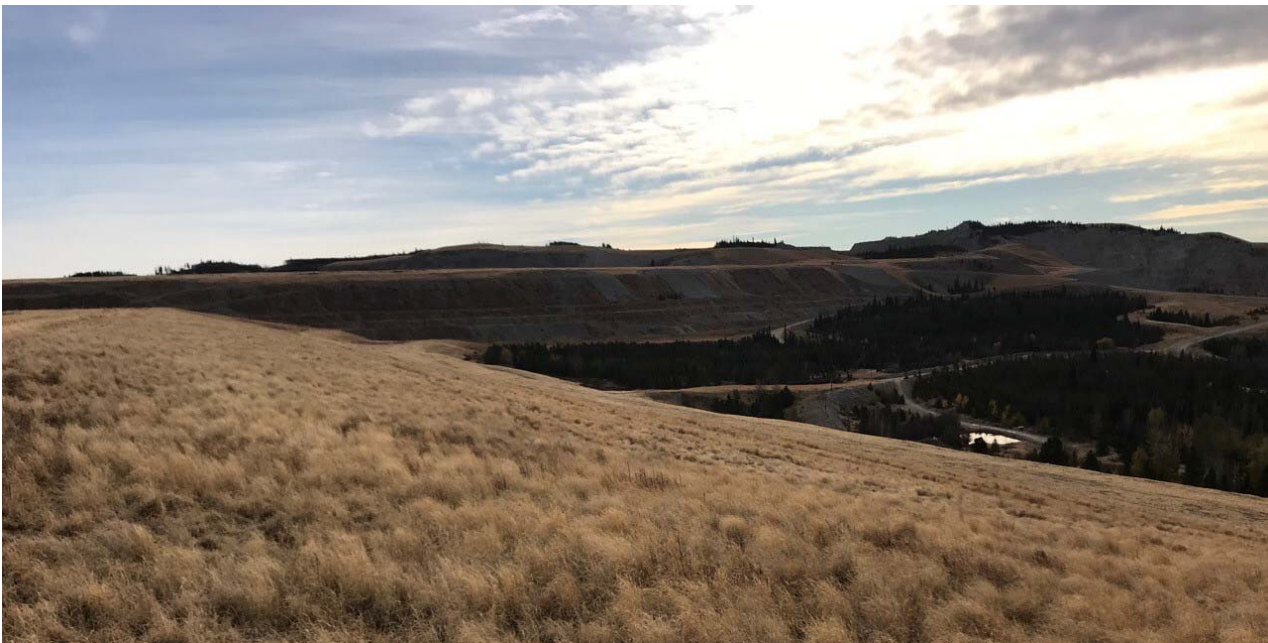
- In 1989, tailings disposal at Bethlehem No. 1 TSF ended (AMEC 2014a).
- In 1993, a sinkhole 4 m to 5 m wide on the surface and 4 m deep was discovered in the tailings beach at Dam No. 1 about 400 m upstream of the dam crest:
 - ◆ In 1994, the sinkhole was backfilled with waste rock. In 1996, it was backfilled again due to continued settlement.
 - ◆ On October 11, 1997, KCB examined the sinkhole and recommended no further action other than ongoing monitoring. In recent years, there has been no significant change in the sinkhole.
- In 2014, THVCP constructed and instrumented a test fill pad in the mid-portion of the south side of the impoundment to characterize the response of the tailings under load.

Photo II-A-8 Sinkhole on tailings beach, no additional cracks or depressions since 2016 inspection (BTH-2017-04)

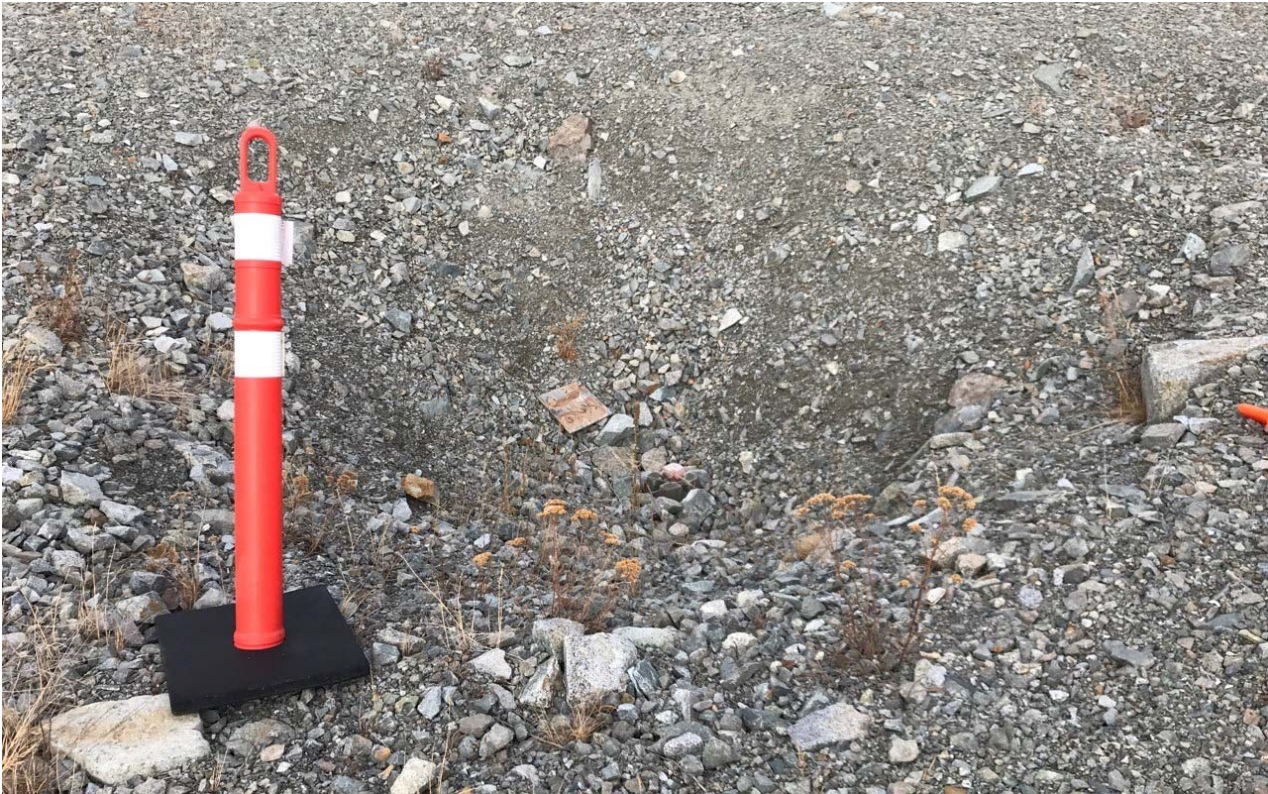
Photo II-A-9 Sinkhole on tailings beach and it's instrumentation (BTH-2017-04)

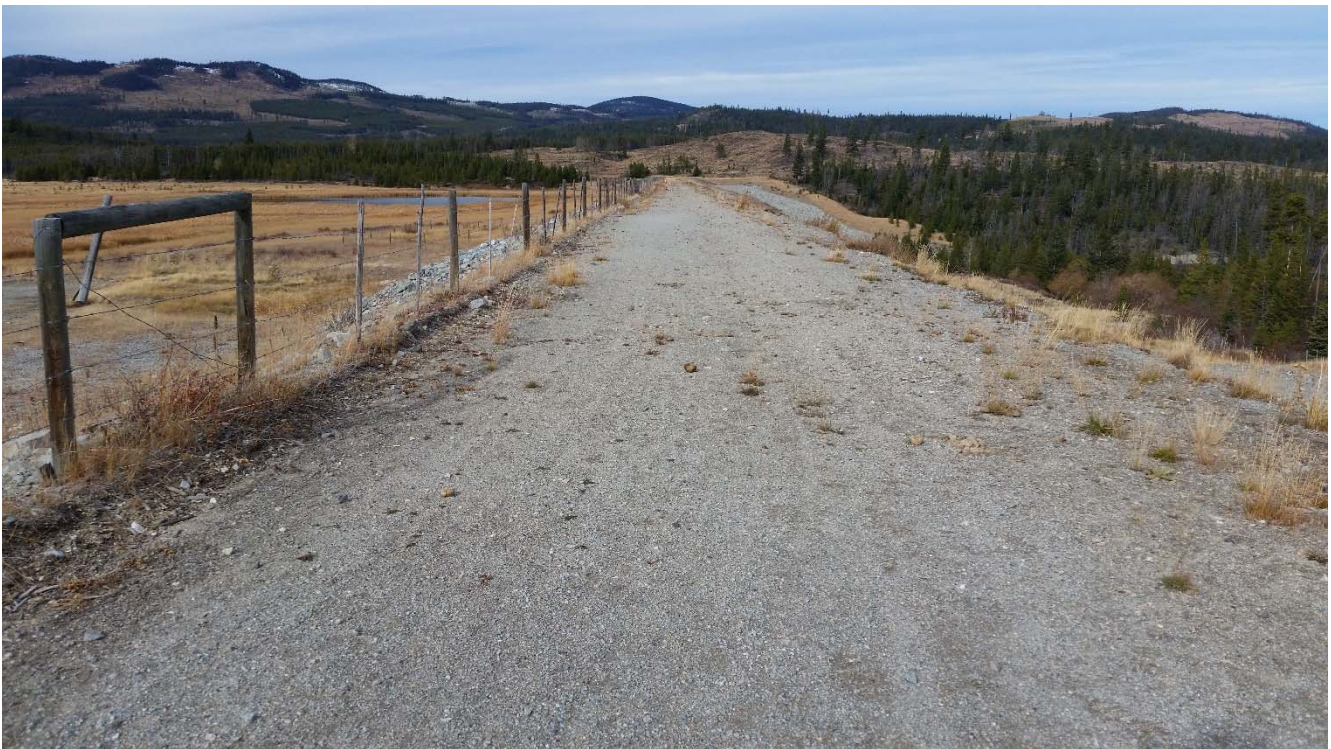
Photo II-B-2 Upstream slope of dam looking towards left abutment. The rockfill riprap on the upstream slope is intact and shows no signs of degradation or erosion (BTH-2017-07)

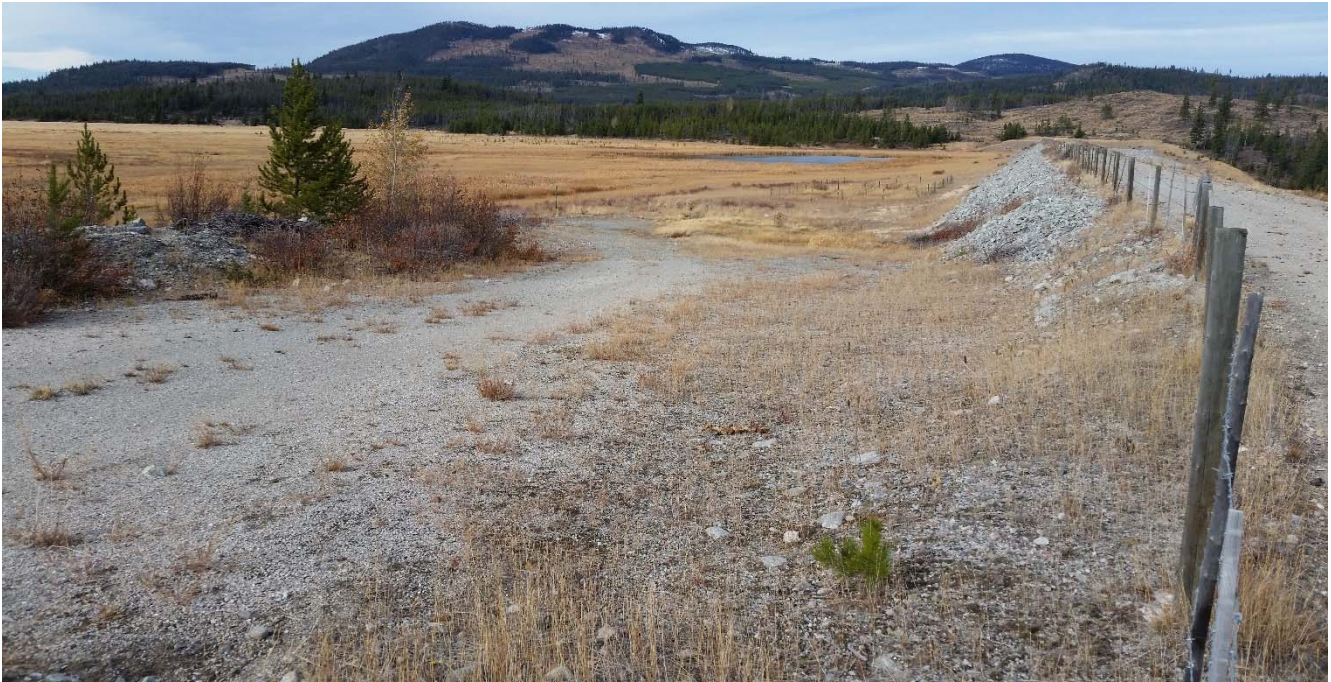
Photo II-B-3 Downstream slope of dam including toe drain near right abutment, no signs of erosion or scouring in outer rock layer (BTH-2017-08)

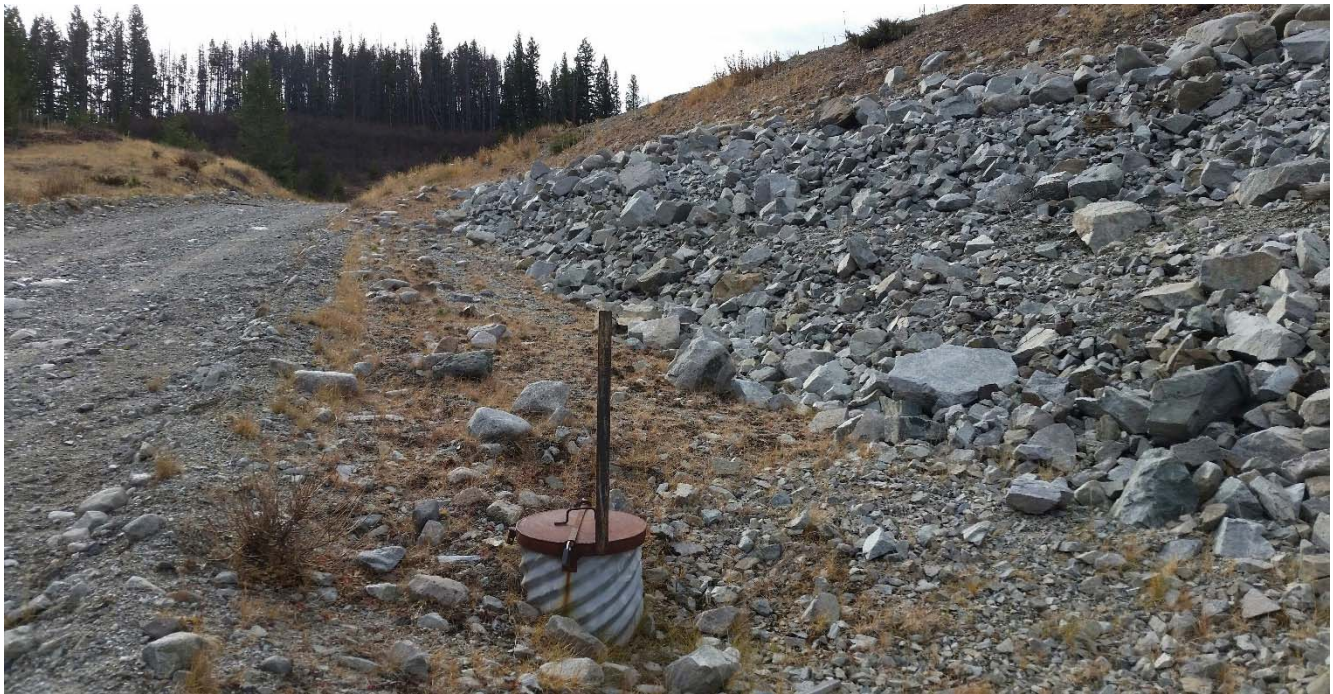
Photo II-B-5 Toe drain located along fence line, no visible damage, view downstream (BTH-2017-10)

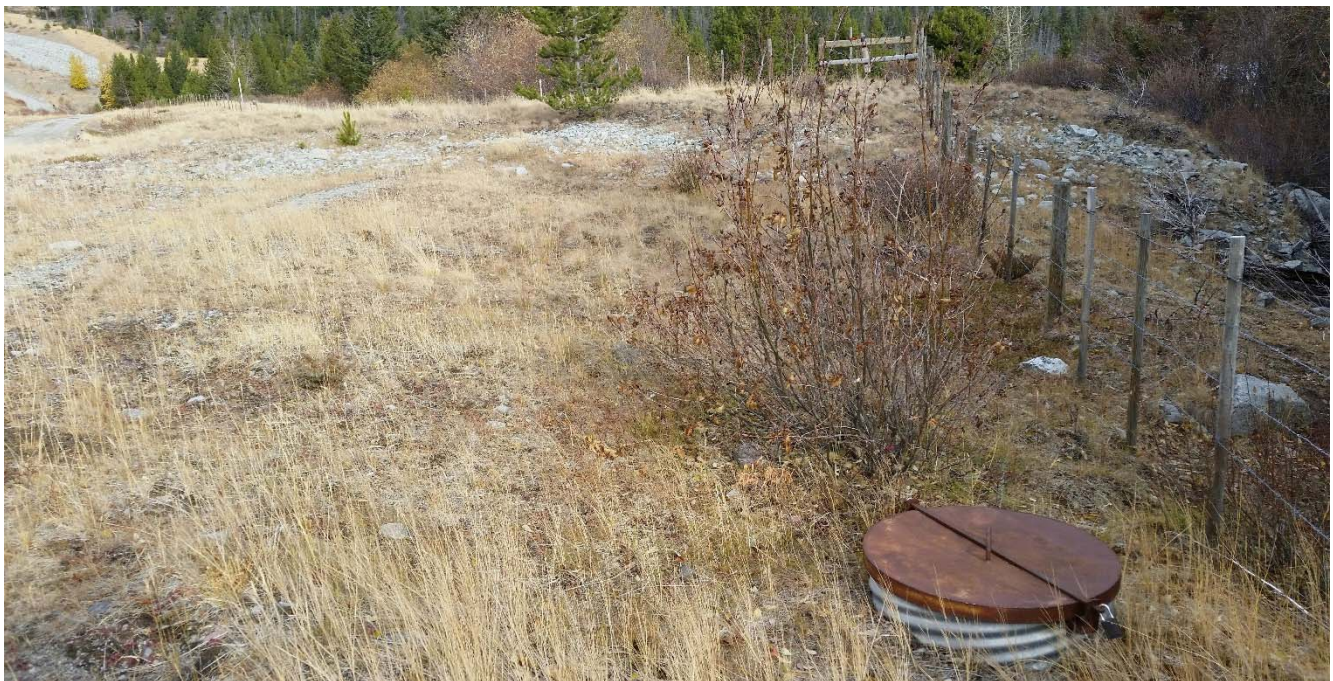
Photo II-B-6 Toe drain, no visible damage, view towards left abutment (BTH-2017-11)

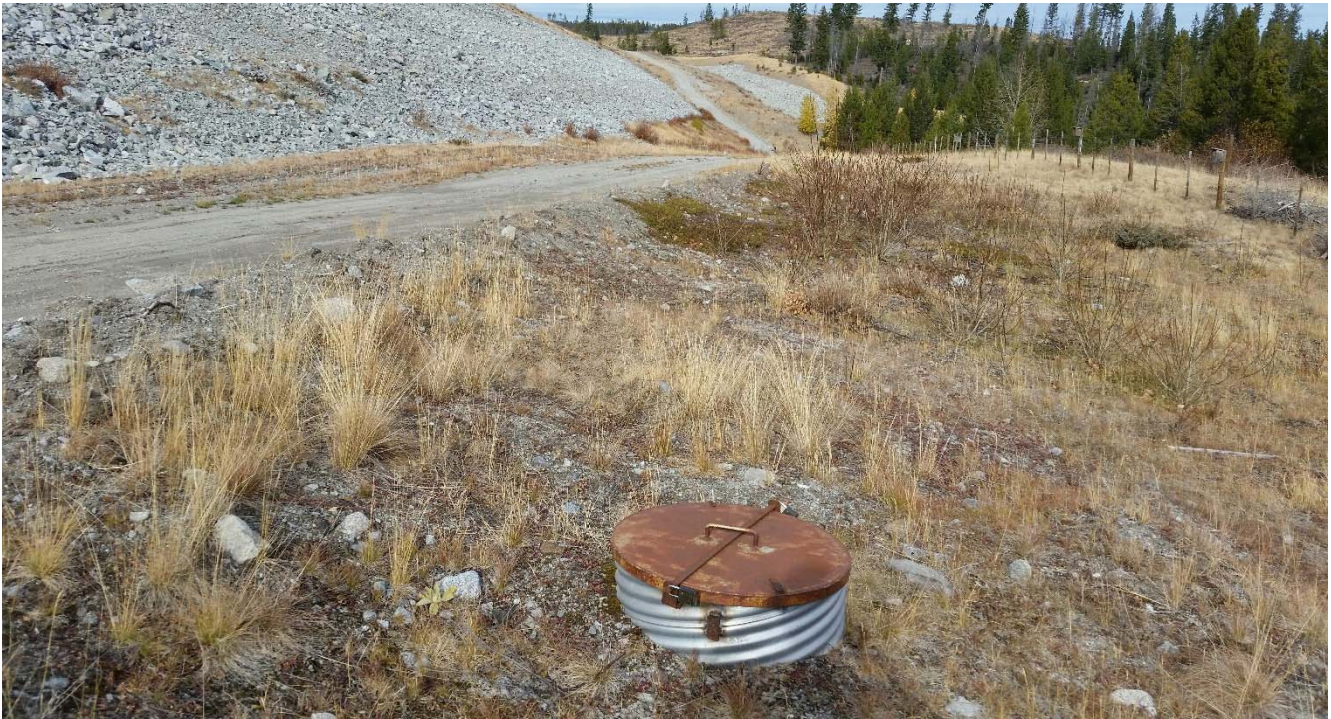
Photo II-B-7 Toe drain, no visible damage, view towards left abutment. Lower portion of dam from toe drain to the service road, transitions from rockfill armour to till, no signs of erosion or deterioration observed (BTH-2017-12)

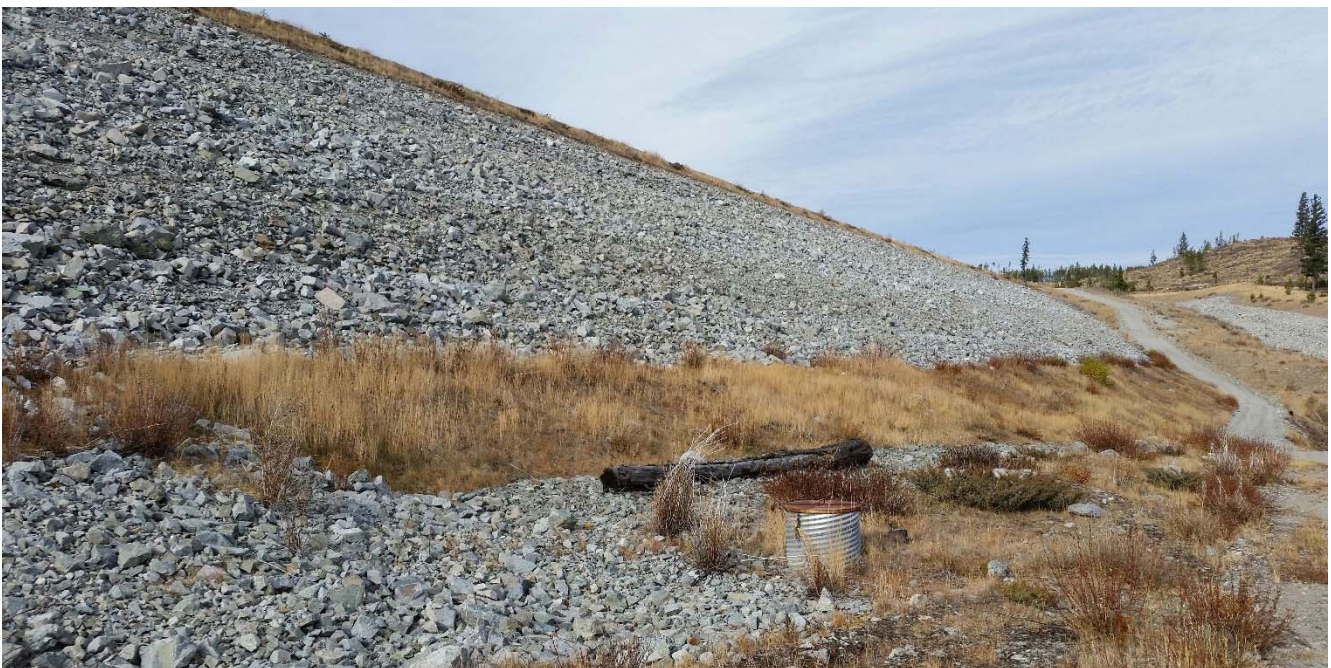
Photo II-B-8 Toe drain, no visible damage, view towards right abutment at the till/rockfill armour transition point (BTH-2017-12)

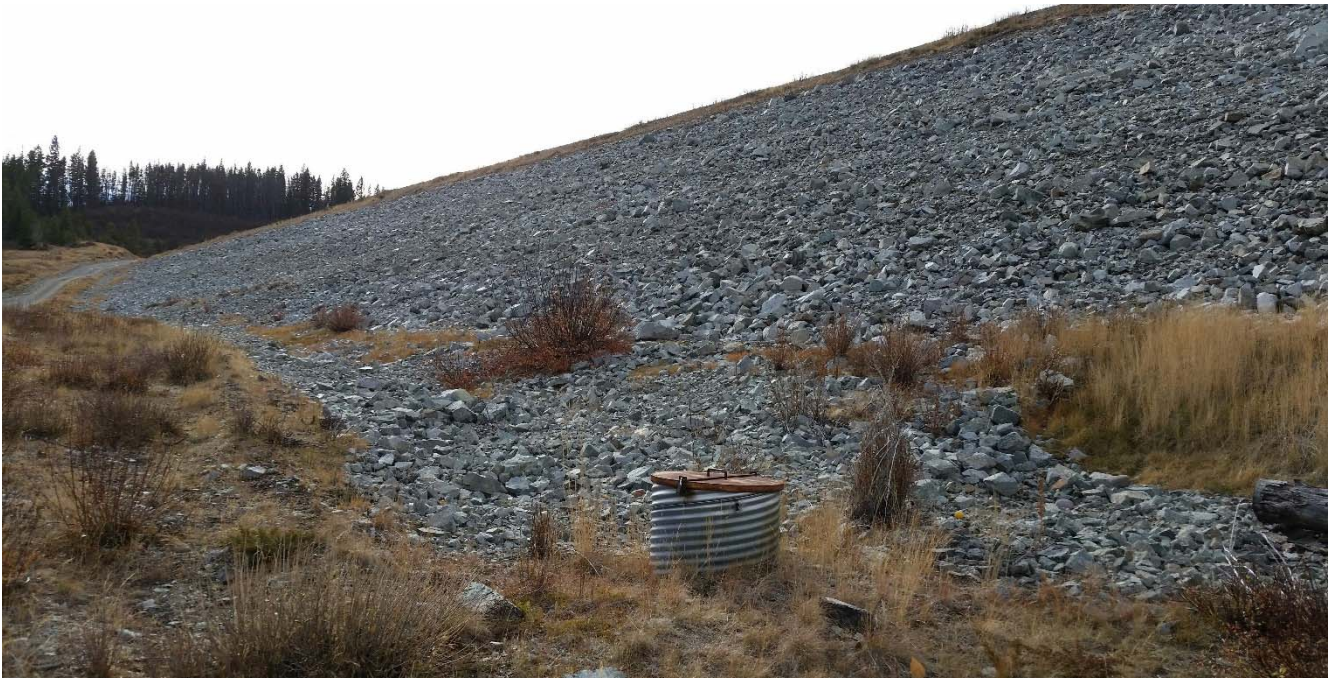
Photo II-B-9 Old gauge-house and decommissioned pump-well. Piezometer 1 standpipe visible on the left, directly behind gauge-house (BTH-2017-13)

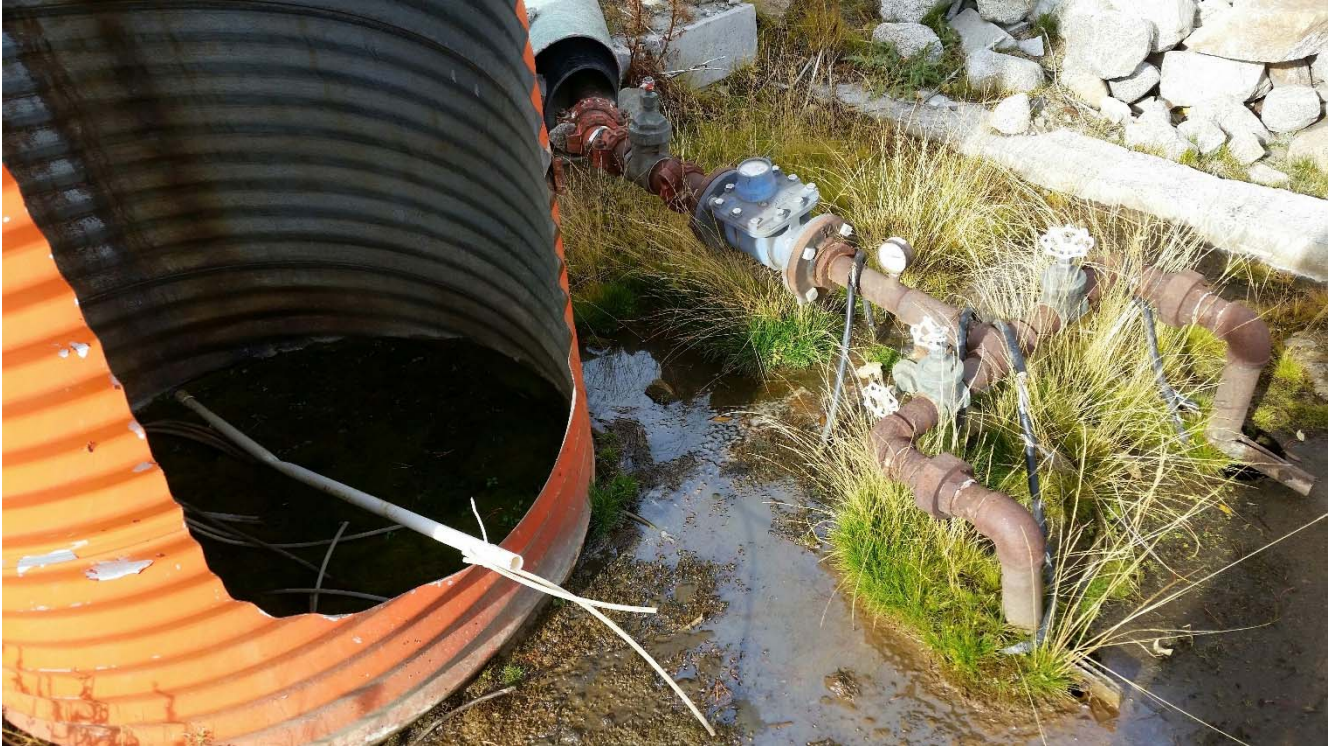
Photo II-B-11 Seepage outflow to riprap lined infiltration basin. Flow is clear and steady flowing at approximately 2 L/s (BTH-2017-13)

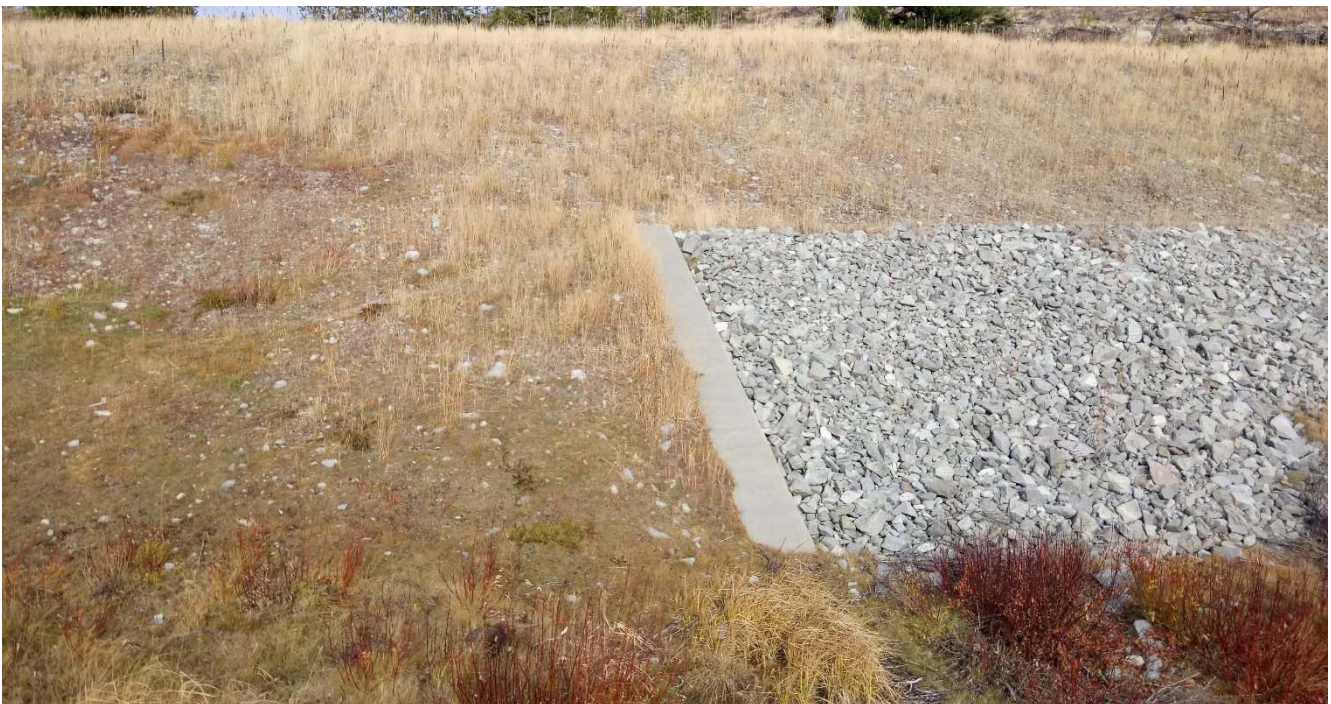
Photo II-B-14 Spillway transition point, view upstream. Trapezoidal channel in good condition with no signs of erosion. Minor vegetation at the invert, should continue to be monitored to ensure it does not reduce spillway capacity (BTH-2017-16)

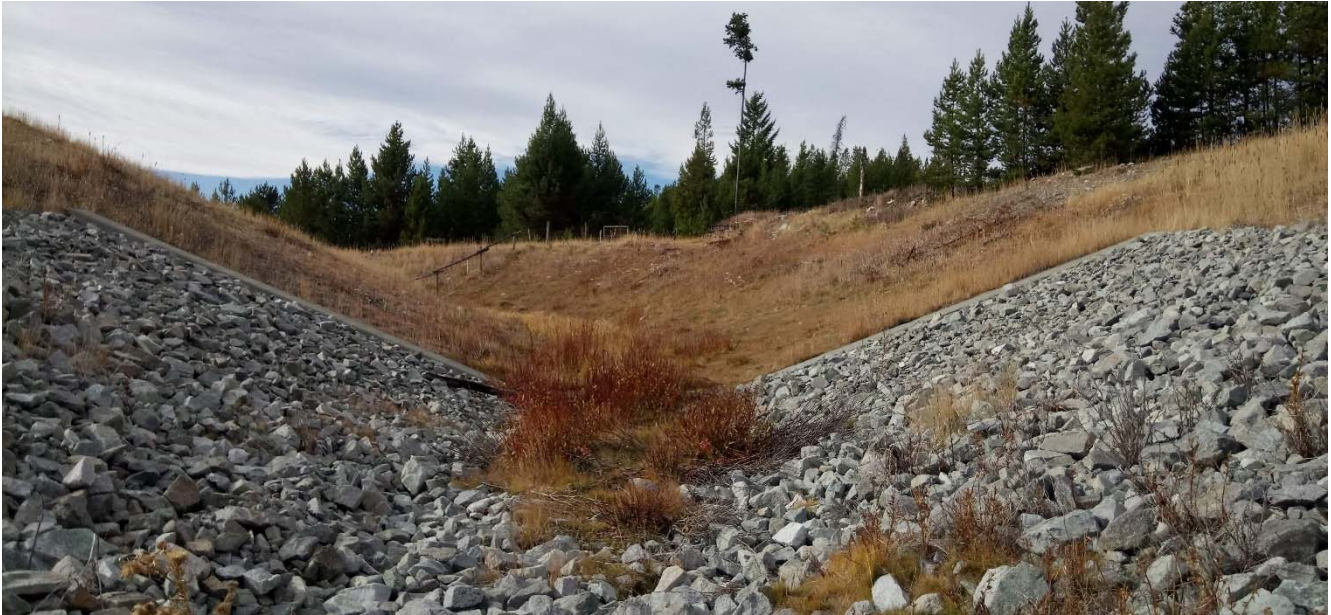
Photo II-B-15 Spillway transition from fine riprap to coarse riprap as the channel steepens, view towards dam crest. Fine riprap size approximately 50-125mm, Coarse riprap approximately 150-300mm (BTH-2017-17)

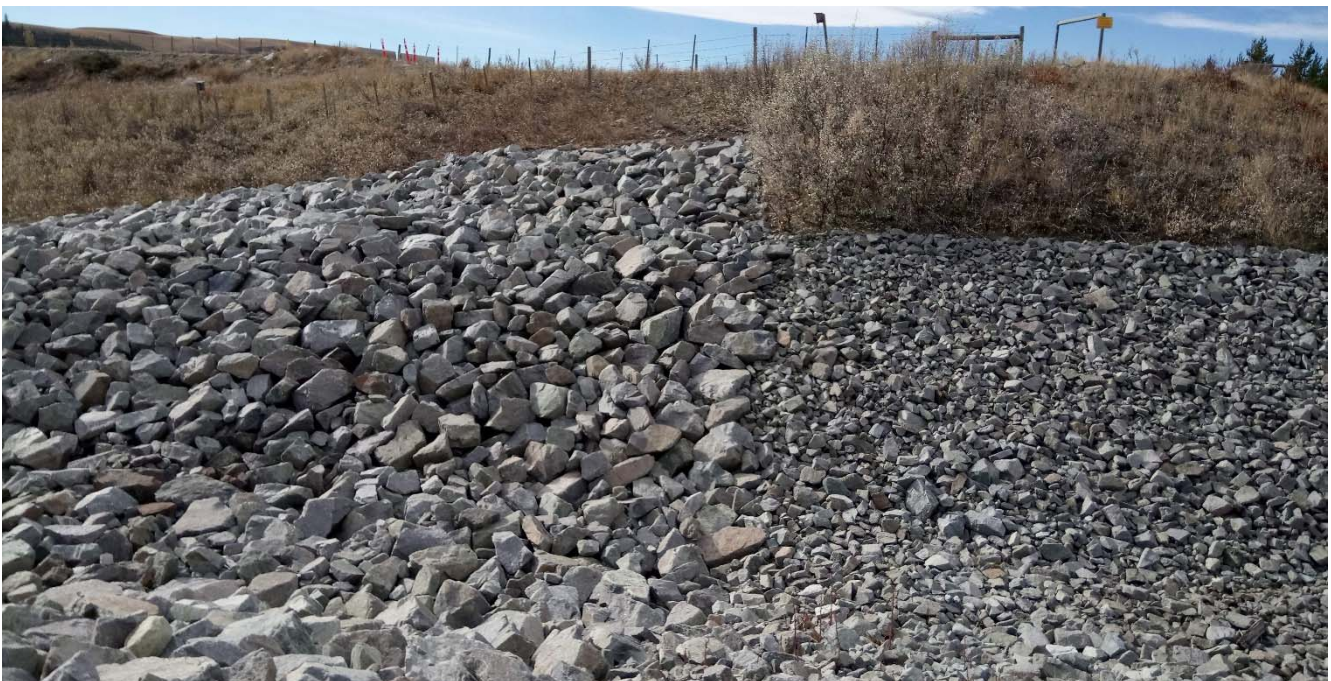
Photo II-B-16 Spillway channel looking downstream towards Bose Lake. Flow discharges past the road via two culverts (~1.2m and 0.5m in size) no signs of deterioration to spillway channel observed (BTH-2017-18)

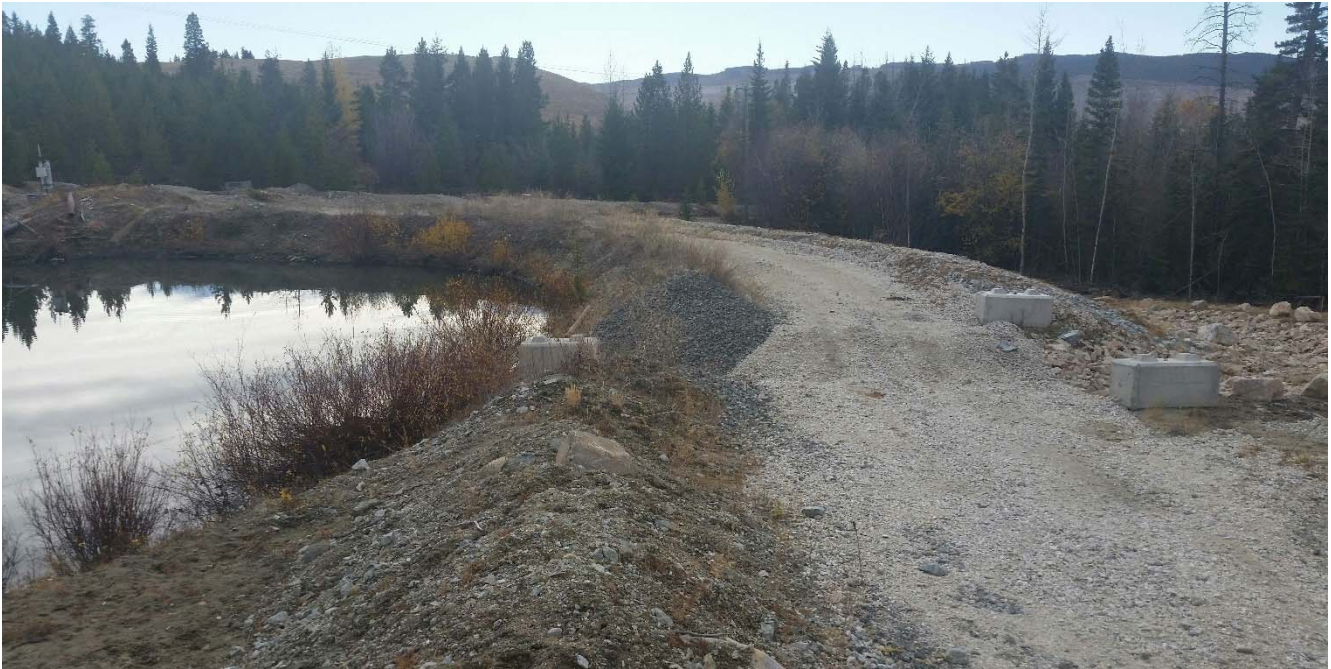
Photo II-C-5 Spillway inlet, trapezoidal channel in good condition, no signs of erosion in fine riprap (BTH-2017-24)

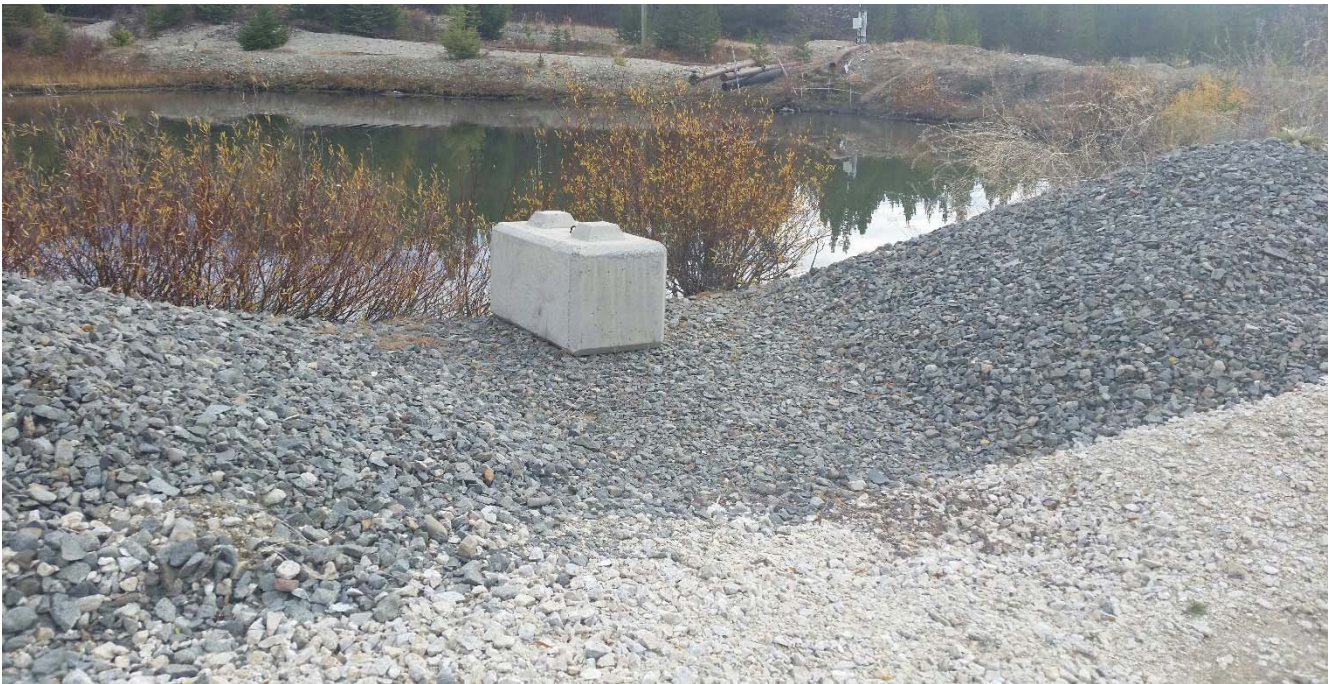
Photo II-C-6 Spillway view downstream from crest of dam, transition to large riprap as channel steepens (BTH-2017-24)

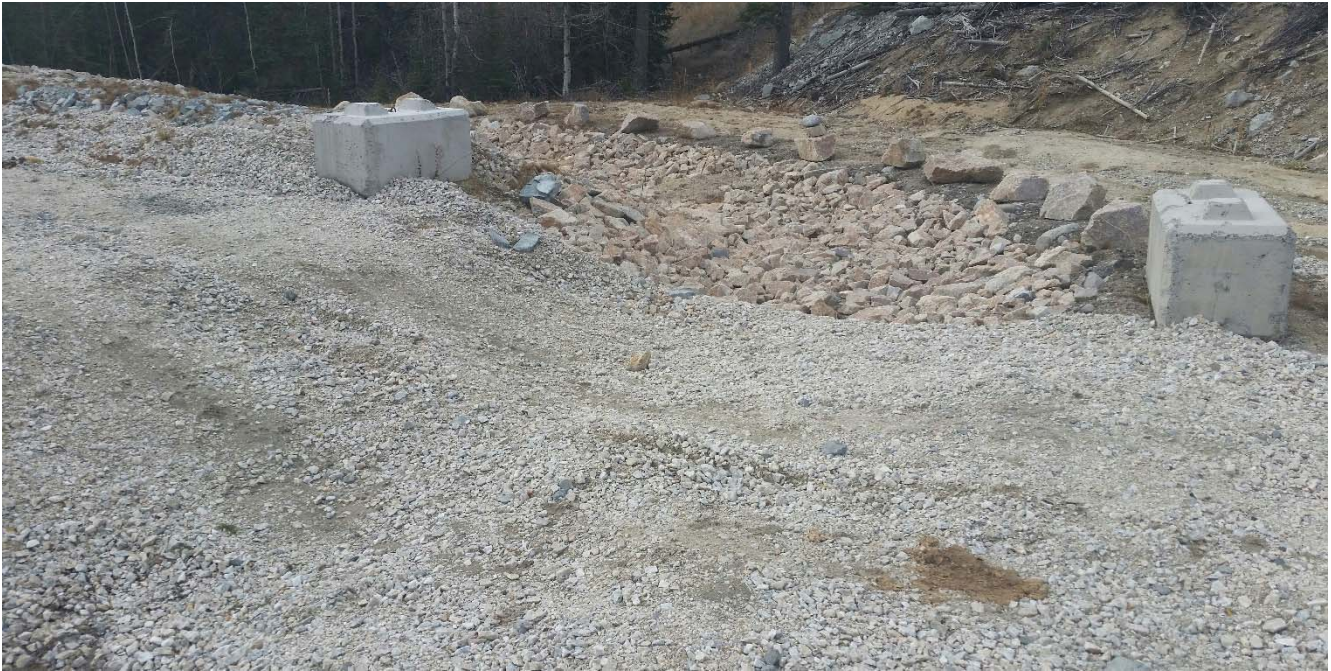
Photo II-C-7 Spillway channel in good condition, no signs of deterioration. Downstream riprap material size 50-300mm with outliers as large as 600mm (BTH-2017-25)

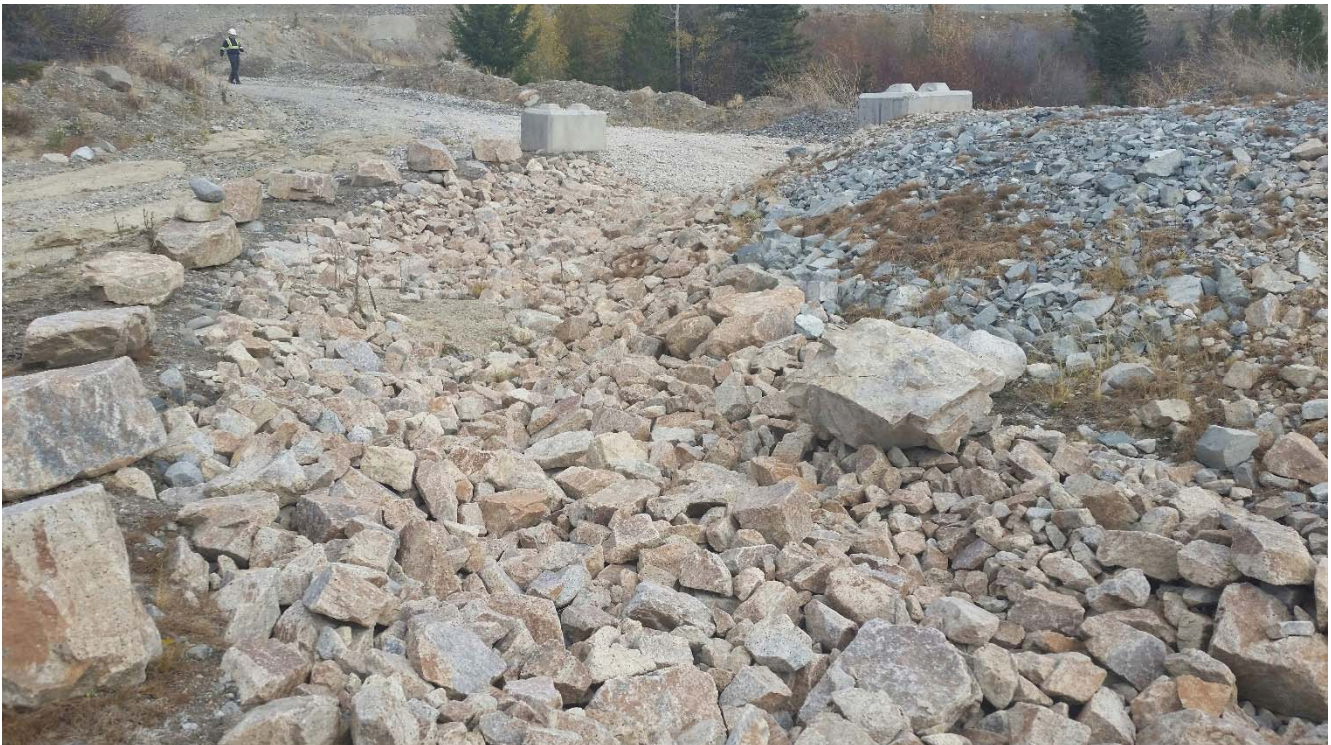
Photo II-C-8 Spillway view downstream from channel bend, no signs of erosion or deterioration, log obstruction present in lower section (BTH-2017-25)

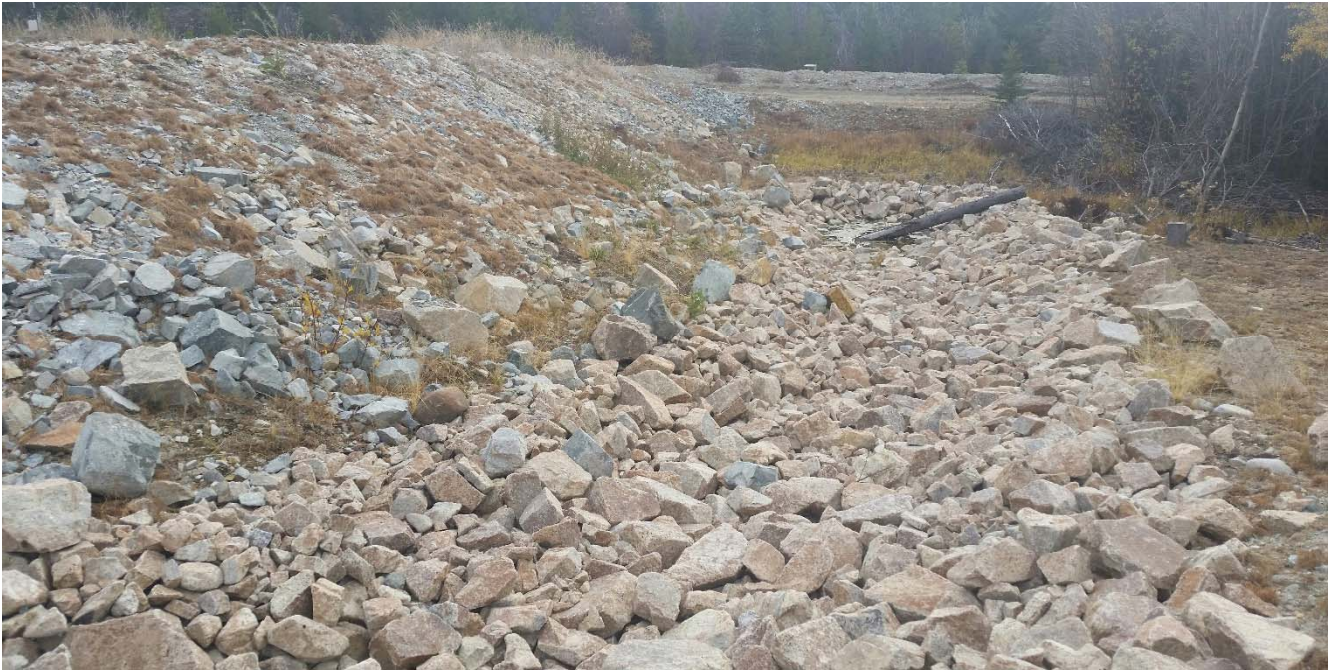
Photo II-C-9 Accumulation of water at the end of spillway riprap (BTH-2017-26)
