Teck Highland Valley Copper Partnership

2017 Dam Safety Inspection Report

Highmont Tailings Storage Facility

March 2018

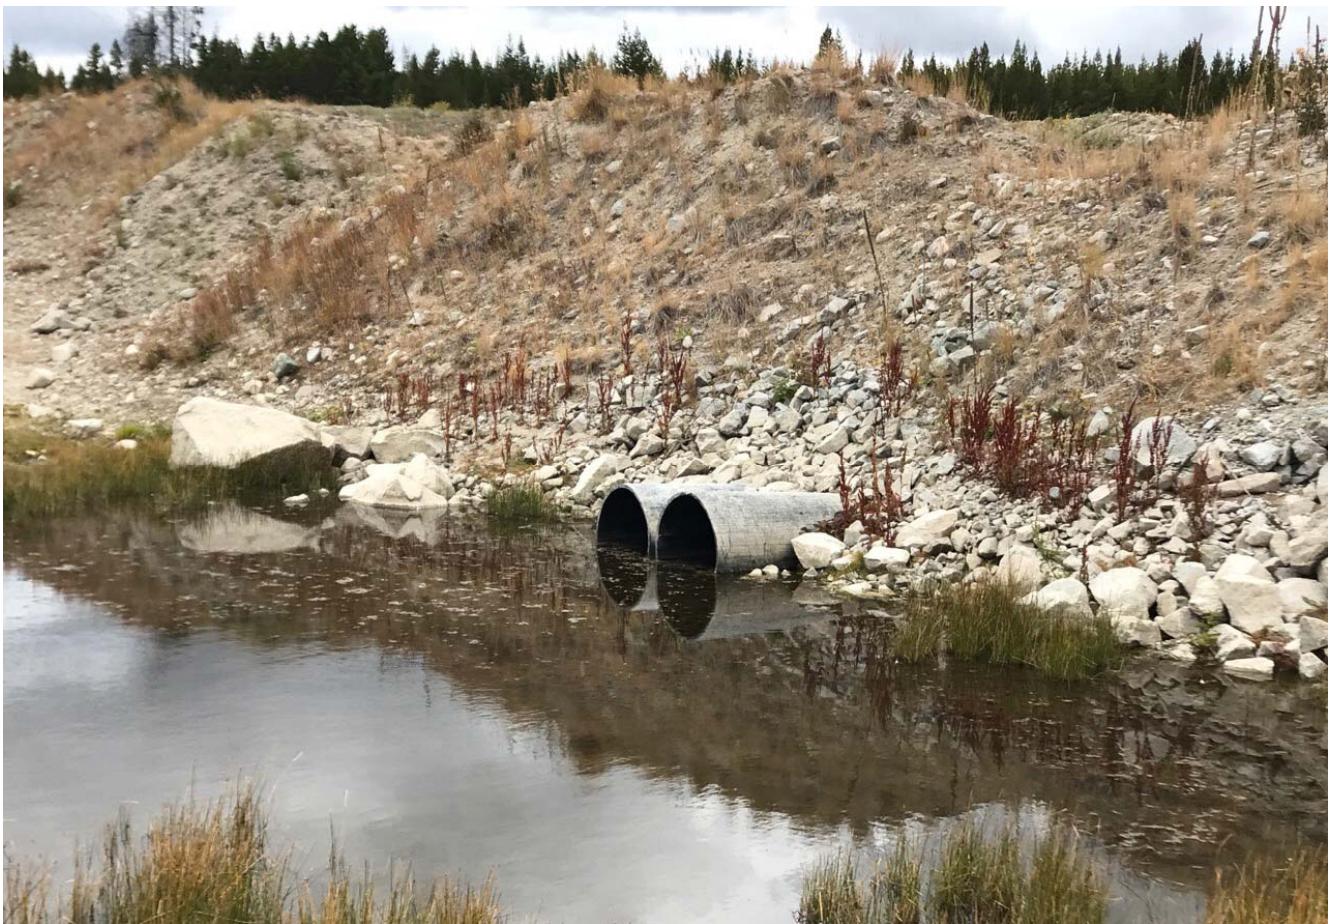
Photo II-A-5 Spillway culverts, upstream side of crest, submerged (HGH-2017-01)

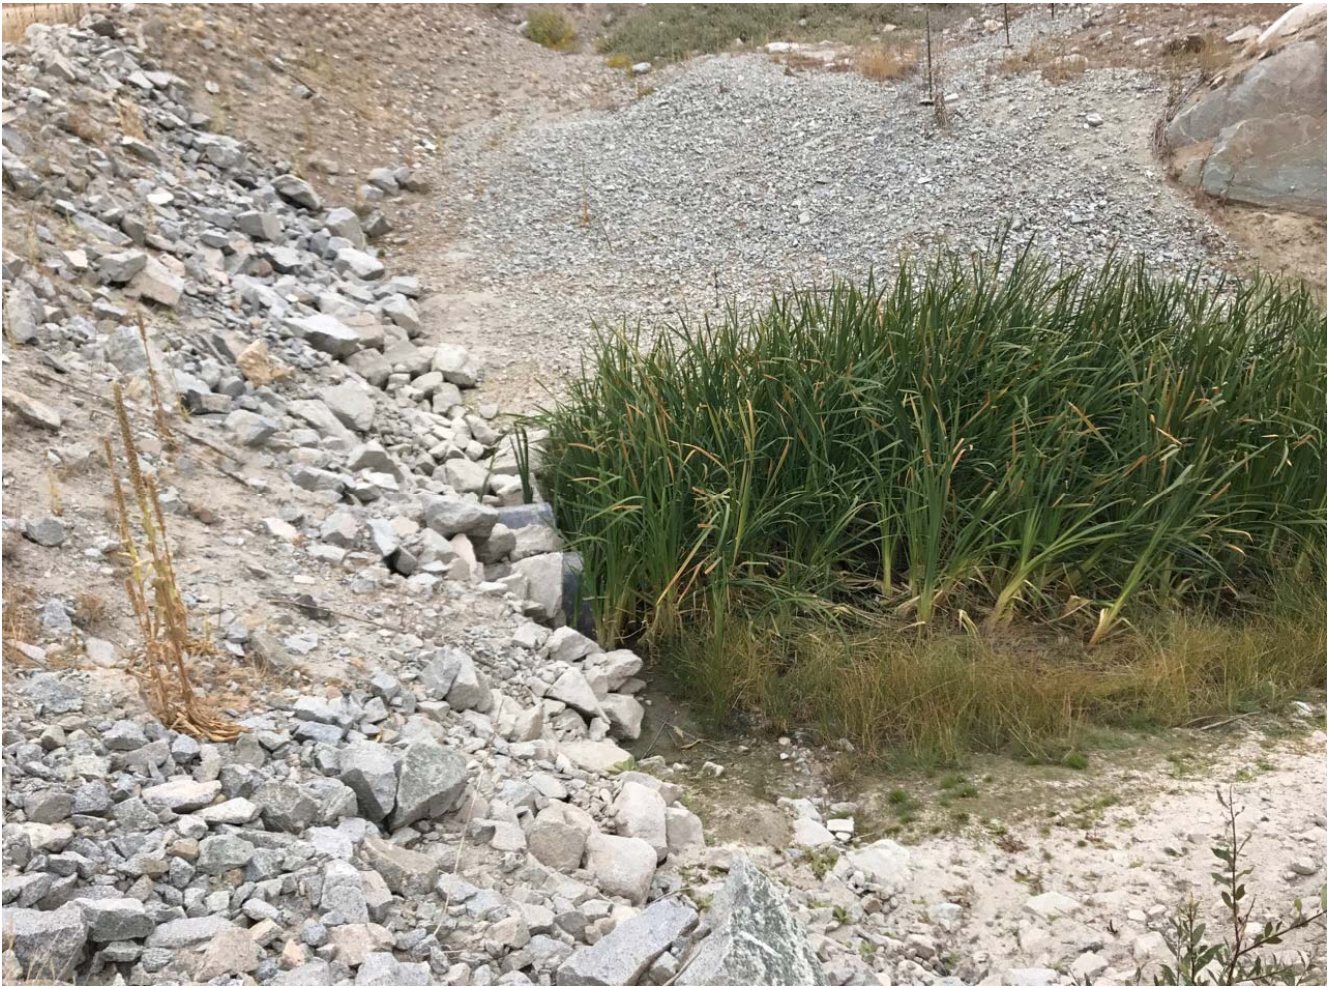
Photo II-A-6 Spillway culverts, downstream side of crest, vegetated (HGH-2017-02)

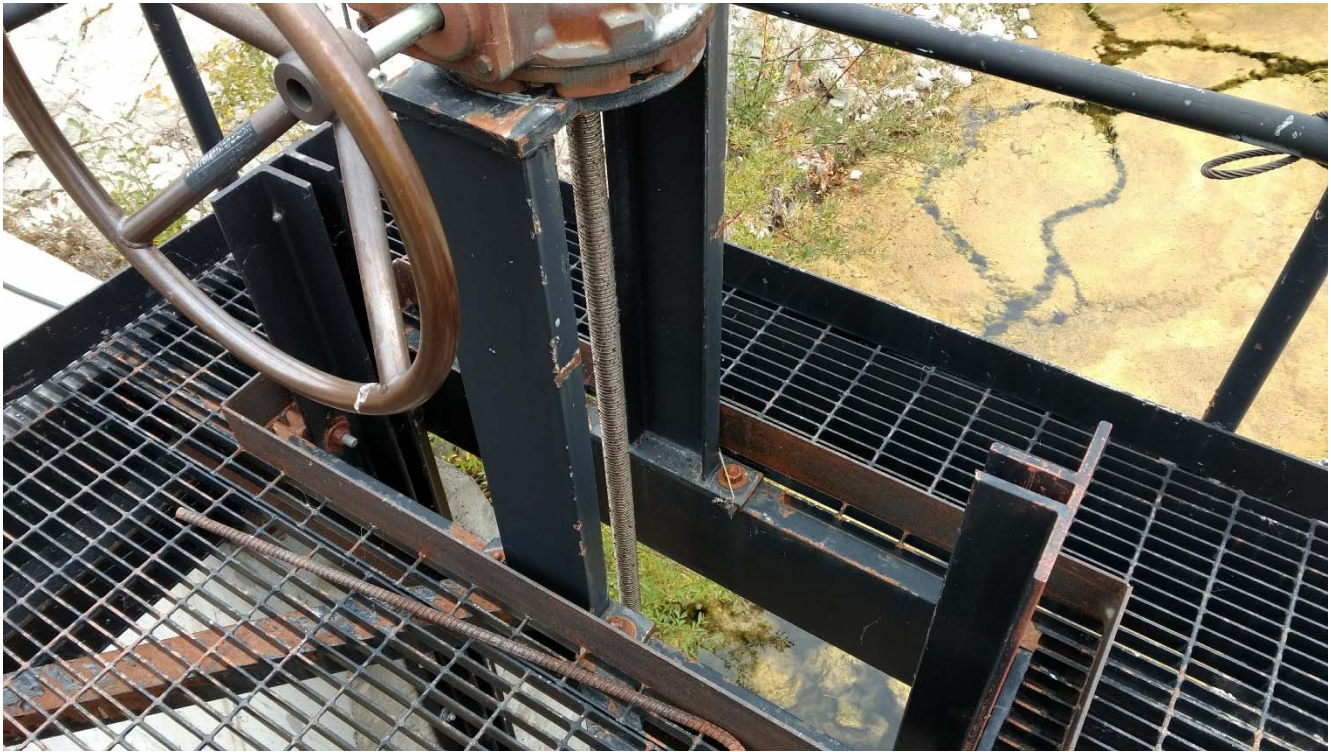
Photo II-A- 7 Spillway flow control gate (HGH-2017-03)

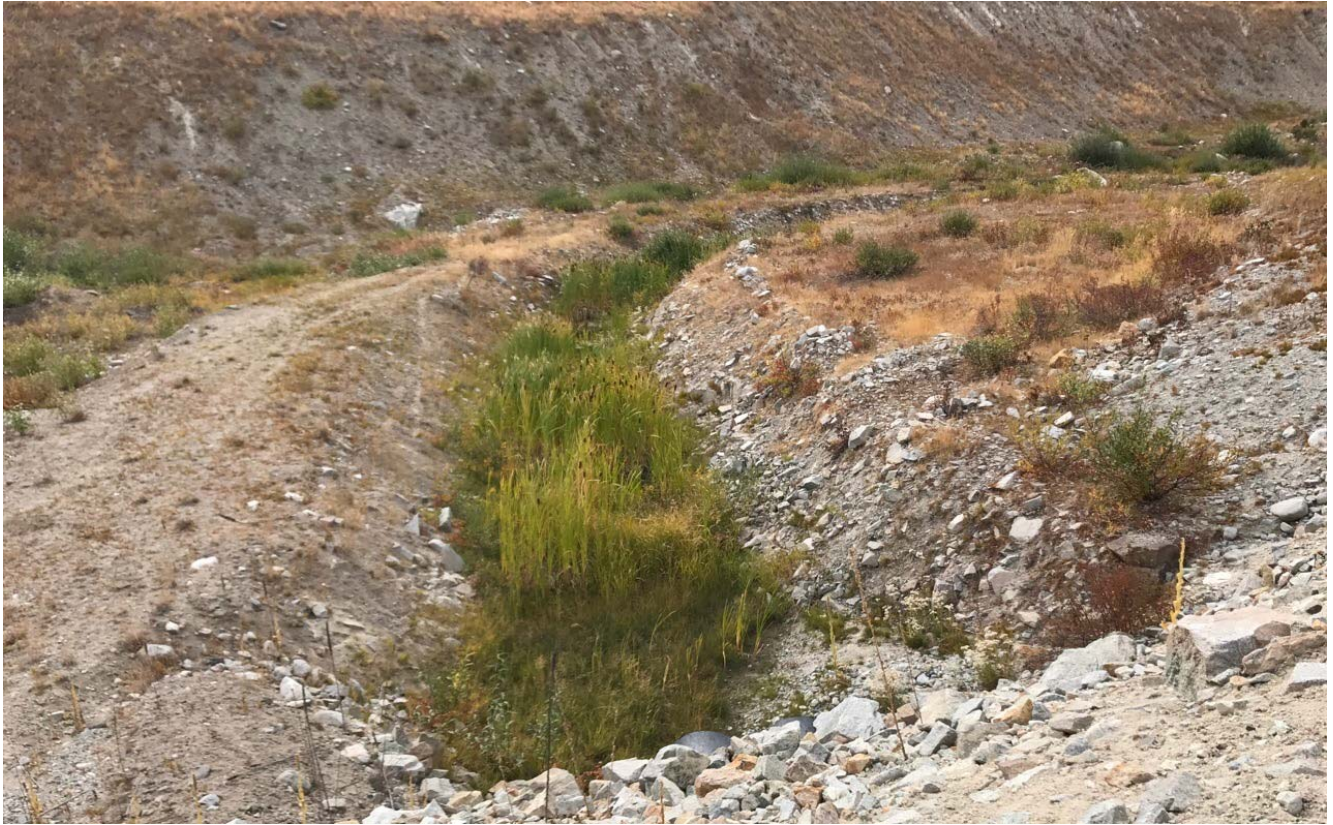
Photo II-A-13 Spillway channel looking downstream from road (HGH-2017-09)

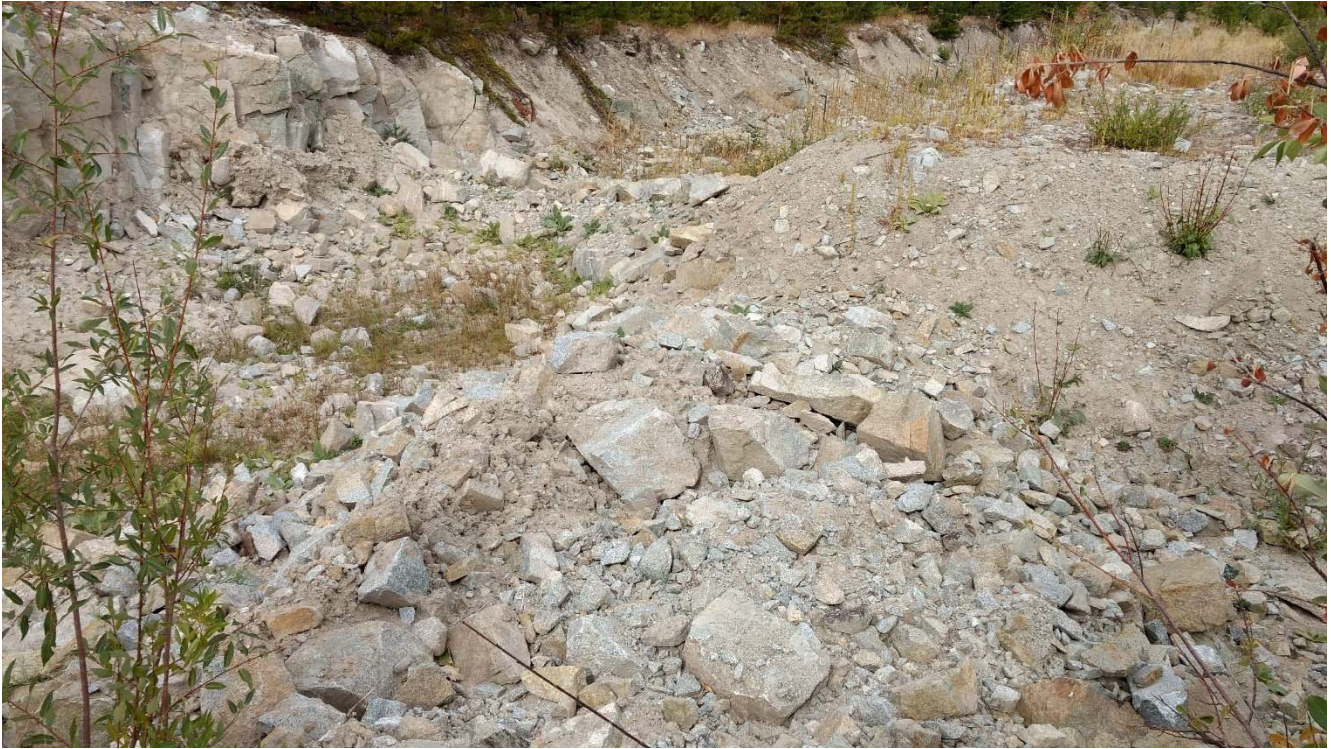
Photo II-A-14 Spillway channel till plug (HGH-2017-12)

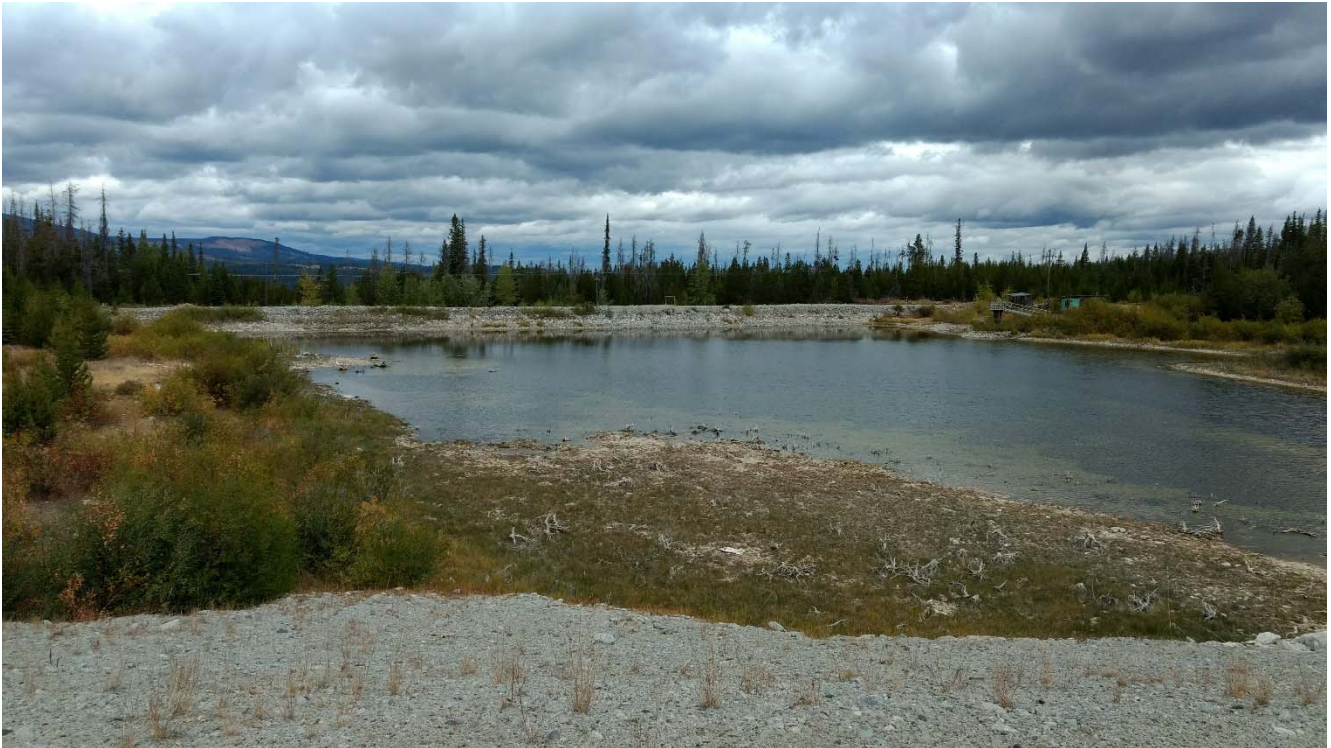
Photo II-B-1 S2: pond overview, looking from toe of North Dam. (HGH-2017-11)

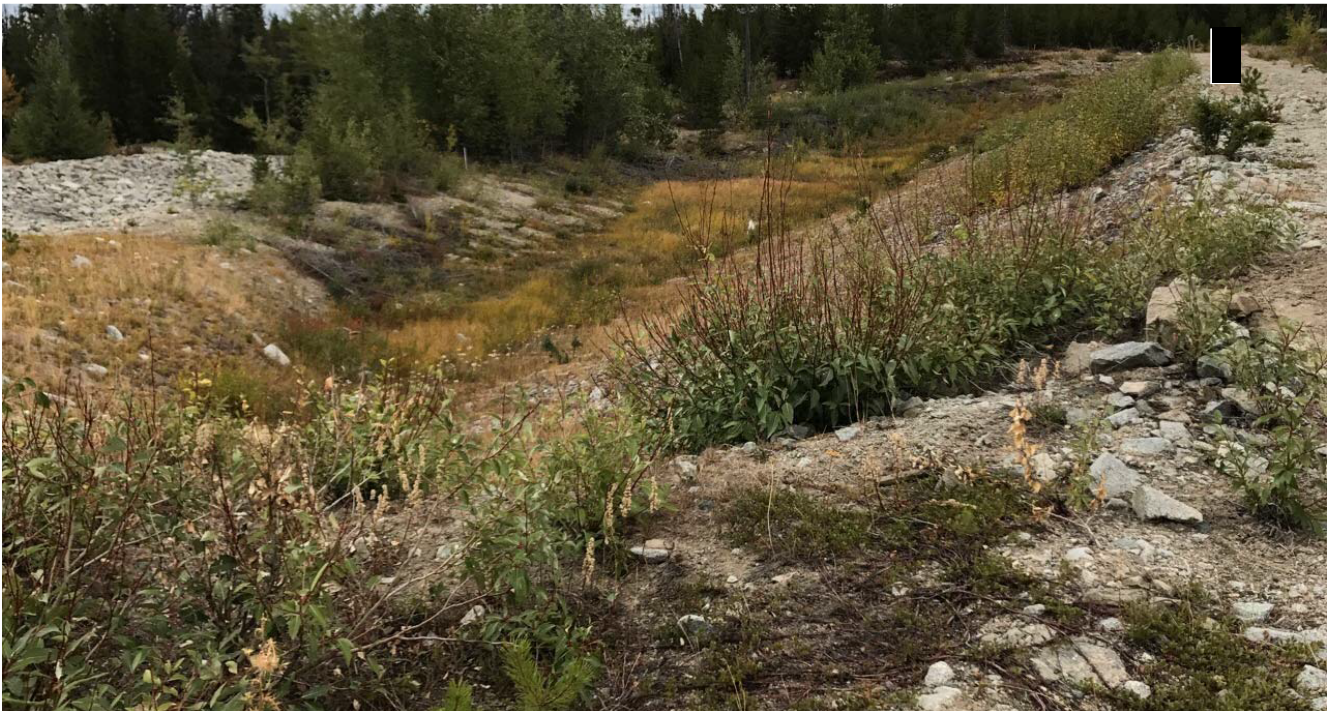
Photo II-B-3 S2: downstream slope looking from left abutment. (HGH-2017-13)

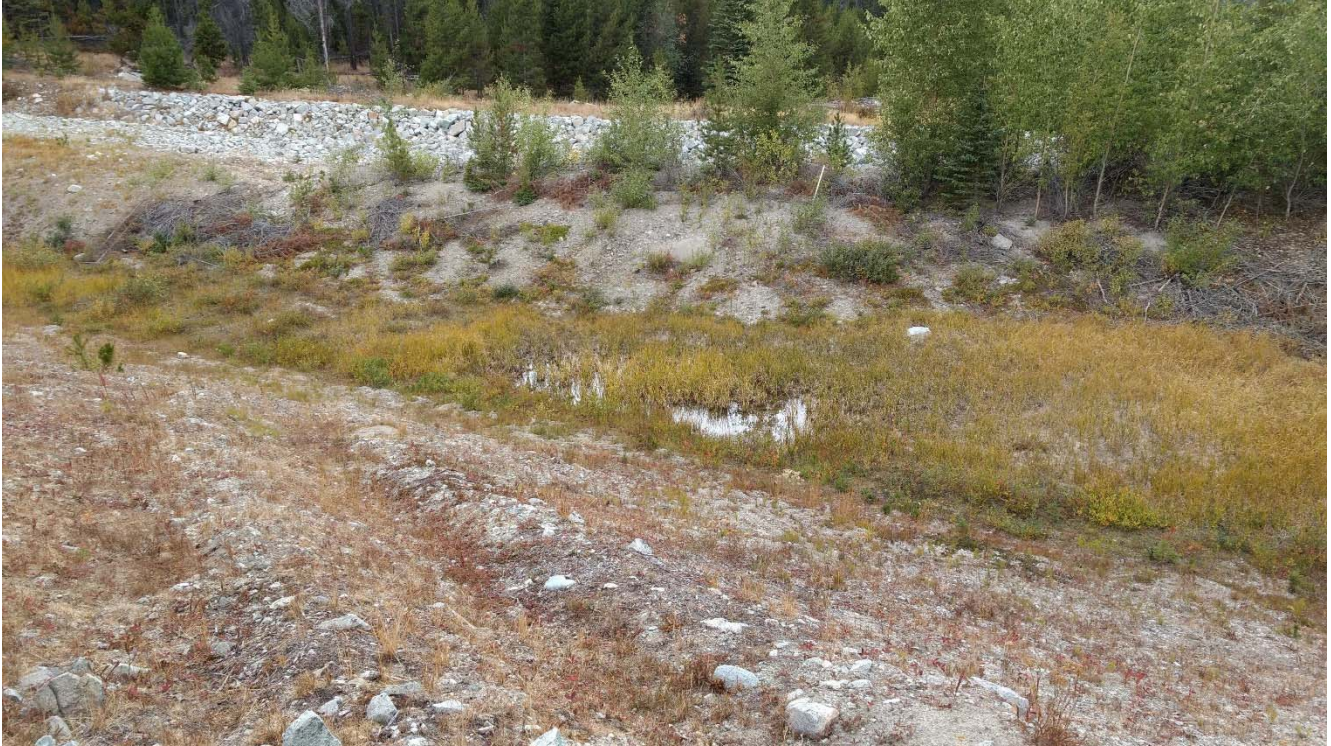
Photo II-B-4 S2: ponded water at downstream toe, similar in size to the pond noted during the 2015 and 2016 DSI. (HGH-2017-14)

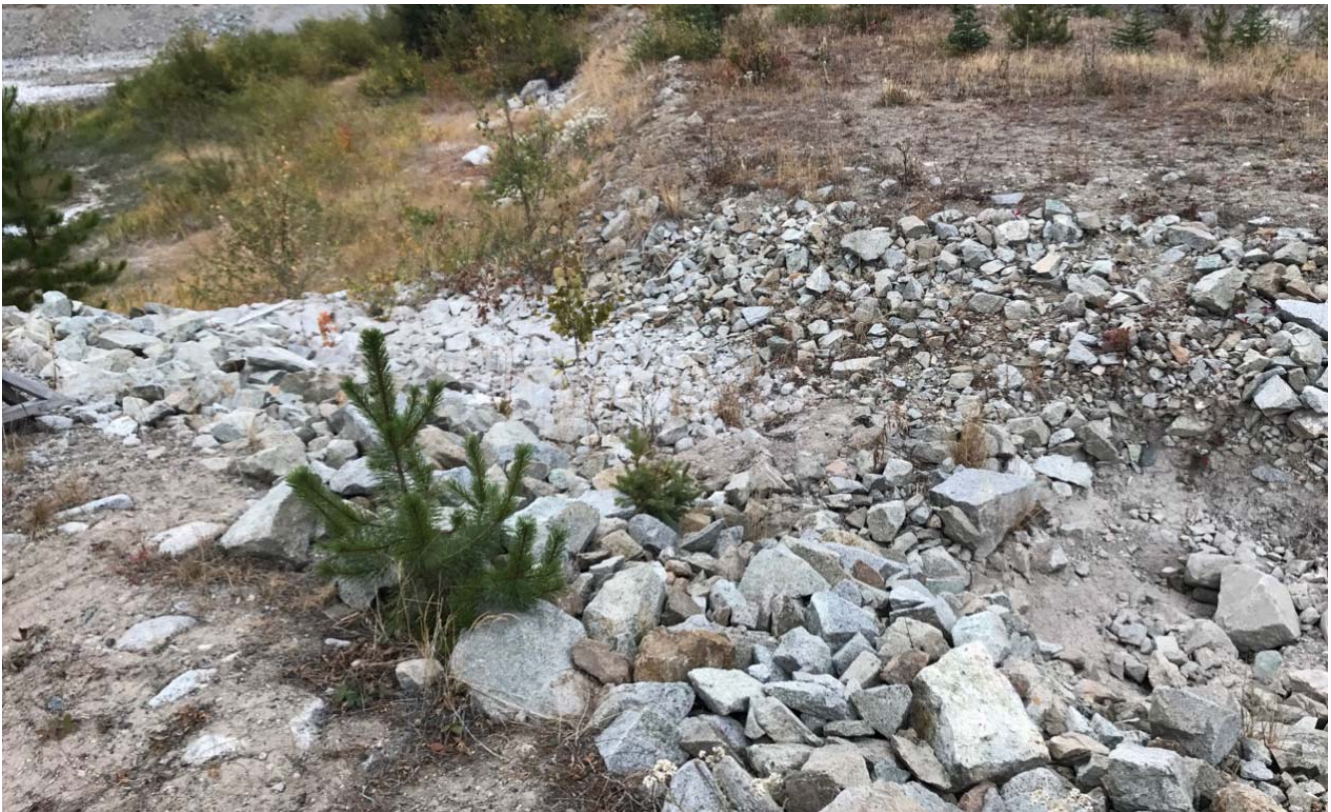
Photo II-B-7 S2: spillway looking upstream towards pond. (HGH-2017-13)

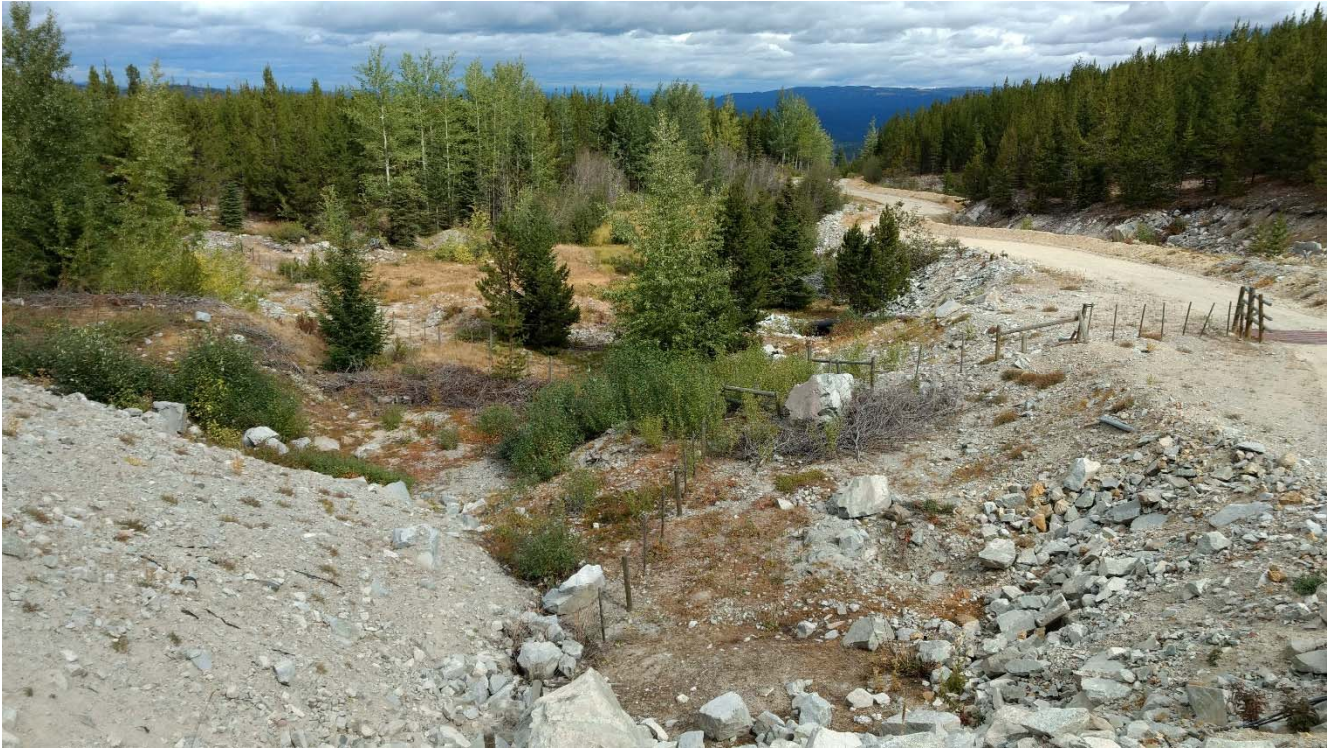
Photo II-B-18 S1: spillway outlet. (HGH-2017-27)

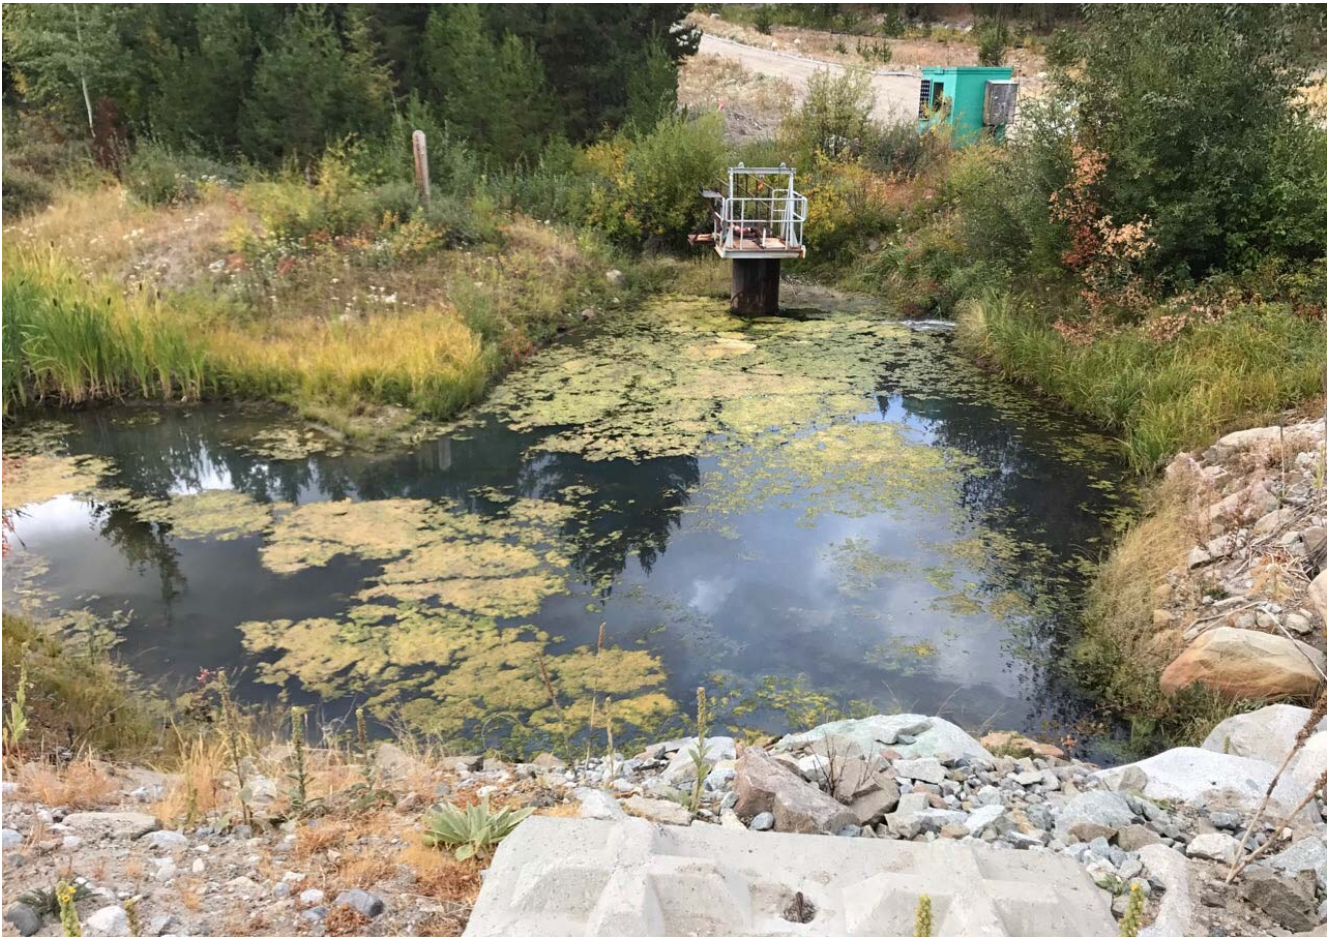
Photo II-B-21 S5: pumping cell with outlet pump to S1 pond. (HGH-2017-36)

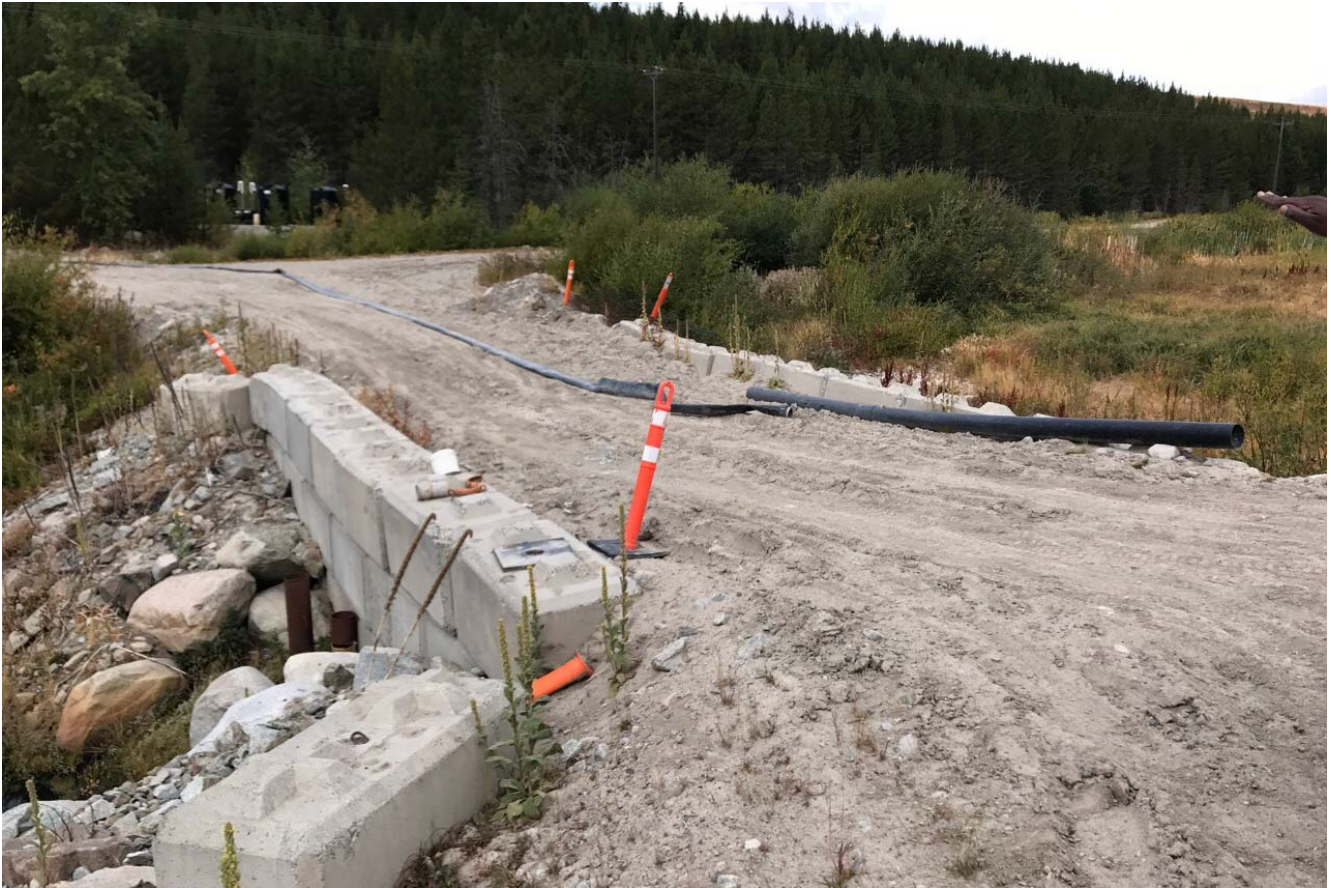
Photo II-B-22 S5: access road between central pond (right of photo) and pumping cell (left of photo). (HGH-2017-36)

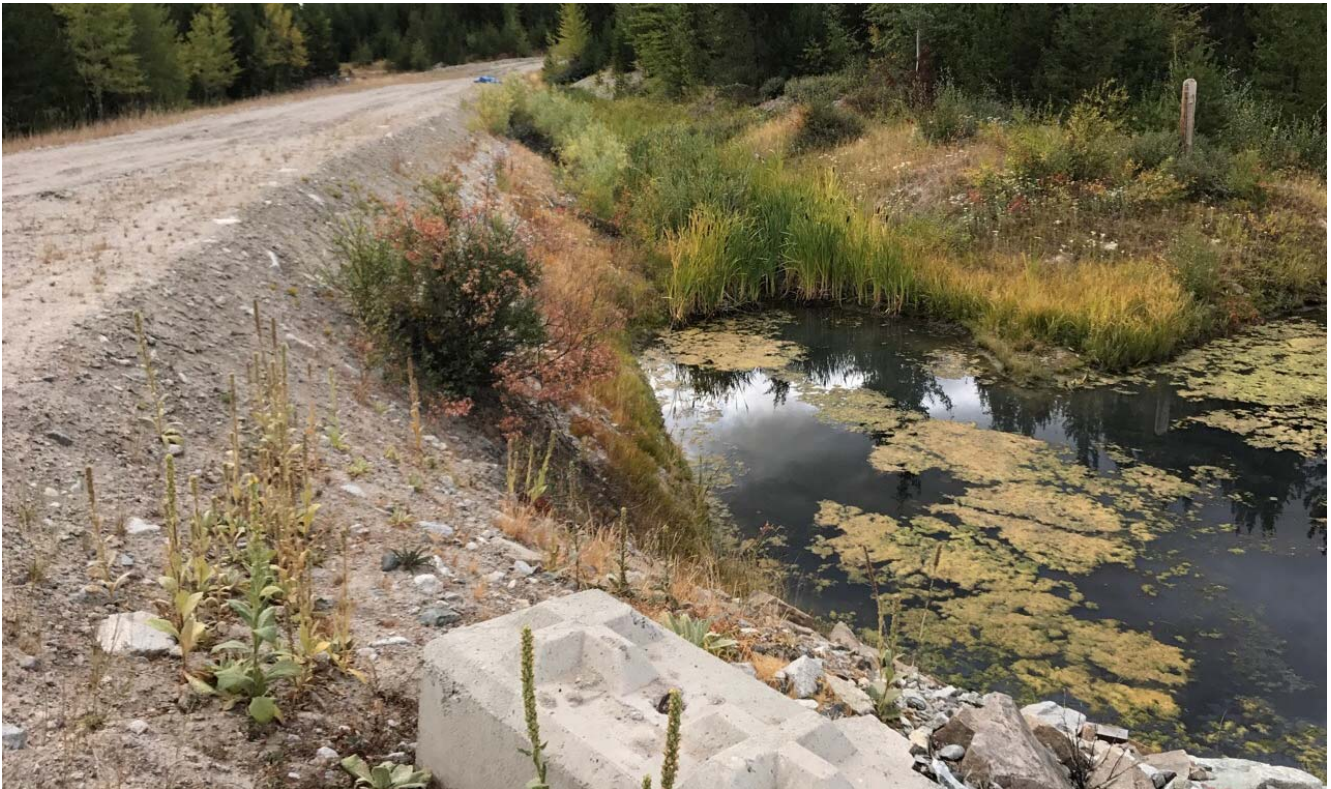
Photo II-B-23 S5: pumping cell looking South towards outlet channel and spillway. (HGH-2017-36)

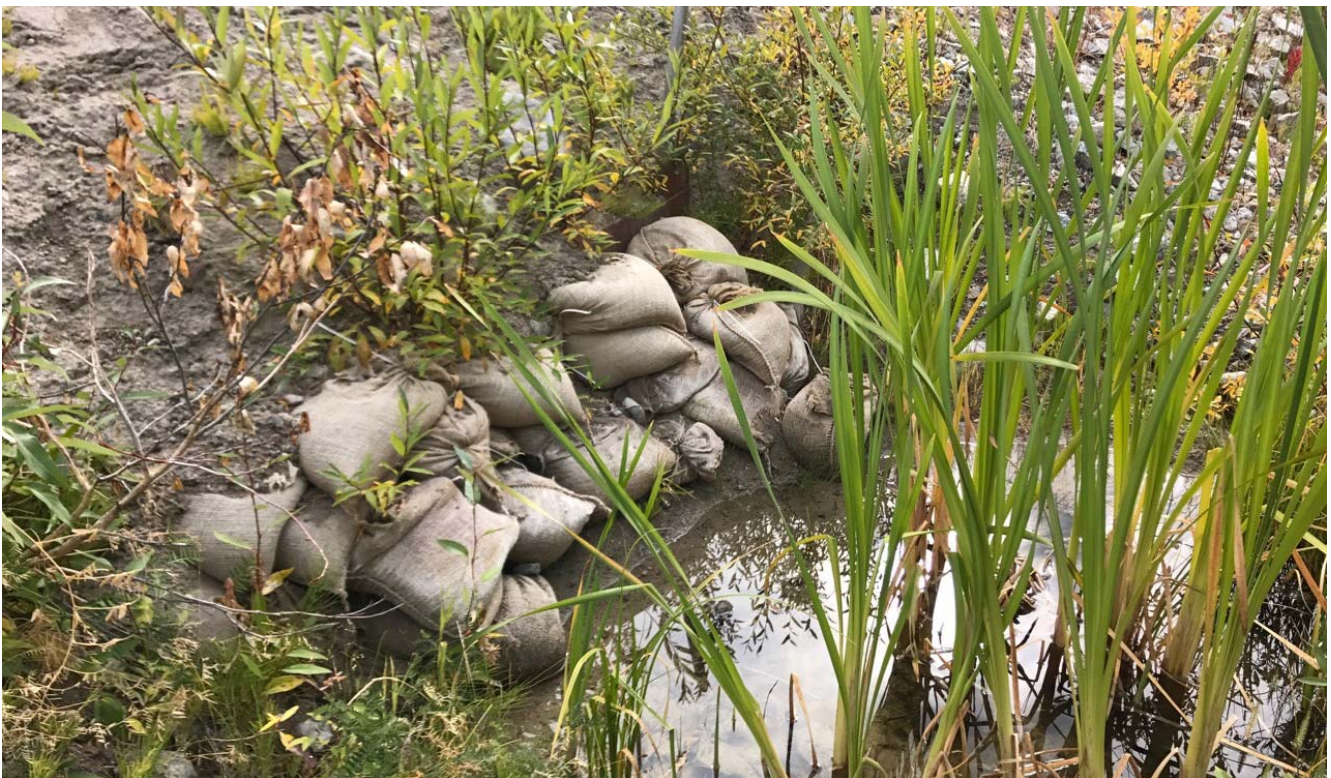
Photo II-B-26 S5: spillway pipes (2x), inlet currently blocked with sand bags. (HGH-2017-37)

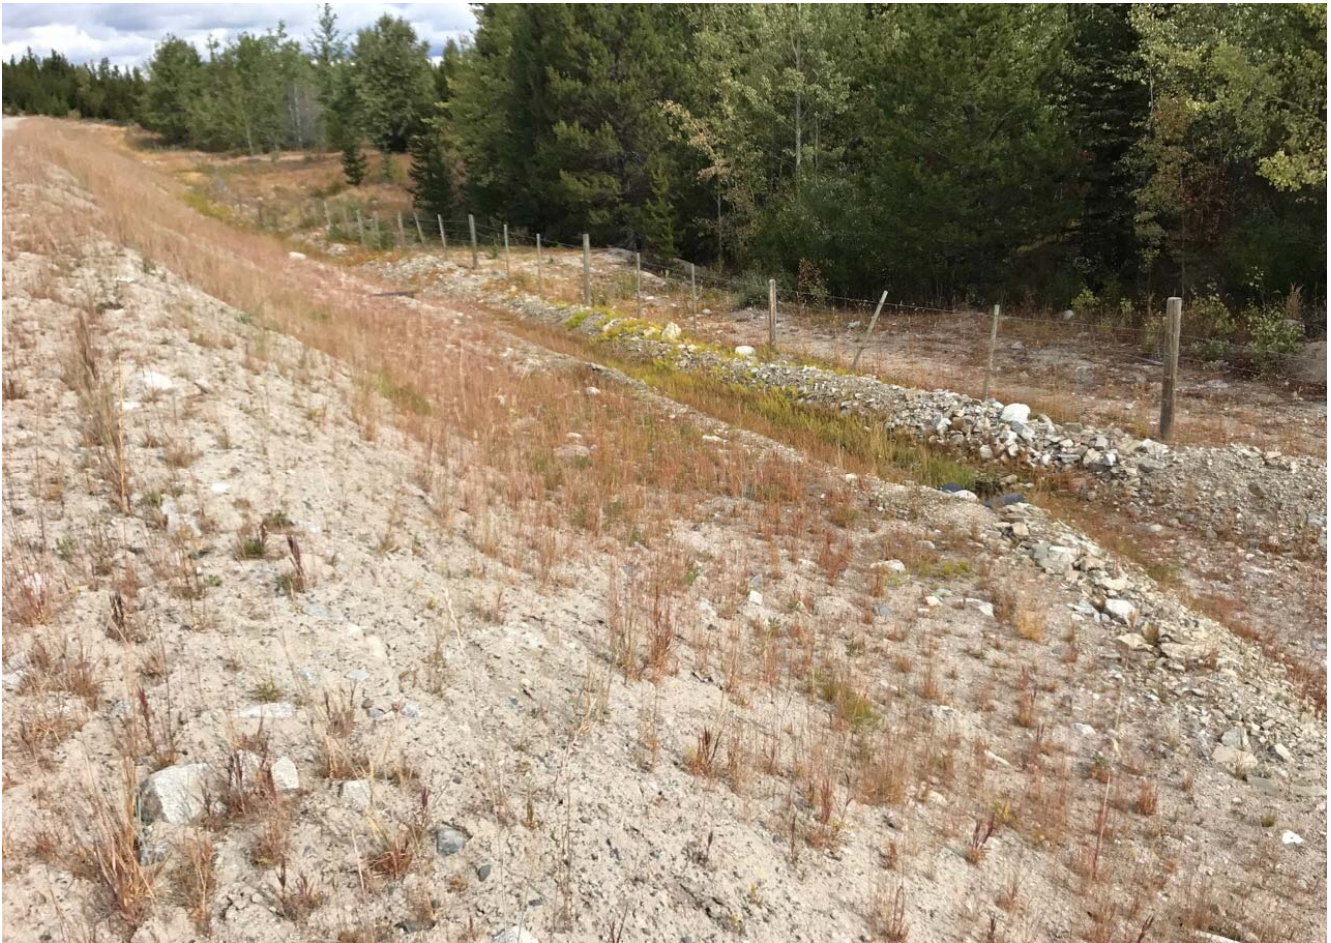
Photo II-B-27 S5: downstream slope and spillway pipes outlet at toe of dam. (HGH-2017-39)
