Teck Highland Valley Copper Partnership

2017 Dam Safety Inspection Report

Trojan Tailings Storage Facility

March 2018

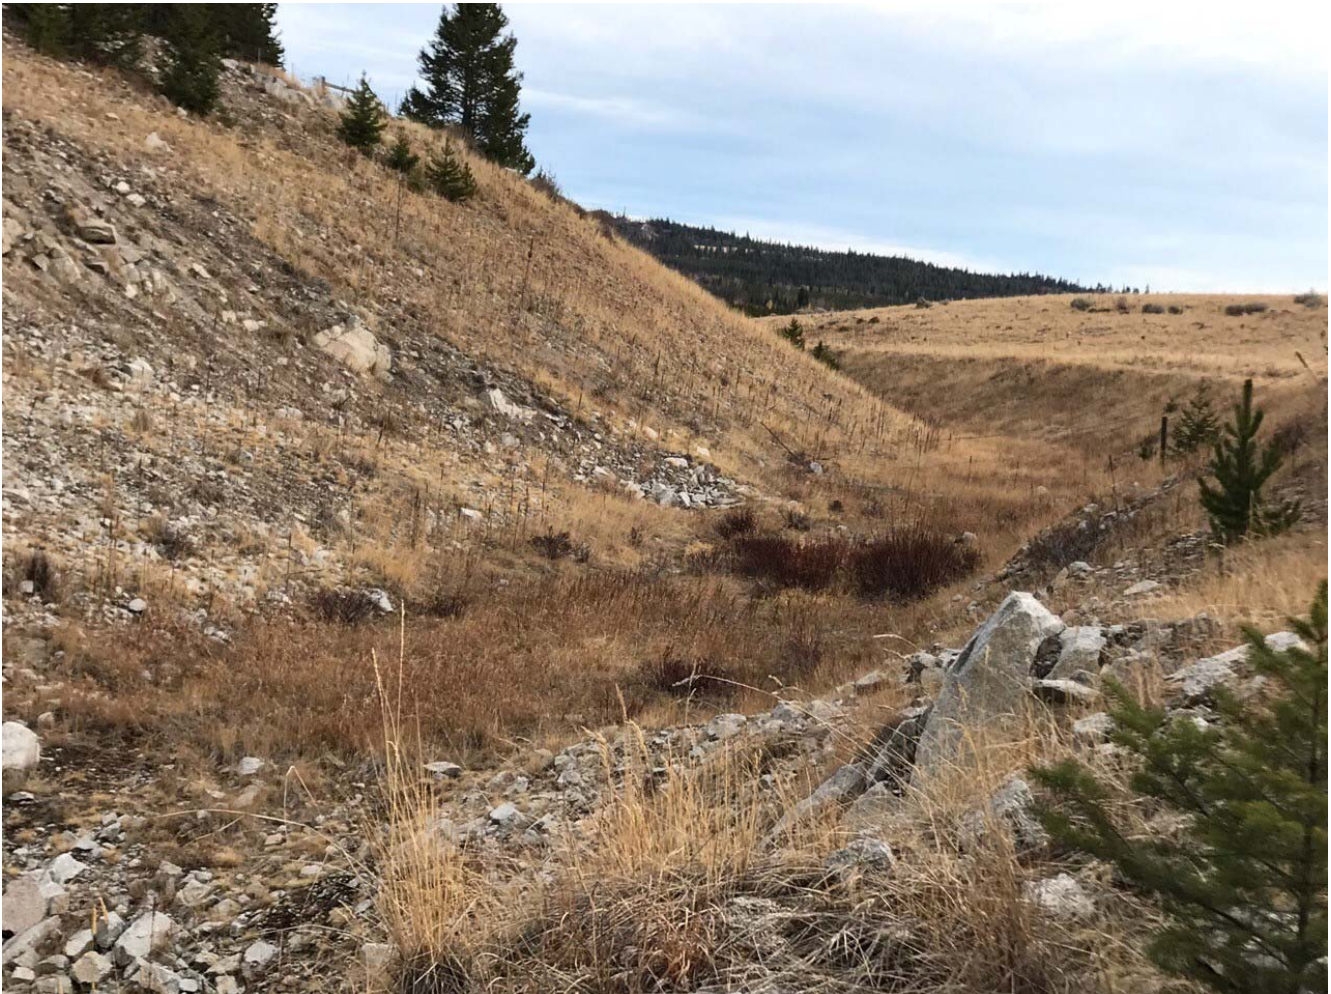
Photo II-A- 18 Spillway curve at transition point from till to bedrock view upstream (TRJ-2017-03)

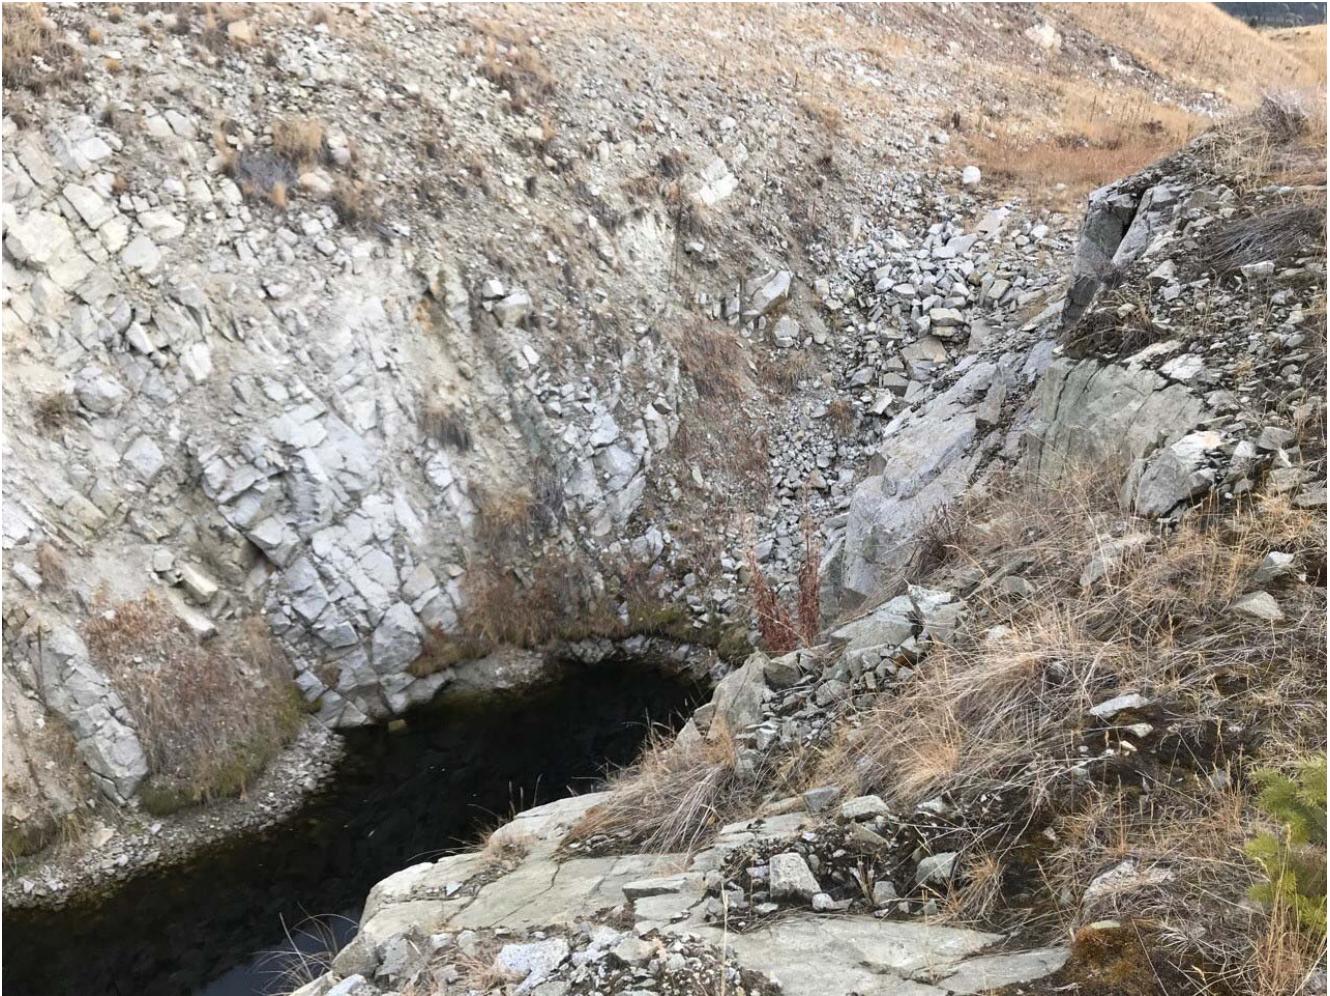
Photo II-A- 19 Spillway channel transition to bedrock with pooled water at low point, minor water level decrease from 2016 DSI inspection (TRJ-2017-03)

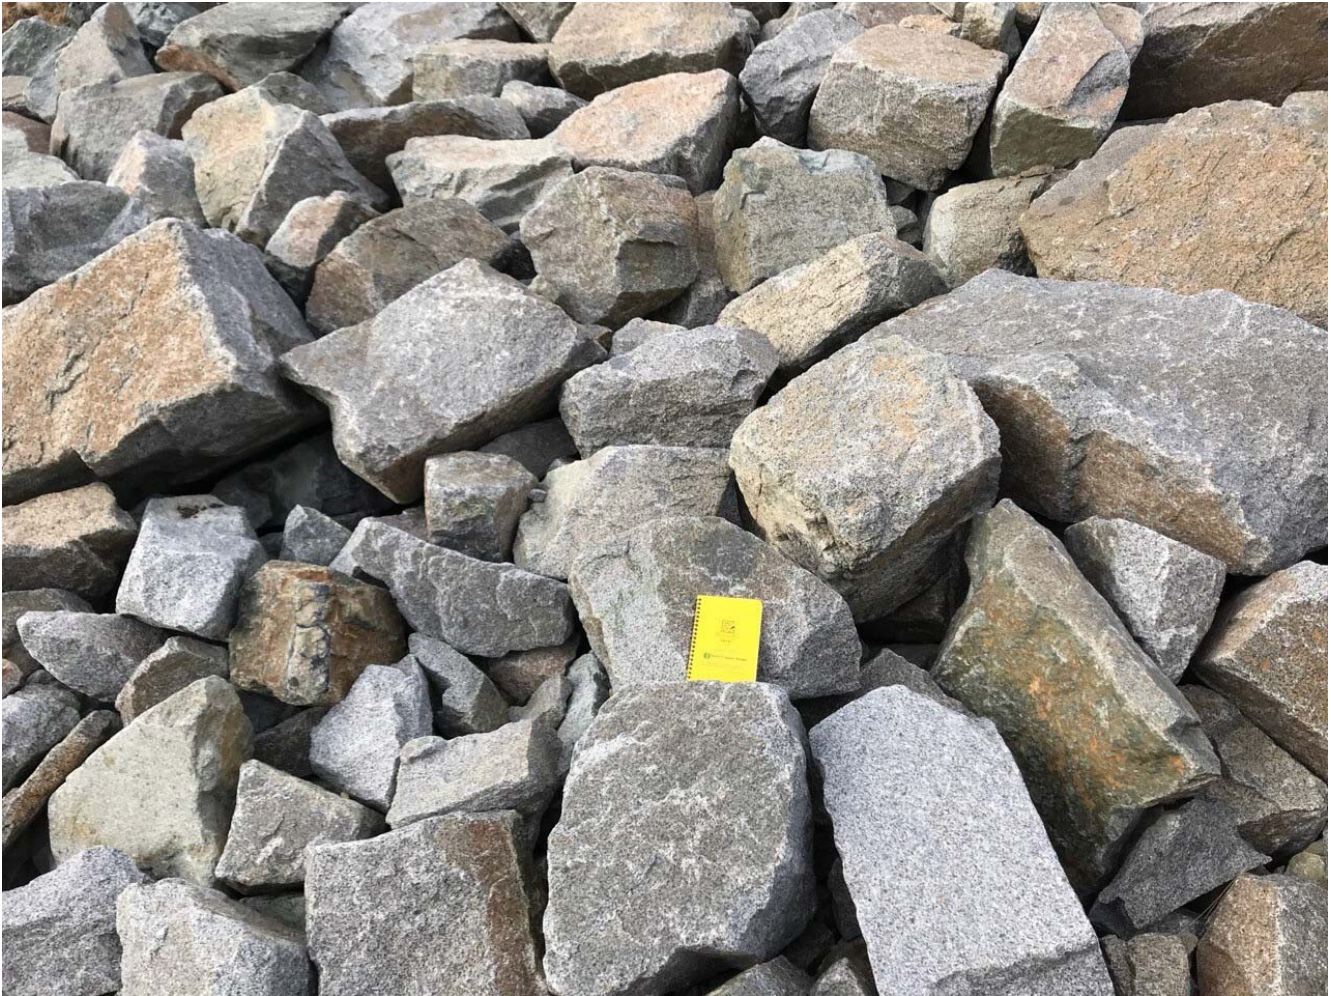
Photo II-A- 22 Overview of large riprap at transition point from large to small. Small riprap ~100mm, Coarser riprap ~150-1200mm (TRJ-2017-04)

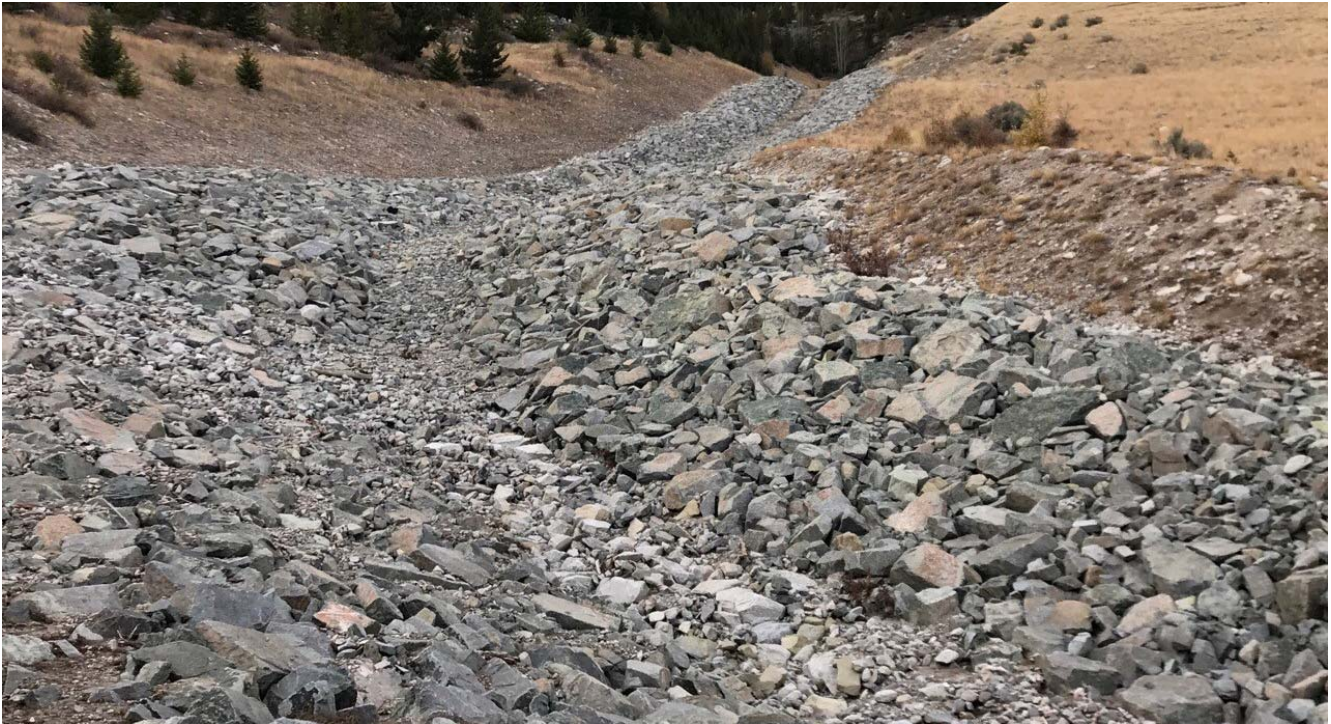
Photo II-A- 23 Spillway channel lower left bank view upstream. Riprap in good condition boulders >1m in size (TRJ-2017-05)

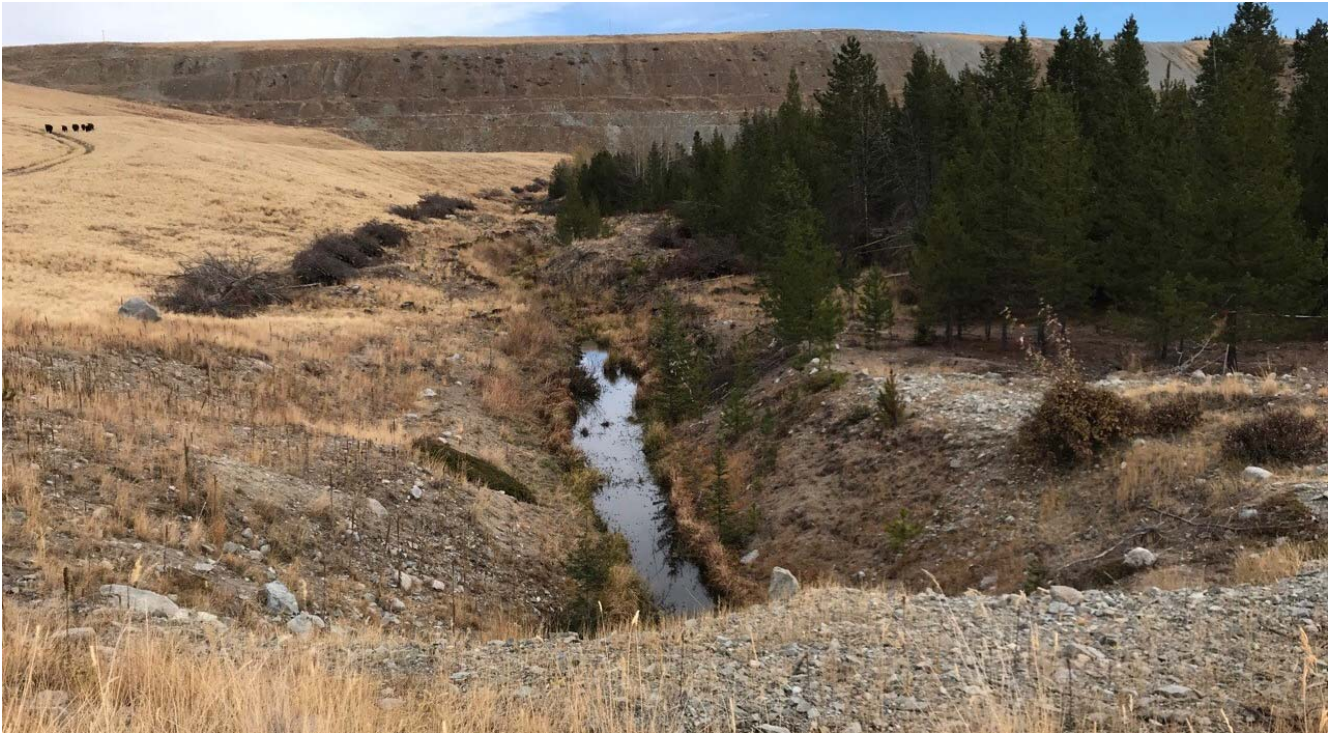
Photo II-A- 25 Seepage collection ditch view towards Bethlehem Dam. Flow observed, along with local ponding at channel low points (TRJ-2017-07)

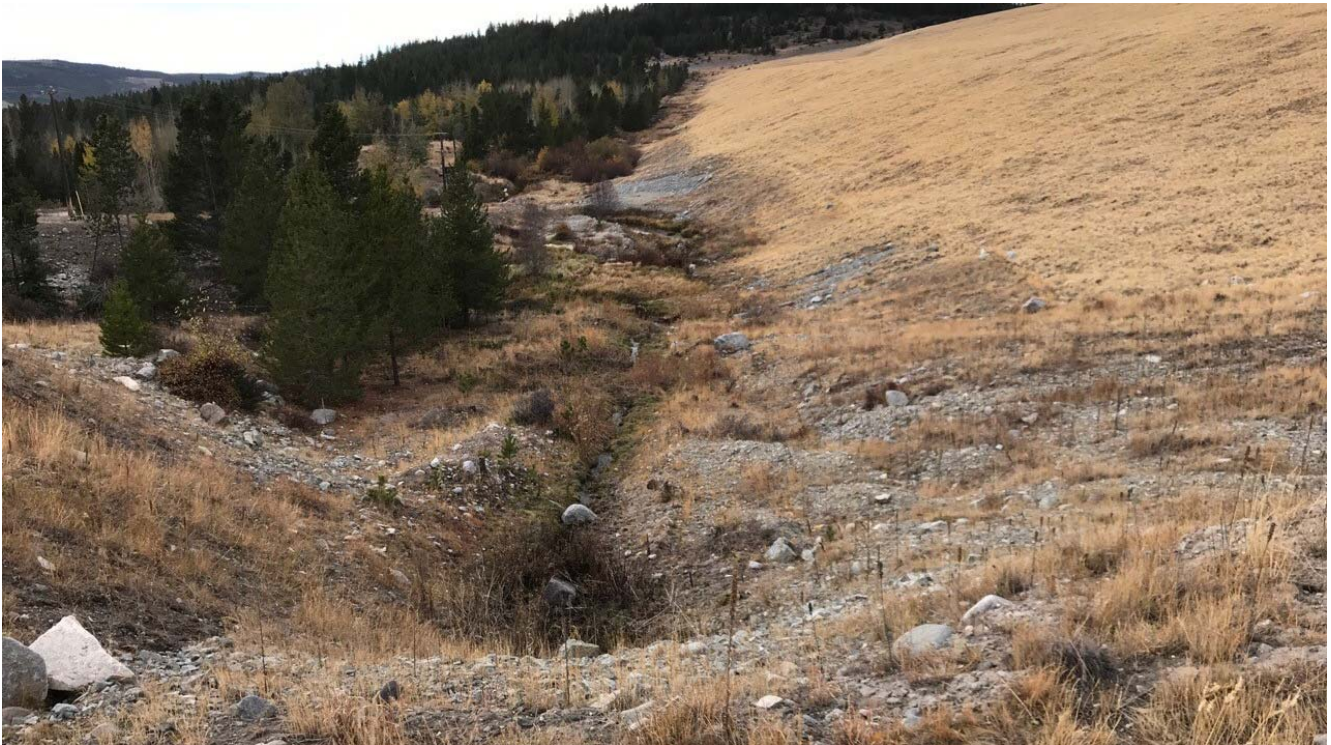
Photo II-A- 26 Seepage collection ditch view towards right abutment, flow observed (TRJ-2017-07)

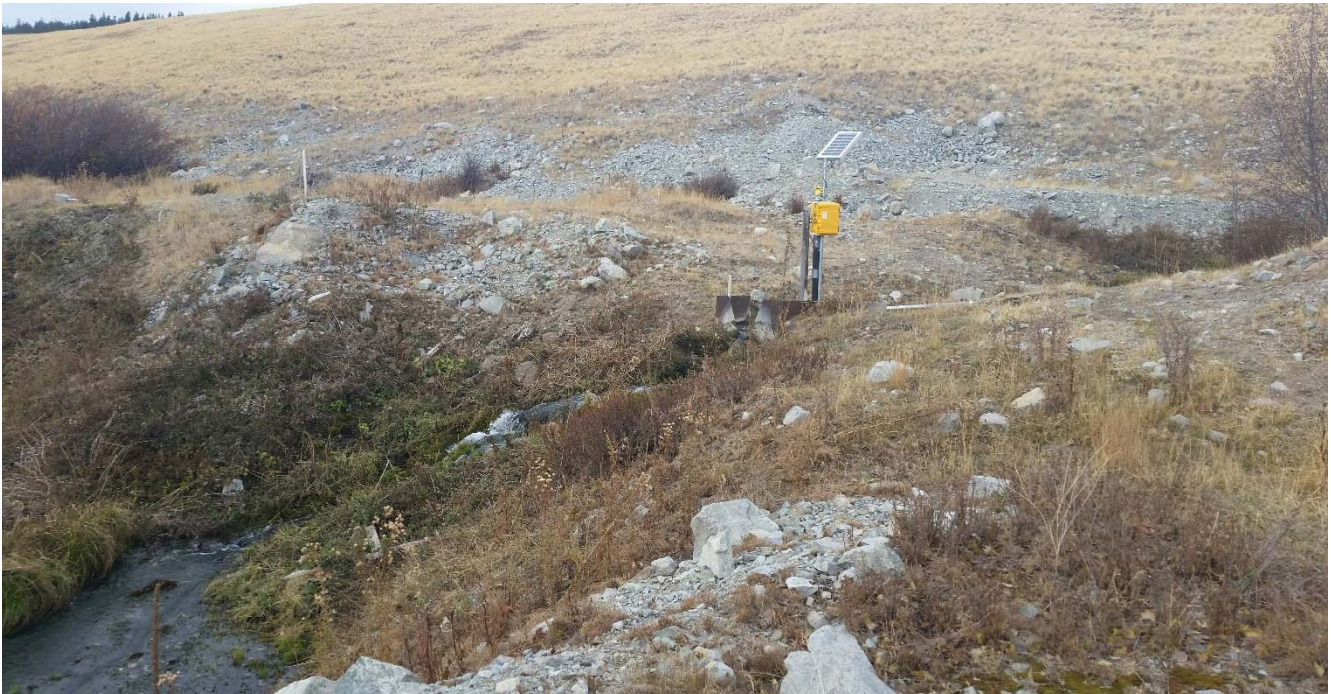
Photo II-A- 27 Weir for left abutment seepage toe drain, flow observed (TRJ-2017-06)

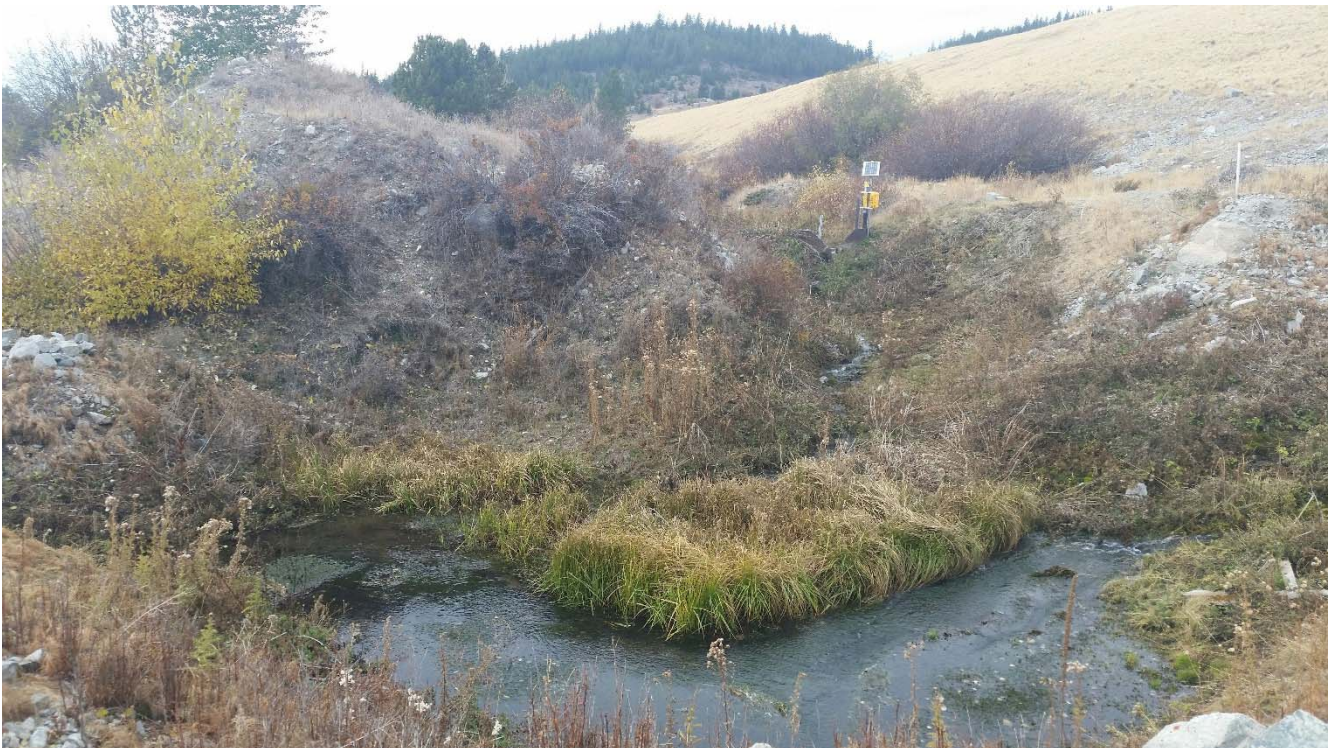
Photo II-A- 28 Weir for right abutment seepage toe drain, flow observed (TRJ-2017-06)

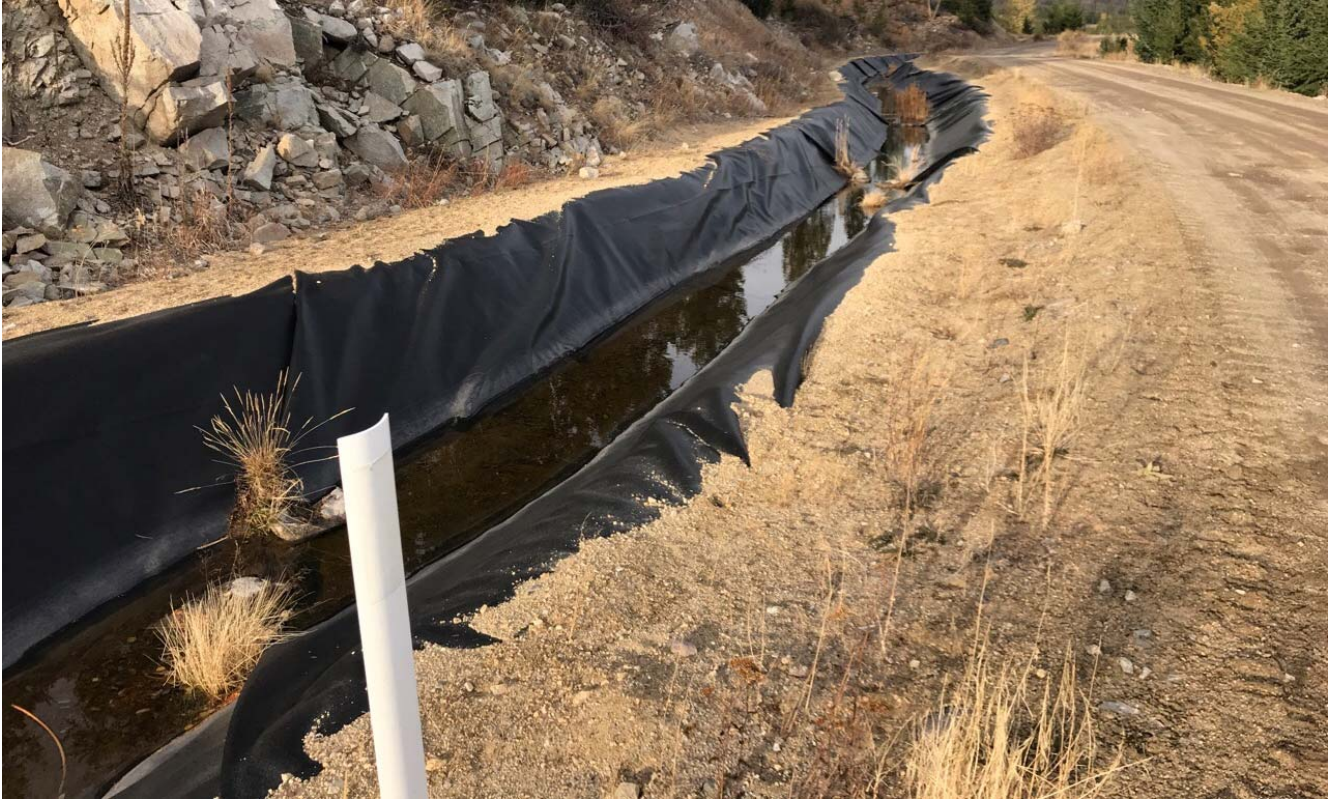
Photo II-A- 29 Lined diversion channel looking upstream, minor vegetation present (TRJ-2017-08)

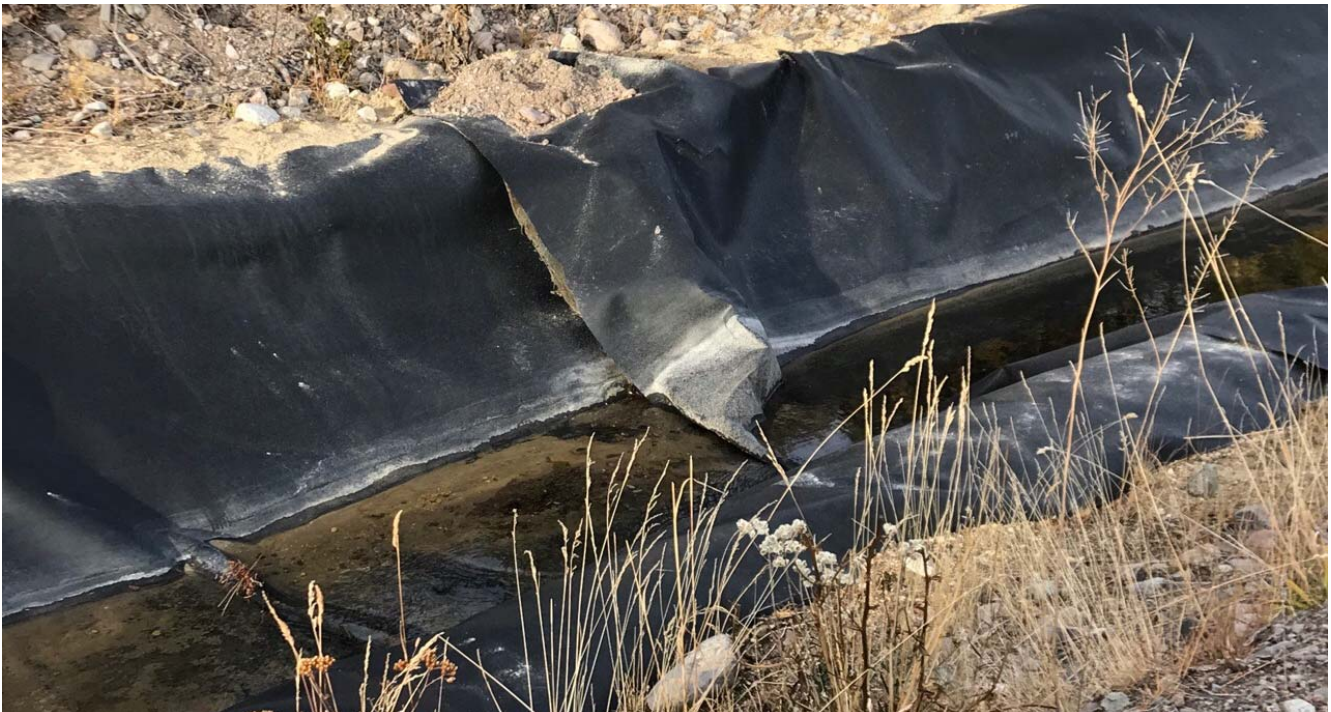
Photo II-A- 30 Damage to liner observed on diversion channel (TRJ-2017-26)

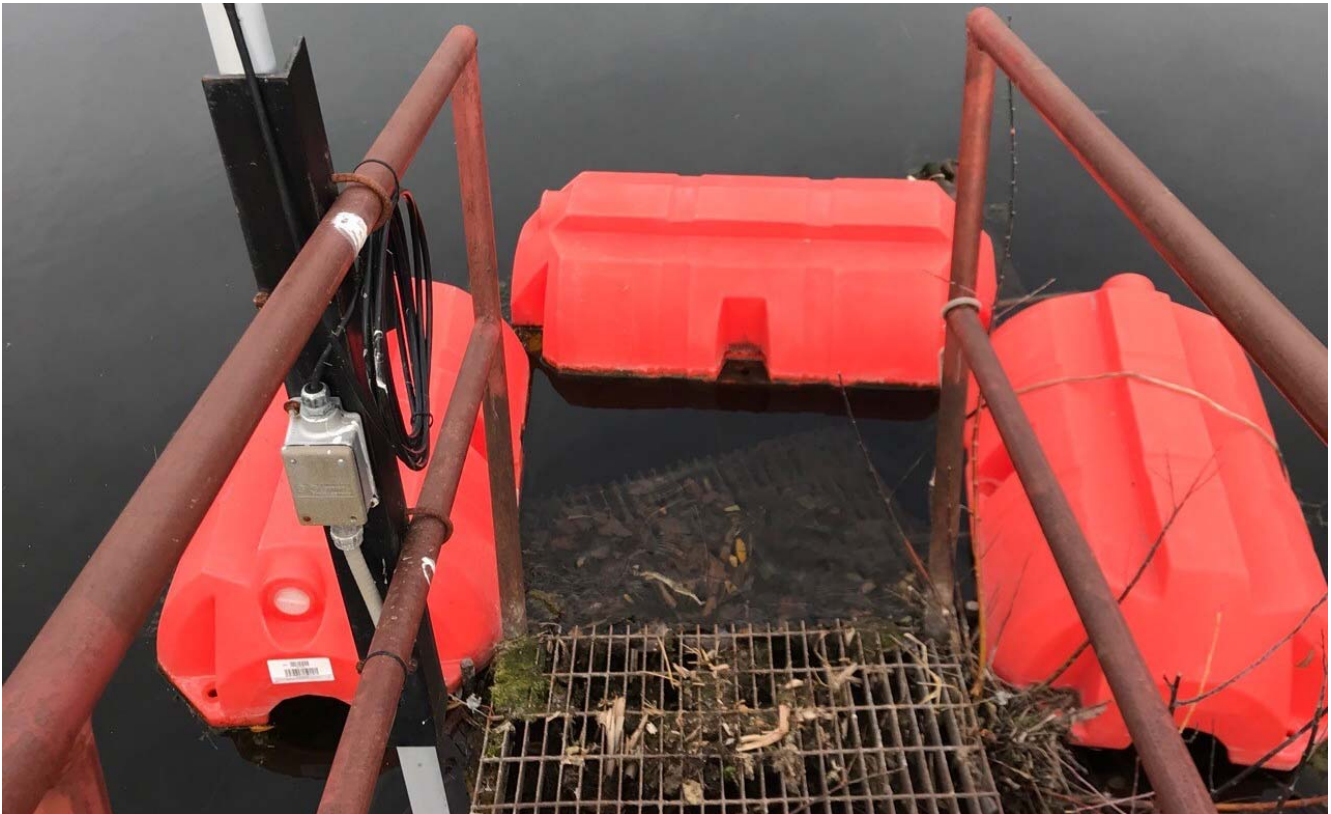
Photo II-C- 10 Debris boom and outfall intake. Obstruction from plant debris present (TRJ-2017-21)
