TECK COAL LIMITED GREENHILLS OPERATIONS

2017 Dam Safety Inspection for Greenhills Tailings Facility

Reference Number: 1778487-2017-130-R-Rev0-2000

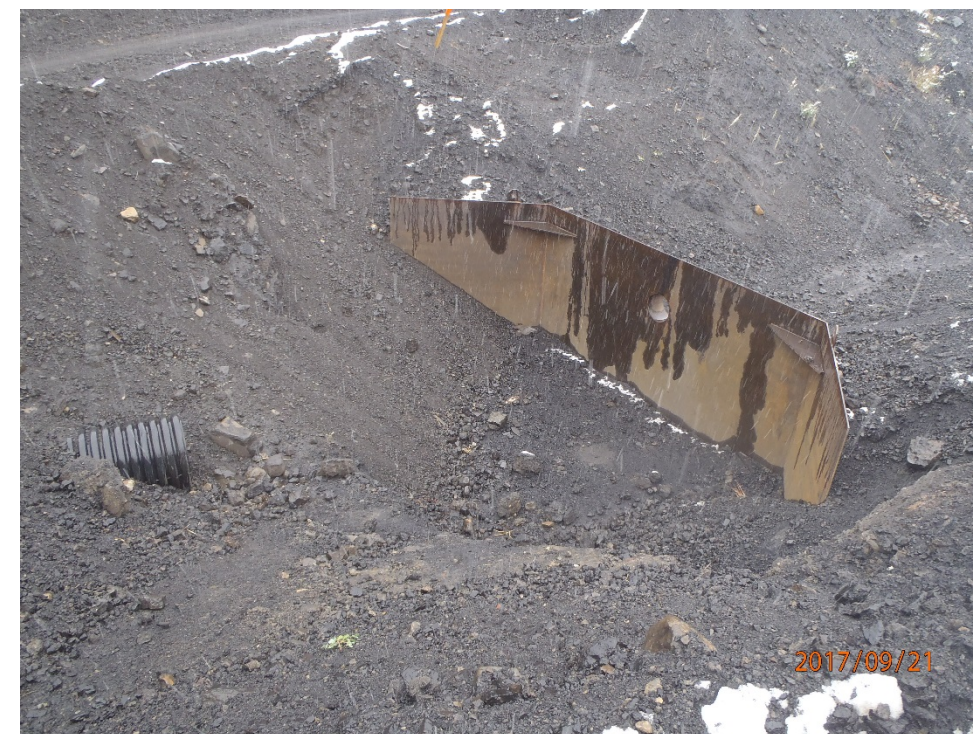
Photograph 12: Site C – view of new weir under construction on west side of refuse dump, looking north. 21 September 2017.

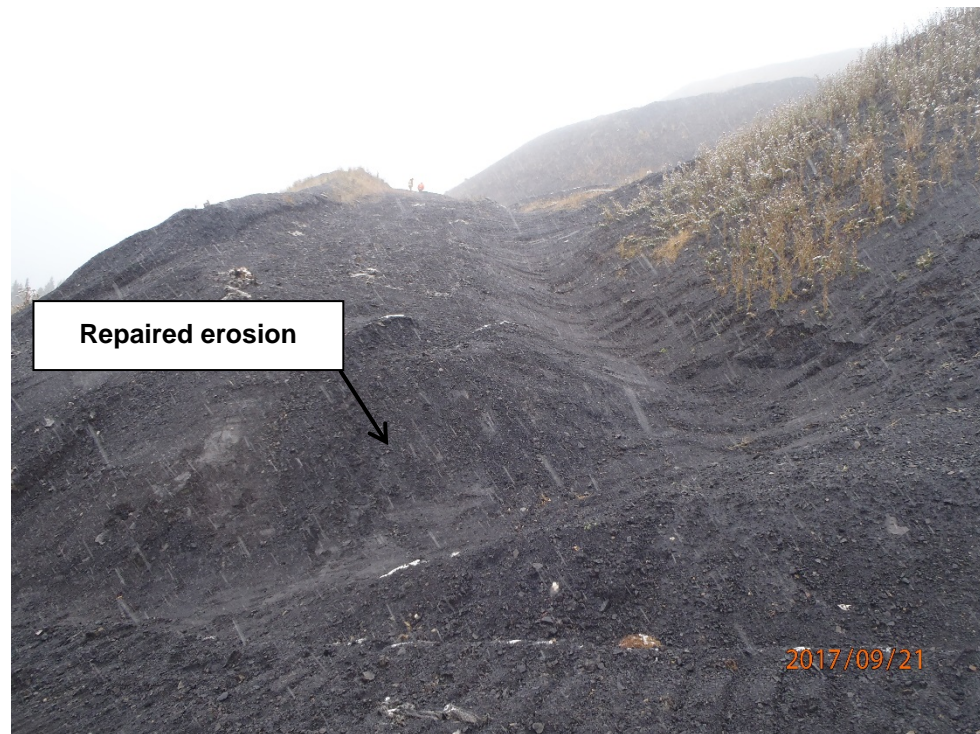
Photograph 13: Site C – repaired stormwater runoff erosion on west side of refuse dump, looking northwest. 21 September 2017.

2016-03	Stormwater runoff erosion channel has formed on the west side of Site C.	OMS Section 7.0	Continued erosion of Site C.	3	Site C erosion is to be repaired.	Q3 2017	Complete	10 to 12
2016-04	Capacity of the West Dam spillway may be insufficient.	n/a	Overtopping of the Main Dam during a large storm event.	3	Review the capacity of the West Dam spillway.	Q2 2017	No longer applicable. The emergency spillway was removed and the strategy for managing storms greater than the design event is currently being reviewed.	-
2016-05 (2015-01)	Broken seepage collection pipe at the toe of Site C.	n/a	Site C drainage impeded.	3	Repair drainage at toe of Site C. Review drainage design.	Q3 2017	Complete	13 to 14
2016-06 (2015-04)	No visual indicator of freeboard.	n/a	Potential for overtopping if GPS data is erroneous.	4	Provide visual marker (staff gauge or other).	Q3 2017	Complete A staff gauge, indicating the TARP warning levels, was installed in 2017.	3

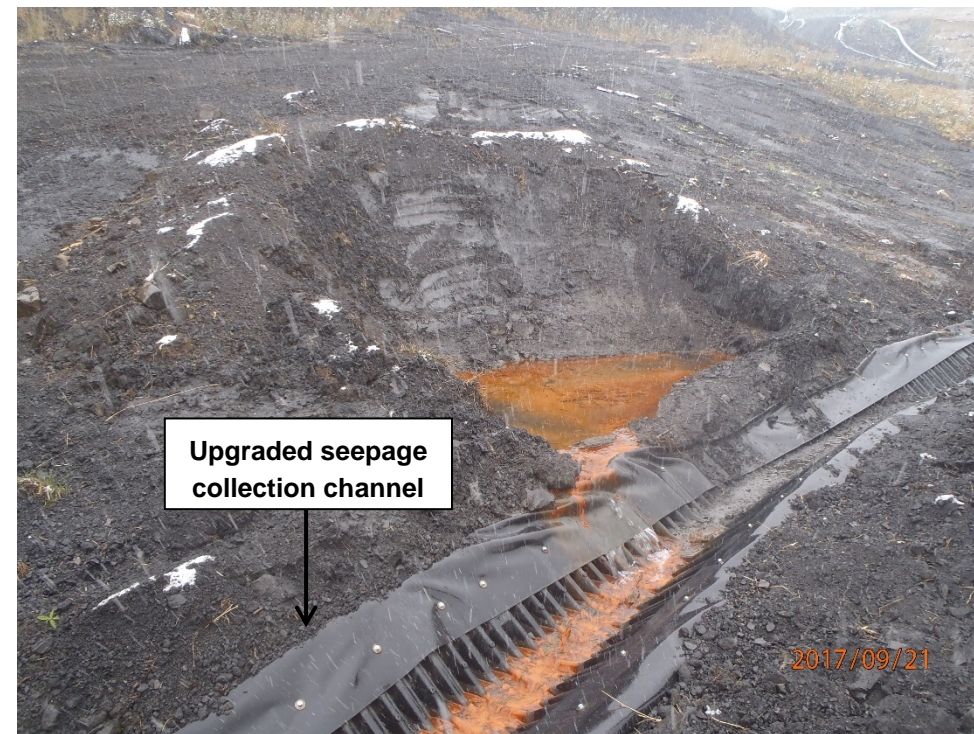
Photograph 14: Site C – view of upgraded seepage collection channel. Seepage water is red-brown. Looking northwest. 21 September 2017.

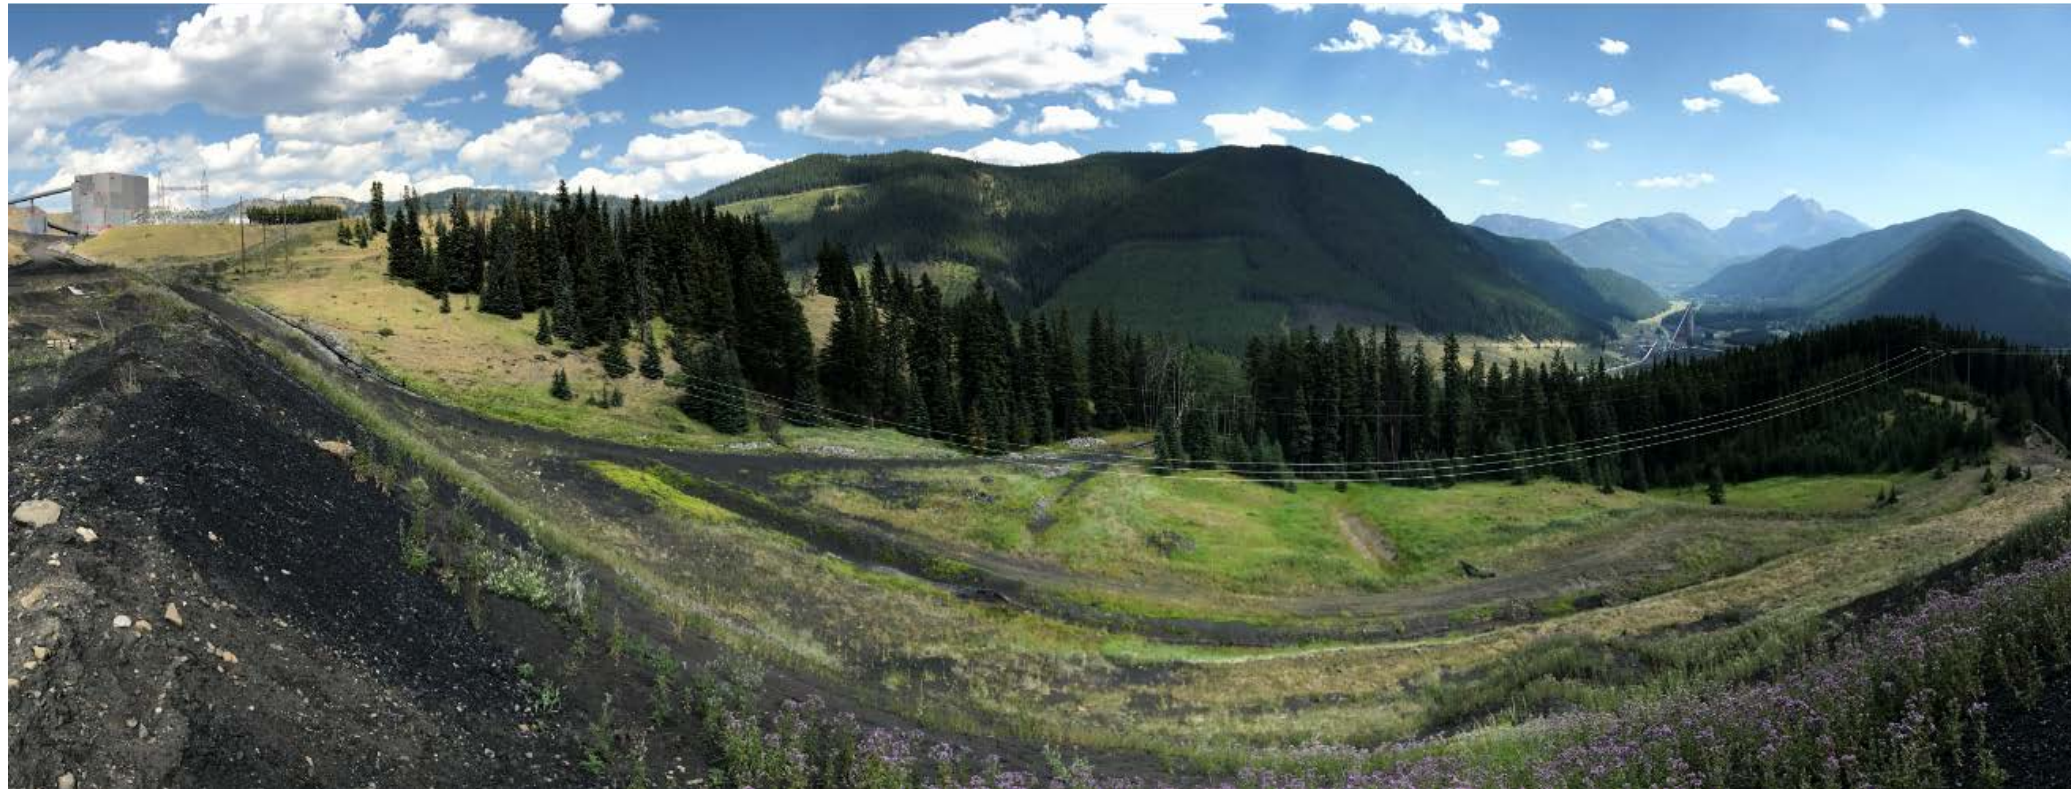
Photograph 17: Historic 2012 Site C failure scarp and toe bulge, looking east. No significant change since 2012. 30 July 2017.

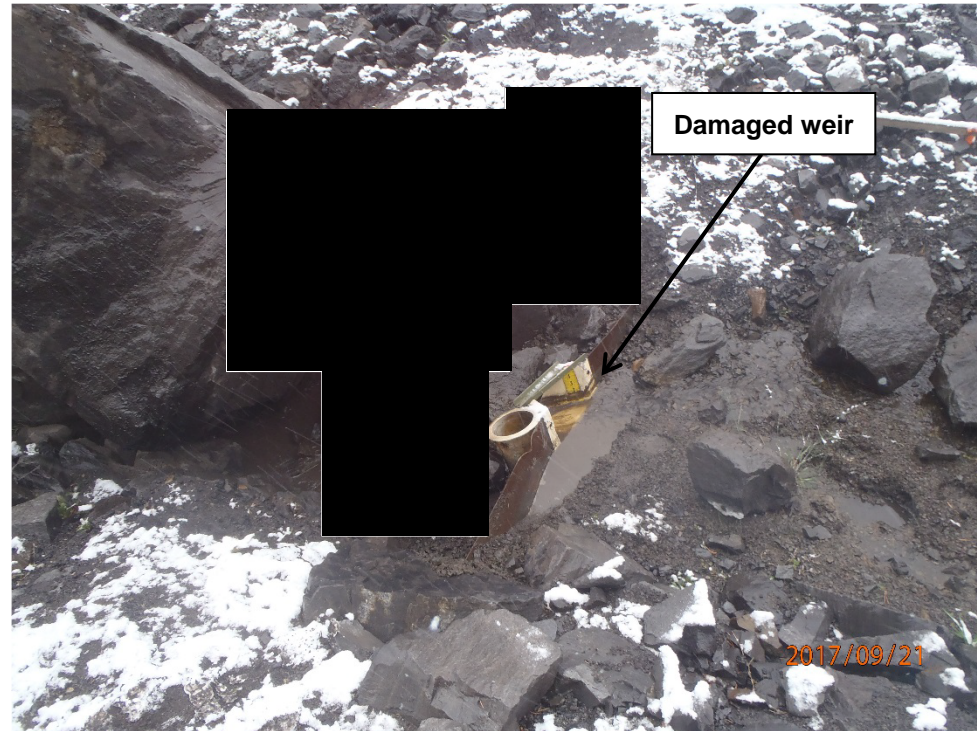
Photograph 25: West Dam – view of damaged weir in drainage channel along downstream slope at south abutment, looking north. 21 September 2017.

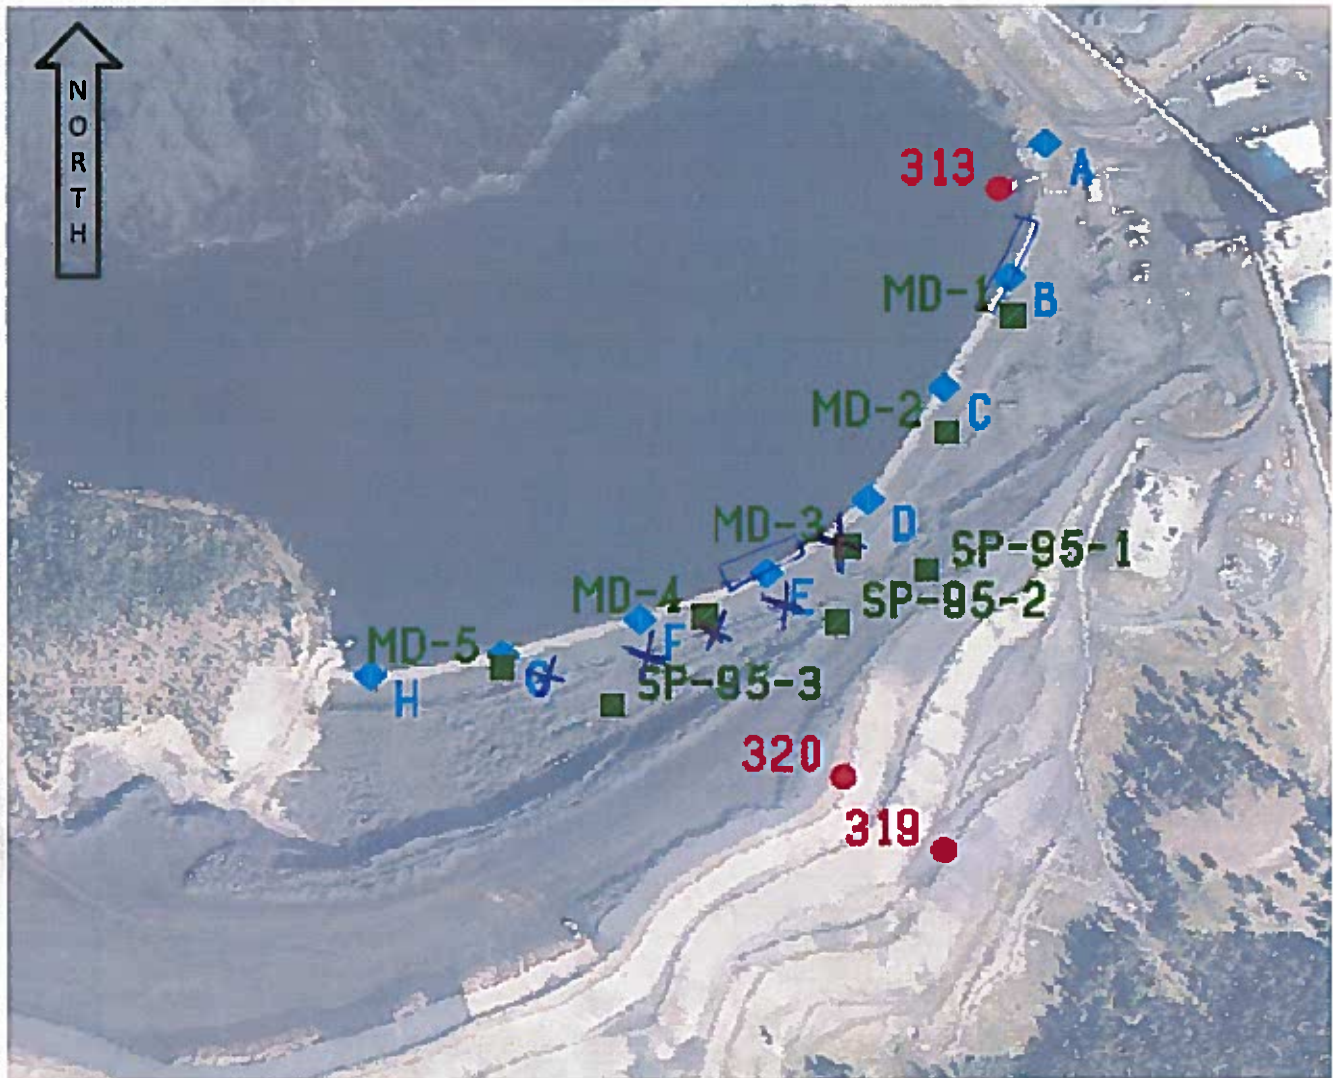
slough on upstream toe
X erosion channels in downstream slope

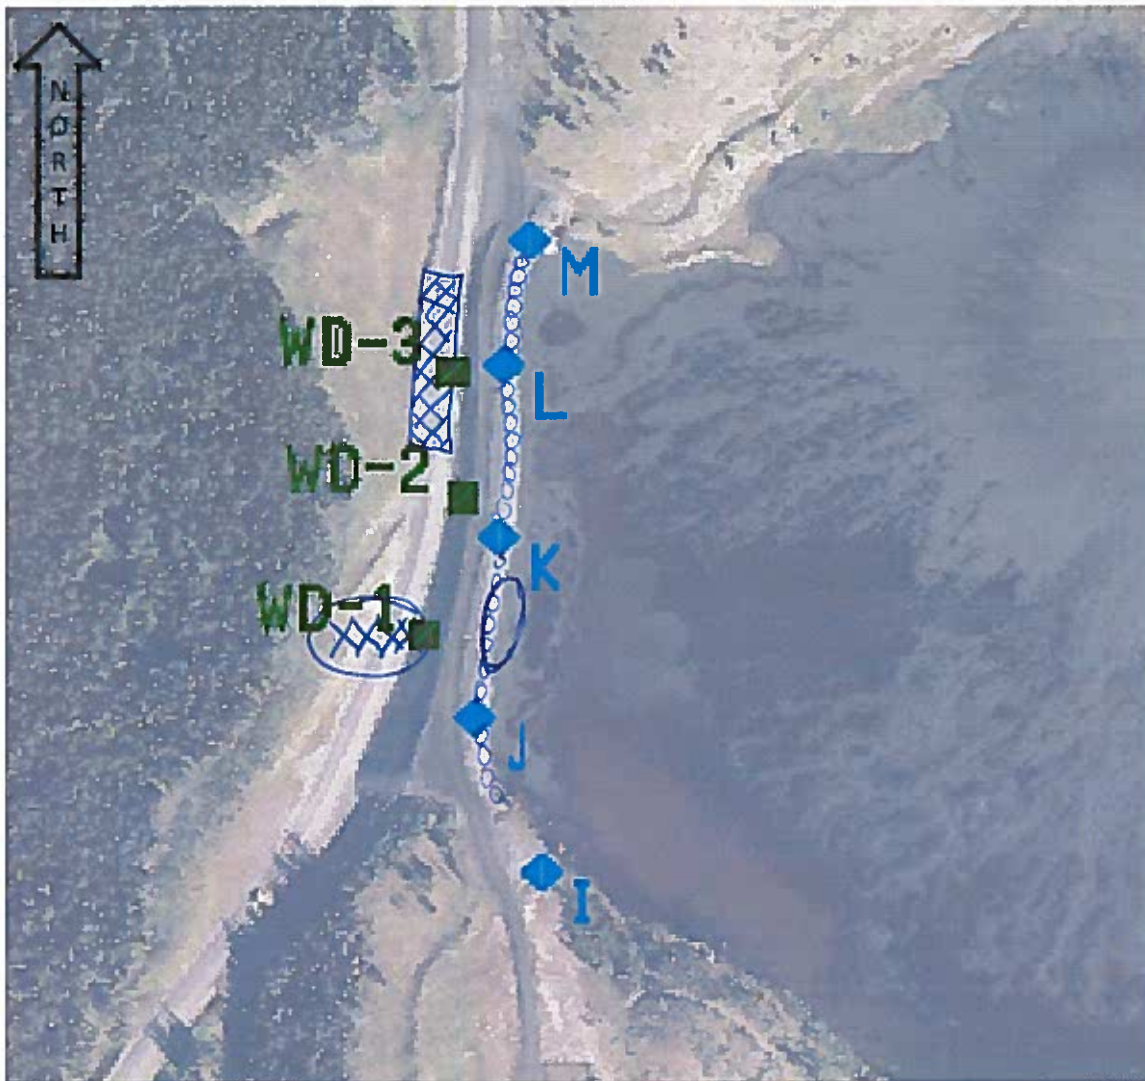
- XXXX - bulge.
- OOOO - minor surficial cracks on crest + fill erosion on slope
- O - low lying grass like veg shallow roots, no concern
- XXX - up to 3ft deep erosion channel

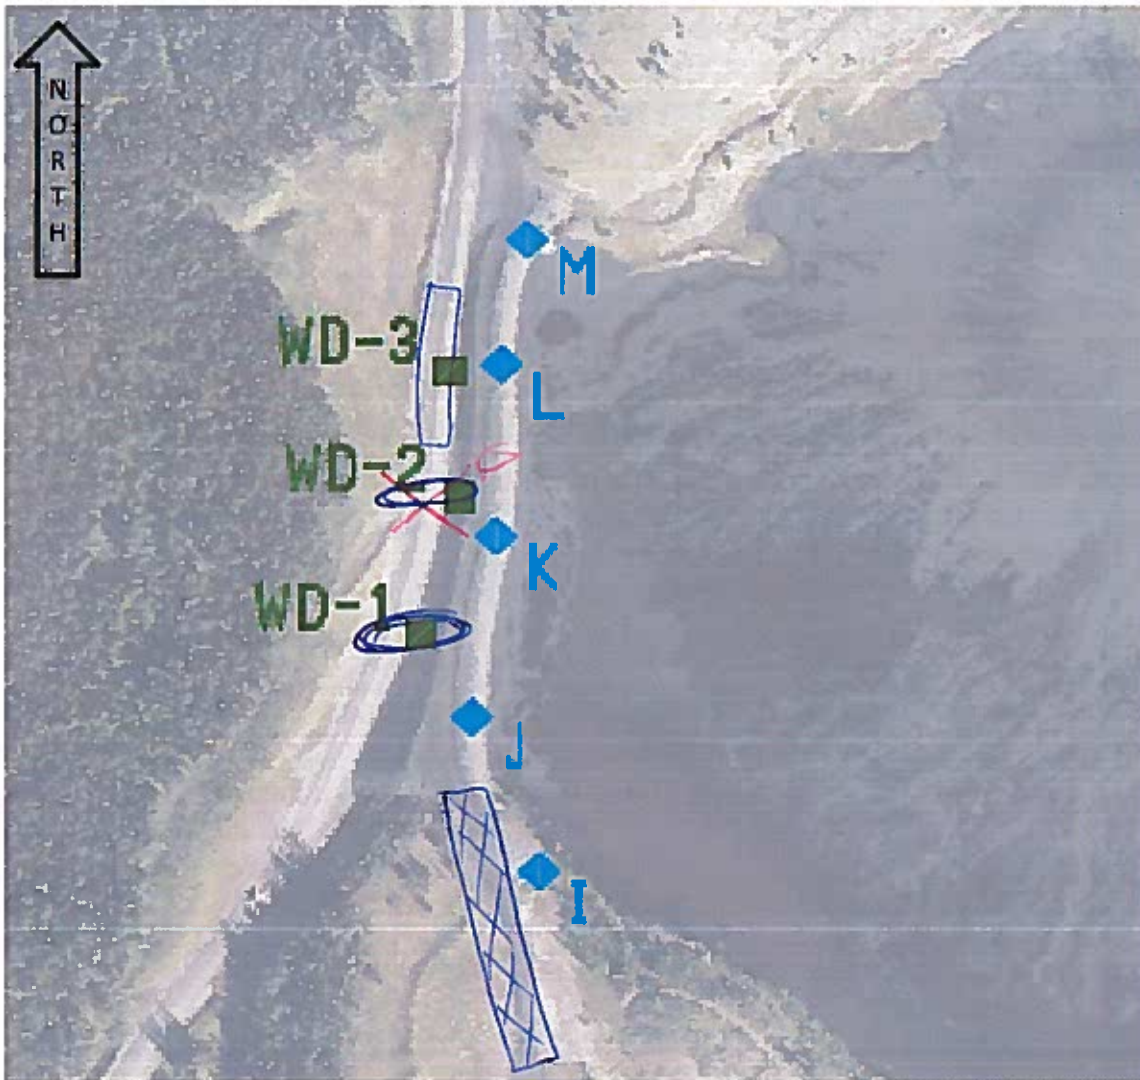
□ - potential area of bulging.

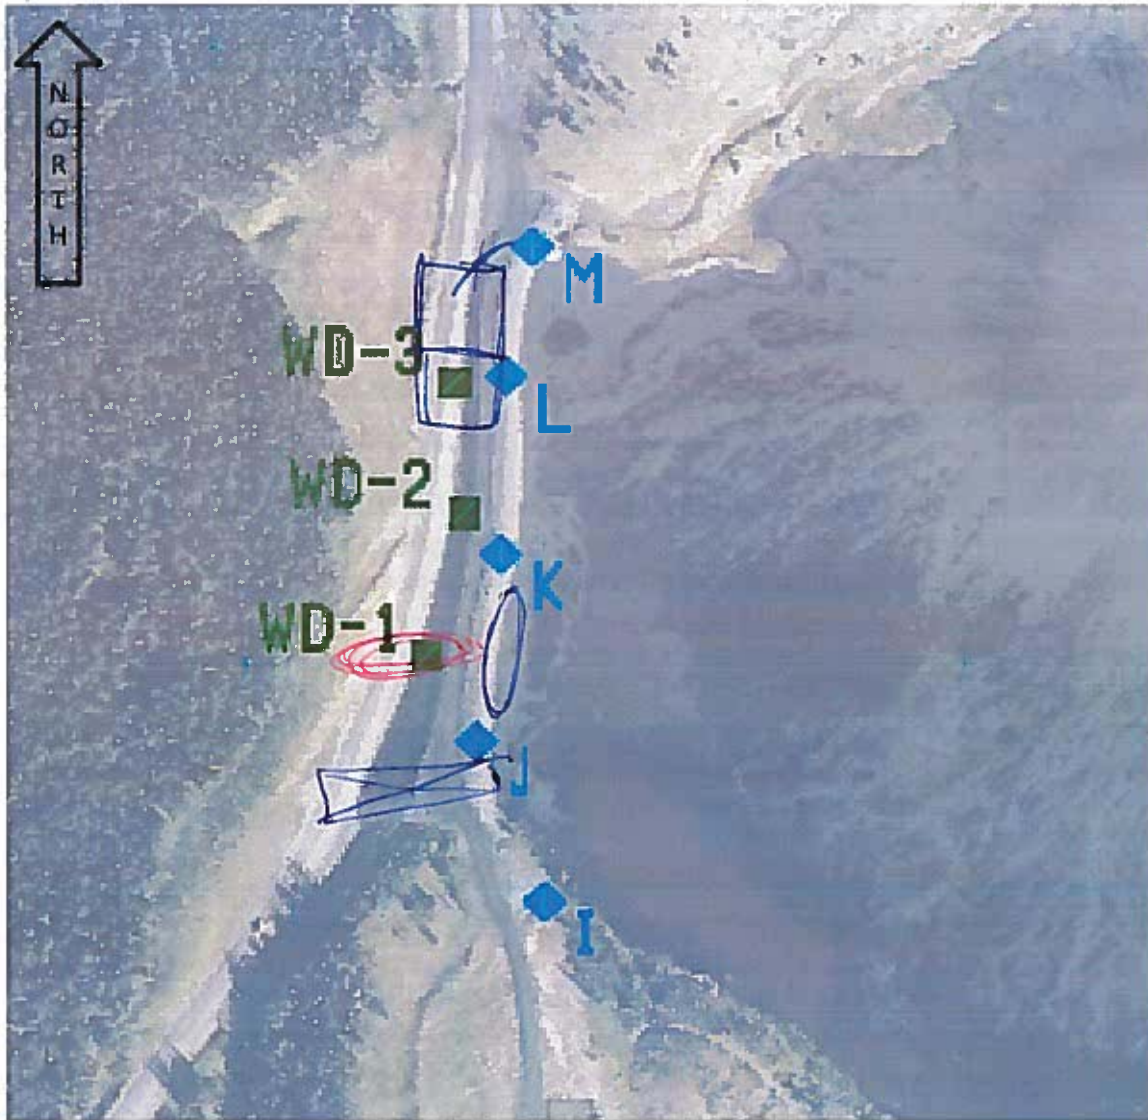
- construction work completed to remove spillway and replace with compacted OCB; work on 17 and 18 Aug; Golder QC on site and testin completed
