**TECK COAL LIMITED  
FORDING RIVER OPERATIONS**

**2017 Dam Safety Inspection for  
North Tailings Pond and South  
Tailings Pond**

**Reference Number: 1784573-2017-129-R-Rev0-1000**

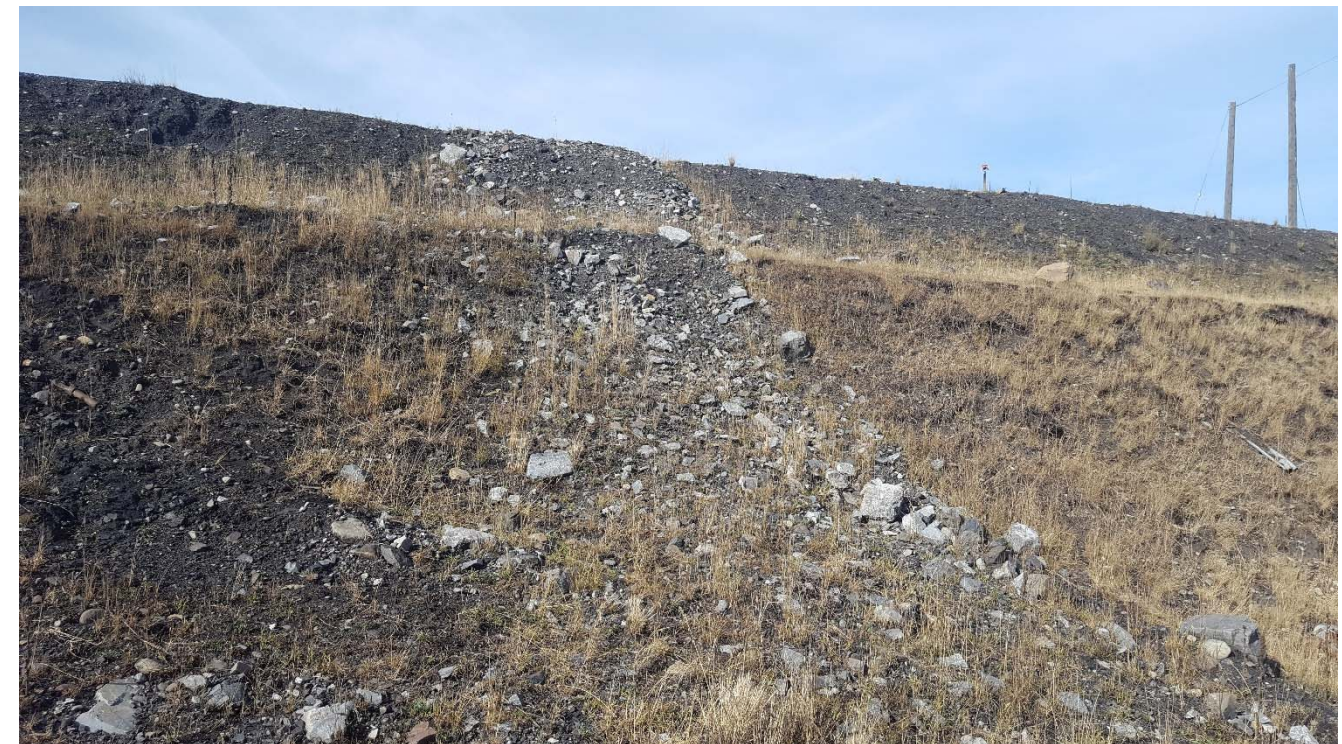
*Photograph 3: NTP dam downstream slope at south abutment with filled erosion channel, looking northwest. 4 October 2017.*

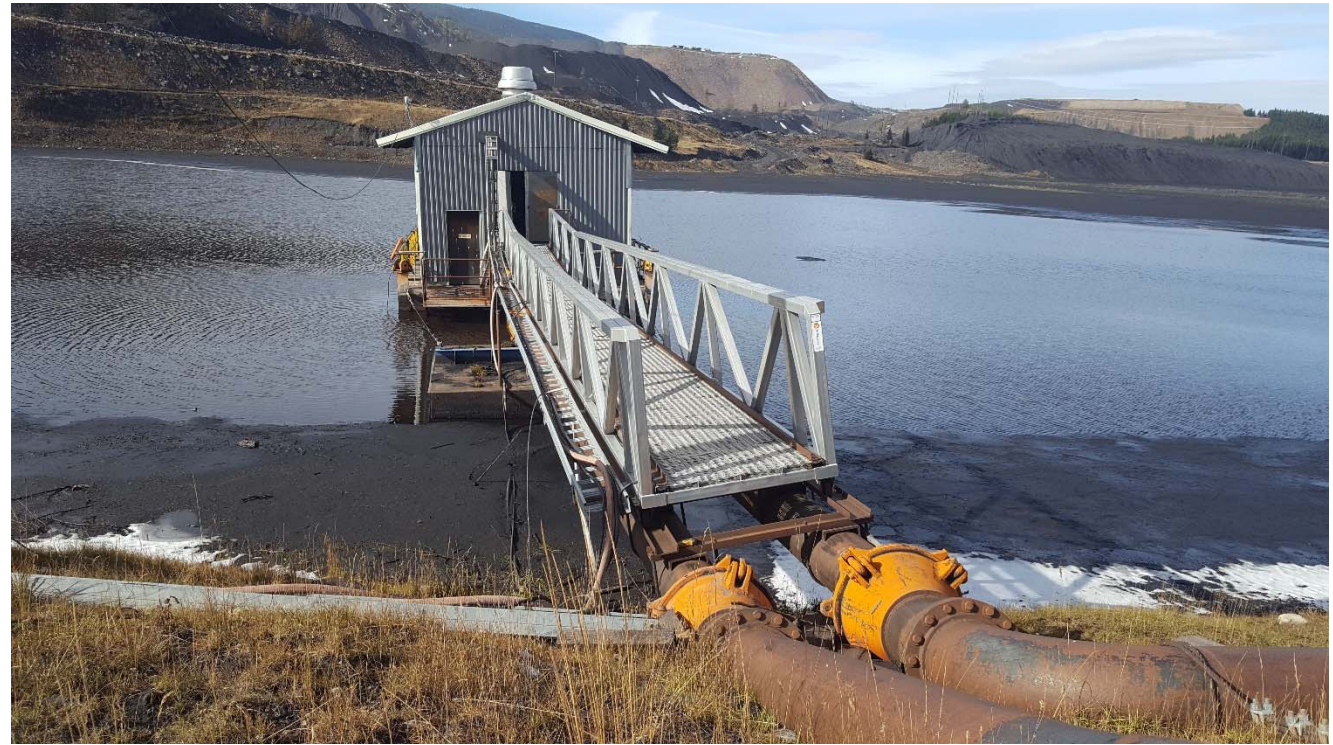
Photograph 5: NTP barge on small pond, looking northwest. 4 October 2017.

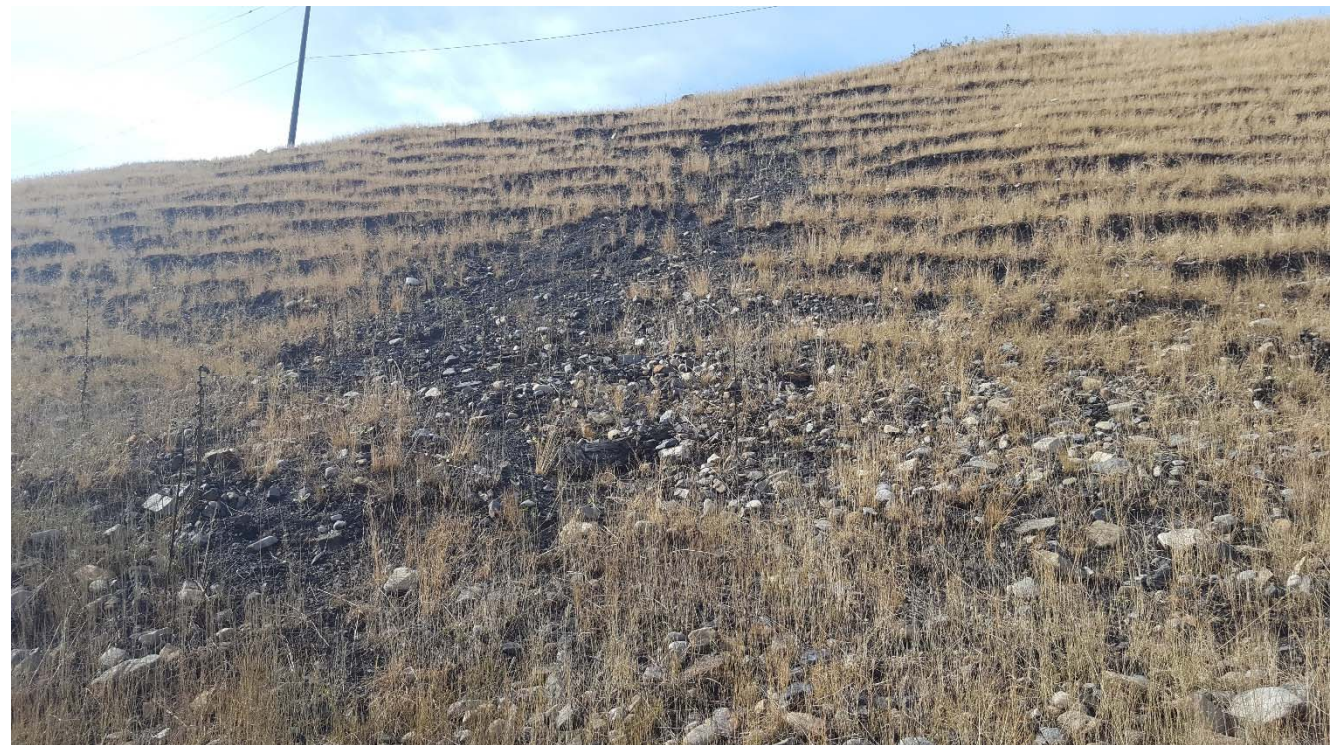
Photograph 7: NTP dam downstream slope with stepped erosion, looking northwest. 4 October 2017.

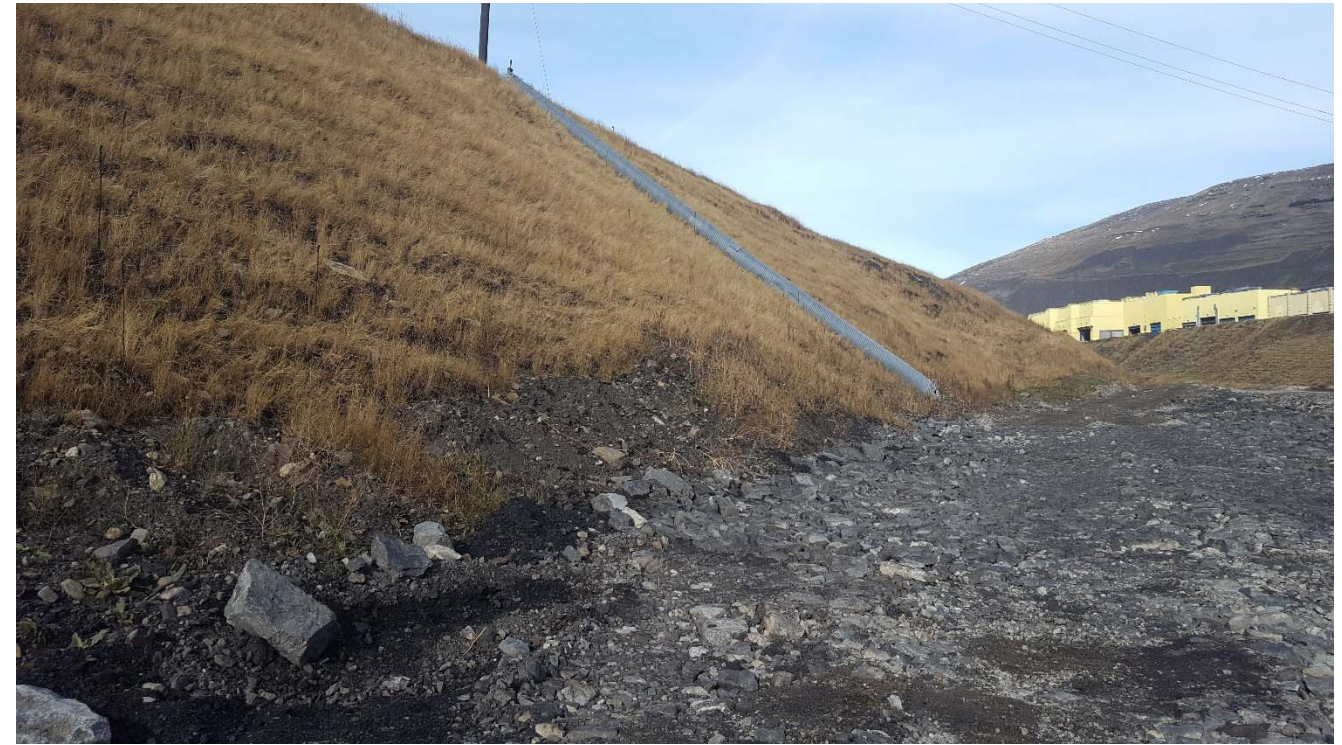
*Photograph 9: NTP dam downstream slope with unused pipe along surface of slope, looking northeast. 4 October 2017.*

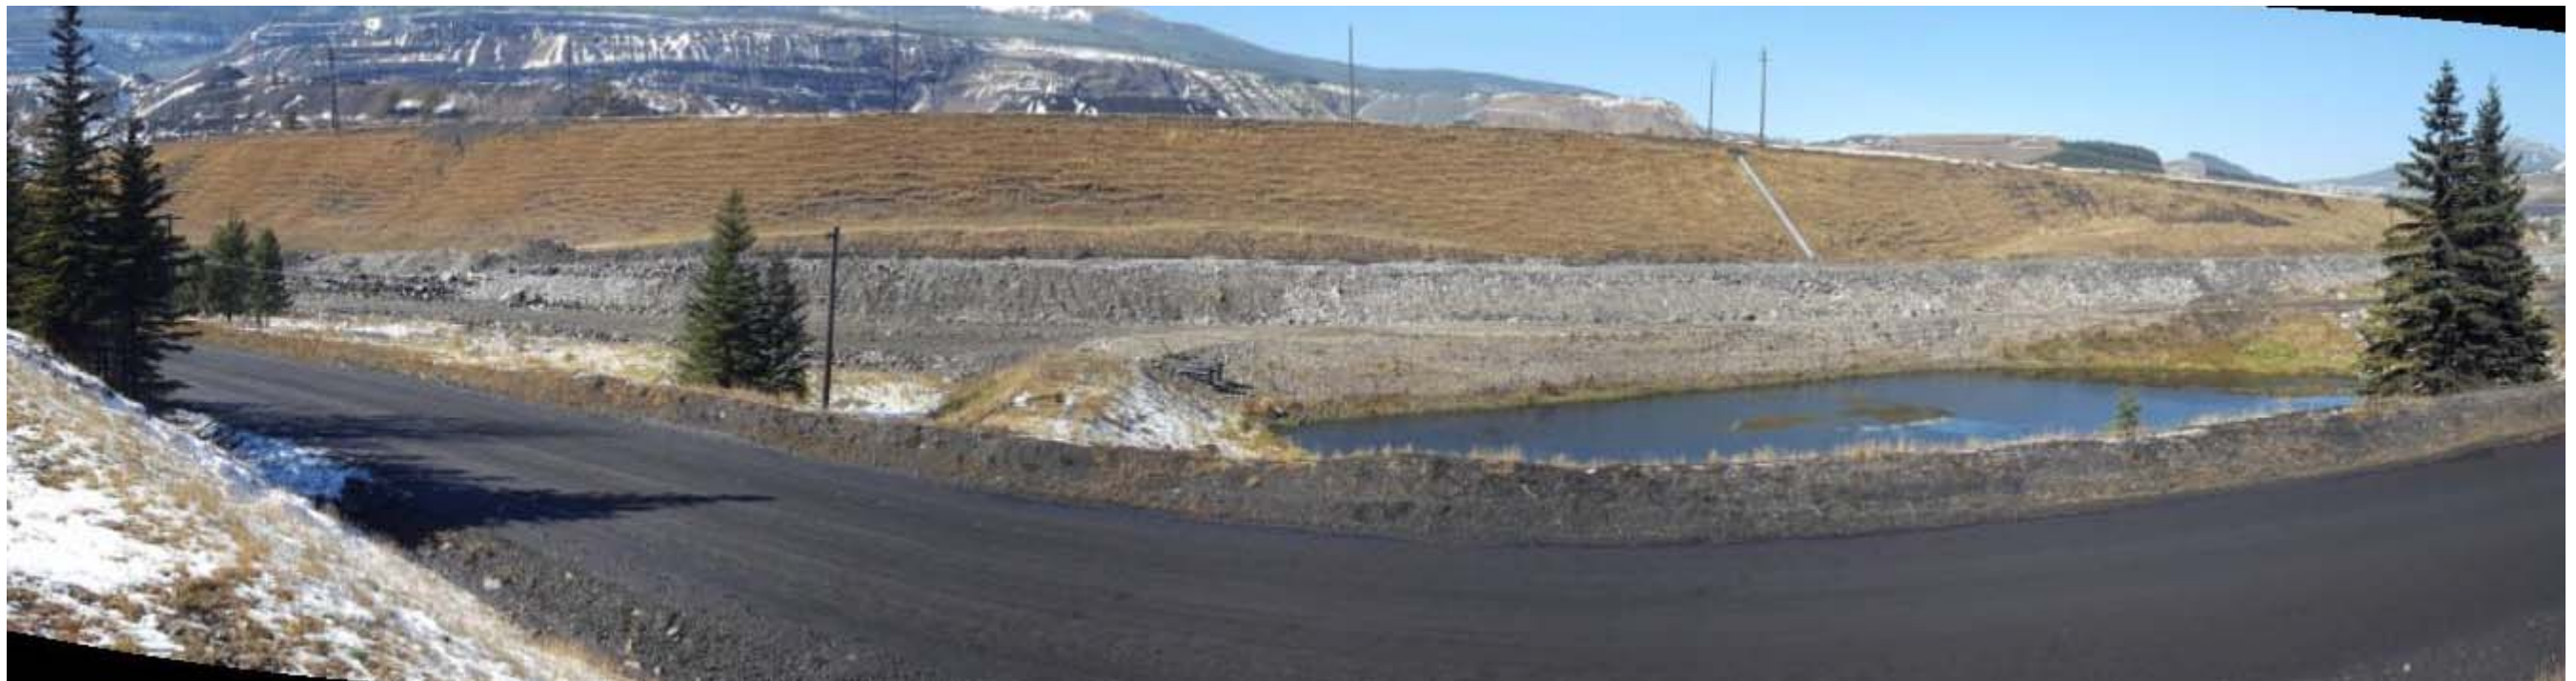
*Photograph 10: NTP dam downstream slope and riprap overview from North Loop Pond, looking northwest. 3 October 2017.*

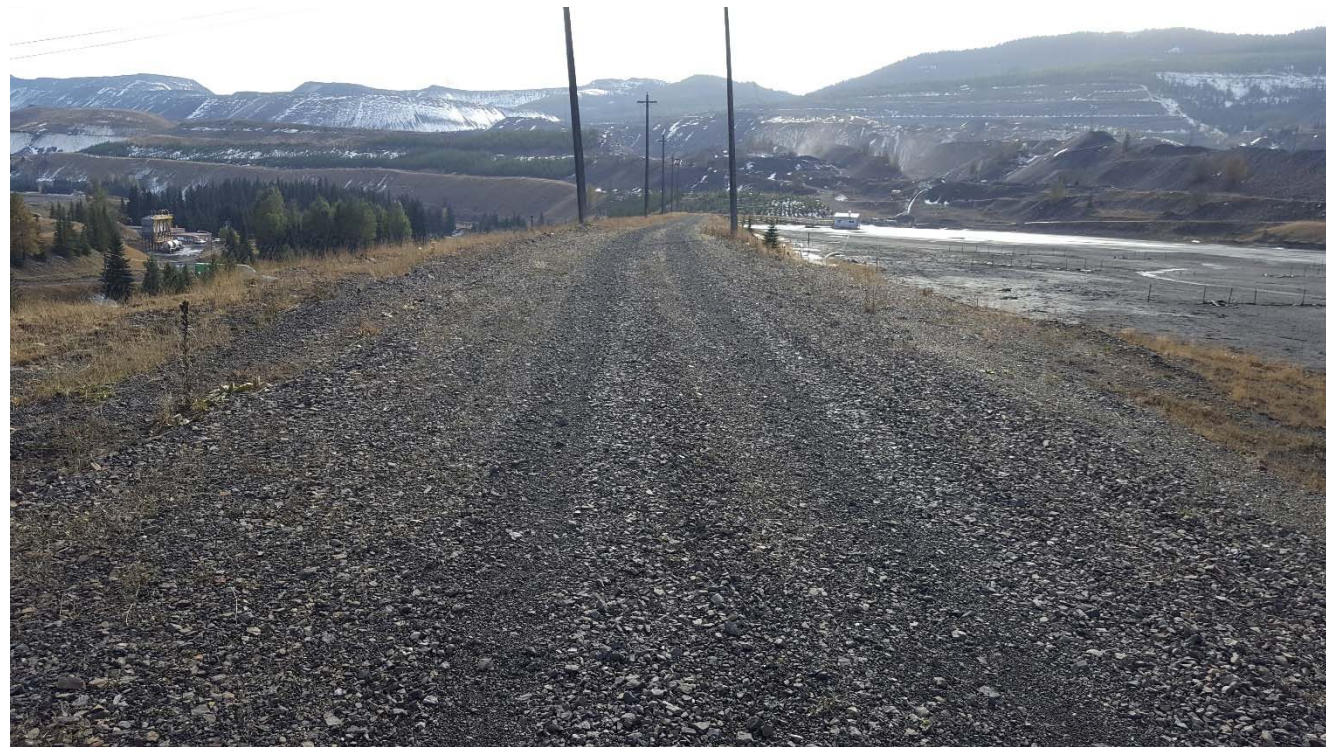
*Photograph 11 : NTP crest, looking southwest. 4 October 2017.*

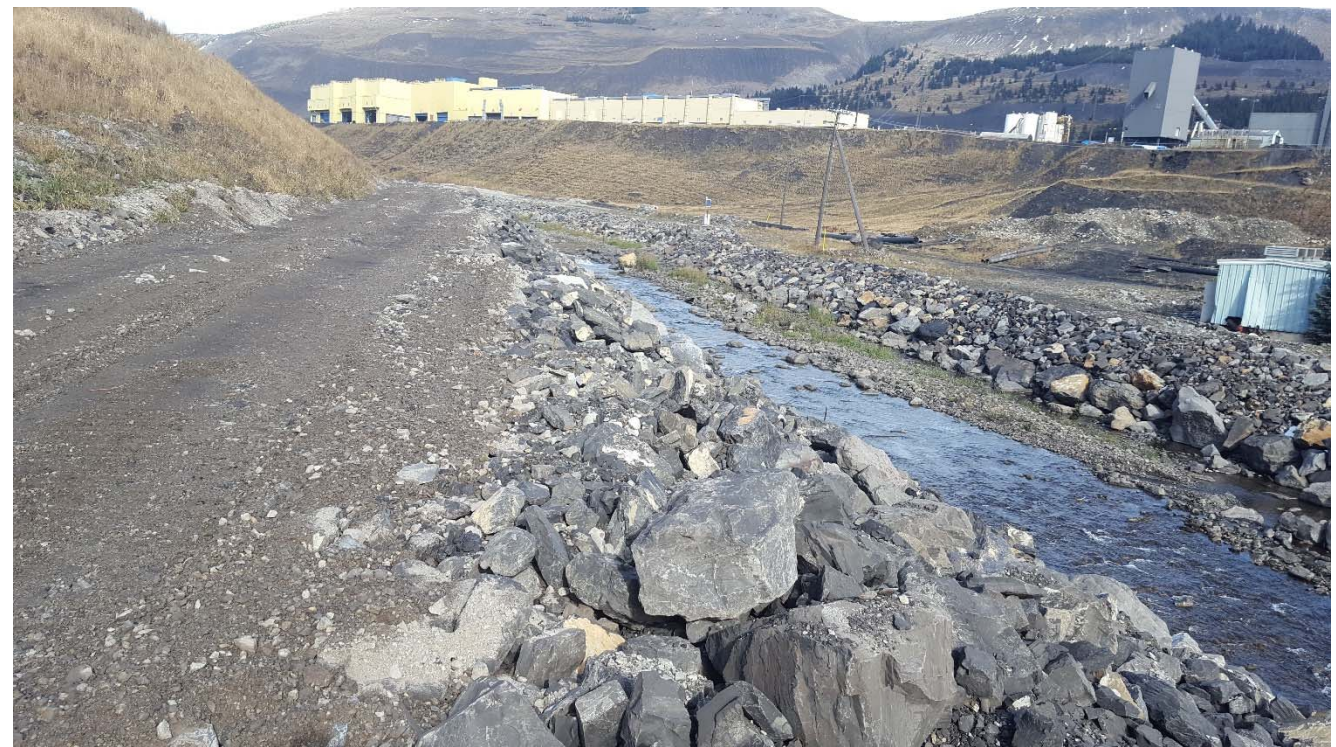
*Photograph 12 : NTP toe, riprap along Fording River, looking northeast. 4 October 2017.*

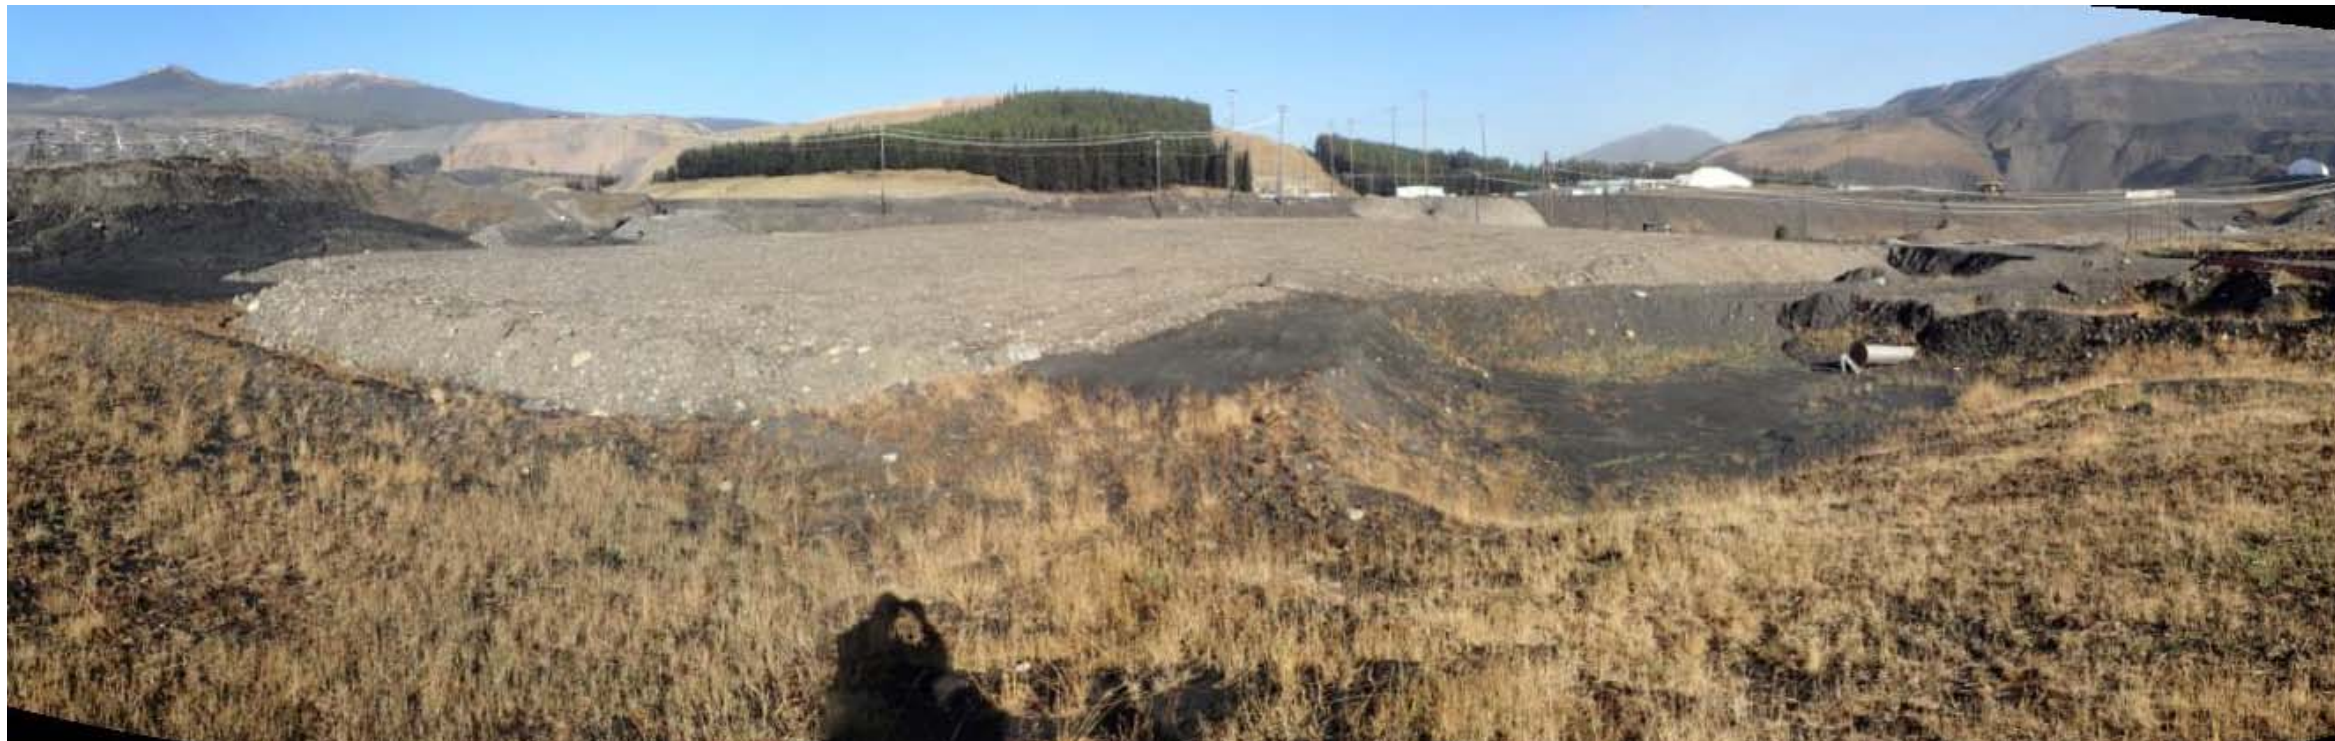
*Photograph 17: NTP near north abutment, dozed till material and unused steel tailings pipe, looking north. 5 October 2017.*

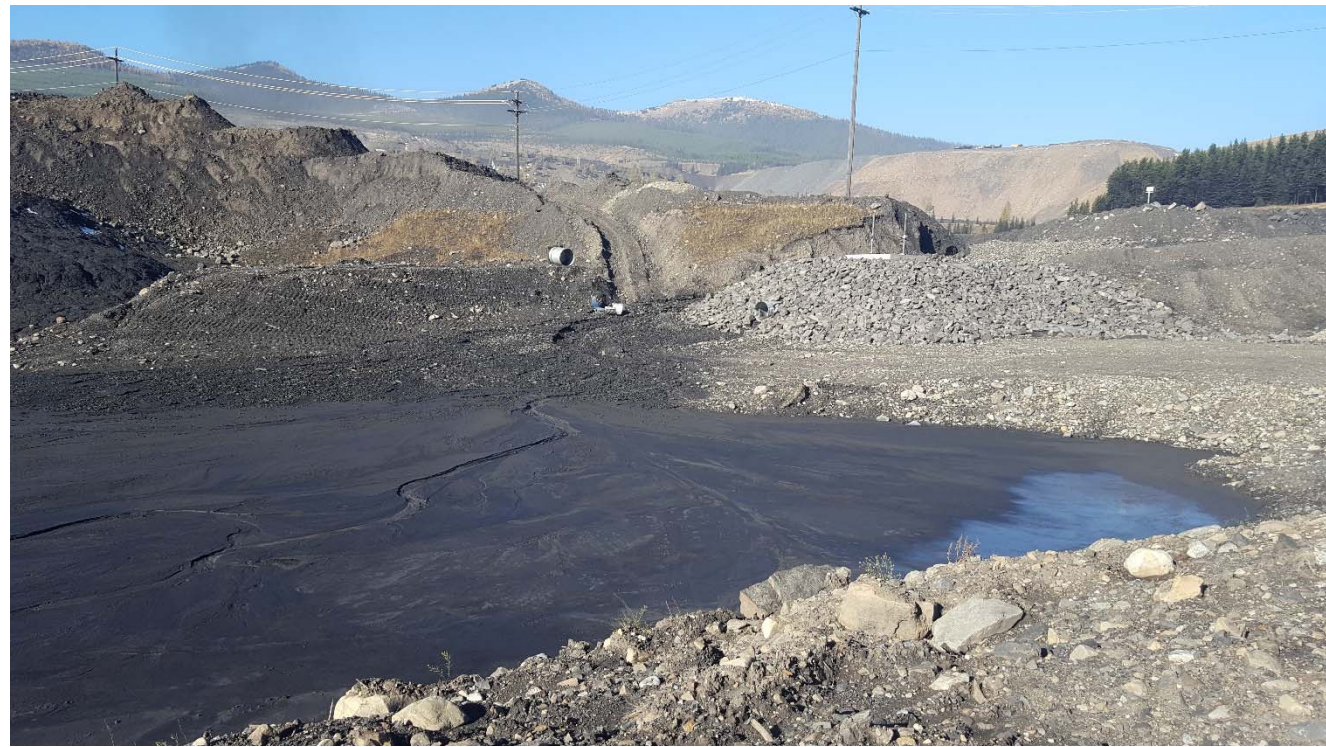
Photograph 18: NTP, surface runoff from haul road ditch reporting to tailings beach, looking west. 5 October 2017.

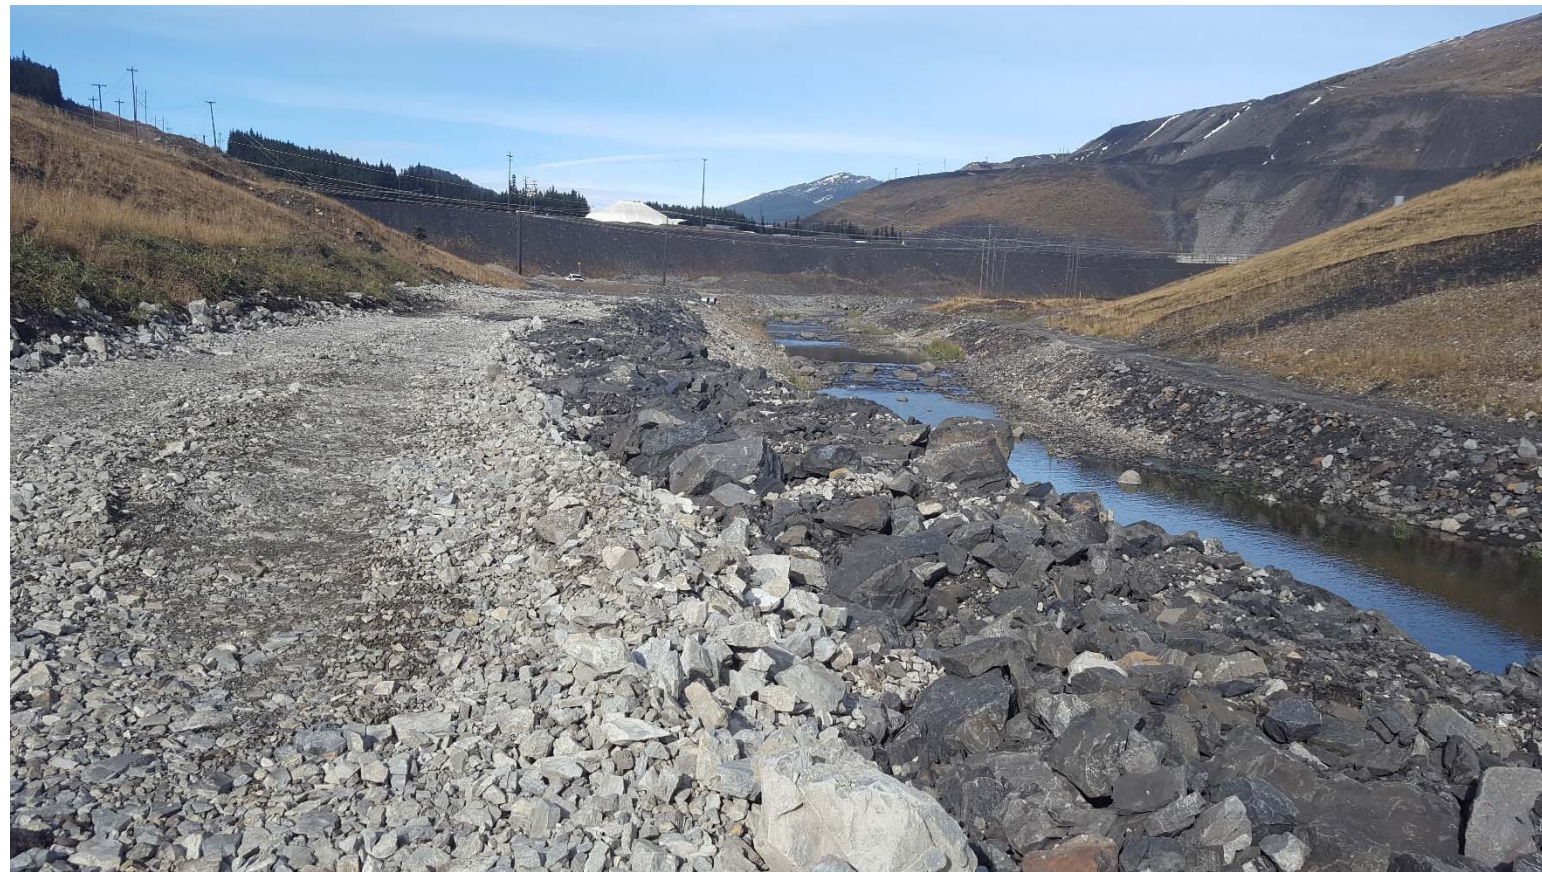
*Photograph 21: NTP dam toe, downstream riprap recently raised, looking north. 4 October 2017.*

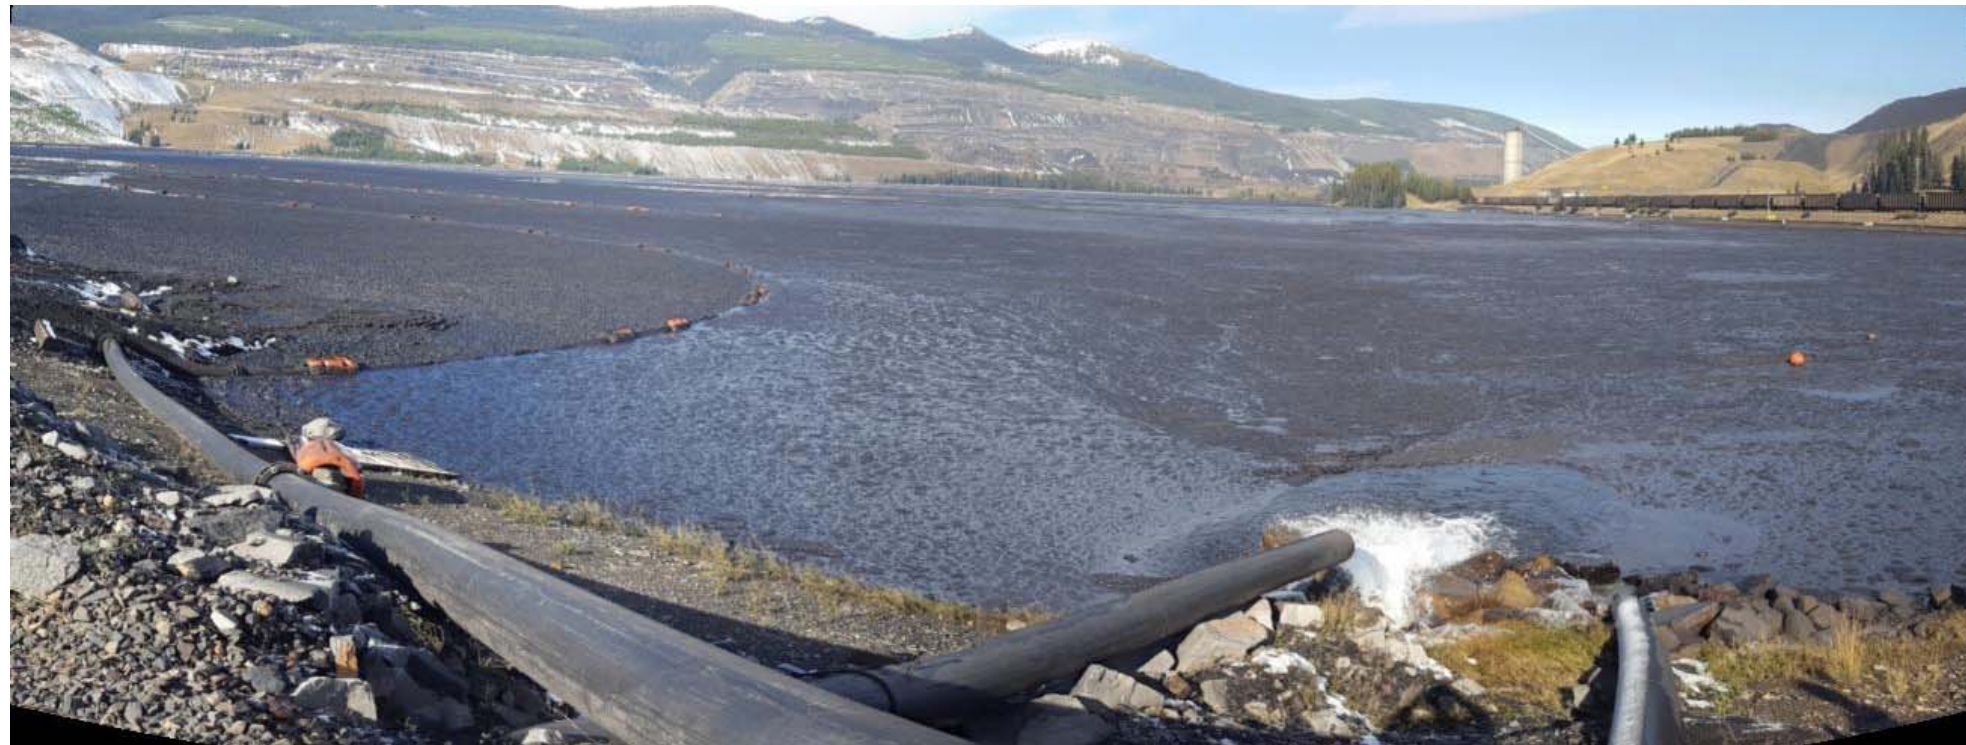
Photograph 27: STP south abutment till blanket area, makeup water lines from Kilmarnock Ponds with riprap protection on blanket, looking northwest. 4 October 2017.

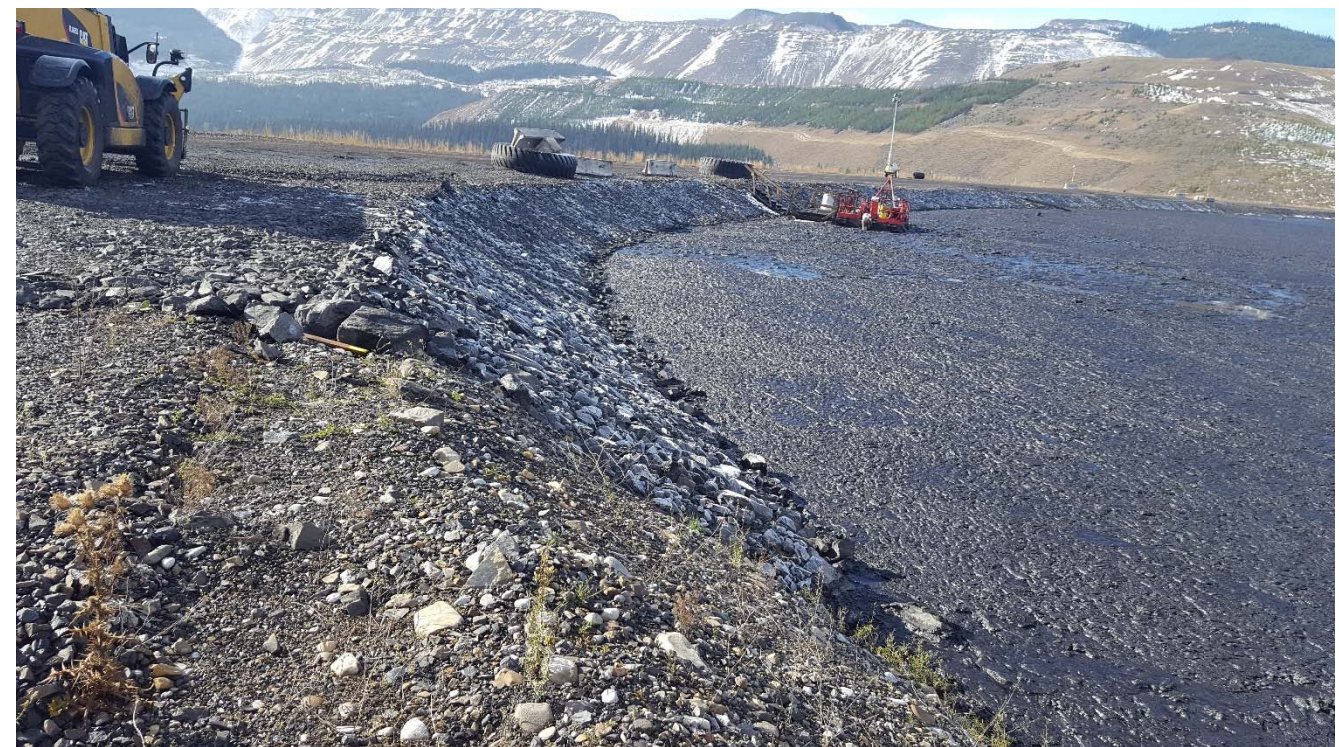
Photograph 29: STP Main Dam, new upstream constructed riprap 1.4H:1V, looking west. 4 October 2017.

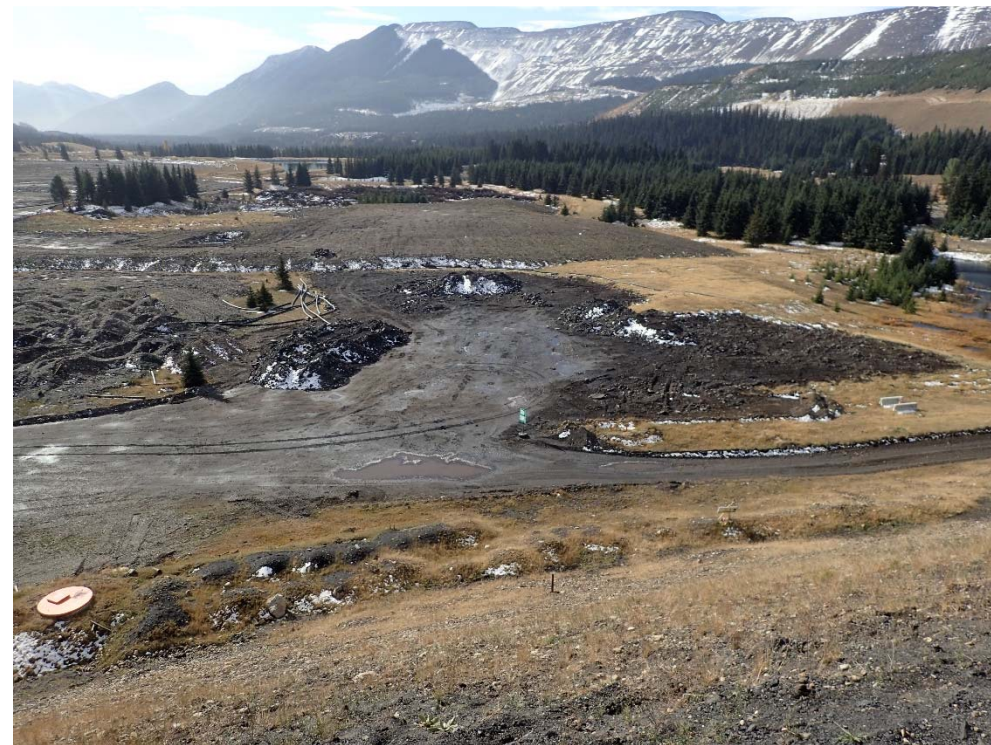
An emergency riprap stockpile is typically maintained at the south end of the STP with an approximate volume of 4,500 m<sup>3</sup>. The stockpile was removed to be used in a rock drain project for the Swift expansion. The riprap stockpile was replaced with better quality material in late 2017. The removal of the stockpile was completed in consultation with the tailings engineer and replaced within a timely manner.

Photograph 33: STP Main Dam, riprap emergency stockpile removed, and Fording River floodplain, looking south. 4 October 2017.

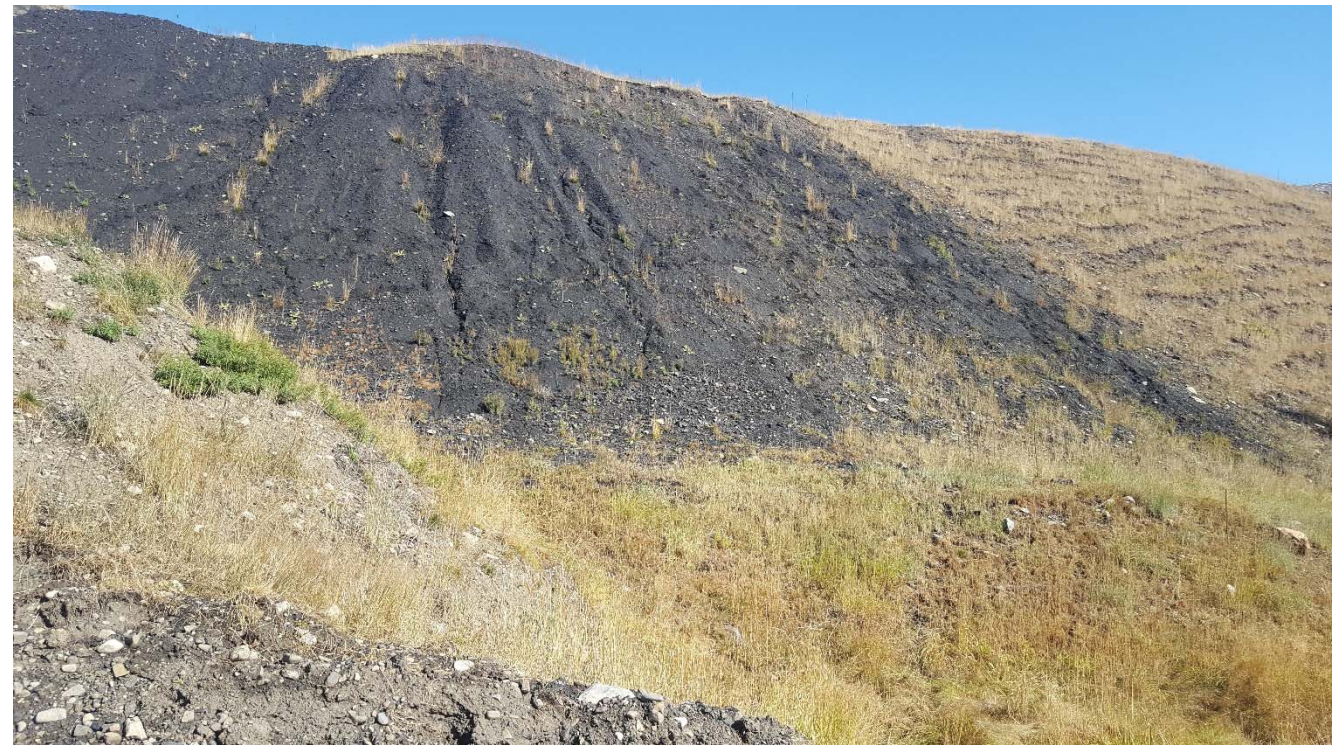
*Photograph 35: STP corner of West and Main dams, looking northeast. Note vegetation not taking root in CCFR. 4 October 2017.*

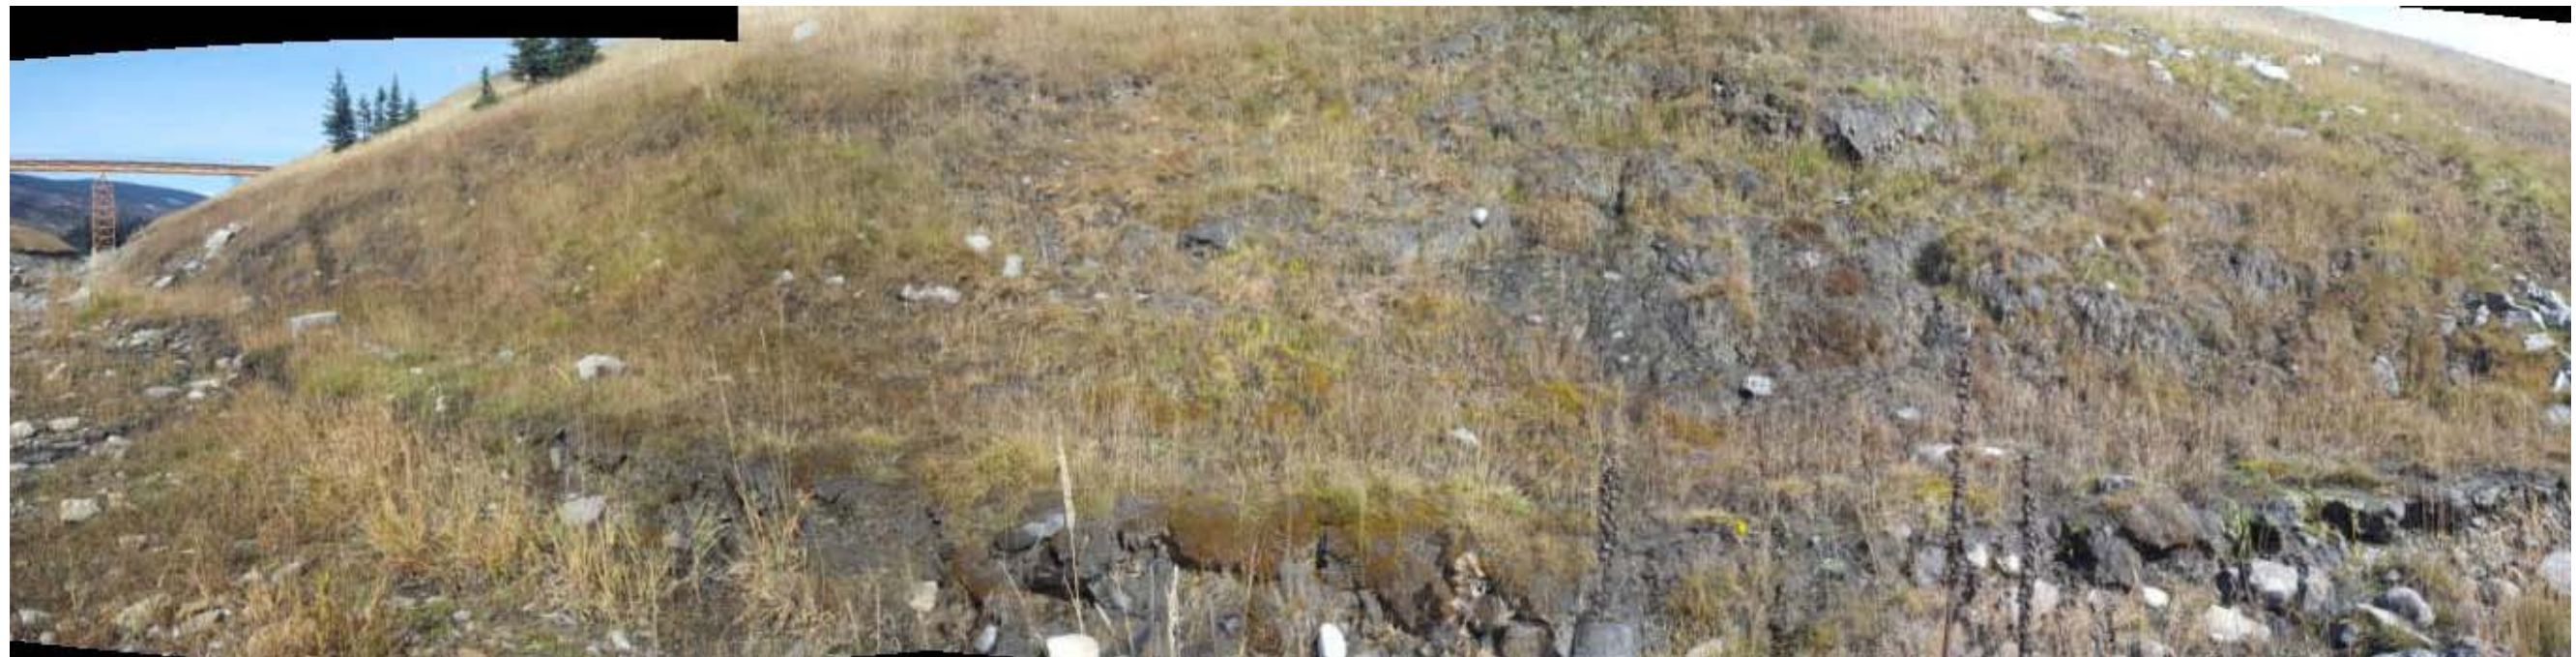
*Photograph 40: STP West Dam, seepage along the downstream toe, looking northeast. 4 October 2017.*

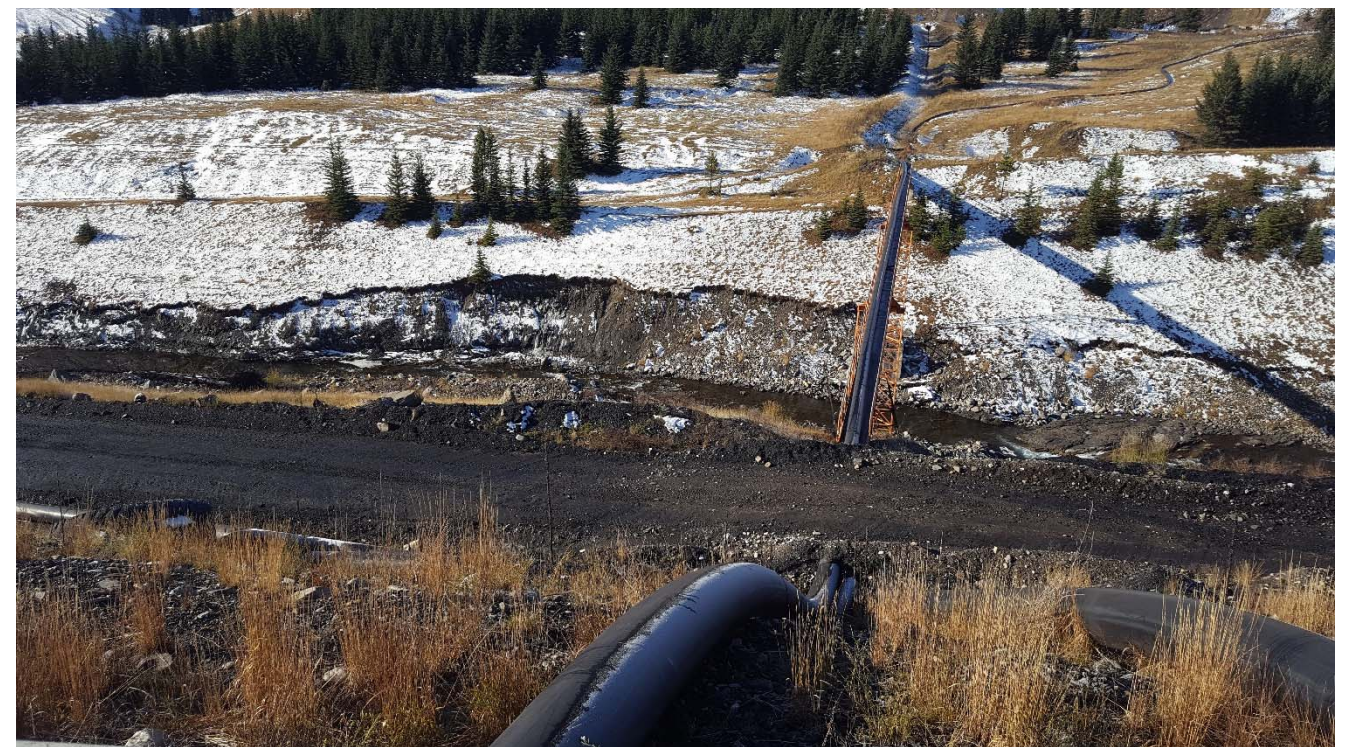
*Photograph 44: STP unused dredge line to 2P-3P Tailings Storage Area on pipe bridge, looking southwest. 4 October 2017.*

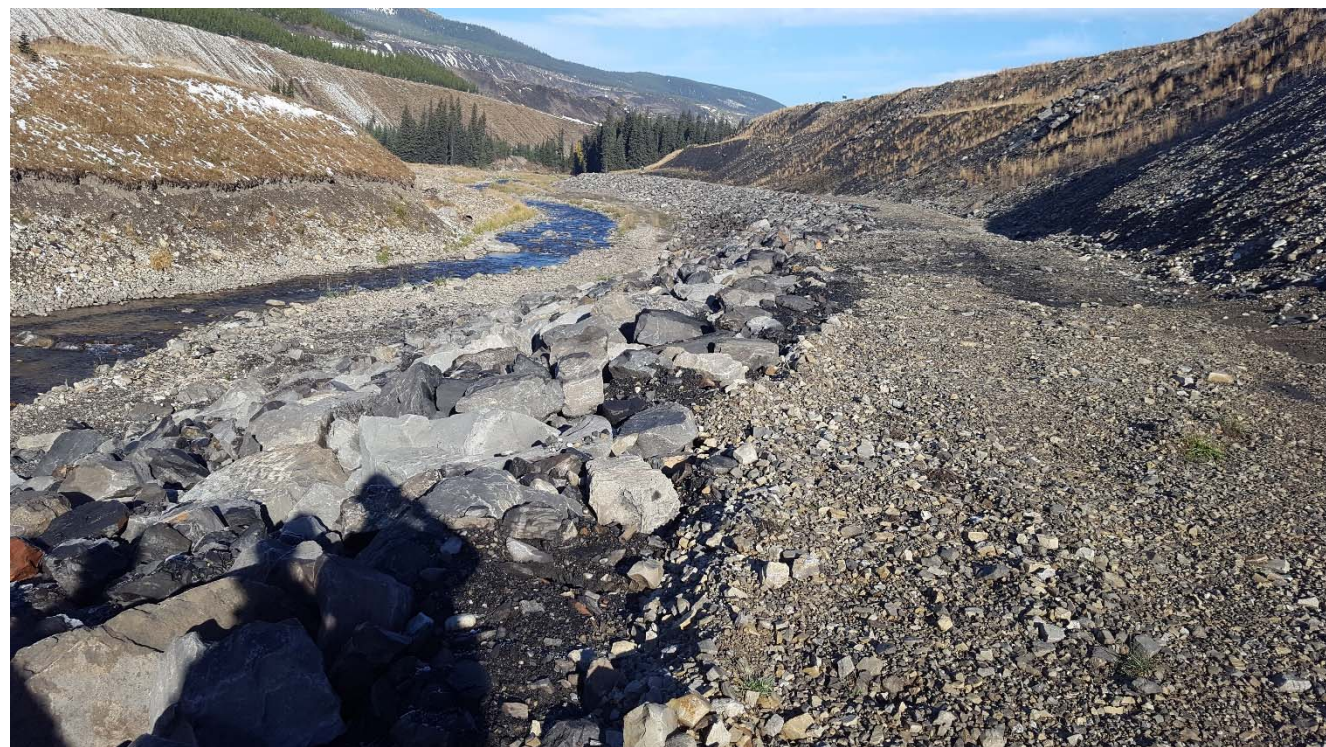
*Photograph 47: STP West Dam, riprap placed at toe of dam for erosion protection from Fording River, looking northwest. 4 October 2017.*

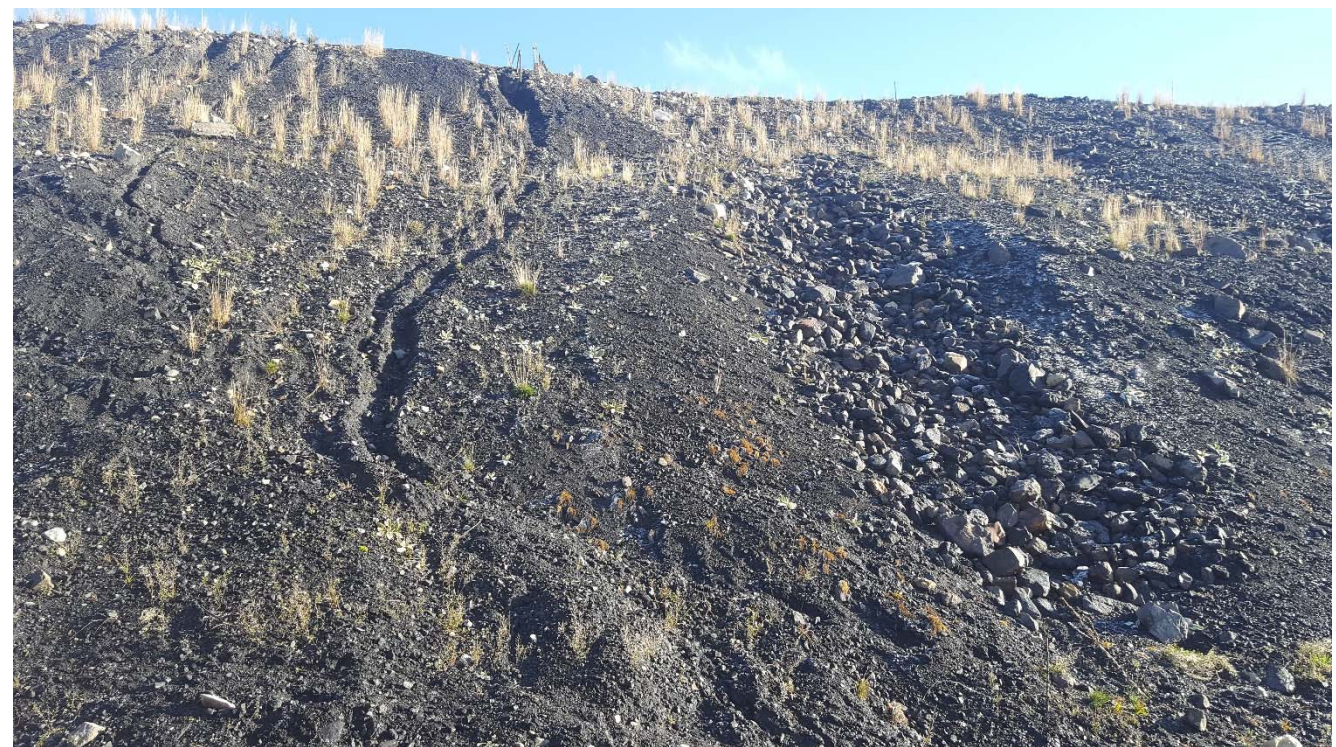
*Photograph 48: STP West Dam, erosion gully and infilled depression, looking northeast. 4 October 2017.*

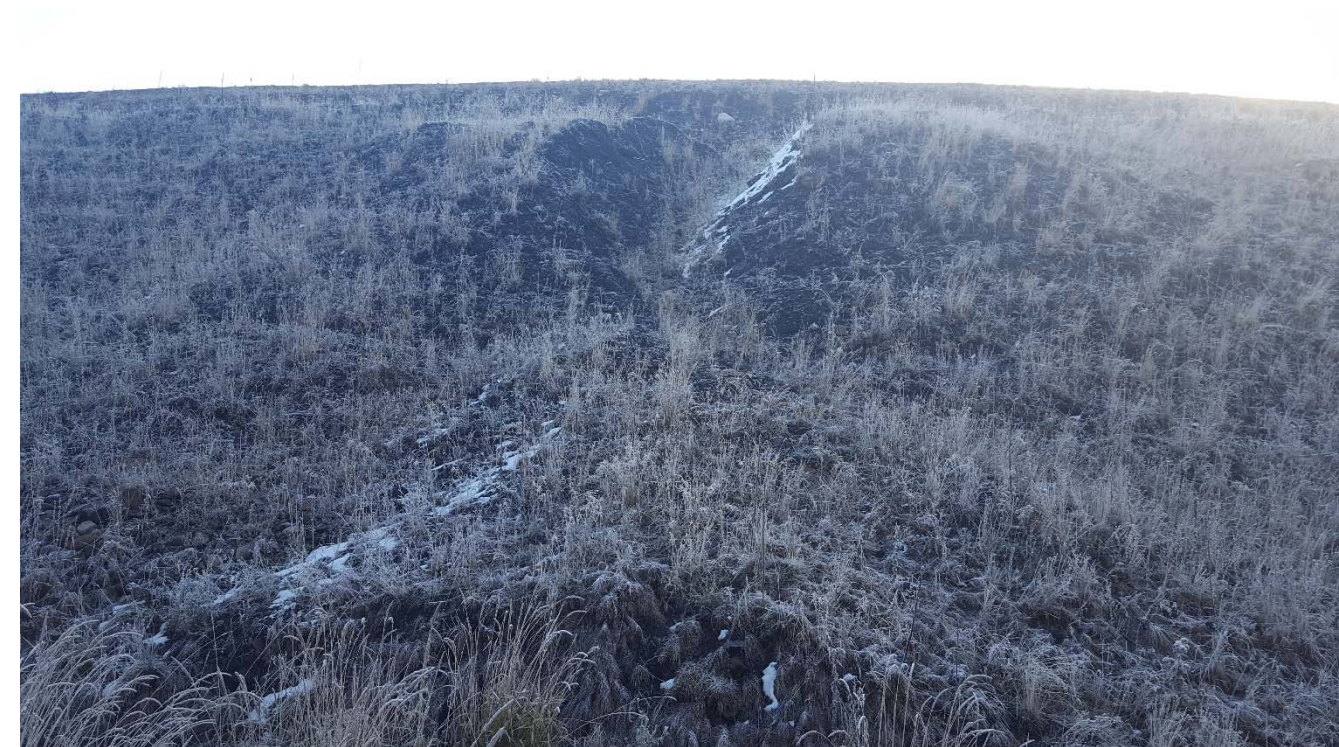
*Photograph 52: STP West Dam, erosion gully, looking east. 4 October 2017.*
