**TECK COAL LIMITED  
FORDING RIVER OPERATIONS**

**2017 Dam Safety Inspection for  
North Tailings Pond and South  
Tailings Pond**

**Reference Number: 1784573-2017-129-R-Rev0-1000**

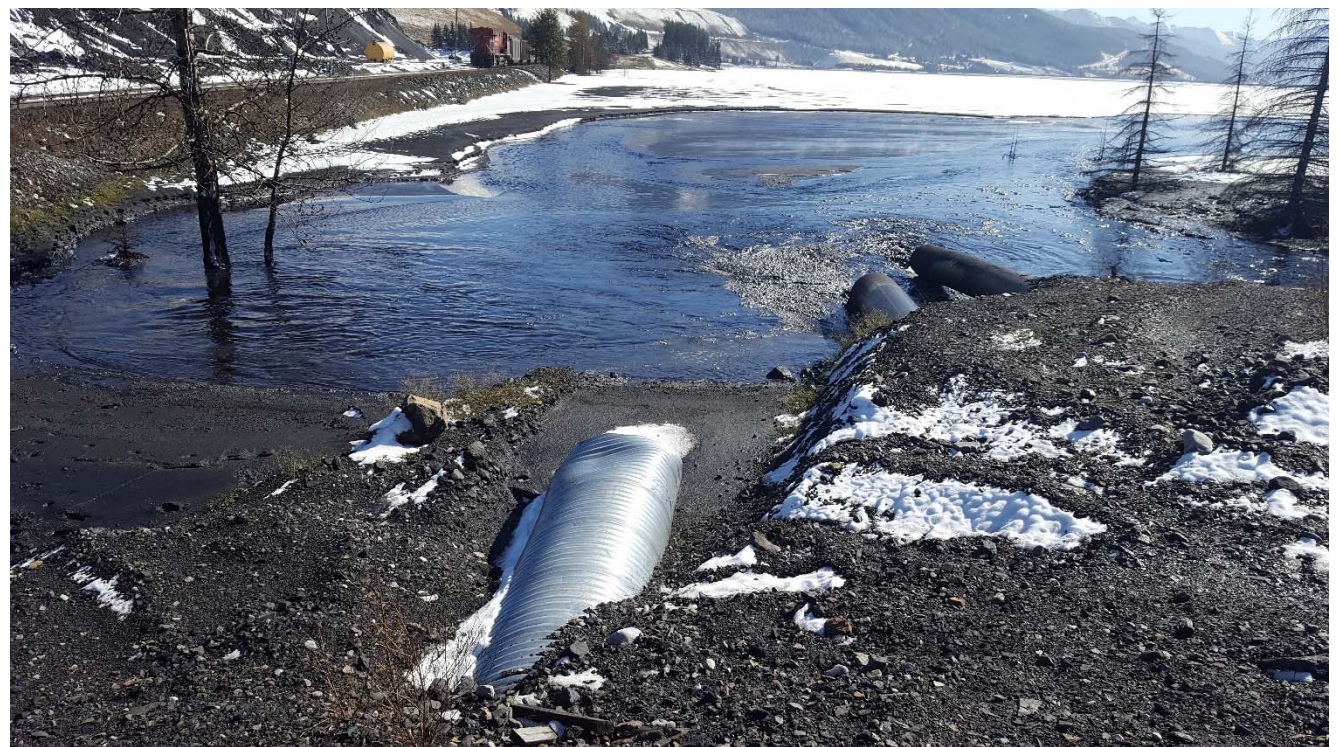
*Photograph 56: STP north abutment, outlet of tailings pipe and water return pipe, looking southeast. 3 October 2017.*

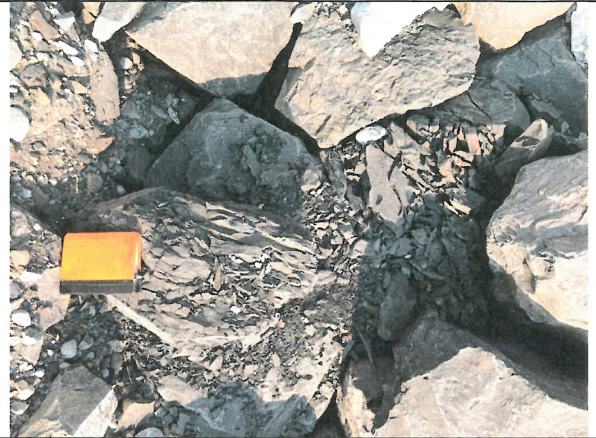
Photo 10: Riprap degradation due to weathering on a surface of a piece of riprap
