**2021 ANNUAL FACILITY PERFORMANCE REVIEW REPORT
DUCK POND OPERATIONS TAILINGS MANAGEMENT FACILITY**

2021 Annual Facility Performance Review Report

Duck Pond Operations Tailings Management Facility

Project No. 21455283 (2000);
Reference No. 21455283-001-R-Rev0-1000

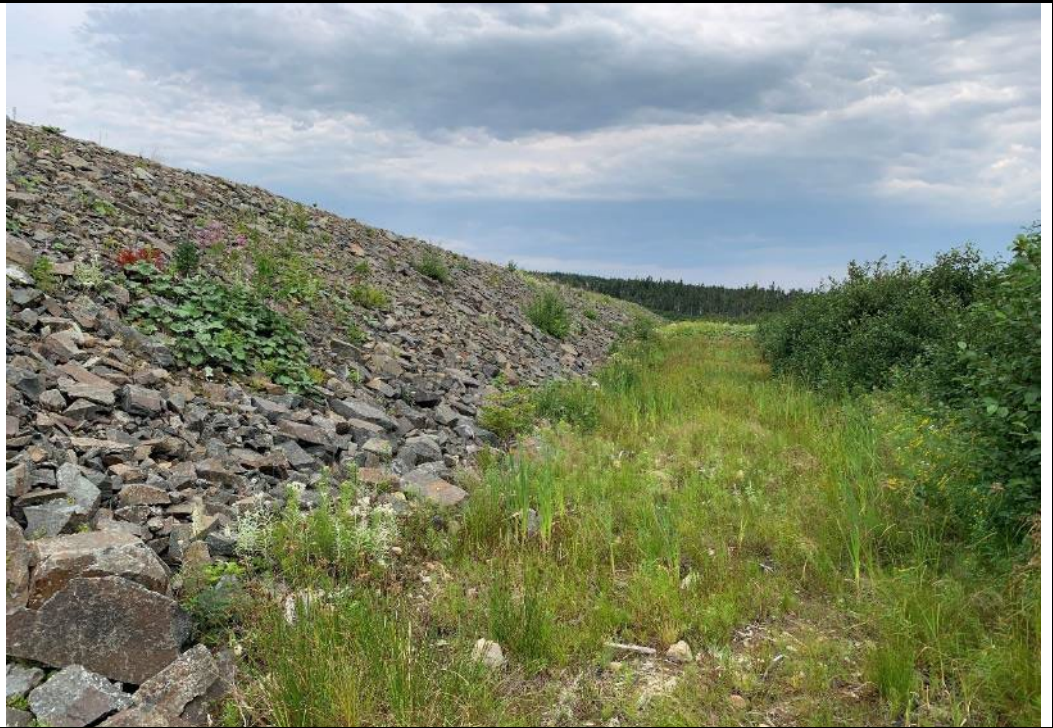
Photograph 1

Dam A downstream shell looking north from Sta. 0+100.

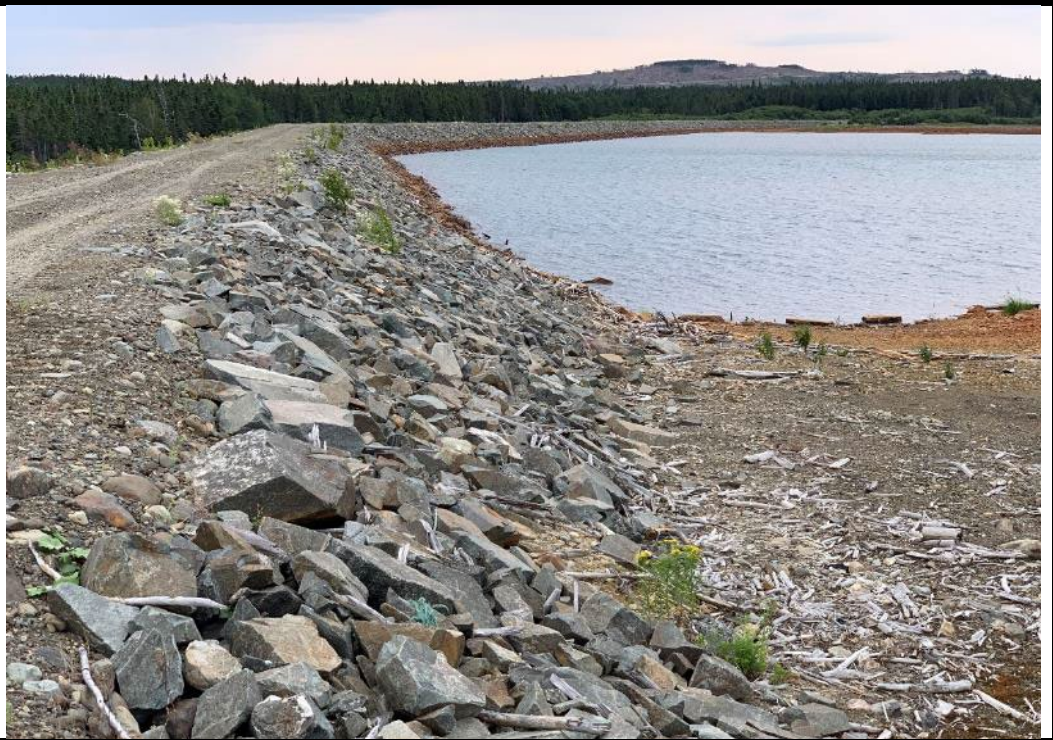
Photograph 2

Dam A upstream shell and crest looking south from Sta. 0+800.

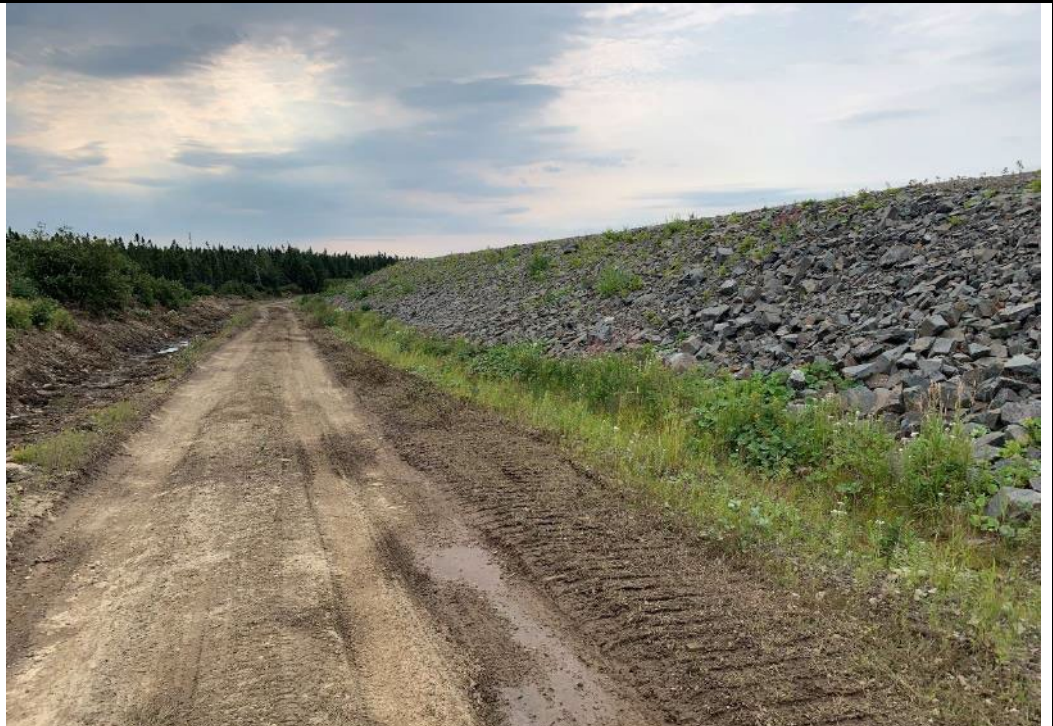
Photograph 3

Downstream shell of Dam A at 0+700.

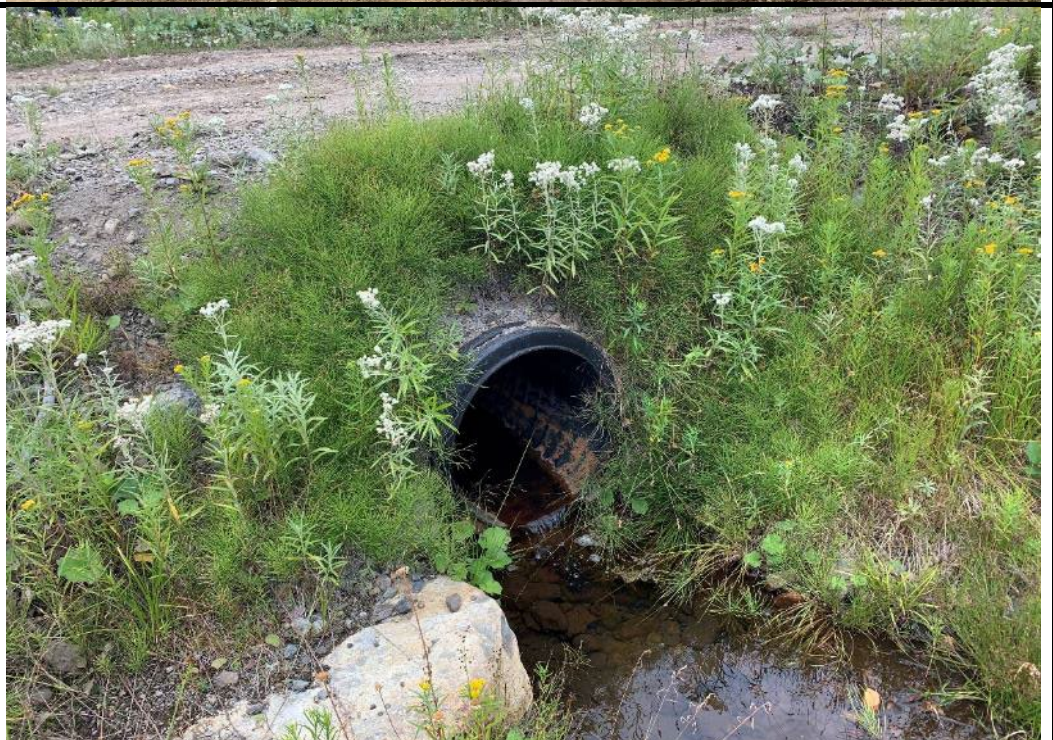
Photograph 4

Sta 0+550, along with surface runoff from the area, flows through the high-density polyethylene (HDPE) culvert beneath the access road to the environment. The water observed at the toe and discharging through the HDPE culvert was clear (i.e., free of sediment) and showed very little sign of discolouration due to oxidation. Although some portion of this water may be seepage from the TMA, it is understood from site personnel that the water quality at the culvert meets discharge criteria. In 2019, Teck started recording the flowrate at the culvert following recommendations in previous years. The flowrate on May 11th, 2021 was 0.9 L/s, which is consistent with historical observations. Golder developed a tracking sheet (attached to Form A in Appendix A) that should be used by Teck in the future to identify any trends in seepage flowrates.

Discharge from culvert beneath access road downstream of Dam A.

The flowrate was consistent with previous rates.

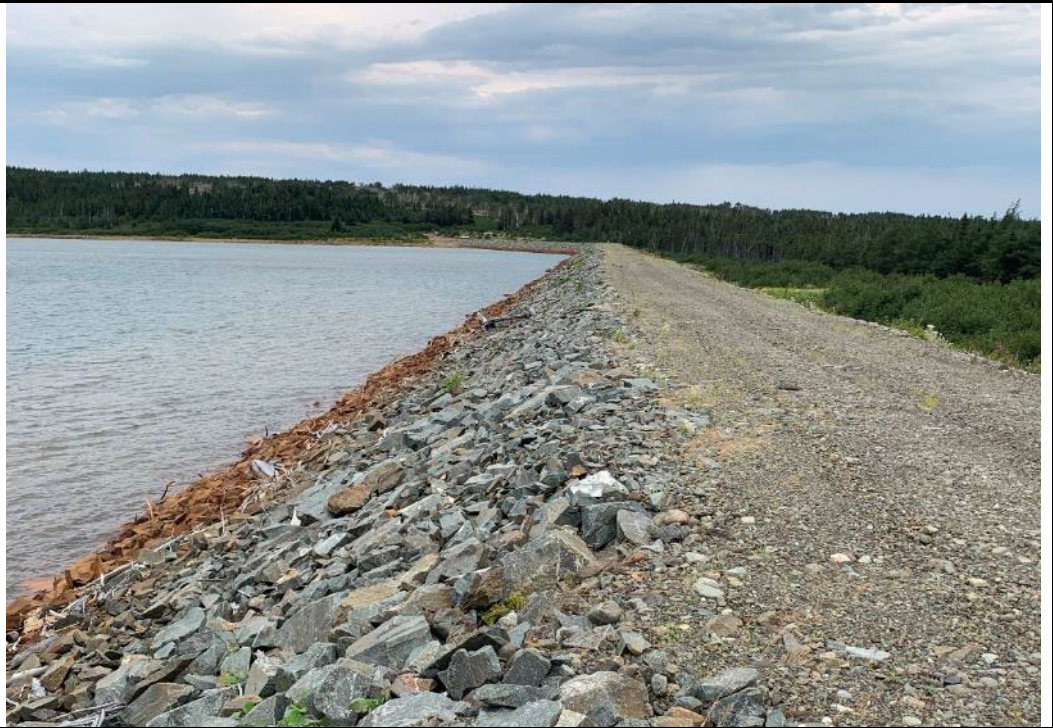
Photograph 5

Upstream slope of Dam A at Sta. 0+300 looking north.

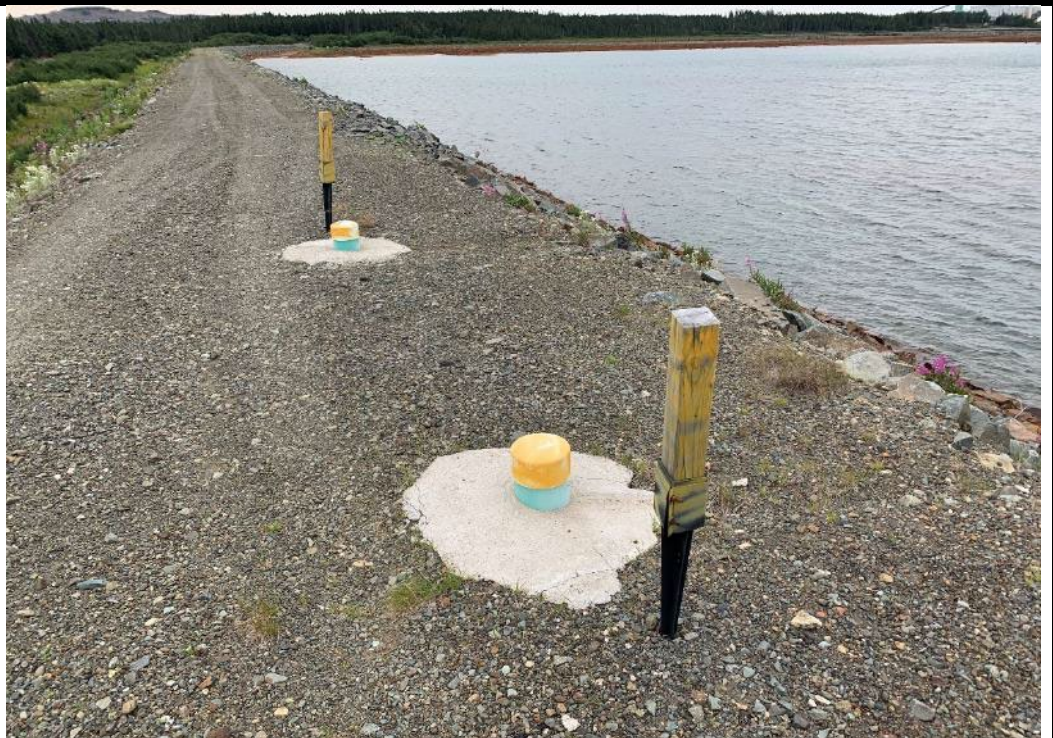
Photograph 6

Three piezometers (P07-01A in one nest and P07-02A and P07-02B in another nest) and a settlement plate (S18-08) were present on the crest of the dam at its maximum height. The instrumentation appeared in good condition; the concrete around the piezometers was in good condition, with only minor cracking around the edges.

Piezometer surface casings (upgraded in 2019).

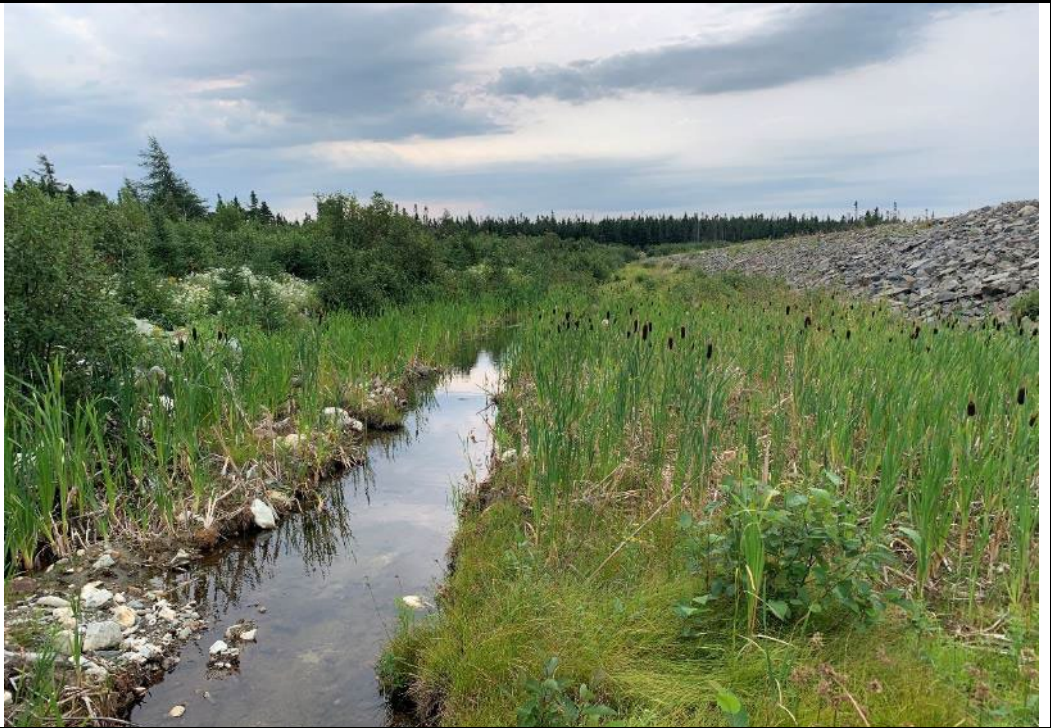
Photograph 7

Ponded water was observed along the toe at some locations and visible seepage was noted. There was no water upwelling or flowing directly out of the toe, and the seepage was noted as slightly more than a trickle.

Downstream toe of Dam A at Sta. 0+200. The collection ditch was cleared of vegetation and debris in 2021, although ponding water is still observed given the flat topography in the area.

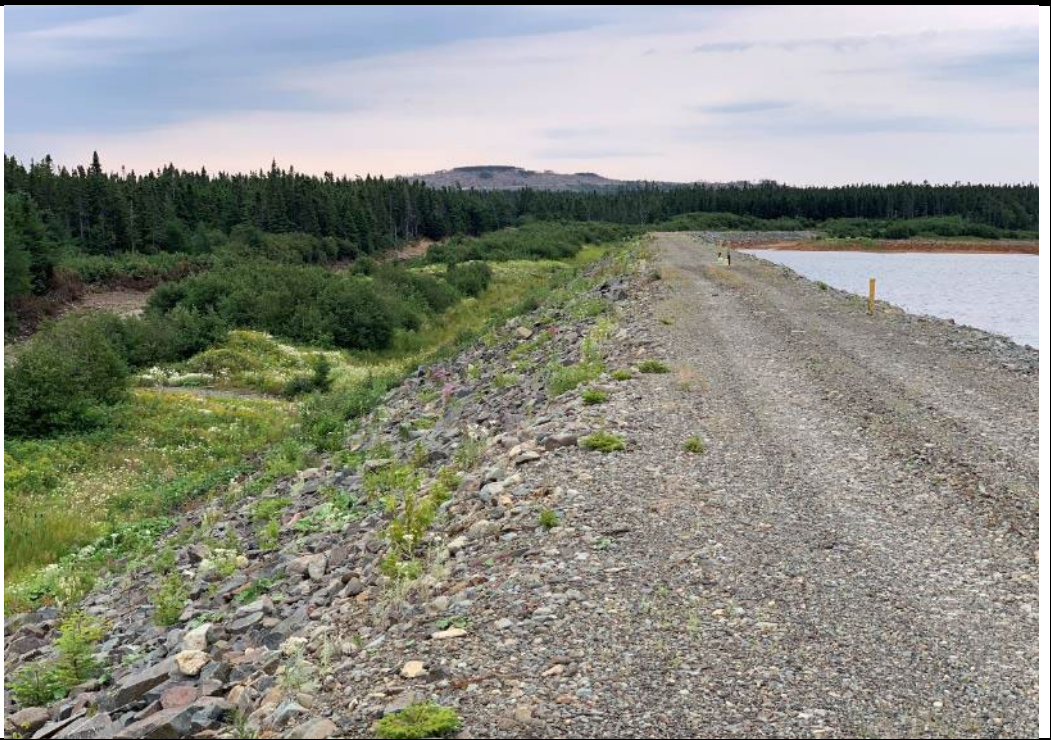
Photograph 8

Downstream slope of Dam A at Sta. 0+600 looking south.

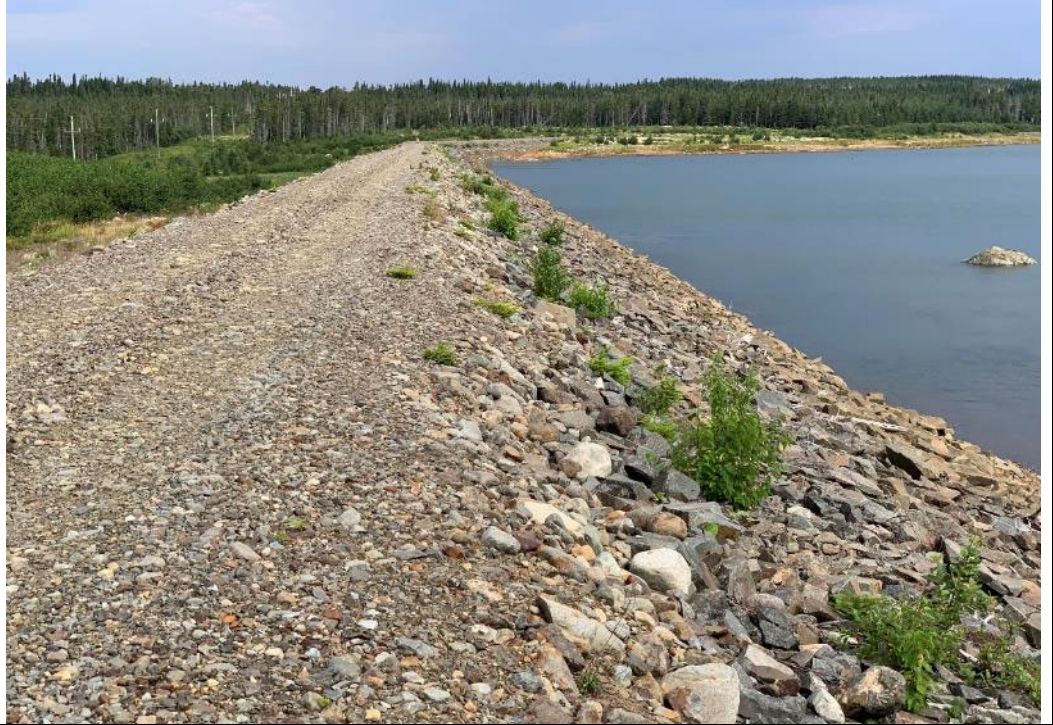
Photograph 1

Dam B upstream shell and crest looking north from Sta. 0+500

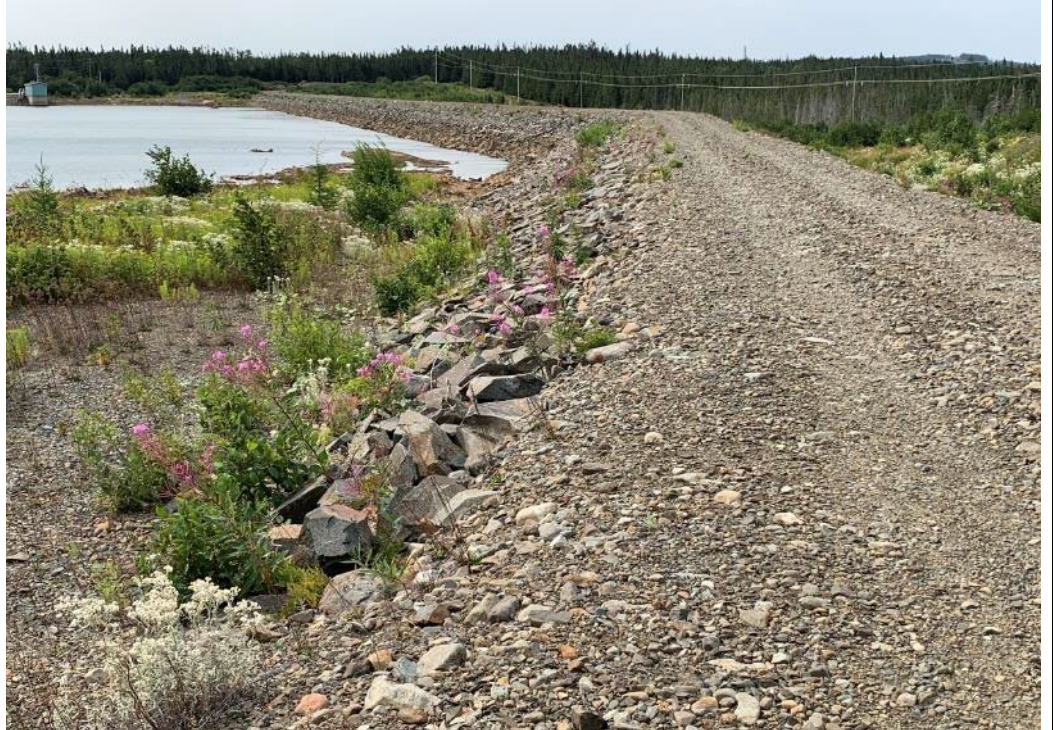
Photograph 2

Dam B upstream shell looking south from north abutment.

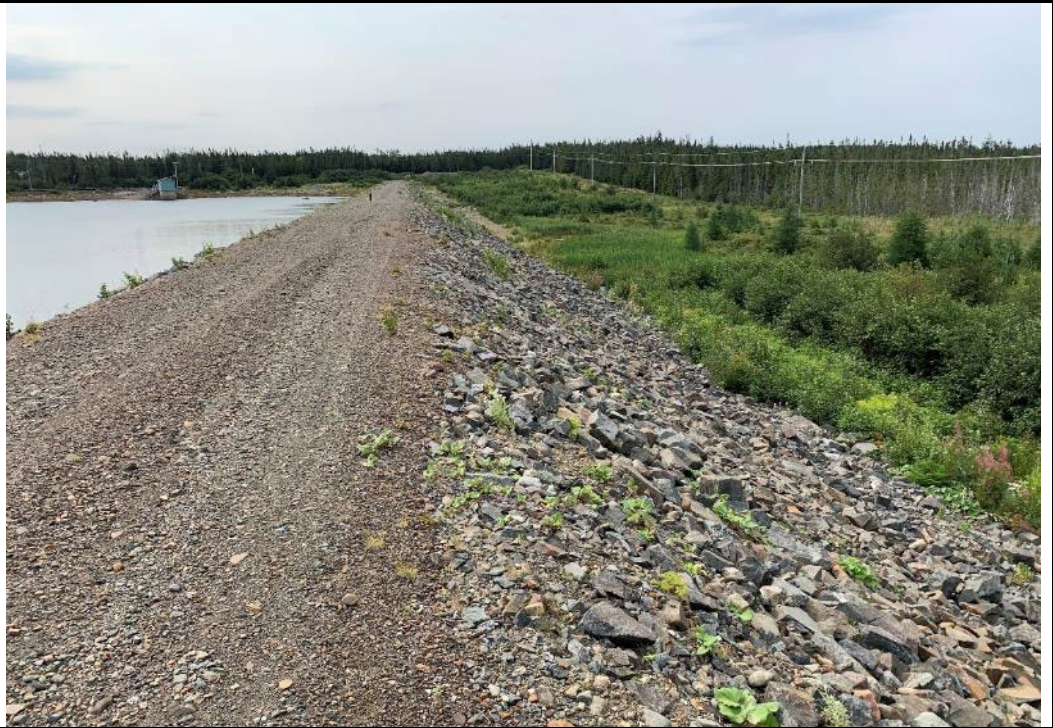
Photograph 3

Dam B crest and downstream slope looking south from Sta. 0+250.

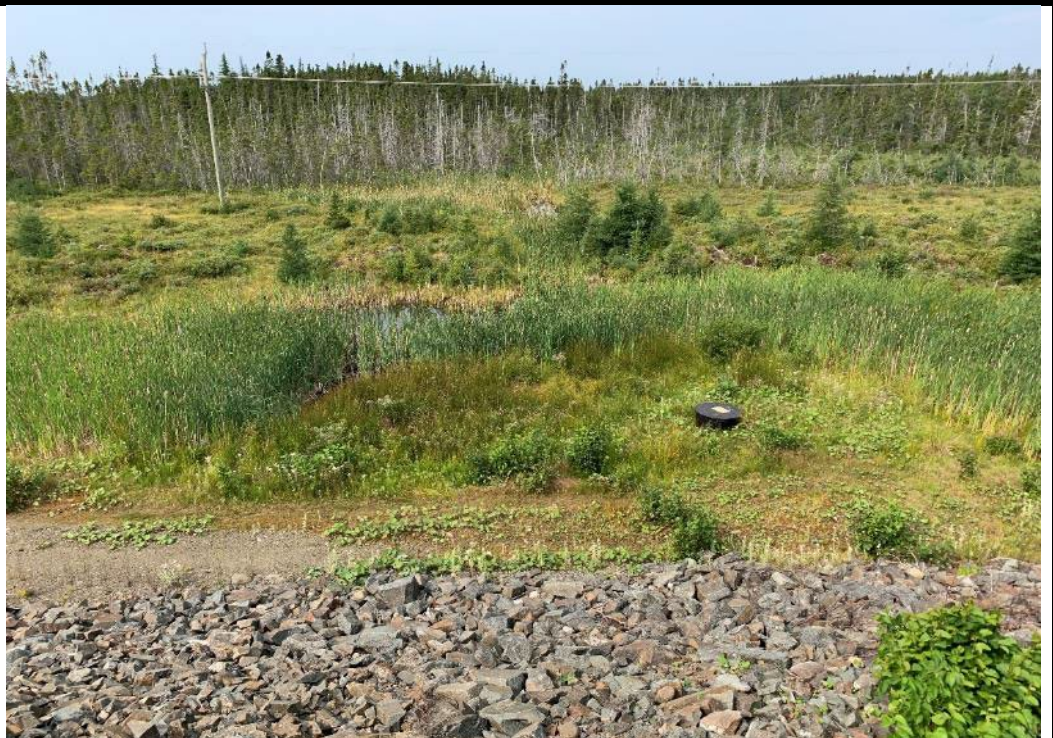
Photograph 4

Similar to previous years, a ponded area was observed at the toe near Sta. 0+250, adjacent to the seepage collection sump. The water coming out from the downstream shell accumulates in this pond before discharging between two overburden spoil piles into a channel that flows towards the Polishing Pond. The water is clear (i.e., free of sediment); however, there are signs of iron staining in the small pond. The flow rate was consistent with observations in previous years and the seepage reports to the Polishing Pond.

Downstream toe and Dam B seepage collection sump. Seepage and local runoff accumulates at this location then migrates through the wetland towards the Polishing Pond.

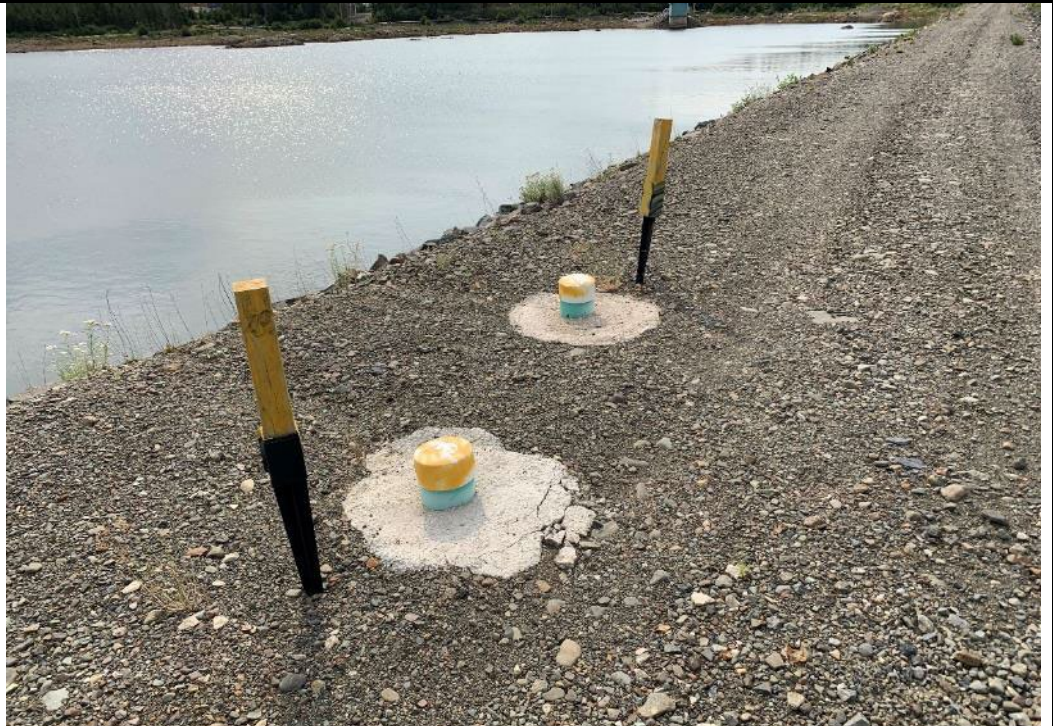
Photograph 5

Four piezometers (P07-03A and P07-03B in one nest and P07-04A and P07-04B in another nest) and a settlement plate (S18-02) were present on the crest of the dam at its maximum height. The instrumentation appeared in good condition; the concrete around the piezometers was in good condition with only minor cracking around the edges.

Piezometer surface casings on Dam B at Sta. 0+300. The surface casings were extended in 2019 to prevent surface runoff entering the piezometers.

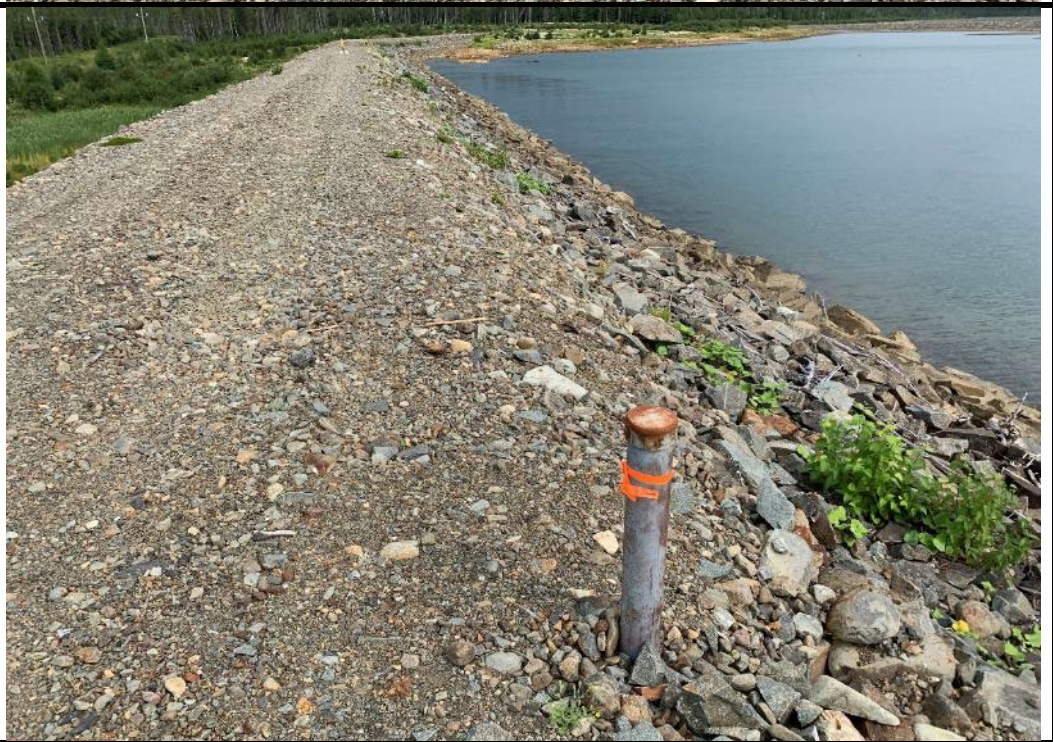
Photograph 6

Surface casing over the Dam B settlement plate.

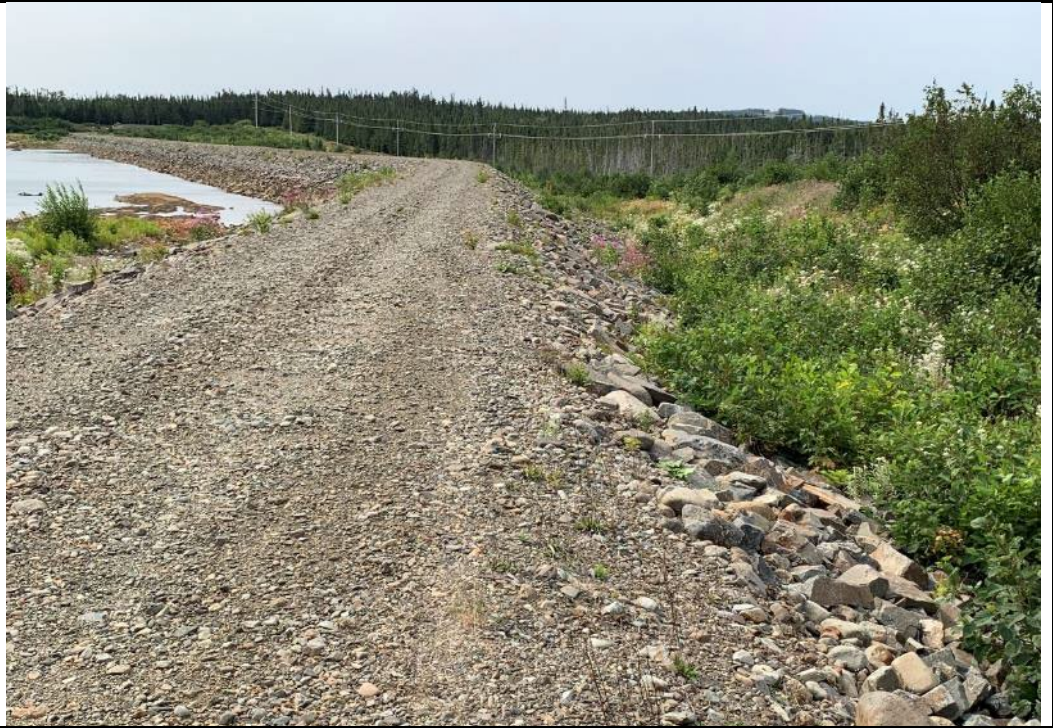
Photograph 7

Downstream shell of Dam B looking south from Sta. 0+050.

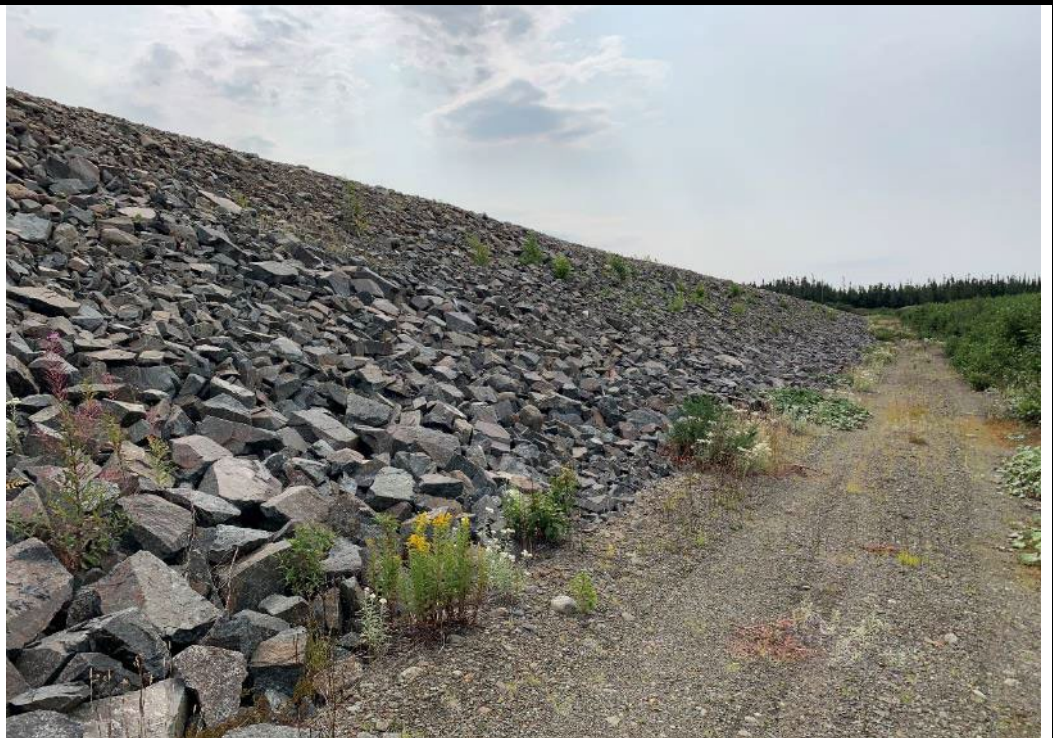
Photograph 8

Downstream slope of Dam B at Sta. 0+300 looking south.

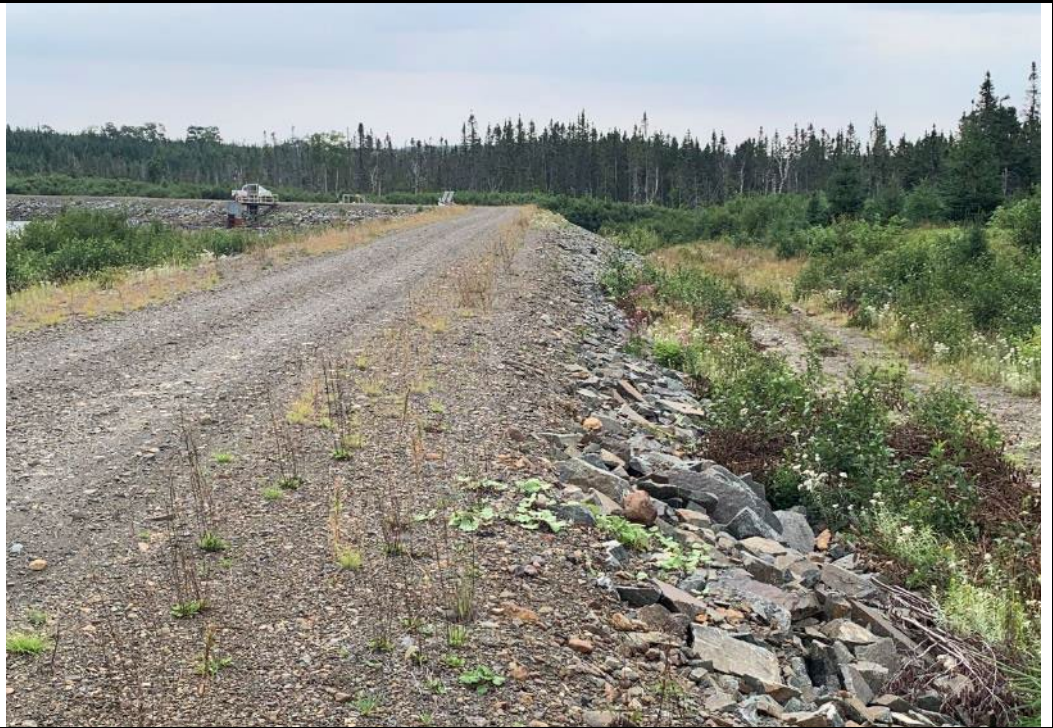
Photograph 1

Dam C crest and downstream shell from the north abutment.

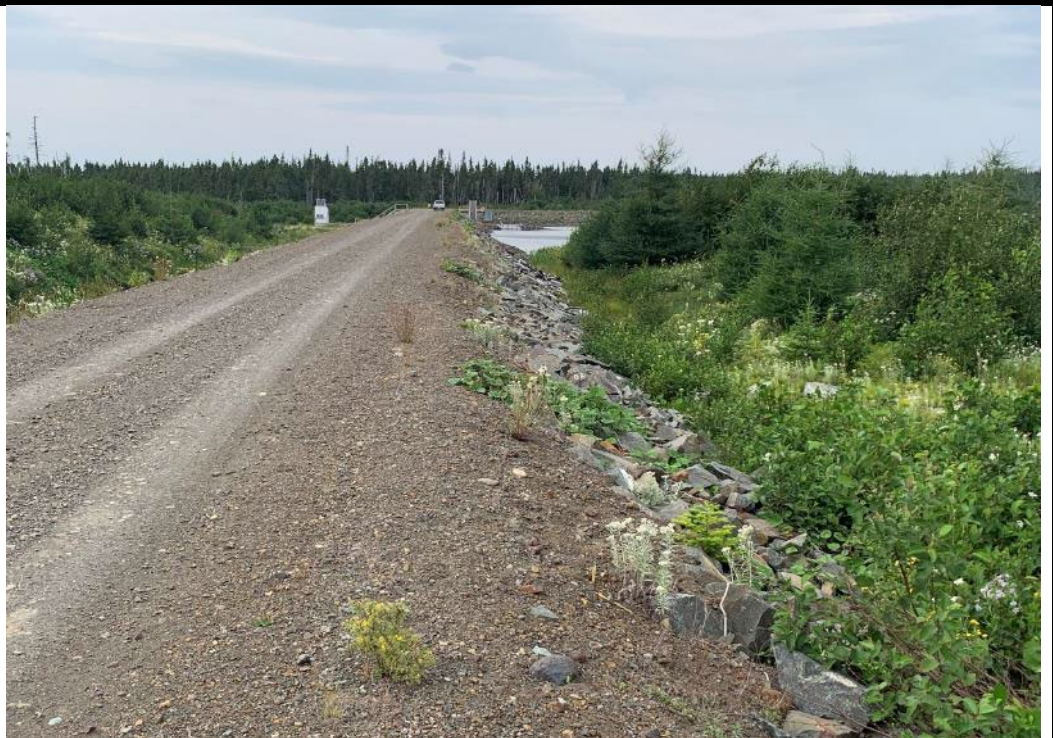
Photograph 2

Dam C crest and upstream shell looking north from south abutment.

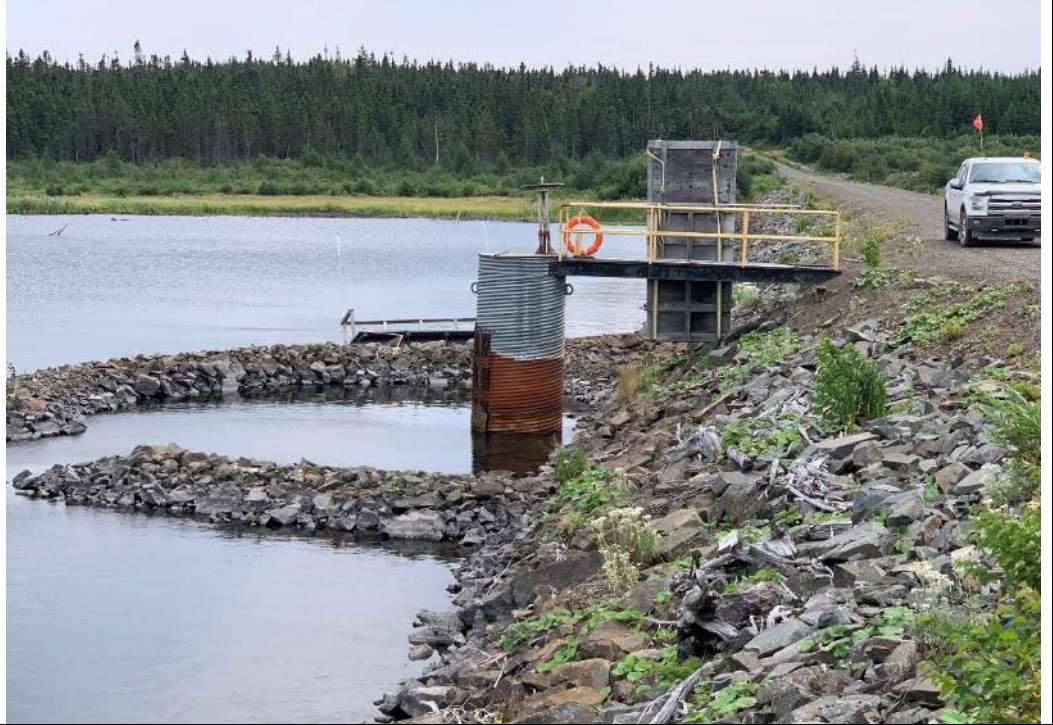
Photograph 3

Dam C	2018-13	Minor rusting was observed around the inlet of the Decant Structure on Dam C.	The structure should be monitored for changing conditions that might affect its integrity.	Ongoing – No change in the condition of the structure in recent years.	3
Diversion Ditches	2018-15	A pipeline crossing was constructed in the winter of 2012/2013 across Diversion Ditch A2 at Sta. 0+350. The pipeline crossing includes a 0.3 m diameter HDPE culvert through the diversion ditch. The culvert is likely too small to convey the design storm flow and appears to be partially blocked with sediment and vegetation. However, the diversion ditch would not be overtopped under the design storm event as there is sufficient freeboard above the crossing to the top of bank on the diversion ditch.	The pipeline crossing should be monitored closely and repaired if damaged.	Ongoing – No observed change in the condition of the structure in recent years.	4

Dam C decant tower inlet.

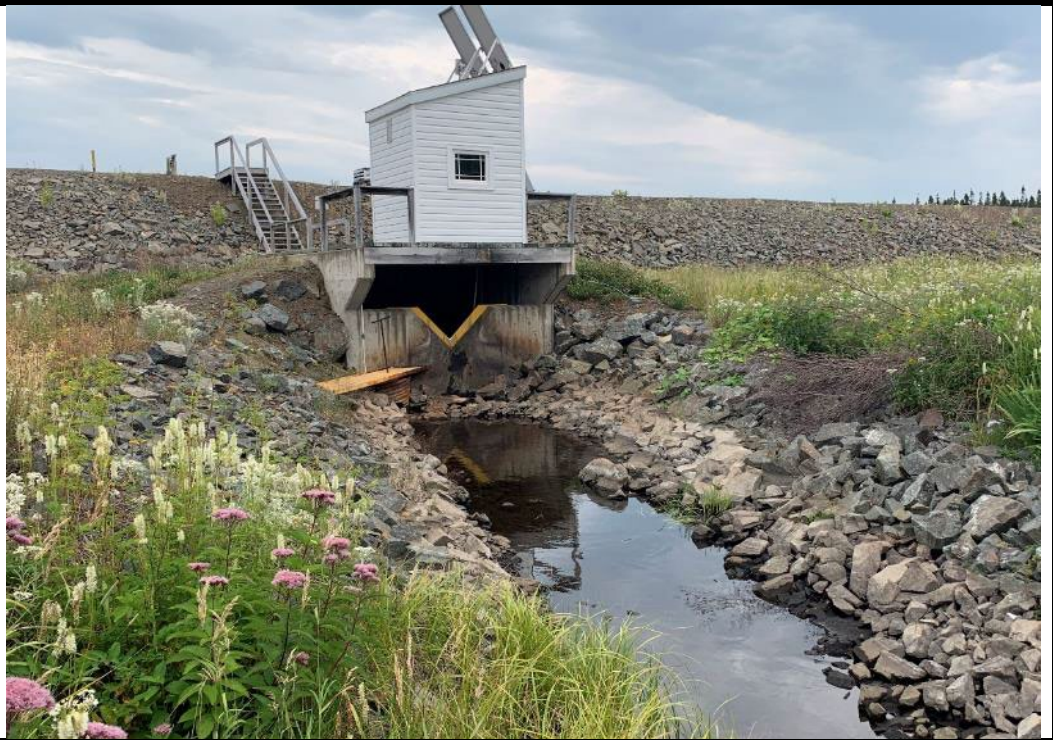
Photograph 4

Dam C hydraulic control structure.

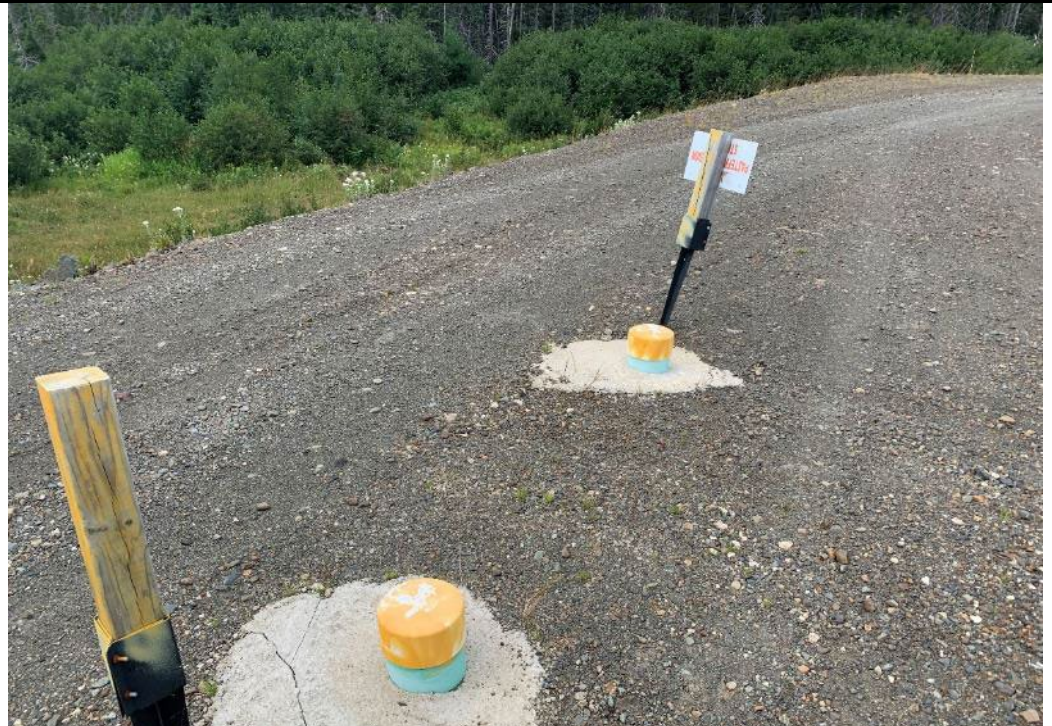
Photograph 5

Piezometer surface casings on the crest of Dam C at Sta. 0+200. The surface casing was extended in 2019 to prevent surface runoff from entering the piezometers.

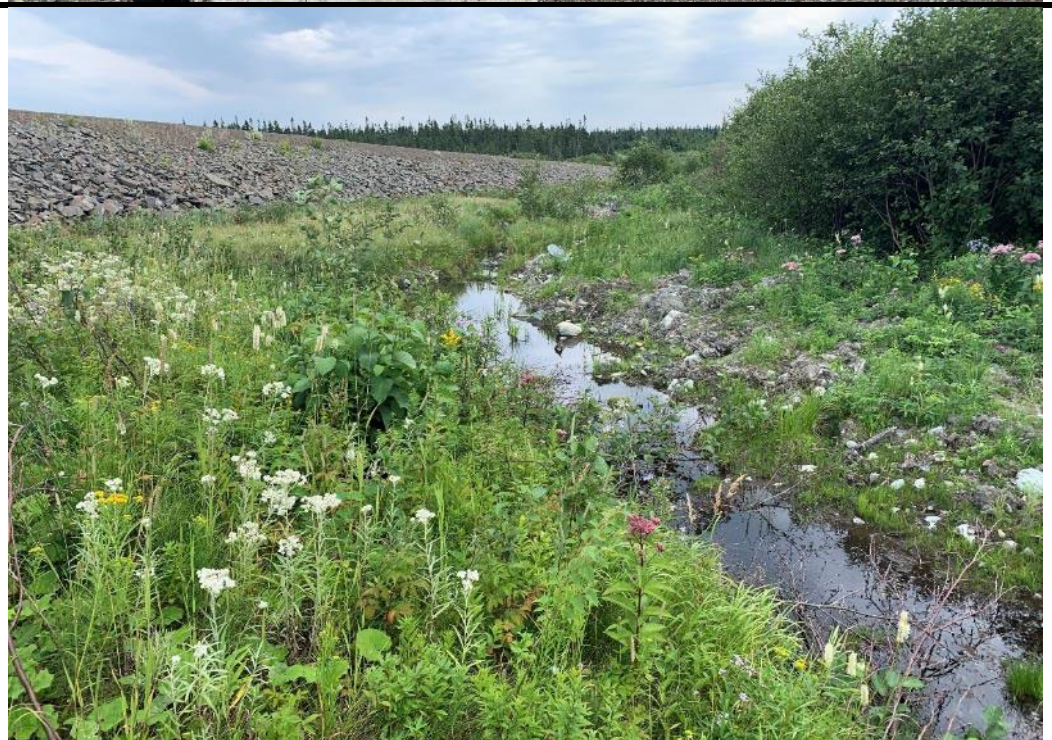
Photograph 6

Downstream shell of Dam C and seepage collection ditch at Sta. 0+200, looking south.

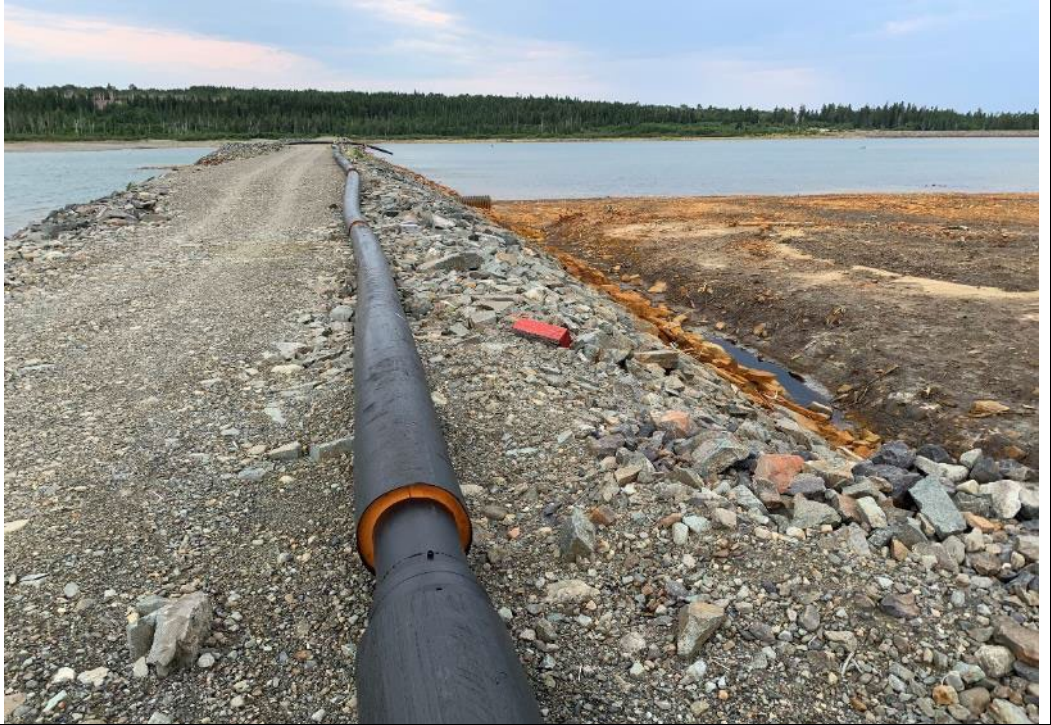
Photograph 1

Berm 1 east slope with HDPE culvert and lime addition pipeline.

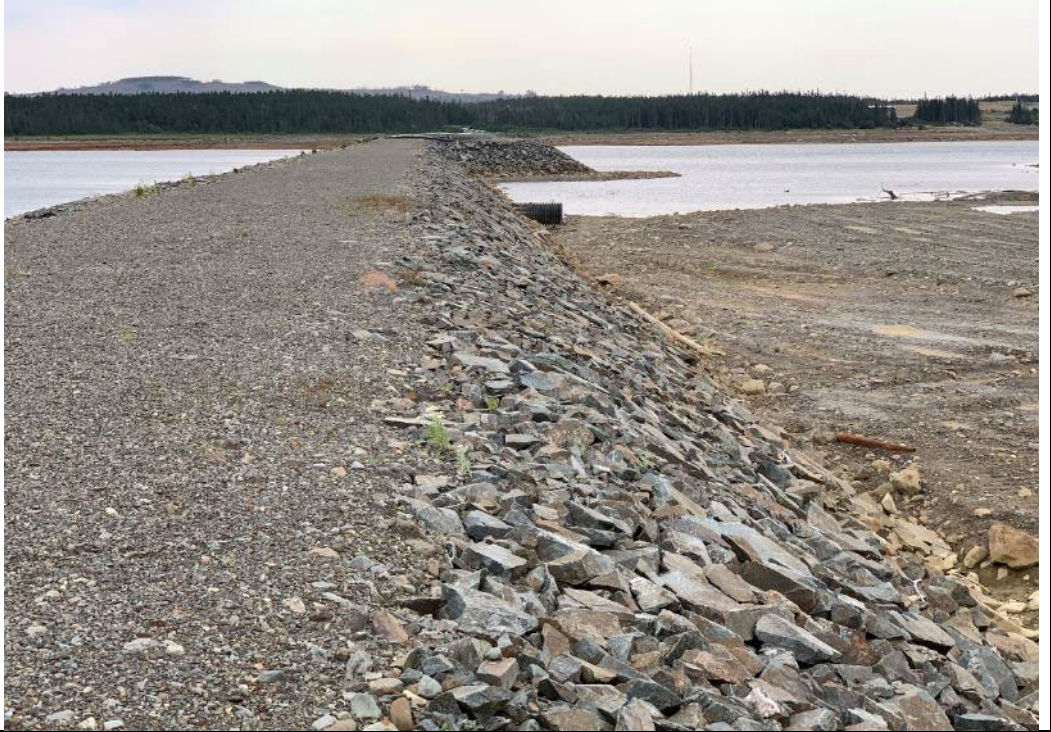
Photograph 2

Berm 1 looking south near north abutment with HPDE culvert connecting Cells 1 and 2.

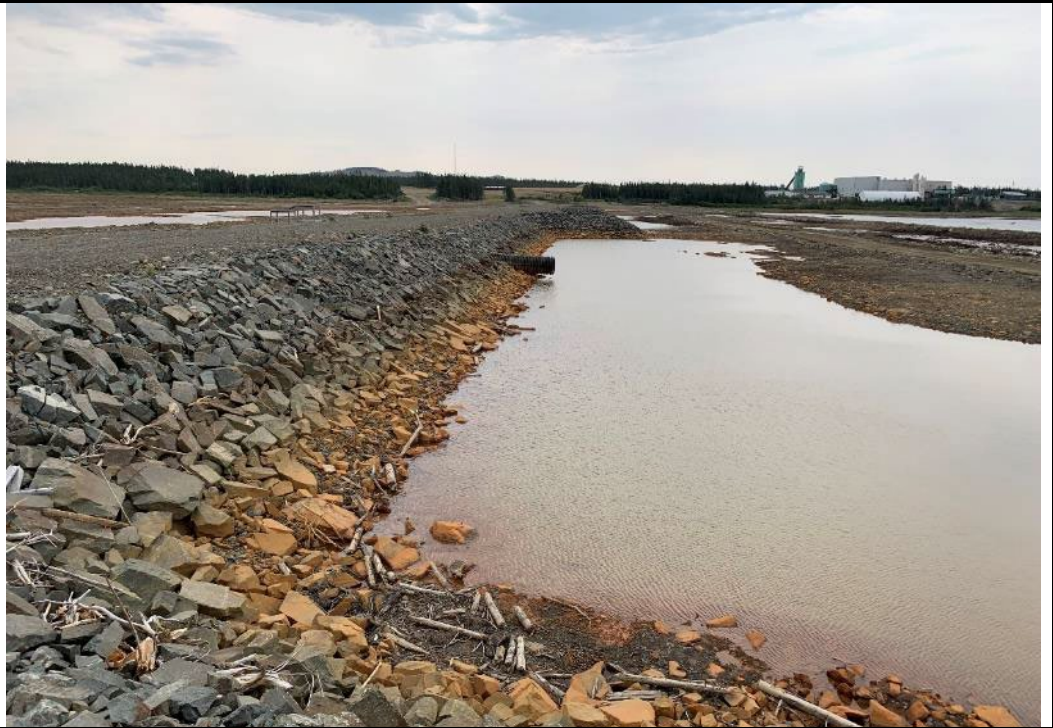
Photograph 3

Berm 2 north abutment looking south with HPDE culvert connecting Cells 2 and 3.

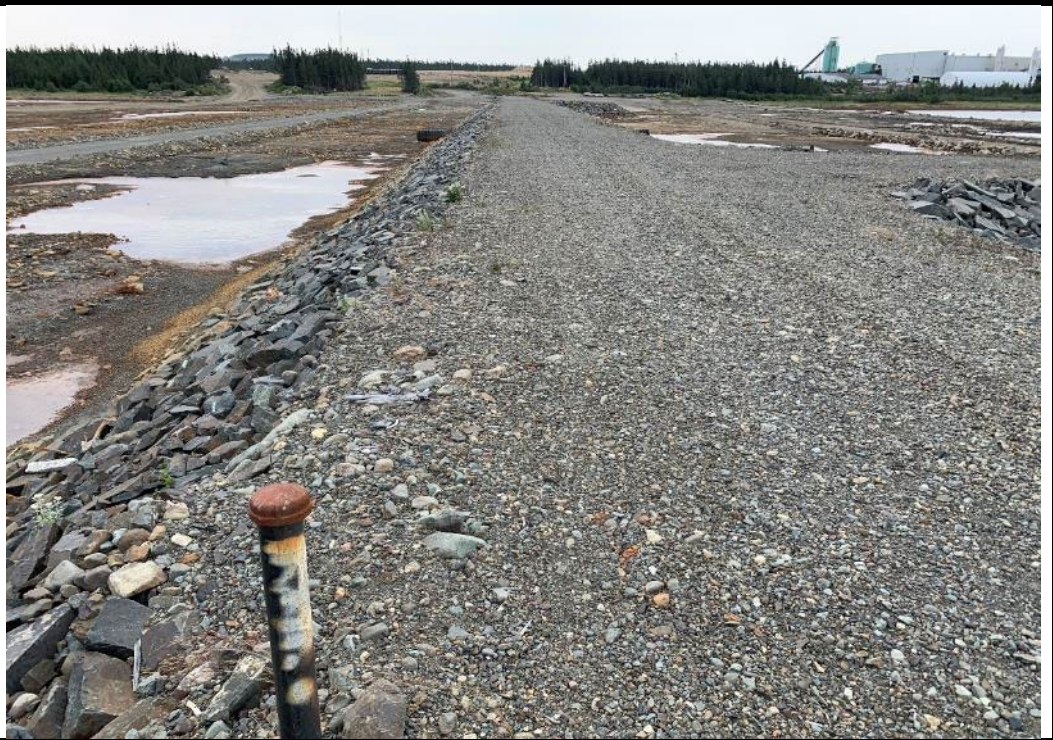
Photograph 4

Berm 2 east slope, looking south. HDPE culvert connecting Cells 2 and 3 in the background and protective casing on settlement plate in foreground.

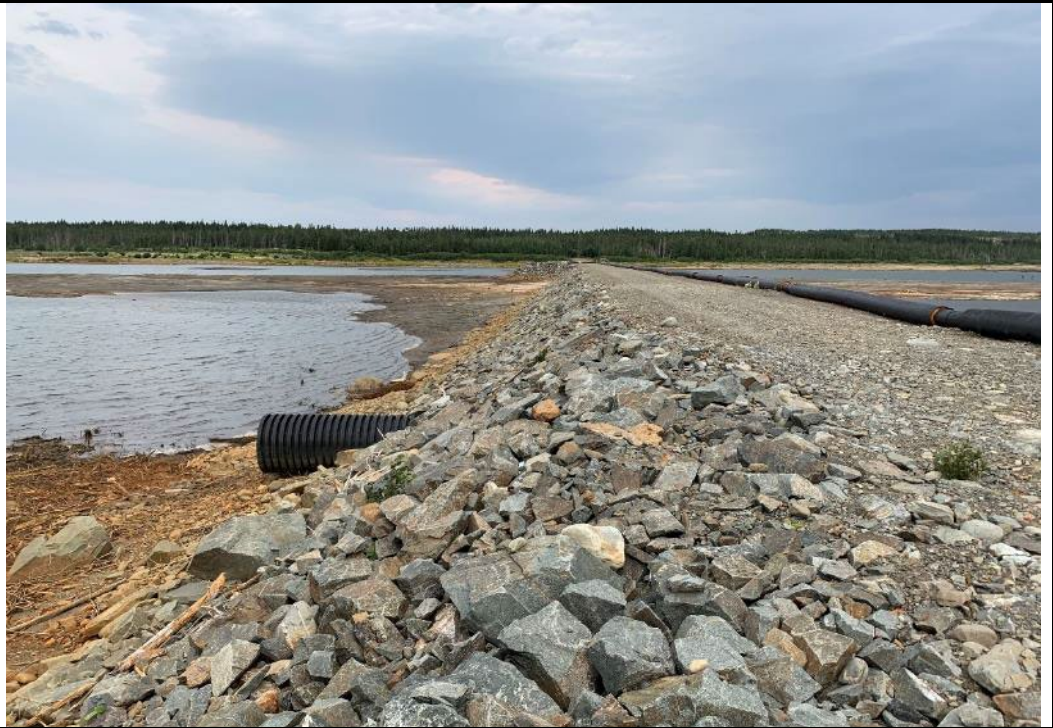
Photograph 5

Berm 3 west slope looking north with culvert connecting Cells 3 and 4

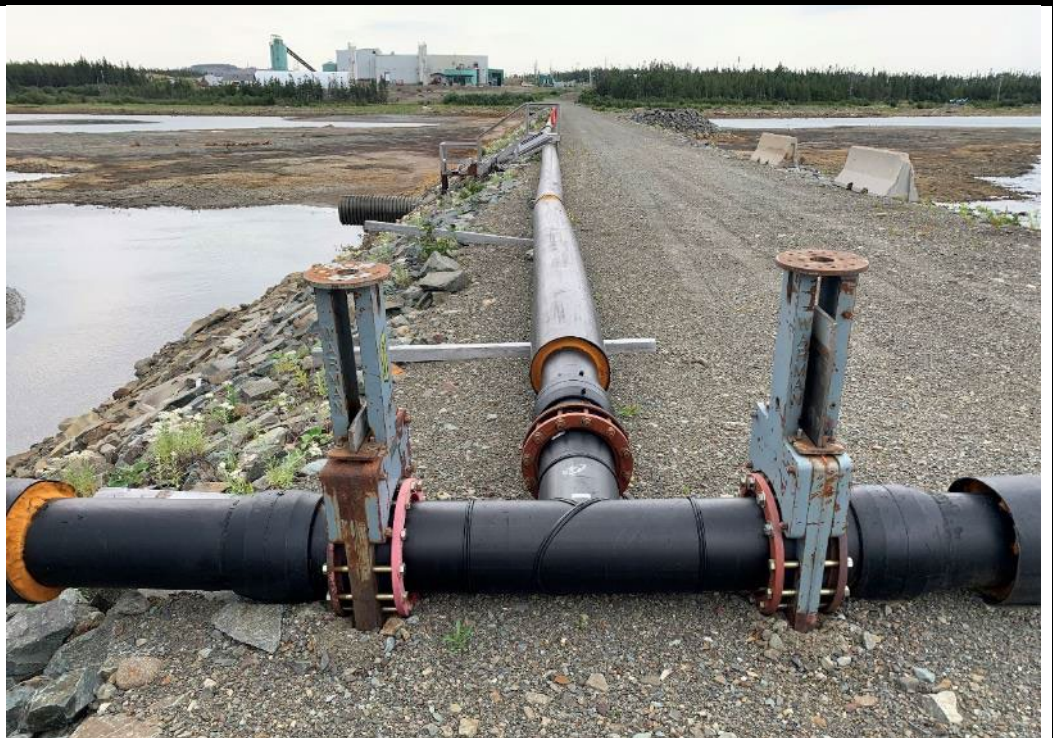
Photograph 6

Berm 3 east slope looking south. Lime addition pipeline and T-valve to control treatment in Cells 3 and 4.
