**2021 ANNUAL FACILITY PERFORMANCE REVIEW REPORT
DUCK POND OPERATIONS TAILINGS MANAGEMENT FACILITY**

2021 Annual Facility Performance Review Report

Duck Pond Operations Tailings Management Facility

Project No. 21455283 (2000);
Reference No. 21455283-001-R-Rev0-1000

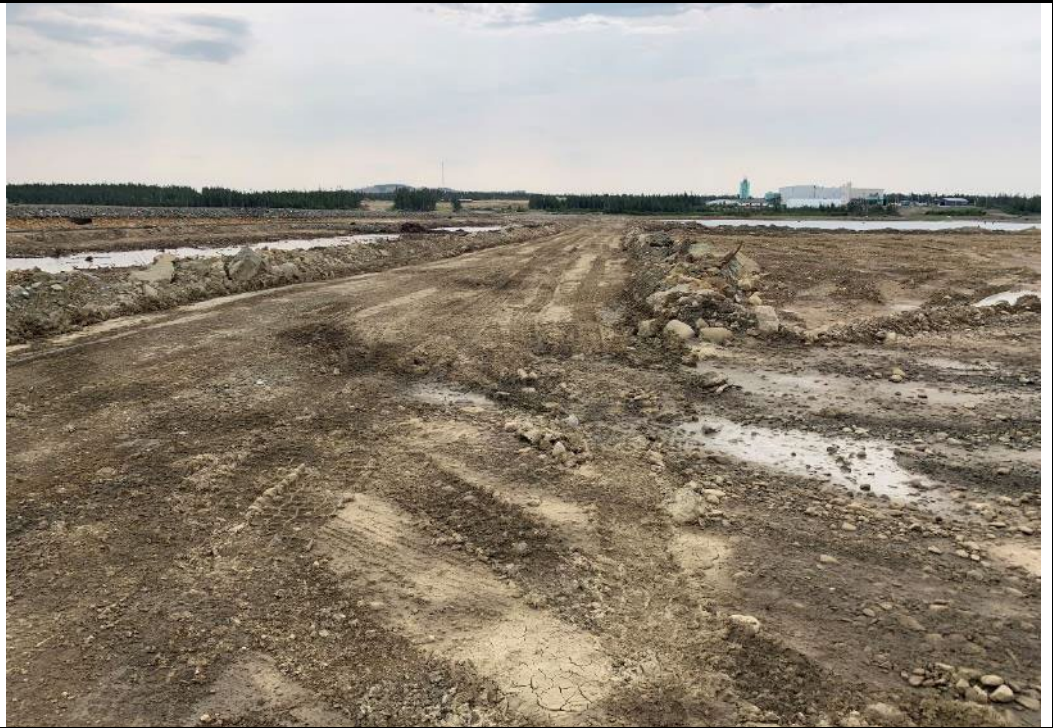
Photograph 7

View of Finger Dyke 4, looking south.

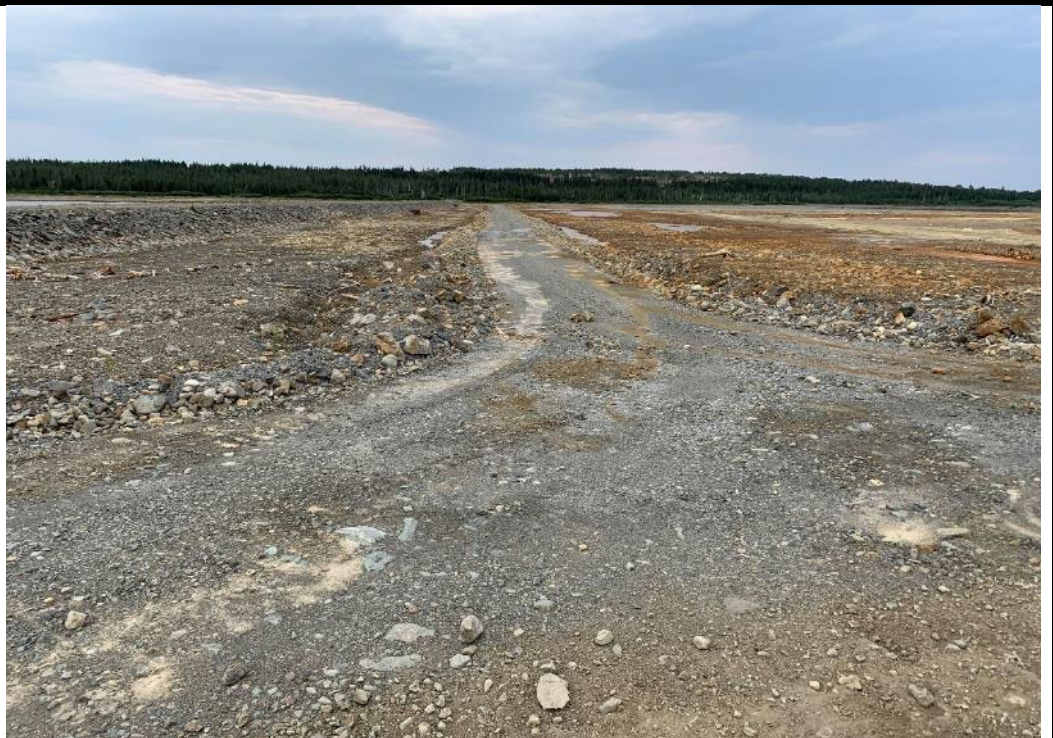
Photograph 8

Finger Dyke 1 looking north.

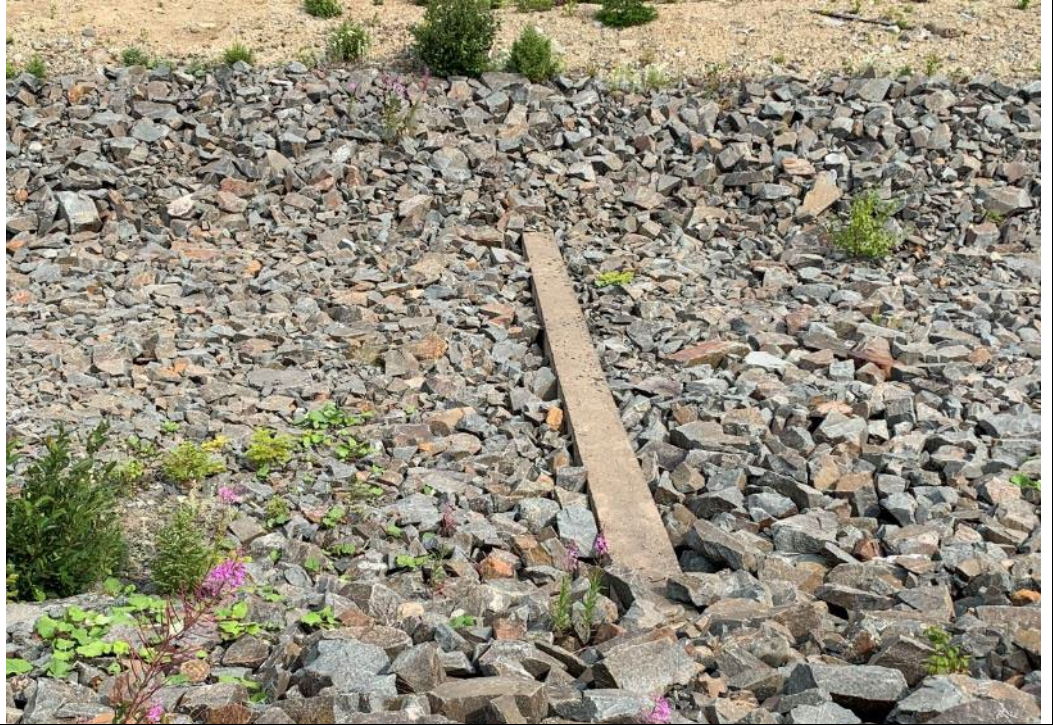
Photograph 1

Dam B emergency spillway concrete sill.

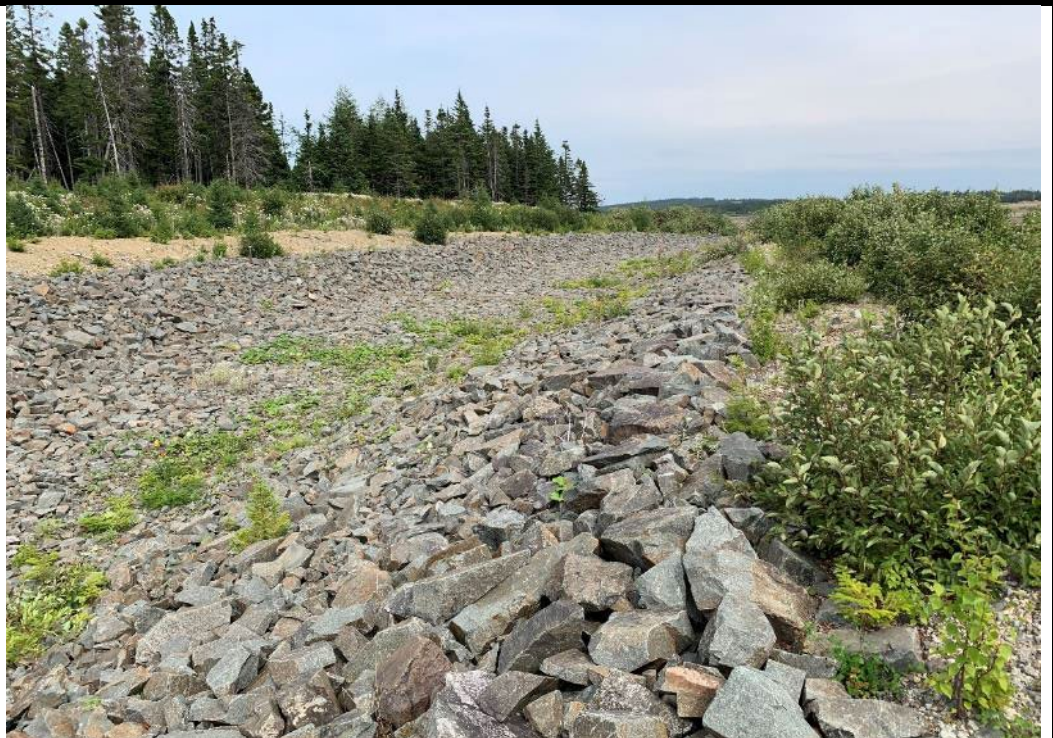
Photograph 2

Dam B Emergency Spillway inlet channel looking towards the TMA.

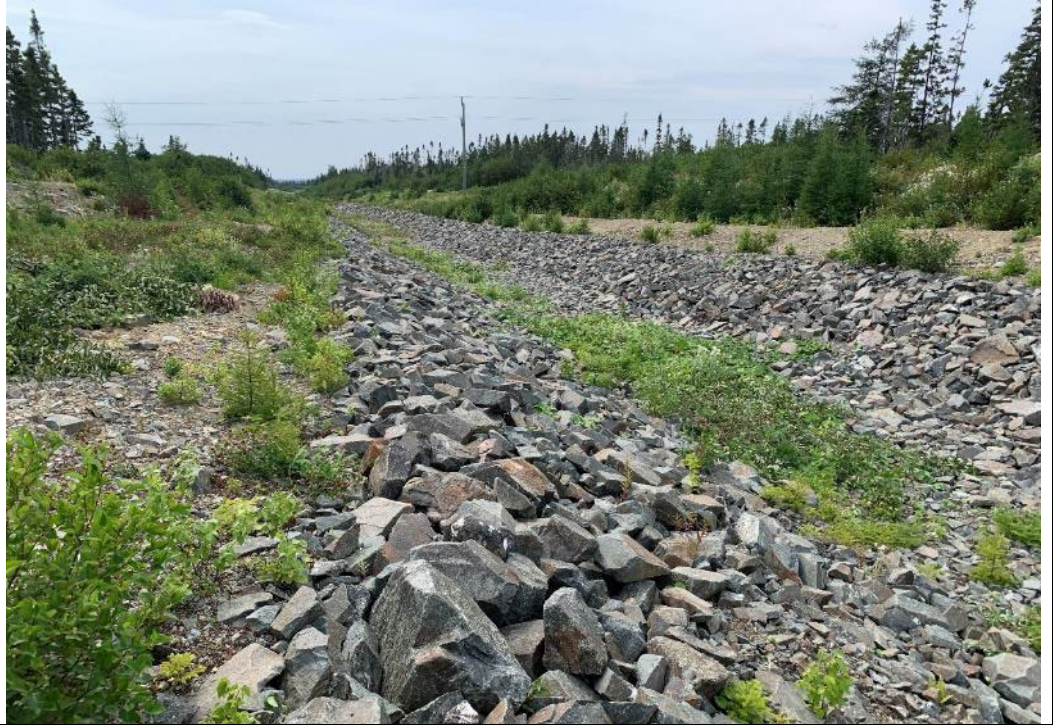
Photograph 3

View of Dam B Spillway channel looking northeast from culverts along Mine Access Road.

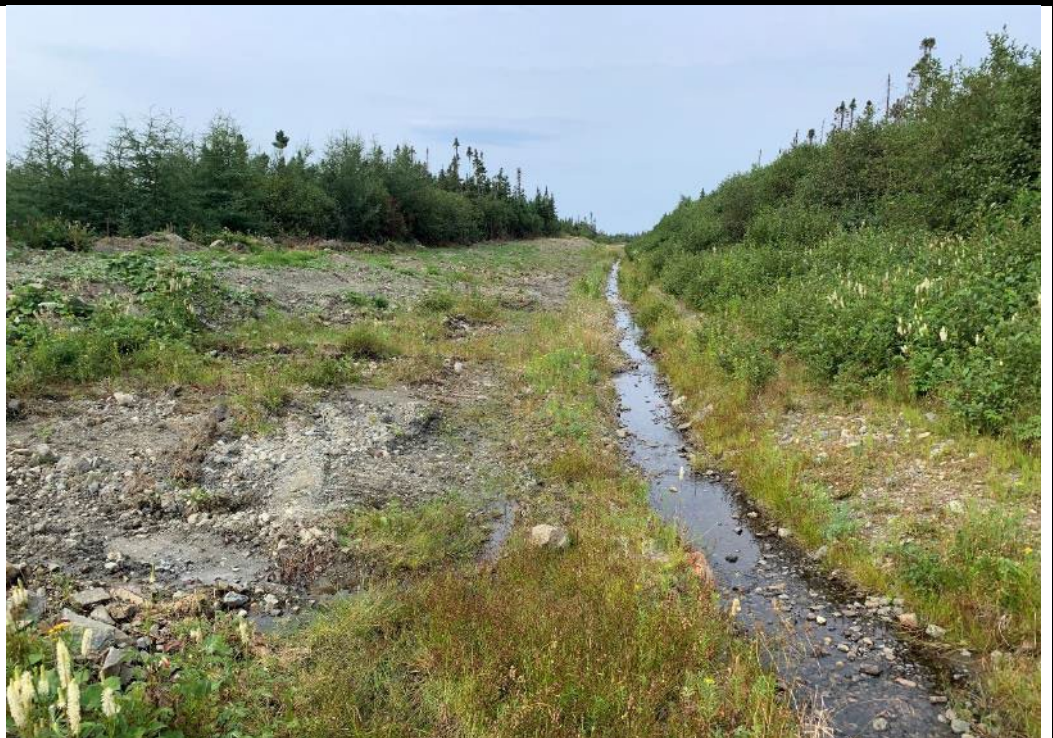
Photograph 4

Dam B spillway channel at confluence with Diversion Ditch B1, looking west towards the mine site access road.

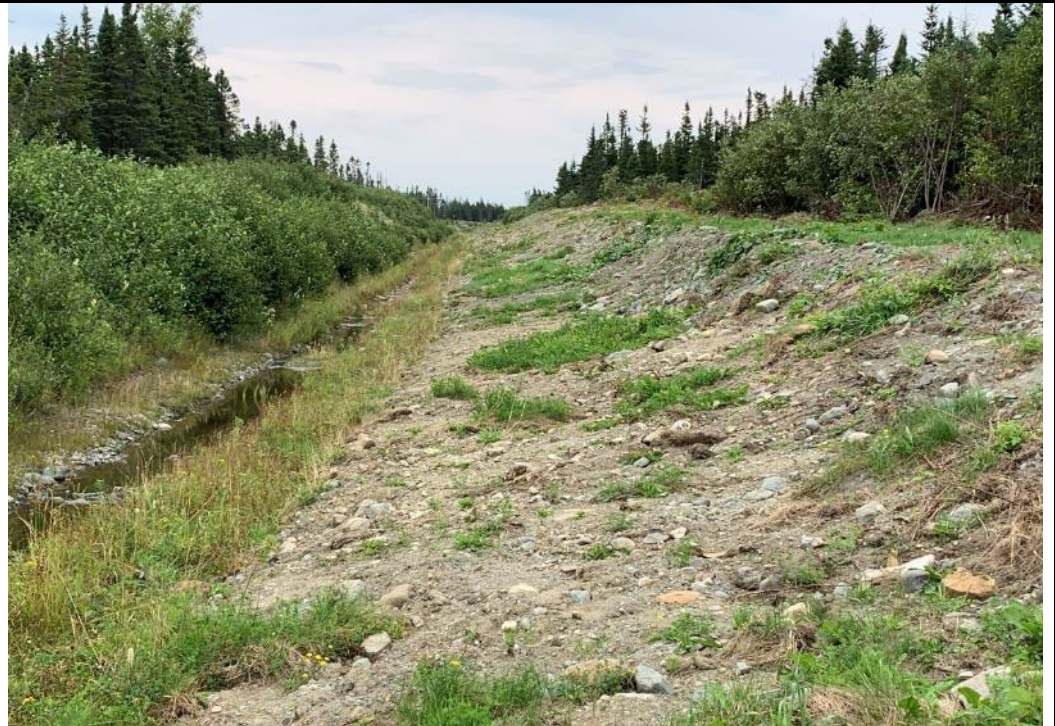
Photograph 5

Dam B Emergency Spillway Channel looking east from the Mine Site Access Road. Spillway channel was clear of debris in 2021.

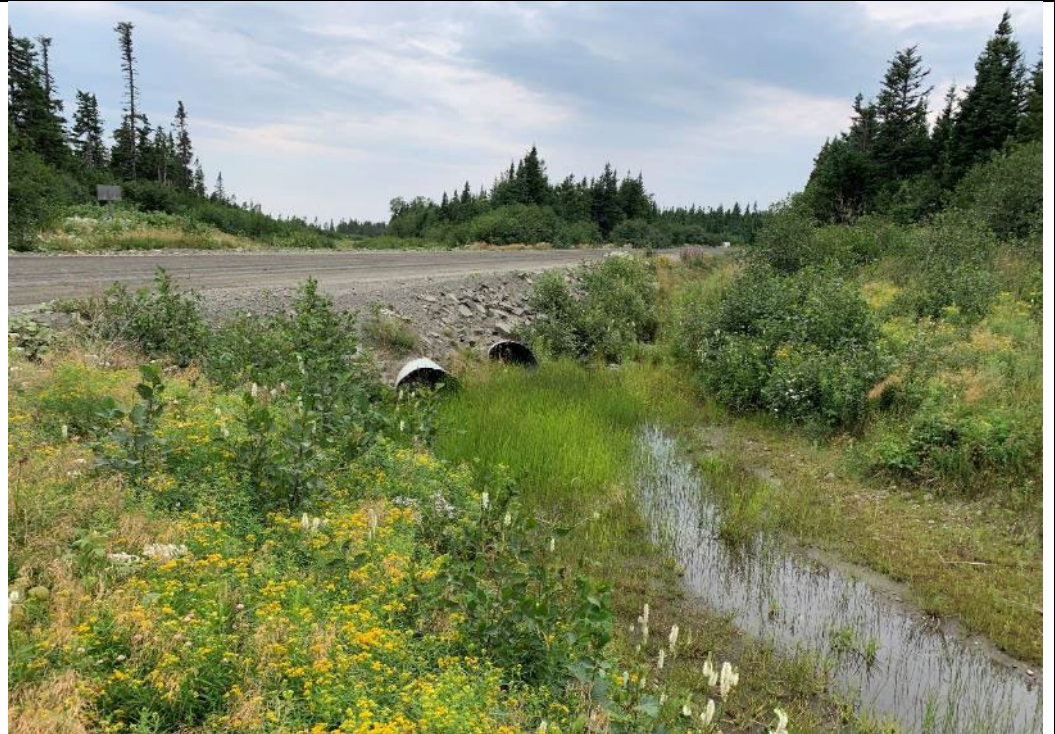
Photograph 6

Inlet of culverts beneath the Mine Site Access Road.

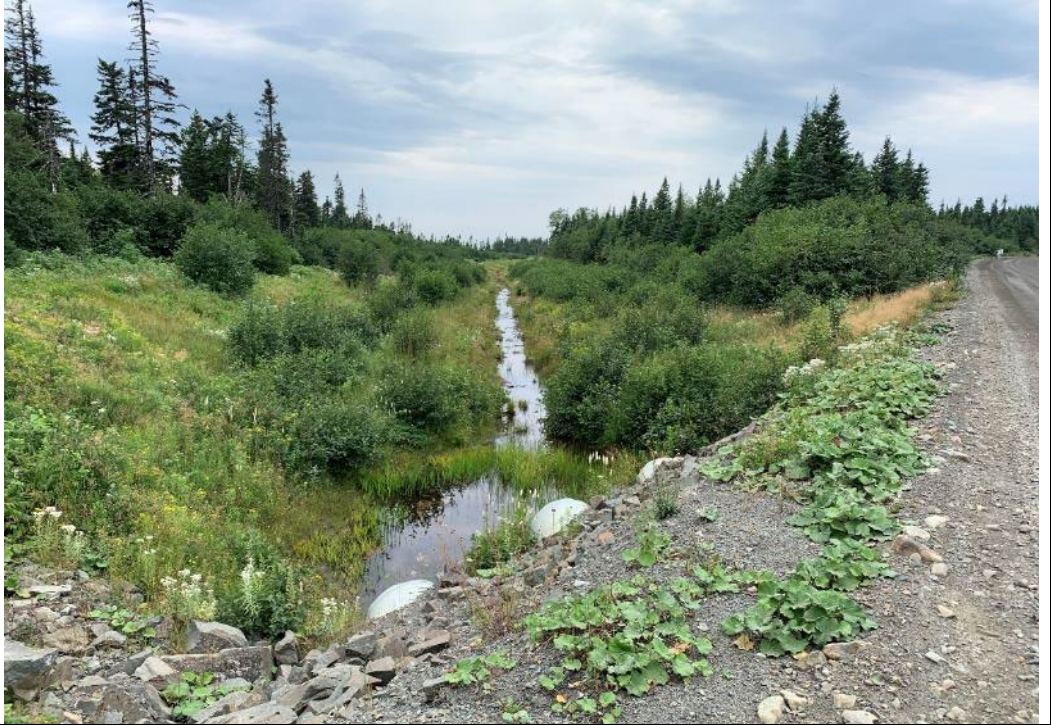
Photograph 7

Dam B Emergency Spillway Channel looking west from Sta. 0+750.

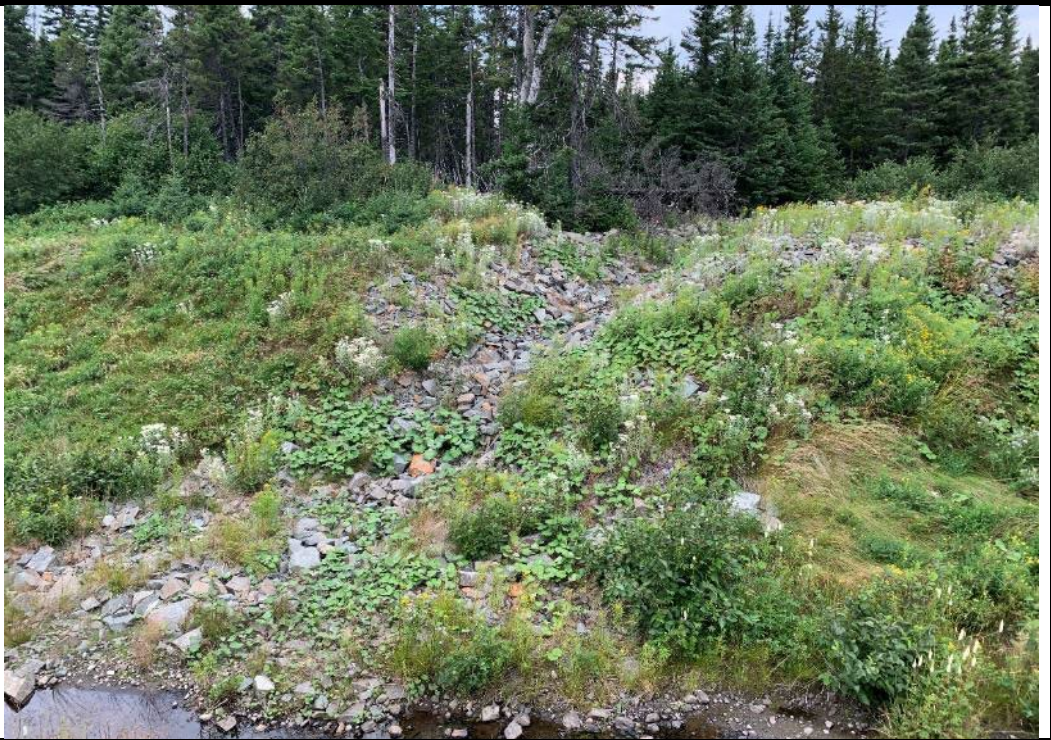
Photograph 8

Historical erosion on channel near Sta. 0+900 was repaired in 2018 with additional rip rap.

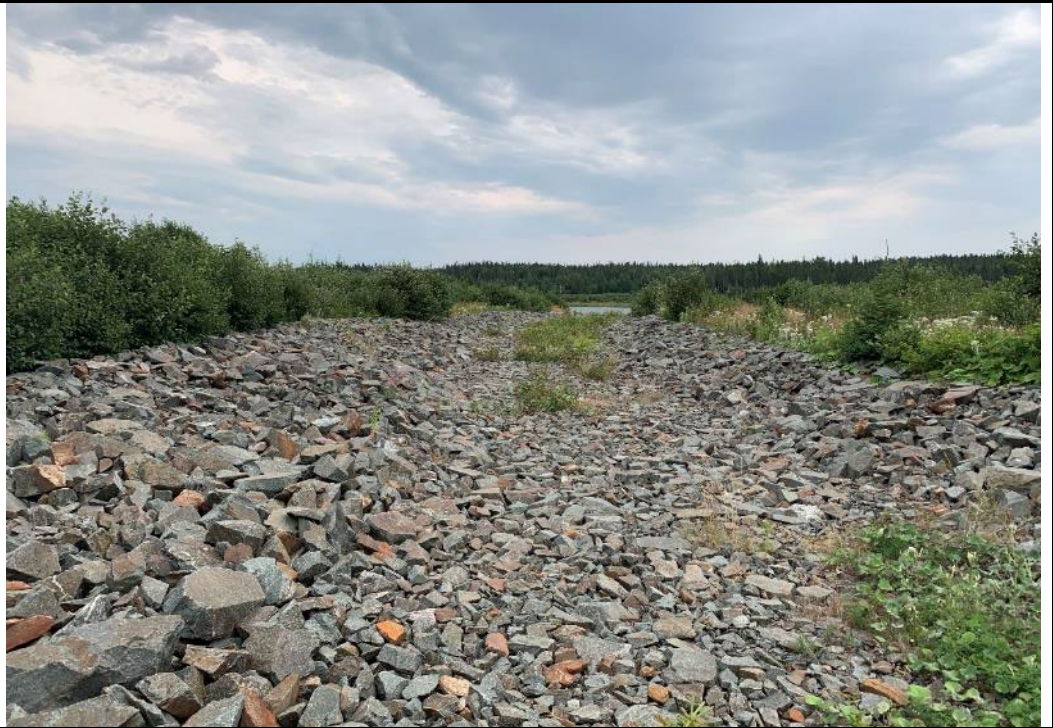
Photograph 1

Dam C Emergency Spillway inlet channel with the Polishing Pond in the background.

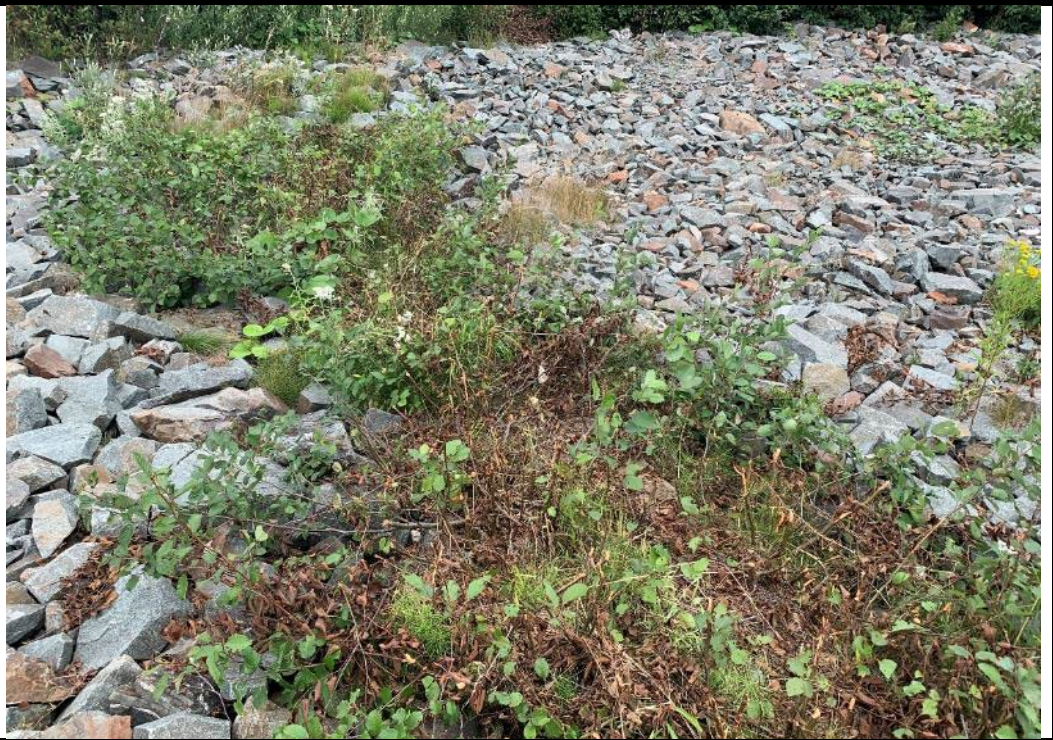
Photograph 2

Dam C Emergency Spillway concrete sill becoming overgrown with vegetation.

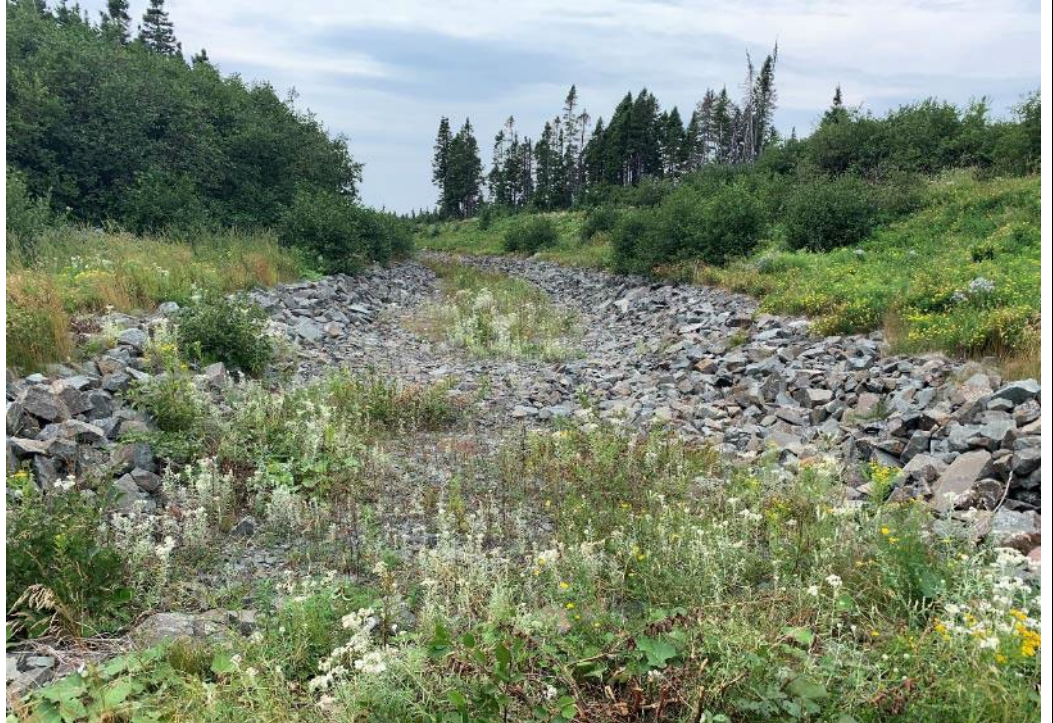
Photograph 3

Dam C Emergency Spillway channel looking downstream.

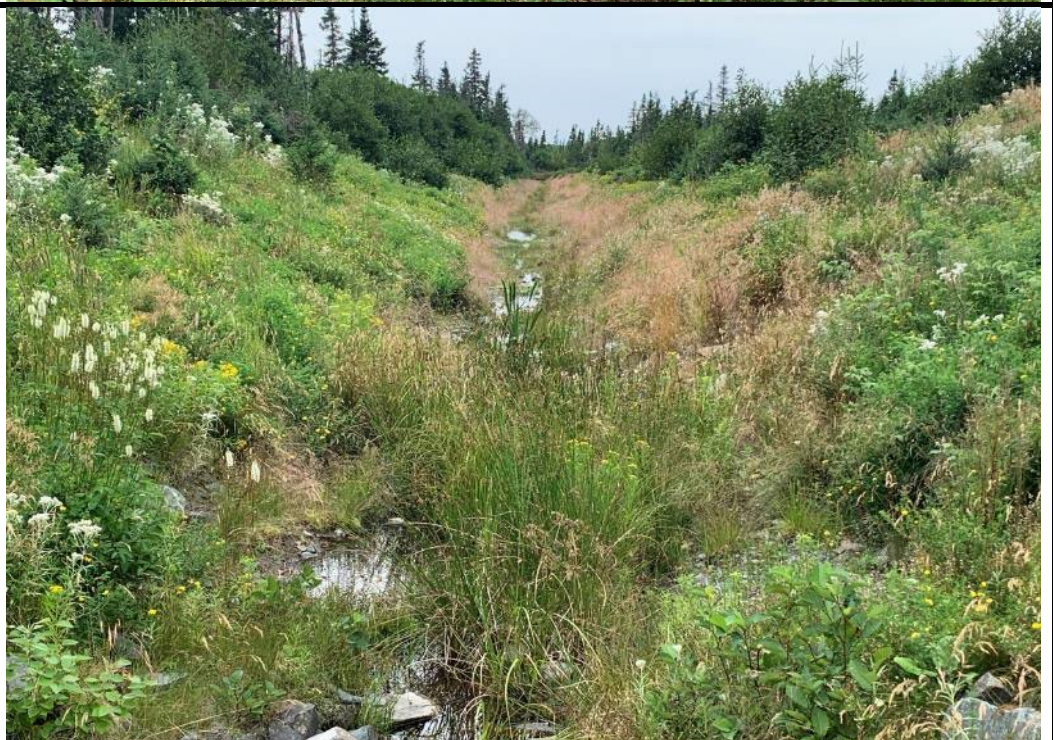
Photograph 4

Dam C Emergency Spillway outlet channel, looking downstream from the end of the rip rap lined section.

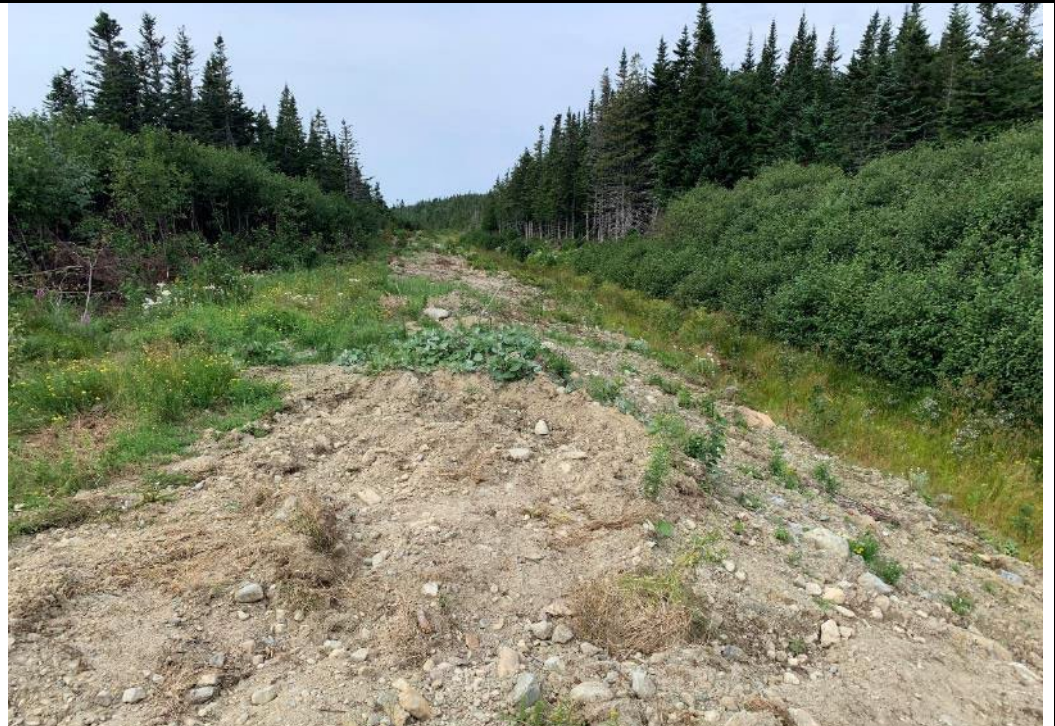
Photograph 1

Diversion Ditch A1 looking west from Sta. 0+800.

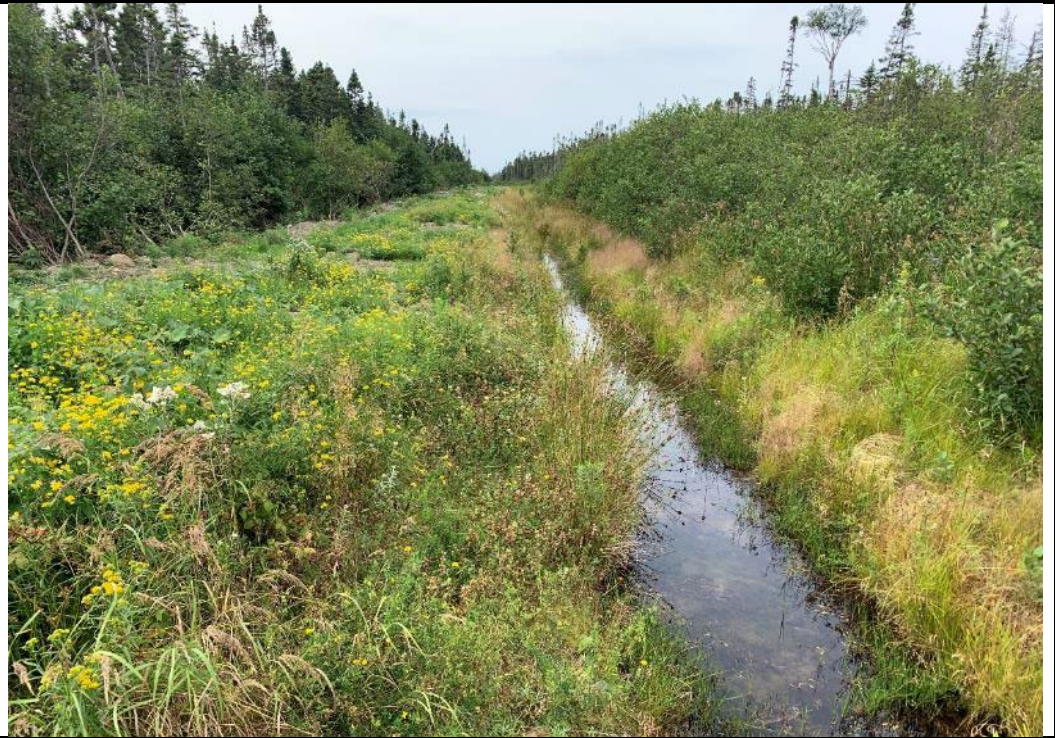
Photograph 2

Diversion Ditch A1 looking west from Sta. 0+200.

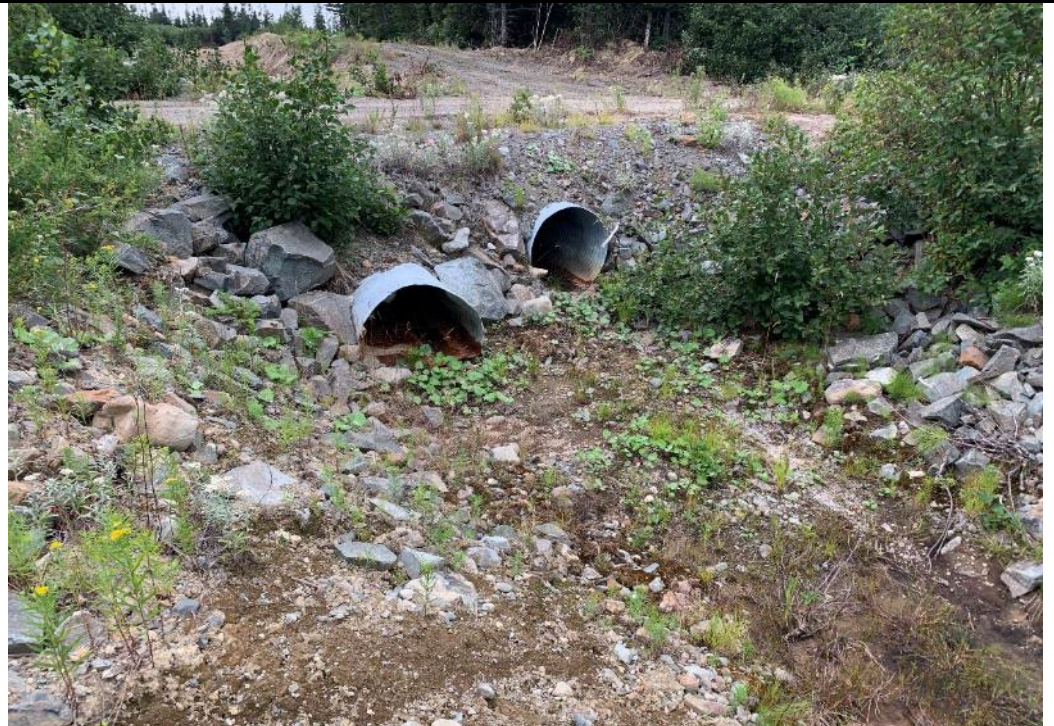
Photograph 3

Diversion Ditch A2 culvert outlets at the access road crossing.

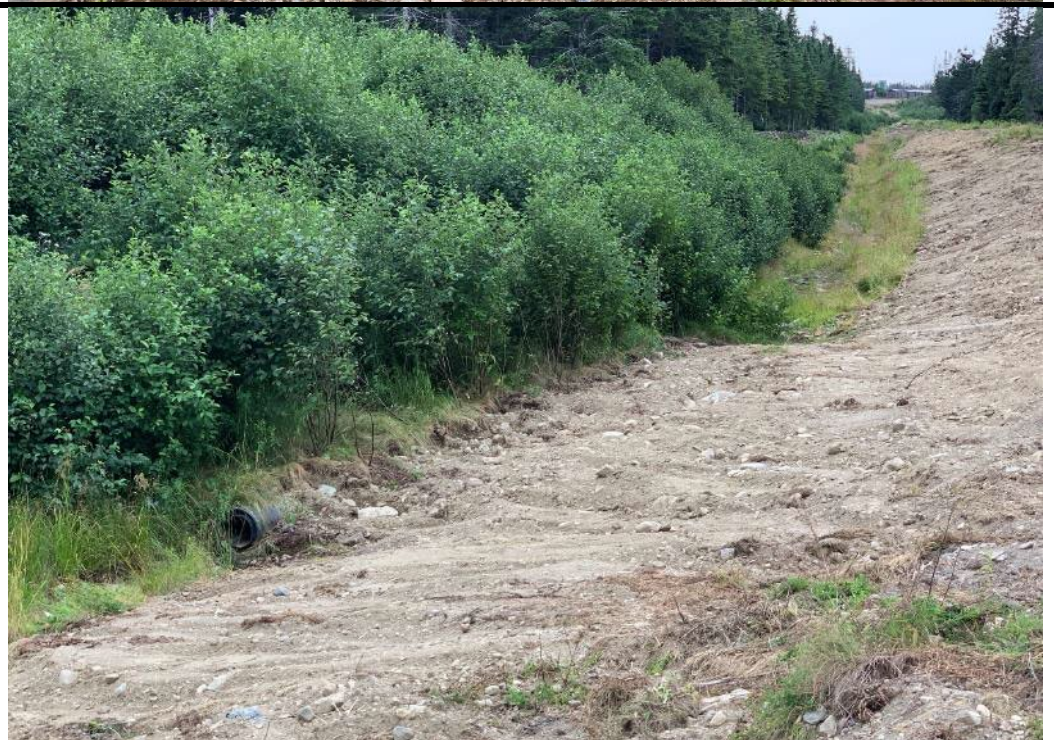
Photograph 4

Diversion Ditch A2 at Sta. 0+350 looking west. Culvert was installed in the ditch for the buried pipeline from Boundary site.

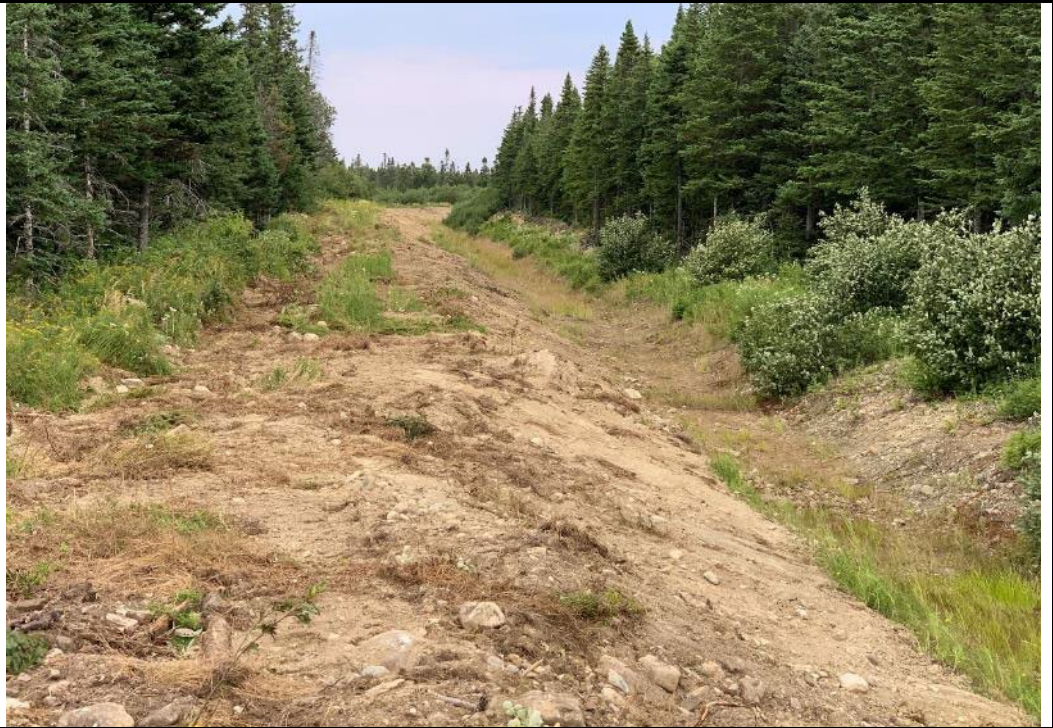
Photograph 5

Diversion Ditch A2 looking east from Sta. 0+100.

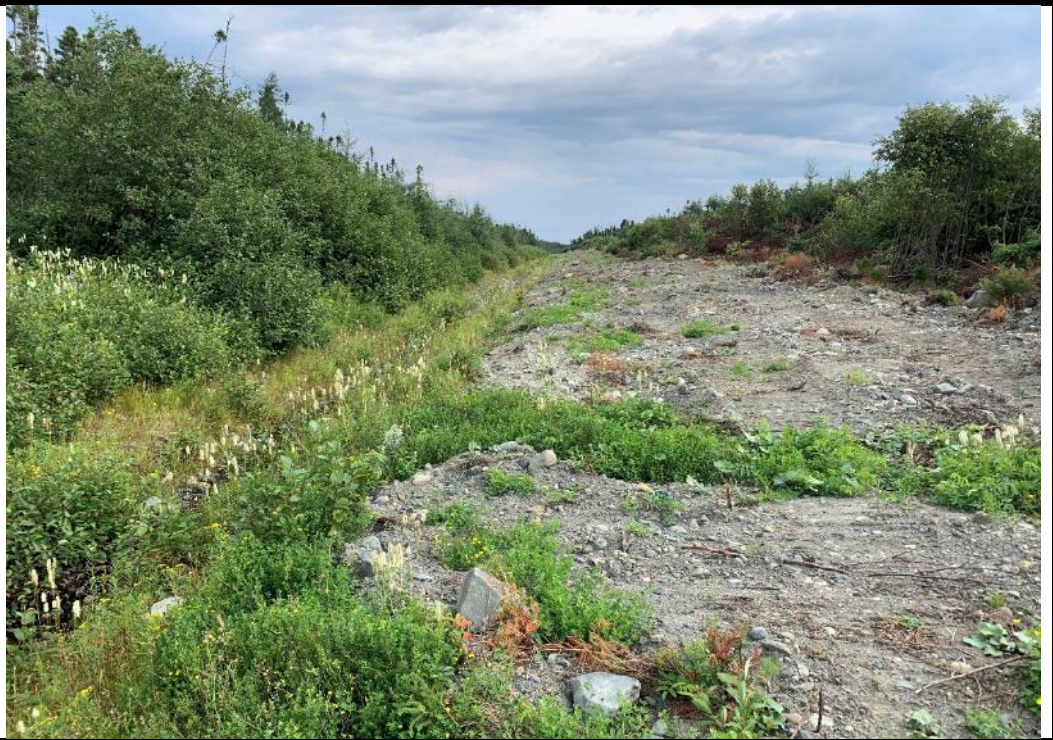
Photograph 6

Diversion Ditch B1 looking east from Sta. 0+500.

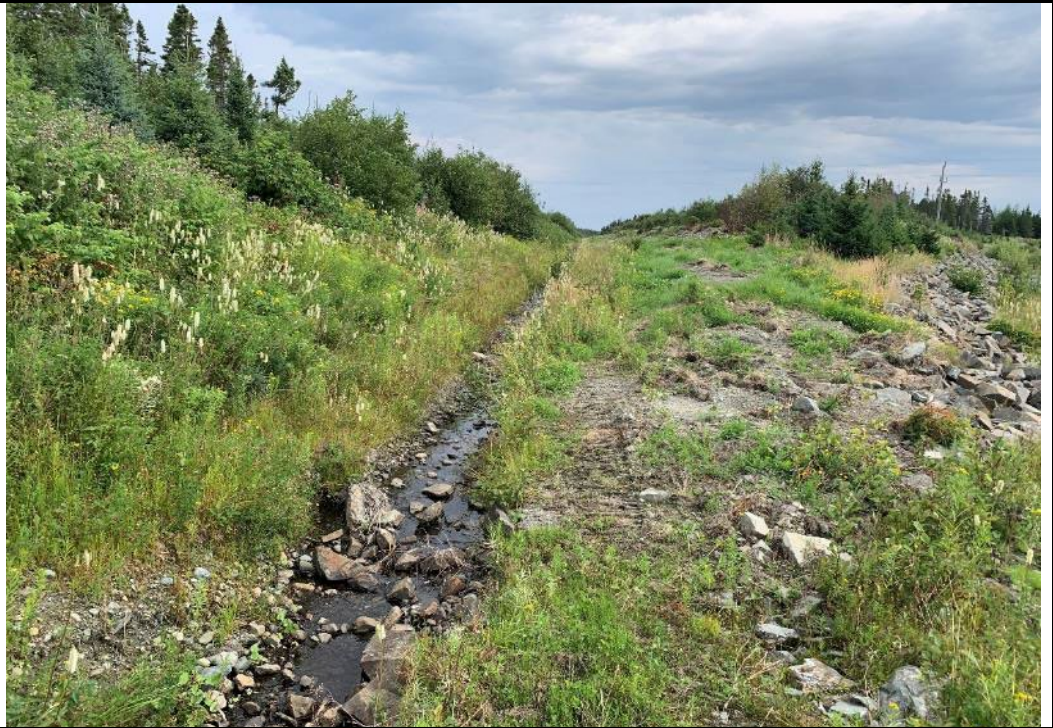
Photograph 7

Diversion Ditch B1 looking east from Sta. 0+700 and the intersection with Dam B Emergency Spillway Channel.

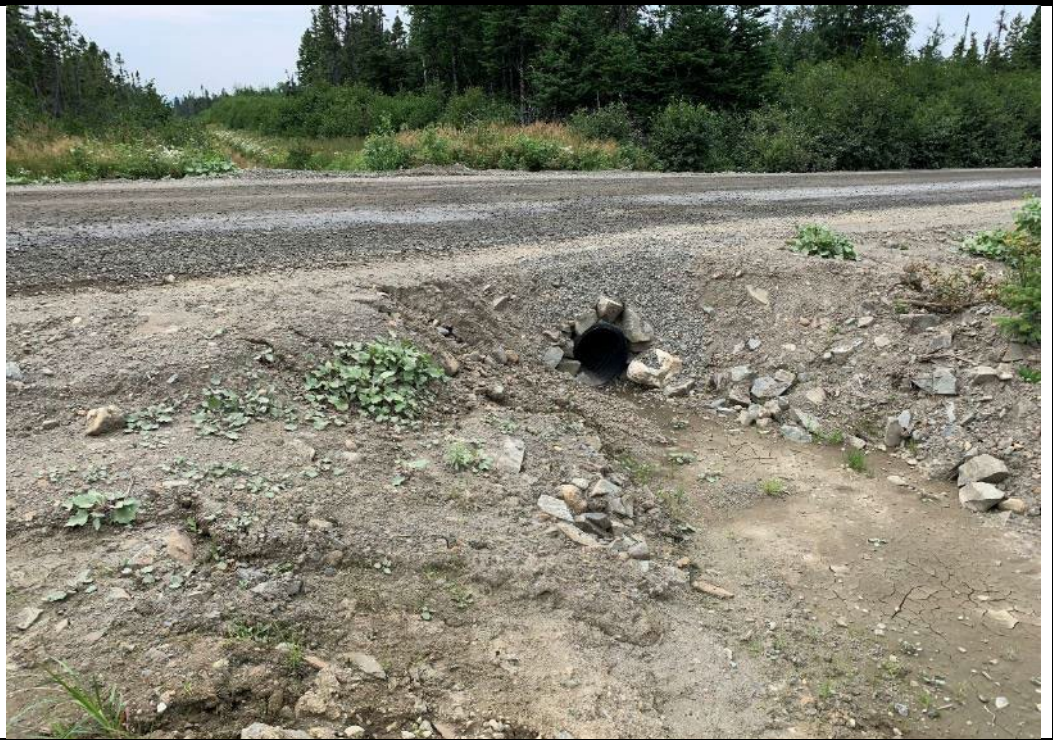
Photograph 8

Diversion Ditch C1 looking at the new HDPE culvert installed in 2021 at the Site Access Road crossing.

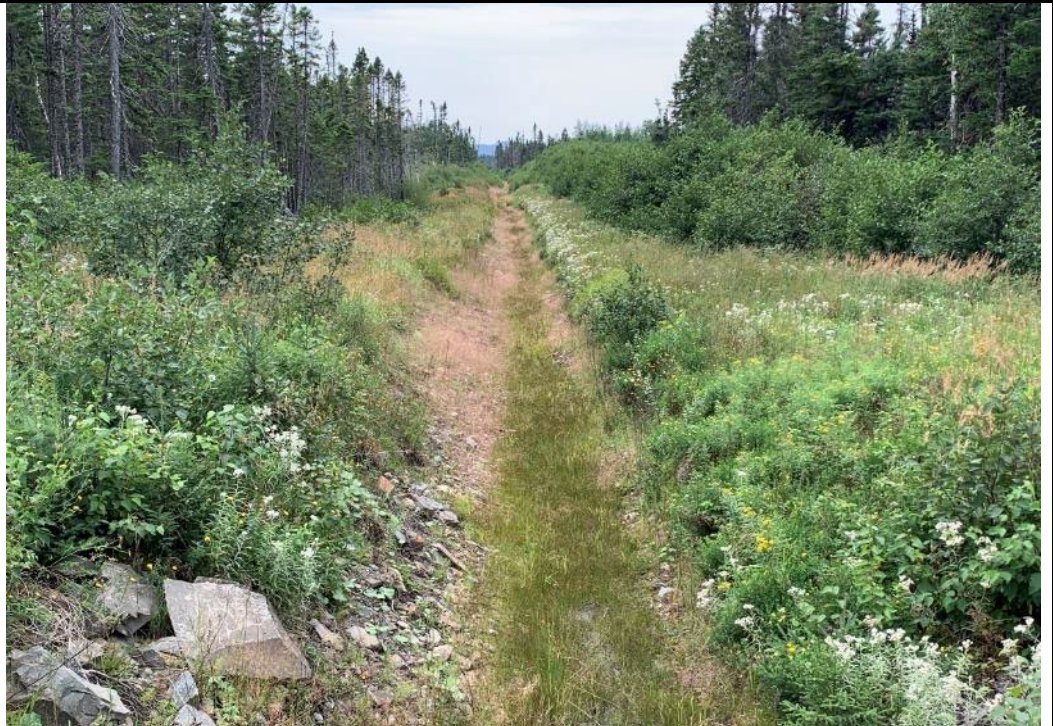
Photograph 9

Diversion Ditch C1 looking west from Sta. 0+150.

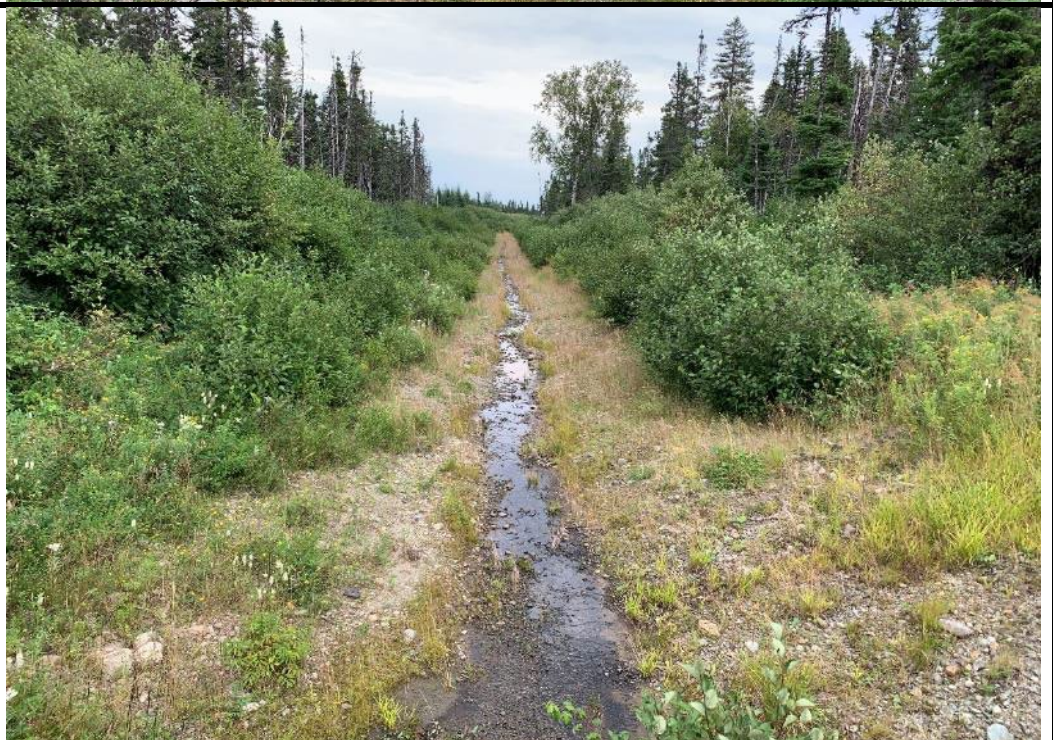
Photograph 10

Diversion Ditch C1, looking east from access road crossing at Sta. 0+750.

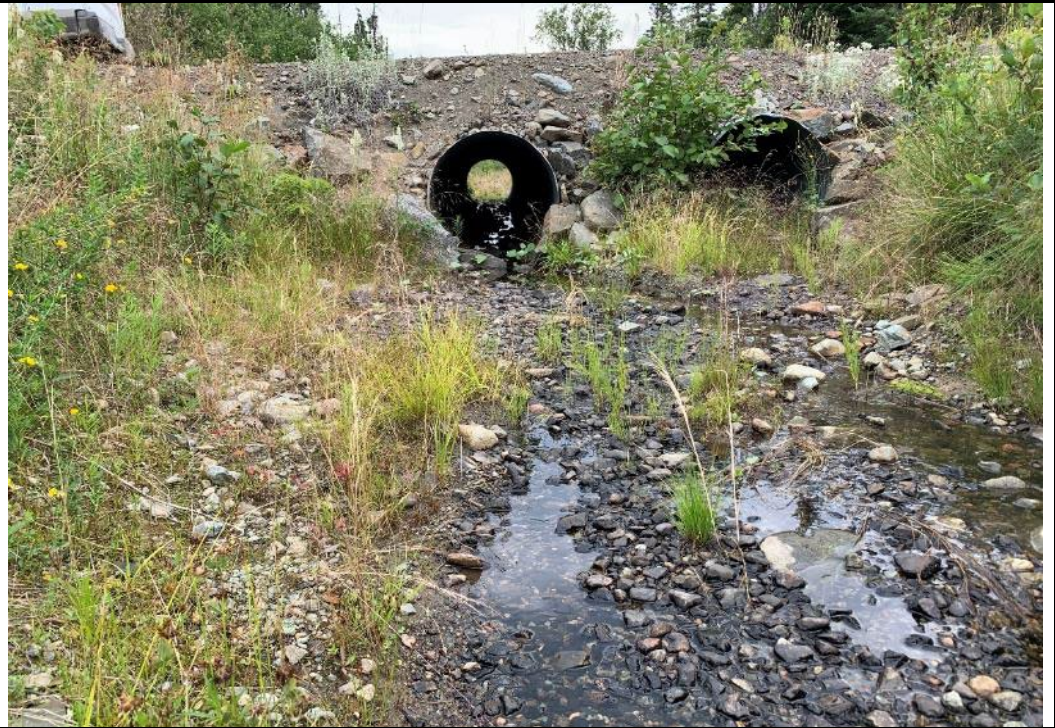
Photograph 11

View of Diversion Ditch C1 culvert (inlet) at the access road crossing at Sta. 0+750.

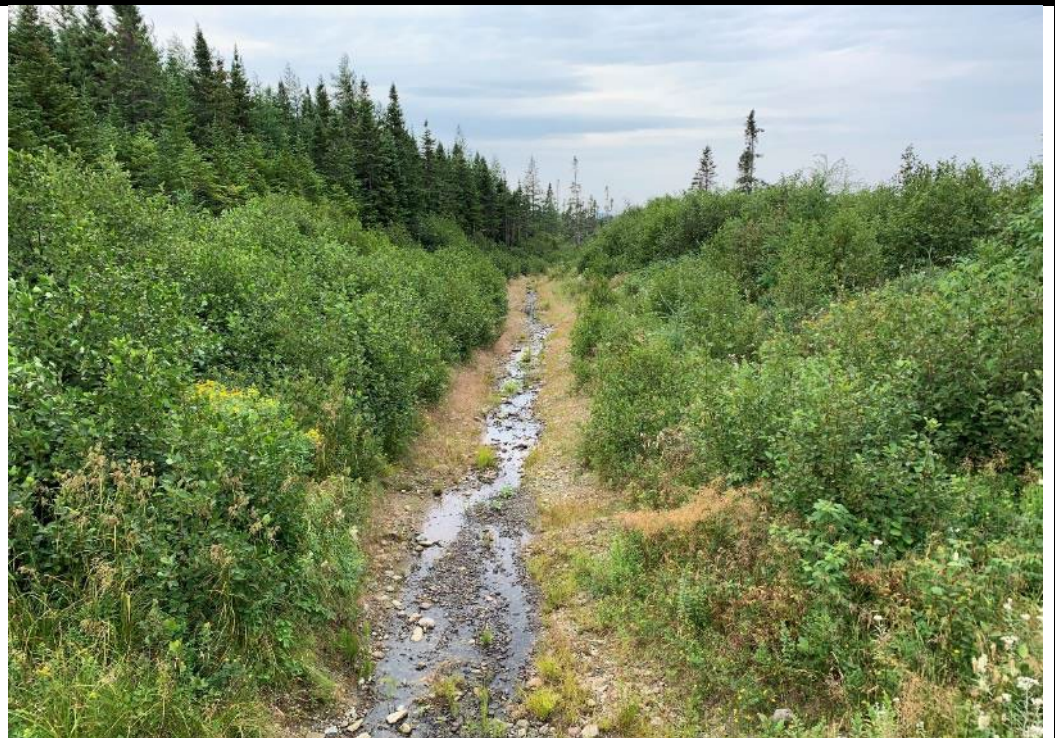
Photograph 12

Diversion Ditch C1 at Sta. 0+750, looking southwest.

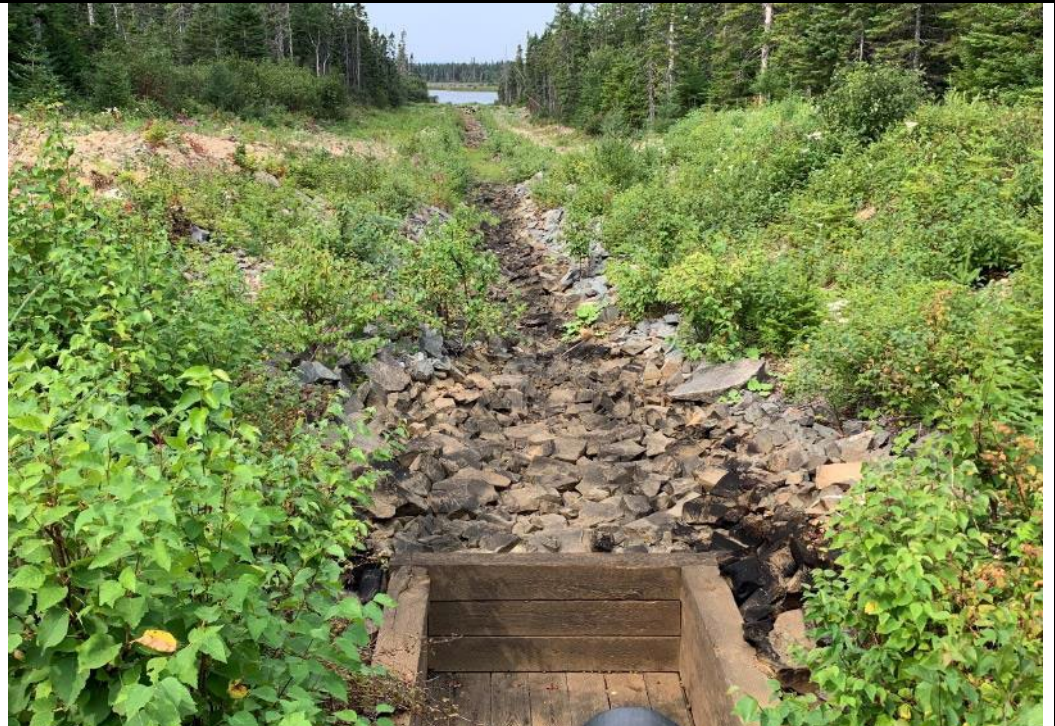
Photograph 1

Discharge Ditch Sta. 0+000 looking downstream towards the Polishing Pond.

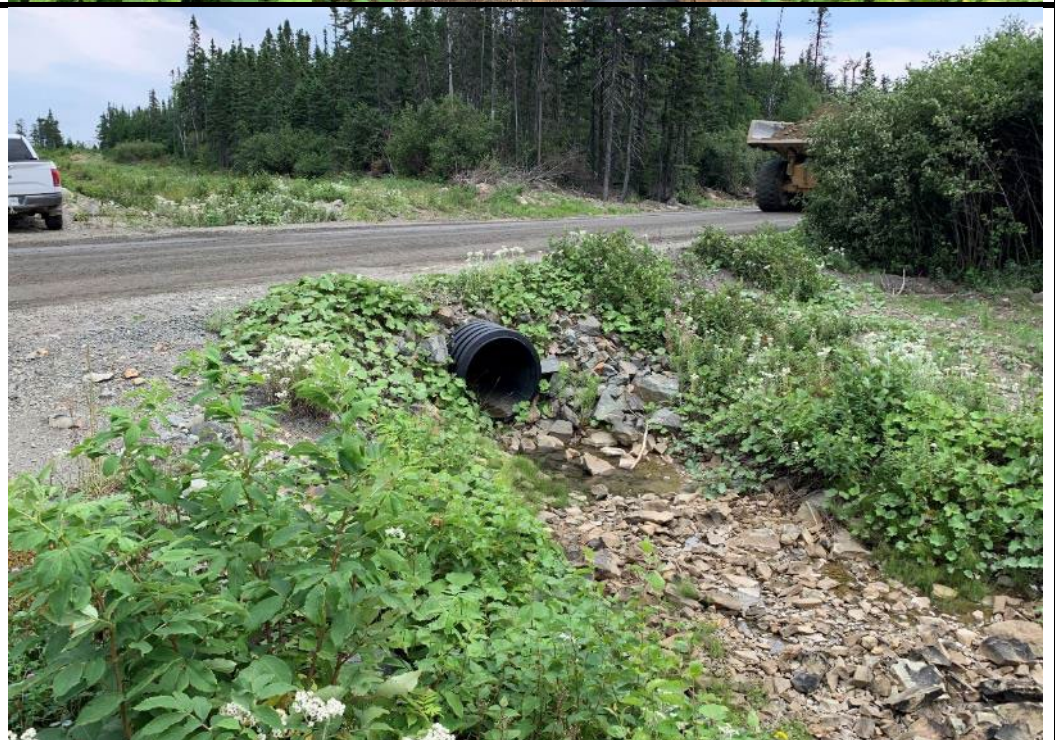
Photograph 2

Culvert Outlet on Discharge Ditch at Sta. 0+225.

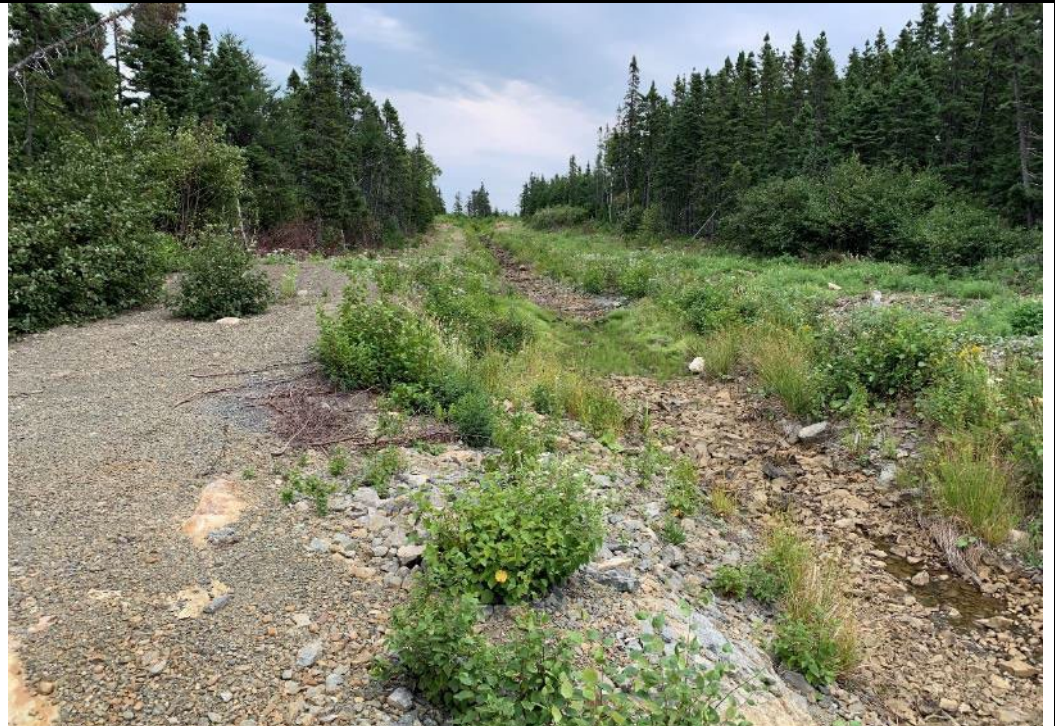
Photograph 3

Discharge Ditch at Sta. 0+220 looking east.
