**2021 ANNUAL FACILITY PERFORMANCE REVIEW REPORT
DUCK POND OPERATIONS TAILINGS MANAGEMENT FACILITY**

2021 Annual Facility Performance Review Report

Duck Pond Operations Tailings Management Facility

Project No. 21455283 (2000);
Reference No. 21455283-001-R-Rev0-1000

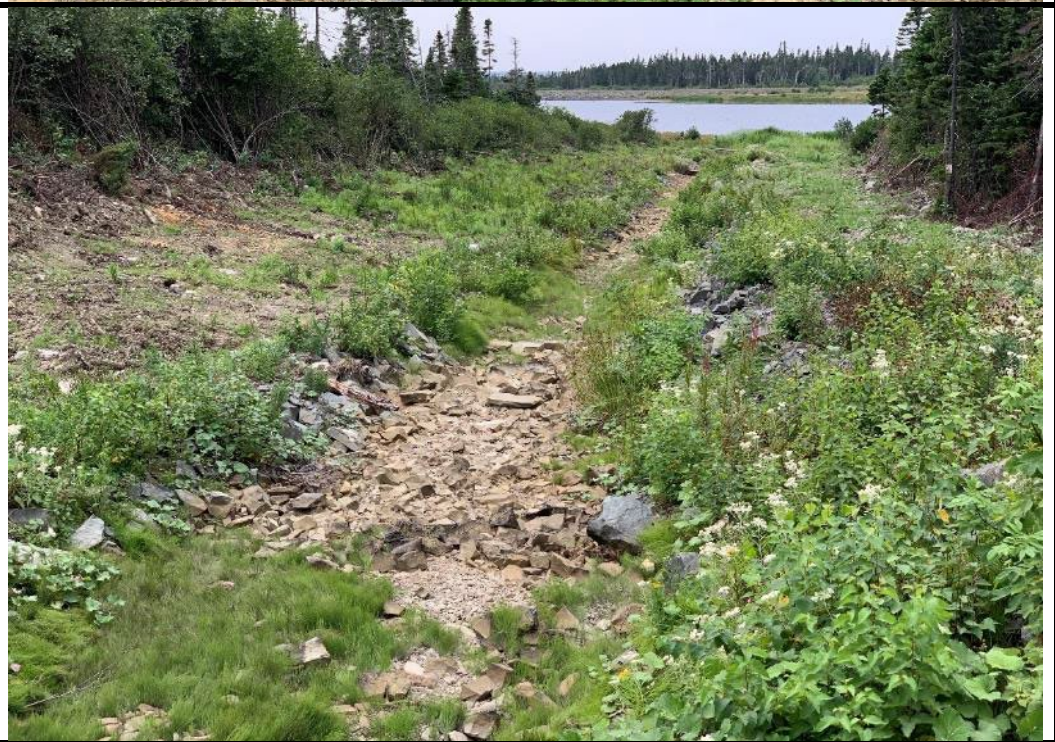
Photograph 4

Discharge Ditch at Sta. 0+250 looking towards the Polishing Pond.

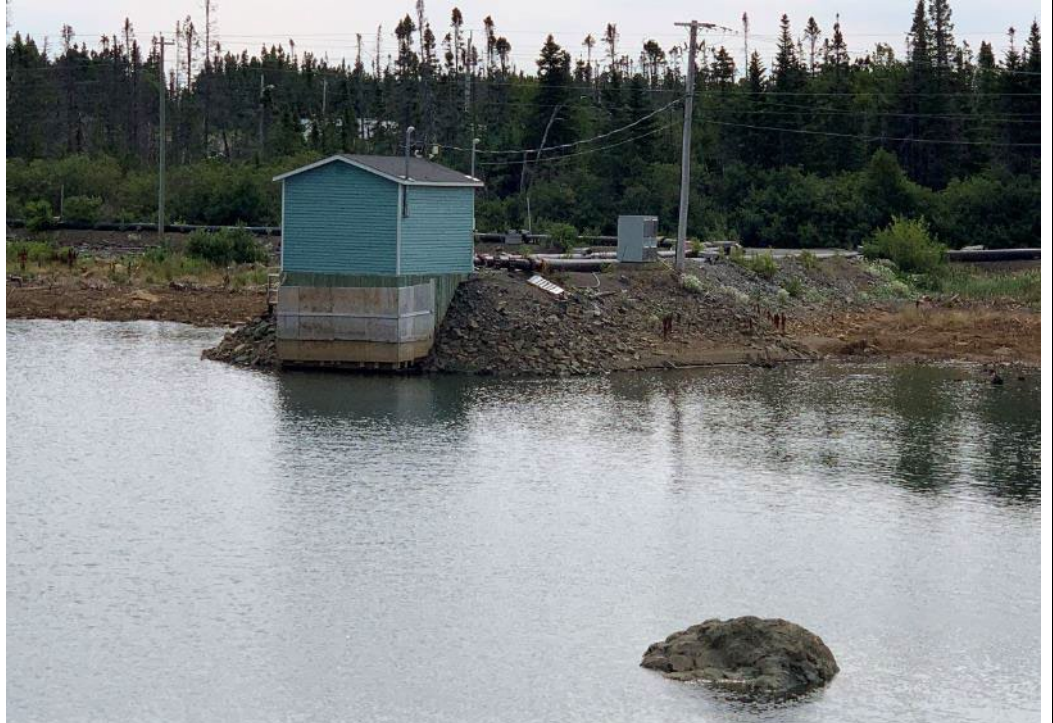
Photograph 1

Water Reclaim Well.

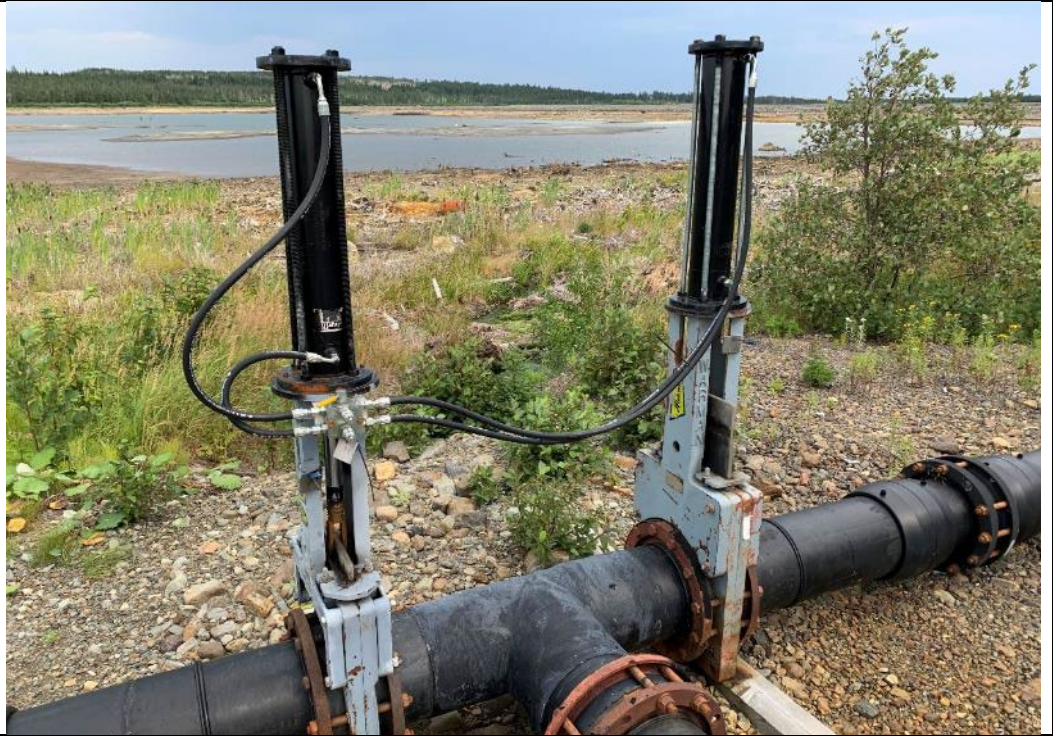
Photograph 2

Pipeline from water treatment plant with T-valve to control flow towards Berms 1 or 3.

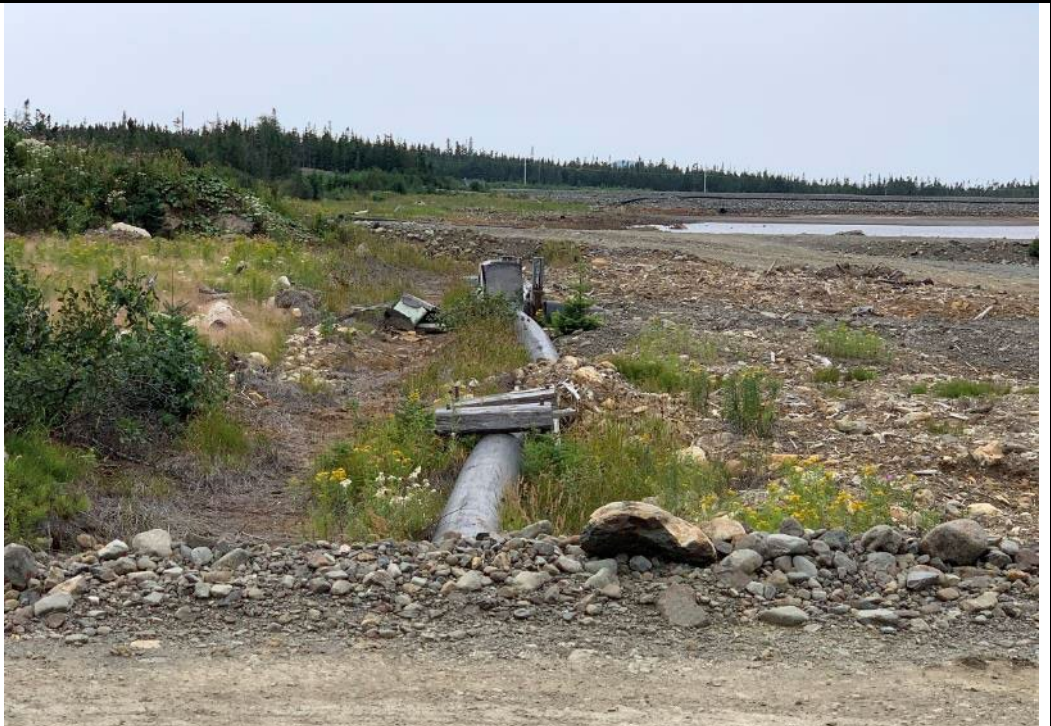
Photograph 3

Water treatment pipeline along southern shore of the TMA.

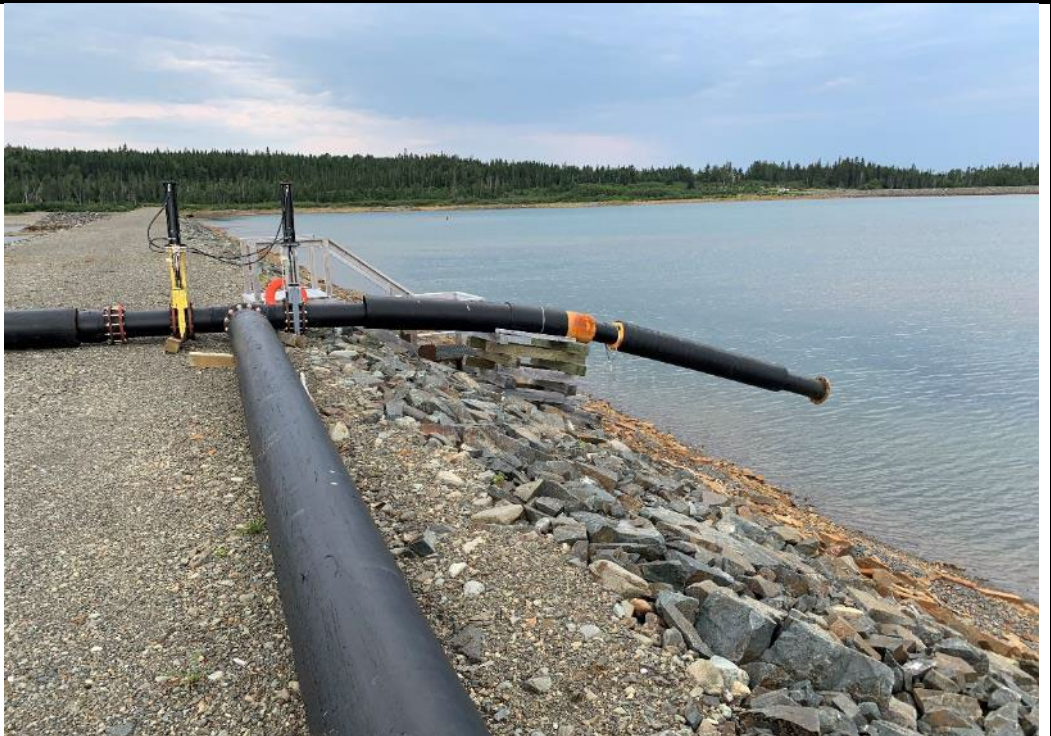
Photograph 4

Water treatment plant discharge pipeline on Berm 1, looking north.

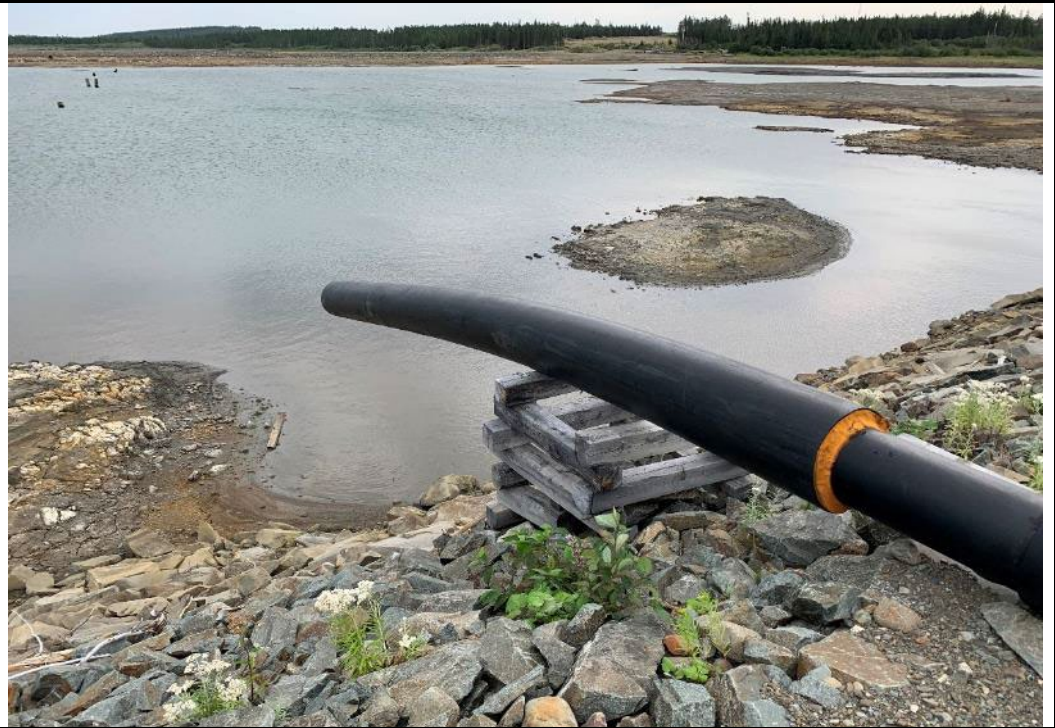
Photograph 5

Water treatment plant
discharge pipeline on Berm 3.
