2022 ANNUAL FACILITY PERFORMANCE REPORT

BEAVERDELL TAILINGS STORAGE FACILITIES

TECK RESOURCES LIMITED

DATE: MARCH 2023

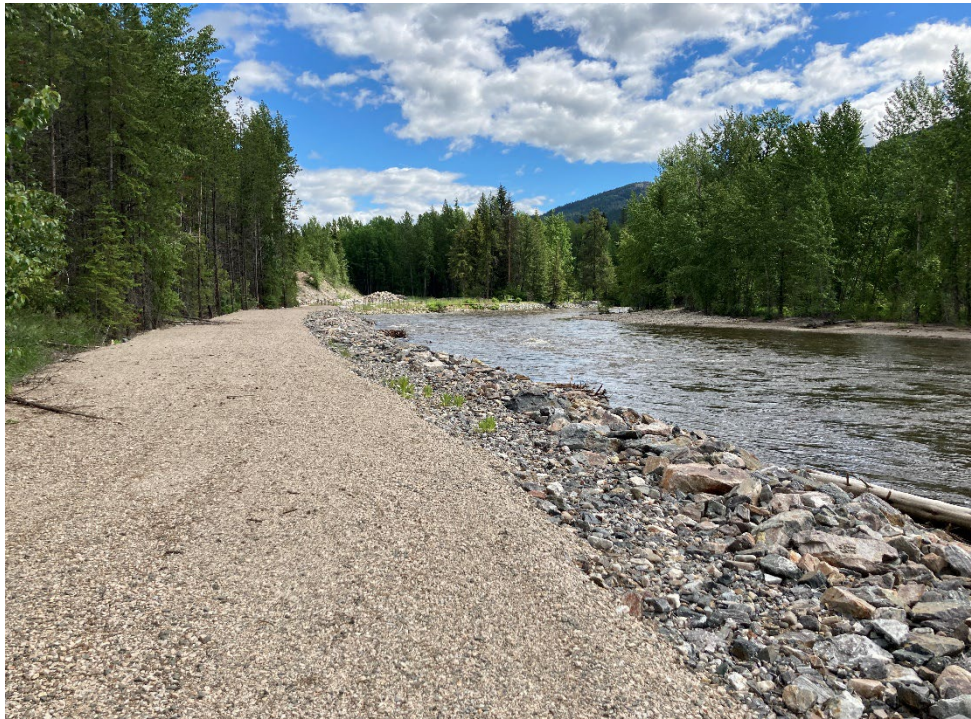
Photo 1: South TSF - Cells 4 and 5 Embankment Toe Erosion Protection Riprap, Looking North. Jun 22, 2022

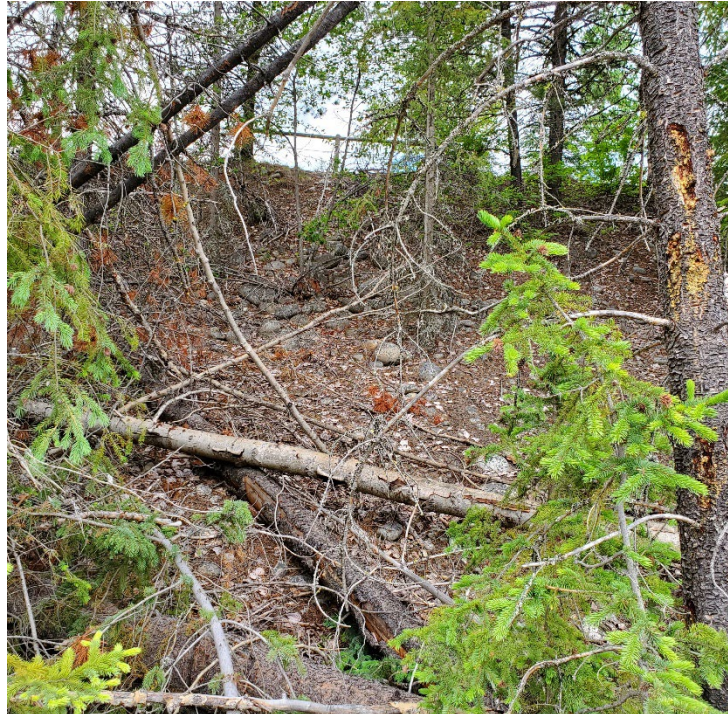
Photo 2: South TSF –Cell 5 Southeast Corner Downstream Embankment Slope, Looking Northeast. Jun 22, 2022

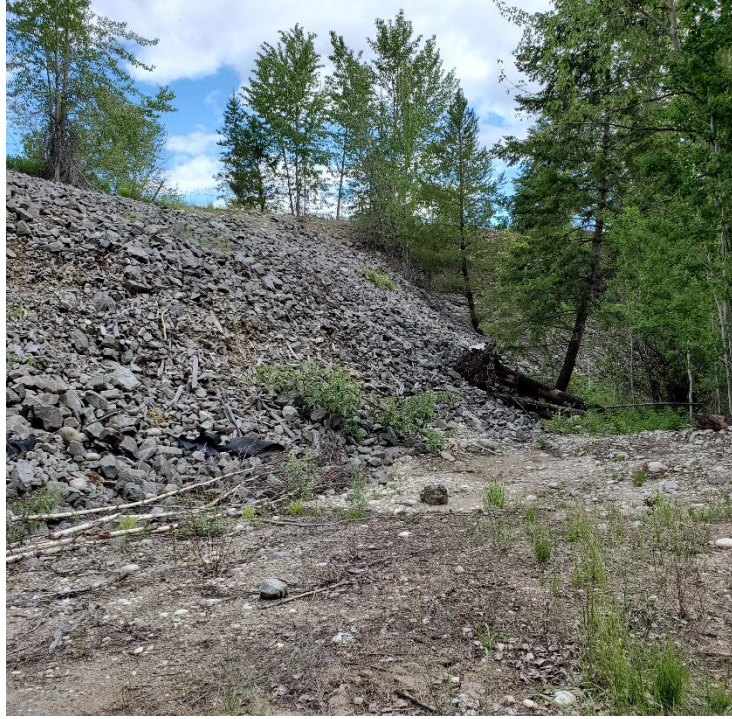
Photo 3: South TSF –Cell 5 South Side Downstream Slope with Rockfill, Looking Northeast. Jun 22, 2022

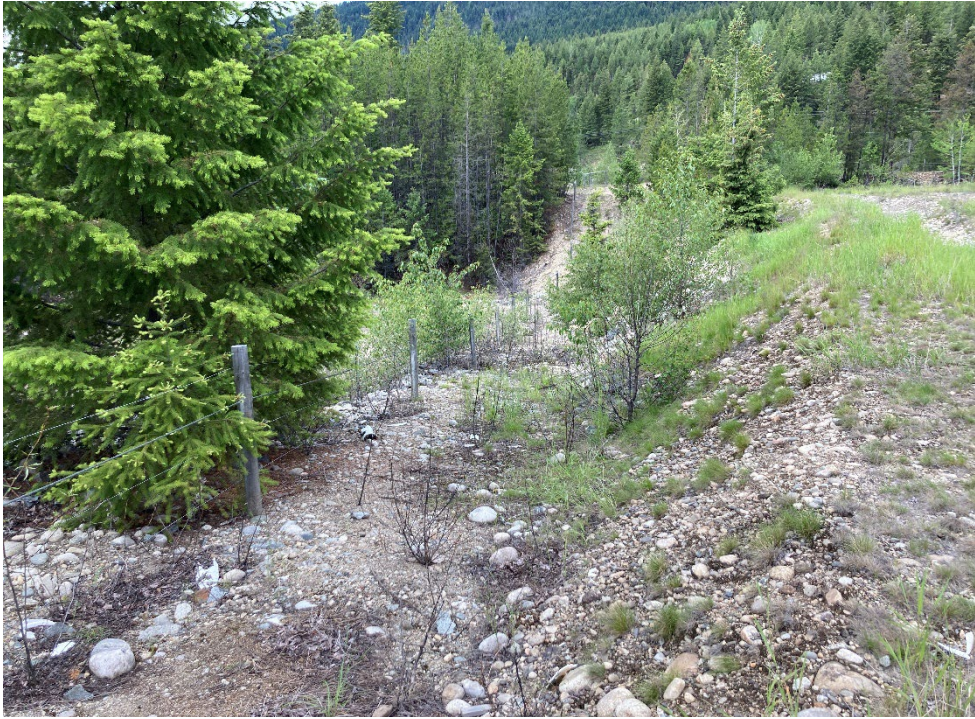
Photo 4: South TSF –Cell 1 Crest and Downstream Slope, Looking Southwest. Jun 22, 2022

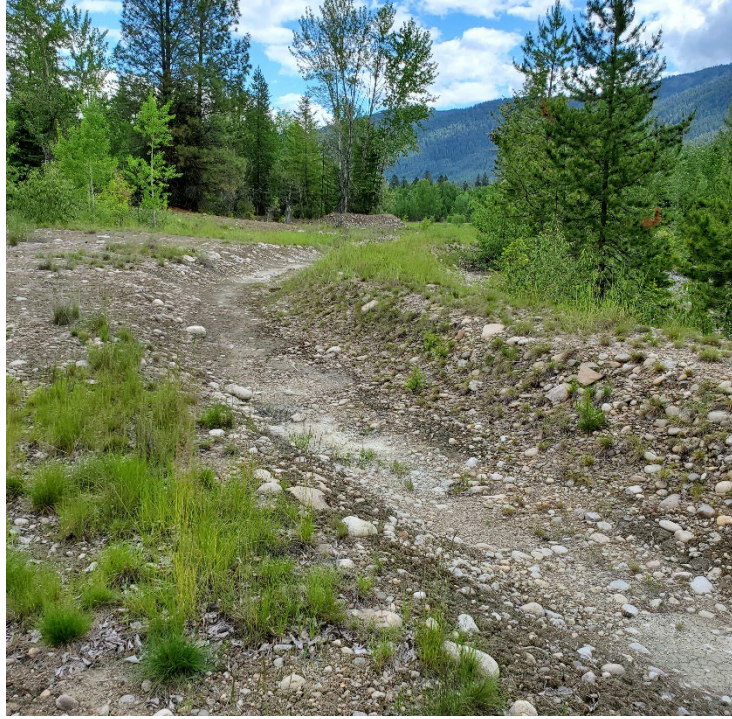
Photo 5: South TSF –Cell 1 Crest and Upstream Ditch to Cell 5, Looking Northeast. Jun 22, 2022

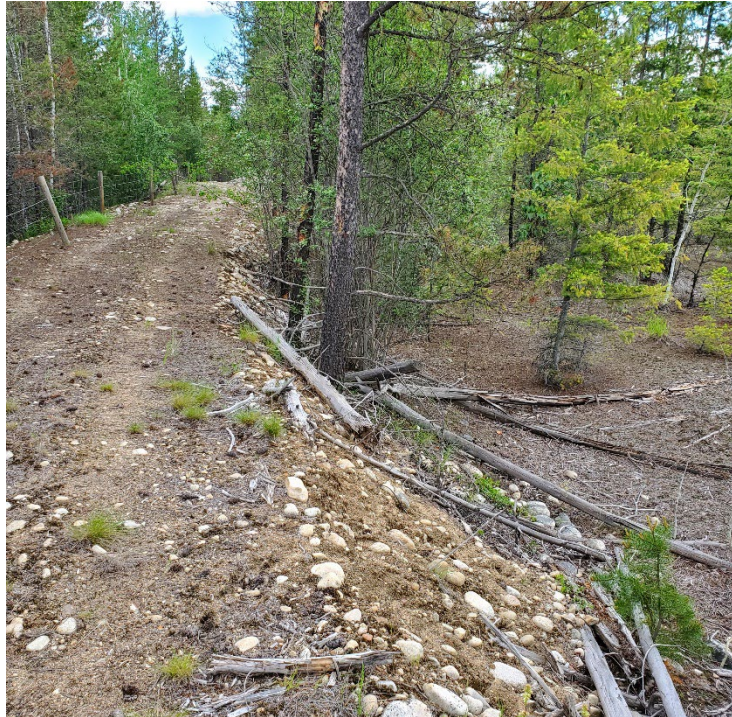
Photo 6: South TSF –Cell 1 West Embankment, Looking North. Jun 22, 2022

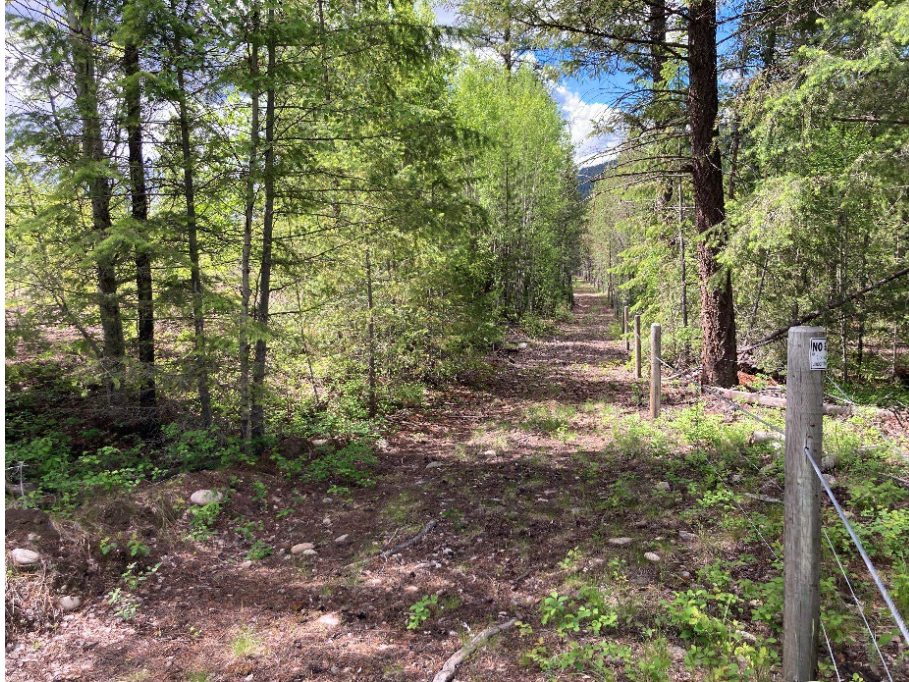
Photo 7: South TSF –Access Road at West Side of Cell 2, Looking South. Jun 22, 2022

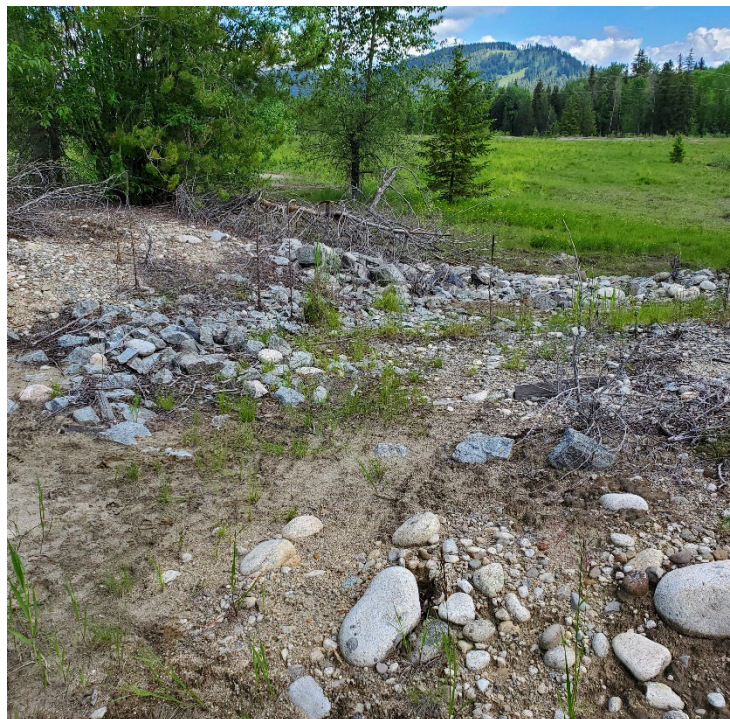
Photo 8: South TSF –Spillway from Cell 5 to Cell 4, Looking Northwest at Cell 5. Jun 22, 2022

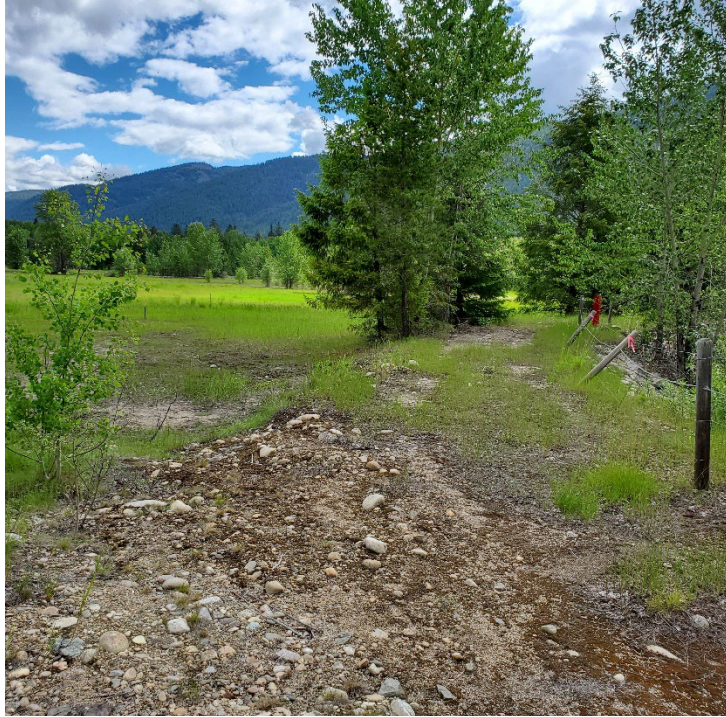
Photo 9: South TSF –Cell 5 Crest and Tailings, Looking North from Cell 1. Jun 22, 2022

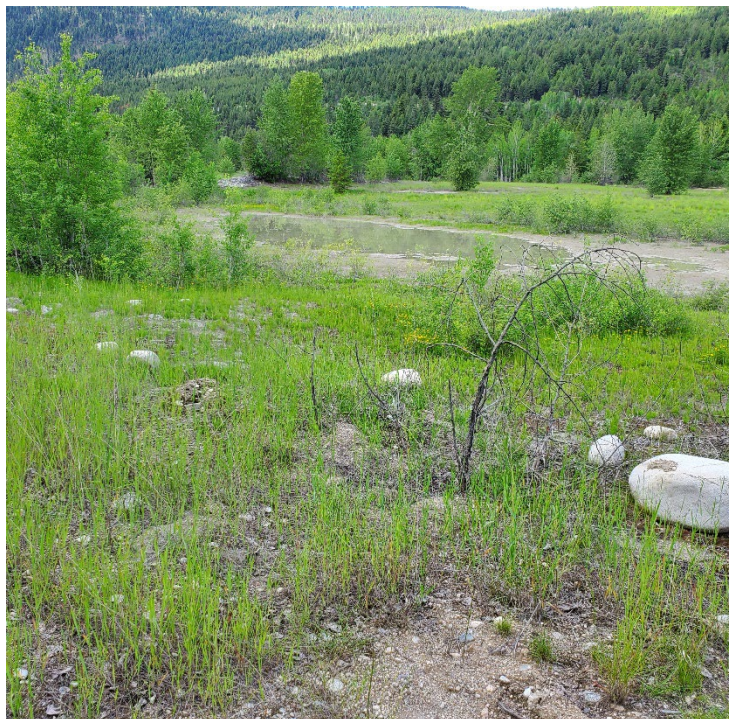
The surface of the Beaverdell TSFs is generally dry; however, small seasonal ponds historically have formed on the surface of tailings in Ponds 3, 4 and 6. During the reporting period small ponding was observed in Cells 4 and 6 during the spring inspection by Teck as well as during the June annual inspection. No ponding was observed in the other cells. The inspections indicated that flood storage and freeboard remained within the acceptable or 'green' threshold criteria.

Photo 10: South TSF –Cell 4 Tailings with Ponding, Looking West. Jun 22, 2022

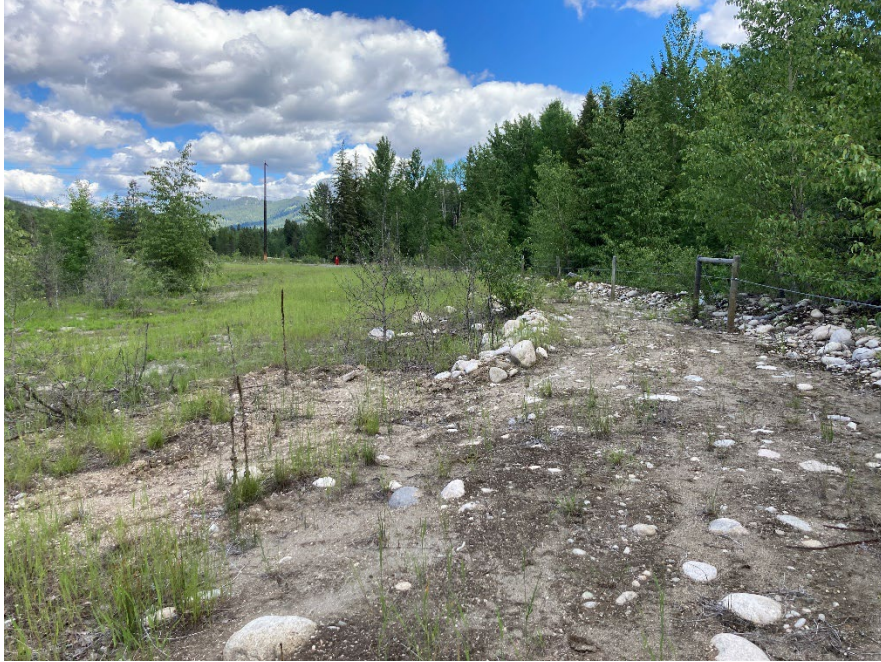
Photo 11: South TSF –Cell 4 Embankment Crest and Tailings, Looking North. Jun 22, 2022

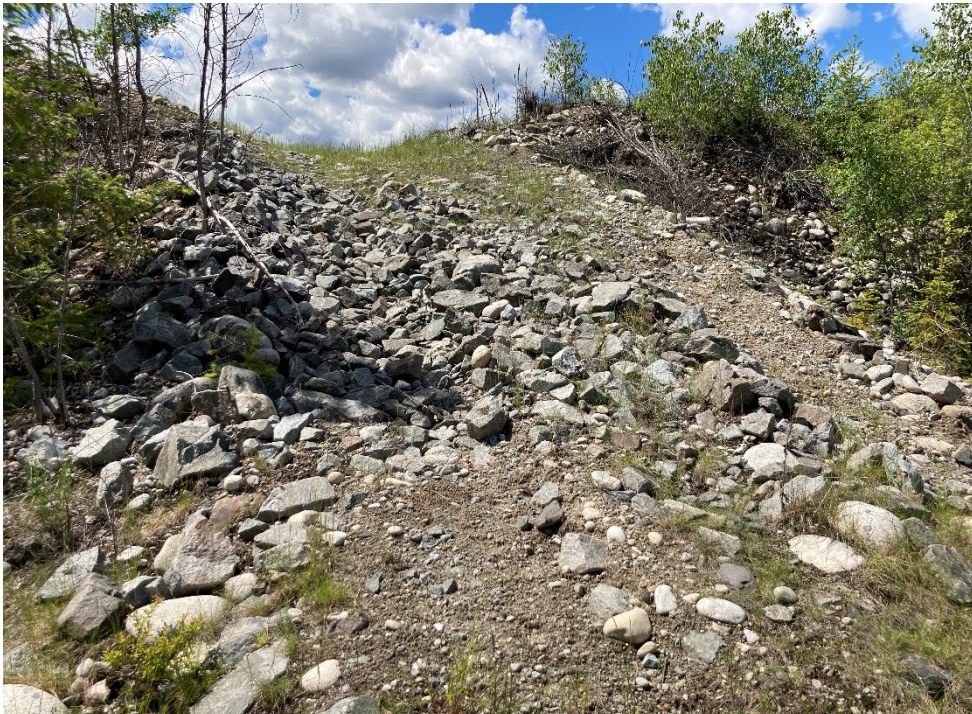
Photo 12: South TSF –View of Spillway Between Cell 3 and Cell 4, Looking South from Cell 3. Jun 22, 2022

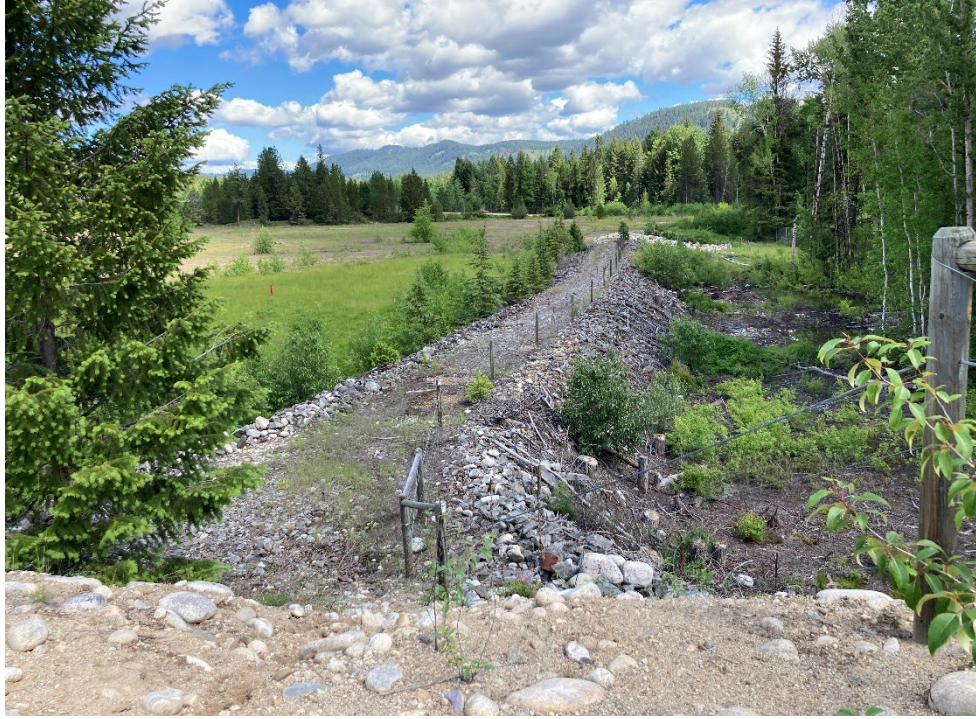
Photo 13: South TSF – Cell 3 Embankment Crest, Downstream Slope and Toe Area, Looking South from Cell 4. Jun 22, 2022

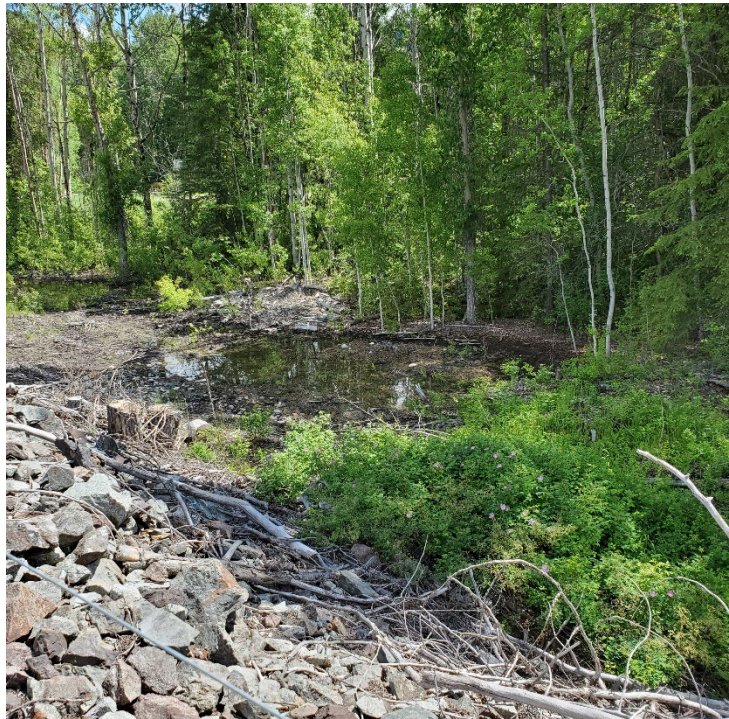
- Seepage or evidence of seepage was not observed on the downstream slopes of the embankments. Ponding was observed in the Cell 3 downstream toe area, which appeared to be sourced from local runoff.

Photo 14: South TSF –Ponding at Cell 3 Downstream Toe, Looking Northeast. Jun 22, 2022

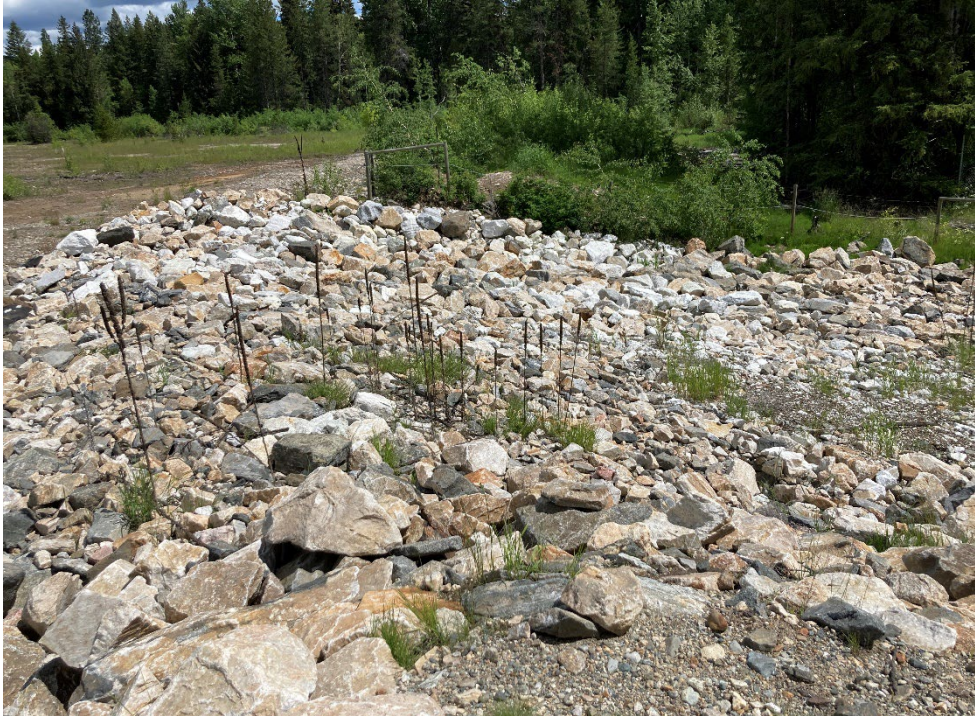
Photo 15: South TSF –Cell 3 Spillway, Looking South. Jun 22, 2022

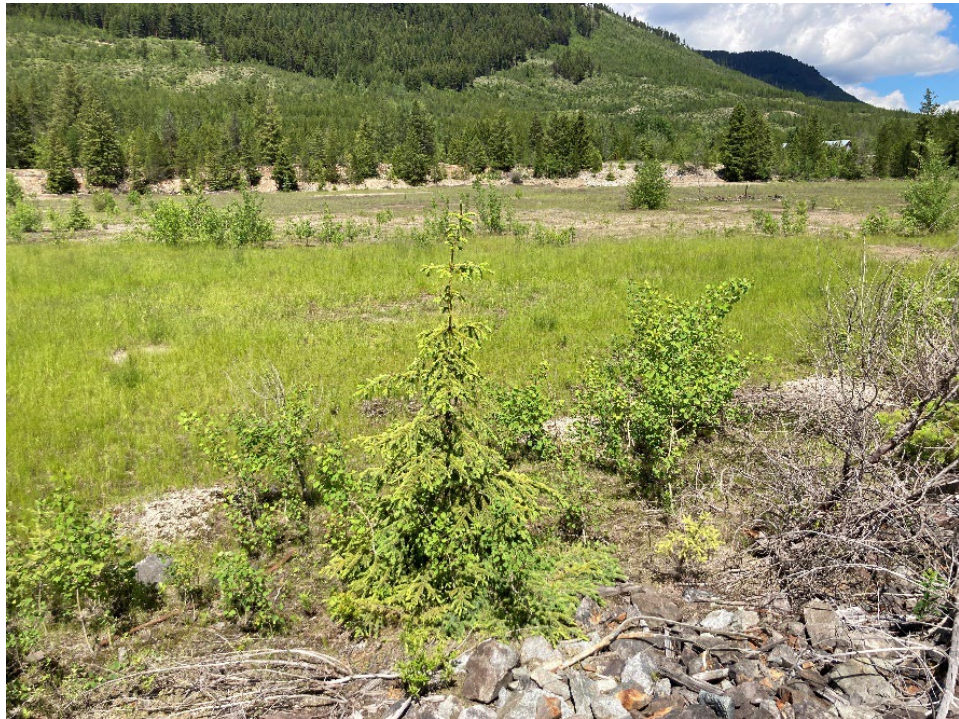
Photo 16: South TSF –Cell 3 Tailings, Looking West. Jun 22, 2022

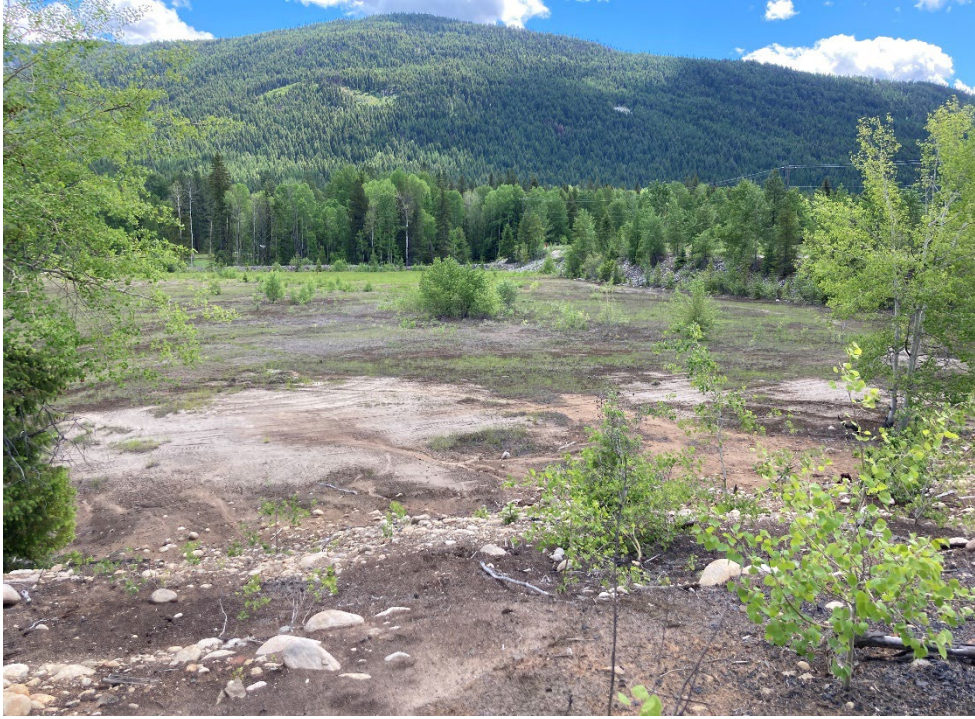
Photo 17: South TSF –Cell 3 Tailings, Looking East. Jun 22, 2022

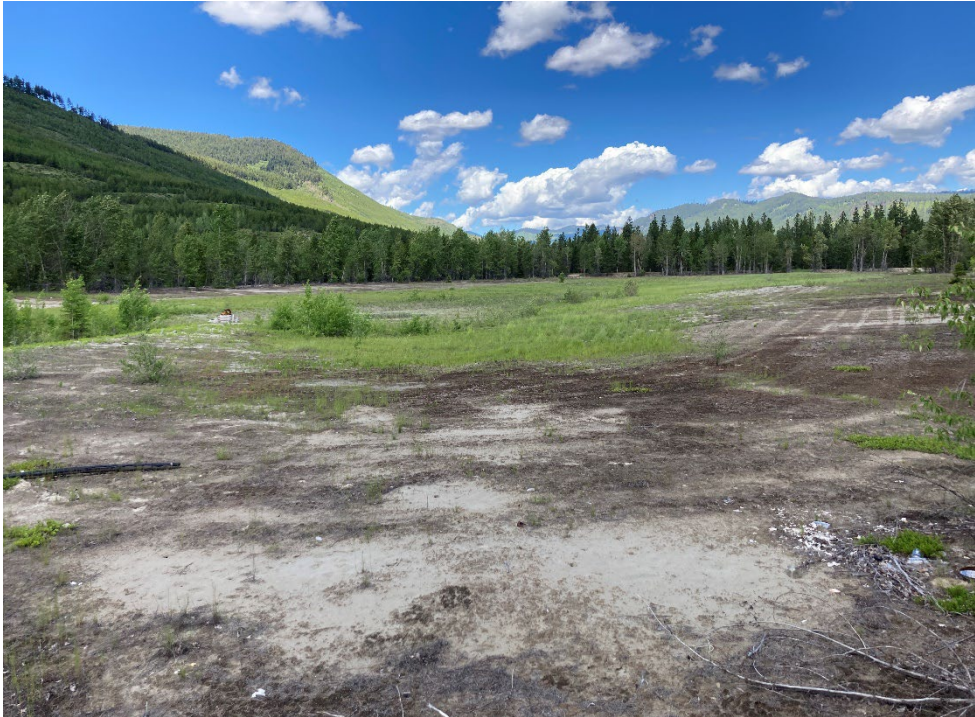
Photo 18: North TSF –Cell 6 Upstream Tailings with Ponding, Looking Northwest. Jun 22, 2022

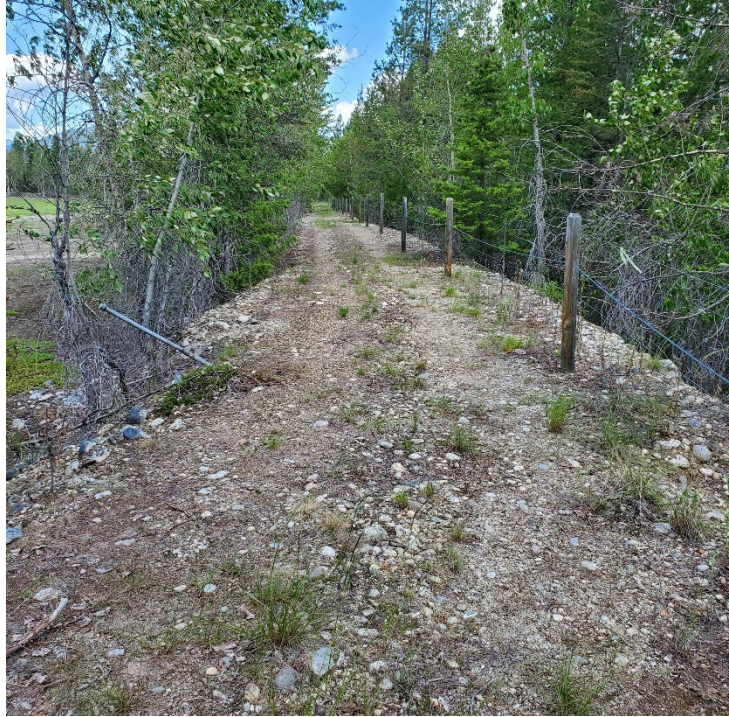
Photo 19: North TSF –Cell 6 East Embankment Crest, Looking North. Jun 22, 2022

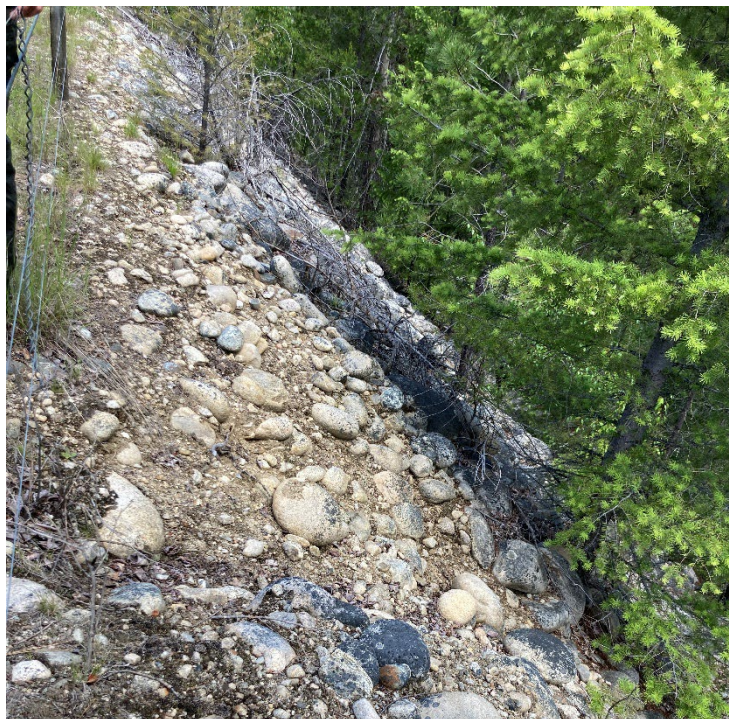
Photo 20: North TSF –Cell 6 East Embankment Downstream Slope Minor Surface Erosion, Jun 22, 2022

water runoff concentrated in areas disturbed by animal activity was observed at several locations on the embankment crests. These areas should be marked in the field by flagging or other means and monitored for continued or increased erosion. The recommendation is further described with timelines provided in Table ES-1.

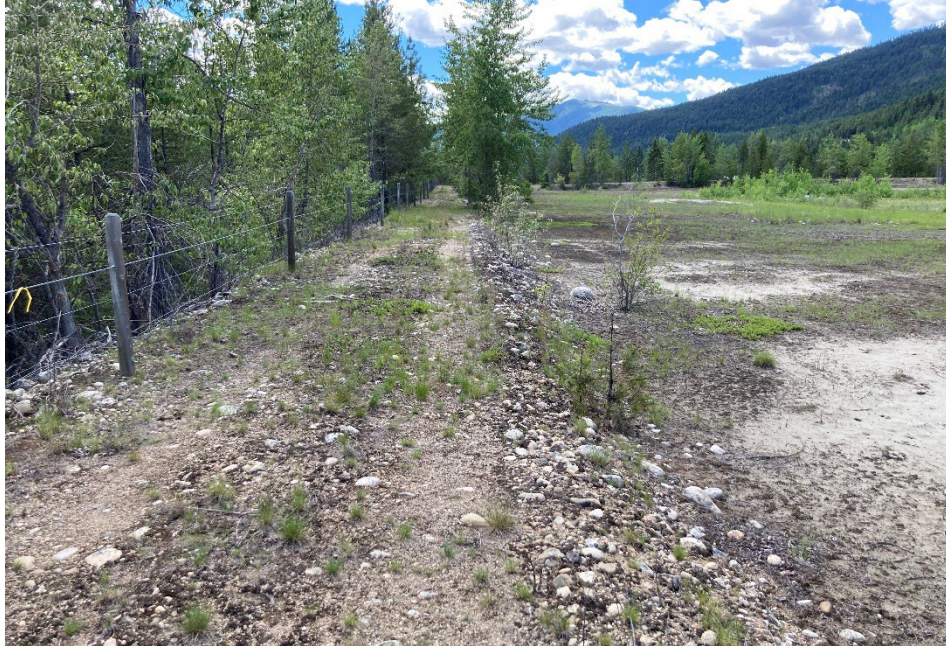
Photo 21: North TSF –Cell 6 East Embankment Crest and Upstream Tailings, Looking South. Jun 22, 2022

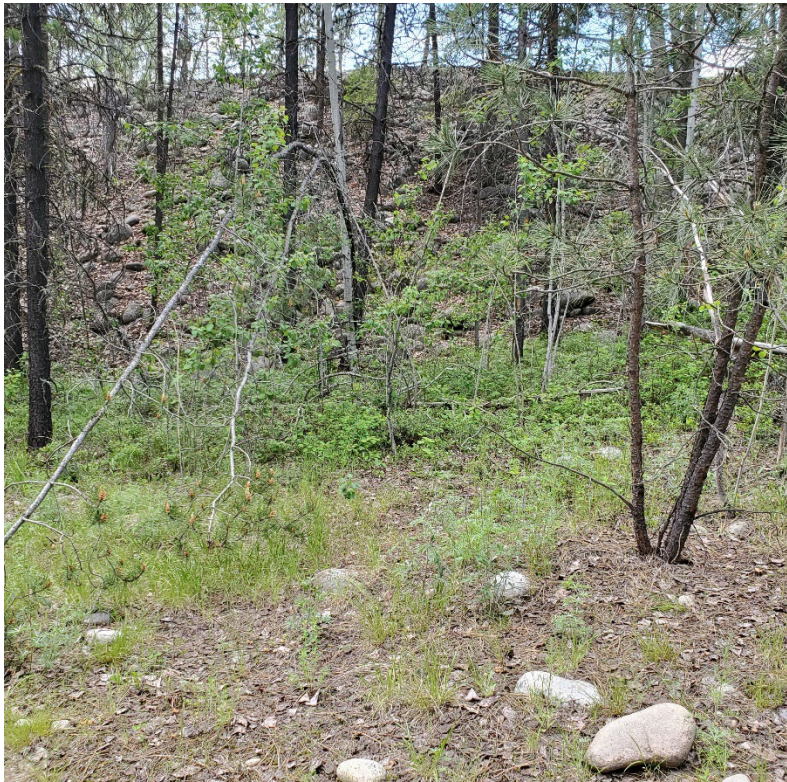
Photo 22: North TSF –Cell 6 Downstream Slope and Toe, Looking West. Jun 22, 2022

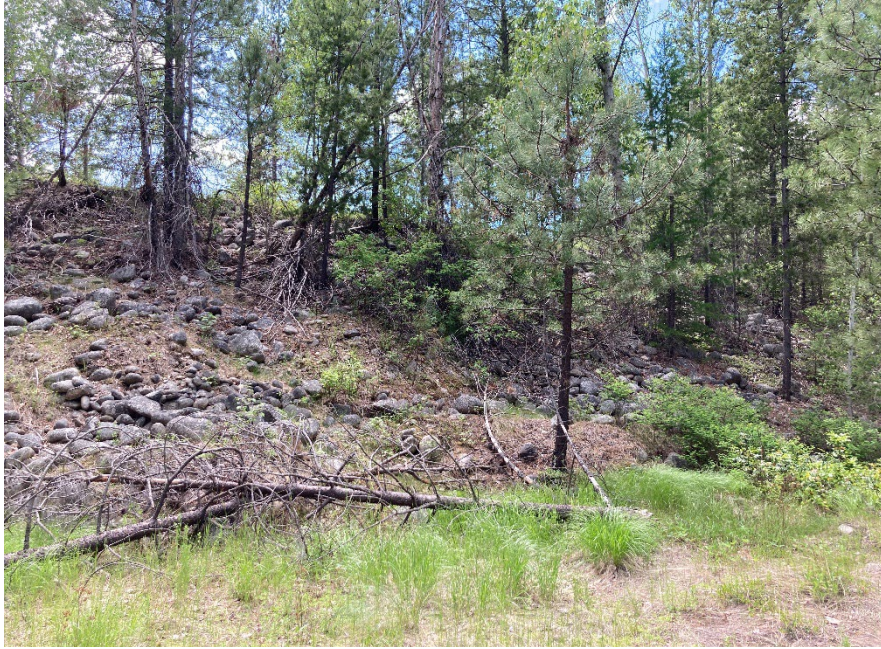
Photo 23: North TSF –Cell 6 Downstream Slope and Toe. Looking Southwest. Jun 22, 2022

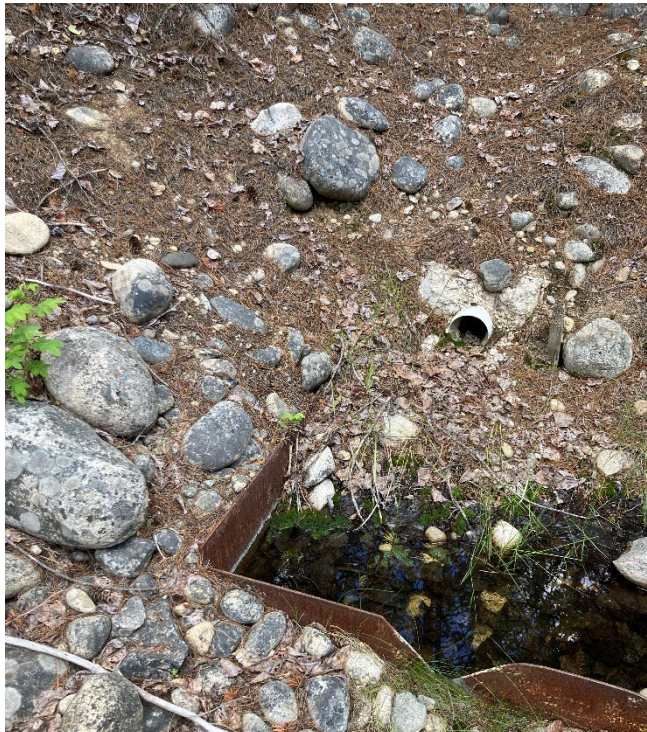
- Sinkholes or subsidence of the tailings surface was not noted, though the entire tailings surface was not observed.
- The outlet pipe for the Cell 6 decant was dry, and some ponding was present in the metal container/weir.

Photo 24: North TSF –Cell 6 Decant Outlet. Jun 22, 2022

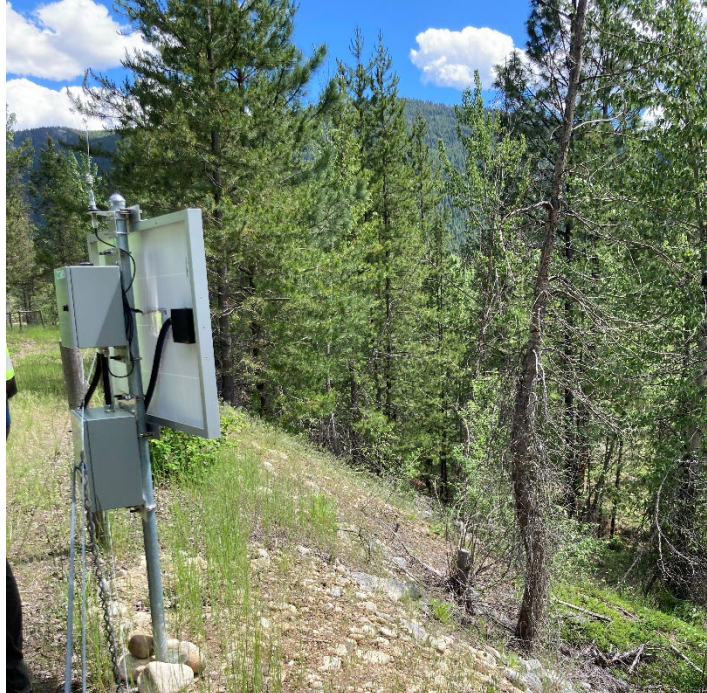
Photo 25: North TSF –Cell 7 South Embankment Downstream Slope near Signal Repeater, Looking East. Jun 22, 2022

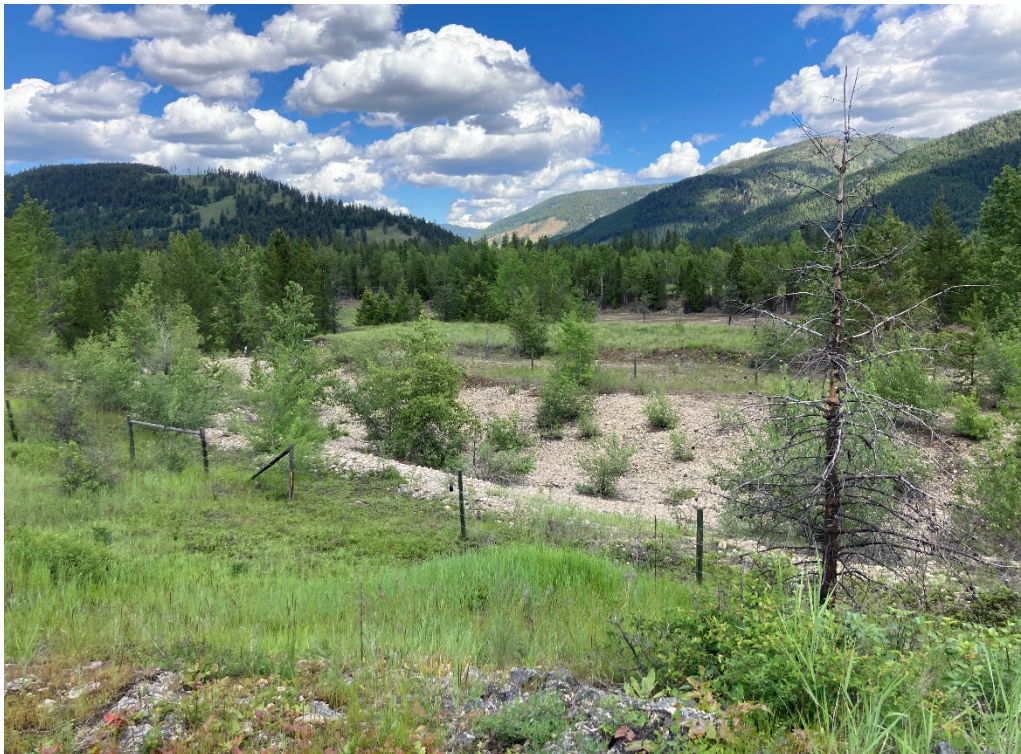
Photo 26: North TSF –Cell 7 Southwest Corner Diversion and Spillway, Looking Northeast. Jun 22, 2022

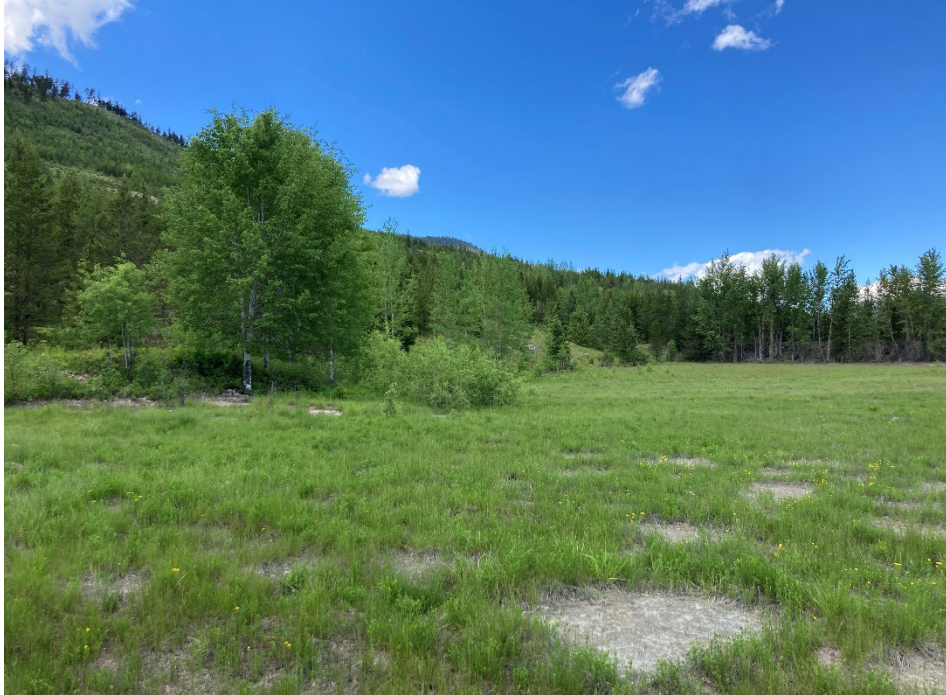
Photo 27: North TSF –Cell 7 West Side Tailings and Backslope, Looking Northwest. Jun 22, 2022

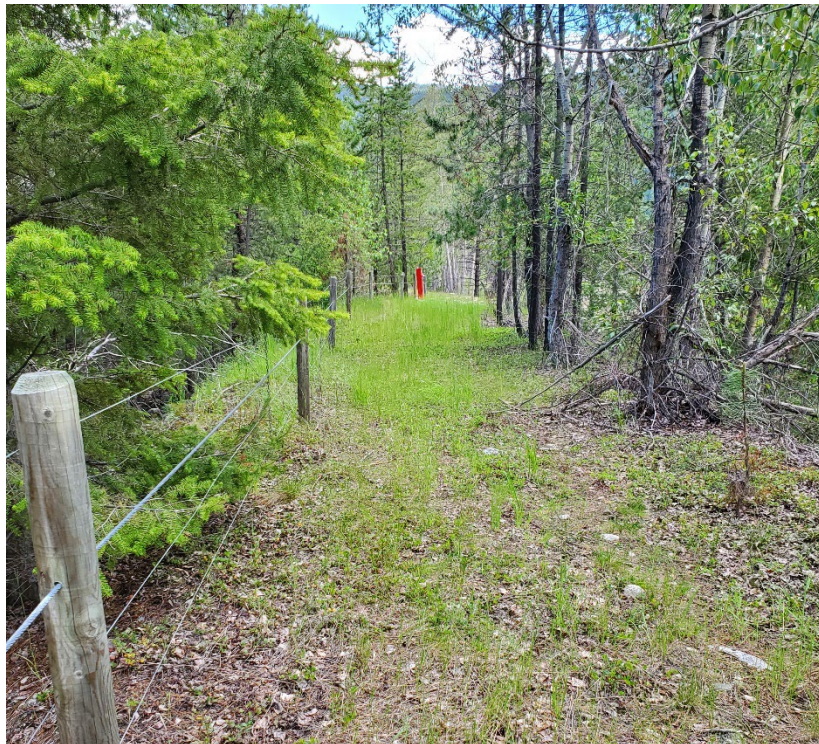
Photo 28: North TSF –Cell 7 North Embankment Crest, Looking East. Jun 22, 2022

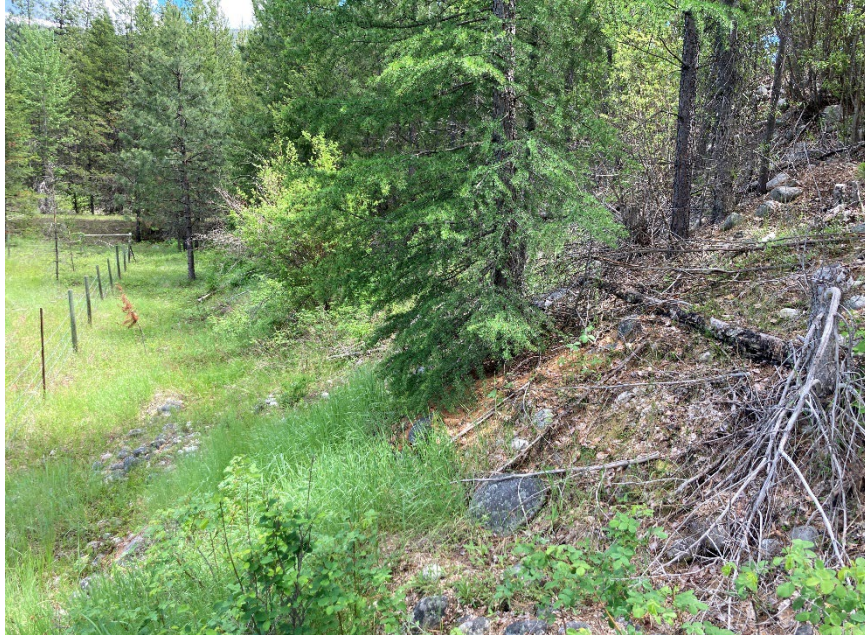
Photo 29: North TSF –Cell 7 North Embankment Downstream Slope and Toe, Looking East. August 19, 2021

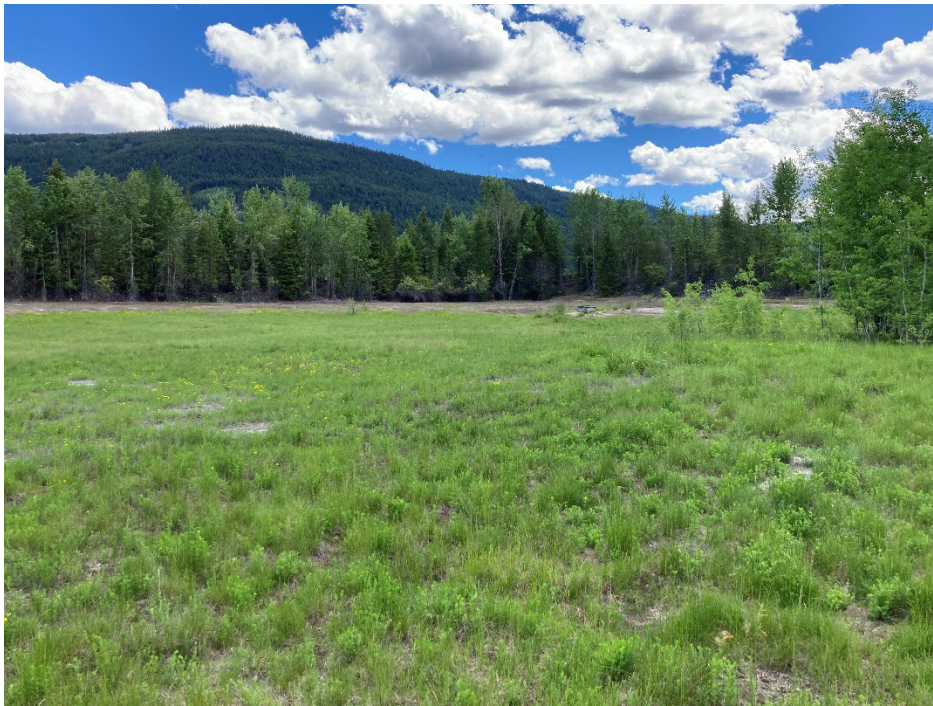
Photo 30: North TSF –Cell 7 Tailings and Plugged Decant Tower. Looking East. Jun 22, 2022

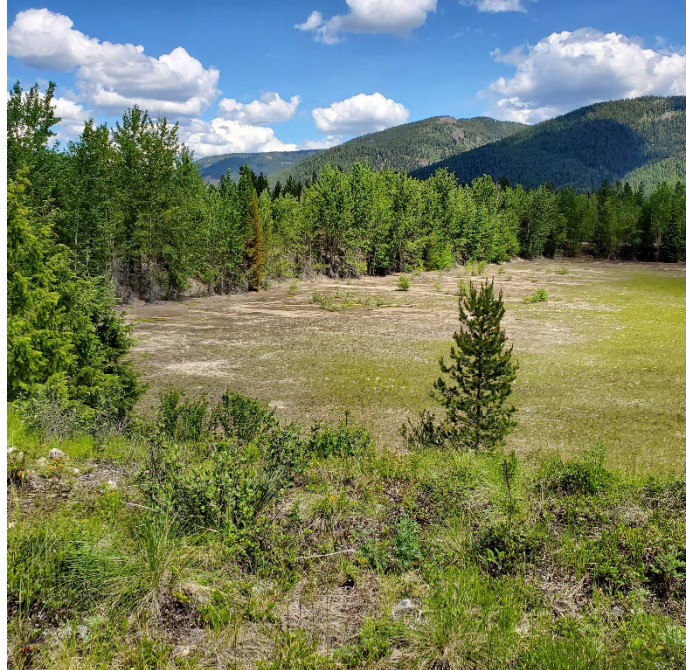
Photo 31: North TSF – Cell 7 Tailings and North Embankment Upstream Face, Looking Northeast. Jun 22, 2022

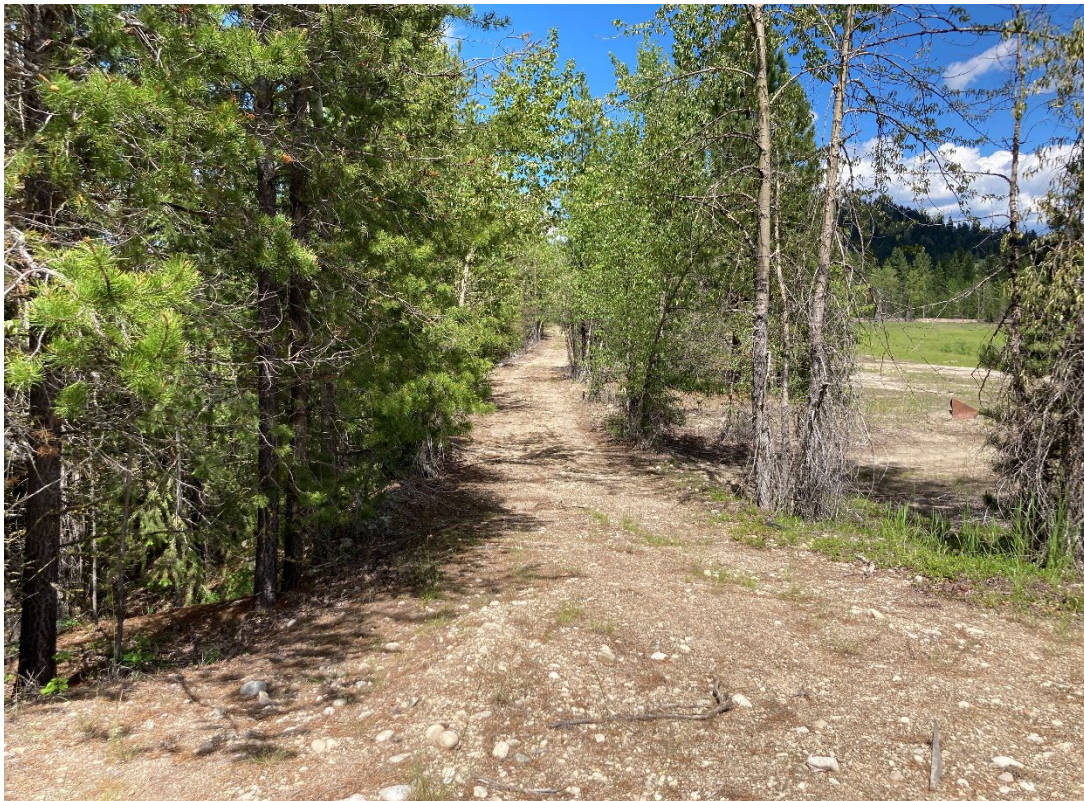
Photo 32: North TSF –Divider Dyke Between Cell 6 and Cell 7, Looking North. Jun 22, 2022
