Teck Coal Limited

Elkview Operations

Coarse Coal Refuse Dump

2022 Annual Facility Performance Report

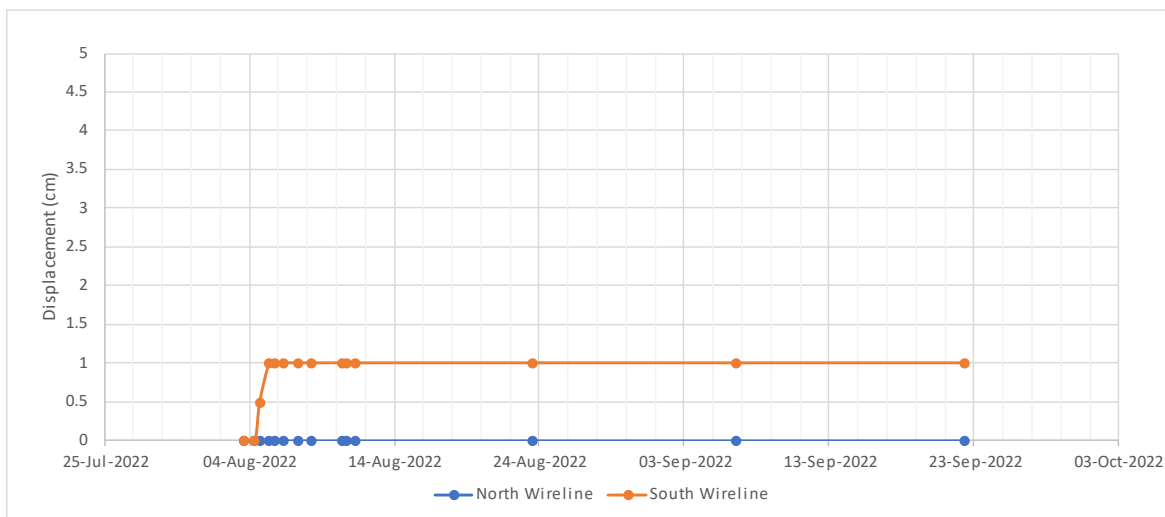
Figure 7.1 Wireline Extensometer Displacements at Southwest Crest Crack

A GPS monitoring unit and two wireline extensometers were installed on the crest surface along the southwest extent of the CCR Dump to monitor the surficial crack at this location. Total displacements across the crack are shown in Figure 7.1. The instrumentation indicates displacements subsided on August 4, 2022, and no further movements have been observed.

2022-03	Potential Deficiency. Surficial cracking developed along the southern crest surface in the summer of 2022. EVO installed a GPS monitoring hub and two wireline extensometers to monitor displacement.	CCR Dump OMS Manual, Section 4.5	Despite the instrument readings indicating displacement subsided in August 2022, continue to monitor the instruments for additional crack displacement. If the cracking continues, then conduct a geotechnical investigation to determine the cause.	3	Continue to monitor the crack displacement to the end of freshet 2023. Then re-evaluate.

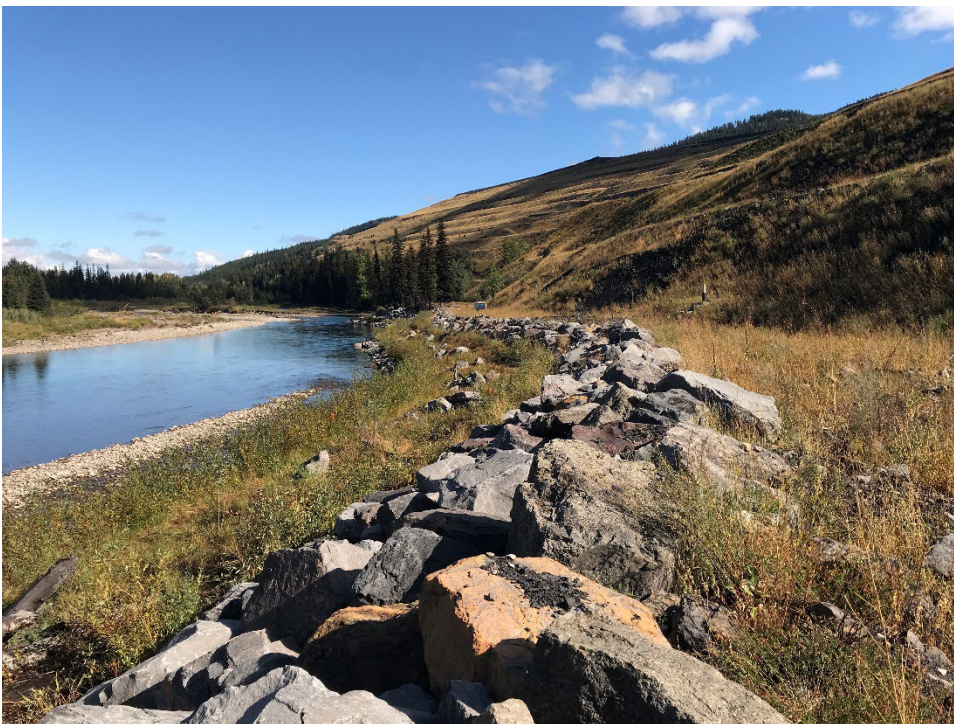
Rip-rap erosion protection at the toe of the CCR Dump appeared to be in good condition during the 2022 AFPR site visit.

Photo I-2 CCR Dump overview and slope toe along the Elk River with riprap. (Looking NE – Taken 20 September 2022)

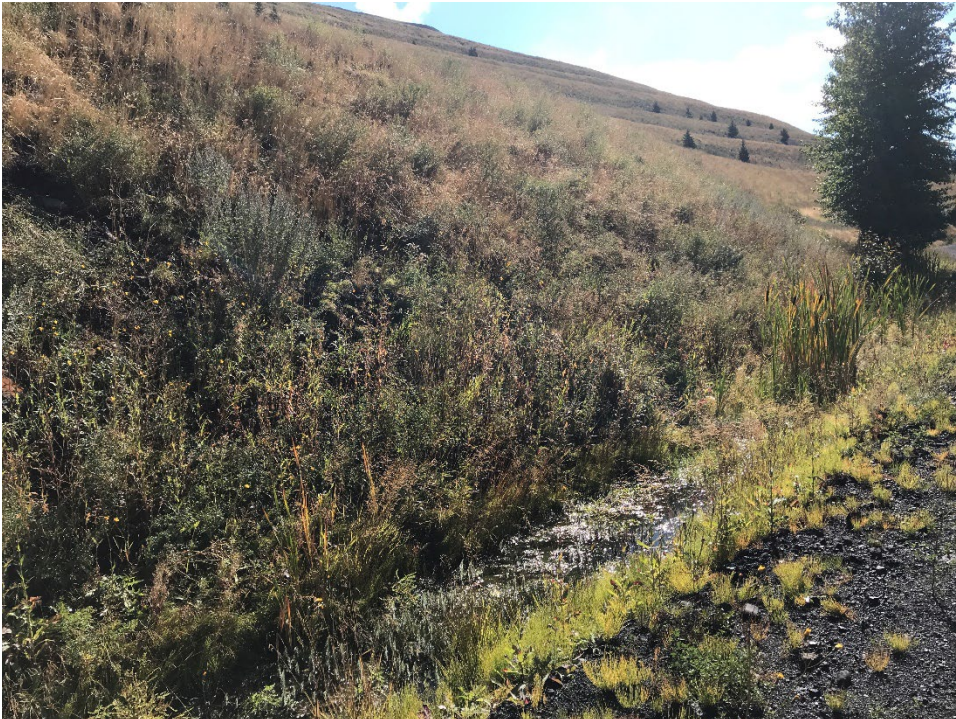
Seepage was observed at several lower interbench slopes along the north end of the CCR Dump in the locations consistent with those observed during the 2021 AFPR site visit (KCB 2022). Seepage was observed to be clear compared to orange colouration observed in some ditch drains during the previous inspection. The observed seepage extent is consistent with historic observations and is not a facility safety concern.

Photo I-6 CCR Dump seepage at bench ditches. (Looking SE – Taken 20 September 2022)

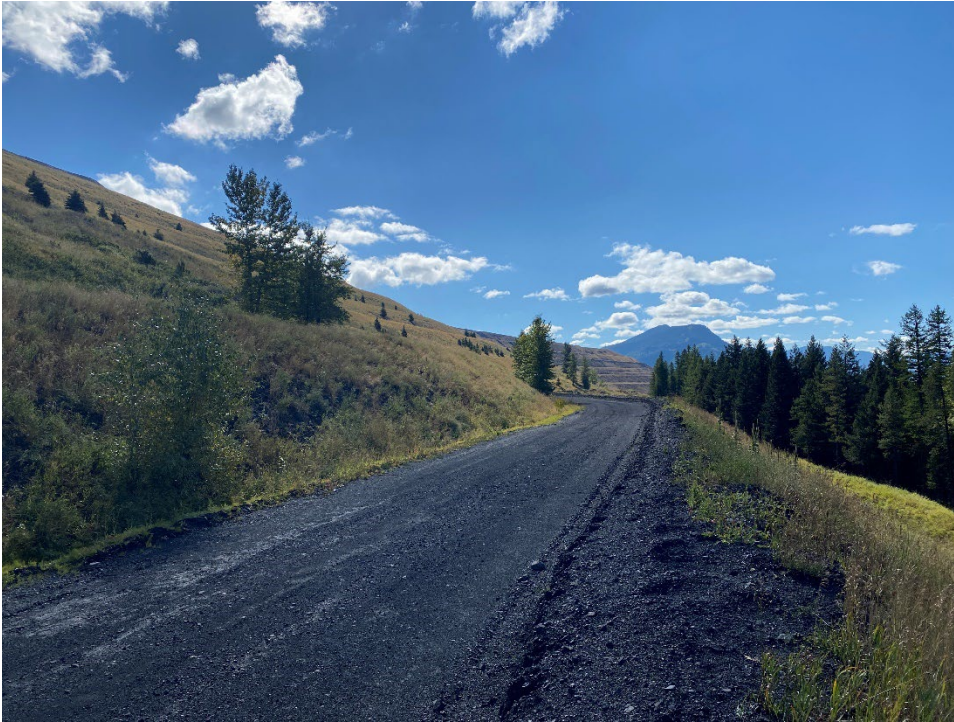
**Photo I-7 CCR Dump slope benches typical condition. Seepage present in upstream ditch.
(Looking south – Taken 20 September 2022)**

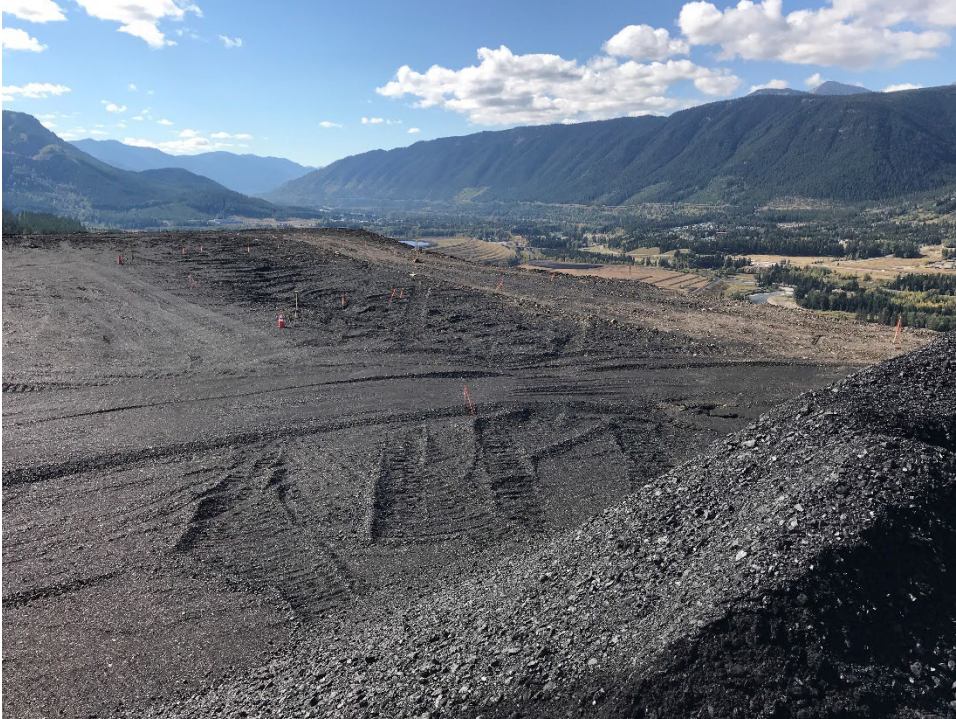
The surficial cracking observed during the 2022 AFPR inspection at the southwest crest surface of the CCR Dump is a normal observed occurrence likely representative of differential settlement of the placed MCR material. Instrumentation monitoring at the cracking indicates displacement subsided in early August 2022. No indications of instability were observed on the CCR Dump surface below the crest at this location.

Photo I-13 CCR Dump surficial cracking behind crest. (Looking SW – Taken 20 September 2022)

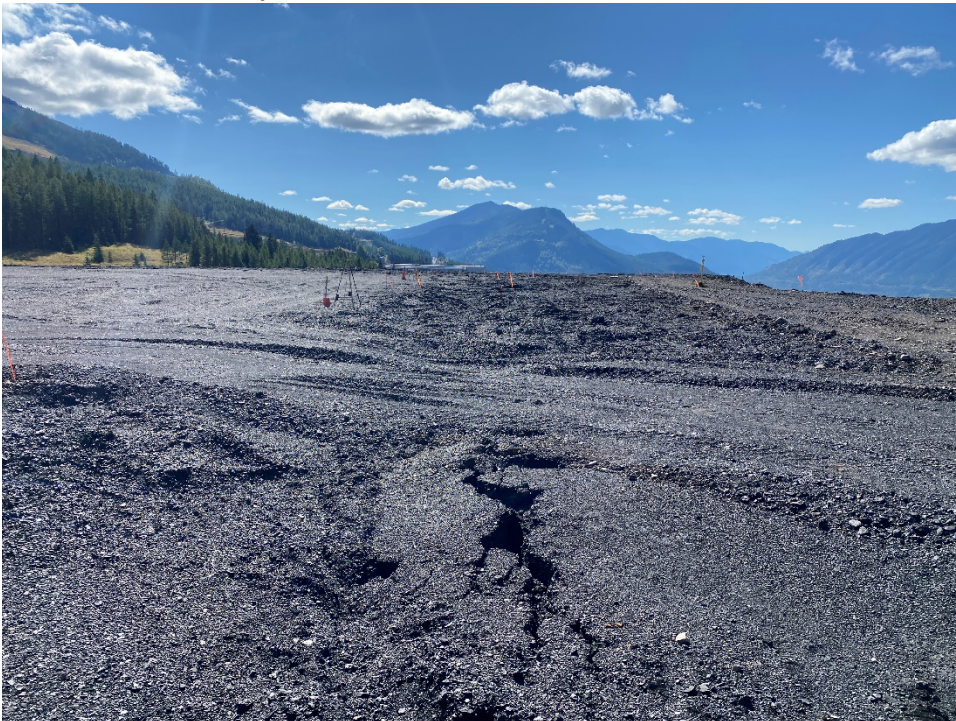
Photo I-3 CCR Dump surficial cracking behind crest. (Looking south – Taken 20 September 2022)

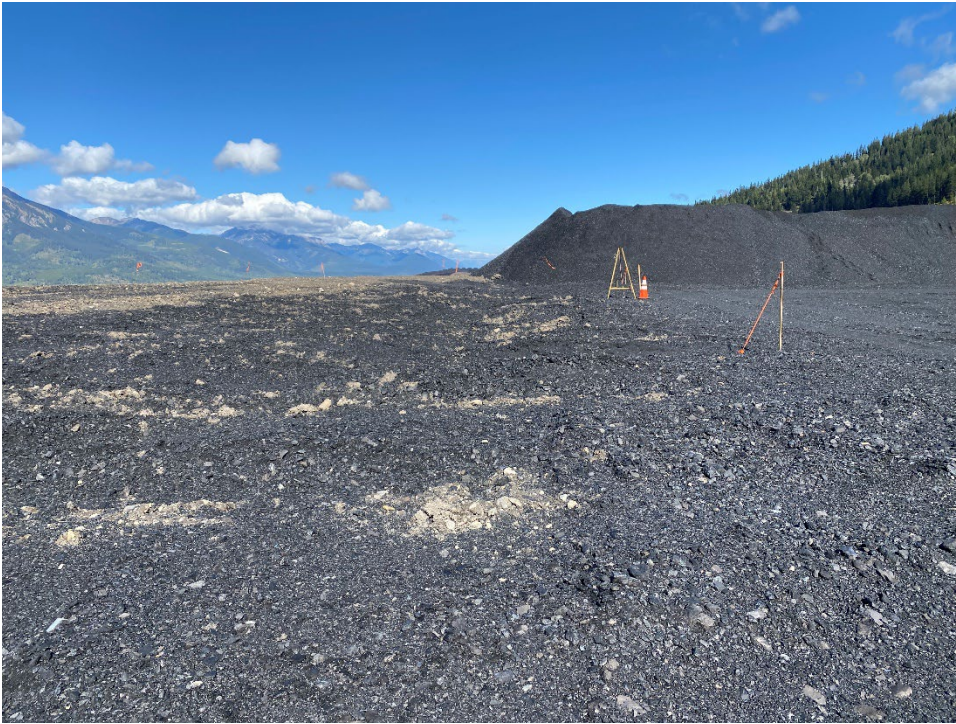
Photo I-15 CCR Dump surficial cracking behind crest, with monitoring instruments. (Looking north – Taken 20 September 2022)

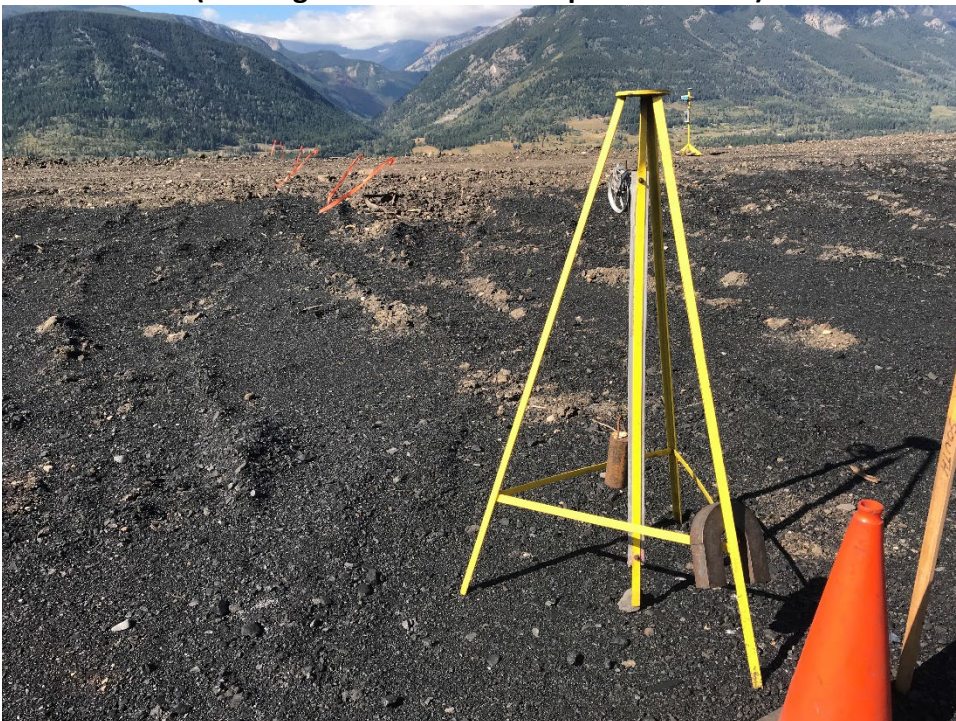
Photo I-16 CCR Dump crack meter instrument monitoring for surficial cracking behind crest. (Looking west – Taken 20 September 2022)

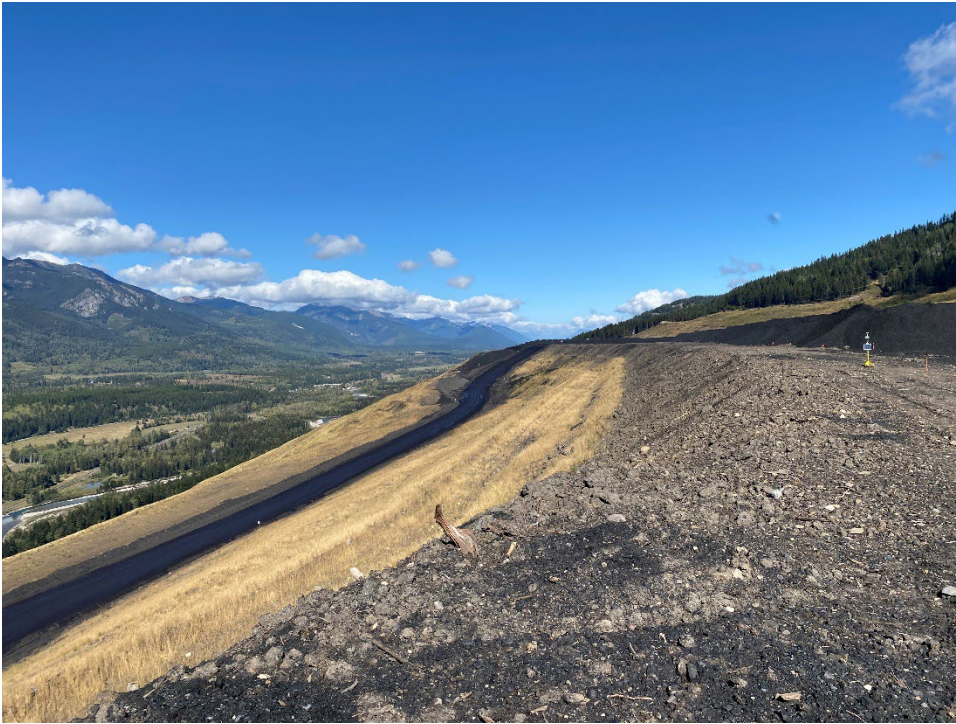
Photo I-17 CCR Dump crest and slope below surficial cracking. (Looking north – Taken 20 September 2022)

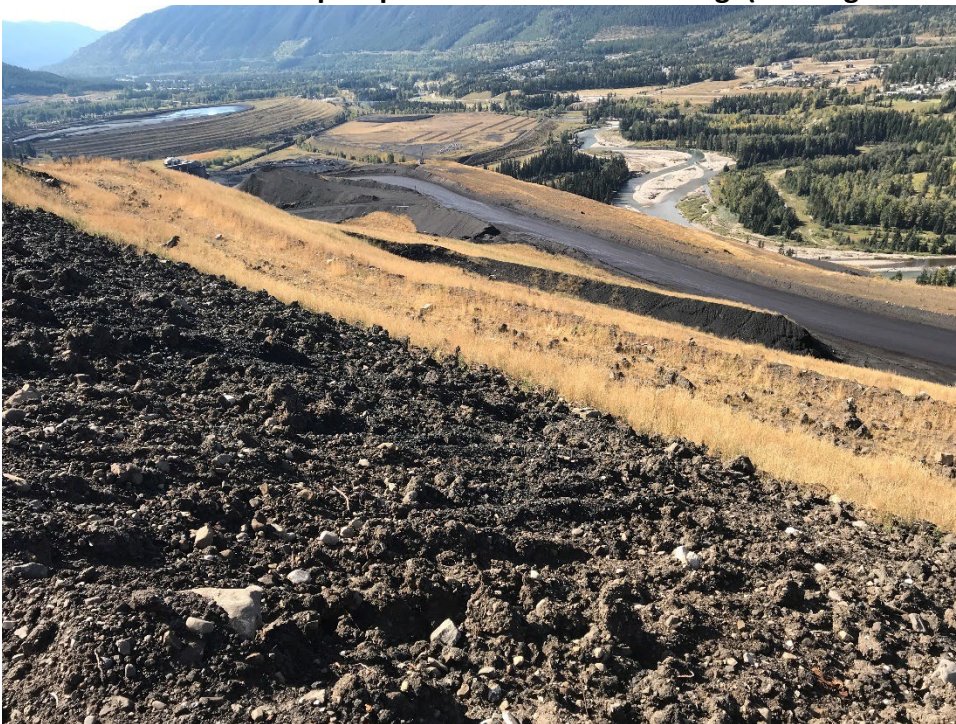
Photo I-18 CCR Dump slope below surficial cracking. (Looking SW – Taken 20 September 2022)

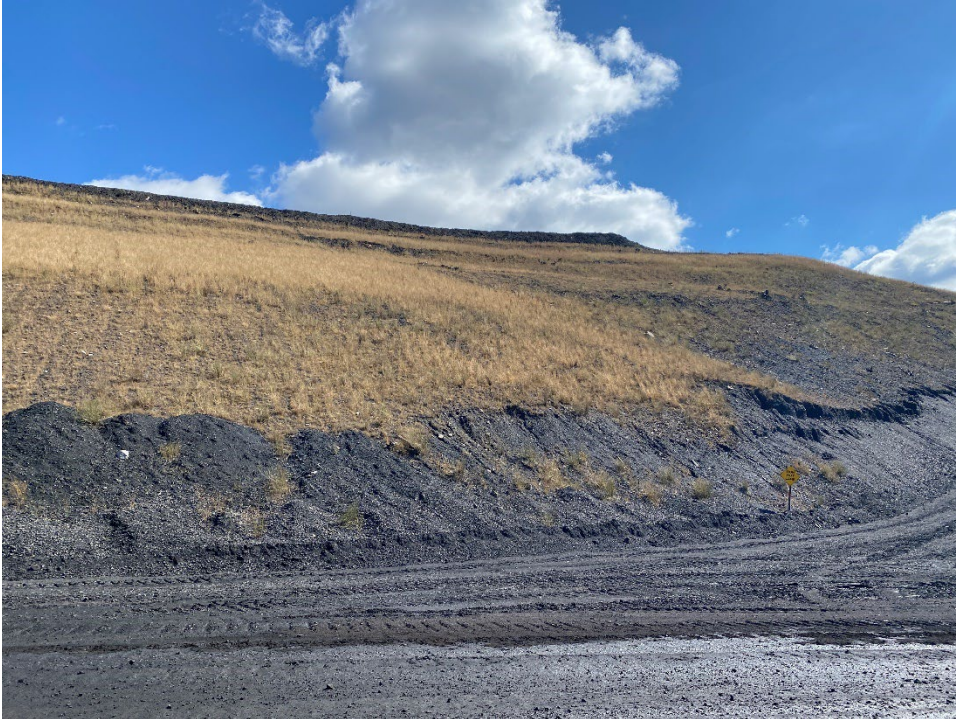
Photo I-19 CCR Dump slope below surficial cracking. (Looking SE – Taken 20 September 2022)
