Teck Coal Limited

Elkview Operations

West Fork Tailings Facility and Lagoons A, B, C, and D

2022 Annual Facility Performance Report

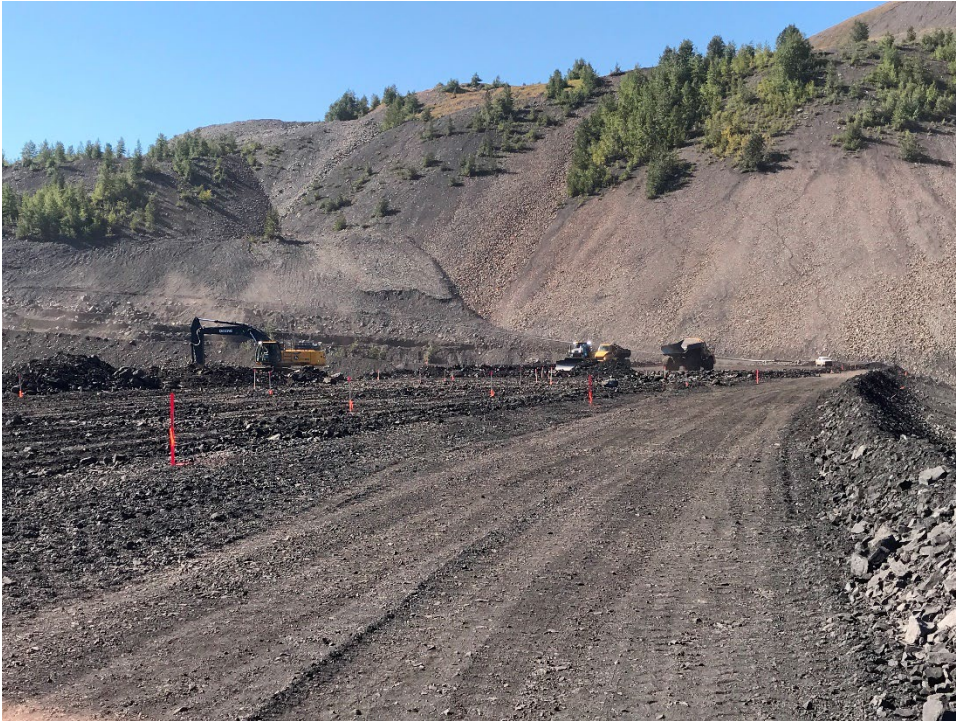
Photo IW-9 WFTF construction raise progress. (Looking west – Taken 21 September 2022)

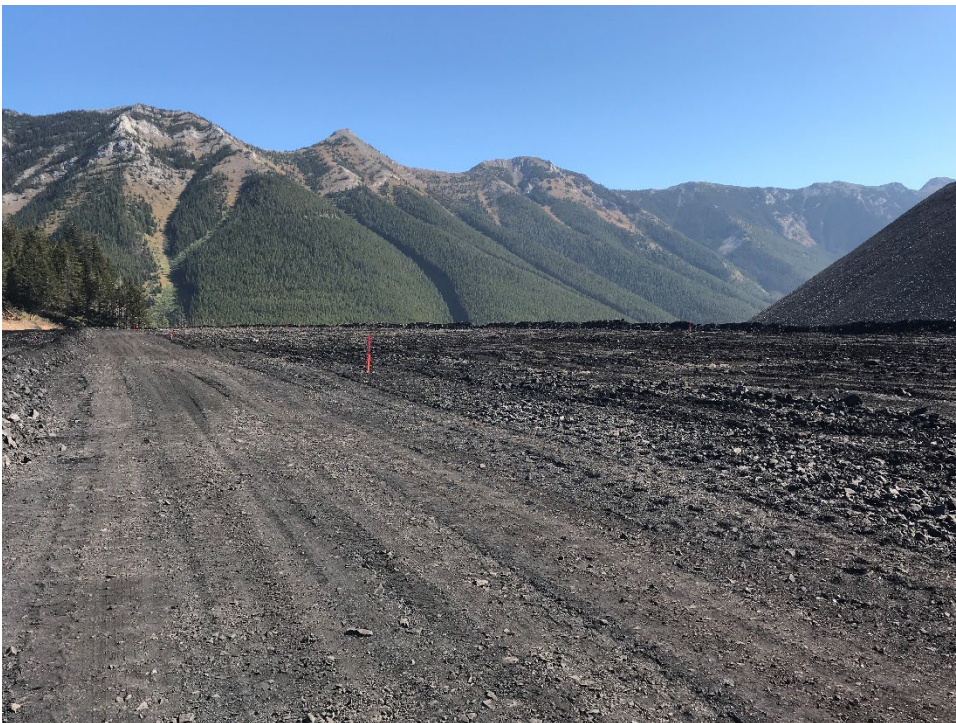
Photo IW-10 WFTF crest typical condition. (Looking SE – Taken 21 September 2022)

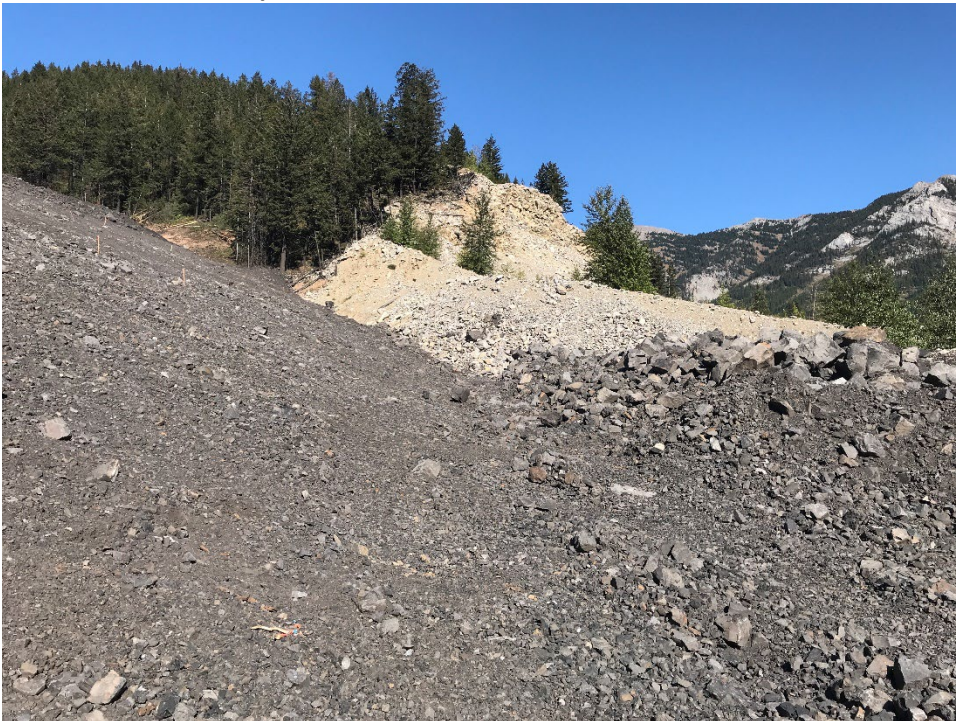
Photo IW-12 WFTF downstream slope at east abutment. (Looking South – Taken 21 September 2022)

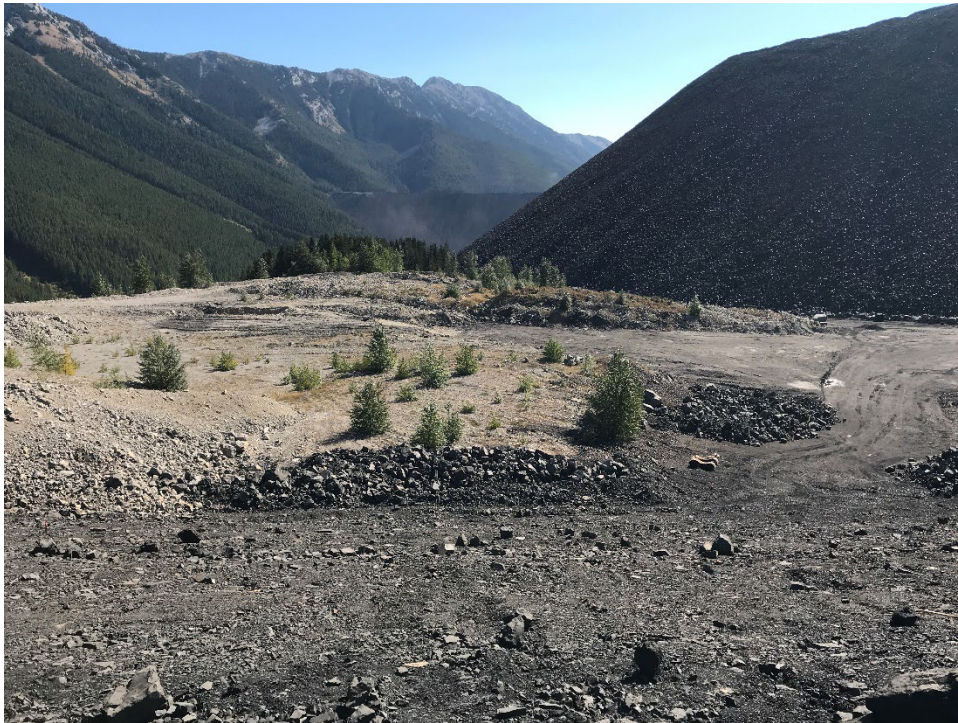
Photo IW-13 WFTF downstream conditions. (Looking south – Taken 21 September 2022)

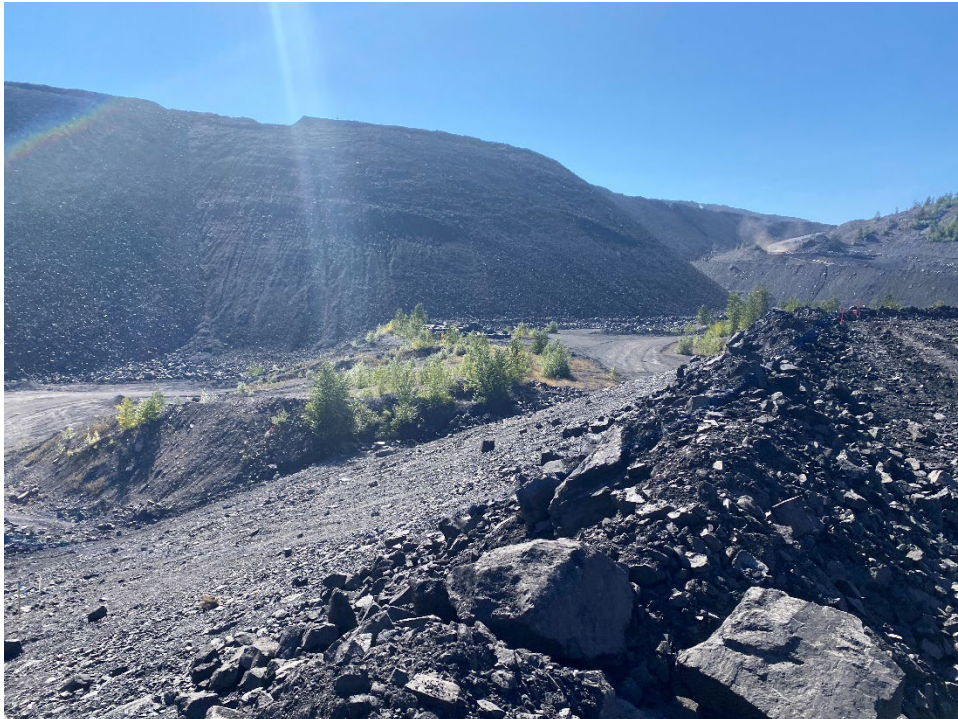
Photo IW-14 WFTF downstream conditions. (Looking SW – Taken 21 September 2022)

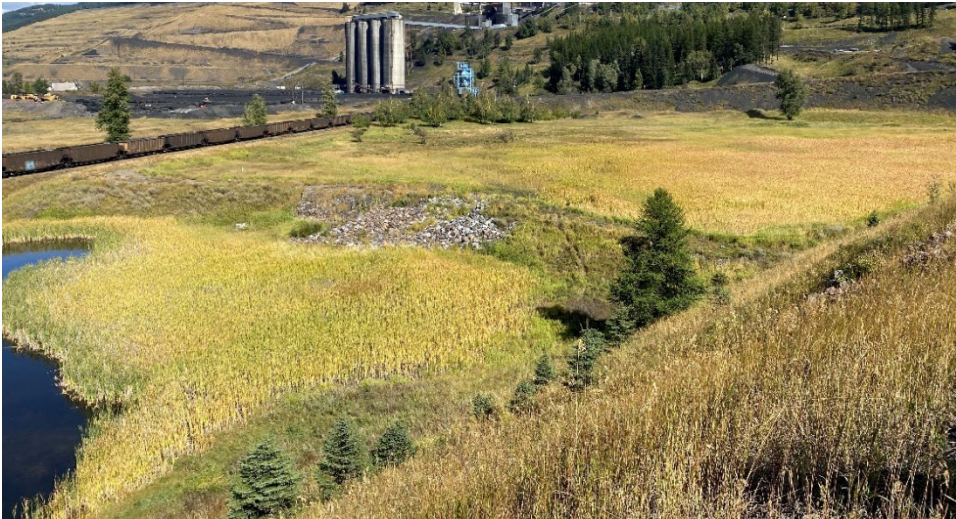
Photo IA-1 Lagoon A general conditions and overview. (From Lagoon D, looking NE – Taken 20 September 2022)

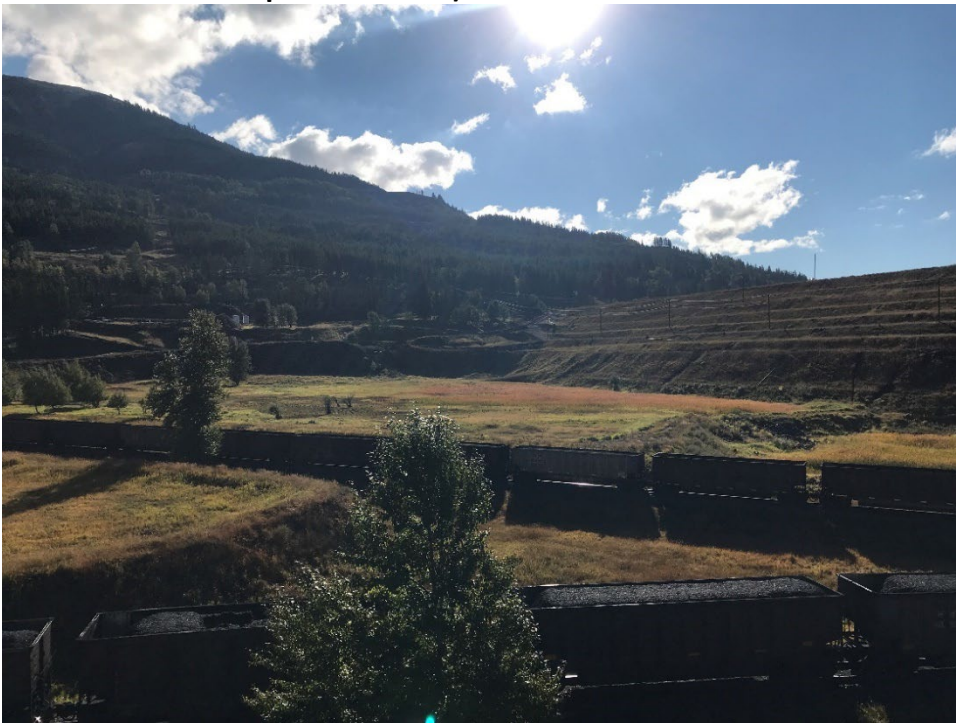
Photo IA-2 Lagoon A general conditions and overview. (Looking SE, from Lagoon C crest – Taken 20 September 2022)

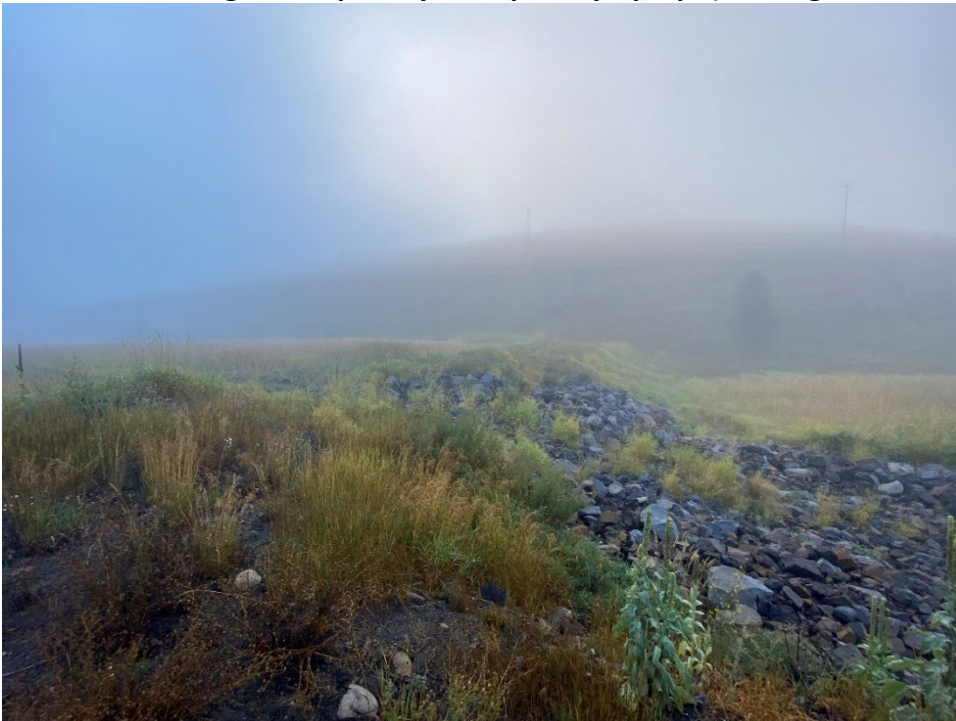
Photo IA-4 Lagoon A spillway and spillway riprap. (Looking south – Taken 20 September 2022)

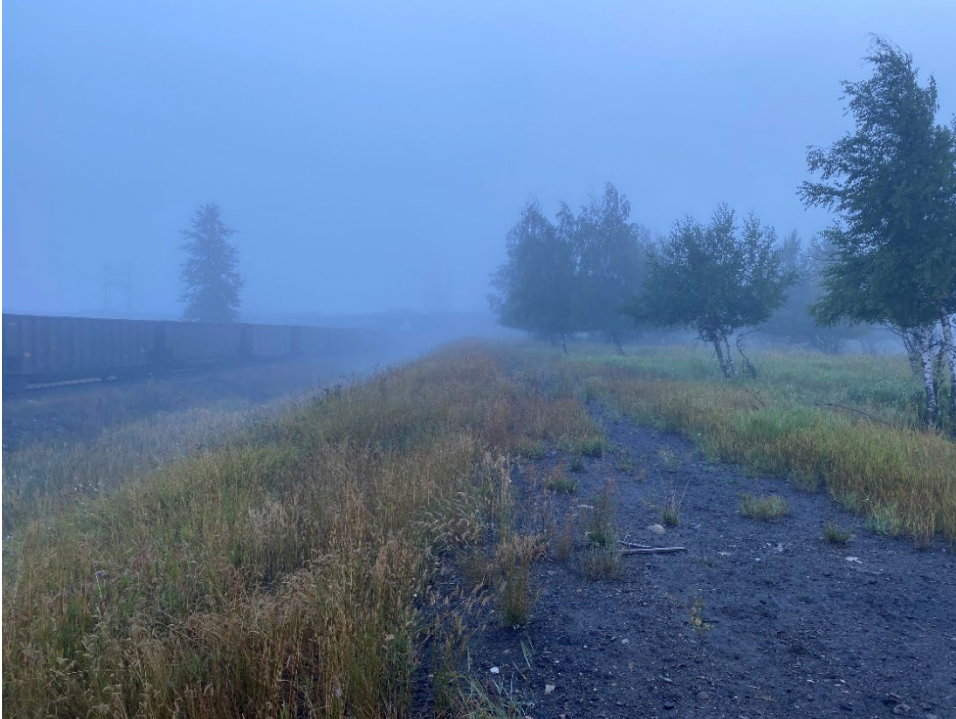
Photo IA-5 Lagoon A crest typical conditions. (Looking NE – Taken 20 September 2022)

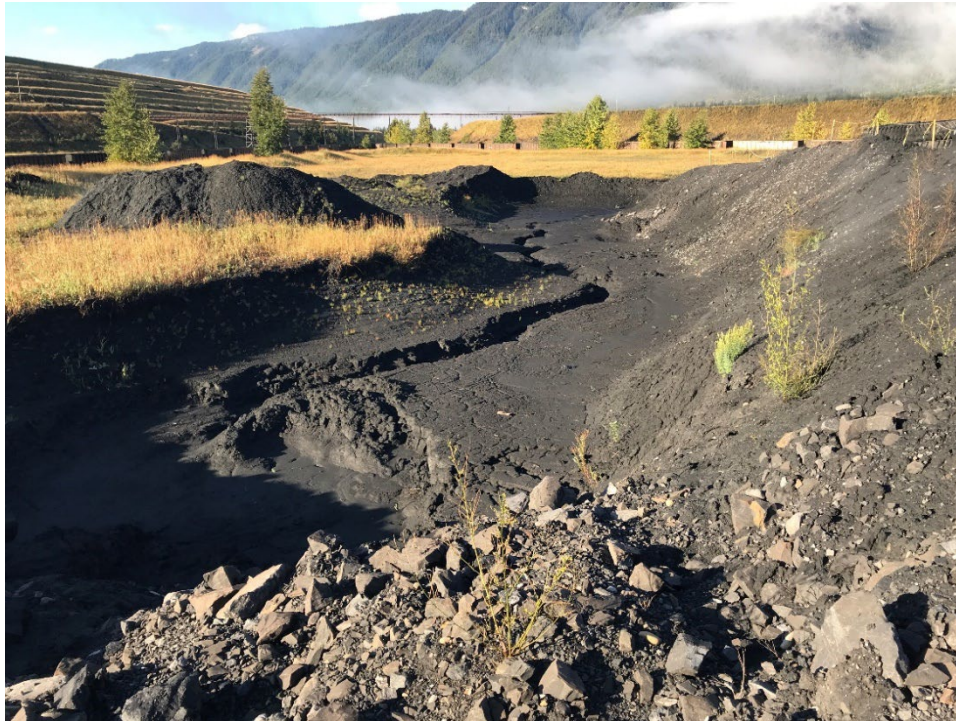
Photo IB-2 Lagoon B sump. (Looking SW – Taken 20 September 2022)

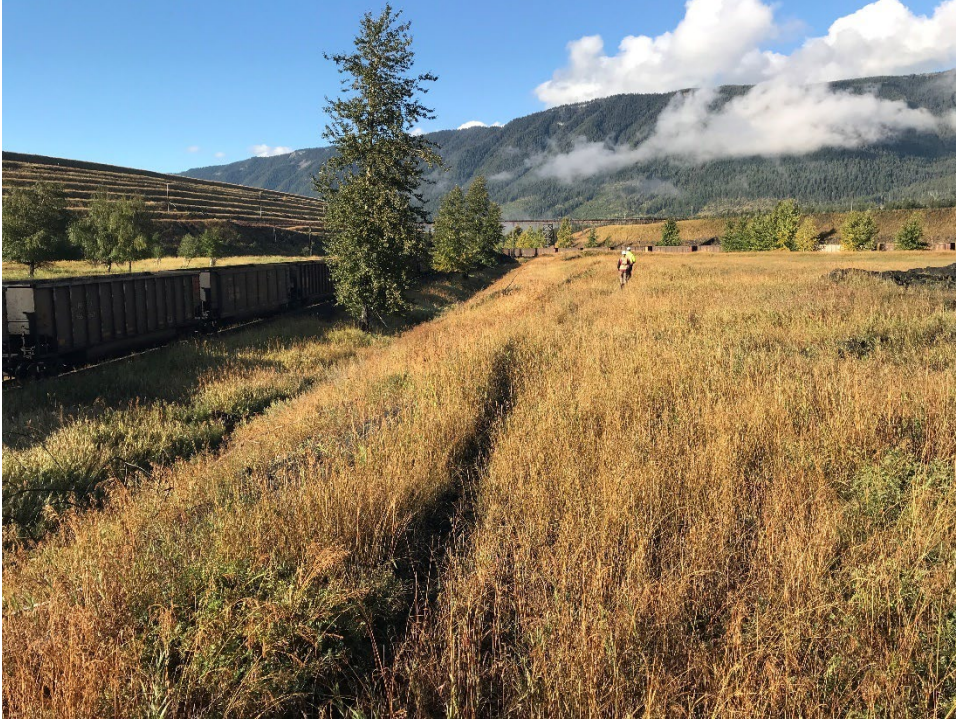
Photo IB-3 Lagoon B crest typical condition. (Looking SW – Taken 20 September 2022)

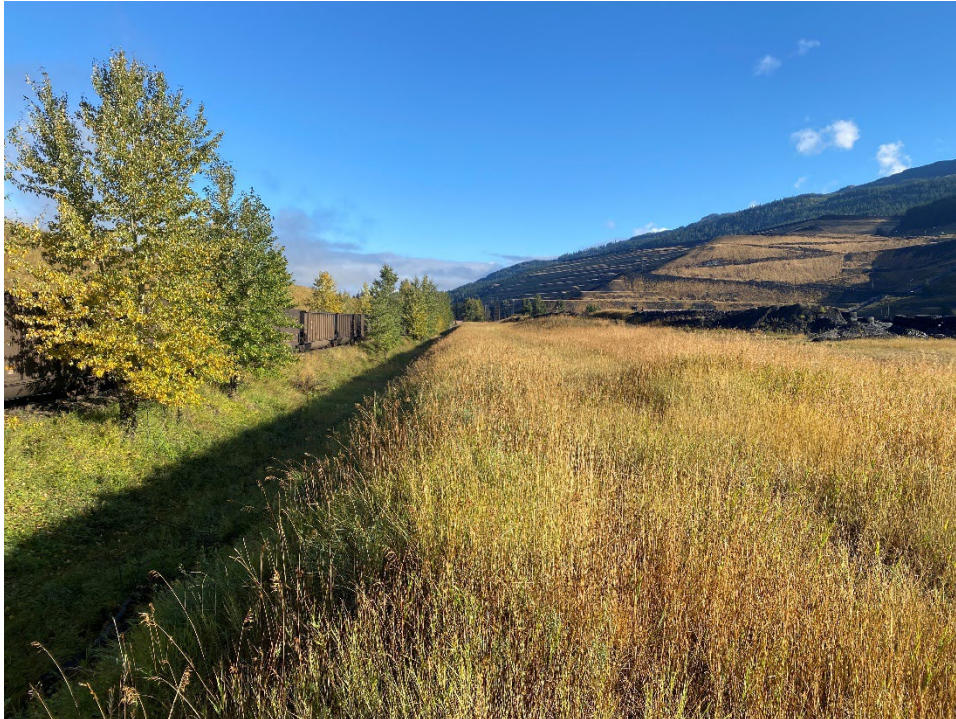
Photo IB-4 Lagoon B crest typical condition. (Looking north – Taken 20 September 2022)

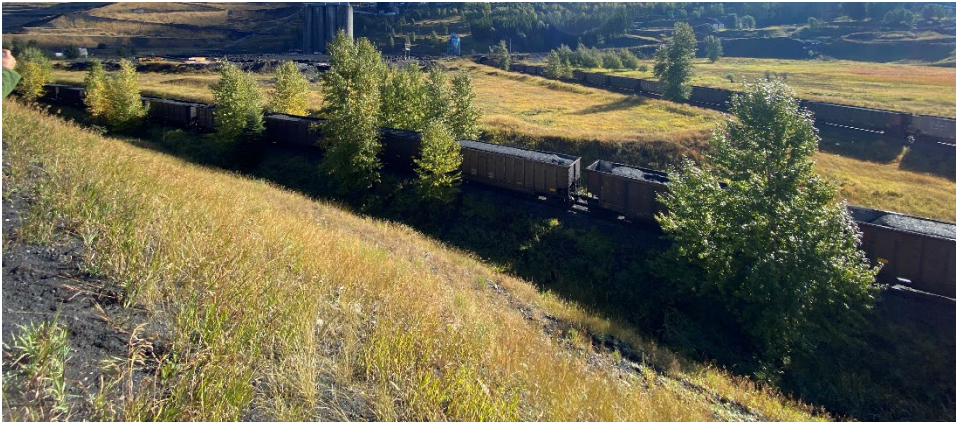
Photo IB-5 Lagoon B crest and surface typical conditions. (Looking SE, from Lagoon C crest – Taken 20 September 2022)

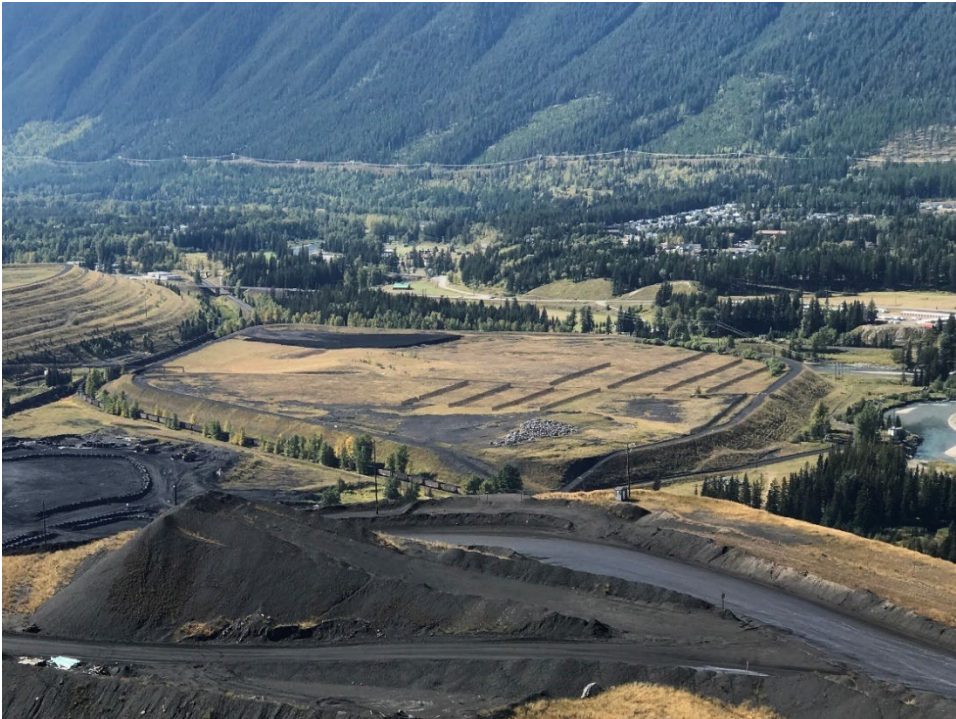
Photo IC-2 Lagoon C overview. (Looking SE from CCR Dump crest – Taken 20 September 2022)

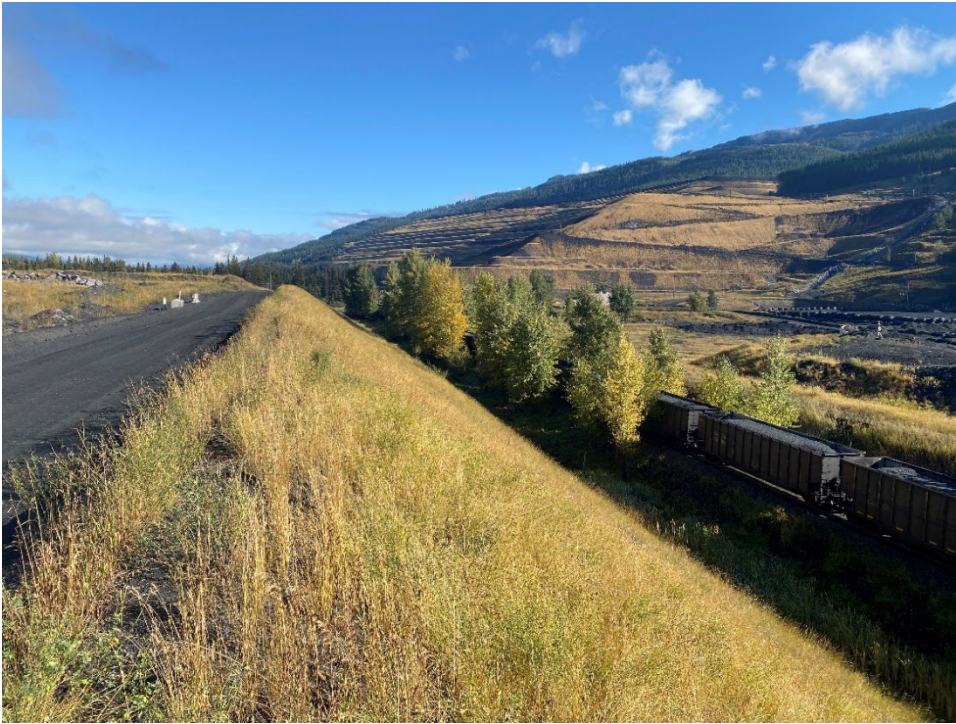
Photo IC-3 Lagoon C crest and embankment typical conditions. (Looking north – Taken 20 September 2022)

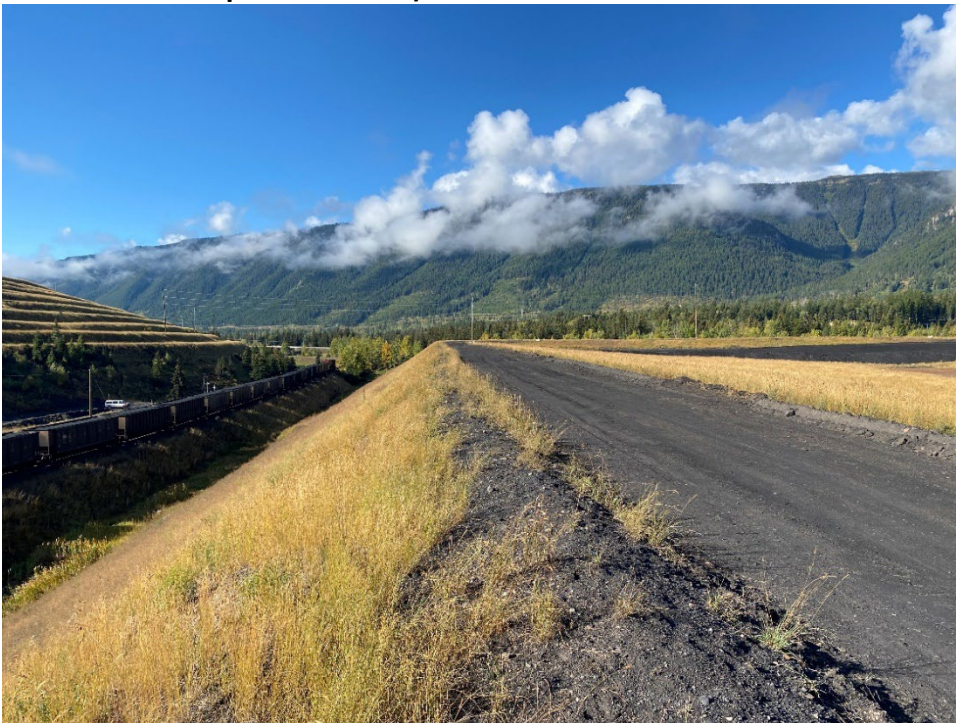
Photo IC-4 Lagoon C crest and embankment typical conditions. (Looking SW – Taken 20 September 2022)

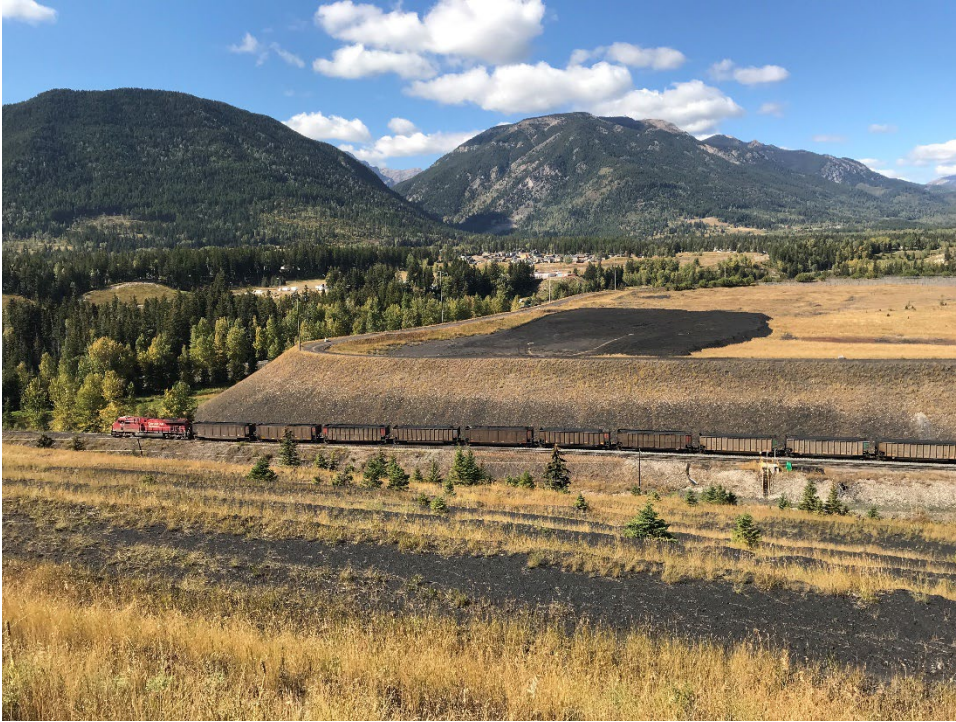
Photo IC-5 Lagoon C sediment placement and typical slope conditions. (Looking NW, from Lagoon D – Taken 20 September 2022)

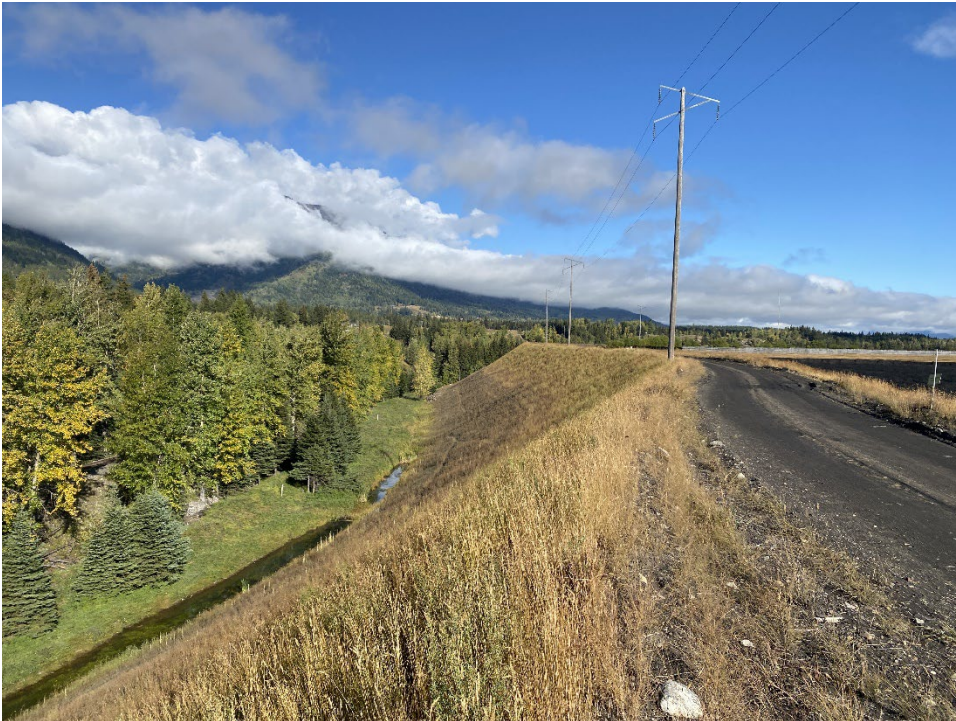
Photo IC-6 Lagoon C crest and downstream slope typical conditions. (Looking north – Taken 20 September 2022)

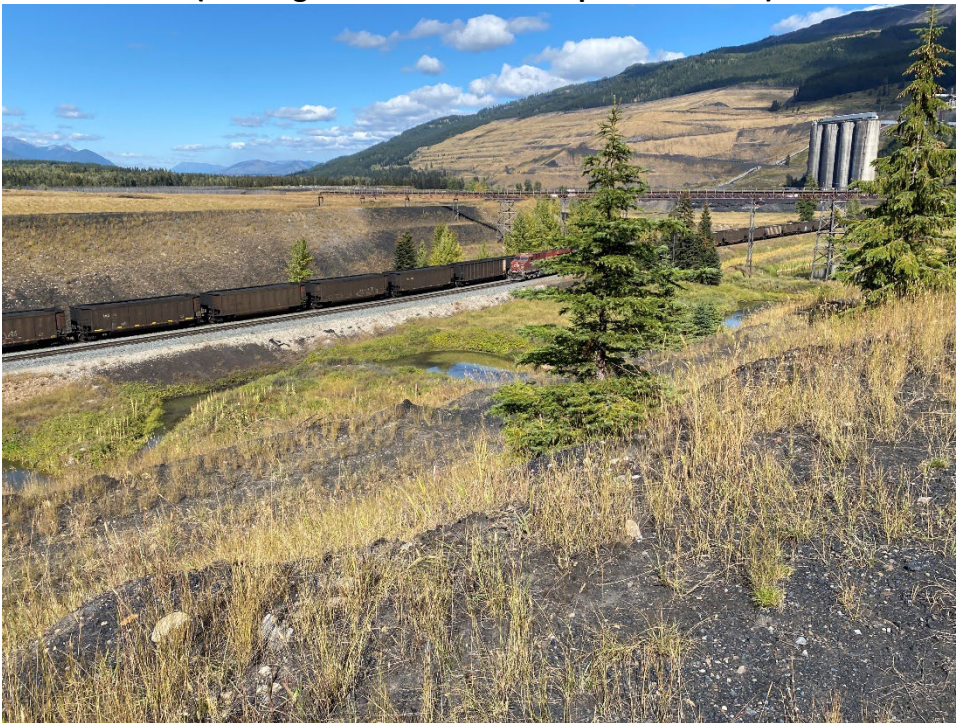
**Photo ID-6 Lagoon D ponding at the embankment toe (Otto Creek) adjacent to the rail line.
(Looking north – Taken 20 September 2022)**

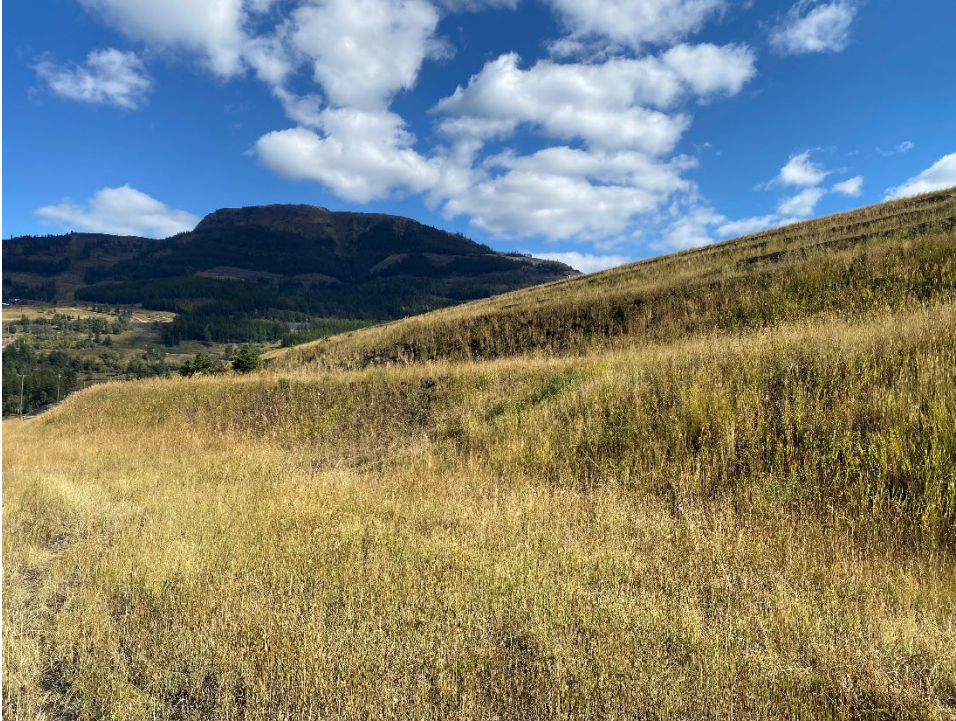
Photo ID-7 Lagoon D bench typical conditions. (Looking east – Taken 20 September 2022)

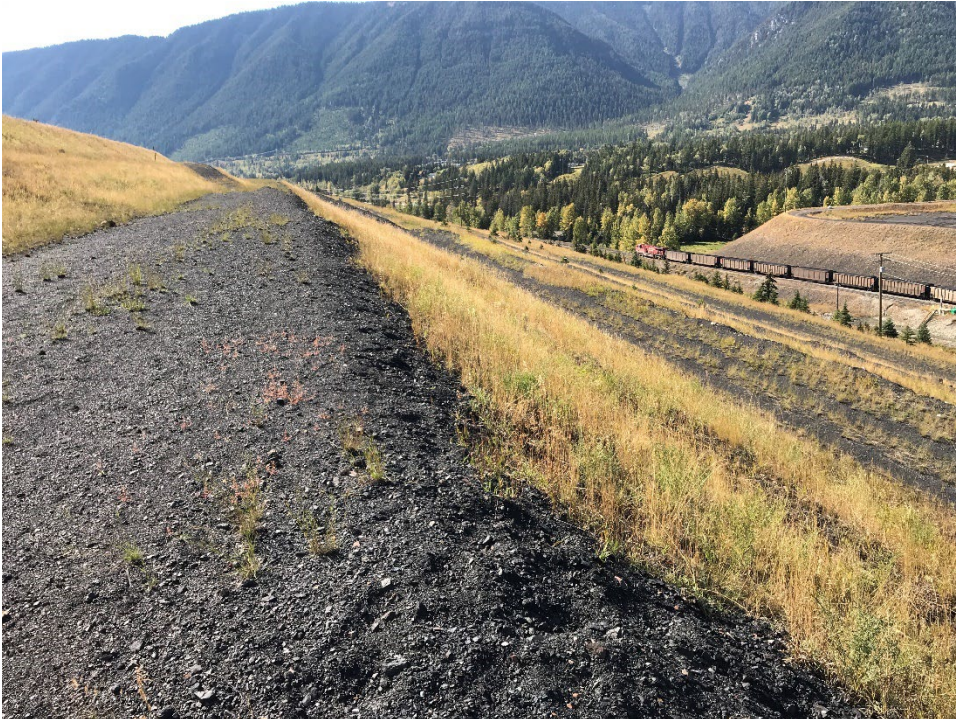
Photo ID-8 Lagoon D bench typical conditions. (Looking west – Taken 20 September 2022)

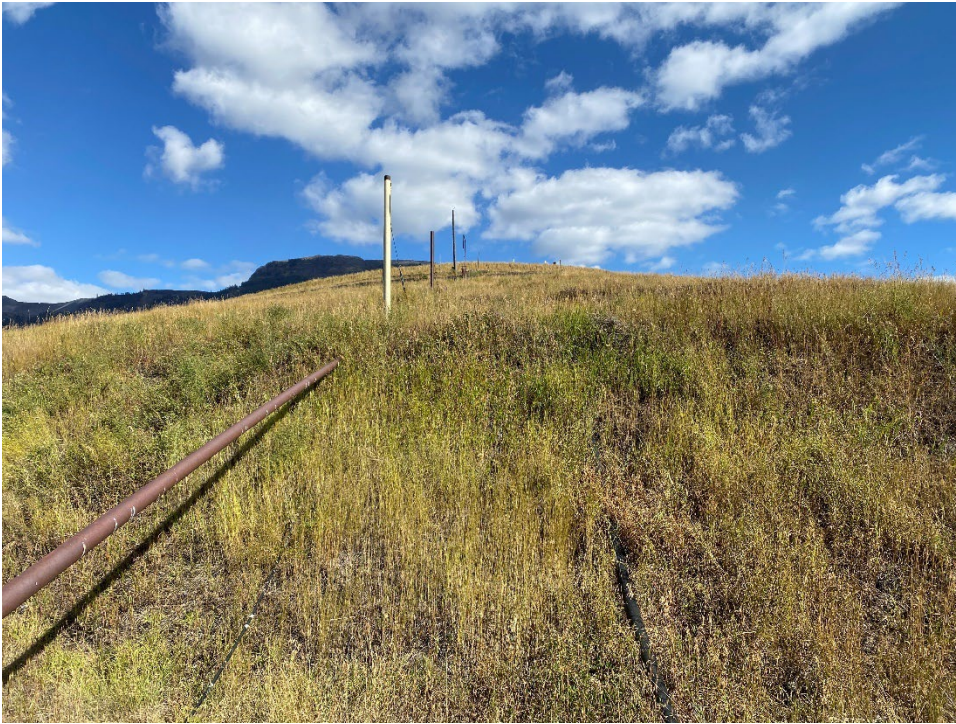
Photo ID-9 Lagoon D decant pipeline and embankment slope. (Looking east – Taken 20 September 2022)

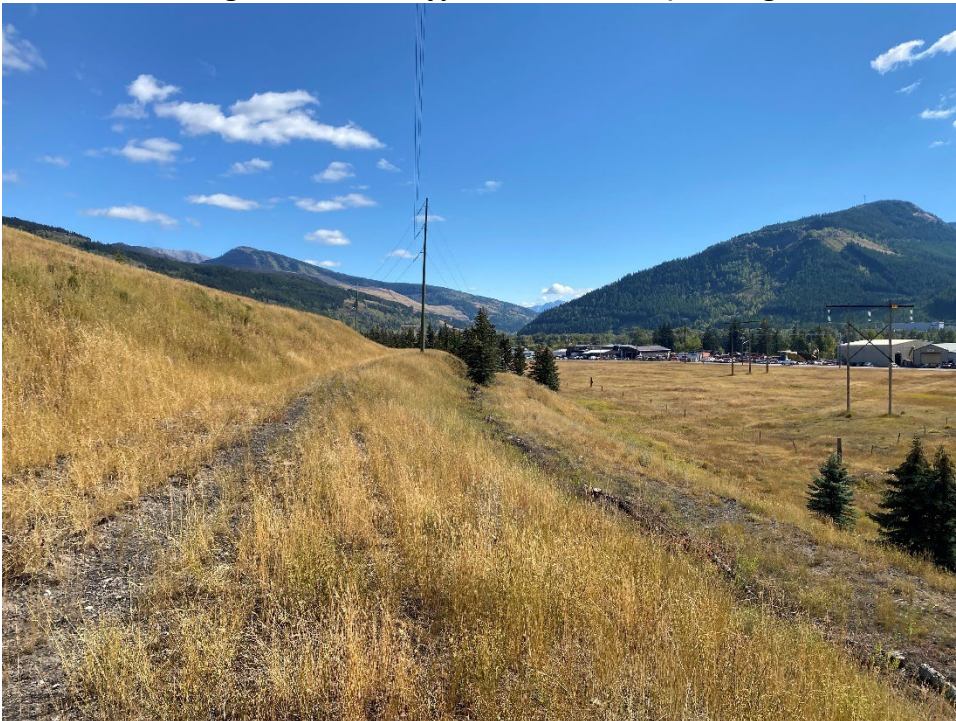
Photo ID-10 Lagoon D bench typical conditions. (Looking SE – Taken 20 September 2022)
