2022 Annual Facility Performance Report for Turnbull Tailings Storage Facility

Teck Coal Limited, Fording River Operations

WSP Canada Inc.

24 March 2023

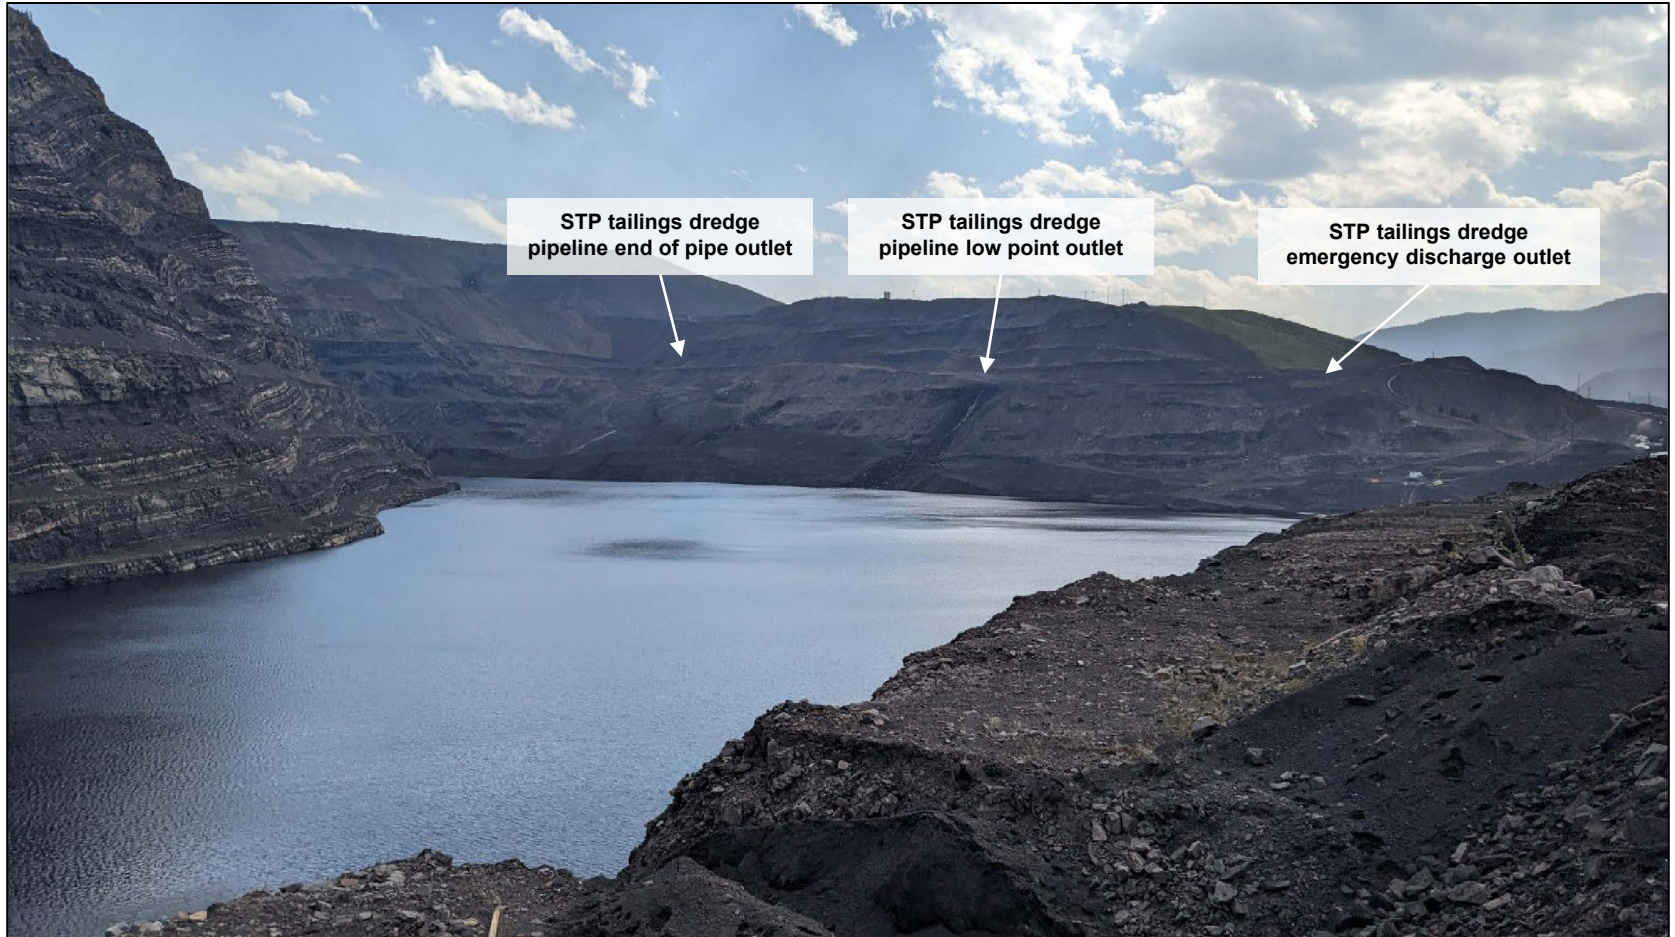
PHOTOGRAPH 1

Turnbull TSF: Overview from north endwall, looking south.

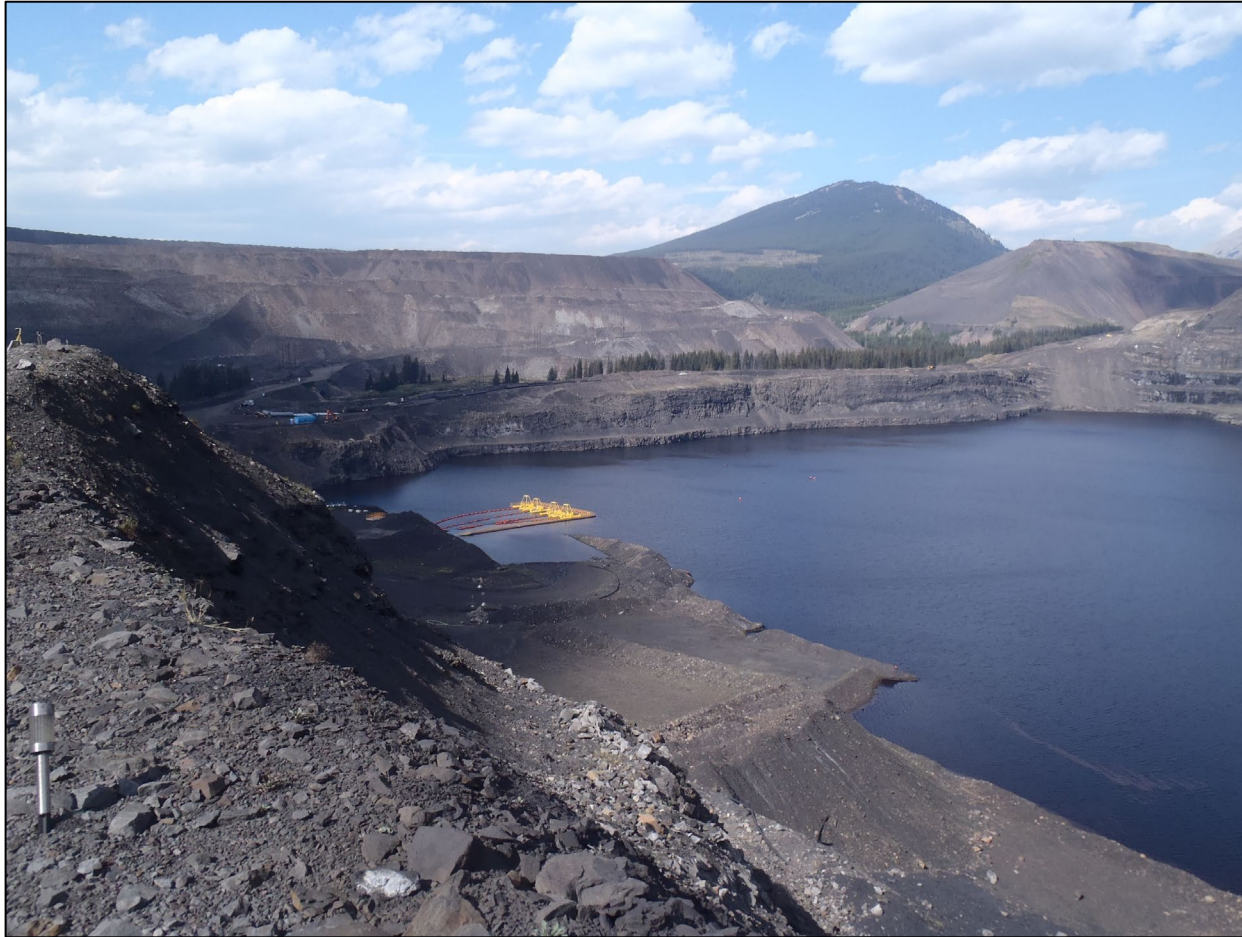
PHOTOGRAPH 2

Turnbull TSF pond, reclaim water intakes, and pipelines, looking north.

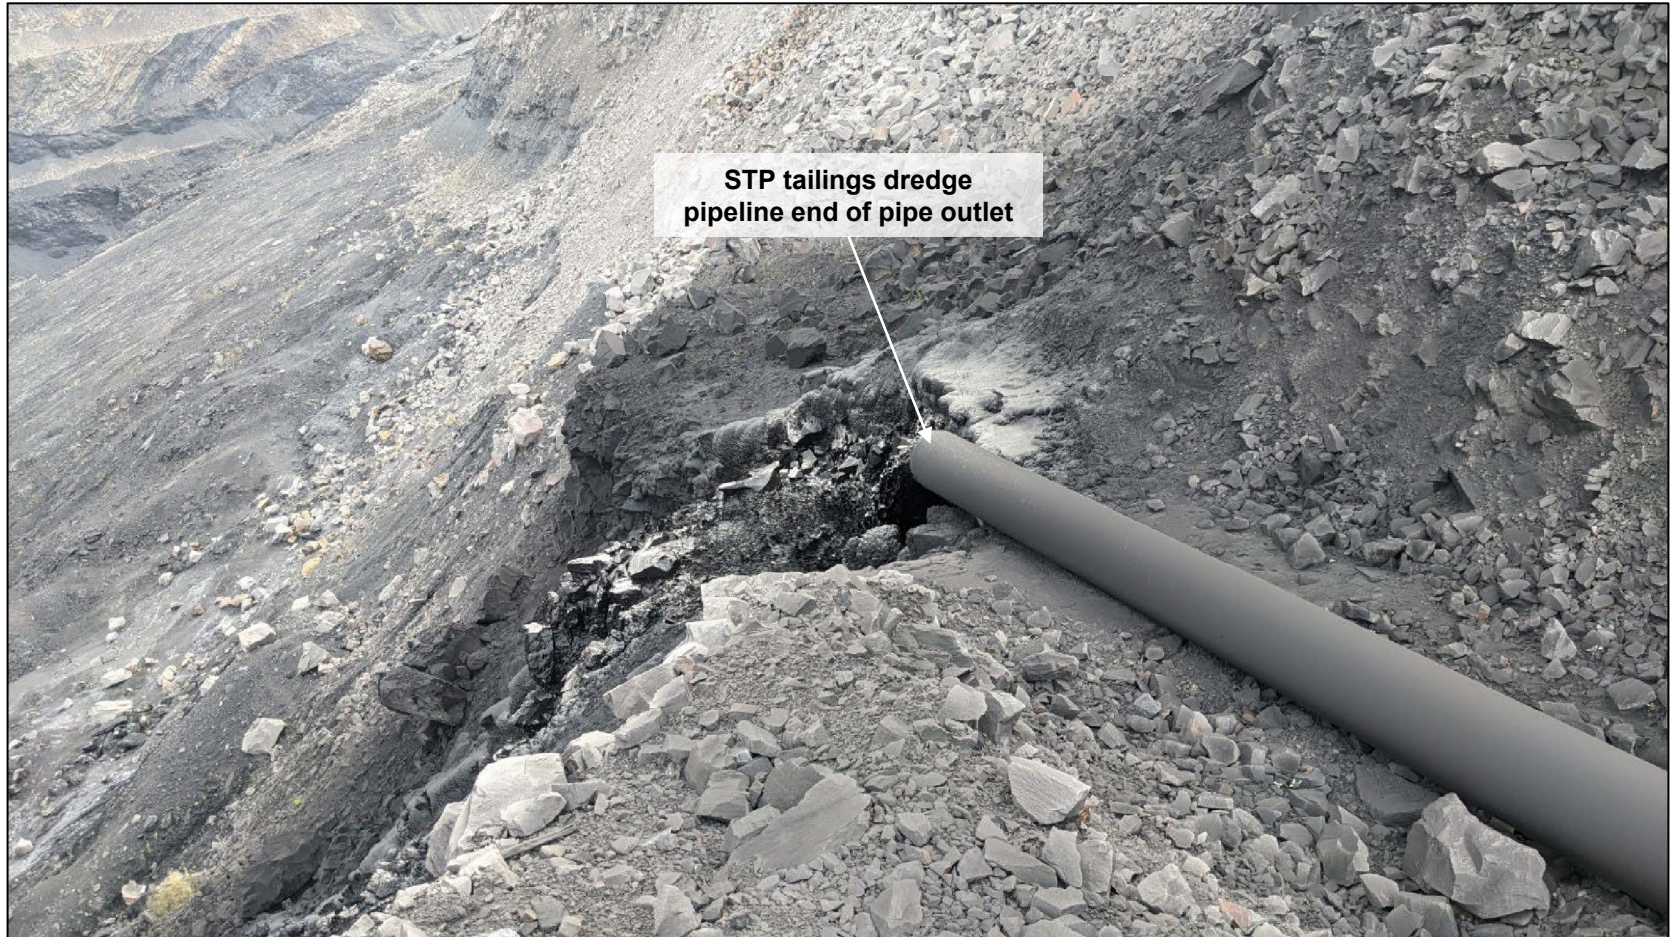
PHOTOGRAPH 3

Discharge of tailings from the South Tailings Pond at the tailings dredge pipeline end of the pipe outlet into the Turnbull TSF, looking southeast.

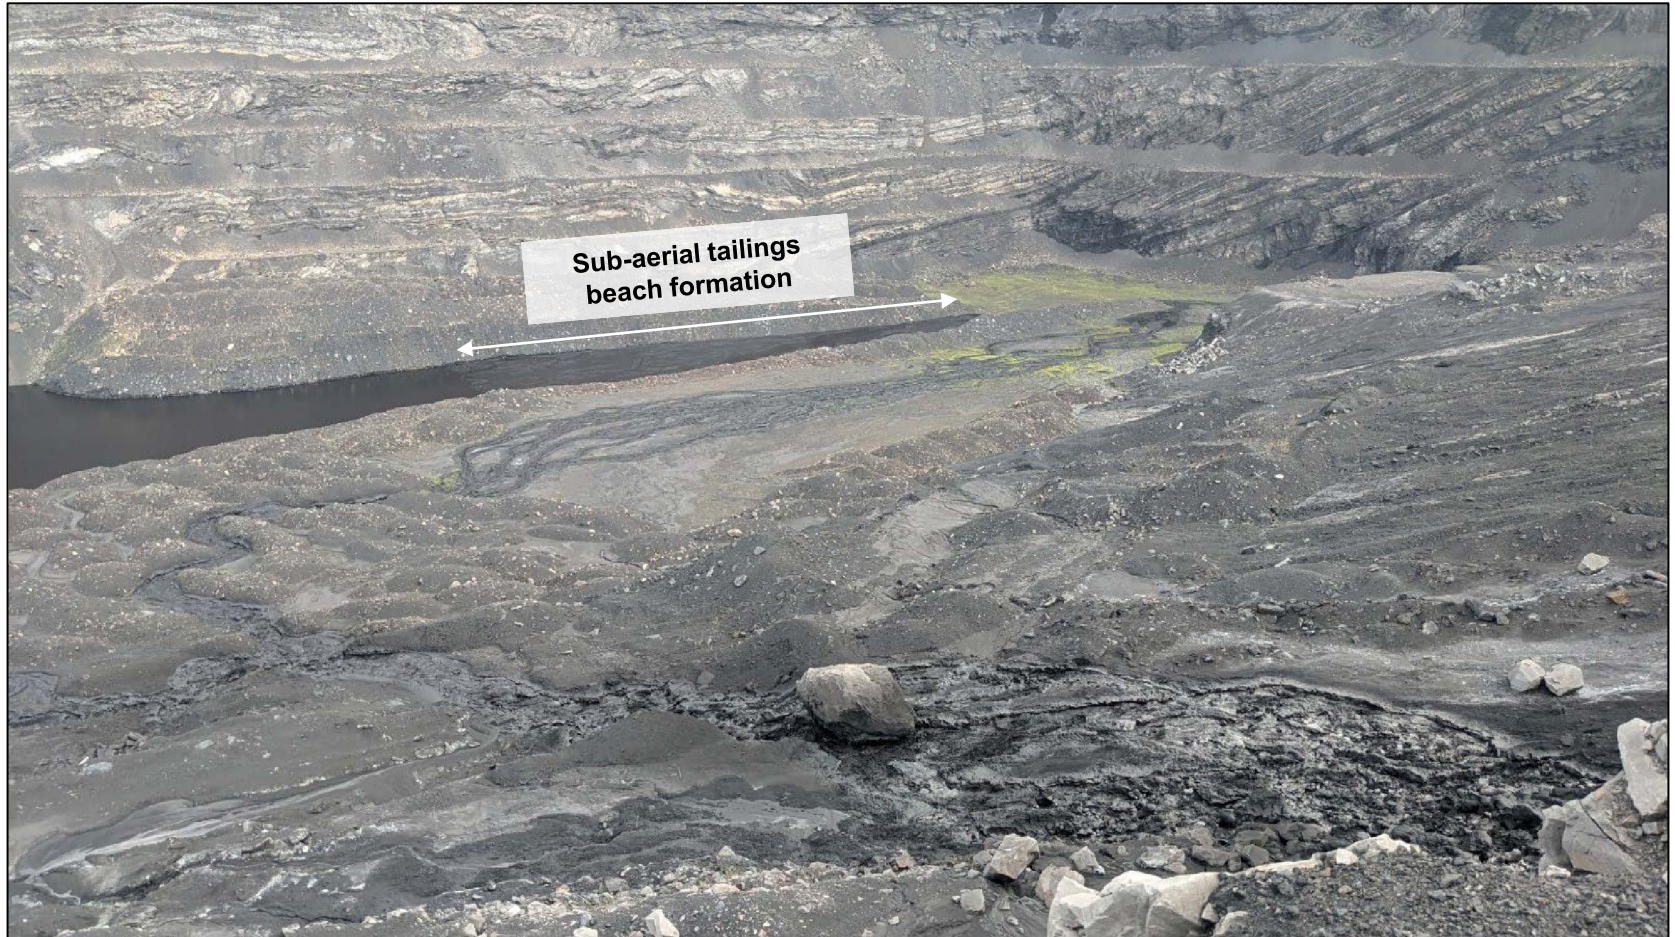
PHOTOGRAPH 4

Tailings deposition and in-pit spoils below the tailings pipeline end of the pipe outlet, looking east.

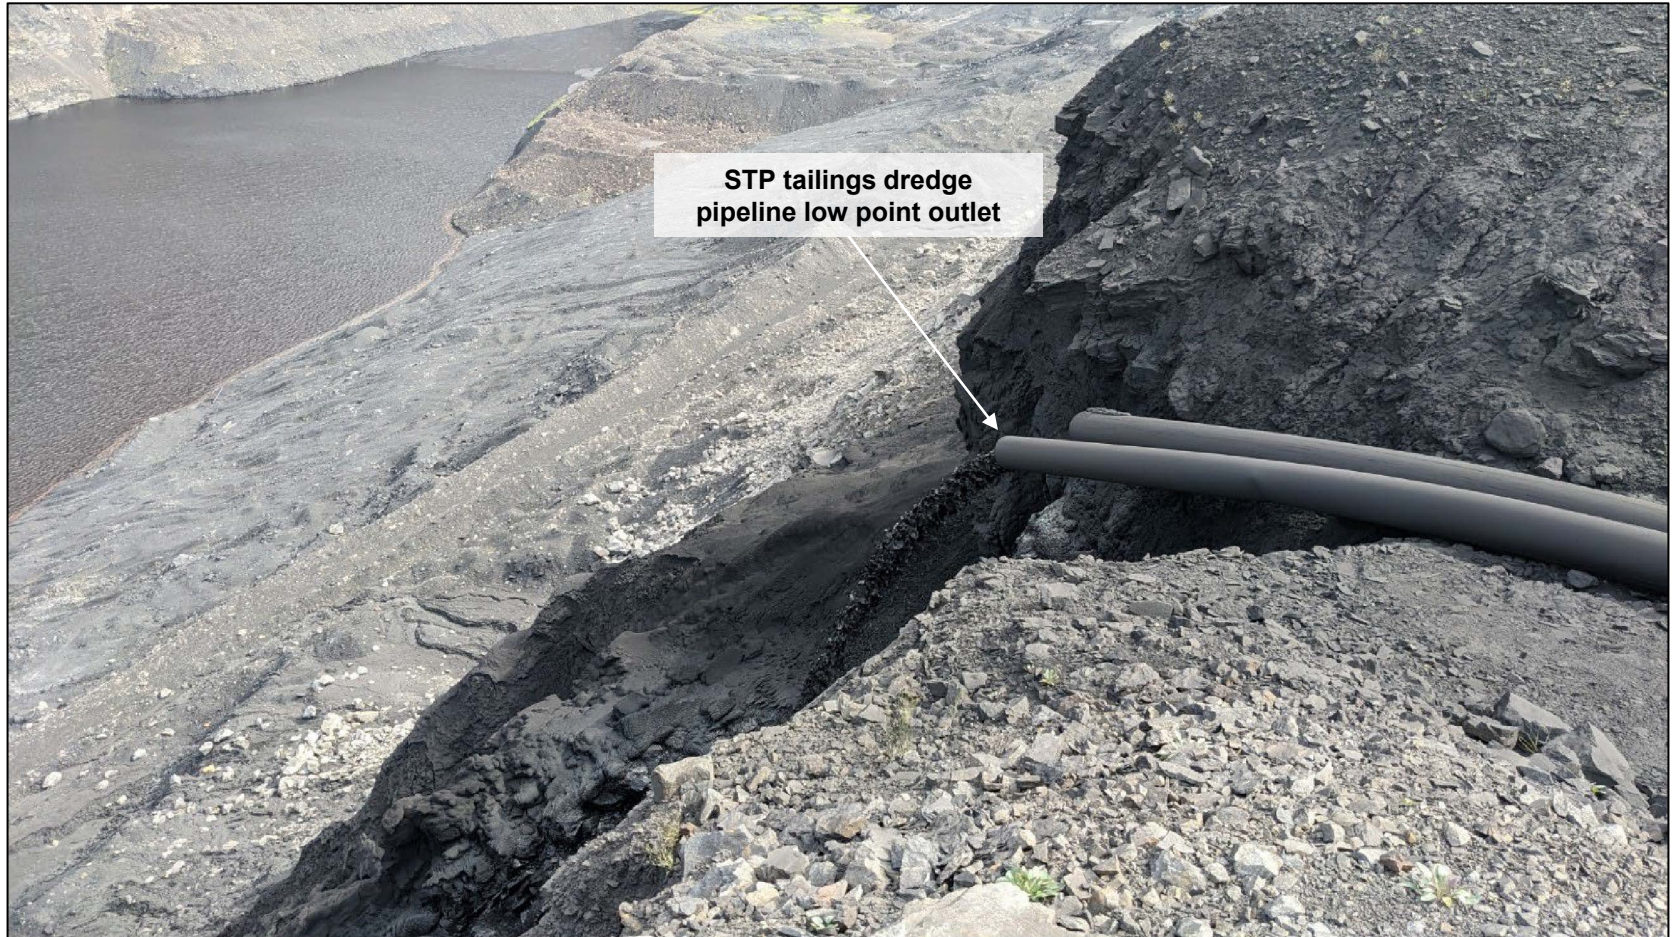
PHOTOGRAPH 5

Discharge of tailings from the South Tailings Pond through the tailings dredge pipeline low point outlet into the Turnbull TSF, looking southeast.

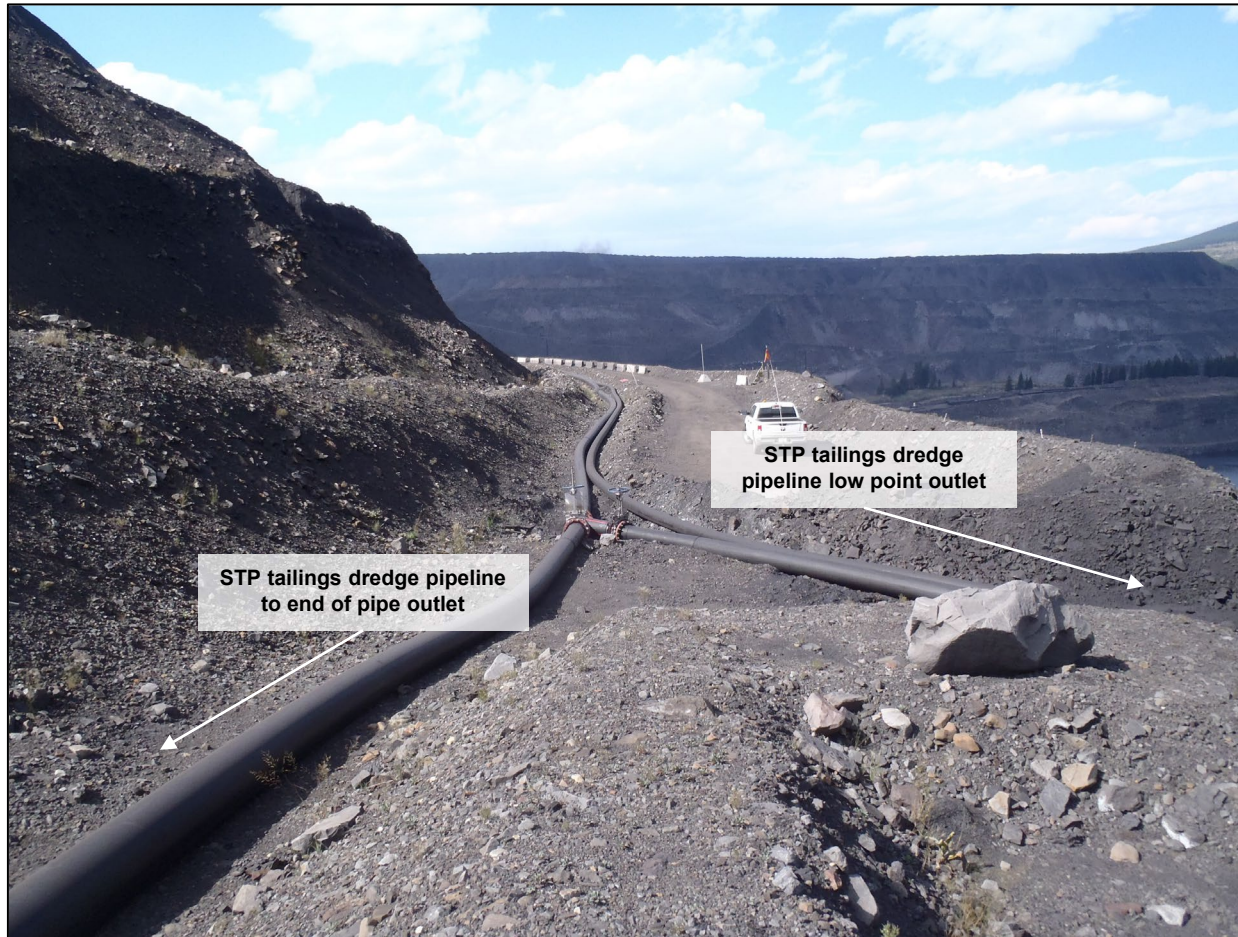
PHOTOGRAPH 6

This failure mode is managed by routine inspections of the pipeline by the dredging contractor during active dredging. During the 2022 site inspection by the EoR, waste rock debris was observed to be collecting between the tailings dredging pipeline berm and the spoils over the low wall in an area within the TSF. No leakage from this pipeline was observed during the reporting period. The debris is to be cleaned out such that the berm could catch travelling rocks from the waste rock slope above the pipeline (recommended action 2020-01 in Table 11).

Turnbull TSF waste rock benched slope above the tailings pipelines on the low wall, looking northwest.

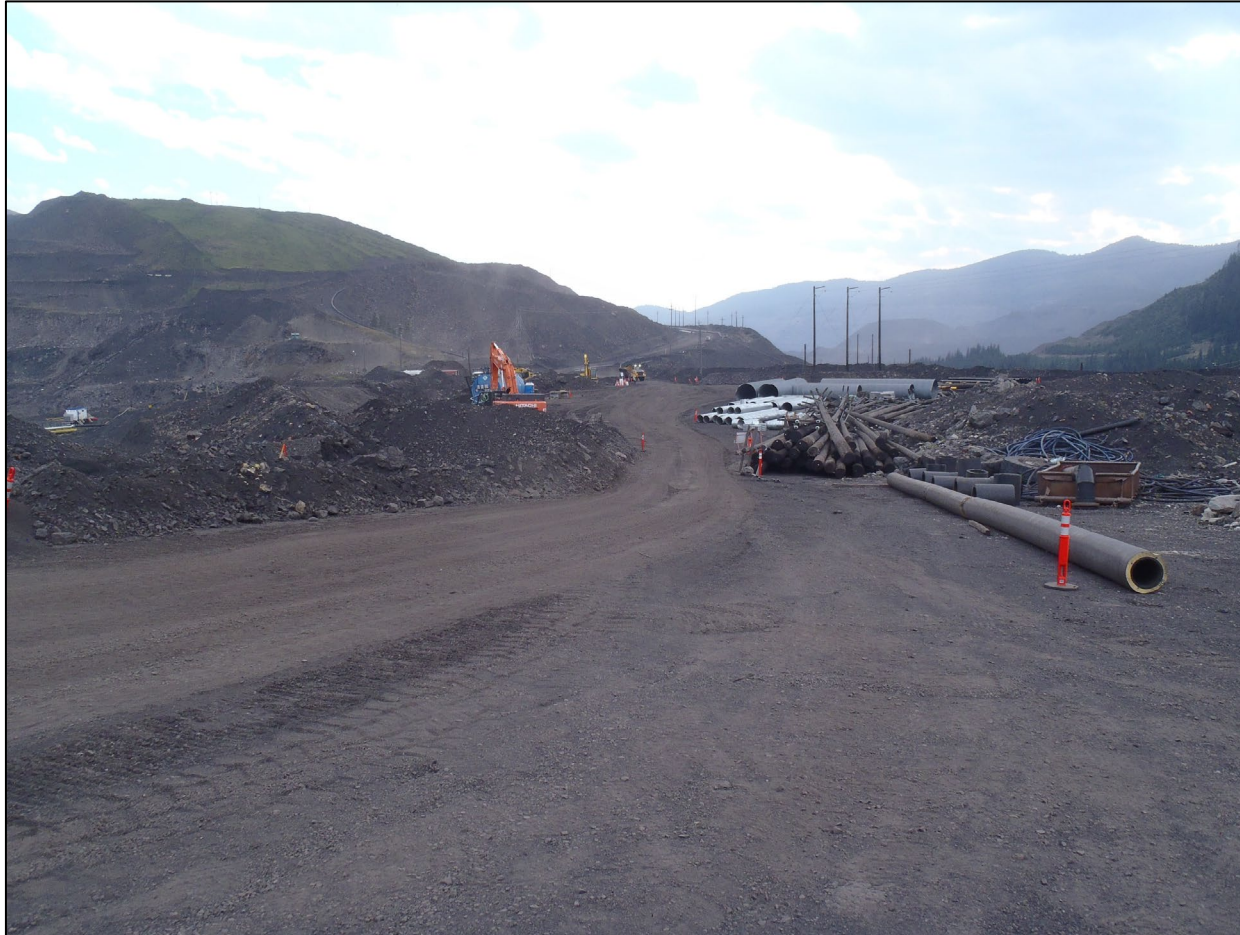
PHOTOGRAPH 7

Waste rockfill and haul road, which is the topographic low point (saddle area) of the Turnbull TSF, looking southwest.

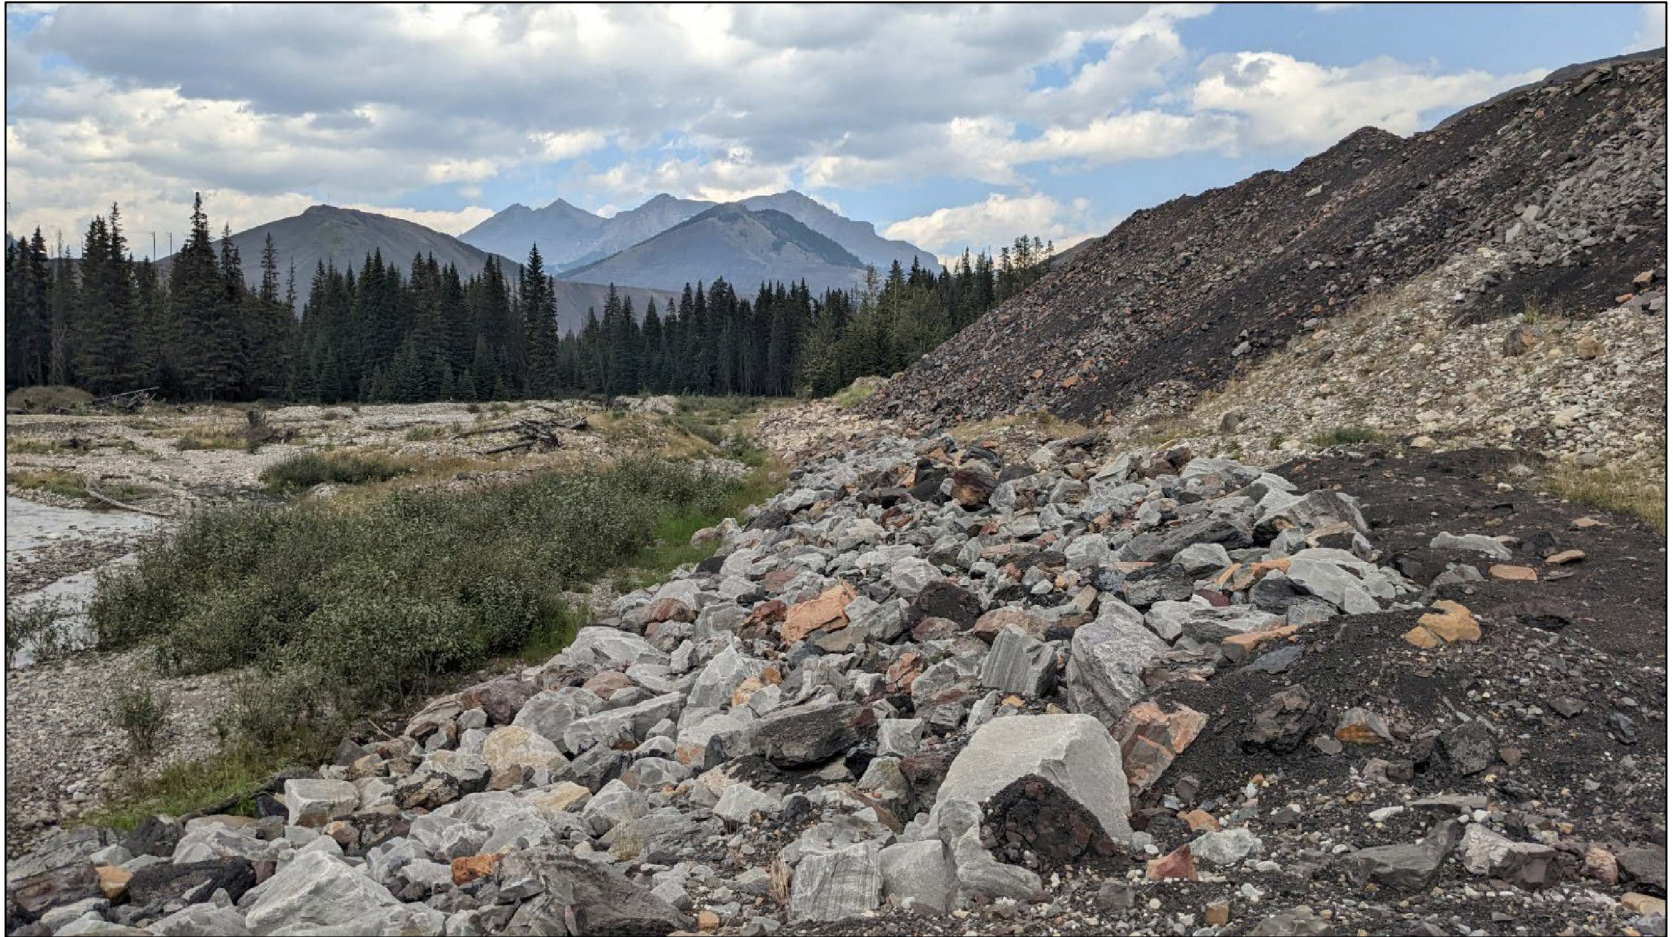
PHOTOGRAPH 8

Turnbull TSF view of the downstream slope, Fording River, and the toe of the low point area waste rockfill, looking northeast.

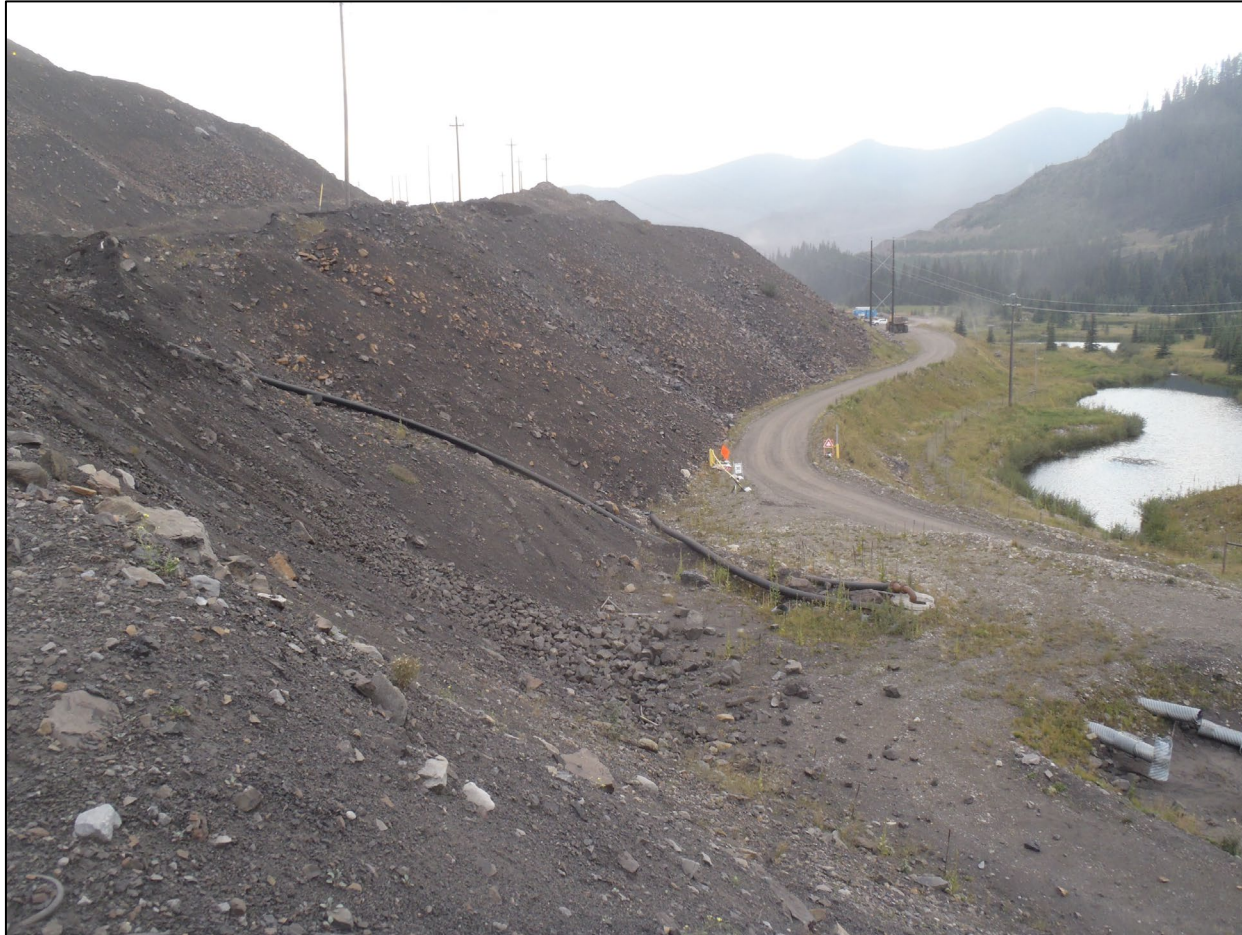
PHOTOGRAPH 9

Turnbull TSF: View of the downstream slope and toe of the low point area waste rockfill, looking southwest.
