2022 Annual Facility Performance Report
Coarse Coal Refuse Facilities

Teck Coal Limited

WSP Canada Inc.

Reference No. 22516234-2022-139-R-Rev0-2000

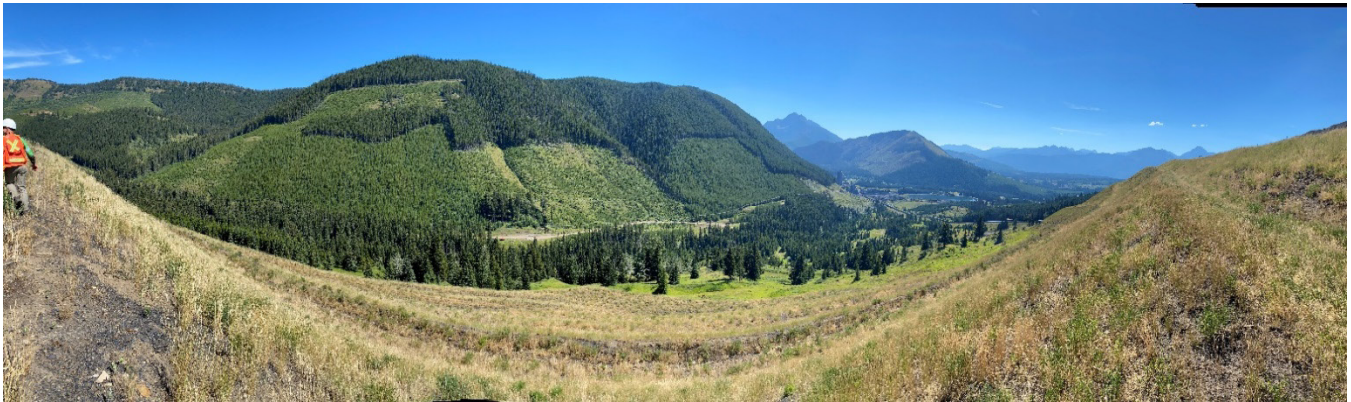
- No signs of instability were observed that are a concern to facility safety.
- Visual observations of the ancient/relict landslide near the southeast toe of the Site A facility did not indicate any signs of recent movement at the time of the 2022 site visit (Photograph 4).

Photograph 4: Site A CCR Facility – Downstream Slope Near Relict Landslide; Looking South, 30 August 2022

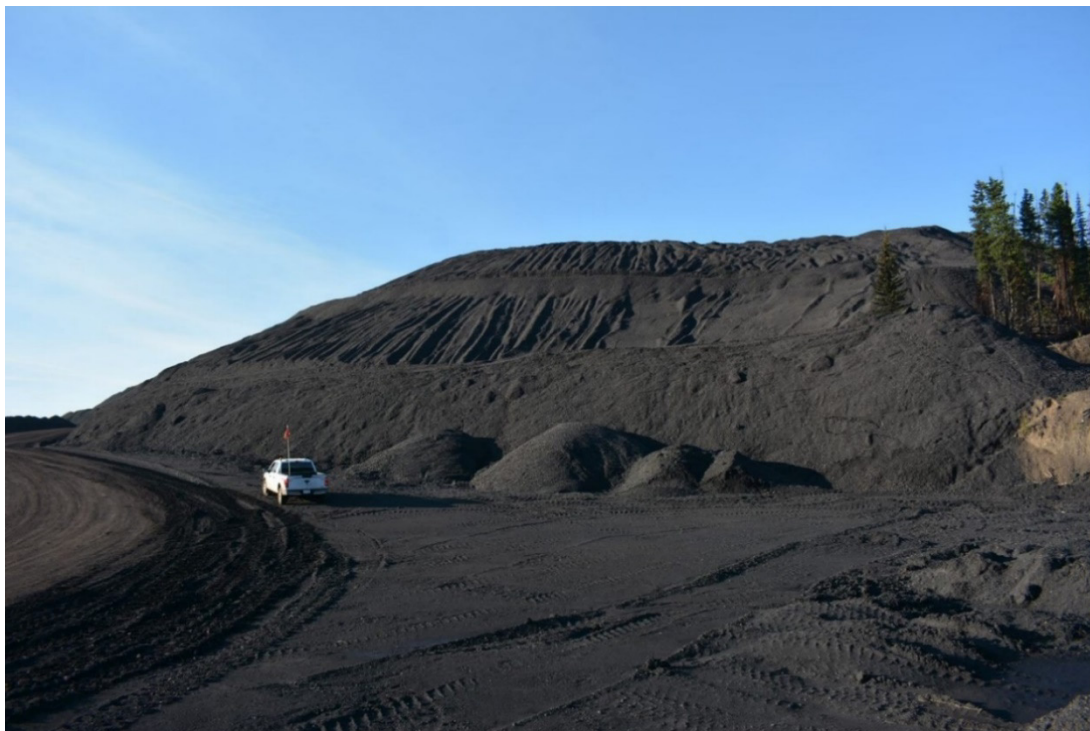
Photograph 9: Site B CCR Facility – Reprofiled Slope at Haul Road Switchback, Looking West, 31 August 2022

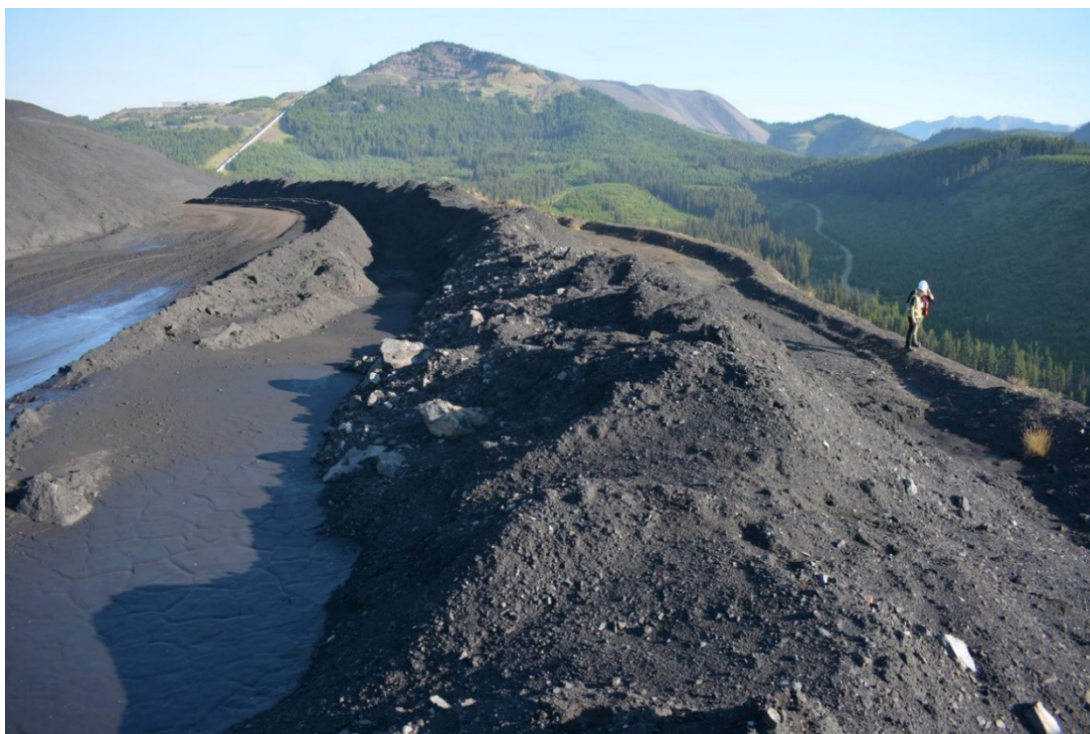
Photograph 10: Site B CCR Facility – Repaired Erosion Area on east side of haul road, Looking North, 31 August 2022

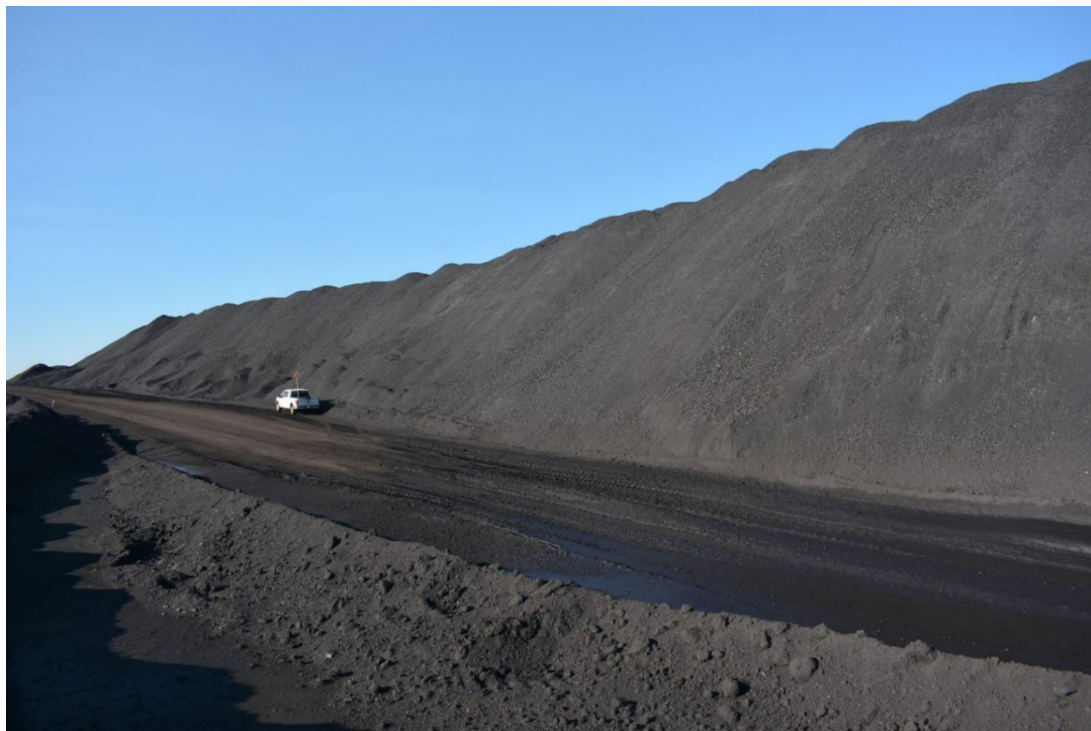
Photograph 11: Site B CCR Facility – Repaired Erosion Area on east side of haul road, Looking Southeast, 31 August 2022

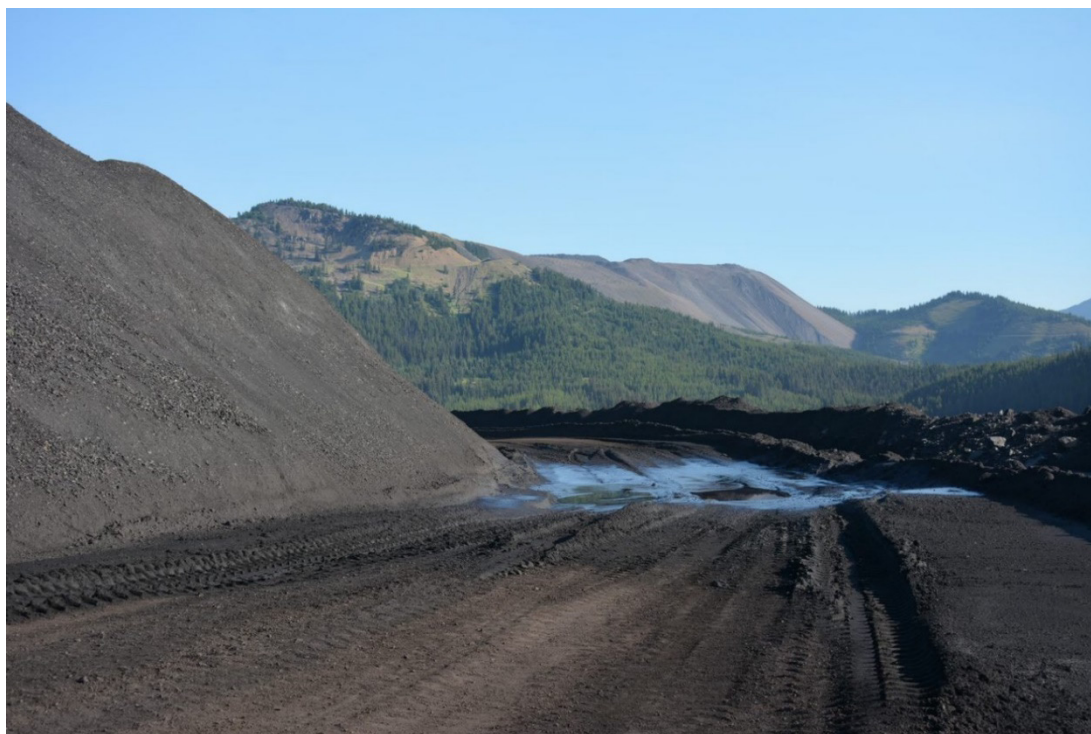
Photograph 12: Site B CCR Facility – Low Spot in haul road, Looking Northeast, 31 August 2022

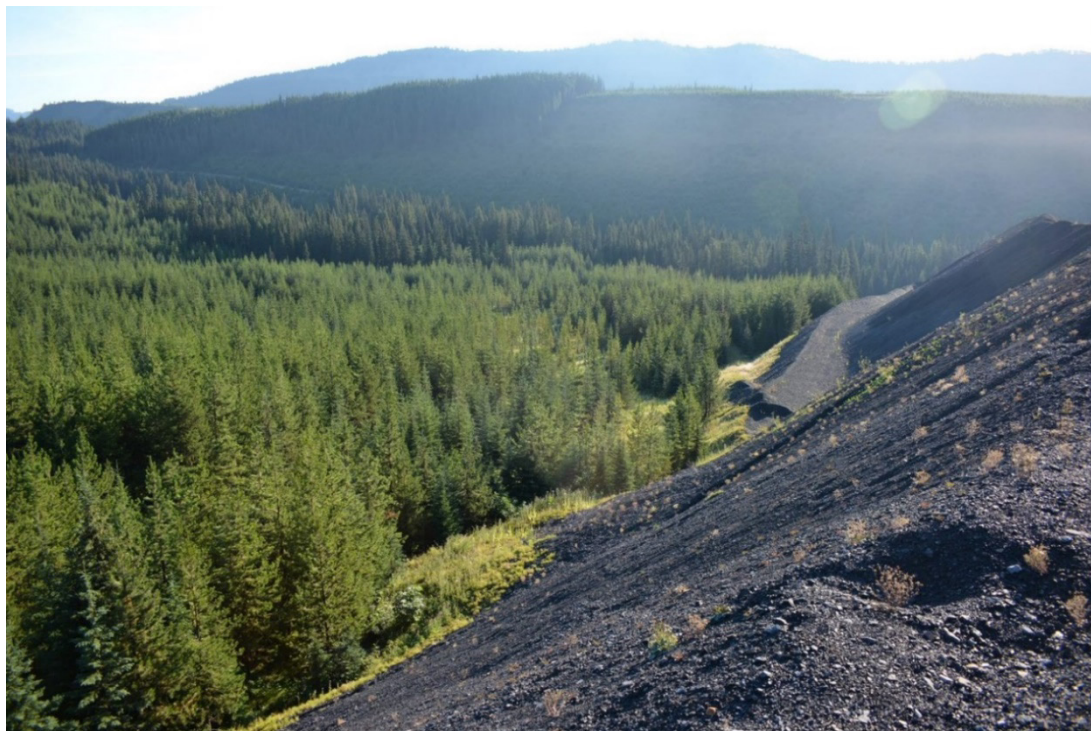
The Site B facility has been extended to the west and north since 2008. No further field investigations are known to have been completed at the facility area since 1994. Observations from the 2022 site inspection indicated that surficial topsoil, organic soils, and soft soils were likely stripped for the abutments as well as in the majority of the toe area of the west and north extensions (Photograph 14). This aligns with available geotechnical assessments, which noted the foundation area was stripped during site preparation (Golder 1993). An area of soft, saturated ground was observed at the toe of the north extension, where topsoil, organic soils, and/or soft soils were potentially left in place prior to CCR placement. Observations of the area indicate that movement of the Site B extension may have occurred during or soon after placement of CCR in the area and that CCR placement in the lower slope area was stopped and the facility set back (Photographs 15 and 16).

Photograph 15: Site B CCR Facility – North and East Extension Toe Area, Looking East, 31 August 2022

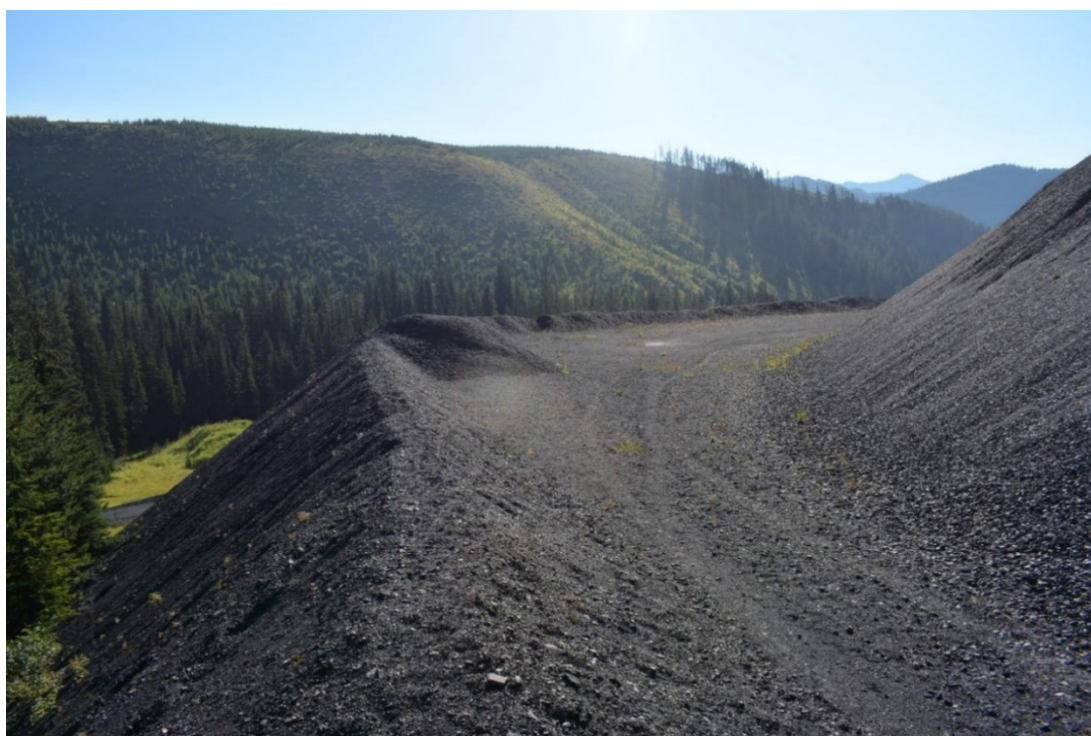
Photograph 16: Site B CCR Facility North and East Extension Lower Bench, Looking East, 31 August 2022

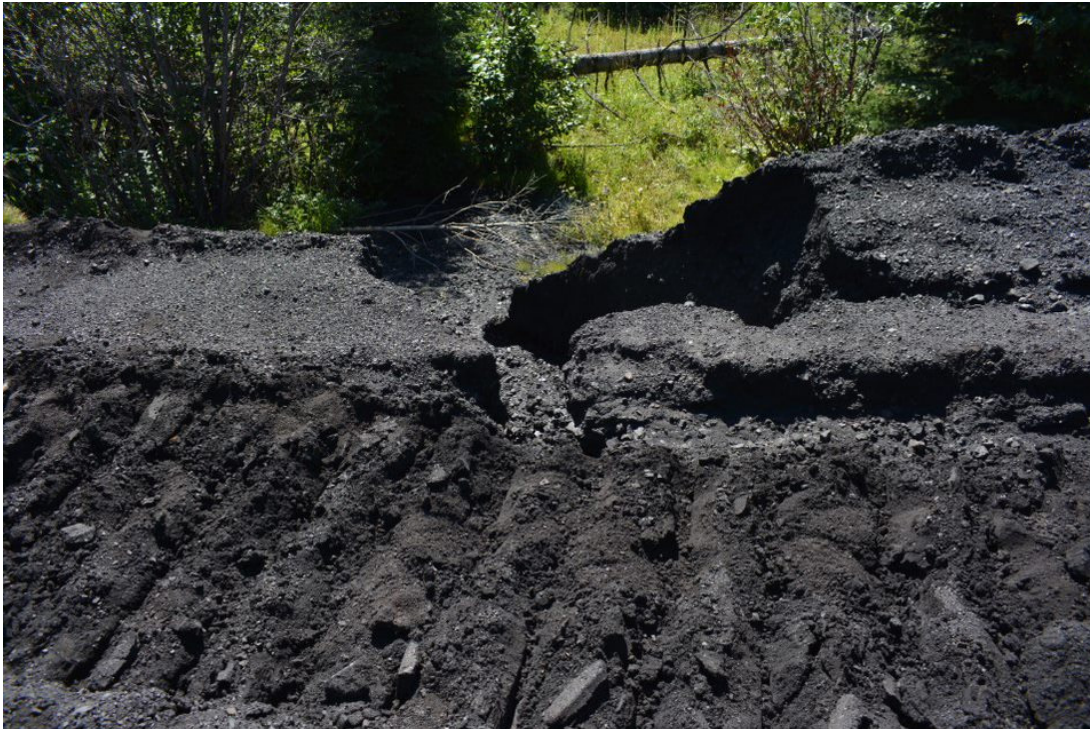
Photograph 22: Site E CCR Facility - Erosion adjacent to the Surface Water Culvert, Looking South, 31 August 2022

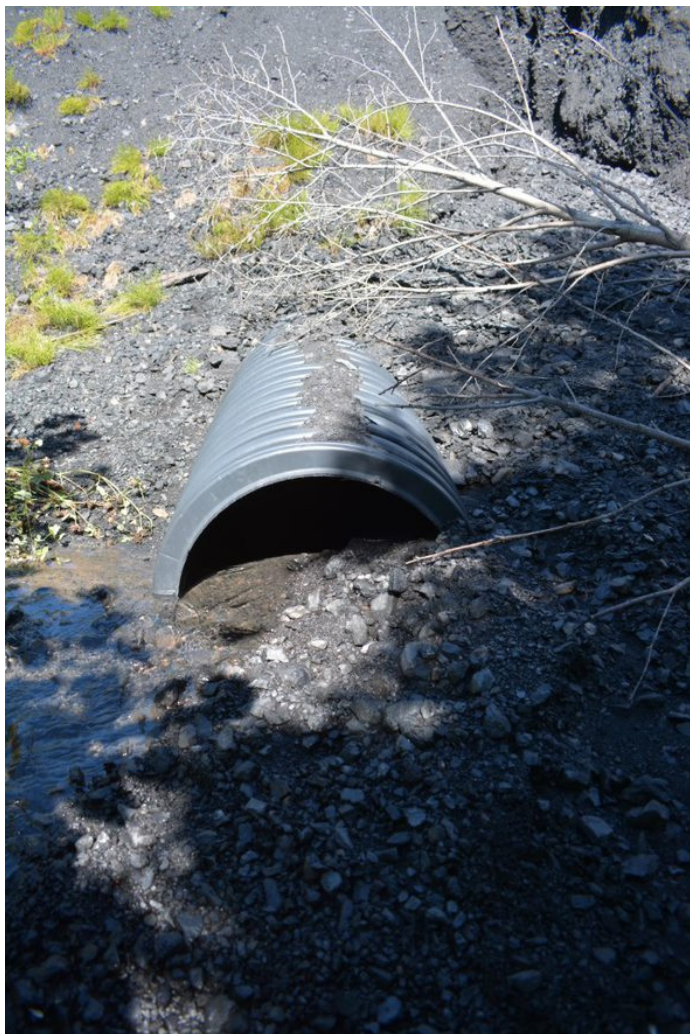
Photograph 23: Site E CCR Facility – Partially Obstructed Surface Water Culvert, Looking North, 31 August 2022
