**REPORT**

**2022 Annual Facility Performance Report**  
*Greenhills Operations Tailings Storage Facility*

**Teck Coal Limited**

Reference No. 22516234-2022-137-R-Rev0-2000

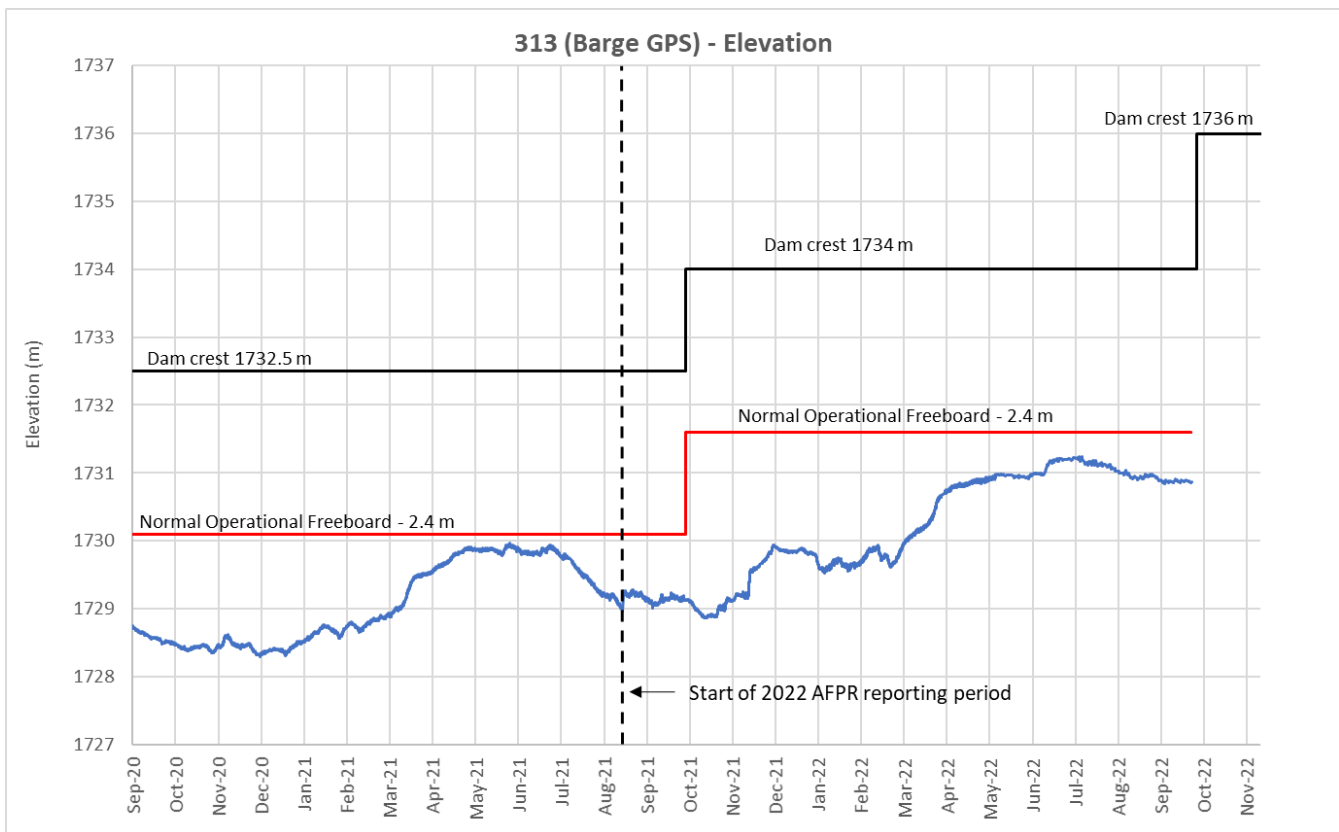
**Chart 3: Tailings Pond Elevation Relative to Standard Operating Freeboard Level**

Data indicates that the pond elevation varied between 1,728.9 m and approximately 1,731.3 m during the 2021/2022 reporting period. The minimum freeboard during the reporting period was approximately 2.7 m; therefore, the normal operating freeboard of 2.4 m was maintained during the 2021/2022 reporting period.

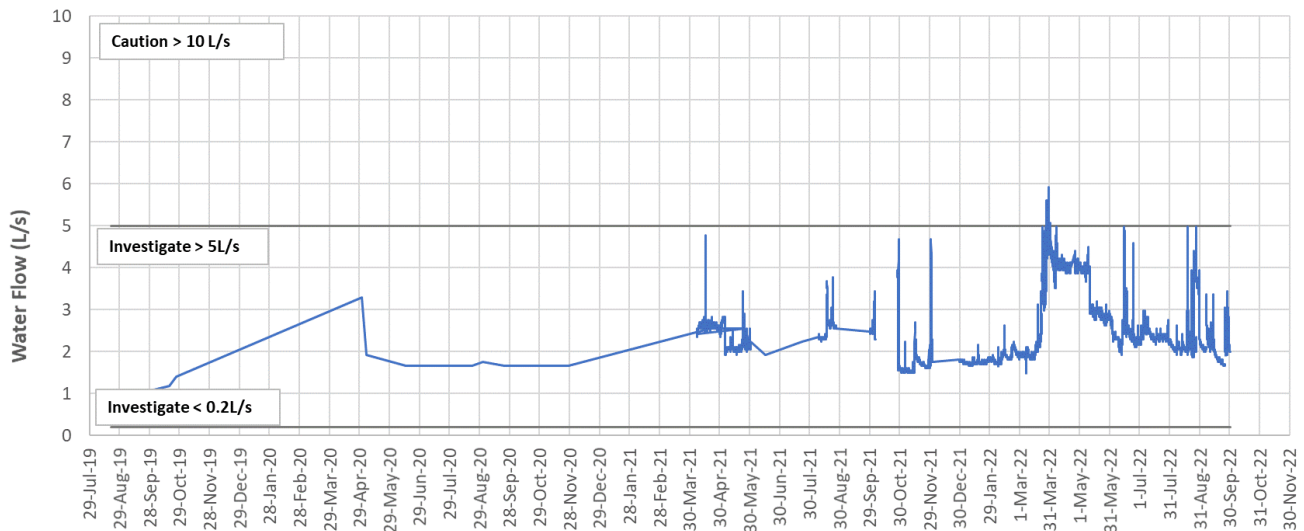
**Chart 6: Main Tailings Dam (Site C) Weir Discharge**

The flows in both weirs were generally low and within the expected range for normal operation. The peaks observed in the WTD and MTD weir data in March and April 2022 are indicative of runoff in freshet and are not considered representative of seepage from the West or Main Tailings Dams.

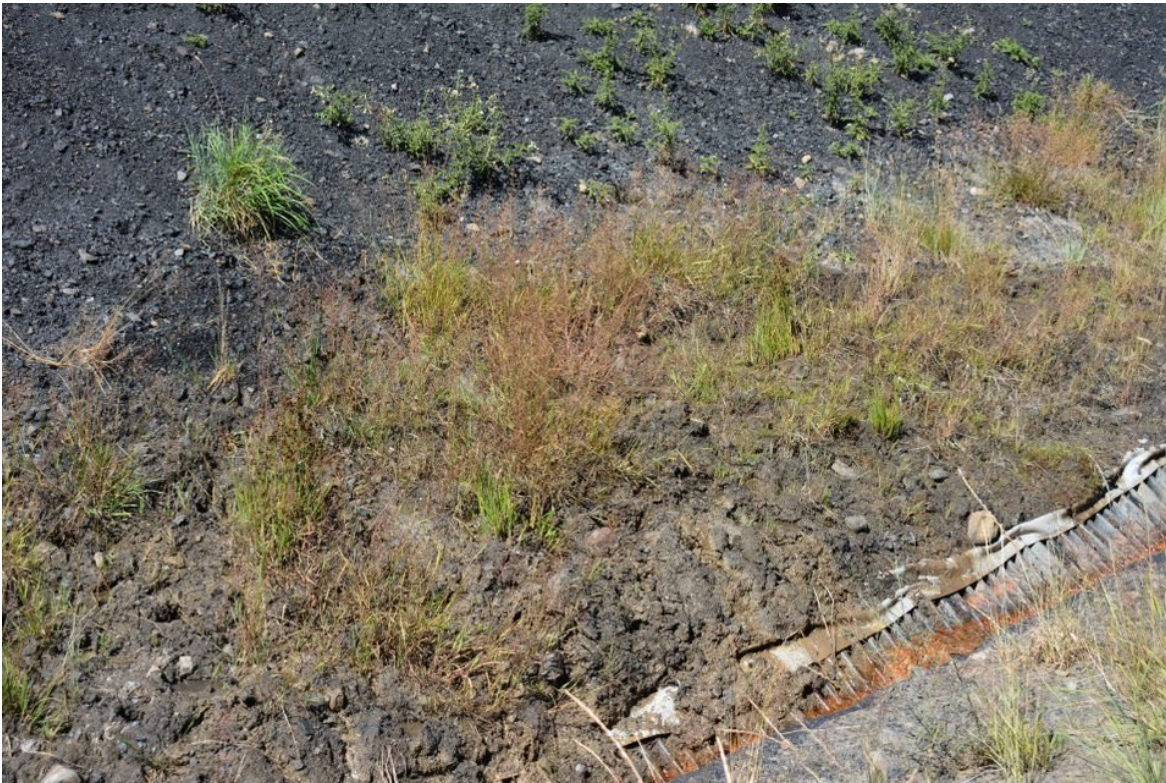
**Photograph 31: Site C CCR Facility – Partial sloughing into Smart Drain at Weir Inlet, Looking North, 30 August 2022**

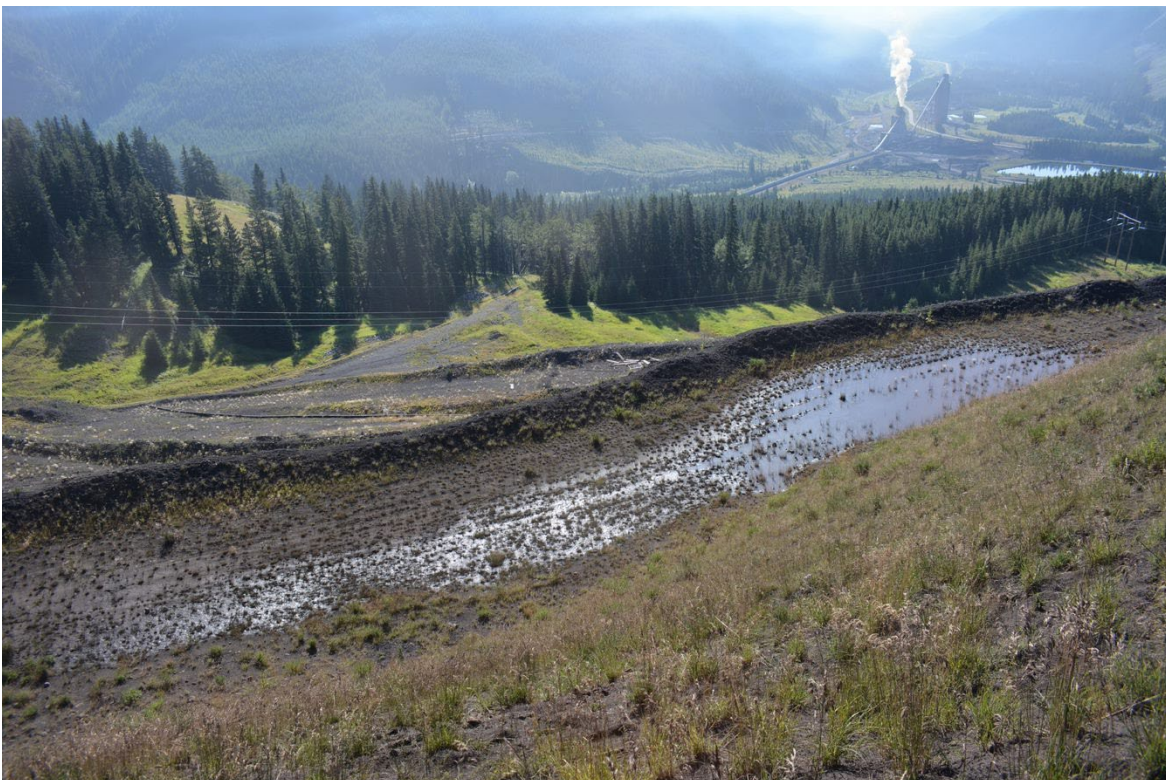
- Cracking was observed on the lowest bench of the Site C CCR facility, as a result of movement of the historic landslide at the toe. Monitoring and planning for remediation were ongoing at the time of this report and conditions do not present a safety concern to the Main Tailings Dam.

Changes to stability of the Site C or integrity during the reporting period included observation of cracking on the lowest bench of the Site C CCR facility, as a result of movement of the historic landslide at the toe. Monitoring and planning for remediation were ongoing at the time of this report and conditions do not present a safety concern to the Main Tailings Dam.

**Photograph 34: Site C CCR Facility – Surface Water Ponding on Intermediate Bench Above Bench with Observed Cracking, Looking south, 30 August 2022**

As part of operations, regrading and resloping of the Site C CCR facility lower bench, as well as improved surface water drainage measures has been completed in response to observed movements/cracking in the area of the historic landslide at the toe of the Site C CCR facility.

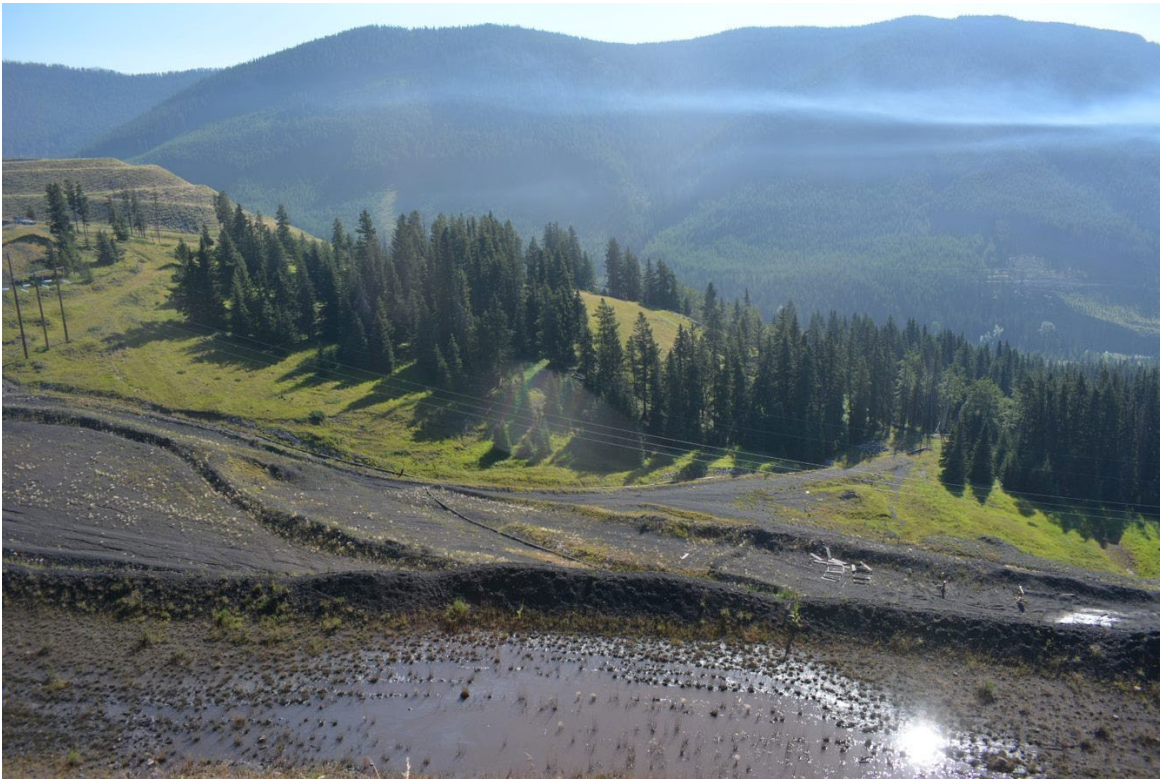
**Photograph 35: Site C CCR Facility – Surface Water Ponding on Intermediate Bench Above Bench with Observed Cracking, Looking southeast, 30 August 2022**

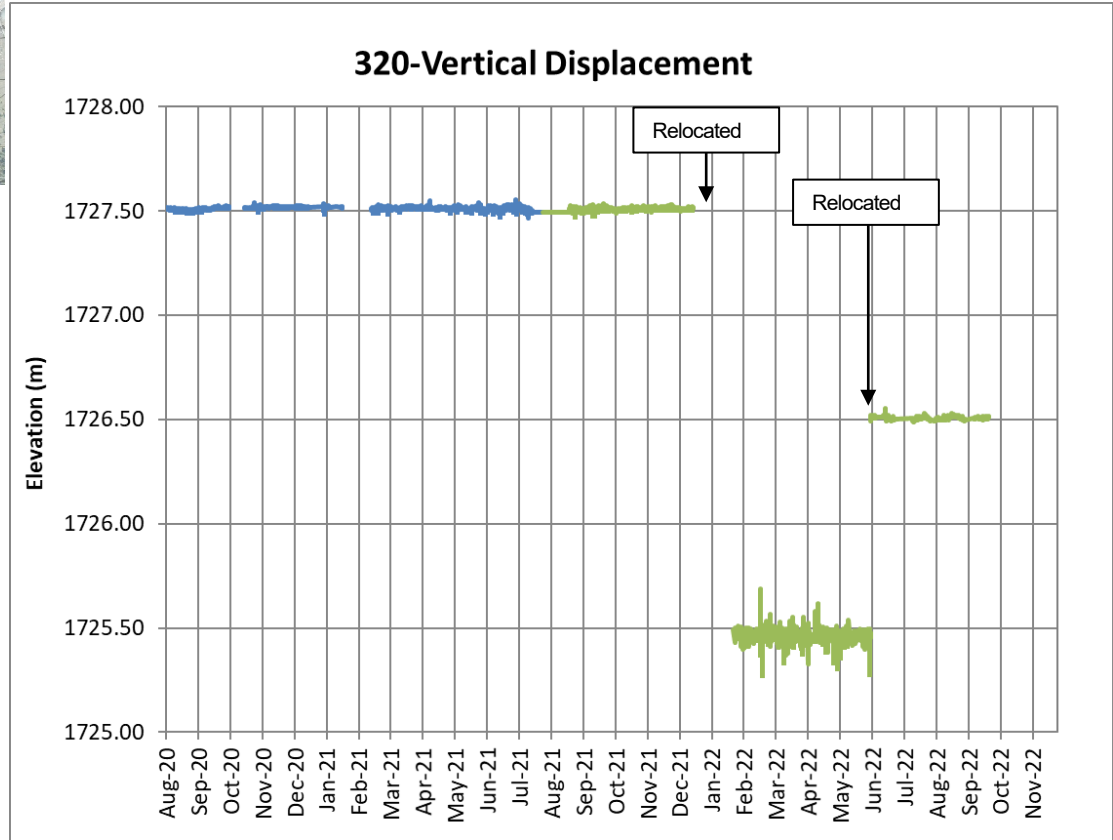
\*Note: GPS 320 relocated to the bench above where cracking was observed

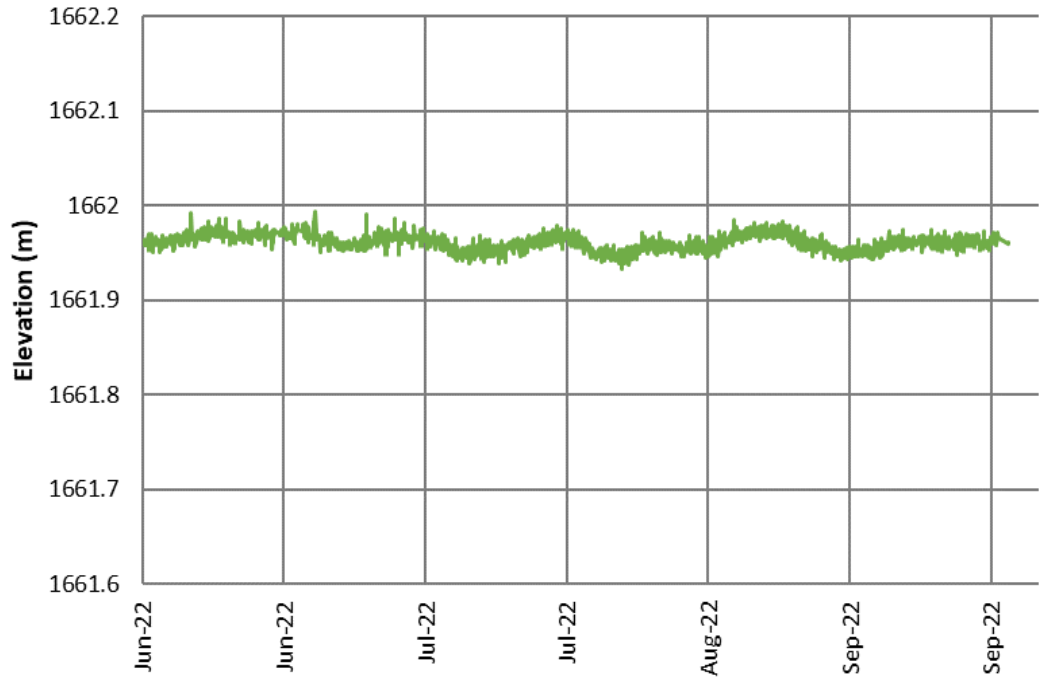
GPS instrument MD-5, renamed 'Site C Toe GPS', was moved from the downstream slope of the Main Tailings Dam to the toe of Site C CCR Facility to provide additional monitoring in the location of observed cracking related to movements of the historic landslide.

\*Note: GPS MD-5 removed and placed as Site C Toe GPS instrument.
