Teck Highland Valley Copper Partnership

2022 Annual Facility Performance Report

Bethlehem No.1 Tailings Storage Facility

March 2023

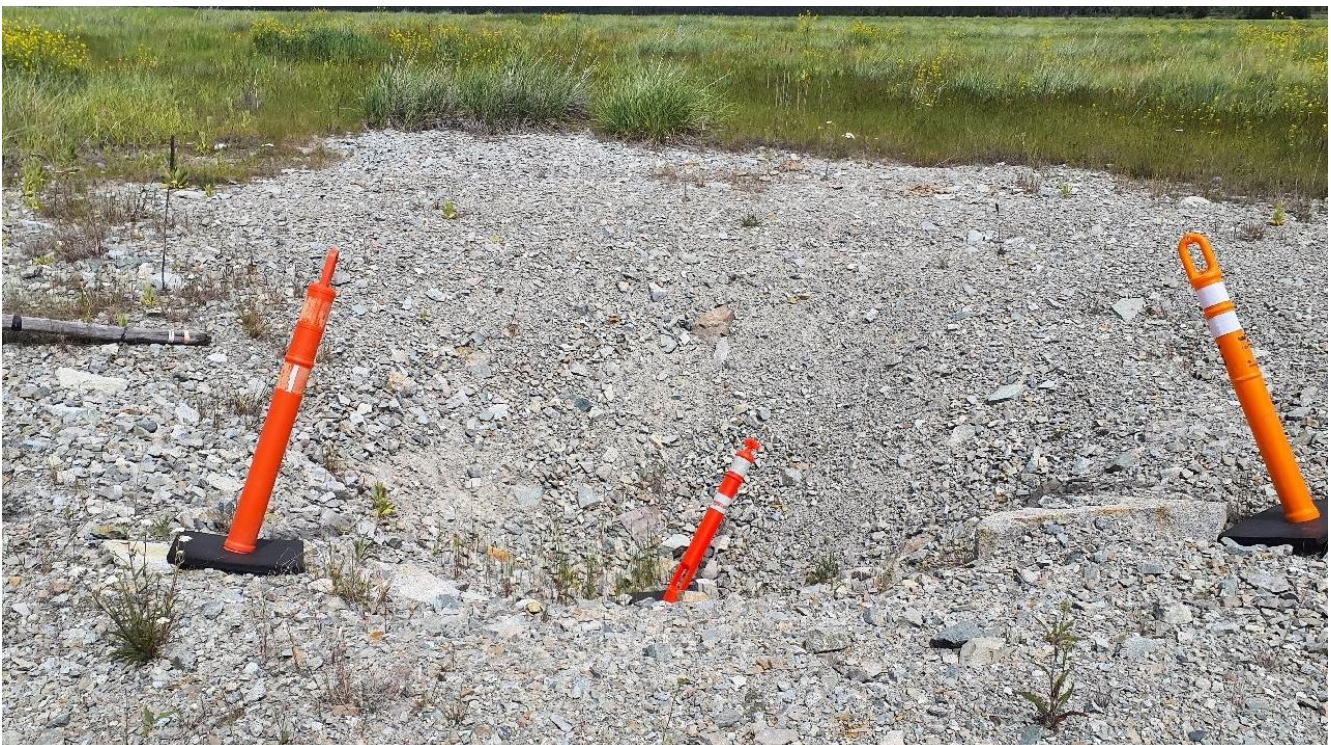
Photo I-A-3 Bethlehem sinkhole on tailings beach, no visual change from 2021 AFPR visual observations (BTH-2022-03)

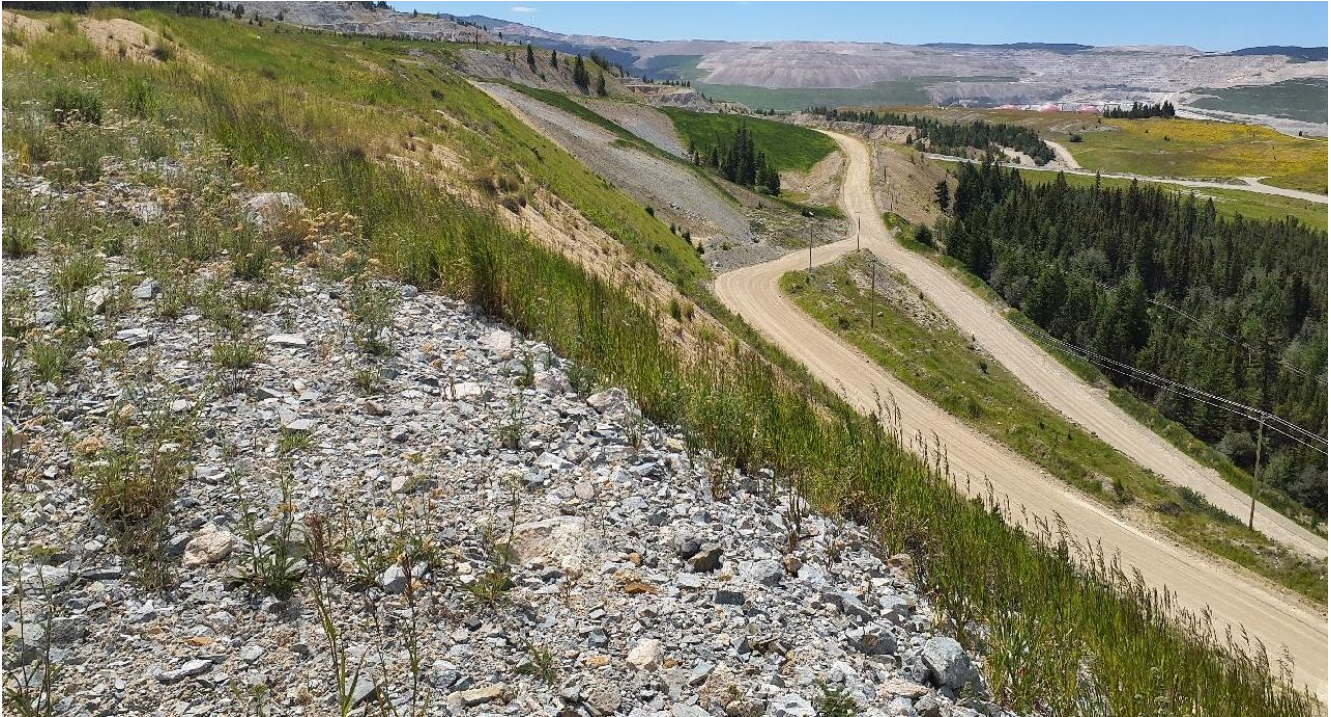
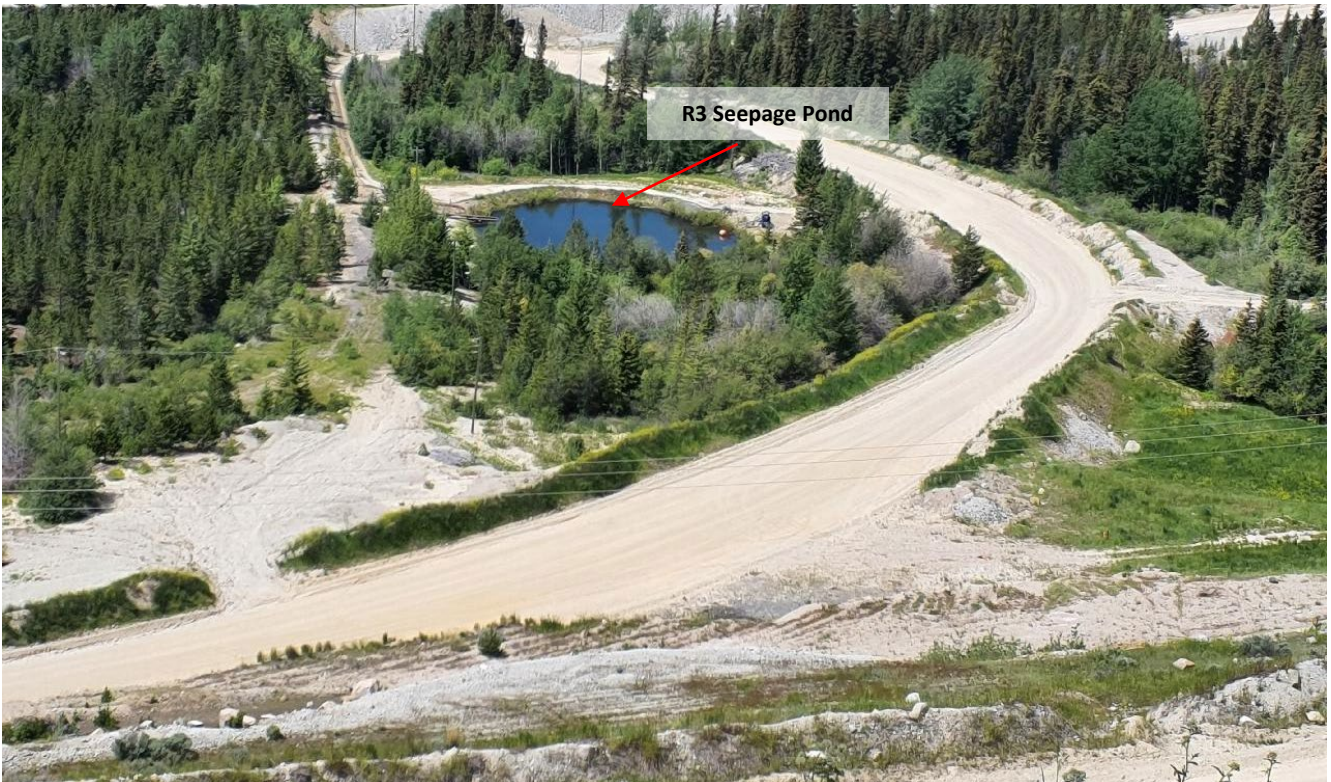
Photo I-A-4 Overview of downstream slope and toe area and of previously documented erosion area. Cracking remains filled, indicating area has been inactive (BTH-2022-04)

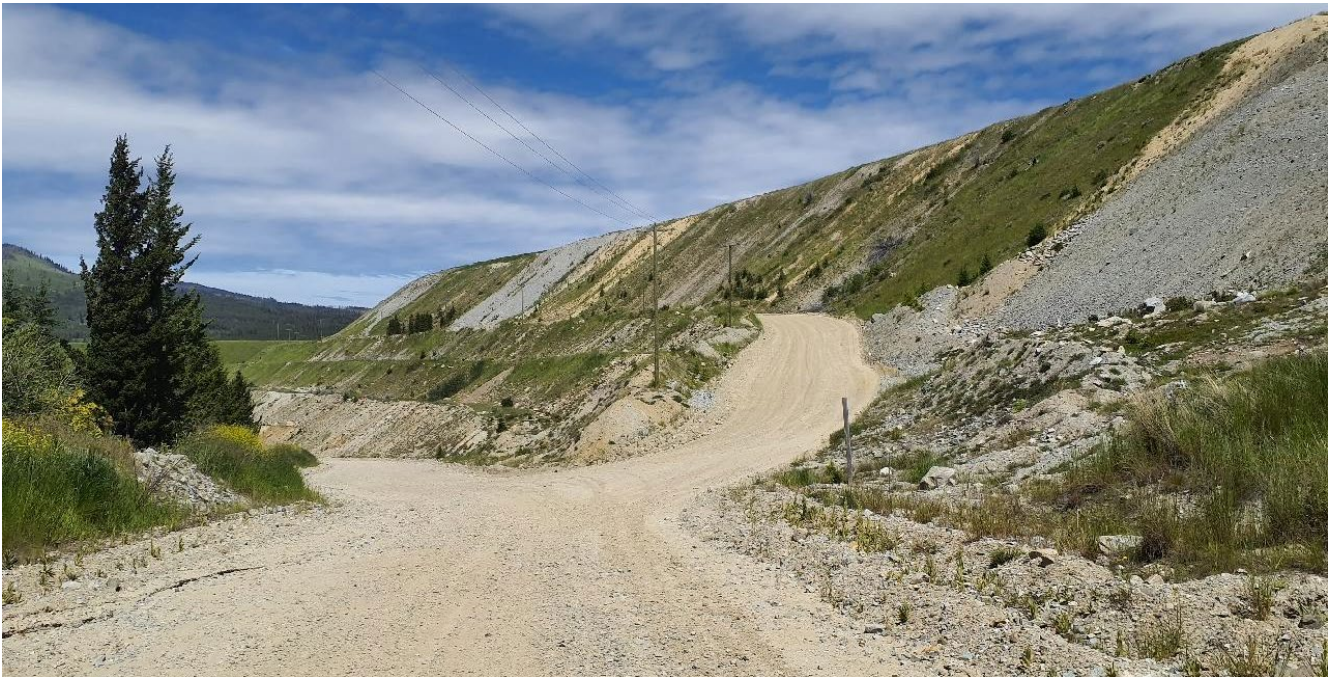
Photo I-A-5 Overview of downstream slope. No new erosion areas were observed (BTH-2022-05)

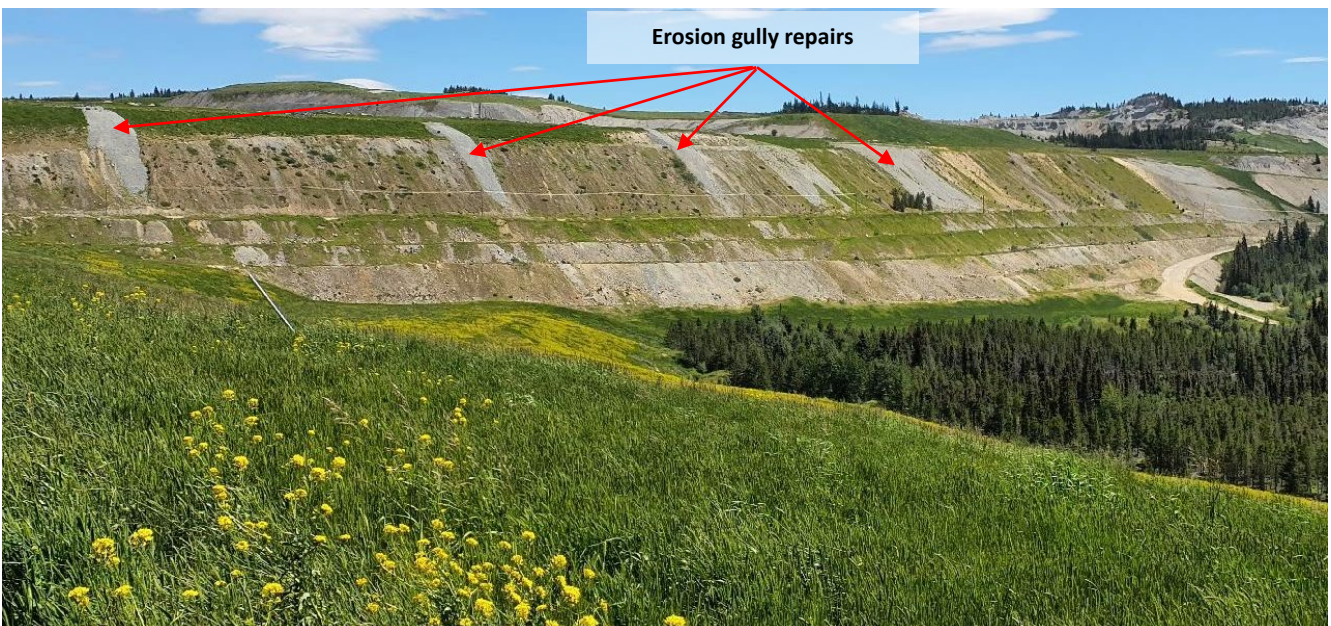
Photo I-A-6 Overview of downstream slope and toe from Trojan Dam. No new erosion areas were observed, and previous repairs are holding up well (BTH-2022-06)

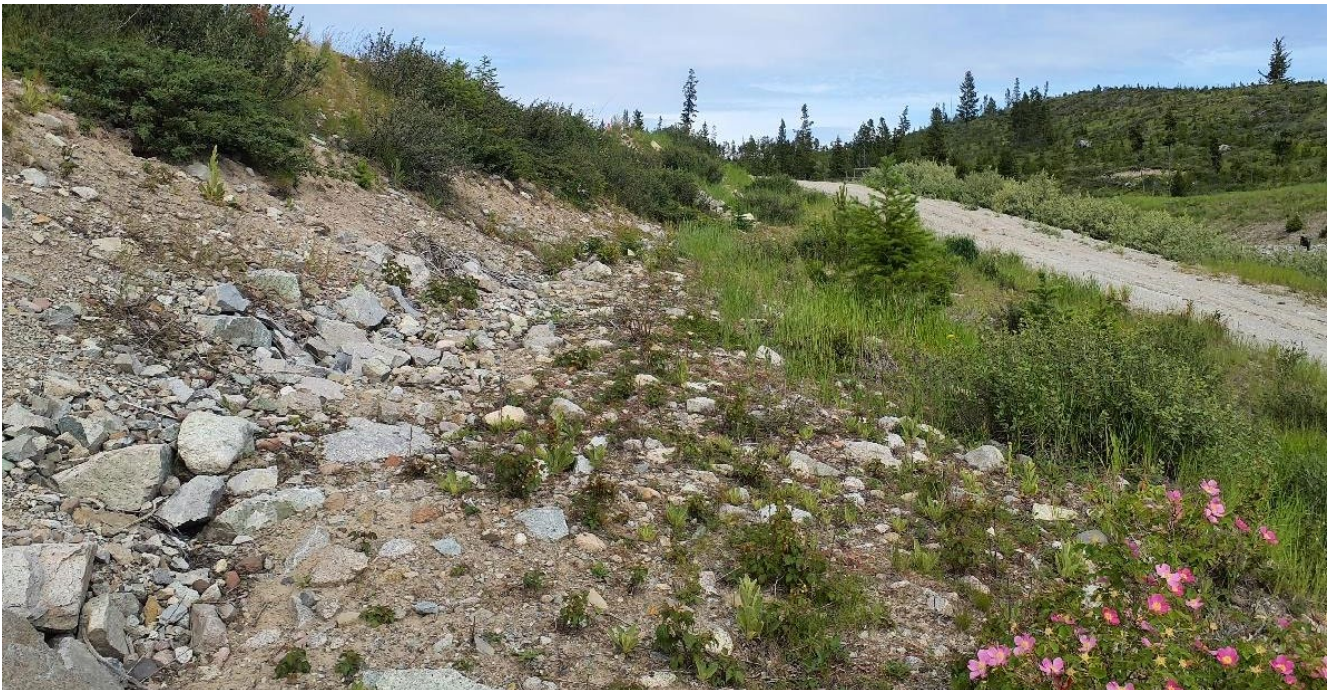
Photo I-B-3 Left abutment with no observation of erosion scours or damage (BTH-2022-09)

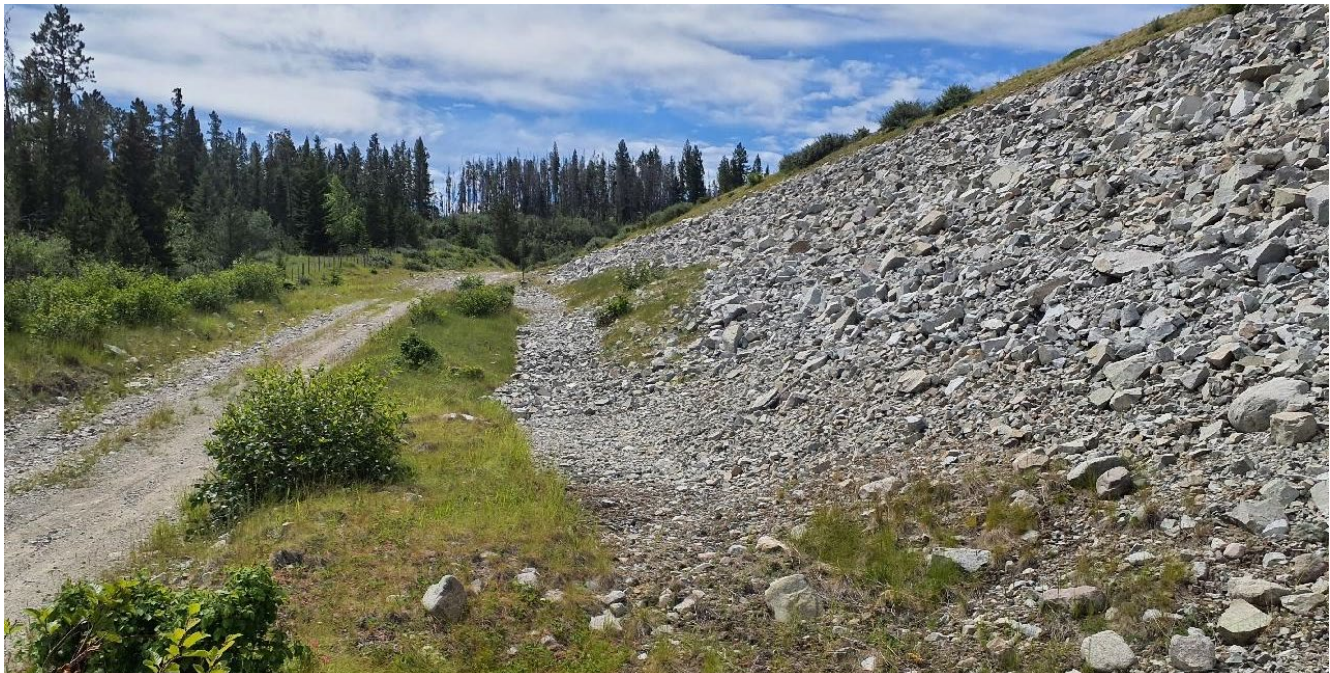
Photo I-B-5 View of downstream slope. Vegetation cover over lower portion of slope suggests this segment of downstream slope is comprised of glacial till fill. No sign of erosion of slope (rock or glacial till) was observed (BTH-2022-10)

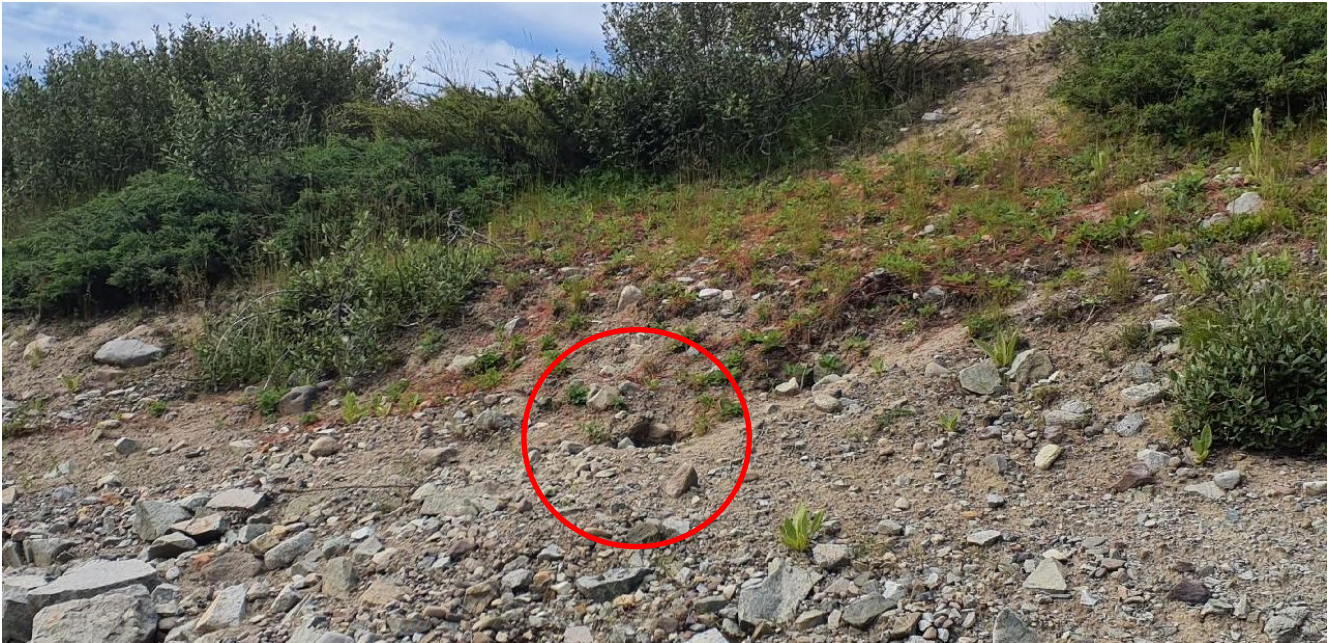
Photo I-B-6 Typical animal burrow observed in the upper glacial till raise. HVC and KCB reviewed potential impact of burrows in the area shown on the photo on the dam performance and concluded the burrows in this area don't represent a concern as this area is above flood levels (BTH-2022-09)

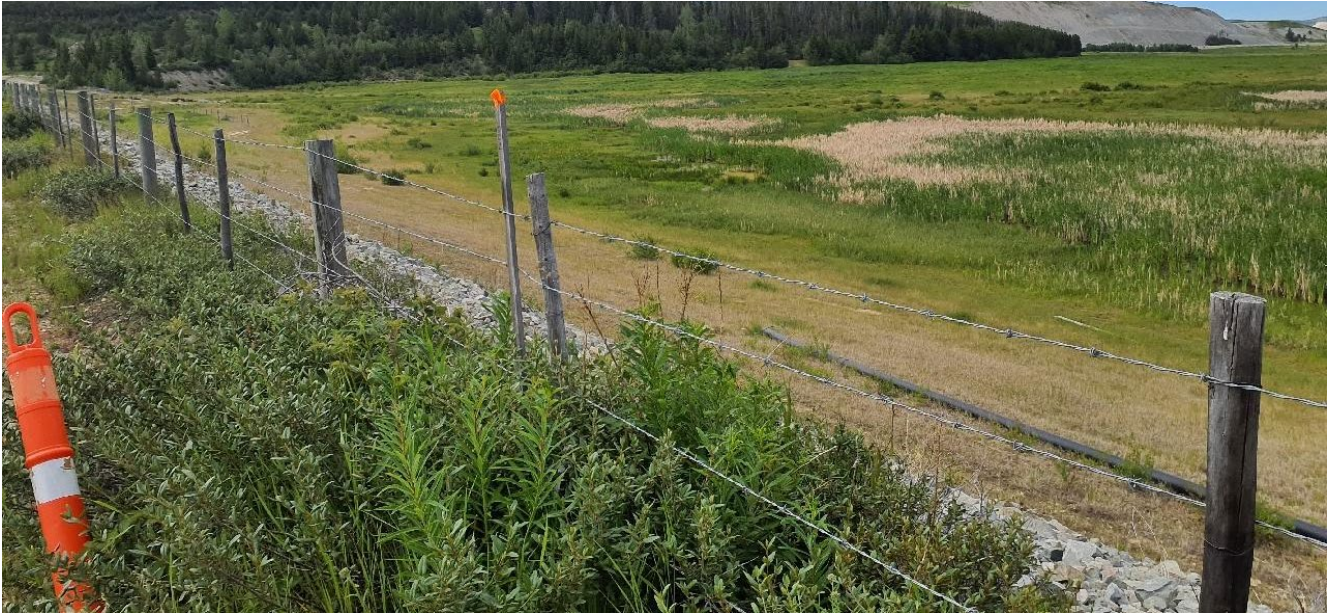
Photo I-B-8 Overview of upstream beach, looking towards right abutment. No sign of erosion or depression was observed (BTH-2022-08)

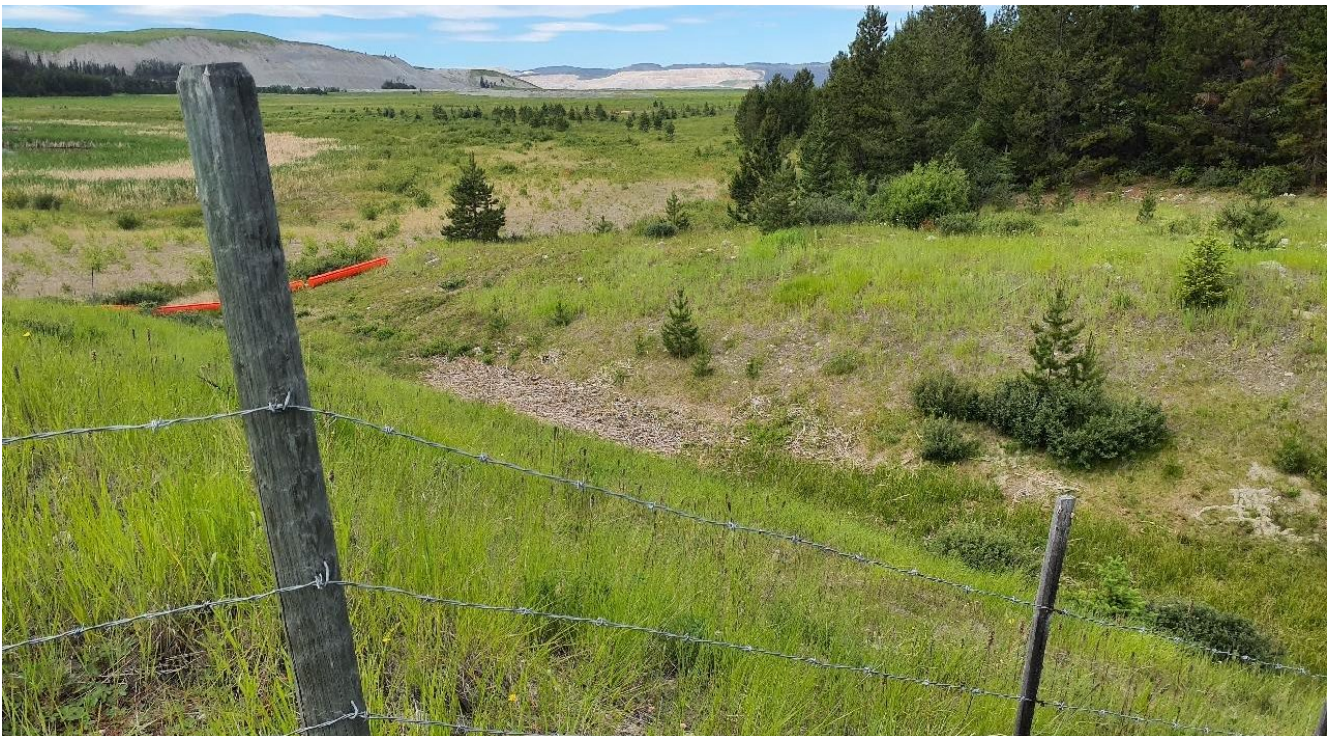
Photo I-B-9 Spillway inlet and approach channel. Channel is vegetated with grass and bushes. Clearing of vegetation is managed as part of routine maintenance (BTH-2022-11)

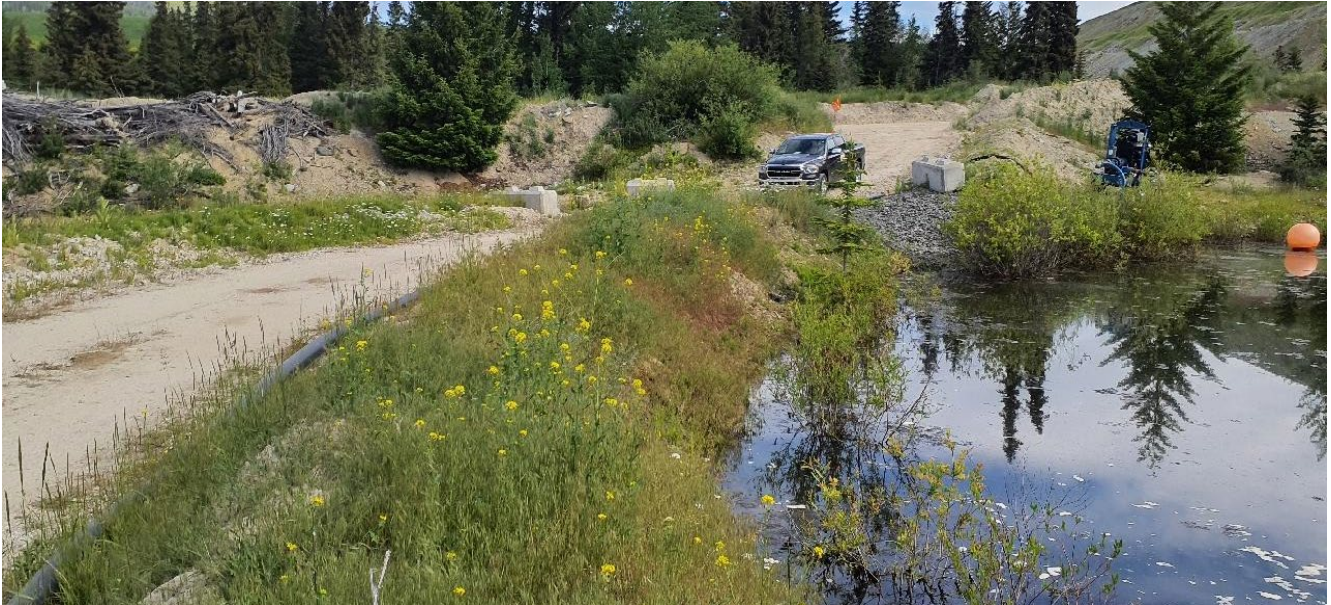
Photo I-C-2 R3 Seepage Pond dam crest, no cracking or no sign of distress was observed (BTH-2022-13)

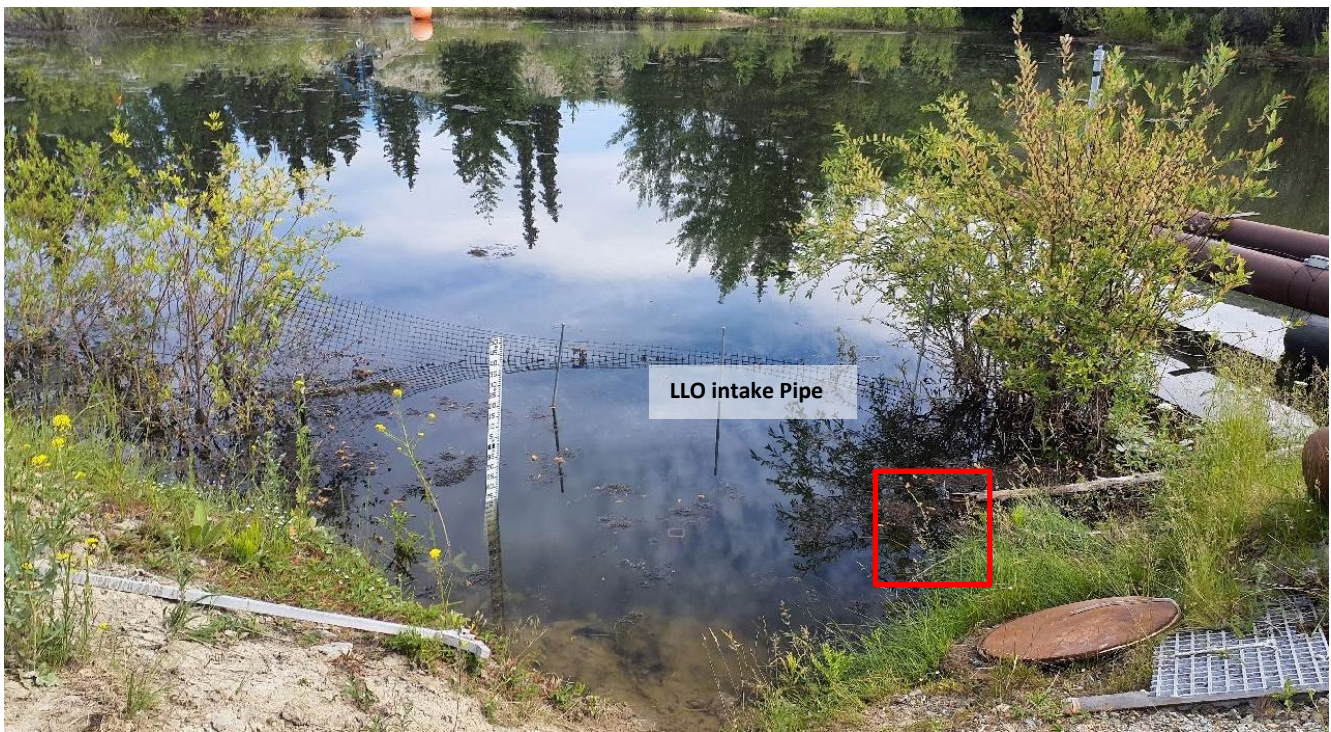
Photo I-C-3 View of R3 Seepage Pond and debris mesh for Low-Level Outlet (LLO). Clear water was flowing at the time of the site visit. The debris mesh is clogged below and above water (BTH-2022-14)

HVC added routine condition assessments of the R3 Seepage Pond LLO pipe to the surveillance program. These are to be completed every five years, but HVC did not define the date of the first condition assessment. KCB supports this addition and recommends the first inspection be completed prior to the end of 2024 and the timing be added to the OMS Manual (HVC 2022).

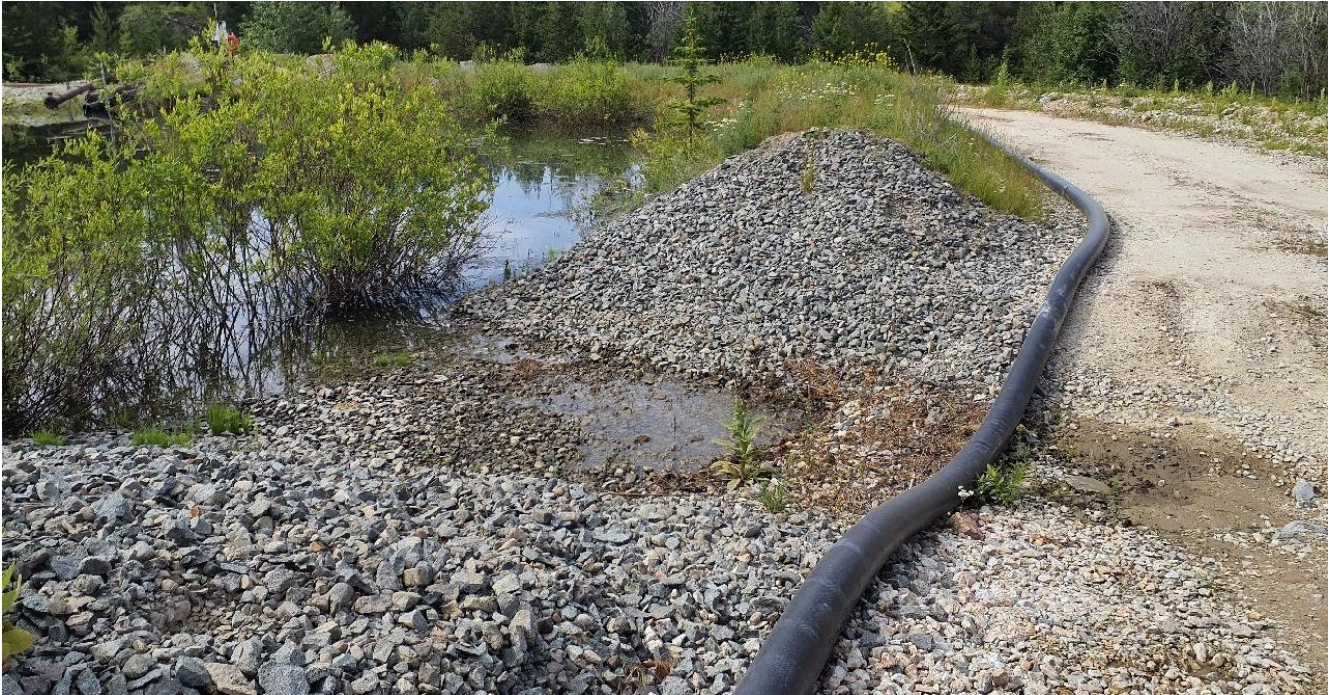
On June 29, 2022, water from the R3 Seepage Pond was discharged through the spillway. This was caused by a blockage in the Low-Level Outlet (LLO) upstream of the junction where outflows from the R3 Seepage Pond and from the R4 Seepage Pond mix (Item 9 on Figure 6). The spillway performed as intended, which is to release water from the basin before it approaches the crest and prevent overtopping. However, based on the conditions under which this occurred, HVC reported the event to the regulator as an unauthorized discharge.

Photo I-C-4 View of spillway inlet, looking downstream. Discharge through spillway was related to LLO blockage, refer to discussion in main text of report (BTH-2022-15)

While HVC worked to remove the obstruction from the LLO, they mobilized a pump to the R3 Seepage Pond that pumped water to the R4 Seepage Pond to maintain the pond level below the spillway invert. HVC was able to partially clear the obstruction from the LLO sufficient to manage the pond level without the aid of pumping. HVC is planning additional works to restore full functionality of the LLO pipe (i.e., clear remaining obstructions and modify the pipe grade to prevent a recurrence). Until this work is completed, KCB recommends HVC maintain standby pumping at the R3 Seepage Pond during freshet to prevent the likelihood of a similar event.

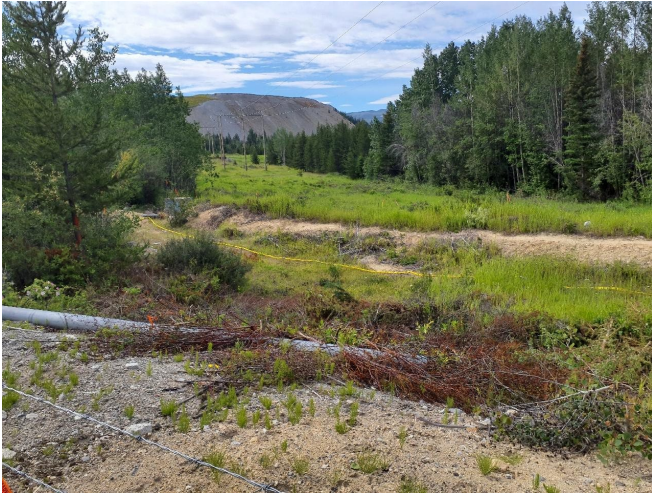
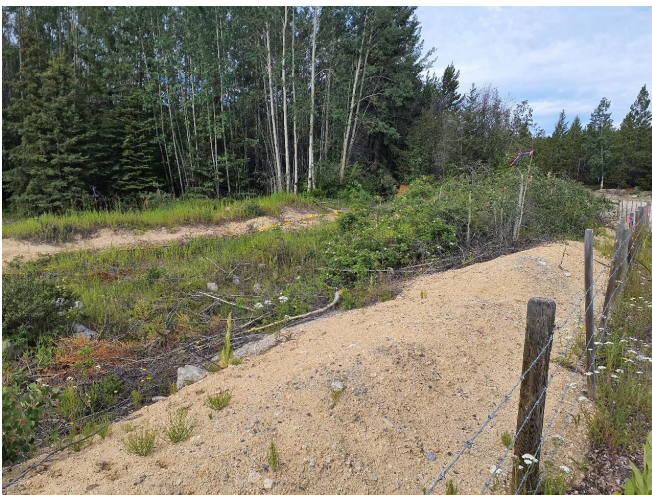
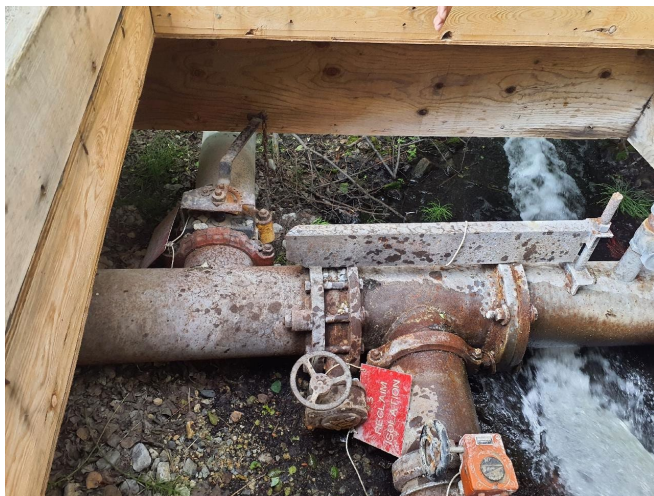
Photo I-C-7 Segment of R3 Seepage Pond LLO pipe that backed up and resulted in spillway discharge, refer to discussion in main text (BTH-2022-16)
