# **Teck Highland Valley Copper Partnership**

## **2022 Annual Facility Performance Report**

*Highland Tailings Storage Facility*

March 2023

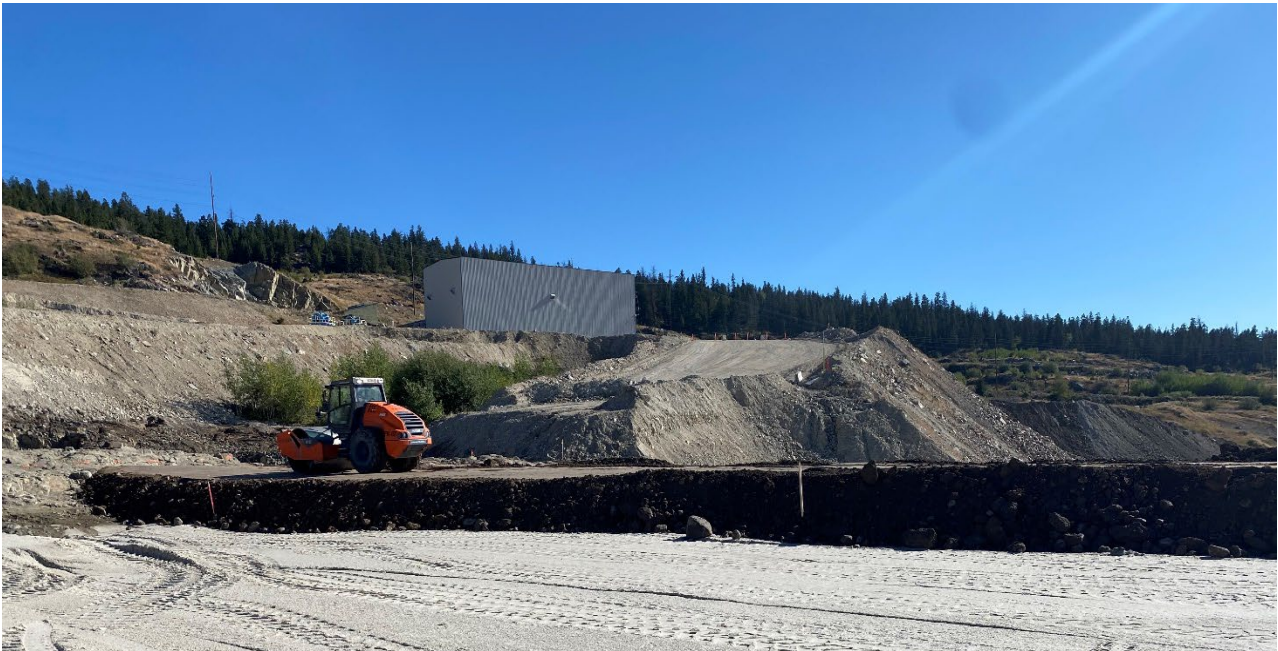
**Photo I-A-9 T2 placement of dam core near south abutment. (LL-2022-05)**

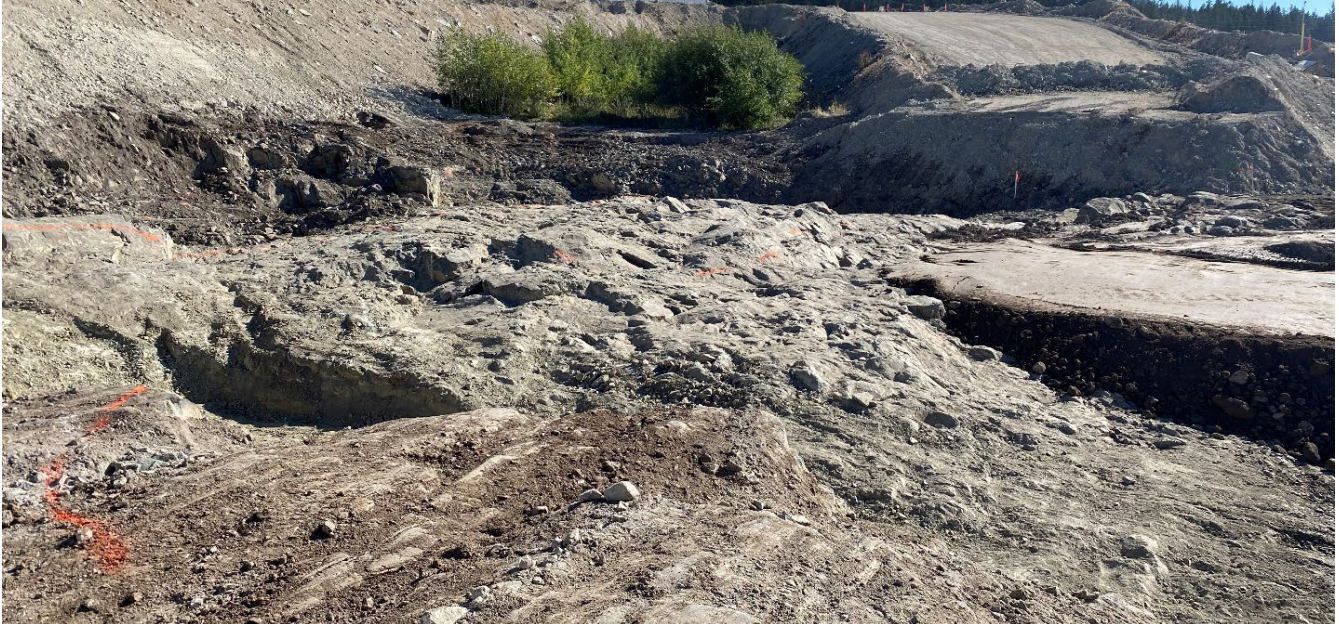
**Photo I-A-10 Prepared foundation at south abutment. Consistent with expected geology, granodiorite bedrock is shallow in this area and exposed for core key in. (LL-2022-05)**

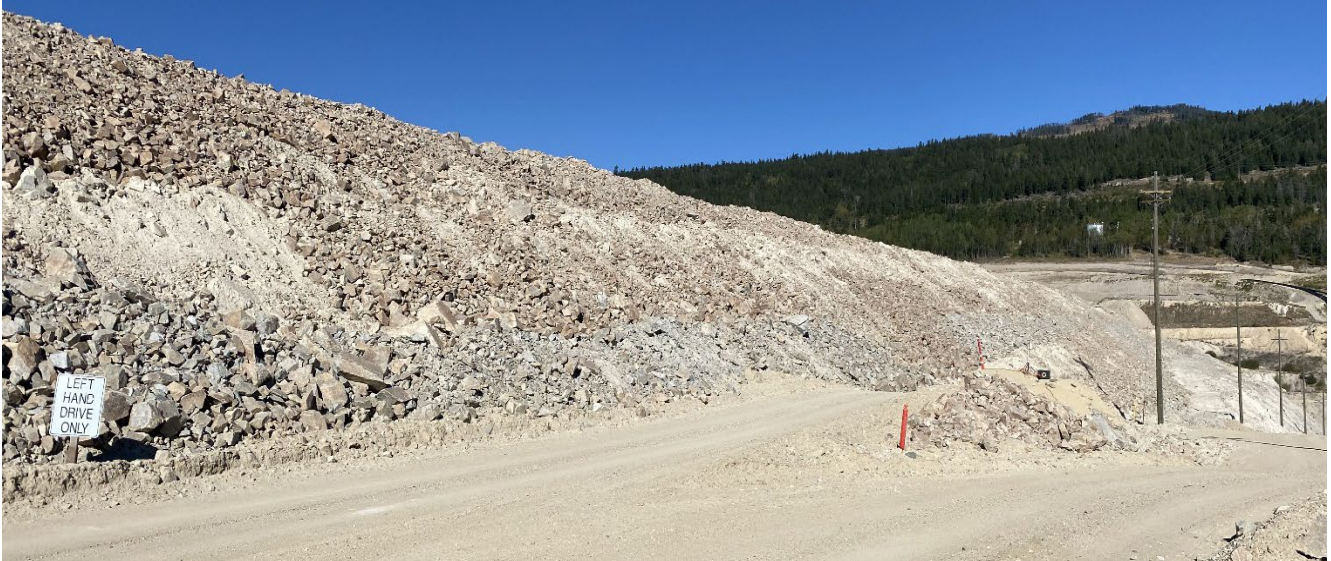
**Photo I-B-8 Mid-Segment downstream slope, upper portion, looking northeast from the H-H Dam access ramp. (HH-2022-03)**

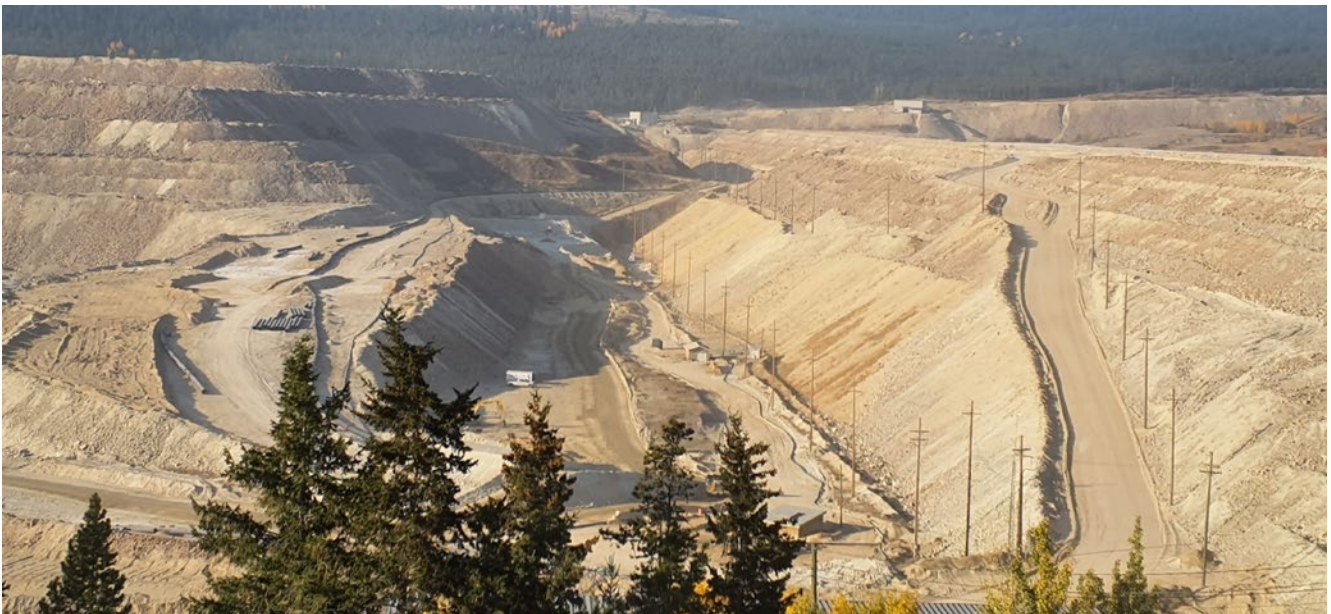
**Photo I-B-9 H-H Dam downstream slope and 24 Mile Waste Dump / buttress area looking southwest from north side haul road. Power line along the toe of slope to be relocated out of area to allow 2023 buttress fill placement. Replacement power poles are visible along access road built into downstream slope. (HH-2022-10)**

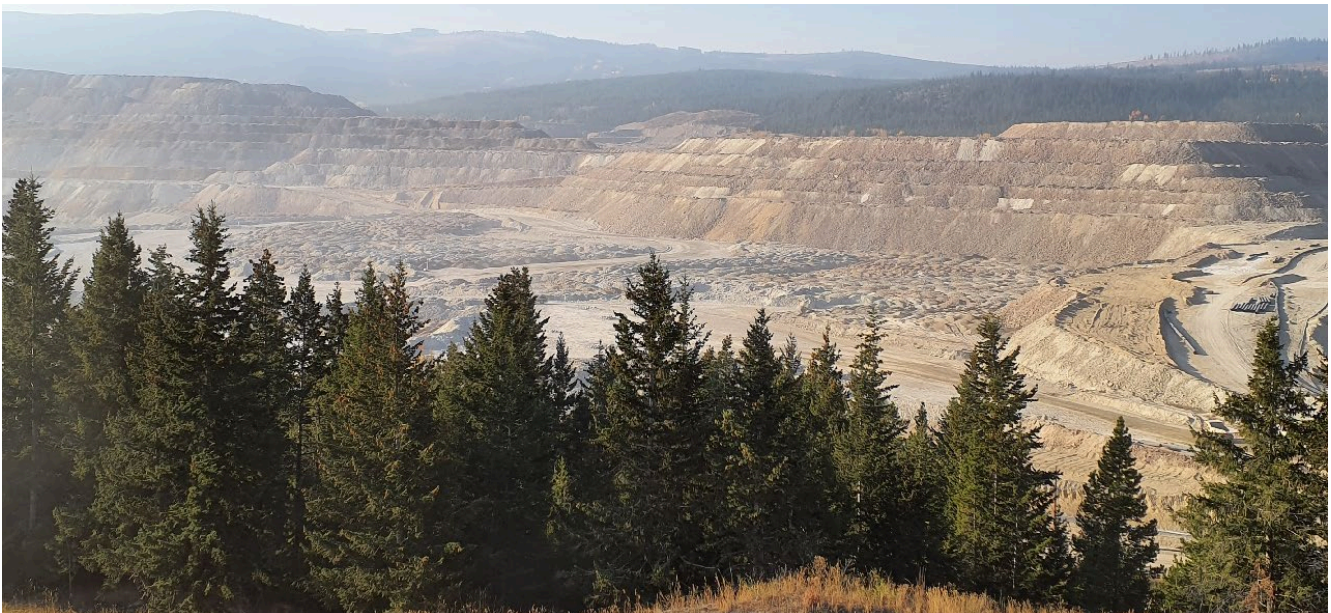
**Photo I-B-13 Overview of 24 Mile Waste Dump downstream of H-H Dam, looking southwest. (HH-2022-10)**

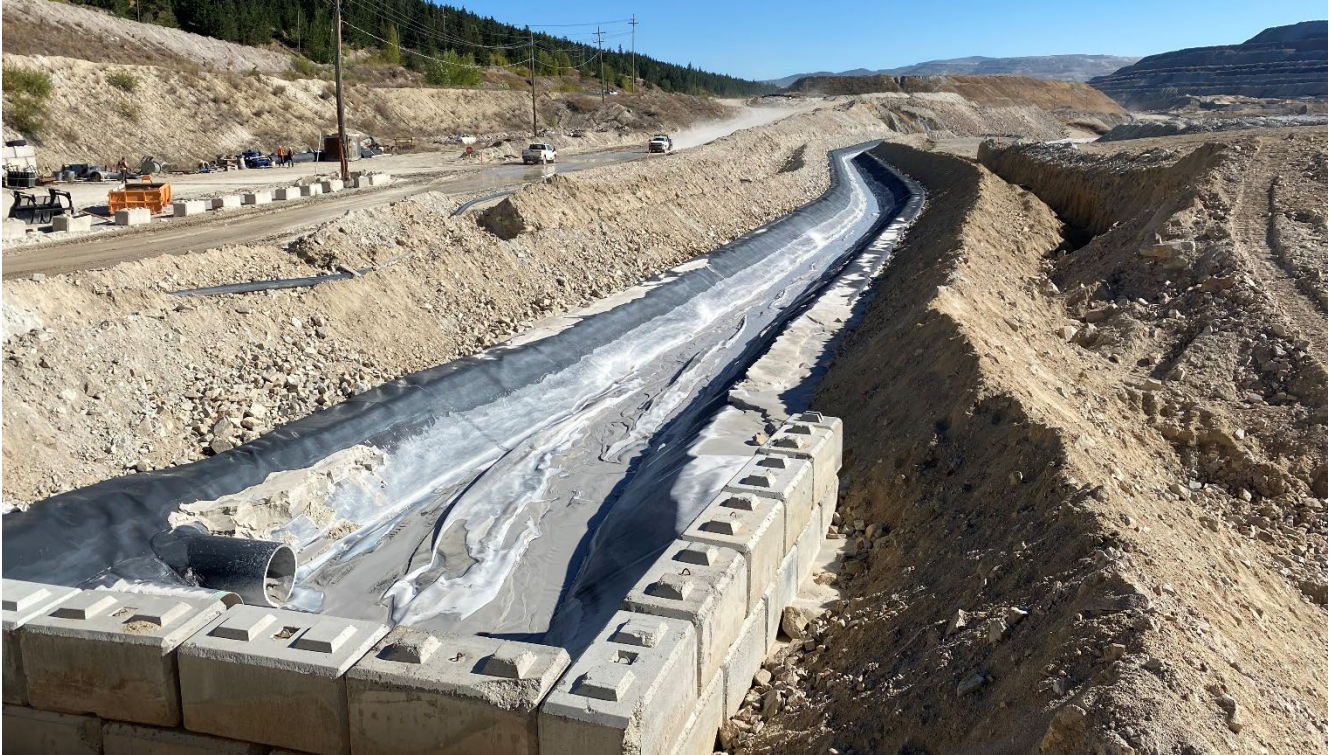
**Photo I-B-14 Upstream segment of the replacement discharge channel, built in 2022, to convey overflow from HH Pumphouse to 24 Mile TSF. (HH-2022-07)**

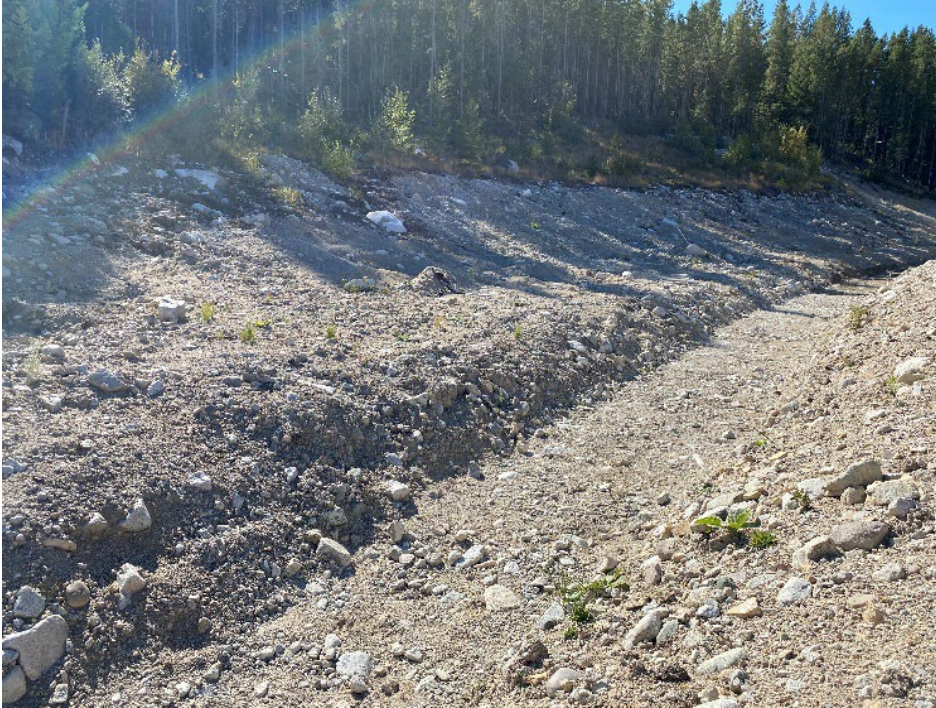
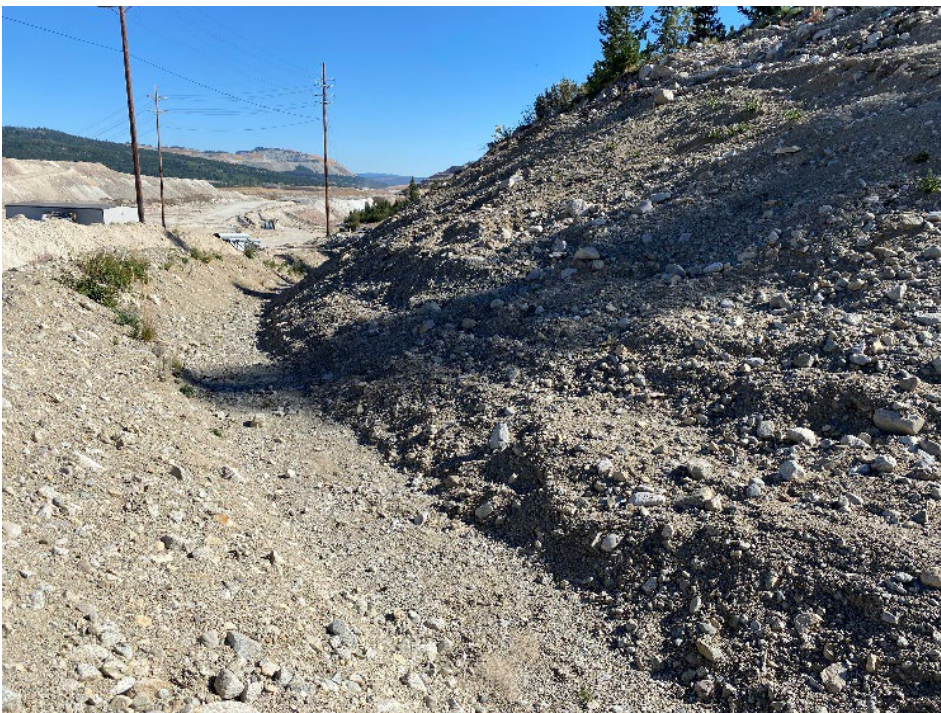
**Photo I-B-15** Mystery Creek diversion excavated to replace decommissioned Mystery Creek culvert. In November 2022, as recommended by EoR, HVC installed a geomembrane liner over the segment of ditch excavated in fill (shown in photo) to reduce seepage losses. (HH-2022-06)
