# **Teck Highland Valley Copper Partnership**

## **2022 Annual Facility Performance Report**

*Trojan Tailings Storage Facility*

March 2023

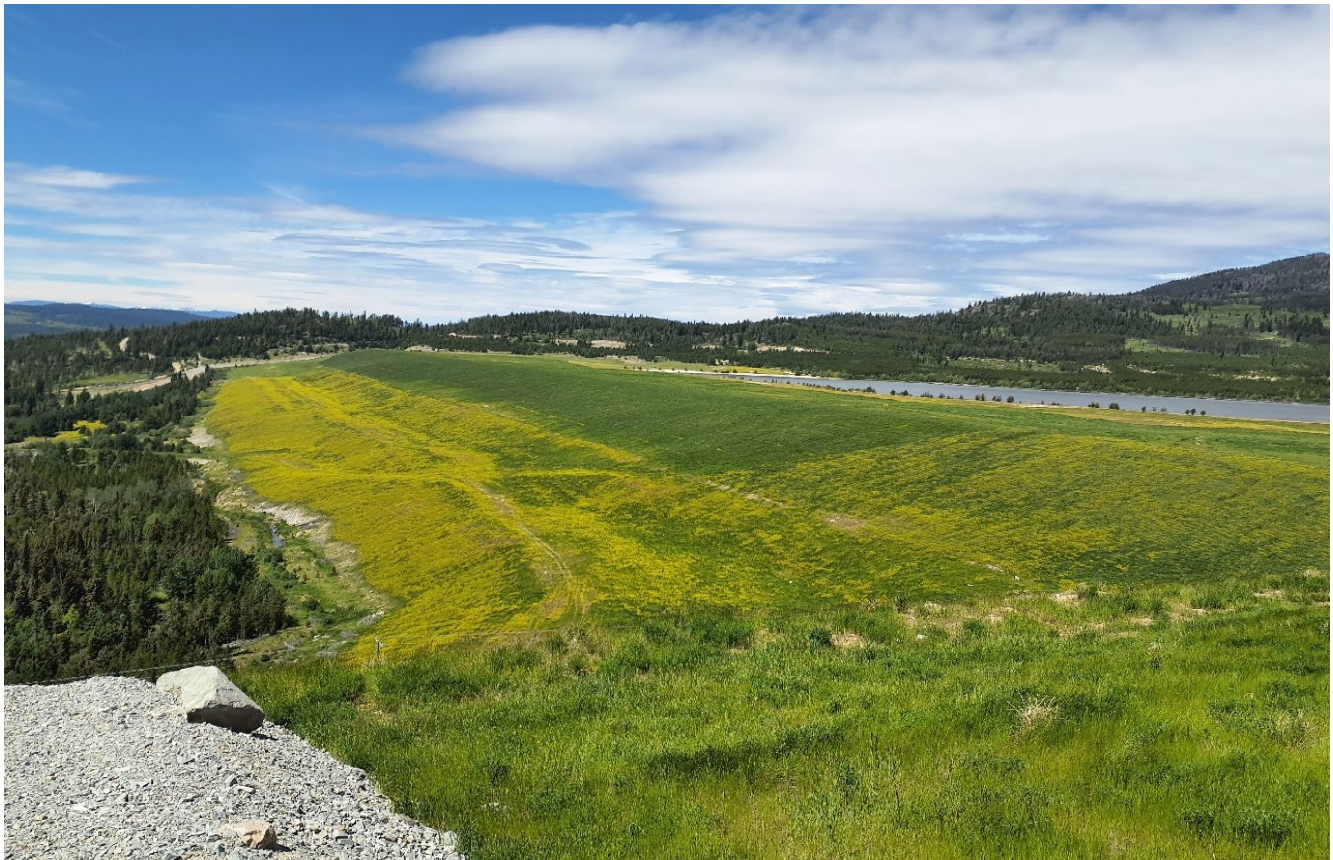
**Photo I-A-1 Overview of Trojan Tailings Pond and Trojan Dam downstream slopes from the Bethlehem Dam crest. No observations of visible erosion or scour (TRJ-2022-01)**

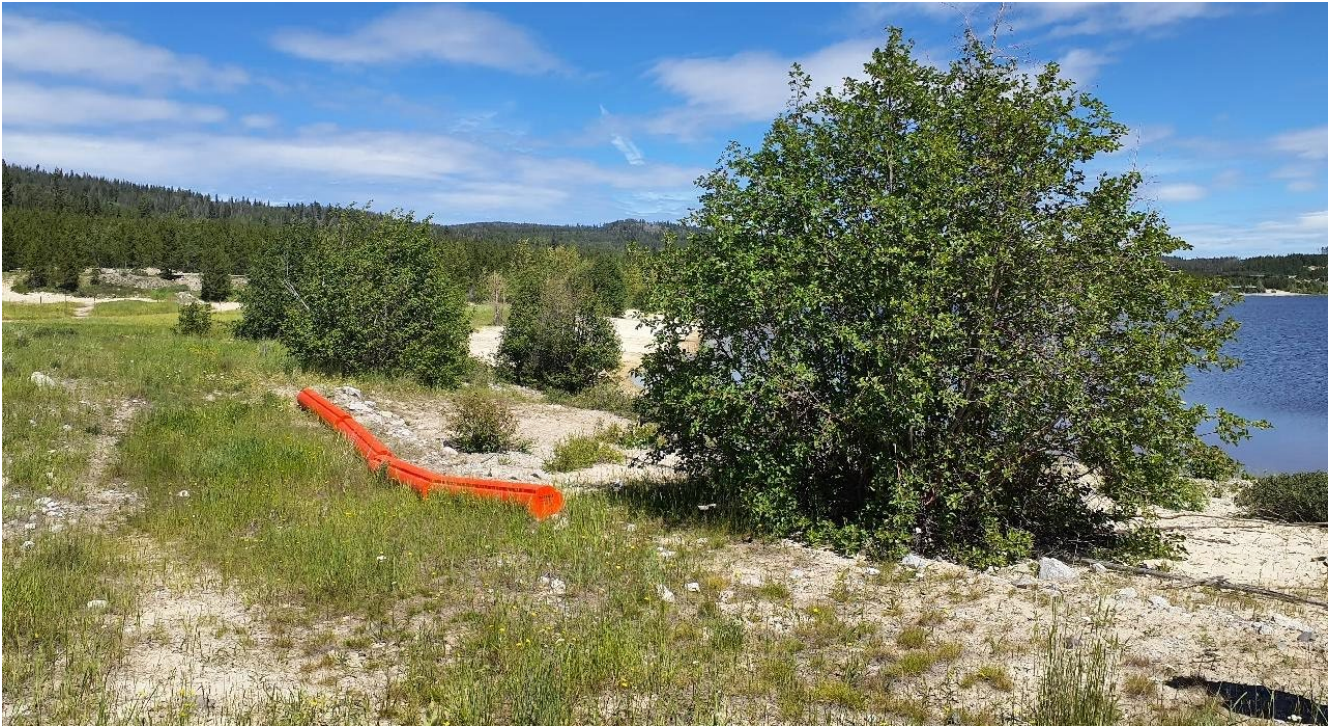
**Photo I-A-4 View of Trojan spillway inlet. KCB observed that the approach channel was clear and debris boom was secured (TRJ-2022-03)**

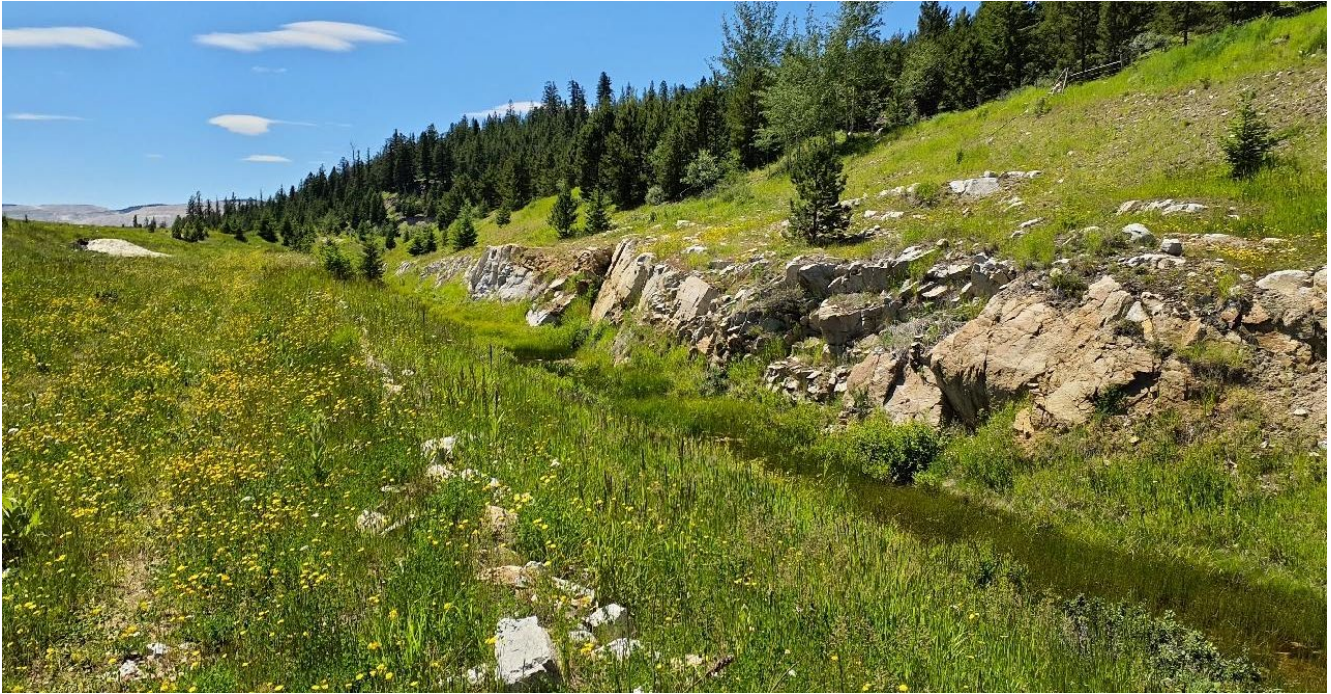
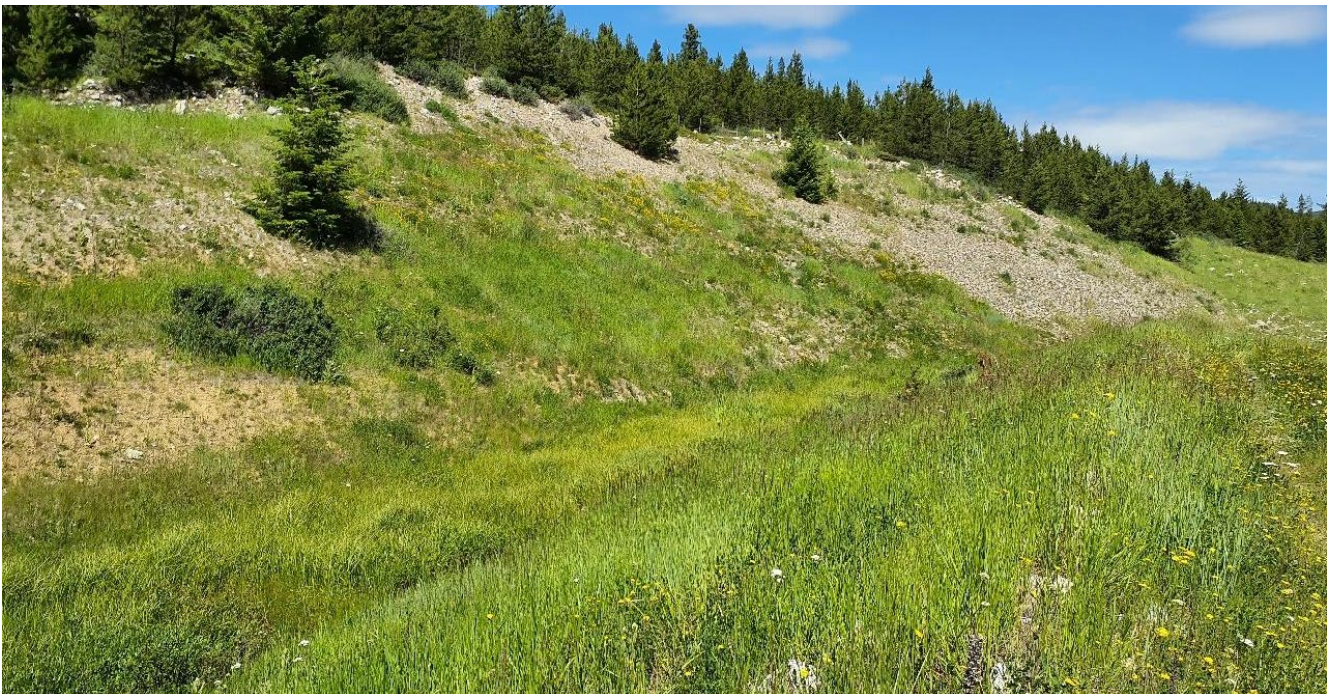
**Photo I-A-6** Upper segment of spillway downstream of approach channel, looking toward southwest (top) and looking toward northeast (bottom). HVC provided a photograph to show that vegetation was cleared after site visit. (TRJ-2022-04)

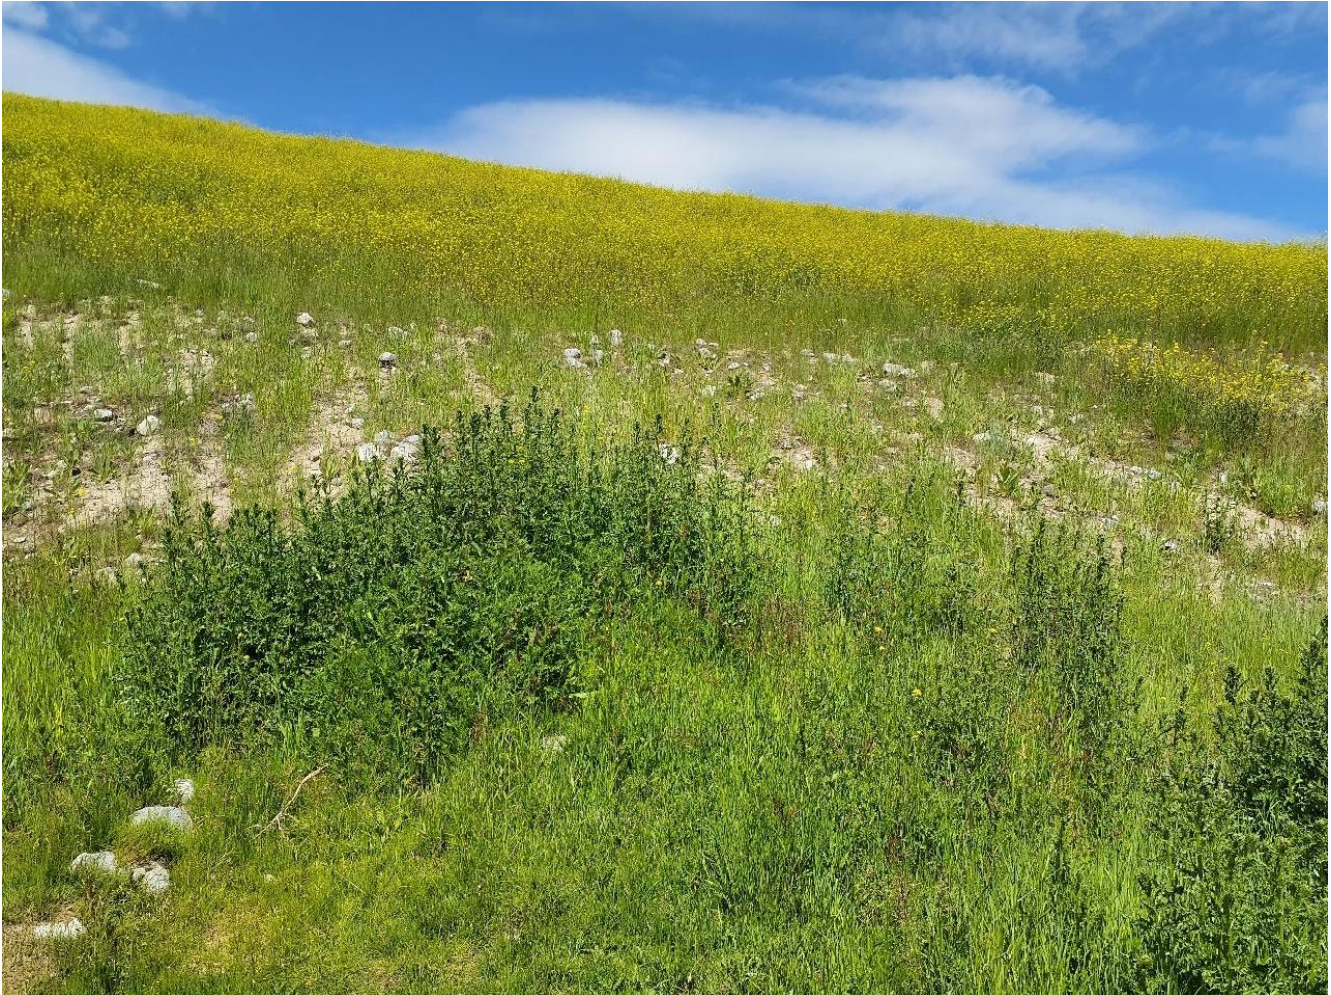
**Photo I-A-8** Place where outlet of culvert below starter dam should be located. Culvert outlet was not seen which suggests it is now buried, likely during reclamation. No issues of concern were observed in area. (TRJ-2022-06)

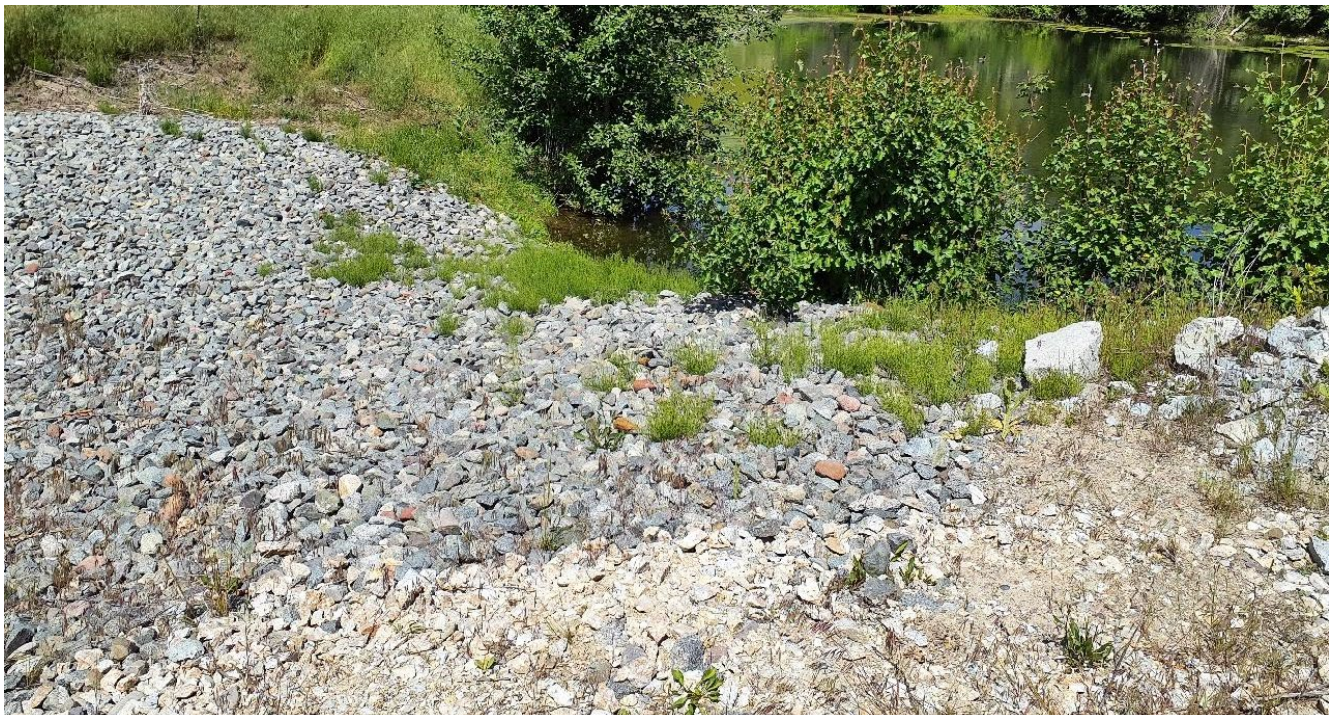
**Photo I-B-3 Overview of pond and spillway inlet which has vegetation debris that will be removed during routine maintenance (TRJ-2022-07)**

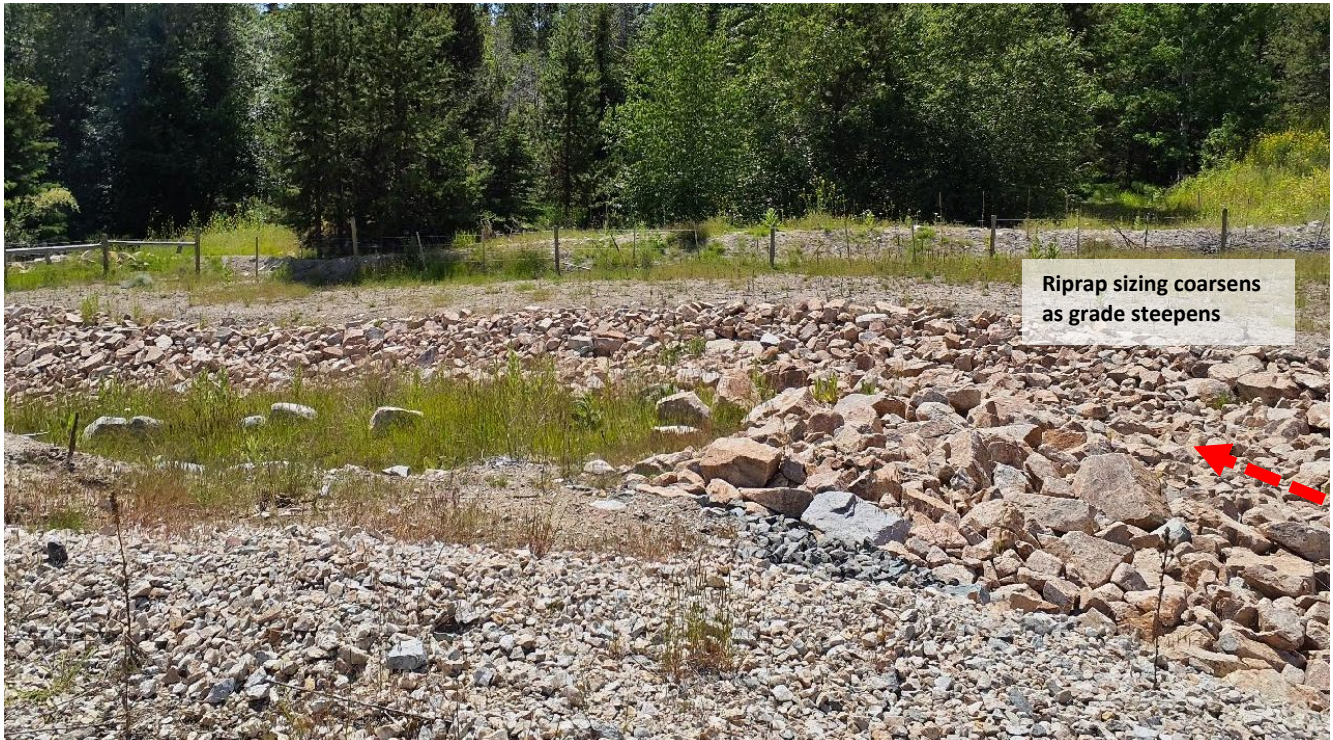
**Photo I-B-4 Spillway Channel downstream of crest. Seasonal growth (grass) is present in the channel but is downstream of inlet and does not impact peak pond level in the reservoir (TRJ-2022-07)**

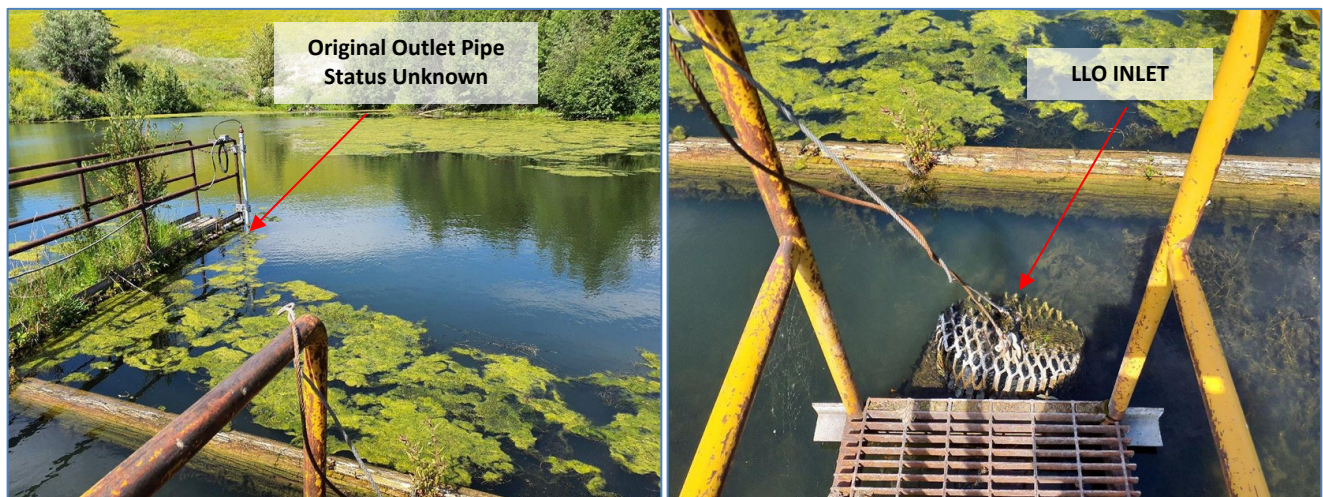
**Photo I-B-5 Overview of the pond and LLO inlet which had minor debris that was cleared during inspection (TRJ-2022-08)**

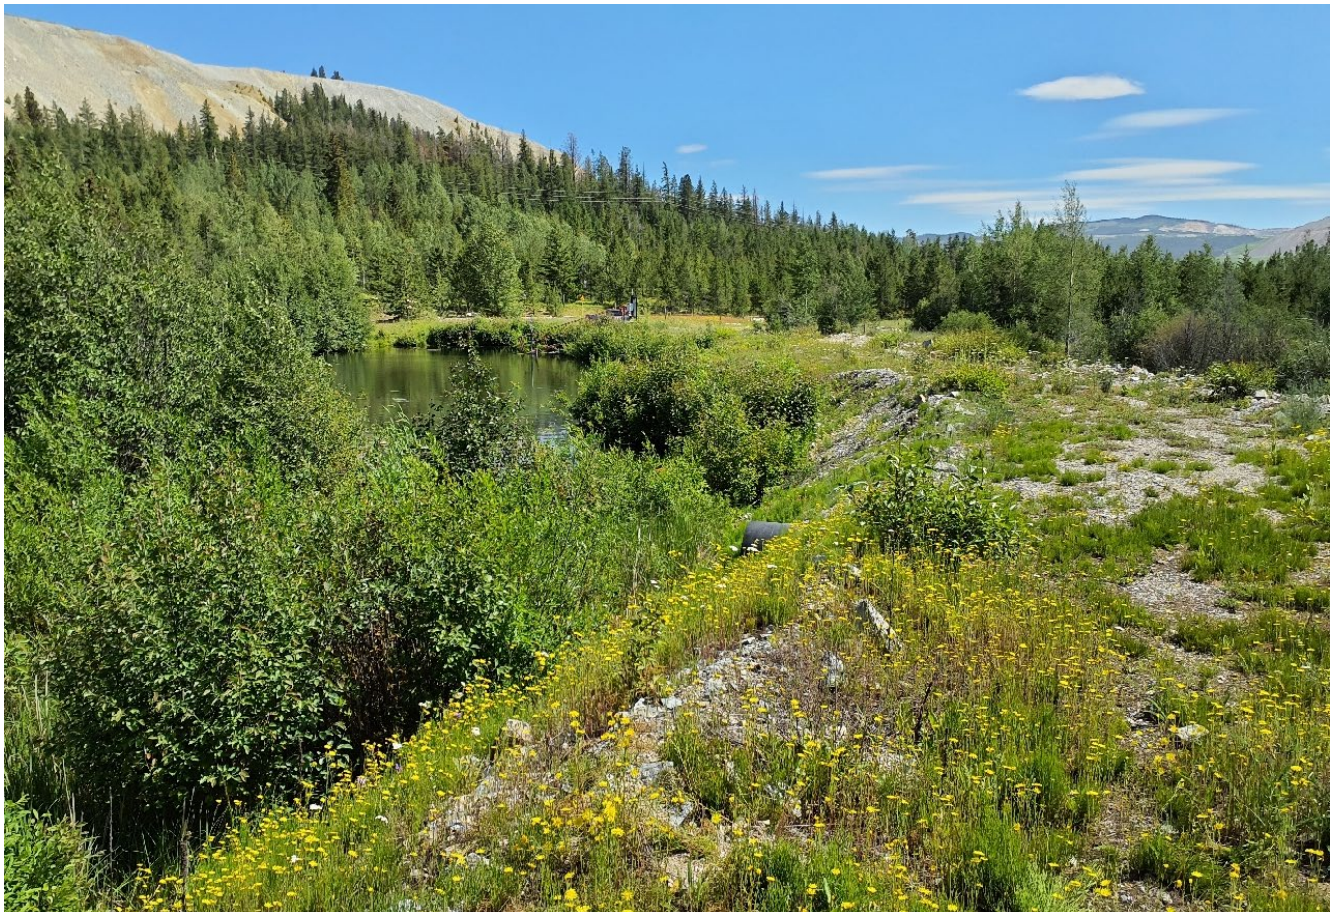
**Photo I-C-1 Overview of Lower Trojan Dam crest from right abutment. Crest is uneven and appears to be sloped (rises from left abutment to right abutment) (TRJ-2022-09)**

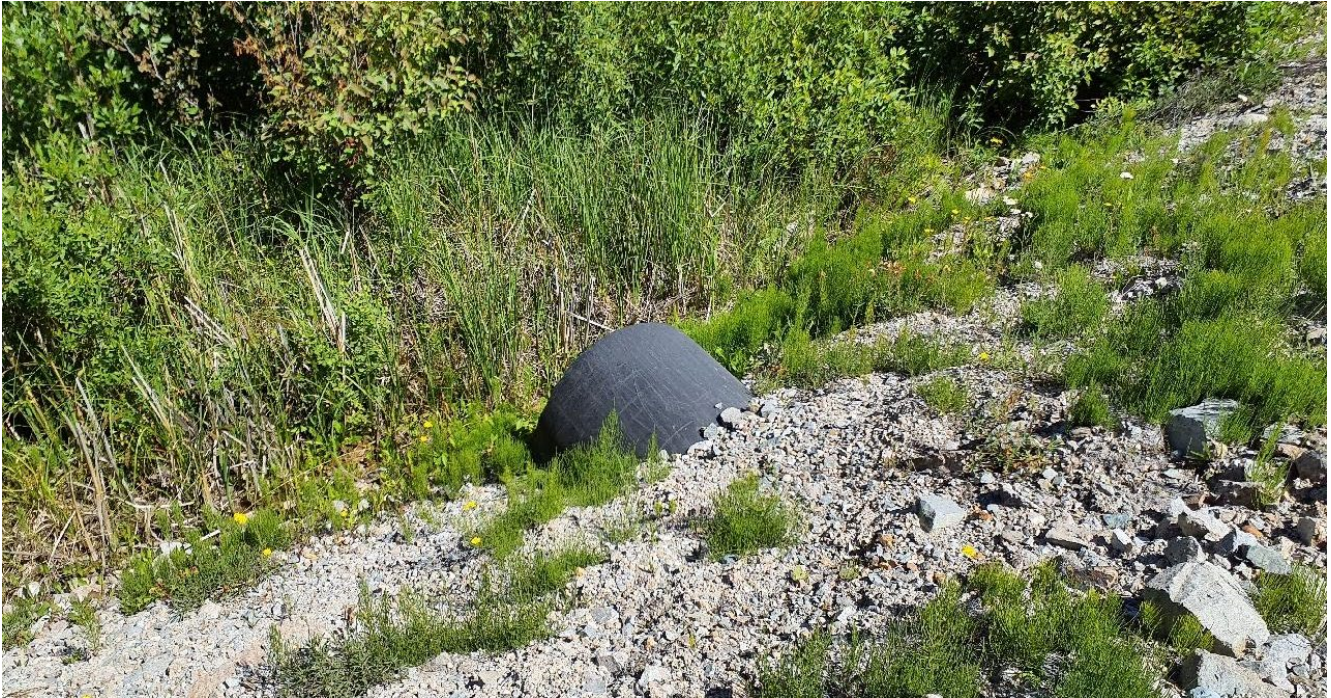
**Photo I-C-4** Upstream slope near right abutment with spillway overflow pipe through the dam. Heavy vegetation was observed in front of the pipe inlet. HVC scrubbed the bushes and cut the grass in front of the pipe inlet after 2022 AFPR site visit (TRJ-2022-10)

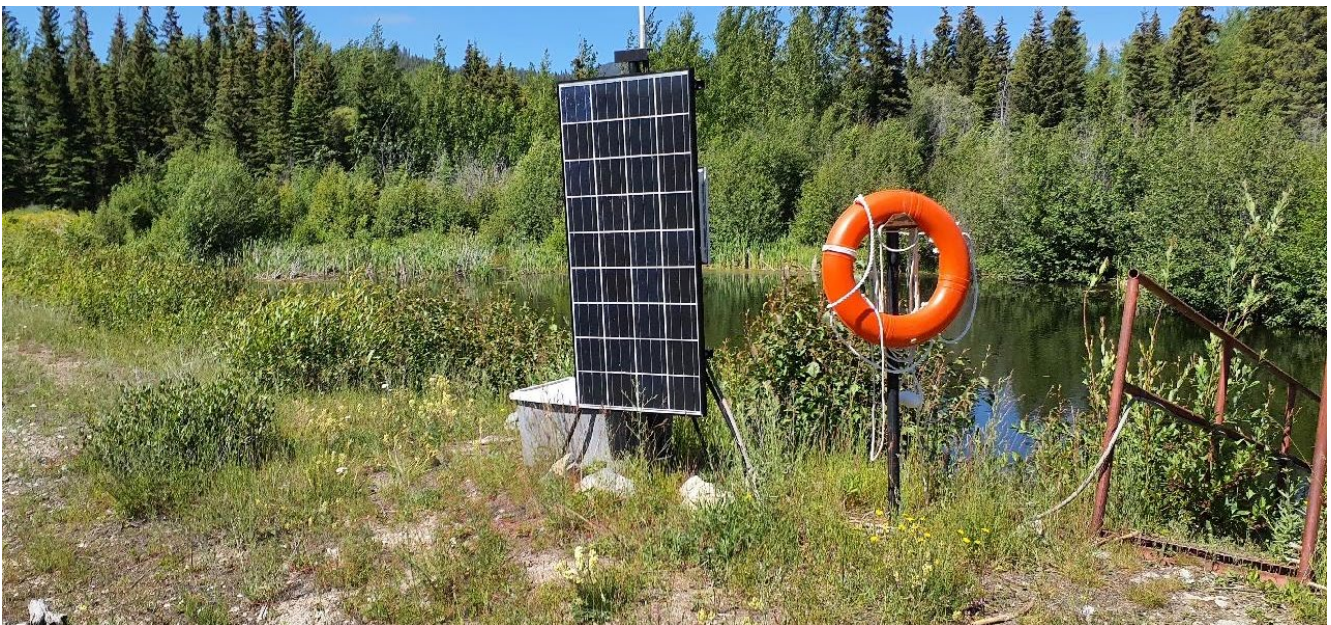
**Photo I-C-5** View of solar panel for remote pond level monitoring. Remote monitoring has been effective to trigger inspections when pond levels rise (TRJ-2022-13)

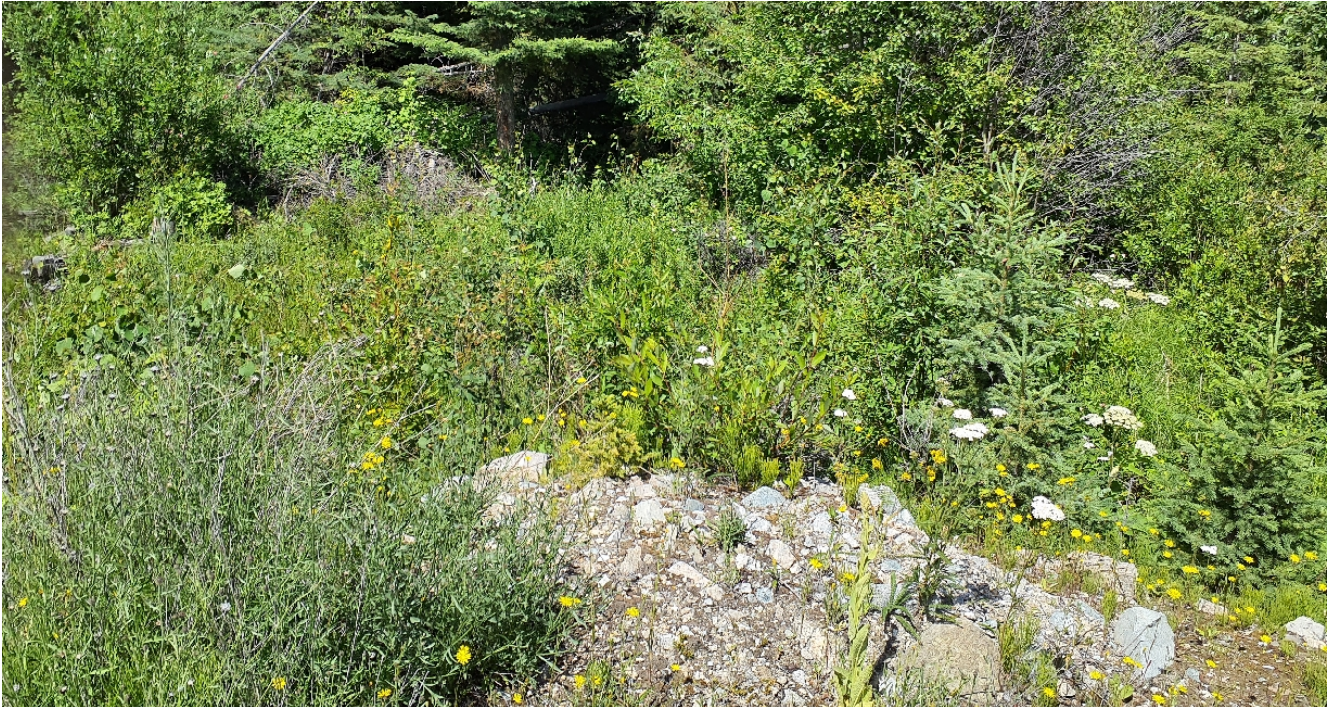
**Photo I-C-6** View of spillway channel inlet. Inlet channel was observed to be densely covered with vegetation. HVC report that vegetation along the inlet of the spillway channel and inlet were cleared after site visit (TRJ-2022-09)

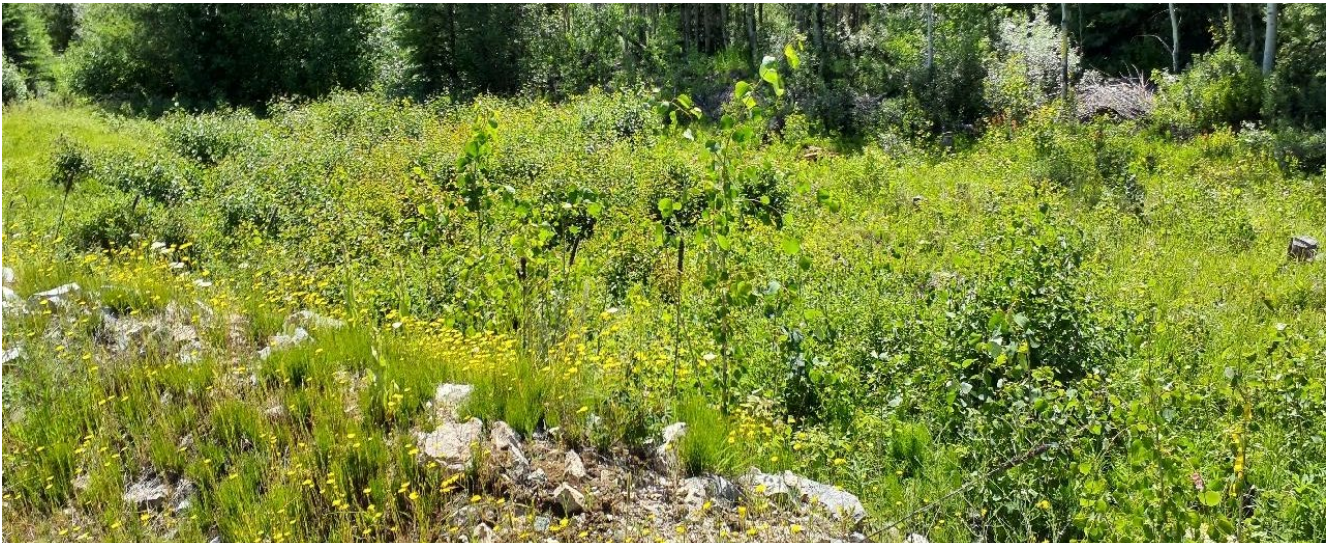
**Photo I-C-7** Spillway channel looking toward south. Channel is observed to be >98% vegetated. HVC report that vegetation along the inlet of the spillway channel and inlet were cleared after site visit. (TRJ-2022-09)

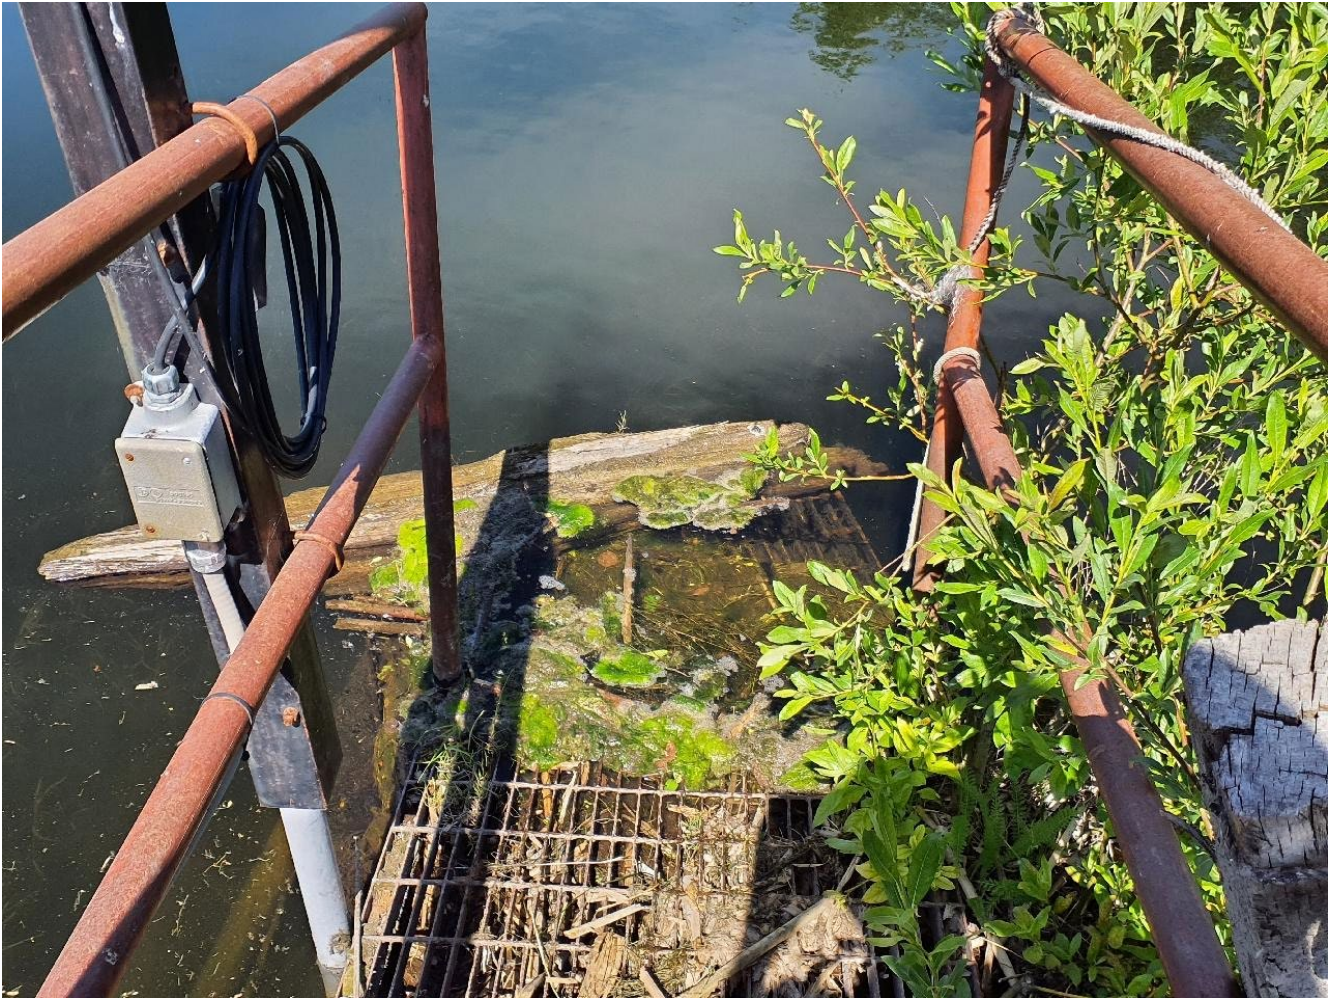
**Photo I-C-8 Low-Level Outlet inlet. During the site visit HVC cleared vegetation accumulated on the LLO intake as a routine maintenance task. Subsequent to the site visit, HVC repositioned the debris boom so it was protecting the intake of LLO which is also a routine task. (TRJ-2022-12)**
