**THURBER ENGINEERING LTD.**

**LINE CREEK OPERATIONS  
TAILINGS STORAGE FACILITIES  
2022 ANNUAL FACILITY PERFORMANCE REPORT**

**Final Report**

Date: March 20, 2023  
File: 31397-3002

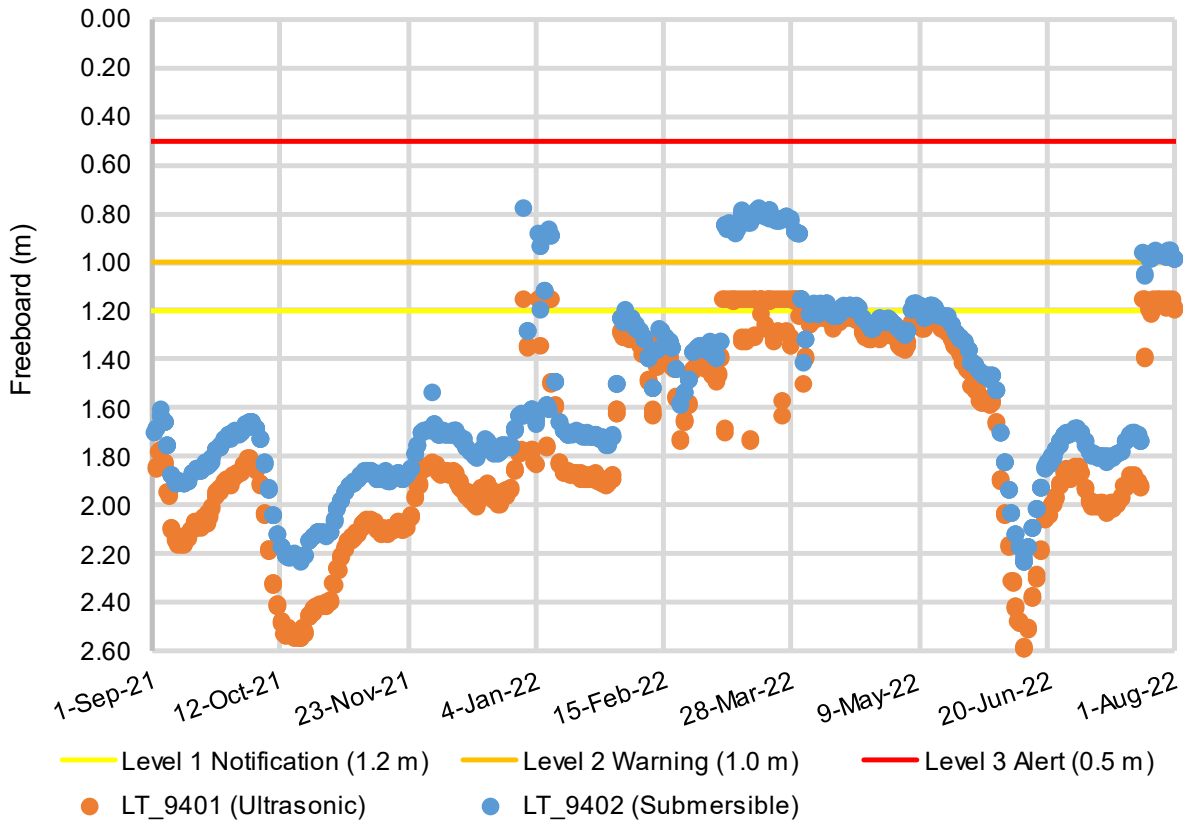
**Figure 3. Pond C Freeboard Measurements from the Real Time Level Monitoring Sensor**

Teck has indicated that LT\_9401 (ultrasonic sensor) does not provide reliable readings when submerged and thus reading from periods of high-water levels should be discarded. No visual inspections verifying the periods when the sensor was submerged where available during this 2022 AFPR. As the ultrasonic sensor provides divergent data from the submersible sensor and does not provide reliable readings at levels when alarms will be triggered, its future utilization should be re-assessed as part of the RLPs monitoring plan, moving forward.

The RLP real-time level monitoring instrumentation in Pond C indicated a freeboard exceedance between March 7 and March 30, 2022. The exceedance occurred during an ice breakup and resulted in a minimum freeboard of 0.87 m being maintained during the exceedance. Similar solutions as recommended in Section 5.3.3 are again proposed to prevent a reoccurrence.

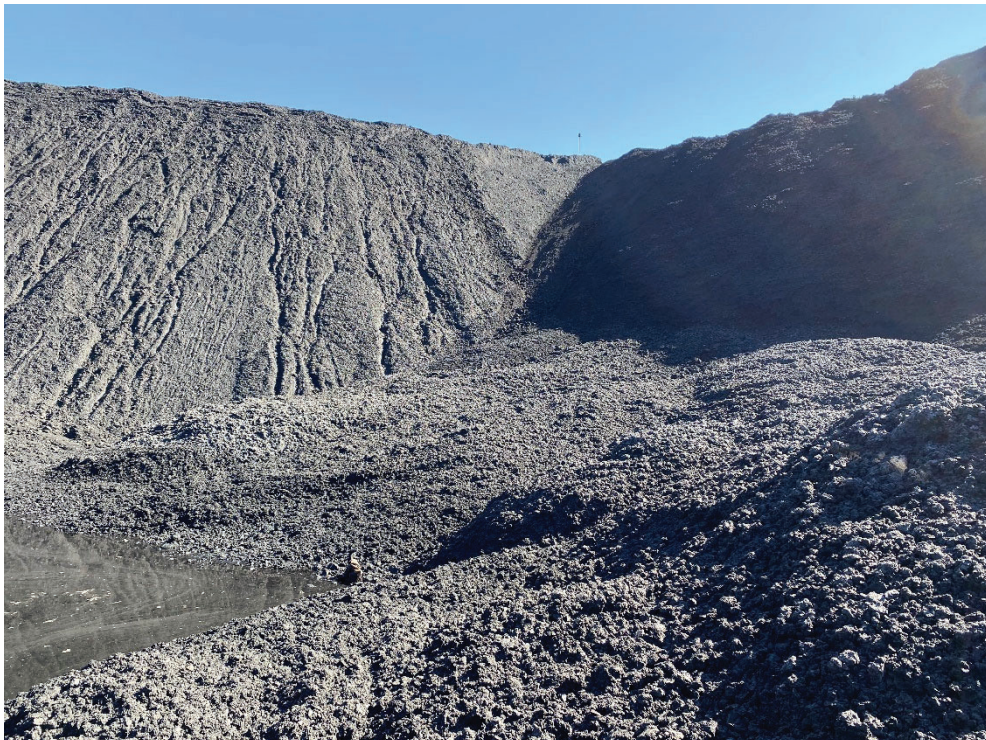
**Photo 2. June 17, 2022 washout event location, looking northeast**

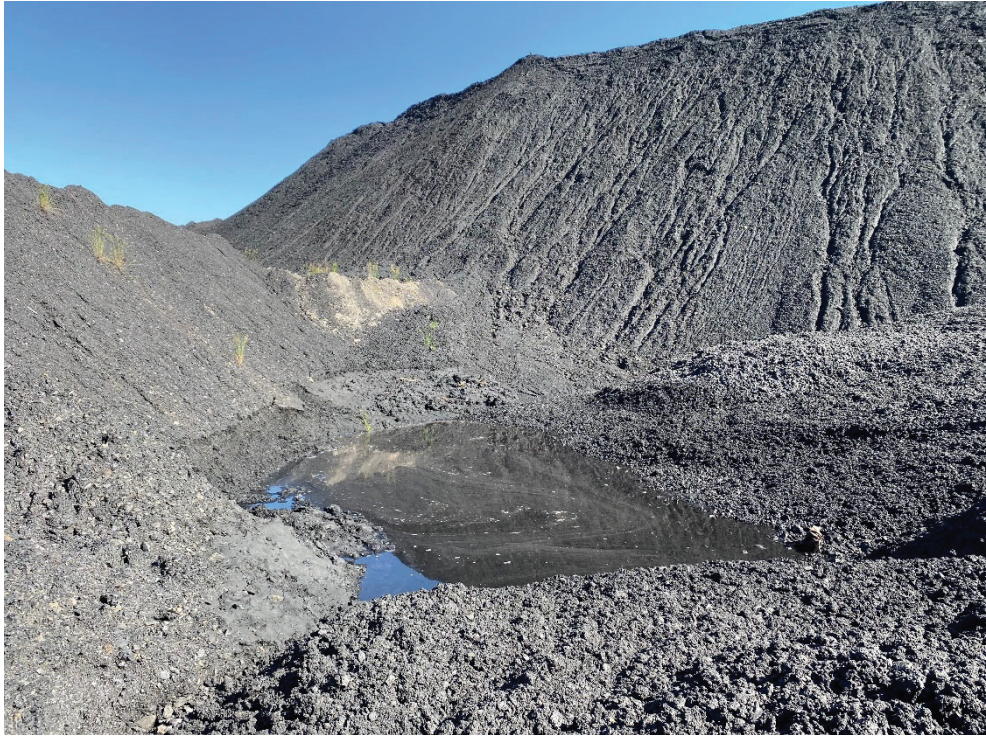
**Photo 3. Soft CCR spoils from June 17, 2022 washout event, looking north**

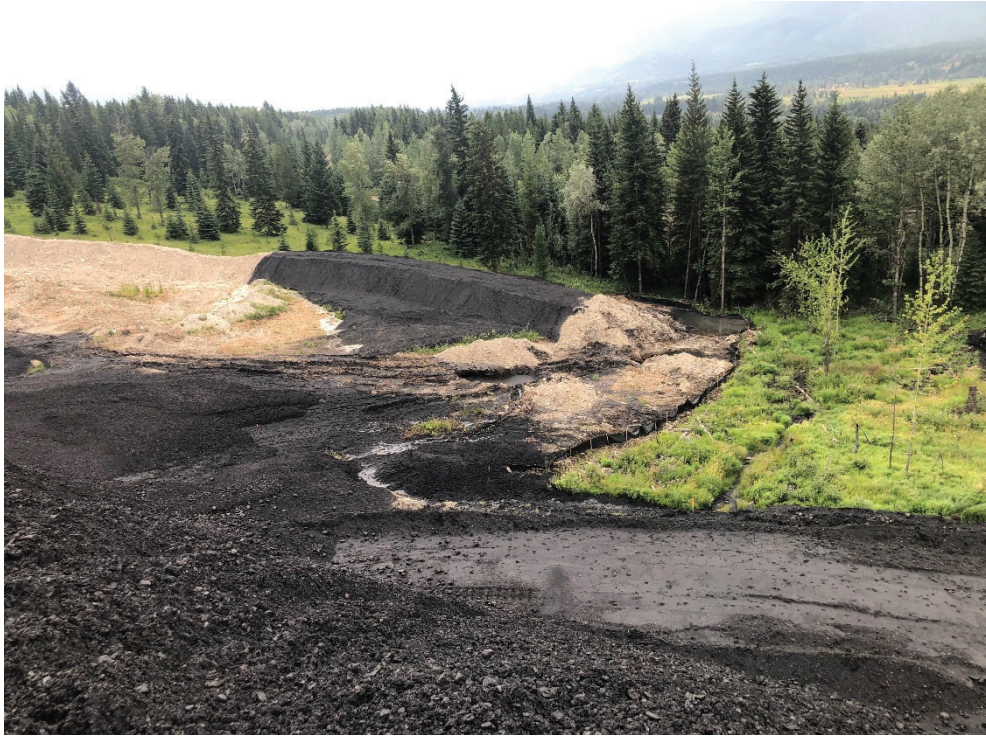
**Photo 5. South runout berm repaired with CCR, looking southwest**

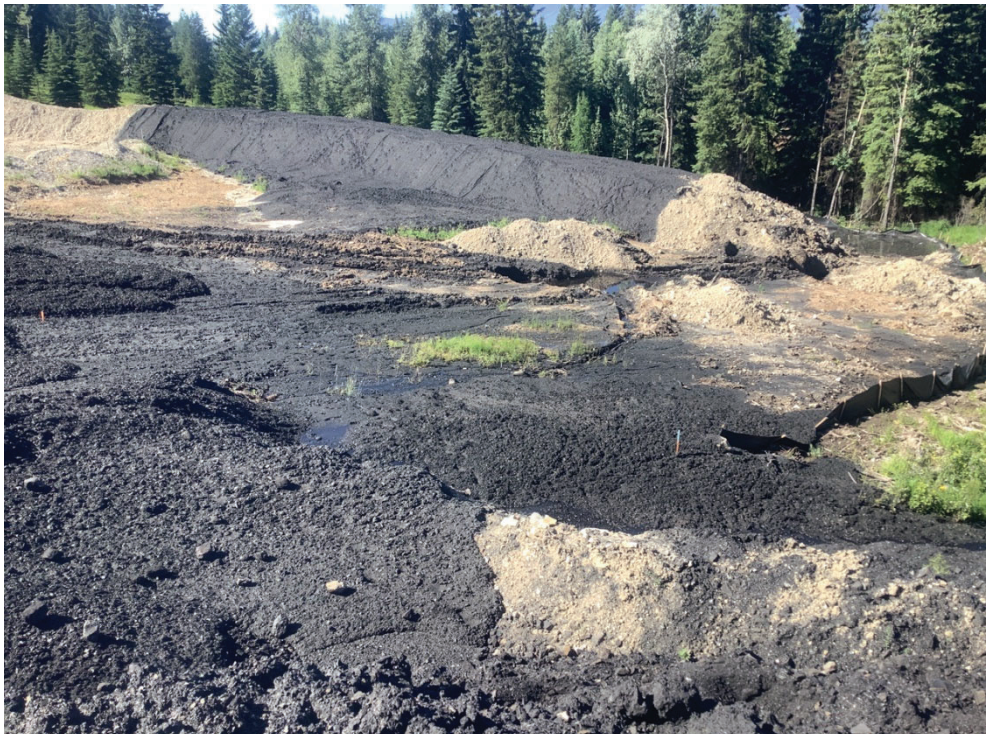
Photo 12. Soft CCR spoils from June 17, 2022 washout event, looking south

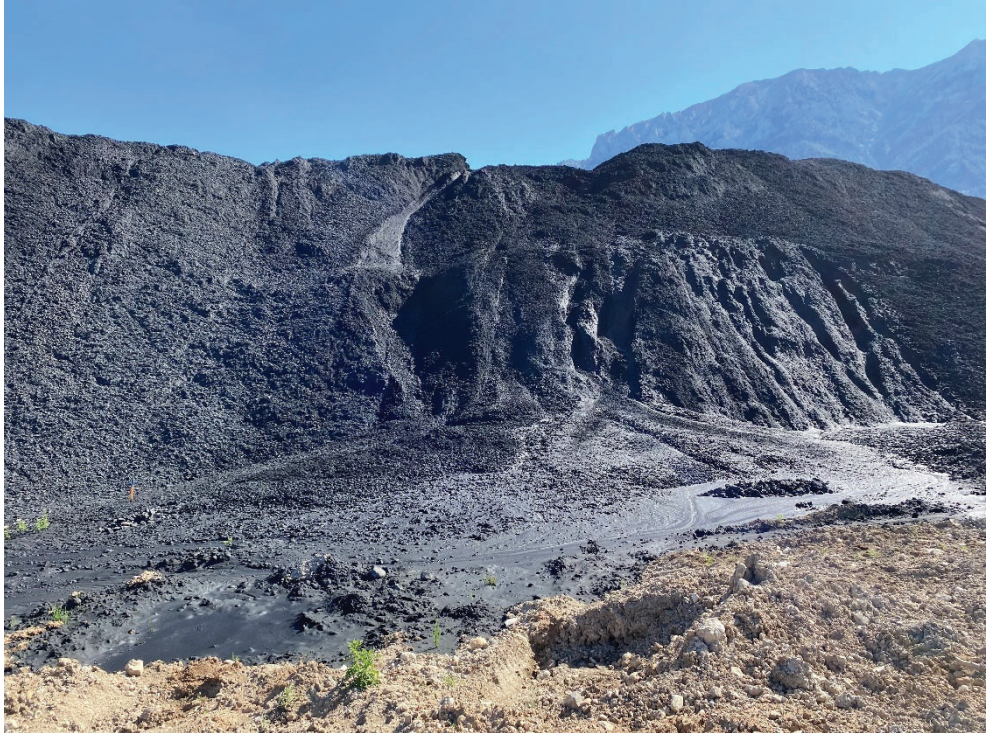
**Photo 15. June 14, 2022 washout location, looking northeast**

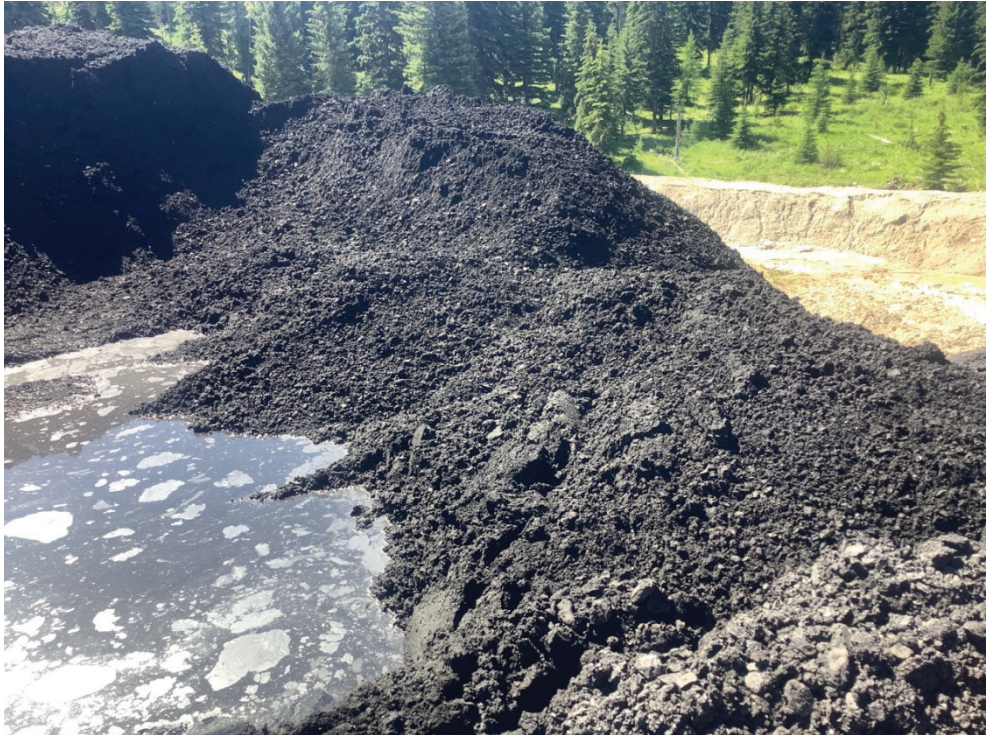
- Insufficient implementation of surface water runoff management was highlighted in the inspection reports. References to water ponding on the facility and near the crest were noted on several inspections and one inspection identified an erosion gully through the 1285 m bench, over the crest, to the 1270 m bench.
- Cracking along the south end of 1300 m bench was identified and began to be monitored during the reporting period. Teck has indicated some quantitative measurements of the crack were collected. Thurber did not receive or review any quantitative monitoring data in relation to the crack monitoring during this 2022 AFPR.

**Photo 17. Water pooling near crest of the 1270 m bench, looking southeast**

Facility	ID #	Deficiency or Non-Conformance	Recommended Action	Priority <sup>1</sup>	Recommended Deadline
ERX	2022-AFPR-04	Standing water near the crest.	The surface water management plan should be reviewed/updated and fully implemented.	2	Q3 2023
Pond Fines Dump	2022-AFPR-04	Limited geotechnical characterization and engineering assessments	Develop a DBM for the facility and conduct engineering assessments to evaluate the risk of failure due to slope instability (e.g., piping, liquefaction, slope failure) of the facility.	2	Q3 2023

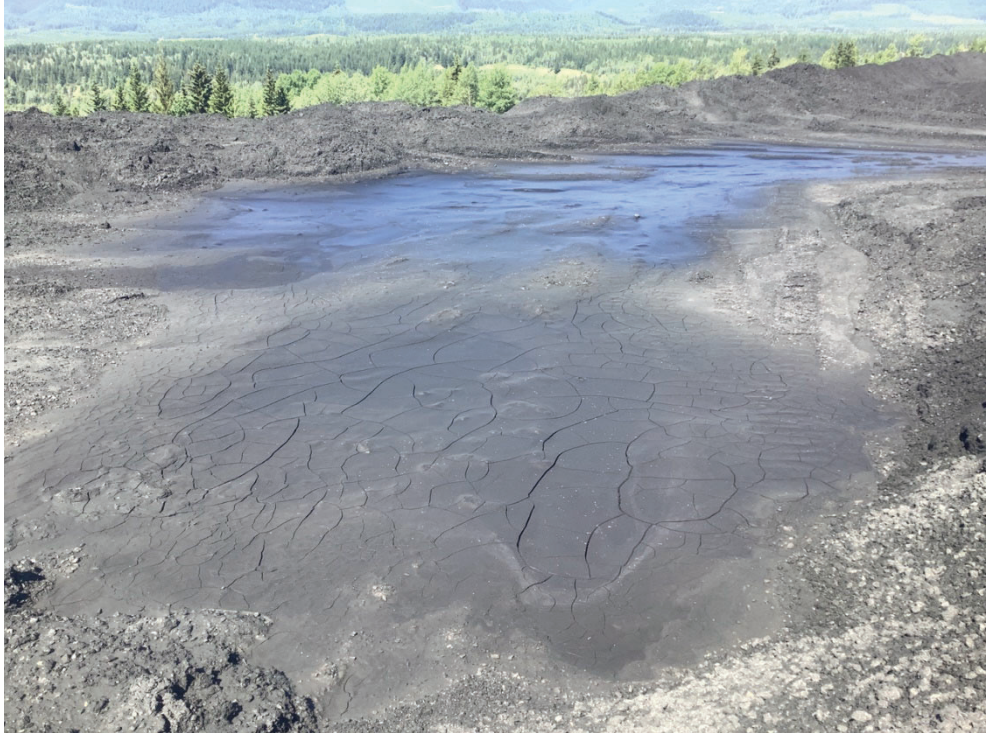
Photo 19. Evidence of water pooling on the 1270 m bench, looking southwest

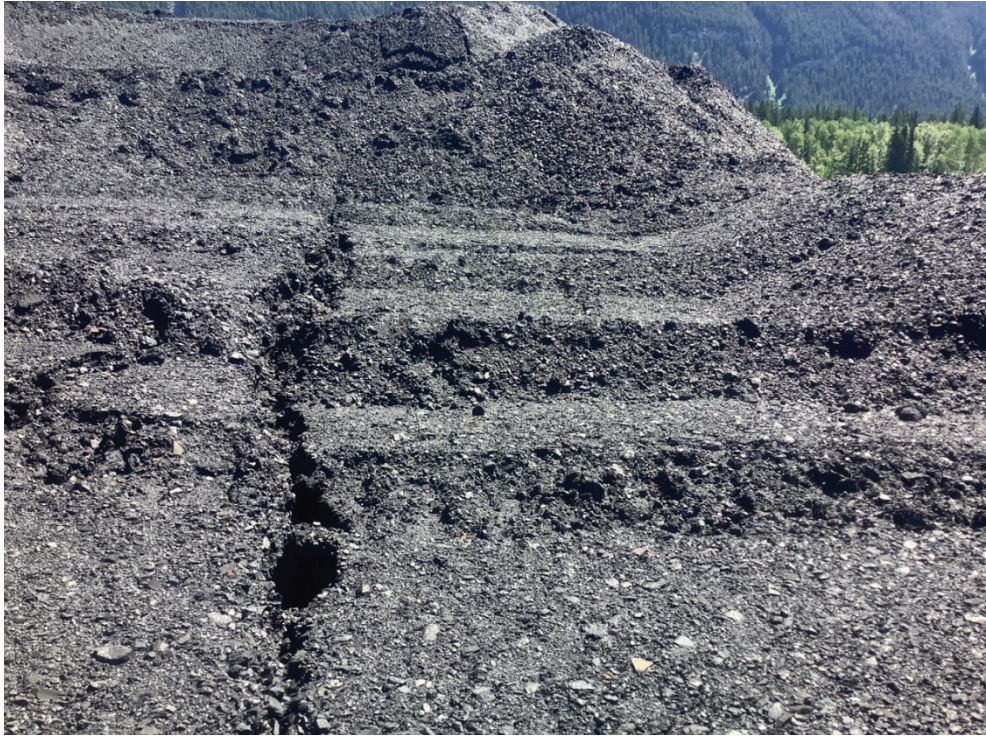
**Photo 27. Crack along the 1300 m bench crest, looking east**

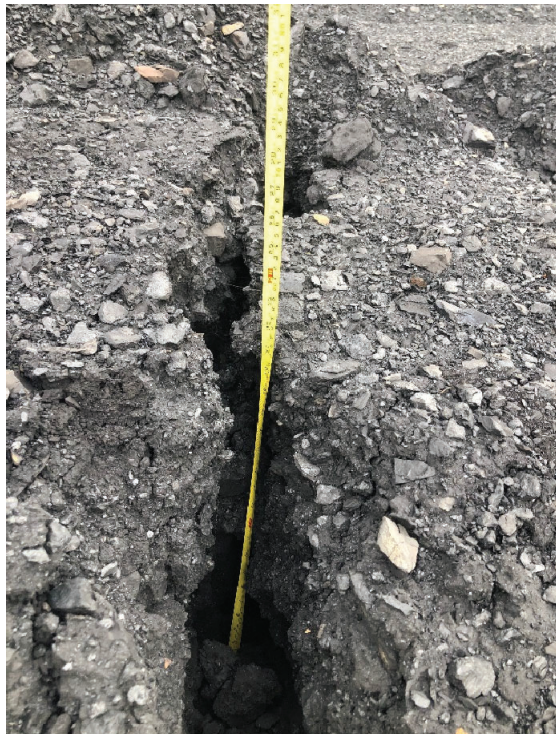
**Photo 28. Crack along the 1300 m bench crest, looking east**

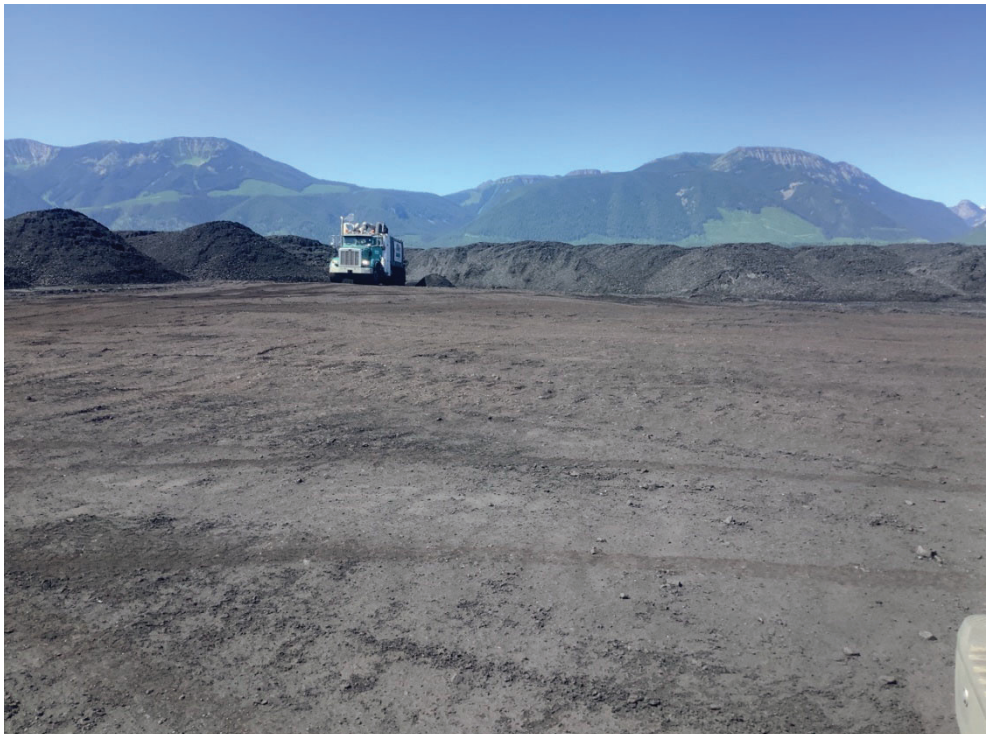
Photo 32. Hydro-vac material being deposited near the crest of the 1300 m bench, looking southwest

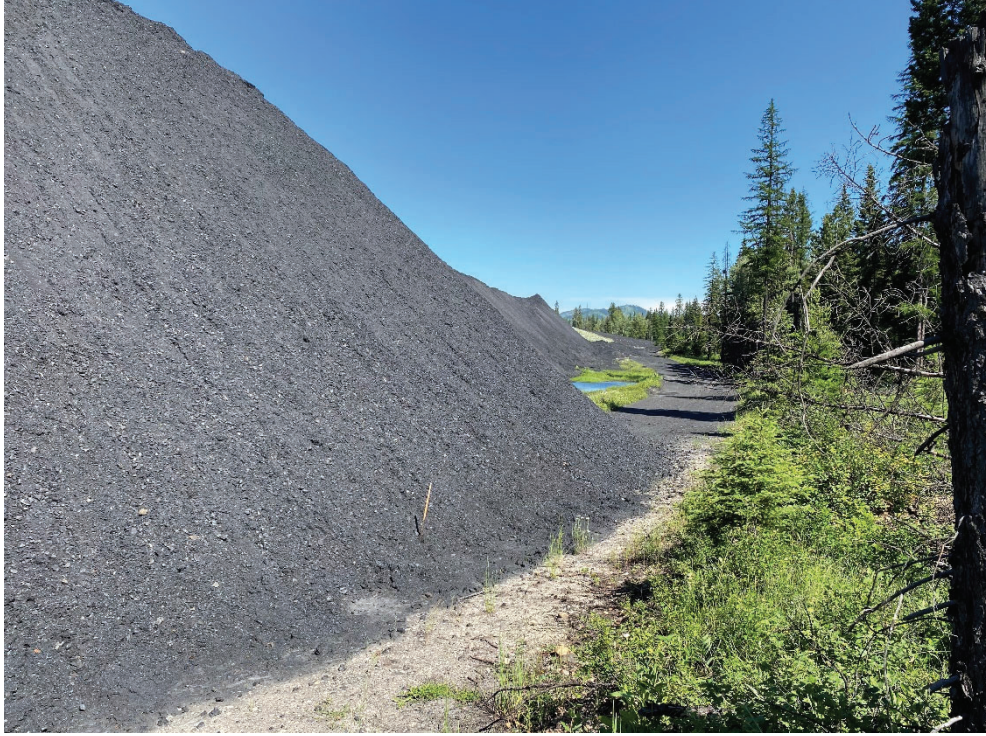
Photo 37. Water pooling along the downstream toe along eastern extents of the ERX, looking north

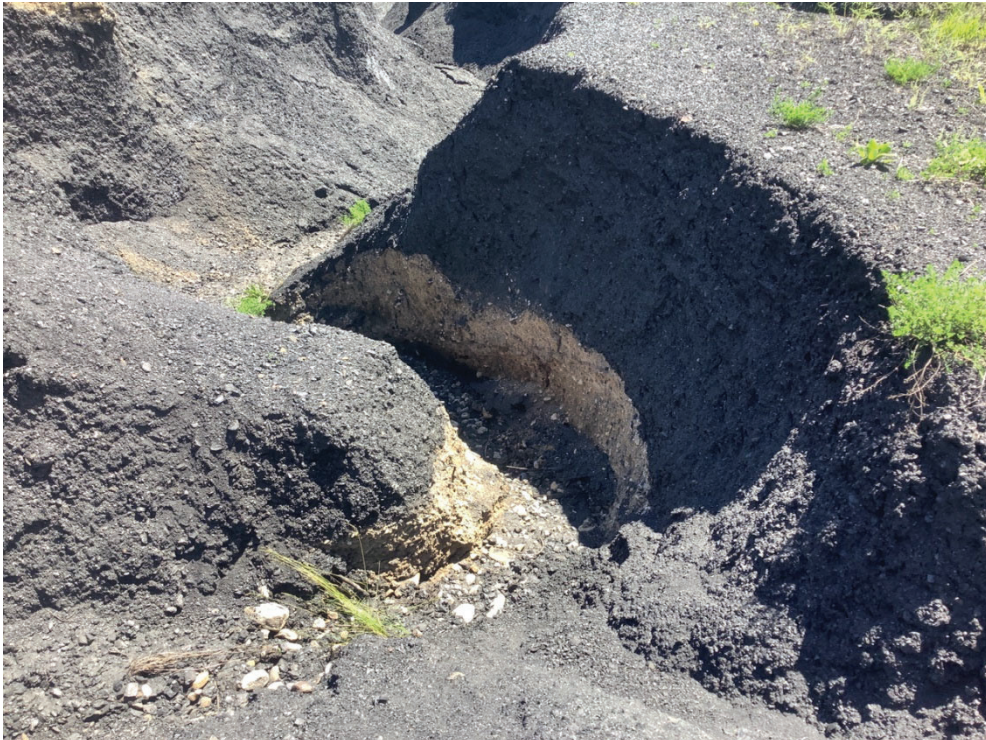
- No additional erosion was identified on the existing erosion gullies on the lower bench during the reporting period.
- Surface water continued to flow along the upstream ditch of the decommissioned mine road at the downstream toe of the PFD.
- Seepage continued to be noted on the downstream slope of the decommissioned mine road in the embankment area. Flow was observed through the culvert.

**Photo 47. Erosion gullies in the downstream area of the Lower Bench, looking south**

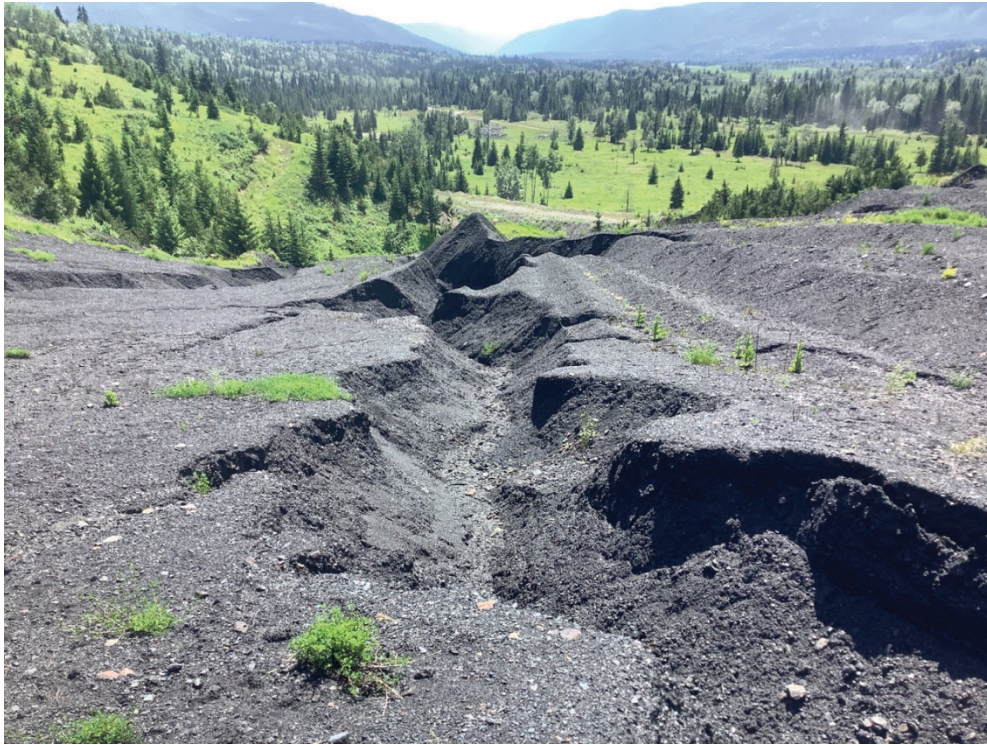
**Photo 48. Erosion gullies at the toe of the Lower Bench, looking south**

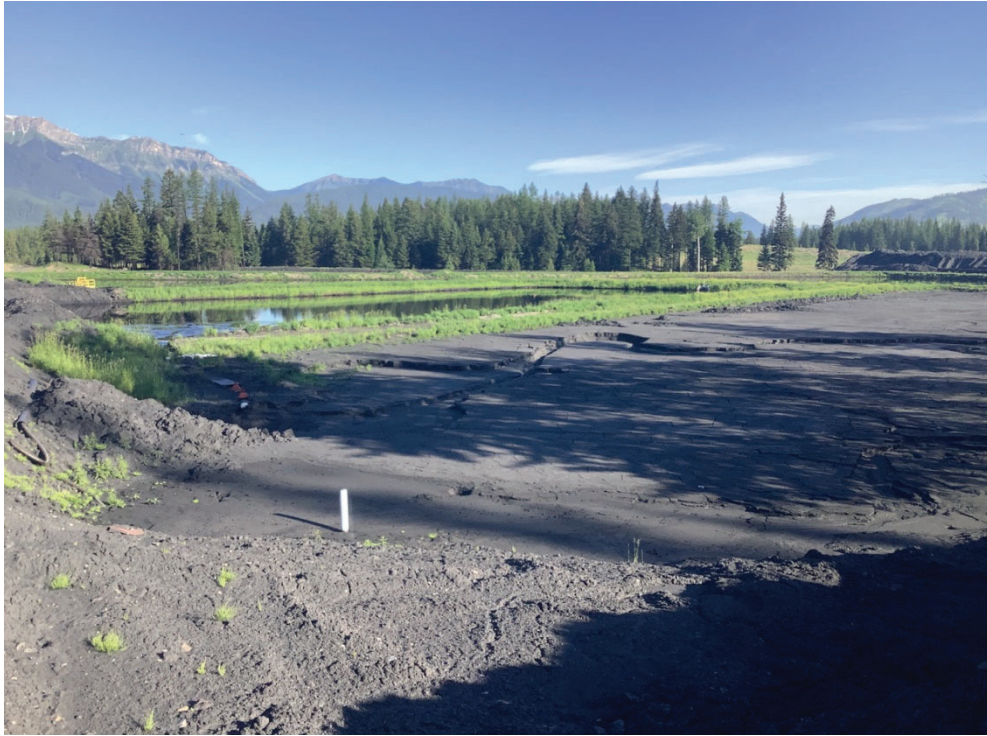
**Photo 61. Pond A awaiting cleanout of sediment, looking northwest**

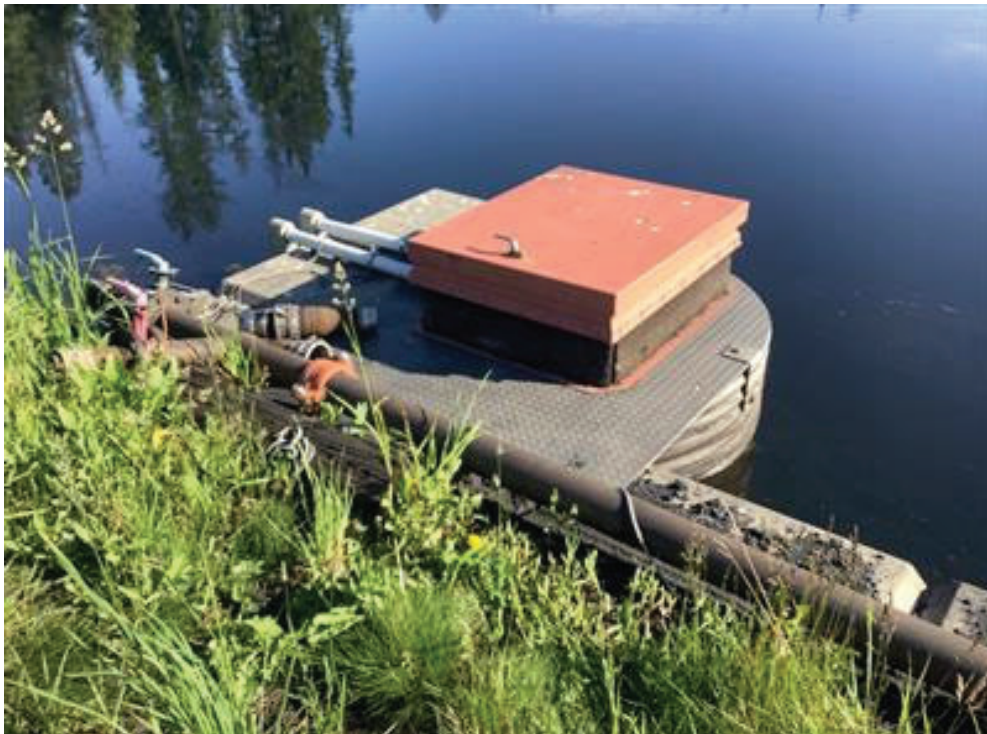
At the time of the 2022 AFPR site inspection (July 13 and 14, 2022), the water level in the stilling well was observed to be approximately 0.4 m lower than the actual water level in Pond C, thus indicating that hydrostatic equilibrium was not being maintained. Following the AFPR site inspection, a clean out of the stilling well was performed by Teck personnel. This clean out also included a calibration of the instrument. As seen in Figure 3, the freeboard reading dropped from 1.74 m to 1.07 m as a result, initiating a Level 1 freeboard notification. The calibration could account for the remaining 0.27 m discrepancy between the observed difference and the two instrument measurements. As the stilling well is the only source of real time monitoring of the RLP, it is essential that the accuracy of the measurements which trigger the freeboard alarms be maintained. Notes included with the data indicate Teck had noticed visible differences between the stilling well and Pond C water levels as early as March 2022 during the event described in Section 5.3.4 above. These differences were initially attributed to the impacts of ice rather than sediment Teck should review the maintenance and inspection policies in relation to the stilling well and develop procedures accordingly for operation in the event of compromised sensors. An extension to the existing staff gauge in Pond C near the stilling well should also be installed to help validate water levels in the case of future discrepancies.

Photo 68. Stilling well containing water level sensors in Pond C, looking north

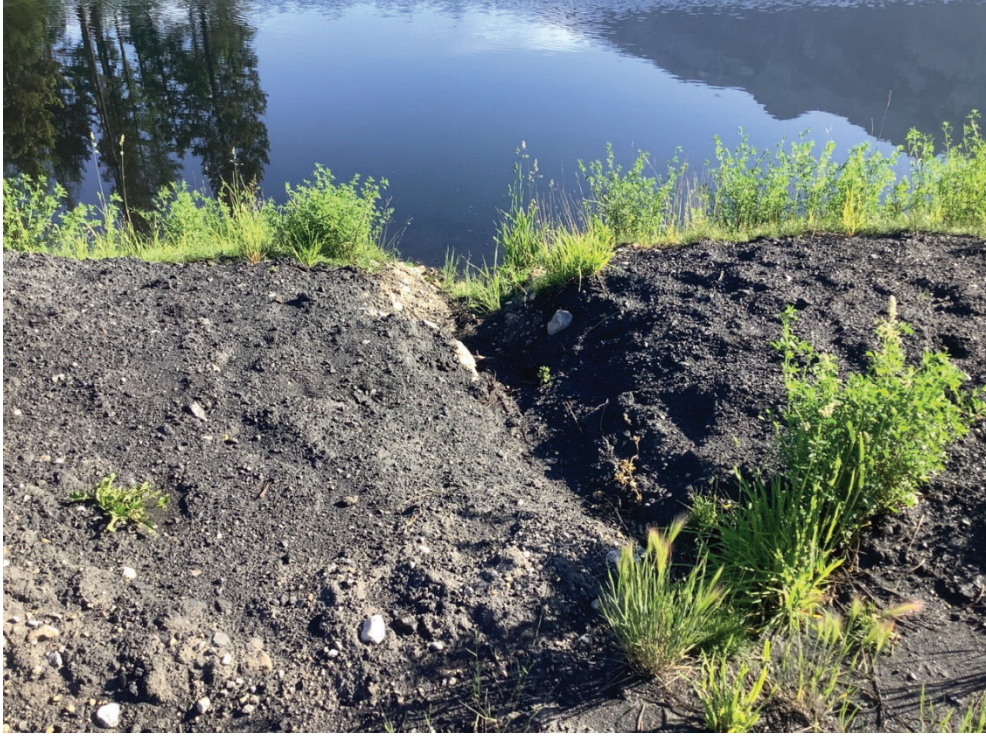
**Photo 69. Erosion along the upstream slope of the Pond C, looking northwest**

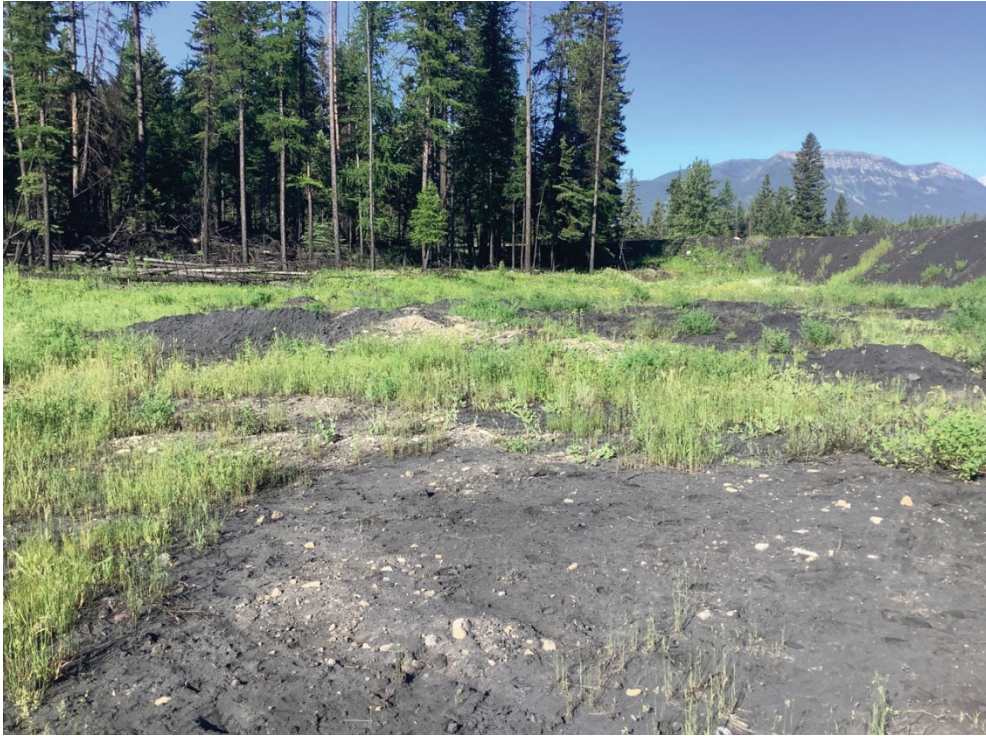
**Photo 73. Old sediment deposits in the basin of Pond D, looking west**

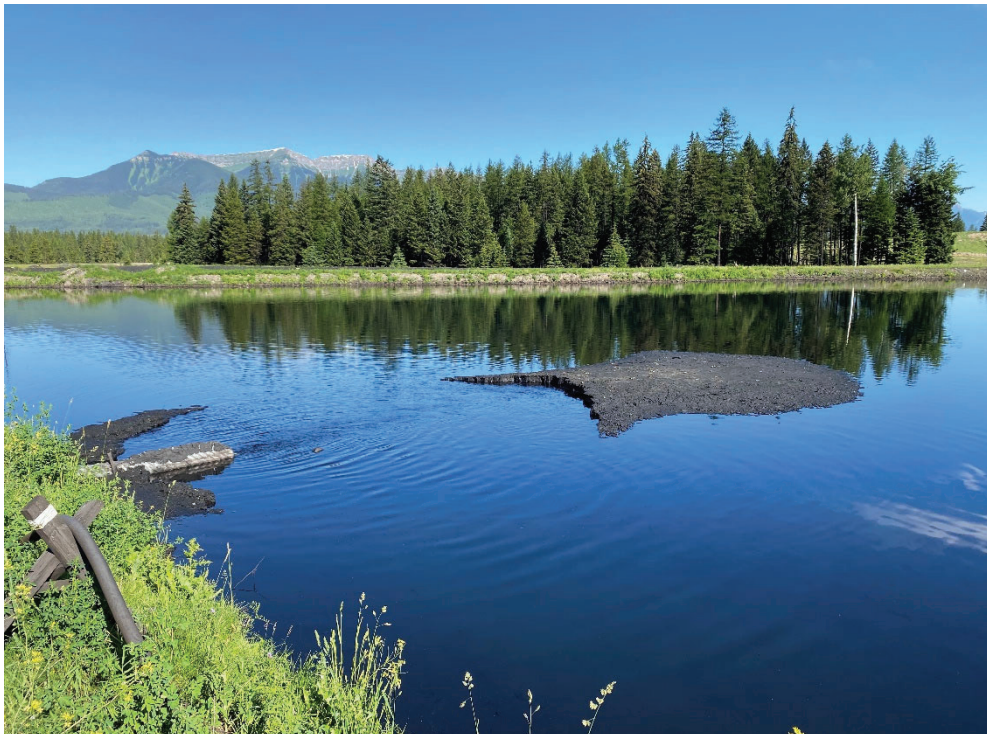
- Ponding and rutting along the crests of embankments were noted. Repairs were completed as part of regular maintenance as specified in the OMS.
- The Pond A/C and Pond B/C culverts were observed to be partially blocked by sediment. These blockages were cleared during cell cleanouts.
- Mature trees and vegetation in Ponds A, C and D were identified as potential blockage hazards for culverts.
- The erosion gully along the discharge pipe box between Pond A and Pond B was monitored following the events described in Section 2.3.3.1.
- The inspections in the spring of 2022 identified a head difference between Pond C and the stilling well containing the water level sensor instrumentation. This was rectified by a cleanout following the 2022 AFPR site inspection as described in Section 5.3.4.

**Photo 82. Sediment build up near the Pond B gated culvert outlet to Pond C, looking northwest**
