2022 ANNUAL FACILITY PERFORMANCE REPORT - LOUVICOURT

TECK RESOURCES LTD.

001-22521237-2000-RA-Rev0-TSF Inspection 2022

27 March 2023

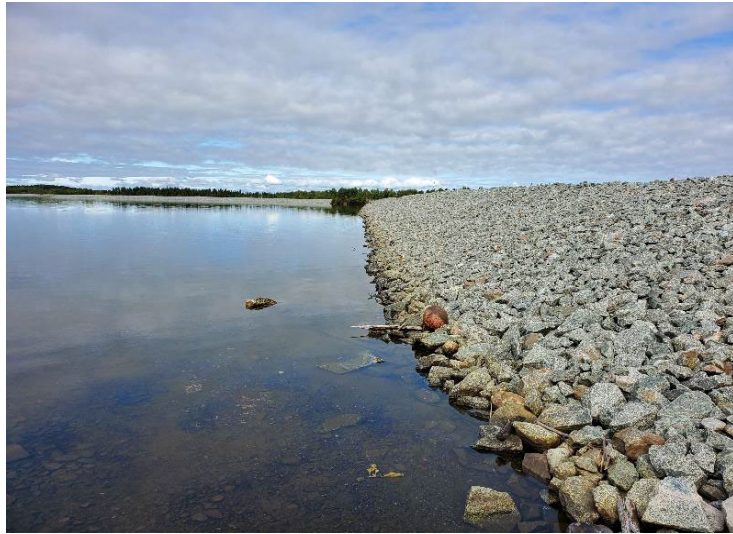
- The riprap on the upstream berms of Dams 1B and 1D, which was repaired with new riprap in 2019 (Photograph 1) was unchanged from the previous inspection.

Photo 1 : Dams 1D – View of the upstream slope with riprap replaced.

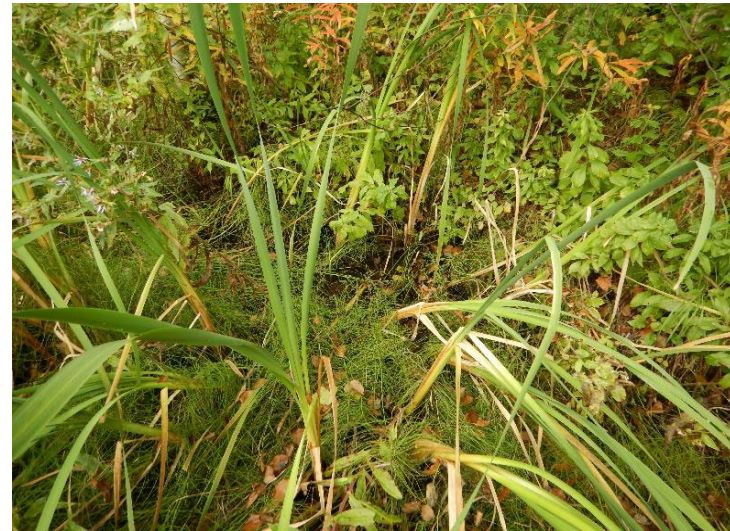
Photo 3 : Flowing water near downstream toe of Dam 1C. Similar flows occur on Dams 1A and 1B.

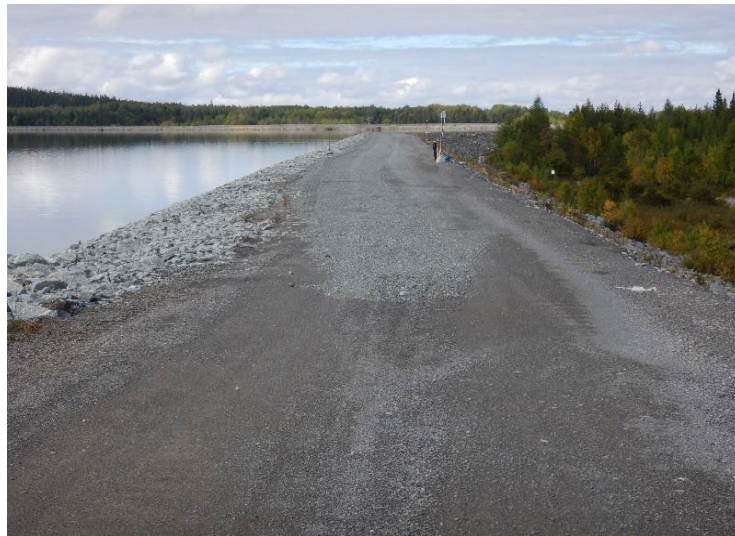
- The riprap on Dams 1A and 1C was replaced in 2022, with the addition of traffic gravel on the crest (Photograph 2).
- Ponding water was observed at the toe of Dams 1A to 1E at the same locations as last year. At several locations, flowing water was either visible or audible near the toe of Dams 1A to 1C and 2B (Photograph 3). The apparent increase of seepage at the toe areas is attributed to a significant rainfall event which occurred on September 19 2022. The locations of current and historic seepage points are presented on Figure 1.

Photo 2 : Dam 1C - Rip rap was recently replaced and traffic gravel was placed on the crest.

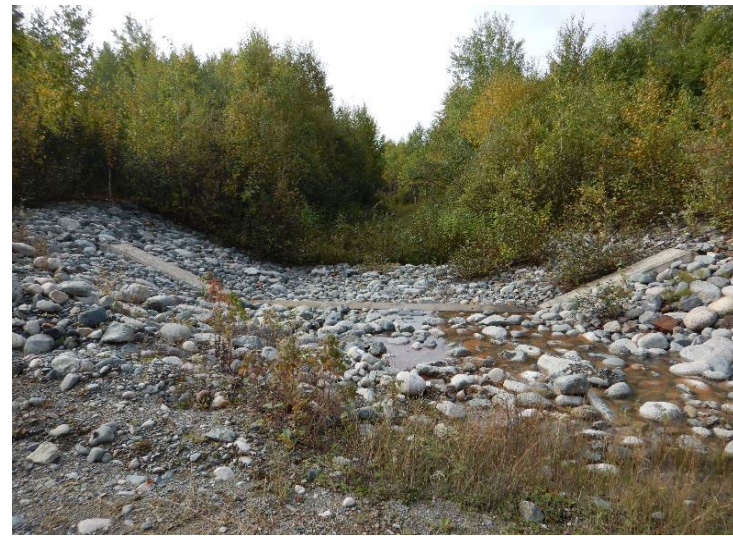
- The emergency spillway located between Dams 1D and 1E (denoted as the second emergency spillway of the TSF) was in good condition but exhibited significant vegetation growth. Vegetation in the downstream channel was cleared in 2020 (Photographs 4 and 5). Historically, vegetation is cleared every other year. It is noted that the spillway was cleared in 2022, after the site inspection.

Photo 4 : Emergency spillway located between Dams 1D and 1E was in good condition but exhibited significant vegetation growth. Vegetation in the upstream channel was cleared later in 2022, after this inspection.

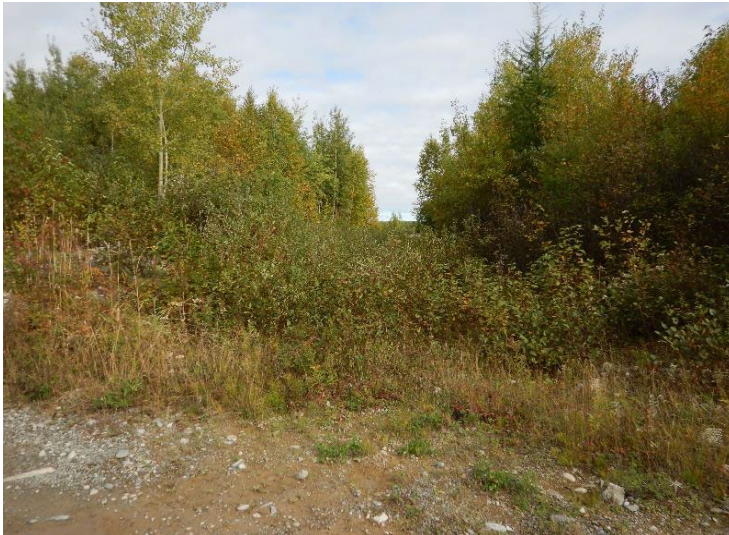
Photo 5 :Emergency spillway located between Dams 1D and 1E was in good condition but exhibited significant vegetation growth. Vegetation in the downstream channel was cleared later in 2022, after this inspection.

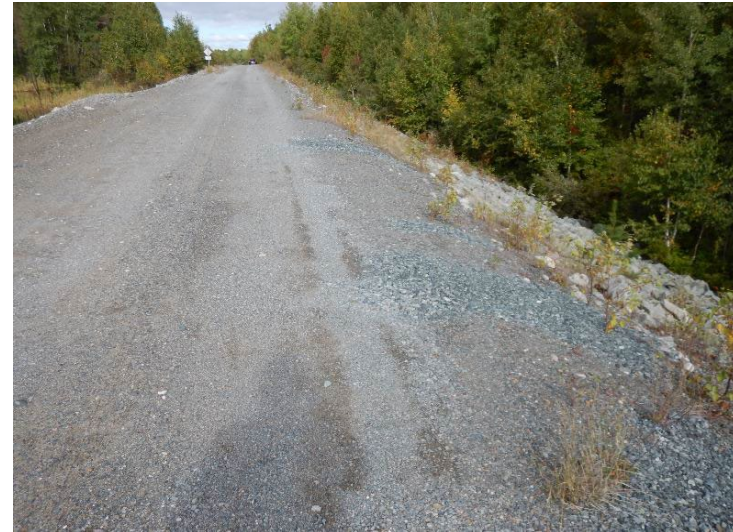
Photo 7 : Crest erosion was nominal, with conditions similar to 2021 when repair was performed.

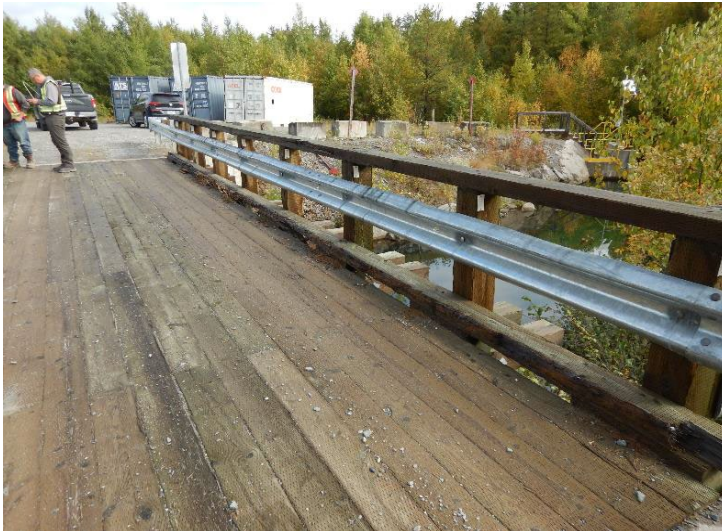
- The access bridge close to the TSF spillway was rehabilitated in 2018 and appears in good condition, although the edge blocks appear to be suffering some scraping, presumably by snow removal equipment (Photograph 6). Other than the signs of recent scraping, the condition in 2022 is similar to conditions observed in 2020 and 2021. If this scraping issue worsens, it may be advisable to protect the timber blocks with metal covering to improve durability, or to replace the timbers.
- Crest erosion was nominal, similar to 2021 conditions, and evidence of crest erosion repair was observed (Photograph 7).
- Vegetation is present at the downstream toe of Dams 1A, 1B and 1C (Photograph 8). This is not a stability concern. Removal of vegetation at the toe could be considered to assist the visual observations during routine inspections.

Photo 6 : Access bridge close to the TSF spillway. Bridge appears in good condition, although the edge blocks appear to be suffering some scraping, presumably by snow removal equipment.

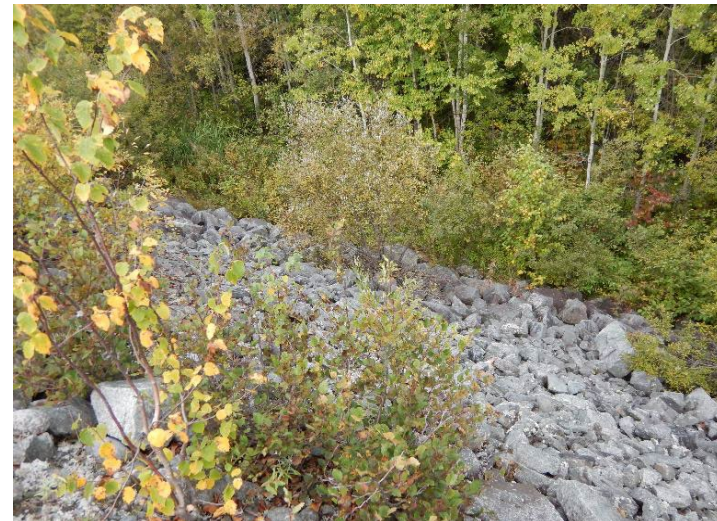
Photo 8 : Typical view of vegetation which is present at the downstream toe of Dams 1 and 2.

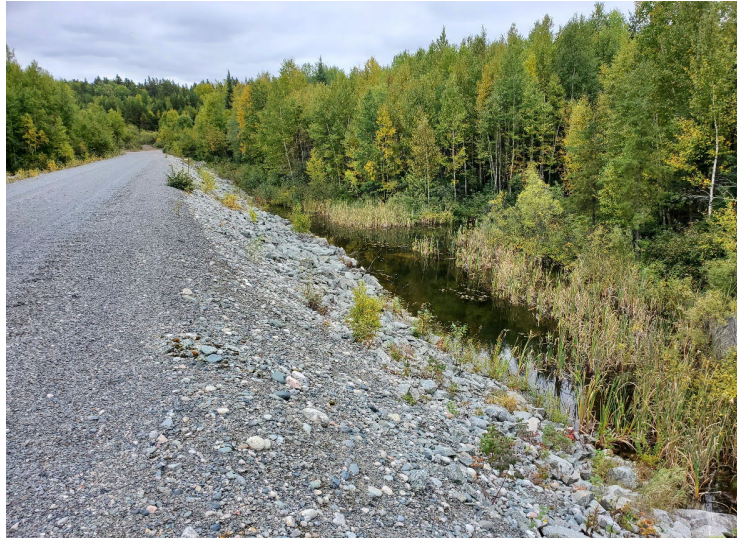
- Stagnant water is observed at the toe of Dam 2A (Photograph 9). The extent of ponding appeared similar to 2021; it is noted that this area represents a zone where the natural topography drains towards the dam toe, such that some accumulation at this location is expected.

Photo 9 : Dam 2A – View of the water accumulation at the toe of the dyke, essentially unchanged since 2021.

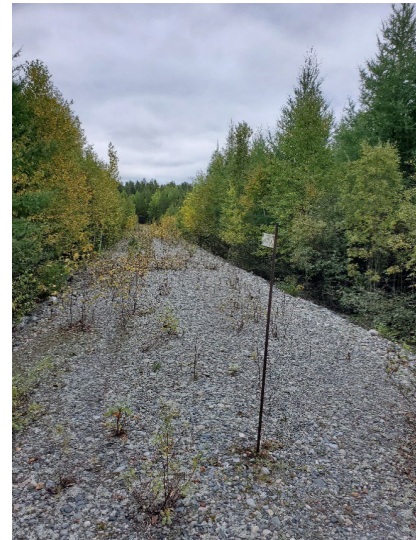
Photo 11 : Dam 4A which does not currently retain water.
Note: limited vegetation on slopes and ridge.

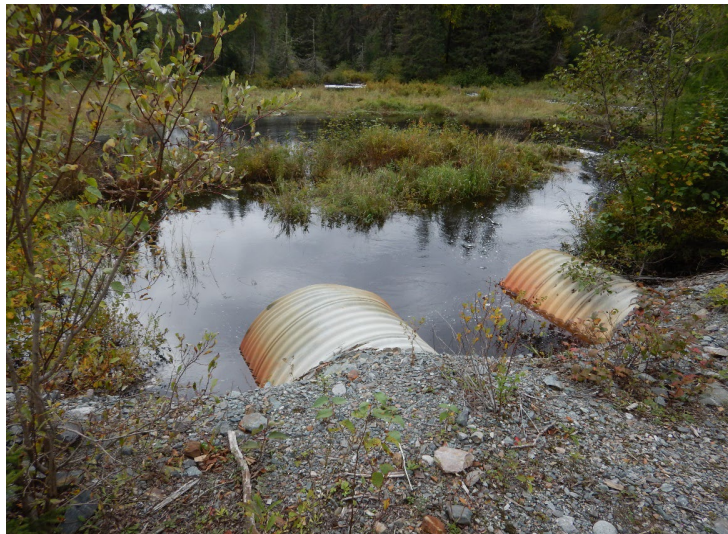
Photo 10 : Culverts on the unnamed creek, northwest of the tailings pond. Water levels were higher than flow in 2021, a possible reflection of significant rainfall on 19 September. No evidence of recent beaver activity in the culverts.

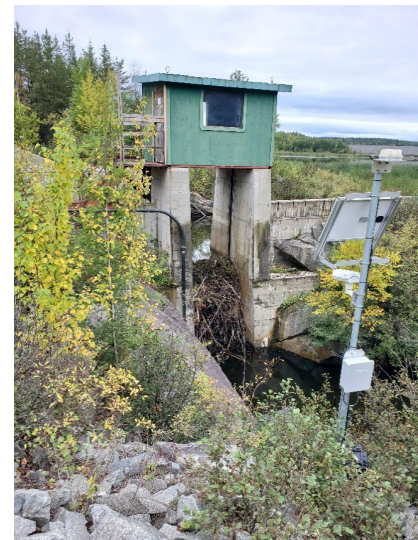
- The main spillway at Dam 4B showed evidence of significant debris accumulation (Photograph 12). It is noted that this debris was removed in 2022 subsequent to the site inspection.

Photo 12 : Dam 4B main spillway – accumulation of debris showing beaver activity in the spillway. It is noted that this debris was removed later in 2022, subsequent to the site inspection.

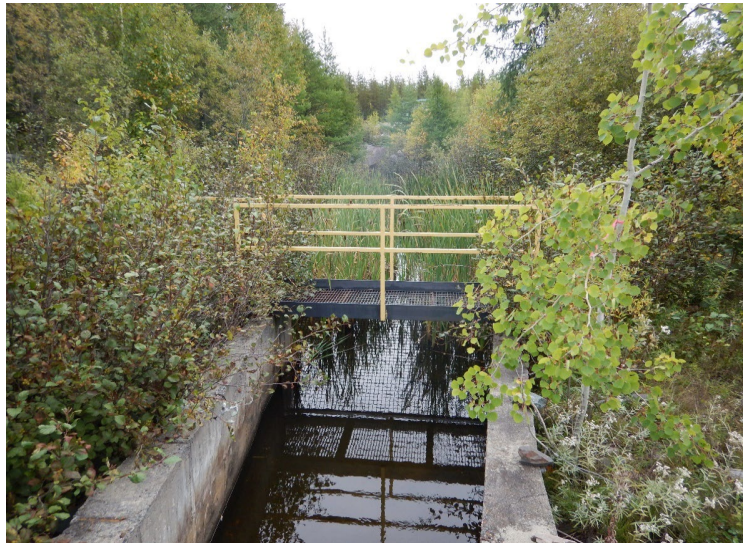
Photo 13 : Dam 4B – Downstream view of the spillway. Outflow channel from the spillway to the Parshall flume contains significant vegetation

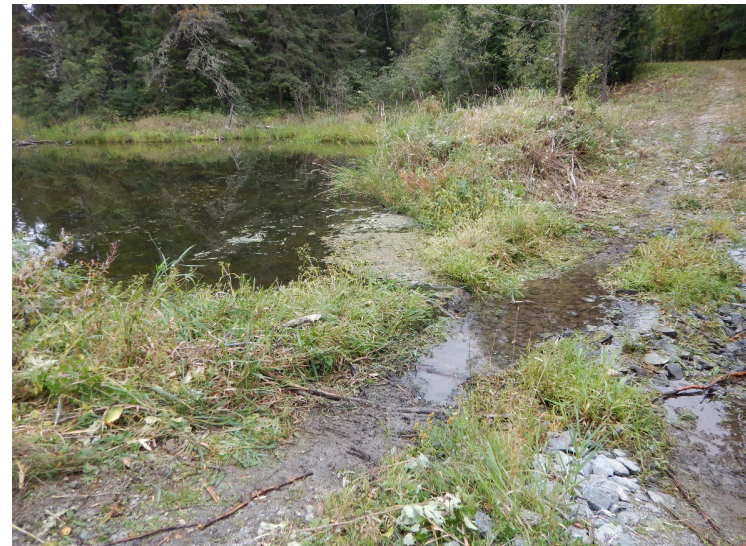
Photo 15 : Foot of dam 4B. Beaver blockage of 2021 removed, with no recurrence of the blockage at the time of 2022 inspection.

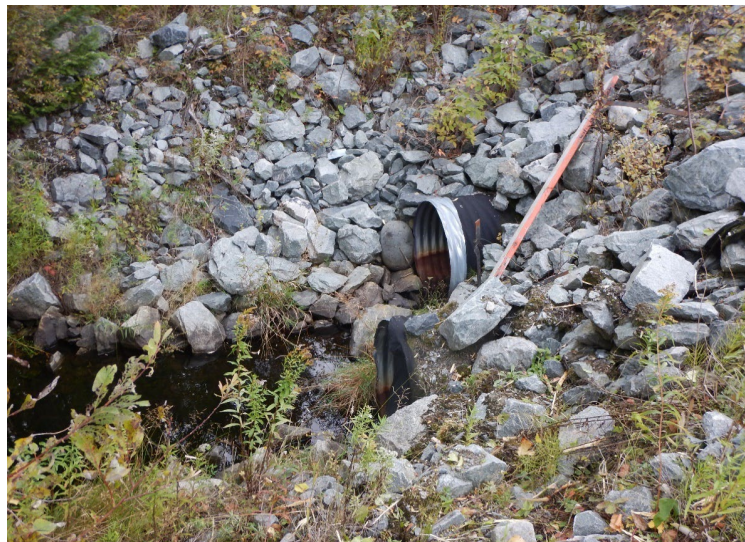
- Culverts at the final effluent point were clear although some limited vegetation is present upstream of these culverts (Photograph 14). There was no significant flow through the outflow culverts.
- The Dam 4B crest was generally in good condition and unchanged from 2020. Survey monuments are visible. No noticeable changes were visually apparent (i.e., damage) to the survey monuments.
- Beaver activity observed at the toe of Dam 4B during the 2021 site inspection was removed in 2021 and no recurrence of beaver blockage has occurred at the time of the 2022 inspection (Photograph 15).

Photo 14 : Outlet channel of the site. Note the limited vegetation upstream of the channel.
