Klohn Crippen Berger

Teck Metals Ltd.

Pine Point Mine Tailings Impoundment Area

2022 Annual Facility Performance Review

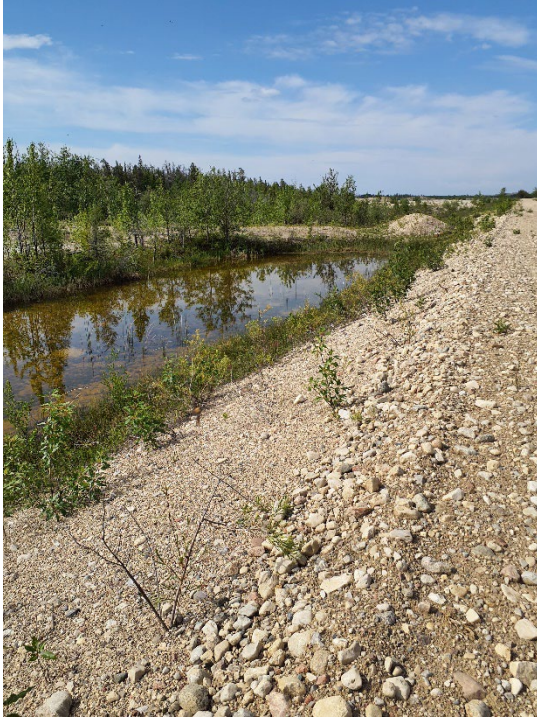
- The South Dyke crest and upstream and downstream slopes were in good condition (Photo II-1 to Photo II-6).
- There was ponded water near the downstream toe of the South Dyke in various locations. The Tailings Surveillance Officer indicated these are permanent pond features (Photo II-1 and Photo II-5).

Photo II-1 South Dyke – looking southwest, permanent pond at downstream toe

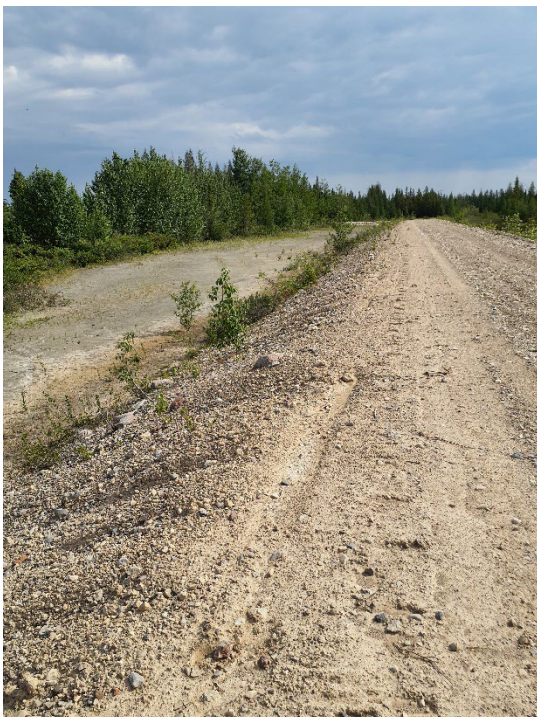
- There were minor rills at several locations on the upstream and downstream slopes of the dyke; none requiring immediate maintenance or repair (Photo II-2 and Photo II-3).

Photo II-2 South Dyke – looking east, minor rills on upstream slope, exposed tailings

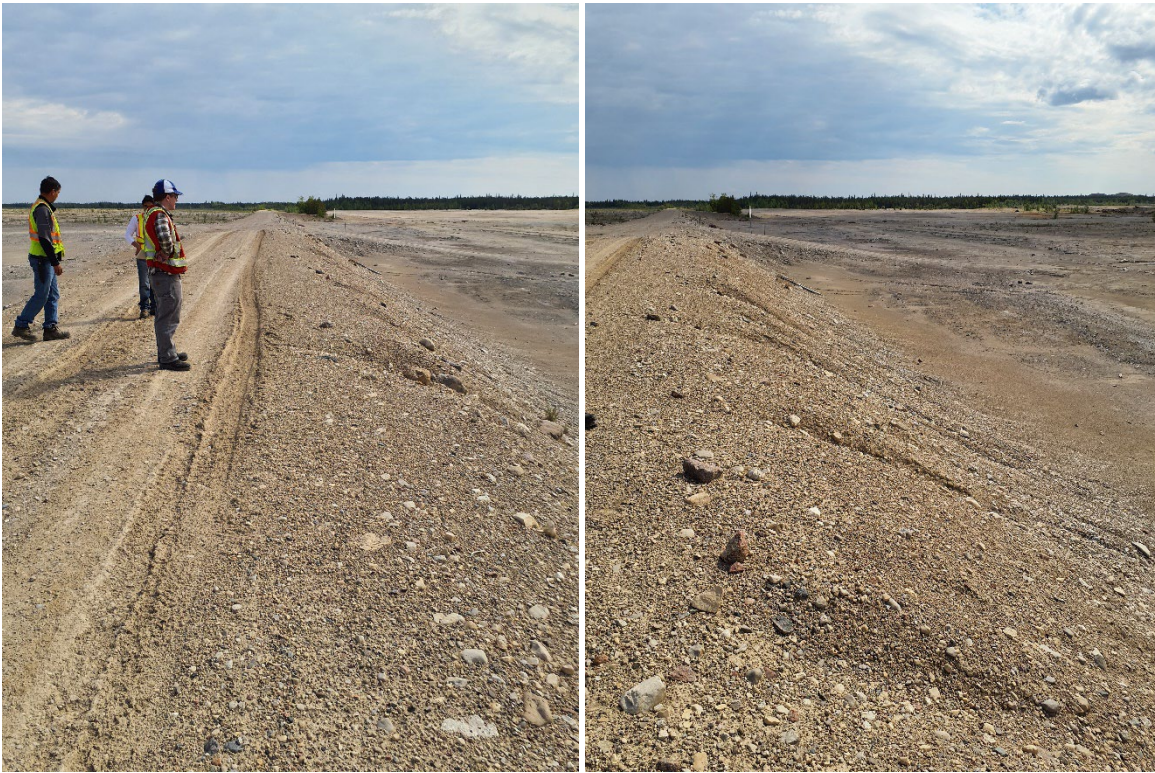
Photo II-3 South Dyke – looking east, rutting on crest and rills on downstream slope

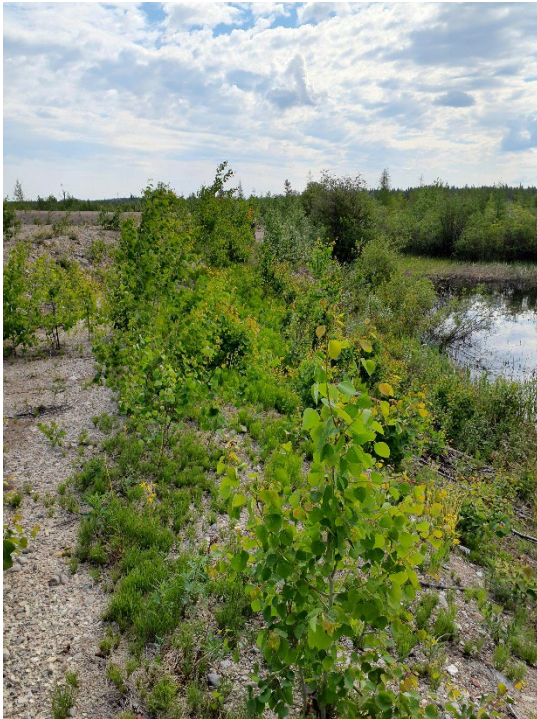
Photo II-5 South Dyke – looking southeast, vegetation on downstream slope and permanent pond at toe

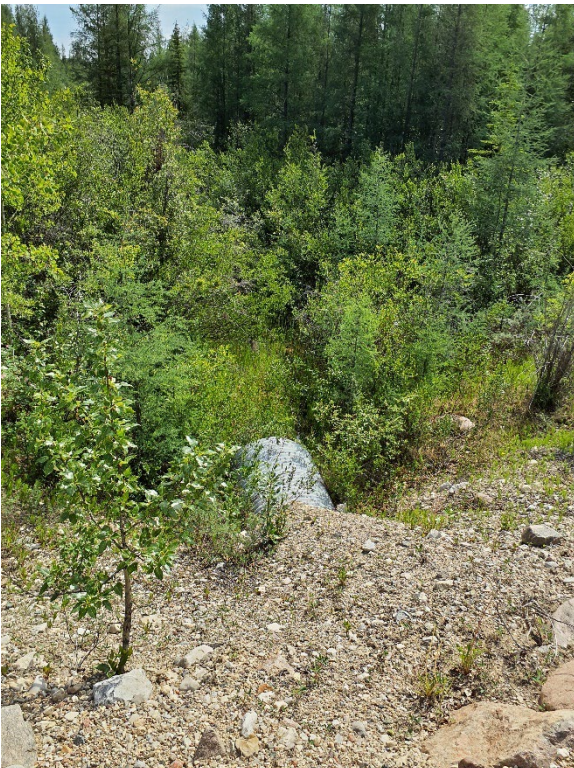
Photo II-6 South Dyke – looking east, culvert inlet at southwest access road

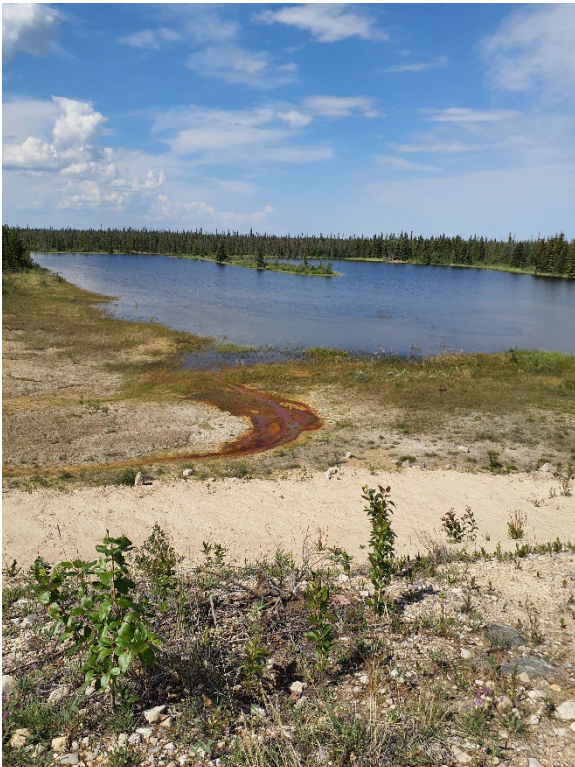
- The West Dyke crest and upstream and downstream slopes were in good condition (Photo II-7 to Photo II-12).
- Maintenance was completed at the two locations of “severe erosion” identified in the 2021 AFPR (Photo II-10 and Photo II-11). The maintenance consisted of regrading the dyke fill, and granular materials were not imported for use. There has been some washing of the fines from the repaired areas and there is minor rilling on the slope.
- Ponding was observed downstream of the toe in some areas, including two larger ponds at the north end. At the dyke toe minor seepage with red staining was observed flowing into these larger ponds (Photo II-10). The seepage water was clear.

Photo II-10 West Dyke – looking west at the permanent pond downstream

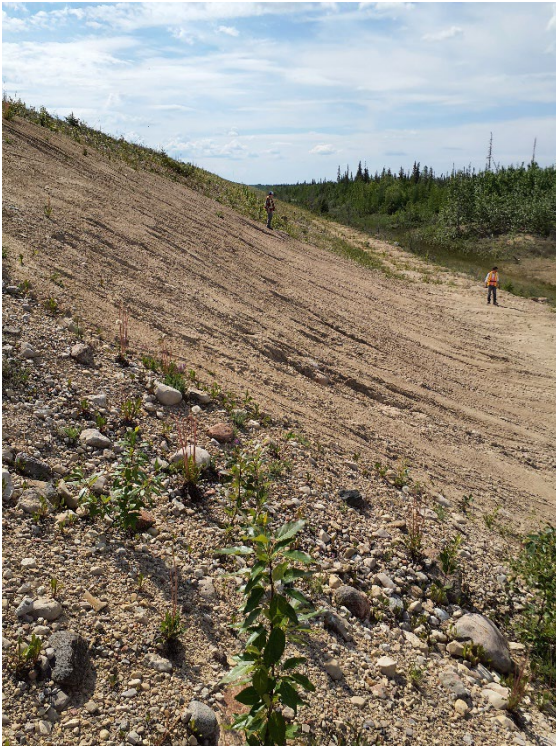
Photo II-11 West Dyke – looking south at an area of 2021 maintenance that saw some minor rill erosion during the 2022 spring melt

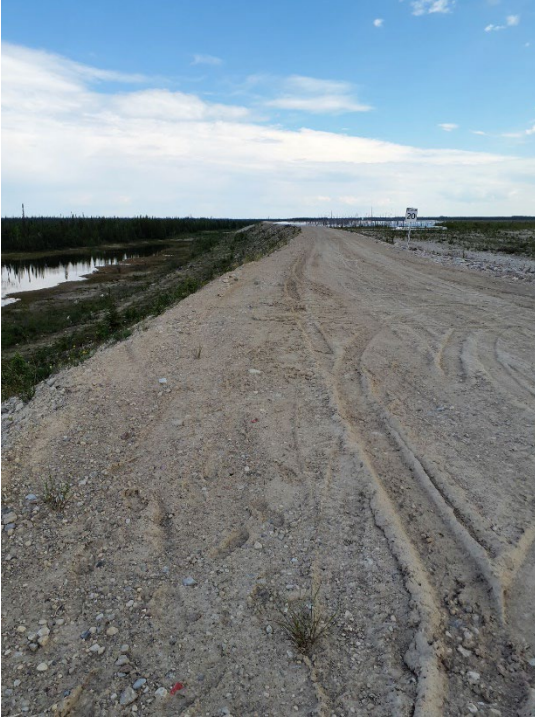
- The North Dyke crest and upstream and downstream slopes were in good condition (Photo II-13 to Photo II-21). Some minor rutting of the crest and rills on the slopes, but none requiring immediate repair.
- The Main Pond was in contact with the upstream slope of the North Dyke across most of its length, apart from a ~200 m zone near the northwest corner. The riprap placed in 2021 is in good condition (Photo II-18, Photo II-19, Photo II-20).
- Ponds were observed downstream of the toe in some areas (Photo II-14, Photo II-15, Photo II-17). No active seepage was observed at the downstream toe.
- Woody debris has been piled near the corner of the North and West Dykes (Photo II-40). This debris is within the Main Pond limits during the inflow design flood and could therefore be mobilized and block the spillway.

Photo II-13 North Dyke – looking east, some rutting on dyke crest

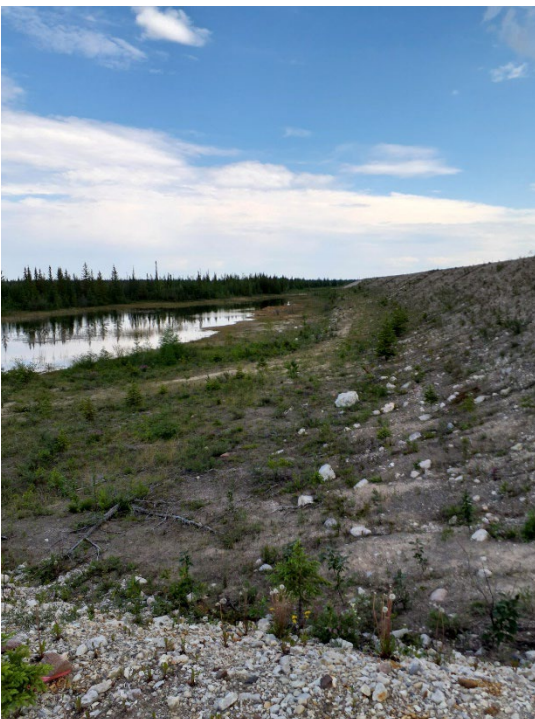
Photo II-14 North Dyke – looking east at the downstream slope and permanent pond at toe

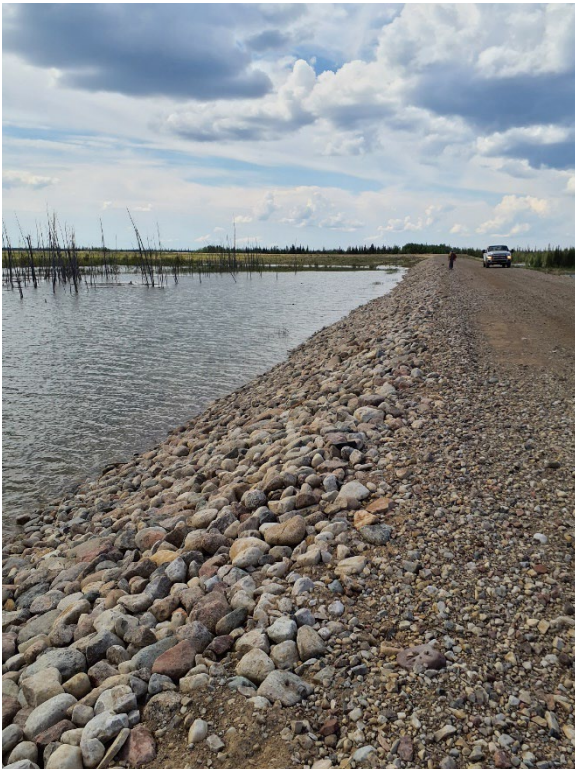
Photo II-18 North Dyke – looking west at the downstream slope where riprap was placed in 2021

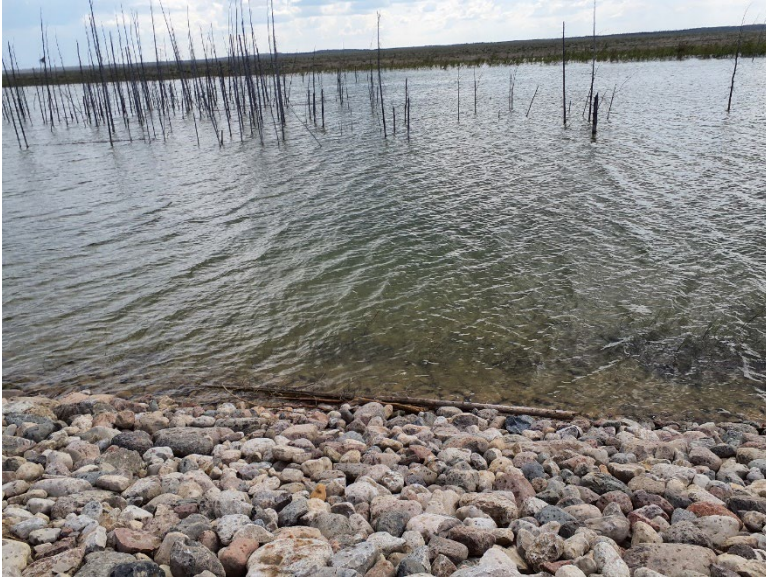
- The concrete Main Pond Spillway structure appeared to be in good condition (Photo II-23, Photo II-24, Photo II-25).
- There are dead trees in the Main Pond, and it is possible that debris mobilized during an extreme flood could reduce the flow capacity of one or both spillways.

Photo II-19 North Dyke – looking south at the 2021 riprap and the trees in the pond

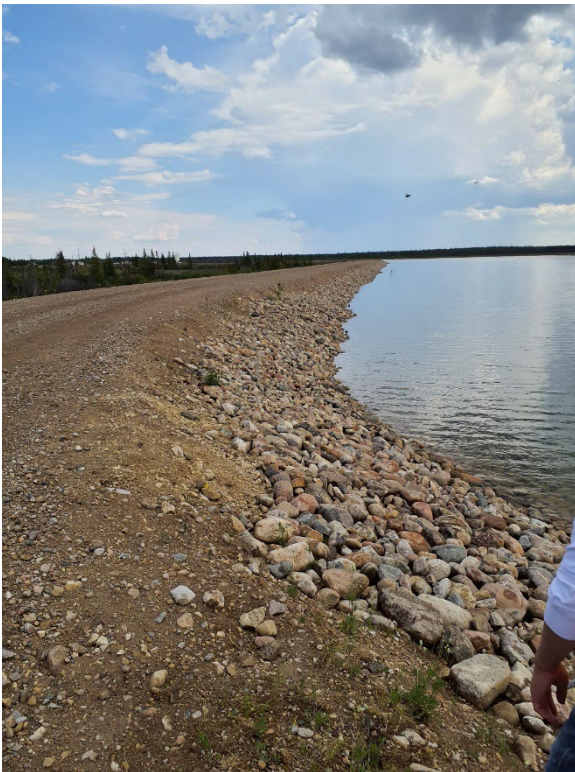
Photo II-20 North Dyke – looking east at the upstream slope and 2021 riprap installation

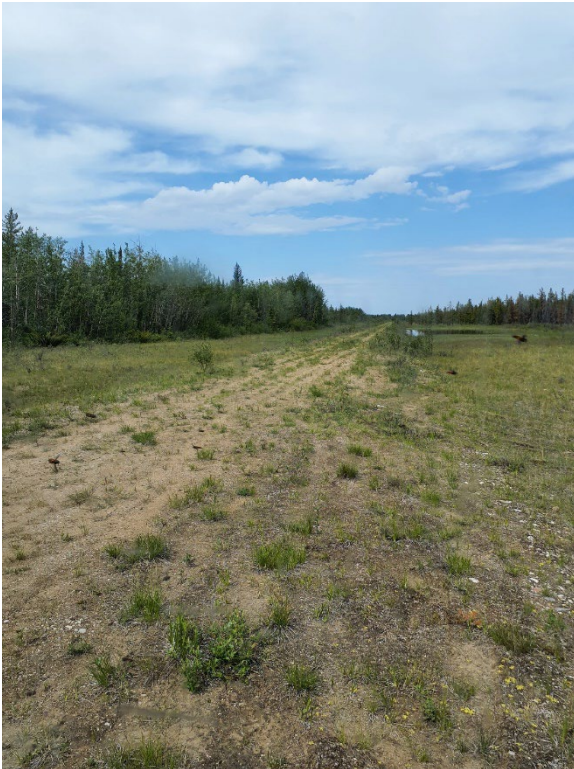
- The East Dyke crest and upstream and downstream slopes were in good condition (Photo II-22).
- There is a permanent pond near the southern end and a seasonal pond near the northern end (Photo II-22).

Photo II-22 East Dyke – looking north at the downstream slope and at the permanent pond located at the downstream toe

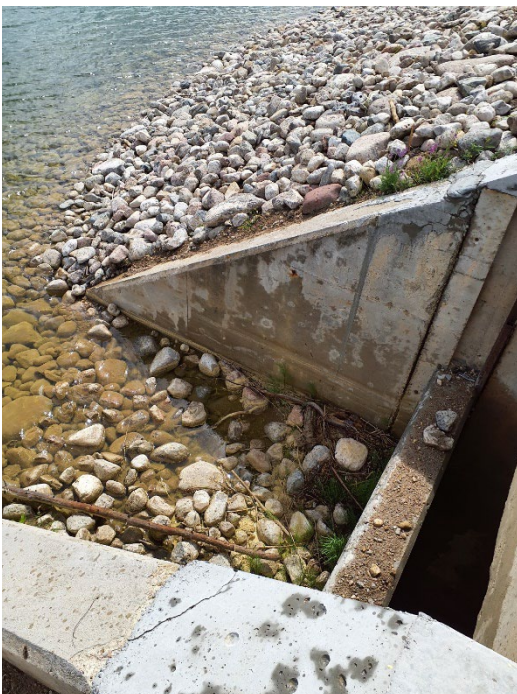
Photo II-24 Main Pond Spillway – looking at the inlet to see the height of the clay plug upstream of the concrete wall

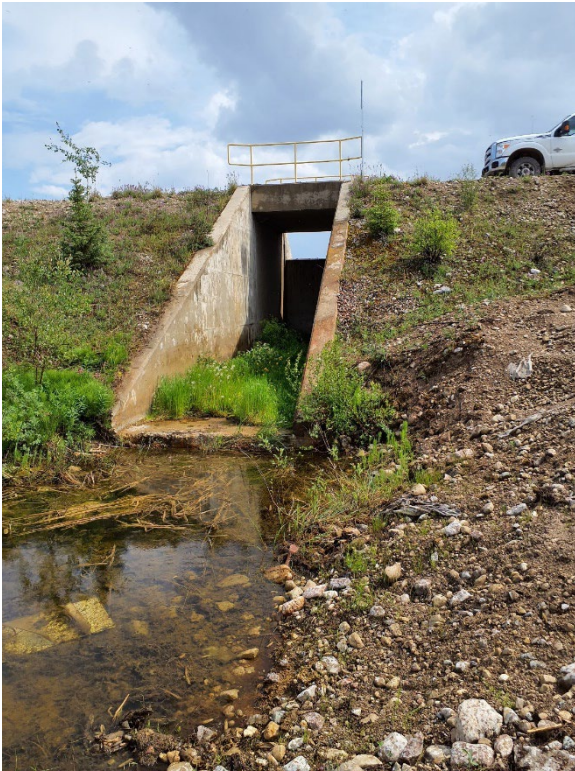
Photo II-25 Main Pond Spillway – looking south into the spillway and at the material at the outlet

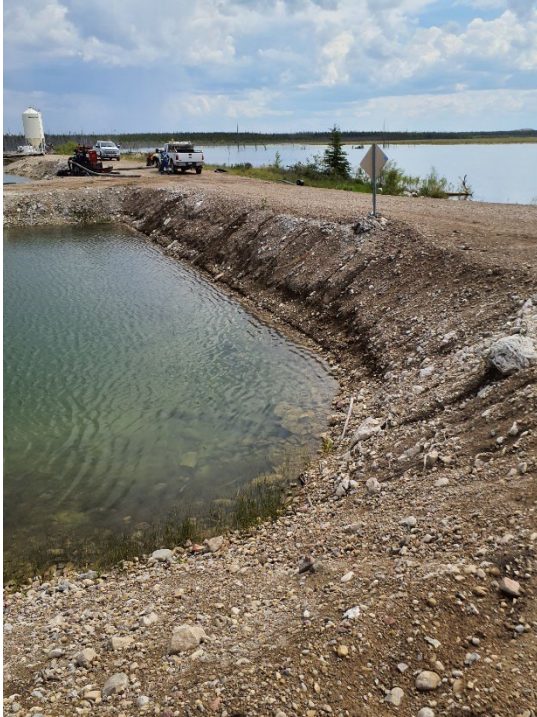
- The Polishing Pond Dykes were in good condition (Photo II-26 to Photo II-31).
- There has been erosion of the upstream slope of the North Dyke and along the Finger Dykes at the Polishing Pond winter water level. This erosion is not currently a major issue, but the condition of the dyke should be inspected during future site inspections and Teck may choose to repair it before the condition deteriorates as part of a best management practice.

Photo II-26 Polishing Pond – looking south; some wave erosion at the winter pond level

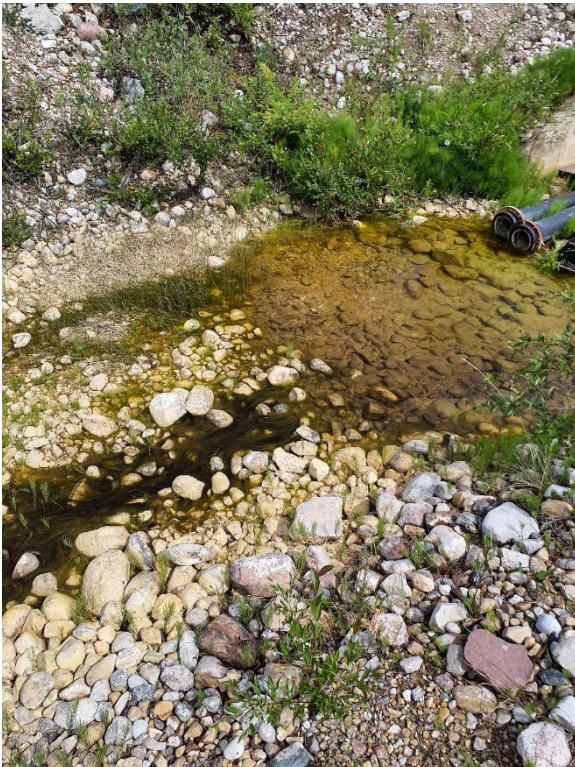
- The concrete Polishing Pond Spillway structure appeared to be in good condition (Photo II-32 and Photo II-35).
- There was no flow in the siphons during the inspection. There was some minor flow in the gravels downstream of the spillway outlet; the seepage was clear (Photo II-35).

Photo II-35 Polishing Pond Spillway – looking at the outlet

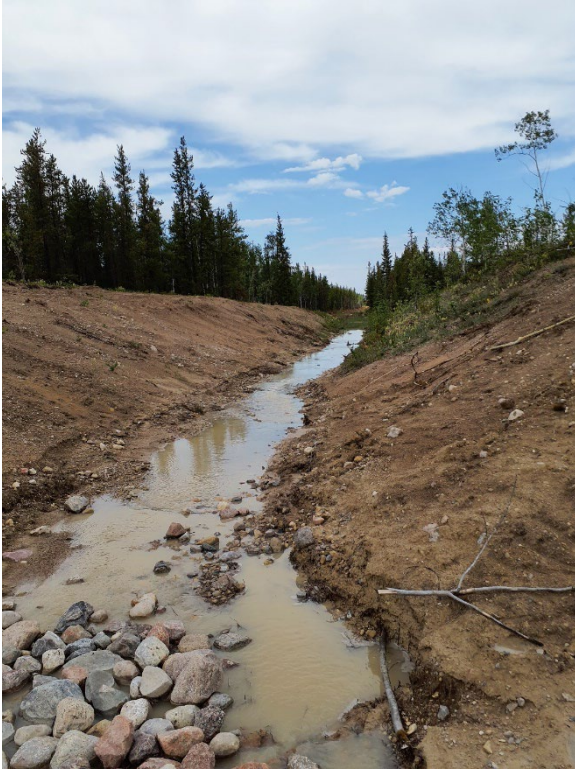
- There was ponded water at the inlet to the East Diversion Ditch (Photo II-1) and flow in the northern portion of the East Diversion Ditch (Photo II-37, Photo II-38 and Photo II-39).
- There was a minor slump in the side of the repaired section of the ditch (Photo II-39) which could restrict flow if it retrogresses. This slump does not impact the TIA's ability to manage the design flood; however, Teck could consider maintenance of the ditch as a best management practice.

Photo II-39 East Diversion Ditch – looking north at a section of 2021 maintenance

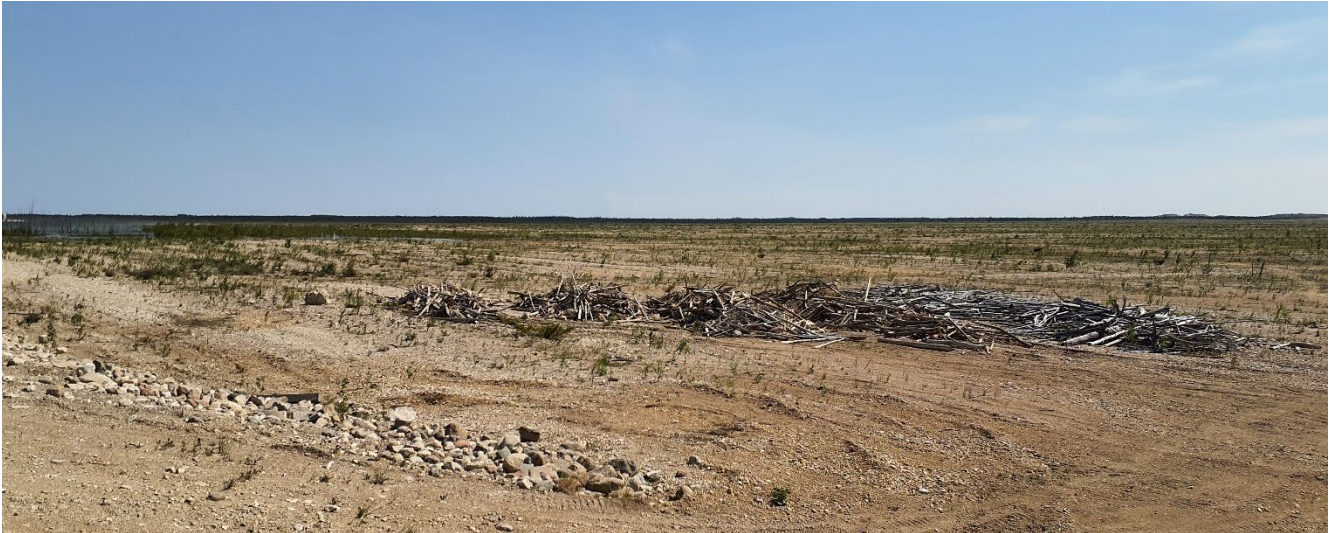
Photo II-40 Looking southeast at the debris piles
