2022 Annual Facility Performance Report

Red Dog Tailings Storage Facility

Red Dog Mine, Alaska

31404122.007-002-R-Rev0

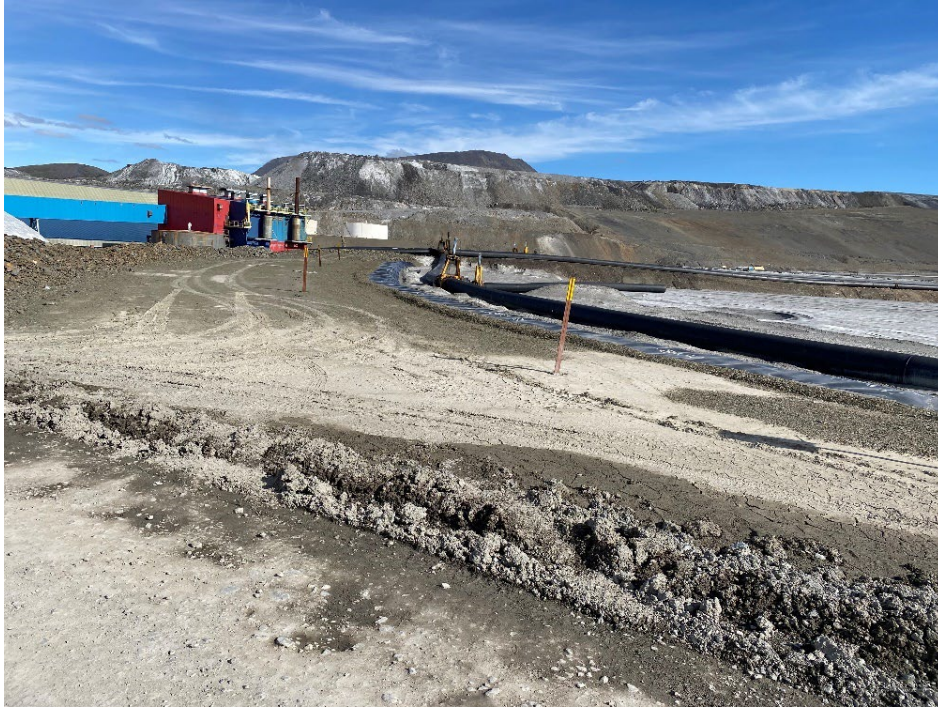
West abutment of Embankment appeared to be in satisfactory physical condition with no indications of erosion, deterioration, horizontal displacement, or other instability (see Photos 1 and 6).

Photo 6: Downstream Slope and Buttress at West Abutment of Embankment

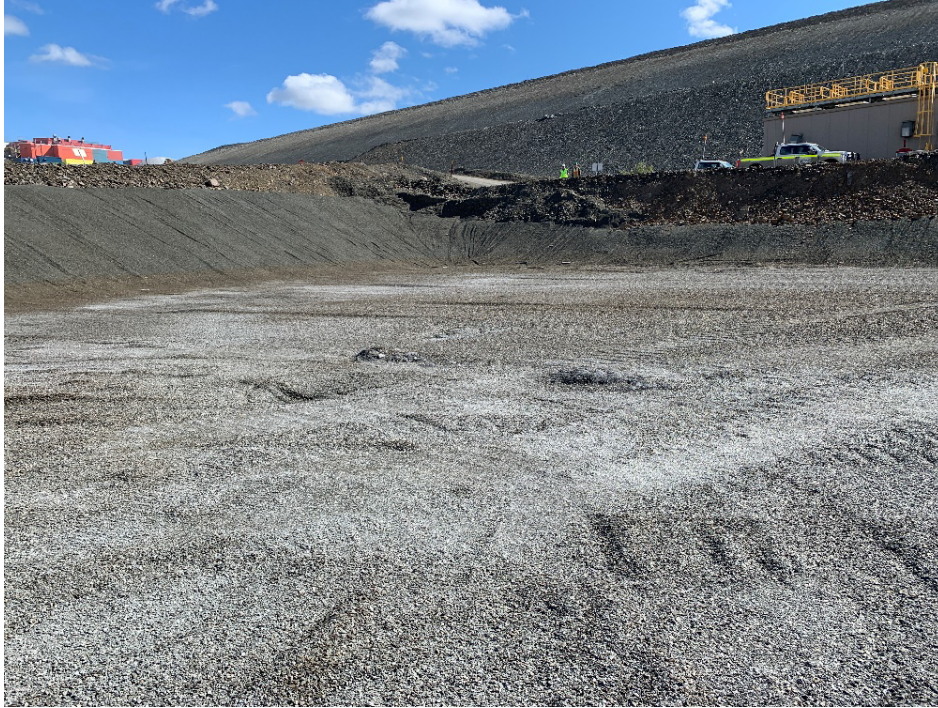
- Some divots were noted in the Soil Type 11 materials covering the geomembrane liner along the floor of the Seepage Collection Pond (see Photo 6). The concern is that the divots may have been produced by the dozer during grading of the Soil Type 11 materials and could have damaged the liner. As a best management practice, recommend using care and soft tooling methods to inspect the liner at these locations and make any repairs, as necessary. Following inspection, the minimum 1 ft thickness of Soil Type 11 should be replaced over the liner. This inspection should be accomplished either this year before winter starts and freezing conditions/snow cover or during the continuing Stage XII construction when the geomembrane liner subcontractor is on site.*

Photo 9: Divots in Seepage Collection Pond Cover Soil

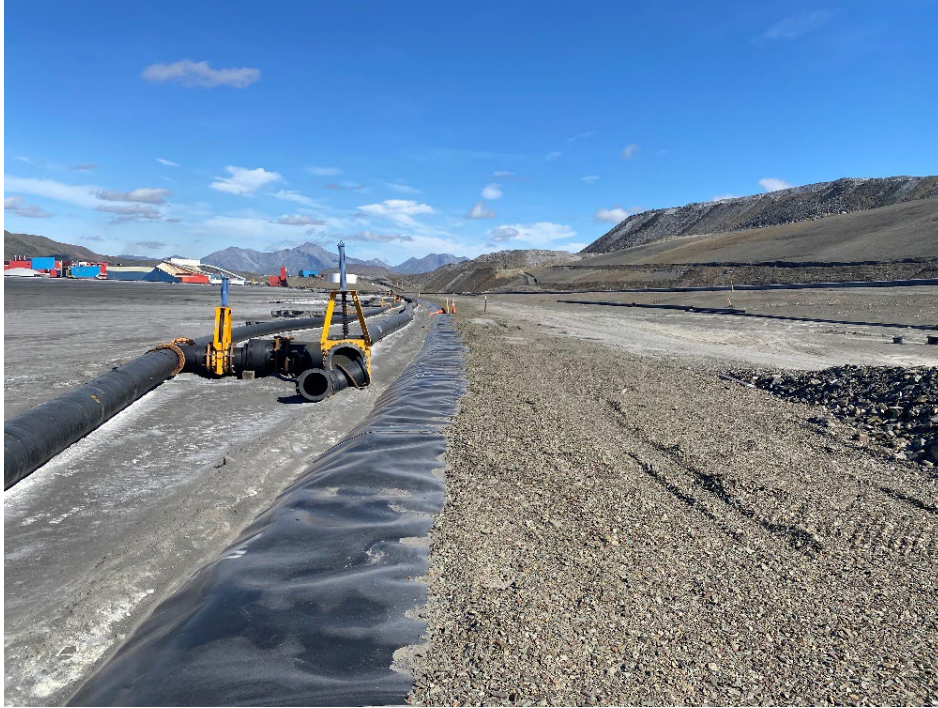
The dam crest appeared to be in satisfactory physical condition with no indications of settlement, cracking, or stability issues (see Photos 2, 3, 5, and 14 to 17). Tire tracks in soft soils were observed along crest of TMD Embankment (see Photo 2) that showed equipment had driven inside of the delimitation markers (either safety candles or reflectors) and came close to the exposed geomembrane liner near the anchor trench at several locations. Driving over the geomembrane liner without protective cover could damage the liner. We understand these occurred during the ongoing Stage XII raise construction and that the contractor had already been notified to stay outside of the delimitation markers. No apparent damage to the geomembrane liner was observed.

Photo 15: Upstream Slope and Crest at South Leg of Wing Wall

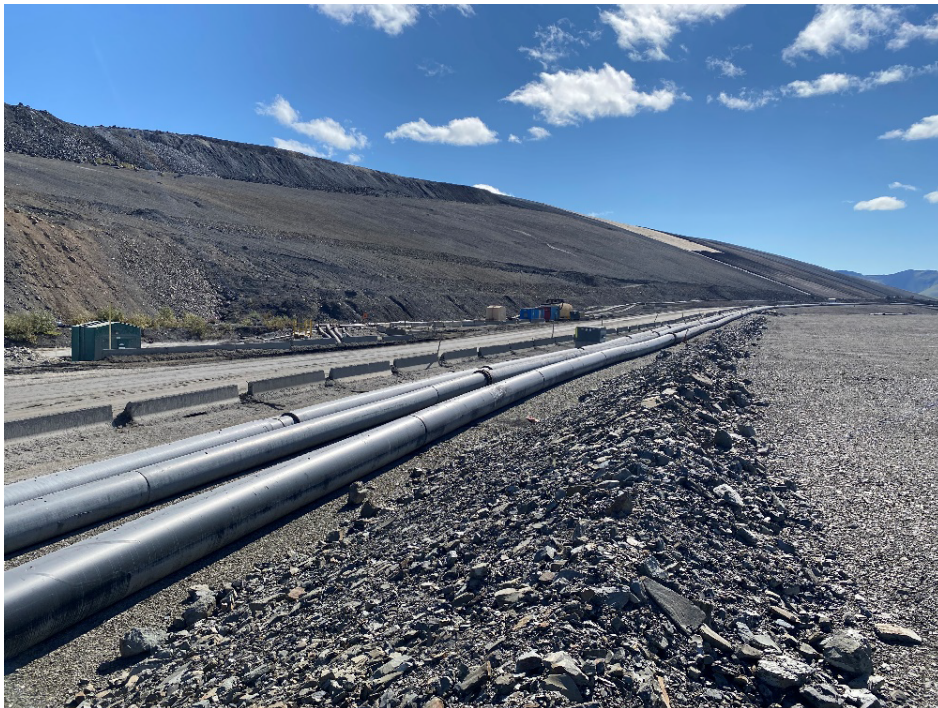
Photo 16: Downstream Slope and Crest at South Leg of TMD Wing Wall

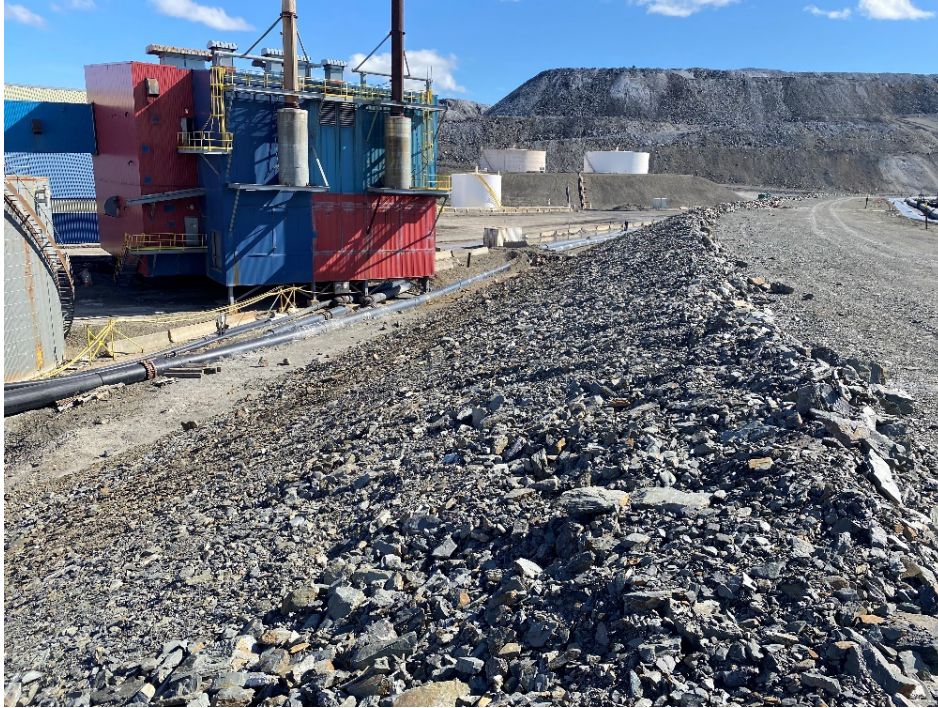
Photo 17: Downstream Slope and Crest at North Leg of TMD Wing Wall
