**Teck Metals Ltd.**

**Sullivan TSF 2022**

***Annual Summary of Tailings Facility  
Performance Report***

A05807A22

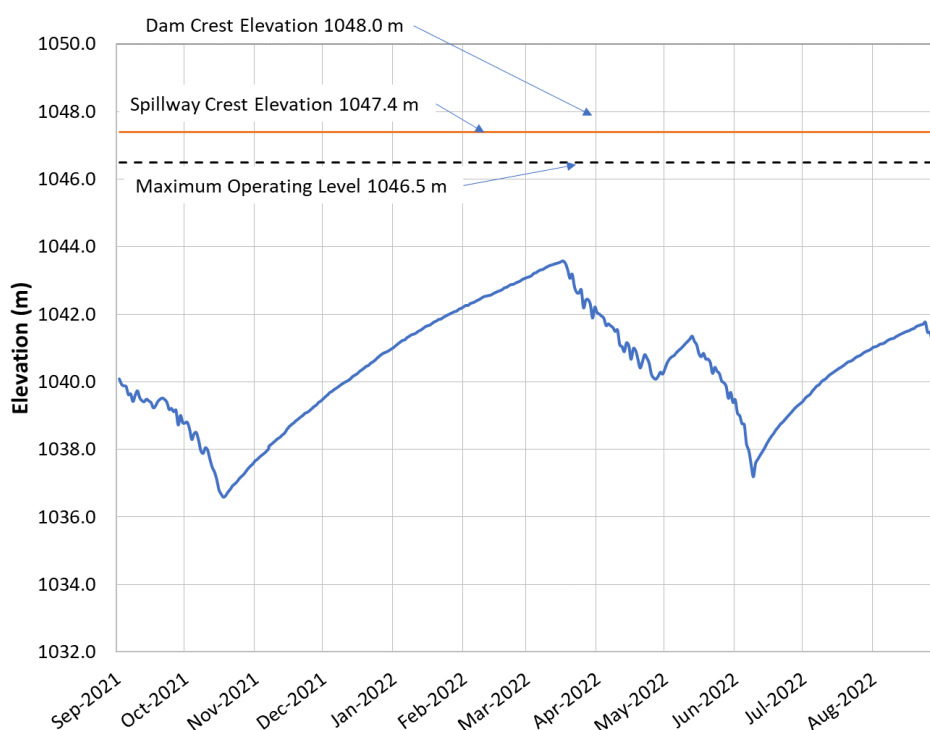
**Figure 3.2 ARD Pond Level 2021 – 2022**

Based on the pond water levels, the maximum level observed during the reporting period was El. 1043.6 m, which occurred on March 16, 2022. This is 2.9 m lower than the maximum operating level (MOL) and is 3.8 m below the spillway crest elevation. There was no water discharged from the ARD Pond spillway to the Iron Pond during the water balance reporting period. The spillway has never discharged since the ARD pond was constructed.

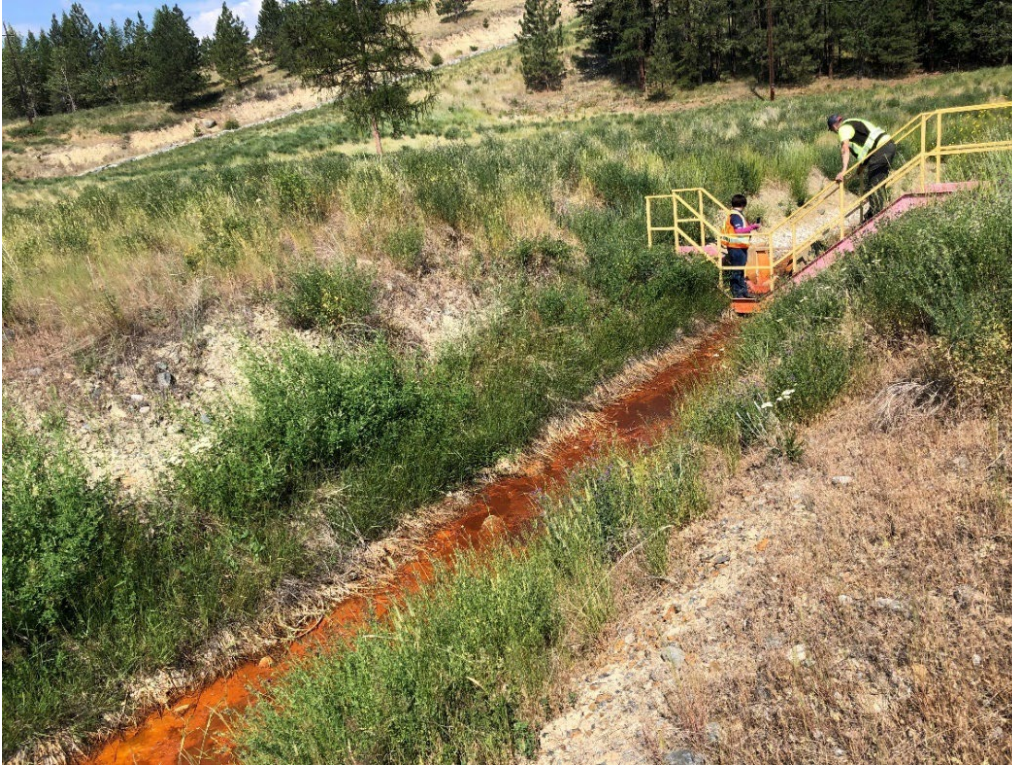
**Photo II.16 Weir #4 worn notch**

- Backfilling of a void near the 943 pump station.
- Repair of steel v-notch weir plates.
- Lowering of low operating level in the Iron Pond.
