Bullmoose Mine

2017 Dam Safety Inspection

Bullmoose Tailings Dam

Bullmoose Mine
Bullmoose Tailings Dam
2017 Dam Safety Inspection – Rev. 1

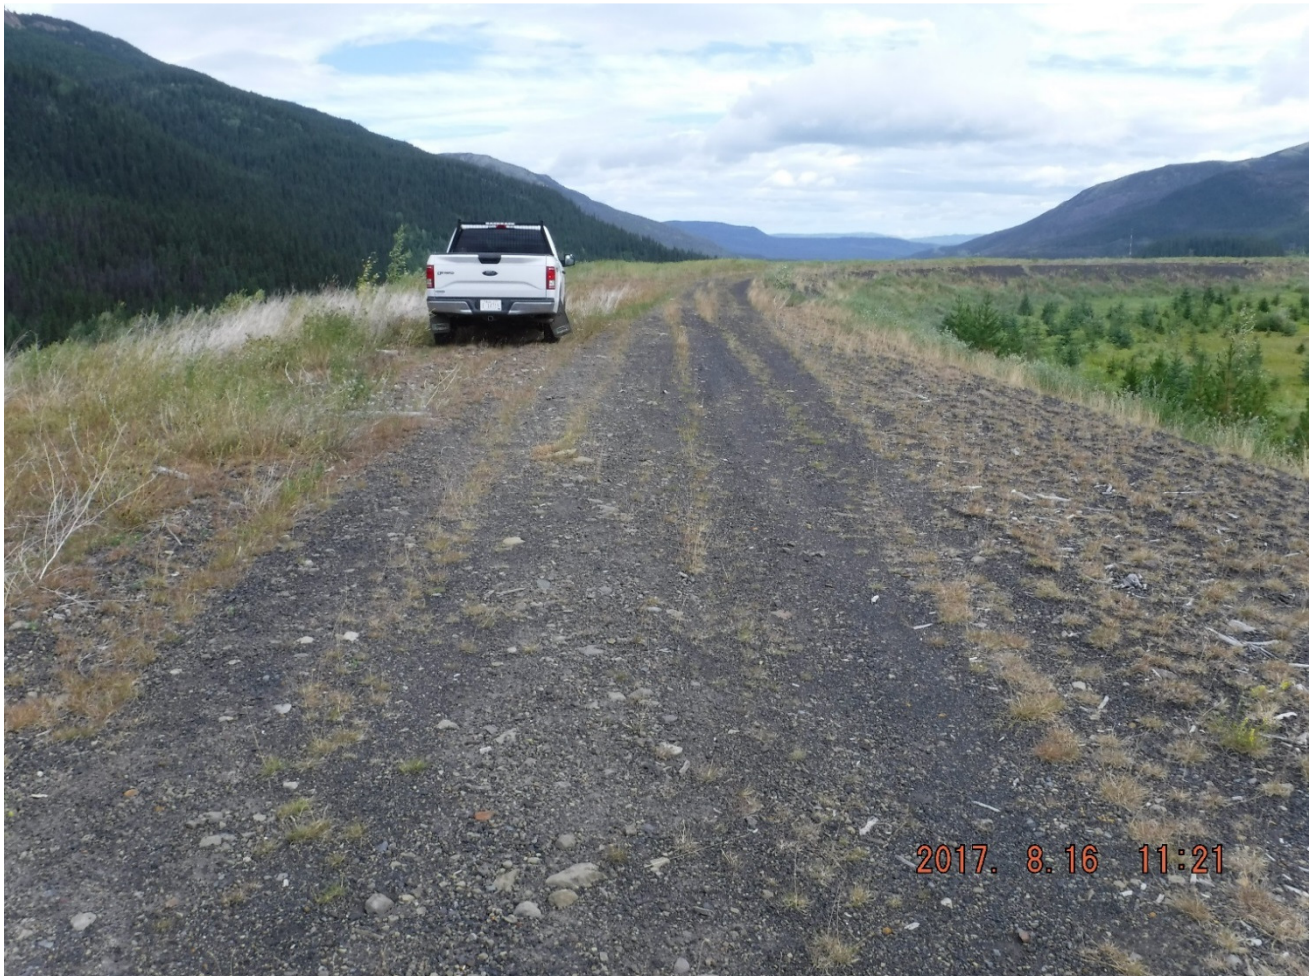
Photo II-1 Overview of BTD crest – good condition and no sign of erosion, settlement or cracking (BTD-2017-01)

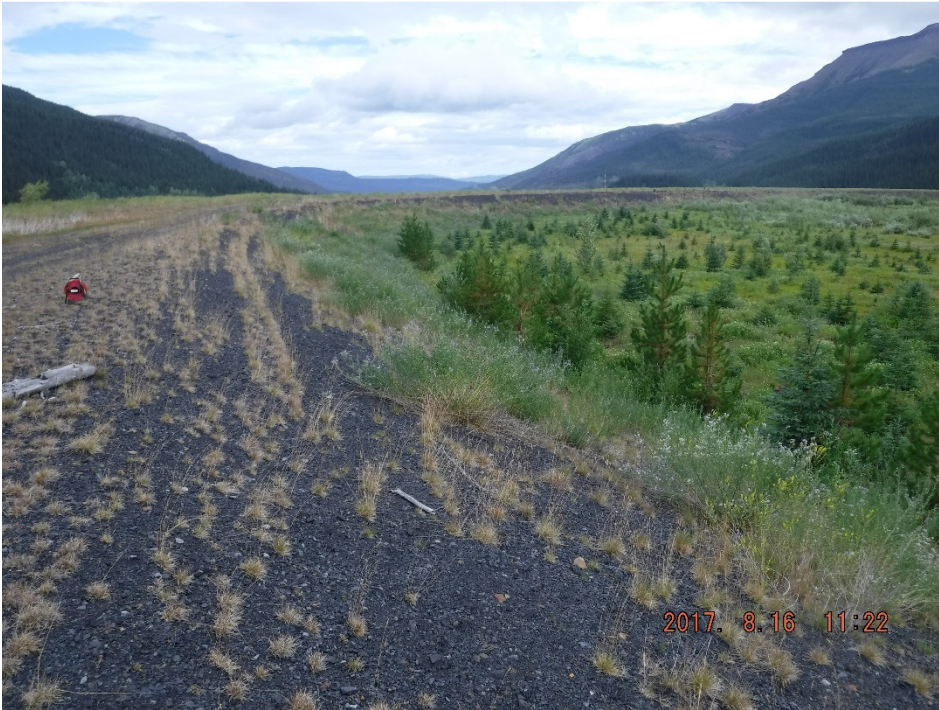
Photo II-2 Overview of upstream slope - looking northeast. Slope is in good condition and no sign of distress (BTD-2017-02)

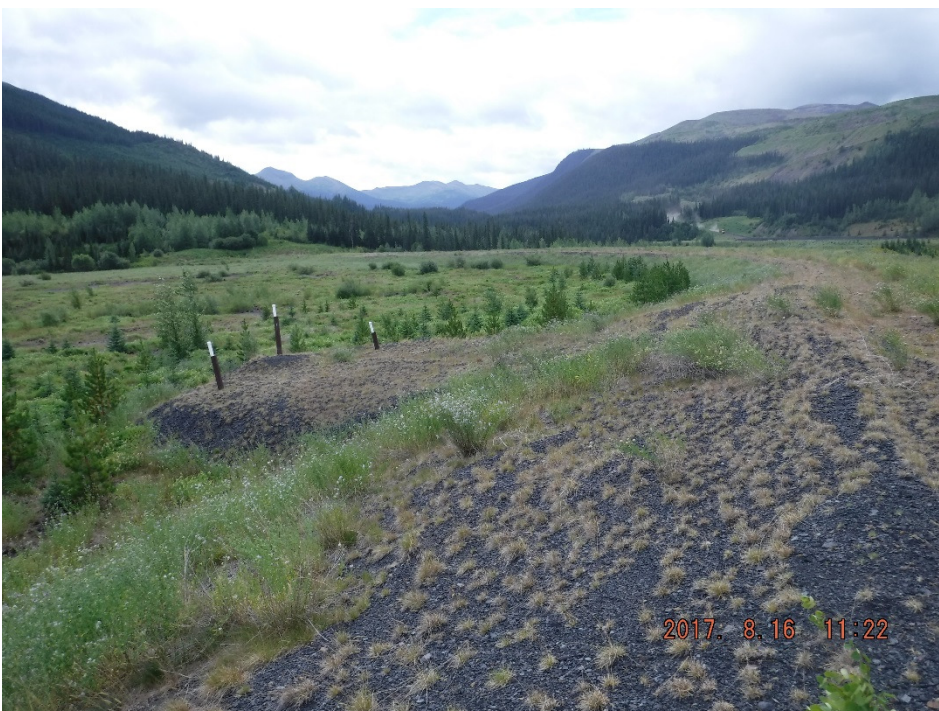
Photo II-3 Overview of upstream slope - looking southwest. Slope is in good condition and no sign of distress (BTD-2017-02)

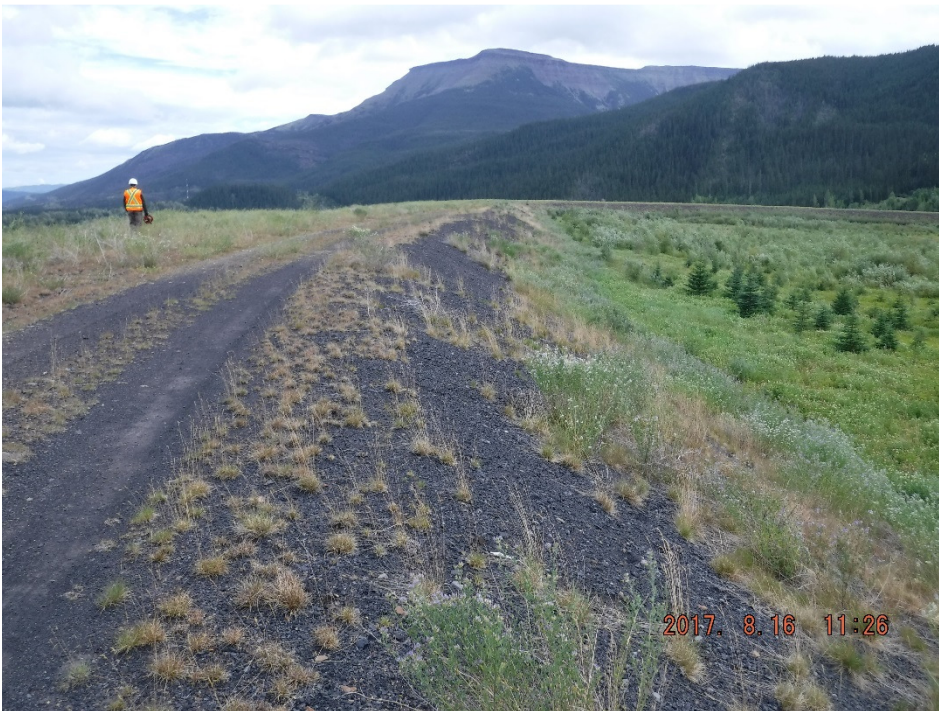
Photo II-4 **BTD crest and upstream slope - looking northeast; no sign of distress (BTD-2017-03)**

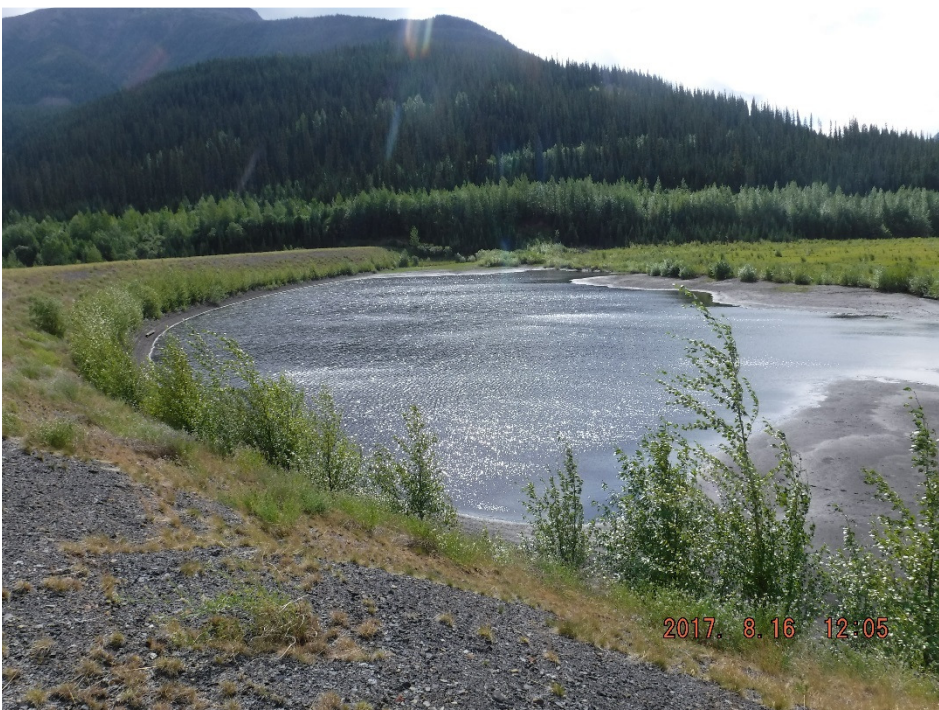
Photo II-5 **Overview of vegetated tailings surface and ponded area - looking southeast; pond is smaller than previous year (BTD-2017-04)**

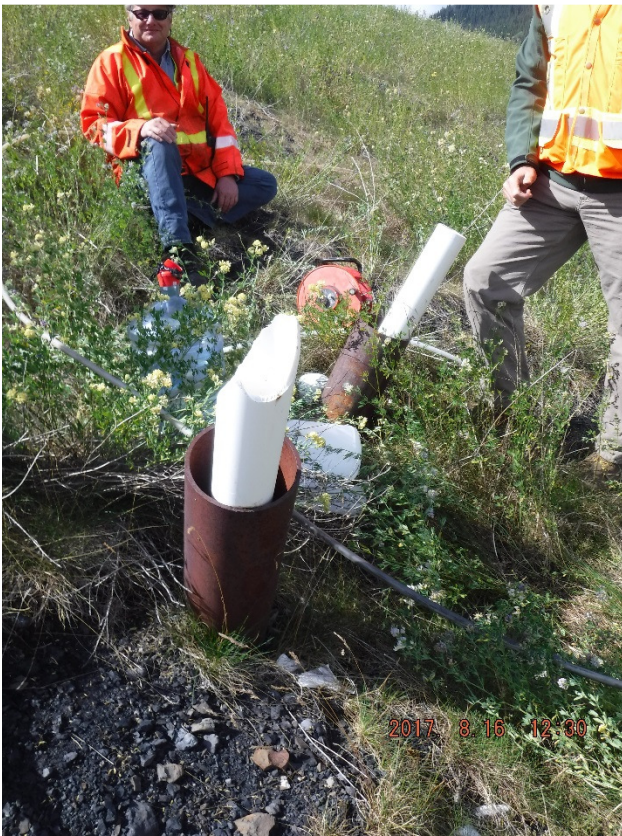
Photo II-8 Standpipe piezometers PA-1 and PA-2. PA-1 top of casing requires repair.

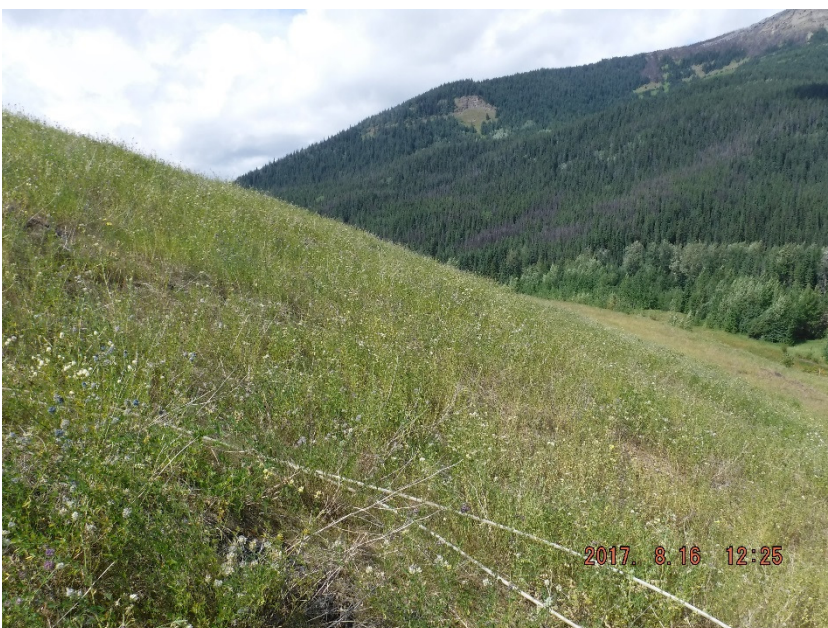
Photo II-9 Overview of the upper portion of the downstream slope – looking northwest. No sign of erosion or distress (BTD-2017-06)

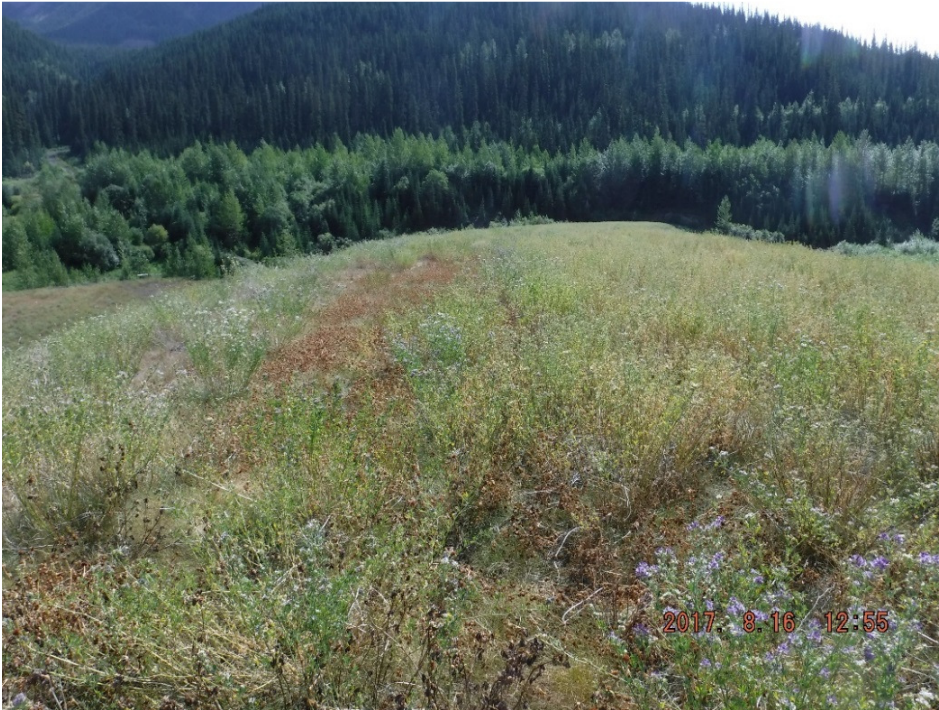
Photo II-10 **BTD crest – well vegetated. Minor rutting from vehicle traffic observed (BTD-2017-07)**

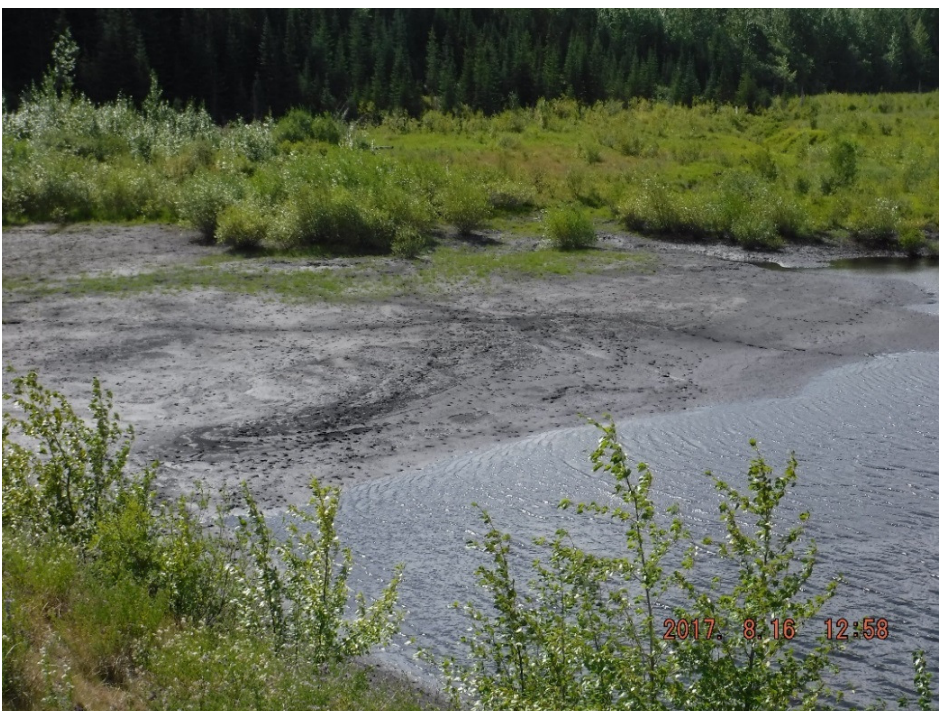
Photo II-11 **Looking south at tailings beach from the BTD crest – animal tracks on tailings surface observed (BTD-2017-08)**

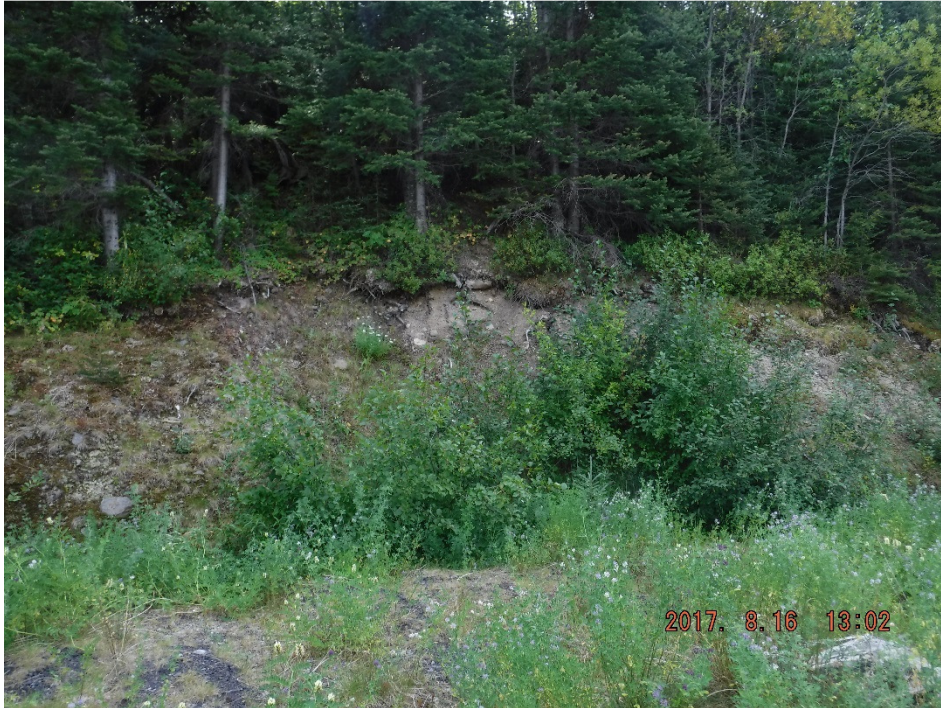
Photo II-12 Over view of BTD east abutment – more vegetation than 2016 (BTD-2017-09)

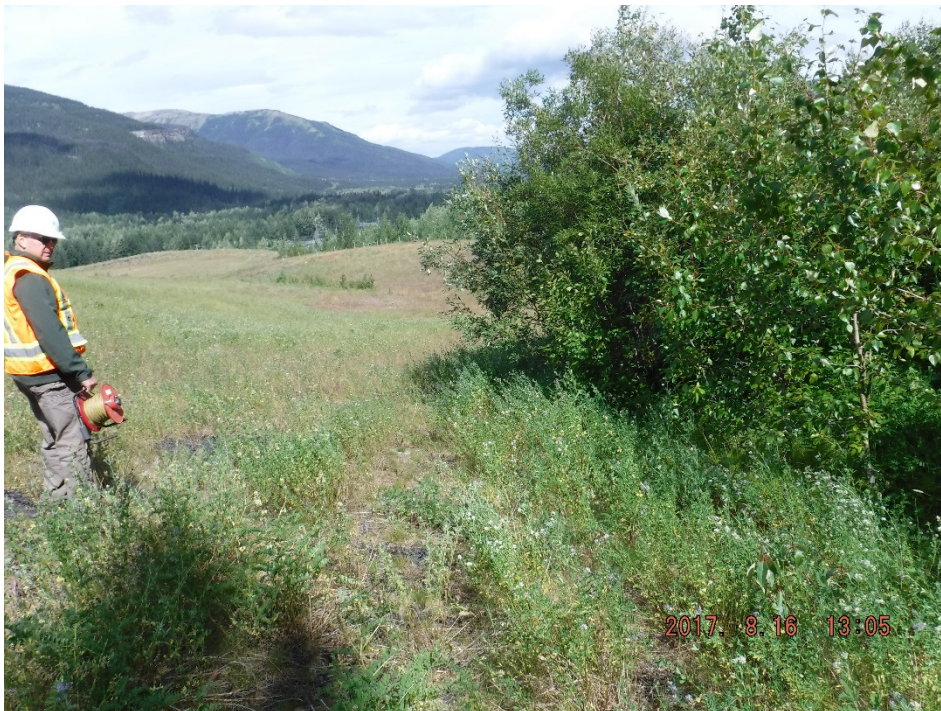
Photo II-13 Looking northeast along the downstream slope and east abutment contact – vegetation is well established (BTD-2017-10)

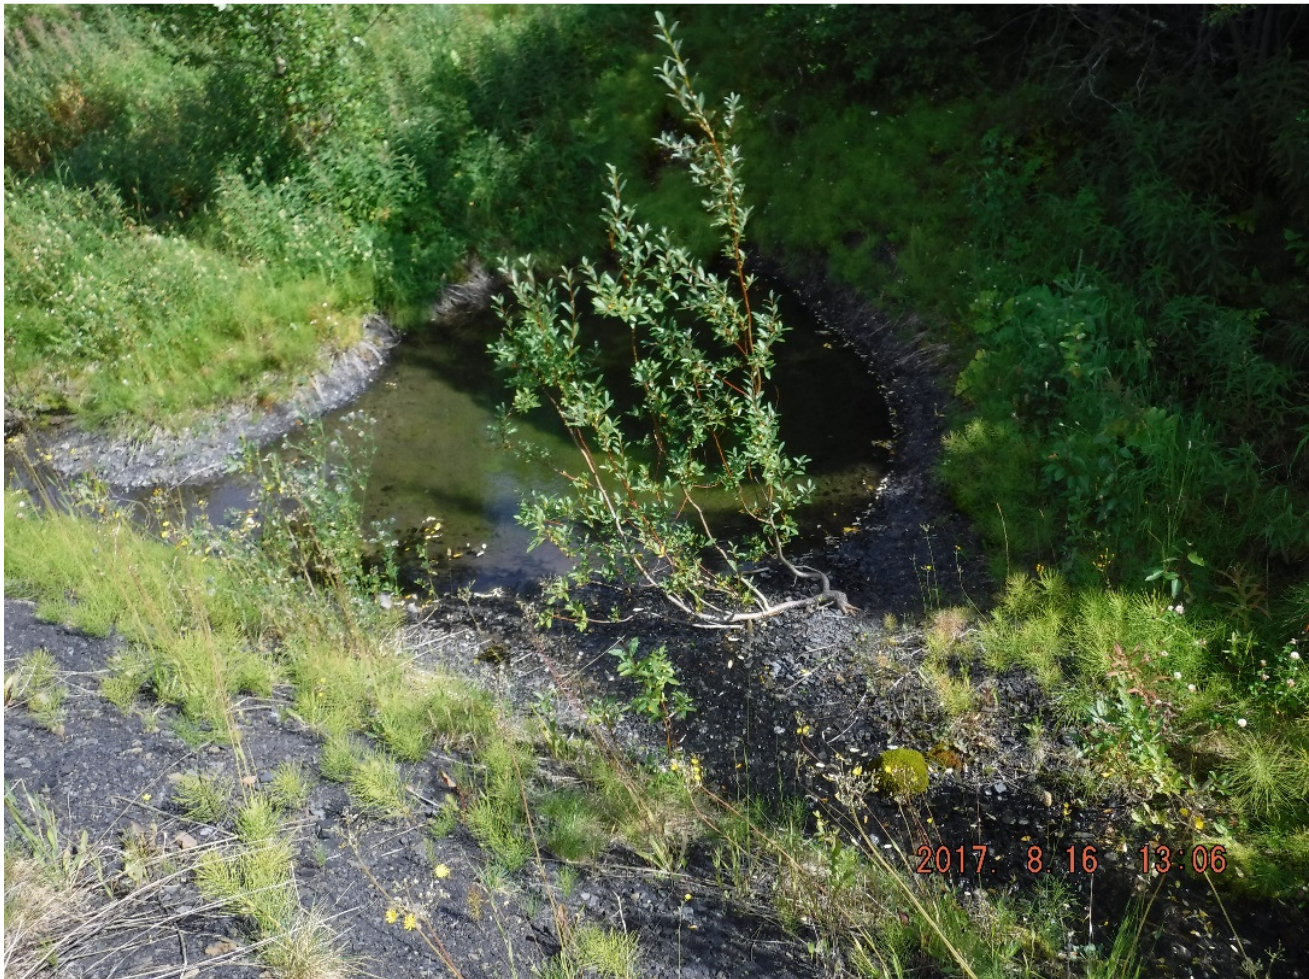
Photo II-14 Side channel which runs downslope from the east abutment – flow was approximately 1 L/min (BTD-2017-11)

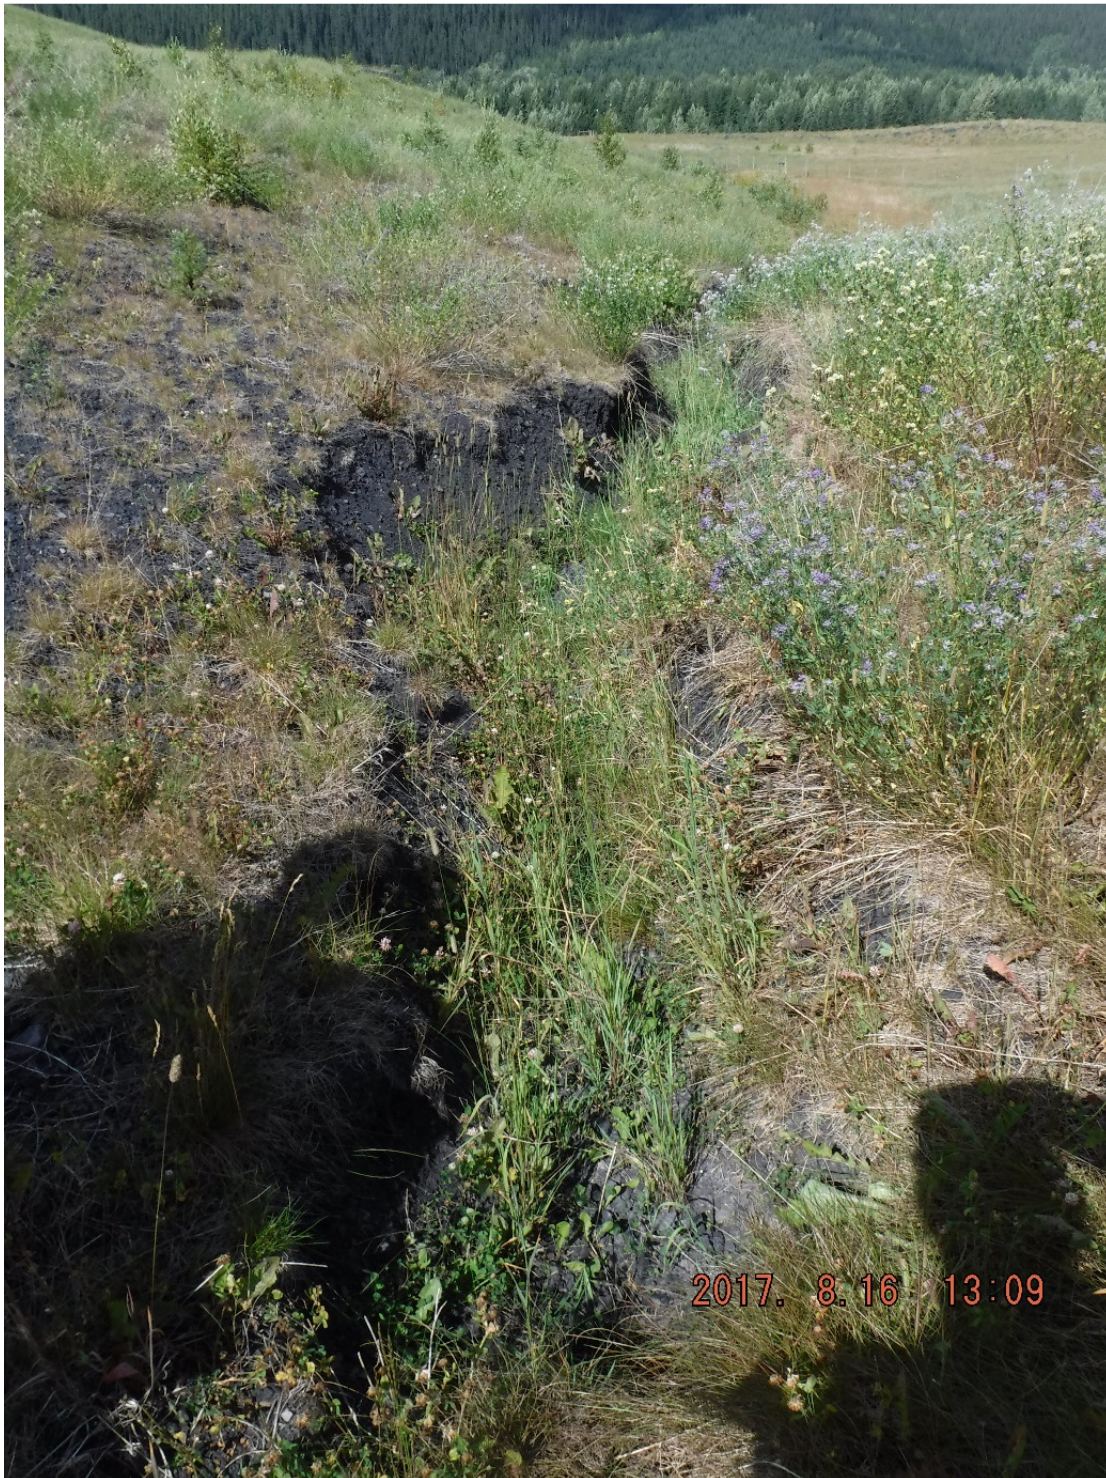
An erosion gully (approximately 0.2 m to 0.3 m wide, 0.8 m to 1.1 m deep, and 10 m to 15 m long), likely formed during the 2017 spring freshet, was observed on the east downstream slope during the DSI site visit; this feature does not represent an immediate dam safety concern.

Photo II-15 Rain/snowmelt erosion feature – the gully is approximately 0.2 m to 0.3 m wide, and 0.8 m to 1.1 m deep, and approximately 10 m to 15 m long (BTD-2017-12)

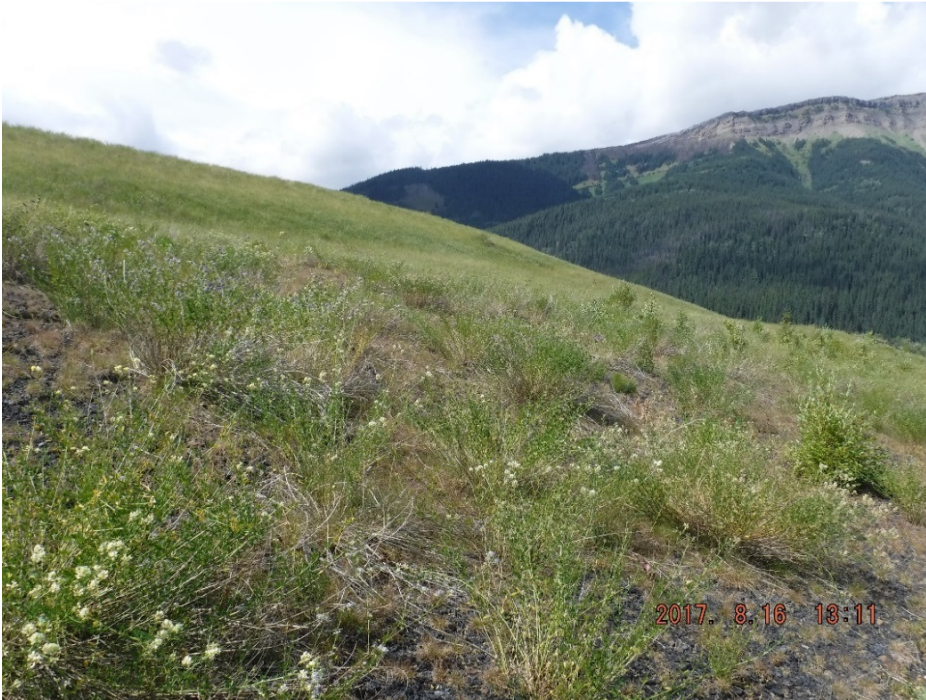
Photo II-16 Overview of the lower portion of the downstream slope – looking northwest. Slope is in good condition with no significant sign of erosion or movement (BTD-2017-13)

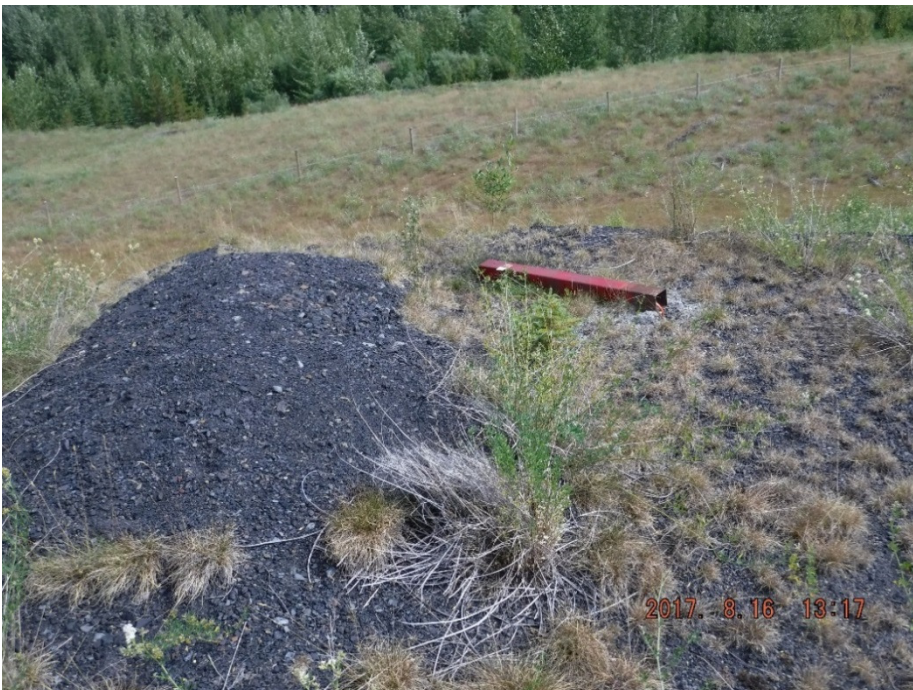
Photo II-17 Piezometer PN-3 – area was identified as unstable in 2015 DSR report; appears to be a pad constructed to facilitate drilling

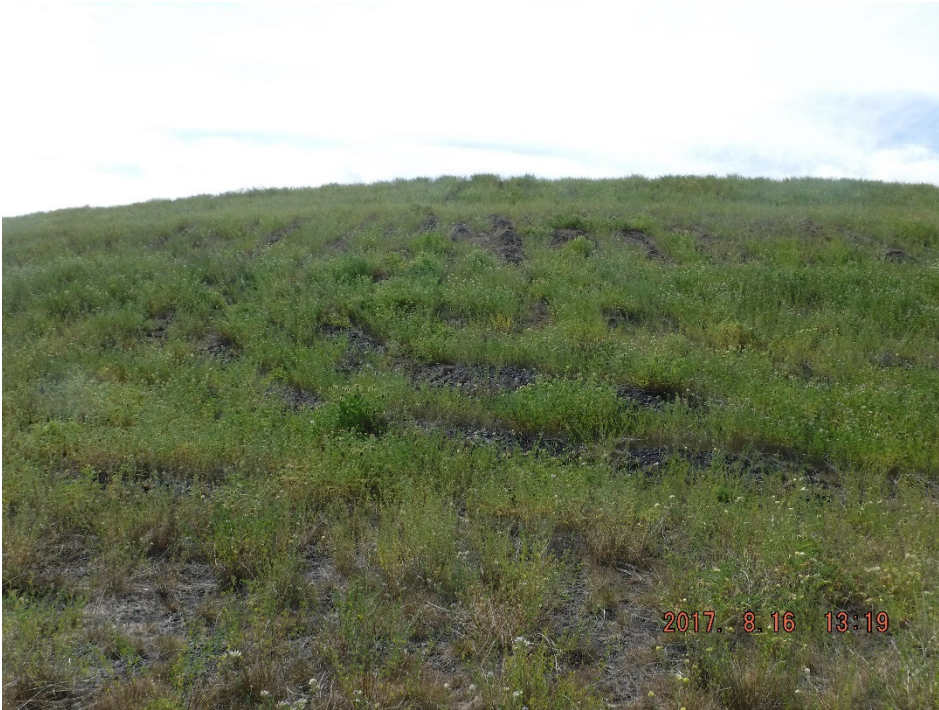
Photo II-18 Overview of the upper portion of the downstream slope – possible slope break observed likely due to normal soil erosion and rilling (BTD-2017-14)

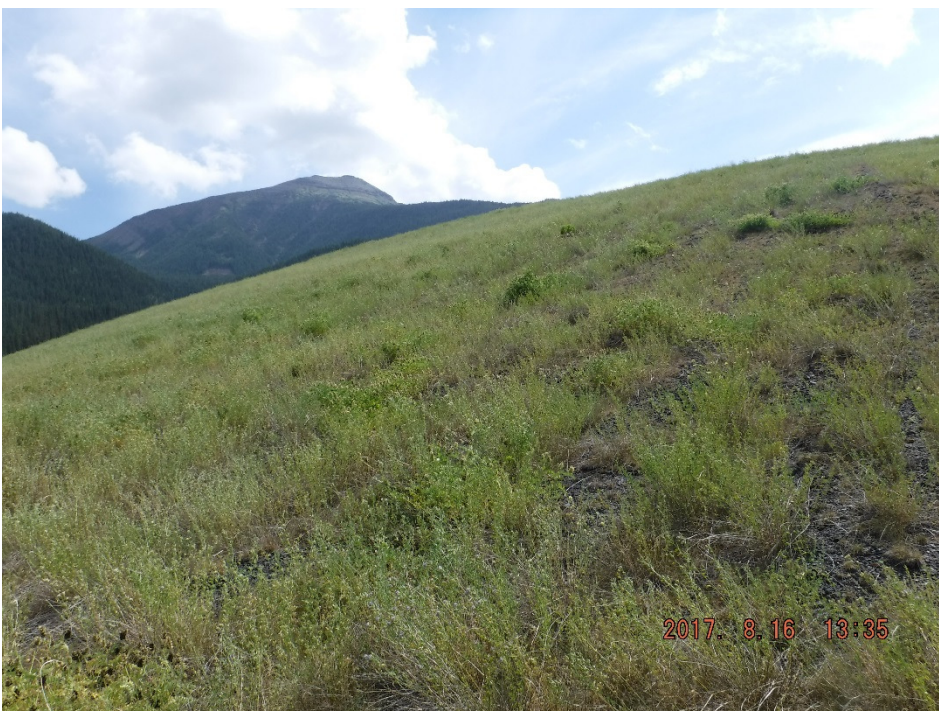
Photo II-19 Upper portion of the downstream slope – looking east. Slope is in good condition with no significant sign of erosion or movement (BTD-2017-15)

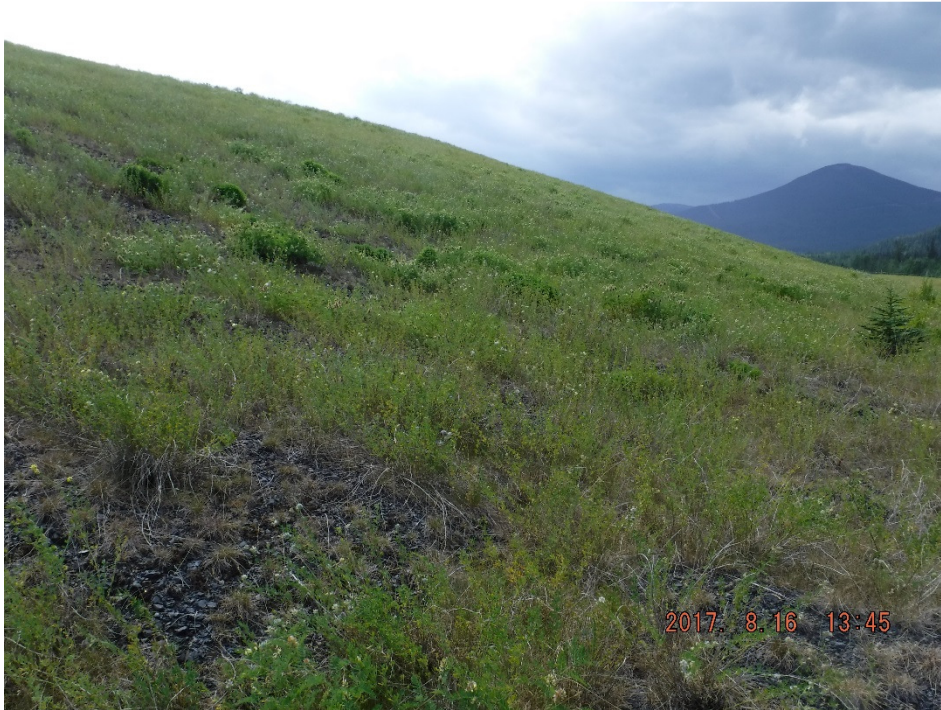
Photo II-20 Upper portion of the downstream slope – looking southwest. Slope is in good condition with no significant sign of erosion or movement (BTD-2017-16)

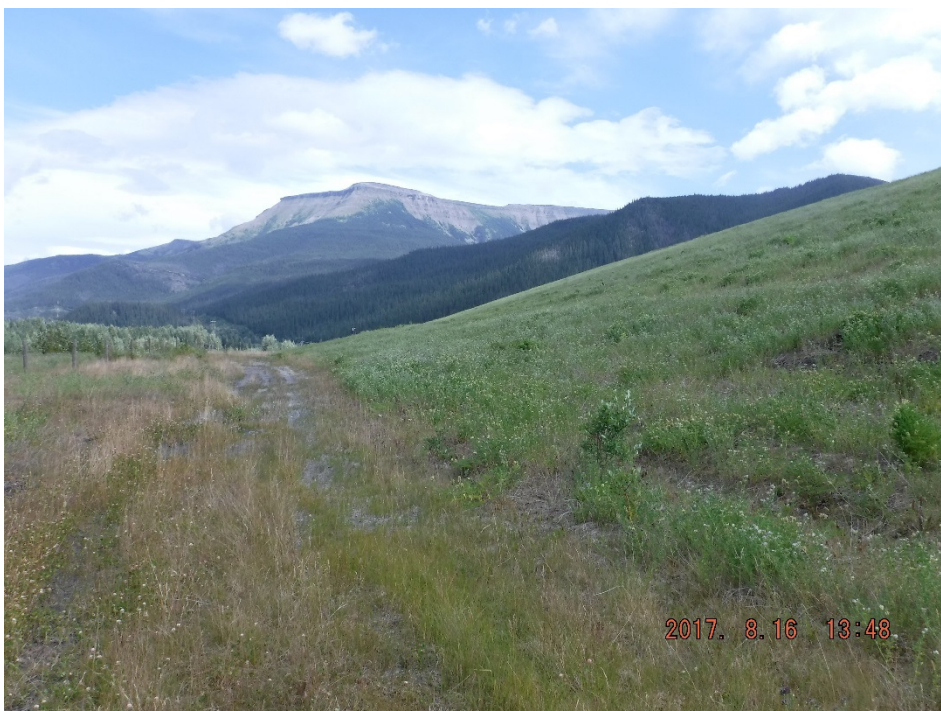
Photo II-21 Upper portion of the downstream slope – looking northeast. Slope is in good condition with no significant sign of erosion or movement (BTD-2017-17)

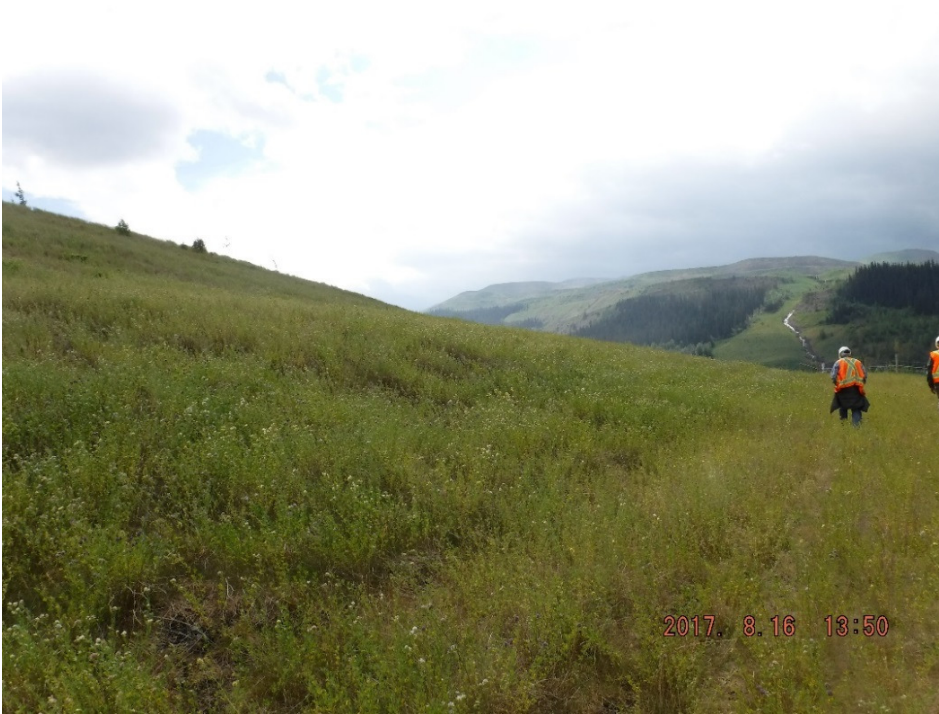
Photo II-22 Downstream slope – looking southwest. Slope is in good condition with no significant sign of erosion or movement (BTD-2017-18)

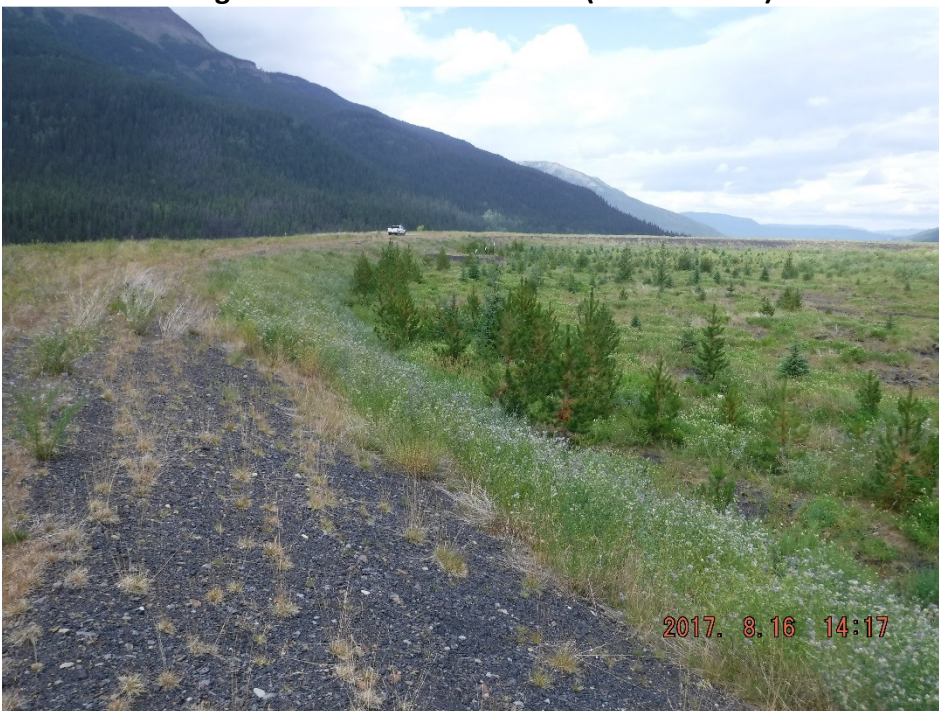
Photo II-23 Upstream slope – looking northeast. Slope is in good condition with no significant sign of erosion or movement (BTD-2017-19)

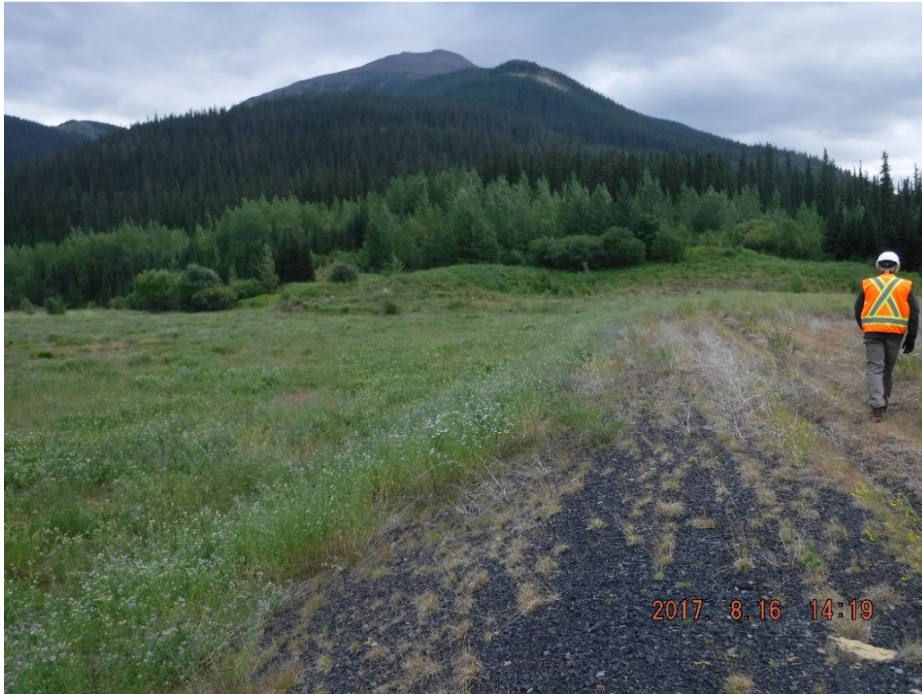
Photo II-24 Upstream slope – looking southeast. Tailings surface elevation is approximately 2 m lower than the crest elevation (BTD-2017-20)

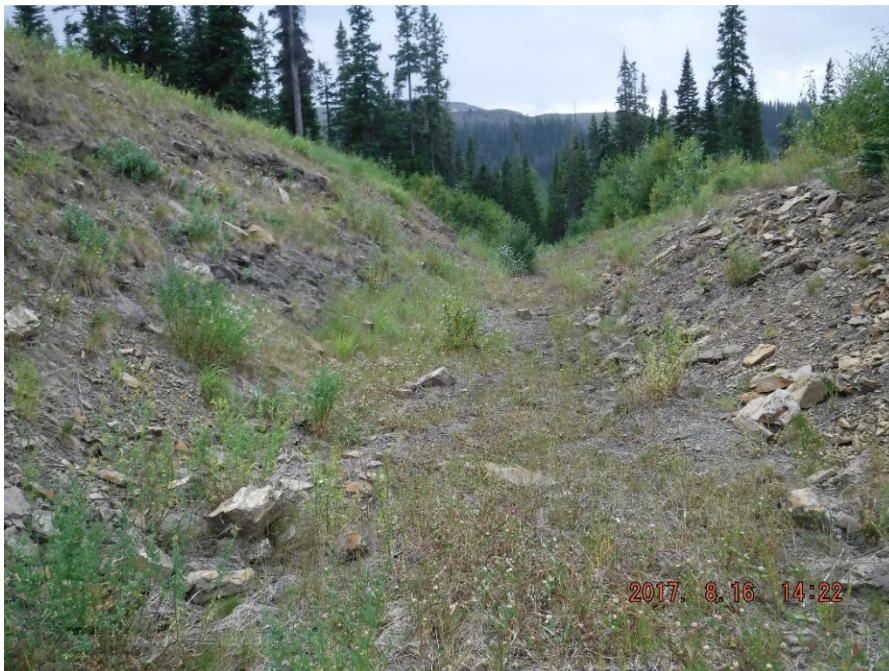
Photo II-25 Spillway channel - looking downstream where channel transitions from riprap lined (invert and right bank) and bedrock (left bank) to channel being entirely in bedrock (BTD-2017-21)

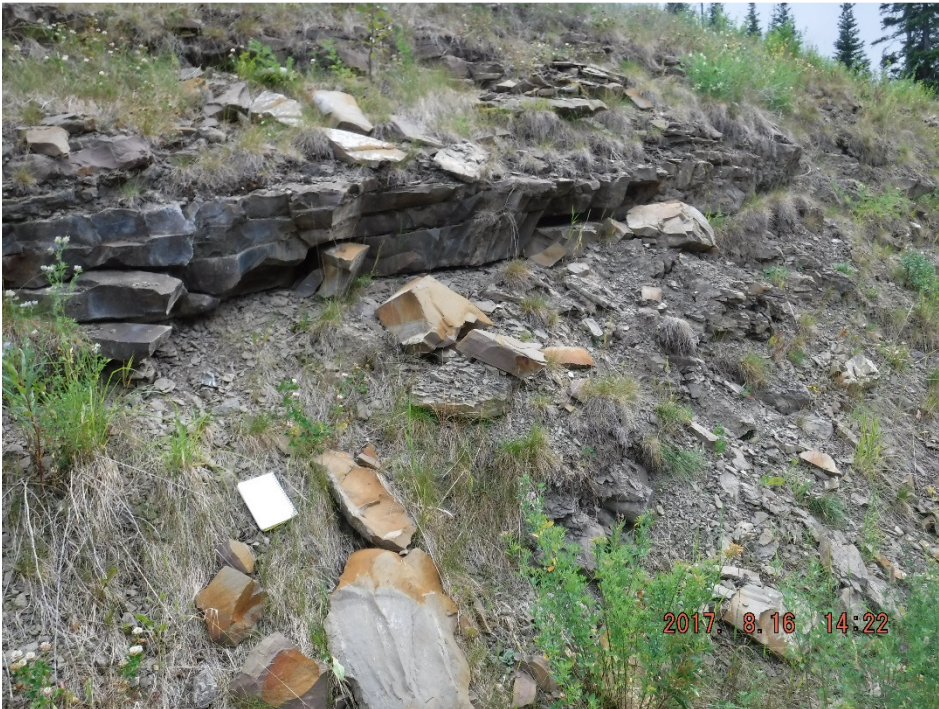
Photo II-26 Typical cut in bedrock on left bank of spillway channel (BTD-2017-21)

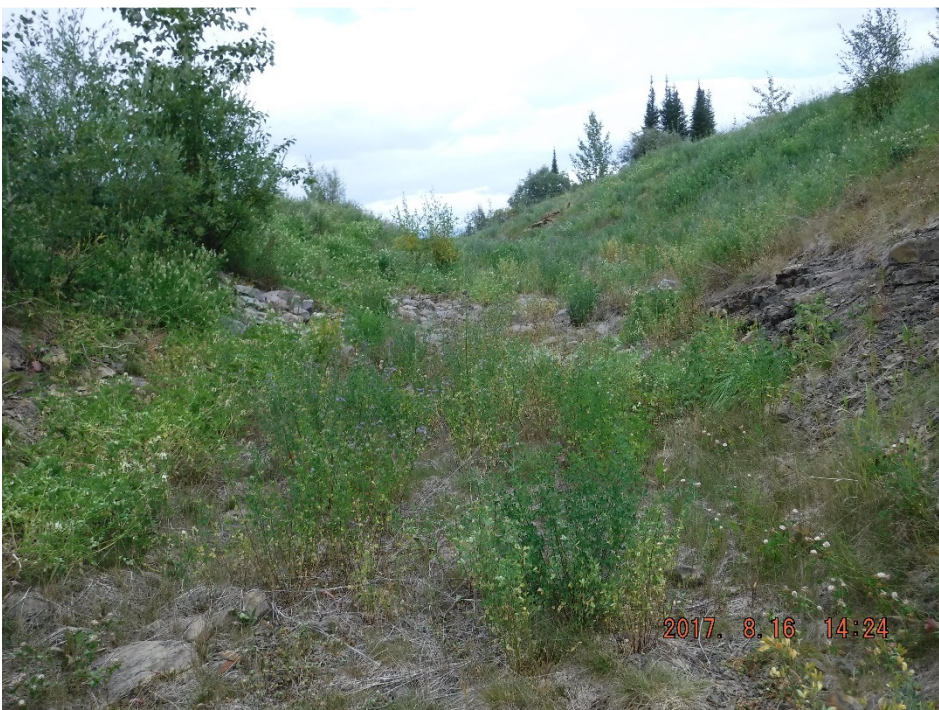
Photo II-27 Spillway inlet – looking northeast. Vegetation is well established; no major obstructions (BTD-2017-22)

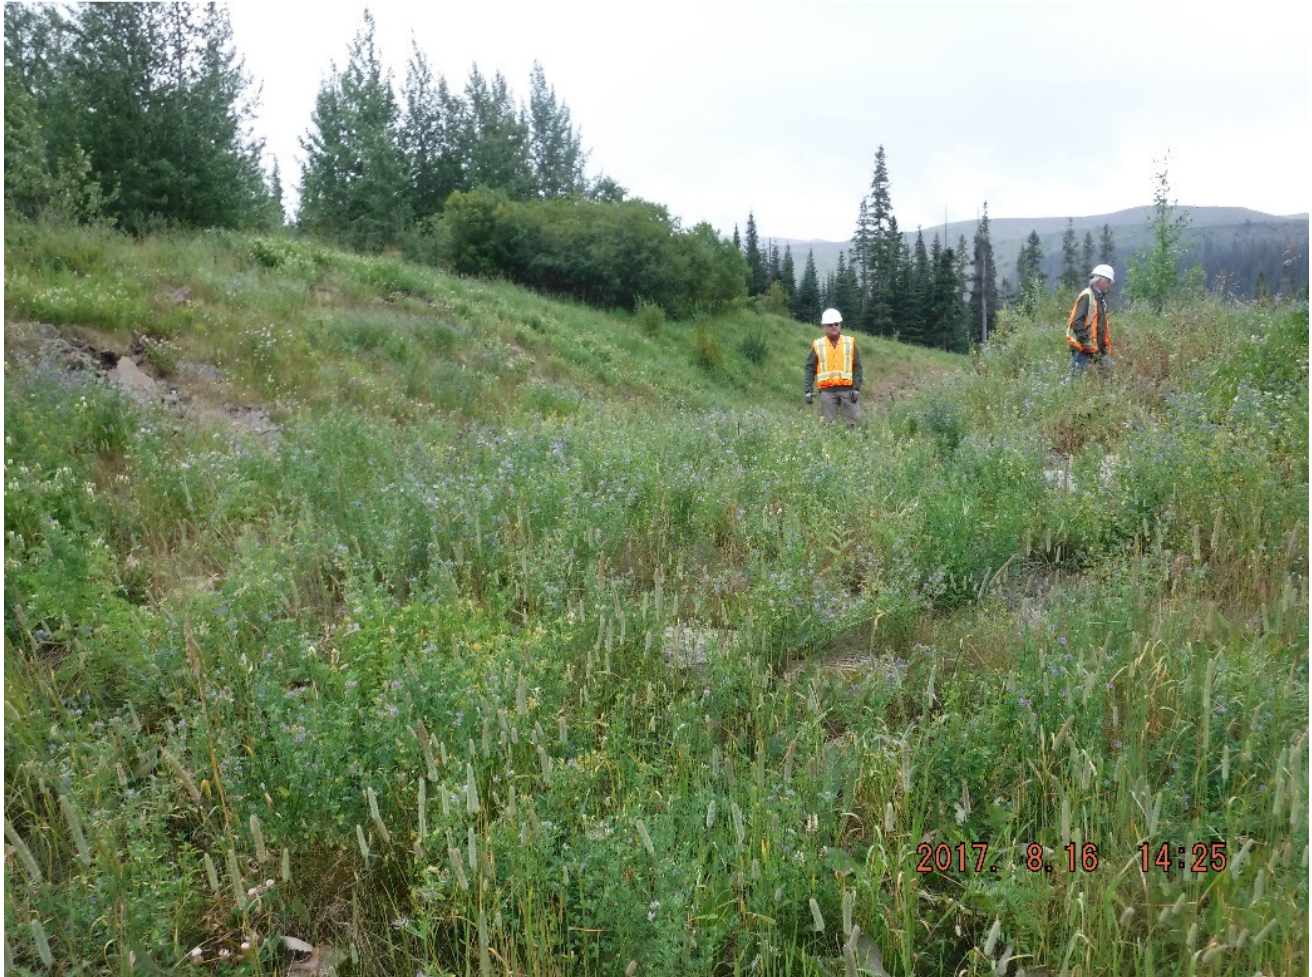
Photo II-28 Spillway inlet – looking southwest. Vegetation is well established; no major obstruction (BTD-2017-22)

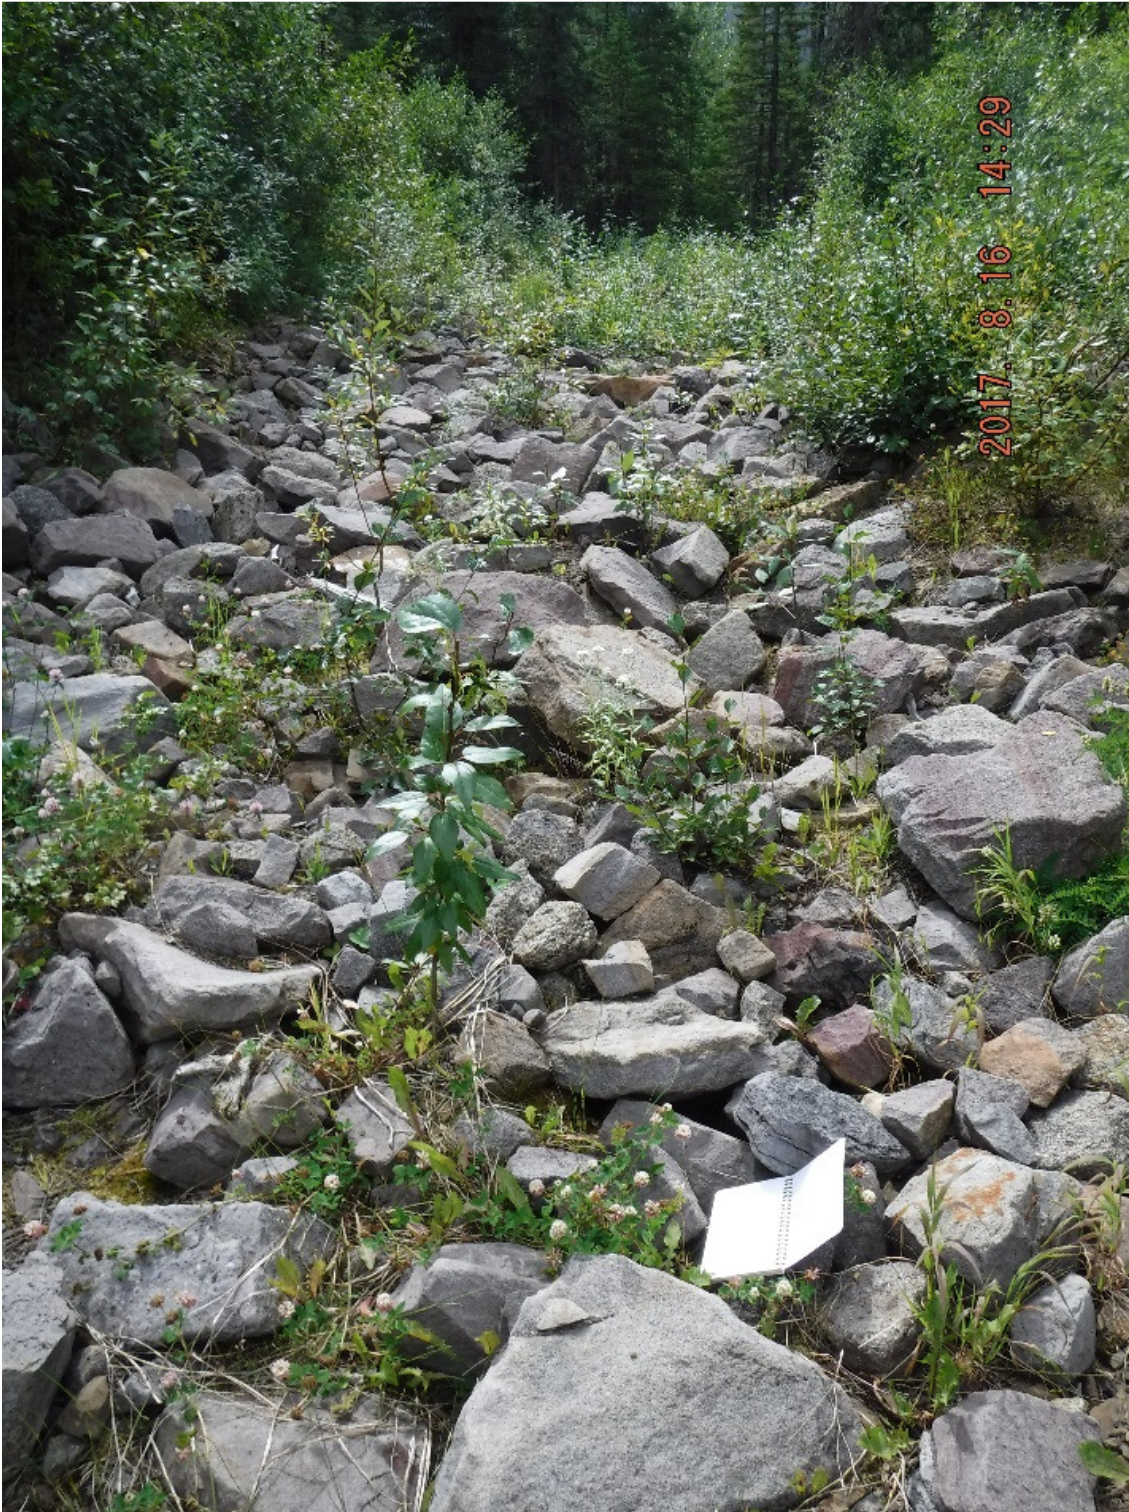
Photo II-29 Spillway channel looking downstream after transition from bedrock to riprap. Channel is armoured with riprap on the invert and side slopes (BTD-2017-23)

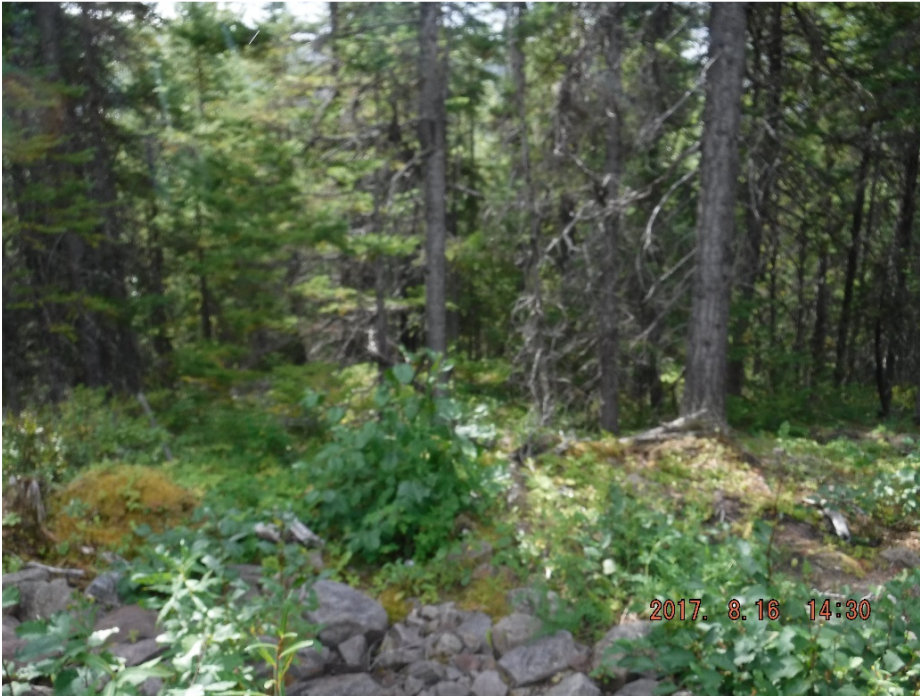
Photo II-30 End of riprap along channel at spillway outfall. Spillway discharges over a natural steep slope (BTD-2017-24)
