Bullmoose Mine

2017 Dam Safety Inspection

Bullmoose Tailings Dam

Bullmoose Mine
Bullmoose Tailings Dam
2017 Dam Safety Inspection – Rev. 1

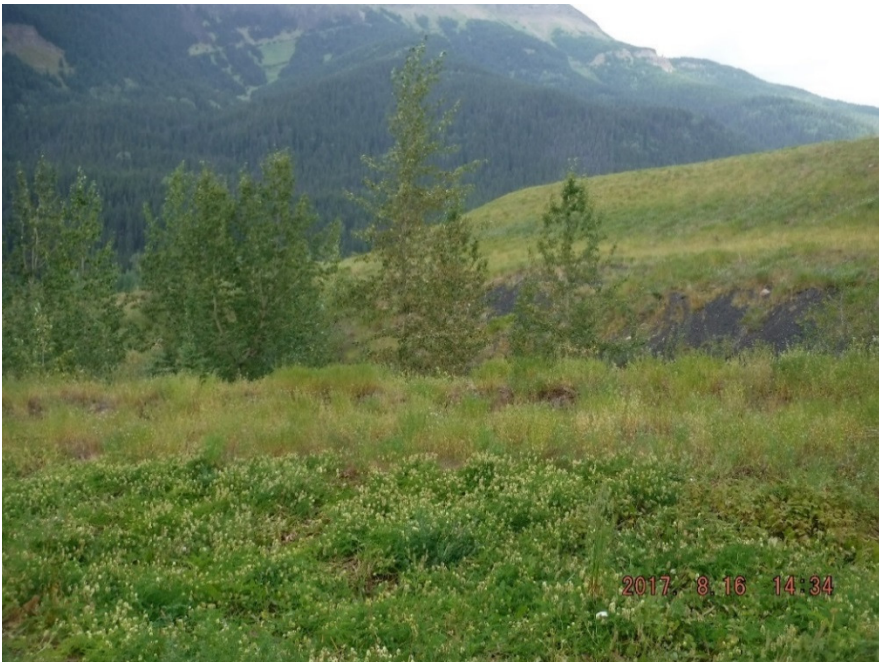
Photo II-31 Toe of the dam along west slope is approximately 1.5H:1V – possibly used as an end dump prior to closure. The slope appears to be stable with no significant sign of erosion or movement (BTD-2017-25)

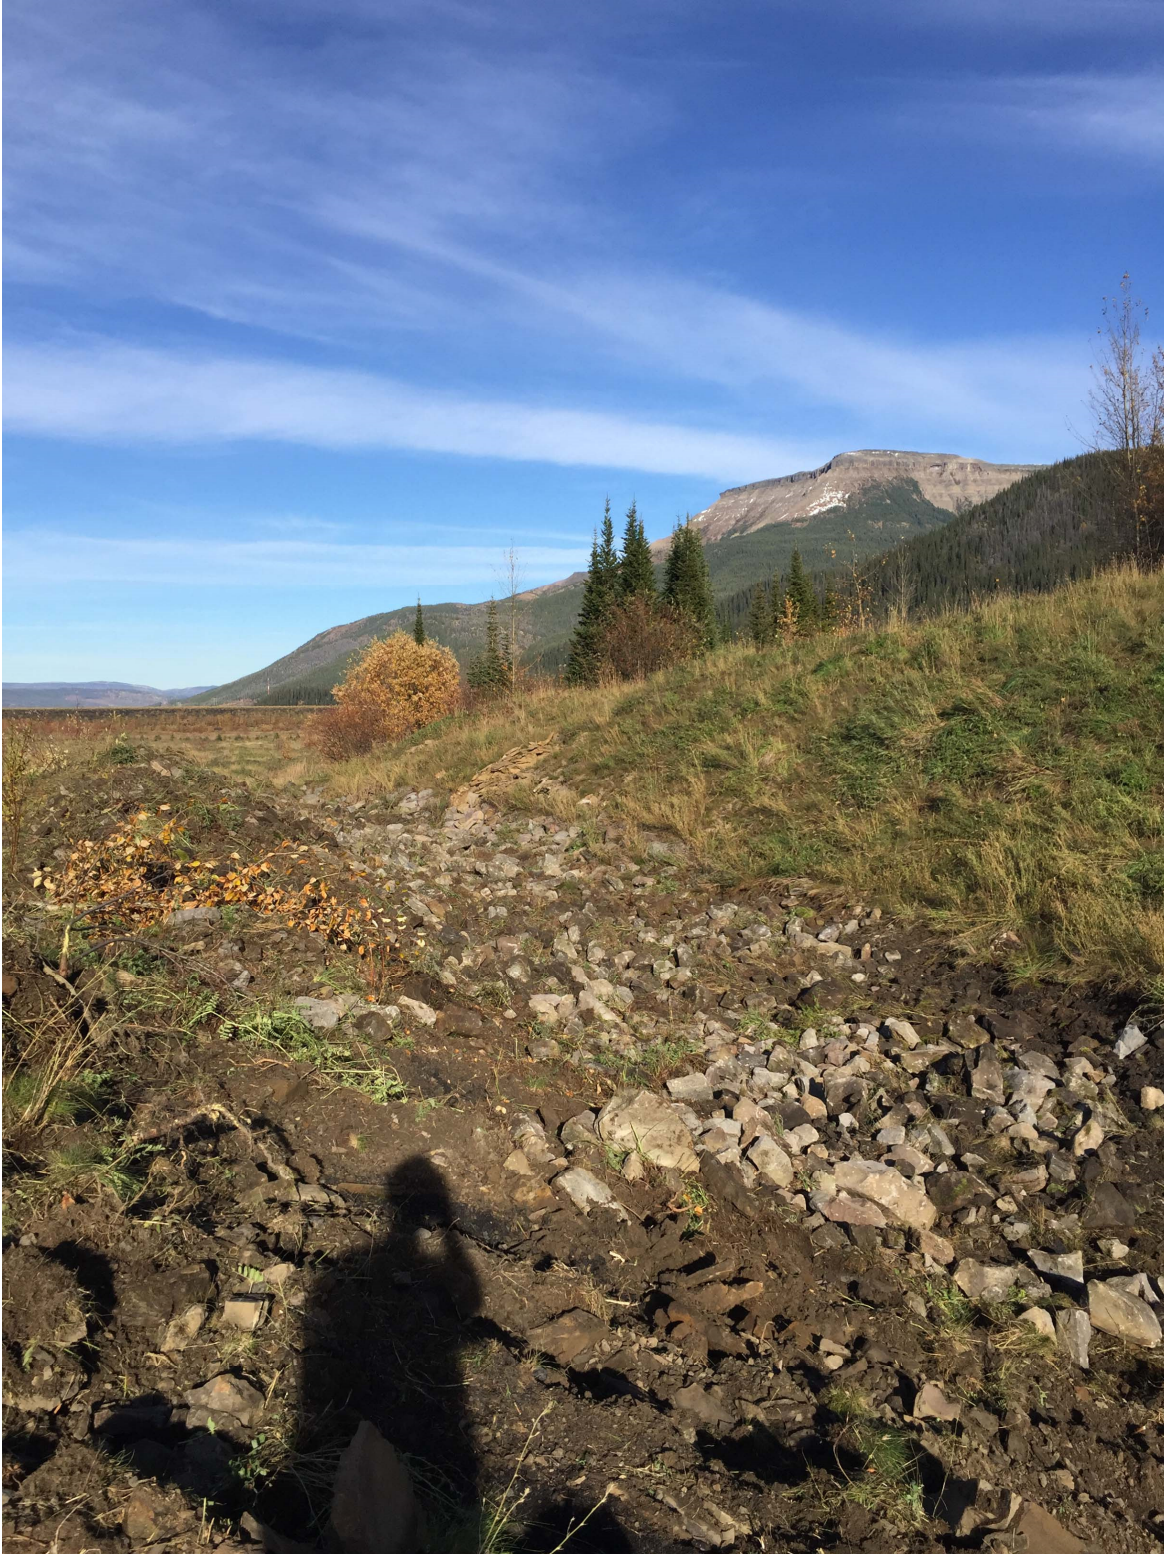
Maintenance work completed in 2017 by Teck includes vegetation clearing at the inlet and along the channel of the BTM spillway in October. Photographs of the BTM spillway after vegetation clearing (provided by Teck) are included in Appendix II. KCB reviewed the photographic records and concluded that the spillway is in satisfactory condition.

Photo II-32 Teck removed vegetation at the inlet and along the channel of spillway in October 2017 – looking northeast (near photograph location BTD-2017-21)
