March 2018

TECK RESOURCES LTD.

Louvicourt Mine Tailings and Polishing Ponds 2017 Dam Safety Inspection

Report Number: 001-1775965-Rev0

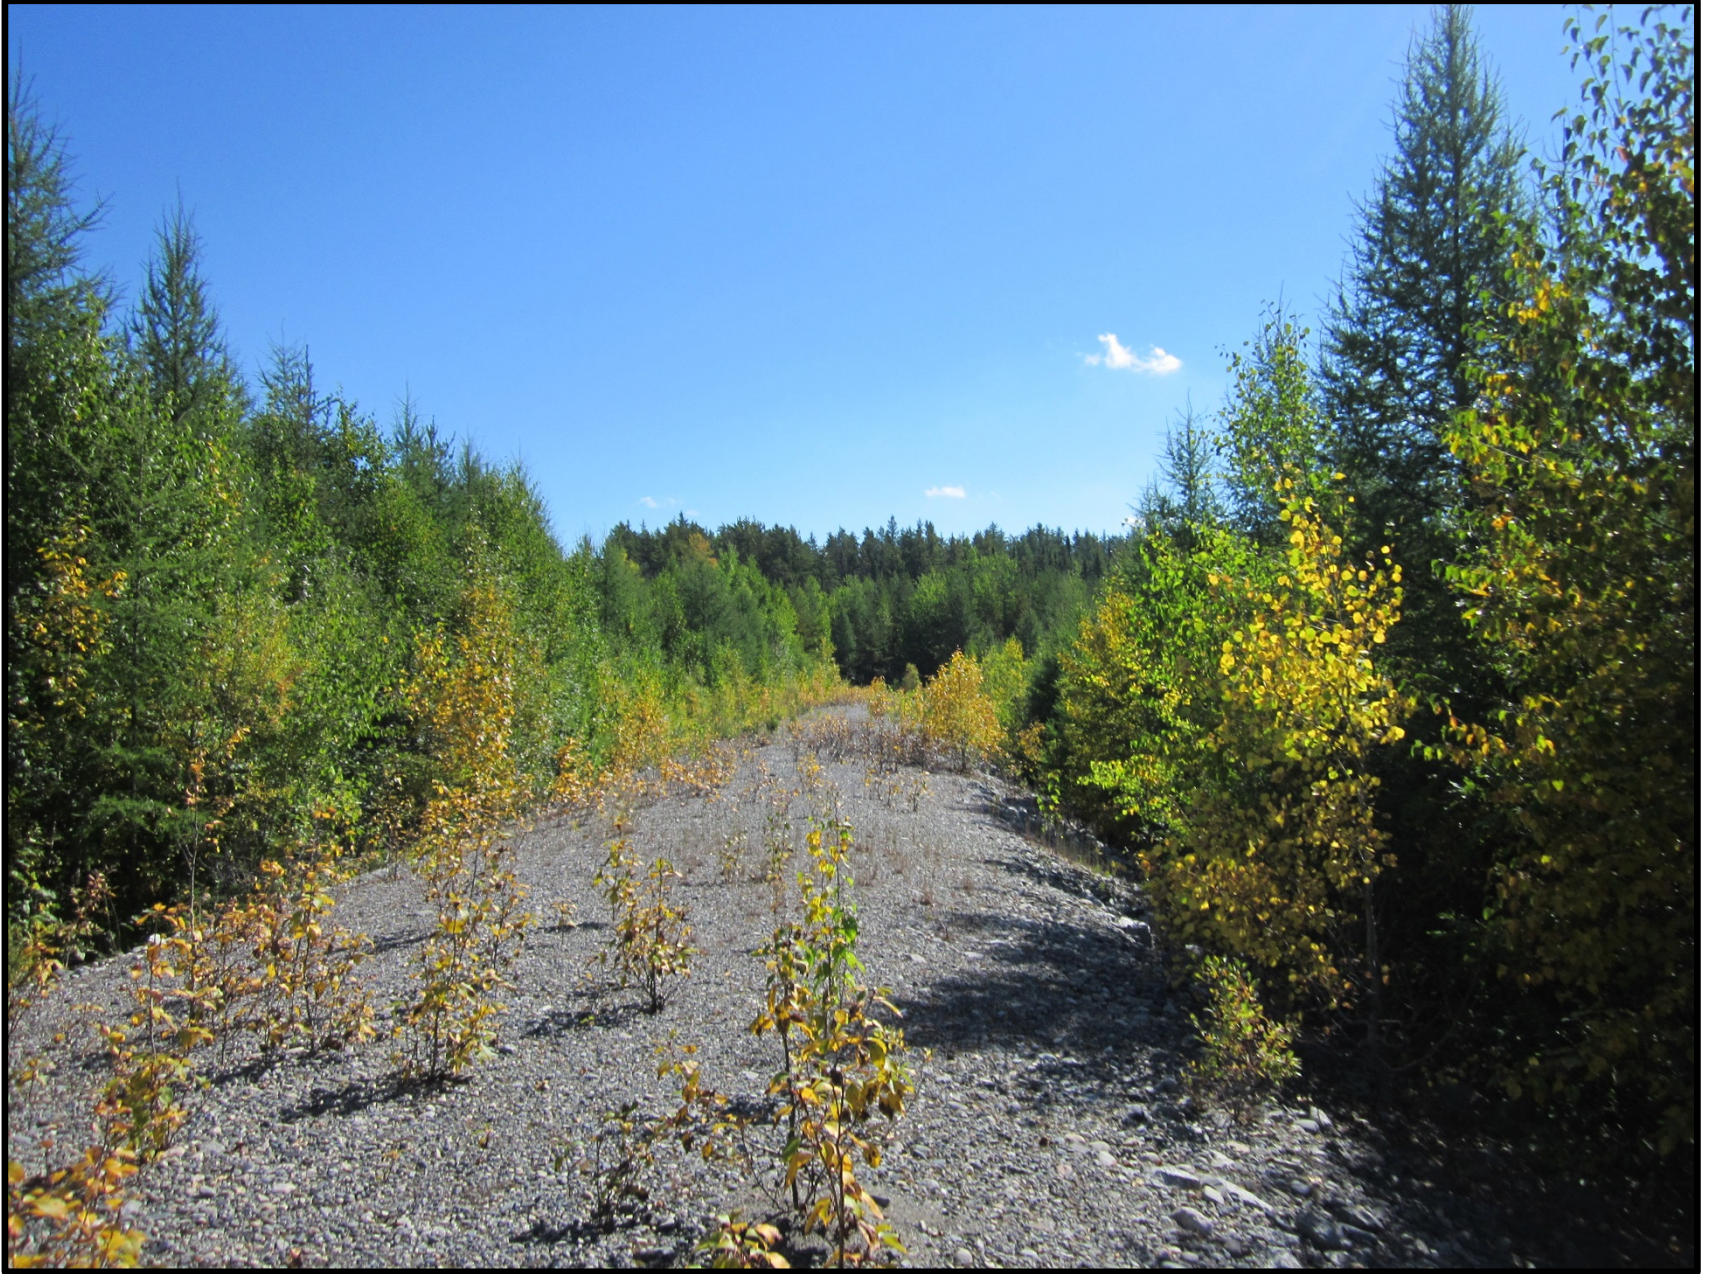
Photograph 1: Louvicourt Mine, Dam 4A

General view of Dam 4A, looking east.

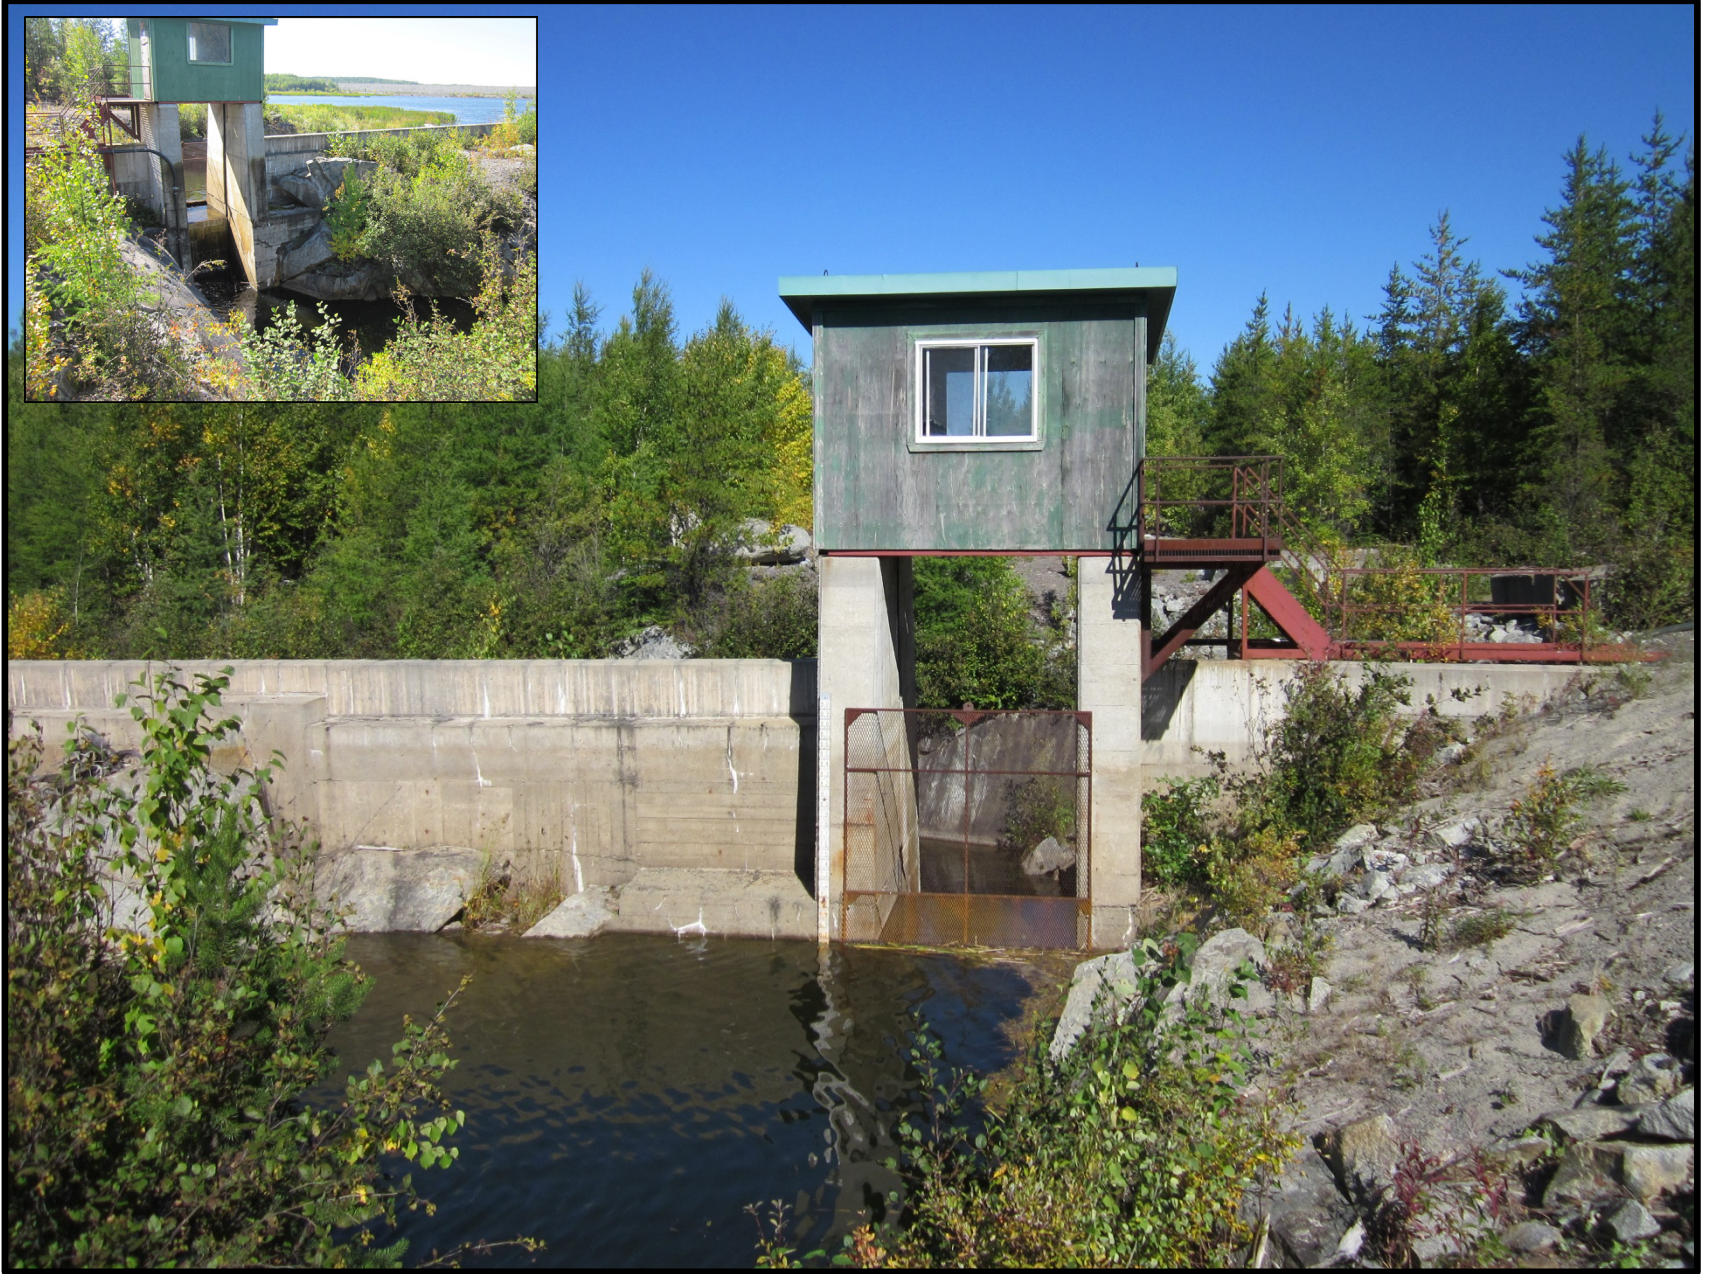
Photograph 2: Louvicourt Mine, Dam 4B

- The spillway at Dam 4B was in good condition and functional.
- Culverts at the final effluent point were clean. The flow rate at the final effluent point was low and water was clear.

Overflow Weir at Dam 4B in good condition.

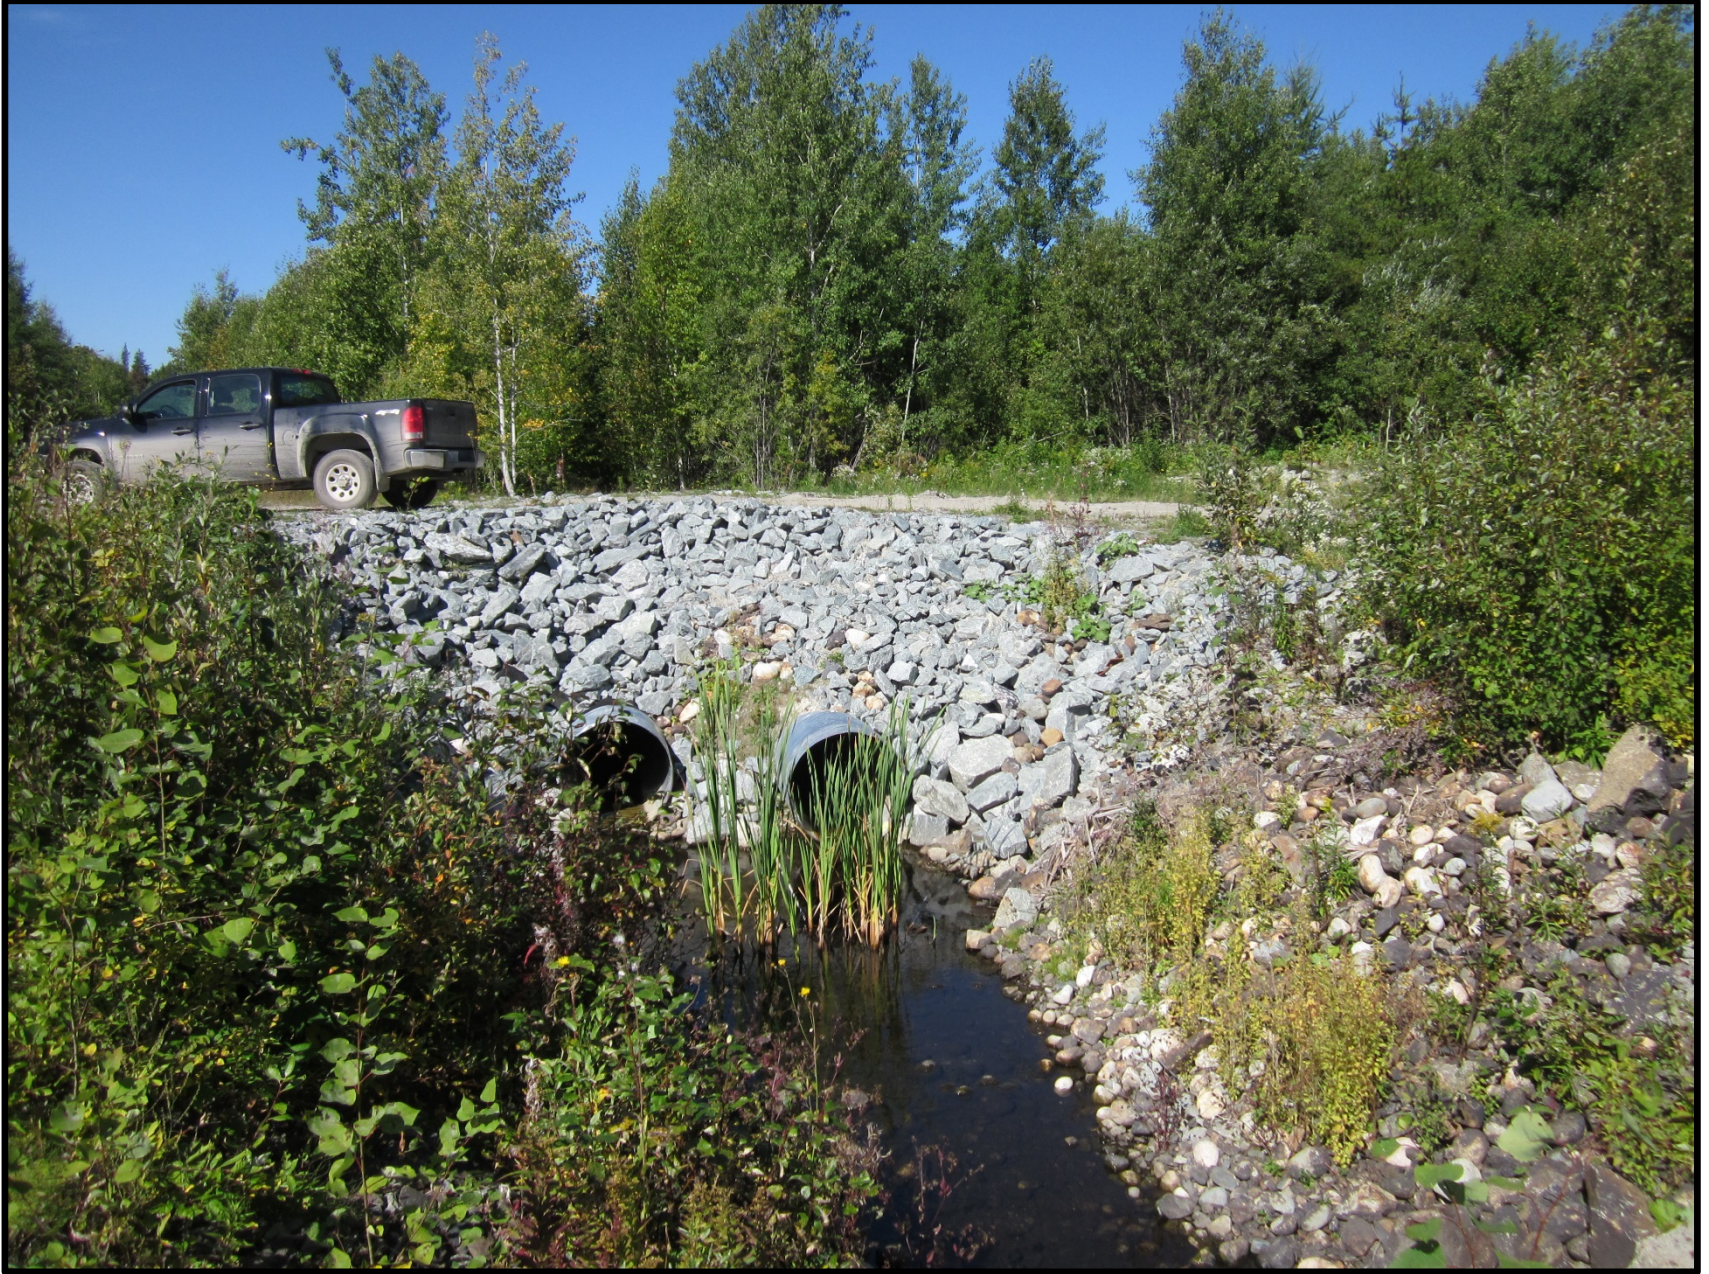
Photograph 3: Dam 4B, final effluent area

Culverts in good condition (recently rehabilitated).

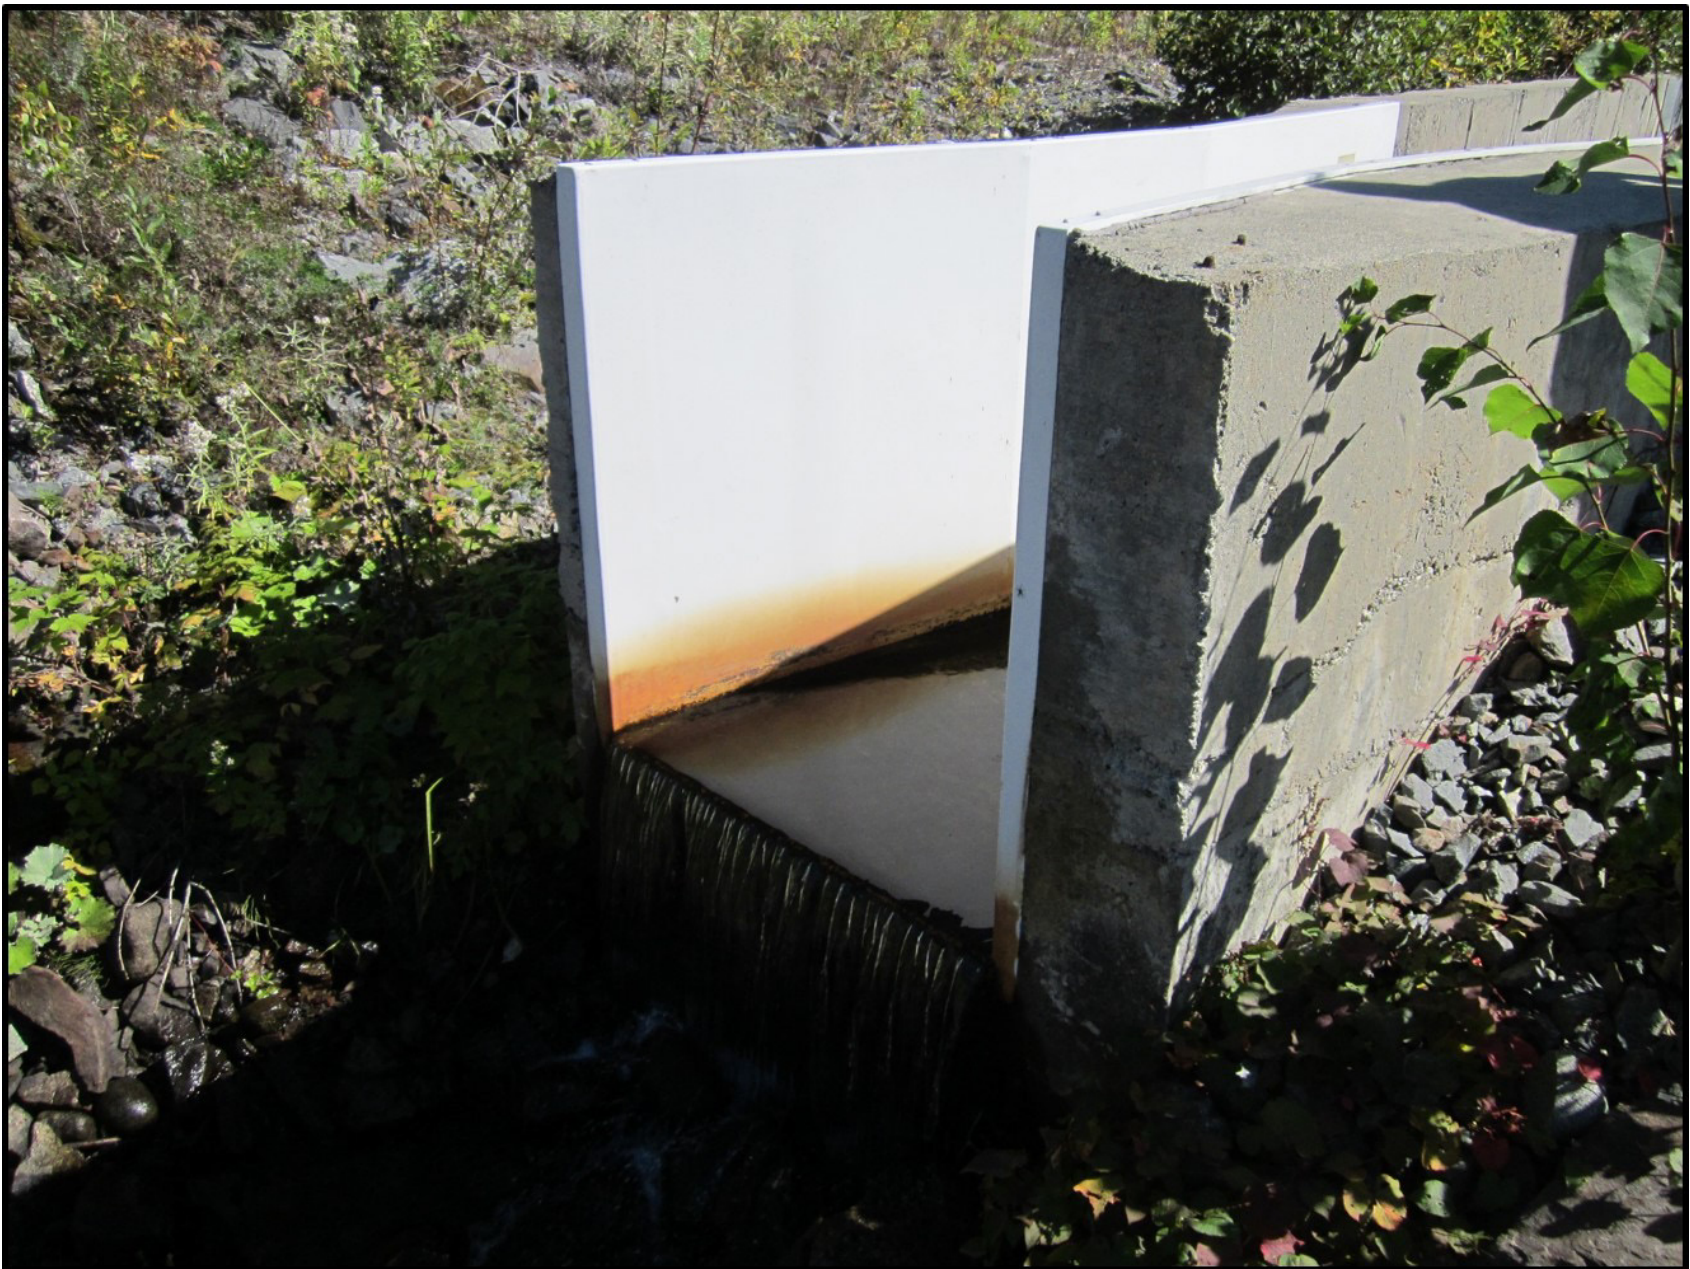
Photograph 4: Final effluent point

Infrastructure in good condition, low flow, clear water.

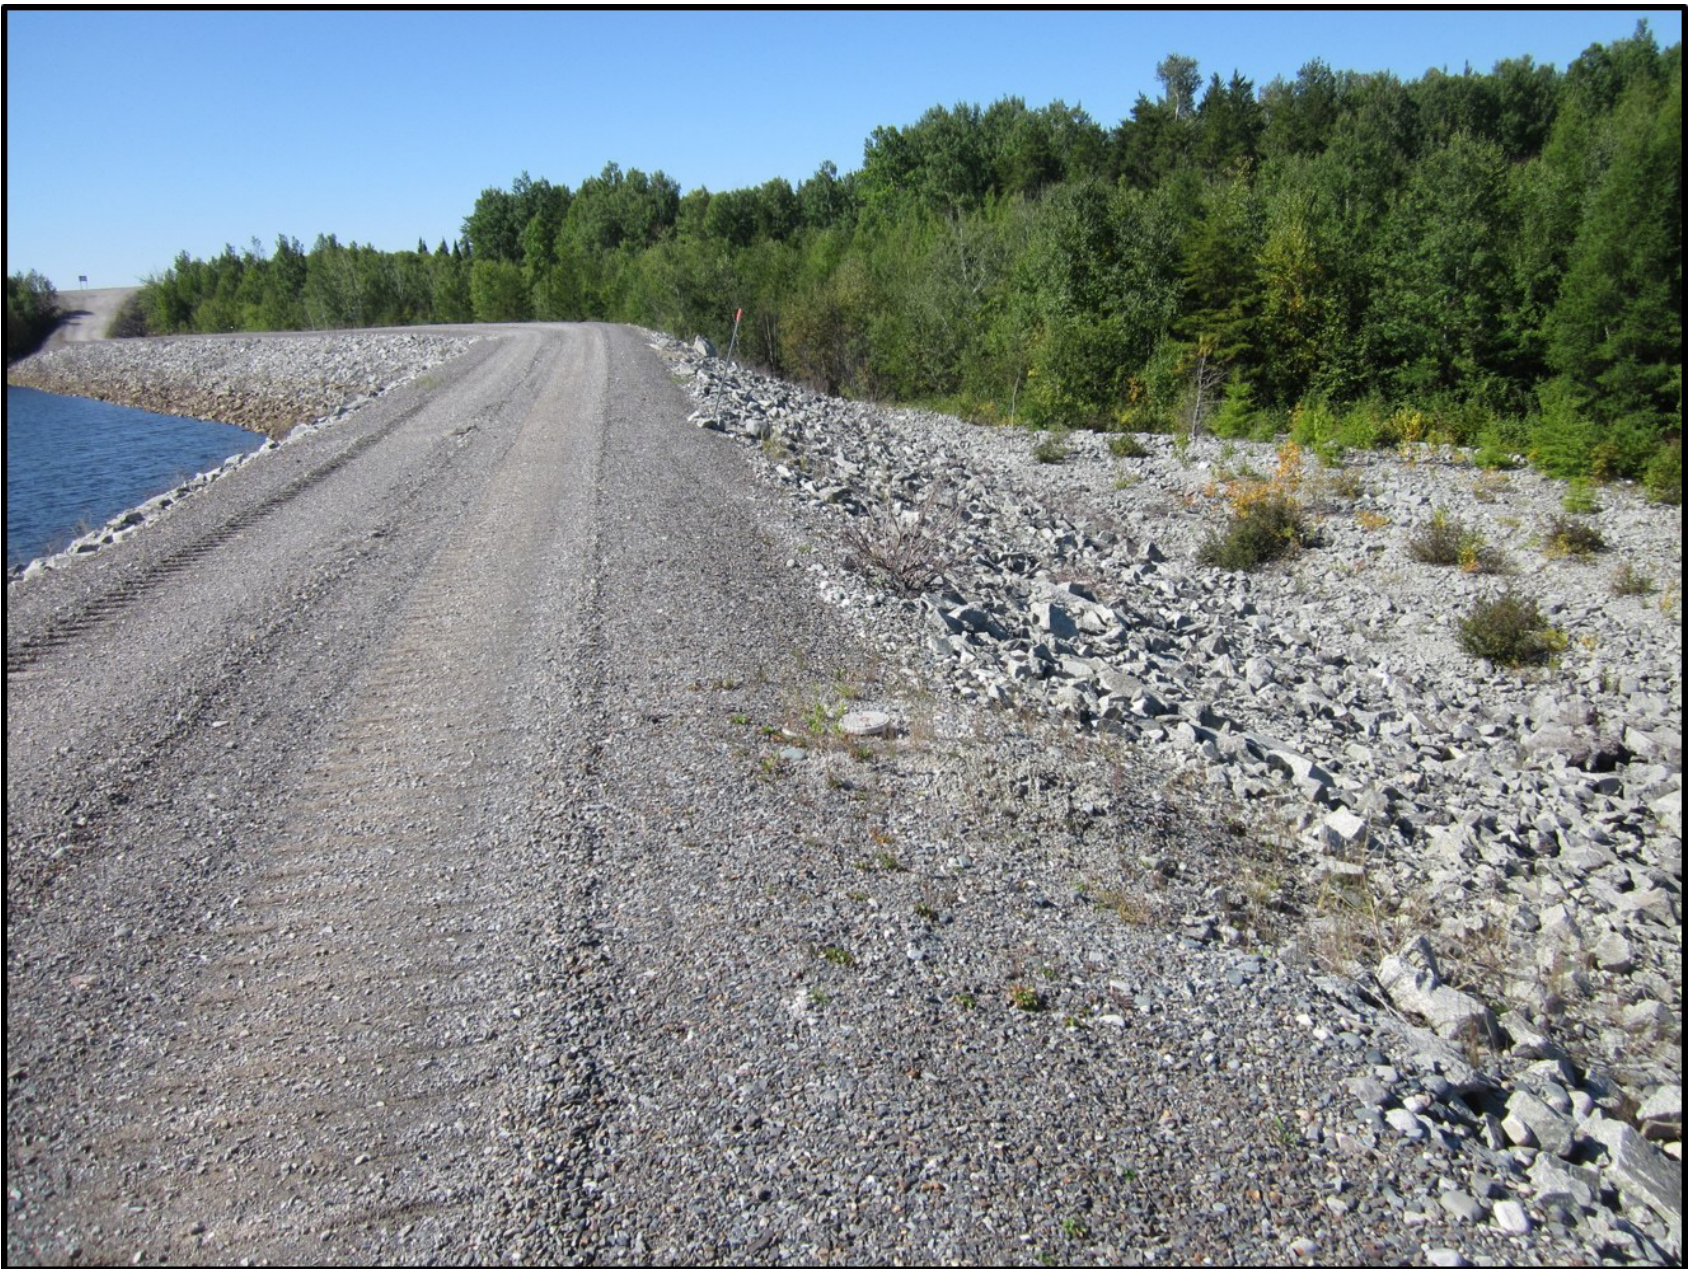
Photograph 5: Dam 4B

- The Dam 4B crest was in good condition with some traces of tracked excavator movement (crest of Dam 4B is not opened in winter). Settlement plates are visible. The crest surface at plate SP11-1 is slightly disturbed, but this disturbance has no noticeable impact on its performance.

View of the crest, settlement point SP11-1.

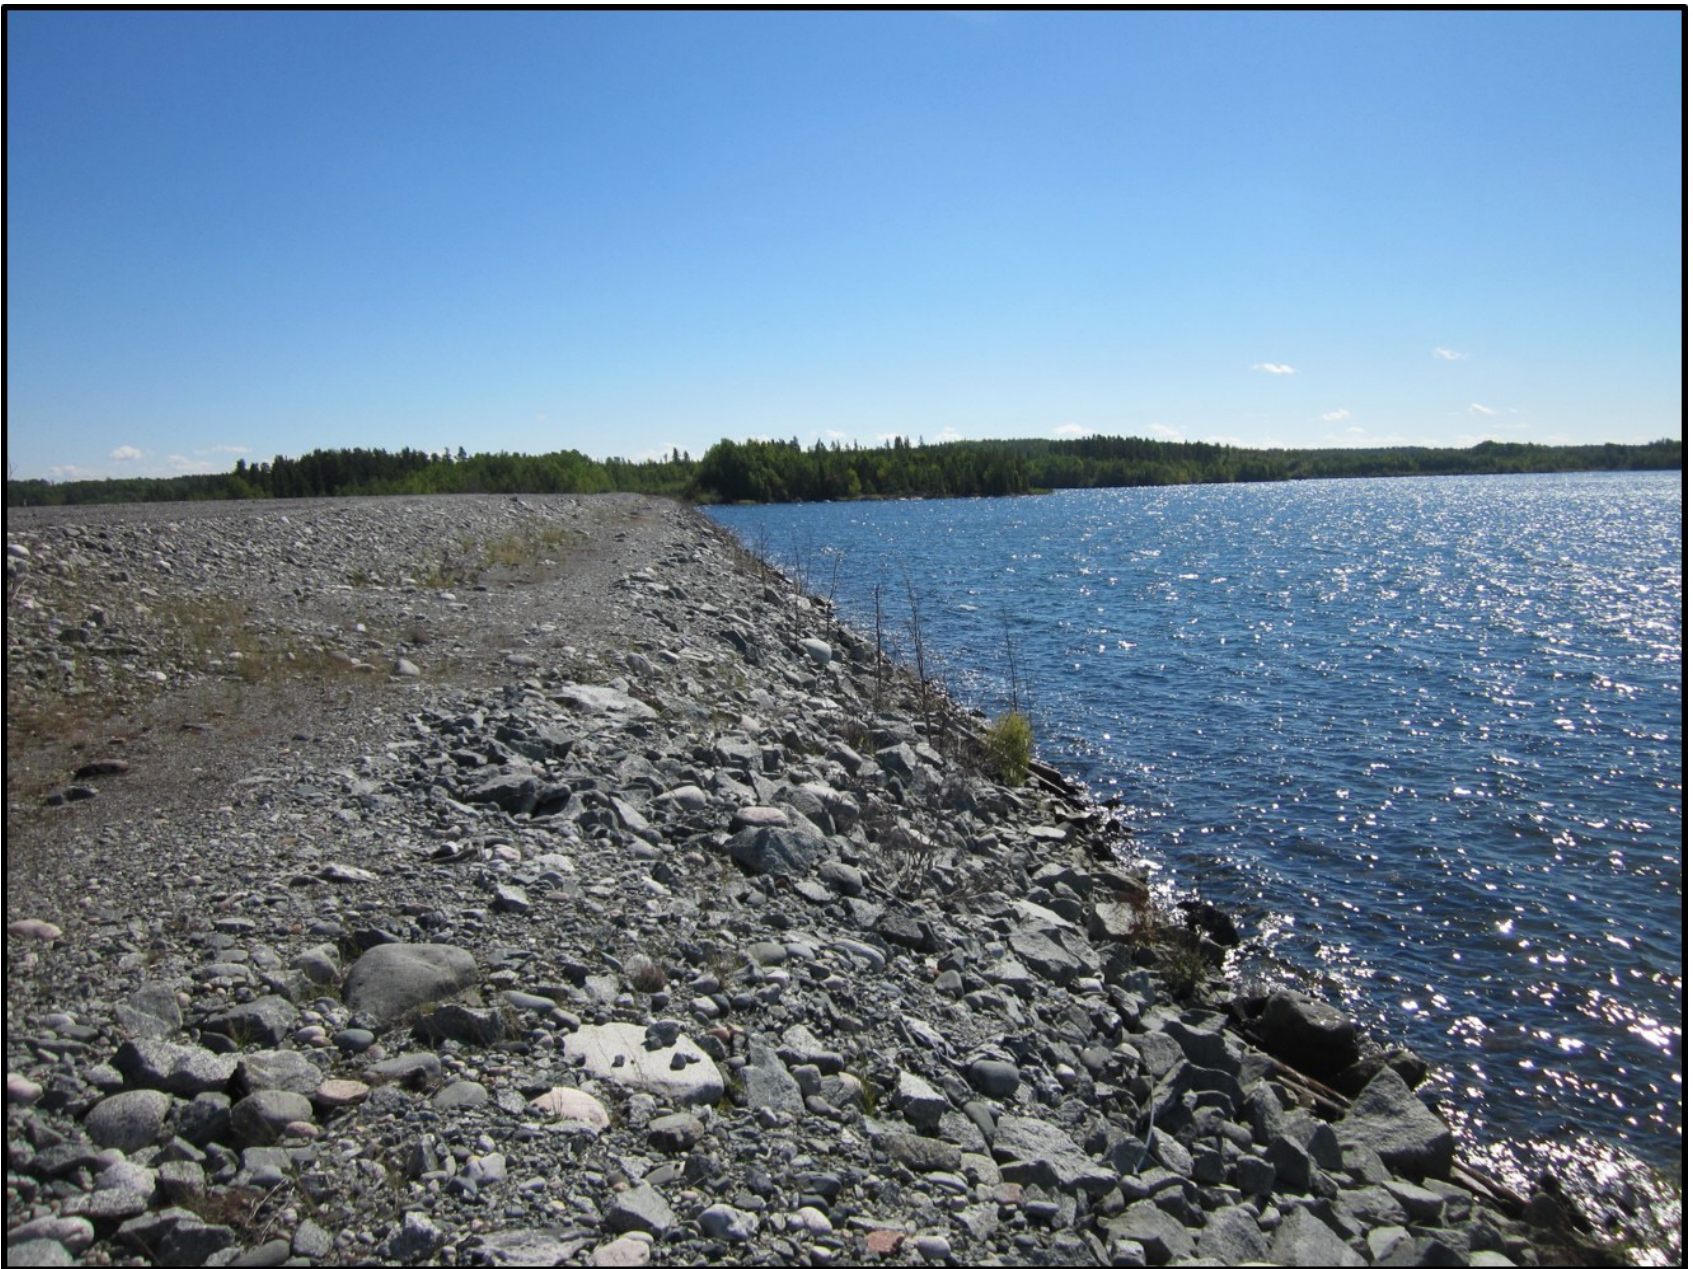
Photograph 6: Dam 1D

- The rip-rap on the upstream berm of Dam 1D has degraded with time by the wave action. The same effect, but on a much smaller scale, has been observed on the upstream slope of Dam 1B.

Localized portions of the dams upstream faces were observed to be steeper than the design value of 2.5H:1V (Photo 6 in Appendix A), however no evidence of instability was noticed. Longitudinal cracks were reported to

Rip-rap, upstream face where rehabilitation effort has been recommended.

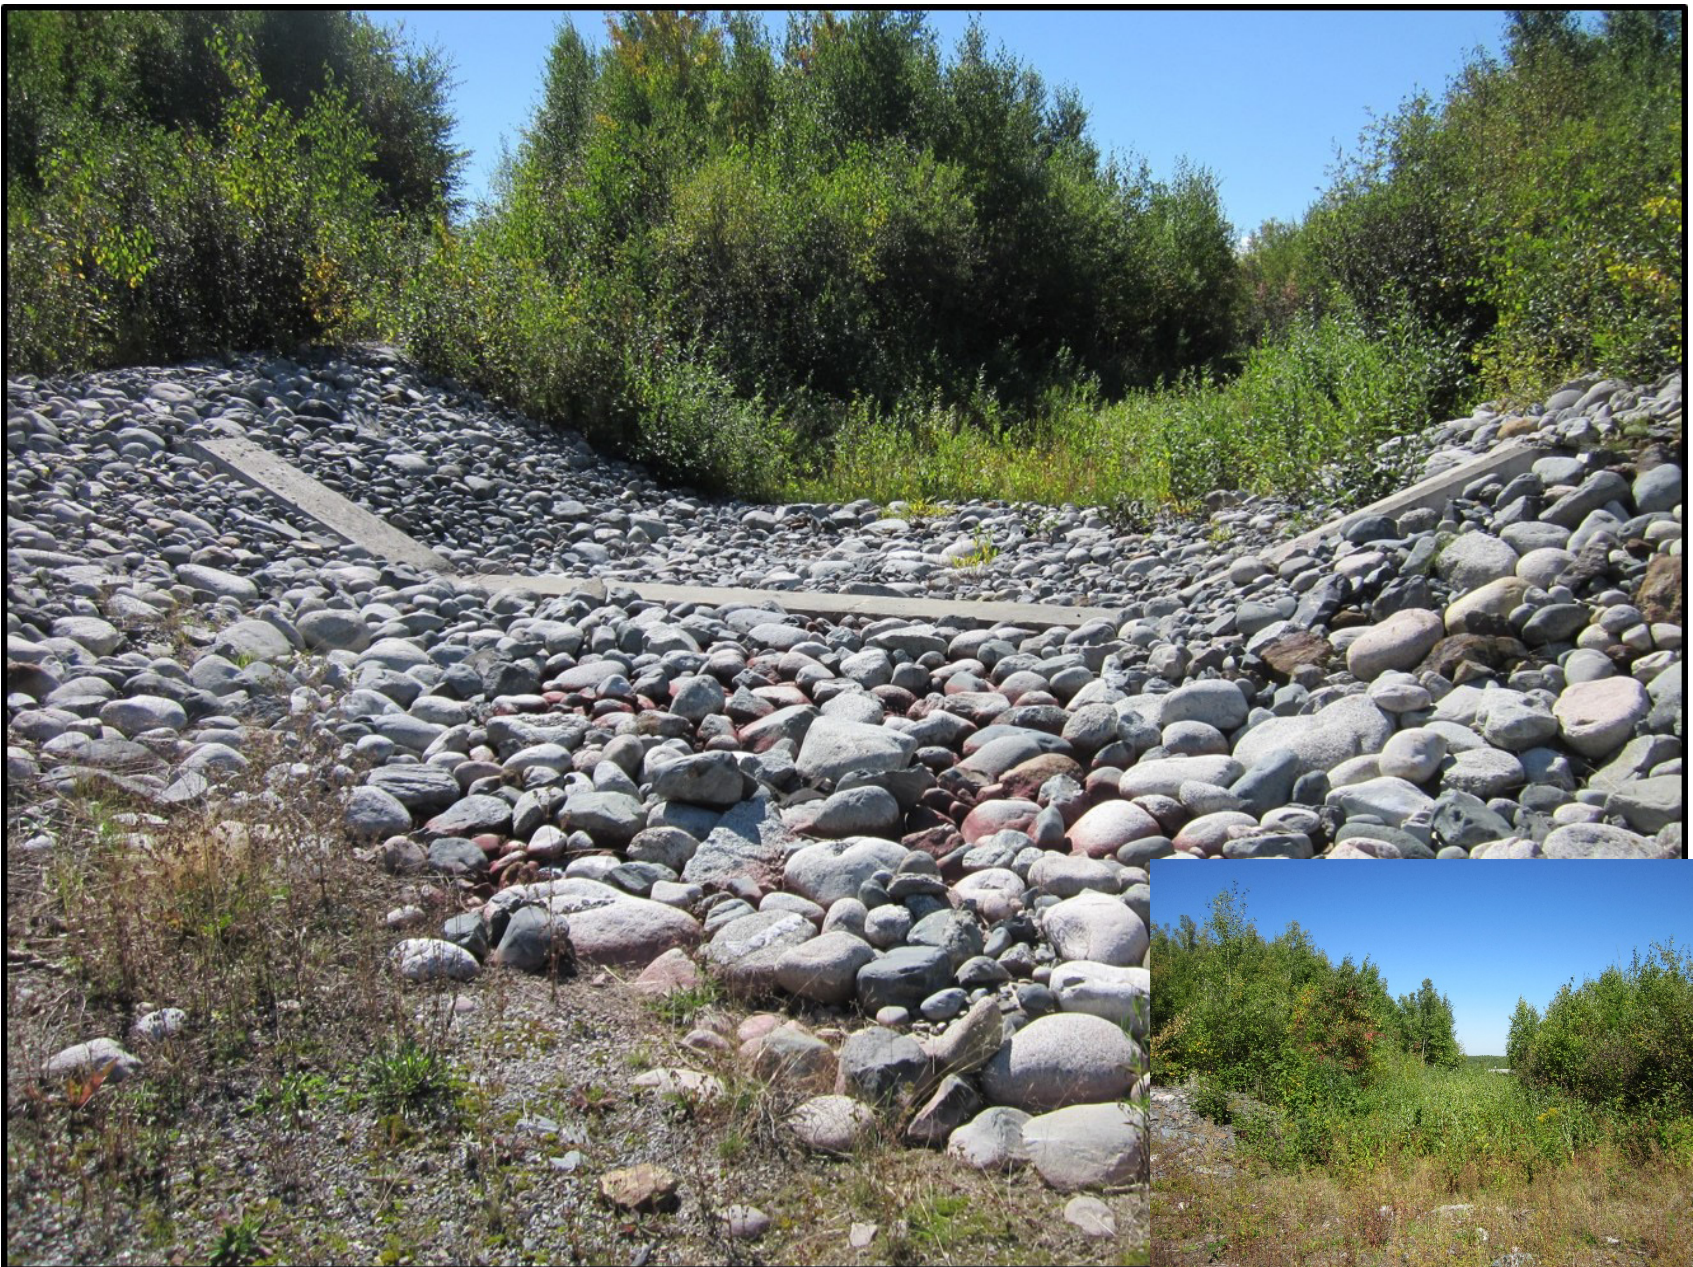
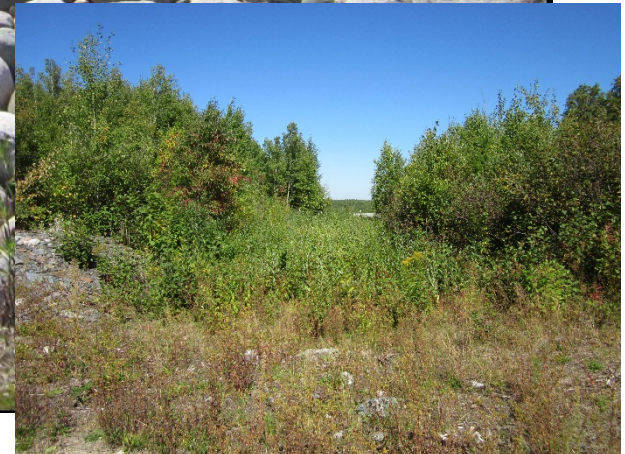
Photograph 7: Dam 1E, emergency spillway

- The emergency spillway located between Dams 1D and 1E was in good condition. Vegetation in the downstream channel is growing and is cleared every two years.

Emergency spillway – bed in excellent condition, downstream channel with some growing vegetation.

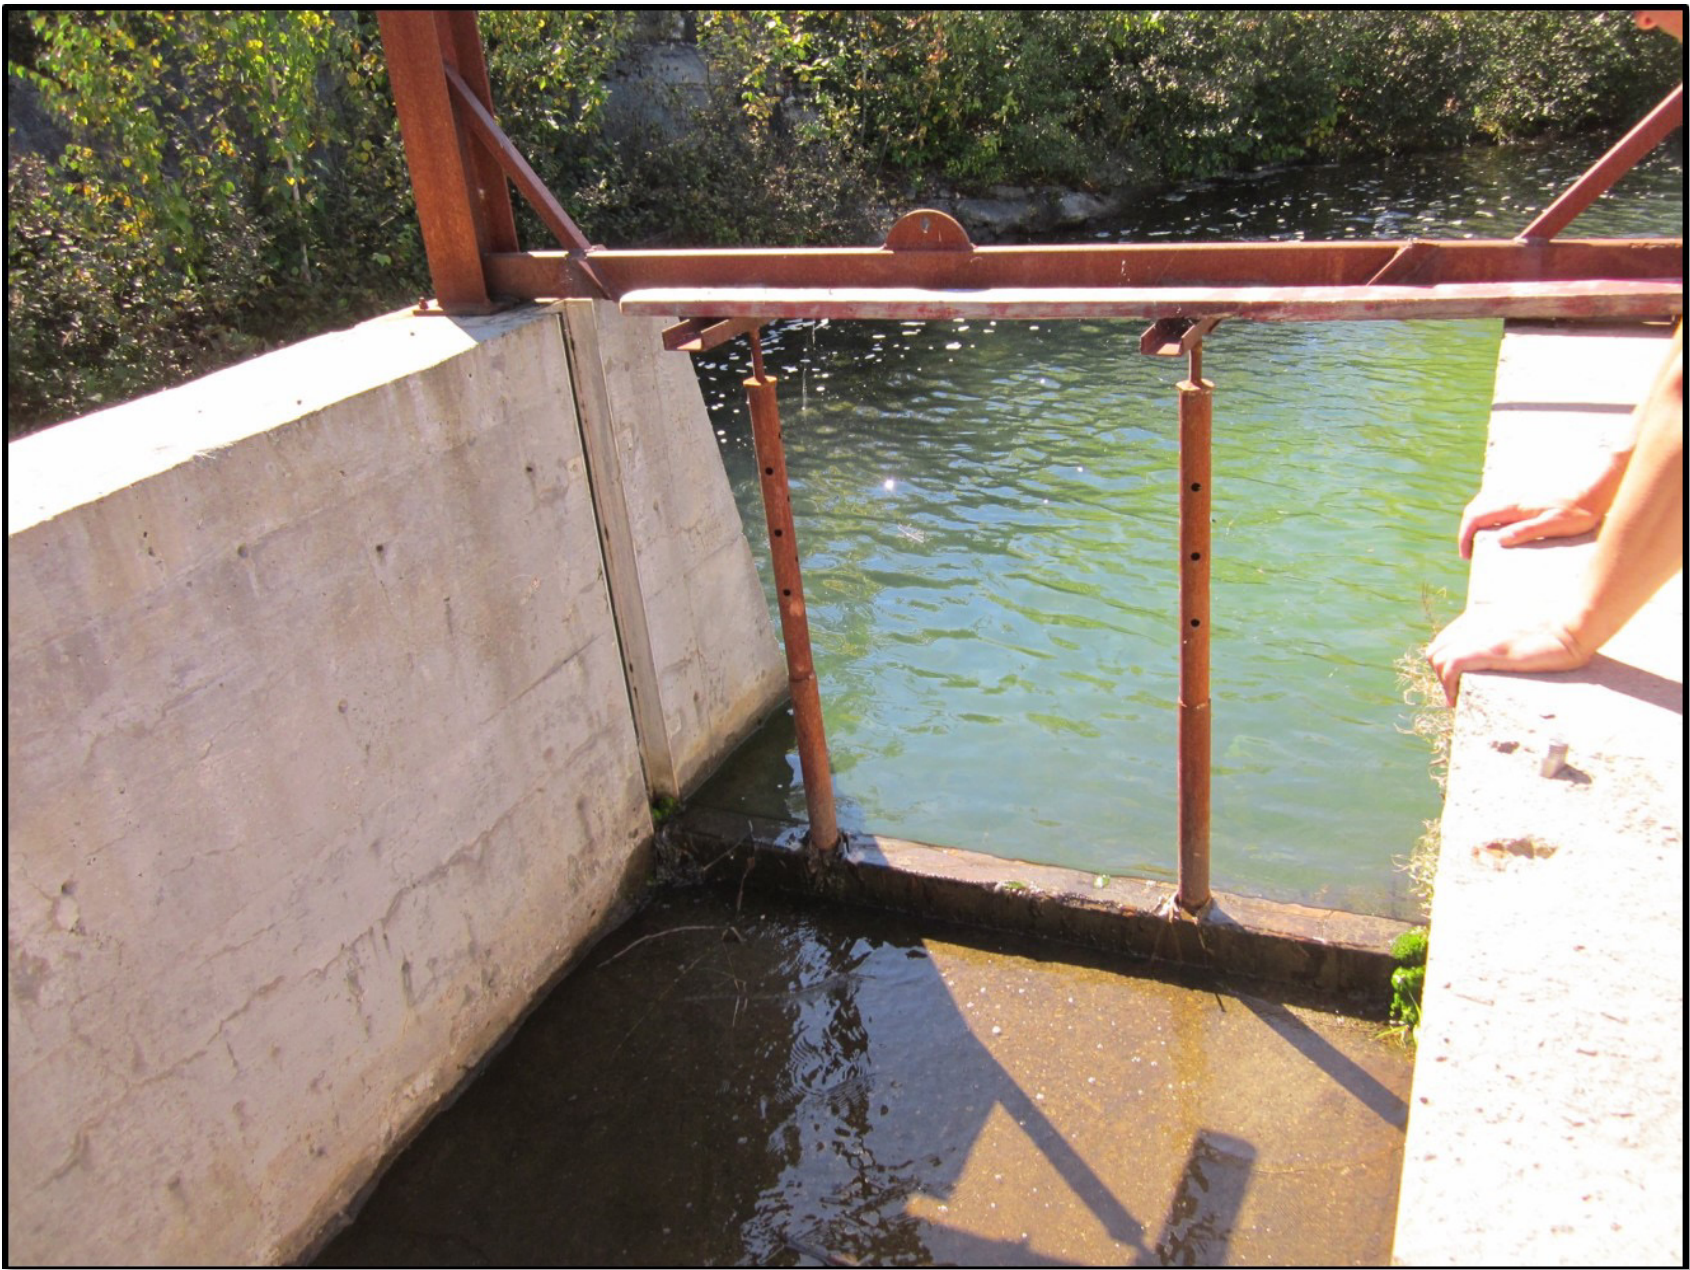
Photograph 8: Tailings pond effluent

- The tailings pond overflow weir was in good condition, there was no debris and water was free flowing. The bridge is planned to be rehabilitated in 2018.

Good condition, no debris, water was free flowing.

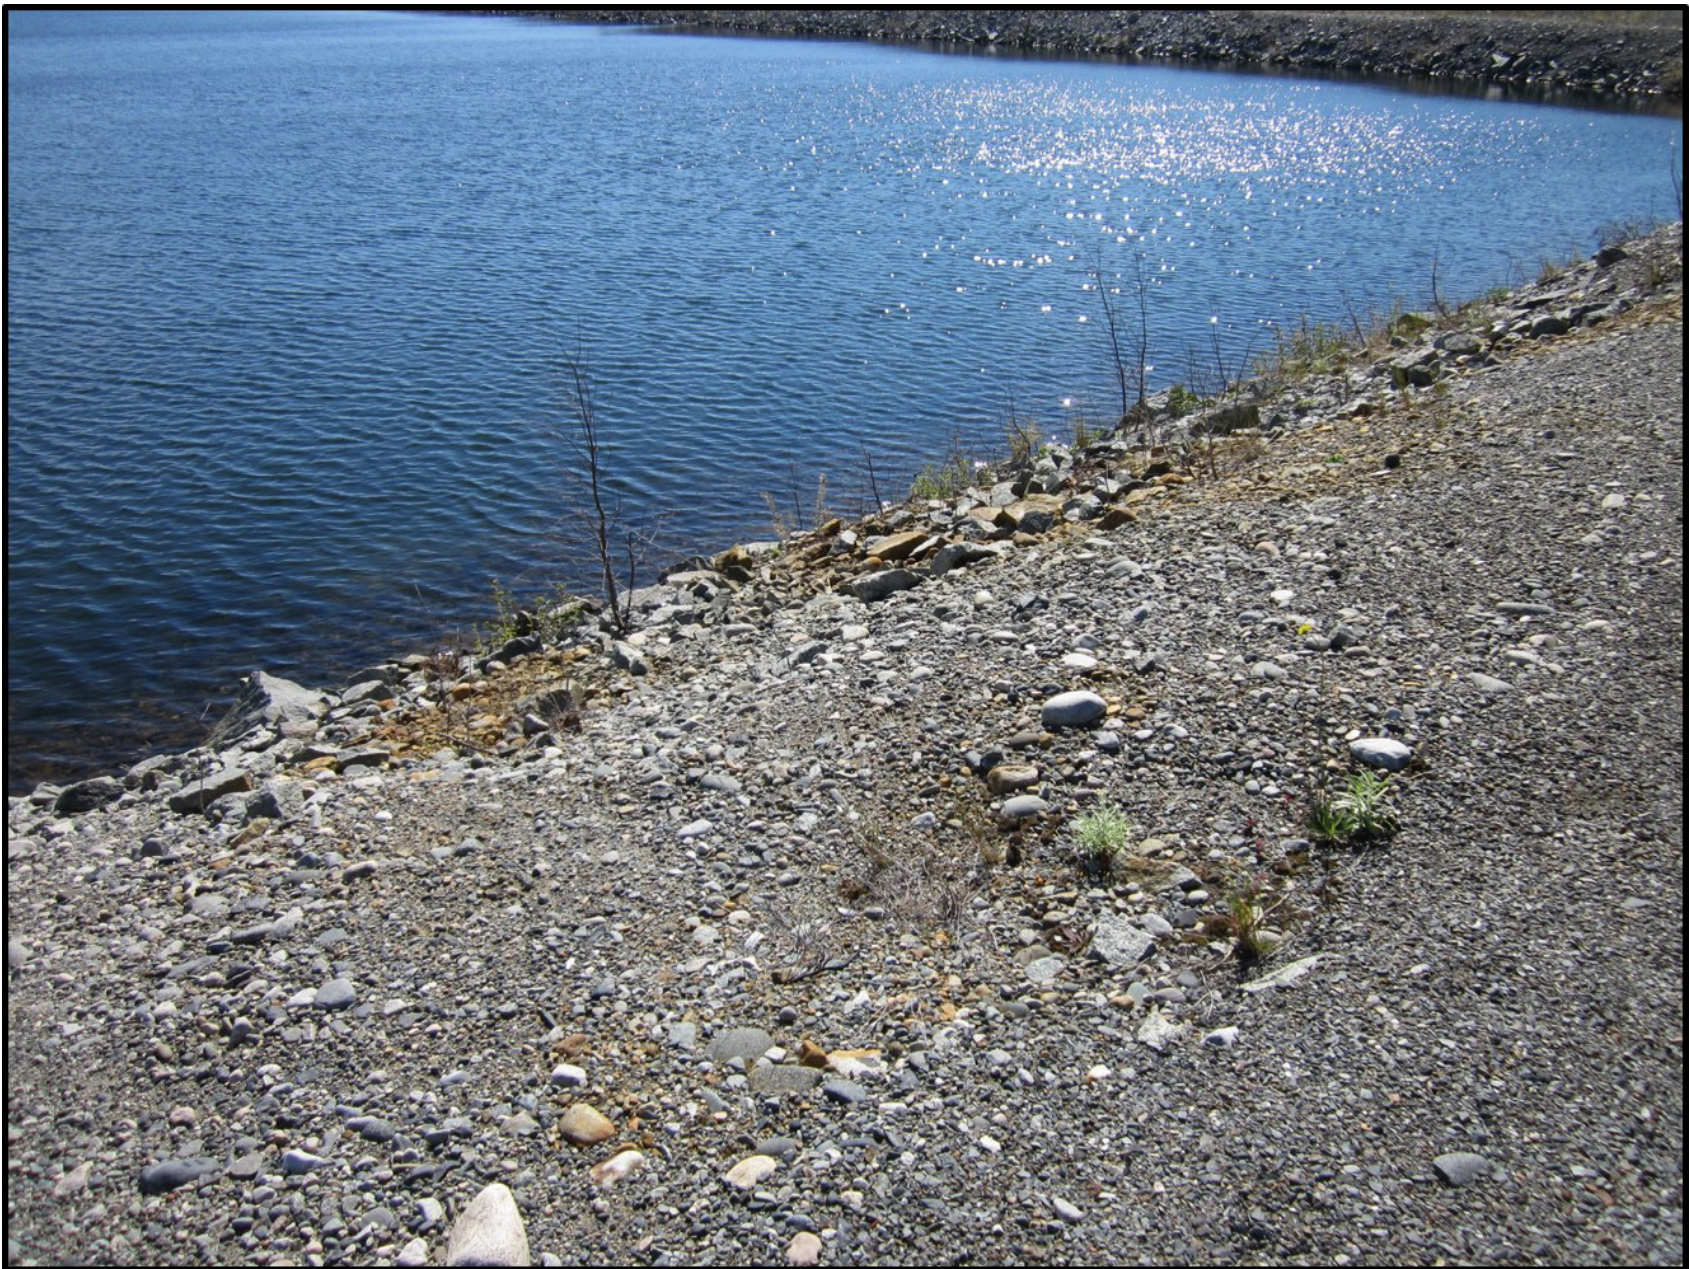
Photograph 9: Dam 1A

- Several minor erosion points are visible at the crest of Dams 1A and 1B. These are to be observed.
- Rebar for settlement point SP-6 was damaged and should be repaired.

Typical minor erosion point visible at the crest of dams 1A and 1B.

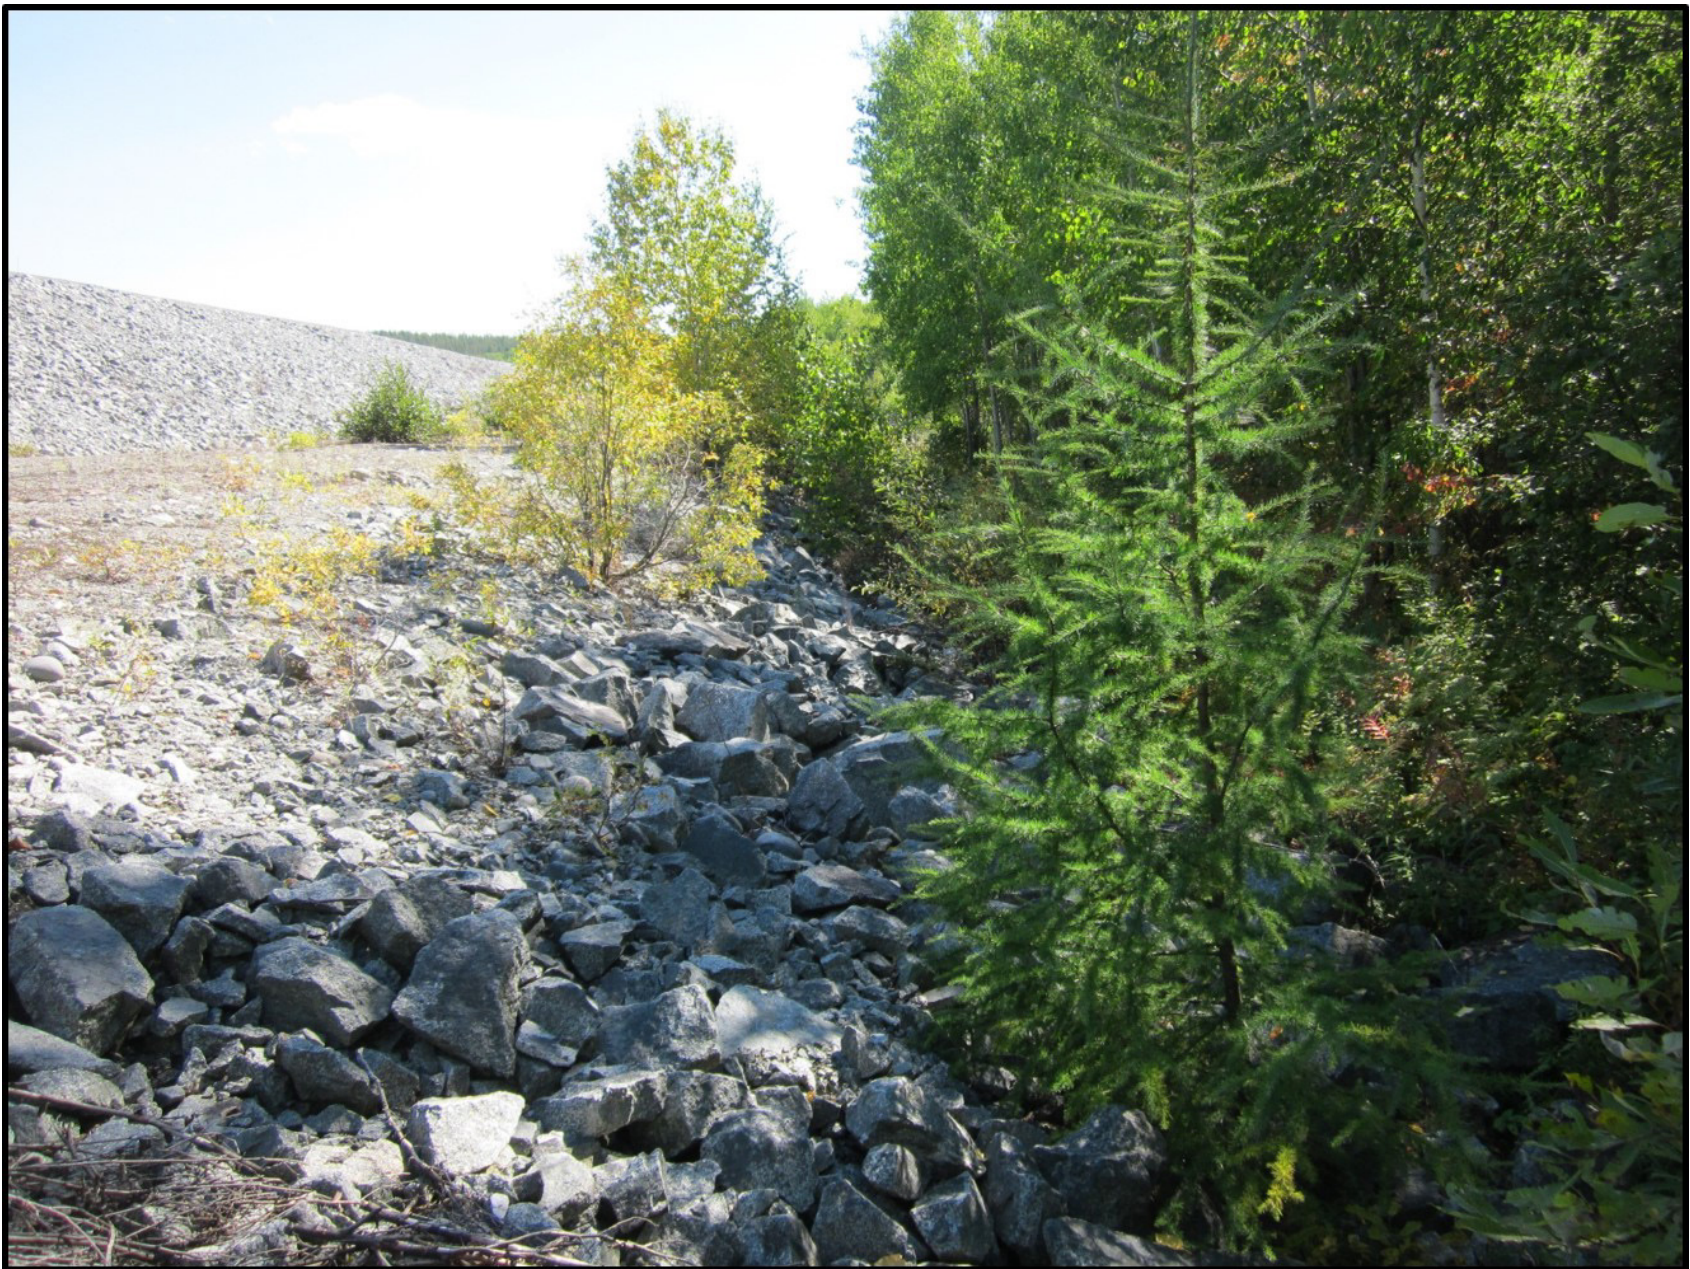
Photograph 10: Dam 2B

Toe of downstream berm, difficult to access because of growing vegetation.
