Teck Metals Ltd.

Pinchi Lake Mine Tailings Storage Facility

2017 Dam Safety Inspection

March 2018

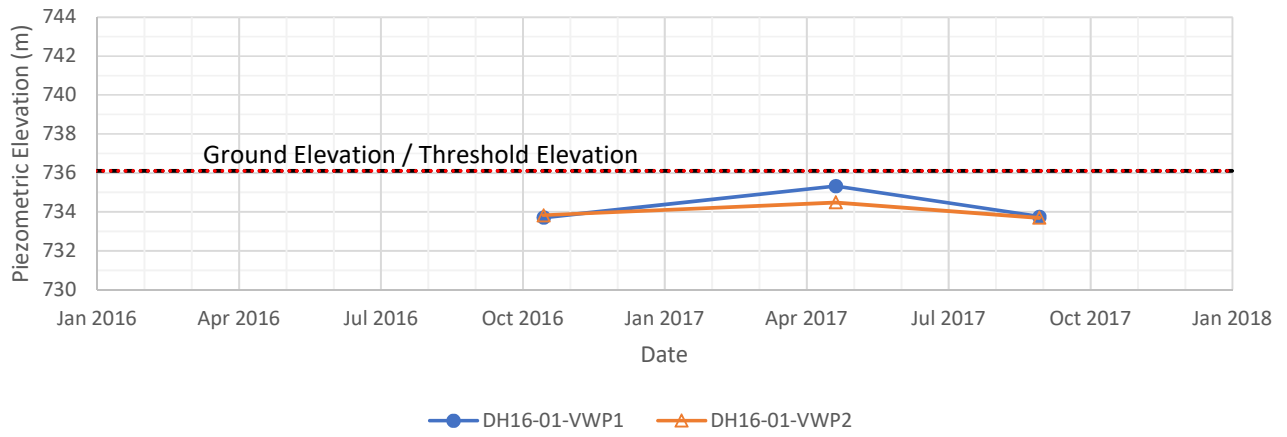
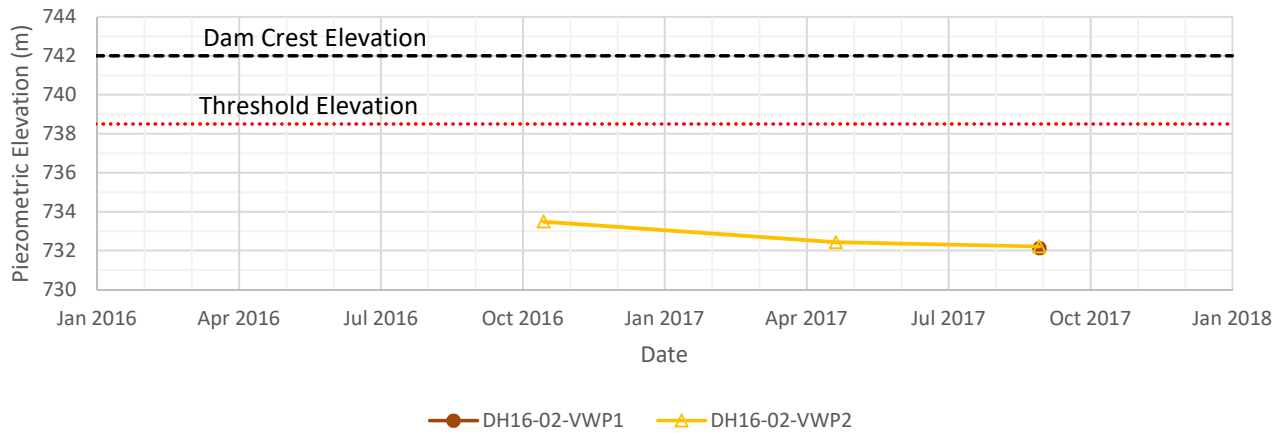
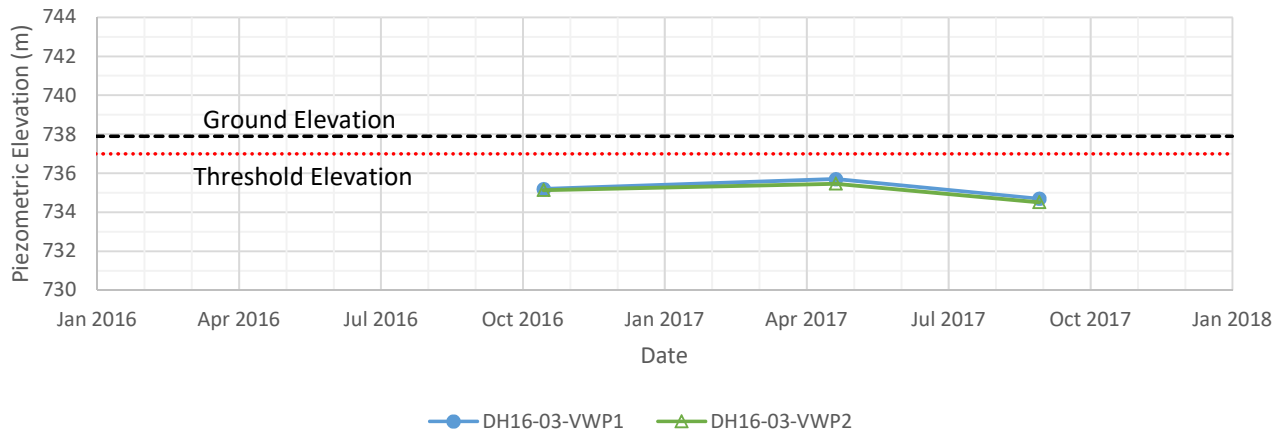
1. DH16-02-VWP1 was previously giving no reading, but a damaged spot in the cable was located during the Aug. 30, 2017 reading. The cable was cut below the damaged spot and the instrument now appears to be functioning properly.

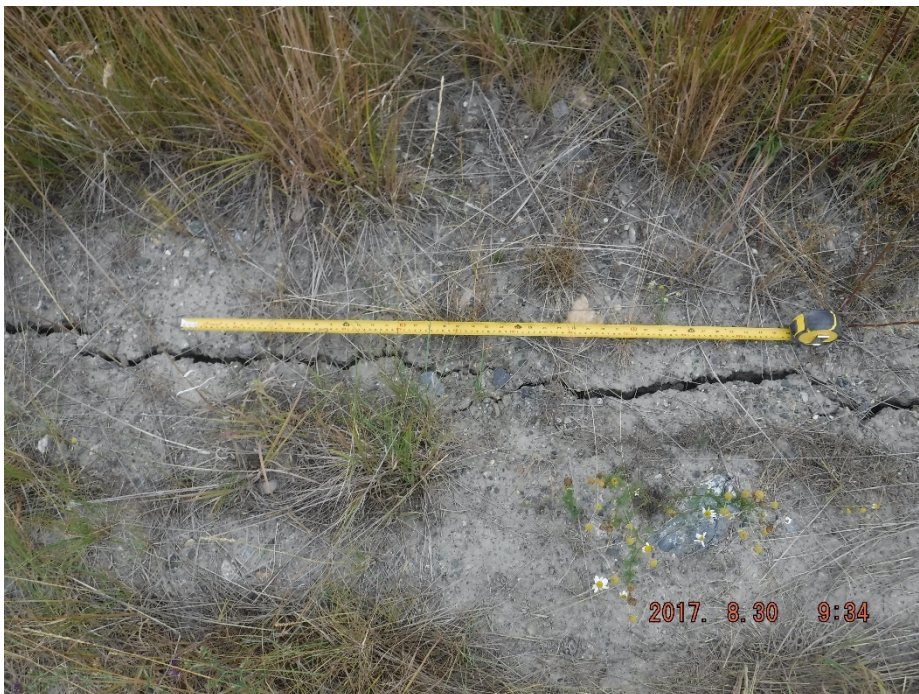
- The dam crest, and upstream and downstream slopes of the Tailings Dam appeared to be in good condition, except as noted below.
- Longitudinal cracks were observed on the dam crest along the southwest leg and south leg of the Tailings Dam (Location 5 in Figure 4.1; Photo II-10). Similar cracks were observed in these areas during the 2015 inspection, but the cracks were not visible in 2016. The cracks appear to be aligned with tire tracks. The cracks are believed to have been formed by loosening and drying of the soil as part of the reclamation and seeding, and may have reopened due to dry conditions over the summer (see Section 3.1). The cracks are not considered to be a dam safety issue.

Photo II-10 Tailings Dam – Southwest Leg, crack on dam crest in tire track.

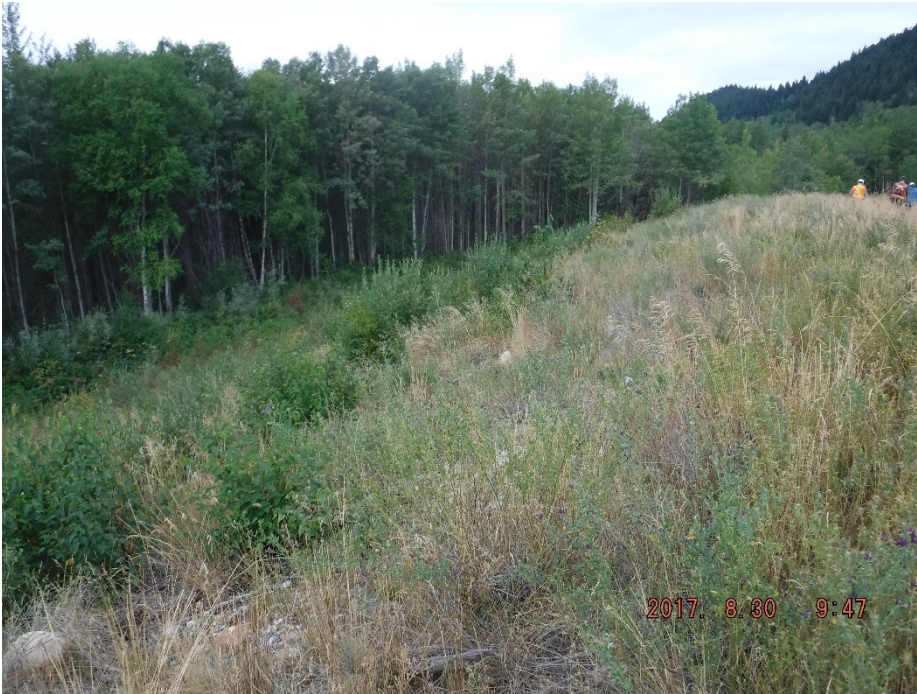
- The ground at the downstream toe of the southwest leg of the Tailings Dam was observed to be damp, and there is increased growth of vegetation in this zone (Photos II-13 and II-14). No flowing or standing water was observed.

Photo II-13 Tailings Dam – Southwest Leg, looking northwest along dam slope towards corner with West Leg.

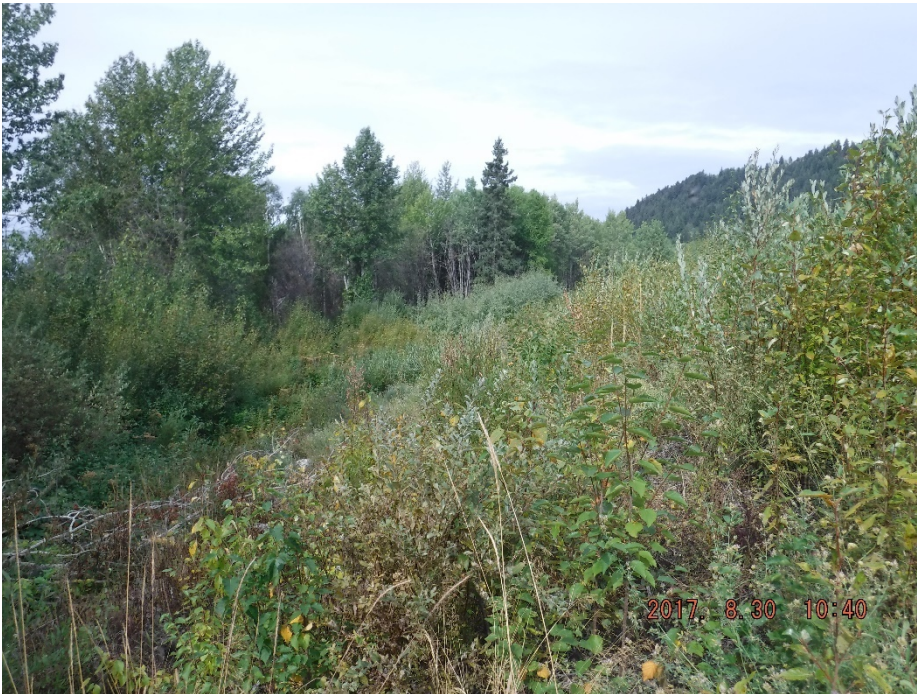
Photo II-14 Tailings Dam – Southwest Leg, looking northwest along dam slope from toe area.

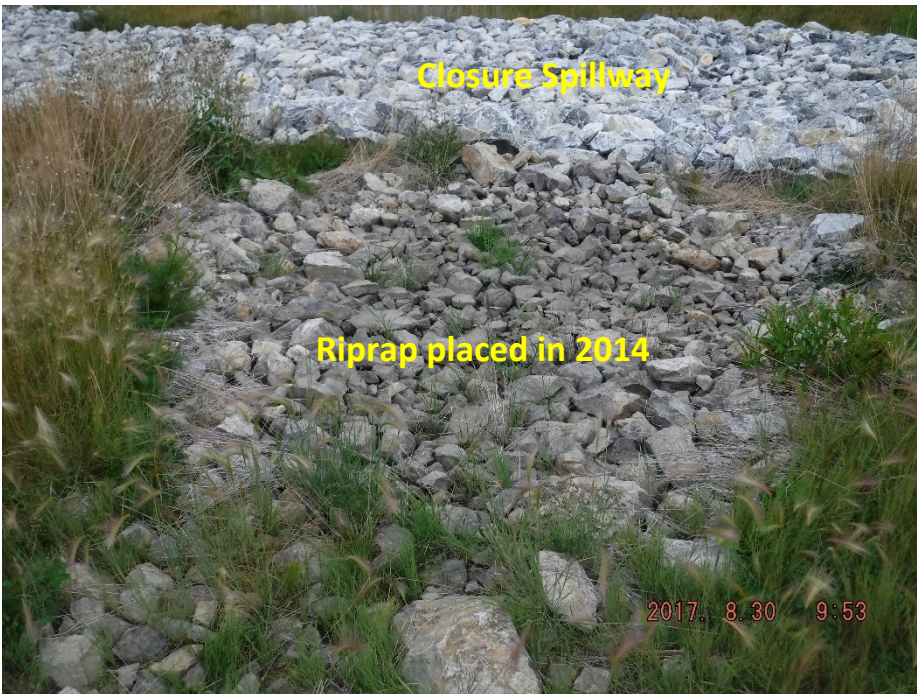
- There was no flowing or standing water in the Tailings Impoundment at the time of inspection.
- The soil cover on the tailings appeared to have good growth of grass (Photos II-2 and II-4 in Appendix II). A detailed inspection of the cover was not conducted as it was not a part of the scope of this DSI.
- As noted during previous inspections, a channel has formed in the soil cover parallel to the southwest leg of the Tailings Dam adjacent to the dam (Location 4 in Figure 4.1). There is good growth of grass and some cattails along most of the channel, with no signs of erosion.
- In 2014, Teck placed riprap at the downstream end of the above-mentioned channel where it discharges into the Closure Spillway (Location 3 in Figure 4.1; Photo II-20). The riprap appears to be performing well.

Photo II-20 Downstream end of surface runoff channel where it discharges to the Closure Spillway, showing riprap which was placed in 2014.

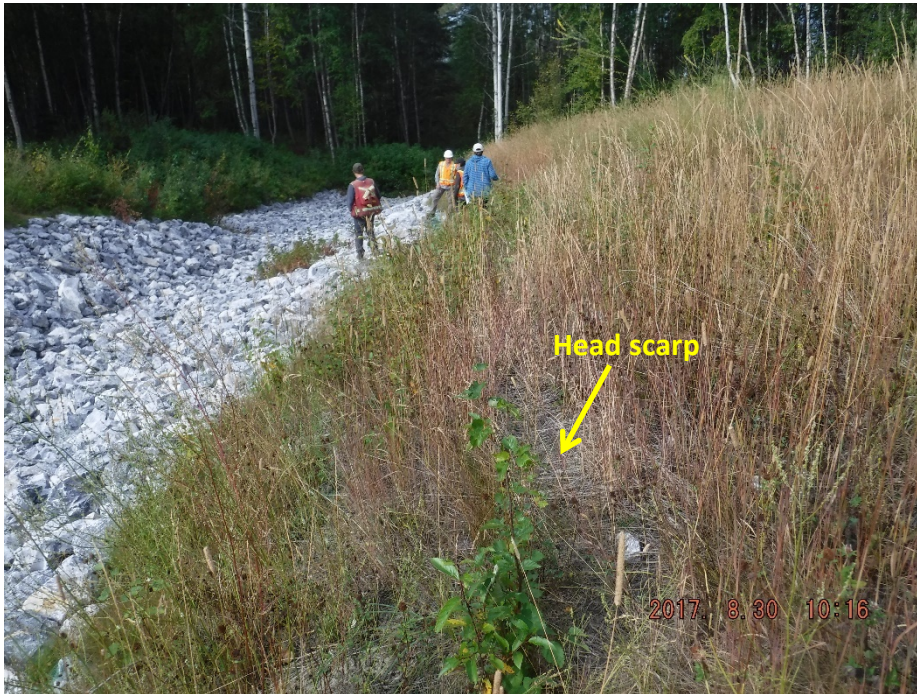
Photo II-23 Closure Spillway – head scarp of slump above right bank

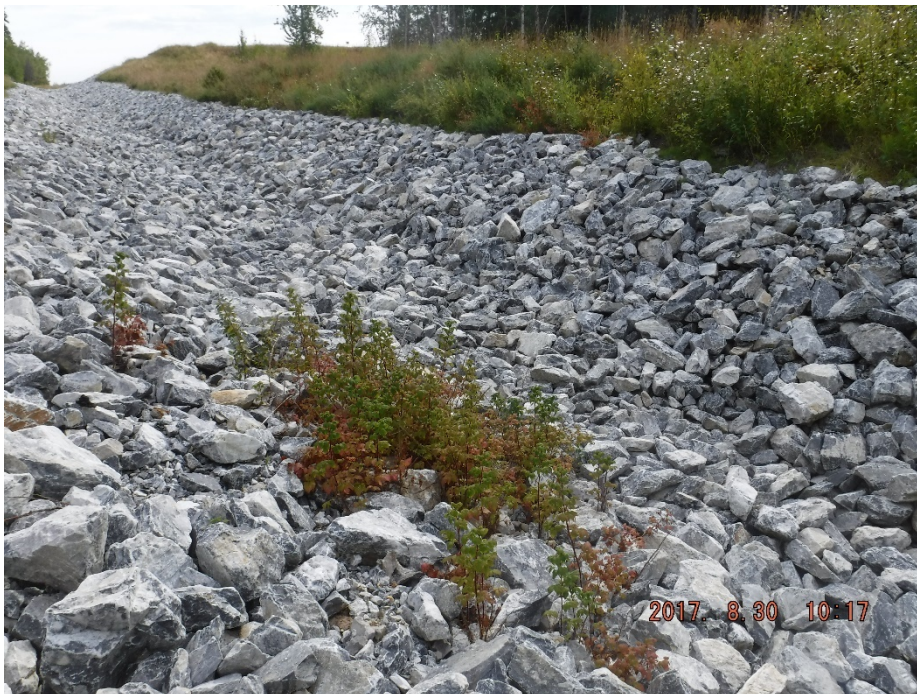
- The riprap along the entire Closure Spillway channel appeared to be in good condition (Photos II-18 to II-25). The spillway has likely not experienced any high flood discharges since it was constructed. Vegetation growth in the channel was minimal at the time of inspection, only a few small shrubs (Photo II-24).

Photo II-24 Closure Spillway – looking upstream from near downstream end of channel. Some minor regrowth of vegetation has occurred in this area.

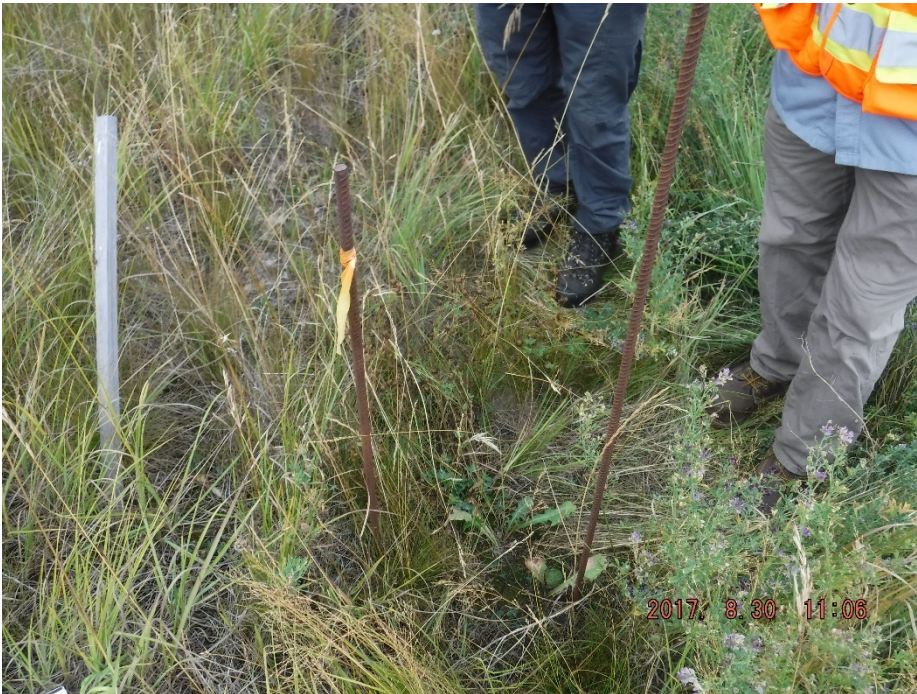
- Tension cracks were observed in 2013 on the slope of Borrow Area A, downslope of the Tailings Dam (Location 6 in Figure 4.1). The locations of the tension cracks are shown in plan and on the cross-sections in the figures presented in Appendix IV. The cracks were difficult to see during this inspection due to heavy growth of vegetation on the slope (Photos II-31 to II-32). No notable changes were observed since the 2016 DSI.

Location 403 showed an increase of 14 mm from Sep. 2016 to Apr. 2017, indicating widening of the cracks. However, the cracks themselves were difficult to see (see Photos II-31 and II-32 in Appendix II) and did not show any indication of widening. Also, the readings before and after the April 2017 reading did not indicate movement, so it is likely that the rods were disturbed and the reading does not represent real slope movements. Locations 103 and 203 show minor fluctuations in the readings with no net change over time. Location 103A has decreased (narrowing of the cracks) over time. The readings currently do not give any cause for concern. Readings should continue to be taken during inspections as described in the OMS Manual to determine whether these trends will continue.

Photo II-31 Borrow Area A – tension crack monitoring rod location 403.

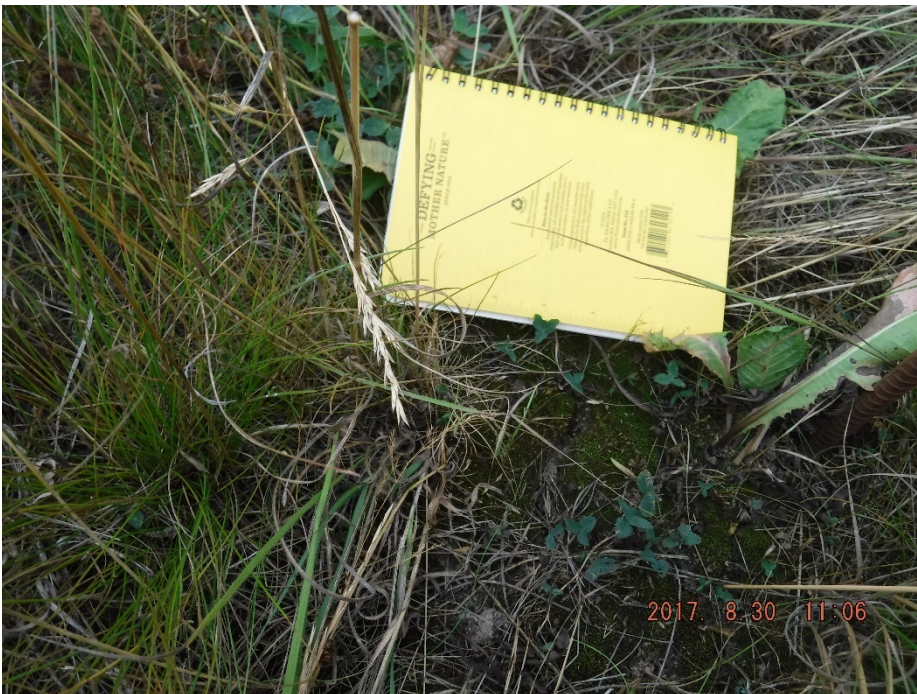
Photo II-32 Borrow Area A – tension crack on slope at monitoring rod location 403. Crack shows no sign of widening compared to previous inspections.

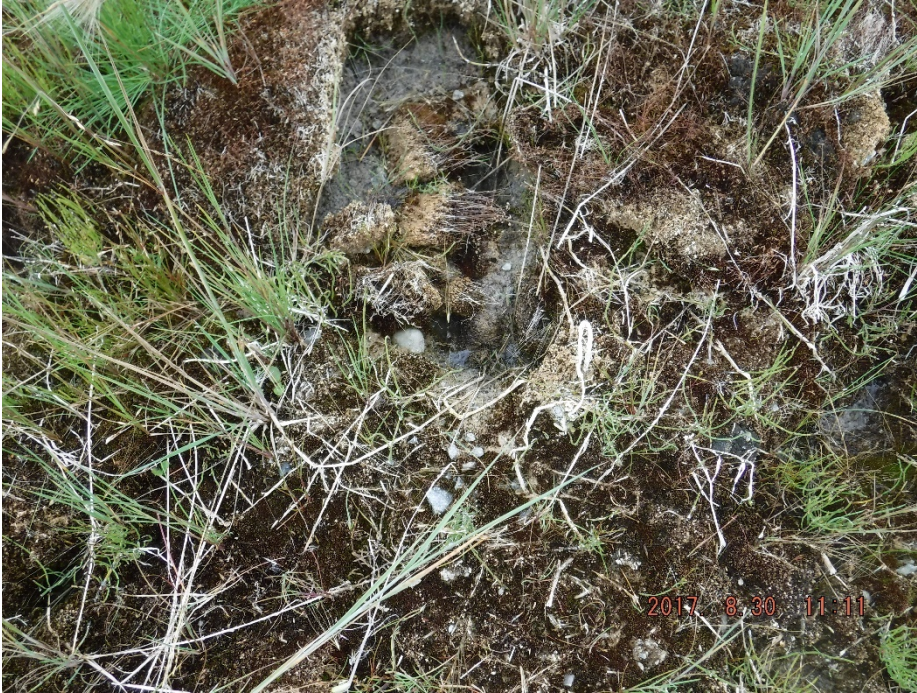
- Four small seepage areas were identified in July 2011 on the slope of Borrow Area A (Location 7 in Figure 4.1). The surveyed locations of these seeps are shown in Figure 1.2, and in the figures presented in Appendix V. Ed Creek originally flowed through the Tailings Impoundment area north of the four seeps, and it is suspected that Ed Creek is the source of the seepage water. During the August 2017 inspection, the ground in the toe area was barely damp, except in the northeast corner of the borrow area where the ground was wet but no seepage was observed (Photo II-33).

Photo II-33 Borrow Area A – wet ground in northeast corner. No flowing water was observed.

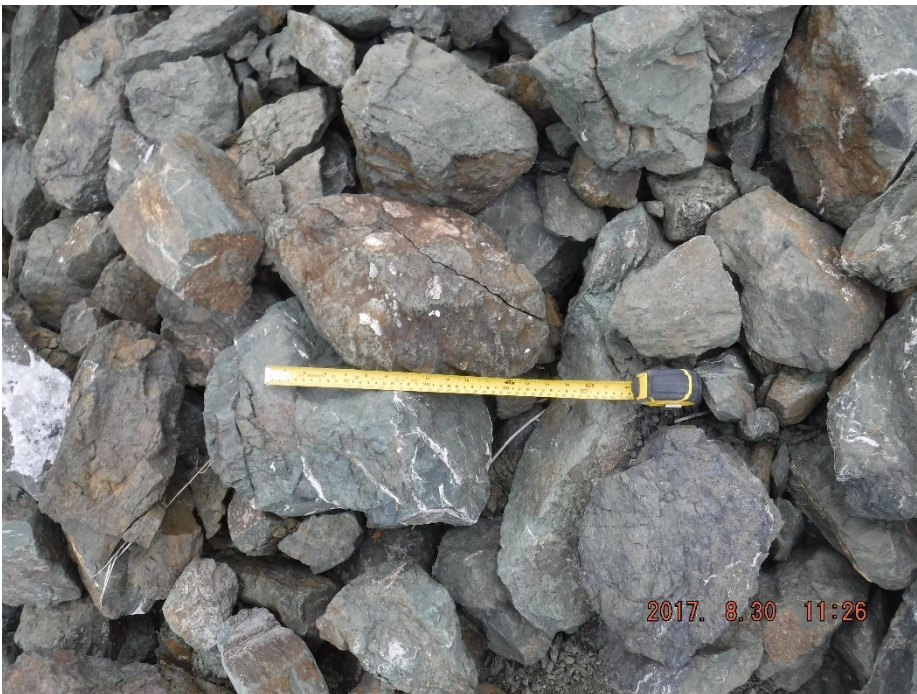
A failure of the Ed Creek Diversion Channel could potentially affect the Tailings Dam by eroding the west bank of the channel towards the dam and undermining the dam foundation. The recommendation from 2014 to re-establish erosion protection still stands, and Teck have been investigating erosion protection options for the channel.

Photo II-38 Ed Creek Diversion Channel – Riprap on right bank, showing weathering and breakage

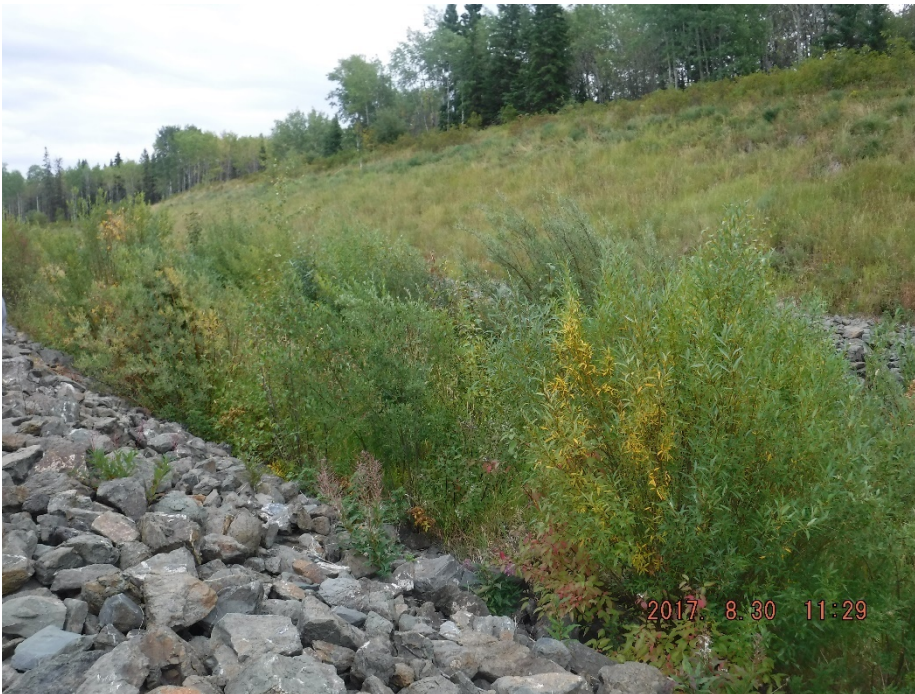
Photo II-39 Ed Creek Diversion Channel, looking upstream from near third bend. Channel base is covered with thick vegetation.

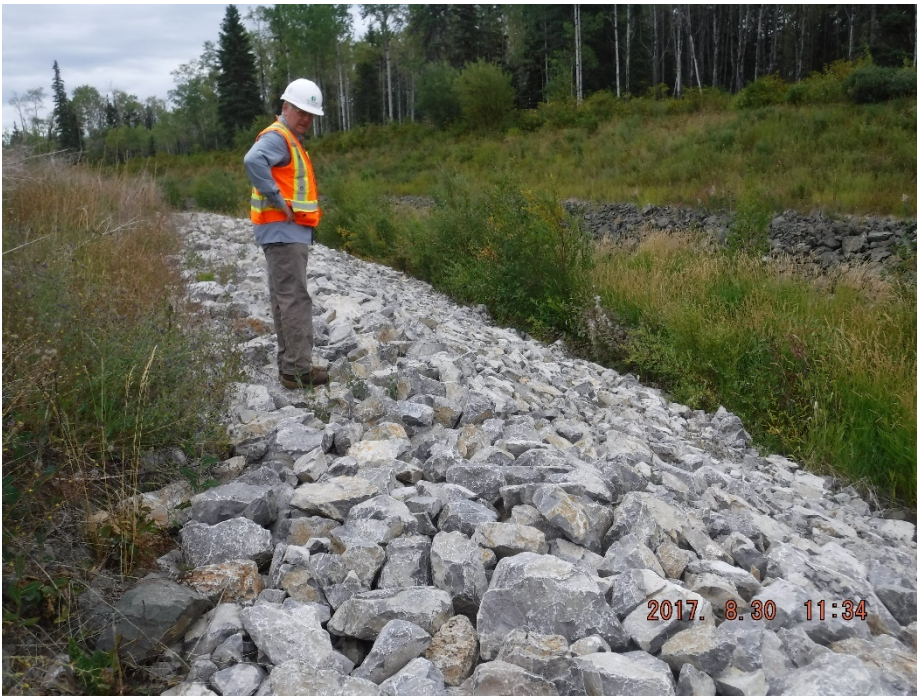
- The 460 mm diameter HDPE culvert on the north bank of the Ed Creek Diversion Channel had some vegetation growing in front of the inlet (see Figure 1.2 for culvert location, and Photo II-46) at the time of the inspection. Teck reported that this vegetation was cleared in October 2017.
- The Ed Creek Diversion Channel had heavy growth of vegetation at the time of the inspection (Photos II-37, II-39 to II-42, and II-44). Teck reported that this was cleared in October 2017.
- Previous annual inspection reports have noted that the riprap along some areas of the Ed Creek Diversion Channel is weathering and breaking up. The riprap along a small section of the channel (Location 8 in Figure 4.1; Photo II-41), where a depression had formed in the riprap surface, was replaced in 2014. This riprap appeared to be in good condition.

Photo II-41 Ed Creek Diversion Channel – area on right bank where riprap was replaced in 2014. Riprap in this area is in good condition.

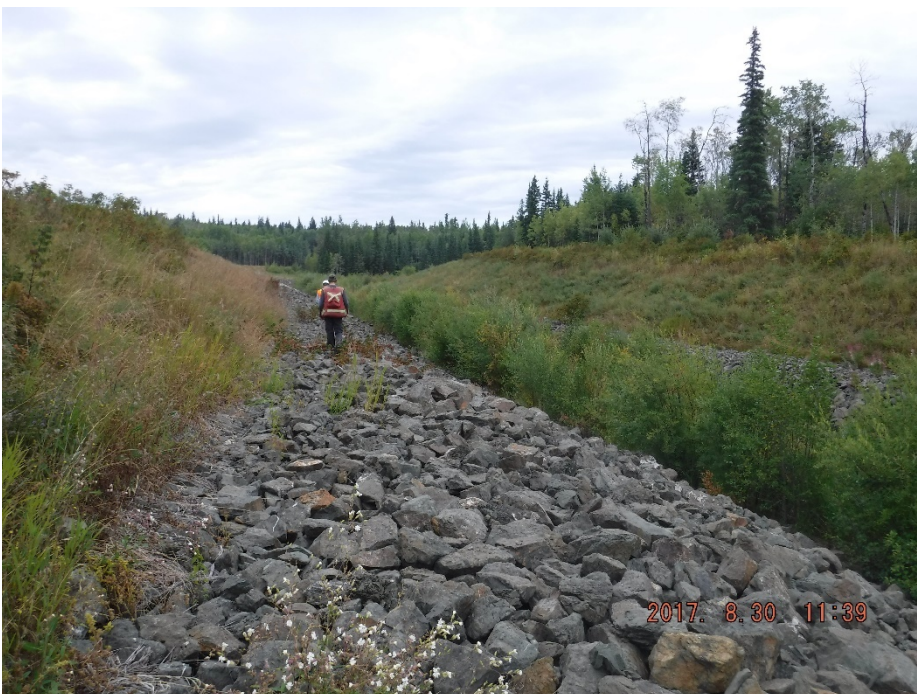
Riprap along the right bank of the channel upstream of Sta. 0+210 appears to be deteriorating more than other reaches of the channel. A depression in the riprap surface was noted in the 2015 inspection along a section of the channel identified as Location 9 in Figure 4.1 (Photos II-42 and II-43). The condition at this location during the 2017

Photo II-42 Ed Creek Diversion Channel – looking upstream from near second bend towards depression in riprap surface (location 9 in Figure 4.1).

inspection was similar to recent years. This area does not require immediate repair and can be dealt with as part of the erosion protection replacement for the entire channel. The existing recommendation (No. 2015-03) to inspect the depression is now considered closed.

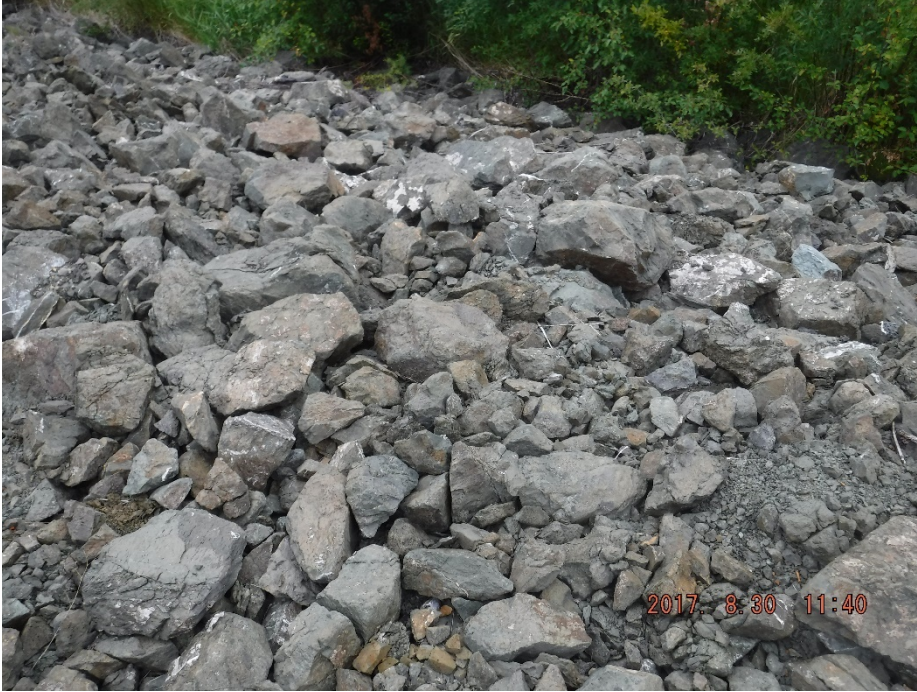
Photo II-43 Ed Creek Diversion Channel - Top of right bank where there is a depression in the riprap surface (location 9 in Figure 4.1), and riprap appears to be deteriorating more than other areas.

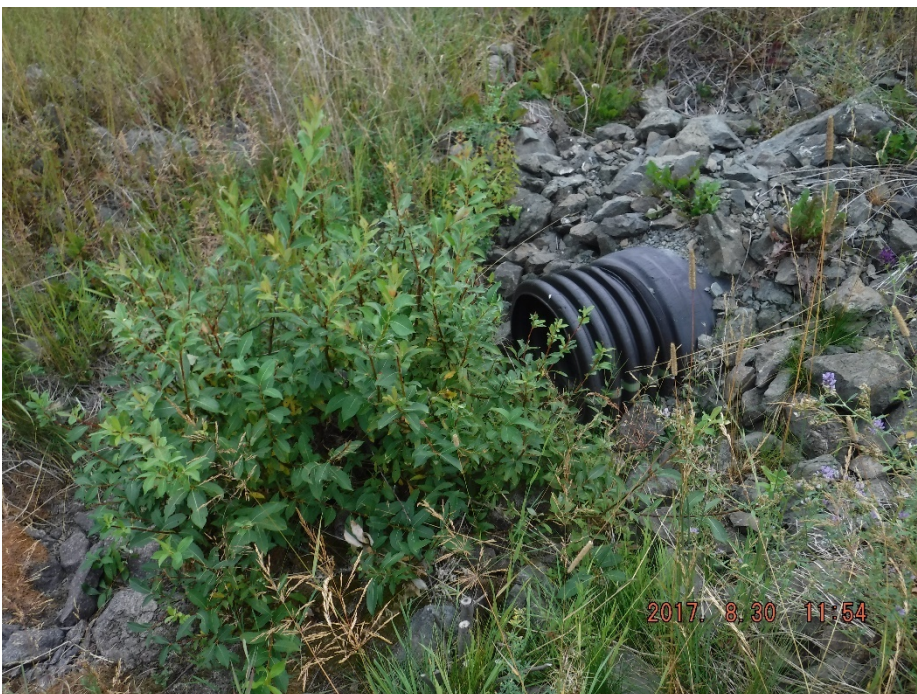
Photo II-46 Inlet of 460 mm culvert on north bank of Ed Creek Diversion Channel. There is vegetation upstream of the inlet that could block the channel during flood conditions.

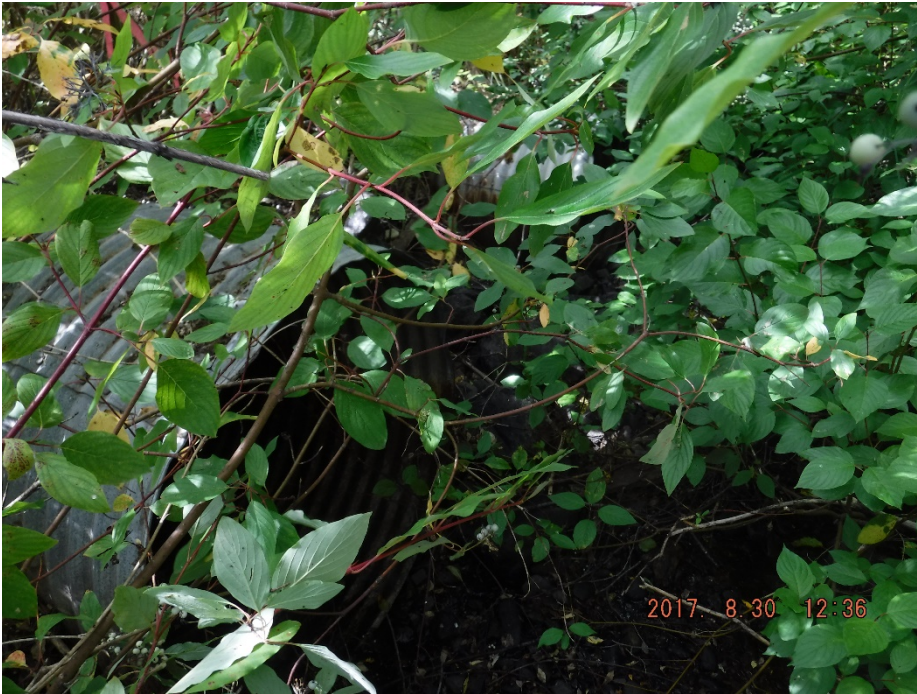
- There are two culverts on Ed Creek under Pinchi Lake Road east of the mine gate (see Figure 1.2 for location). Debris was cleared from the inlet of the culverts in April 2017. Although the inlets were clear of debris at the time of the inspection, there was debris and vegetation in the channel upstream that could be mobilized during flood conditions (Photos II-47 and II-48). A blockage of the culverts could potentially cause a washout of the road, and a sudden failure of the road embankment may subject the Ed Creek Diversion Channel to large flood flows. Monitoring of these culverts is included in the inspection checklists in the OMS Manual, and will continued to be monitored in future inspections.

Photo II-47 Inlets of Ed Creek culverts under Pinchi Lake Road. Vegetation is not currently blocking the inlet but could become mobilized during flood conditions.

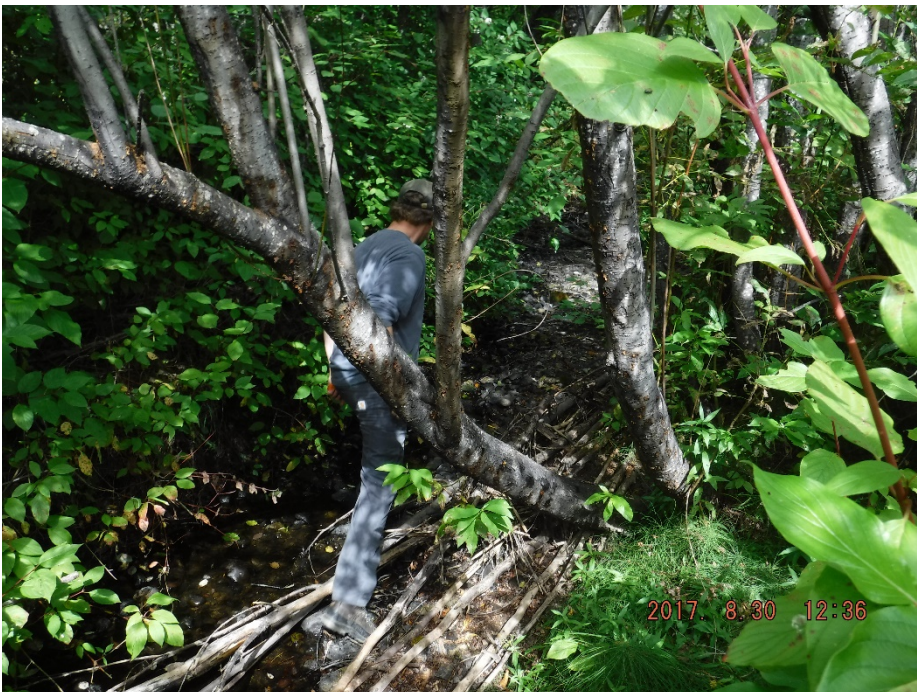
Photo II-48 Ed Creek culverts under Pinchi Lake Road, looking at channel upstream of culverts. There is debris in the channel.
