6 March 2018

2017 Dam Safety Inspection Pine Point Tailings Impoundment Area Pine Point, NT

Submitted to:
Teck Metals Ltd.
601 Knighton Road
Kimberley, BC
V1A 1C7

Reference Number: 1776943-003-R-Rev1-1600

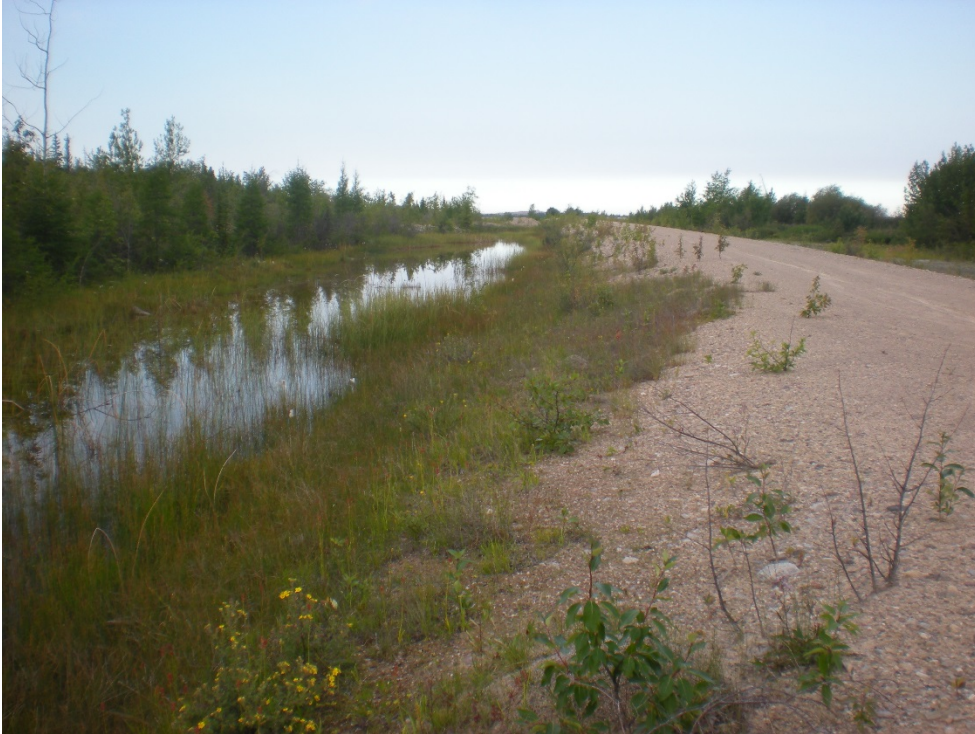
Photograph 1: South Dyke – Downstream Face at East End, Looking West. 27 July 2017

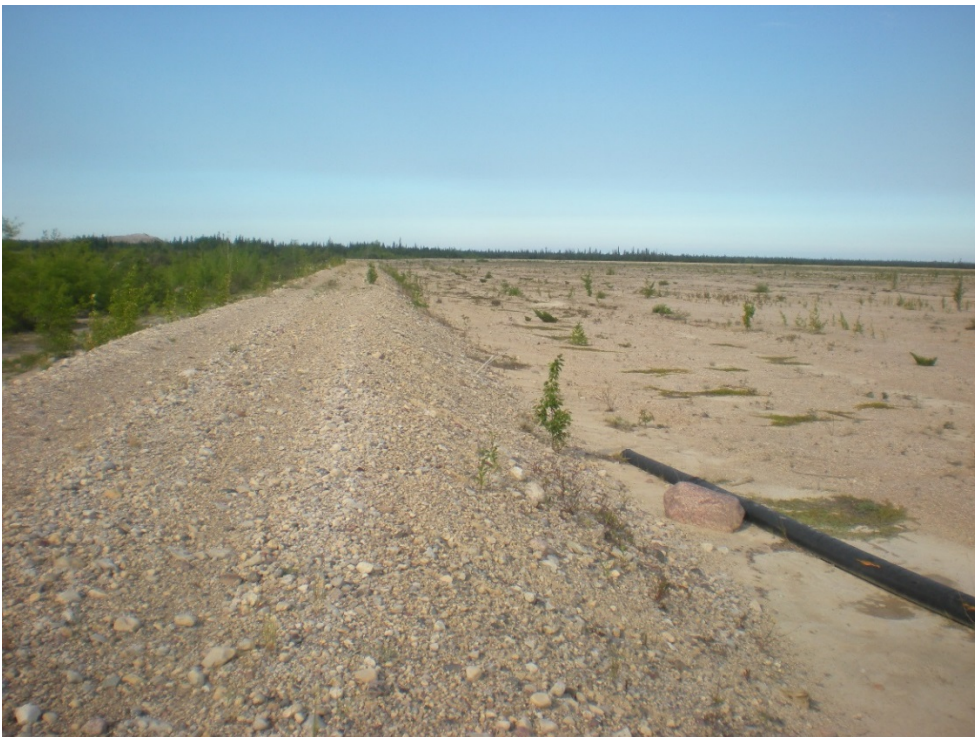
Photograph 2: South Dyke – Upstream Face of Central Portion, Looking West. 27 July 2017

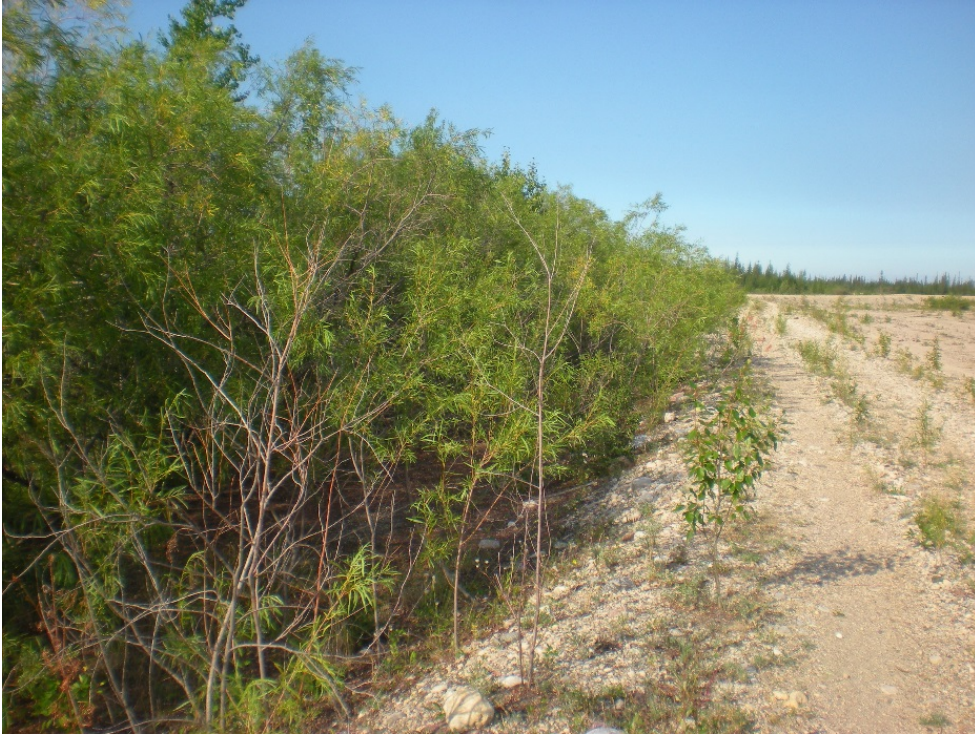
Photograph 3: South Dyke – Downstream Face of West End with Vegetation, Looking West. 27 July 2017

- Clearing of vegetation should continue in accordance with the OMS manual. Vegetation regrowth will be an ongoing issue. Priority should be given to the western portion of the south dyke, where some of the densest vegetation was observed. Teck has indicated that spraying and vegetation clearance was completed in summer 2017.

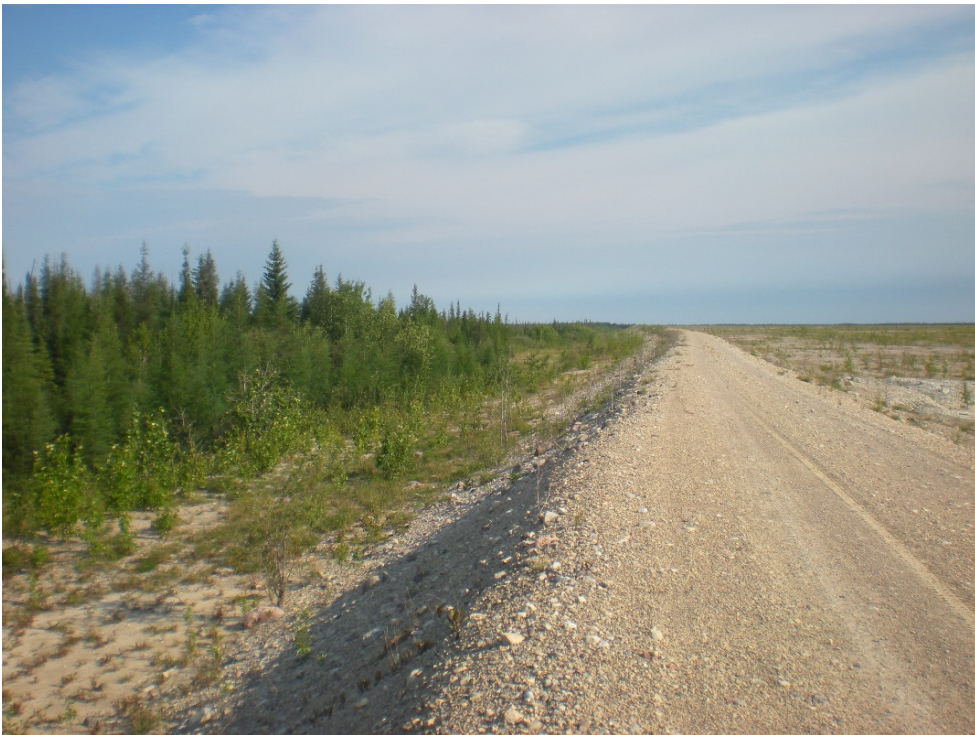
Photograph 4: West Dyke – Downstream Face, Looking North. 27 July 2017

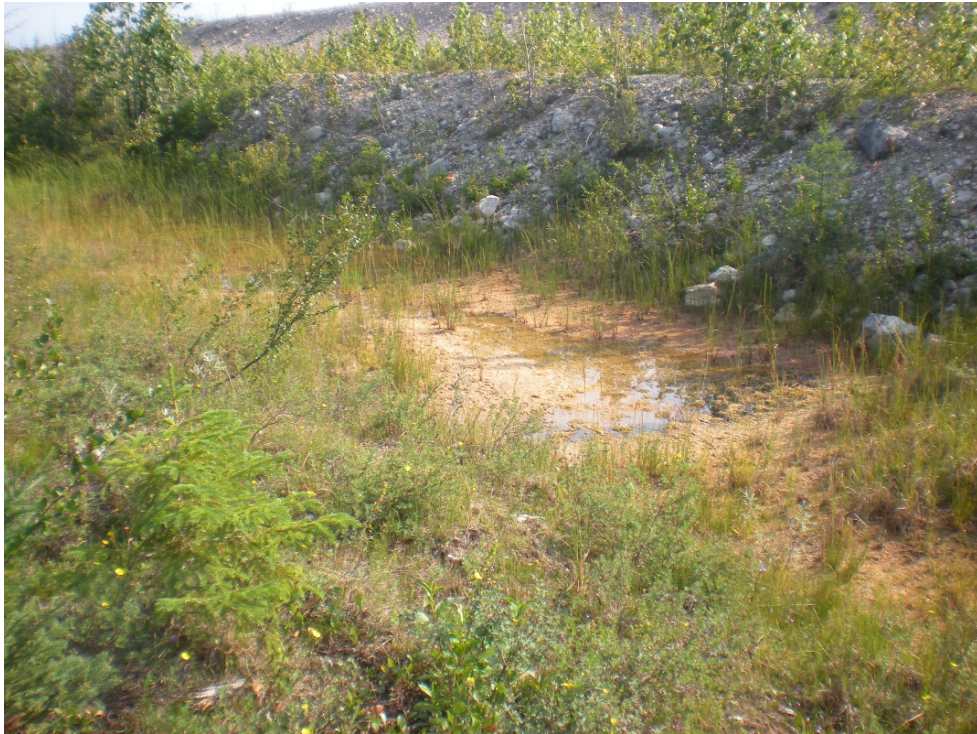
Photograph 5: West Dyke, South End. Ponded Water Downstream Of Toe, Looking North. 27 July 2017

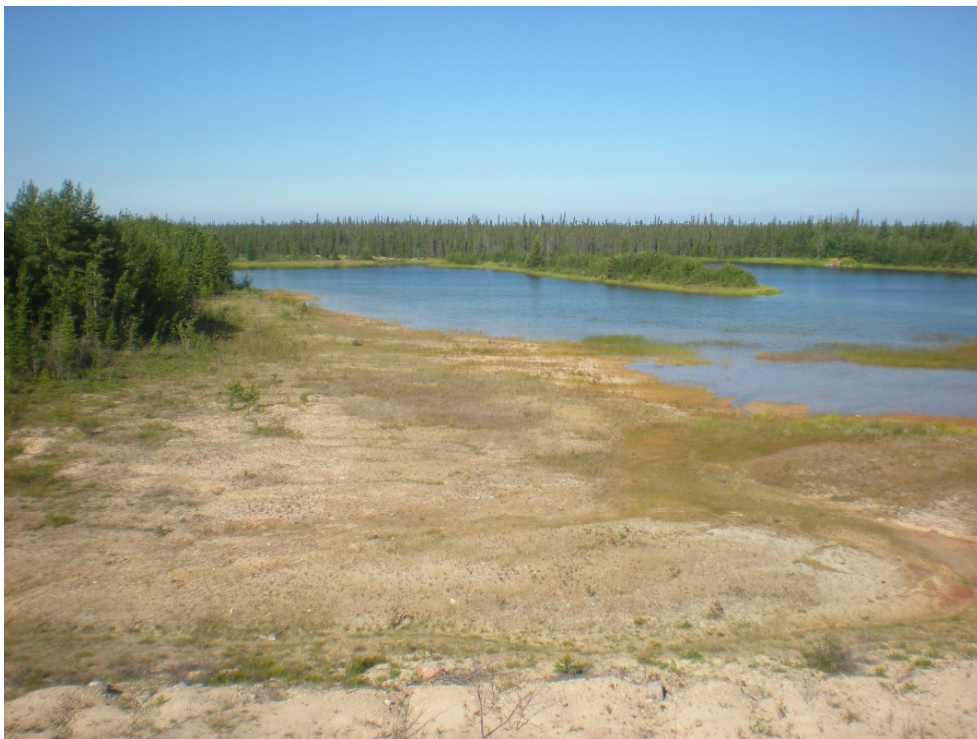
Photograph 6: West Dyke – Downstream Drainage Course near North End - Dry. 27 July 2017

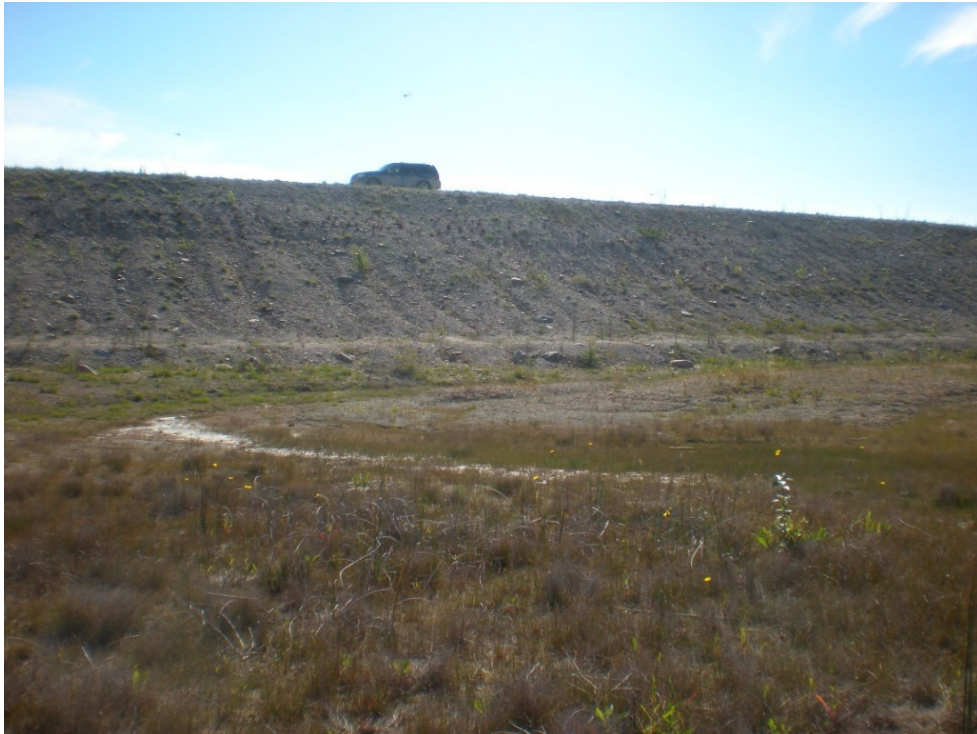
- Other than the ongoing clearing of vegetation, there is no other maintenance noted for 2017.
- The formation of erosion gullies on the downstream slopes of the south, west, and east dykes has been observed during previous site inspections. In the last seven years of inspections, including 2017, the degree of erosion has not been observed to increase significantly.

Photograph 7: West Dyke, Downstream Side – Looking East, Stable Erosion Features. 27 July 2017

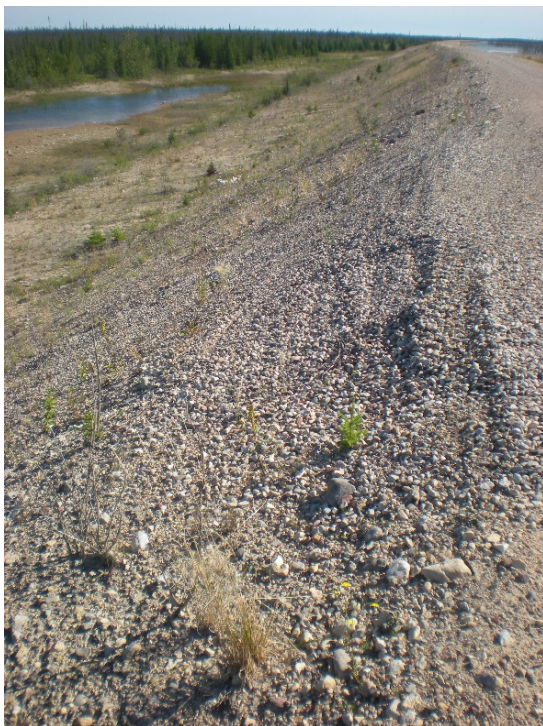
- Dykes are in overall good condition. Repairs made to a number of minor erosion features, by placing dam fill on the downstream side of the north dyke in 2016 were observed to be in place and intact. Minor erosion rills in other portions of the north dyke, including a 4 to 5 m section at the ramp remnant, do not appear to have grown significantly and do not impact dam integrity.

Photograph 8: North Dyke – Downstream Slope (left side of photo) with 2016 Patch on Erosion Feature in Place, Looking East. 27 July 2017

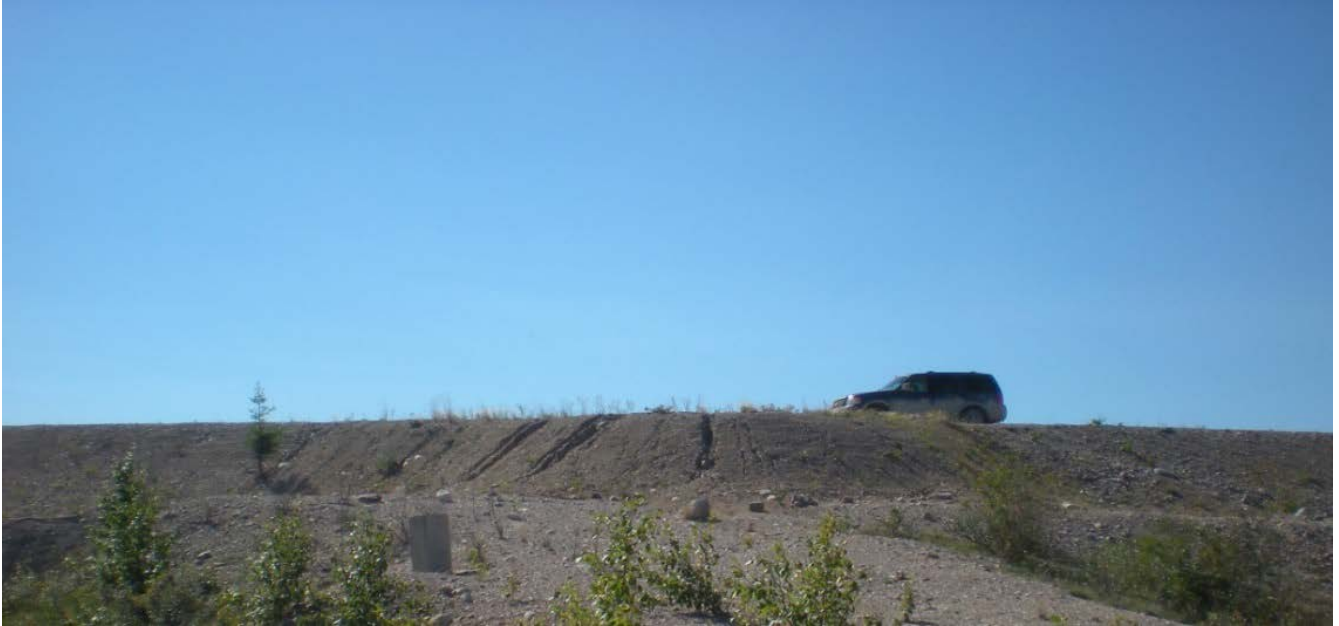
Photograph 9: North Dyke – Erosion Feature on Downstream Slope (former ramp, non-structural), Near Center (dogleg), Looking South. 27 July 2017

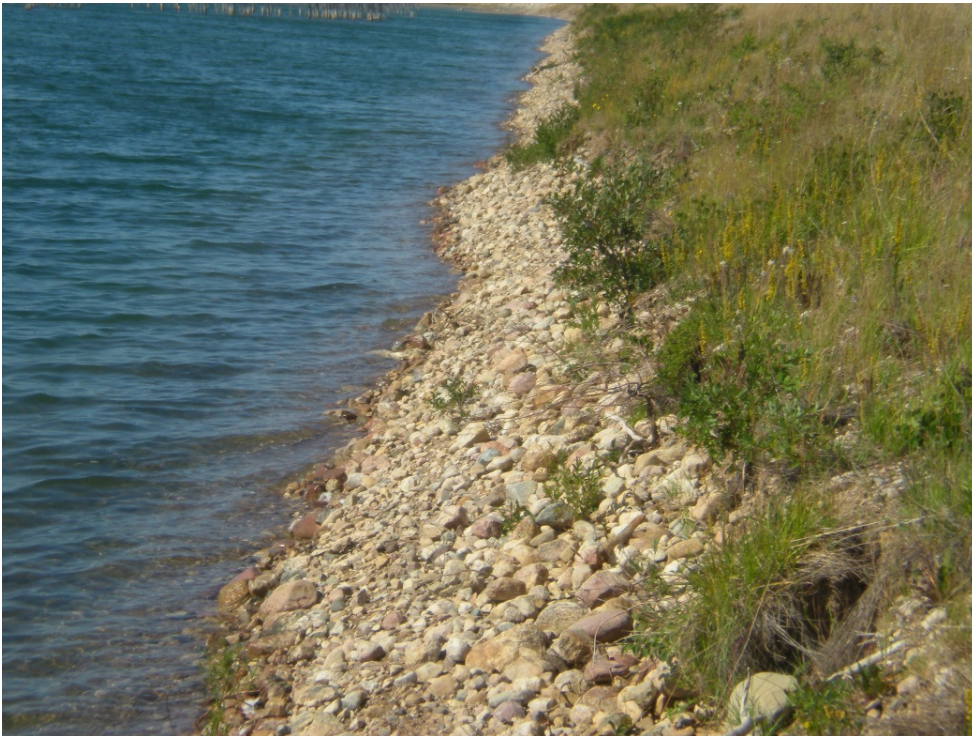
There is the potential for ongoing erosion of the upstream face of the north dyke. Historical erosion in this area has previously been repaired and may require additional maintenance in the future. The upstream slope is inspected annually to confirm that erosion does not compromise stability in the future.

Photograph 10a: North Dyke Upstream Face, Gravel and Cobbles at Pond Waterline. 27 July 2017

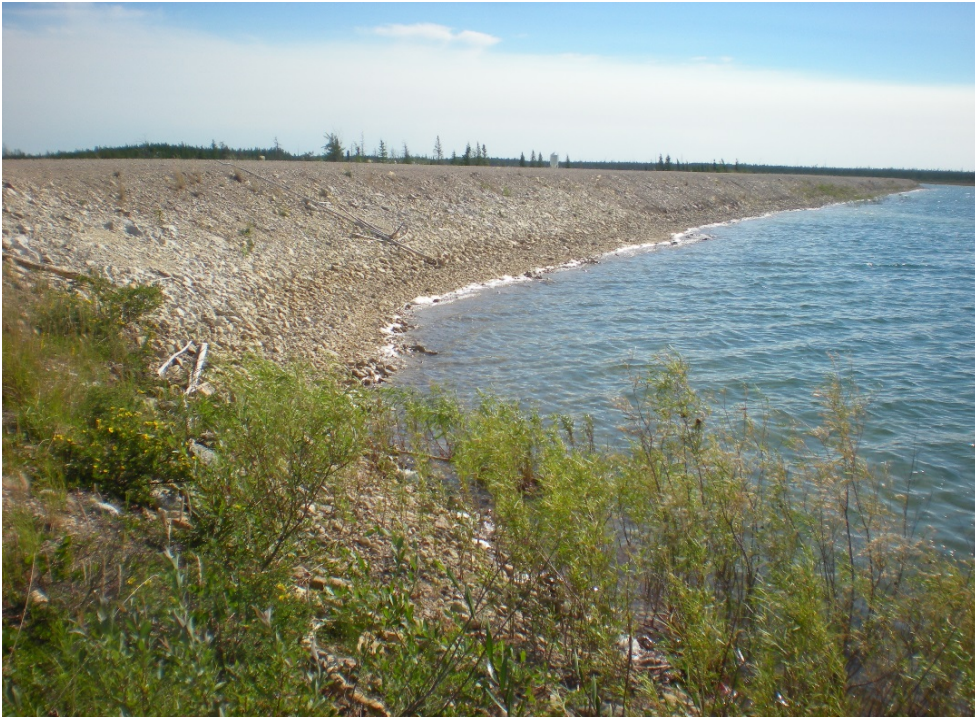
Photograph 10b: North Dyke Upstream Face, Gravel and Cobbles at Pond Waterline, at Dogleg Looking East. 27 July 2017

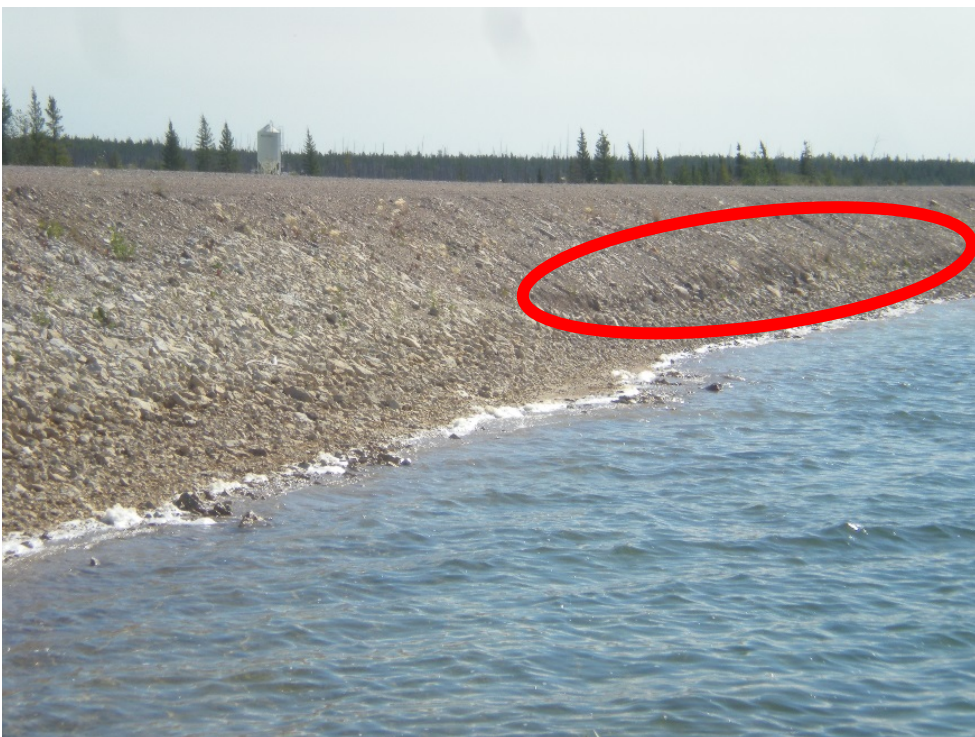
- Erosion
 - Wave cut erosion—During the 2014 and 2015 inspections, erosion was observed at the central section of the north dyke at or just above the water level. In 2016 repairs were made to a test section of the north dyke to evaluate if coarser fill is necessary for restoration. These repairs were in good condition at the time of the inspection. The erosion in areas that had not been repaired in 2016 did not increase significantly between 2016 and 2017.

Photograph 10c: North Dyke Upstream Face, Gravel and Cobbles at Pond Waterline, at Dogleg Looking East. Detail Showing Possible Sloughing of Previous Repair. 27 July 2017

Structure	ID Number	Deficiency or Non-conformance	Applicable Regulation or OMS Manual Reference	Recommended Action	Priority	Recommended Deadline/Status
North dyke	2014-01	Erosion observed on the pond side of the north dyke with potential to cause dyke instability.	OMS manual Section 5.5.2	<p>Continue observation and evaluation of replacement fill placed in 2016 throughout 2018 monitoring period.</p> <p>Should restored area indicate adequate performance, repair the remaining sections of observed erosion in 2019 with the same fill material used in the trial.</p> <p>Should significant erosion occur within the test section during 2018, complete a new test restoration using coarser fill in 2019, or evaluate alternative approaches such as periodic repair work on the fill.</p>	3	end of Q2 2019

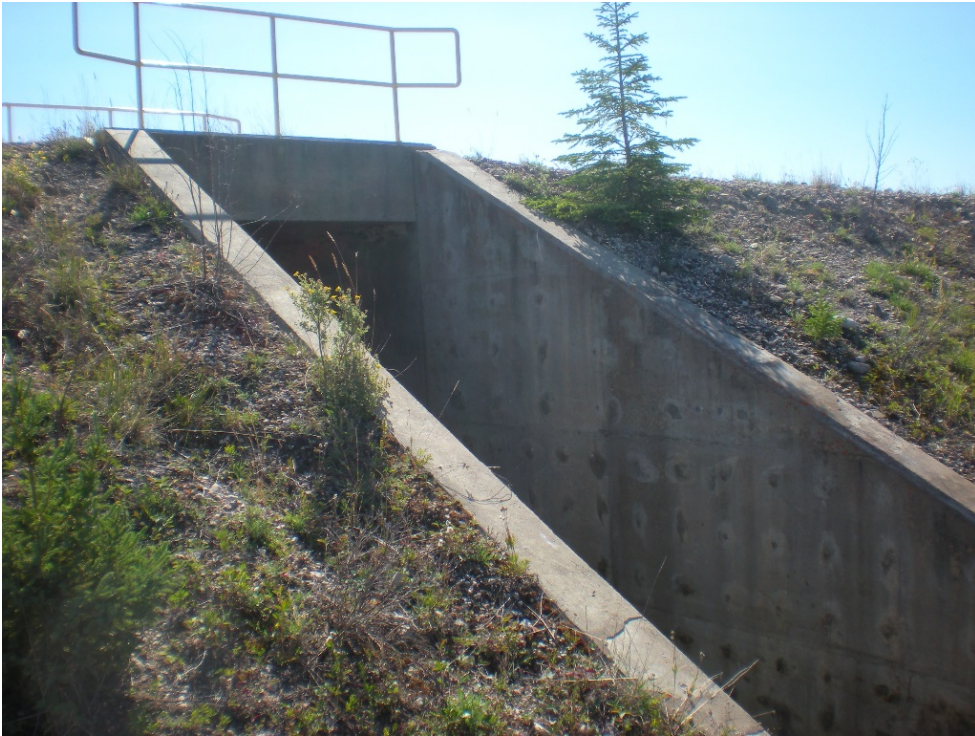
Photograph 11a: Main Pond Spillway (Spillway No. 1). 27 July 2017

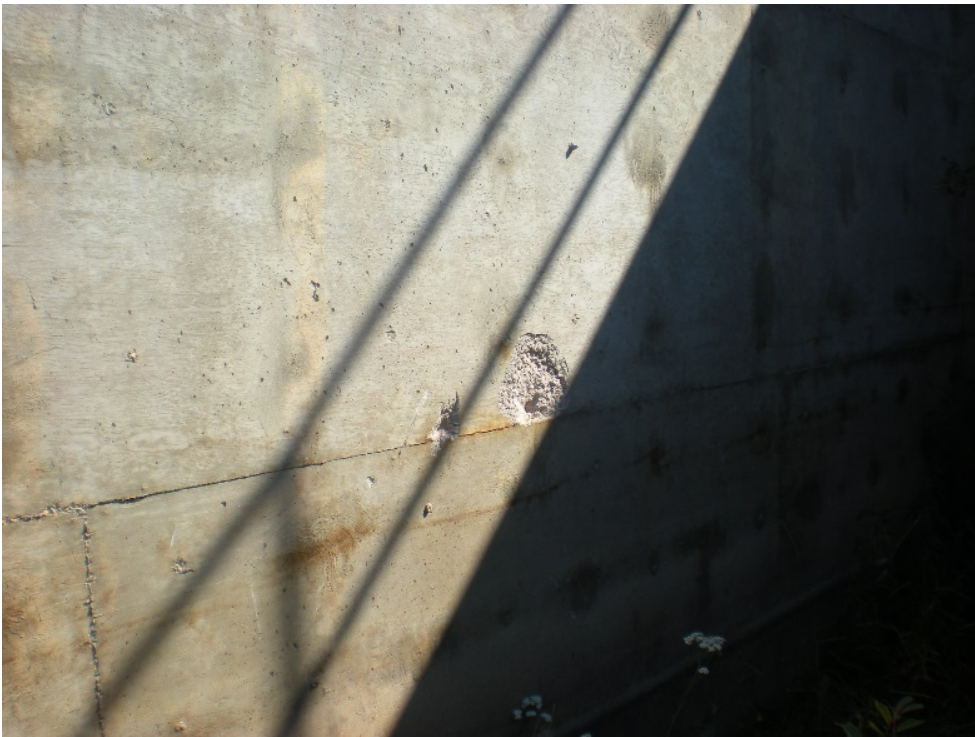
Photograph 11b: Main Pond Spillway (Spillway No. 1). Detail of Limited Spalling 27 July 2017

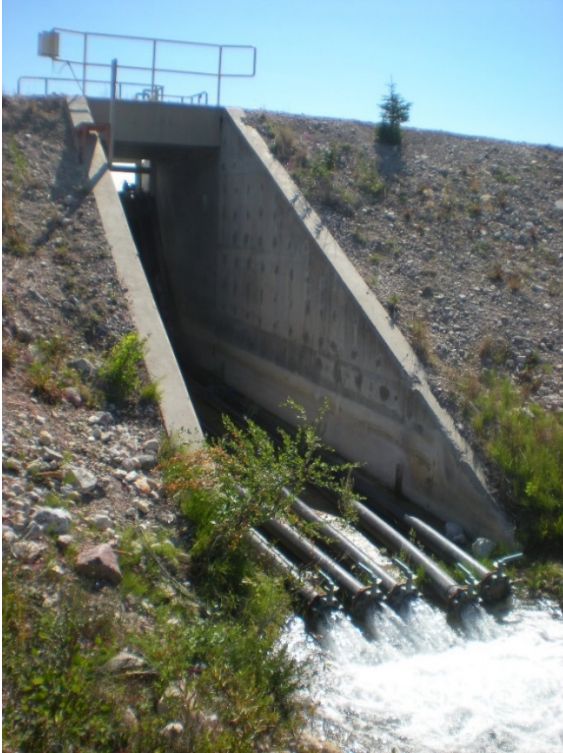
Photograph 12: Settlement Pond Spillway (Spillway No.2) – Syphon Piping Discharge at Outlet. 27 July 2017

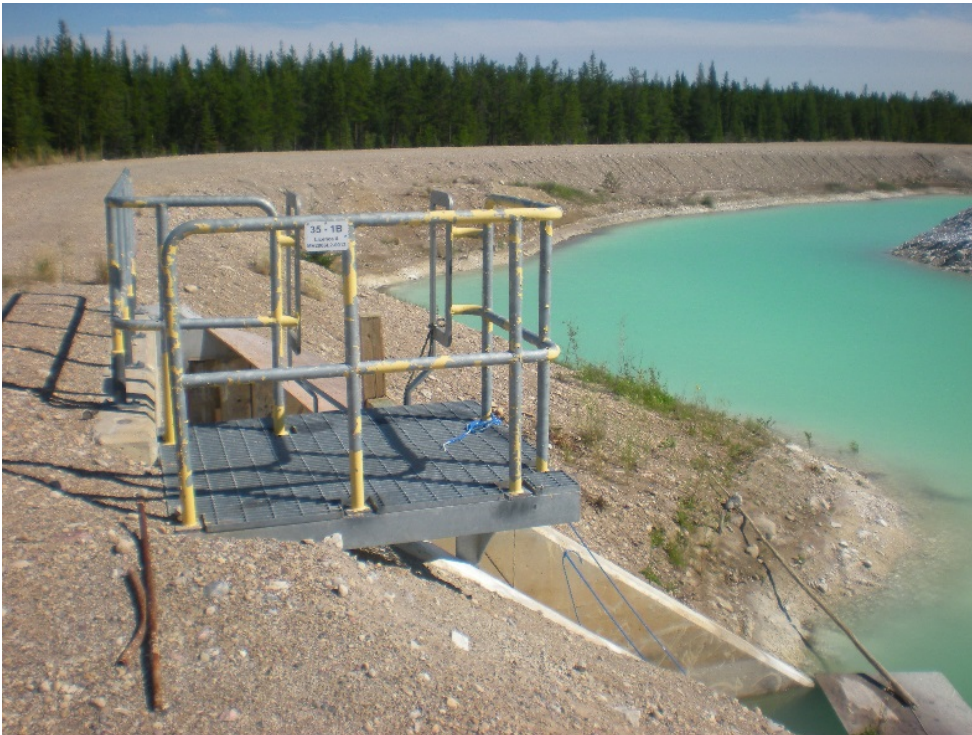
Photograph 13: Settlement Pond Spillway (Spillway No.2) – Settling Pond Side. 27 July 2017

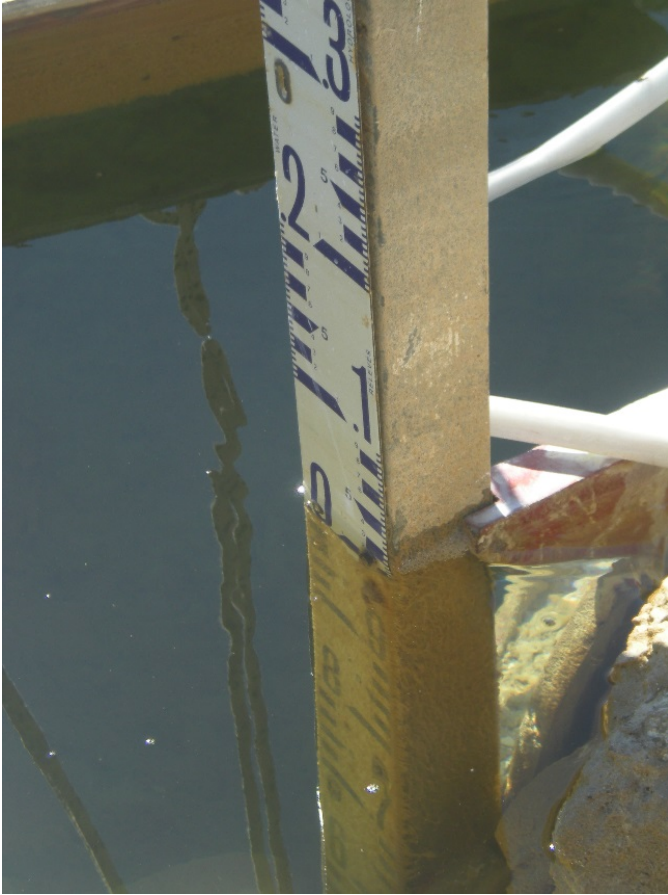
Photograph 14: Main Pond Water Level at Culvert Intake to Settling Pond (201.03 m). 27 July 2017

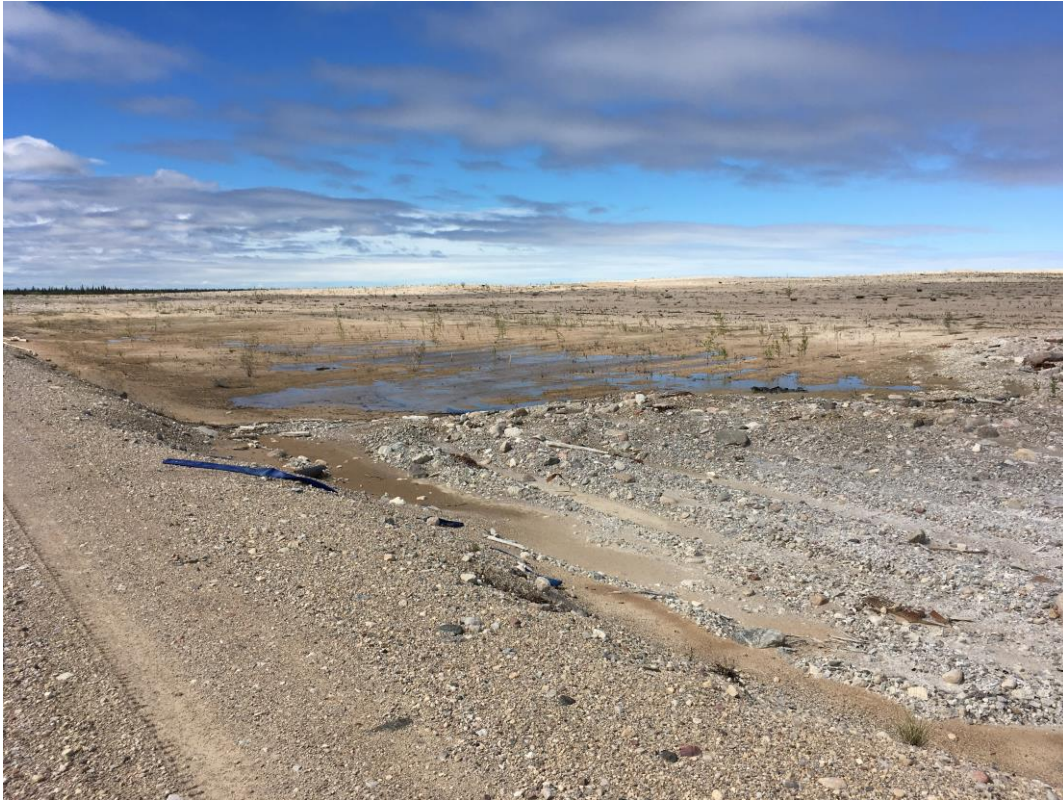
South Dyke, Central Area, minor seasonal water upstream side

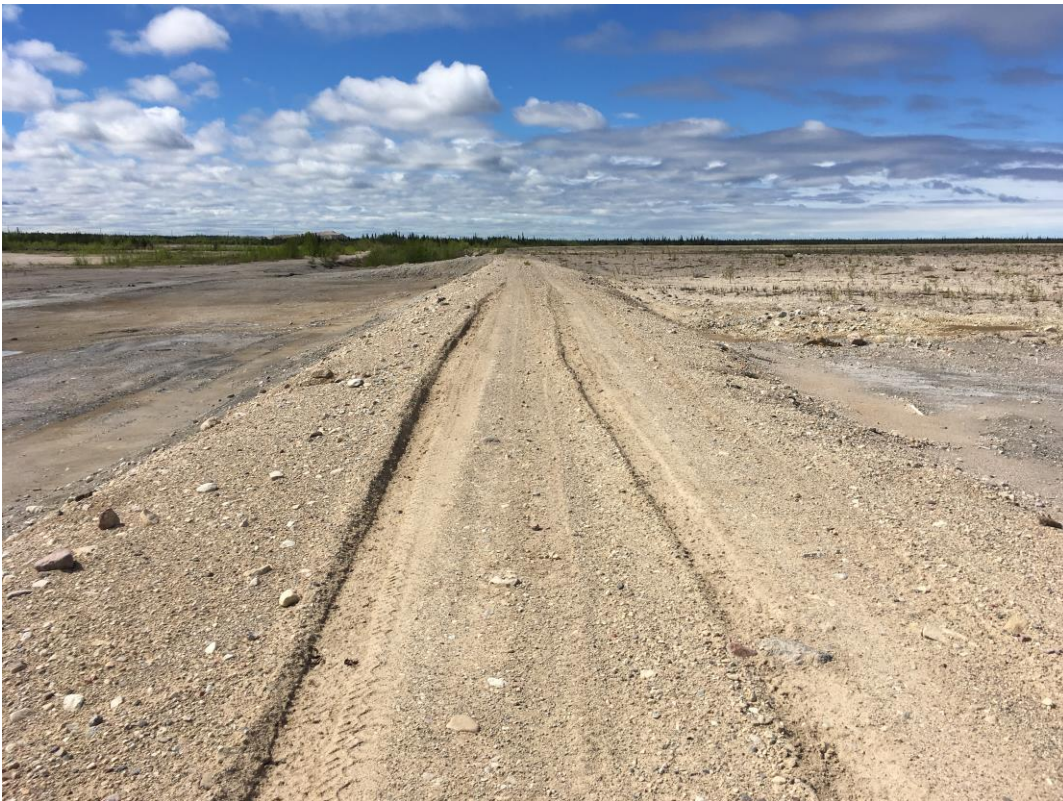
South Dyke, Central area facing east, minor vehicle rutting

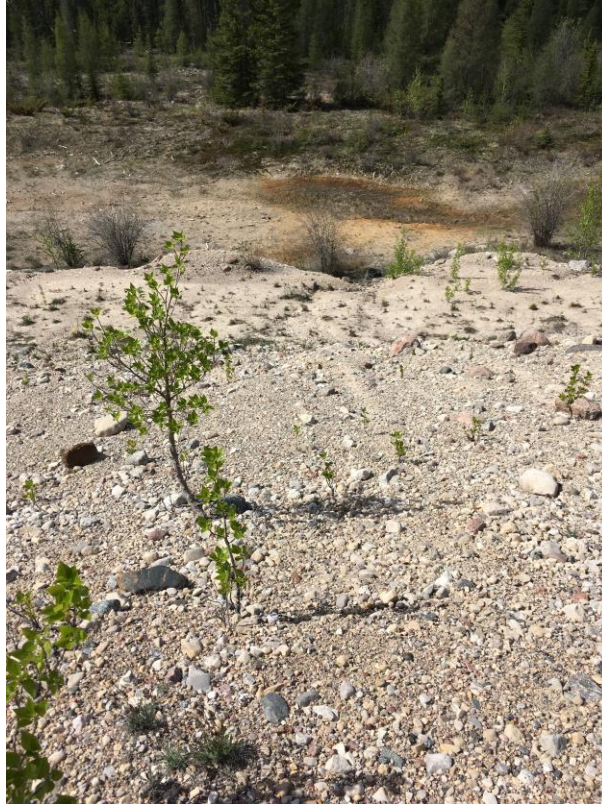
West Dyke, minor staining near toe, Approximate Station 19+00

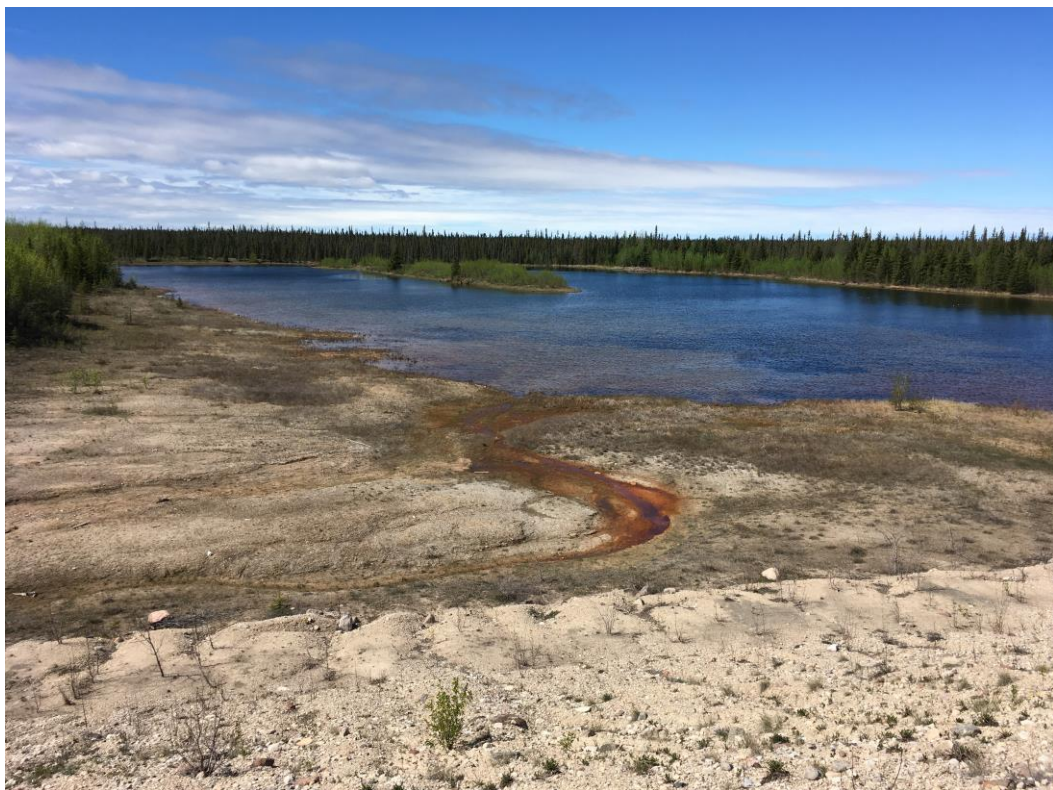
West Dyke, staining near toe.

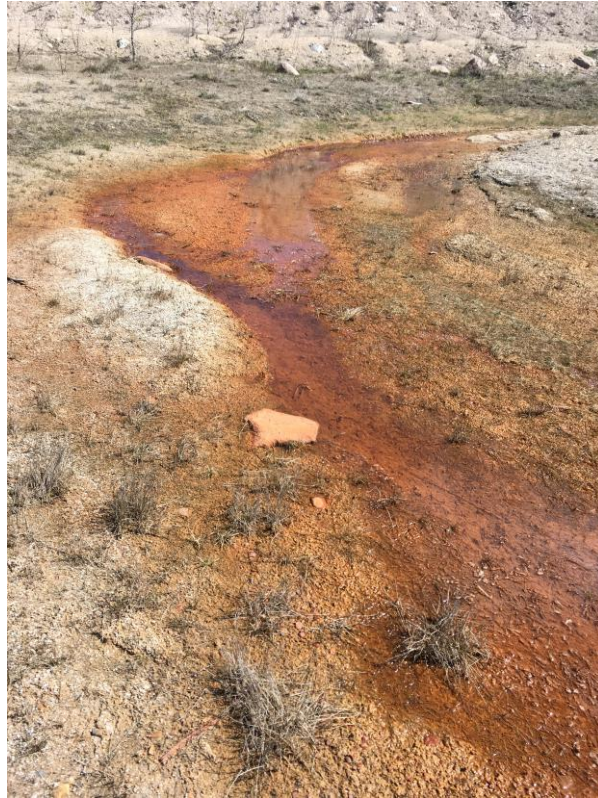
West Dyke, Previously Observed Boil Area, Staining near toe, facing East.

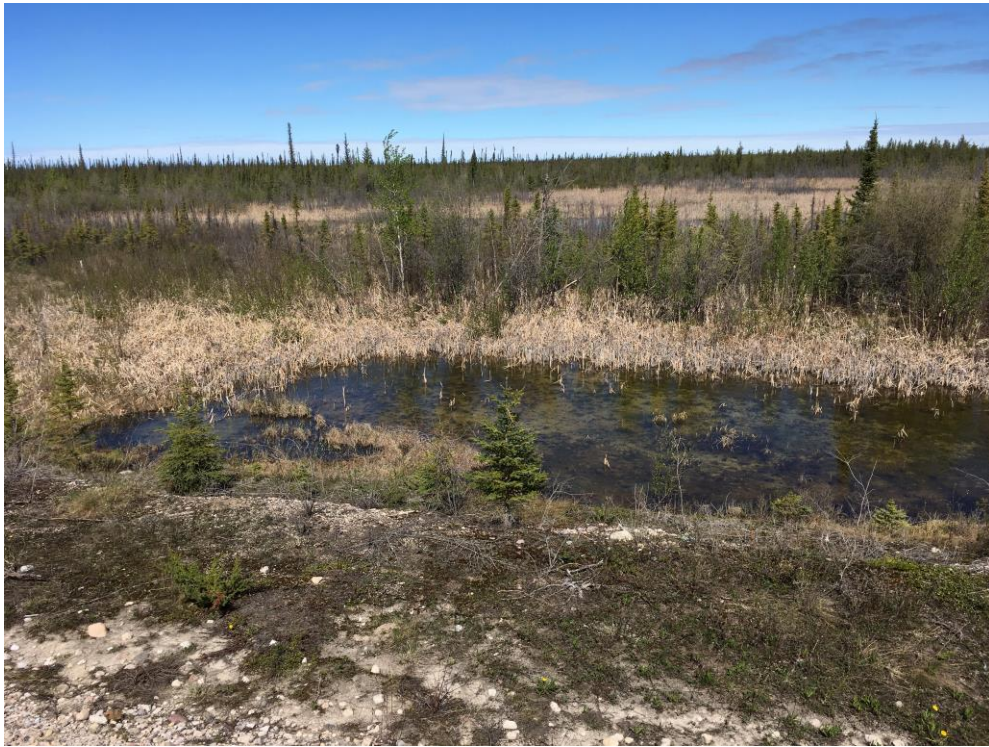
North Dyke, dog leg section, facing north, staining at toe.
