Teck Coal Limited – Elkview Operations

**Tailings Storage Facilities
West Fork Tailings Facility
and Lagoons A, B, C and D**

2017 Dam Safety Inspection

Final Report

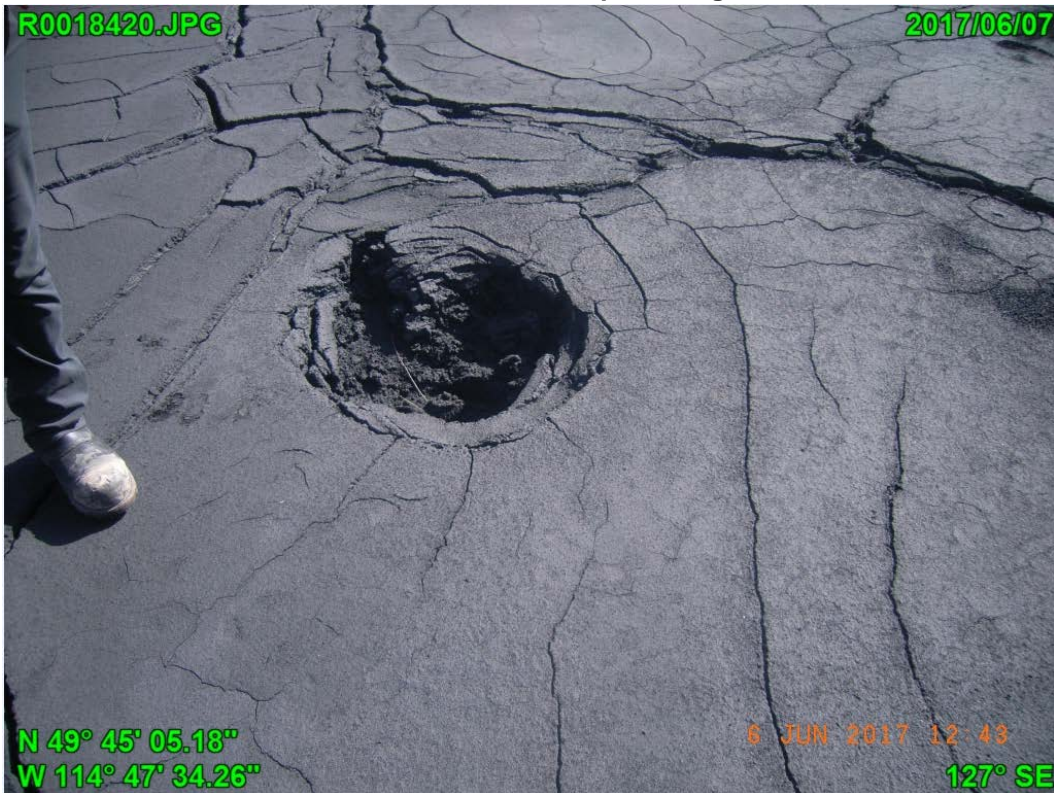
Photograph F - 10: Showing a sinkhole on the west side of the WTFF near the Adit dump.

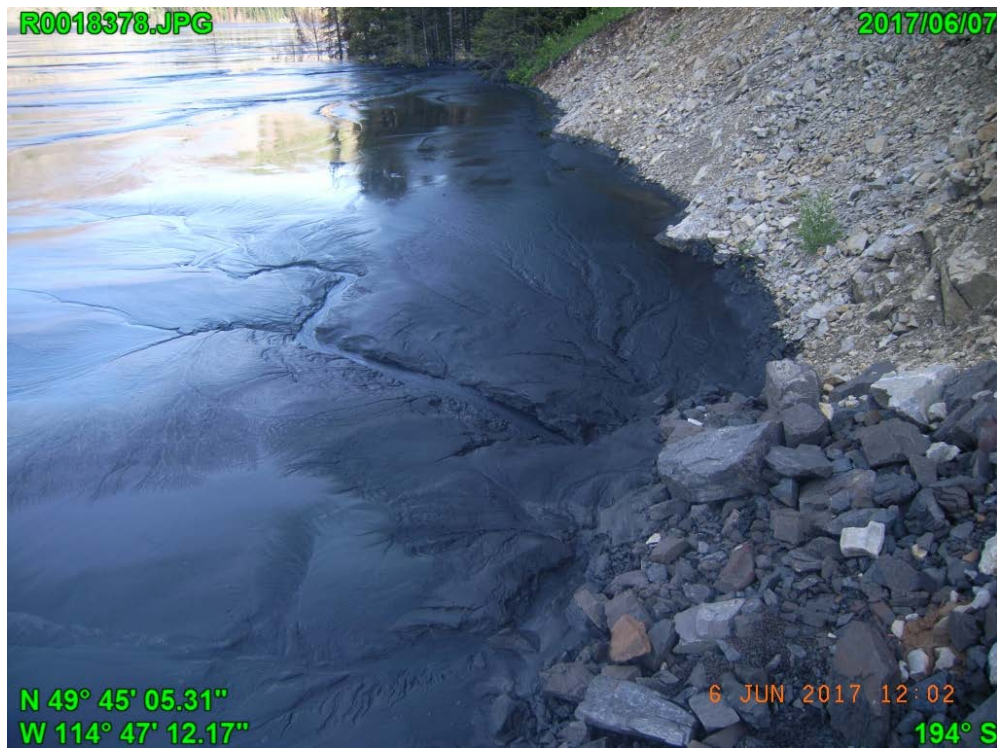
Photograph F - 16: Showing tailings beach at southeast corner of the basin, looking north. Noted seepage track on the tailings beach.

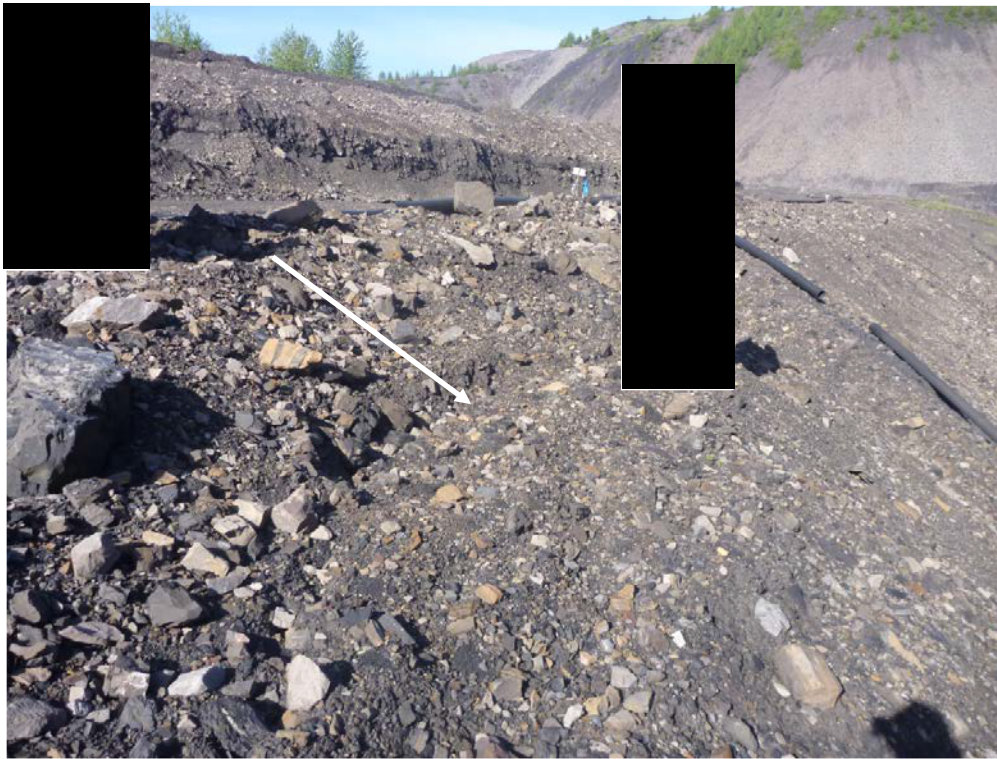
Photograph F - 19: Showing a longitudinal cracking around spigot 5 (Photo P1100577, 06/06/2017).

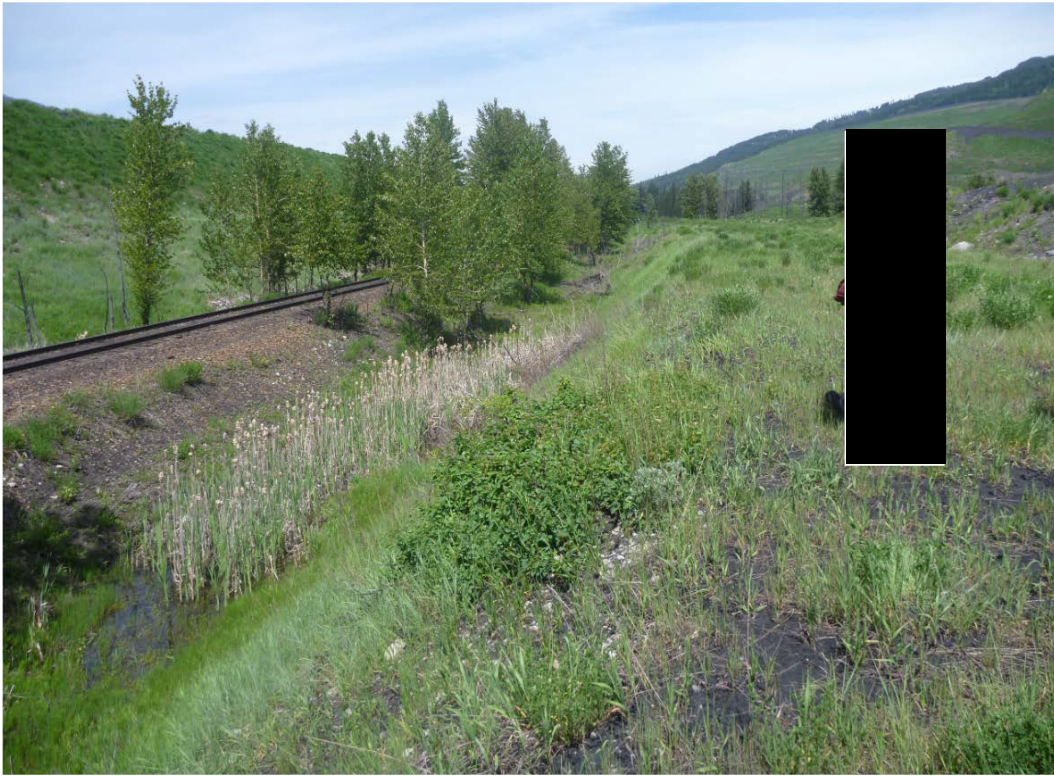
Photograph H - 5: Showing downstream slope of north end of the west embankment of Lagoon B, looking north. Noted ponded water at toe. (Photo No. P1100786, 2017/06/07)

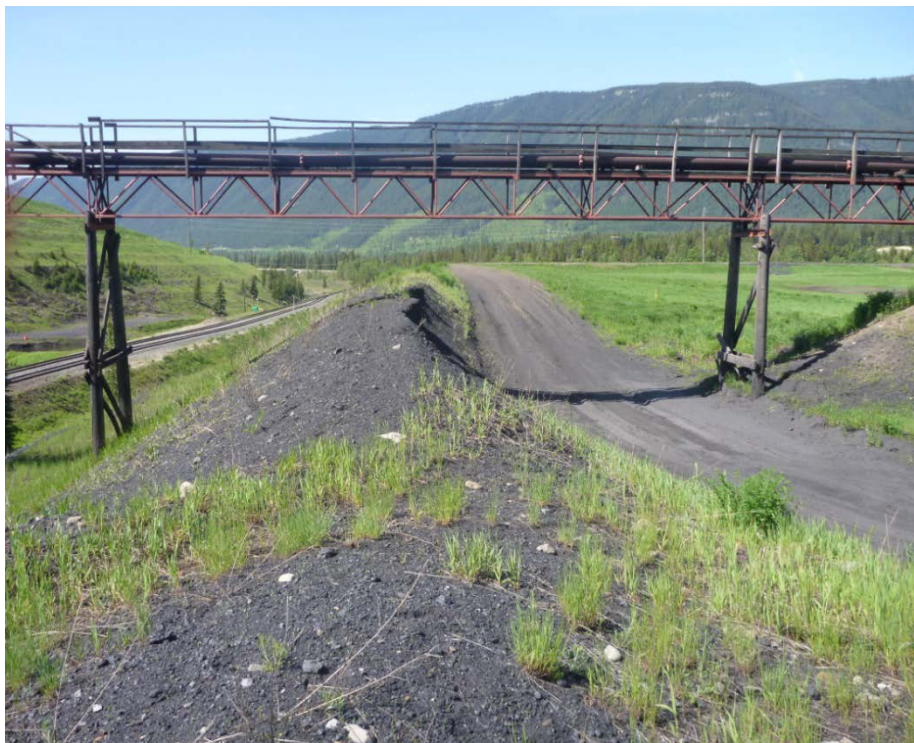
Photograph I - 12: Showing the crest and shoulder of Lagoon C south embankment, looking southwest. Noted the crest is narrow and the access road is depressed underneath the trestle. (Photo No.P1100623, 2017/06/07)

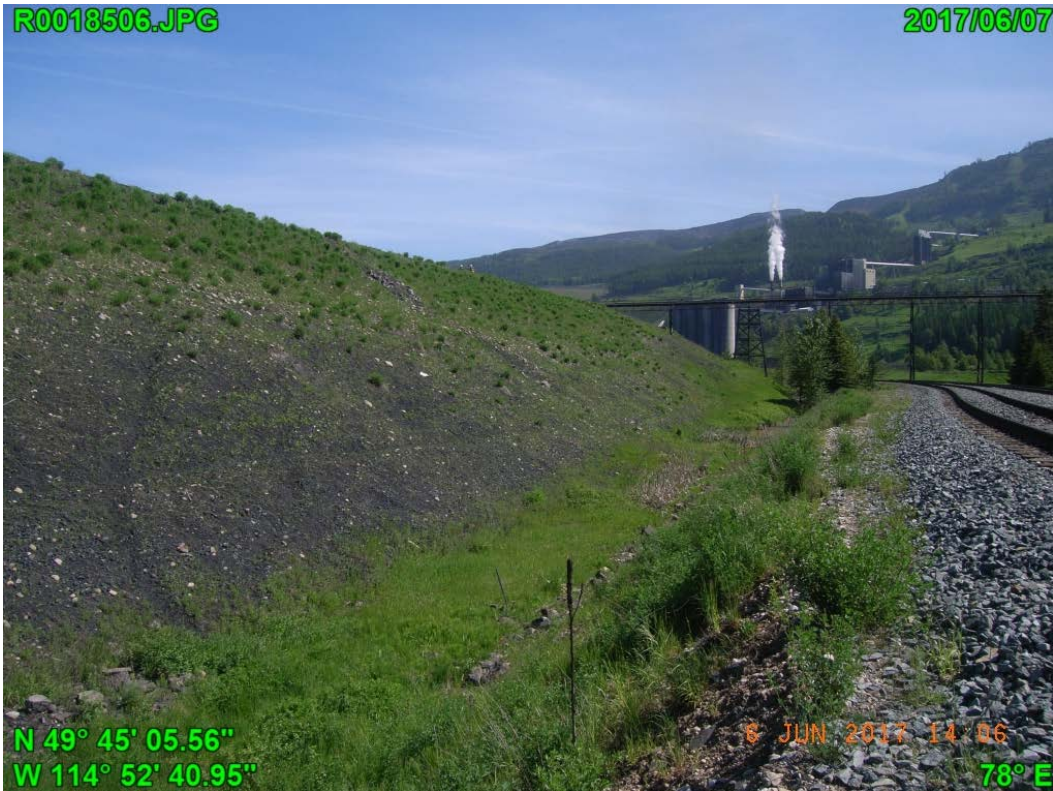
Photograph I - 13: Showing south slope and erosion on south slope of Lagoon C, looking northeast.

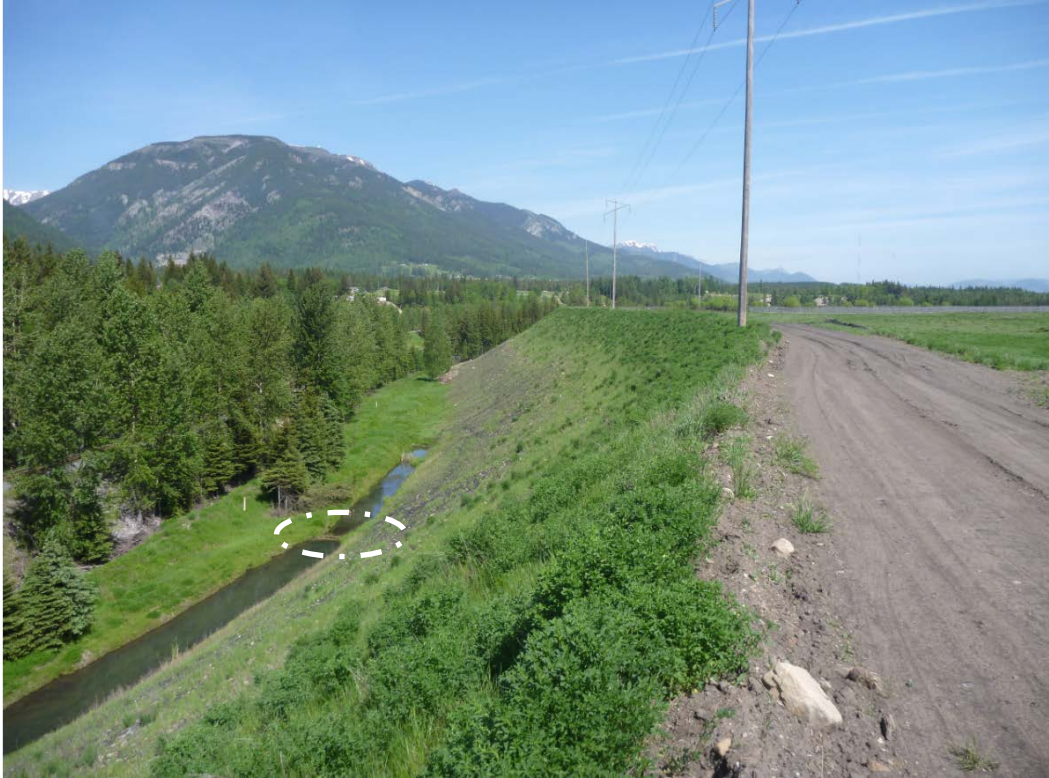
Photograph I - 15: Showing west crest and slope of Lagoon C at southwest corner, looking northwest. Noted beaver activities at the pond (Photo No. P1100644, 2017/06/07).

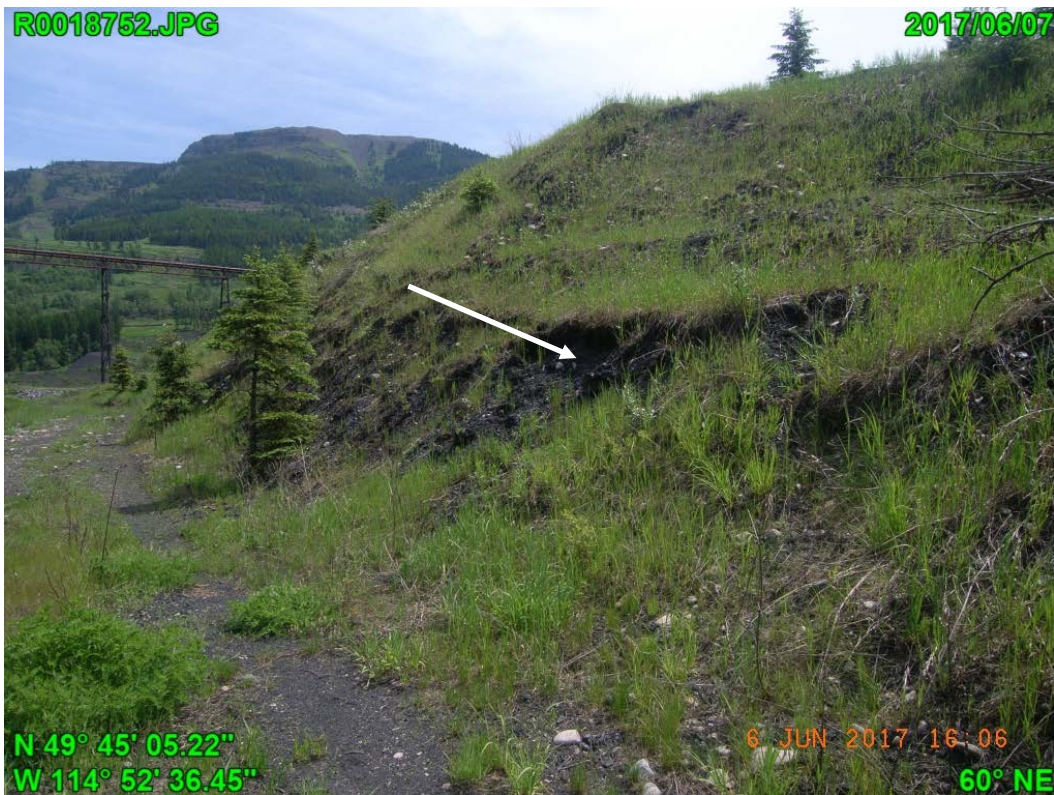
Photograph J - 15: Showing the toe and lower section of north slope of Lagoon D, looking northeast. Note erosion at the toe.

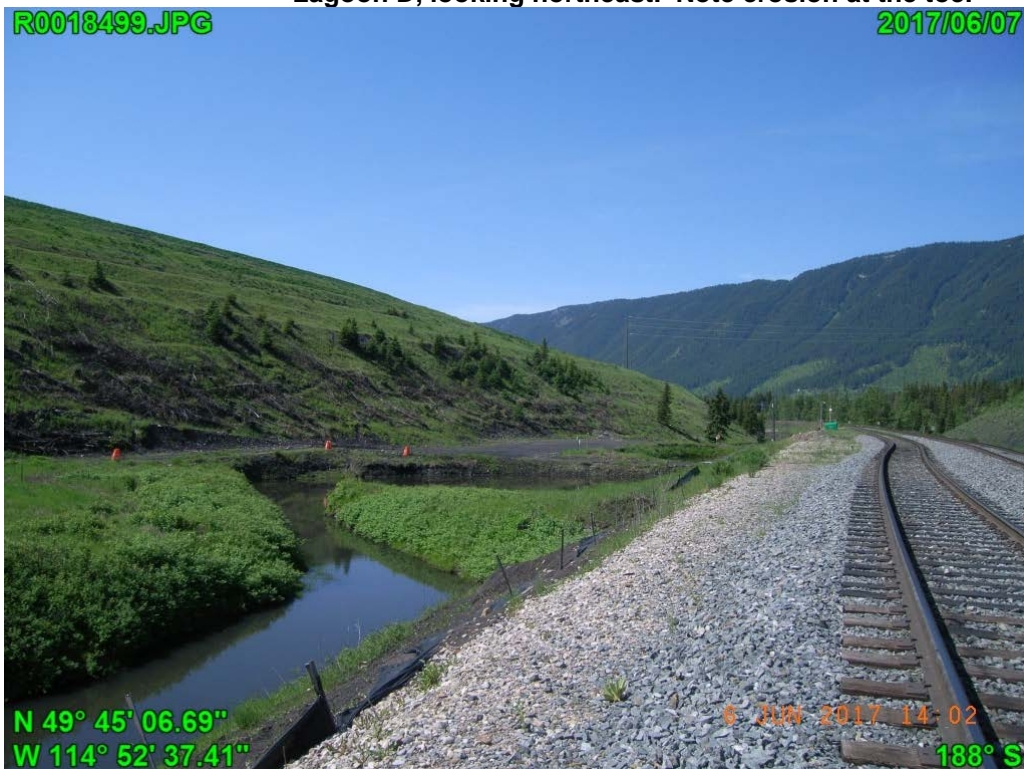
Photograph J - 16: Showing the lower north slope of Lagoon D, looking southwest. Noted Otto Pond at the toe and erosions on the slope.

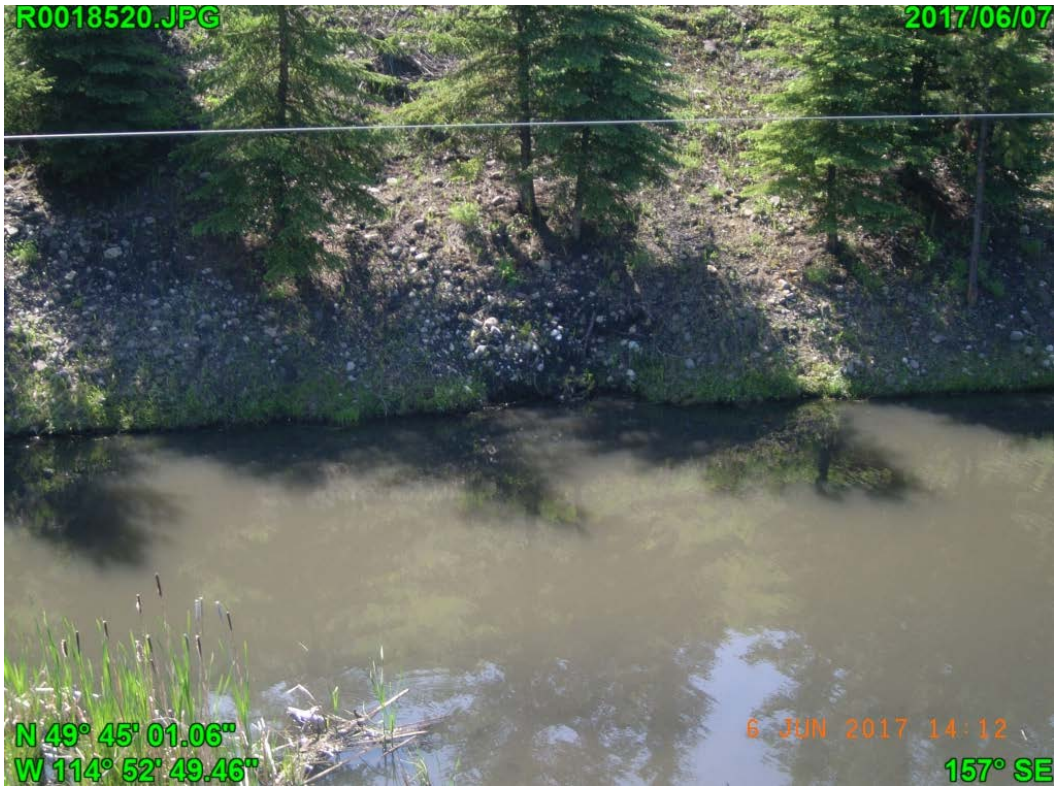
Photograph J - 17: Showing an erosion at the bank of the pond located at the toe of north slope of Lagoon D, looking south.

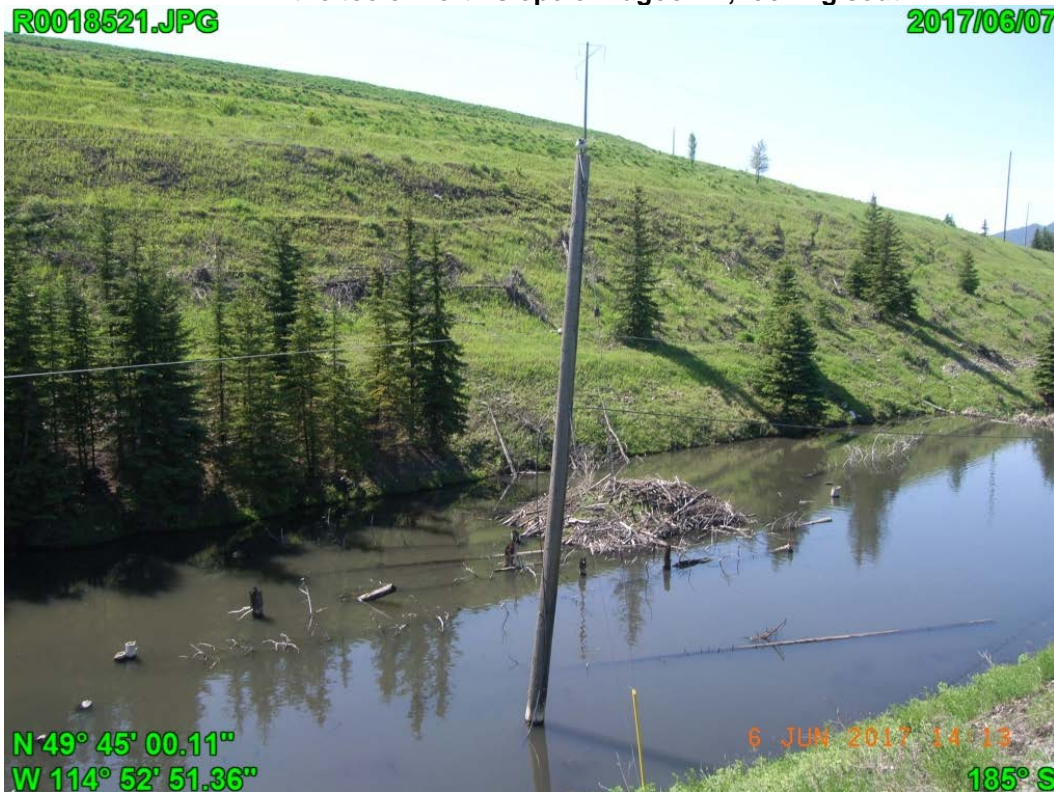
Photograph J - 18: Showing the toe at west end of the north slope of Lagoon D, looking southwest. Noted beaver activities within this area.

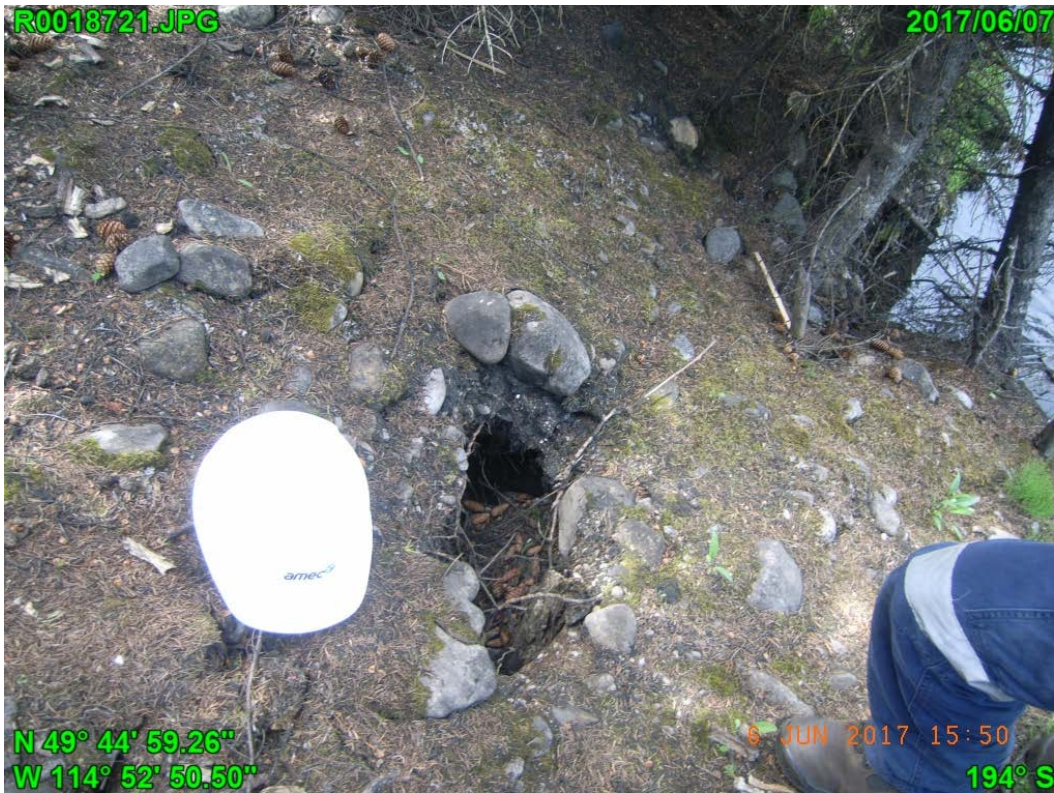
Photograph J - 19: Showing an animal burrow on the toe of north slope of Lagoon D, looking southwest.

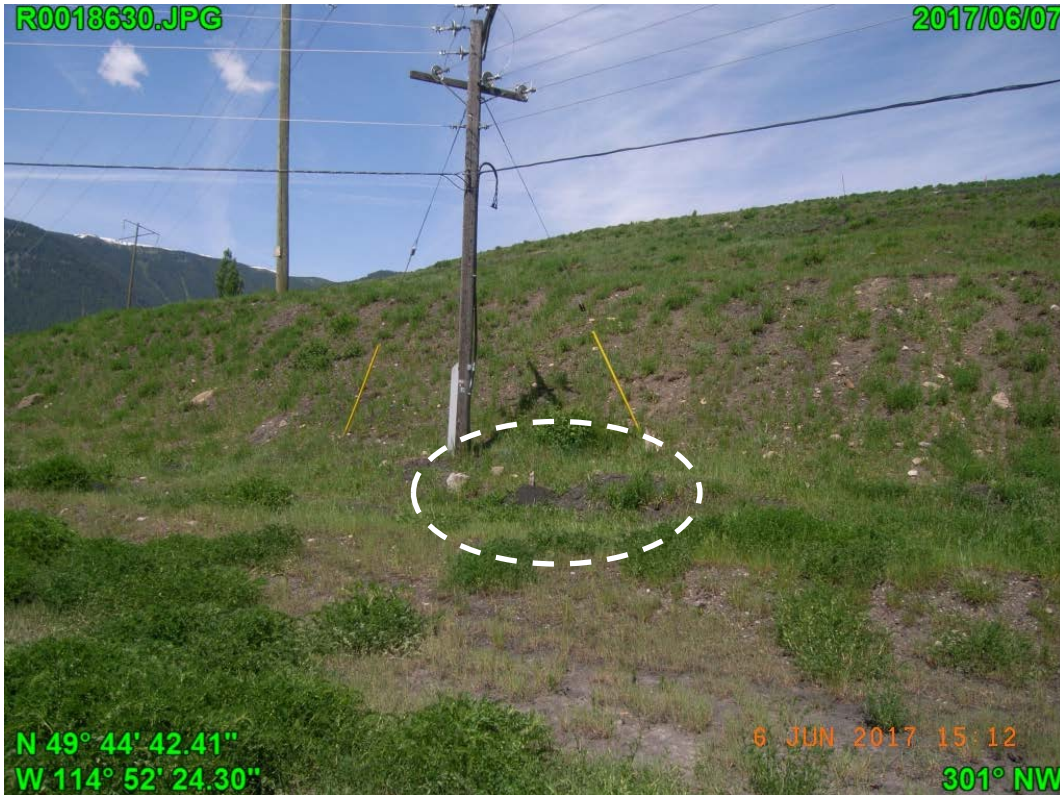
Photograph J - 33: Showing the toe and lower south slope at south corner of Lagoon D, looking northwest. Noted an animal burrow at the toe.
