REPORT

2022 Annual Facility Performance Review
Swift South Spoil Co-Management Facilities

Reference No. 22516328-2022-122-R-Rev0-1700

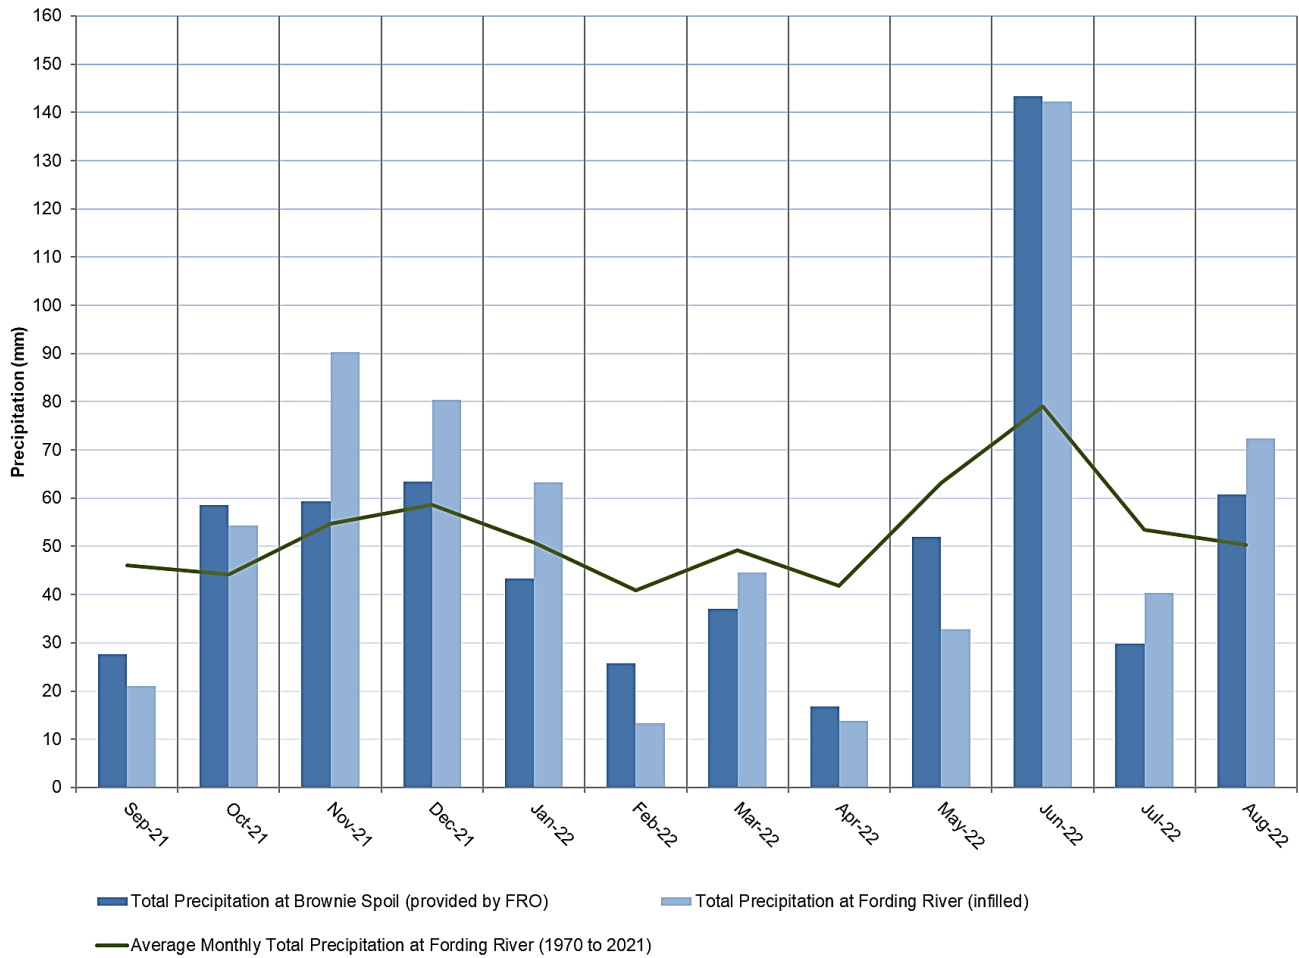
Chart 1: Monthly Precipitation Data from 1 September 2021 to 31 August 2022

The precipitation data in Table 3 indicate the annual precipitation at FRO was approximately average, with the Fording River (infilled) dataset from 1 September 2021 to 31 August 2022 being higher than the long-term average of 631 mm and the Brownie Spoil weather station dataset being slightly lower than the long-term annual average. A similar observation can be made from [Error! Reference source not found.](#)

No facility performance issues associated with precipitation during the reporting period were noted.

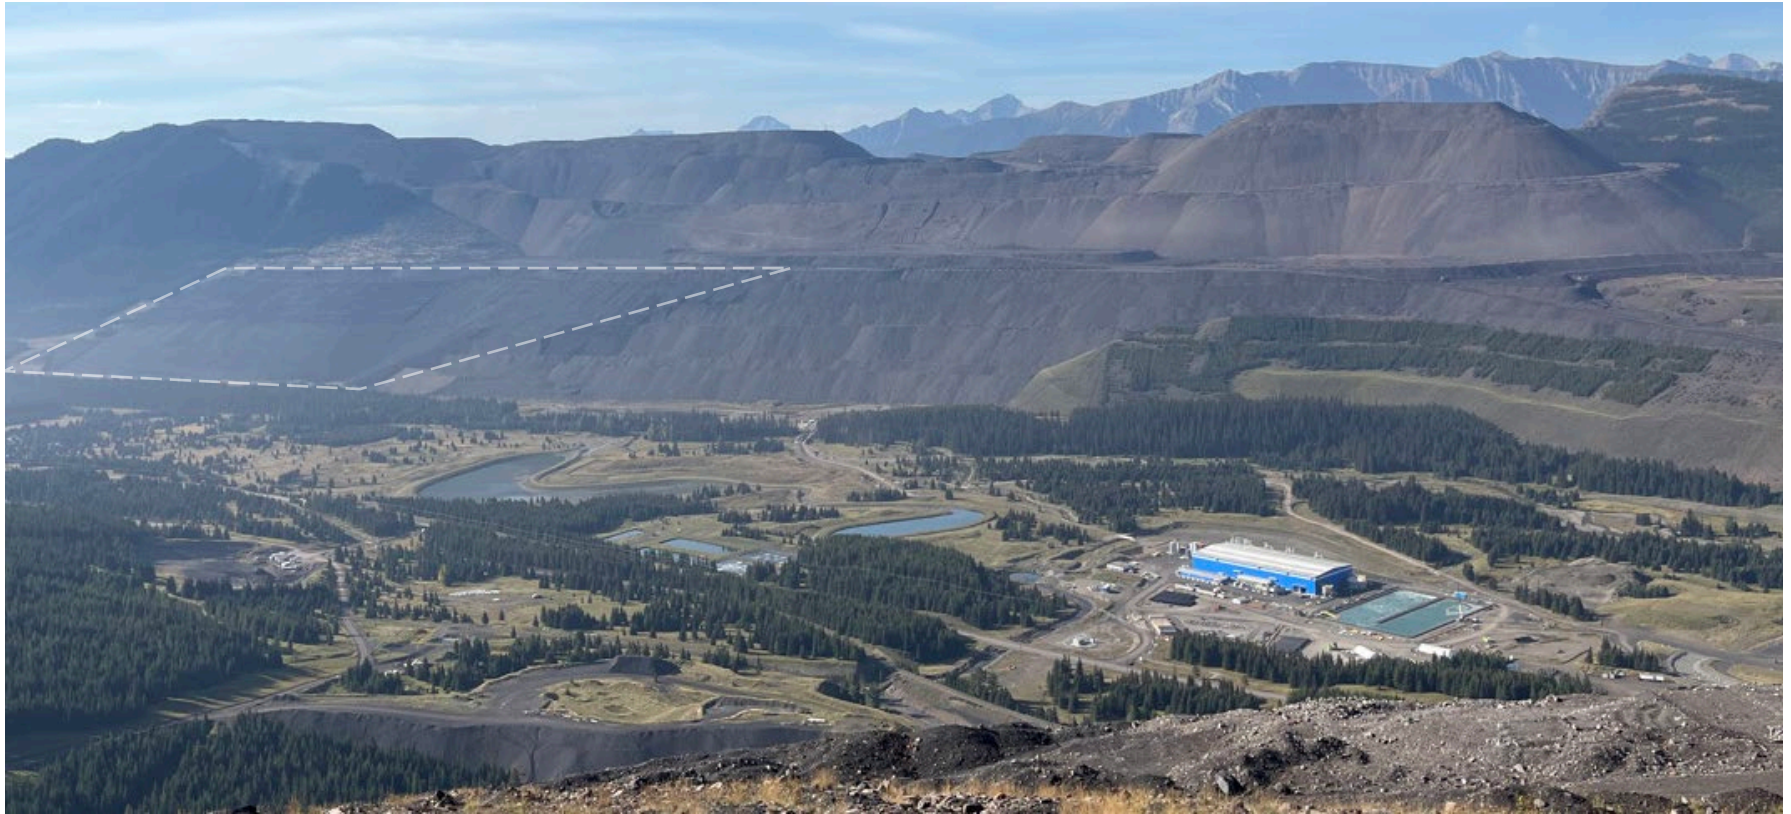
PHOTOGRAPH 1

Overview of Swift South Spoil, looking southwest from Old South Spoil; at the time of the inspection the CMF was encapsulated within Swift South Spoil. Re-sloping of the south end of the Swift South spoil is underway (white dash).

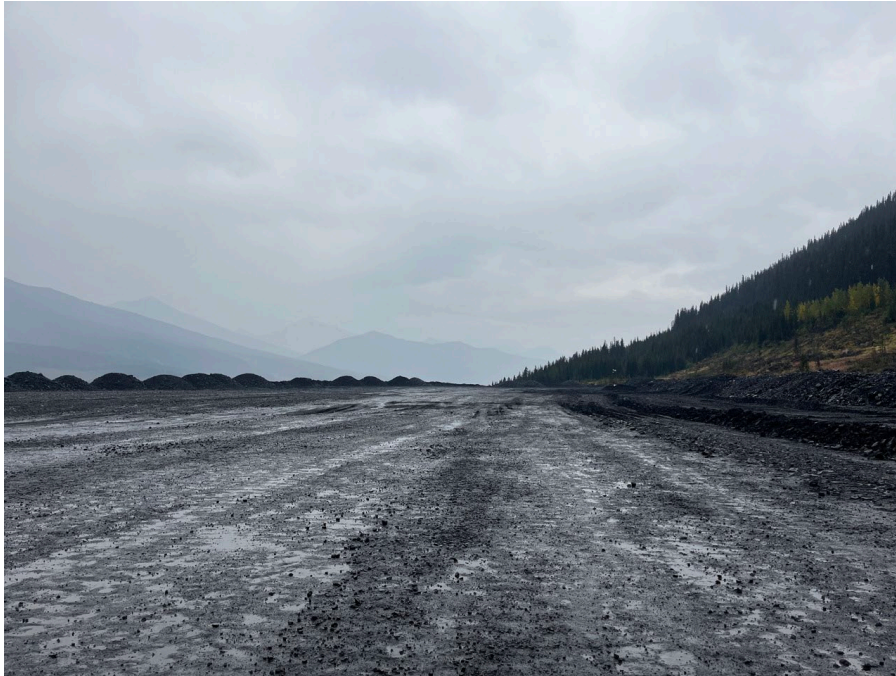
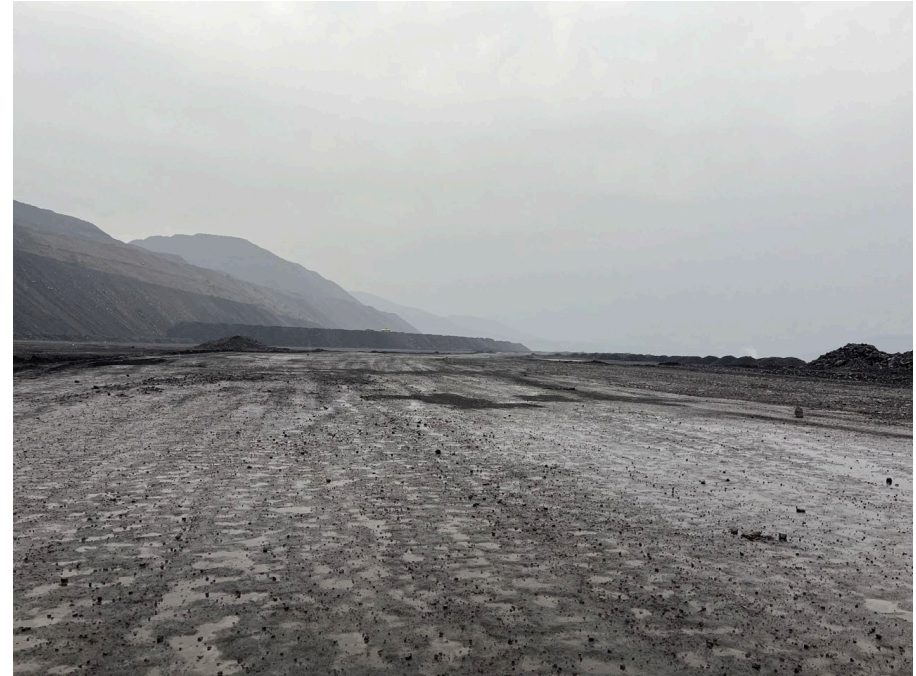
PHOTOGRAPH 2 (LEFT) and 3 (RIGHT)

- Construction of the Swift South Spoil CMFs was complete to elevation 1,785 m and the facilities were fully encapsulated by a minimum of 15 m of waste rock.
- Based on visual inspections, the Swift South Spoil CMFs appeared safe with no deficiencies that require immediate action (Photograph 1).
- The waste rock platform encapsulating the Swift South Spoil CMFs was in good condition with a relatively flat surface and no observed cracking or significant rutting (Photographs 2 and 3).

View from on the Swift South Spoil platform at 1,800 m, appearing well compacted, looking southeast (Photograph 2) and northwest (Photograph 3). The CMF was encapsulated within the Swift South Spoil at the time of the inspection.

INSPECTION ITEM	PHOTO	OBSERVATIONS, COMMENTS & OTHER DATA
1. PLATFORM CONDITIONS		
1.1 Crest Elevation	2, 3	1,785 m for CMFs, 1,800 m for spoil platform. Facility was completely encapsulated by waste rock at time of site inspection.
