# **Subject Matter Expert Report: CHANNEL DEWATERING. Evaluation of Cause – Decline in Upper Fording River Westslope Cutthroat Trout Population**

December 6, 2021

**Ecofish Research Ltd.**

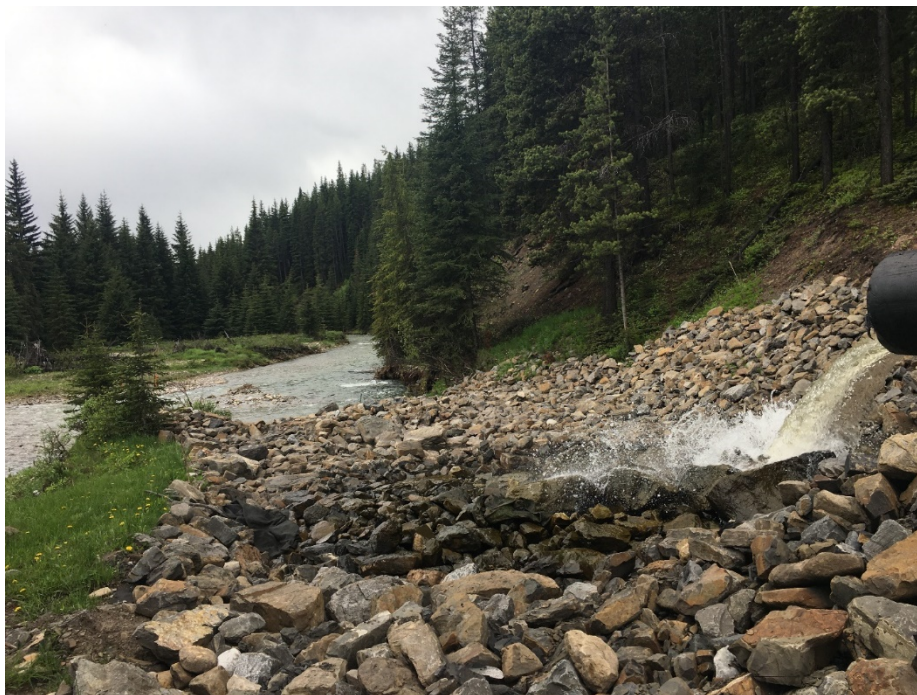
**Figure 3** Discharge from Post Ponds Channel on June 17, 2020.

It was assumed for this assessment that the diffuse discharge through rip rap followed by the 1 m drop into the UFR provides a barrier to fish upstream movement into the Post Sediment Ponds Channel except under extreme flood events (Wilm, pers. comm. 2020). Post Sediment Ponds channel was considered non-fish bearing and therefore potential stranding risk to fish was not assessed (not applicable).

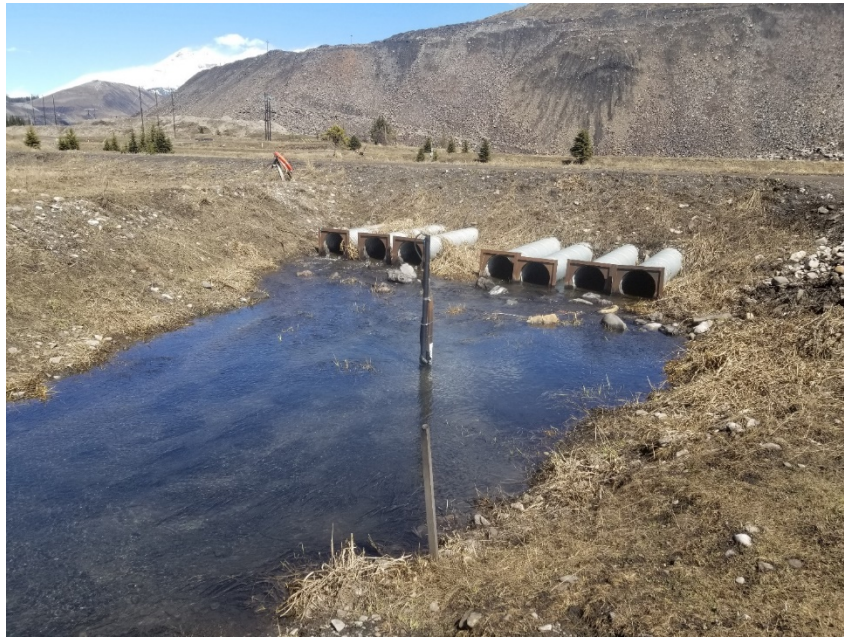
Figure 7. Discharge culverts on Clode Creek on April 28, 2020.

The Clode Settling Ponds outlet consists of seven corrugated steel pipe culverts with fish screens (Nupqu Development Corporation 2020) (Figure 7), which act as a partial fish barrier (i.e., only to larger, older life stages) between Clode Creek and the Clode Creek Settling Ponds (Map 3 of Appendix A). Fish have access from the Fording River to the 172 m of Clode Creek downstream of the pond outlet culverts (Nicholl *et al.* 2018) (Figure 8, Figure 9).

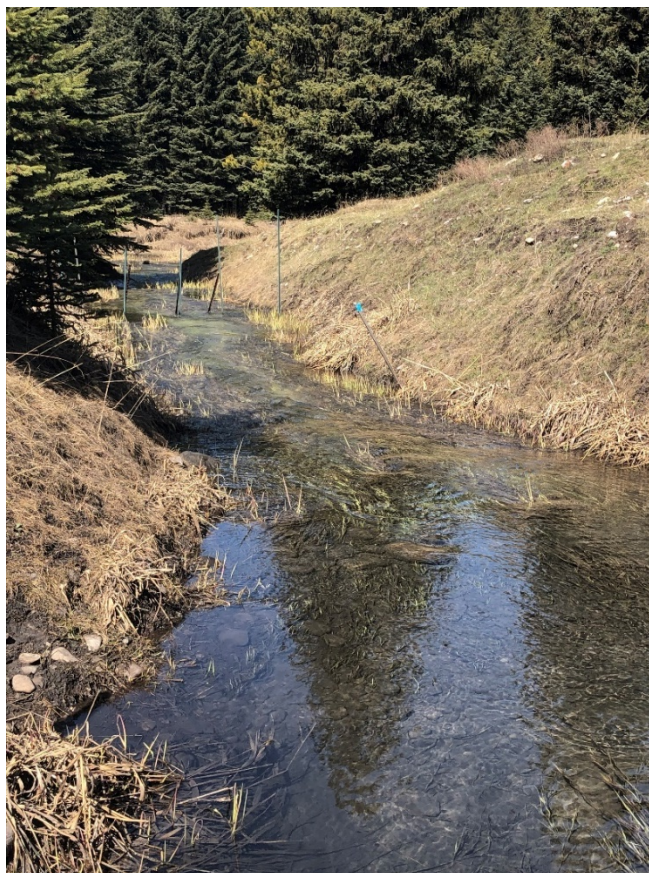
Figure 8 Downstream of discharge culverts on Clode Creek on May 5, 2020.

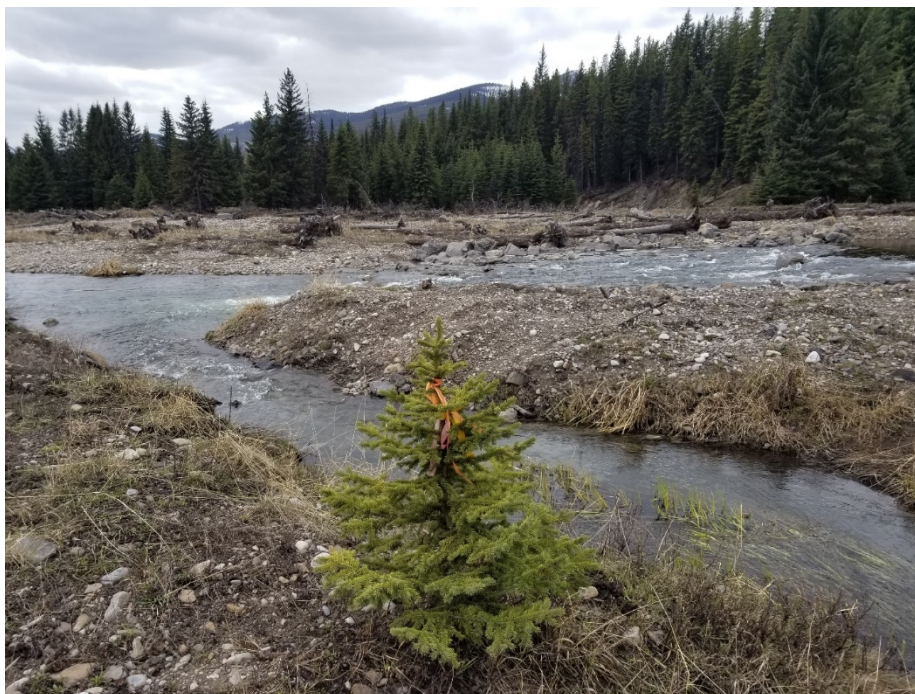
**Figure 9** Clode Creek and Fording River confluence on May 12, 2020.

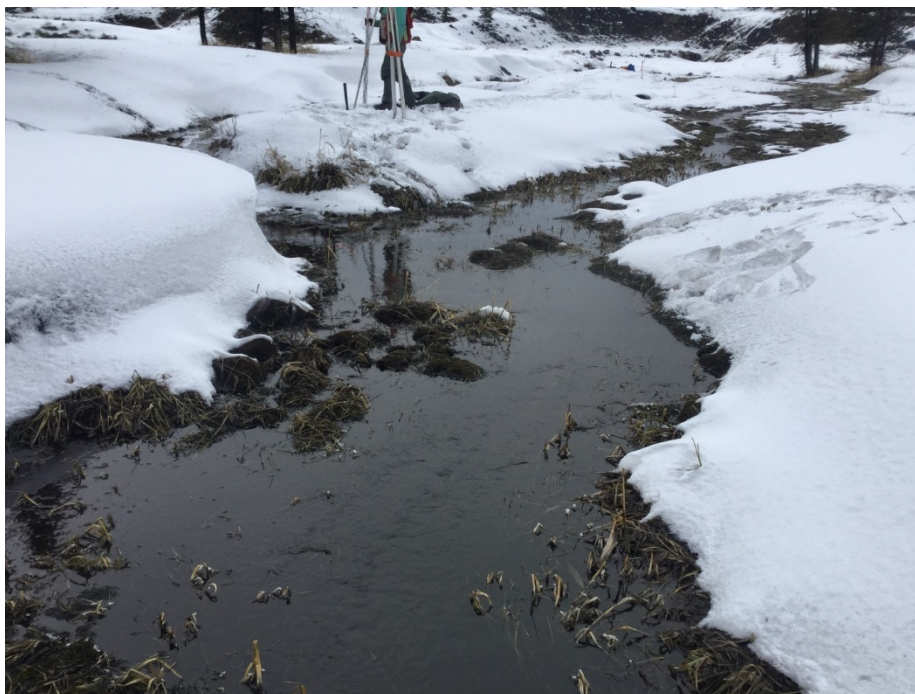
**Figure 11. Grassy Creek on March 12, 2020.**

Grassy Creek may be wetted throughout the year and no barrier to fish passage has been identified; the entire length (236 m) of the watercourse was assessed as accessible to fish (Nicholl *et al.* 2018) (Figure 11). Fish presence has been documented in Grassy Creek: 21 juvenile WCT were recorded during a fish community survey completed in 2019 (Smithson 2019).

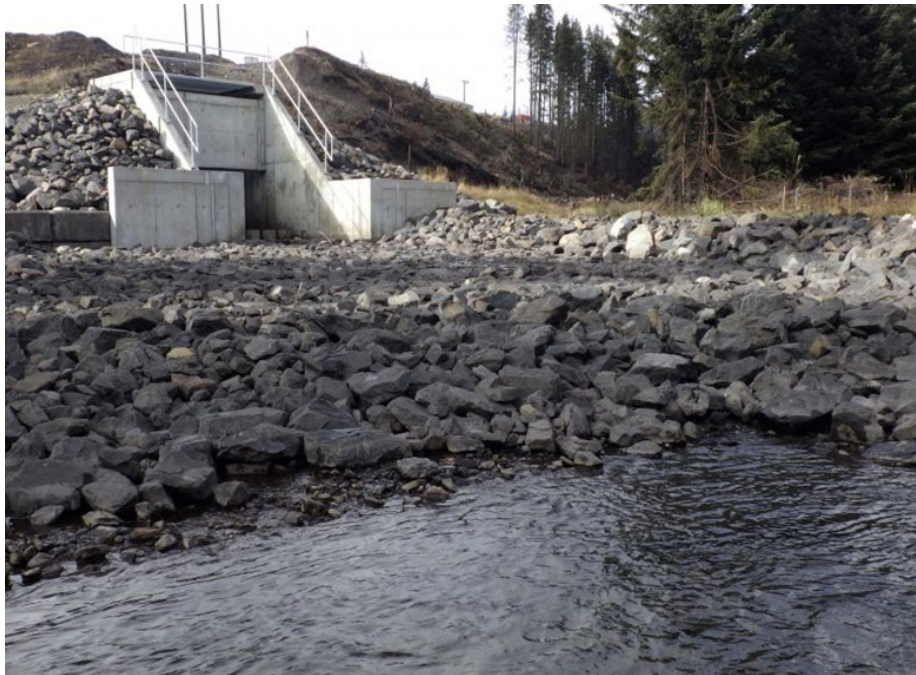
**Figure 12. Looking upstream from the UFR (foreground) at Lake Mountain Creek and the fish exclusion structure on October 9, 2018.**

Lake Mountain Creek discharges from Lake Mountain Ponds into the UFR (Map 6 of Appendix A). A concrete fish exclusion structure, located 23 m upstream of the UFR confluence (Map 6 of Appendix A), was constructed in 2017 as part of the Lake Mountain Reach 1 Bypass construction and the channel downstream was infilled with rip rap. Lake Mountain Ponds provide the operational control for Lake Mountain Creek.

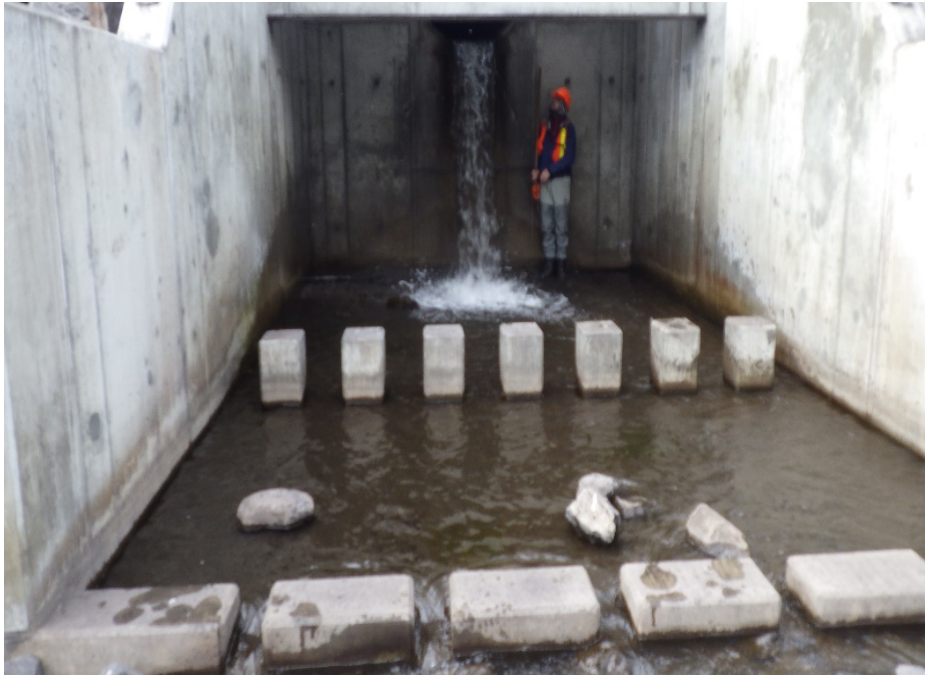
Figure 13. Plunge pool at base of fish exclusion structure at Lake Mountain Creek on October 9, 2018.

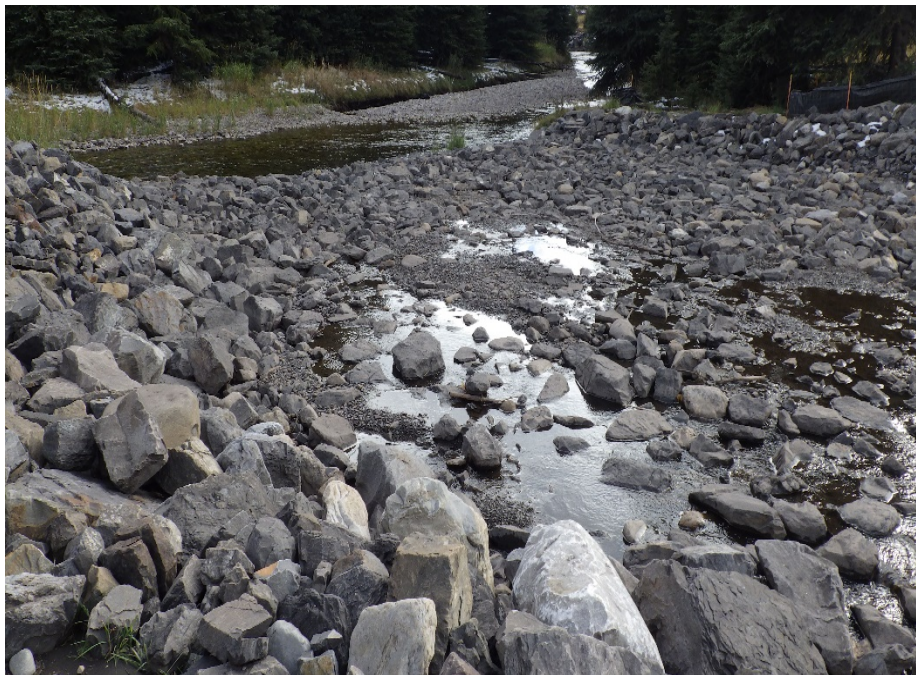
Figure 14. Looking downstream from the fish exclusion structure in Lake Mountain Creek through the rip rap channel towards the UFR on October 9, 2018.

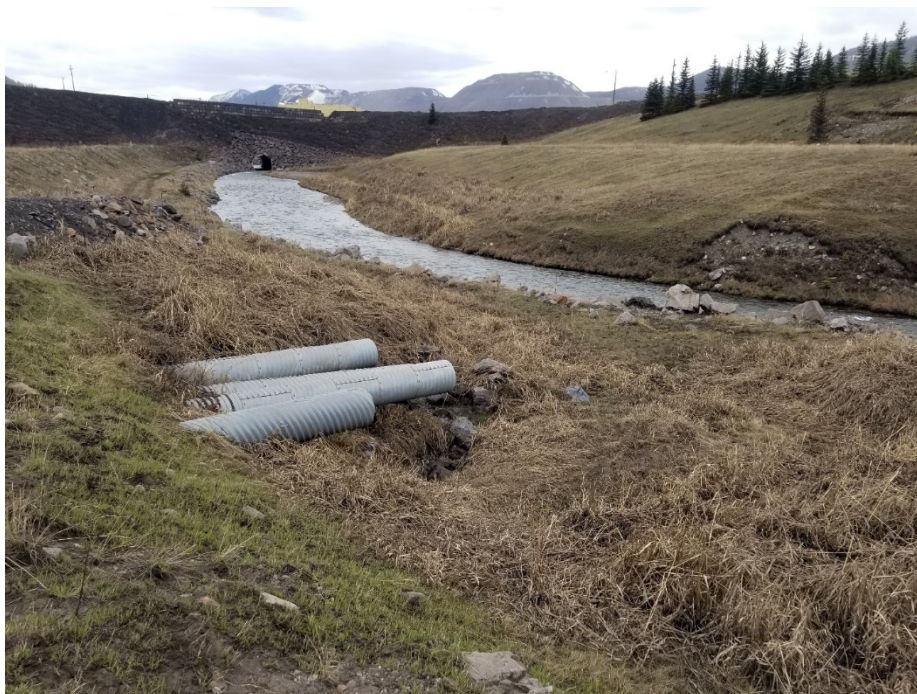
**Figure 16** Discharge culverts in Eagle Settling Ponds Channel on May 12, 2020.

It was assumed for the the purposes of this assessment there is no fish access to the Eagle Settling Pond Channel except under extreme flood events; it was assumed that the elevated bench at the bank of the UFR, along with the rip rap section below that diffuses flow, provide a barrier to fish upstream movement (Wilm, pers. comm. 2020). Thus, potential stranding risk to fish was not assessed (not applicable).

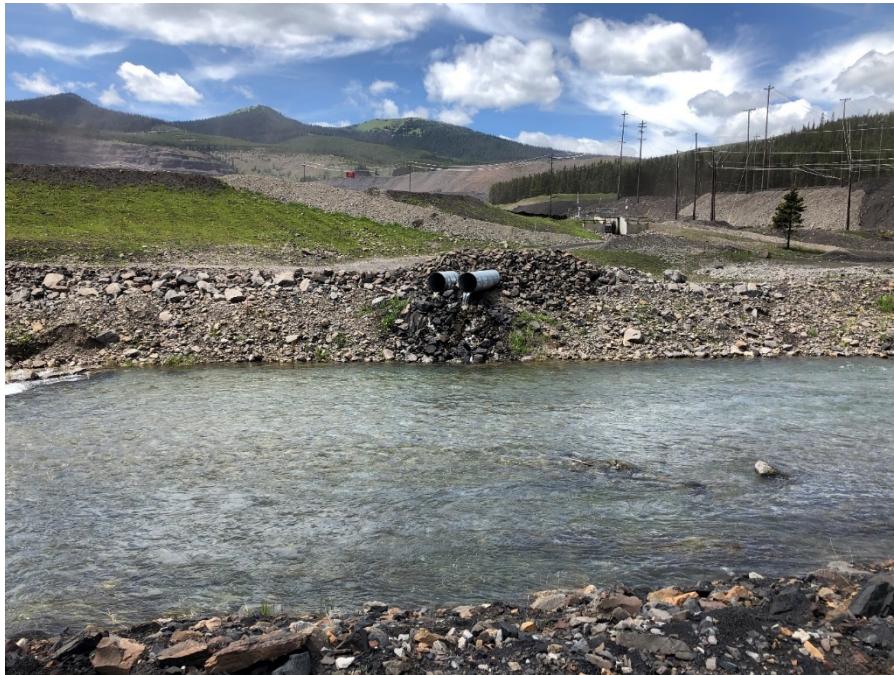
Figure 17. Discharge culverts in Liverpool Sediment Ponds Channel on June 22, 2020.

Water from the Liverpool Sediment Ponds flows into the UFR through a constructed channel (Map 8 of Appendix A). This channel has two elevated culverts near the confluence of the channel with the UFR (Nicholl *et al.* 2018) (Figure 17) and a fish exclusion structure upstream from the culverts.

A concrete fish exclusion structure with a 2 m vertical drop (Figure 17) is located ~75 m upstream of the confluence with the UFR (Map 8 of Appendix A). In addition to the fish exclusion structure, two hanging culverts, located on the bank of the UFR, are also barriers to fish. The hanging culverts are about 3.0 m above the water surface elevation of the UFR and water flowing through the culverts drops 0.65 m onto a steep rip rap bank. The culverts, which are located at the downstream end of the channel, are believed to prevent upstream fish passage at all flows except under extreme flood events (Nicholl *et al.* 2018); thus, potential stranding risk to fish was not assessed (not applicable).

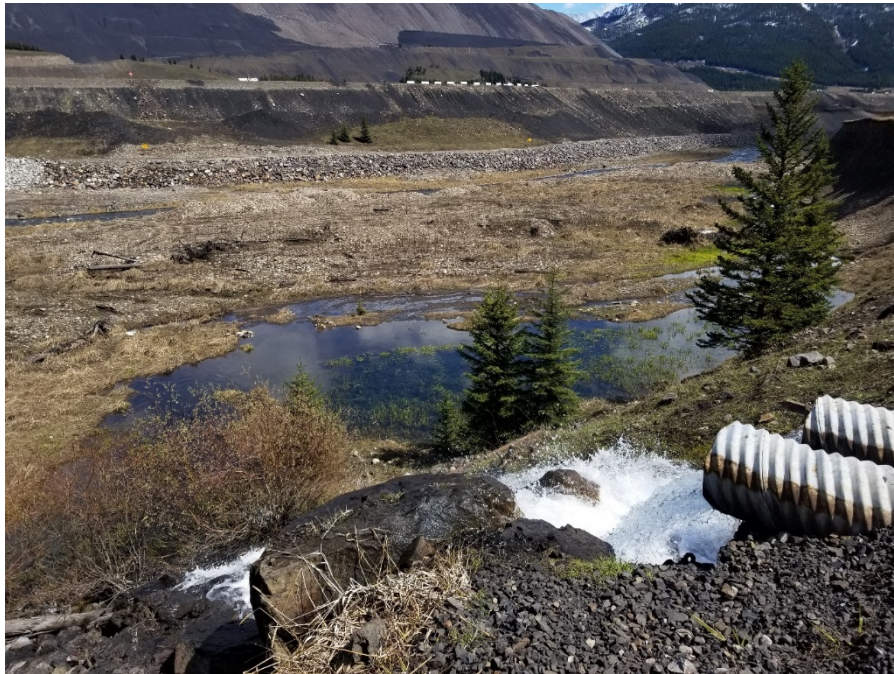
**Figure 20. Discharge culvert on Smith Ponds Channel on May 13, 2020.**

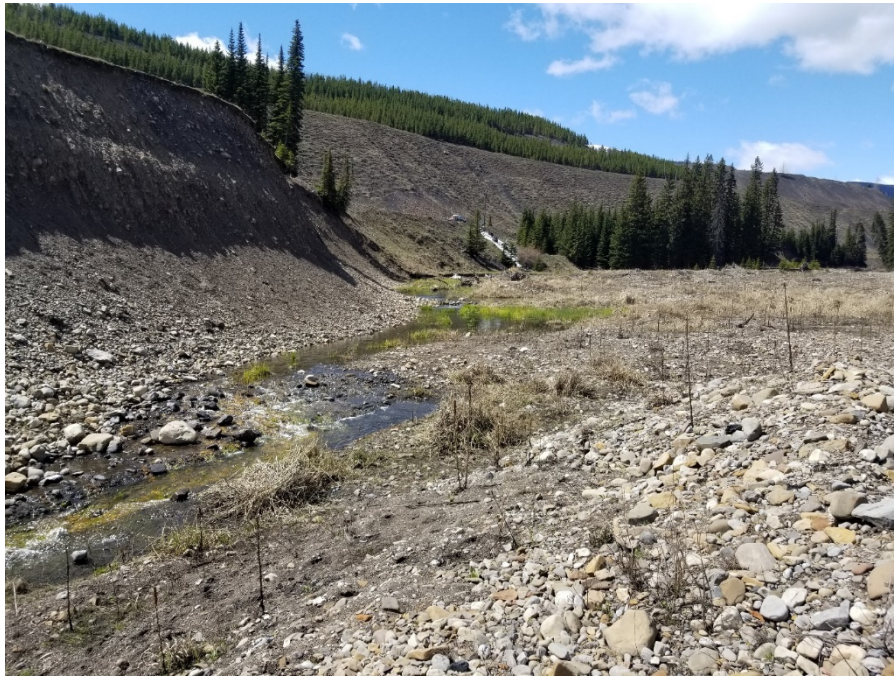
**Figure 21. Smith Ponds Channel downstream of culverts on May 13, 2020.**

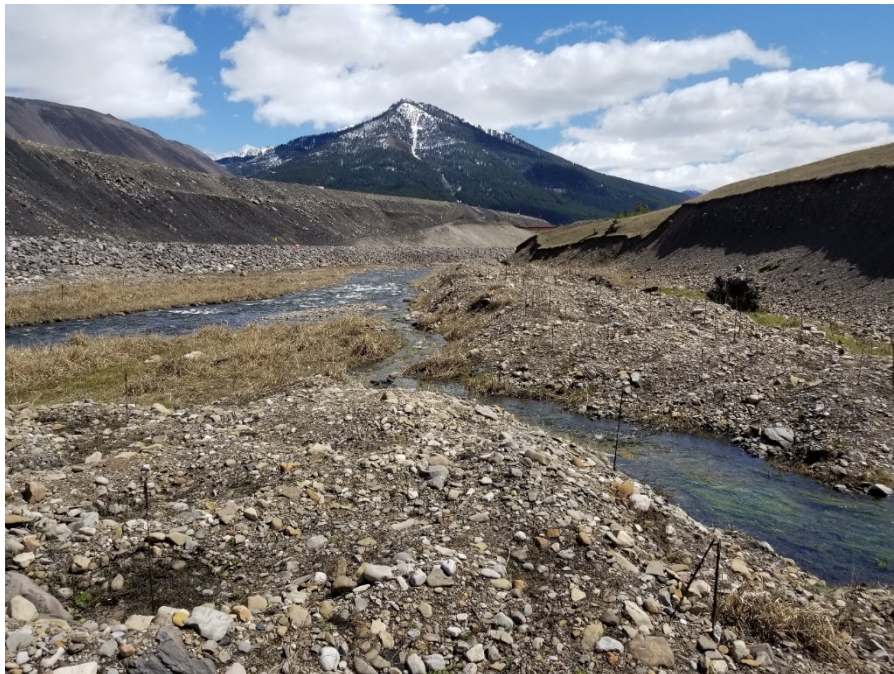
**Figure 22. Smith Ponds Channel and UFR confluence on May 13, 2020.**

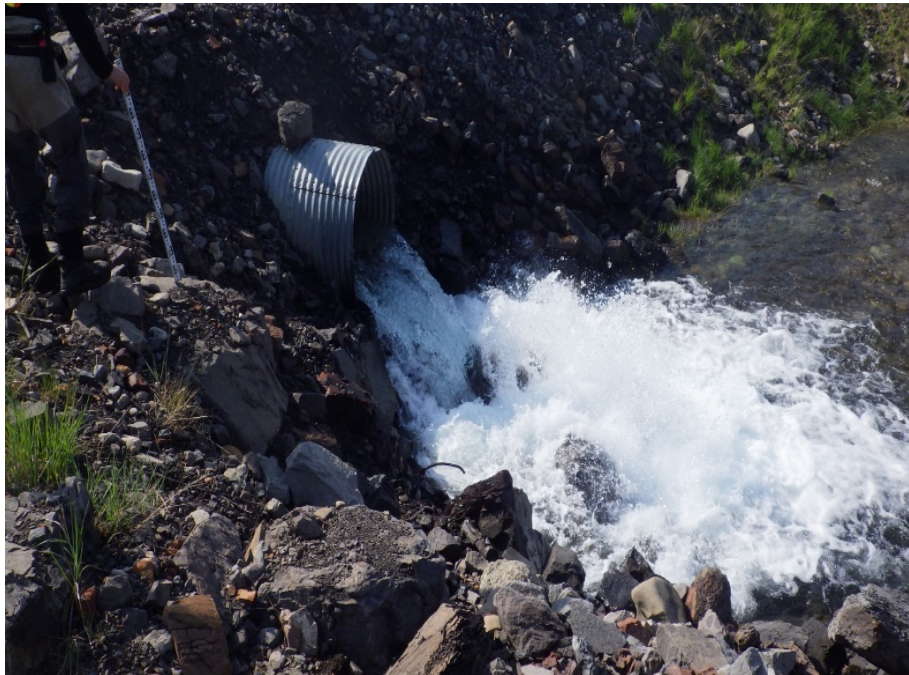
Figure 24. Discharge culvert on Kilmarnock Phase 1 Discharge Channel, June 6, 2018.

At the upstream end of the Kilmarnock Phase 1 Discharge Channel, a hanging culvert prevents fish from entering the Kilmarnock Phase 1 Secondary Pond (Wilm, pers. comm. 2020) (Map 12 of Appendix A). Water flowing through this culvert drops 0.8 m onto a 1.5 m rip rap landing (Figure 24). Prior to September 2018, the entire Kilmarnock Phase 1 Discharge Channel was accessible to fish, from its confluence with the Fording River Side Channel to this culvert, whenever flow was present in the channel (Nicholl *et al.* 2018). In September 2018, a fish fence was installed within the Kilmarnock Phase 1 Discharge Channel upstream of the confluence with the Fording River Side Channel and fish no longer had access to the Kilmarnock Phase 1 Discharge Channel (Teck Coal Ltd. 2019a, Wilm, pers. comm. 2020).

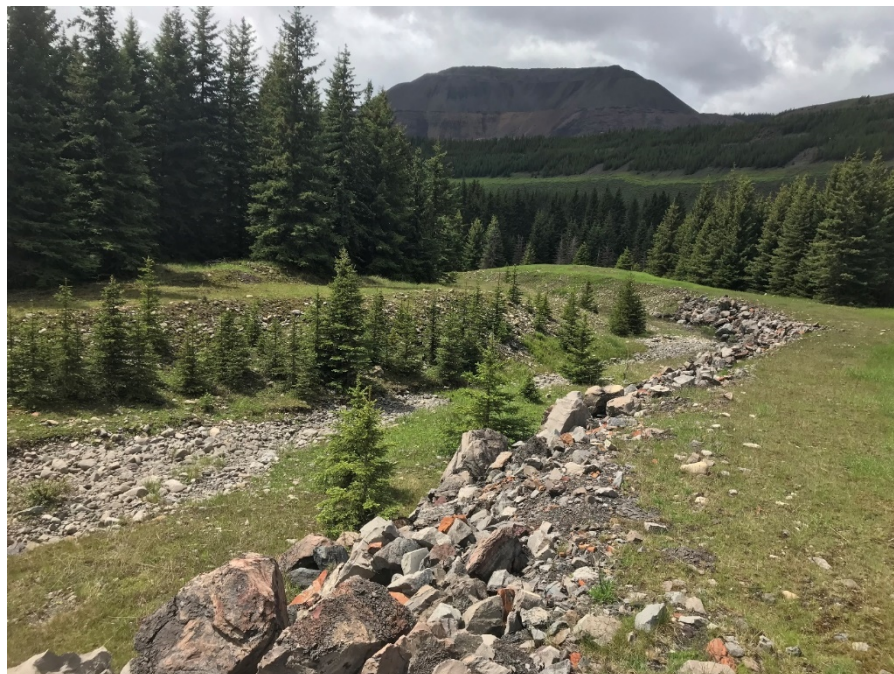
Figure 25. Kilmarnock Phase 1 Discharge Channel on June 14, 2020.

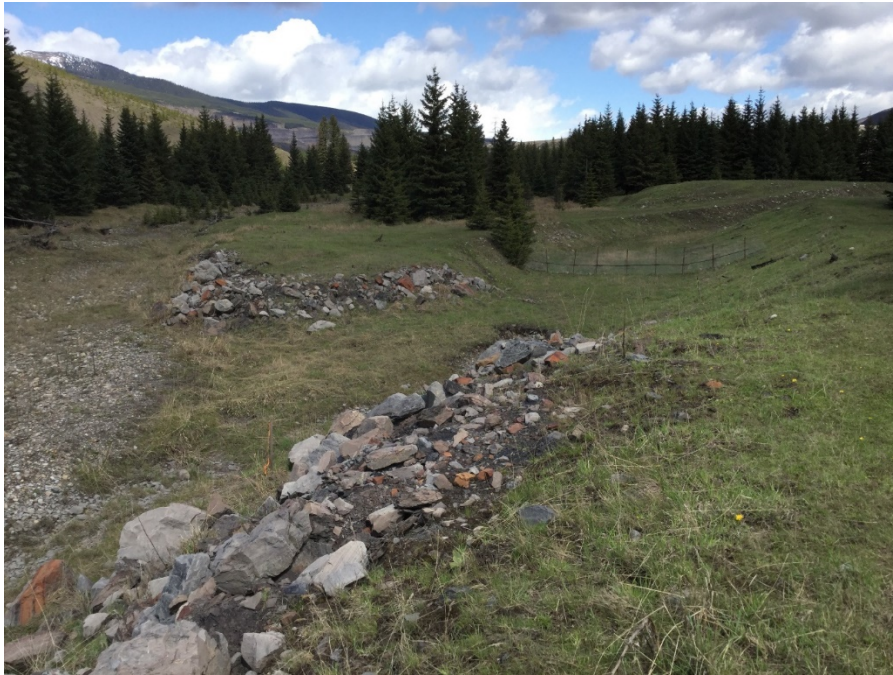
Figure 26. Kilmarnock Phase 1 Discharge Channel and Fording River Side Channel confluence on June 14, 2020.

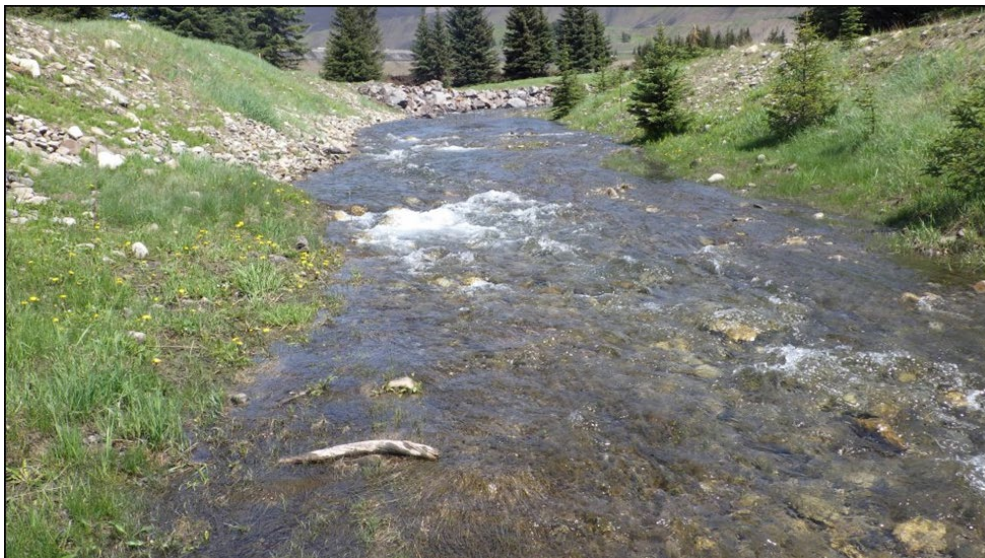
Figure 27. Looking upstream at riffle mesohabitat unit (FHAP unit #12) in the Kilmarnock Phase 1 Discharge Channel on June 6, 2018.

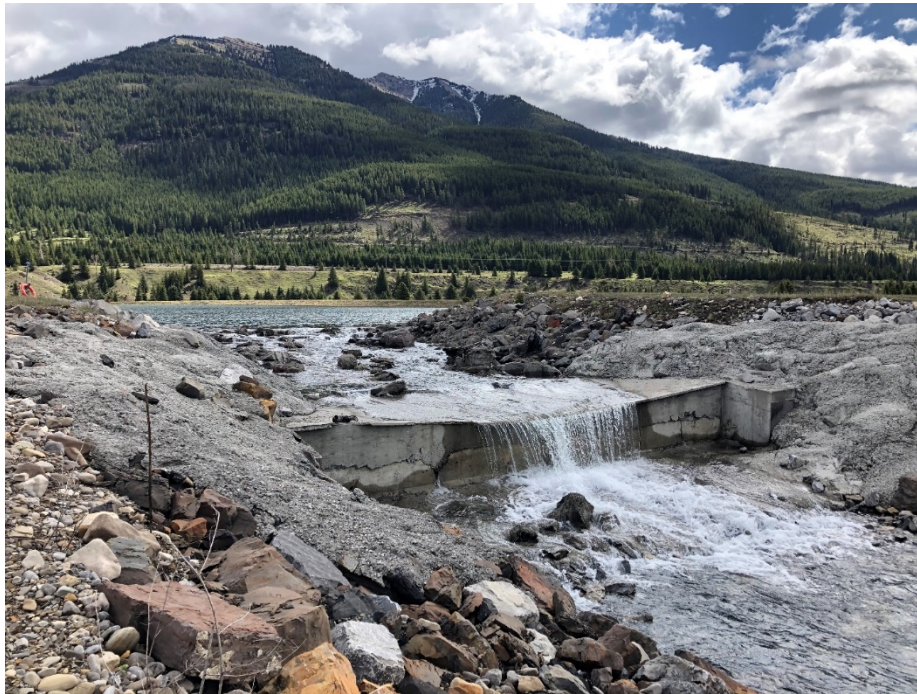
Figure 29. Kilmarnock Creek Phase 2 fish exclusion structure on May 26, 2020.

The Kilmarnock Phase 2 Discharge Channel has a fish exclusion structure, 15 m length  $\times$  10 m width  $\times$  1.0 m height, near its upstream end that is designed to carry water from the Kilmarnock Phase 2 Secondary Pond over a 1 m vertical drop onto a concrete pad 3 m in length and from there through 30 m of rip rap (Figure 29). Fish have access to the channel from the confluence with the UFR mainstem to the exclusion structure (Ecofish unpublished data, 2019) (Figure 30, Figure 31).

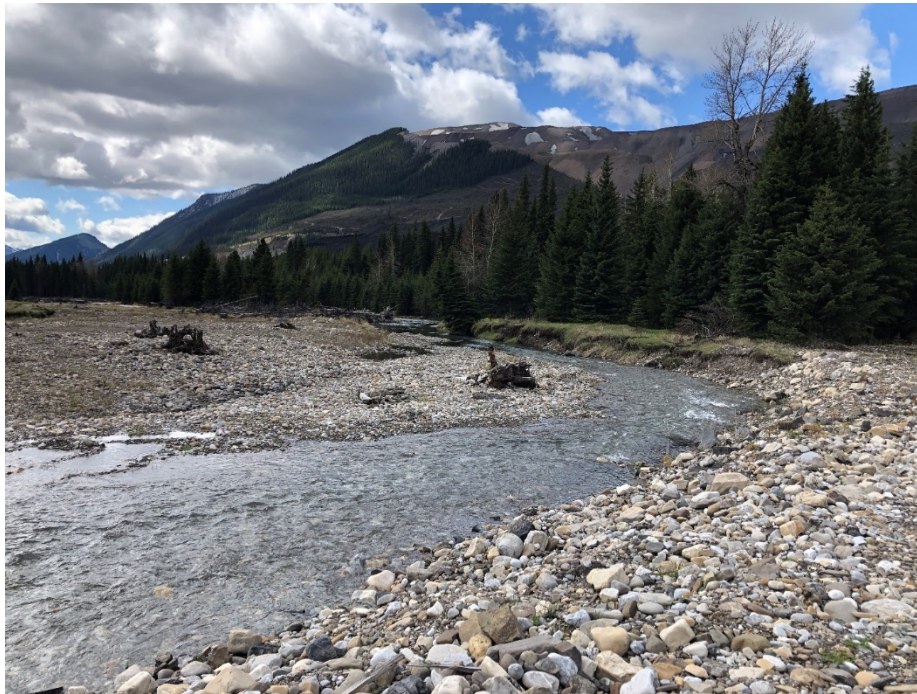
Figure 31. Kilmarnock Creek Phase 2 Discharge Channel on May 26, 2020.

The Kilmarnock Phase 2 Discharge Channel receives discharge and seepage from the Kilmarnock Phase 2 Secondary Pond as well as surface water and groundwater seepage from the UFR. Kilmarnock Creek flows into Kilmarnock Phase 2 Secondary Pond and may at times flow out of the pond and through the channel (Map 13 of Appendix A). The channel has a fish exclusion structure near its upstream end (Map 13 of Appendix A) and immediately downstream of this exclusion structure is a rip rap section approximately 30 m in length (Figure 29). The Kilmarnock Phase 2 Discharge Channel discharged into the mainstem of the UFR immediately downstream of the rip rap section prior to the fish habitat offsetting work within this area in 2018 that realigned the UFR mainstem further to the west. Following the offsetting work, the Kilmarnock Phase 2 Discharge channel extends for 175 m below the rip rap to the UFR (Figure 30, Figure 31).

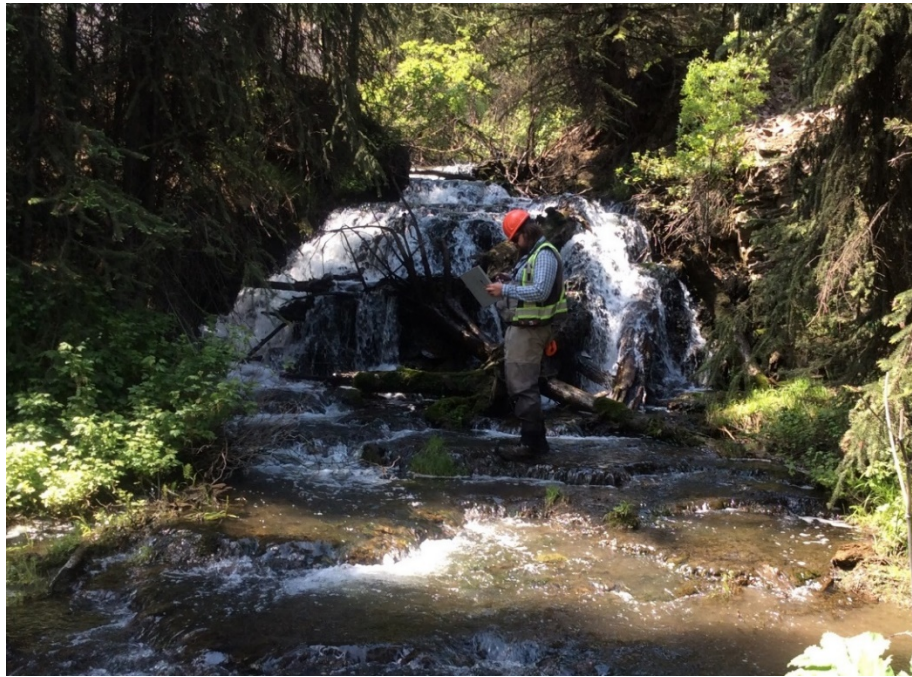
Figure 33. Cascade barrier on Swift Creek on June 7, 2018.

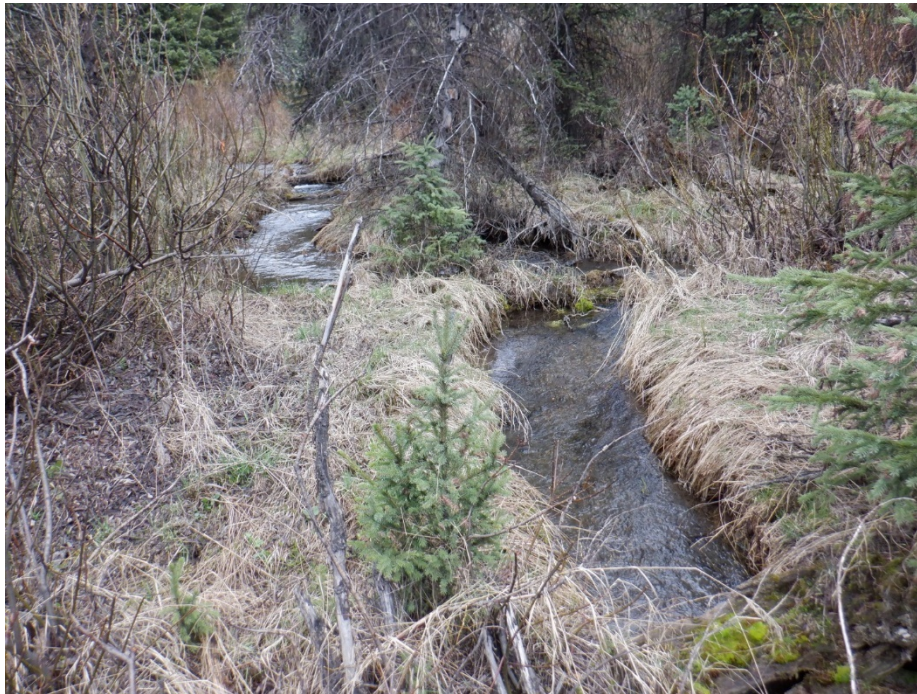
Figure 37. Porter Creek on May 13, 2019.

Porter Creek receives discharge from Porter Creek Pond and water flows from the pond to the UFR through an approximately 260 m channel (Map 16 of Appendix A; Figure 37).

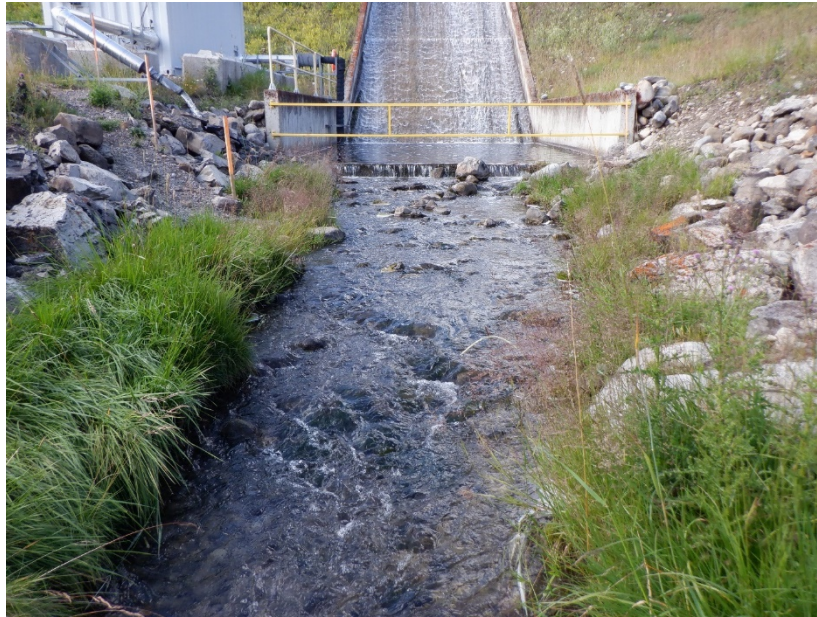
Figure 43. Looking upstream at the fish exclusion structure on Lower Greenhills Creek on August 13, 2019.

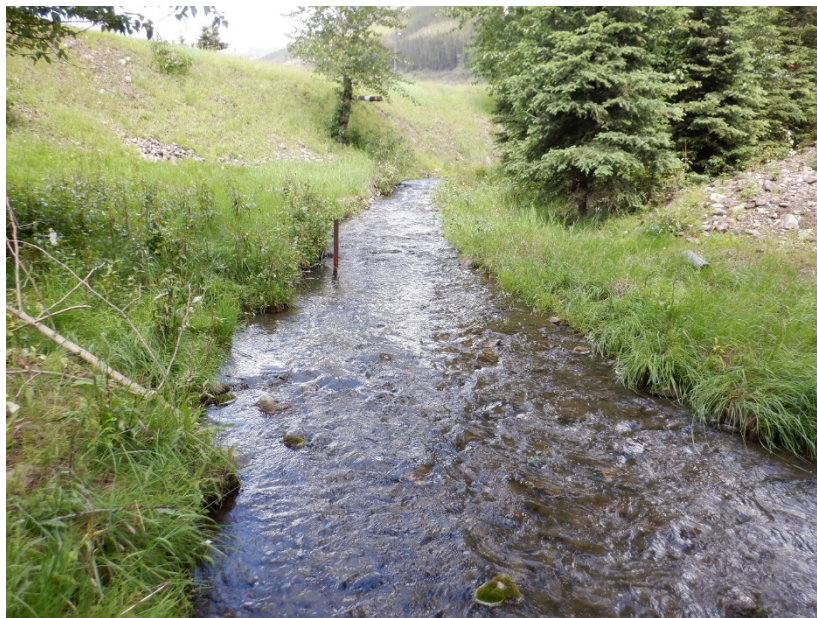
Figure 44. Lower Greenhills Creek on June 26, 2019.
