**Report:** Data Report for the Tributary Evaluation Program

**Data Report for the  
Tributary Evaluation Program**

Prepared For:  
**Teck Coal Limited**  
Sparwood, British Columbia

Prepared By:  
**Minnow Environmental Inc.**  
Georgetown, Ontario

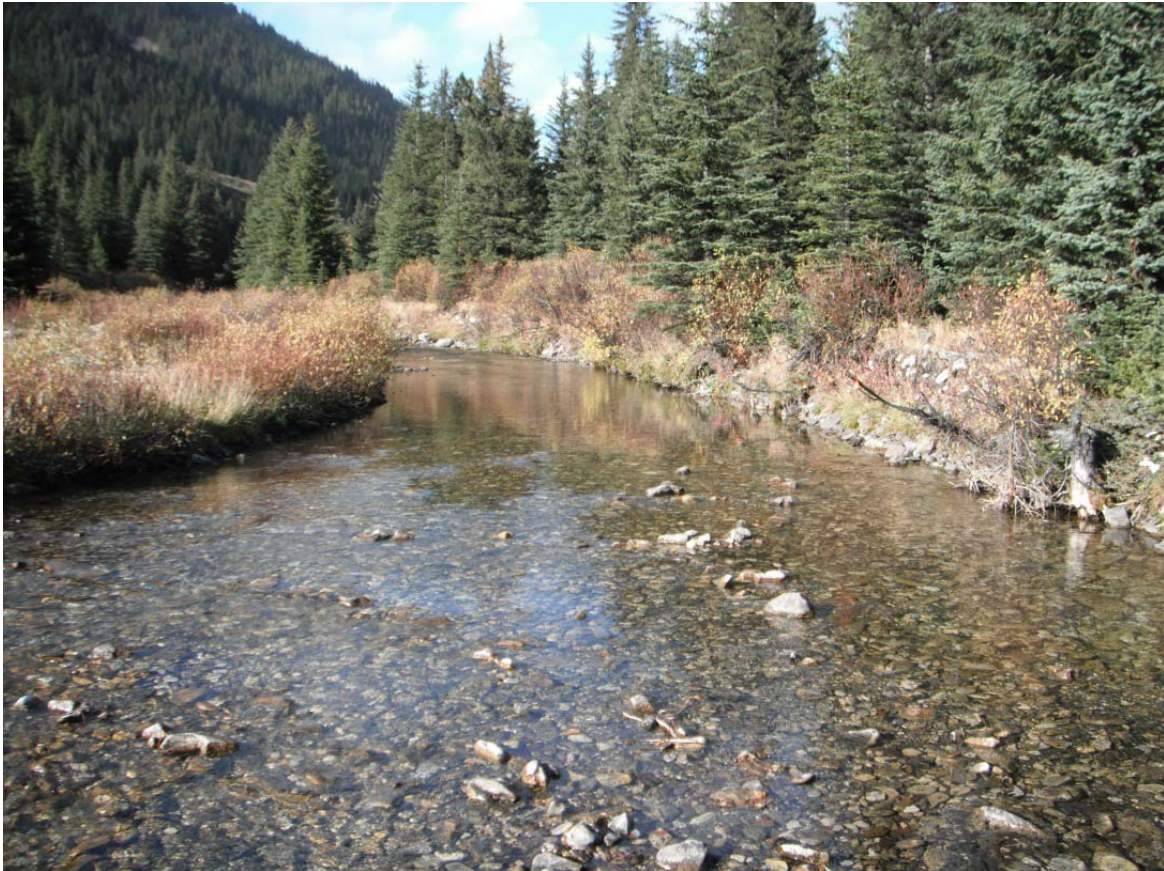
**Photo 3.1 Fording River upstream from Henretta Creek (Golder 2014a).**

A 530-m area of stream was surveyed in September 2011, located 4.5 km upstream from the confluence with Henretta Creek (Golder 2014a). The surveyed area consisted of 51% riffle, 31% cascade, 15% glide, and 3% pool habitat, with mean stream gradient of 3% (Photo 3.1). Substrates were primarily cobble, gravel, and boulder. The mean stream gradient was 3% and average bankfull width was 5.2 m. Average mid-channel depth was 0.2 m. Cover was present at only about 8% of the surveyed area and included overhanging vegetation and boulders, with large woody debris in some glides and pools. Riparian vegetation was dominated by young mixed forest or shrubs. Isolated pockets contained substrate suitable for spawning. The Fording River upstream from mining provides suitable habitat for all life stages of WCT when water flows are adequate to support fish. No barriers to fish migration were observed in or near the surveyed area (Golder 2014a).

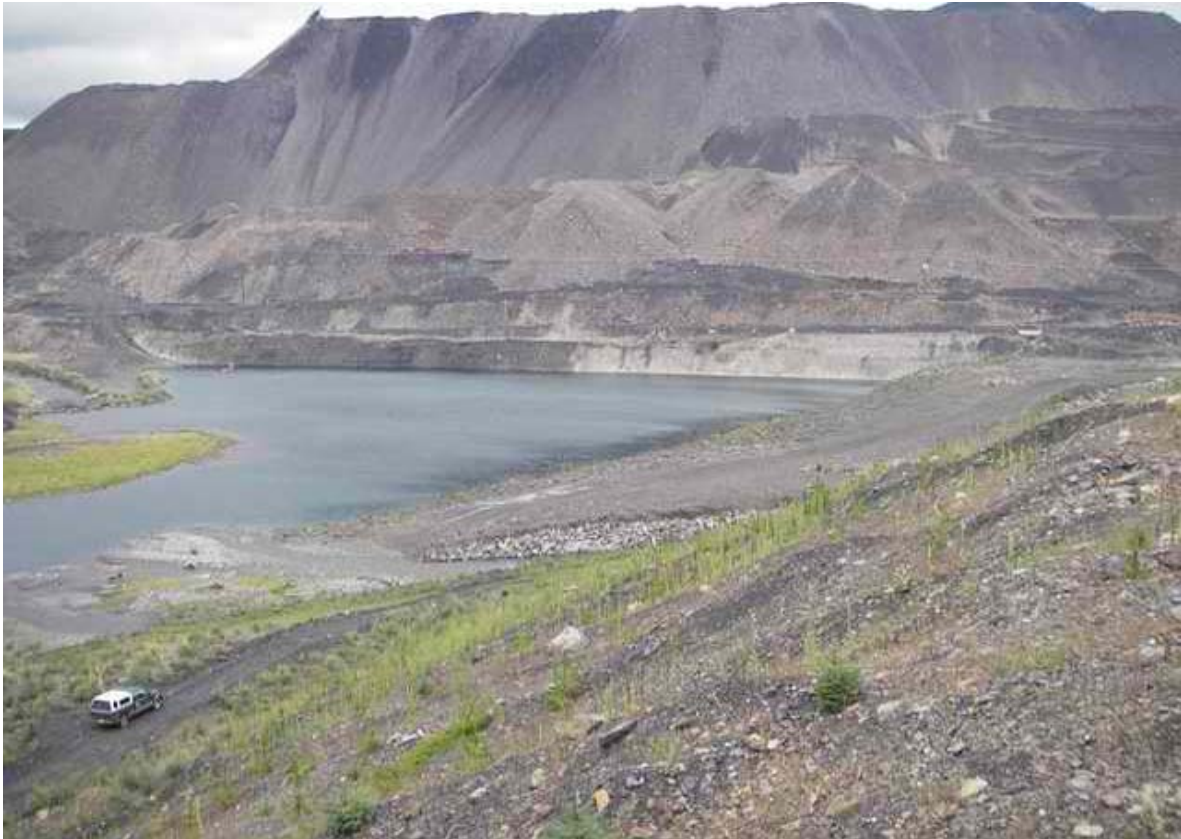
**Photo 3.2: Henretta Lake (Wright et al. 2005).**

Henretta Creek was diverted in the early 1990s into a series of culverts to allow for mining of the Henretta Pit (Wood and Berdusco 1992). Once mining was complete, new channels were constructed at the inlet and outlet of the pit and water was allowed to flow into the pit, creating Henretta Lake and a reclaimed-channel and flow-through lake system (Photo 3.2). Instream reclamation was completed in 1999. In August 2002, V-weirs, small stone lines, wing deflectors, spawning gravel placement, and boulder clusters were constructed in the reclaimed channel downstream from Henretta Lake to increase habitat diversity. The reclaimed channel and lake were heavily influenced by the 2013 floods (Cope et al. 2013).

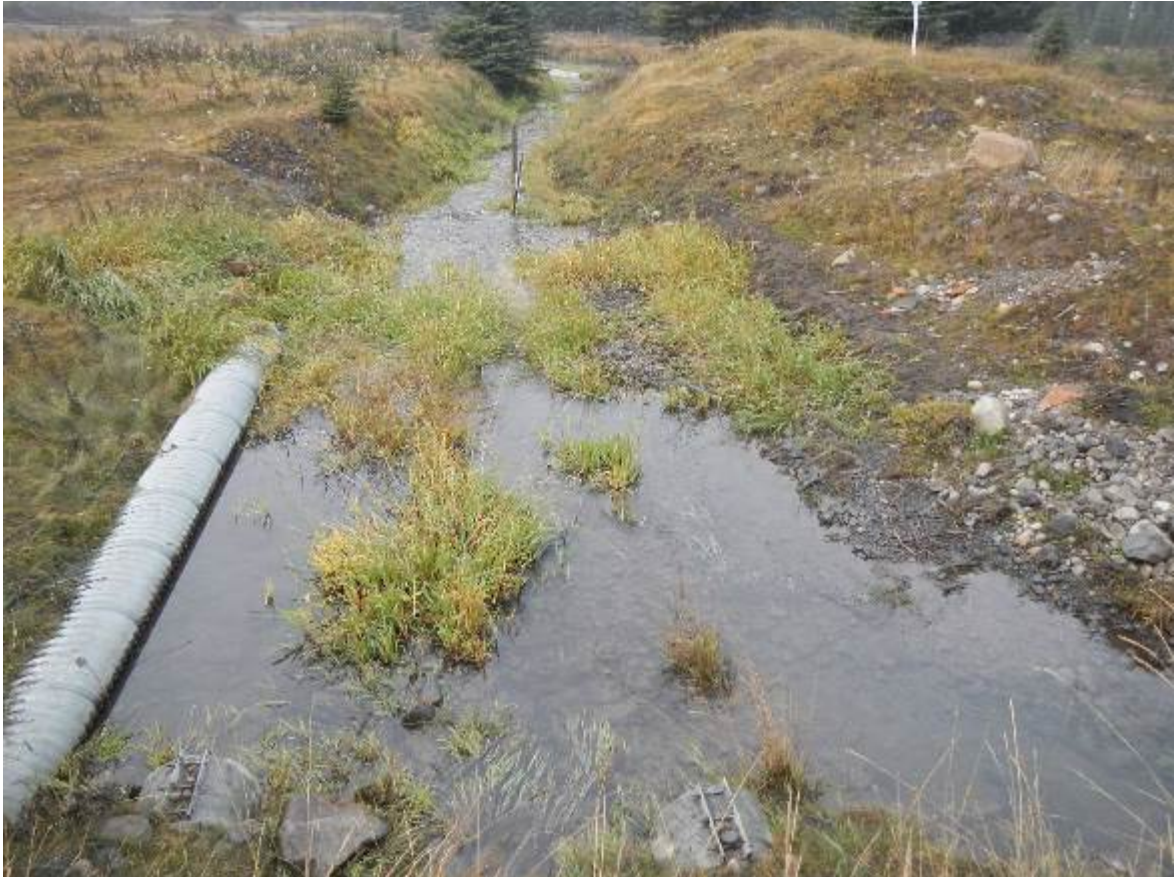
**Photo 3.3: Clode Creek downstream from Clode Ponds (Golder 2014a).**

The lower portion of the creek has been moved from its original confluence with the Fording River. On topographic maps based on aerial imagery from 1972, Clode Creek entered the Fording River where the Eagle Sediment Ponds are currently located. The CWB dataset has Clode Creek flowing into Fish Pond Creek. However, Clode Creek has been diverted into the Clode Settlement Pond system adjacent to Fish Pond Creek. The remaining, lower portion of the creek consists of the East Settling Pond (180m x 34m, mean depth 2 m), the Main Settling Pond (150m x 280m; mean depth 2-3 m; collectively referred to as Clode Ponds), and the 100-m section of Clode Creek that discharges from the Main Settling Pond to the Fording River (Golder 2014a). The Clode Ponds were

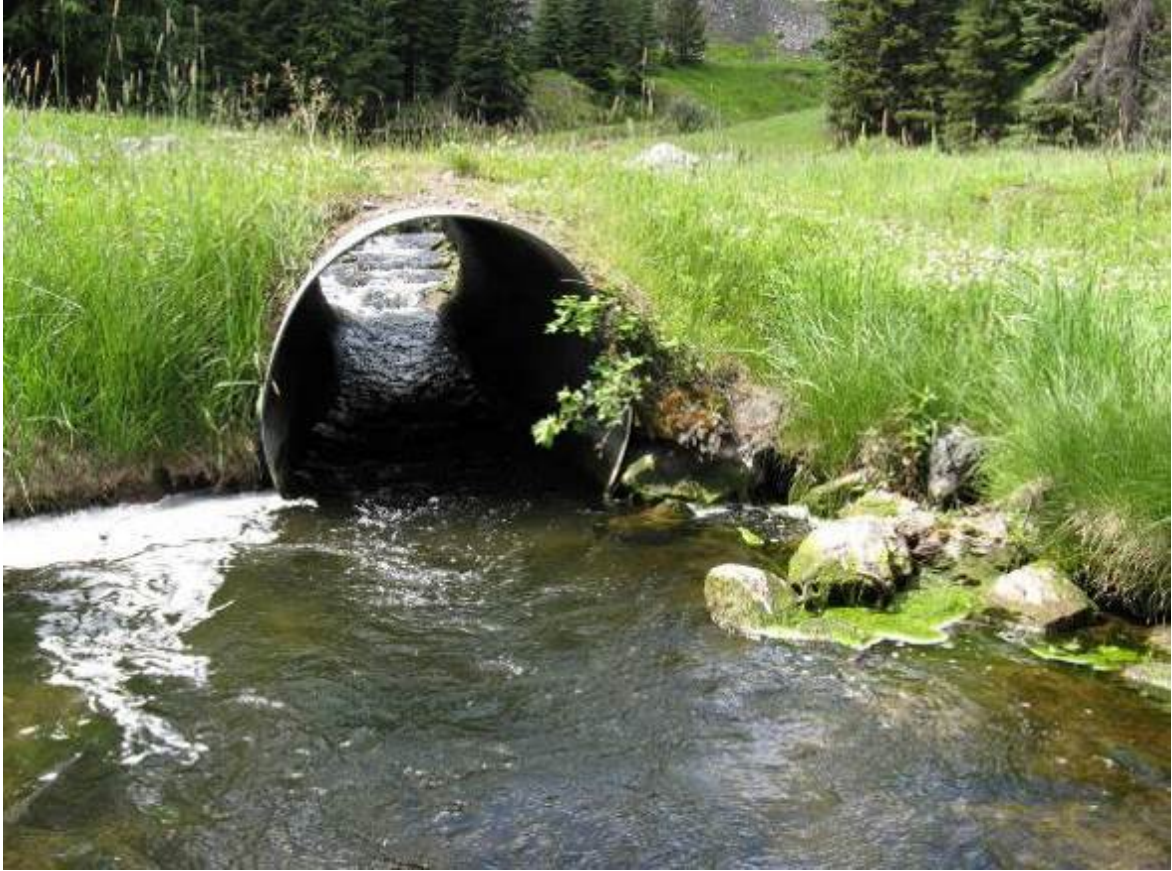
**Photo 3.4: Culvert at Clode Pond access road in the lower section of Lake Mountain Creek (Golder 2014a).**

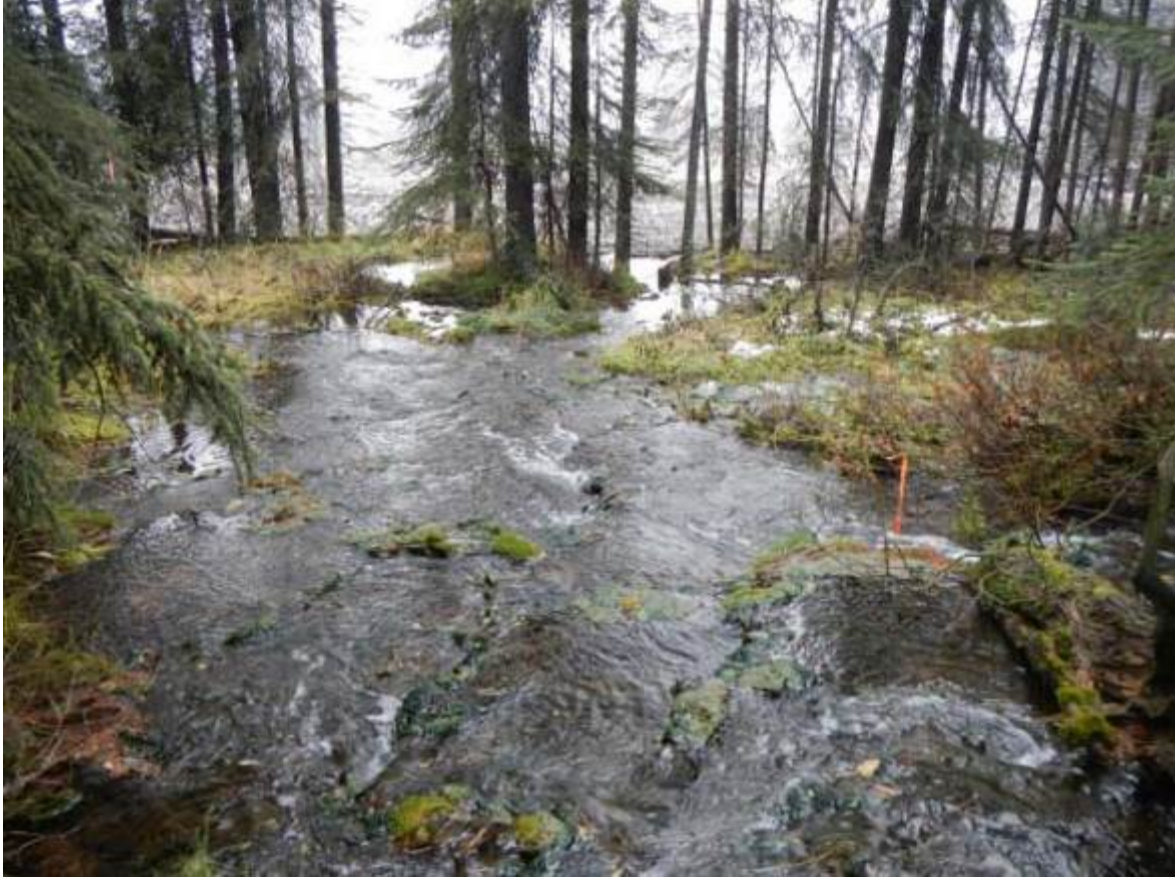
**Photo 3.5: Swift Creek at the Fording River post-flood 2013 (Golder 2014a).**

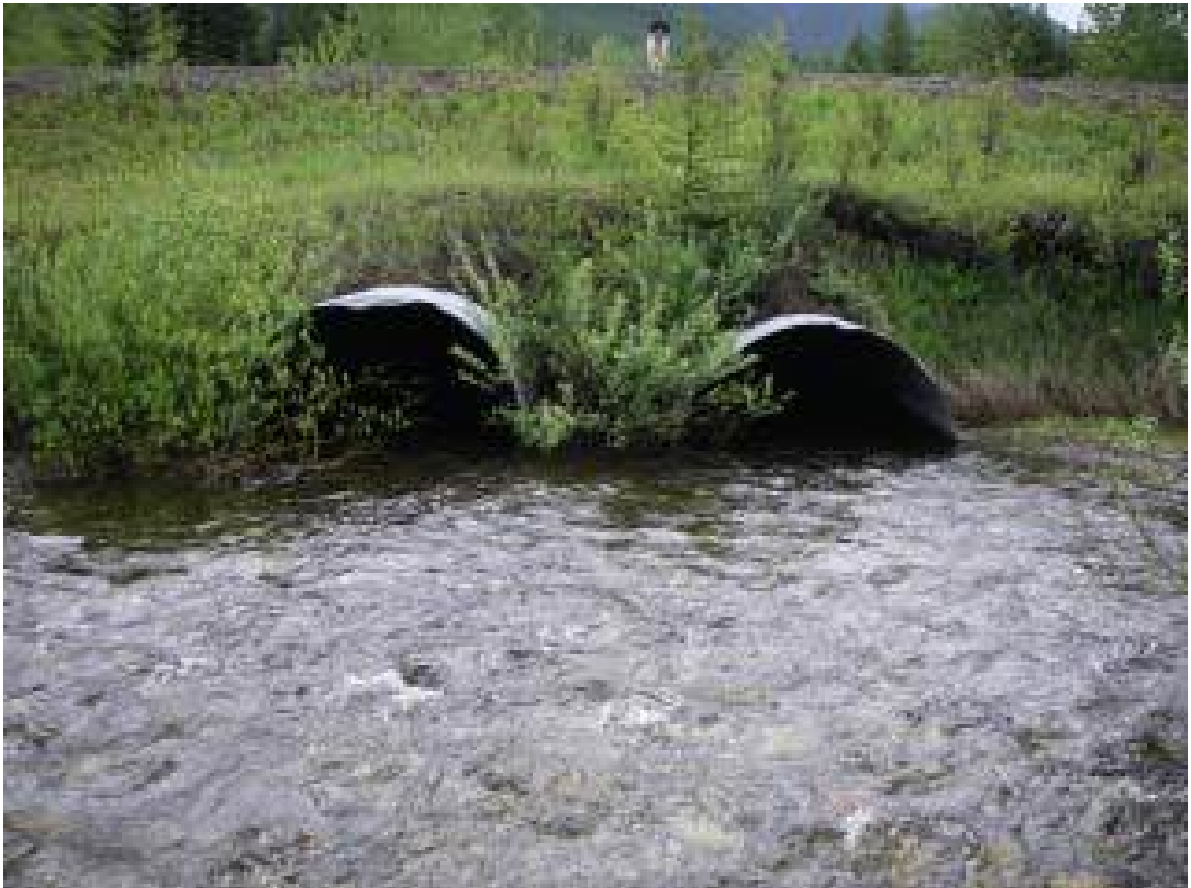
**Photo 3.6: Paired culvert crossing under Fording Road in Dry Creek (Teck 2011b).**

LCO's Dry Creek flows north from its headwaters to the Fording River. An unnamed tributary (often referred to as the East Tributary), joins Dry Creek from the east about 5 km upstream from the confluence with the Fording River. A railway and two road crossings are located along the lower portion of Dry Creek. The railway and one road crossing are paired culvert crossings (Photo 3.6), whereas the second road crossing is a clear-span bridge.

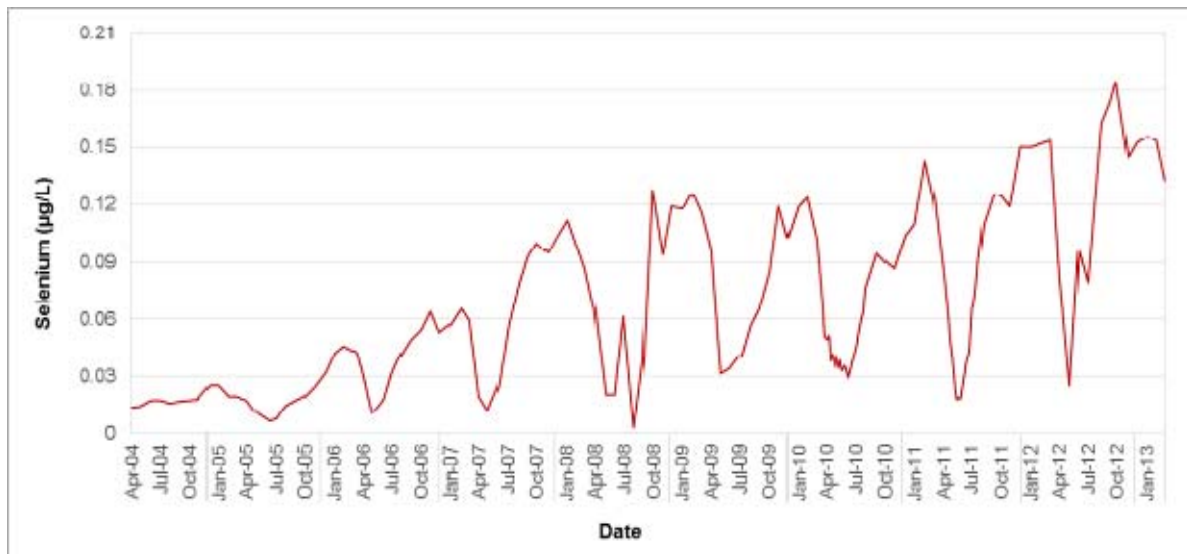
**Figure 3.3: Selenium concentration trend over time (2004-2013) in Greenhills Creek at the confluence with the Fording River (GH\_GH1).**

Based on samples collected near the mouth of the creek, water quality, benthic invertebrate community and tissue selenium concentrations were characterized as “poor”, with the exception of bird dietary selenium exposure (i.e., invertebrate consumption), which was characterized as “good” (Windward et al. 2014; Table 3.2). Increasing trends in the concentrations of selenium, nitrate, sulphate and cadmium were reported (Zadjlik and Minnow 2013; Figure 3.3) and low levels of calcite have been observed (calcite index: 0.4; Active water treatment is scheduled to begin in 2026, treating water from GHO’s West Spoil (influencing Thompson, Leask, and Wolfram Creeks) as well as a portion of upper Greenhills Creek (Teck 2014). Treated effluent will discharge to Thompson Creek.

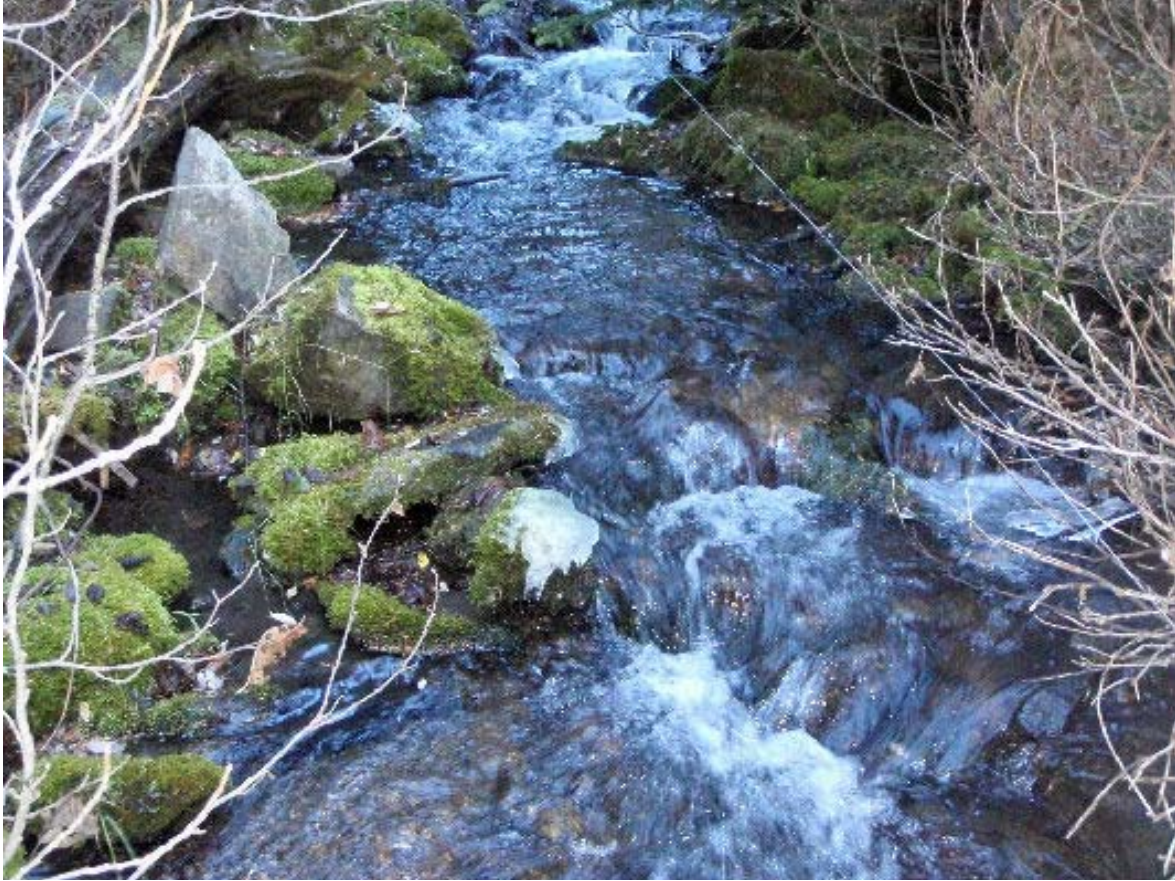
**Photo 4.1: Typical riffle-glide morphology in Grace Creek (Teck 2011b).**

None of the catchment area of Grace Creek has been disturbed by mining activities (Table 4.1; Photo 4.1). No mining disturbances are planned for the future (Table 4.1). Of the total stream length of 45 km, 31% is connected to the main stem whereas the remainder is fragmented (Table 4.3). The catchment has been disturbed by forestry activities and roads (Table 4.1).

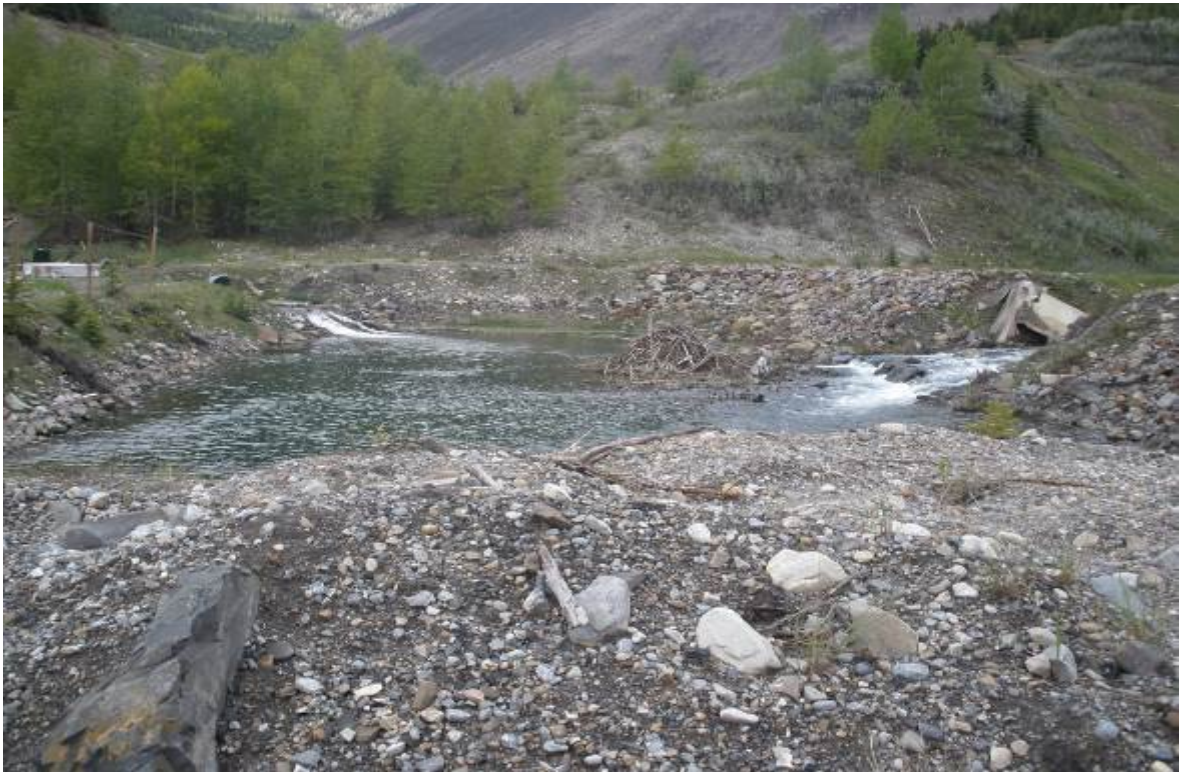
**Photo 4.2: Downstream end of the rock drain in Line Creek (Minnow unpublished).**

A rock drain associated with LCO is located about 9 km upstream from the Fording River and covers about 3.8 km of Line Creek (Photo 4.2). West Line Creek, which flows into Line Creek near the downstream end of the rock drain, has been heavily influenced by mining and Teck recently constructed an AWTF to reduce selenium and nitrate loads from West Line Creek into Line Creek. Near the site of the AWTF and downstream from the AWTF outfall, South Line Creek (which is not mine-influenced) also flows into Line Creek. Mine-related pits and spoils are situated in the Line Creek watershed primarily upstream from the confluence with South Line Creek and coal is transported to a processing plant near the Fording River by a conveyor that parallels Line Creek (Arnett and Robinson 2010). For about 2.5 km upstream from the rock drain, Line Creek flows through historical and active mining areas, as well as through past forestry cutblocks. Farther upstream, the headwaters of Line Creek and Tornado Creek each flow for about 4.5 km through areas that have been influenced historically by forestry but not mining before joining together at the upstream end of the mine.

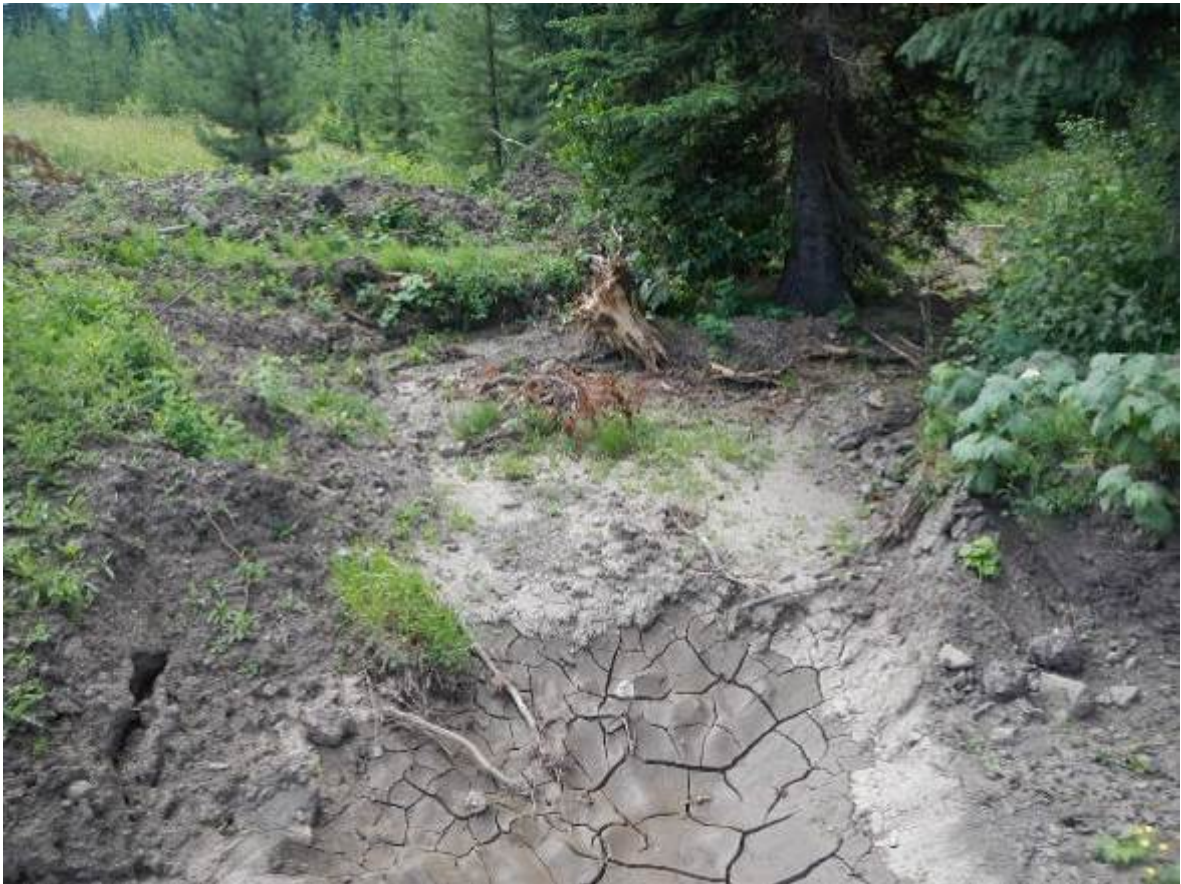
**Photo 5.1: Dry creek bed in Branch F Creek (Lotic 2015b).**

In September 2013, the creek was characterized as dry from the Elk River to the FSR (Lotic 2015b; Photo 5.1). Additional visits in February 2014, and July 2014 again found the channel dry, so no biological sampling occurred. Branch F Creek has an average gradient of 15.3% and an average channel width of 0.80 m, and there is a gradient barrier (slope greater than 30% for 30 m) located at its confluence with the Elk River (Lotic 2015b). The stream is considered non-fish bearing (Lotic 2015b).

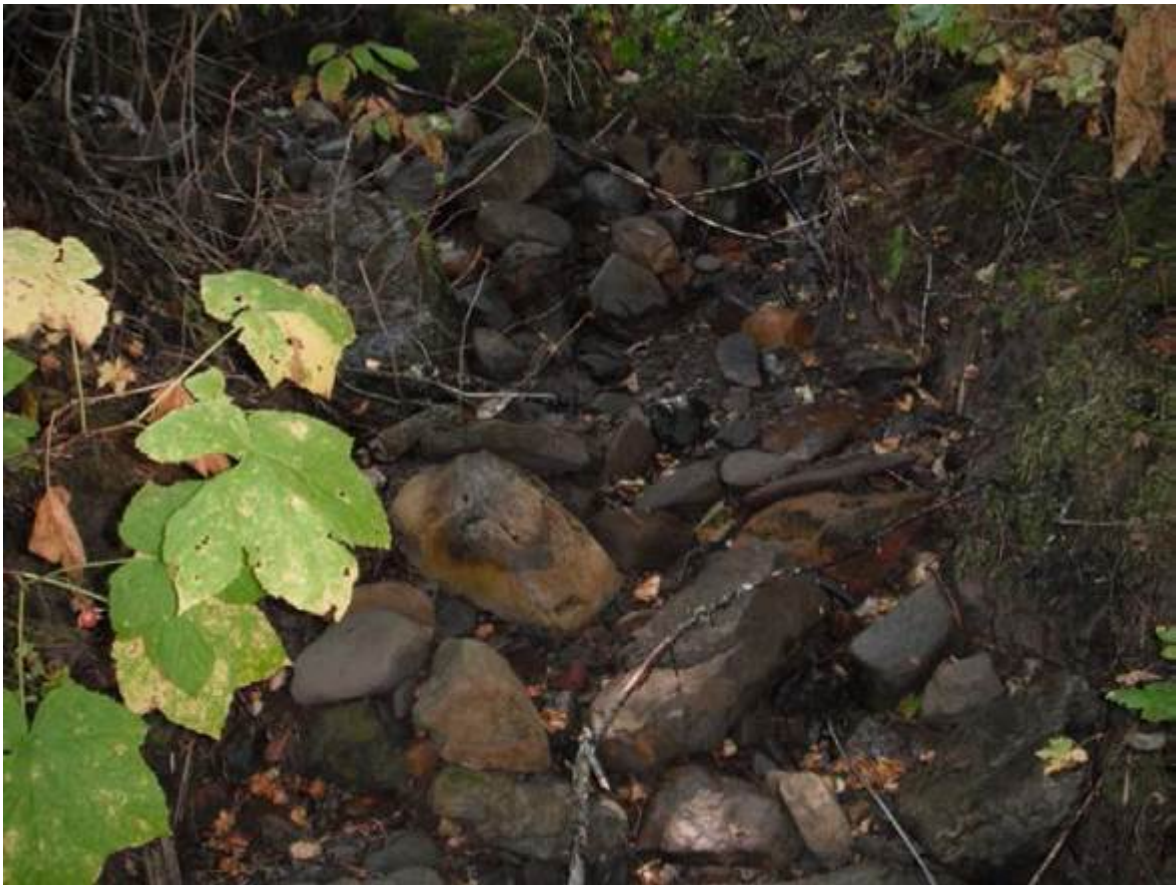
**Photo 5.2: Dry creek bed in Wolf Creek (Lotic 2015b).**

Wolf Creek has average gradient of 25.7% and average channel width of 1.43 m (Lotic 2015b). In September 2013, most of Wolf Creek was dry, except for some standing water present over a short section downstream from the Round Prairie FSR (Photo 5.2). There was also a dry 5-m-high cascade/fall at the confluence of Wolf Creek and the Elk River that would serve as a barrier to fish movement. Wolf Creek was also dry in February 2014 and was largely subsurface between the FSR and Elk River in July 2014. As a result no biological sampling was conducted. Wolf Creek is considered to be non-fish bearing (Lotic 2015b).

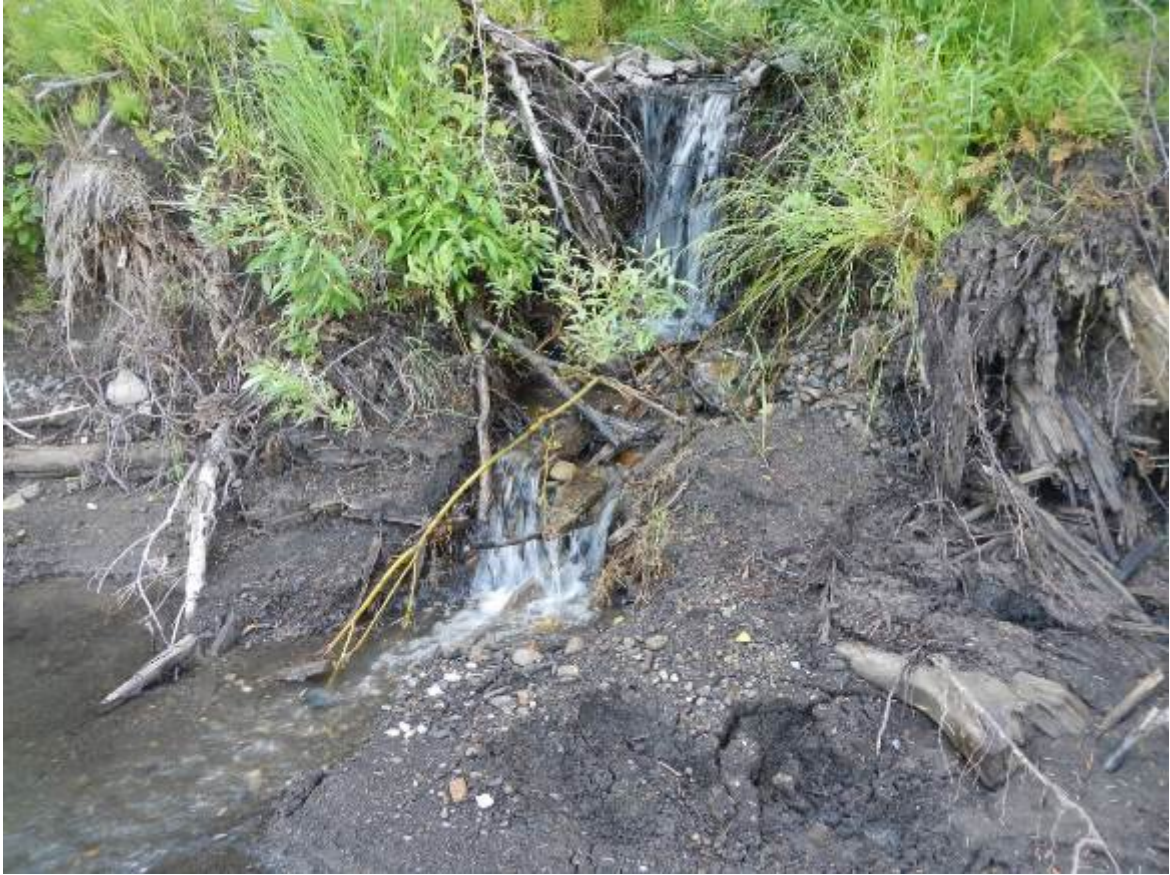
**Photo 5.3: Two-meter-high waterfall at the confluence of Willow Creek with the Elk River (Lotic 2015b).**

There was only a 10 m fish bearing section in Willow Creek North bordered by the two-metre-high cascade/waterfall on its downstream end (Photo 5.3) and the gradient barrier of 25% for 20 m at its upstream end (Lotic 2015b). The cascade/waterfall at the Willow Creek and Elk River confluence was considered a barrier to upstream fish migration through all but high flow periods. It is likely that the one fish captured in Reach 1 was stranded above the first barrier when the Elk River receded following the spring 2013 record flood. There was no suitable salmonid spawning habitat as the cobble substrate was too large. Pools and glides for holding and feeding areas for adults were lacking. Overall, only the lower 10-m of Willow Creek North has potential for use by sub-adult life-stages of fish during the open-water season, and there is connectivity with the Elk River only during high water flows. The remainder of the creek is non-fish bearing (Lotic 2015b).

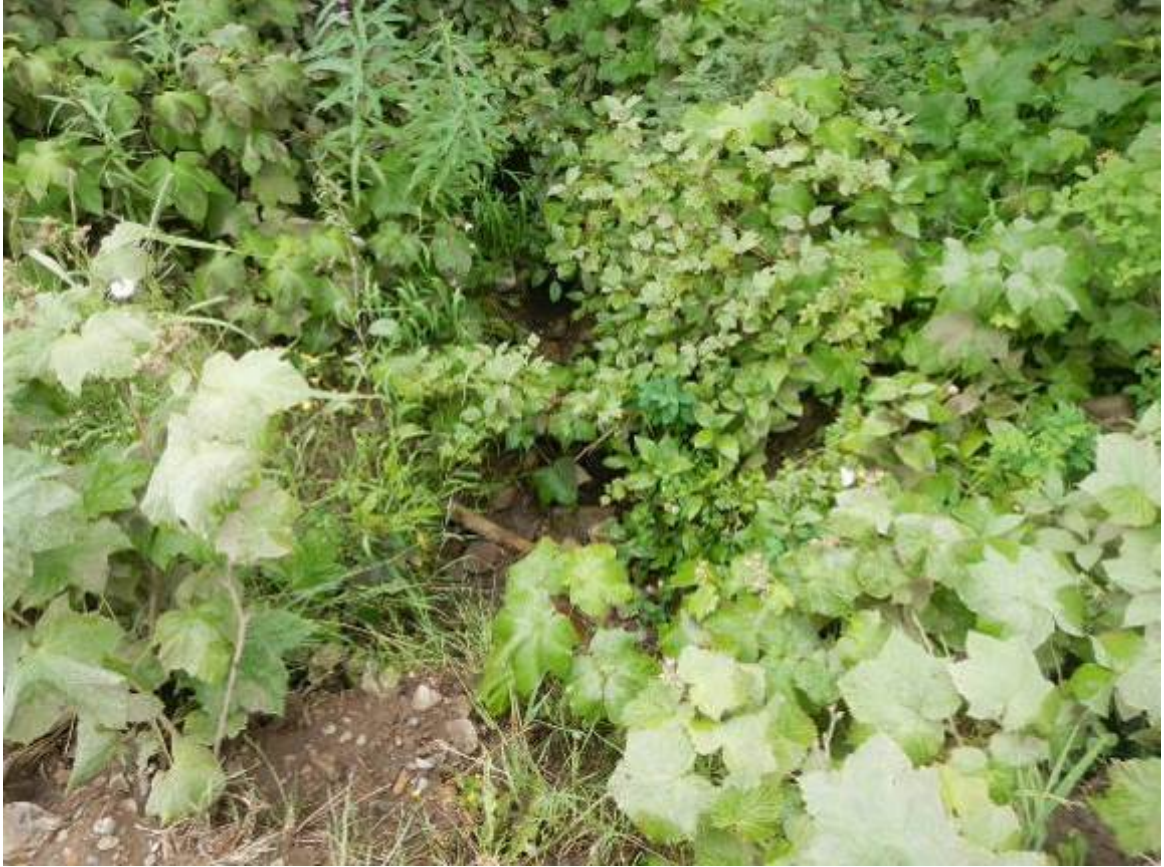
**Photo 5.4: Dry creek bed in Cougar Creek (Lotic 2015b).**

Cougar Creek has an average gradient of 24% (Lotic 2015b). There is a gradient barrier of 37% slope for 30 m immediately upstream from its confluence with the Elk River. In September 2013, Cougar Creek was reported as dry from the Elk River up to the FSR (Photo 5.4). It was also dry during surveys in February 2014 and July 2014. Therefore, no biological sampling was completed. The combination of dry conditions and gradient barrier preclude fish presence at any time of year. Cougar Creek is classified as non-fish bearing (Lotic 2015b).

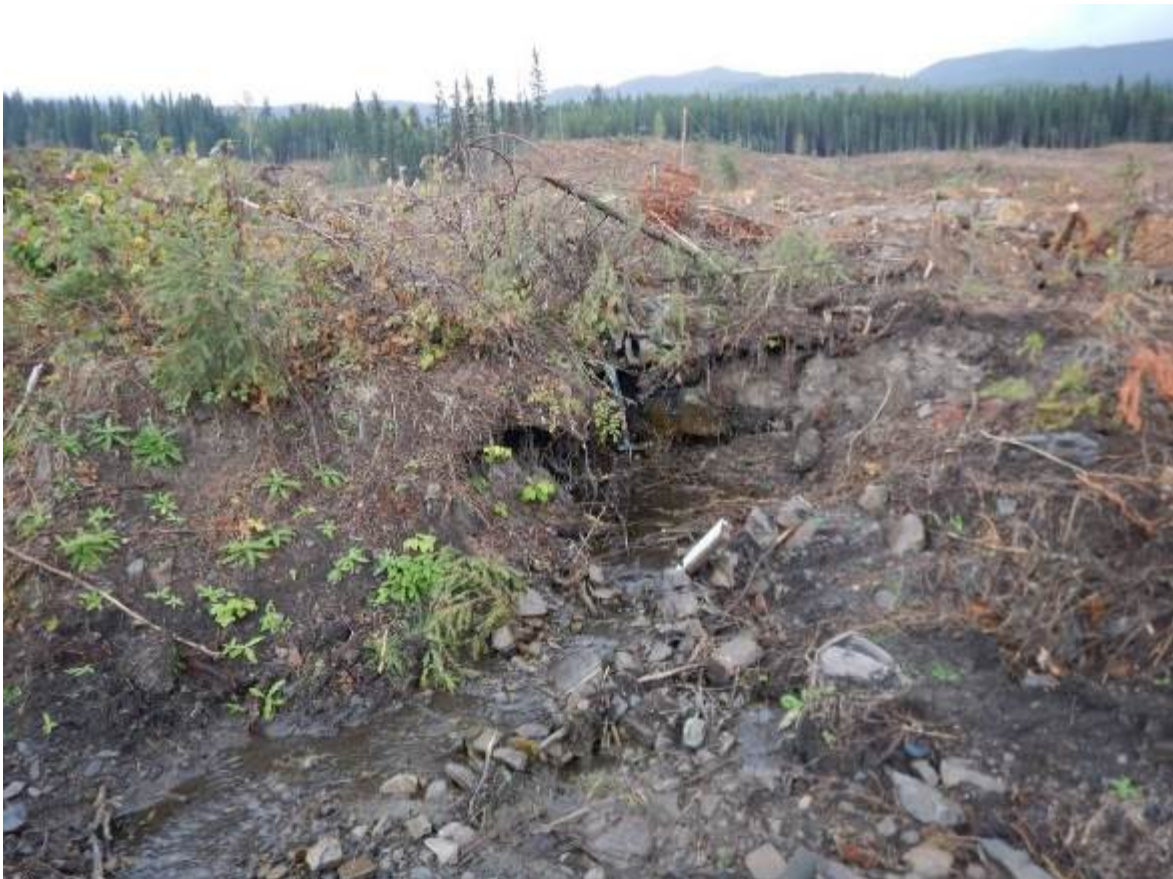
**Photo 5.5: Extensive logging in Mickelson Creek (Lotic 2015b).**

About 24% of the total catchment area of Mickelson Creek has been disturbed by mining activities (Table 5.1). Mining is currently occurring within the permit boundary will continue into the near and far future as part of the Cougar Pit Expansion Project. The catchment has also been disturbed by forestry activities and roads (Table 5.1). All of the total stream length of 9.3 km is fragmented or has been lost (Table 5.3). The stream flows into a newly constructed sedimentation pond that has no surface connection to the Elk River (Lotic 2015b). The water from the pond decants to Leask Creek and Leask Pond, which also has no overland connection to the Elk River. The catchment has also been disturbed by forestry activities and roads (Table 5.1, Photo 5.5).

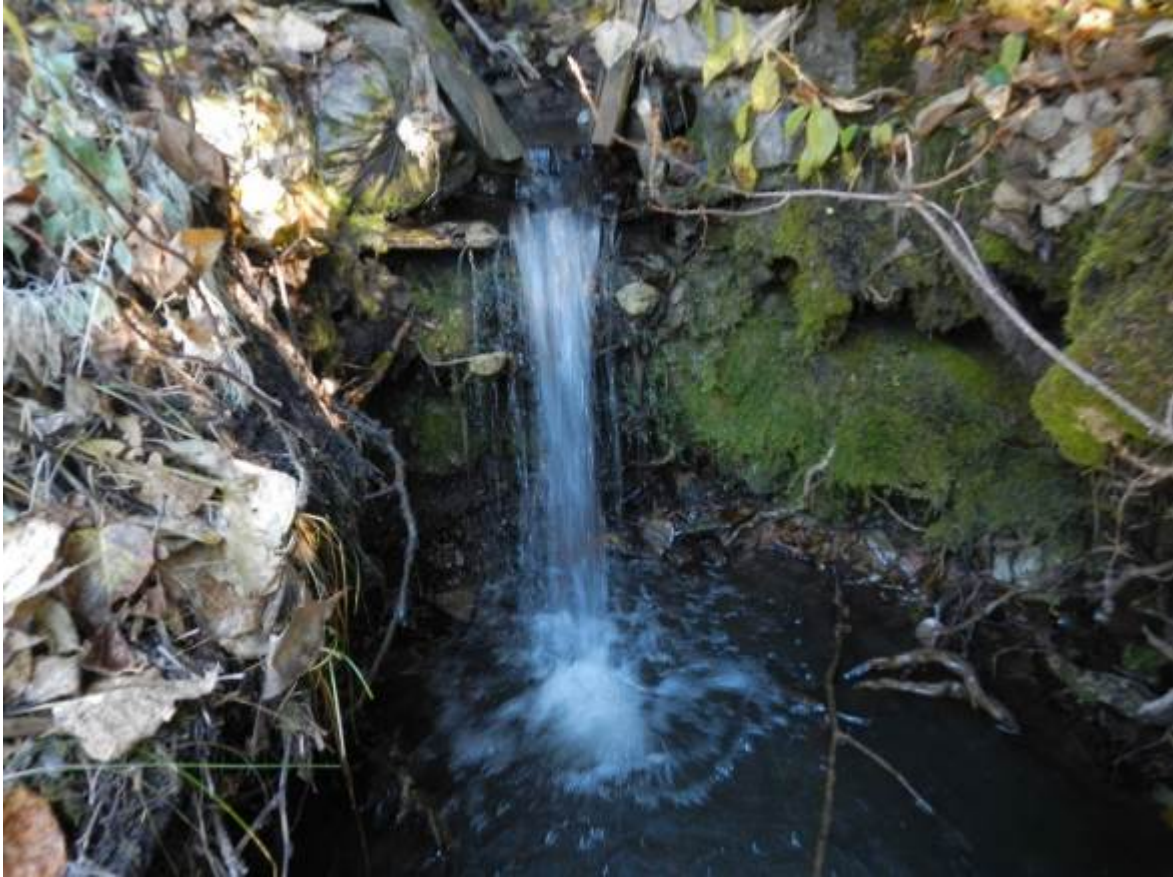
**Photo 5.6: One metre tall waterfall on Mickelson Creek upstream from the Round Prairie Forest Service Road (Lotic 2015b).**

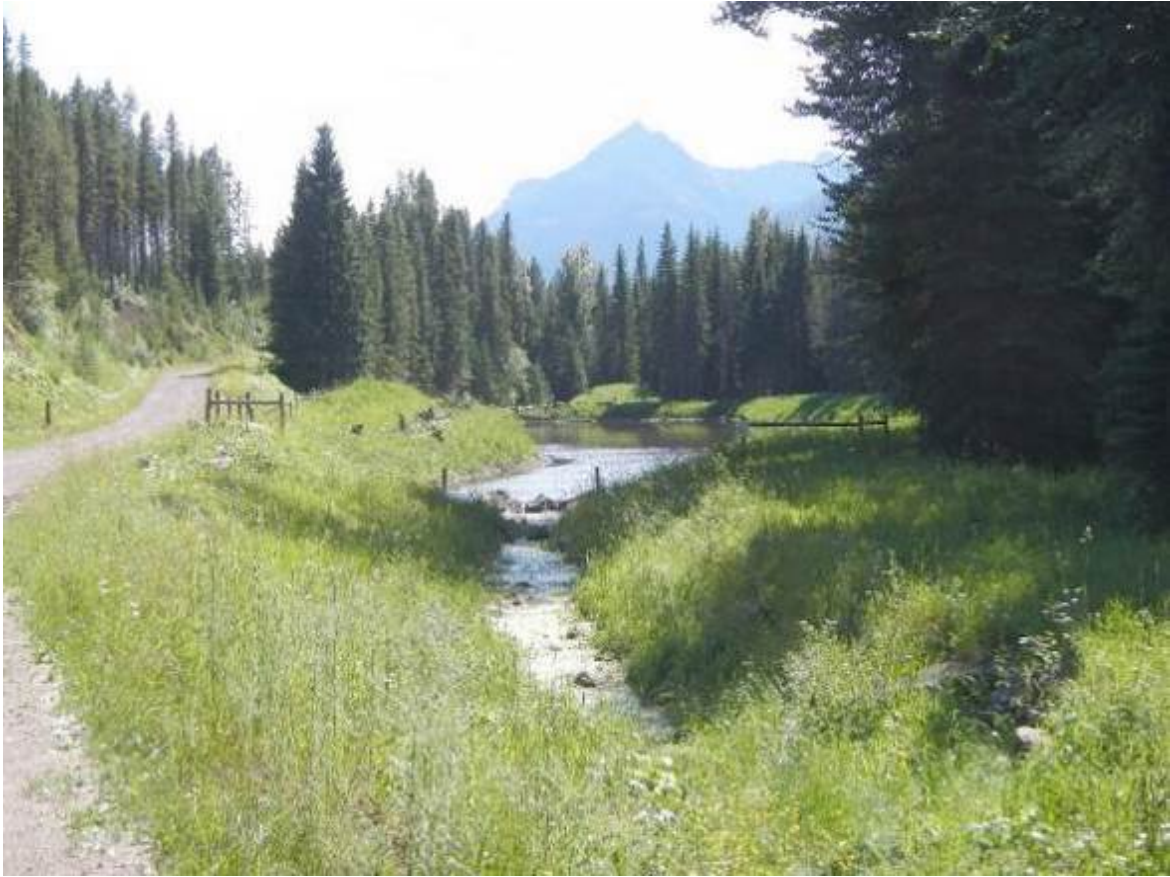
**Photo 5.7: Downstream sedimentation pond at Leask Creek (Lotic 2015b).**

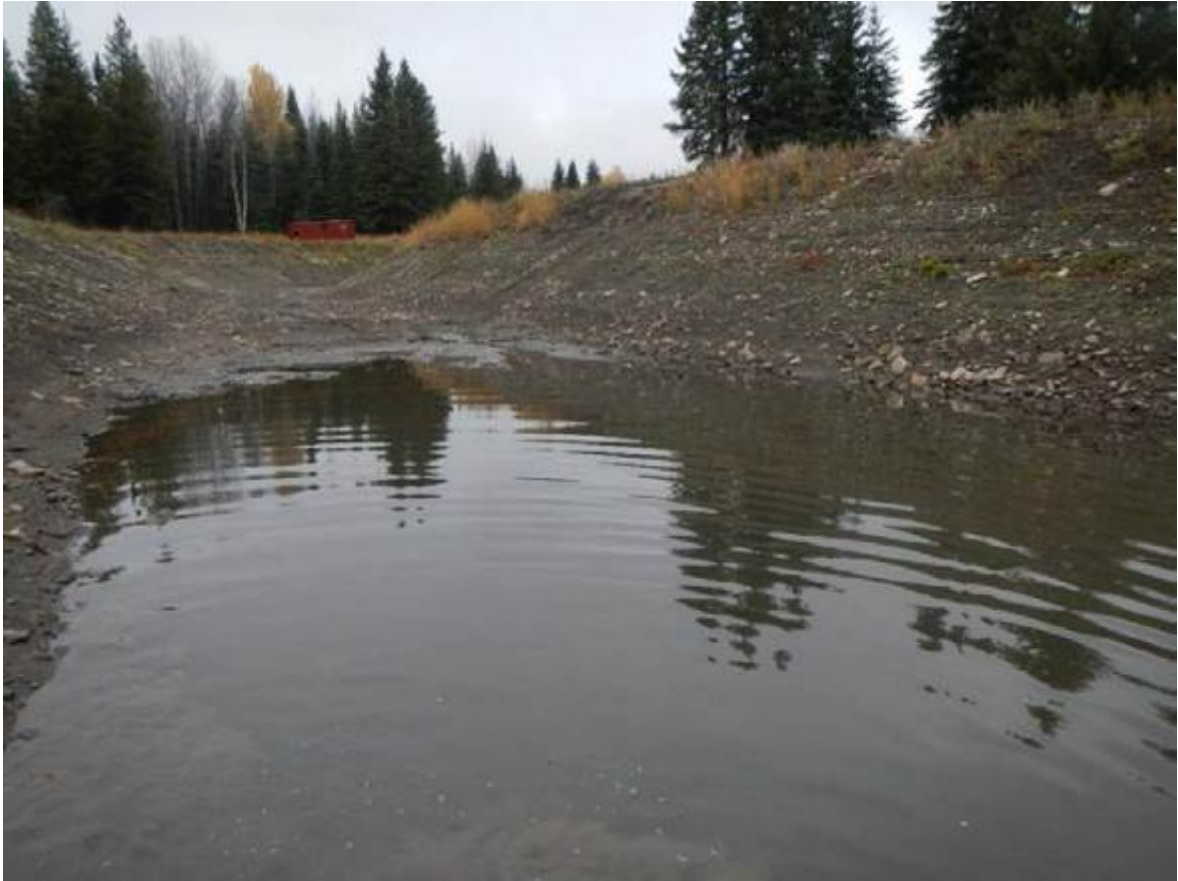
**Photo 5.8: Upstream view of downstream sedimentation pond on Wolfram Creek (Lotic 2015b).**

Fish and habitat surveys were conducted in 1994, and more recently in July and September 2012 (Lotic 2015b). The most downstream section of Wolfram Creek consists of two man-made sedimentation ponds (about 2,958 and 1,843 m<sup>2</sup>; Photo 5.8). The downstream pond is dry most of the year. The water depth of the ponds fluctuates substantially throughout the year, and there were no macrophytes observed growing in the ponds. The culvert crossing at the FSR may be a barrier to fish movement in low flow (Lotic 2015b). There was no overland connectivity between the ponds and the Elk River. The stream extends upstream for 290 m before splitting into the north and south branches. It has a step-pool morphology and an average gradient of 10.6%. The dominant substrate was cobble and gravel and the average bankfull width was 4.36 m (Lotic 2015b).

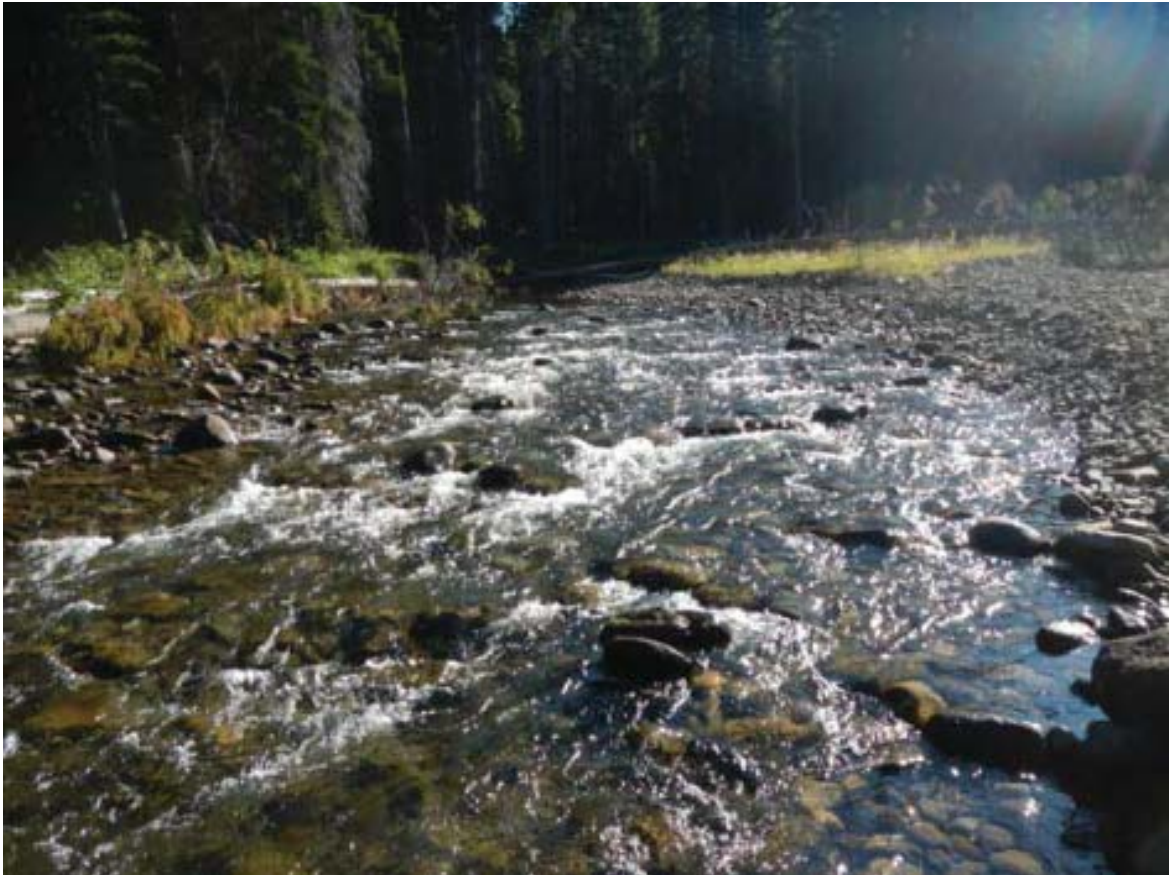
**Photo 6.1: Typical riffle habitat in Leach Creek (Golder 2015).**

Fish and fish habitat surveys were conducted at two areas in the upper and lower portions of Leach Creek, respectively, in 2007 and 2008 (Golder 2015a). An area located 25 m upstream from the confluence with Michel Creek was surveyed again in 2012 (Golder 2015a). Stream morphology of the surveyed area in the upper watershed was characterized as cascade-pool with predominantly glide (40%), riffle (27%), and cascade (27%) habitats and substrate composed of cobble, boulder, and gravel (Golder 2015a; Photo 6.1). Mean bankfull width was 3.2 to 7.4 m (Golder 2015a). The surveyed area in the lower watershed had stream gradient and bankfull width of 1.5% and 18 m, respectively, with habitat dominated by glides (49%), riffles (39%), and pools (12%; Golder 2015a). The dominant substrates were gravel, cobble, and boulder. Riparian vegetation throughout the watershed was mixed mature forest (Golder 2015a).

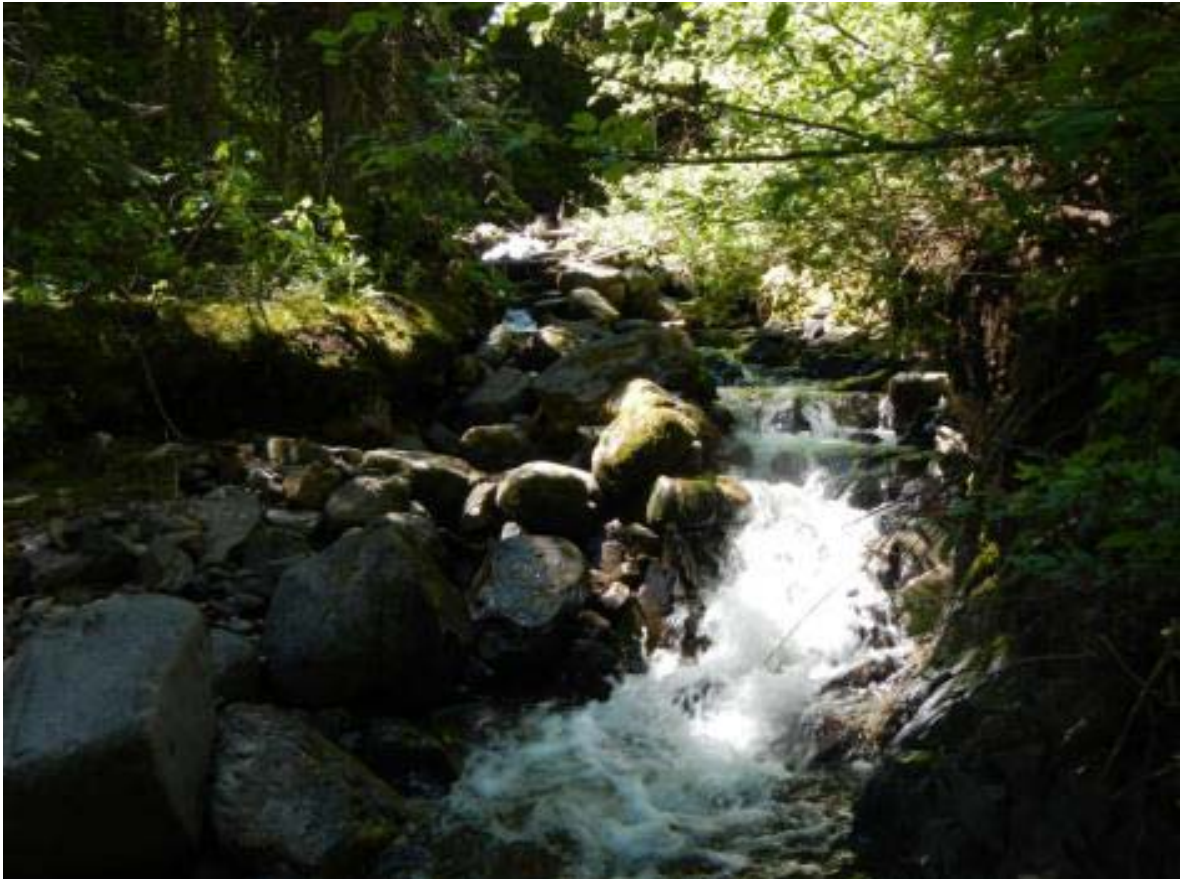
**Photo 6.2: Carbon Creek cascade barrier (Golder 2015).**

The provincial database does not have records of fish historically captured in Carbon Creek (Golder 2015a). A gradient barrier is present mid watershed (about 4 km upstream from Michel Creek), consisting of a 27% gradient bedrock cascade 6 m in length, with a 31% gradient boulder cascade for 15 m slightly farther upstream, that together are suspected to preclude upstream movement of fish (Photo 6.2). No fish were observed upstream from these barriers over multiple surveys. Lower Carbon Creek provides suitable habitat for all life stages of fish during the open-water season. Both adult and juvenile westslope cutthroat trout have been captured or observed, as well as eastern brook trout. A variety of instream and overhead cover is present, such as large and small woody debris, overhanging vegetation, and some deep pools (e.g., 0.4 m). Areas with gravels suitable for spawning are present, and two redds were observed during the spring 2012 spawning survey. The downstream (4 km) fish-bearing portion is considered to provide suitable habitat for all life stages of fish during the open-water season and for overwintering. Spawning gravels suitable for resident trout were also observed (Golder 2015a).
