**Report:** Data Report for the Tributary Evaluation Program

**Data Report for the  
Tributary Evaluation Program**

Prepared For:  
**Teck Coal Limited**  
Sparwood, British Columbia

Prepared By:  
**Minnow Environmental Inc.**  
Georgetown, Ontario

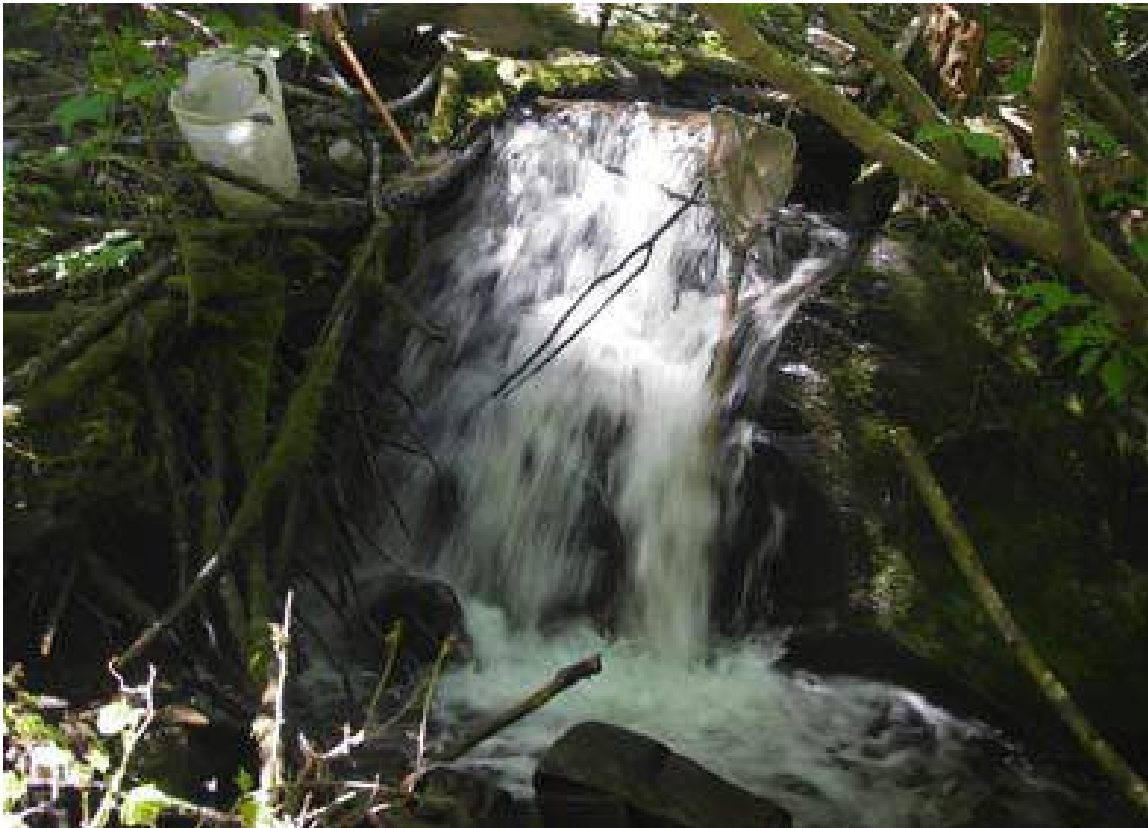
**Photo 6.3: Bedrock falls on Snowslide Creek (Golder 2015).**

Between the upper and lower reaches described above is a potential barrier that has been characterized as both a 1.5-m vertical drop, and a 2-m bedrock cascade with 26% gradient (Golder 2015a; Photo 6.3). Slightly upstream from that is a bedrock falls downstream from which the stream goes subsurface due to a talus slope (521 m in length with a gradient of 52%); this is considered to be a permanent barrier to upstream fish migration. No fish have been found in the upper 1.8 km of the creek. The fish-bearing reach includes both westslope cutthroat trout and eastern brook trout. The dominant cover was overhanging vegetation, along with cobbles and boulders, and woody debris. There is suitable habitat for all life stages of fish during the open-water season. Pockets of spawning gravels suitable for salmonids were observed throughout. Overwintering potential was considered to be low to moderate (Golder 2015a).

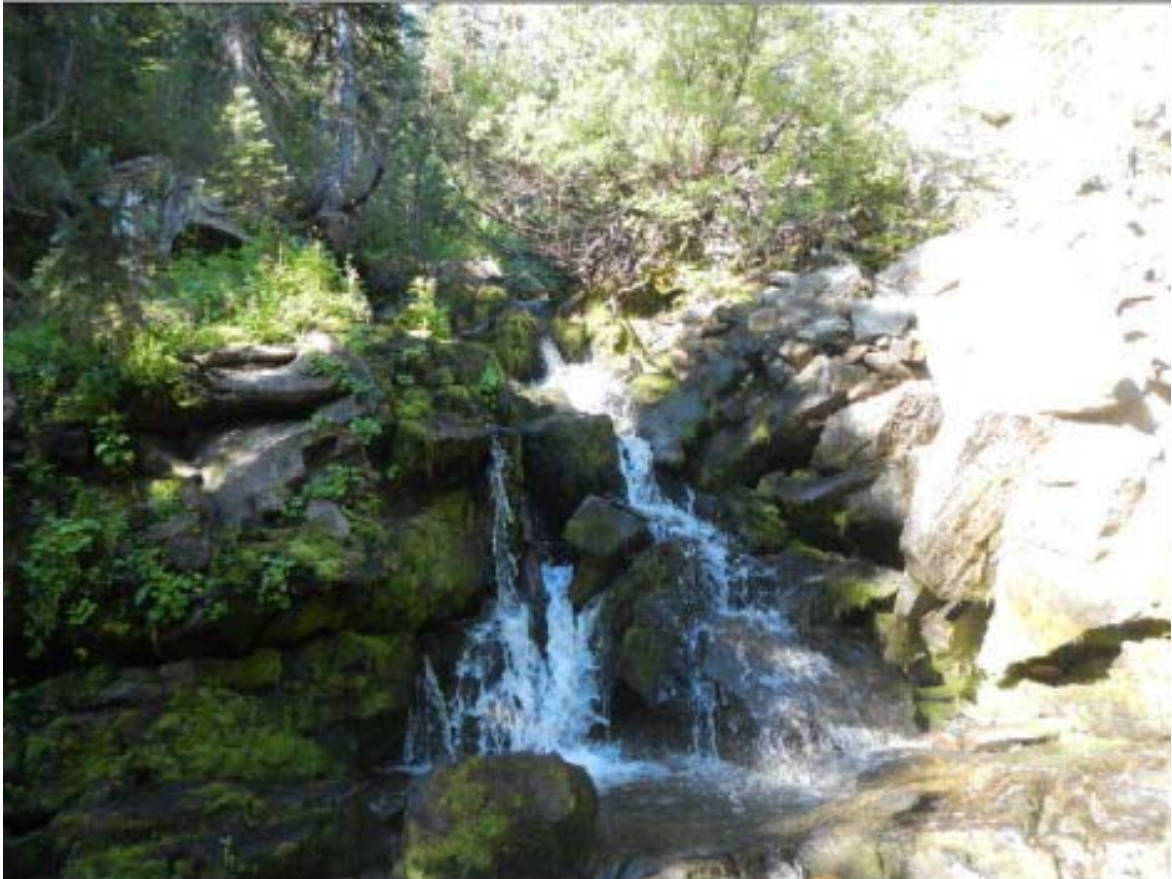
**Photo 6.4: Example of steep-gradient cascade barrier in Wheeler Creek (Golder 2015).**

The provincial database did not include fish distribution records for Wheeler Creek (Golder 2015a). Technical reports indicate westslope cutthroat trout and eastern brook trout have been captured or observed (Golder 2015a). About 8.5 km upstream from Michel Creek along the main stem is a 28% bedrock cascade, extending over 7 m, which acts as a permanent barrier to upstream fish migration. Temporary and semi-permanent barriers (e.g., steep-gradient, rock-debris cascades or falls) also limit access by fish to most of Little Wheeler Creek and an unnamed tributary to the north of Wheeler Creek (Photo 6.4). Surveys upstream from the barriers in 2012 did not yield fish. In the fish-bearing portion of Wheeler Creek, instream cover includes overhanging vegetation, undercut banks, boulder, and woody debris, although the small quantity of woody debris gave the fish-bearing reaches a poor rating for salmonid summer and winter rearing habitat. A small amount of channel braiding was noted in the most downstream reach. A 9-m side channel (Reach 2) and two 4-m side channels (Reach 3) were considered to be accessible during most flows while a 12-m side channel (Reach 2) is likely accessible only during high flows (Golder 2015a).

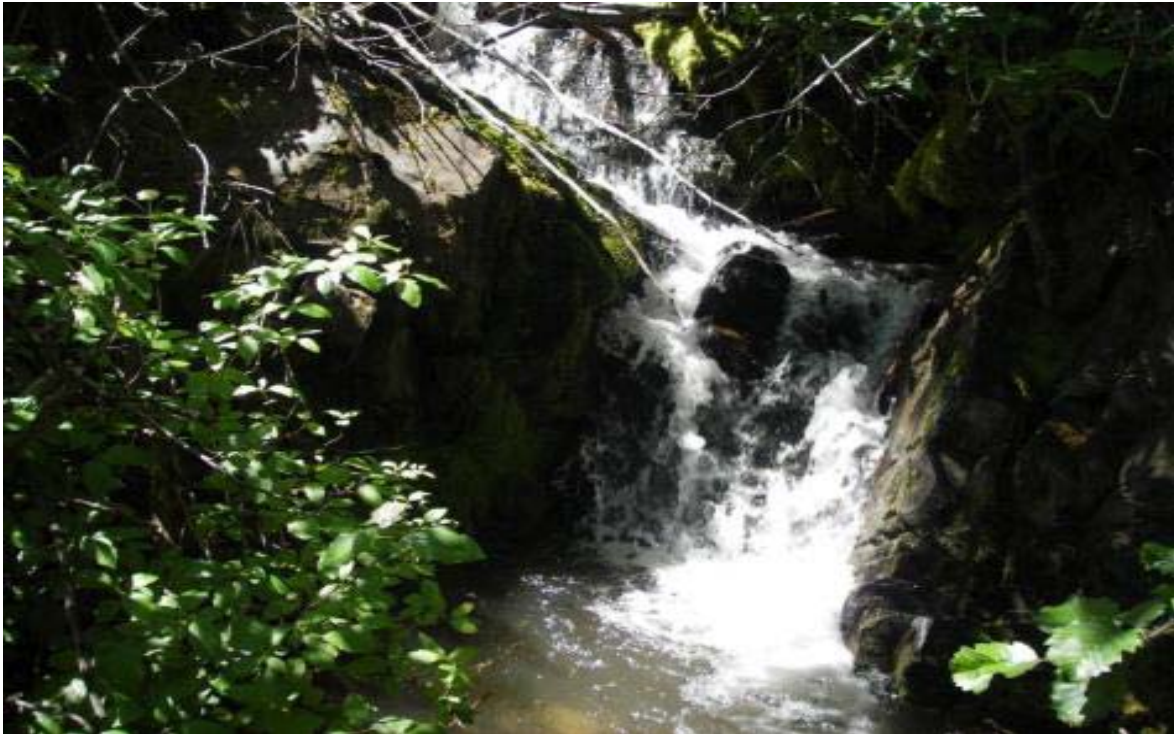
**Photo 6.5: First rock-fall barrier to fish movement on Unnamed Michel Creek Tributary (Golder 2015).**

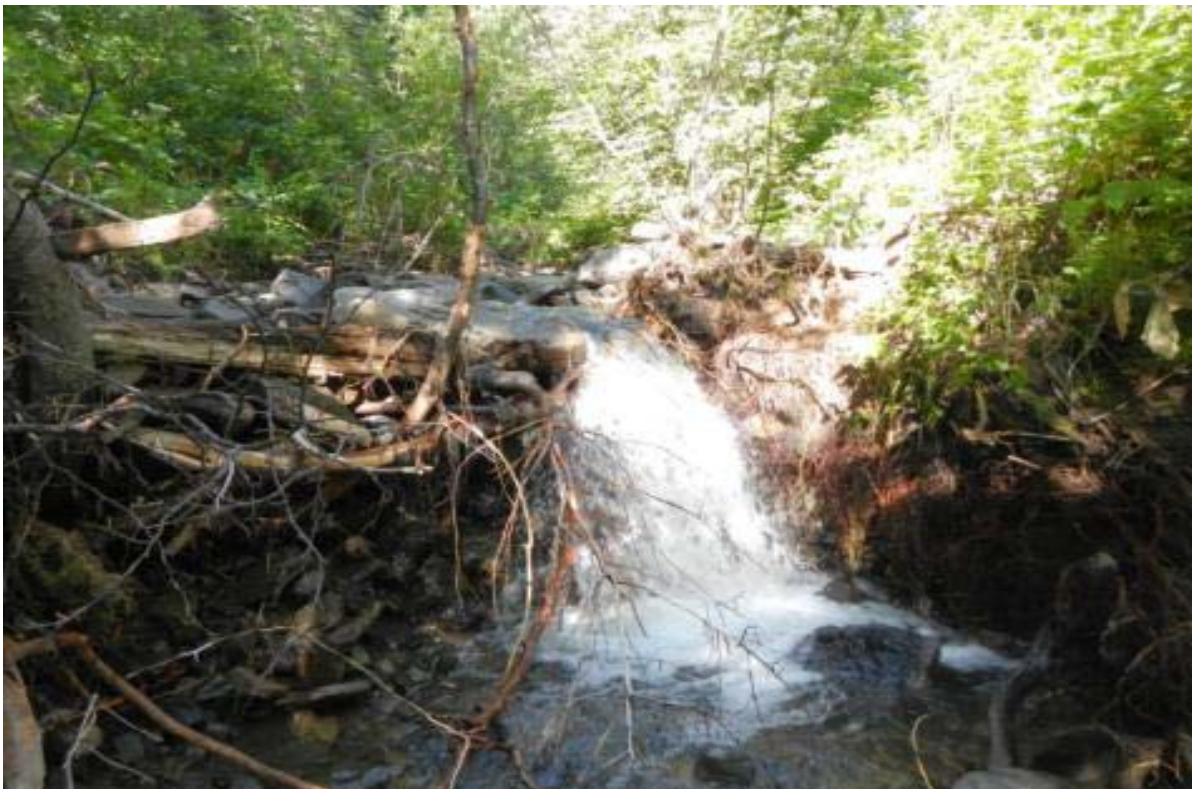
**Photo 6.6: Second rock fall barrier to fish movement on Unnamed Michel Creek Tributary (Golder 2015).**

Two falls were identified within the lower portion of the creek, the first being about 130 m upstream from the confluence with Michel Creek and the second 140 m upstream from the first falls, which are both expected to limit the movement of fish from Michel Creek into Unnamed Michel Creek Tributary (Golder 2015a; Photo 6.5, Photo 6.6). Downstream from the lower falls, westslope cutthroat trout have been captured. Instream cover types included overhanging vegetation, boulders, undercut banks, and woody debris. There were isolated pockets of spawning substrate and there is moderate overwintering potential. Off-channel habitat was observed as a side channel habitat accessible to fish only at high flows. Based on multiple years of sampling, the creek upstream from the falls was classified as non-fish-bearing (Golder 2015a).

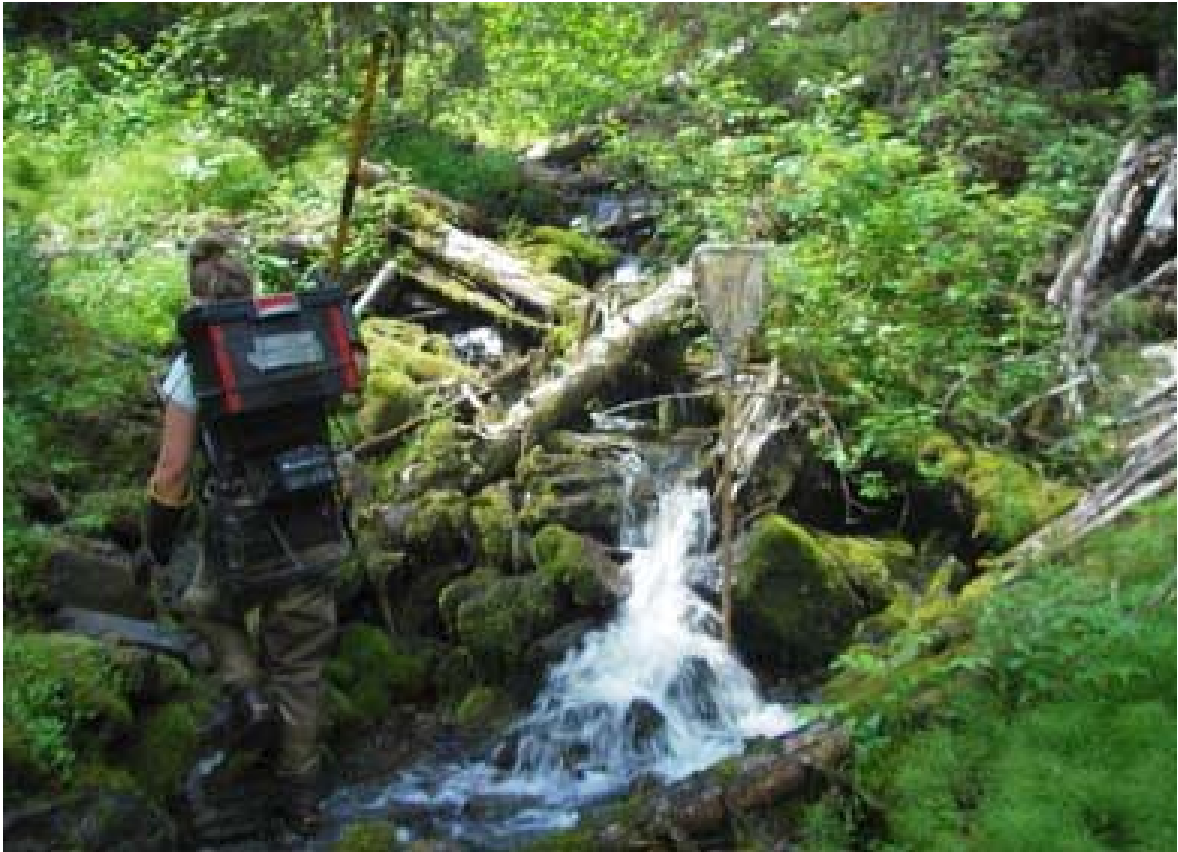
**Photo 6.7: Gradient barrier defining upstream fish distribution limit in Fir Creek (Golder 2015).**

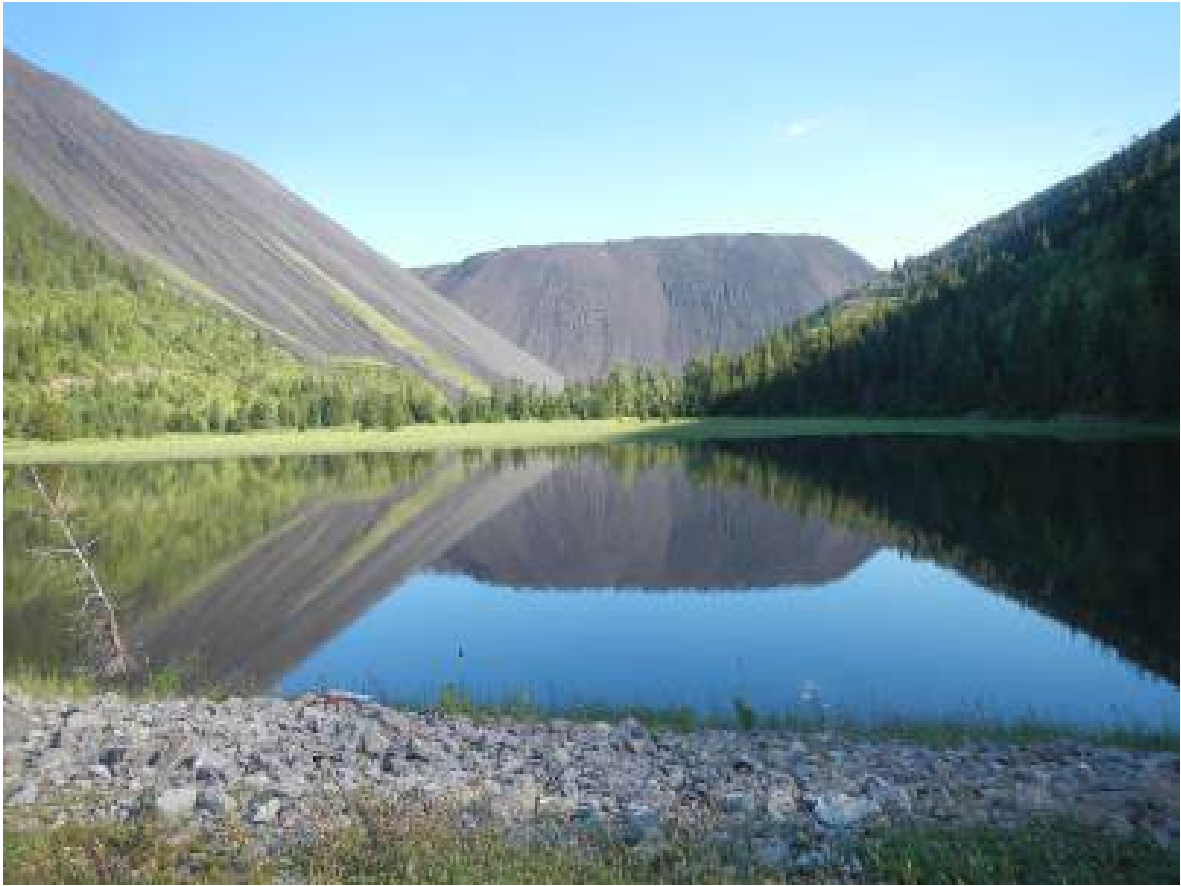
**Photo 6.8: Most downstream pond in Erickson Creek headwaters (Lotic 2015a).**

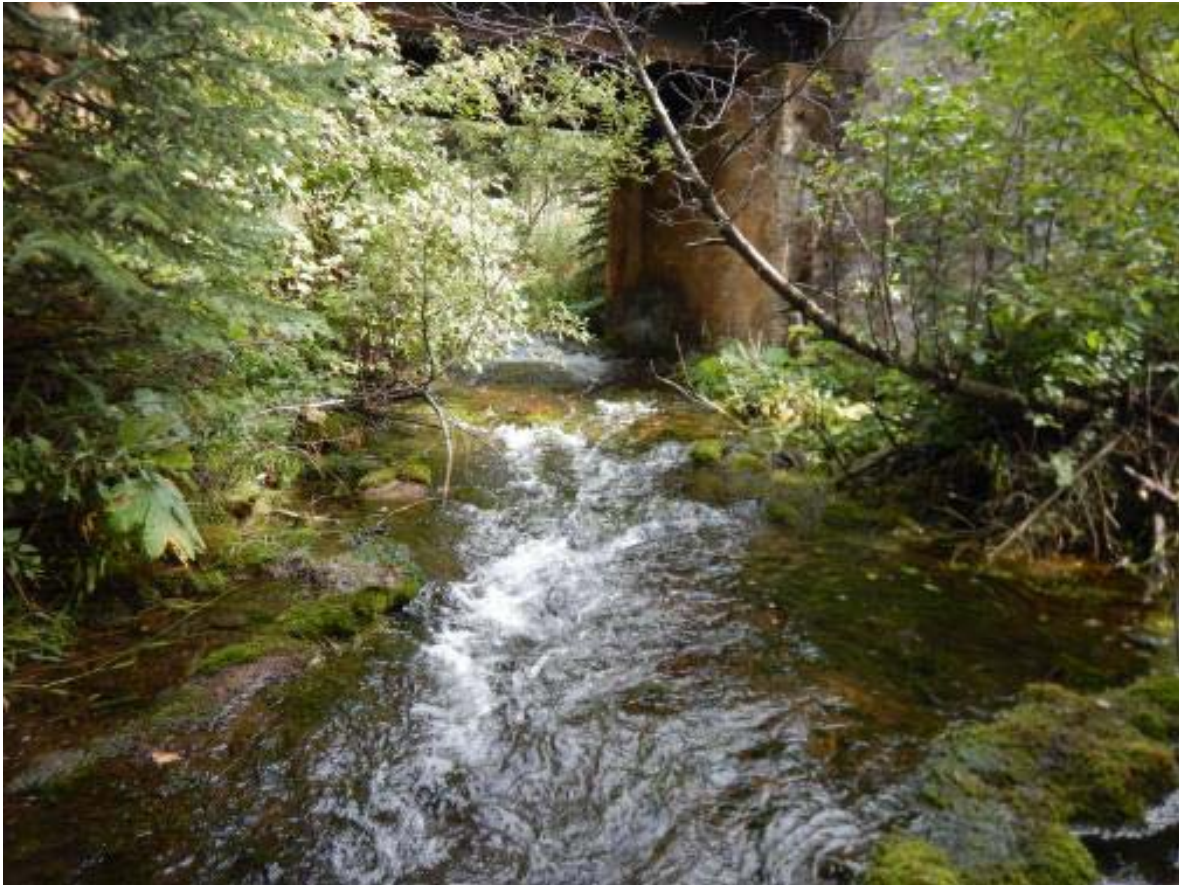
**Photo 6.9: Moss and calcified streambed in Erickson Creek (Lotic 2015a).**

A fish and fish habitat survey was conducted in the lower watershed in 2009 and four areas along the creek and the four headwater ponds were surveyed in 2013 and 2014 (Lotic 2015a). The lower 290 m of the creek from the confluence with Michel Creek to a 2-m-high waterfall, is dominated by riffle-pool form with several cascades, a gradient of 4%, and bankfull width of 5.6 m. In this section of the creek, calcite is considered the dominant substrate, with a large amount of moss also growing in the stream (Photo 6.9). Riparian vegetation was predominantly coniferous forest. Only this lower section of creek is fish-bearing due to the barrier waterfall. Although westslope cutthroat trout, bull trout, and mountain whitefish have been reported in Erickson Creek historically, fish densities are low. There is no suitable spawning habitat due to calcite deposits and a lack of suitable spawning gravel. There is also poor cover. Overwintering habitat potential was considered moderate, based on water quality and water depths (Lotic 2015a).

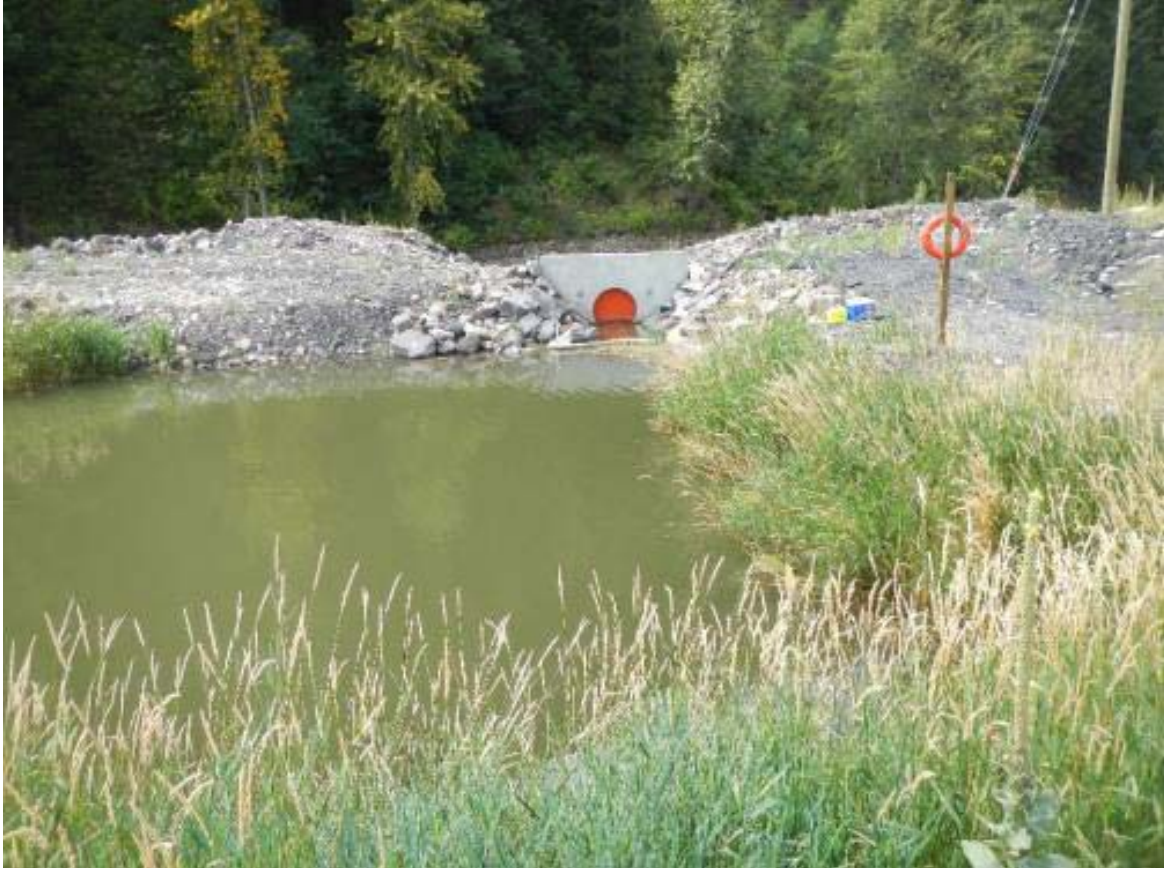
**Photo 6.10: Downstream view of the concrete culvert and flap valve for Gate Creek (Lotic 2015a).**

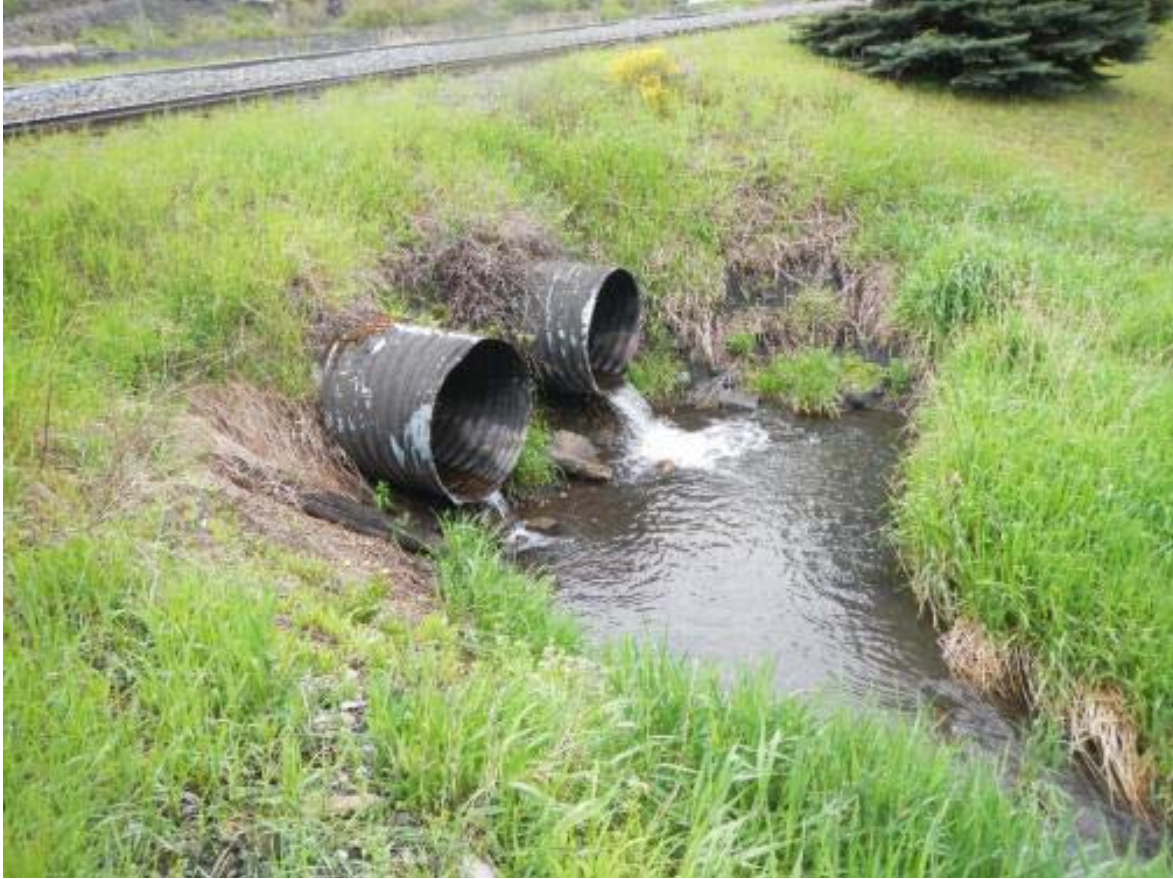
**Photo 6.11: CPR double culverts in Bodie Creek (Lotic 2015a).**

Only the lower, channelized portion of the stream is considered fish-bearing (Lotic 2015a). The culvert located immediately downstream from the lower settling pond, is considered a barrier to upstream fish movement (Photo 6.11). Fish were salvaged from the sediment ponds in 2007 and none were observed when the ponds were dewatered for maintenance in 2014. The lower reach of Bodie Creek provides very little cover for fish, consisting mainly of overhanging grasses. The habitat is suitable for cyprinids (minnows) and catostomids (suckers), with some spawning potential particularly for longnose dace. Fish species captured or observed in the creek include westslope cutthroat trout, brook trout, mountain whitefish, longnose sucker, and longnose dace, with longnose dace (family Cyprinidae) found in highest density. Lack of cutthroat trout fry suggests lack of spawning within the creek itself, but moderate juvenile densities suggest it is utilized for off-channel rearing (Lotic 2015a).

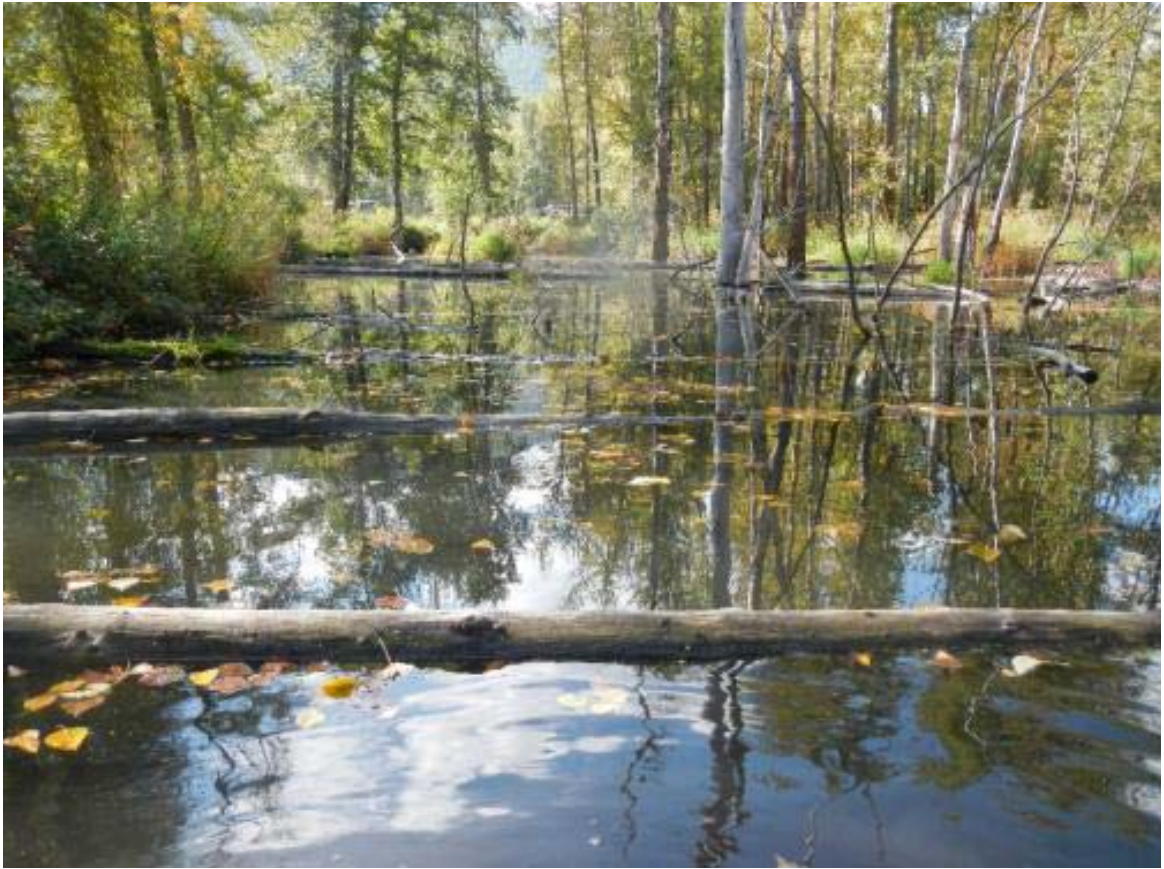
**Photo 6.12: Wetland habitat in lower Aqueduct Creek (Lotic 2015a).**

Fish and fish habitat surveys were completed in 2005, in March and August-September, 2013, and in January, 2015 (Lotic 2015a). The downstream portion of Aqueduct Creek is a wetland (pond) habitat (1,720 m<sup>2</sup>) with a seasonal overland connection to Michel Creek through a culvert under the Great Northern Road, which runs parallel to the creek (Lotic 2015a; Photo 6.12). Substrate in the pond is composed of fine particles. There is good cover provided by overhanging and aquatic vegetation, large woody debris, and a 2-m deep area at the southern end of wetlands. The riparian vegetation was mixed forest, dominated by mature cottonwood. Longnose sucker are present and likely reside in the pond year-round, where there is suitable habitat present for spawning, feeding/resting, and overwintering of this species. The habitat is not

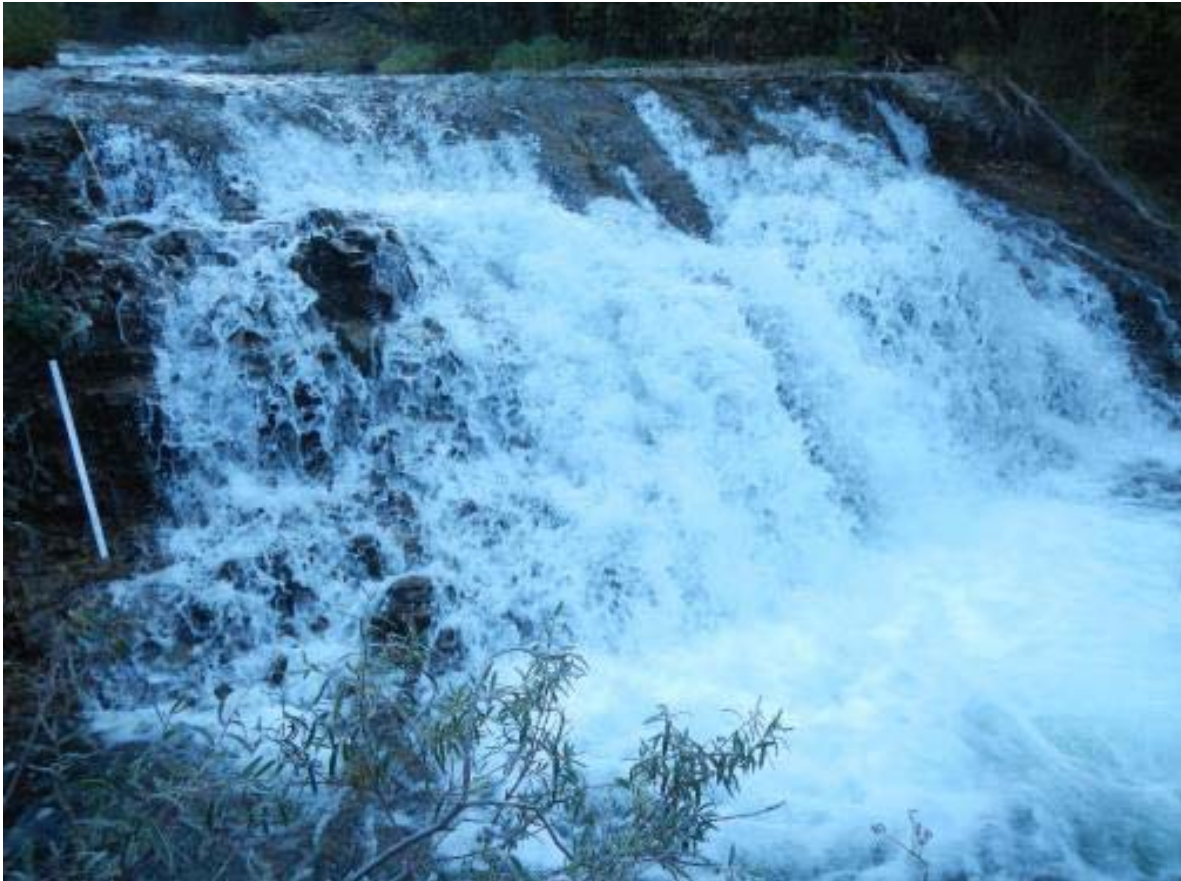
**Photo 7.1: Upstream view of the 3 m high waterfall below the Grave Lake confluence in Grave Creek (Lotic 2015a).**

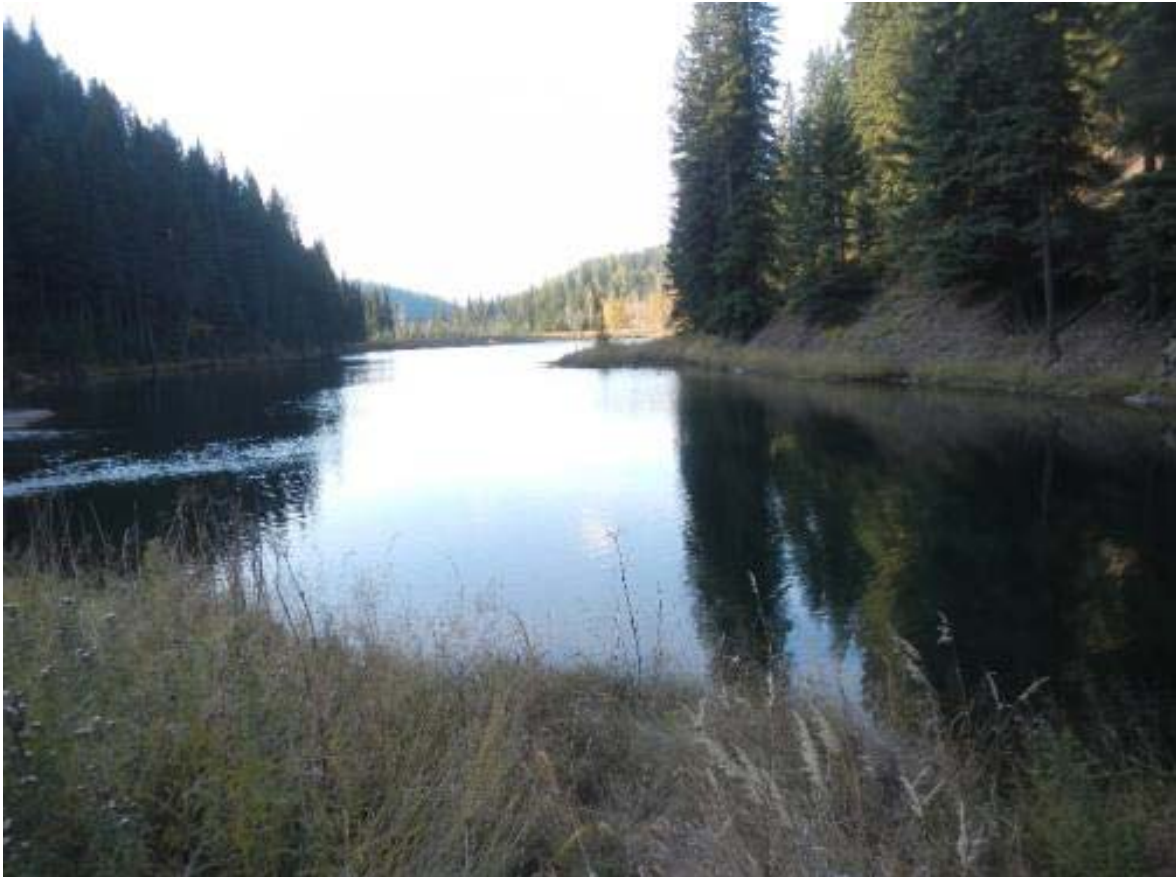
Harmer Creek flows into Grave Creek and its headwaters, upstream from the confluence with Dry Creek, are not exposed to any direct mining activities. A dam and spillway is located on Harmer Creek, about 0.5 km upstream from the confluence with Grave Creek, is a barrier to upstream fish movement (Lotic 2015a). The dam creates Harmer Pond, which is about 19,000 m<sup>2</sup> and has a maximum depth of 5 m (Photo 7.2).

**Photo 7.2: Harmer Pond 0.5 km upstream of the confluence of Harmer Creek with Grave Creek (Lotic 2015a).**

Harmer Pond appears to provide habitat suitable to support all life stages of fish year-round except for spawning, but no recent surveys have caught or observed any fish (Lotic 2015a). Cutthroat trout have been captured in the creek upstream from the pond so both the creek and pond are considered fish-bearing. Upstream from the pond to the confluence with Dry Creek is habitat suitable for all life stages, with fair cover, good overwintering potential, and confirmed spawning. However, use by fish might be limited by warm summer temperatures. There are no barriers preventing access by trout to the headwaters upstream of mining influence, where there is also diverse habitat for all life stages, including potential spawning and overwintering habitats (Lotic 2015a).

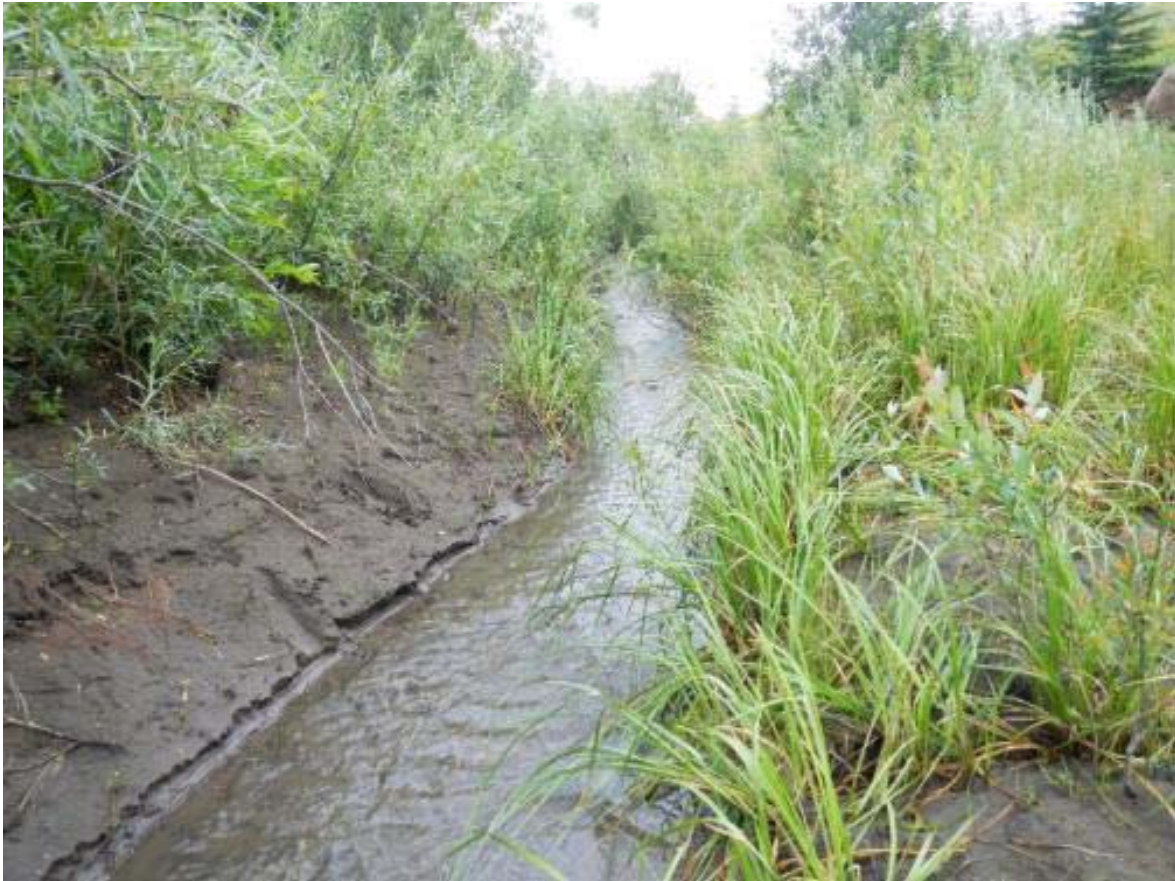
Based on a survey conducted in June 2013, Lotic (2015a) reported that the lowest section of Six Mile Creek is channel habitat about 170 m long flowing into the Elk River (Photo 7.3). The upstream limit of this section is marked by a concrete spillway, which also represents the upstream limit of fish distribution in Six Mile Creek. A 100-m section was characterized as riffle-pool morphology, with mean gradient of 1.25%, average bankfull width of 1.6 m, and substrate dominated by gravels and fines (Lotic 2015a). The riparian vegetation was mainly shrubs. Immediately upstream from the spillway is the lower settling pond (8,745 m<sup>2</sup>), where the substrate is fines and supports macrophyte growth in the first two meters of littoral zone. Calcite was observed in the pond at low levels (CI value: 0.80). Upstream from the lower settling pond, the creek extends for about 2.75 km to the Lower Valley Road, where two additional settling ponds are located. In the surveyed section of the creek, a step-pool morphology was present with a very steep slope (42%) and a mean bankfull width of 2.21 m with some calcite present (CI range: 0.51 to 0.98). The riparian vegetation upstream from the spillway was mainly grasses and sedges (Lotic 2015a).

**Photo 7.3: Channel habitat in lower Six-Mile Creek (Lotic 2015a).**

Fish presence was unknown for Six Mile Creek until the baseline assessment was completed in June 2013 and 2014 (Lotic 2015a). Fish species that were present in the lowest section of Six Mile Creek downstream from the concrete spillway included mountain whitefish, longnose dace, longnose sucker, redbreast shiner, westslope cutthroat trout, eastern brook trout, and bull trout. There was good cover (60%), provided primarily by overhanging vegetation, with some small woody debris. There were extensive areas of suitable spawning gravel for salmonids in the riffles and glides, although no fish were observed spawning during the surveys. Six Mile Creek had habitat potentially suitable for all life-stages of fish, including potential overwintering (Lotic 2015a). However, the overall small size of the stream makes it most suitable for small size classes. Low gradient and moderate velocity flows over riffles and glides provided excellent rearing habitat for fry and juvenile salmonids and multiple life stages of longnose suckers and longnose dace. It may provide refuge for Elk River fish during freshet but high water temperatures in the

summer (>17.0°C) preclude use by salmonids at that time of year. No fish are present upstream from the spillway (Lotic 2015a).

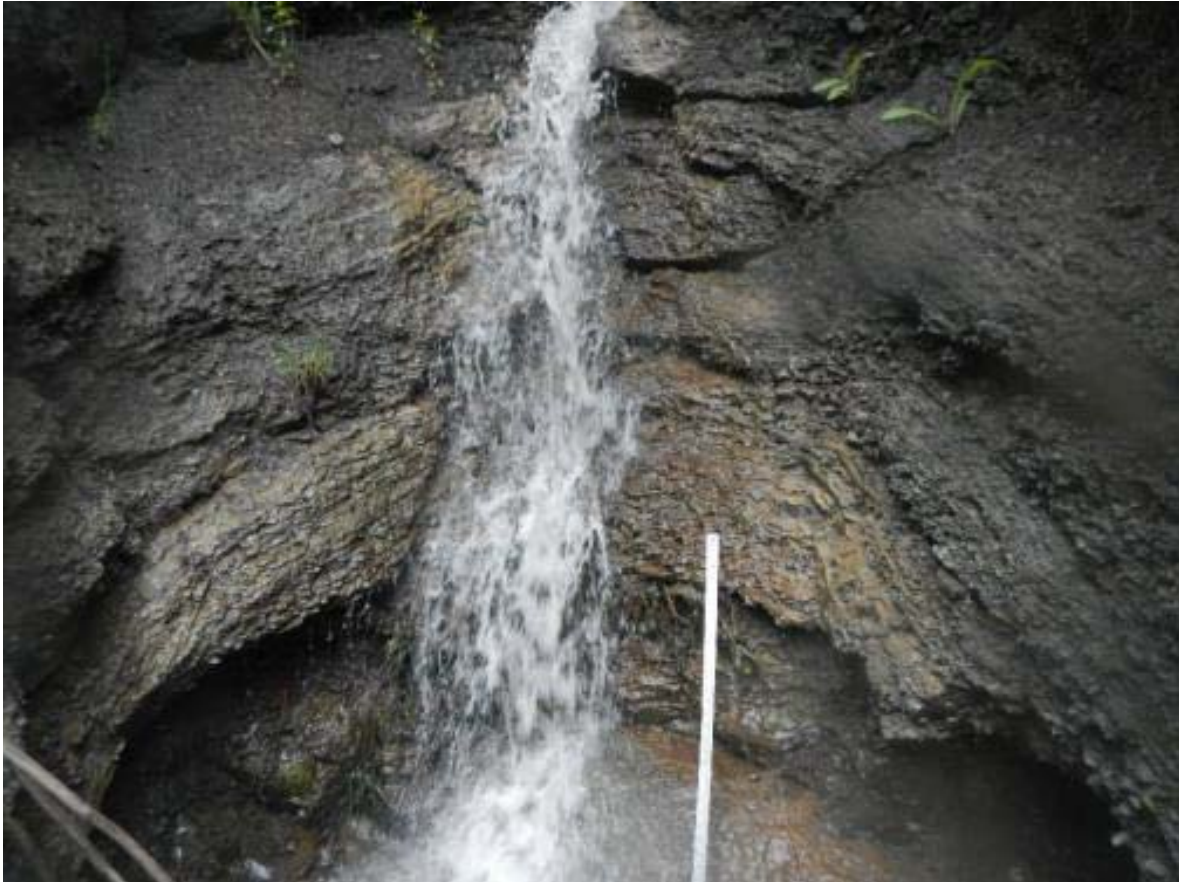
**Photo 7.4: View of 2 m tall waterfall at the confluence of Fennelon Creek with the Elk River (Lotic 2015a).**

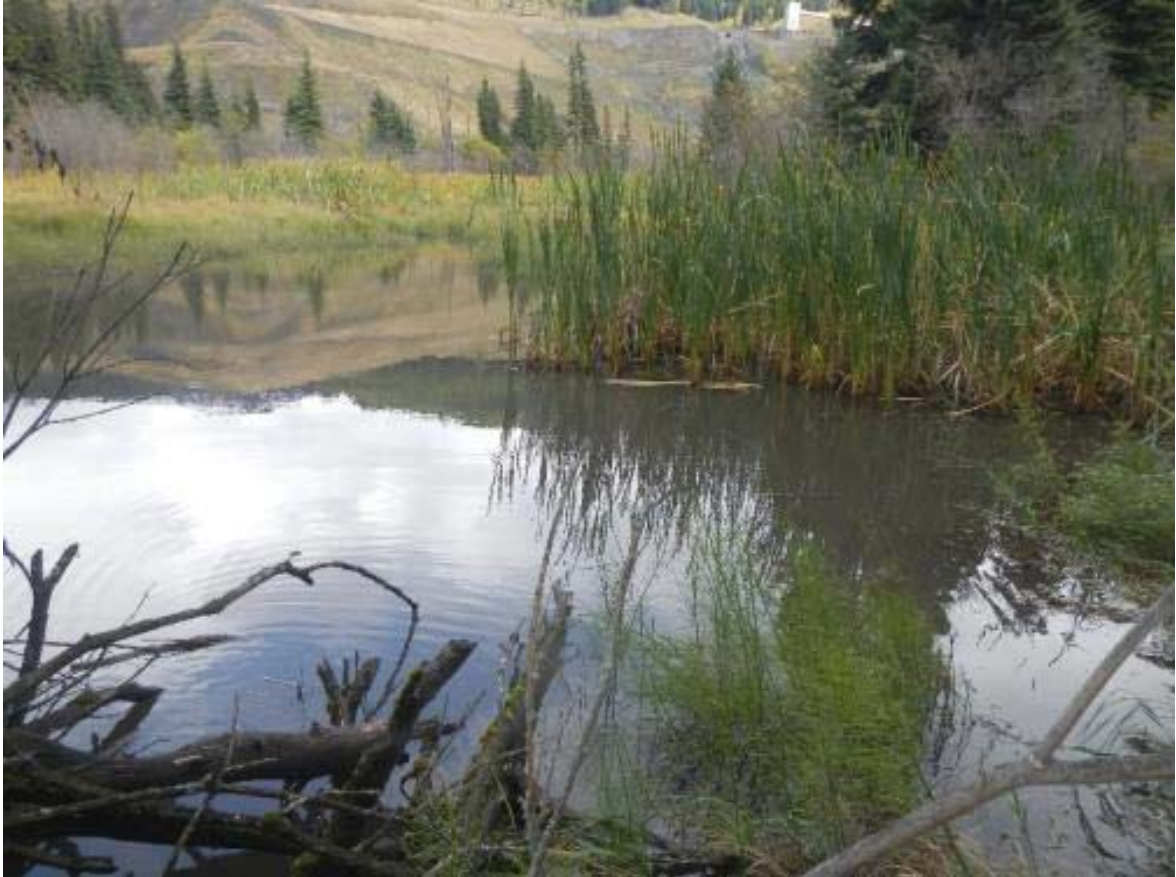
The section of Goddard Creek closest to the confluence with the Elk River is lentic, and referred to as Goddard Marsh (4,872 m<sup>2</sup>; Lotic 2015a; Photo 7.5). Goddard Creek drains through multiple culverts into Goddard Marsh and there is permanent flow out of the marsh to the Elk River through a small channel that averages 1.84 m wide. Numerous studies of fish and aquatic habitat were conducted in Goddard Marsh between 2002 and 2013 (Lotic 2015a). The marsh measured 1.2 m deep in September 2013, with substrate dominated by fines. It is permanently inundated and supports abundant cattails and sedges, which grow throughout the marsh for up to about 40 m channel width, with mixed forest riparian vegetation bordering the cattail growth (Lotic 2015a).

**Photo 7.5: Goddard Marsh at the confluence of Goddard Creek and the Elk River (Lotic 2015a).**

Fish species captured or observed in Goddard Creek include longnose sucker, redbreast shiner, longnose dace, mountain whitefish, eastern brook trout, and westslope cutthroat trout (Lotic 2015a). The macrophytes, deep water and submerged woody debris provide abundant instream cover. Overhead cover was limited in the ponded water areas.

However, within the narrow, channelized sections of the marsh, cattails provided abundant overhead cover. There was no suitable spawning habitat for salmonids in the marsh due to the fine substrate, but the habitat is suitable for longnose sucker spawning. Goddard Marsh also provides good overwintering habitat, as adequate water depths were present and the marsh did not completely freeze (Lotic 2015a).

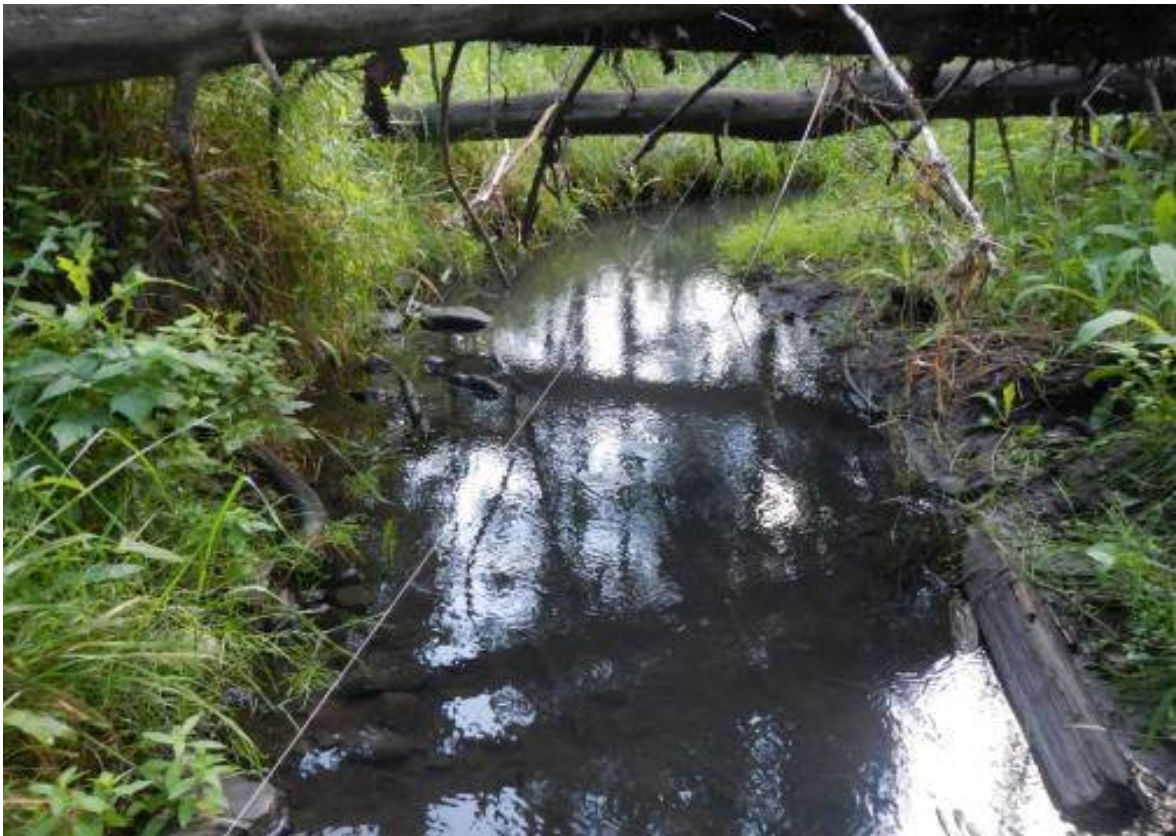
**Photo 7.6:** Channelized section of Otto Creek between the rail line and the tailings lagoons (Lotic 2015a).

Surveys were completed in 2001, 2013 and 2014 (Lotic 2015a). The most downstream reach of the creek (total of 145 m) was characterized by riffle-pool morphology, with an average gradient of 1.9%, an average bankfull width of 3.4 m, and substrate was dominated by fines and gravel. Calcite was observed at low levels (CI: 0.30). Upstream from Highway 43 is a 900-m reach that includes a series of ponds/wetlands confined between the EVO rail loop and tailing lagoons, and separated by beaver dams. There were three wetland cells at the downstream end and four settling pond cells at the upstream end. Vegetation was dominated by coniferous trees and grasses.

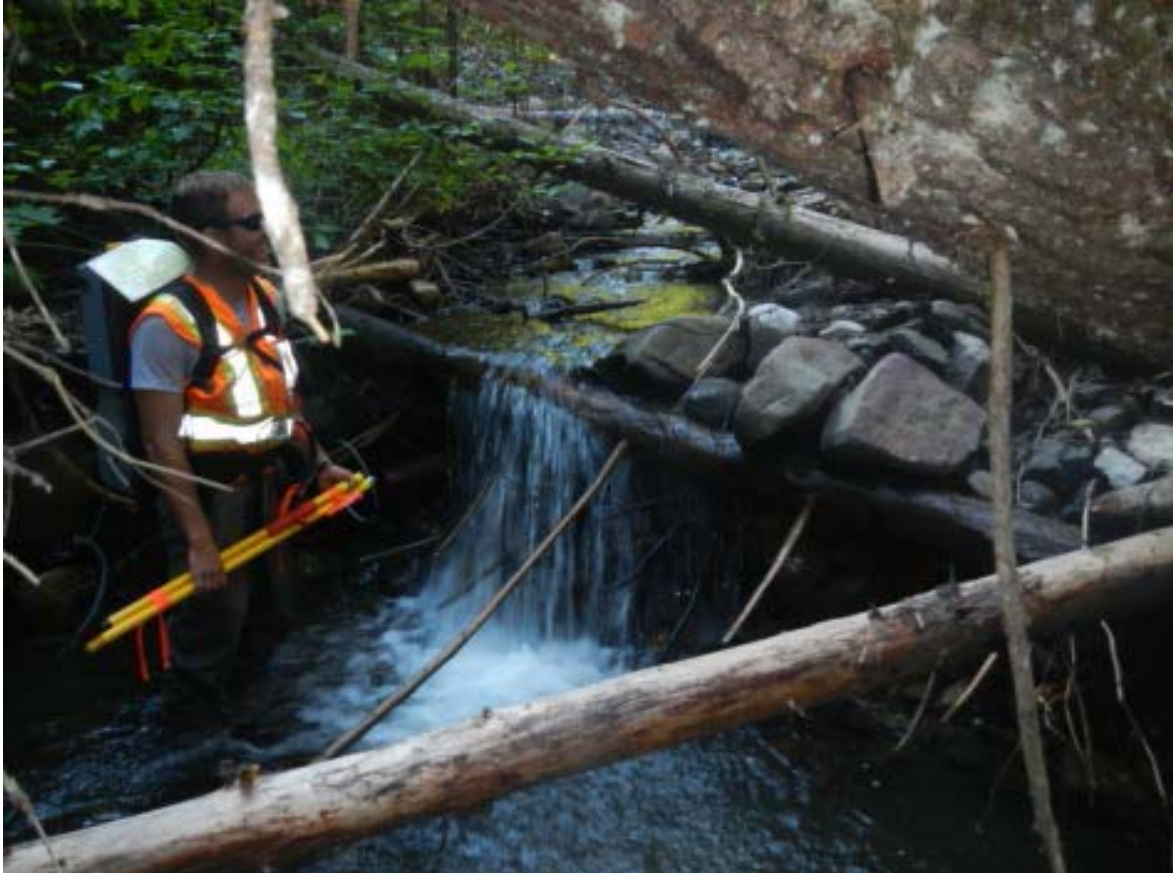
**Photo 7.7: Typical large woody debris/sediment wedge acting as a temporary barrier on Transmission Creek (Golder 2015).**

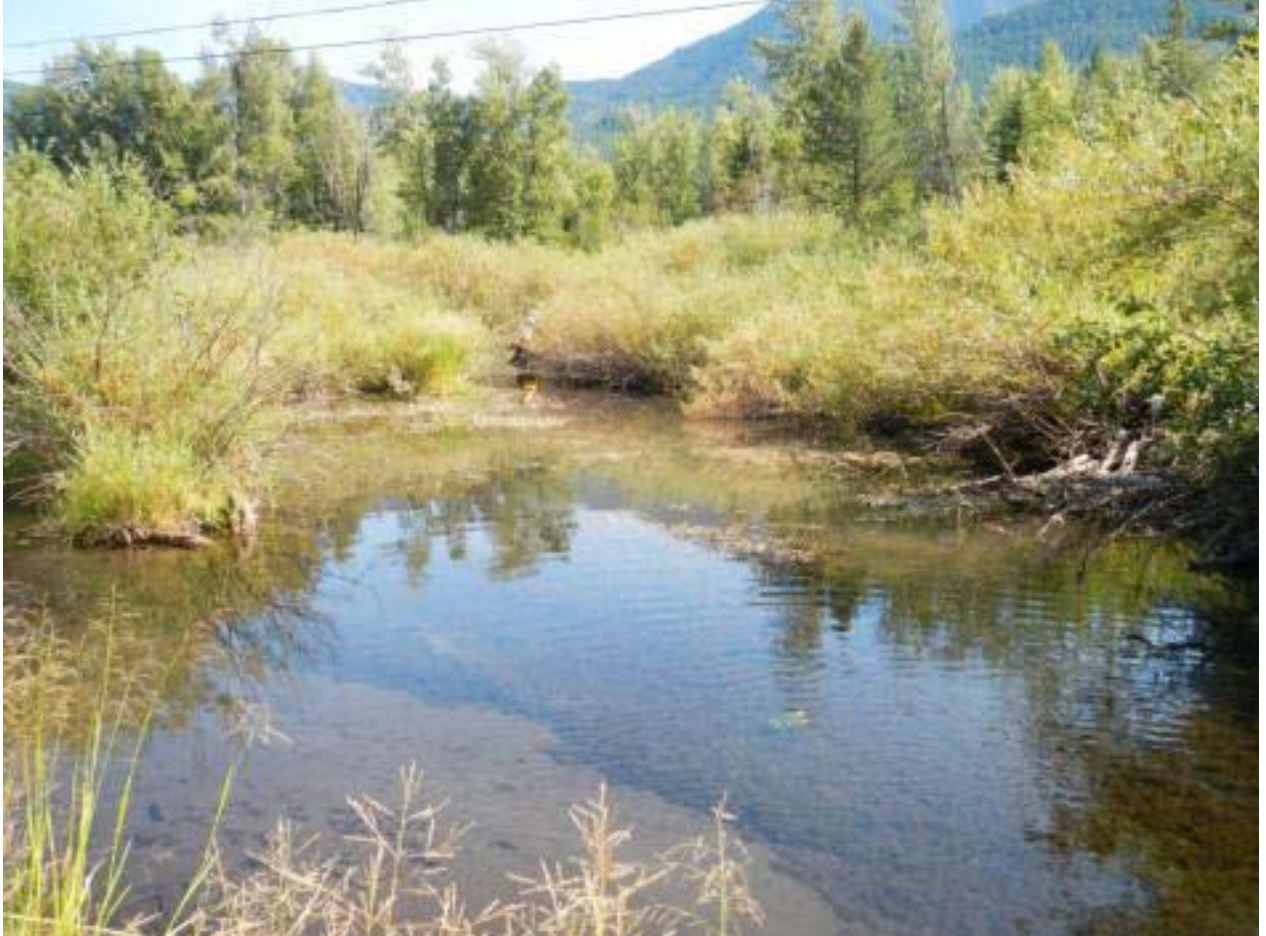
Fish and fish habitat surveys were conducted in 2007, 2012, and 2013 (Golder 2015a). This first surveyed section (85 m) of Mine Creek was lentic habitat located about 4 km upstream from the confluence with Hosmer Creek (Golder 2015a; Photo 7.8). The area was dominated by a series of pools and low flow glide areas, with a mean gradient of only 0.3%. The dominant substrate was fines with some gravel, and the average bankfull width was 3.20 m. A culvert was noted within the site. A second surveyed area (100 m) was located 6.6 km upstream from the confluence with Hosmer Creek. This section was

**Photo 7.8: Lentic area in Mine Creek, upstream of the confluence with Hosmer Creek (Golder 2015).**

dominated by riffle habitat (83.8%), with cascade, glide, and pool habitat units also present, classifying it as riffle-pool morphology. Dominant substrates included cobble, gravel and boulder and the bankfull channel width was 3.3 m. A third area (100 m) was surveyed about 8.7 km upstream from the confluence with Hosmer Creek, which was classified as cascade-pool morphology, dominated by cascade habitat (70.9%), with glide and riffle habitat units also present. The dominant substrate was cobble, gravel and boulder and the bankfull width was 3.93 m. Two unnamed tributaries join Mine Creek in the northern portion of the catchment, about 7 and 8 km upstream from the confluence with Hosmer Creek (Golder 2015a). Riparian vegetation was dominated by shrubs and grasses in the downstream sections and mixed mature forest in the upstream sections. No off-channel habitat was observed (Golder 2015a).

brook trout indicates that the lentic areas on Mine Creek provide rearing and holding/feeding habitat. The shallow water depths at the time of the survey in August 2013 precludes the use of the area as overwintering habitat for adult fish species, but may provide adequate overwintering habitat for juvenile eastern brook trout. In the upstream lotic areas, the presence of juvenile and adult fish species indicates suitable rearing, holding, and feeding habitat are present. Trace amounts of suitable resident trout spawning gravels were observed. Gradient barriers limit fish access to headwaters (Golder 2015a).
