Evaluation of Industrial Chemicals, Spills and Unauthorized Releases

SME Report for Evaluation of Cause: Upper Fording River Westslope Cutthroat Trout Population Decline

19136042 Rev0

June 2021

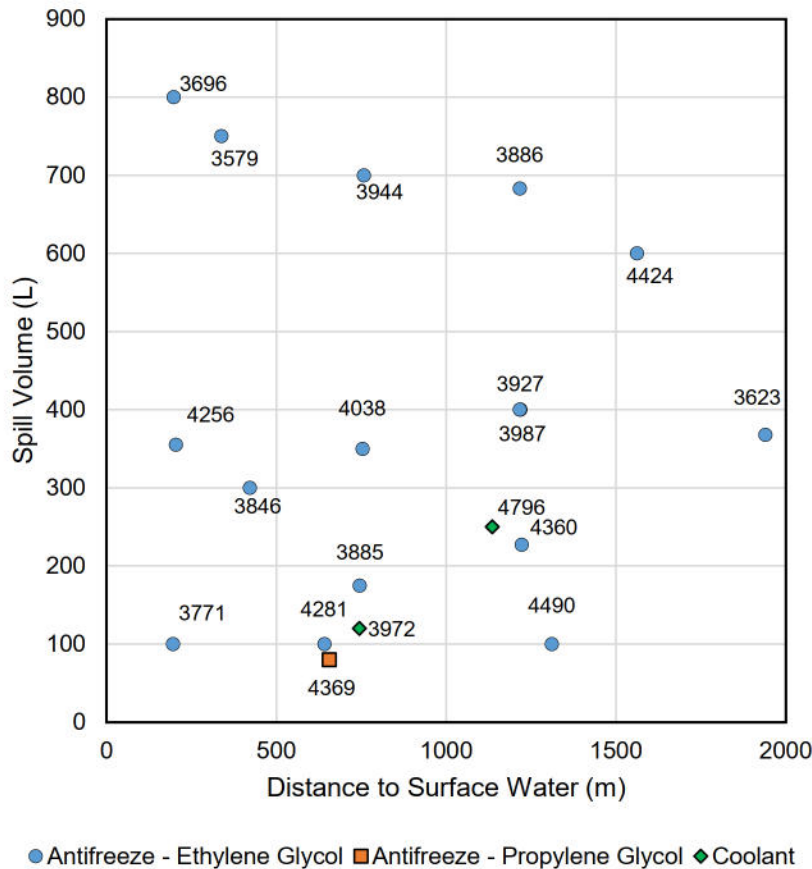
Figure 2: Antifreeze Spills: Spill Volume in Relation to Distance to Surface Water

In summary, antifreeze and coolant spills occurred to ground, and most often at a distance of greater than 500 m from surface waters. Cleanup actions were undertaken at most of the spills (14 out of 19). The five spills that were not cleaned up occurred at distances of between 198 and 1,562 m from surface water. However, environmental fate properties indicate that degradation is likely fast in soil and/or water. Based on the above information, antifreeze was considered to have a low likelihood of reaching a watercourse and was not evaluated further.

Notes: units are litres (L) and meters (m). Symbols are annotated with incident number. Information obtained from Table C-1.

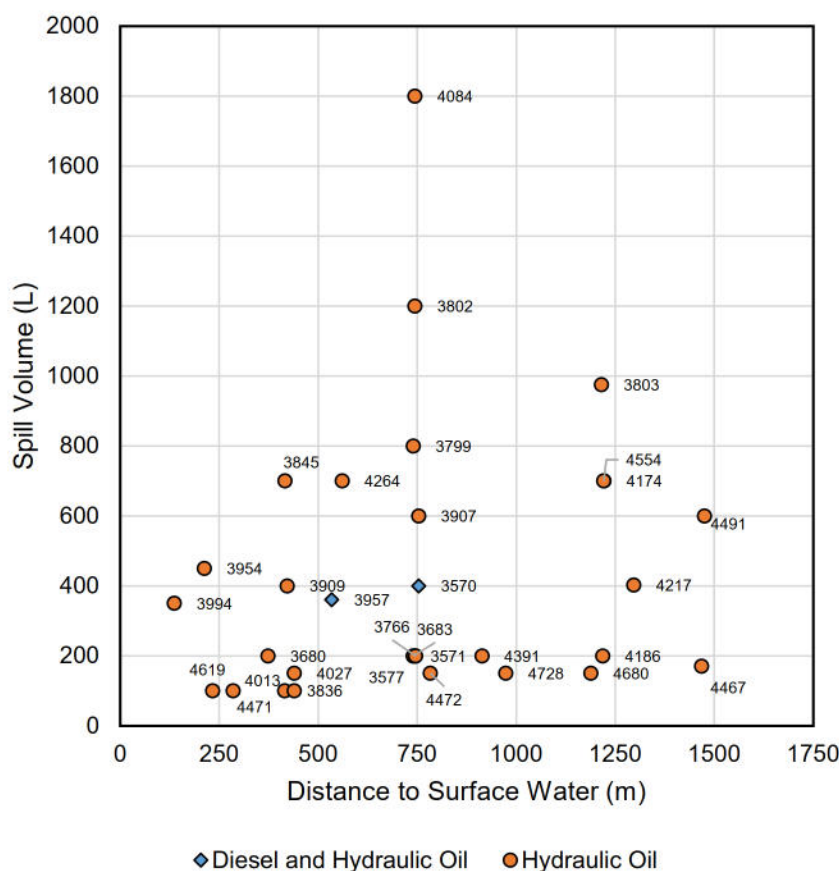
Figure 4: Hydraulic Oil Spills: Spill Volume in Relation to Distance to Surface Water

Notes: units are litres (L) or meters (m). Symbols are annotated with incident number. Information obtained from Table C-1.

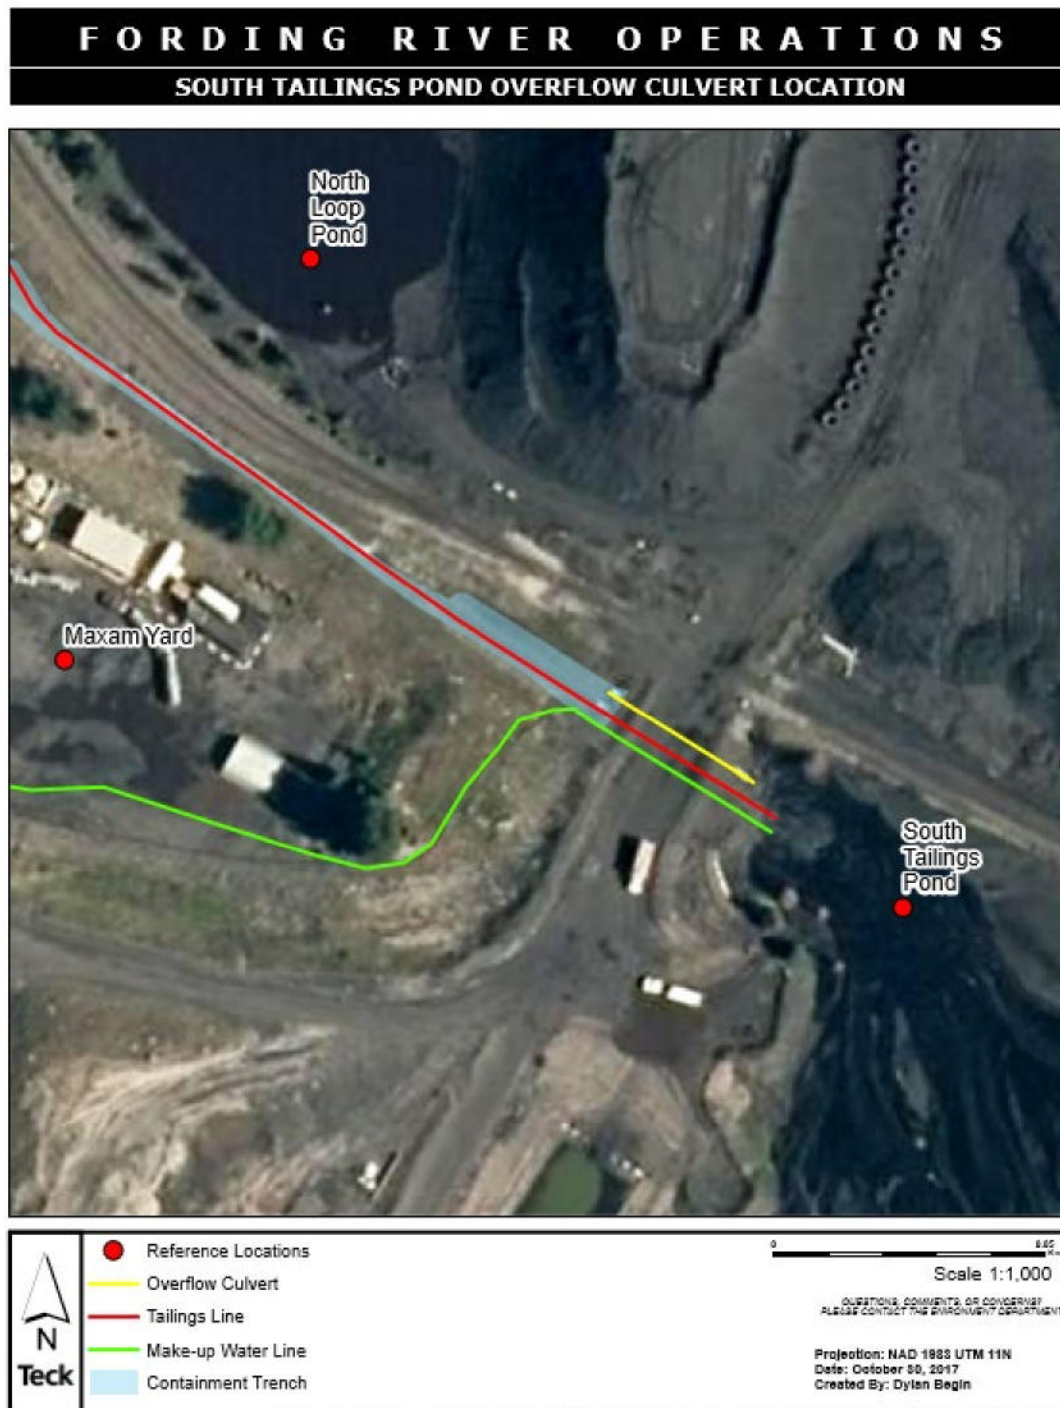
Figure 5: Map for Incident 3611

Because the material was contained to the trench, tailings from this event was considered to have a low likelihood of reaching a watercourse and was not evaluated further.

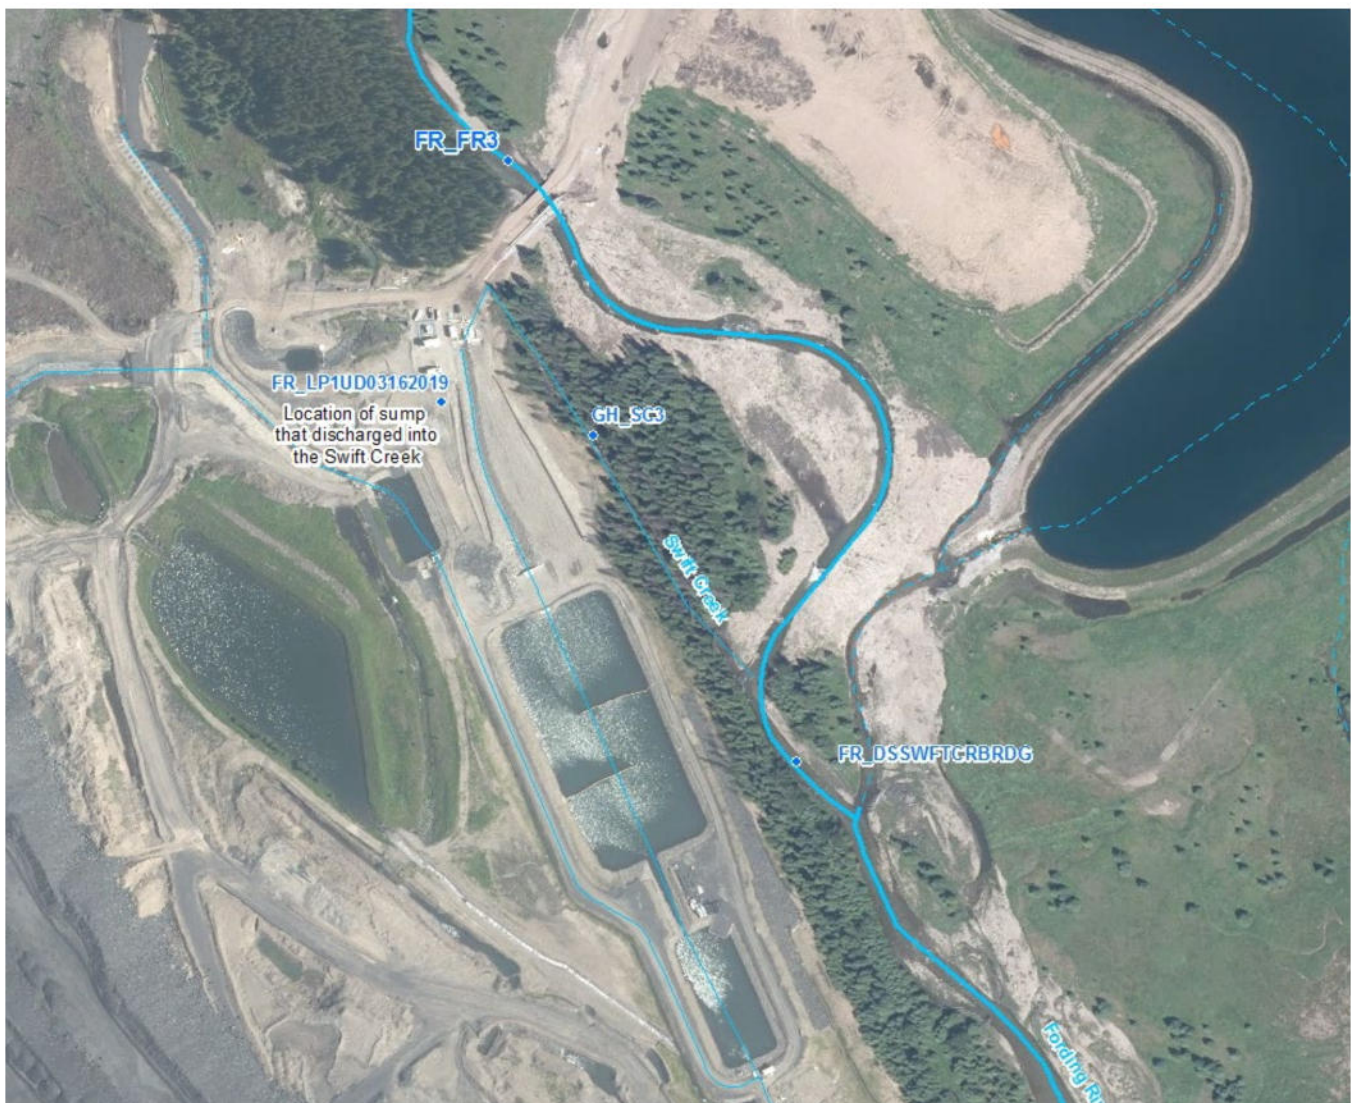
Figure 7: Map for Incident 4670 (Provided by Burroughs 2020)

On 20 July 2019, approximately 900 L of process water discharged to the Fording River via Swift Creek.²² The event was preceded by snow followed by rain, which temporarily overwhelmed a local sump and silt fence.

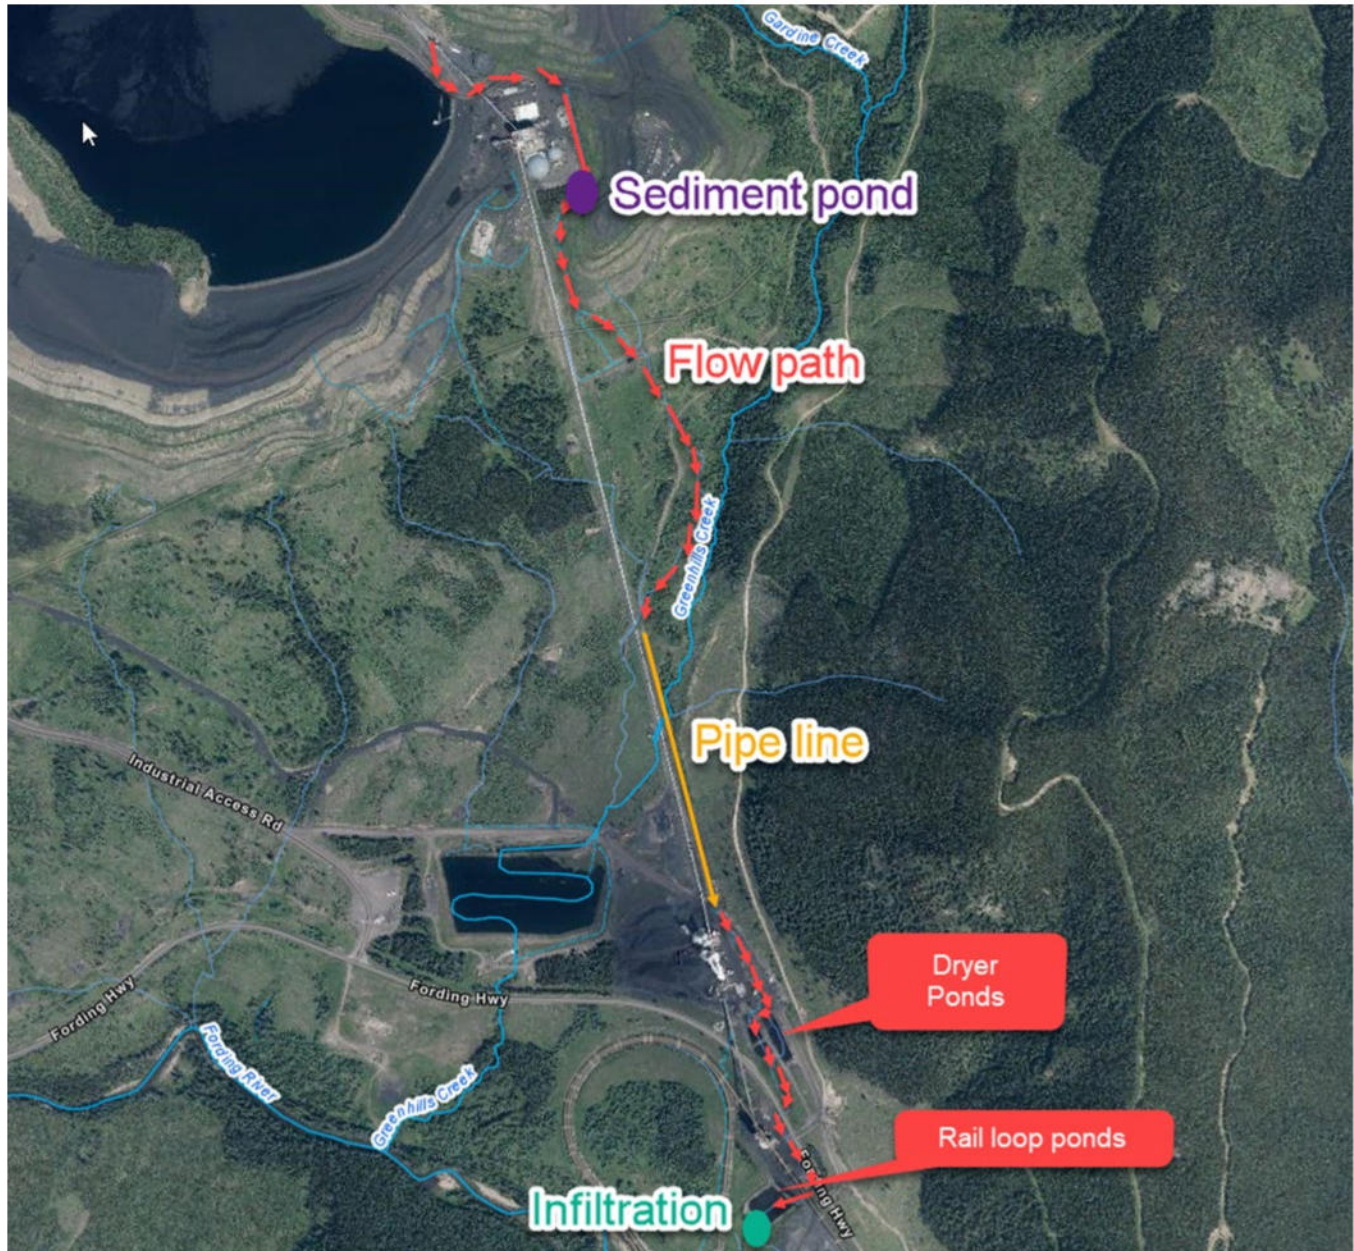
Figure 8: Map and Flow Path for Incident 3787 (Provided by Stickney 2020b)

In summary, the lack of chemistry data precluded an evaluation of potential acute or chronic effects of the material itself. Therefore, this event could not be ruled out as a potential contributor. Evidence for contribution is interpreted to be weak given that the spill is expected to dilute in intermediate watercourses, as well as that the spill occurred in the lower end of the watershed and at the end of the decline window (August 2019). The role of this event in the WCT decline is interpreted to be negligible to minor with uncertainty dependent on the composition of the spilled material.

Note: red arrows show expected flow path.

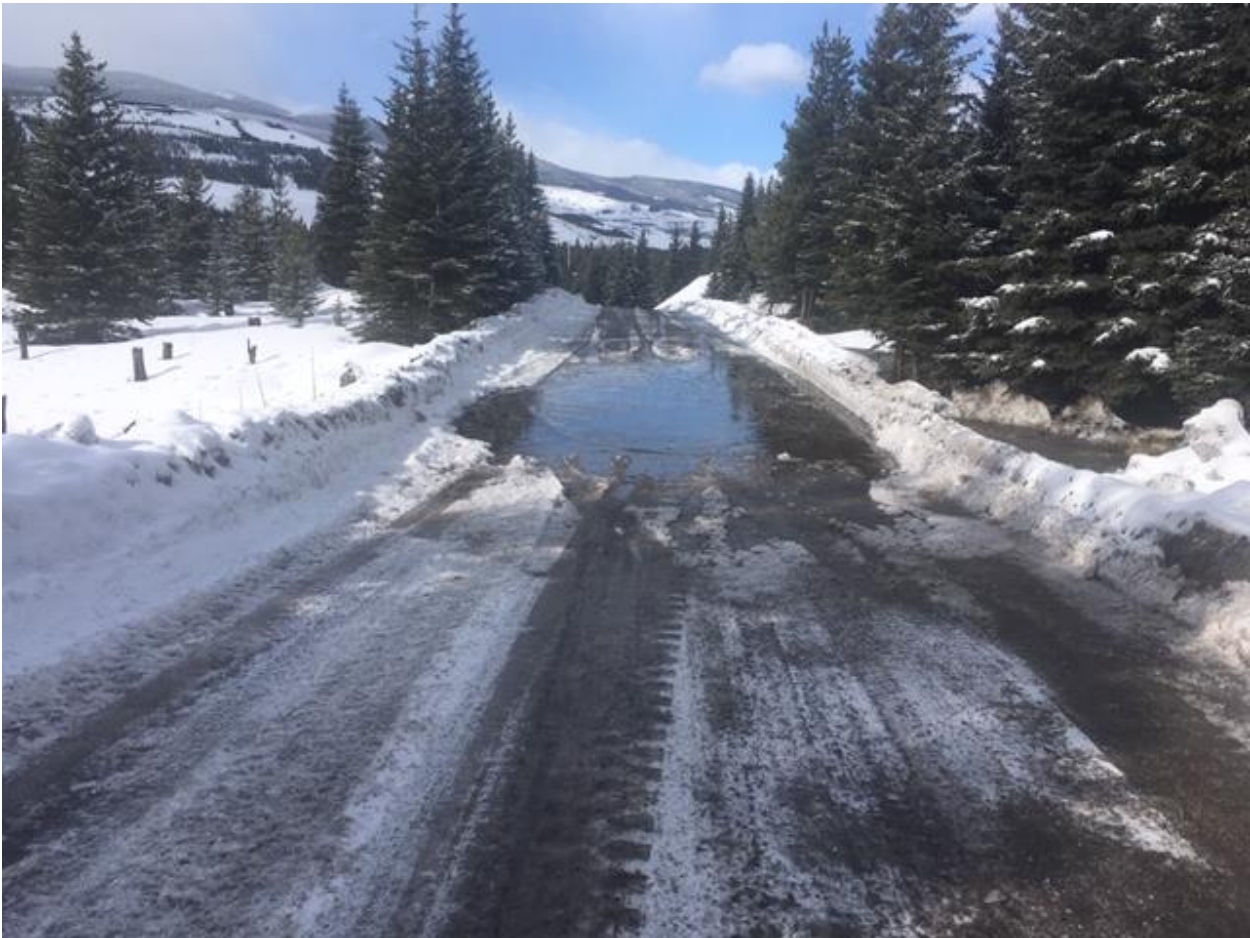
Photograph 1- Unauthorized Discharge located in the low lying depression on the Swift Creek access road.

Measures Taken to Stop the Event and Reduce Risk
