Teck Highland Valley Copper Partnership

2017 Dam Safety Inspection Report

Highland Tailings Storage Facility

March 2018

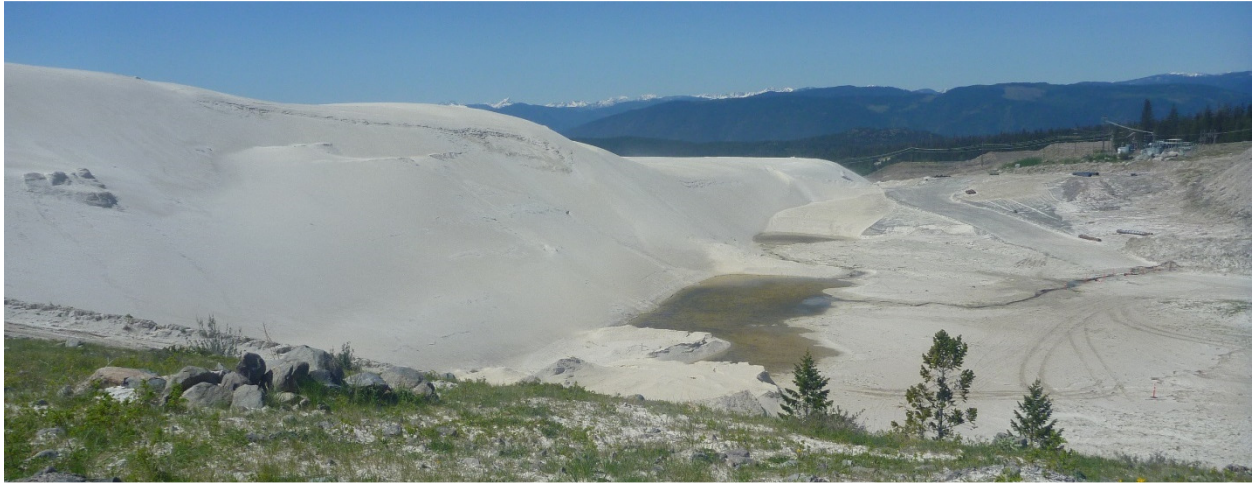
Photo 1- Poned Water At North Toe of North Buttress Berm (facing west)

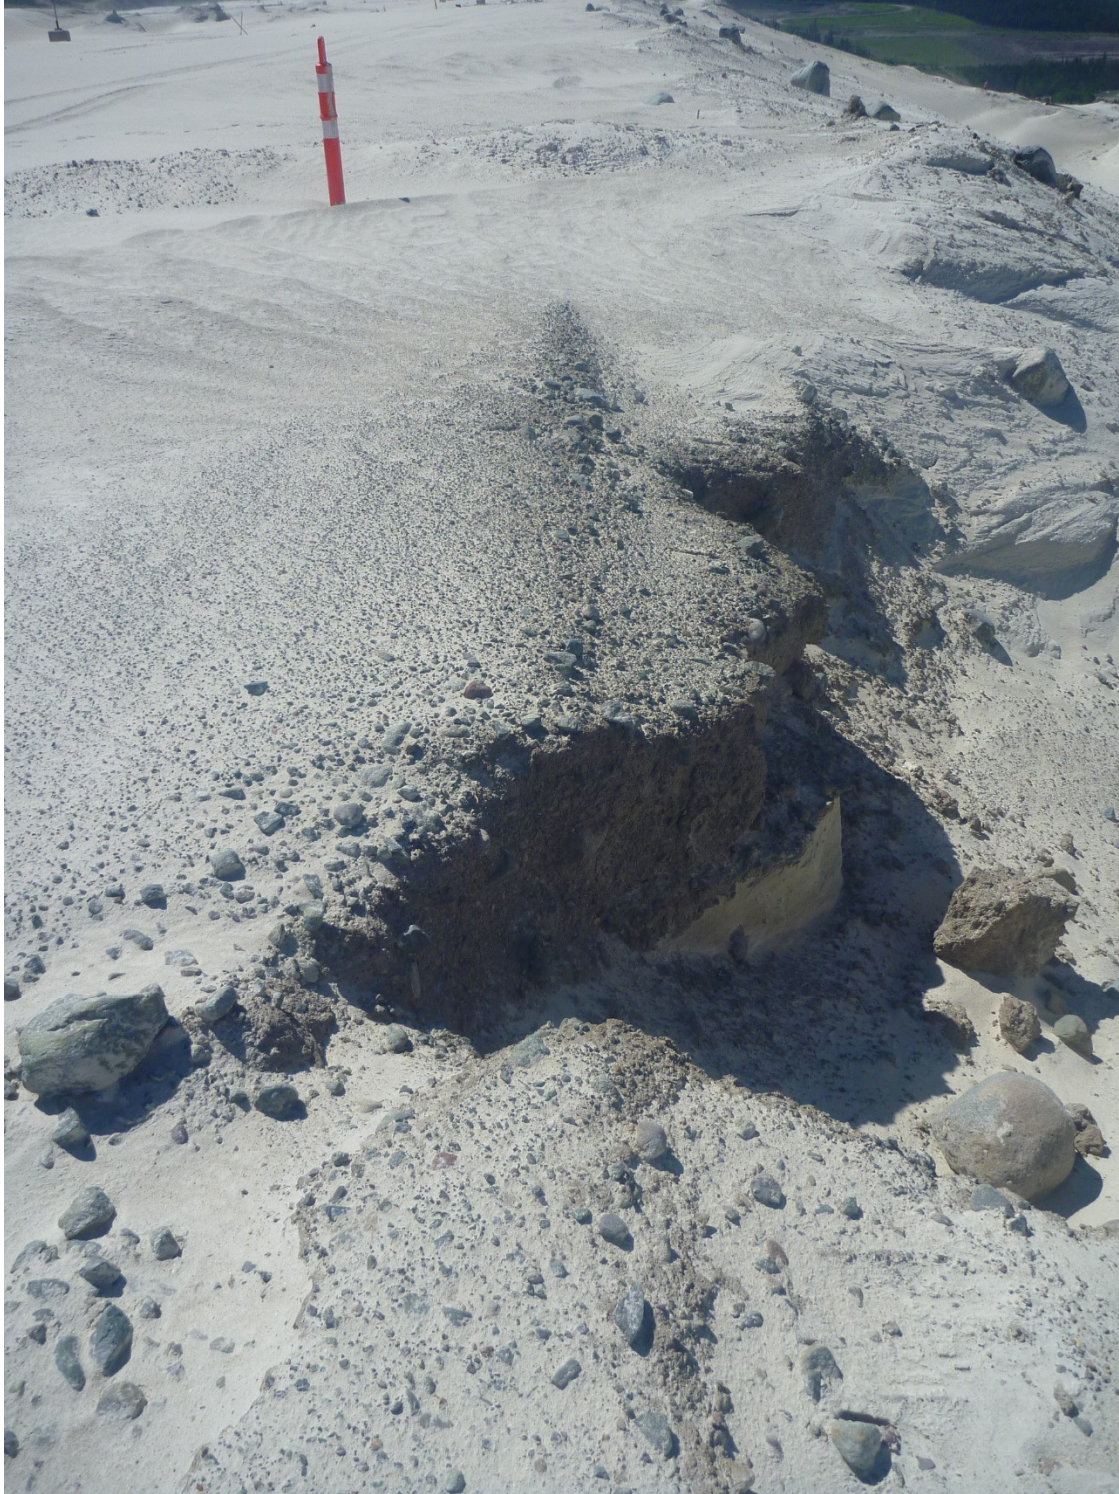
- Erosion feature (approx. 0.5 m deep) at ~ Sta. 2+750 has eroded the downstream edge of the Till Core Zone (location shown in Figure 1). Will require repair during the next construction raise. Erosion feature should be surveyed for record purposes. (Photo 3)

Photo 3 – Erosion feature in downstream edge of Till Core Zone at ~ Sta. 2+750

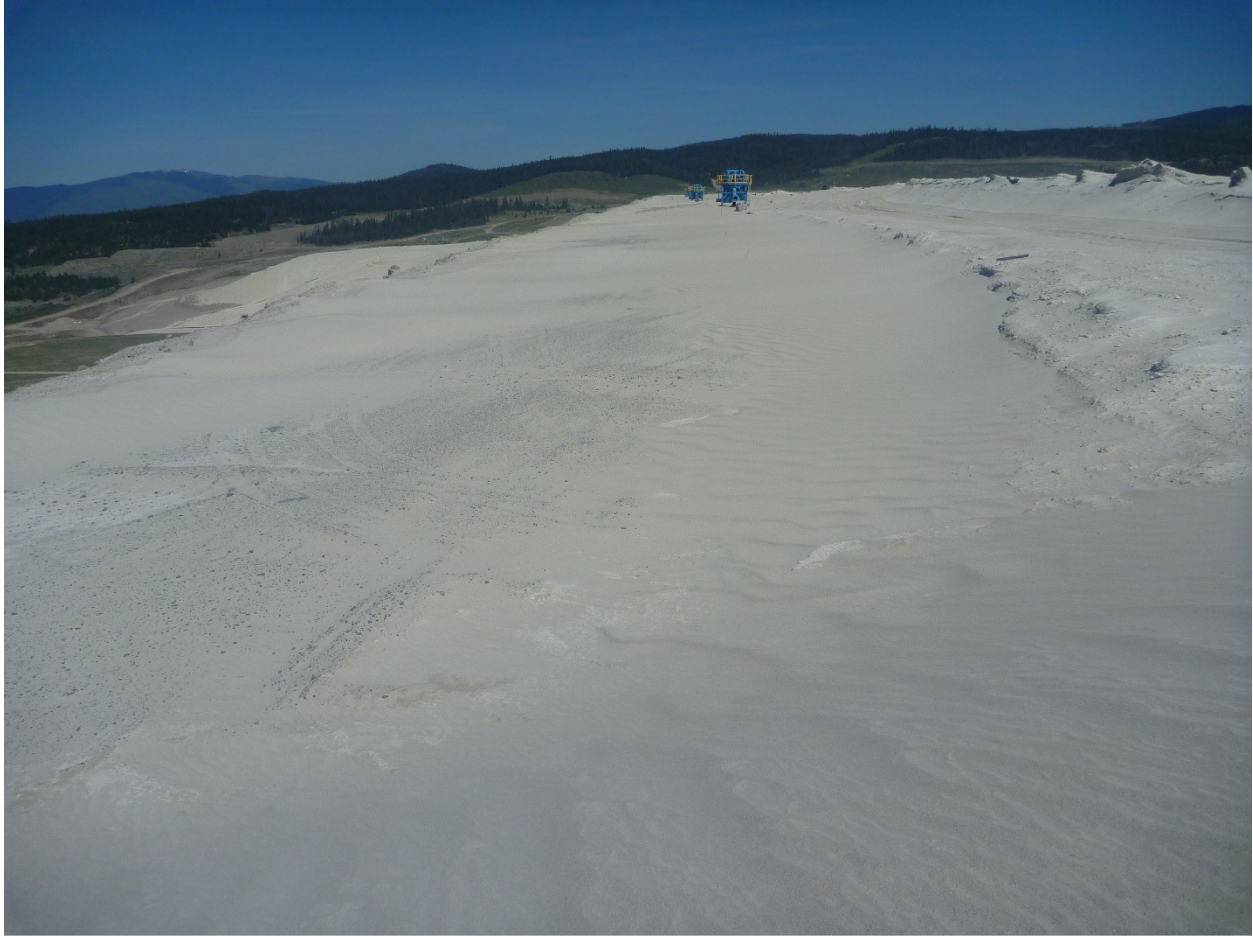
Photo 5 – Windblown sand cover on Till Core Zone

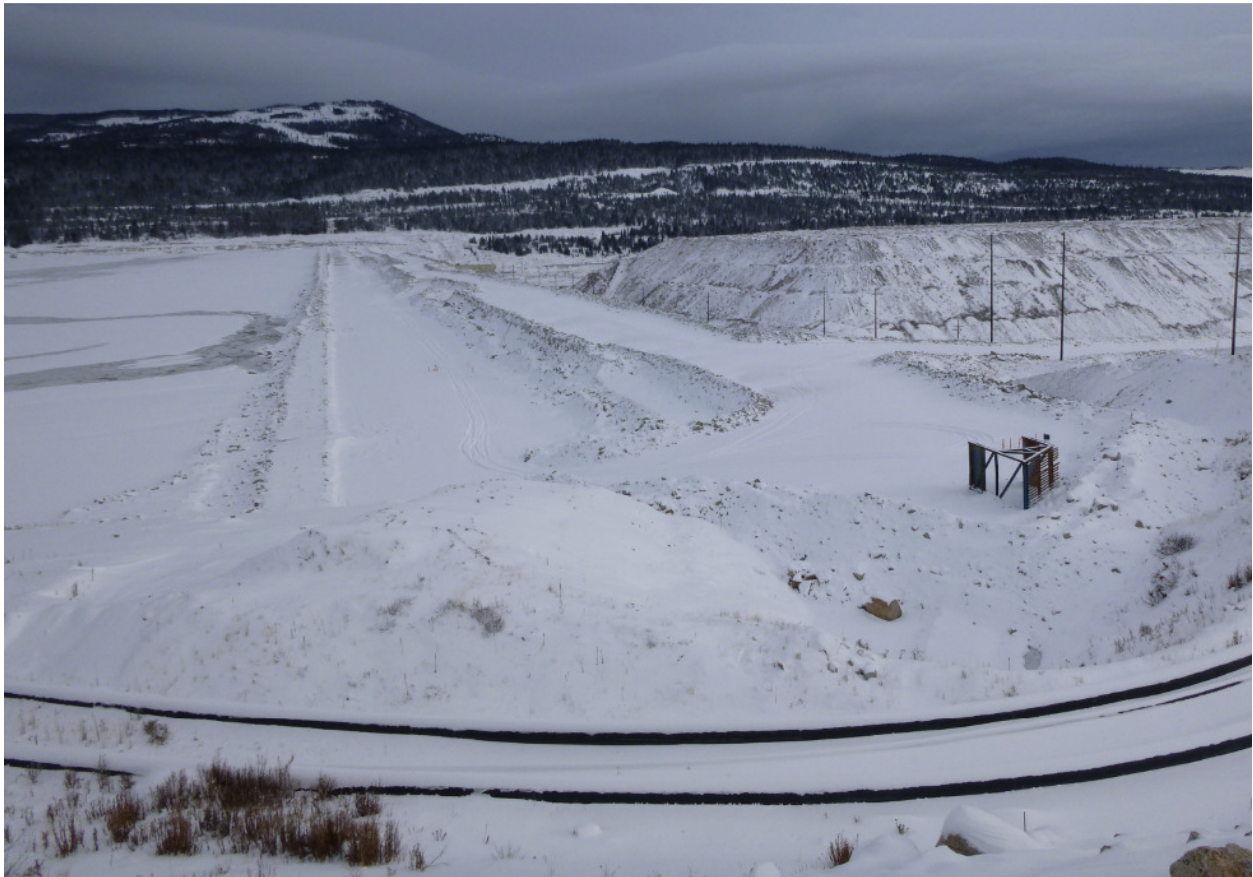
Photo 1 – Most of the H-H Dam was snow covered at the time of the inspection (looking northeast).

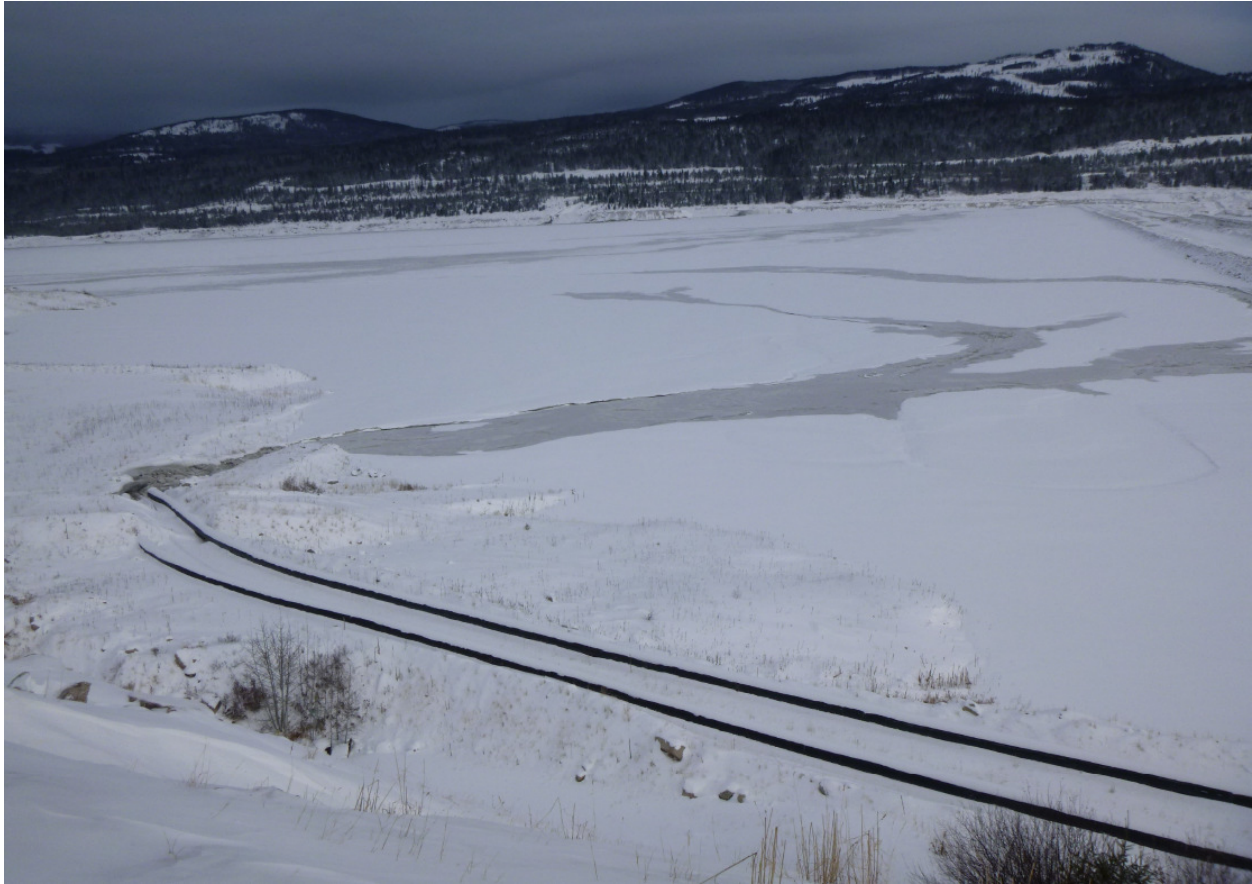
1. Most of the H-H Dam was covered in snow and observations were made to the best of their ability during the current conditions (Photo 1). Evidence of previous discharge from SS1/SS2 along/near the u/s RF2 face approximately between Sta. 0+600 to 0+750 (Photo 2 and 3).
2. Recently dumped d/s RF2 material observed between west side of I-9 waste dump and the west access road onto the dam (Photo 4).
3. Sections of the till core zone were heavily rutted across the dam (Photo 5).
4. Observed area where HVC Mine Ops hauled, dumped and wheel packed d/s RF2 material from December 8 to 10, 2017. The material was placed between ~Sta. 1+475 to ~Sta. 1+625 to ~El. 1268 m to support and buttress the SG2 where cracking had previously occurred (refer to MRM-2017-004) (Photo 6).
5. Current tailings discharge northwest of the east abutment (Photo 7).

Photo 2 - Evidence of recent discharge from SS1/SS2 along/near the u/s RF2 face approximately between Sta. 0+600 to 0+750 (looking northeast).

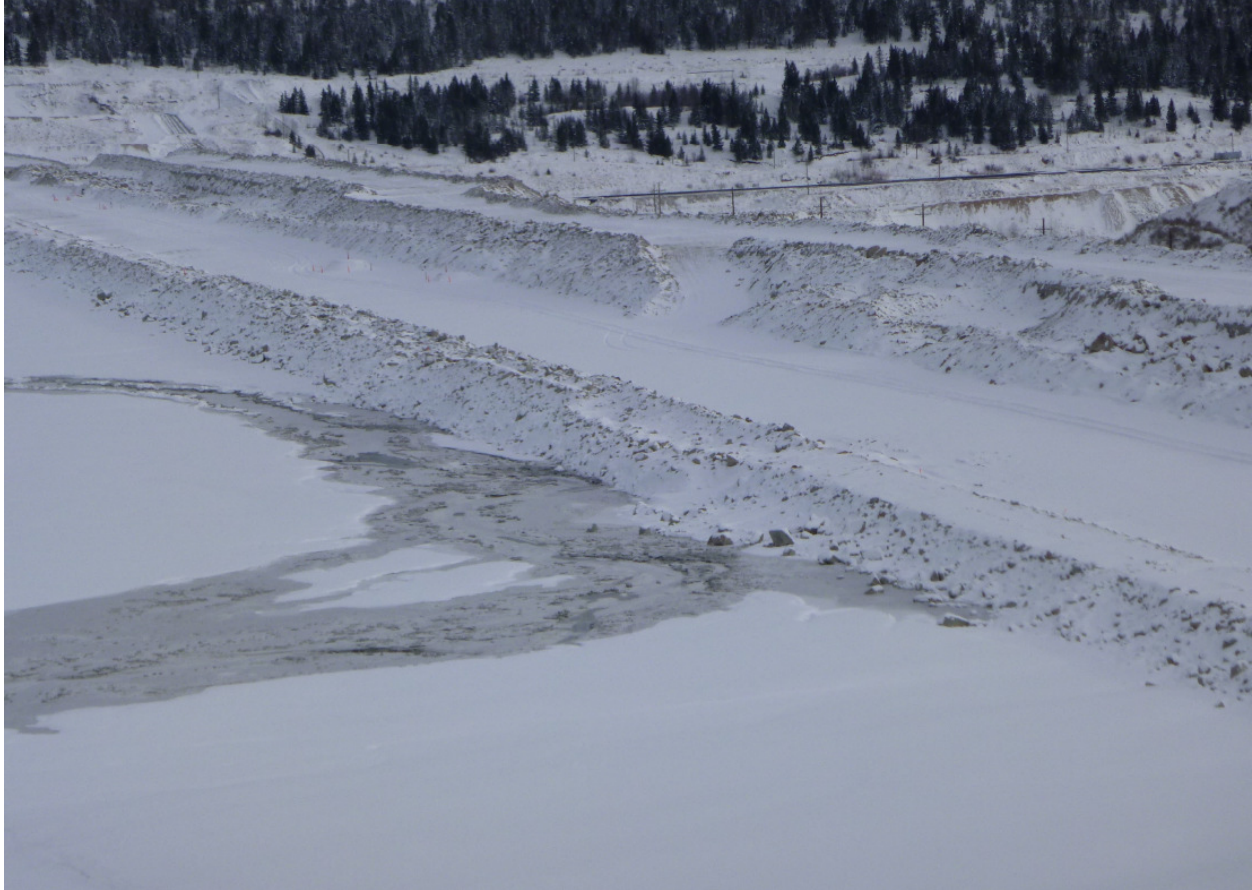
Photo 3 - Evidence of recent discharge from SS1/SS2 along/near the u/s RF2 face approximately between Sta. 0+600 to 0+750 (looking east).

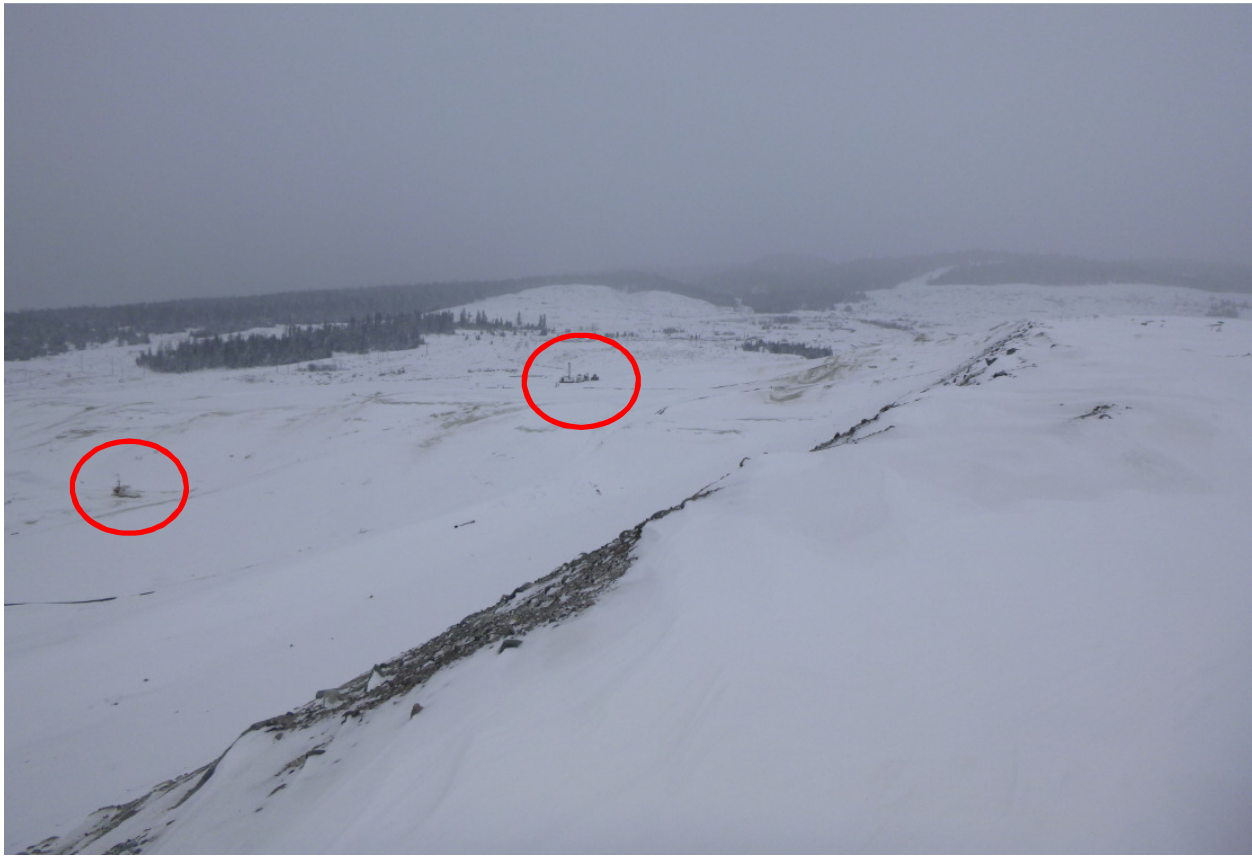
Photo 1- Entire L-L Dam was snow covered at the time of the inspection; two drill rigs seen on the North Buttress Berm (looking North).

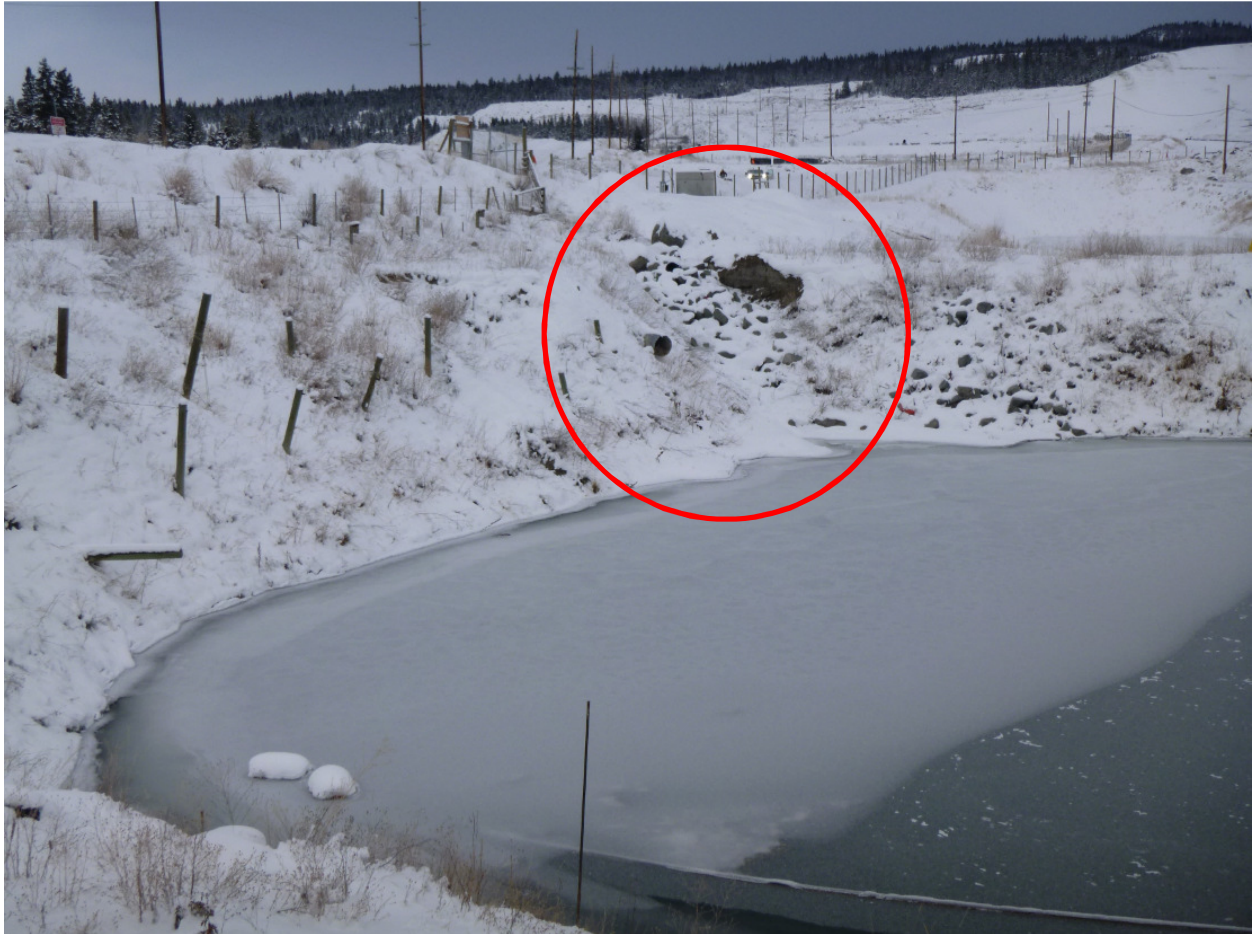
Photo 5 – No flow from Woods Creek Diversion into the Reclaim Pond (looking north).

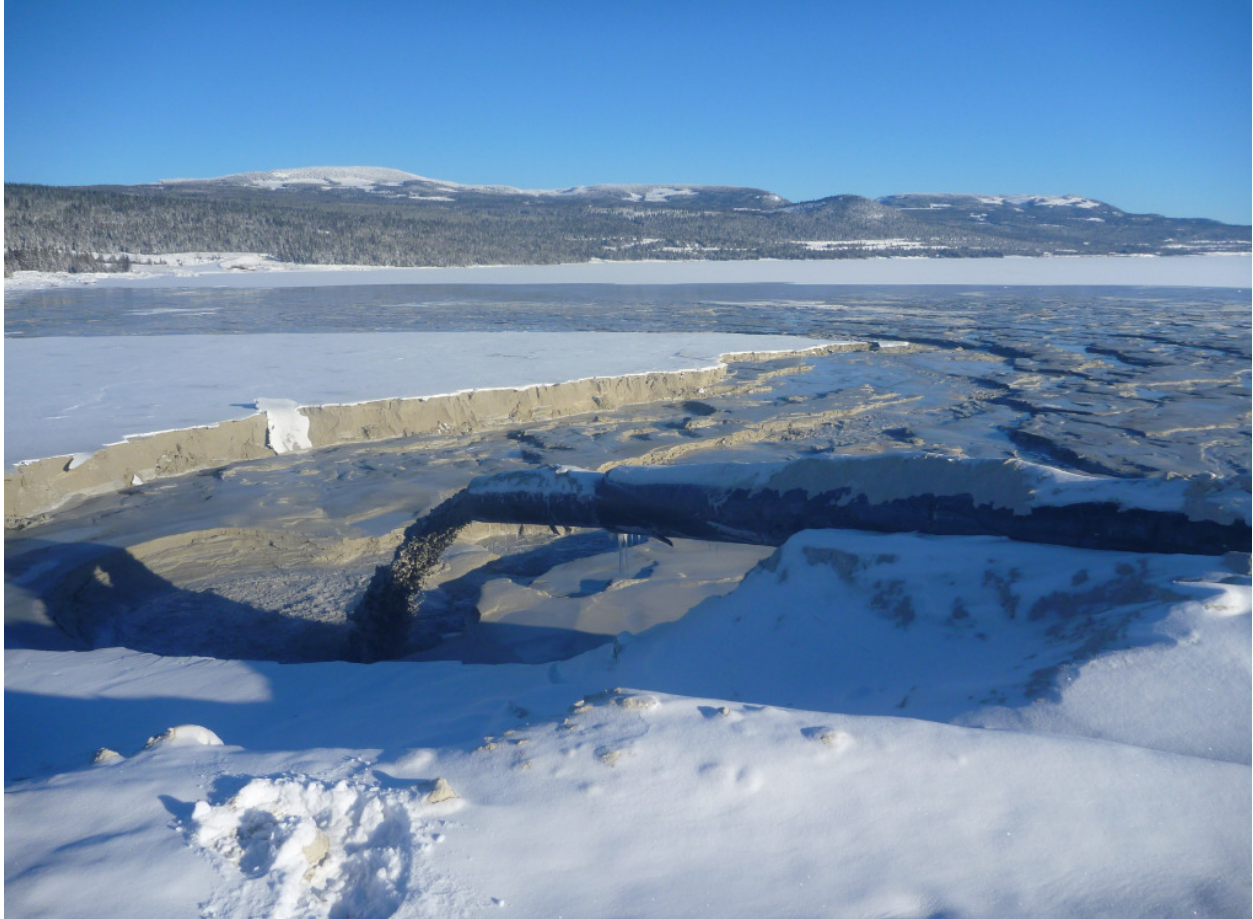
Photo 6 – Tailings discharge locations at Sta. 3+500 and 3+600 (photo taken on 17-12-20).

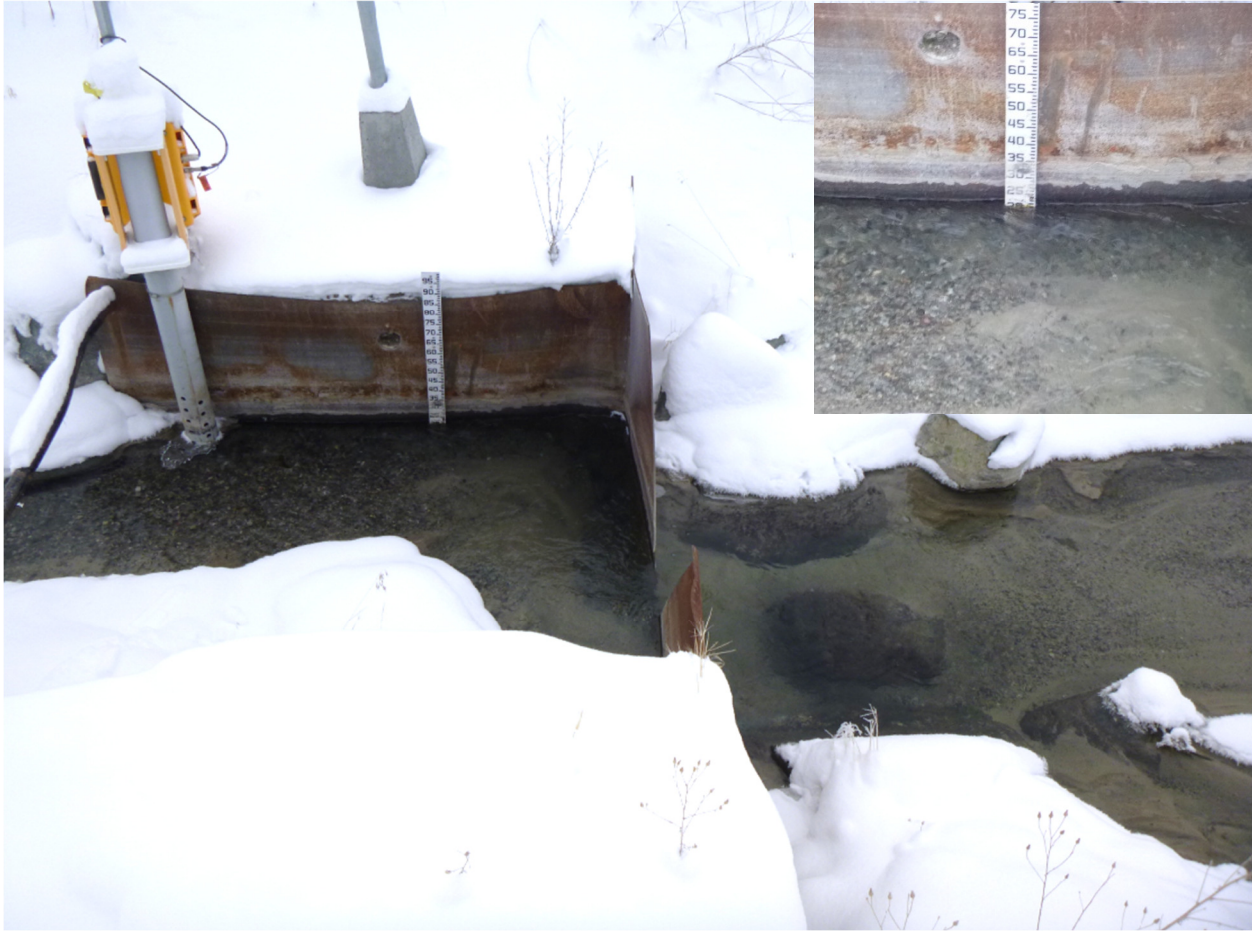
- Outlet flow is combined with flows from Jim Black Lake prior to measurement at Point B weir (LL—FS-03)— flow should be measured separately.
- Point B weir (LL—FS-03) is checked with sediment and should be cleaned out to ensure accurate measurements

Photo 7 – Point B weir with accumulated sediment in weir box and outfall.

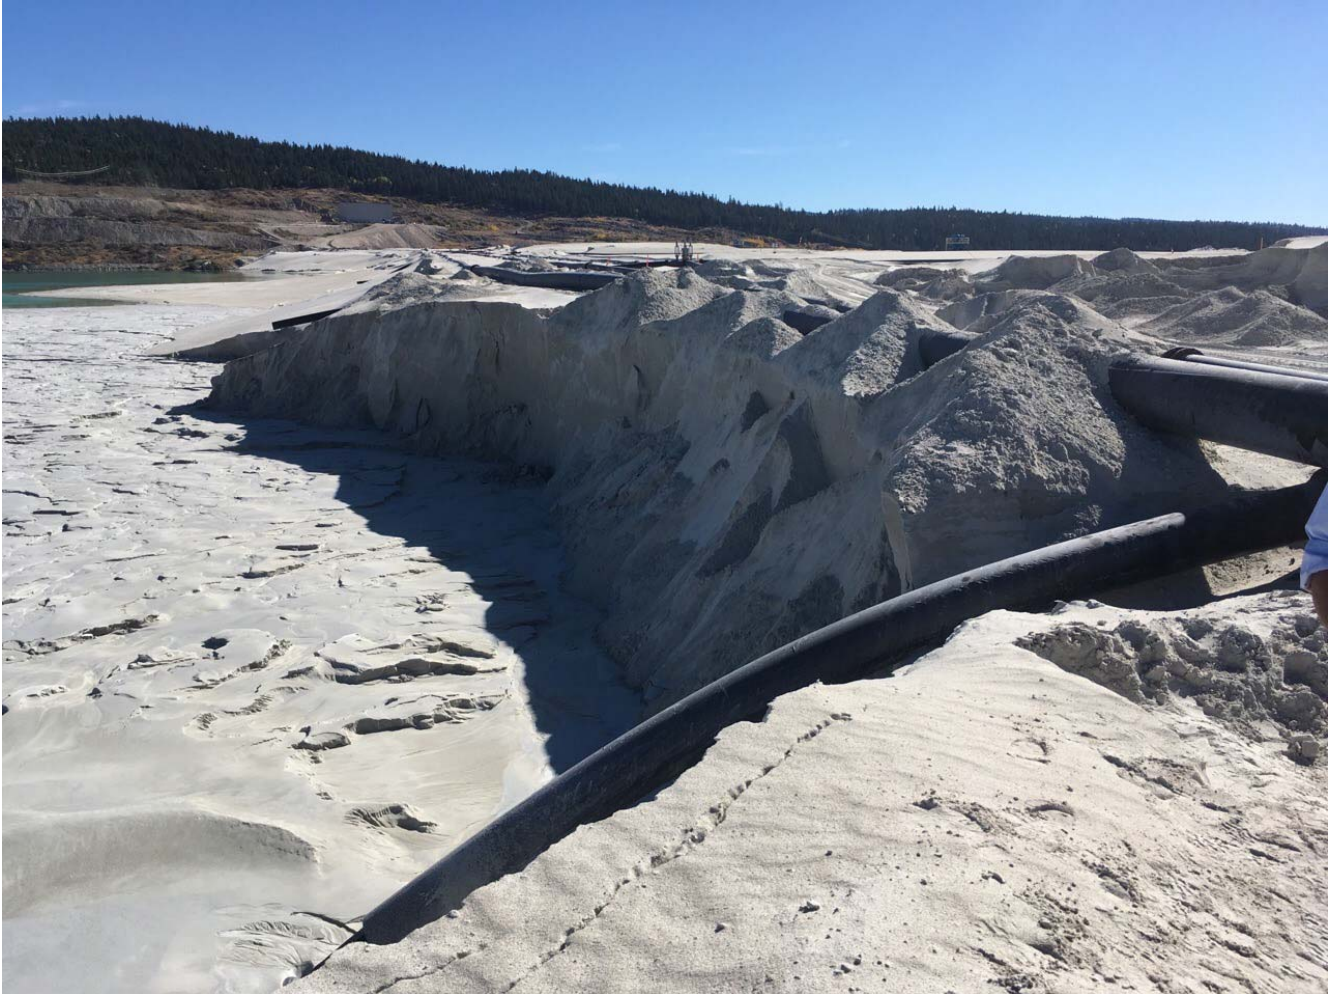
Photo II-A-6 Upstream Dam Face – Undercutting at Beaching Location – Facing North (LL-2017-10)

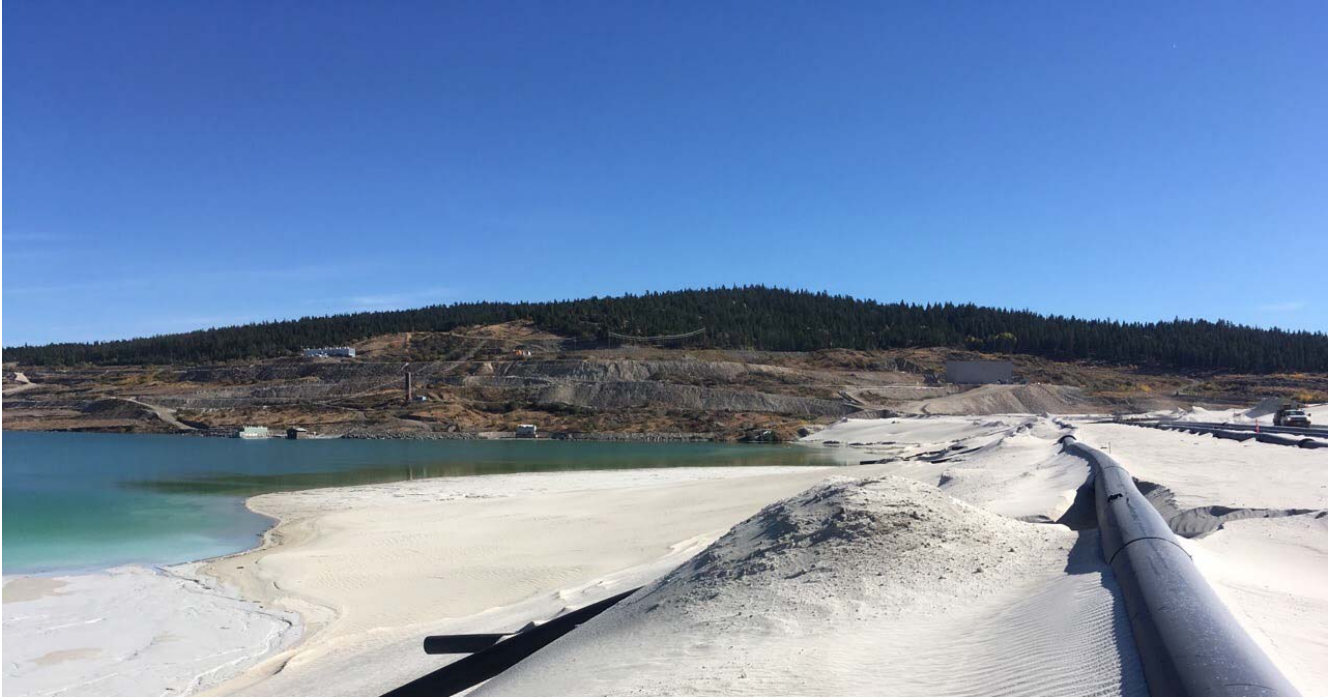
Photo II-A-7 Pond at the Toe of the Upstream Dam Slope – Facing South (LL-2017-09)

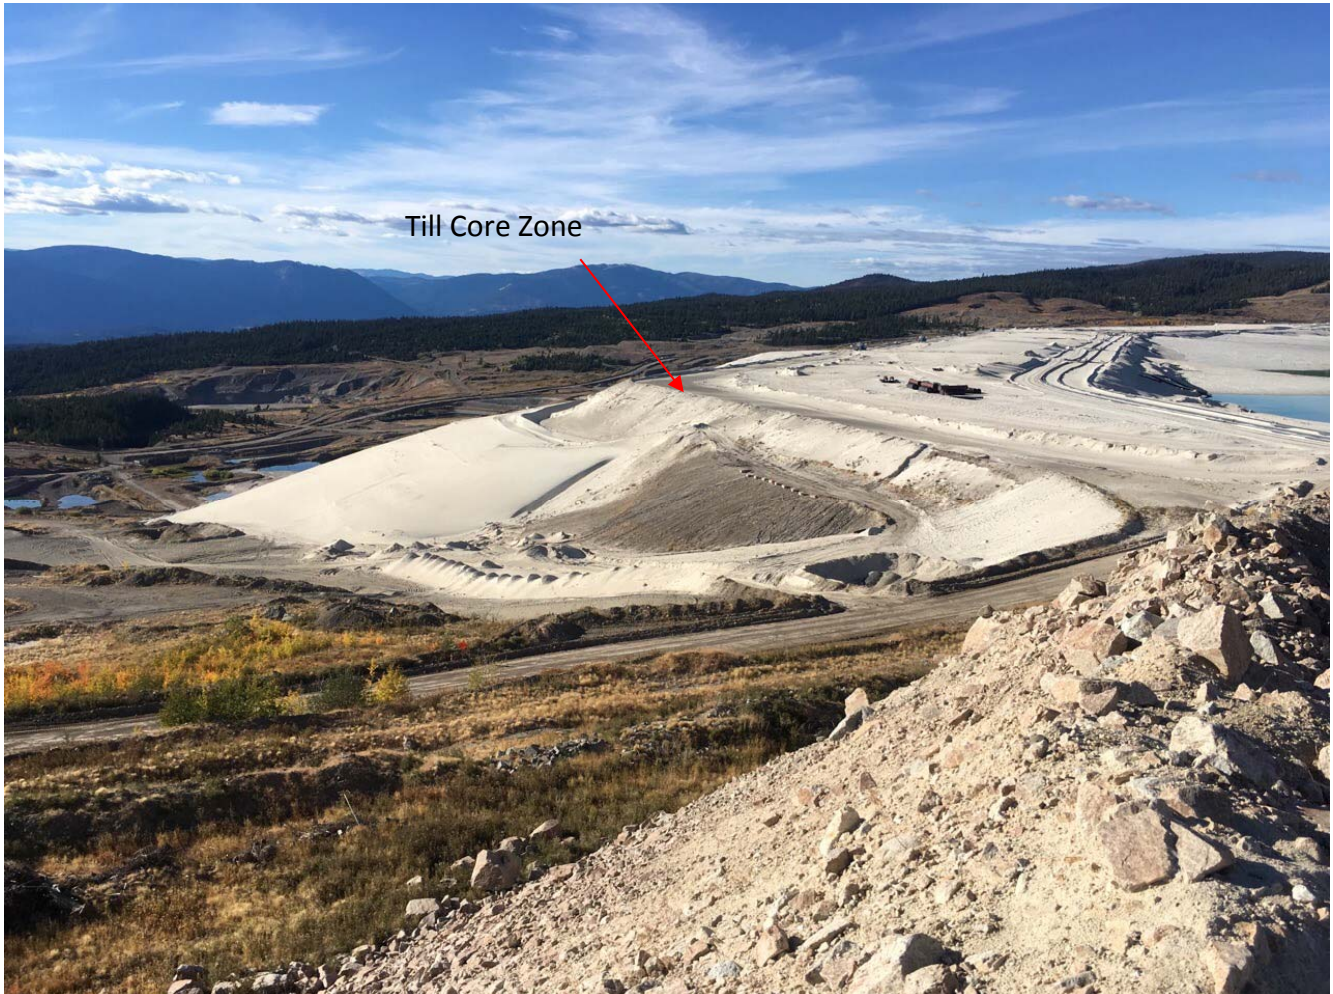
Photo II-A-8 Downstream face at South Abutment - Facing North (LL-2017-02)

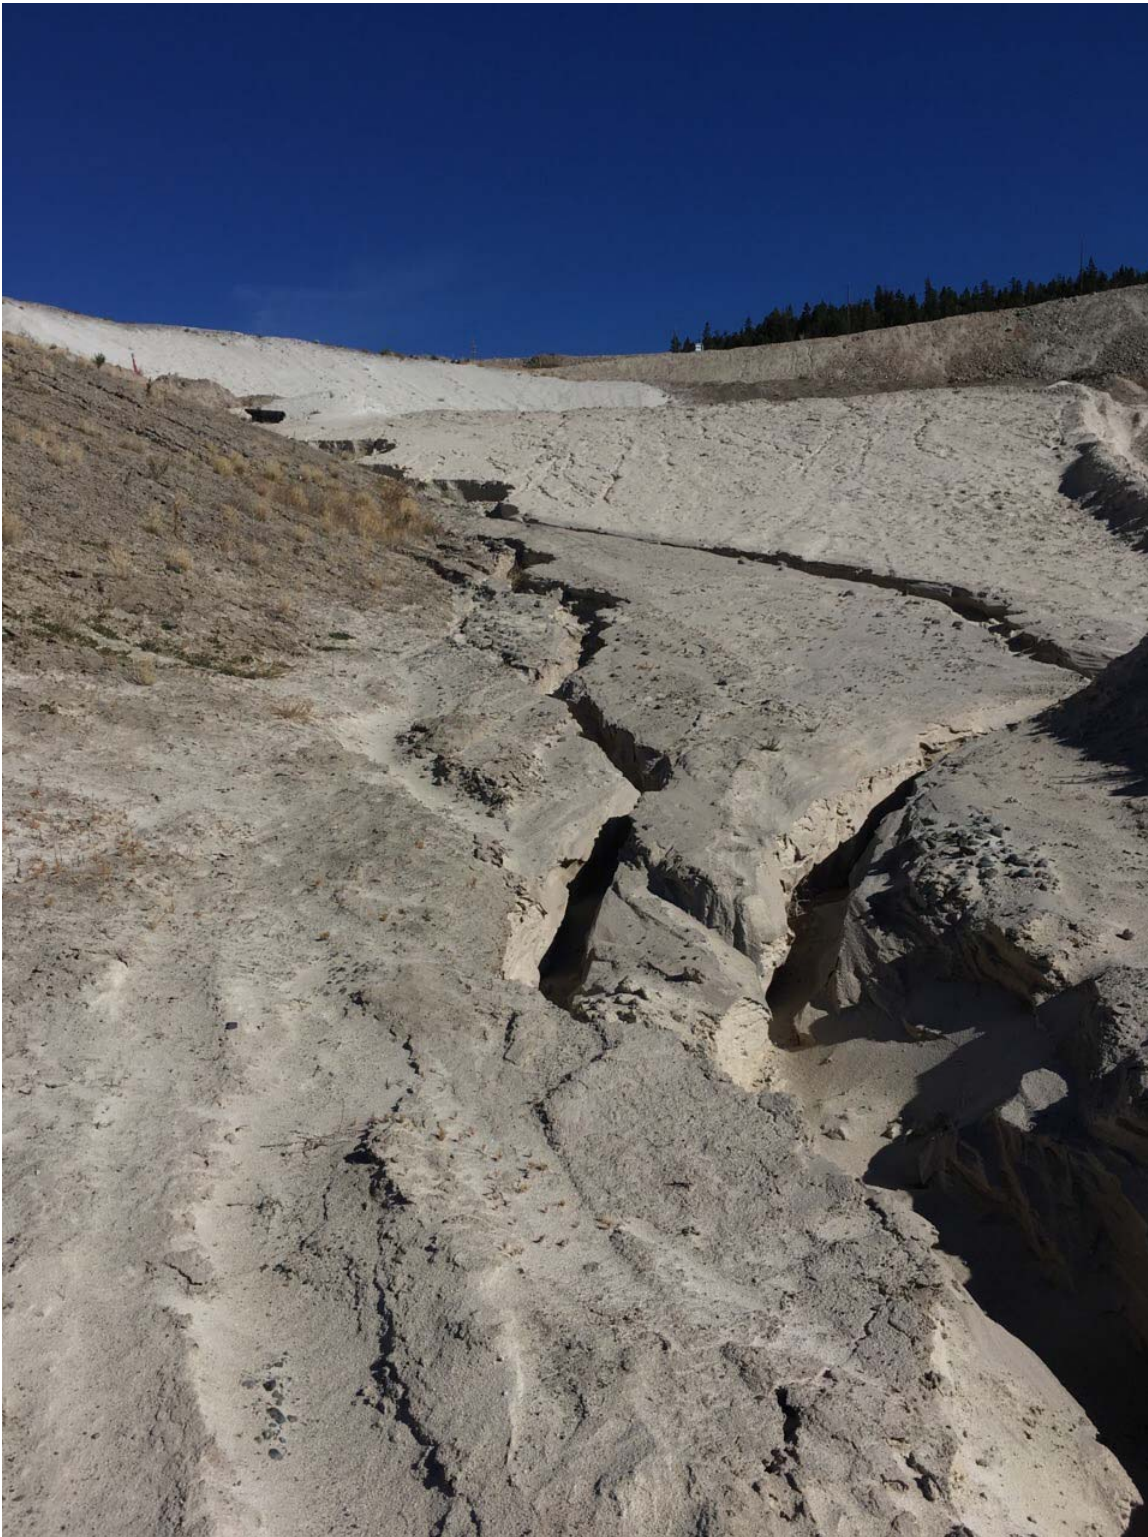
Photo II-A-9 South Dam – Erosion from Cyclone House Spill (LL-2017-06)

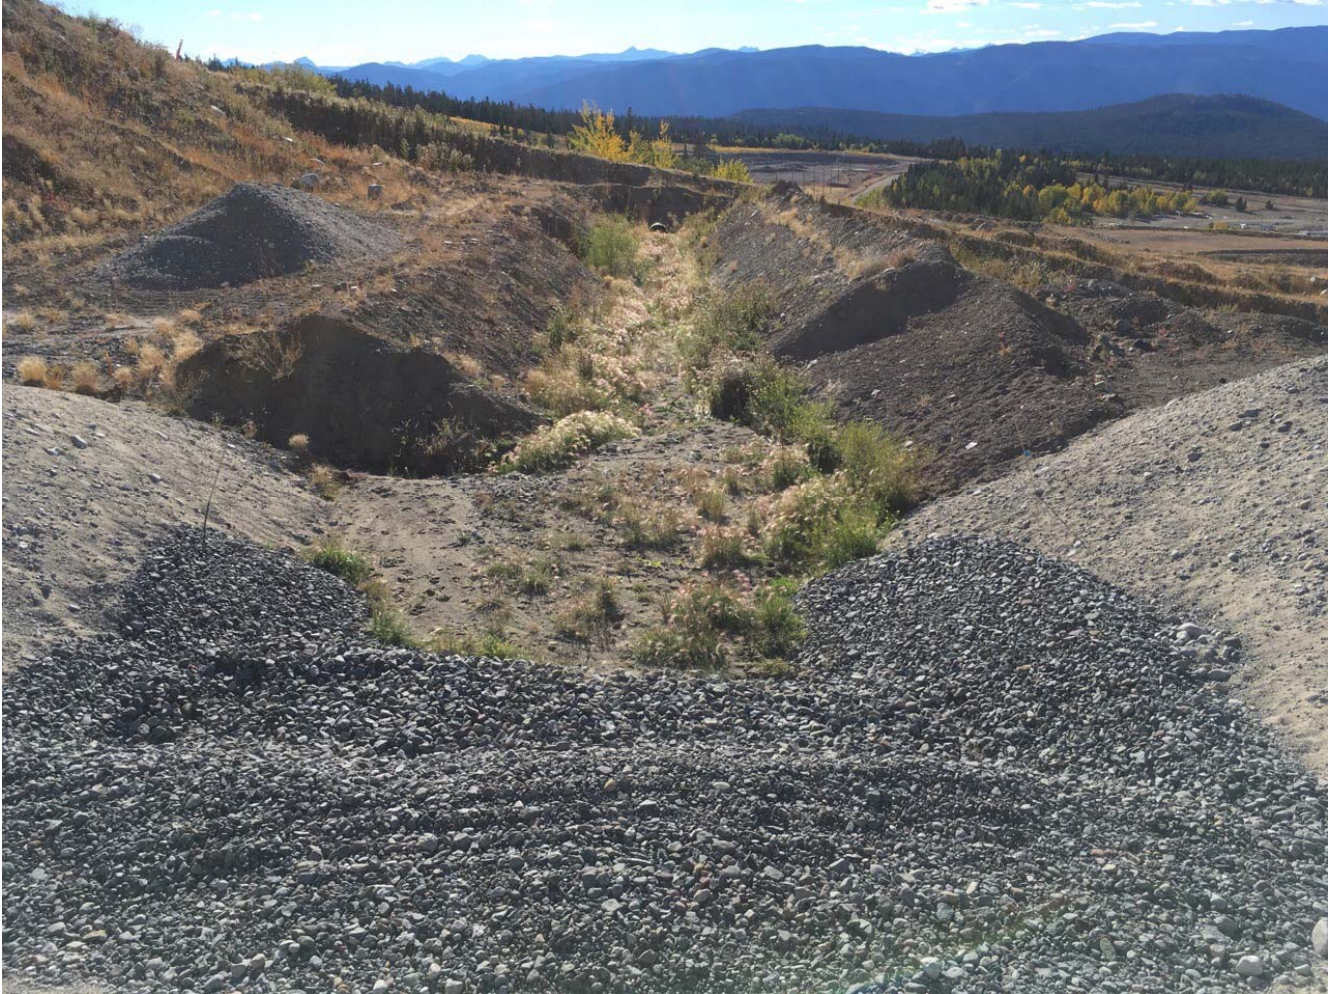
Photo II-A-10 South Dam – Major Drain Outlet with <1 L/min Flow Rate (LL-2017-05)

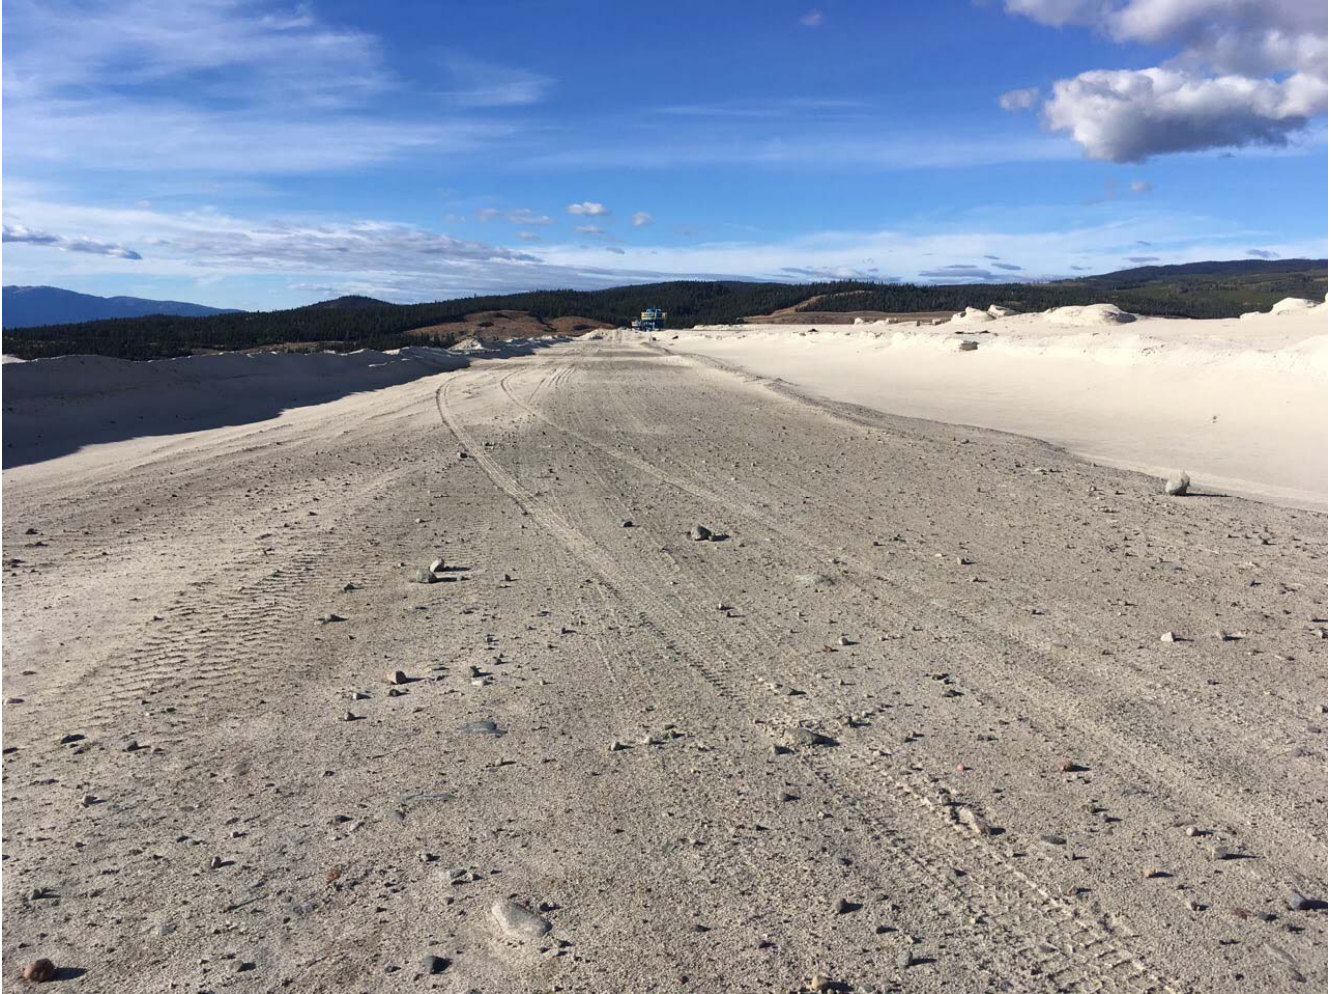
Photo II-A-11 South Dam Till Core Zone – Facing Northwest (LL-2017-08)

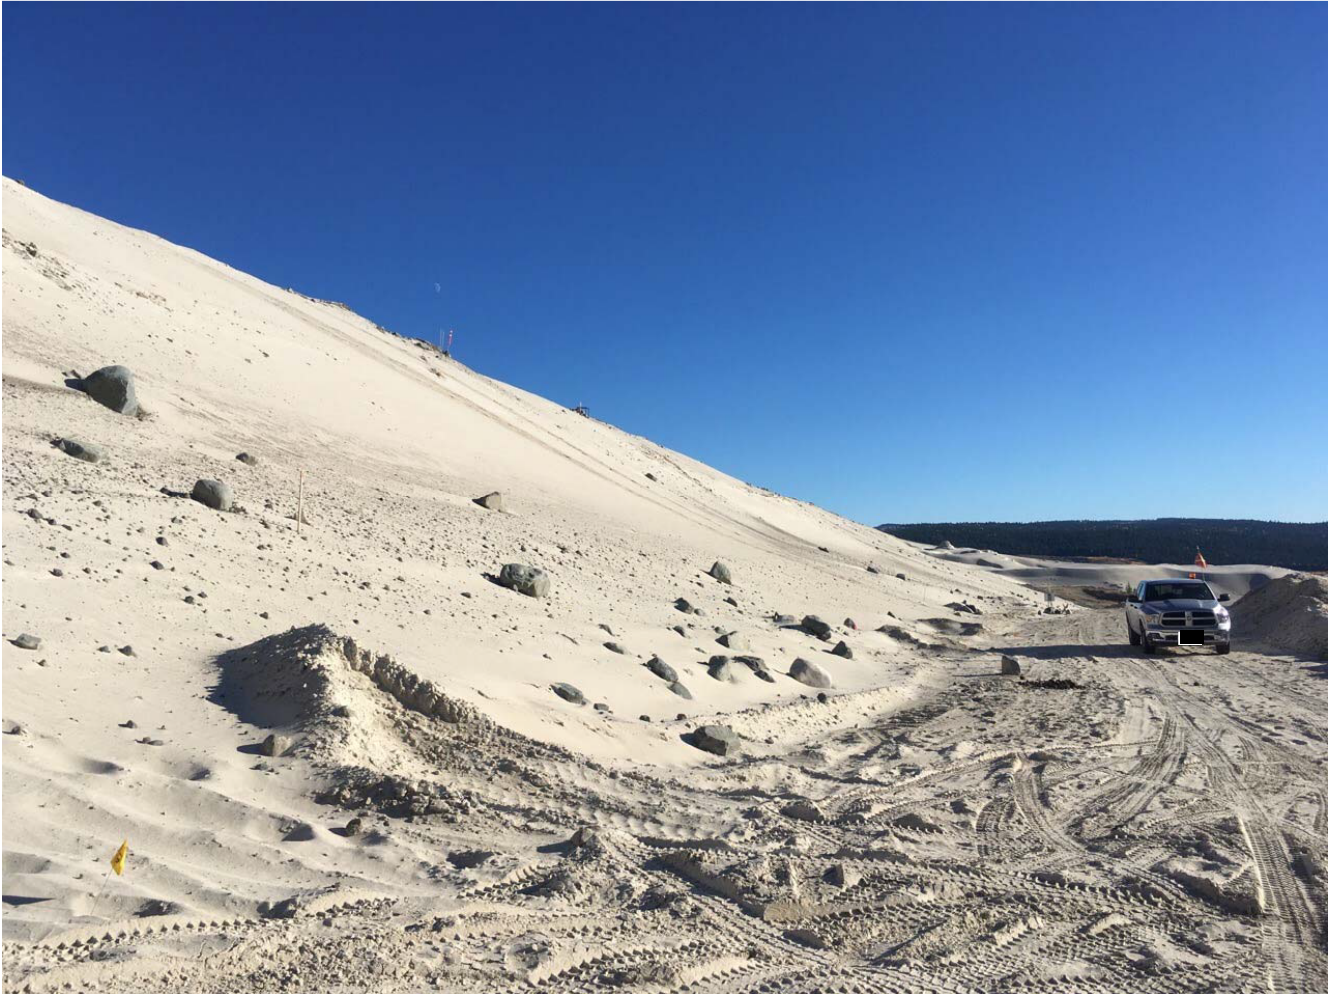
Photo II-A-13 North Dam Downstream Toe – Facing South (LL-2017-16)

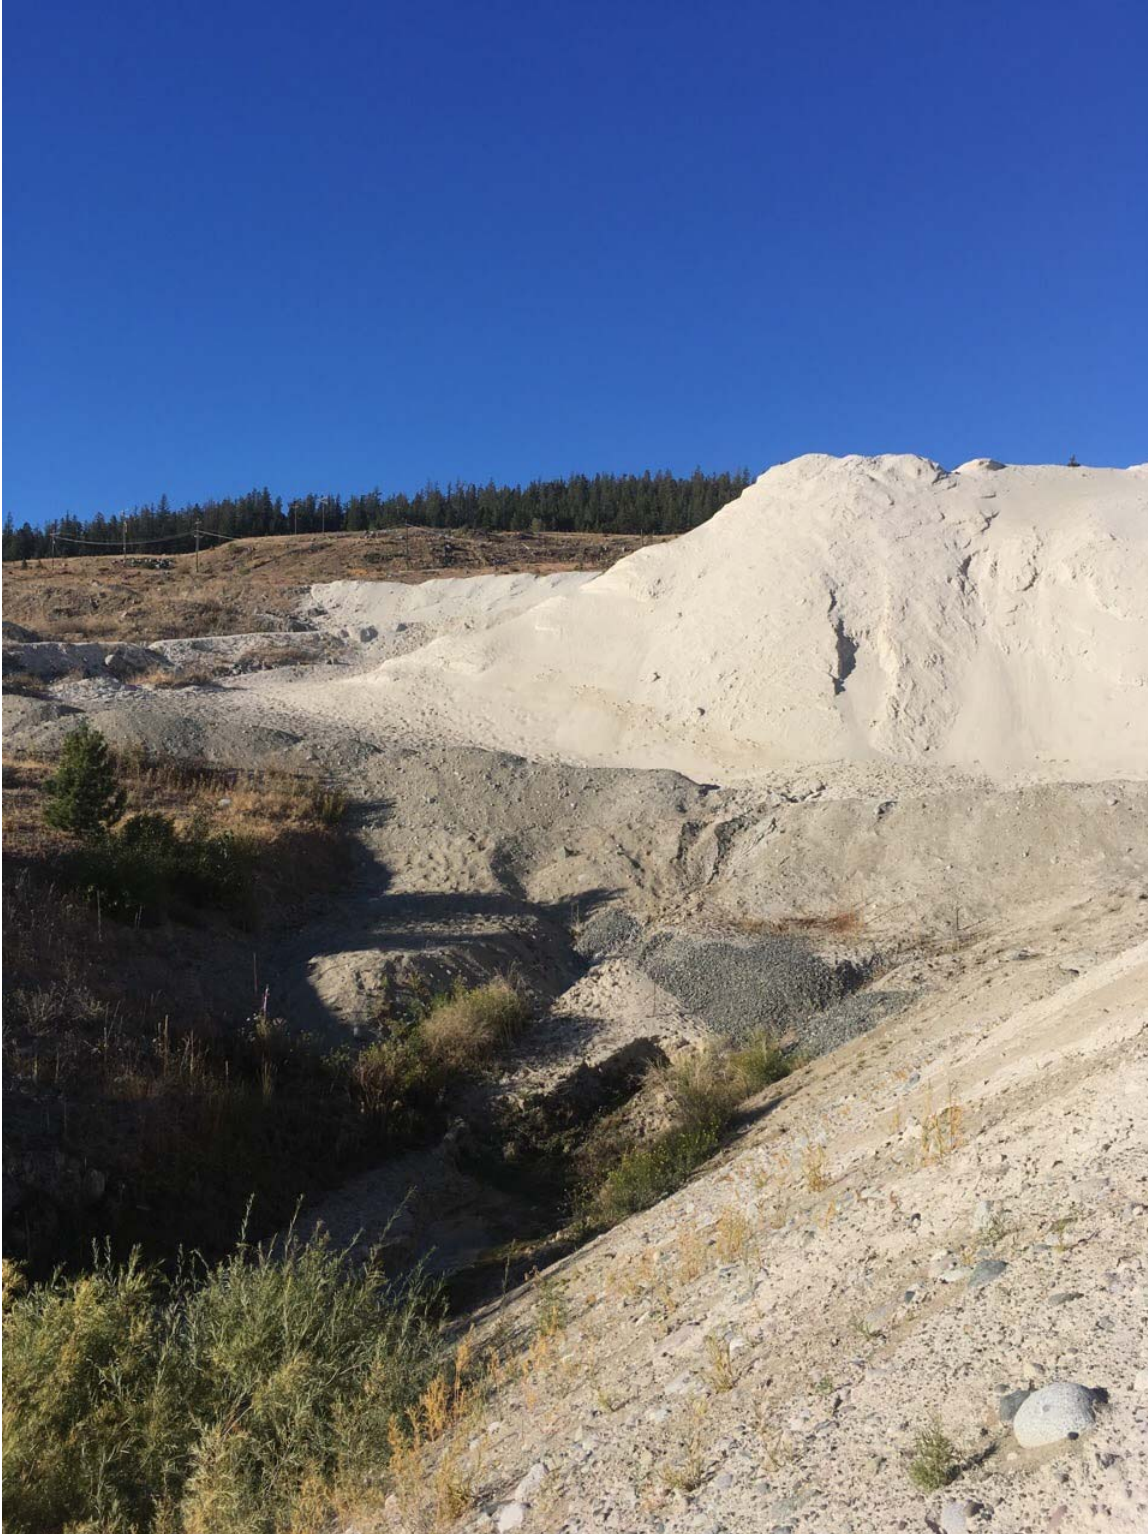
Photo II-A-14 North Dam Drain – Facing North (LL-2017-16)
