Teck Highland Valley Copper Partnership

2017 Dam Safety Inspection Report

Highland Tailings Storage Facility

March 2018

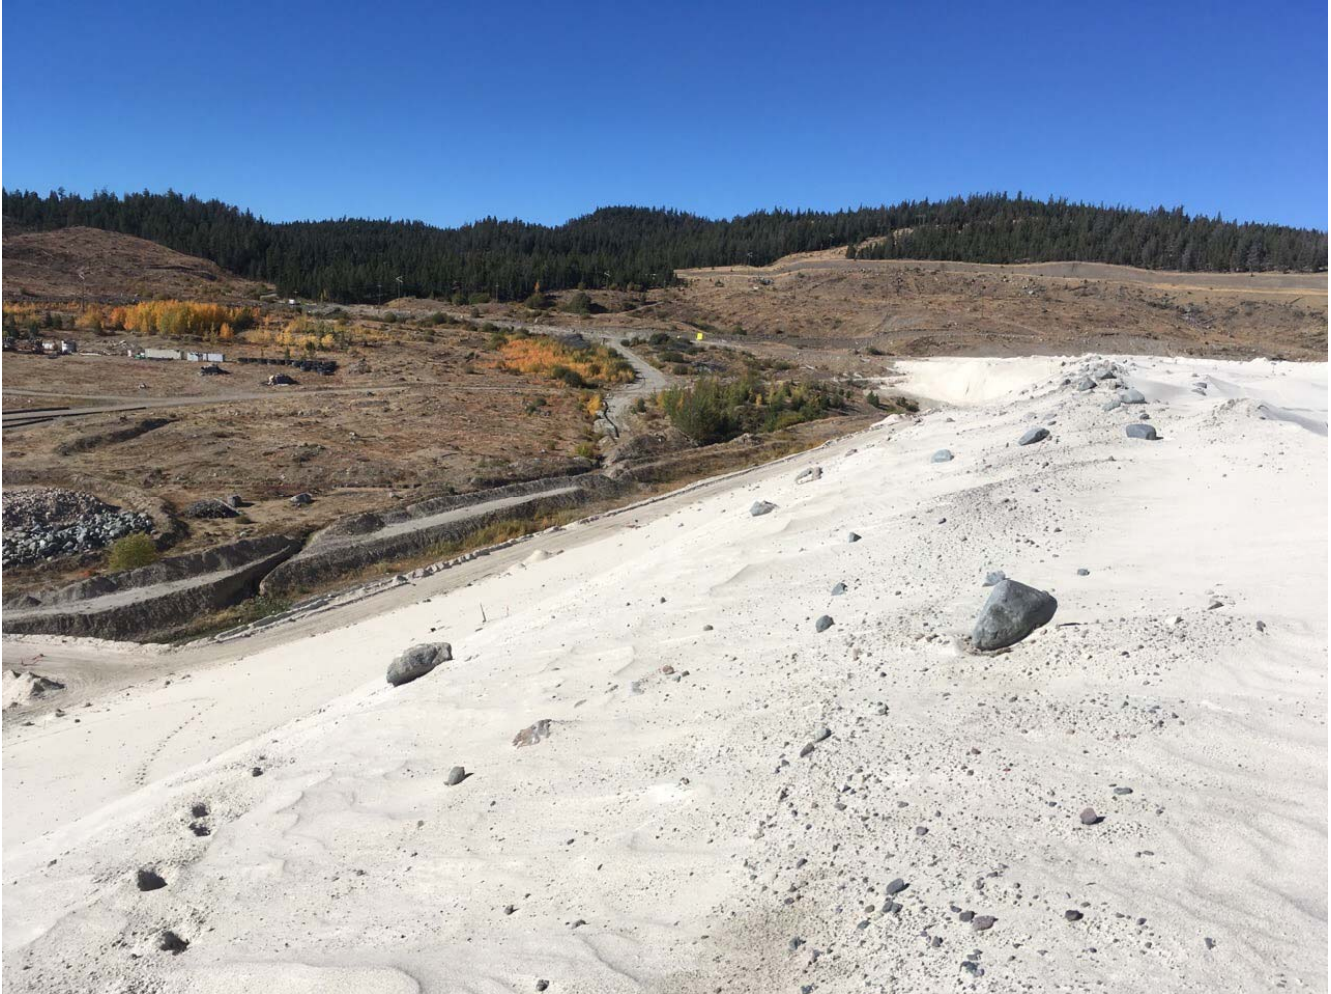
Photo II-A-15 North Dam Downstream Slope – Facing North (LL-2017-17)

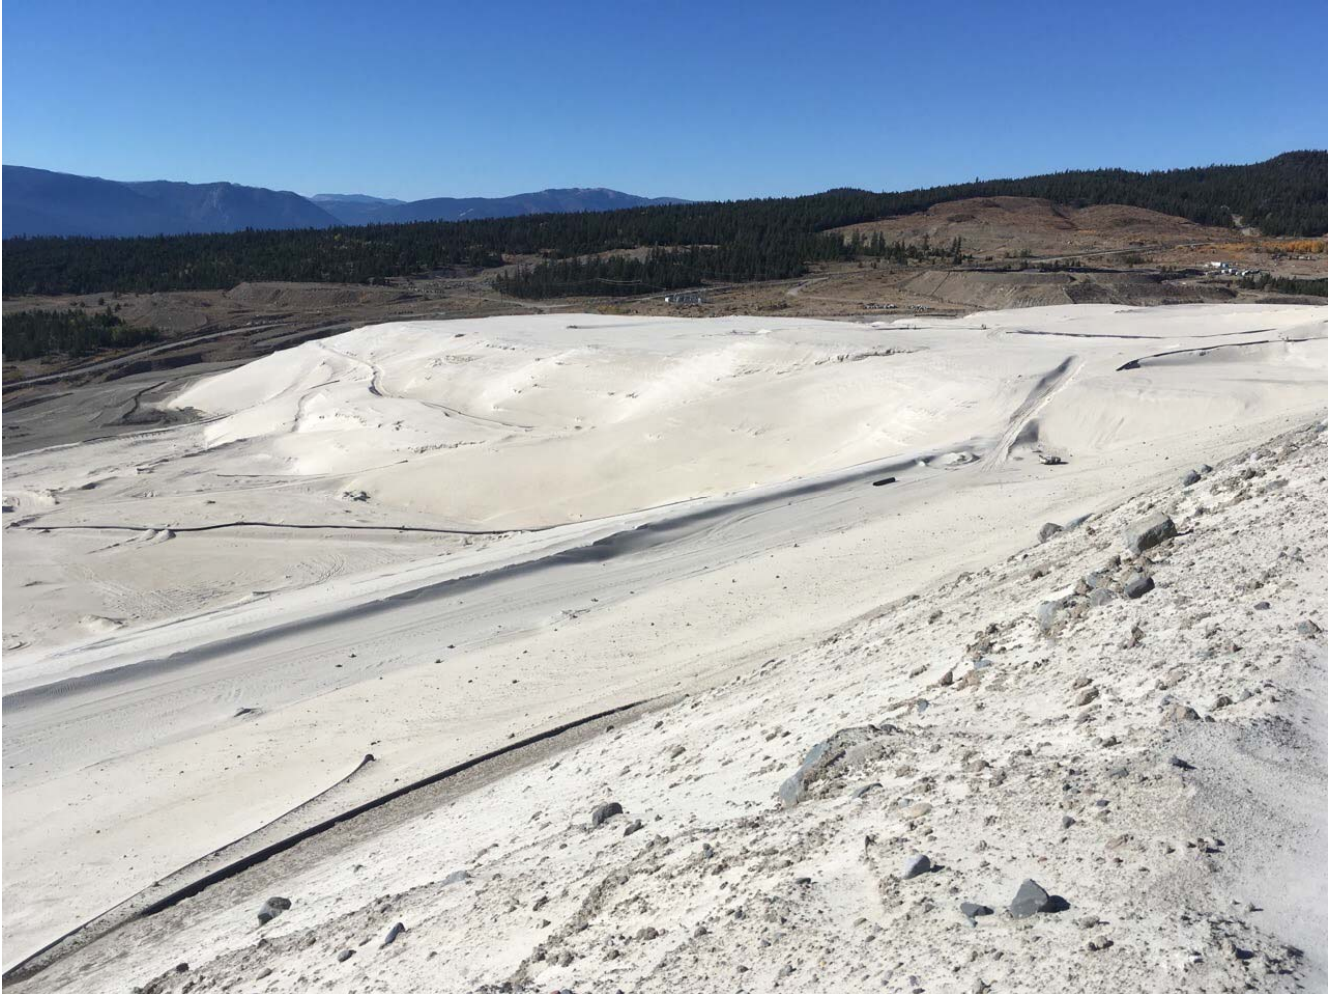
Photo II-A-17 North Buttress Berm South Slope – Facing Northwest (LL-2017-19)

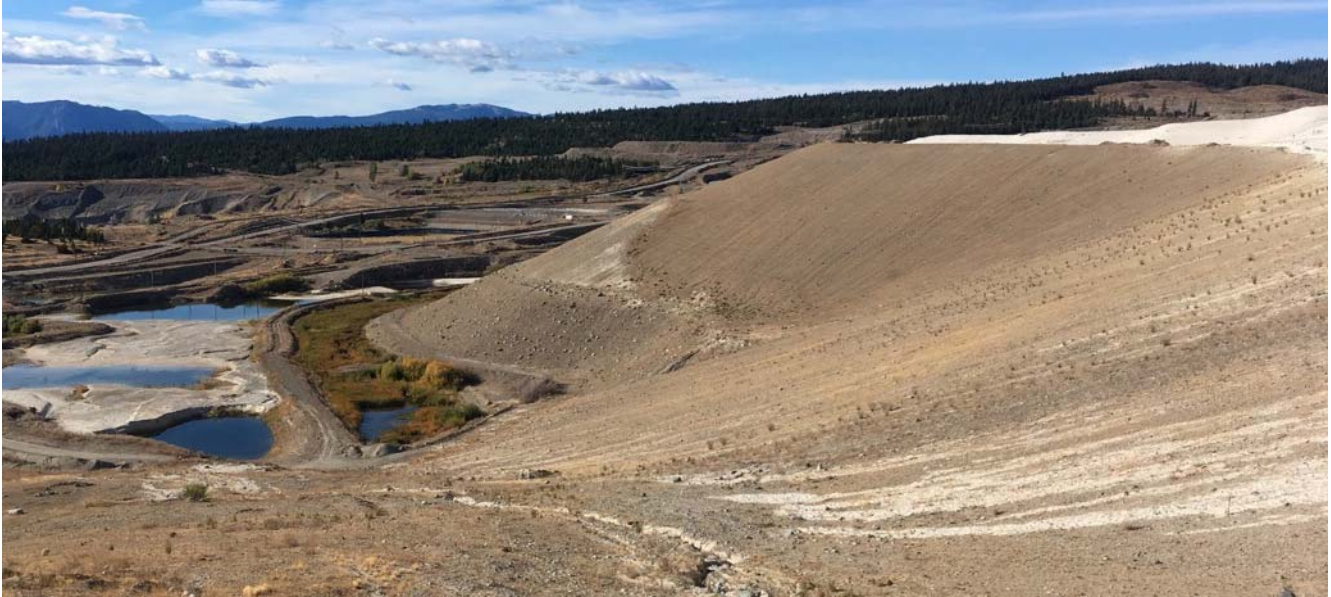
Photo II-A-18 Toe and Downstream Face of South Dam - Facing Northwest (LL-2017-24)

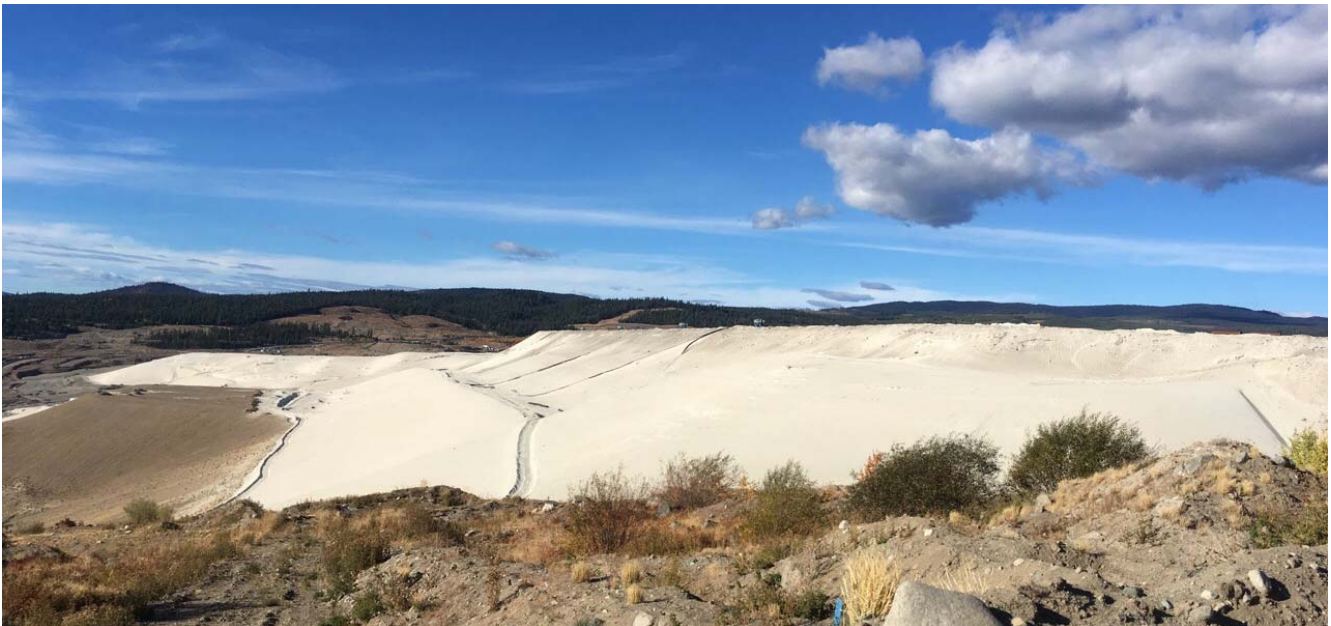
Photo II-A-19 Downstream Slope of South Dam - Facing North (LL-2017-04)

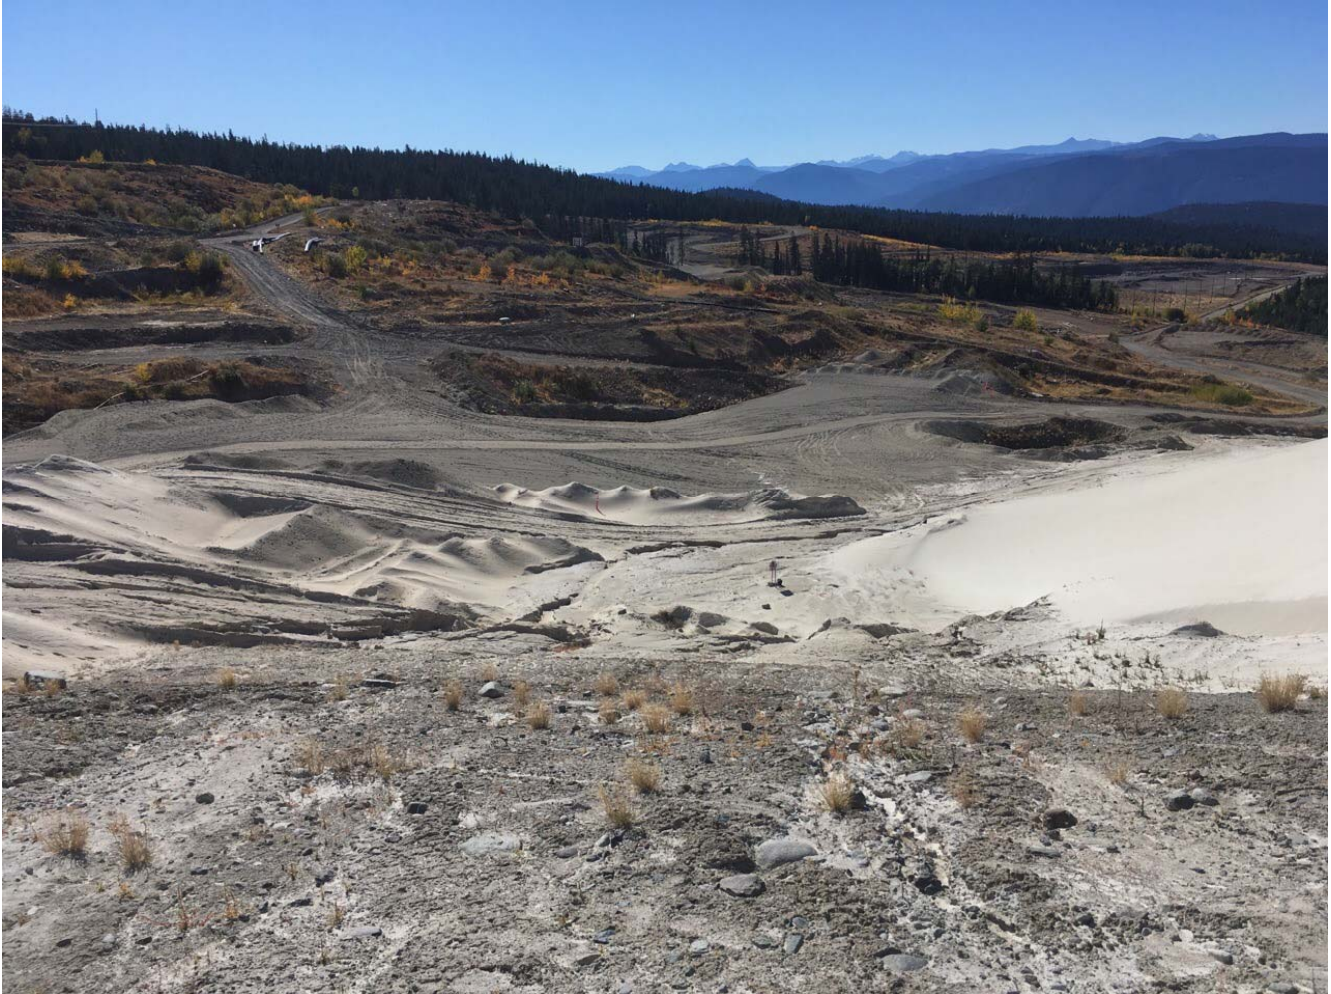
Photo II-A-20 Downstream Toe at South Abutment - Facing East (LL-2017-07)

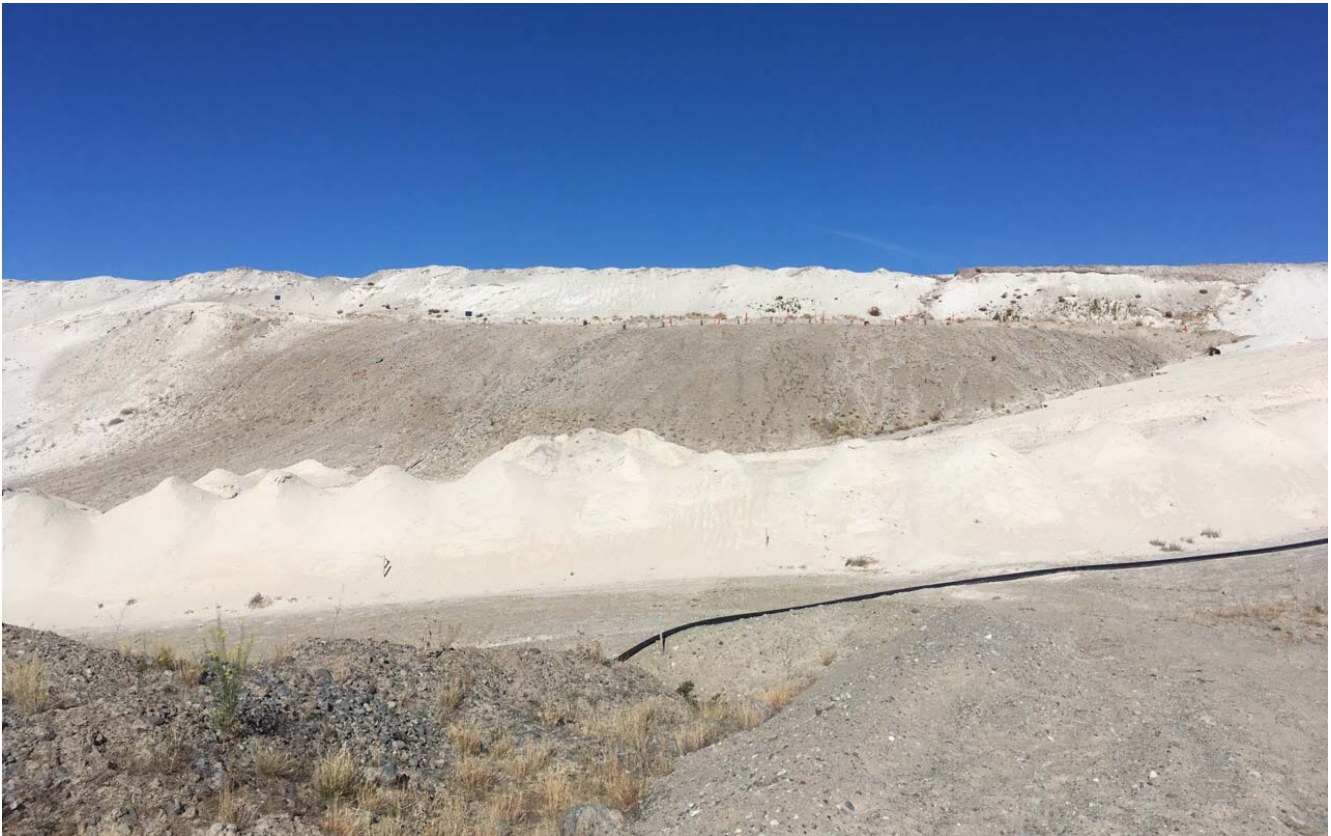
Photo II-A-21 Downstream Slope at South Abutment - Facing Northwest (LL-2017-03)

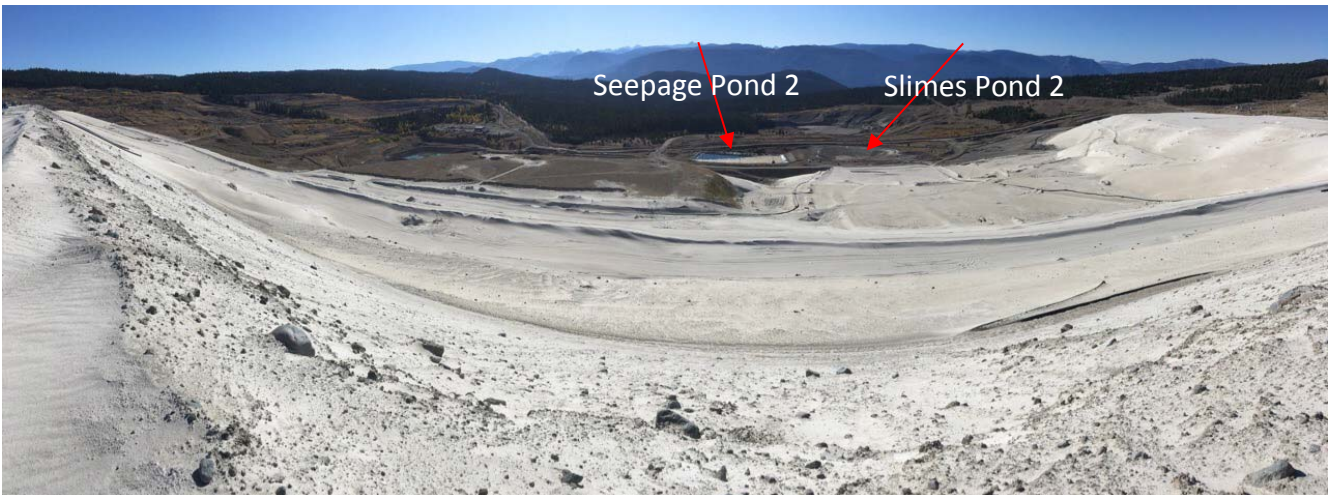
Photo II-A-22 Valley Buttress and Valley Buttress Berm Extension - Facing West (LL-2017-19)

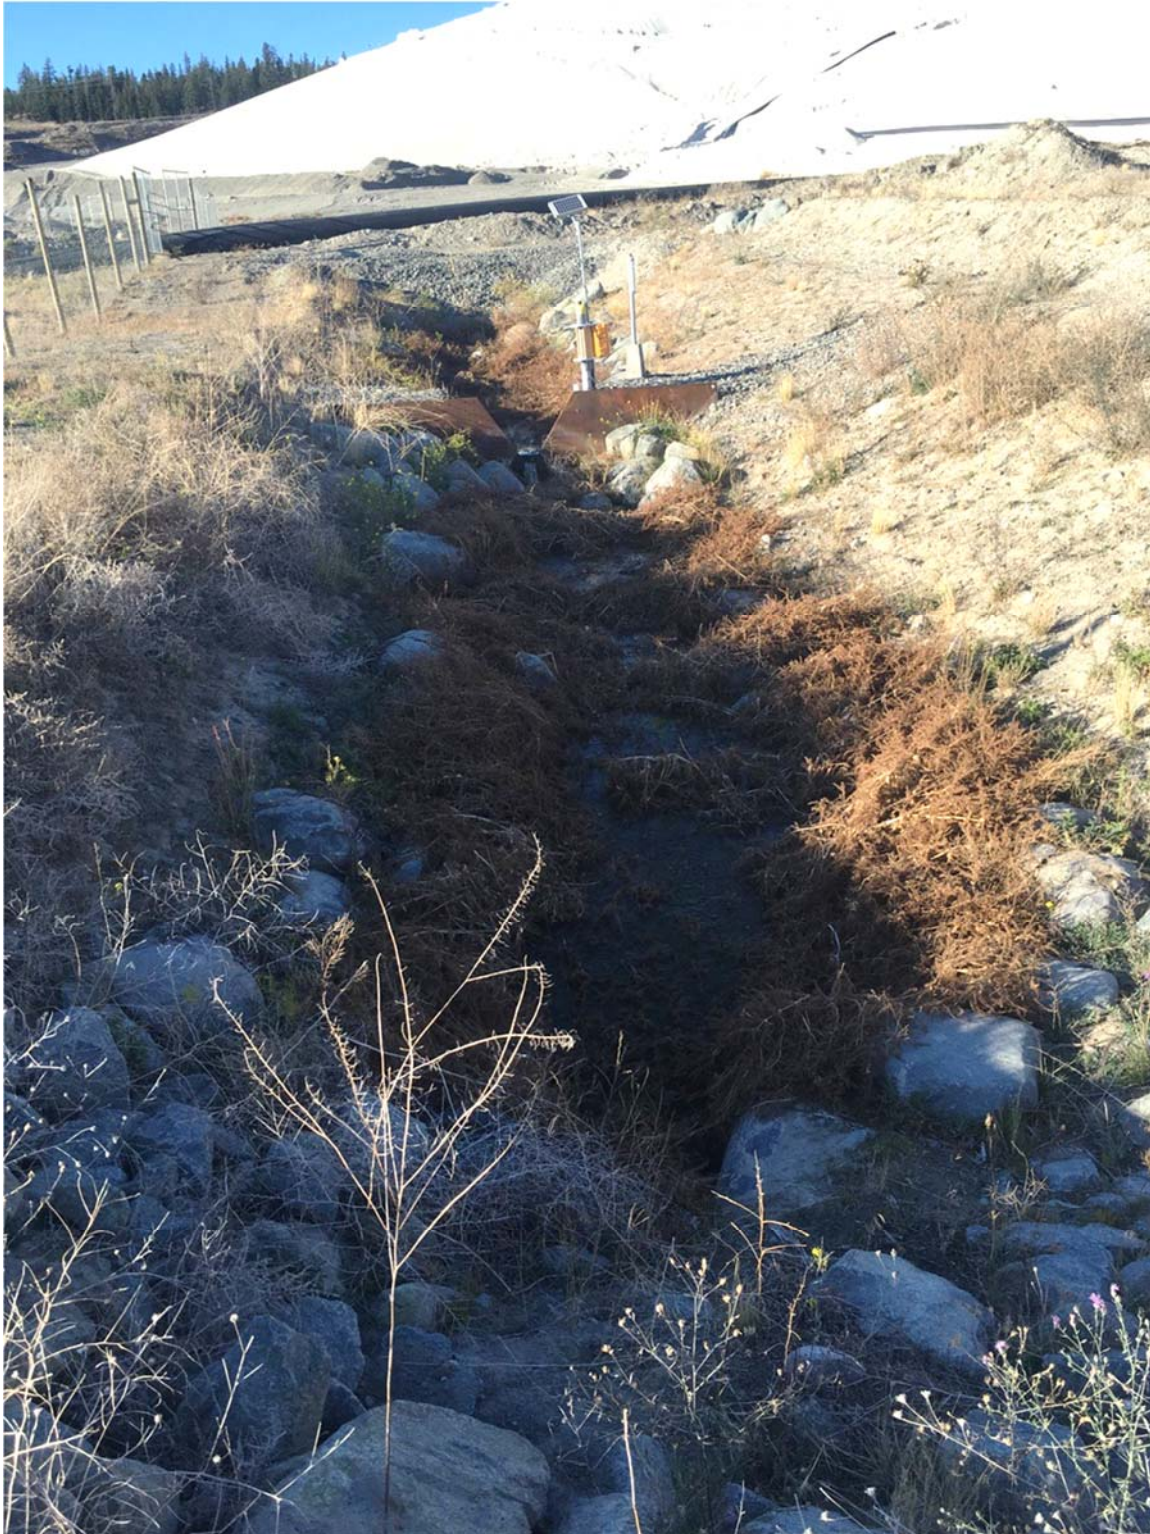
Photo II-A-23 Finger Drain No.1 Measuring Weir (LL—FS-01) (LL-2017-20)

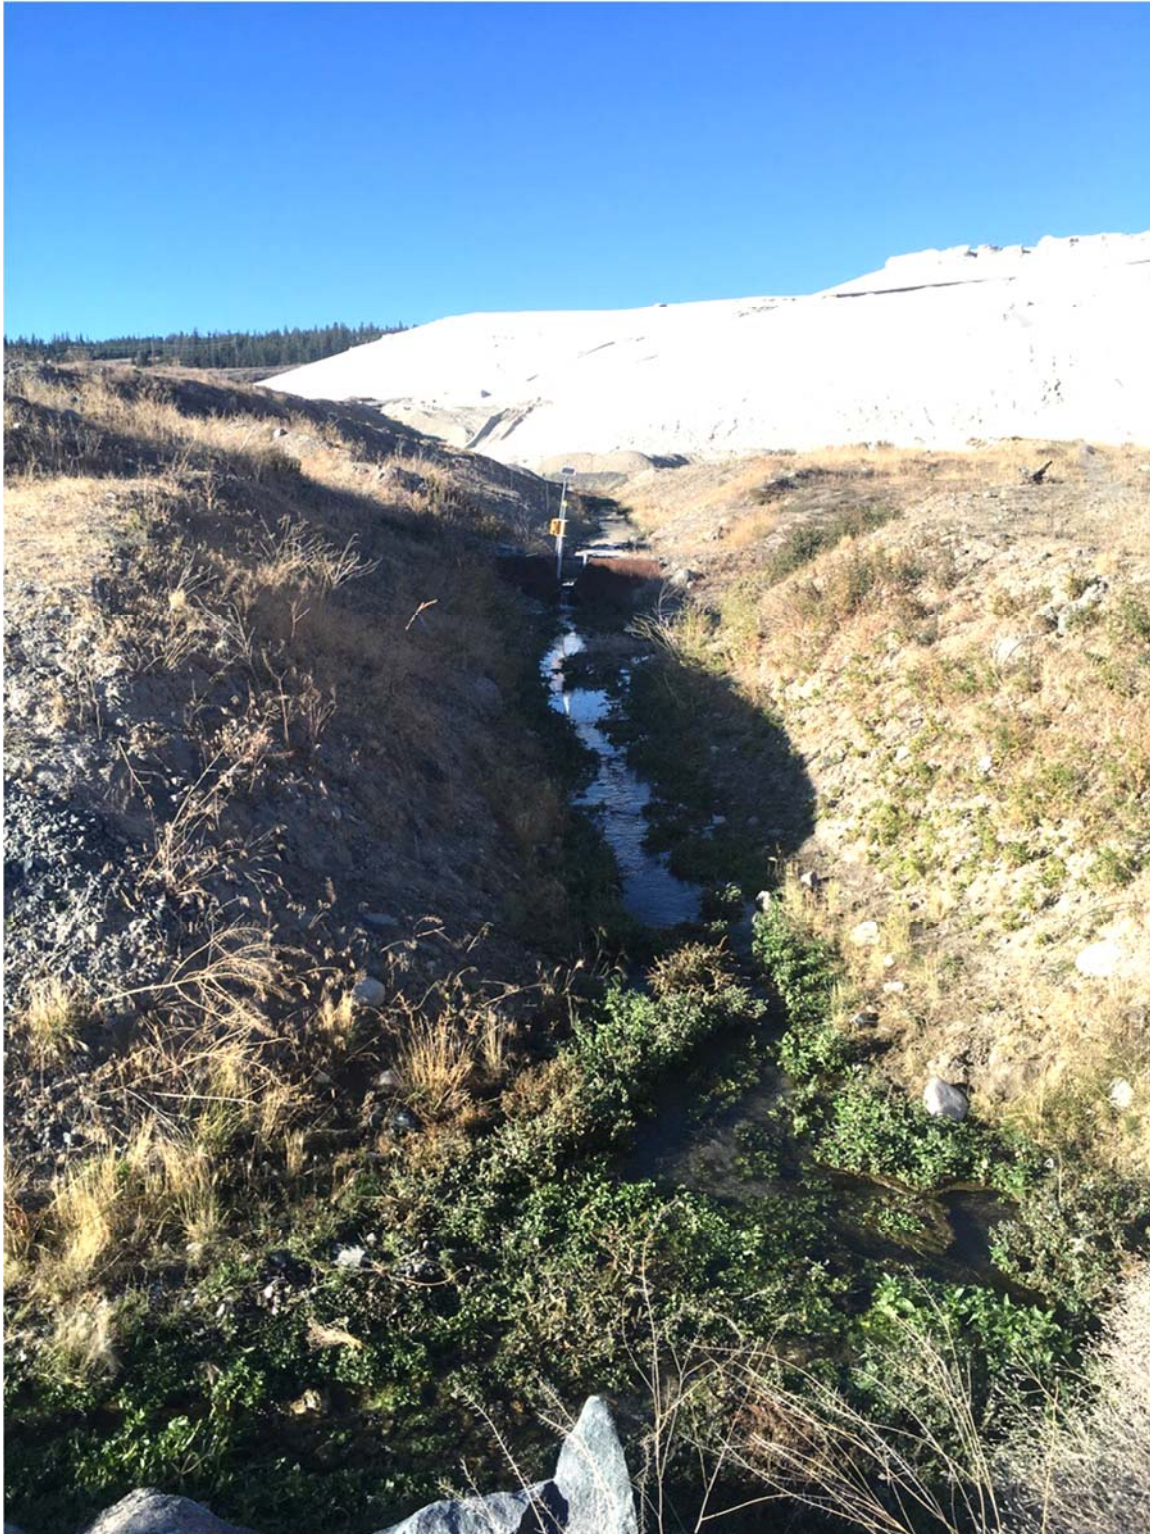
Photo II-A-24 UVD/LVD Drain Measuring Weir (LL—FS-02) (LL-2017-22)

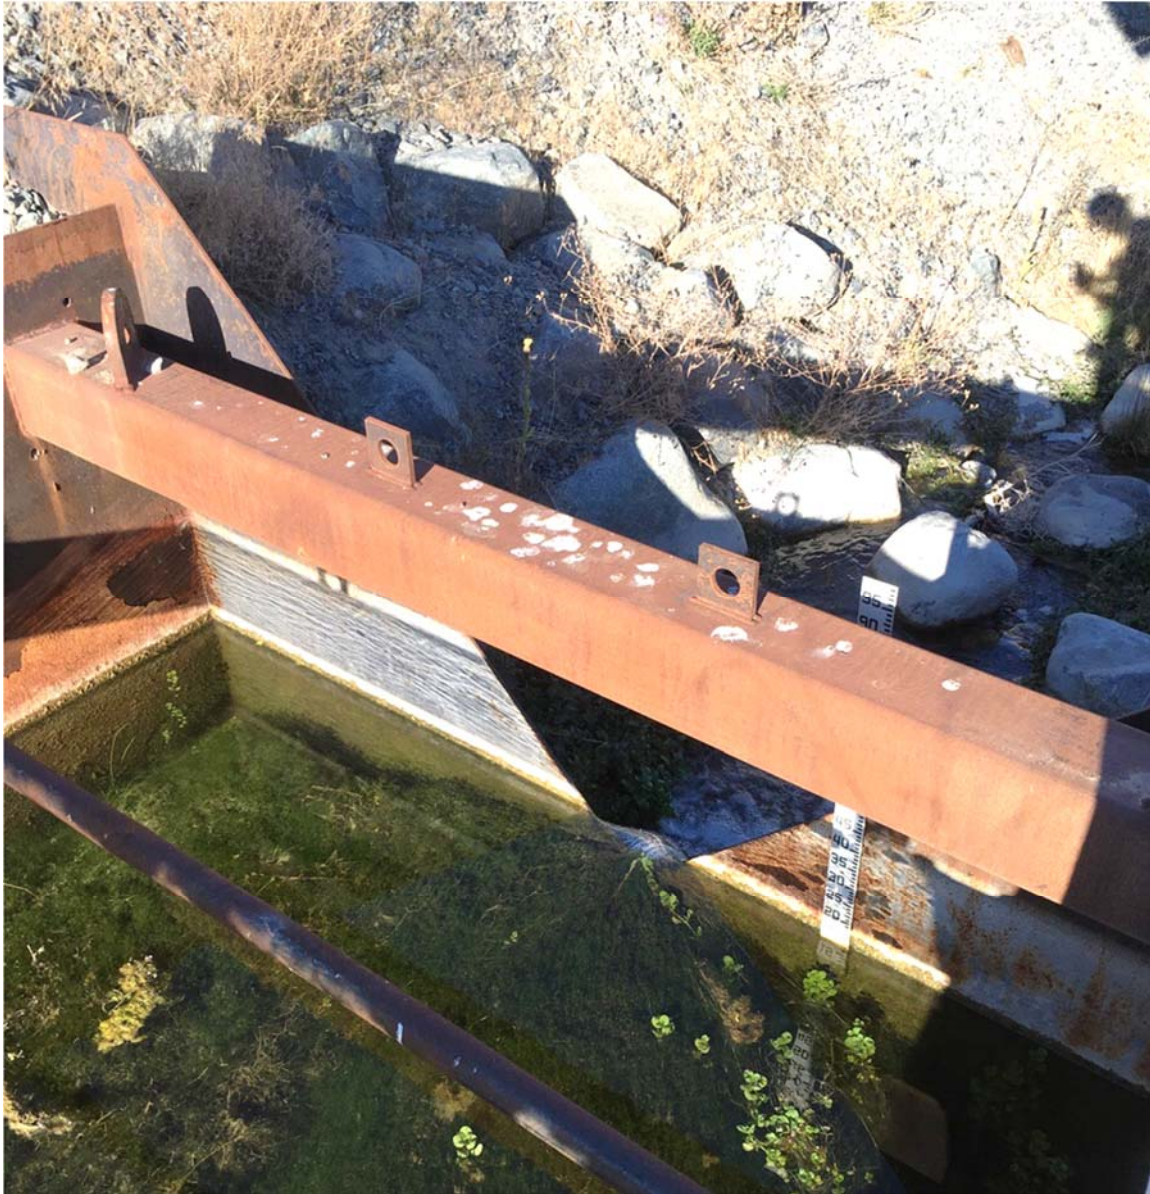
Photo II-A-25 Seepage Pond 2 Weir (LL—FS-04) (LL-2017-21)

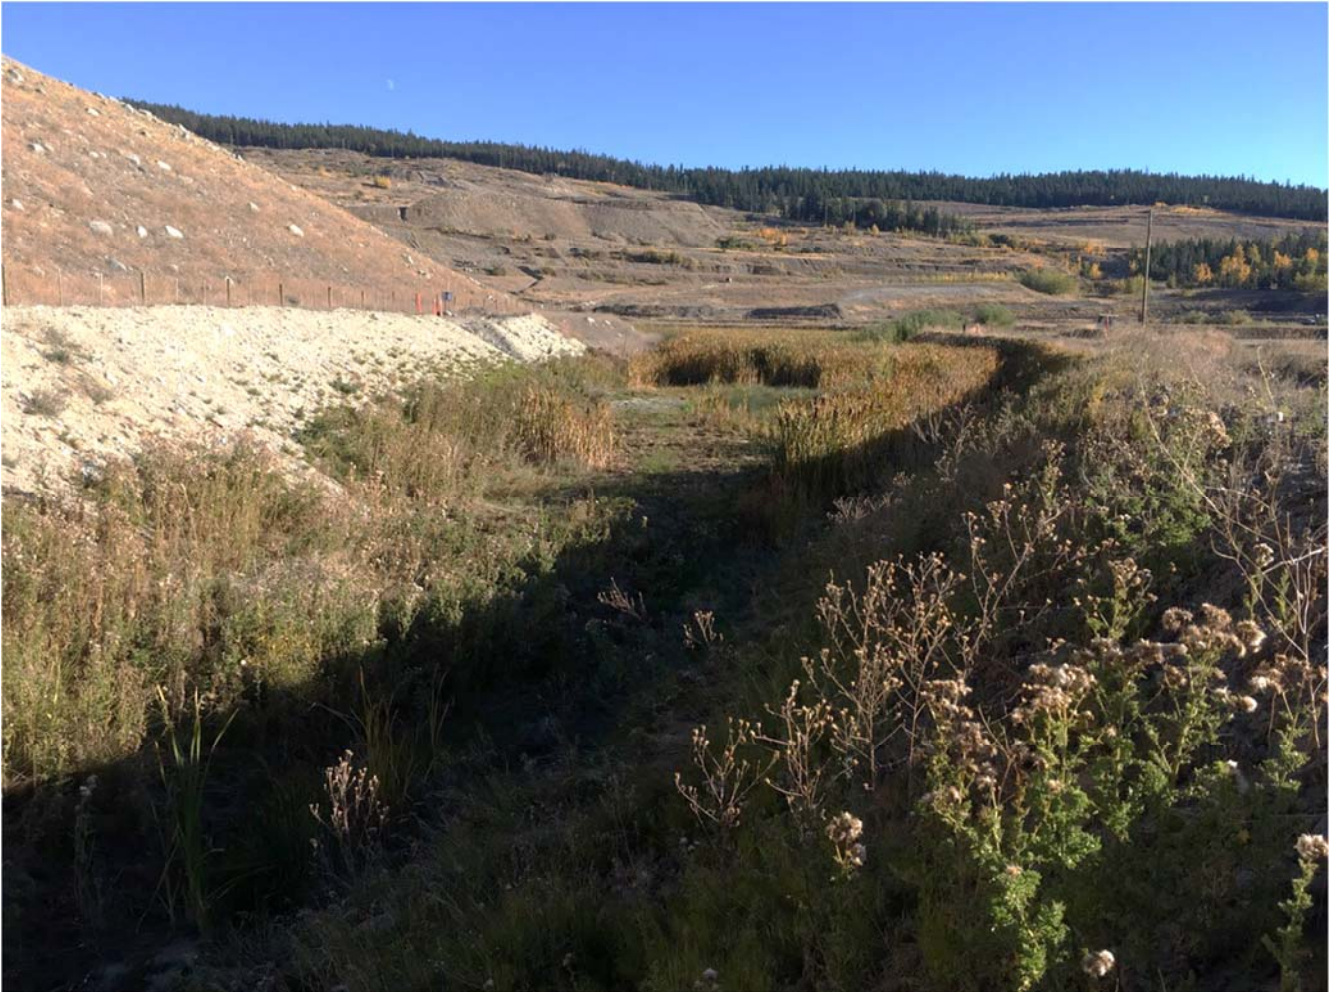
**Photo II-A-26 Point A Weir – No Flow, Overgrown by Vegetation and No Longer Functional (KCB3)
(LL-2017-23)**

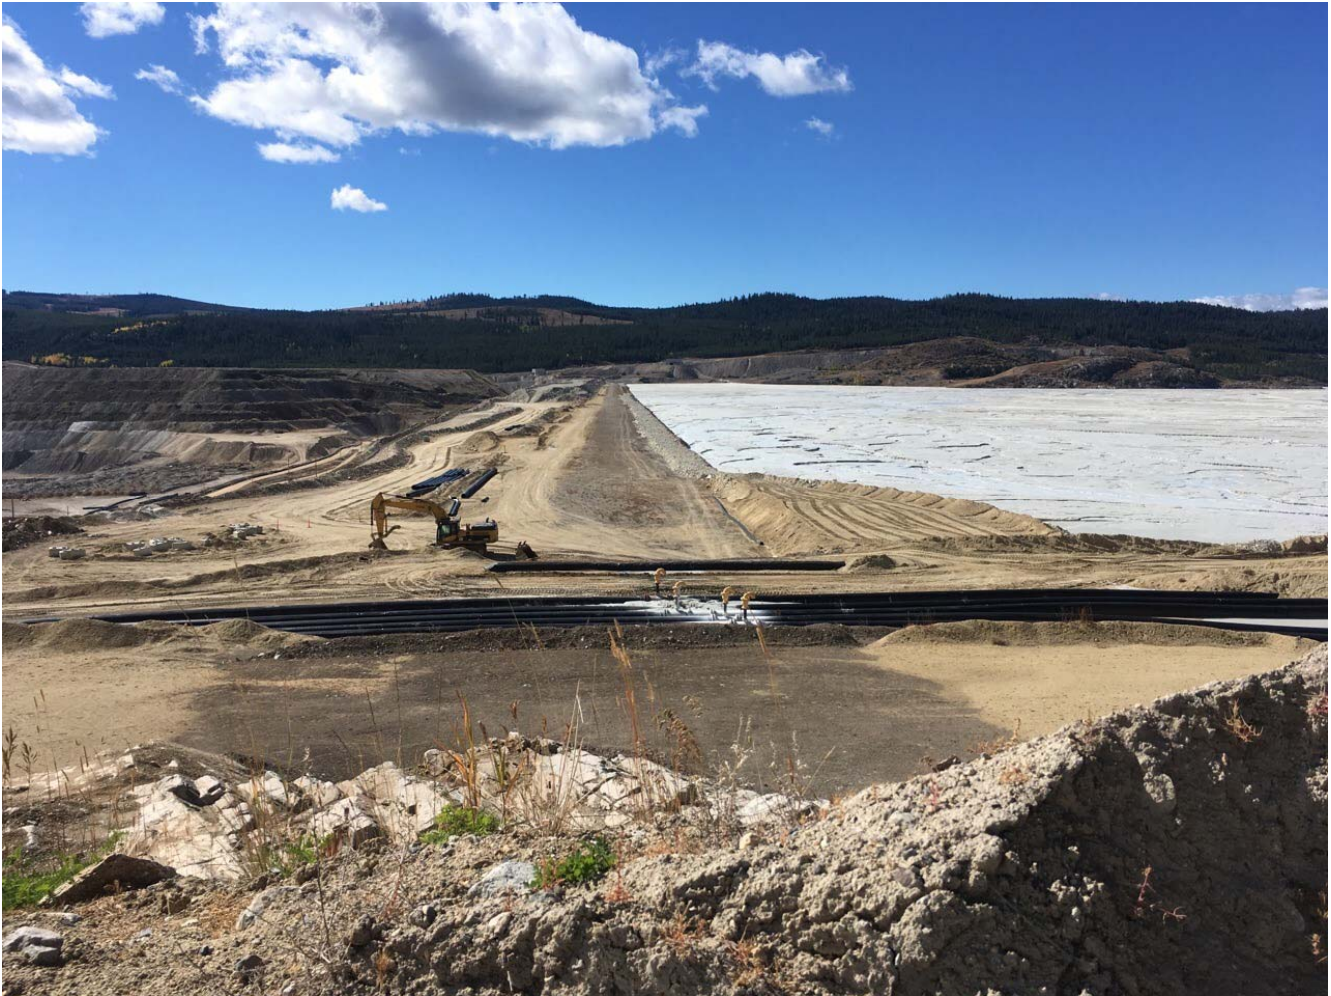
Photo II-B-2 Overview of Dam from East Abutment and Exposed Bedrock from 2015 Abutment Foundation Preparation Works (HH-2017-09)

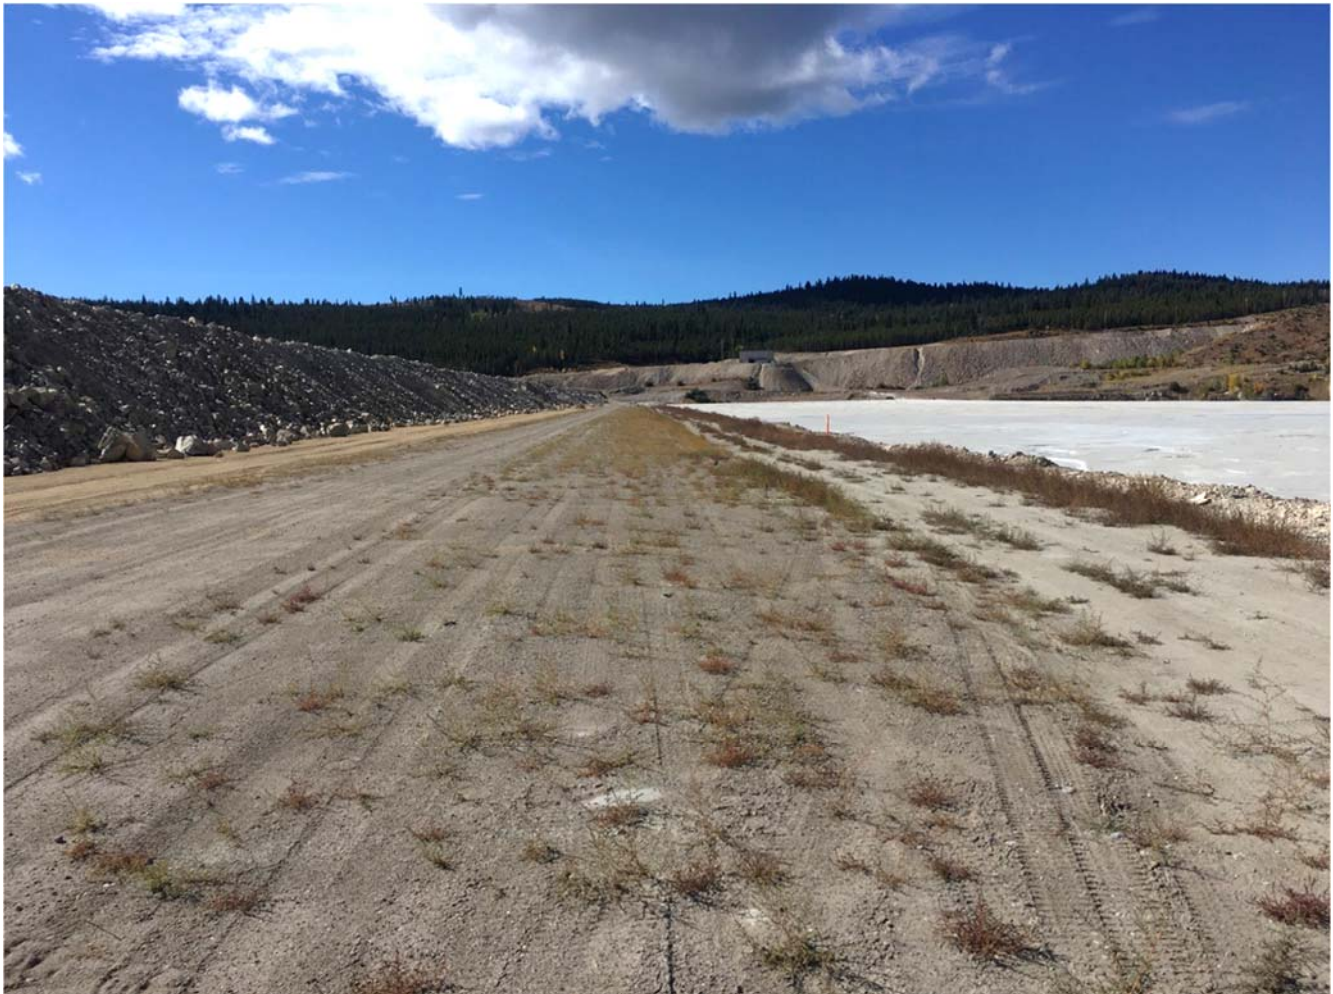
Photo II-B-3 Till Core Zone and RF1 Zone - Facing Southwest; sporadic vegetation growth (HH-2017-05)

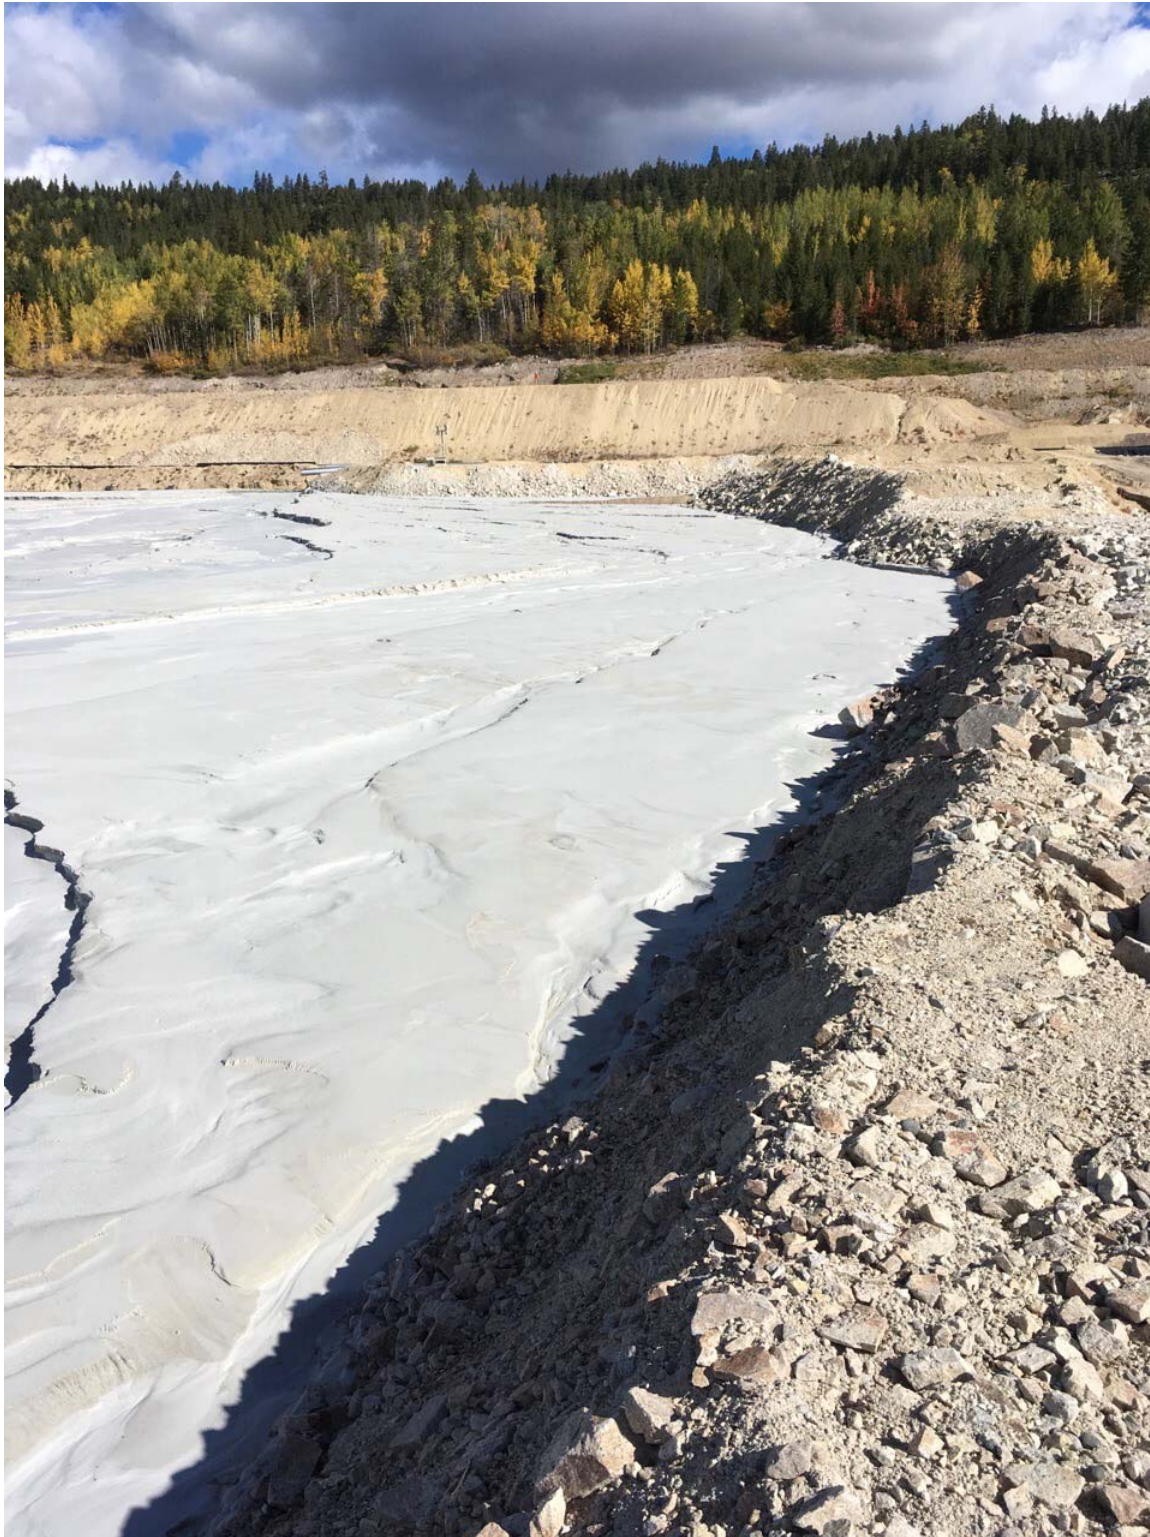
Photo II-B-8 Upstream Face of Dam - Facing Northeast; RF2/RF1 buffer zone on the upstream edge of dam crest, approx. 1 m high; available buffer is approx. 0.5 m (HH-2017-08)

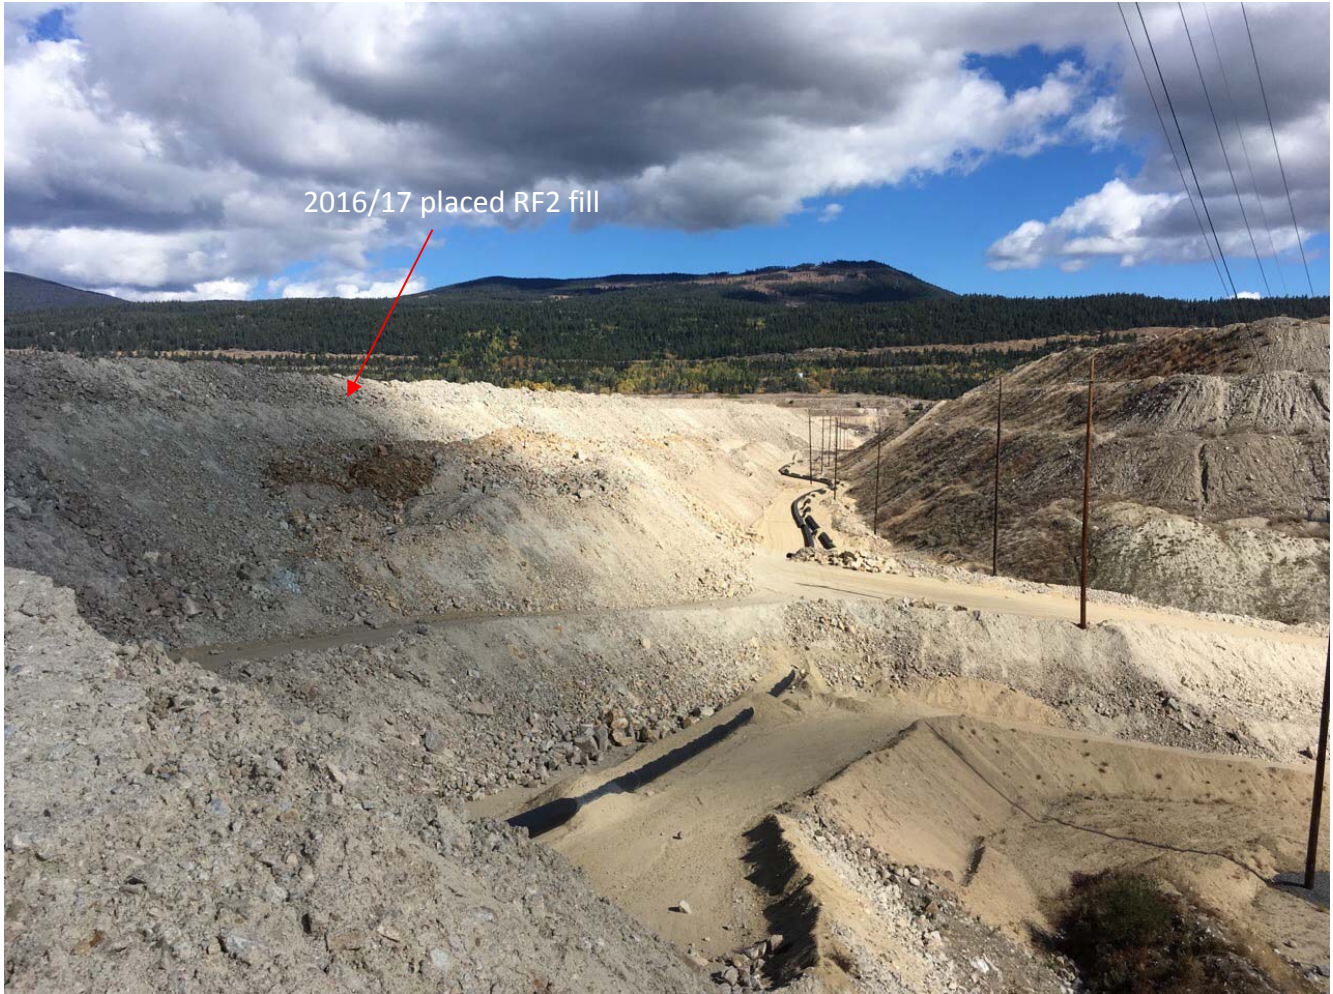
Photo II-B-9 Downstream Face of Dam - Facing Northeast (HH-2017-02)

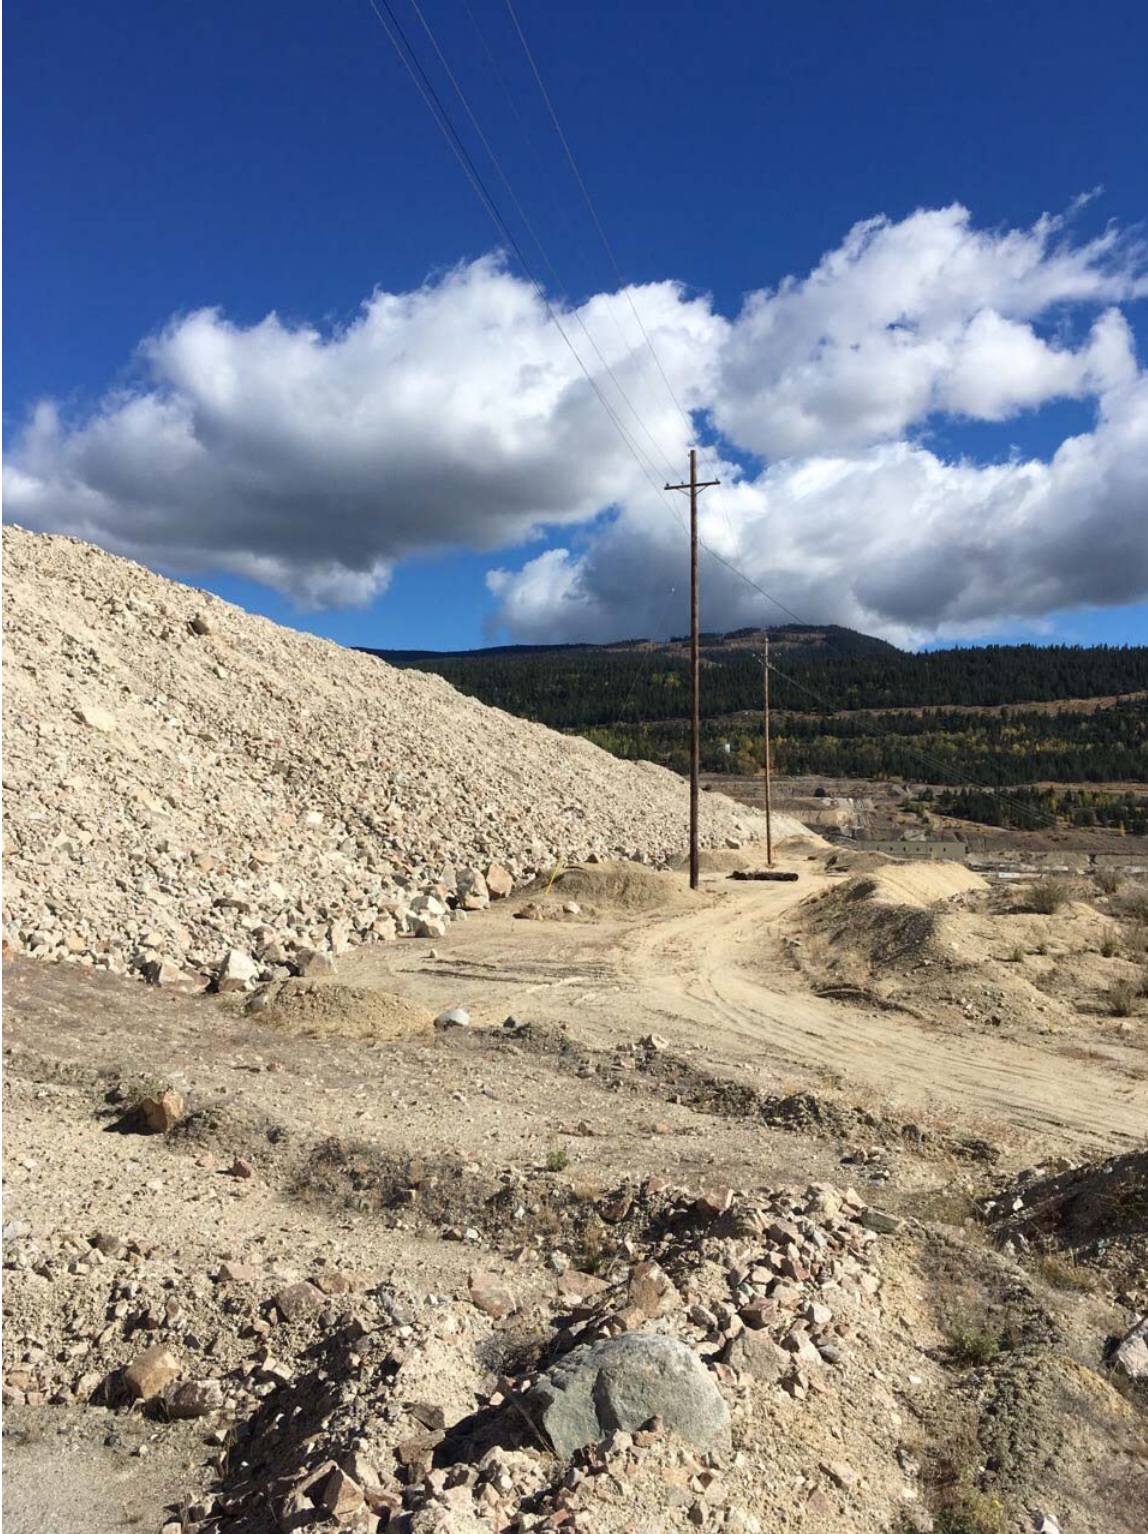
Photo II-B-10 Downstream Face of Dam - Facing Northeast (HH-2017-15)

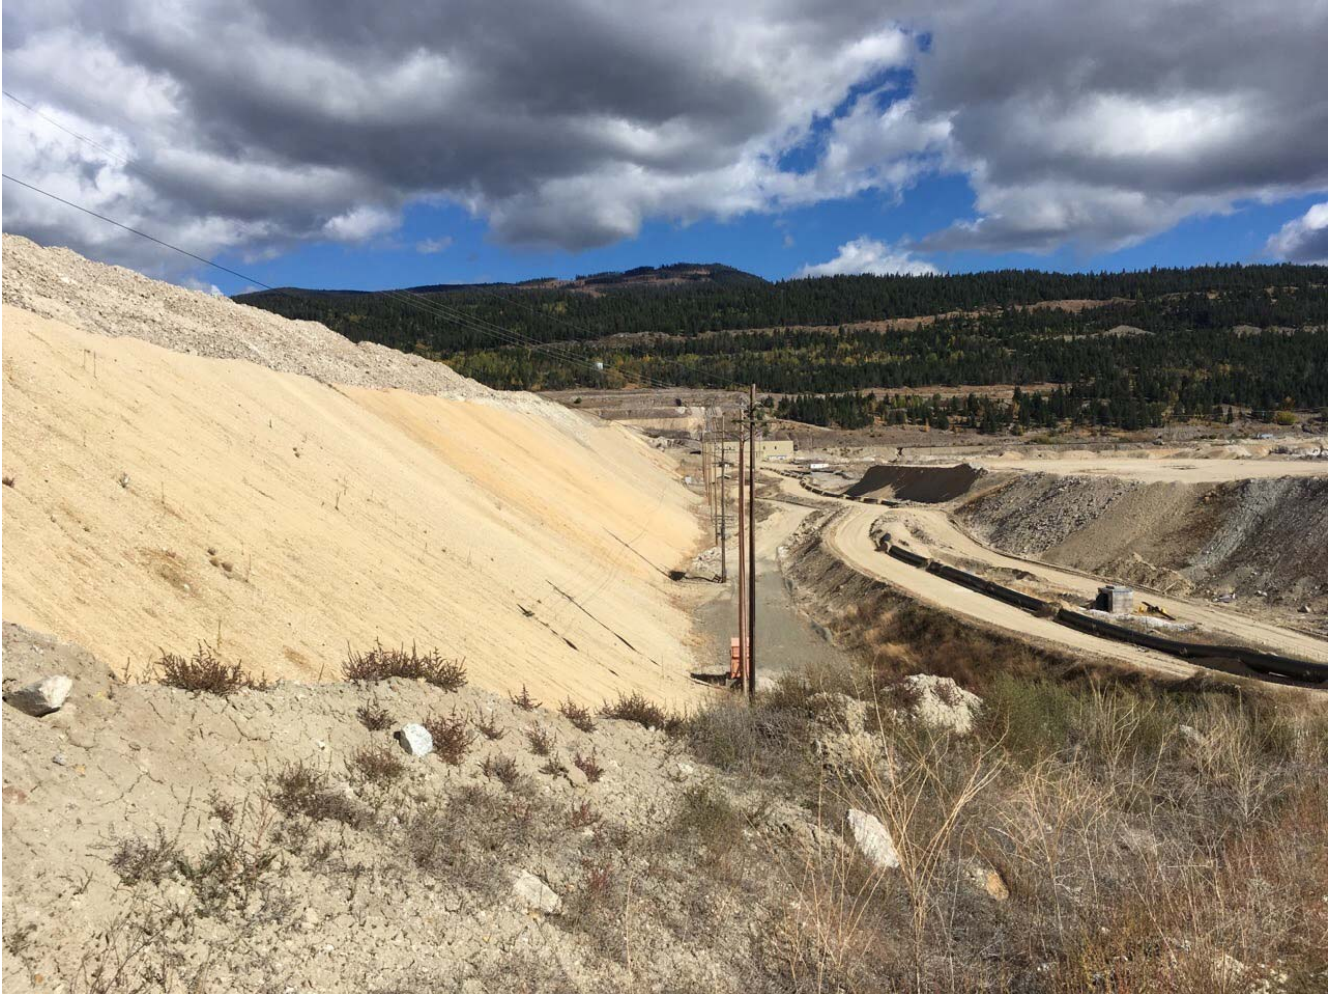
Photo II-B-11 Downstream Toe of Dam - Facing Northeast (HH-2017-14)
