Teck Highland Valley Copper Partnership

2017 Dam Safety Inspection Report

Highland Tailings Storage Facility

March 2018

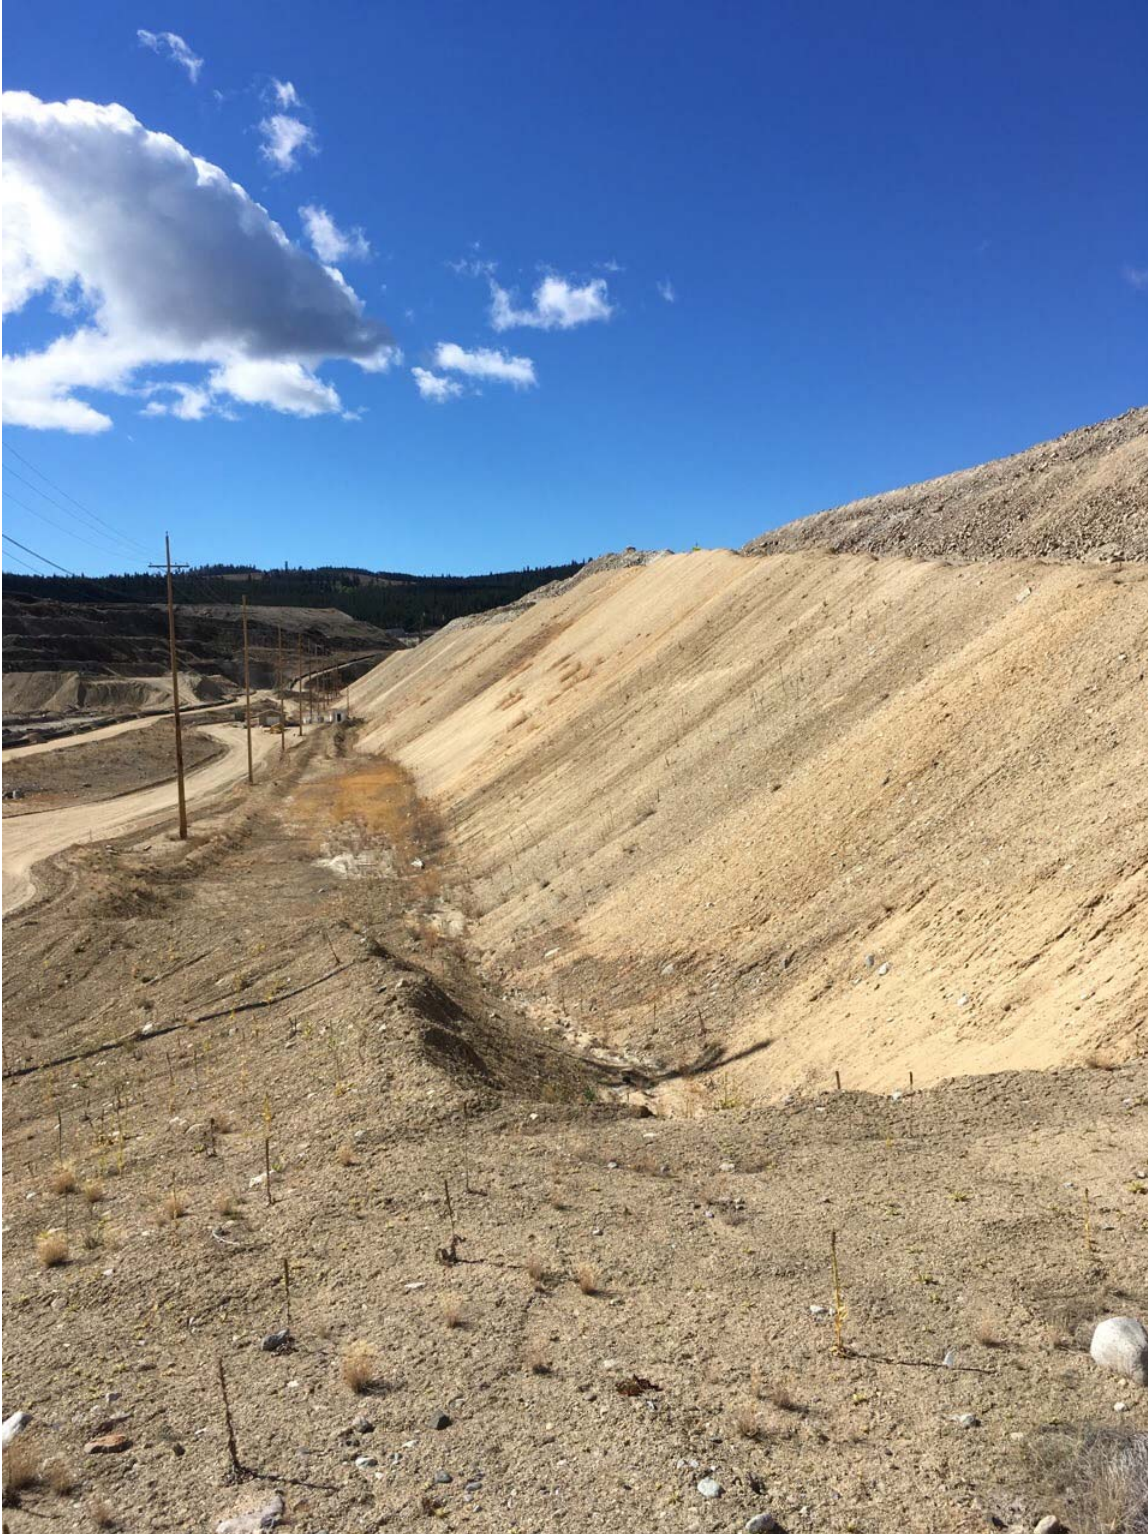
Photo II-B-12 Downstream Toe of Dam - Facing West (HH-2017-13)

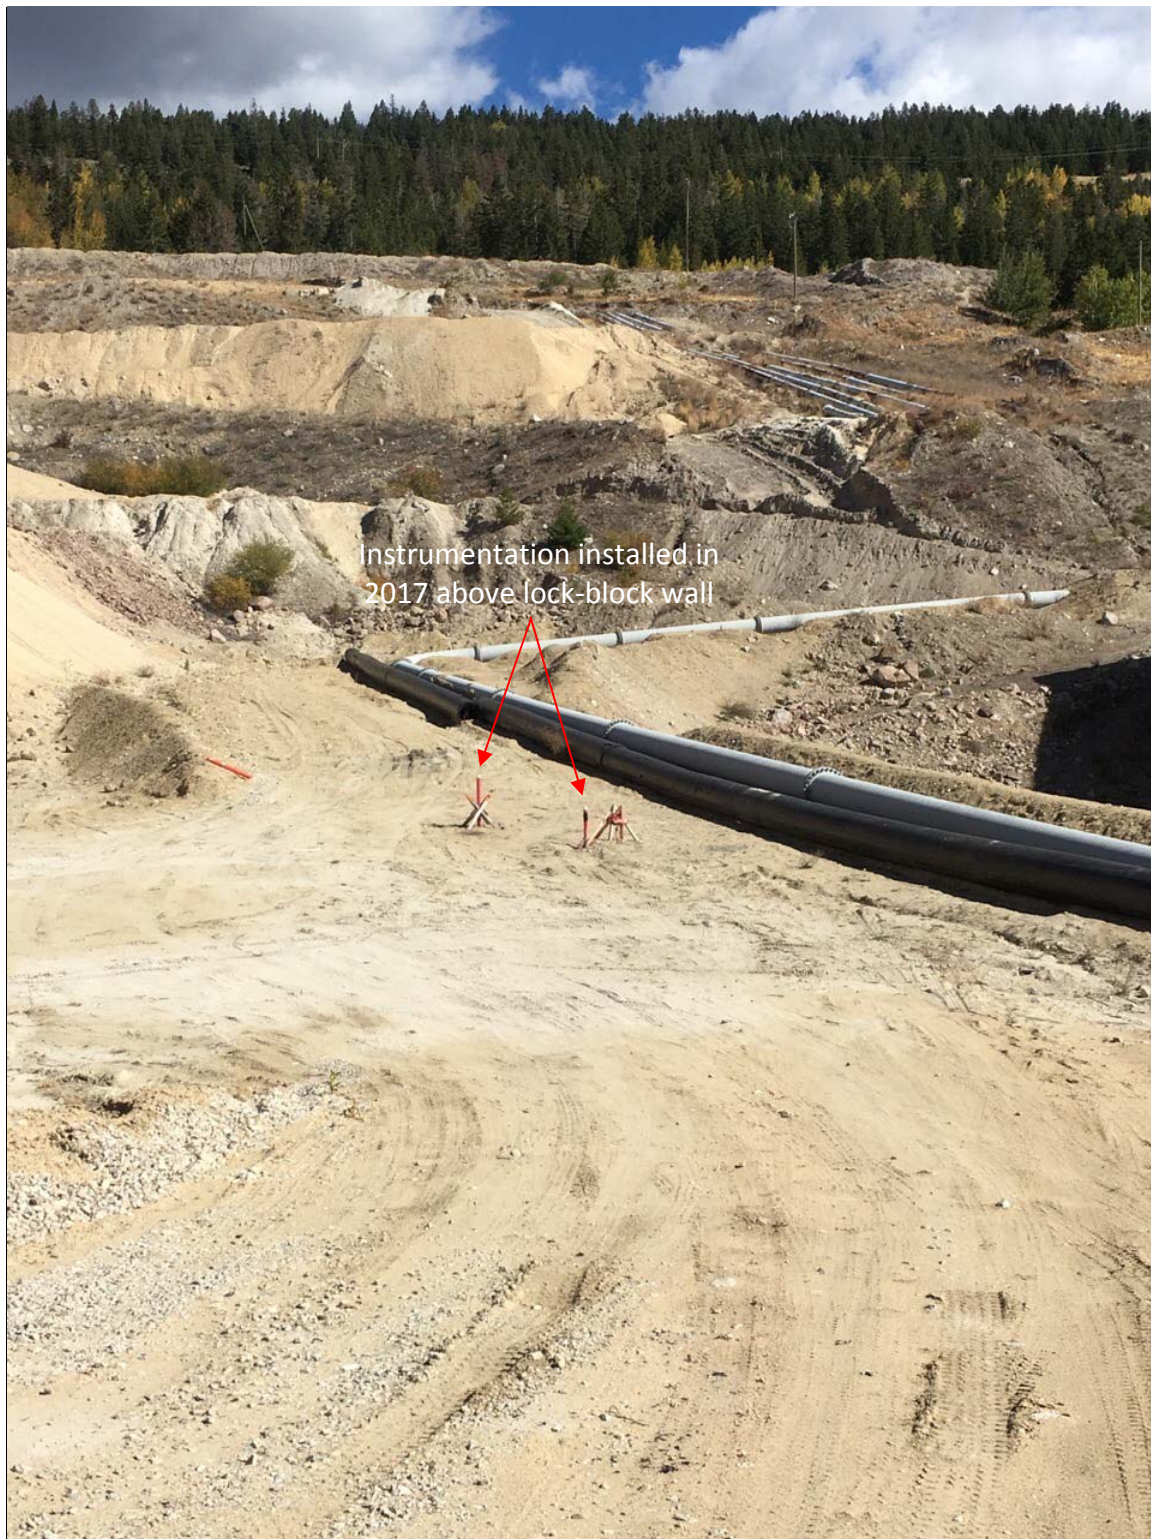
Photo II-B-13 East Abutment - Facing Northeast; new VWP, inclinometer and settlement system installed in 2017 behind the H-H Pumphouse lock-block retaining wall (HH-2017-12)

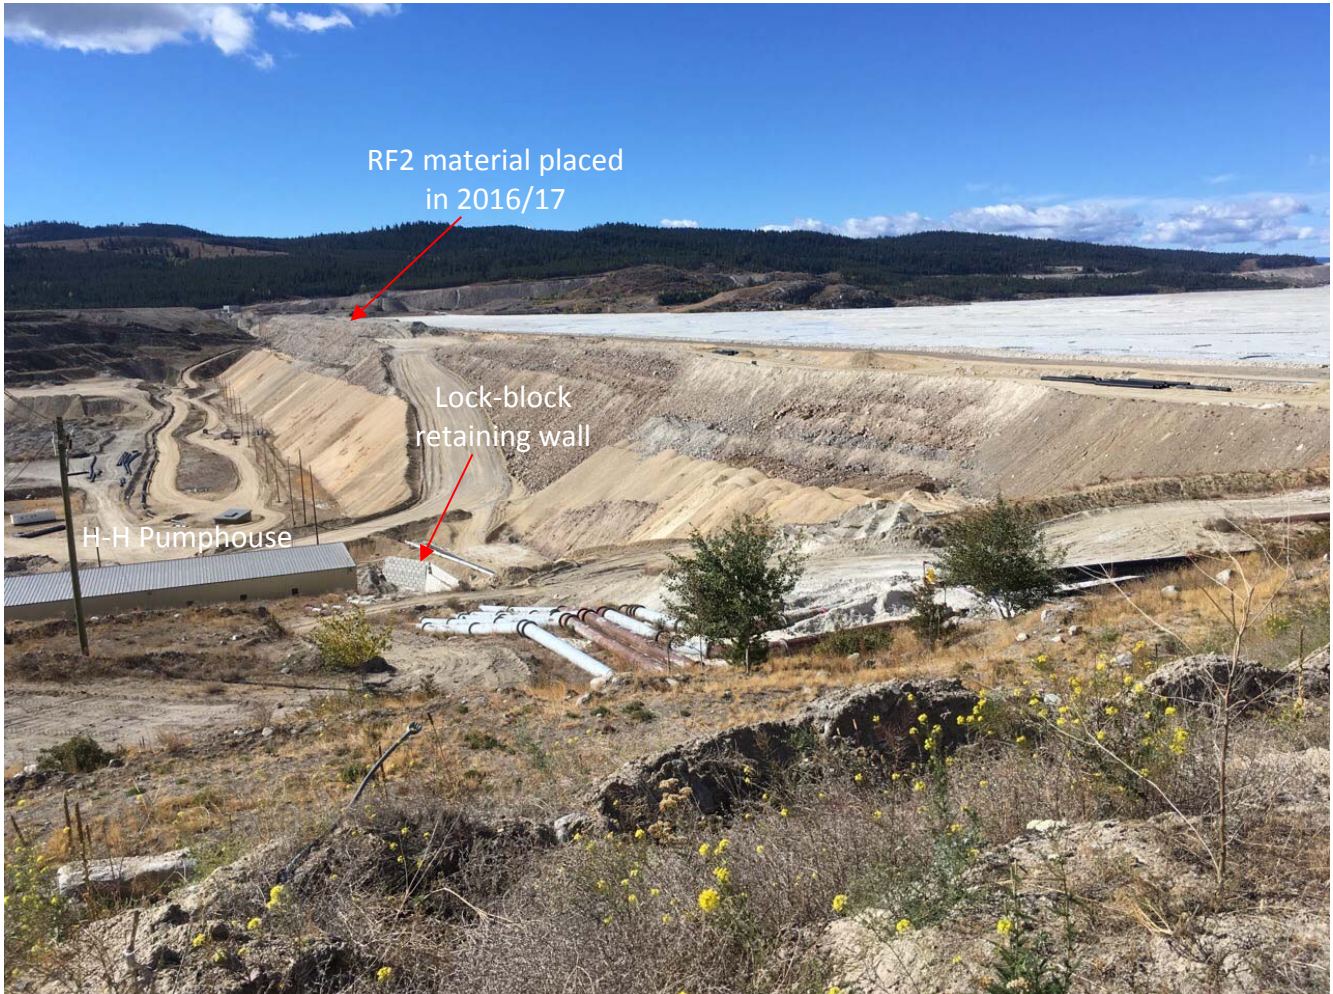
Photo II-B-14 Downstream Face of Dam - Facing West (HH-2017-10)

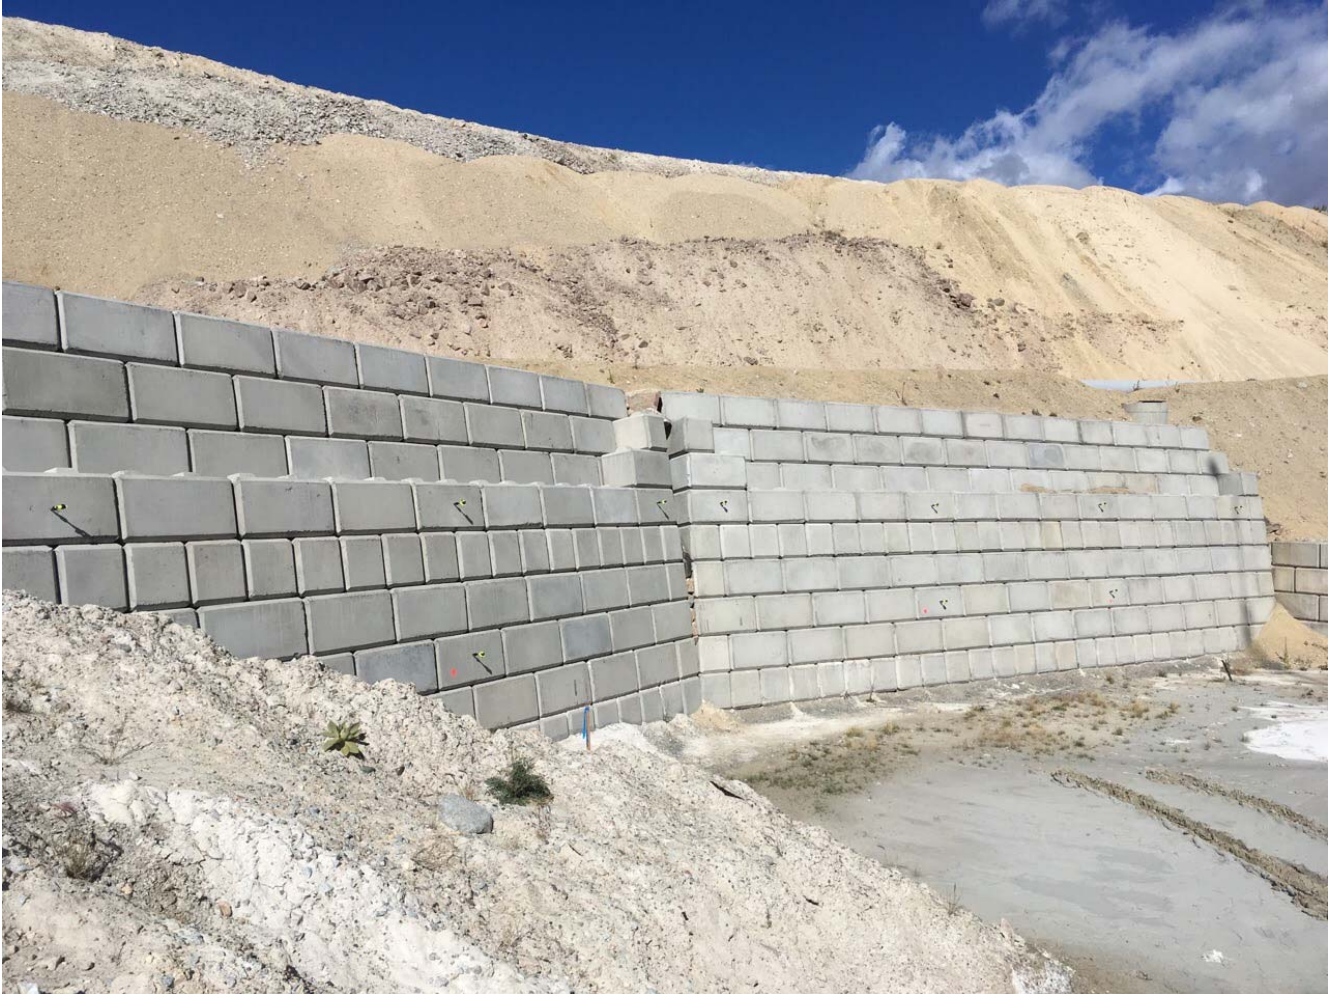
Photo II-B-15 Lock-block Retaining Wall at Toe of Dam; new survey prisms (HH-2017-11)

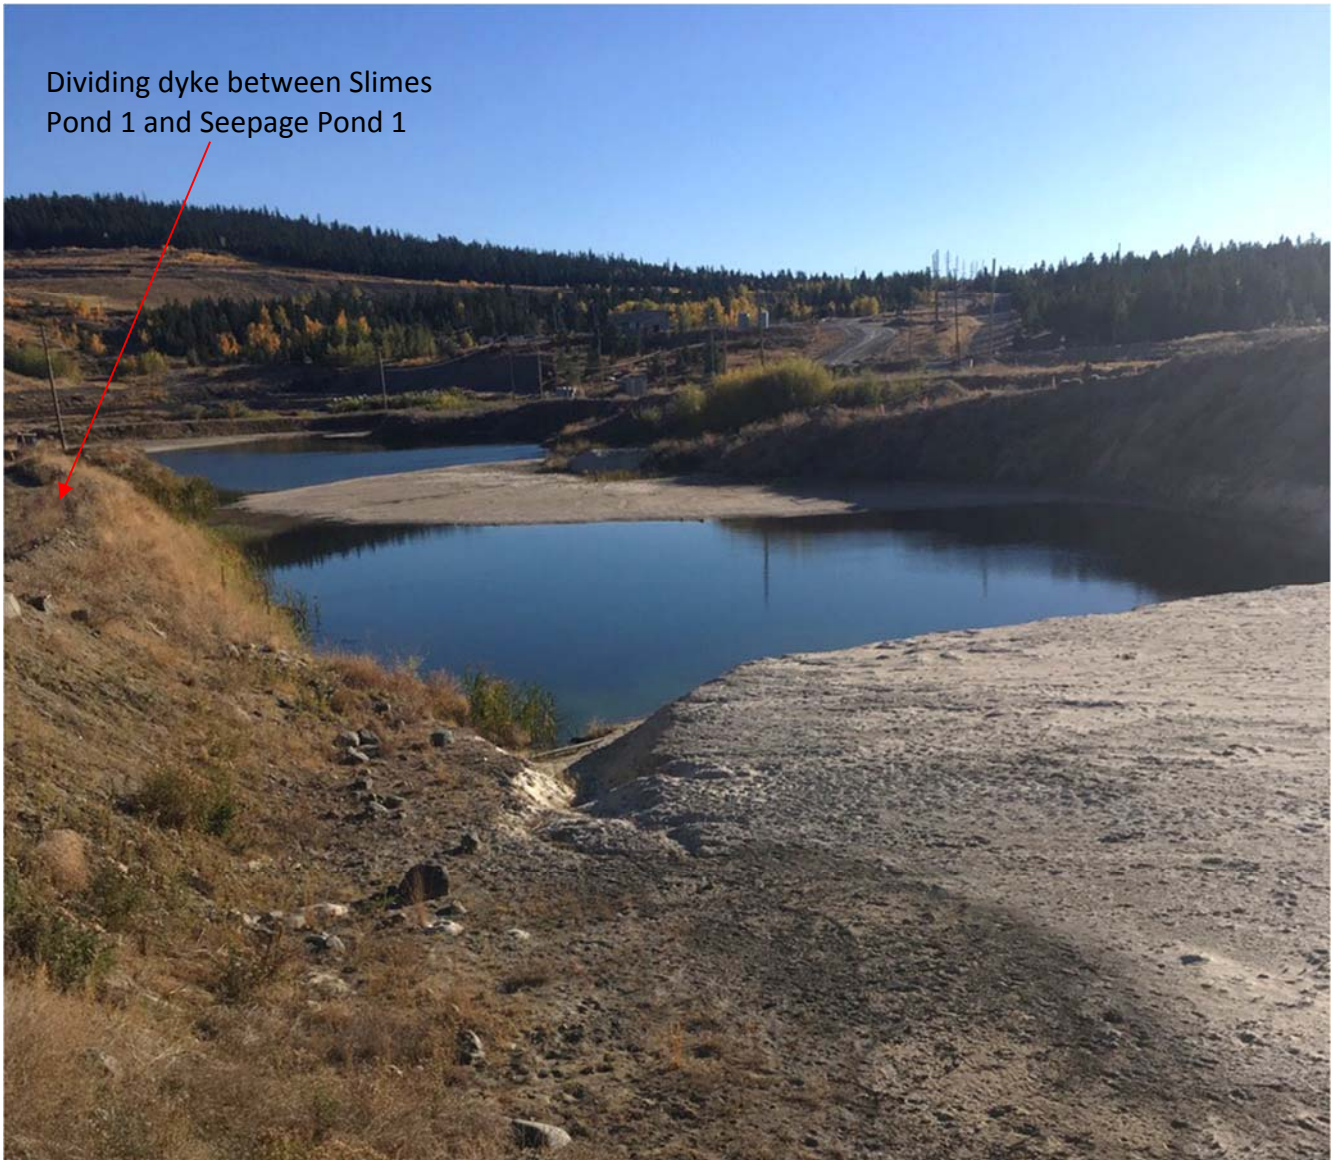
Photo II-C-2 Slimes Pond 1 – Facing South (SS-2017-04)

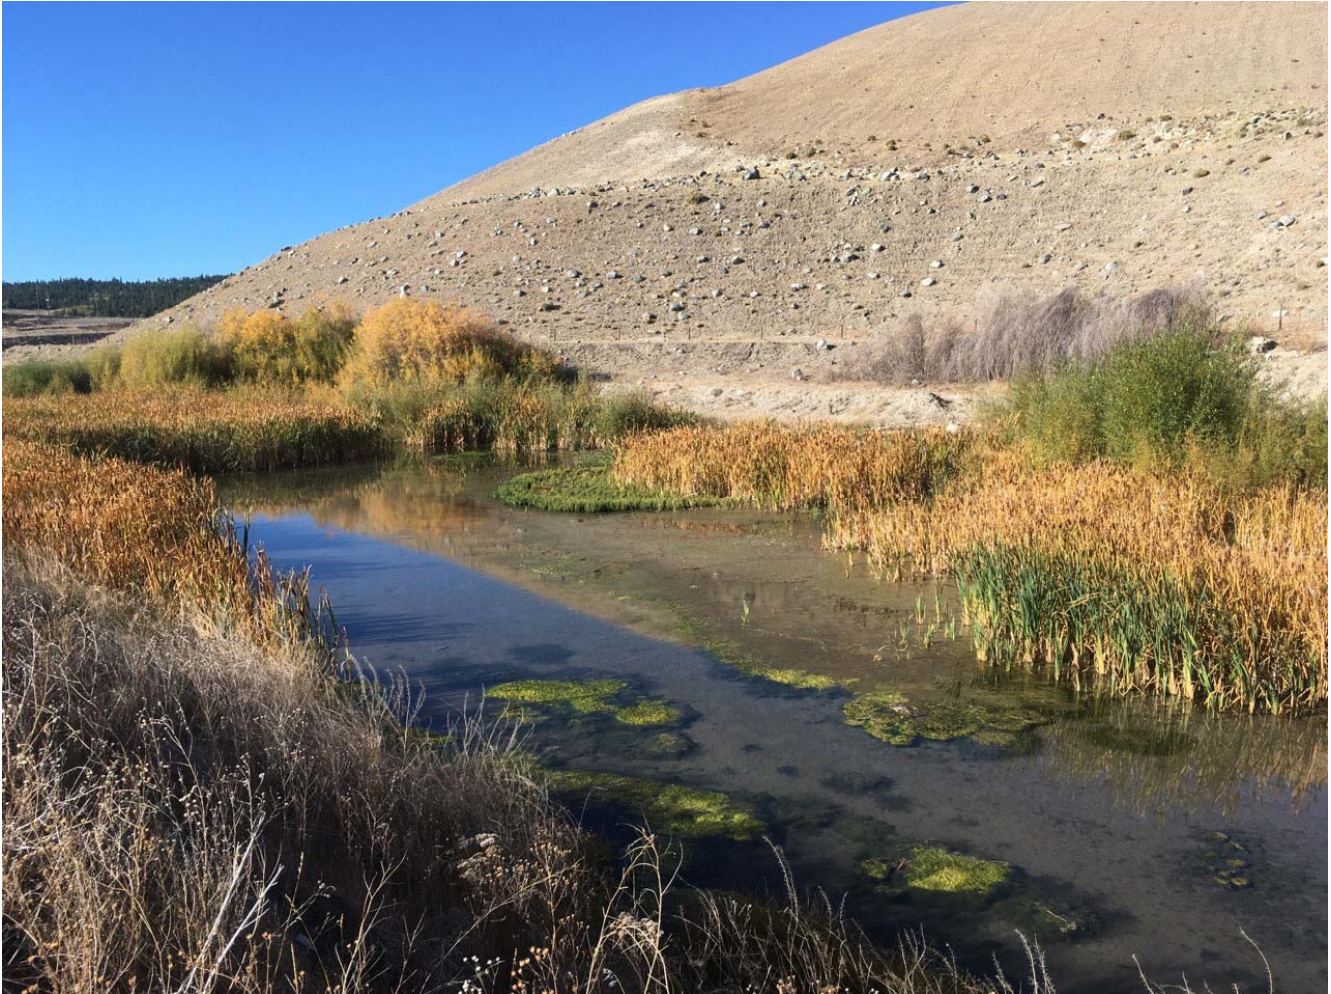
Photo II-C-4 South End of Seepage Pond 1 – Facing Northwest (SS-2017-03)

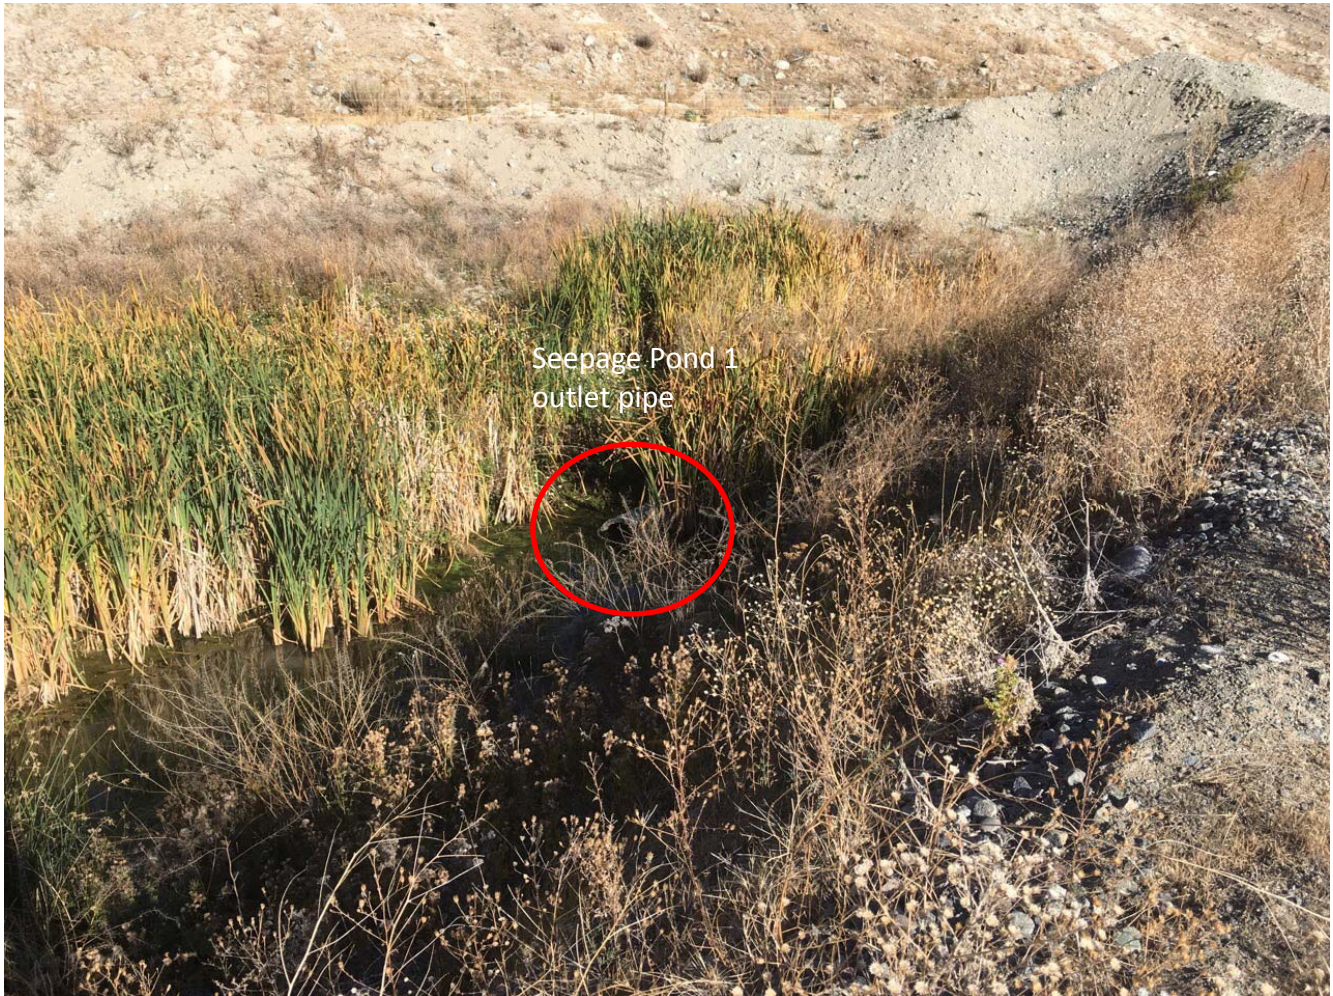
Photo II-C-5 Seepage Pond 1 Outlet (SS-2017-03)

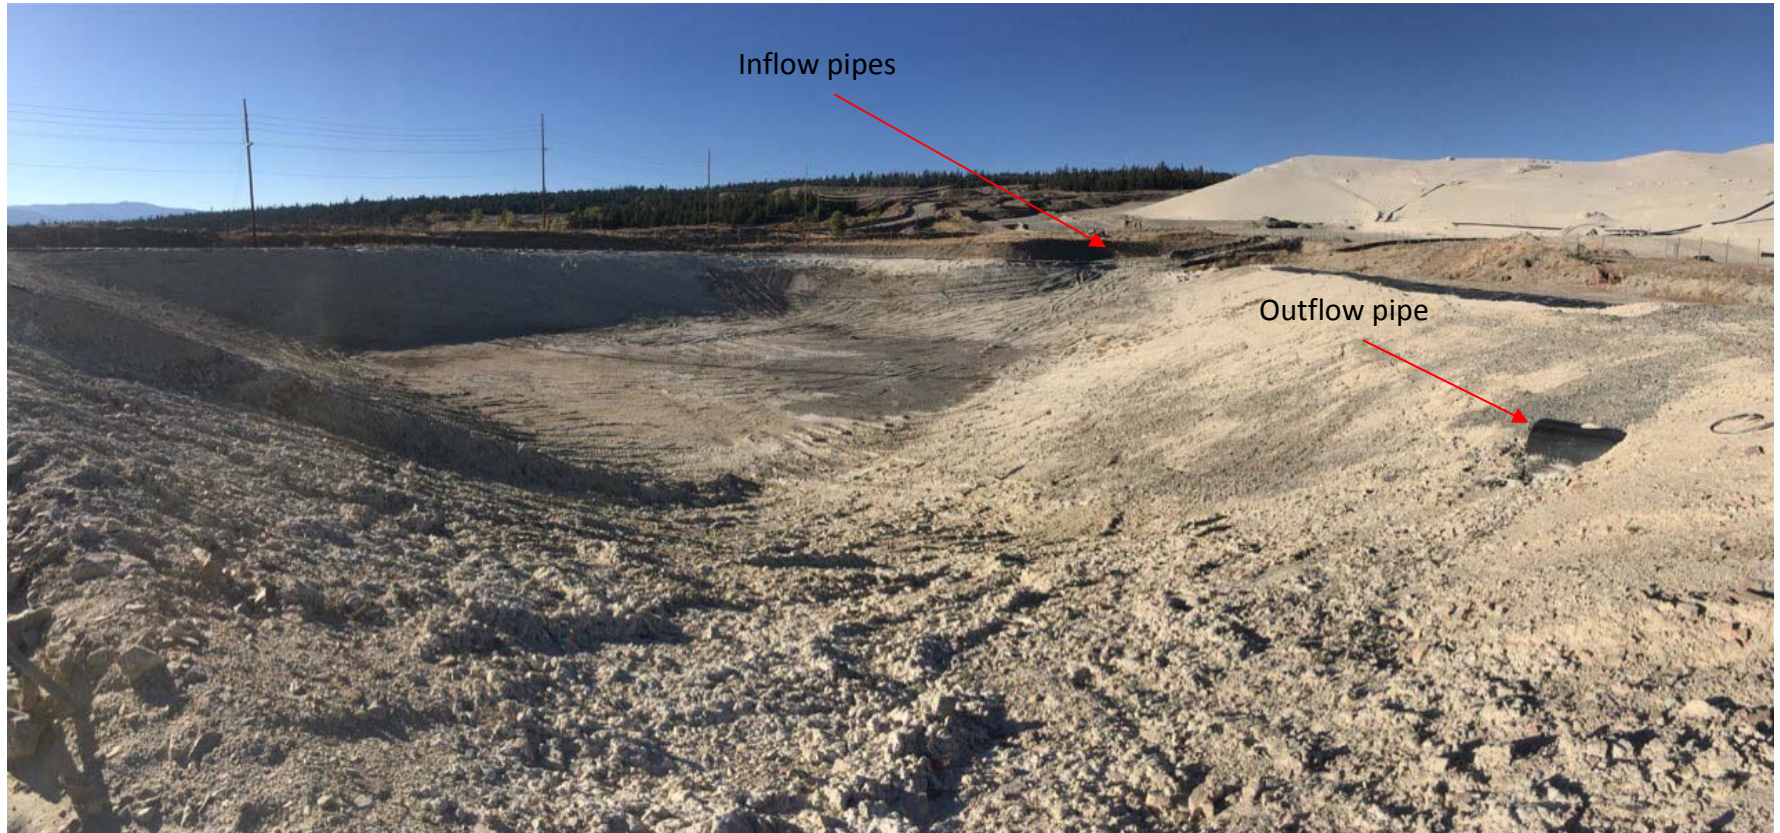
Photo II-C-6 Slimes Pond 2 – Slimes excavate/removed in 2017 – Facing North (SS-2017-05)

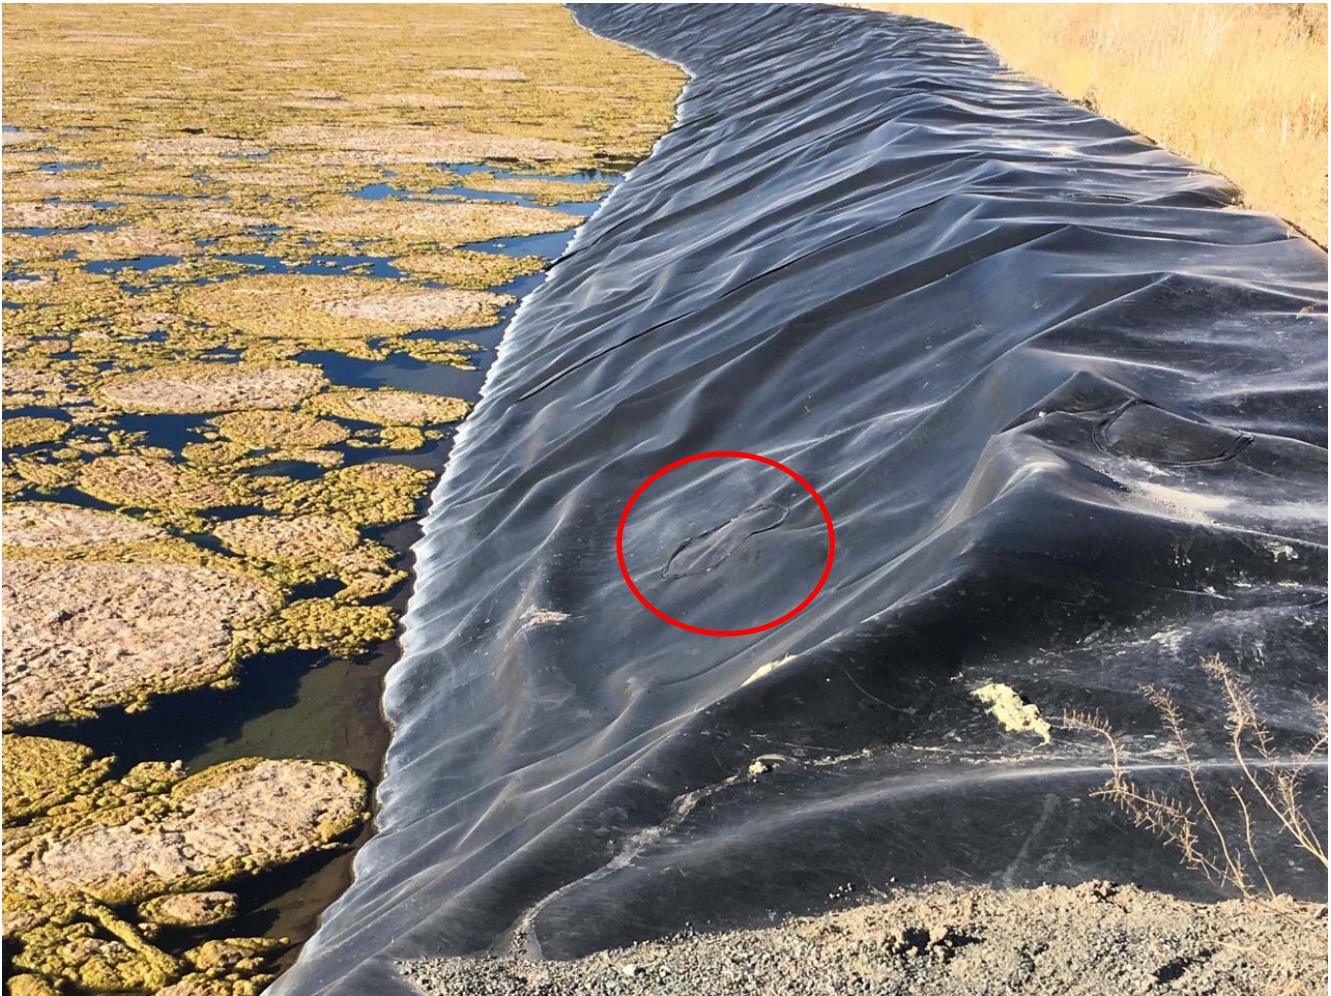
Photo II-C-11 Seepage Pond 2 Tear in Liner Repaired in 2017 – On east side of pond (SS-2017-08)

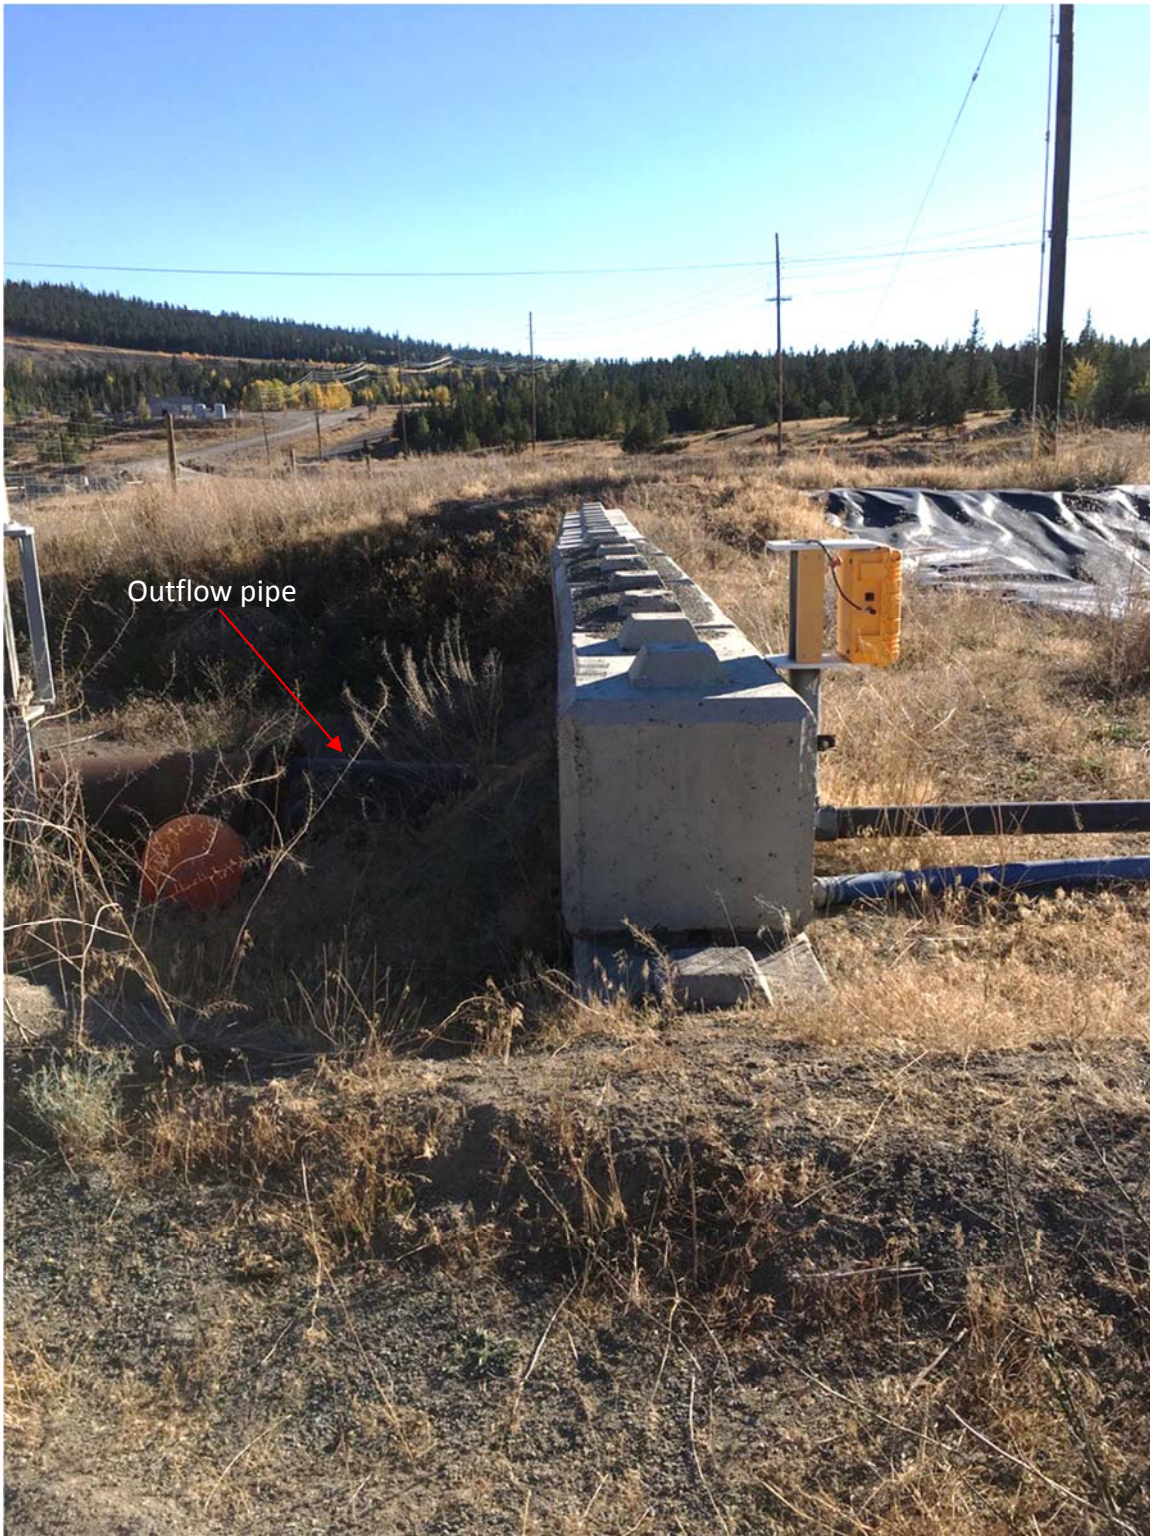
Photo II-C-12 Seepage Pond 2 Outlet Pipe and Lock-block Wall (SS-2017-07)

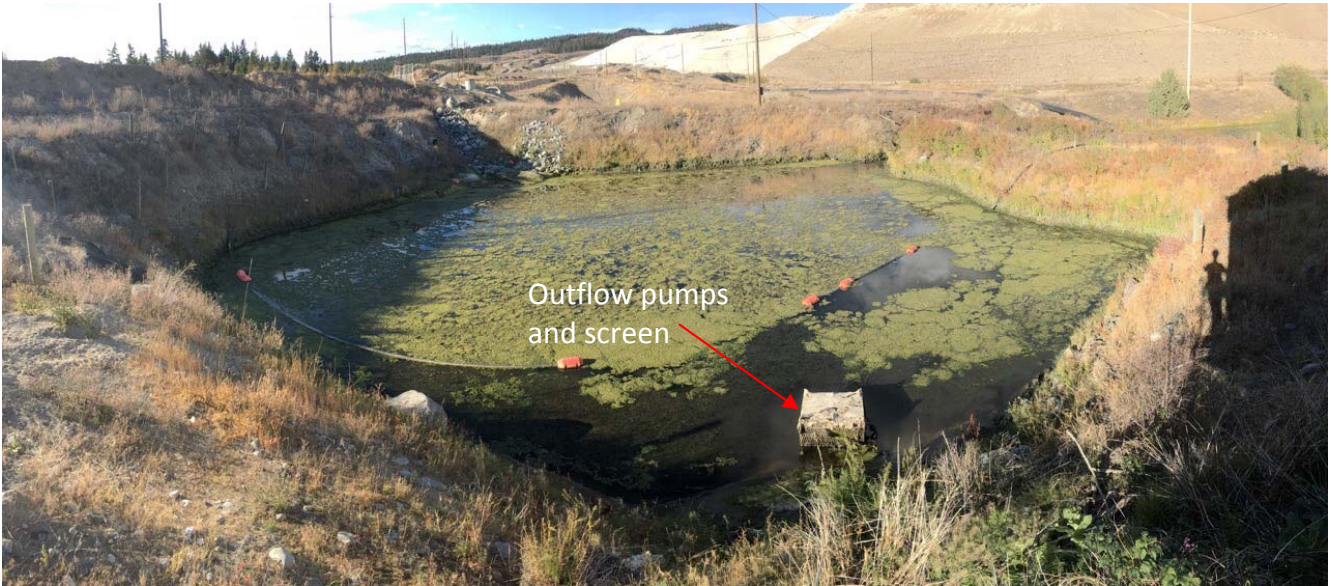
Photo II-C-13 Seepage Water Reclaim Pond – Facing North (SS-2017-09)

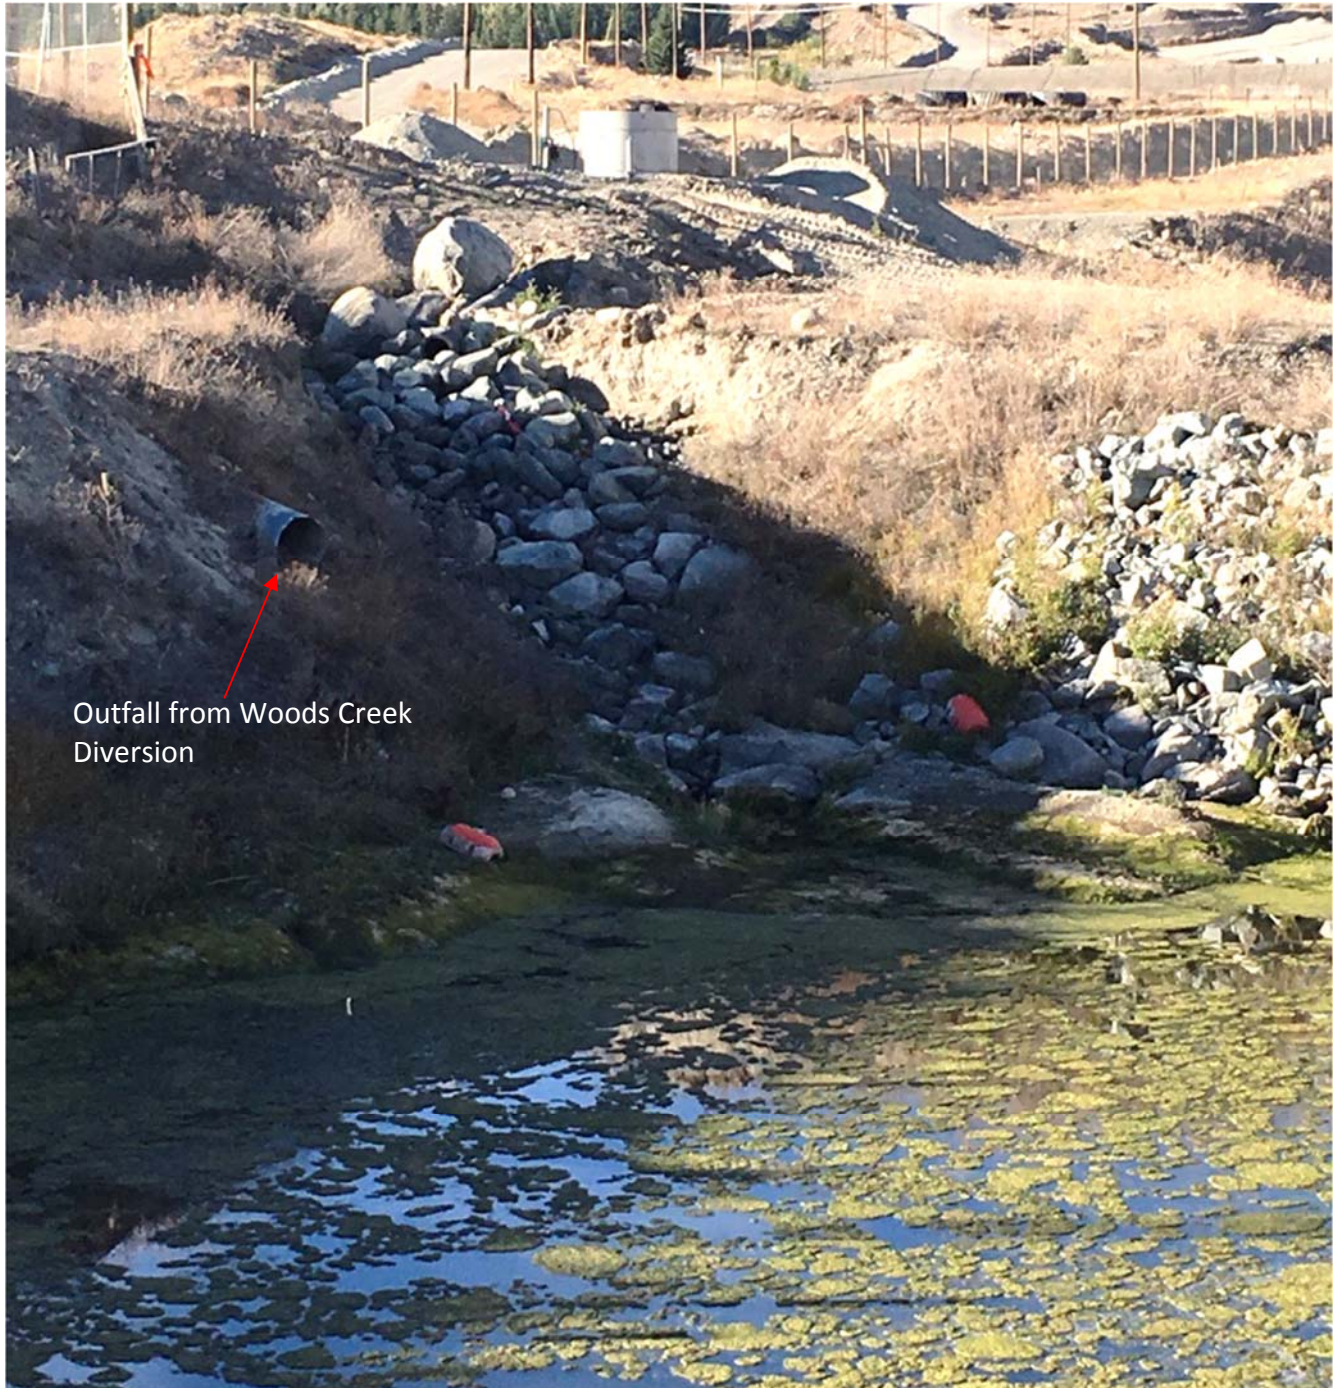
Photo II-C-14 Seepage Water Reclaim Pond – Outfall from Woods Creek Diversion – Facing Northwest (SS-2017-09)

Outfall from Woods Creek
Diversion

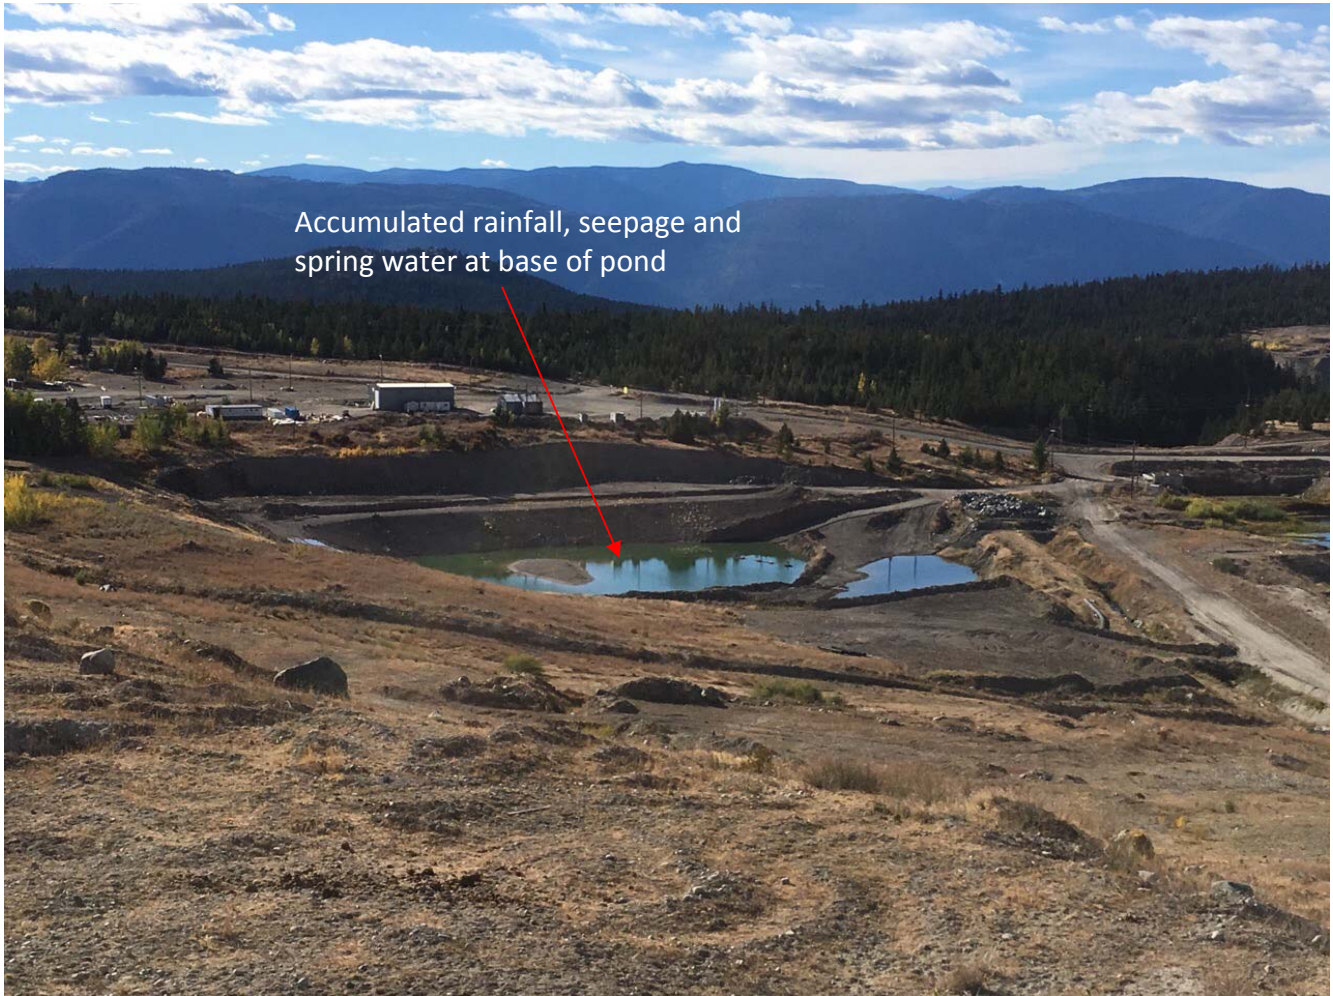
Photo II-C-15 Slimes Pond 3 (partially constructed) – Facing West (SS-2017-01)

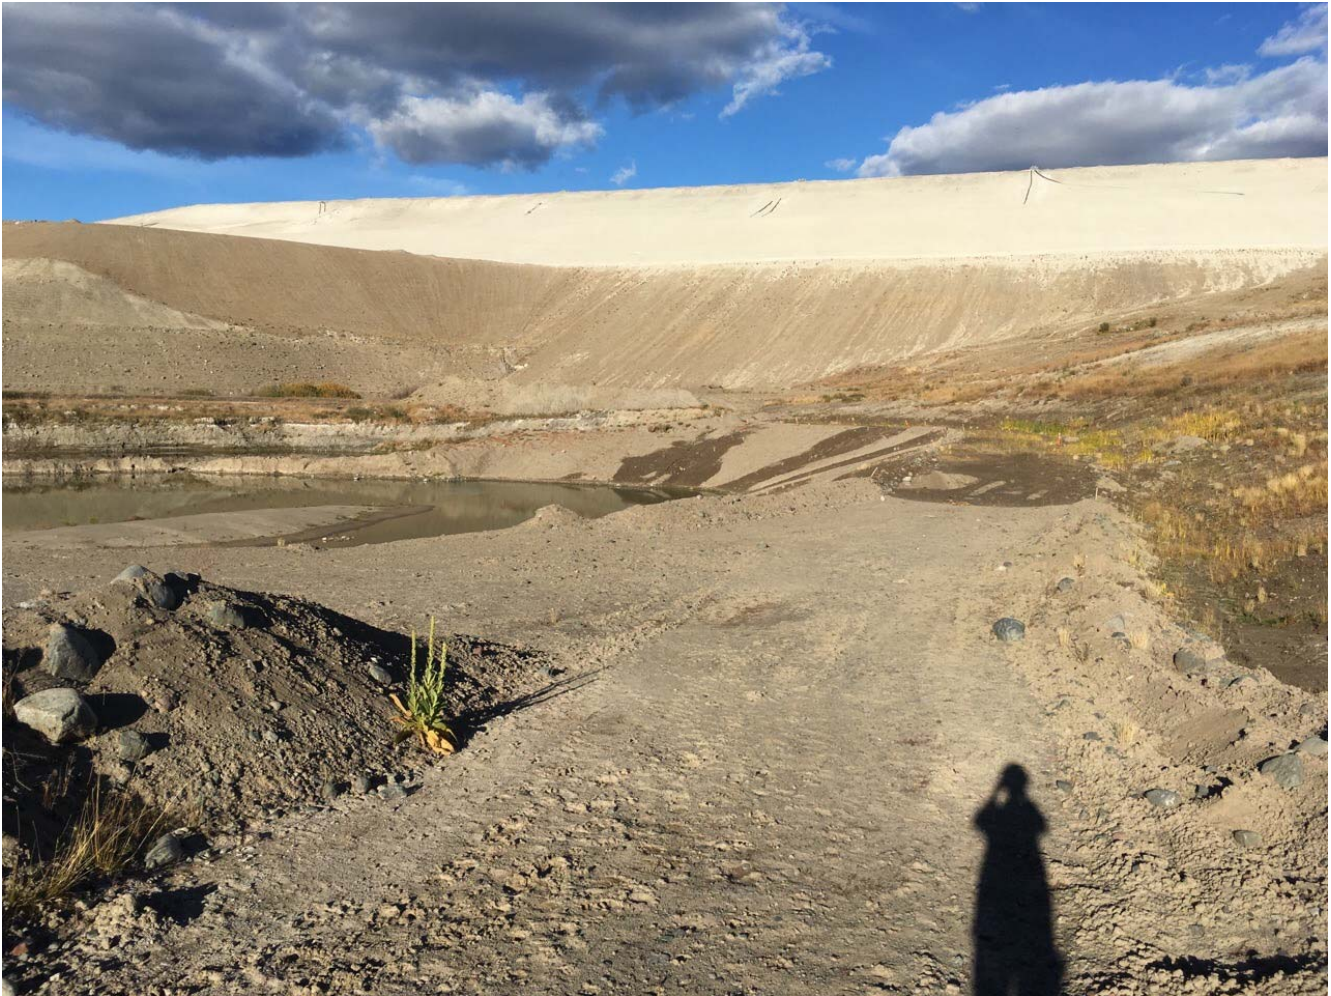
Photo II-C-17 Slimes Pond 3 (partially constructed) – Ponded Water on Crest from Spring Lines in Slope – Facing East (SS-2017-11)

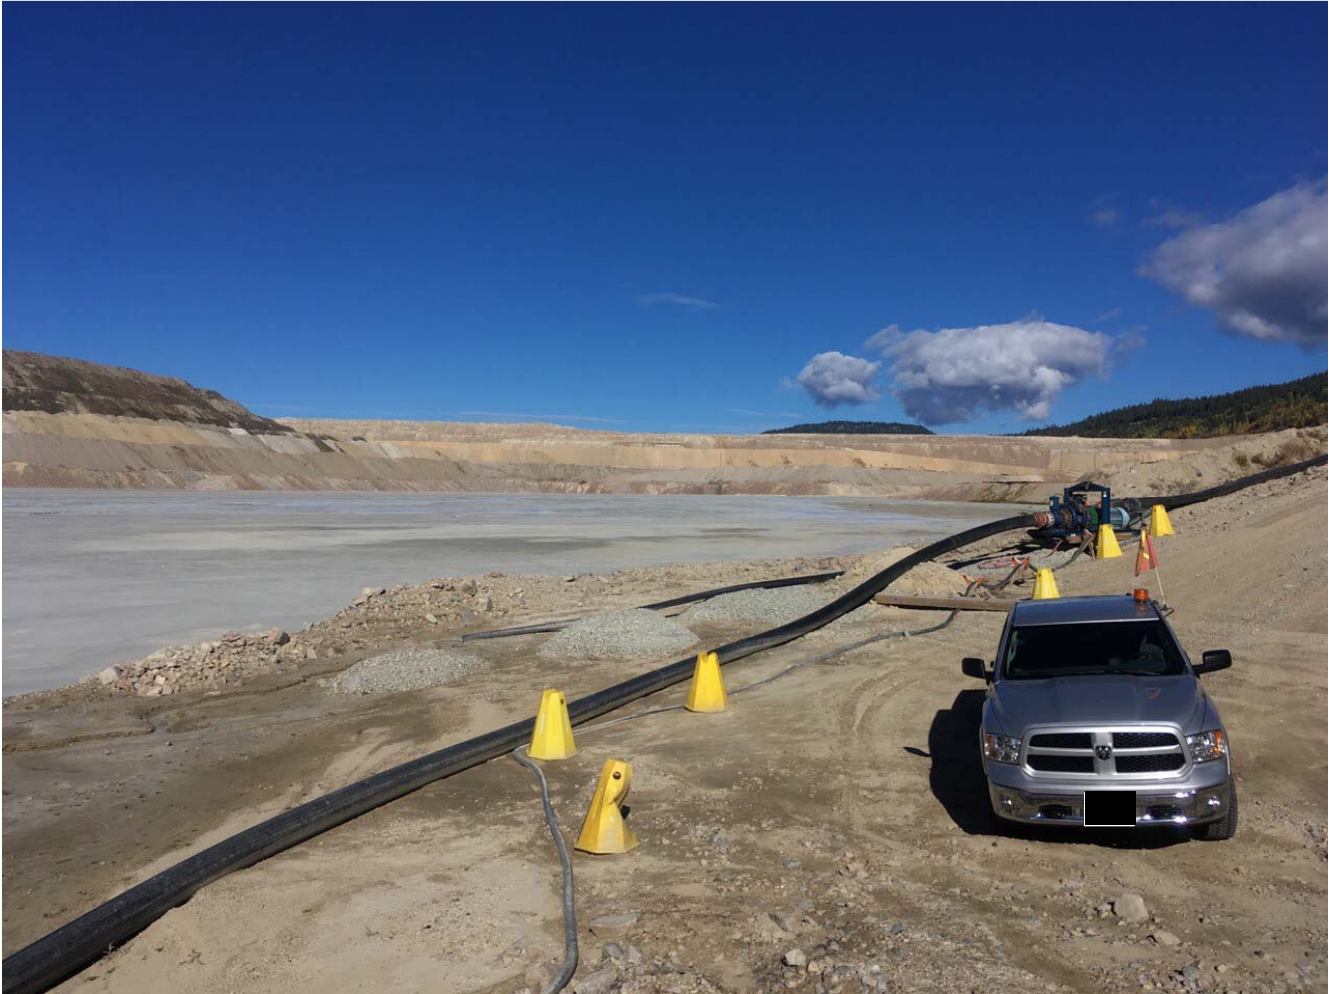
Photo II-D-3 Outflow pump location, facing H-H Dam (northwest) (ML-2017-02)

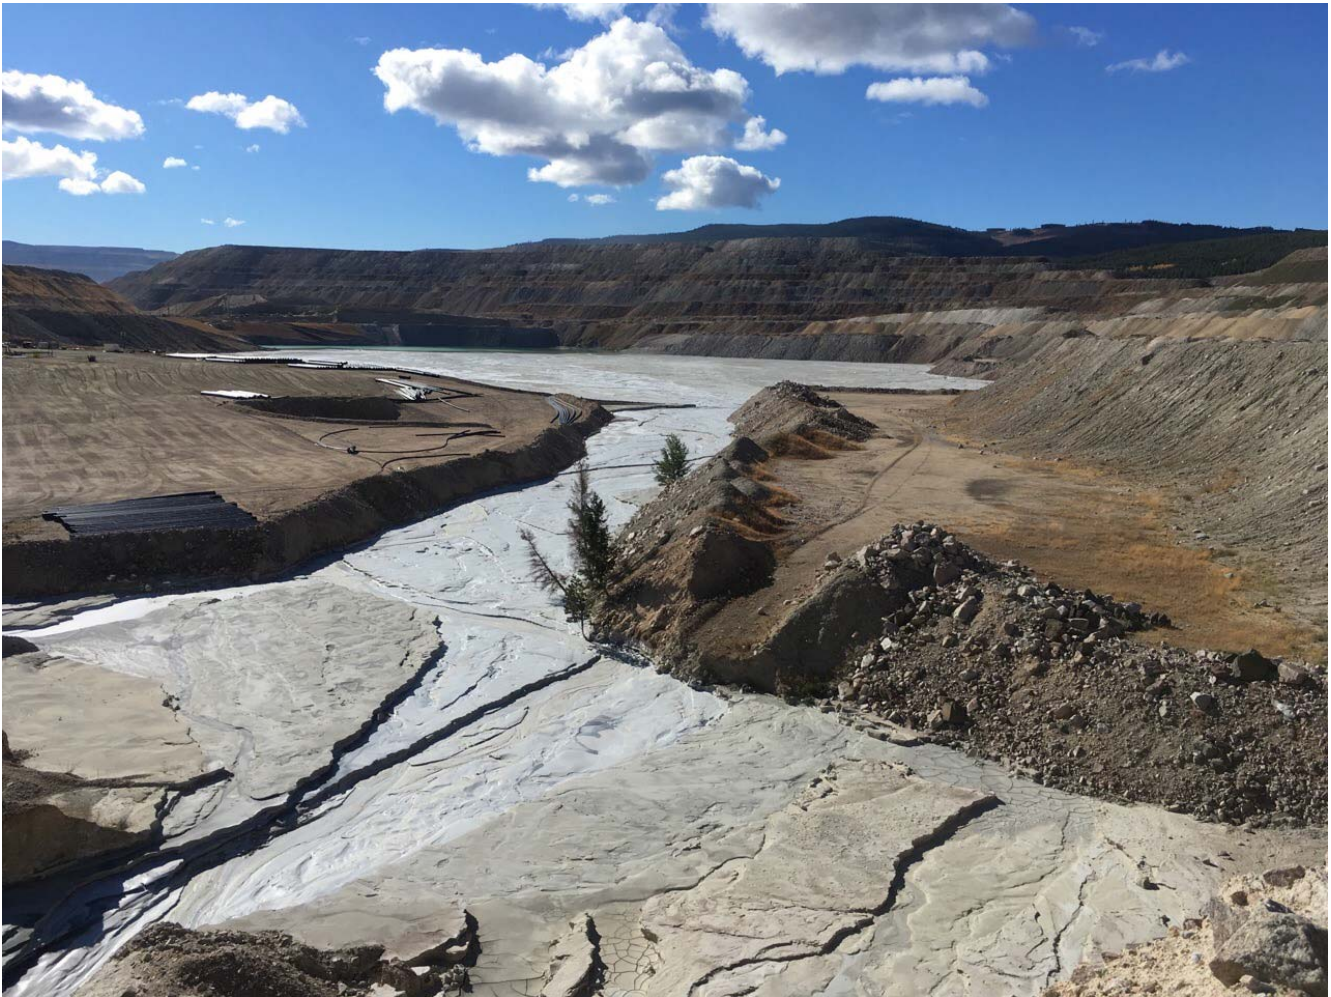
Photo II-D-6 H-H Pumphouse outflow channel, facing south (ML-2017-05)
