Teck Highland Valley Copper Partnership

2017 Dam Safety Inspection Report

Highland Tailings Storage Facility

March 2018

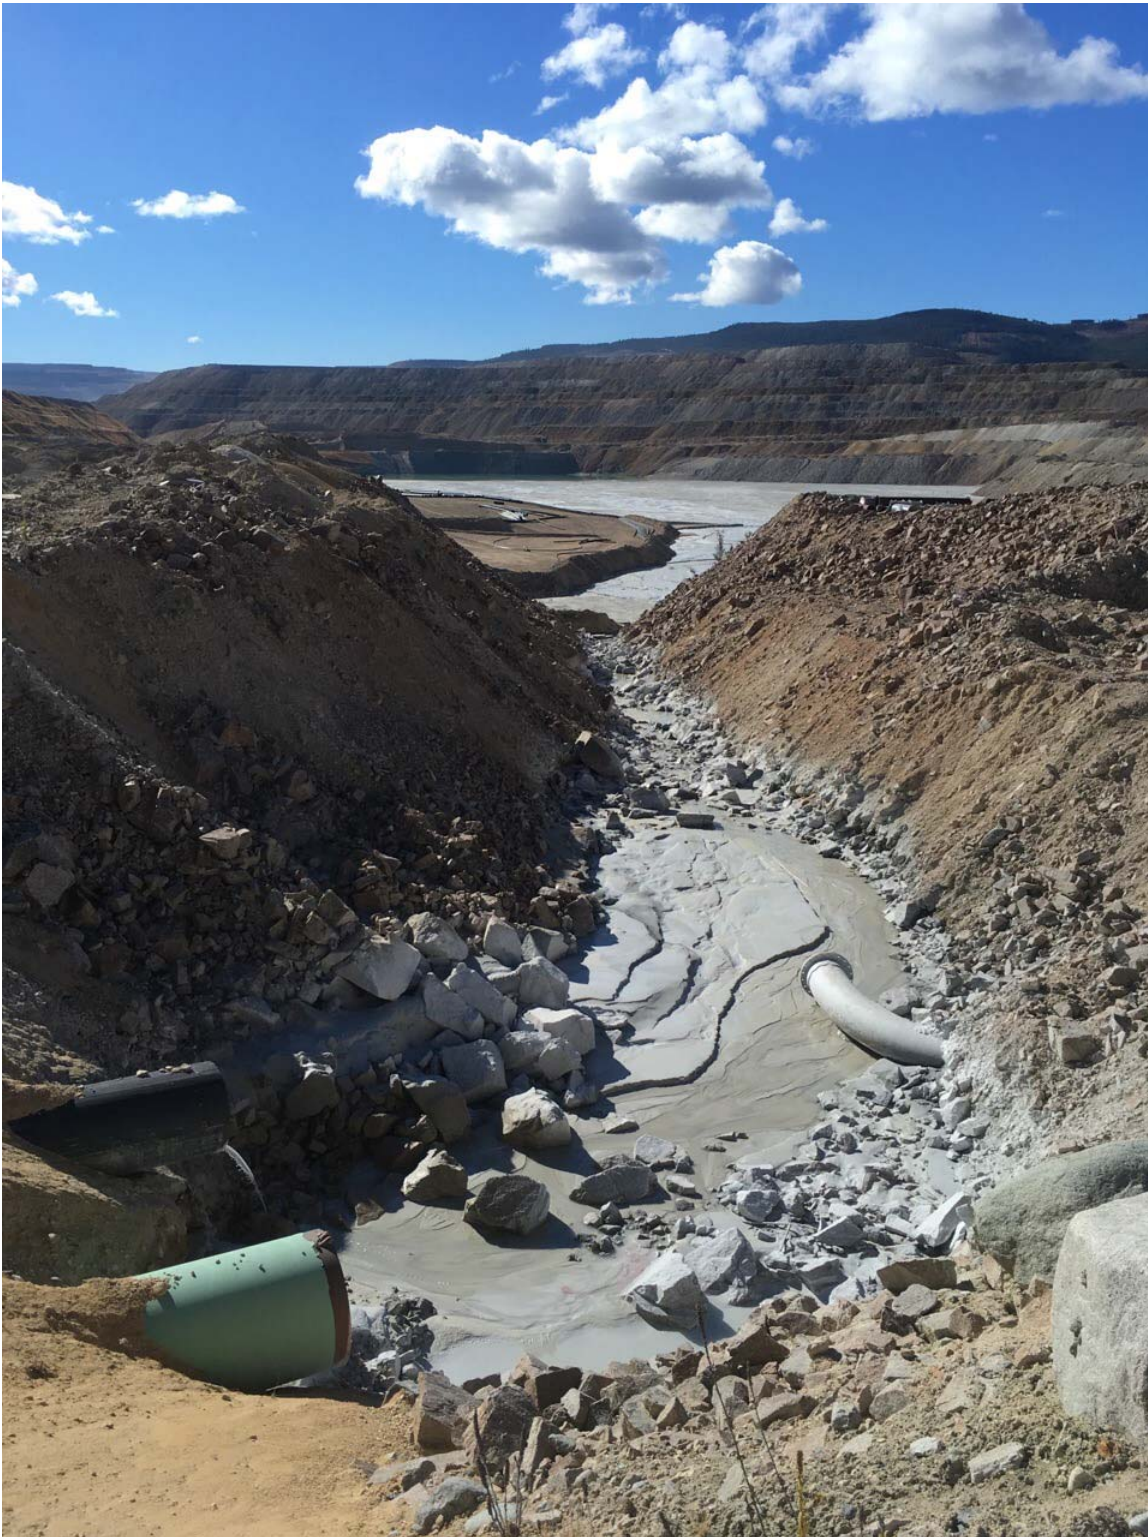
Photo II-D-7 H-H Pumphouse emergency dump outflow pipes, facing southwest (ML-2017-06)
