**TECK WASHINGTON INCORPORATED
PEND OREILLE MINE – TAILINGS DISPOSAL FACILITY # 3**

2017 ANNUAL INSPECTION REPORT

VA101-18/22-1
Rev 0
February 2, 2018

**2017 ANNUAL INSPECTION REPORT
VA101-18/22-1**

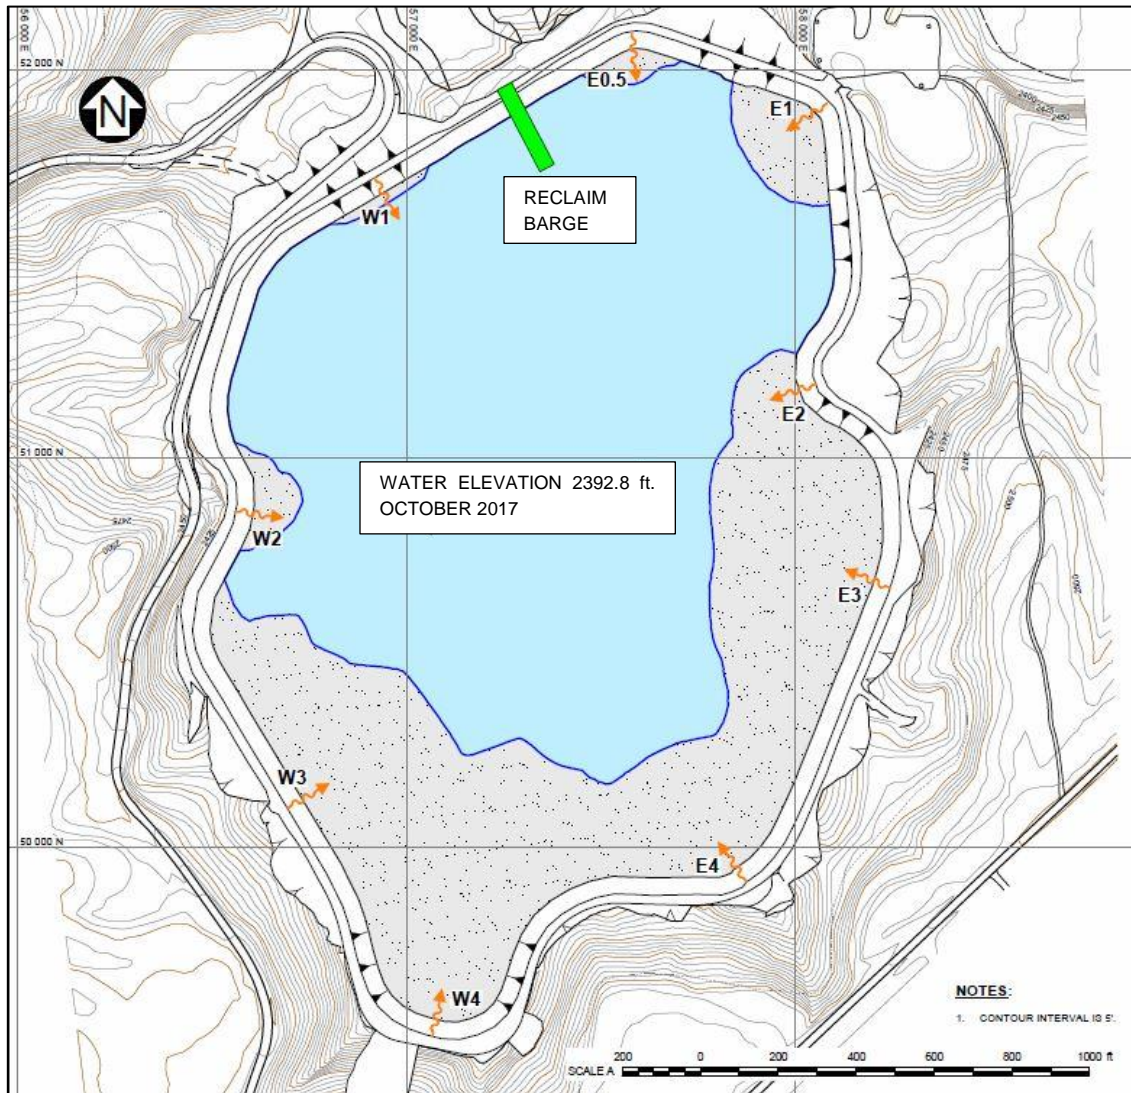
Figure 2.1 Tailings Disposal Facility #3 – General Arrangement

A series of photographs collected during the site inspection are provided in Appendix A. Pond and tailings beach configurations at the time of the inspection are shown schematically on Figure 2.1.

A sketch showing the sequential filling plan for the facility is presented on Figure 2.2. The tailings beaches and supernatant pond at the time of the inspection in September 2017 are reflected on Figure 2.1.

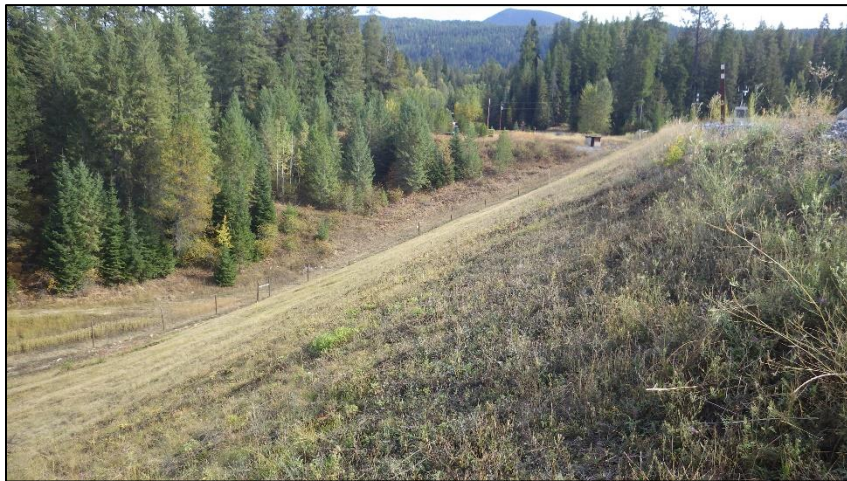
No signs of distress were noted during the inspection of the Northeast and Northwest Embankments. No seepage, wet or soft spots were observed on the downstream slopes. The embankment slopes were approximately planar and there was no evidence of cracking, bulging, or slumping in the embankment fill. The embankment crest appeared to be level with no signs of differential settlement or distress. The abutments appear sound with no evidence of erosion, seepage, settlement or cracking. There was no evidence of animal burrowing on the crest. TWI implements an ongoing pest control program during the summer months, which has proven effective. The reclaimed downstream embankment slopes were mowed during the summer as part of the ongoing maintenance of the dam. Trees were removed from the left abutment of the northeast dam from a previous State Dam Safety recommendation. The “sink hole” was inspected and no issues were noted. It should continue to be inspected annually by a Geotechnical Engineer. Routine inspections by mine personnel can be suspended.

PHOTO 23 – Downstream face of Northeast Dam.

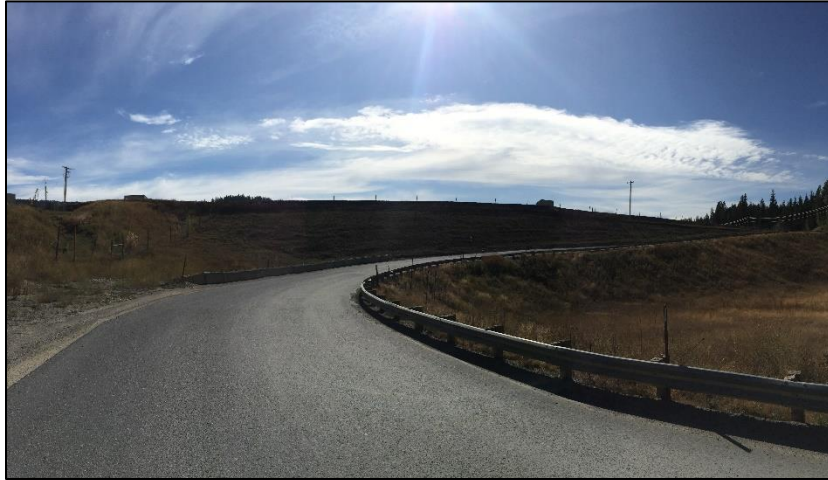
PHOTO 25 – Mine access road and downstream slope of Northwest Dam.

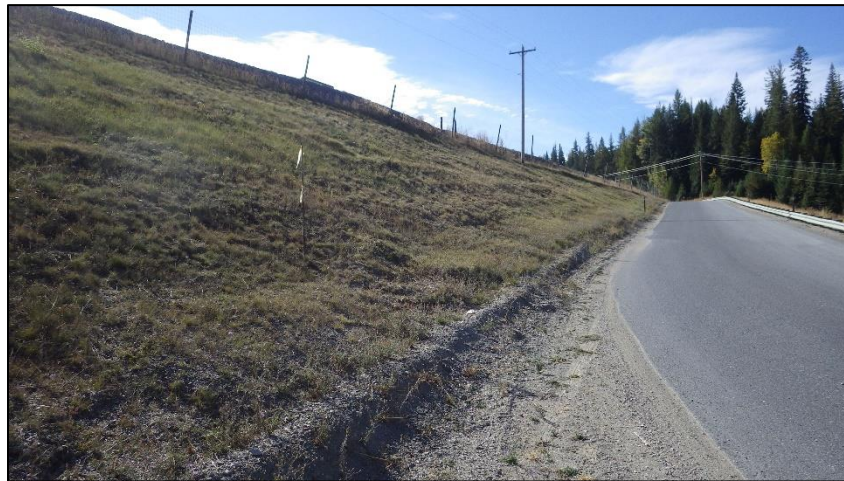
PHOTO 26 – Downstream slope of Northwest Dam.

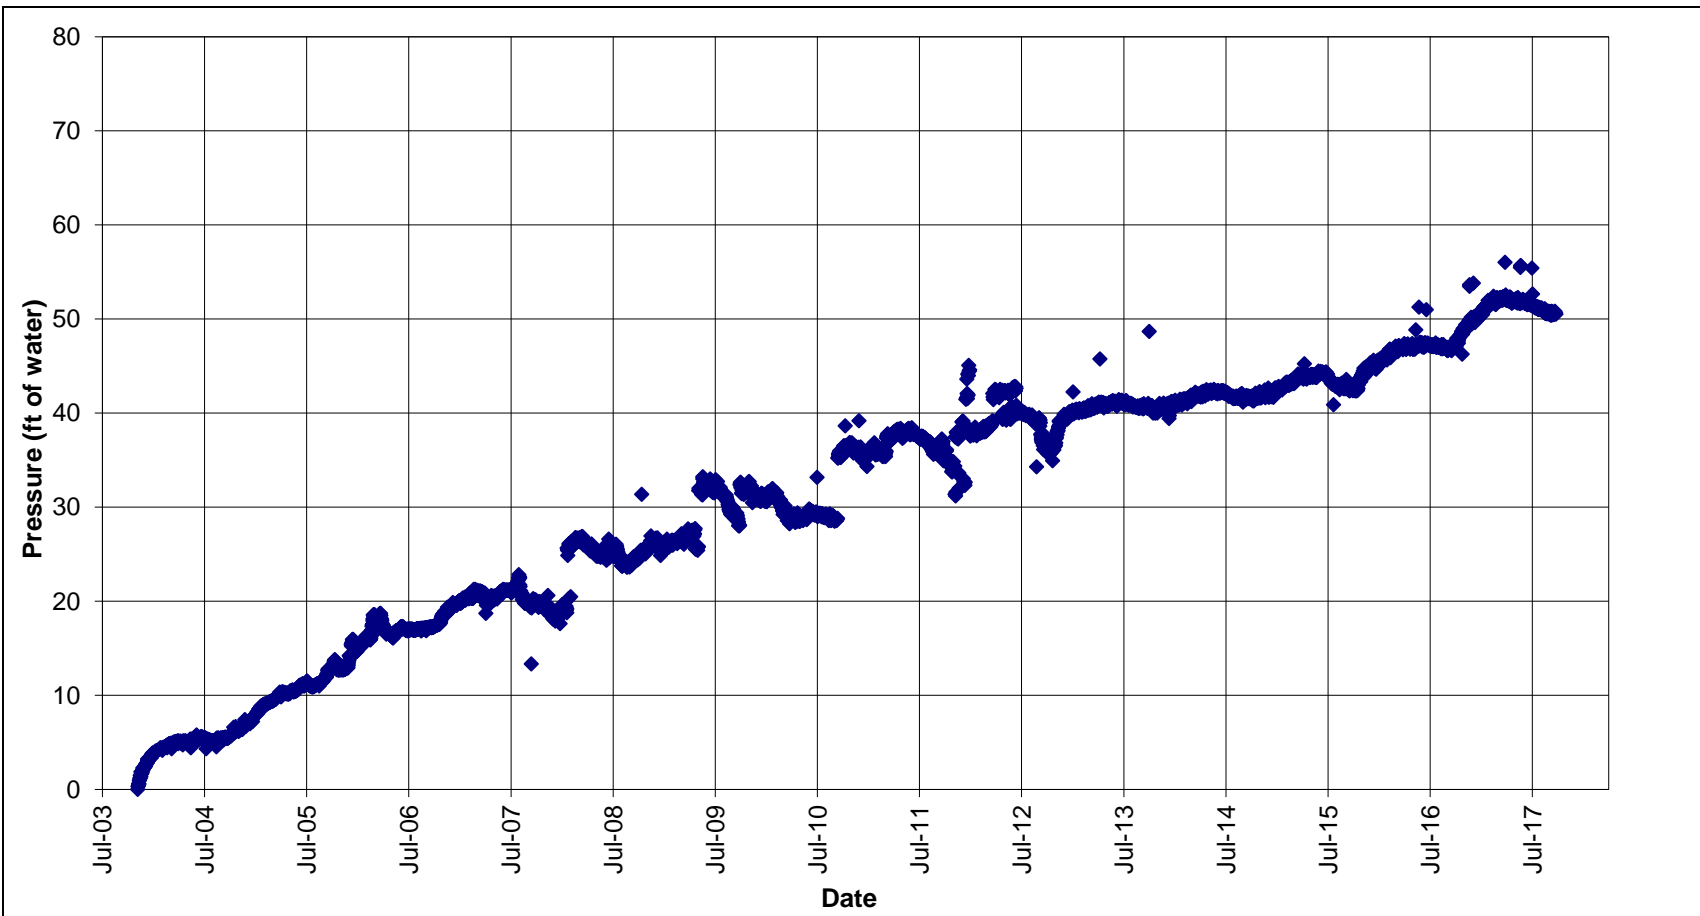
TECK WASHINGTON INCORPORATED	
PEND OREILLE MINE	
TAILINGS DISPOSAL FACILITY #3 CALCULATED PRESSURE FOR PIEZOMETER BU-1	
<i>Knight Piésold</i> CONSULTING	P/A No. VA101-18/22
	REF. NO. 1
FIGURE B-1	
	REV 0

Basin Underdrain piezometers (BU-1 to BU-5) record hydrostatic pore pressures consistent with the tailings pond water elevation and fluctuate with the pond water level. Readings are adjusted for barometric pressure and show a slight jump upwards at the start of 2008 when the old barometer was replaced with a new barometer. A similar rise/step occurred in May 2012 with a new barometer replacement. Piezometer BU-3 did not function correctly when first installed in 2003. The original readout box was replaced with a new piezometer readout box in May 2009. The BU-3 piezometer readings starting in May 2009 follow the trends of the other functioning Basin Underdrain piezometers. Piezometer BU-3 data was previously not reported in annual inspection reports due to erroneous readings but has been added since 2014 when the monitoring data indicated similar responses and trends with the other four Basin Underdrain piezometers. The Basin Underdrain piezometers recorded pore pressures mirroring the increasing tailings pond elevation, which is consistent with expectations. Piezometer BU-5 has experienced a period of fluctuating and scattered data points commencing in July 2014. There is no real trend observed in the scatter of points but the monitoring trend is still discernible within the data cluster.

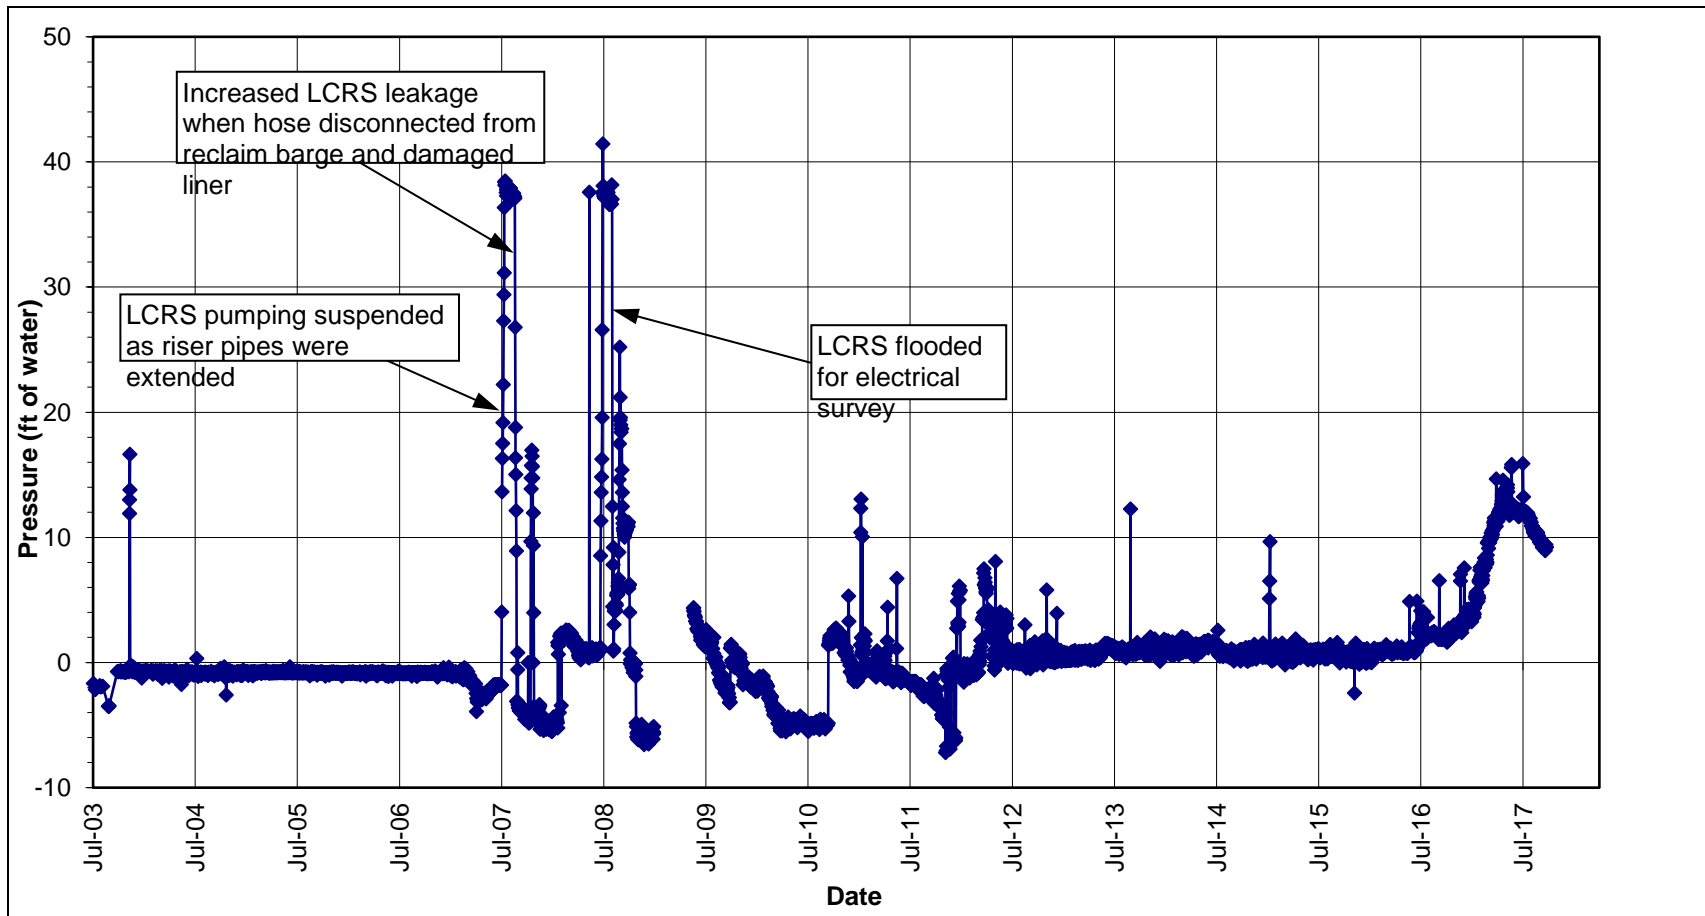
TECK WASHINGTON INCORPORATED
 PEND OREILLE MINE
 TAILINGS DISPOSAL FACILITY #3
 CALCULATED PRESSURE FOR PIEZOMETER
 LCRS-1

The piezometers installed in the LCRS (LCRS-1, 2 & 3) trench typically indicate negative pore water pressures confirming the LCRS trench sand and gravel is unsaturated and drained. There was a brief period when the LCRS pump was replaced and the LCRS responded with a slight increase in pore pressures. The higher levels recorded in the LCRS were found to be indicative of the higher level sensors on the pump on-off control system. The level sensors were adjusted to a lower elevation in the riser pipe and pore pressures decreased back downwards to historic levels. The LCRS piezometers indicate the LCRS system is performing well within design tolerances as water pressures within the LCRS trench are decreasing towards the minimal level normally observed.

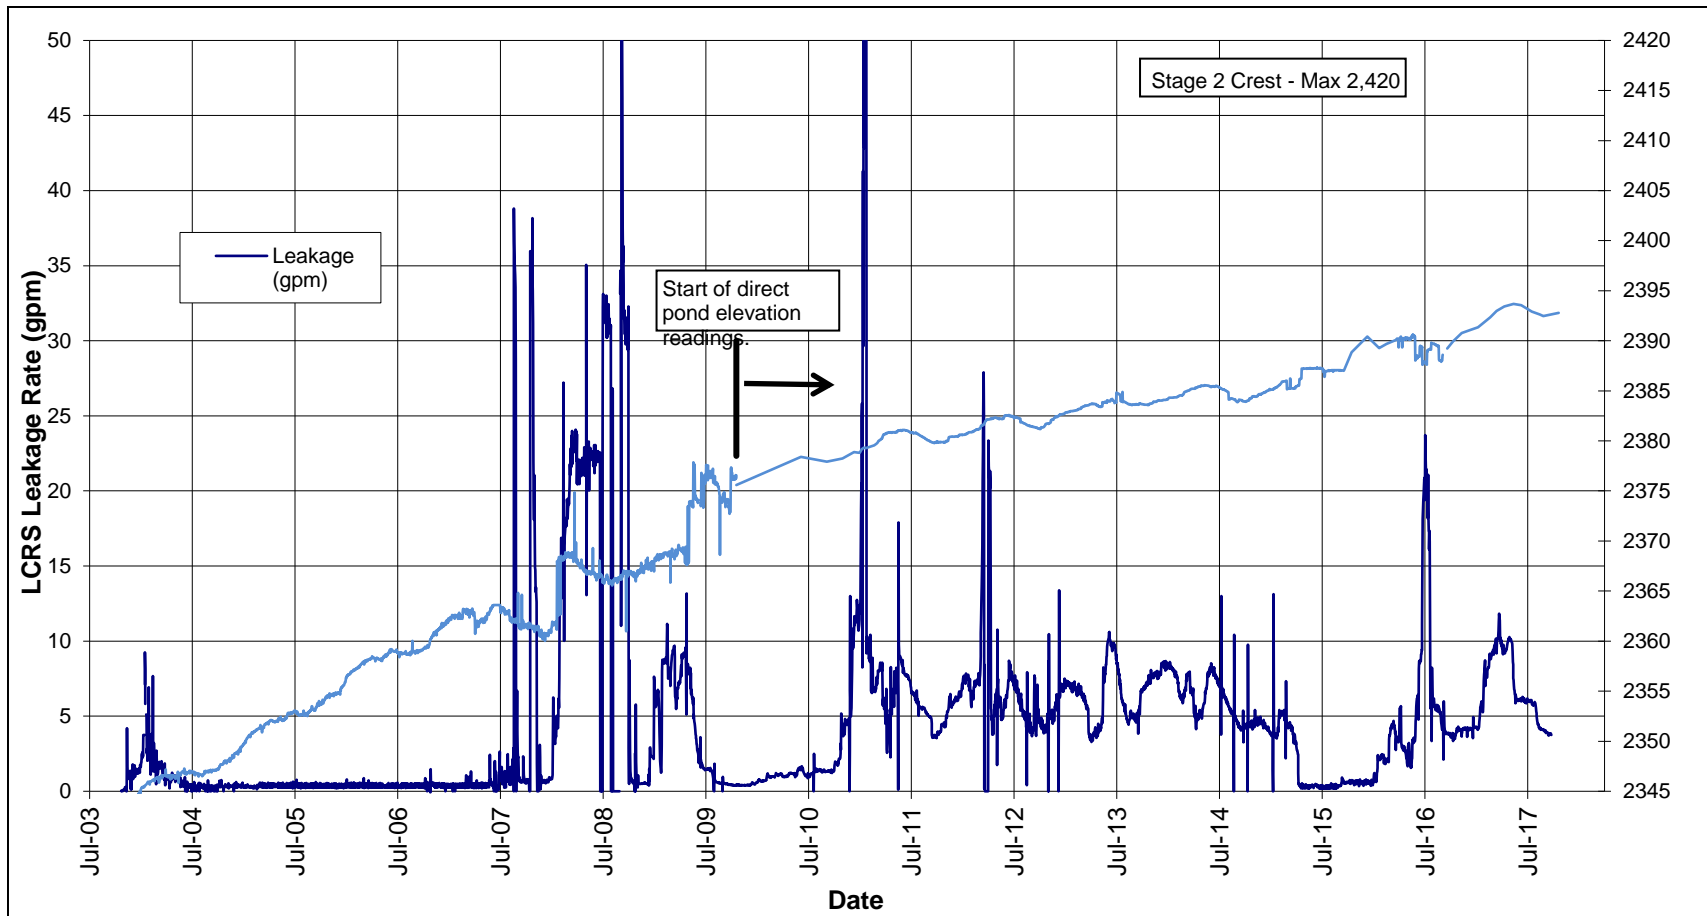
TECK WASHINGTON INCORPORATED	
PEND OREILLE MINE	
TAILINGS DISPOSAL FACILITY #3 LCRS LEAKAGE RATE	
<i>Knight Piésold</i> CONSULTING	P/A NO. VA101-18/22
	REF. NO. 1
FIGURE B-10	
REV 0

Leakage rates remained at historical levels from March 2015 to February 2016. The LCRS flow rates fluctuated above and below the Level 1 Action Leakage Rate from February 2016 to June 2016. Leakage rates peaked at 23 gpm in July 2016, just below the Level 3 Action Leakage Rate and two liner leaks were suspected: one near the barge area and one near the LCRS area. Tailings discharge and sand bag placement were focused in suspected leak areas and leakage rates decreased to the range of 2 to 4 gpm below the Level 1 Action Leakage Rate of 5 gpm.

In January 2017, the leakage rate again exceeded the Level 1 Action Leakage Rate peaking in May 2017 at approximately 10 gpm. Suspected liner leaks were sealed and the leakage rate was reduced to below the Level 1 Action Leakage Rate in August 2017. TWI continues to monitor leakage rates and uses acoustic sounding methods to detect leaks as necessary.

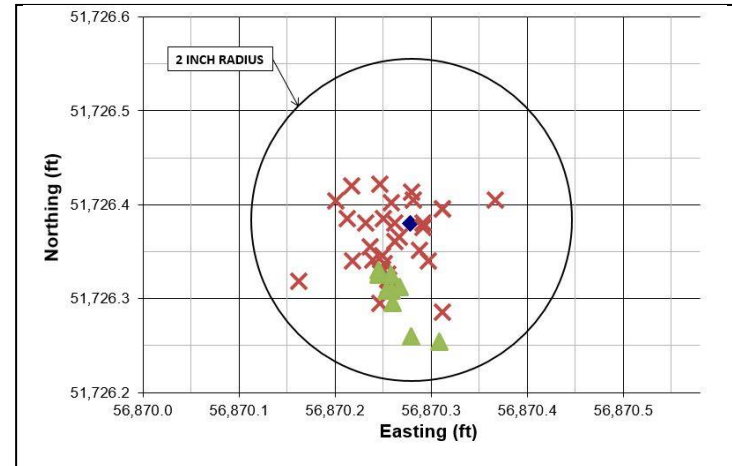
M5 Plan View

The survey monuments recorded no significant movement over the past 12 months.
