Teck Highland Valley Copper Partnership

2017 Dam Safety Inspection Report

7-Day Pond

March 2018

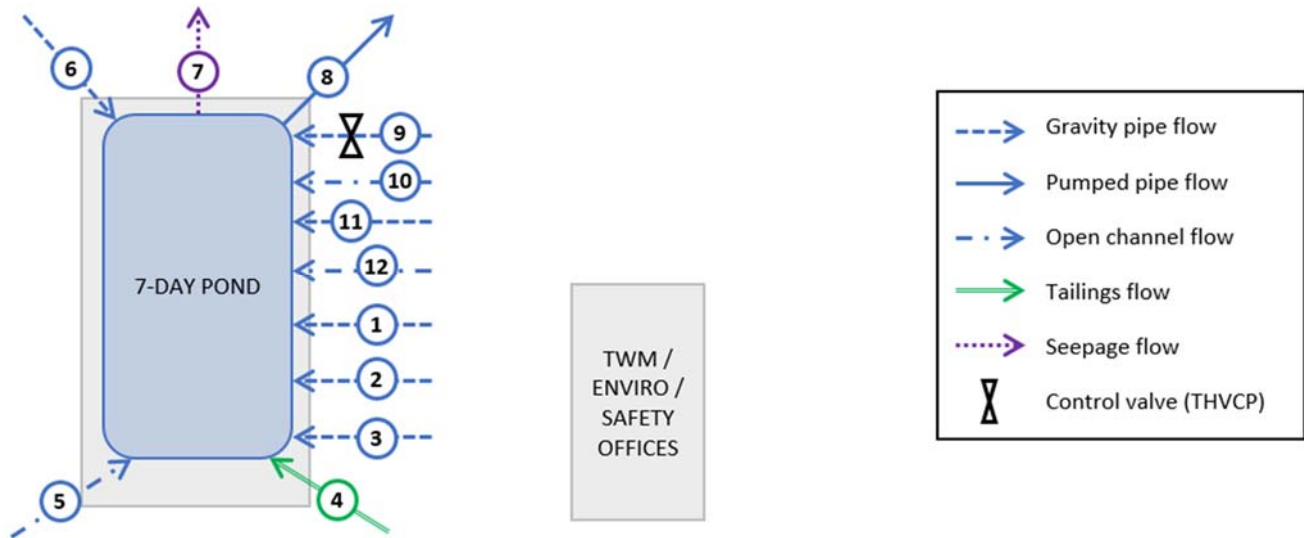
Figure 4.1 Process Flow Diagram for 7-Day Pond

Outflows include evaporation, seepage into the wishing well sump in the Valley Pit which are then pumped to the Mill, and pumped flows to the Mill Diversion Line (MDL) which is commissioned as needed. The portable pump at the northeast corner of the pond was decommissioned in August 2016 due to insufficient water levels for operation. The pump has not been deployed since, and there were no outflow controls at the time of inspection.

No.	Name	Description	Status
1	Inflow #1	HDPE pipe	Non-operational
2	Inflow #2 (a.k.a. Dog & Easy)	36" dia. HDPE pipe, irregular flow from: i) overflow from MOP (connects U/S of discharge point); ii) overflow from sump in Mill which collects excess surface water from cleaning activities.	Operational
3	Inflow #3	HDPE pipe, semi-regular flow from thickener overflow (majority) and surface water around the Mill (minor component).	Operational
4	Tailings Dump Line	No line existing. If needed, a new one could be opened up to 7-Day Pond.	Non-operational
5	Overflow from Mill Water Pumphouse	Irregular open channel overflow from 325 ft Thickeners	Operational
6	Inflow Culvert	900 mm dia. HDPE legacy culvert	Decommissioned
7	Seepage to Valley Pit	Seepage reports to Wishing Well Sump in Valley Pit	N/A
8	Pump to Mill Diversion Line	1x HDPE pipeline and portable pump (deployed when needed)	N/A
9	Witches Brook Drain	1x HDPE pipe with control valve	Operational

10	Inflow from Sewage Treatment Plant	Regular, treated effluent in trench running south to north and discharging at the NE corner of the pond	Operational
11	Inflow from No. 4 Crusher	1x HDPE pipe, irregular flow	Operational
12	Inflow from Truck Wash	Surface runoff from truck wash collected by drainage ditch	Operational

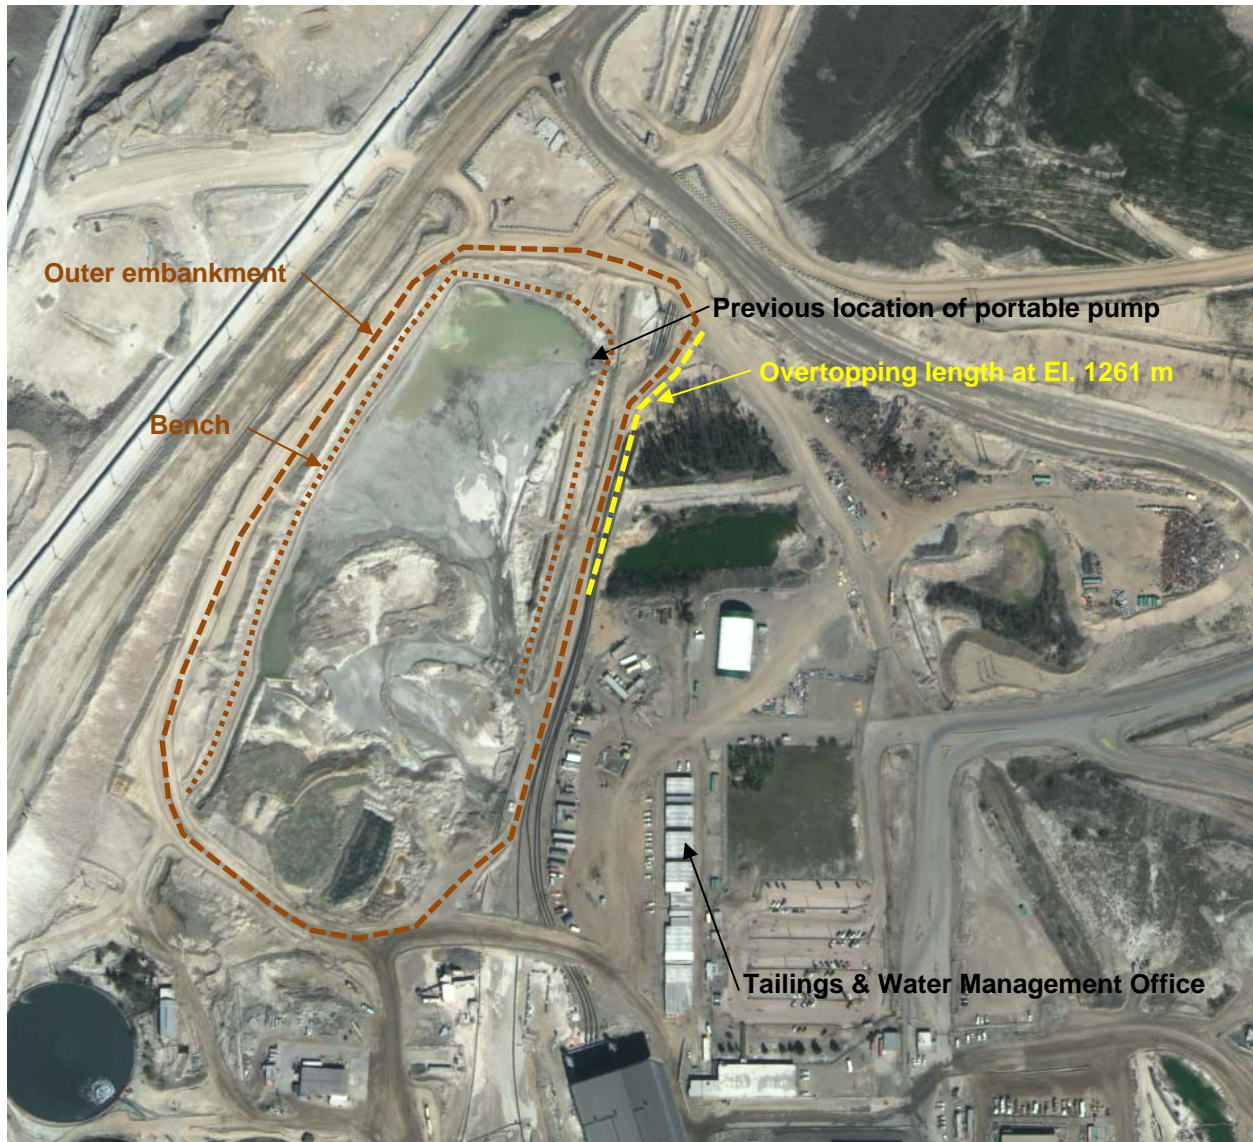
SITE PLAN
(May 1, 2016 PhotoSat image)

- 1) The inflow pipe in the northwest corner of the pond was not flowing at time of inspection.
- 2) Inflow pipes #1 and #3 at the southern end of pond were flowing at time of inspection. Flow rates were not measured. Inflow pipe #2 was not flowing at time of inspection.
- 3) Inflow pipe #1 is buried by tailings.
- 4) No outflow was noted at time of inspection. Inflows were either seeping out of the pond or accumulating in the pond.
