Teck Highland Valley Copper Partnership

2017 Dam Safety Inspection Report

Bethlehem No. 1 Tailings Storage Facility

March 2018

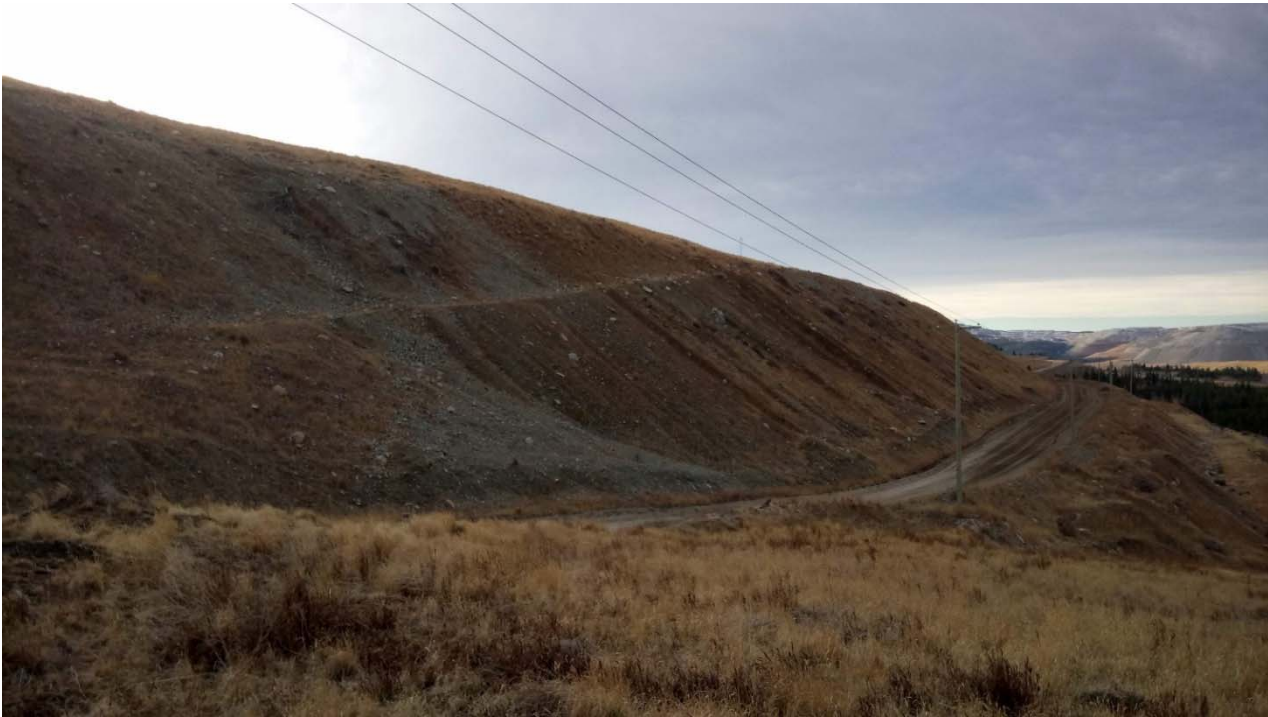
Photo II-A-7 Downstream slope of dam, view looking east from Trojan Dam crest (BTH-2017-06)

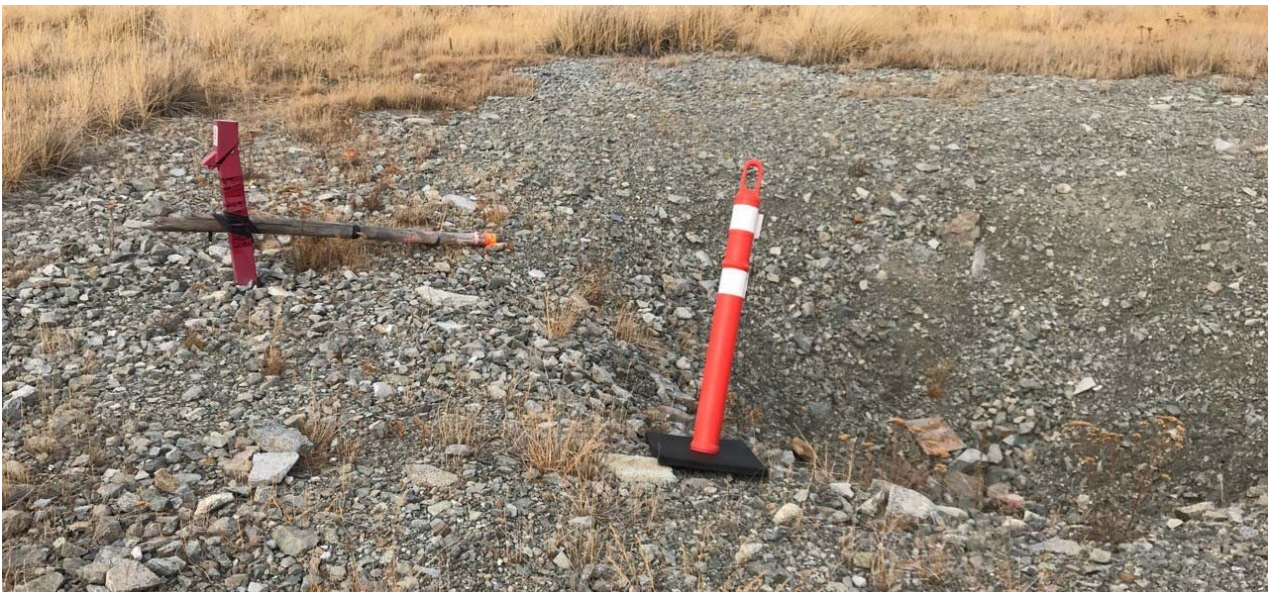
Photo II-A-9 Sinkhole on tailings beach and it's instrumentation (BTH-2017-04)

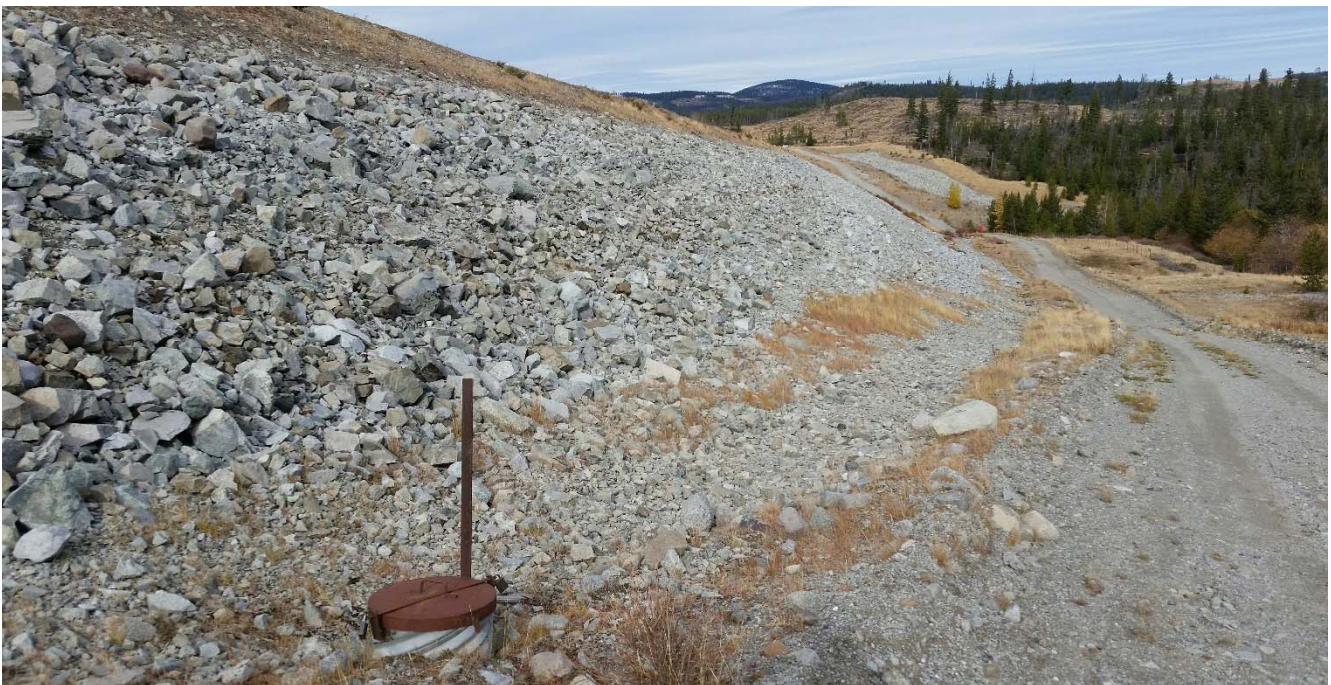
Photo II-B-4 Downstream slope of dam including toe drain near right abutment, view towards right abutment (BTH-2017-08)

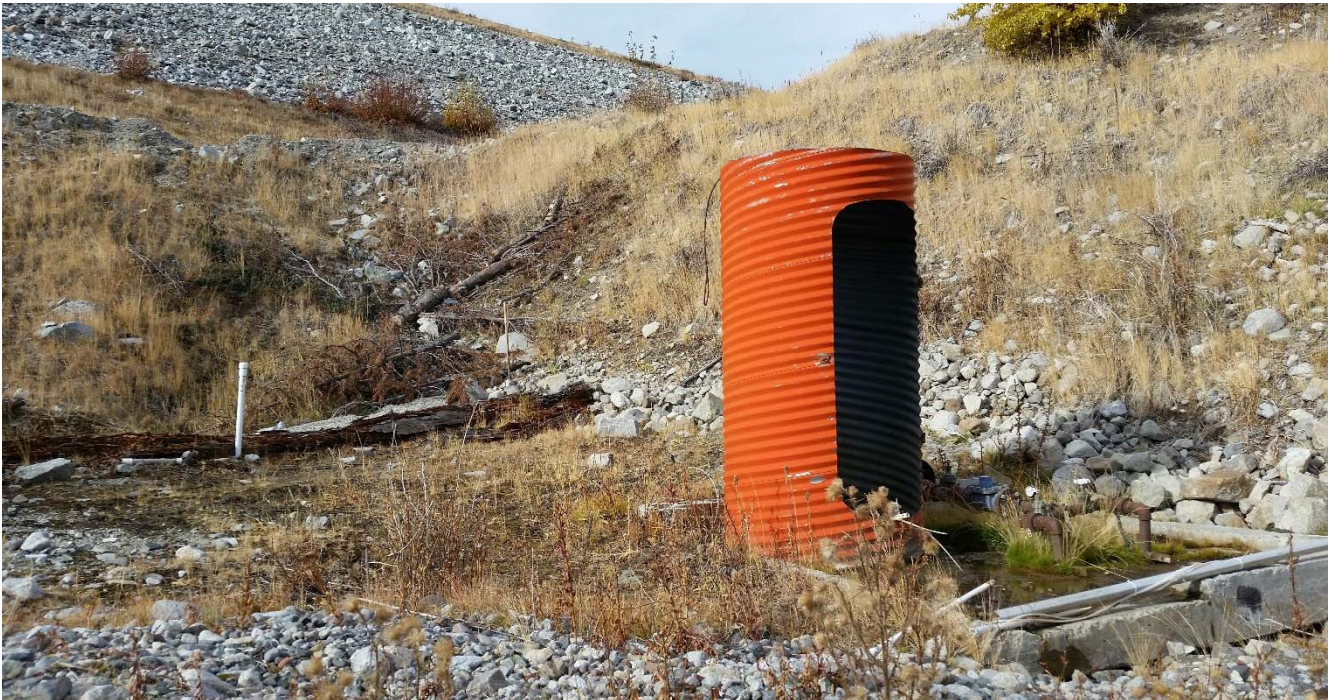
Photo II-B-10 Seepage outfall valve control at gauge-house (BTH-2017-13)

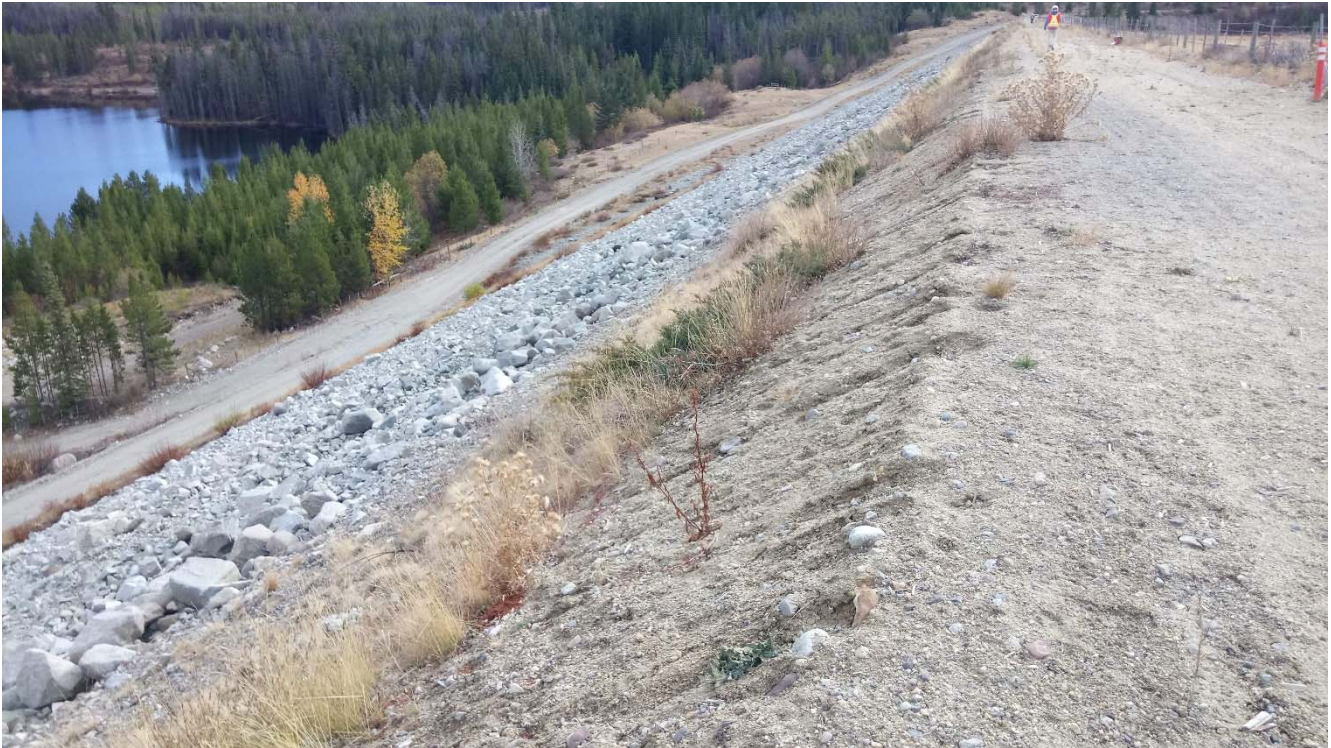
Photo II-B-20 Signs of erosion along crest and upper till section of the downstream slope of the dam (BTH-2017-21)

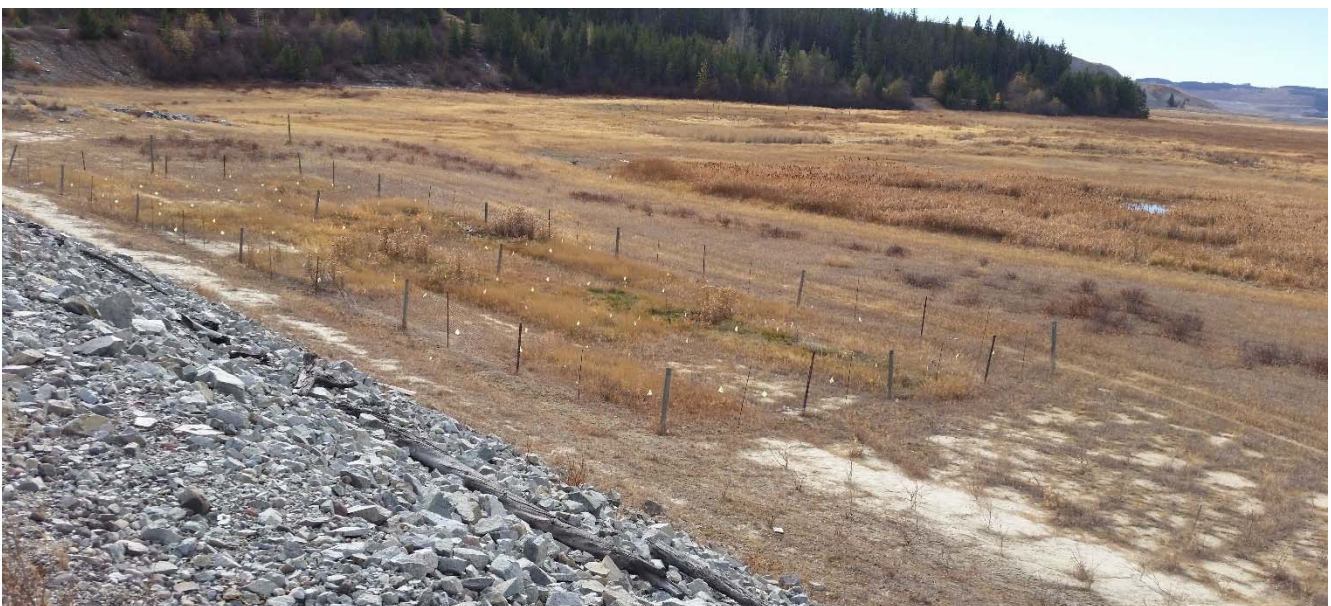
Photo II-B-21 View of fenced off reclamation area from crest of dam (BTH-2017-22)

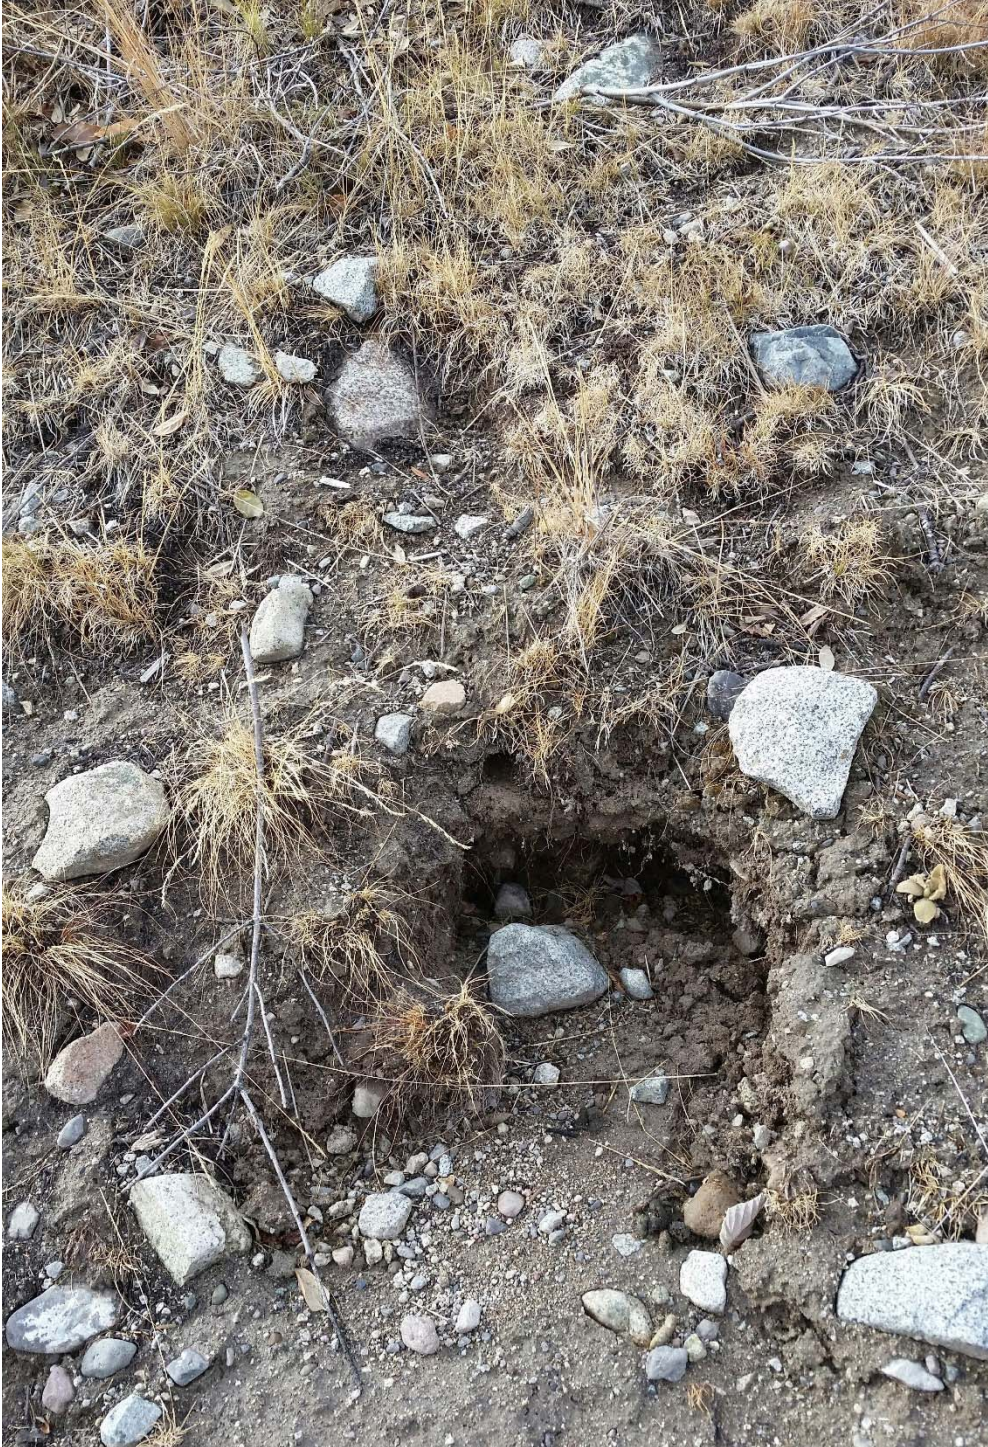
Photo II-B-23 Possible animal burrow site near right dam abutment. (BTH-2017-09)

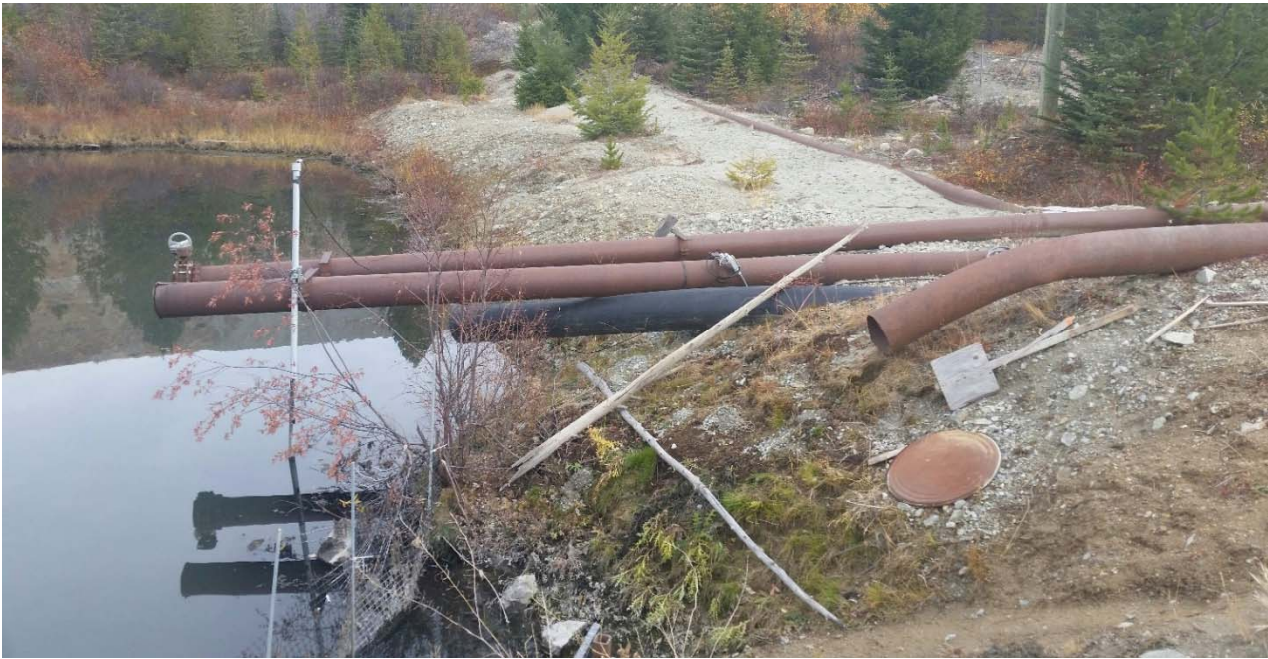
Photo II-C-2 Decommissioned outflow pipes, and surrounding debris (BTH-2017-27)

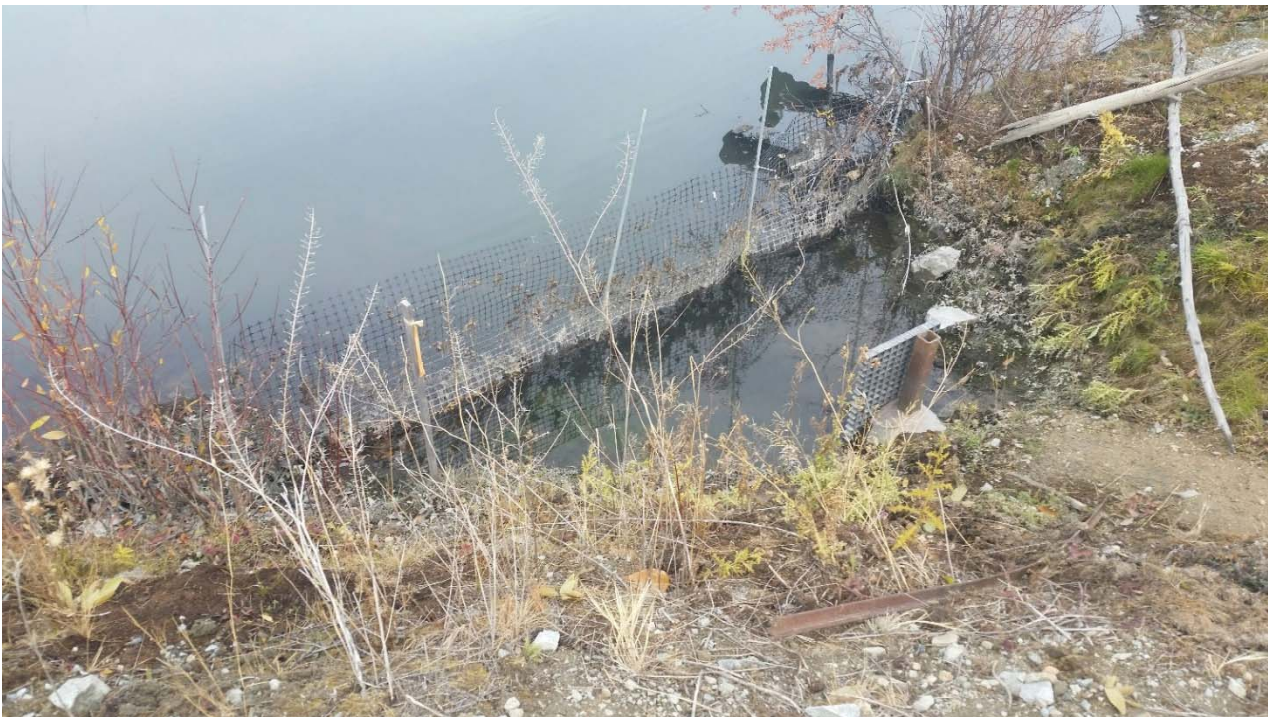
Photo II-C-3 Outlet intake with clear trash rack and debris fence with minor obstructions (BTH-2017-27)

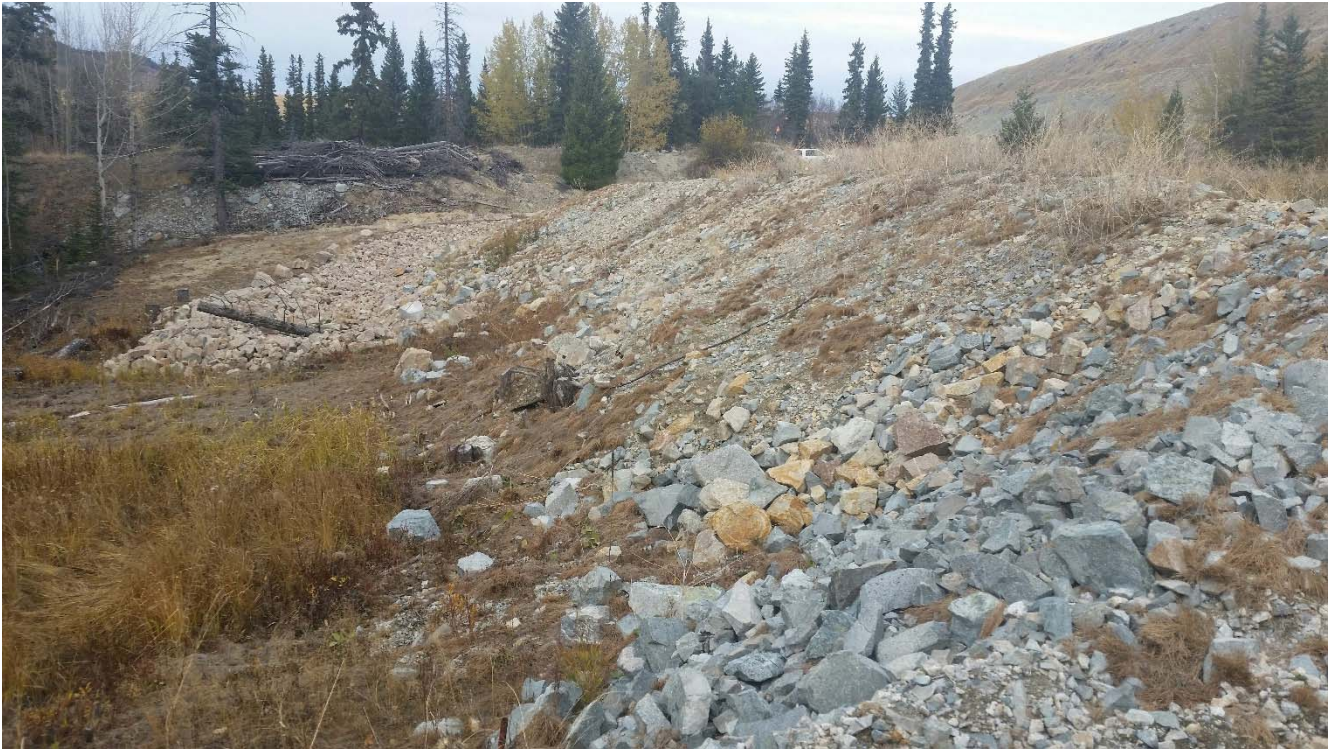
Photo II-C-10 Downstream slope of dam, view towards right abutment and spillway, no signs of erosion or deterioration (BTH-2017-28)
