Teck Highland Valley Copper Partnership

2017 Dam Safety Inspection Report

Highmont Tailings Storage Facility

March 2018

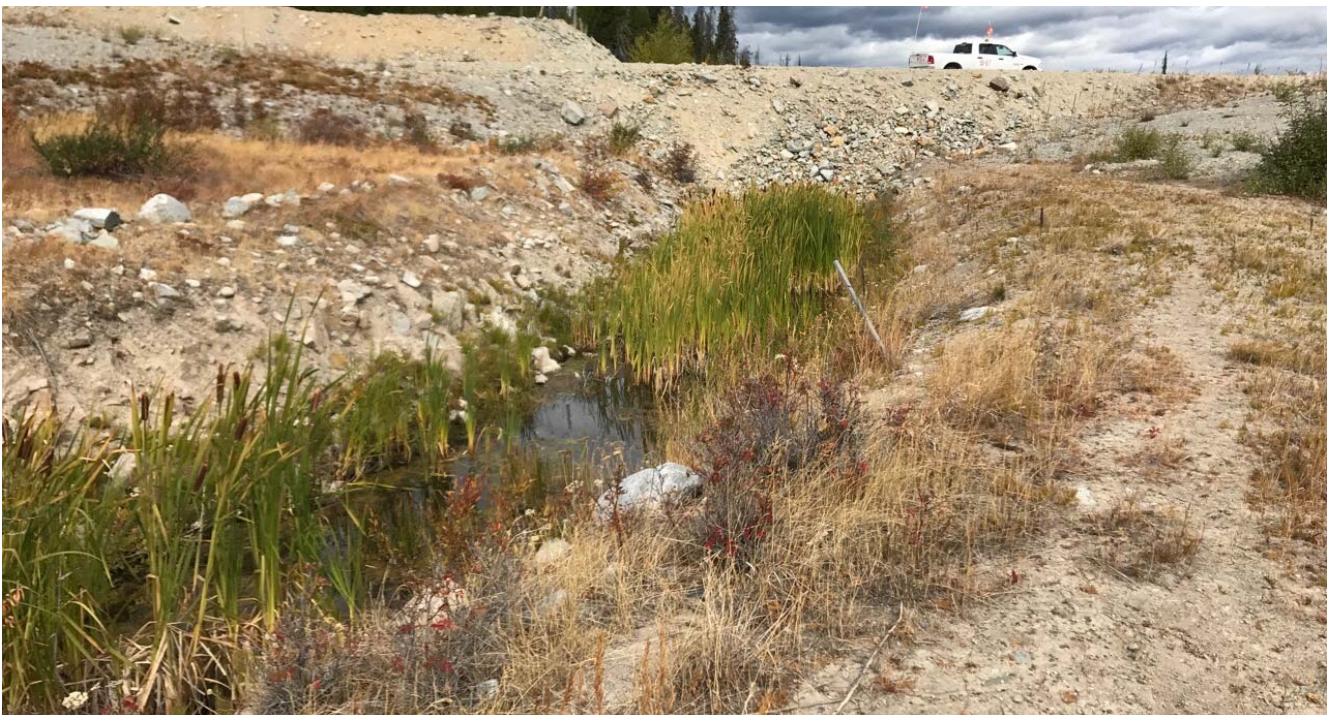
Photo II-A-10 Spillway channel looking downstream, vegetated showing standing water (HGH-2017-06)

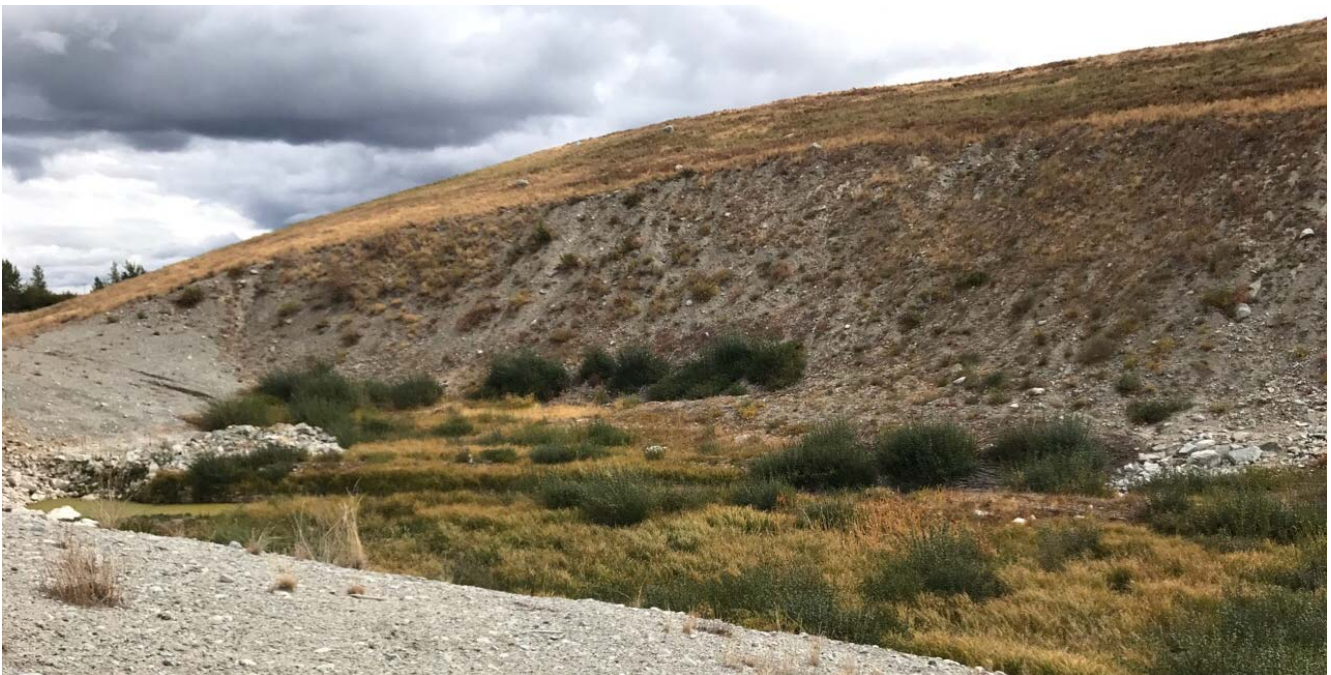
Photo II-A-15 Steepened section of downstream slope (HGH-2017-08)

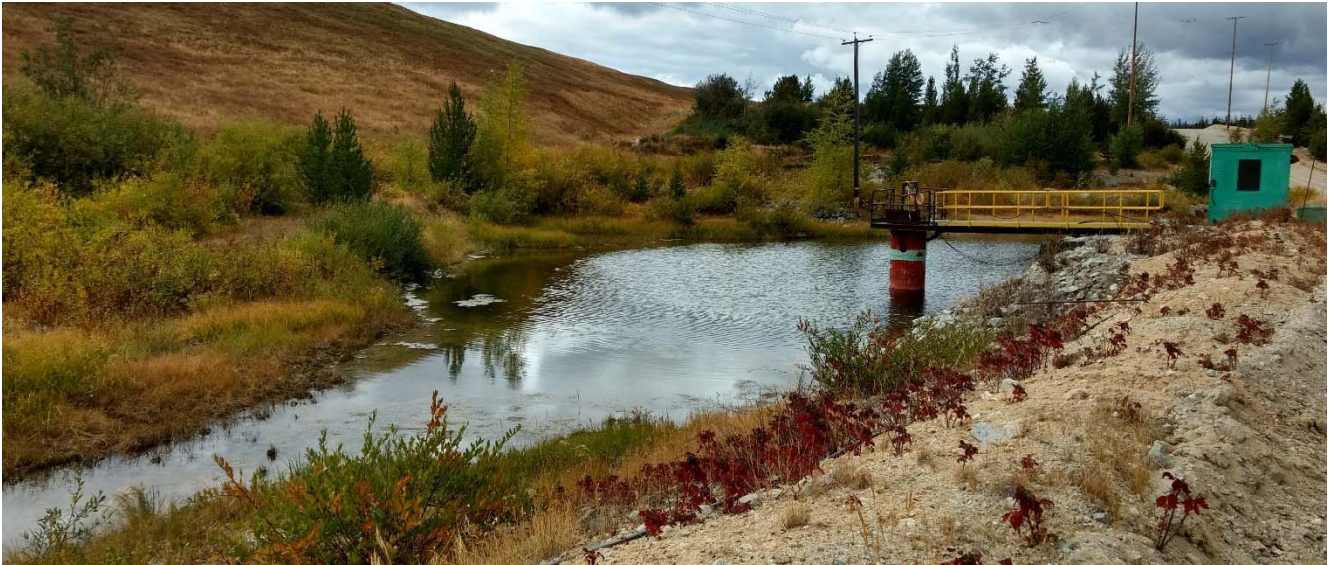
Photo II-B-10 S8: upstream slope, right abutment and spillway intake to S1 pond. (HGH-2017-17)

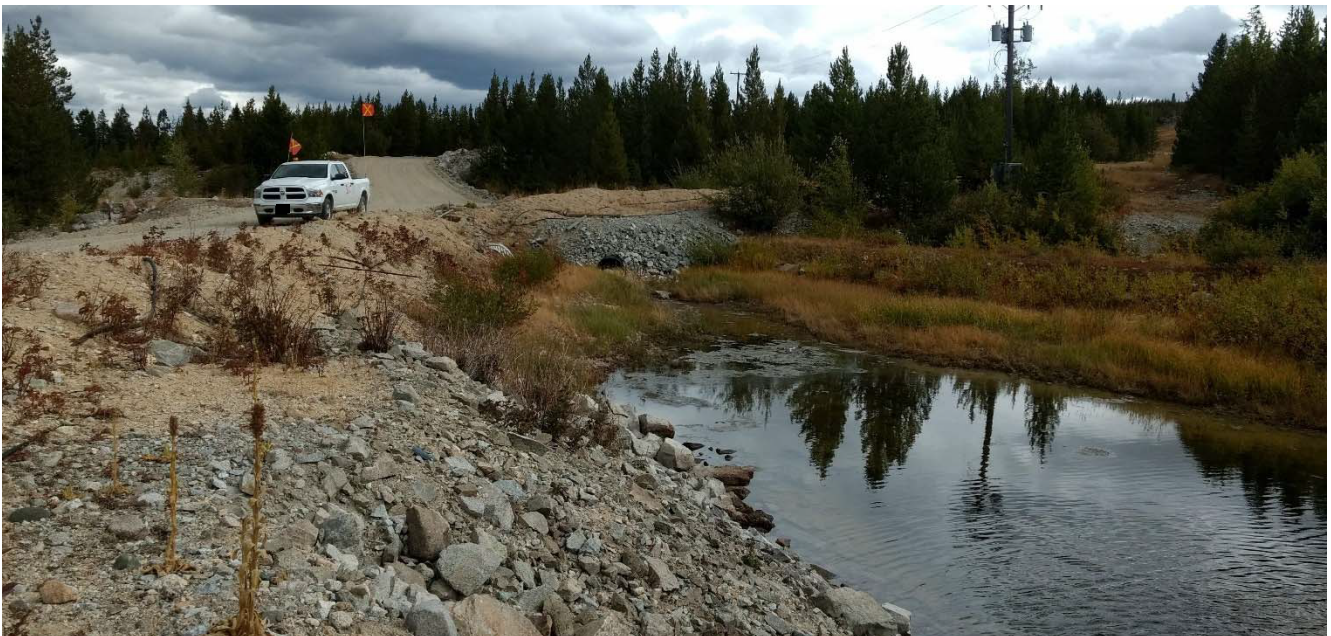
Photo II-B-11 S8: downstream slope looking West from right abutment. (HGH-2017-18)

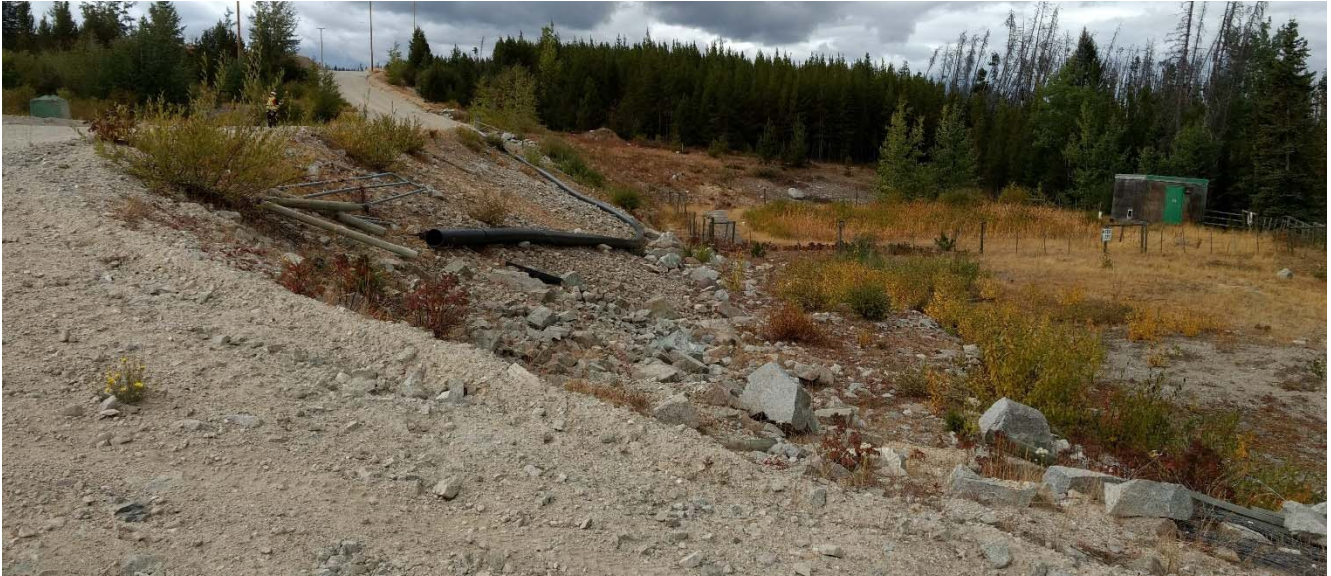
**Photo II-B-12 S1: Highmont spillway diversion pipe to S1 pond.
(HGH-2017-19)**

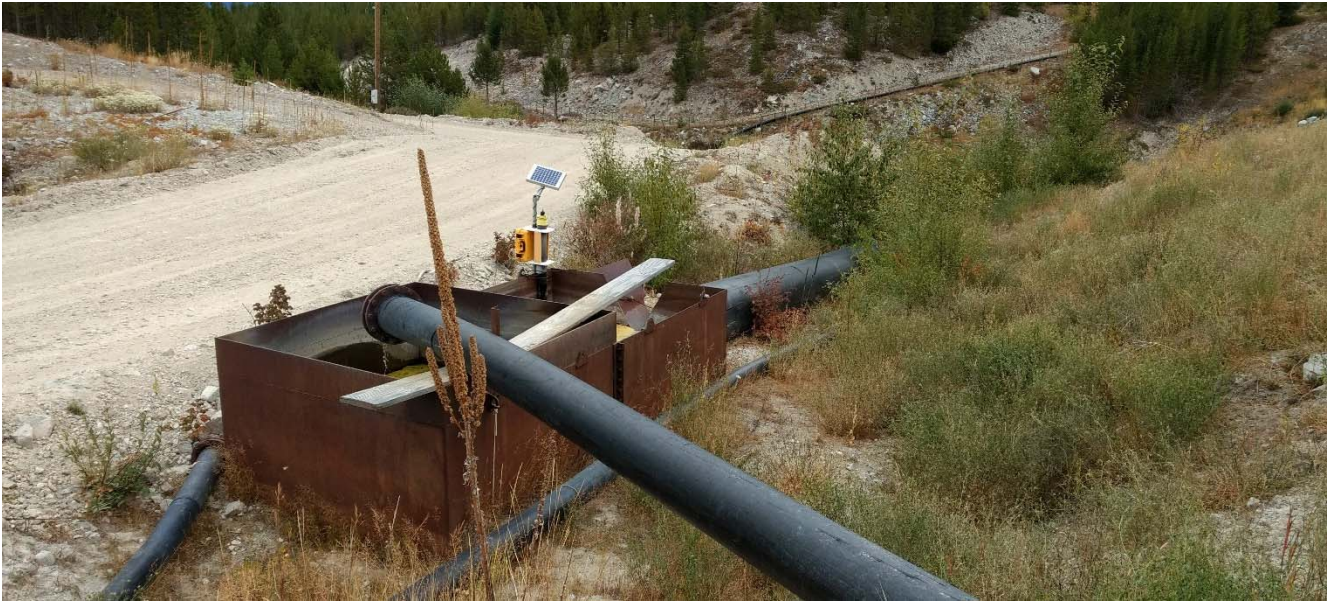
**Photo II-B-13 S1: flow measurement weir HM-S1-FS-01 for S1 inflow diverted from Highmont
spillway. (HGH-2017-19)**

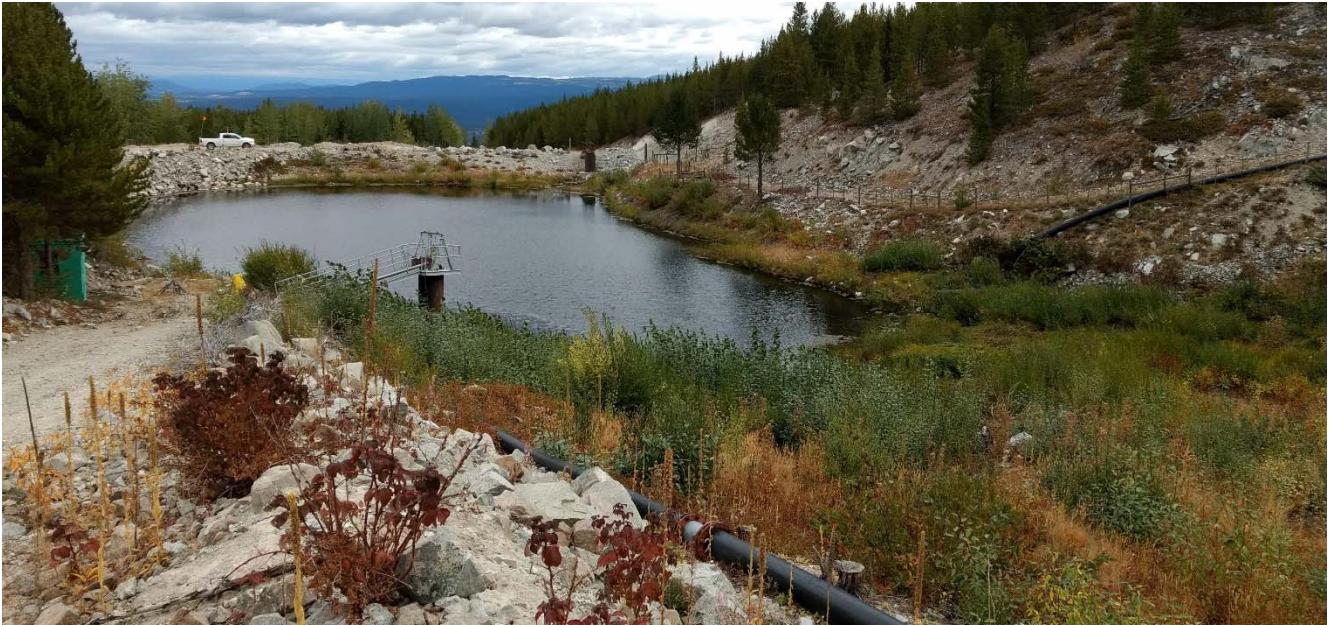
Photo II-B-15 S1: dam crest looking East towards right abutment. (HGH-2017-24)

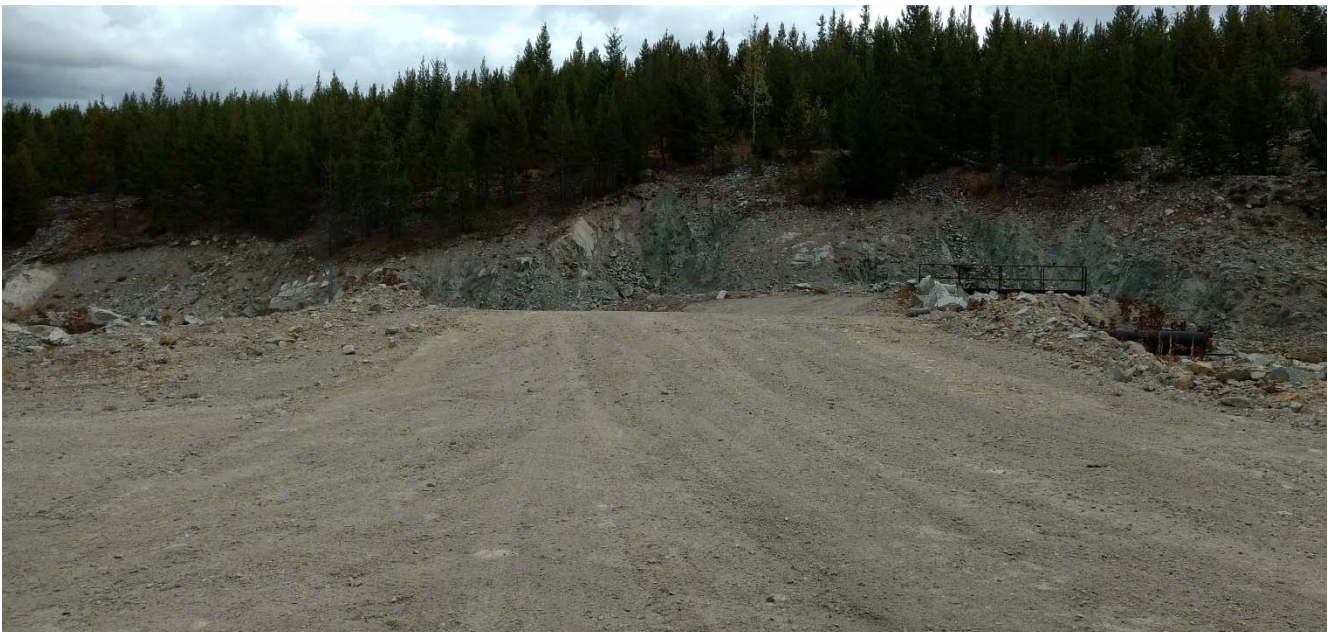
Photo II-B-16 S1: downstream slope looking East toward spillway. (HGH-2017-29)

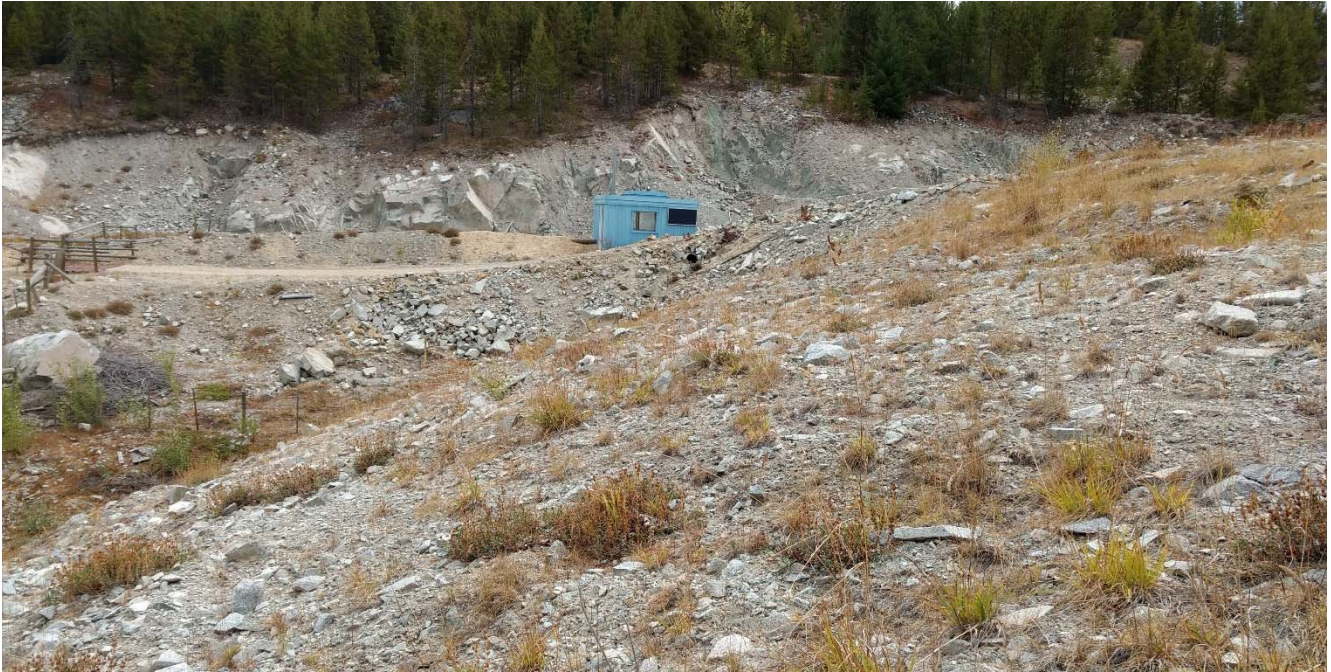
Photo II-B-17 S1: spillway channel and pipe intake looking downstream. (HGH-2017-28)

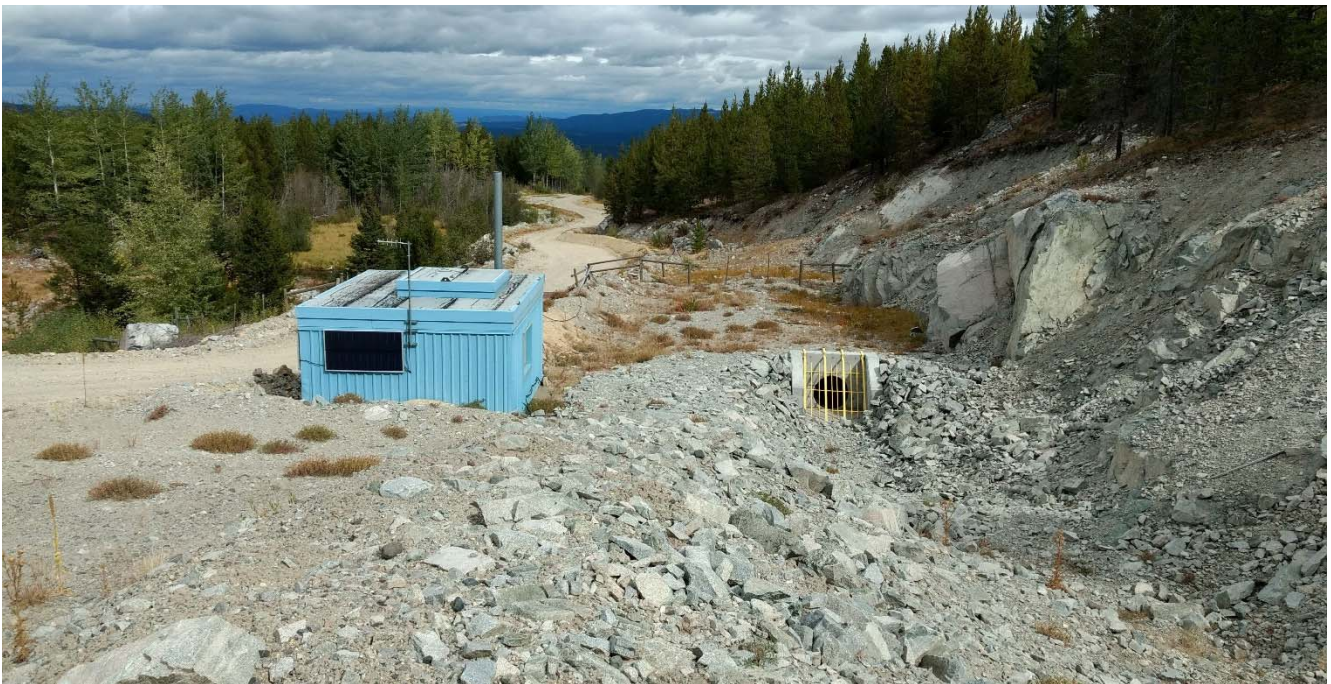
Photo II-B-18 S1: spillway outlet. (HGH-2017-27)

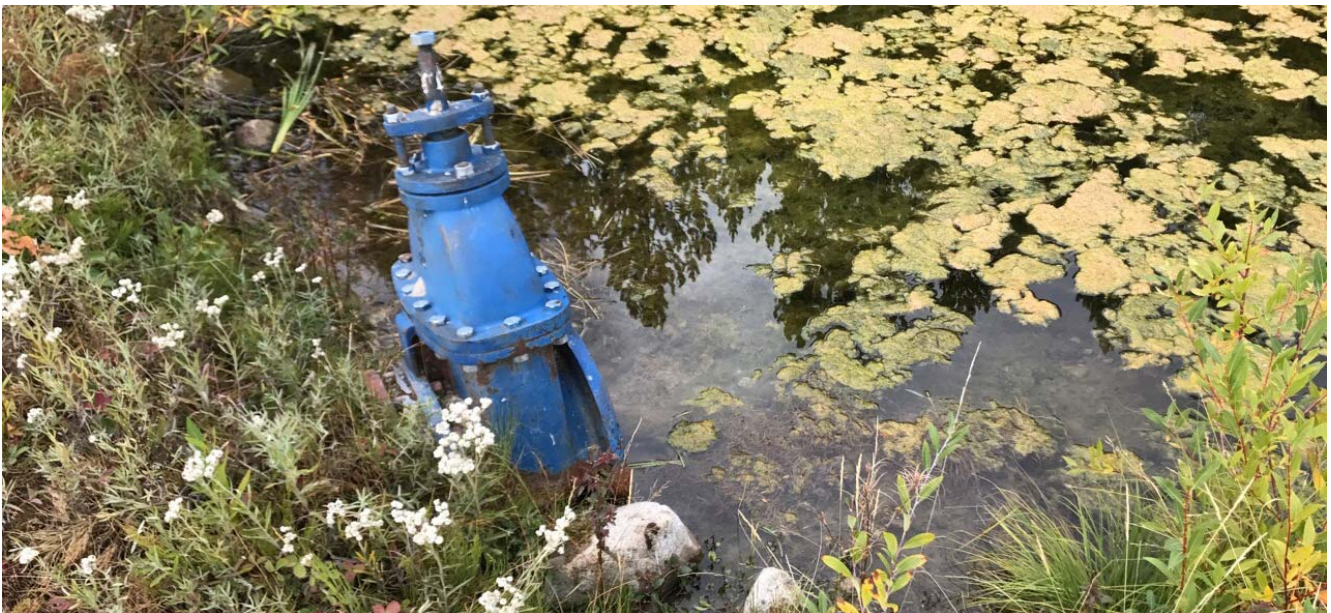
**Photo II-B-25 S5: seepage inflow to perimeter pond, flow rates measured using bucket.
(HGH-2017-35)**

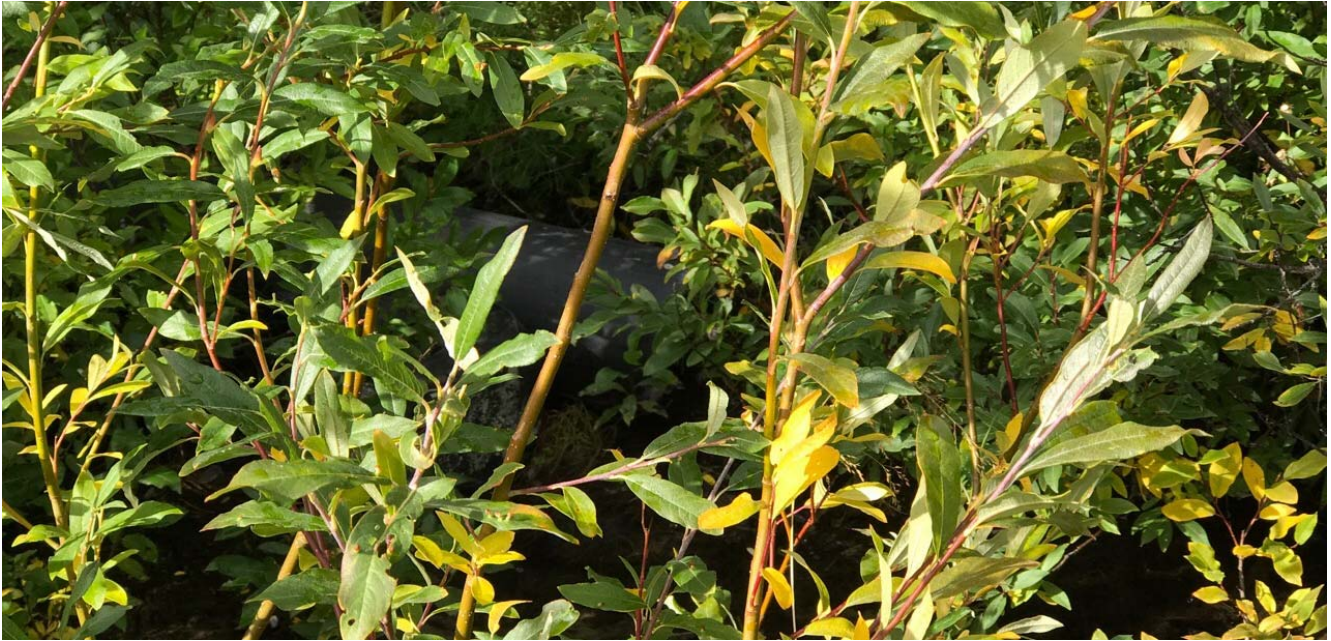
Photo II-B-26 S5: spillway pipes (2x), inlet currently blocked with sand bags. (HGH-2017-37)
