Teck Highland Valley Copper Partnership

2017 Dam Safety Inspection Report

Trojan Tailings Storage Facility

March 2018

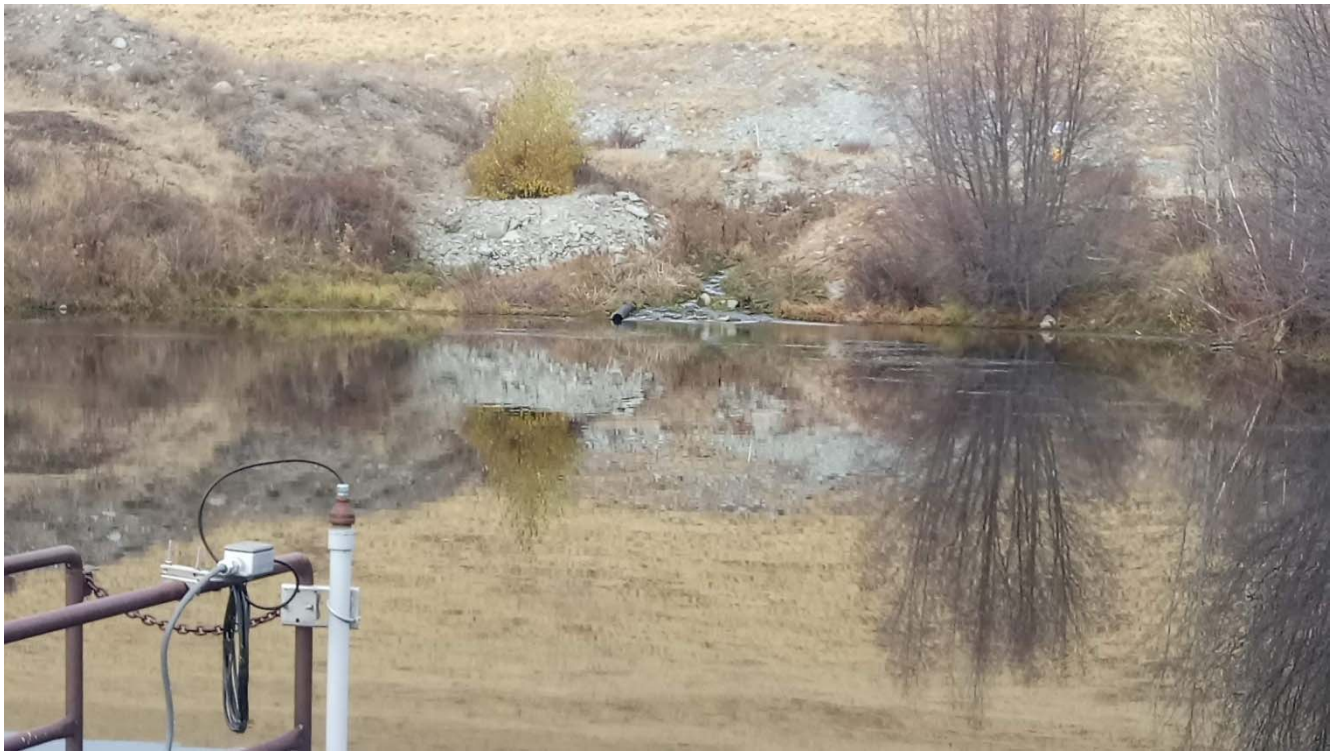
Photo II-C- 1 Overview of R4 seepage pond (TRJ-2017-20)

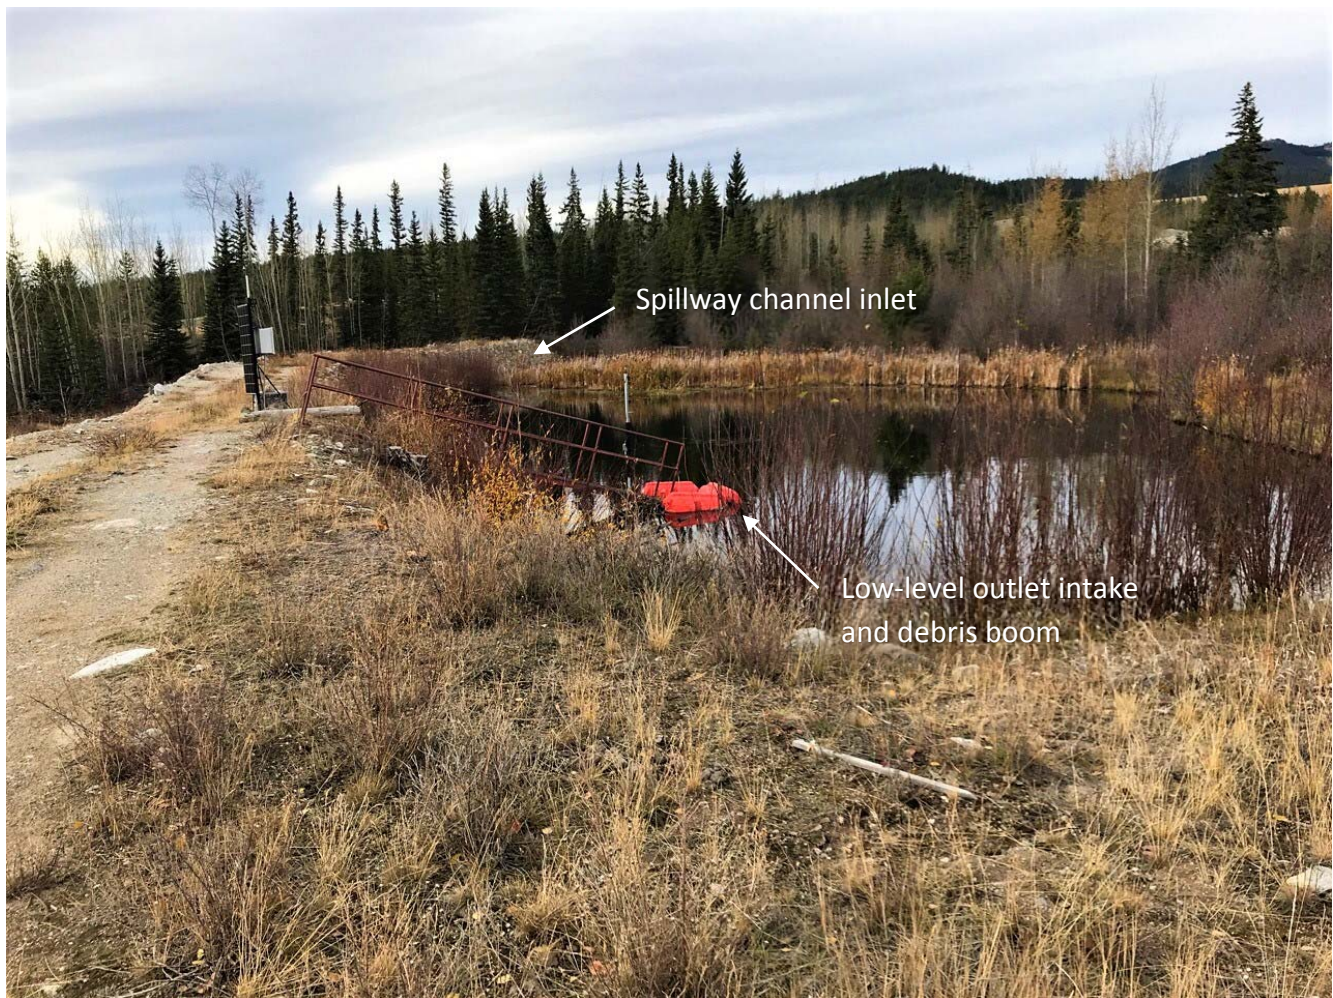
Photo II-C- 2 Dam Crest, view towards left abutment (TRJ-2017-23)

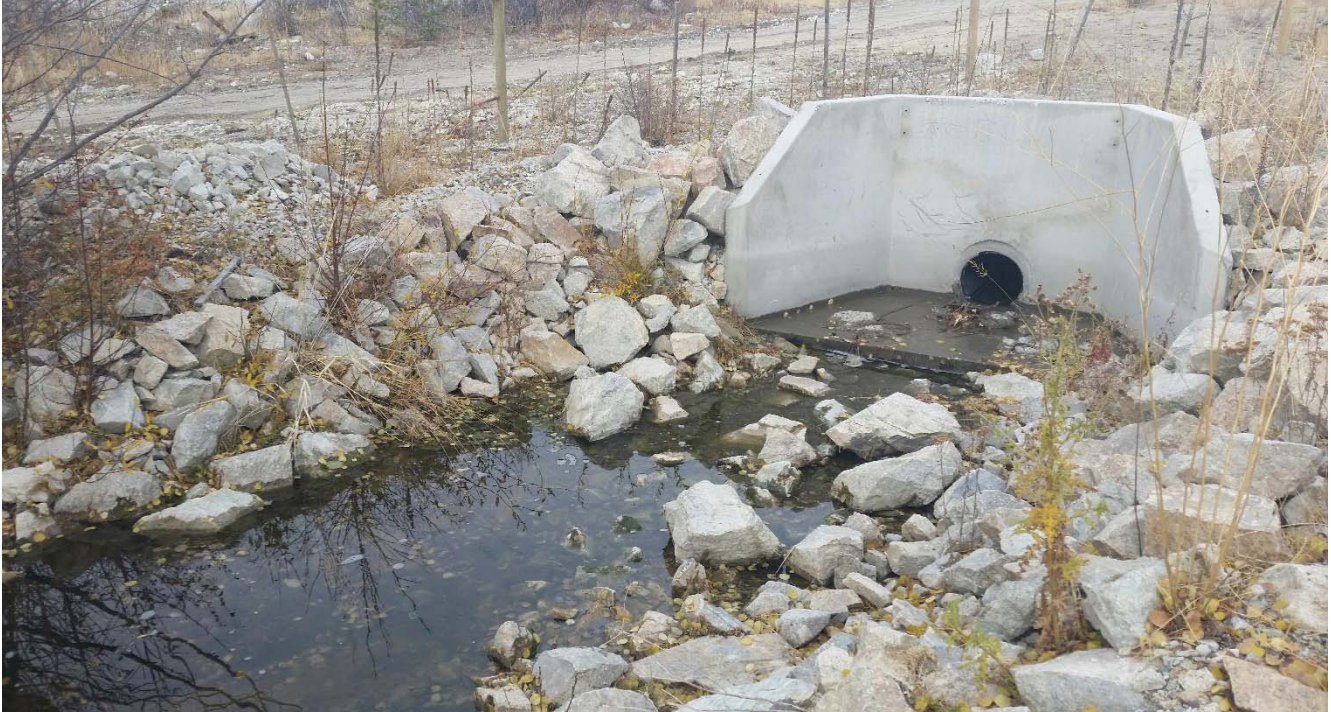
Photo II-C- 13 Discharge channel to weir, obstruction from large rocks present in channel (TRJ-2017-25)
