TECK COAL LIMITED GREENHILLS OPERATIONS

2017 Dam Safety Inspection for Greenhills Tailings Facility

Reference Number: 1778487-2017-130-R-Rev0-2000

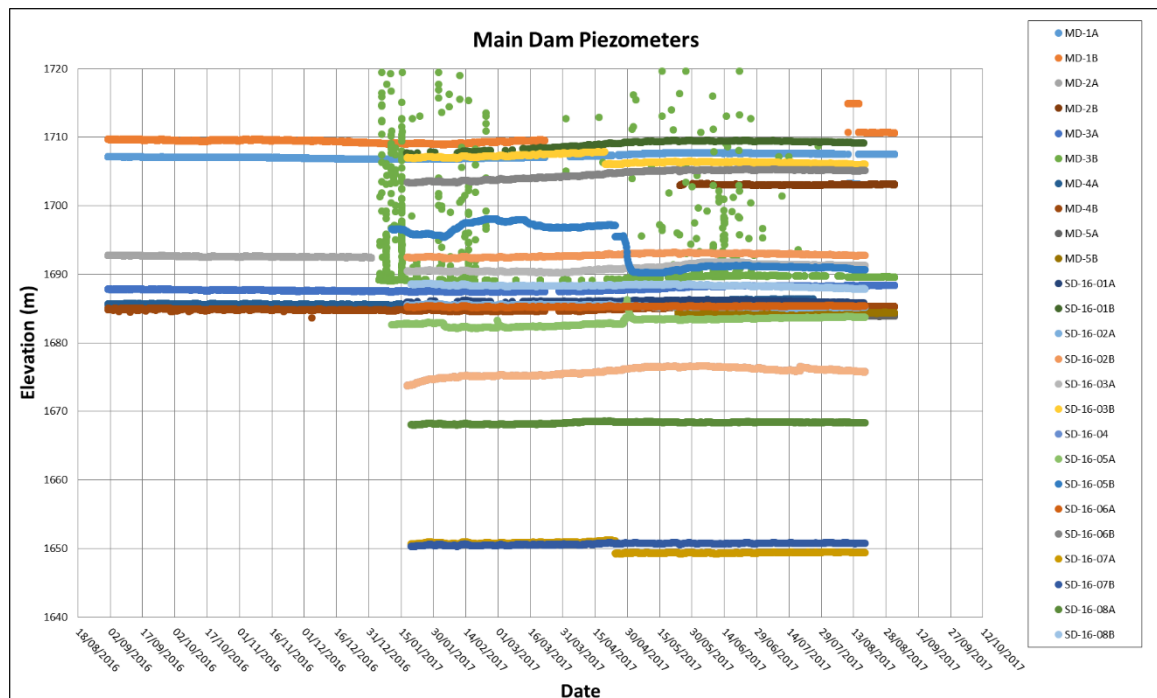
Chart 5: Main Tailings Dam Piezometer Data

Overall, there appears to be little change in the measured phreatic surface in 2017 compared to previous measurements and the phreatic surface in the compacted coarse refuse material was relatively low and stable.

It is recommended that the dataloggers be checked for the piezometers which reported erroneous data (VW11-MD-1B) and for the 2011 piezometers for which no data was reported for the reporting period (VW11-MD-1B, VW11-MD-3B, VW11-WD-1A and 1B, VW11-WD- 2B, VW11-WD-3A). VW11-MD-3B, VW11-WD-2A and VW11-WD-3B, which also reported erroneous and/or no data for the reporting period, are functioning correctly as of January 2018. If the dataloggers are functioning correctly and the piezometers are found to be faulty, a plan should be developed to repair or replace the faulty piezometers in any areas identified as critical and not covered by the recently installed instruments.

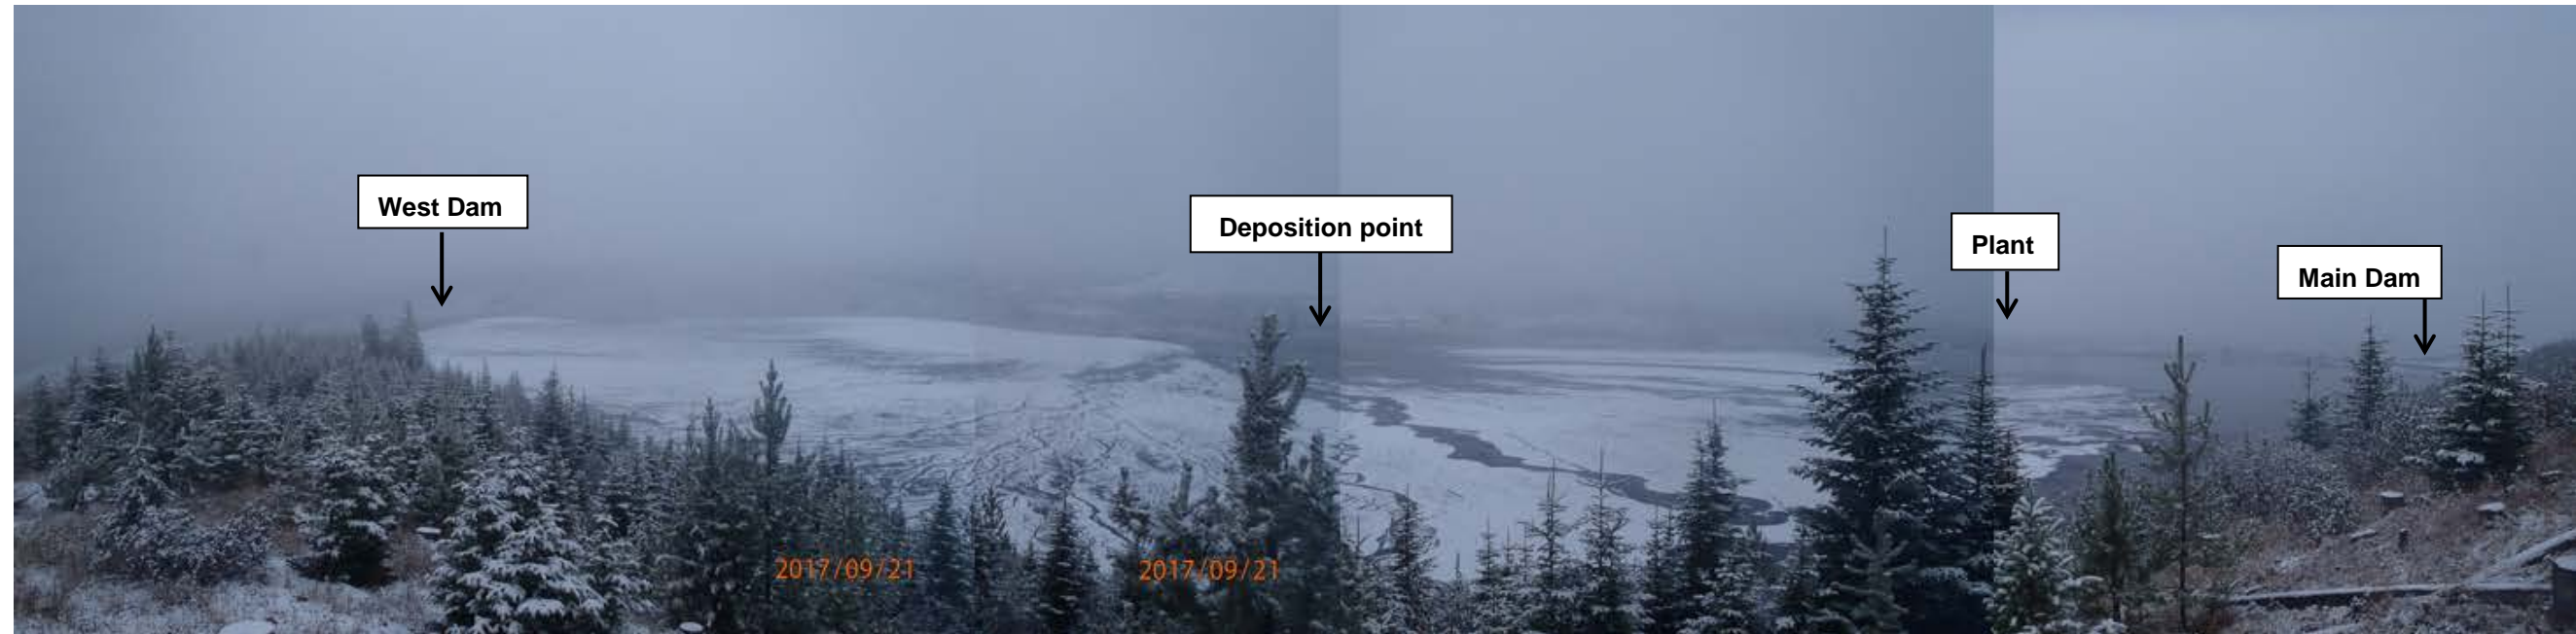
The tailings deposition location was moved, between September 2016 and September 2017, to approximately 250 m northwest of the 2016 location (Photograph 1, Appendix A).

Photograph 1: Overview from rise of natural ground to the south, looking northeast. 21 September 2017.

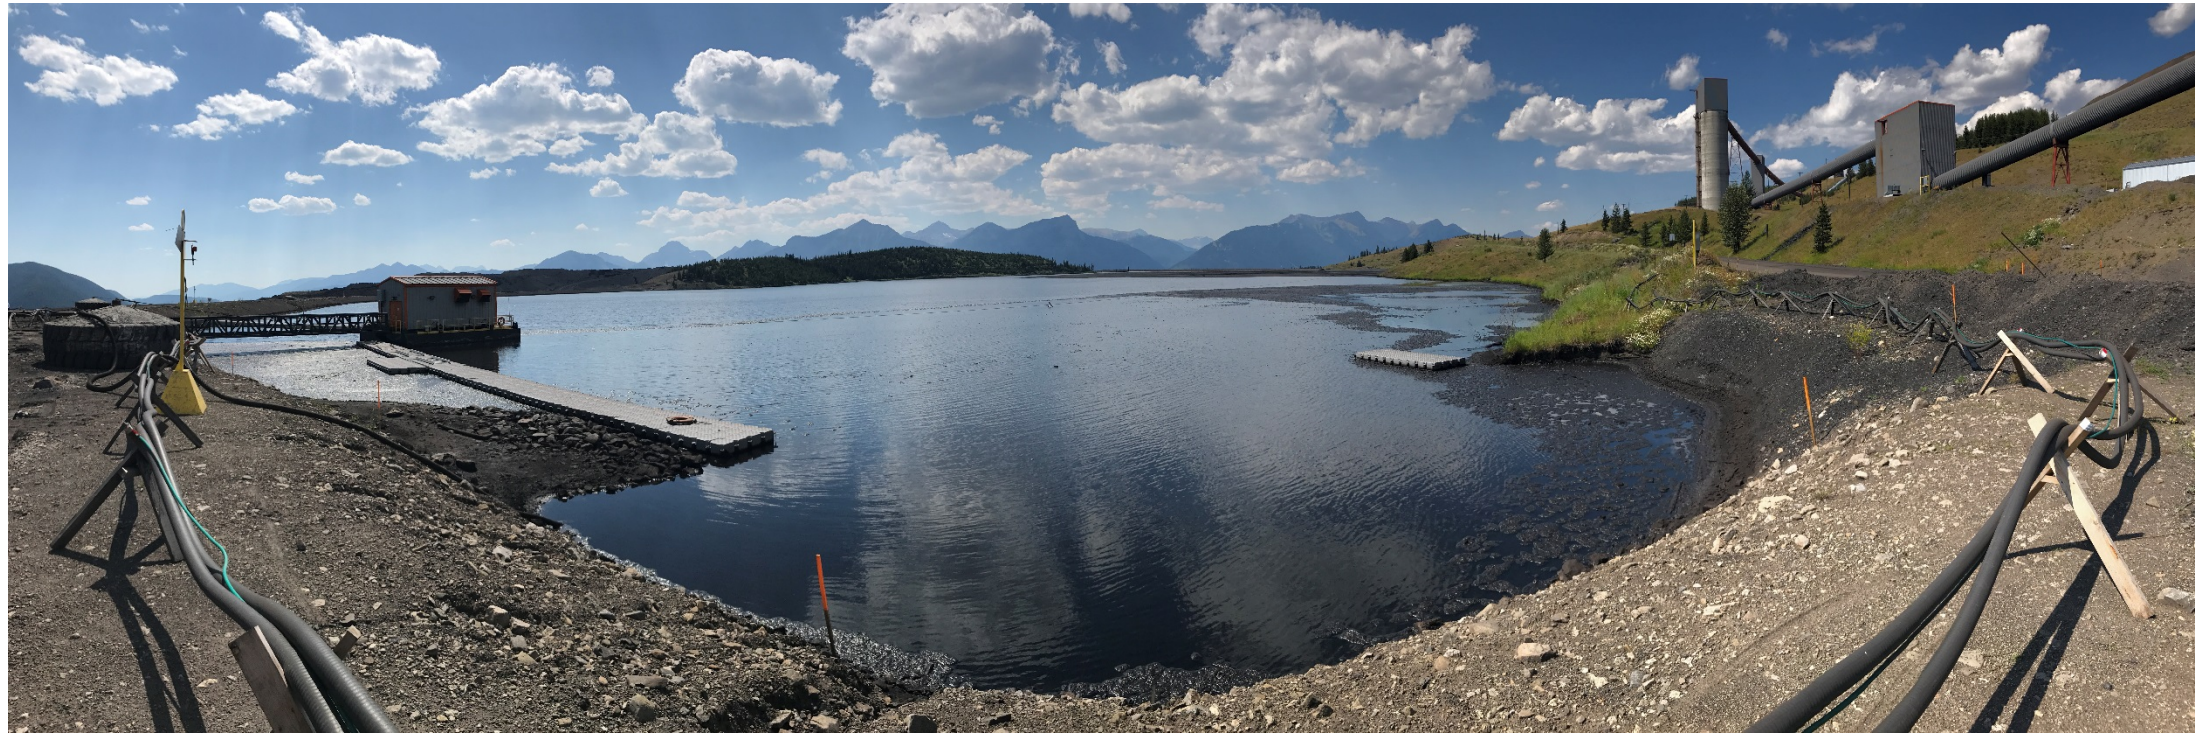
Installation of a staff gauge was recommended in the 2014 DSI (Golder 2014f) in order to provide a secondary pond level measurement. The staff gauge is intended to provide a quick way to confirm freeboard, especially with the performance issues with the GPS monitoring noted in the 2014 DSI. Visual indicators of water level in addition to electronic measurement are considered to be best practice. A staff gauge, indicating the TARP warning levels, was installed in 2017 (Photograph 3, Appendix A).

The majority of the upstream slopes of the Main and West Dams were observed to be 2H:1V. Golder and Teck has observed some minor sloughing of the upstream slope during the reporting period. At the time of the inspection, the upstream slope was being regraded to 2H:1V and riprap was being placed to protect the steeper slopes from further erosion (Photographs 3, 4, 5, 19, and 20 in Appendix A).

Photograph 3: Main Dam – overview of barge, looking southwest. 30 July 2017.

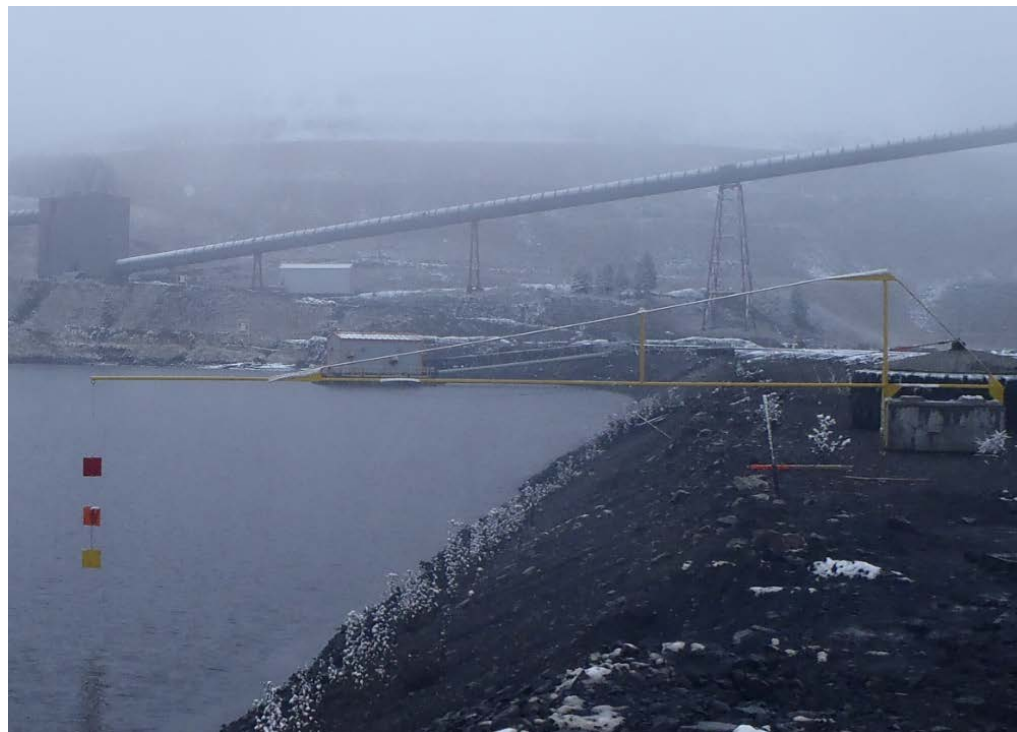
Photograph 4: Main Dam – overview of barge, east abutment, pond level indicator, and natural ground north of GHO Tailings Pond, looking north. 21 September 2017.

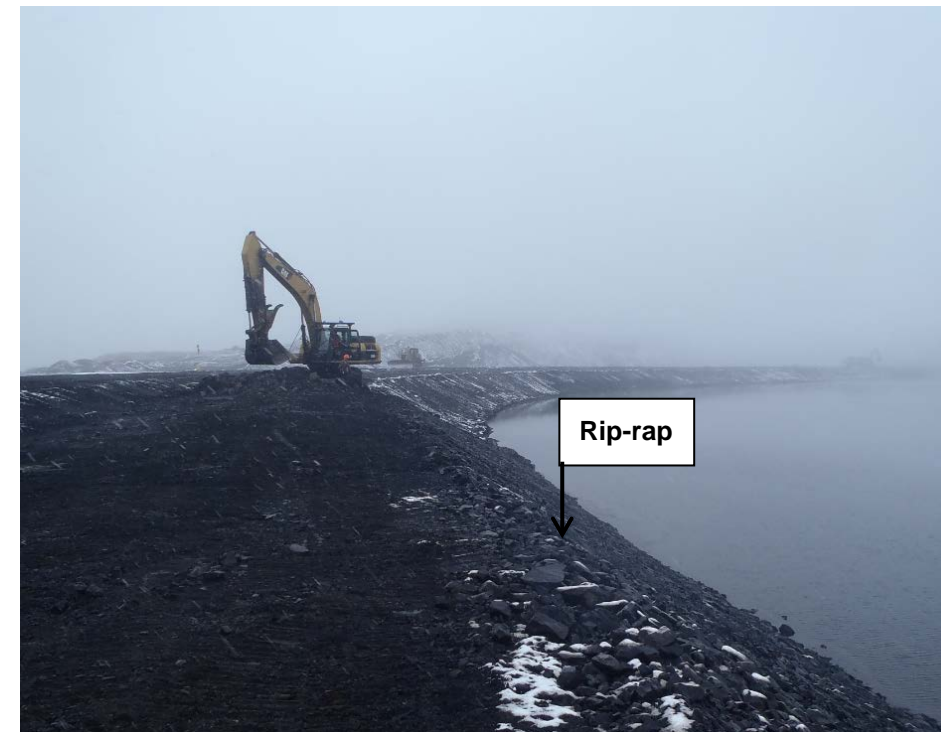
Photograph 5: Main Dam – upstream slope and crest, looking southwest. 21 September 2017.

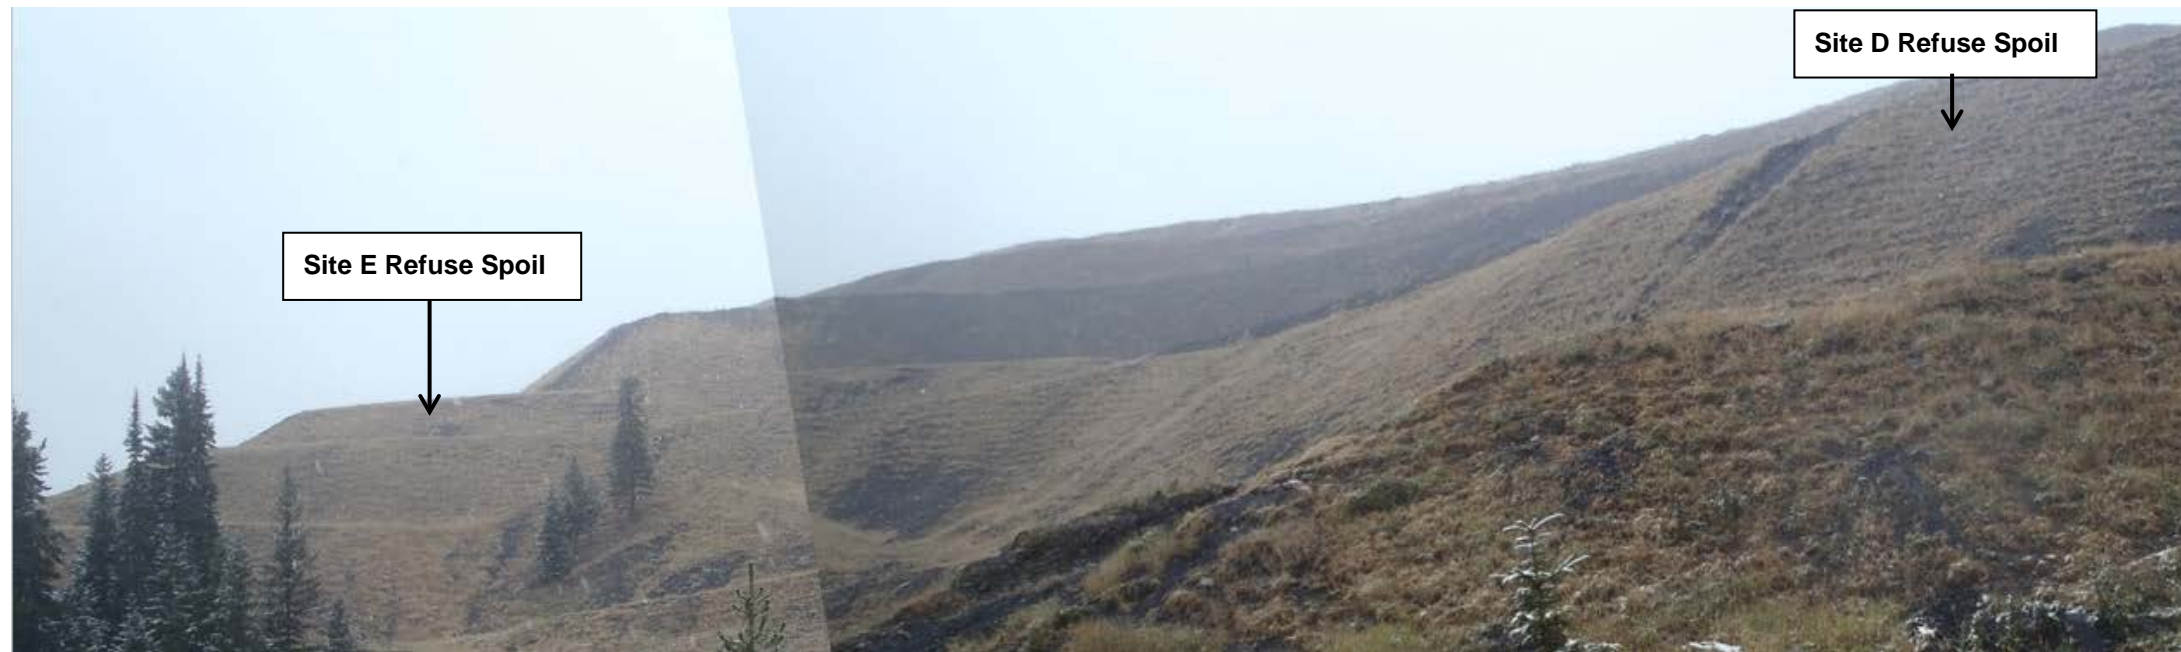
Teck have improved the stormwater management on the downstream slope of Site C such that ponding of water has been minimized and the erosion, observed in 2016 DSI, has been repaired (Photographs 10 to 12 in Appendix A). Improvements have also been made to the seepage collection at the downstream toe of Site C (Photographs 13 and 14 in Appendix A).

Photograph 10: Site D and E – overview of Site D and Site E coarse coal refuse spoils, looking northwest. 21 September 2017.

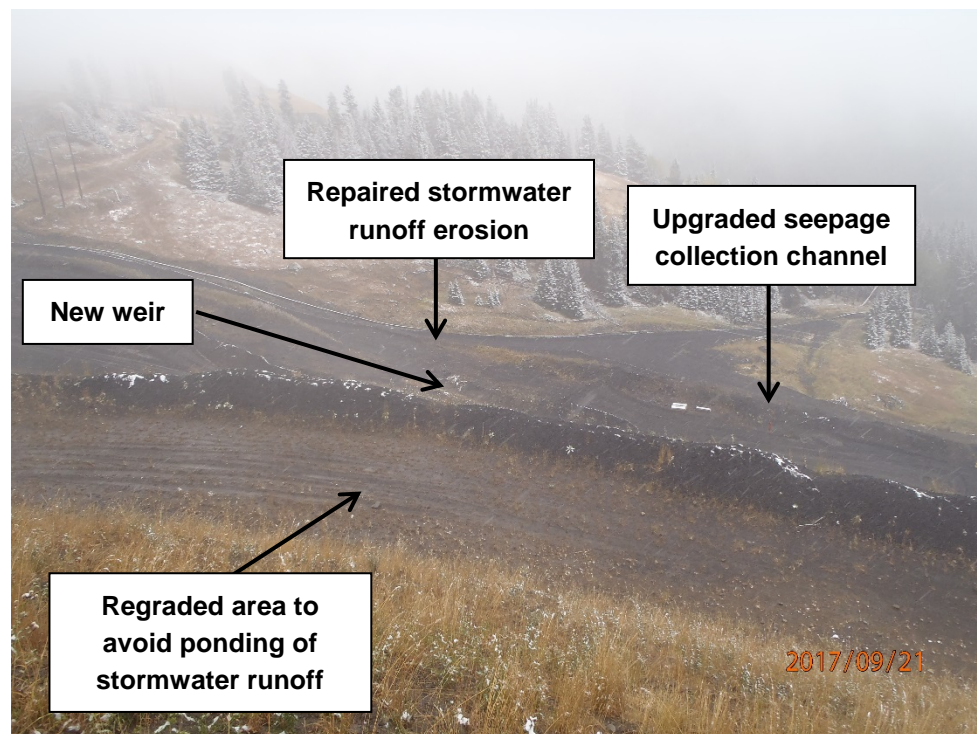
Photograph 11: Site C – view of west side of refuse dump, looking east. 21 September 2017.

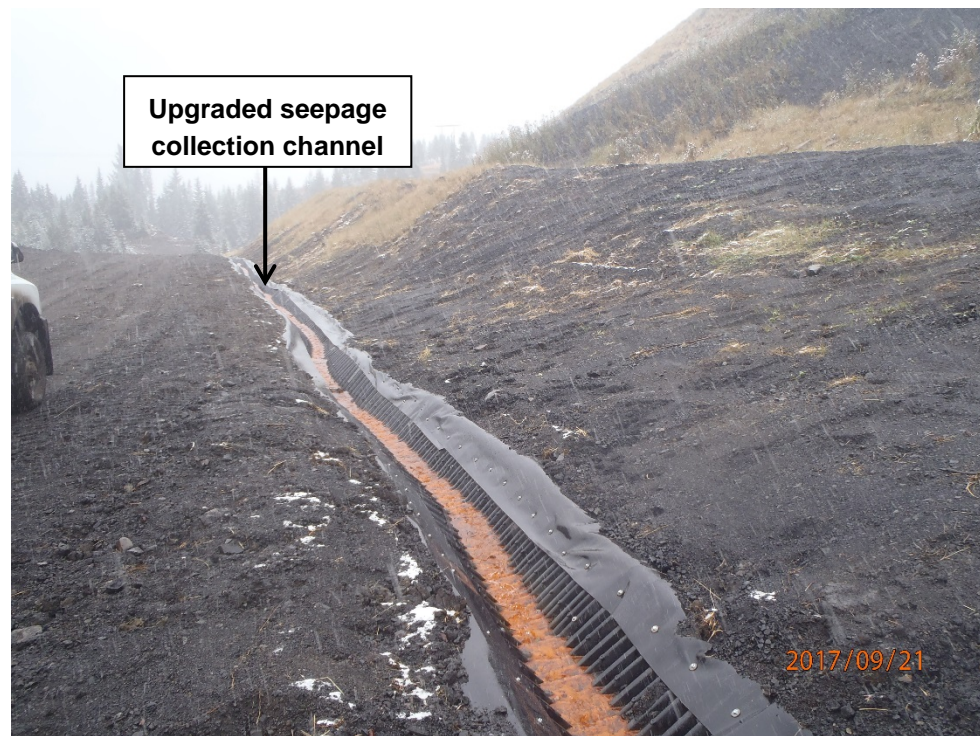
In the area downstream of the Main Dam, the downstream face is buttressed by the Site C and Site D coarse refuse spoils. The Site C coarse refuse spoil (located downstream of the Main Tailings Dam) provides additional support to the Main Dam. The instability observed on the lowest bench of Site C in 2012 (Golder 2013a) appears to have been arrested by the combination of improving surface drainage and not placing additional coarse refuse (Photographs 15 in Appendix A).

Photograph 15: Site C – upgraded seepage trench at toe of Site C refuse spoil, looking southwest. 21 September 2017.

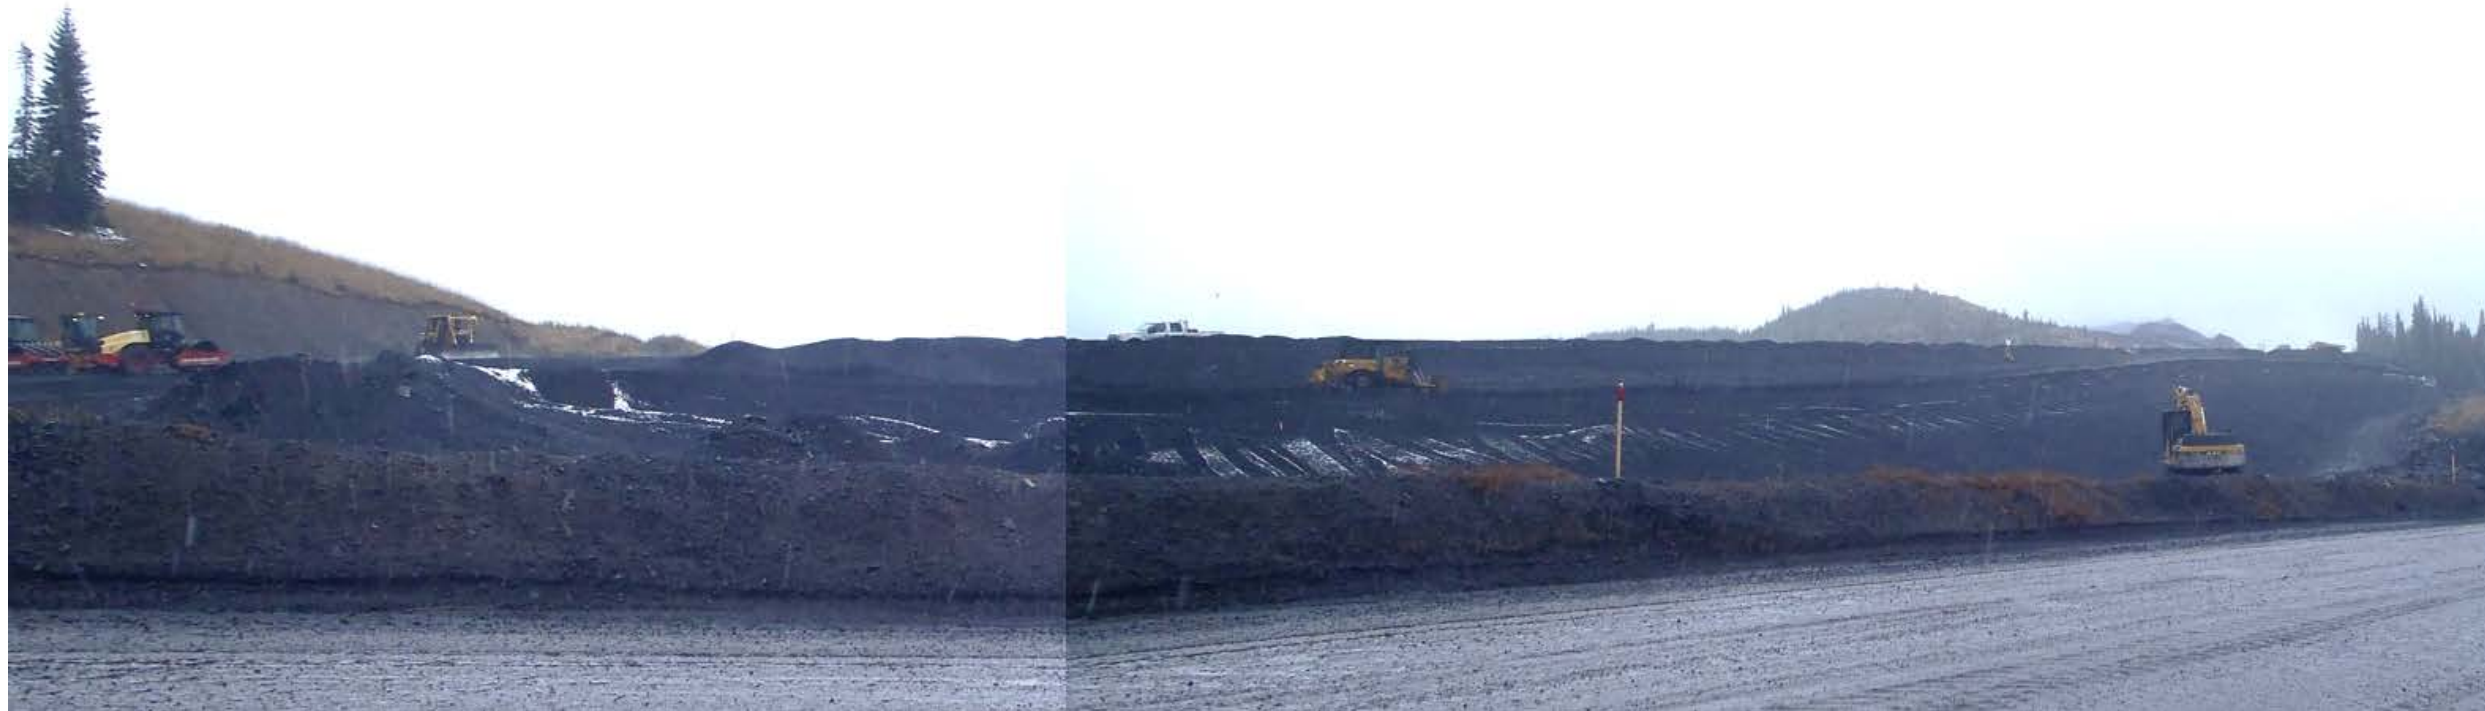
Photograph 19: West Dam – overview of downstream slope under construction, looking southeast. 21 September 2017.

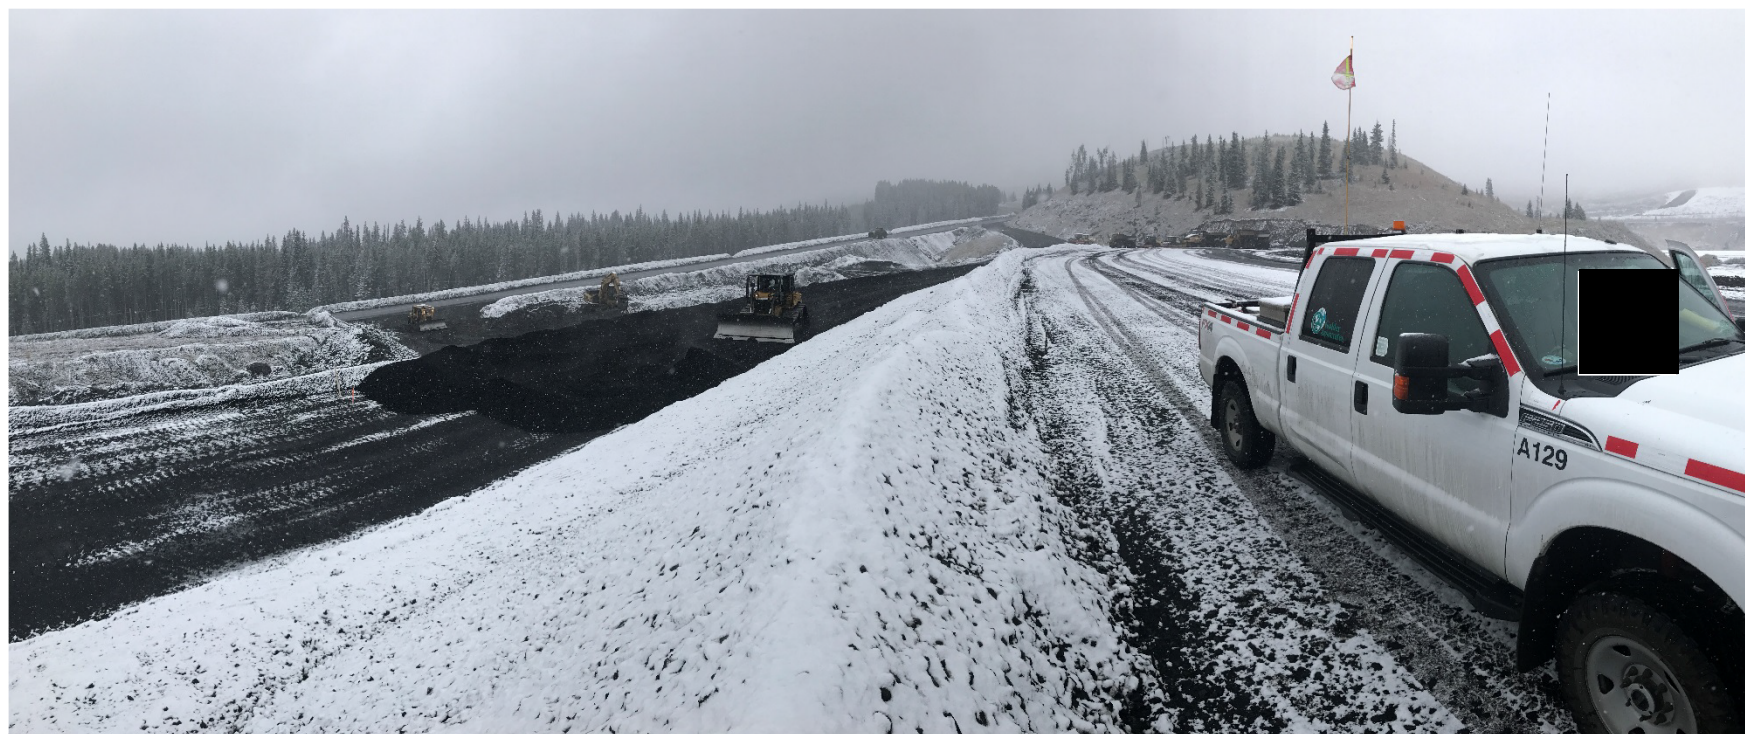
Photograph 20: West Dam – downstream slope under construction, looking north. 21 September 2017.

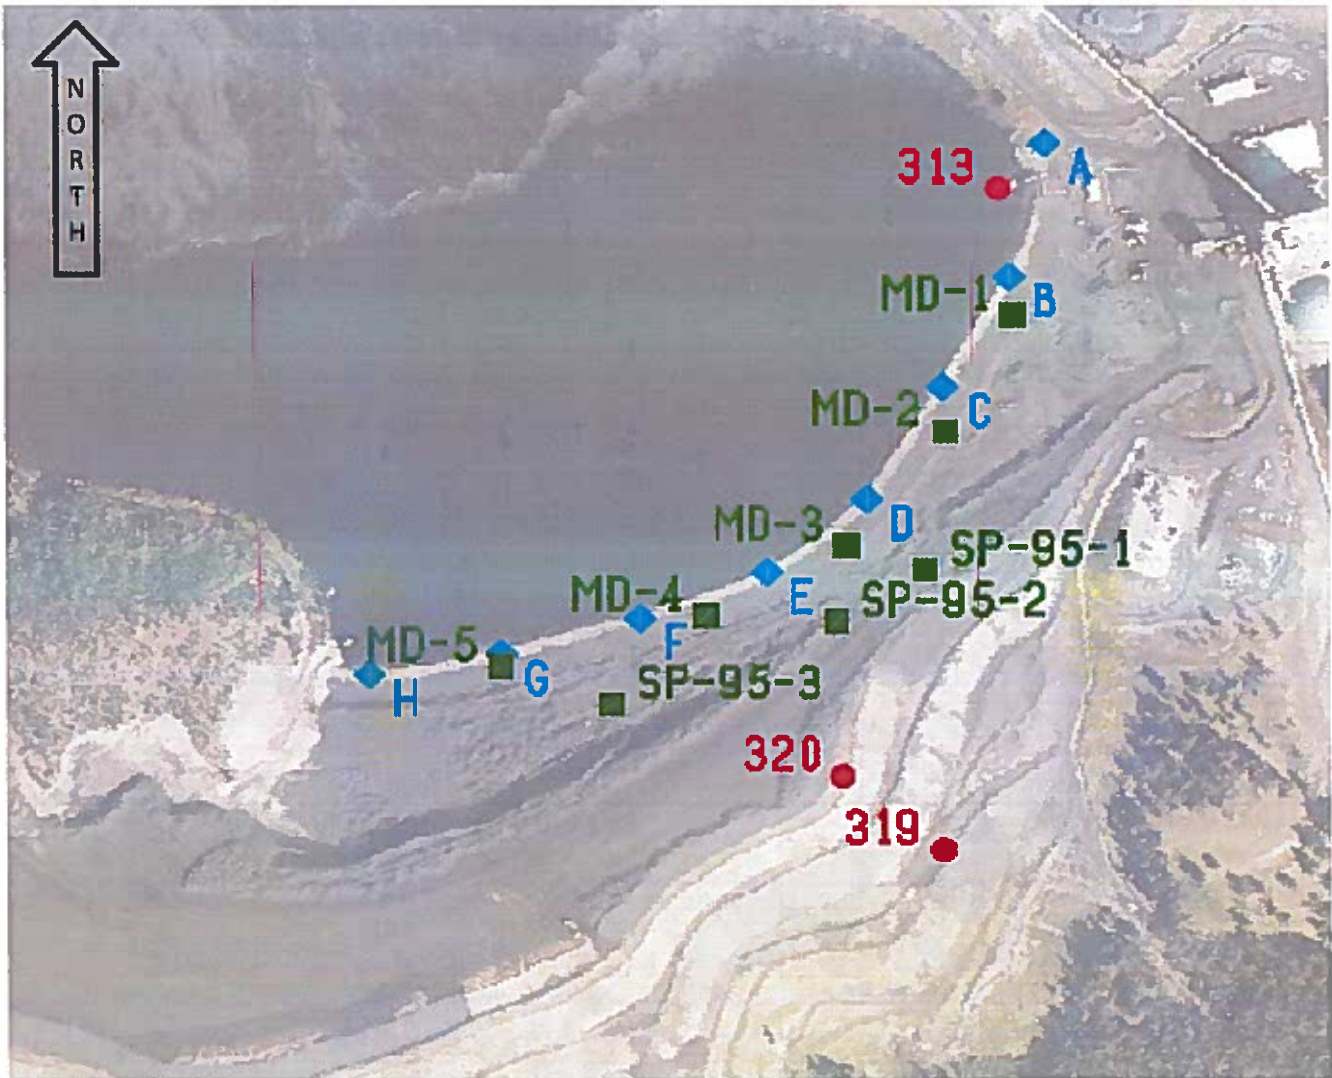
Pond Map:

- SITE C DRAINAGE BROKEN
↳ FOLLOW UP REQUIRED → STEELING NOTICE
→ WORK ORDER IS OUTSTANDING.
