**TECK COAL LIMITED  
FORDING RIVER OPERATIONS**

**2017 Dam Safety Inspection for  
North Tailings Pond and South  
Tailings Pond**

**Reference Number: 1784573-2017-129-R-Rev0-1000**

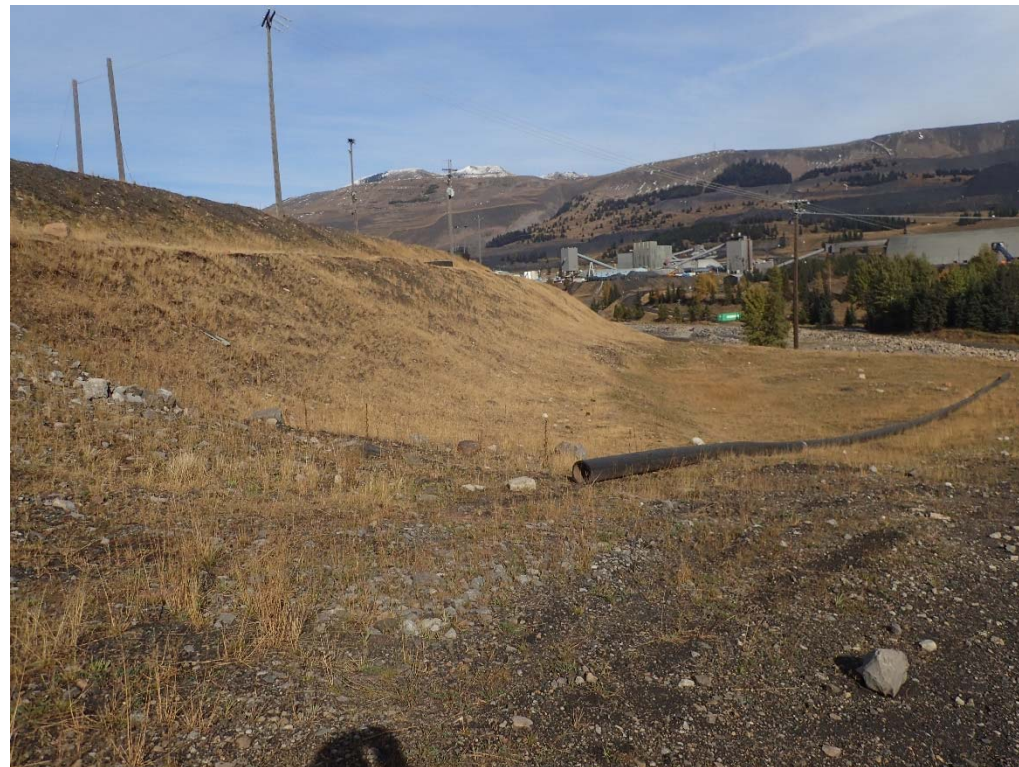
*Photograph 2: NTP dam downstream slope overview from south abutment, looking northeast. 4 October 2017.*

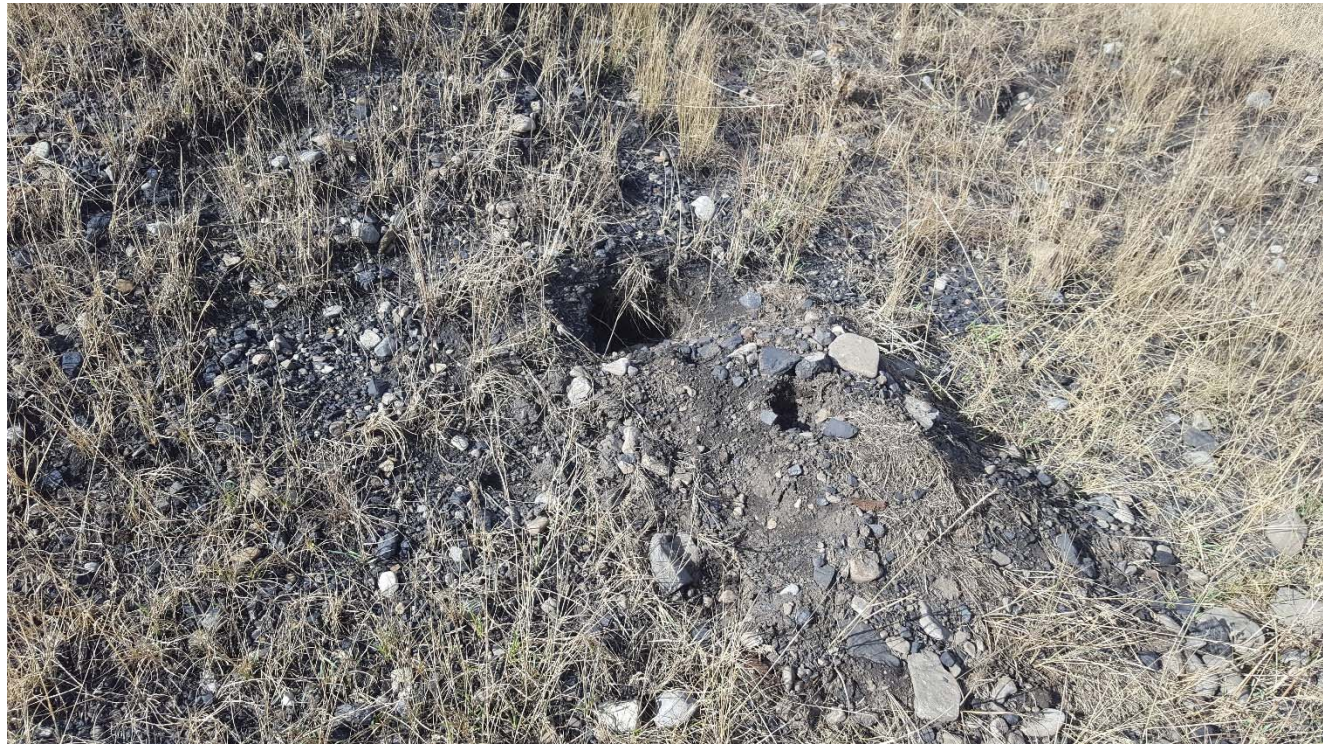
Photograph 4: NTP downstream toe, animal burrows near south abutment, looking northwest. 4 October 2017.

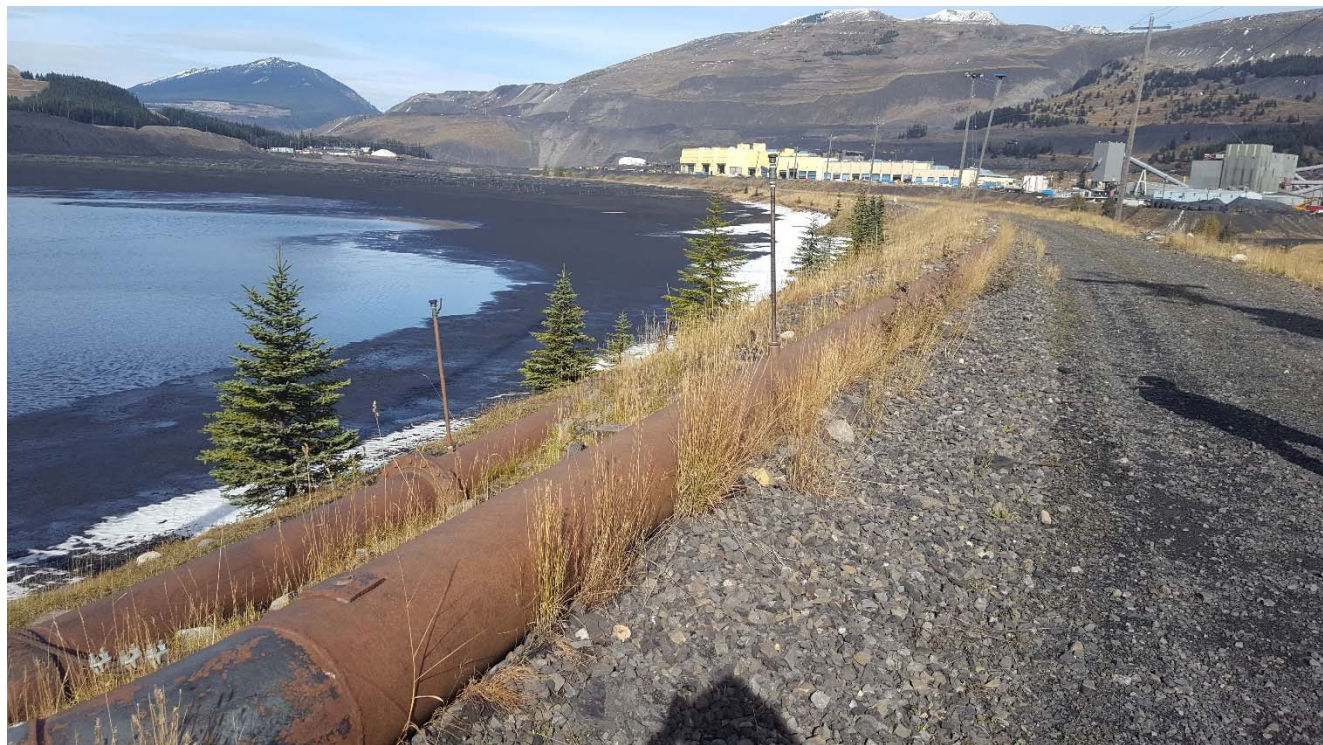
Photograph 6: NTP dam upstream slope with small trees and vegetation growing, and unused reclaim pipes, looking northeast. 4 October 2017.

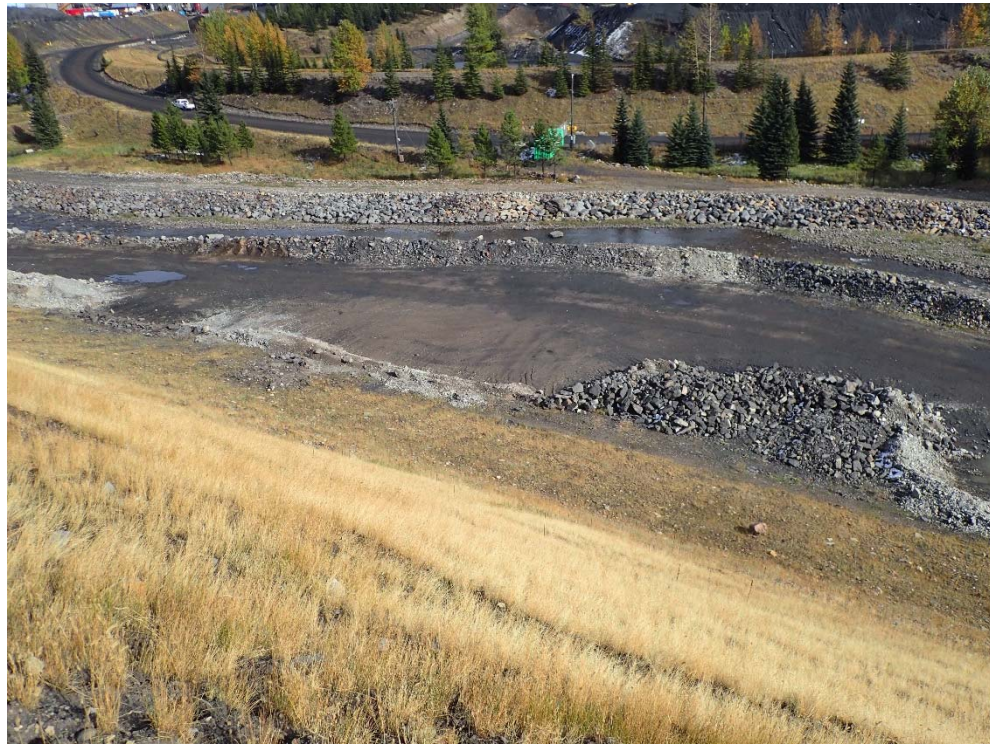
*Photograph 8: NTP dam downstream slope and toe with riprap staging area, looking east. 4 October 2017.*

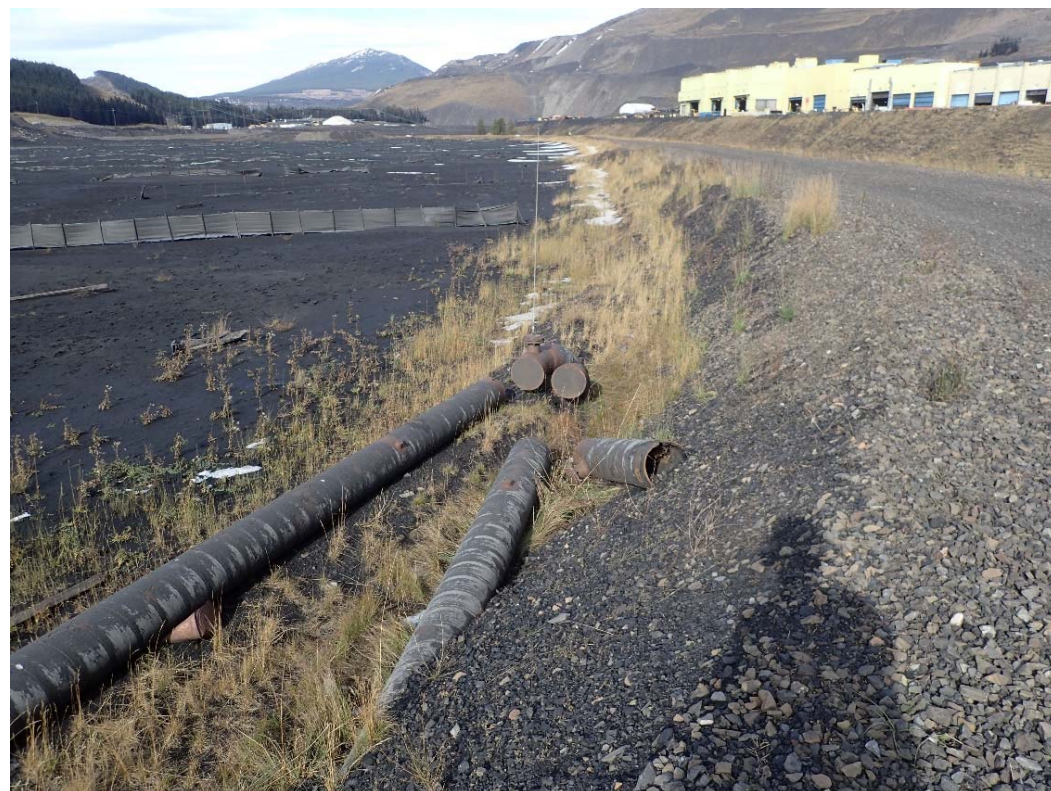
*Photograph 13 : NTP unused dual reclaim pipes on upstream slope and crossing under crest, looking north. 4 October 2017.*

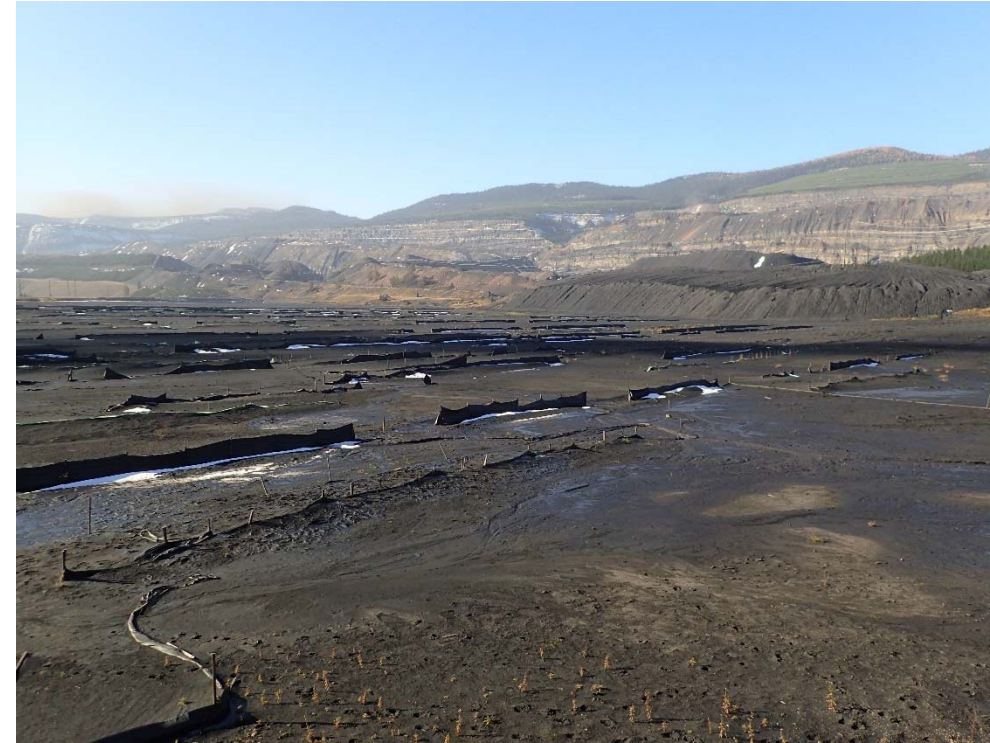
*Photograph 16: NTP, tailings surface with silt fencing for dust control, looking southwest. 5 October 2017.*

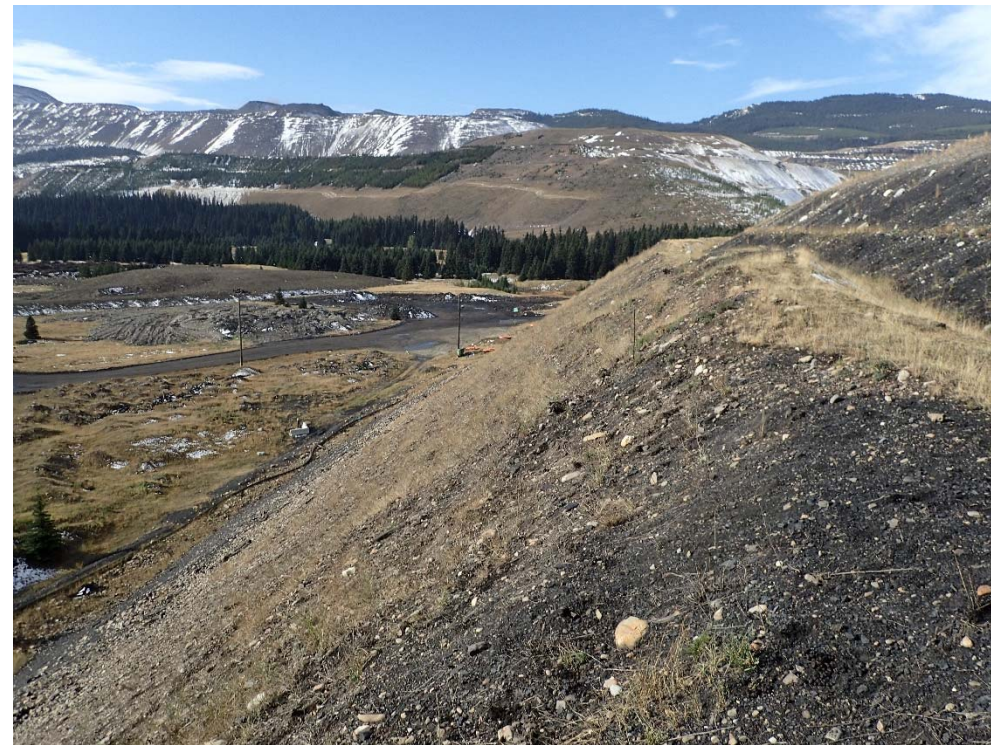
Photograph 31: STP Main Dam, downstream slope at mid-slope bench (approximately elev. 1,630 m), looking west. 4 October 2017.

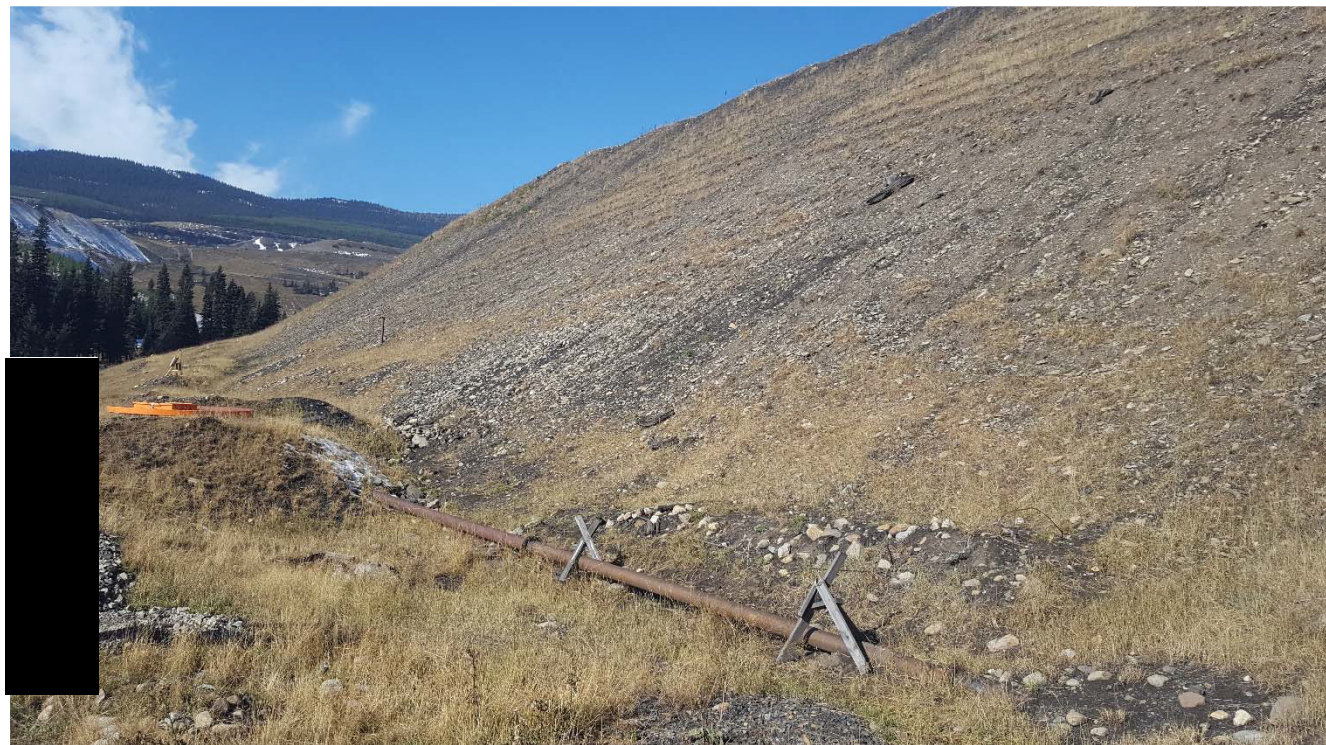
Photograph 32: STP Main Dam, downstream slope and toe at seepage return well, looking west. 4 October 2017.

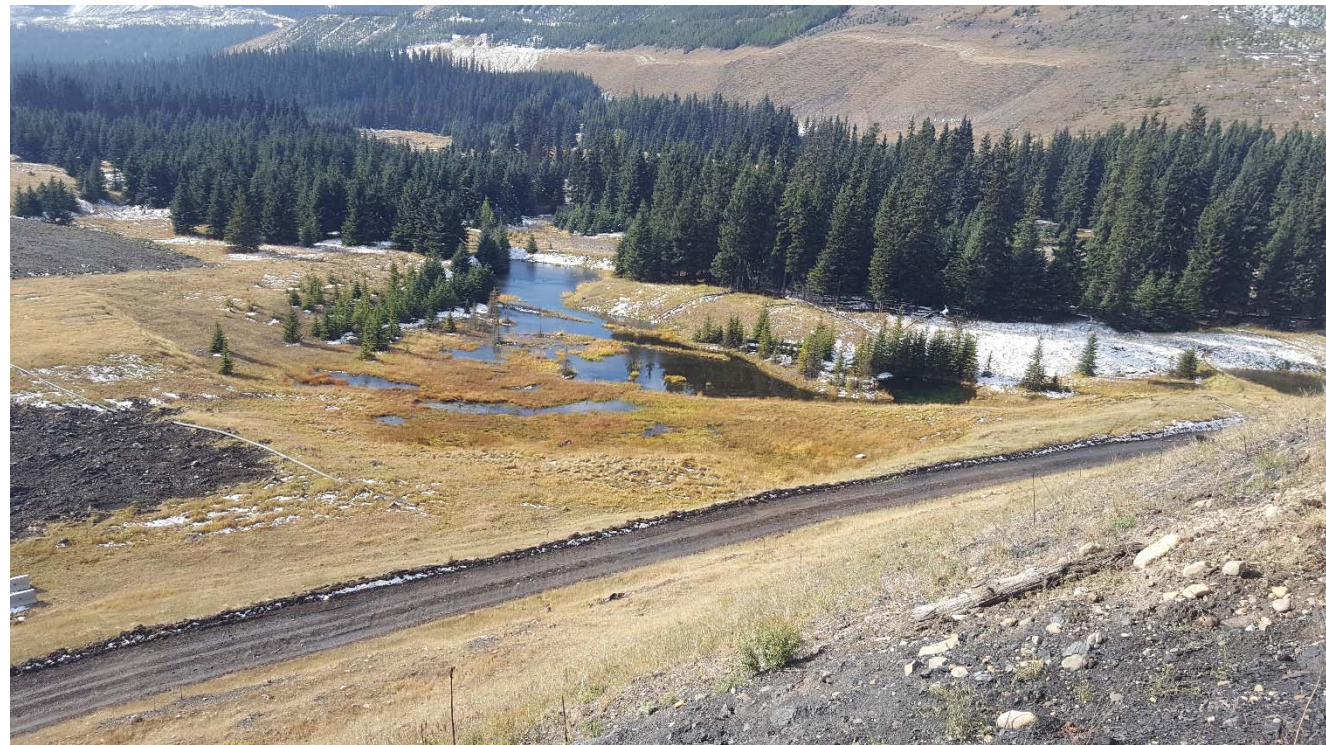
- No zones of subsidence or any sinkholes were observed that would indicate voids due to either suffusion or piping.
- A pond is present at the north end of the West Dam near Stn. -0+050 (Appendix A, Photograph 33). This pond is assumed to be due to surface water from the Maxam Yard.
- An old river channel is present past the downstream toe of the Main Dam (Appendix A, Photograph 34). This is consistent with previous years.

*Photograph 34: STP Main Dam, persistent ponding downstream of toe in old river channel, looking southwest.  
4 October 2017.*

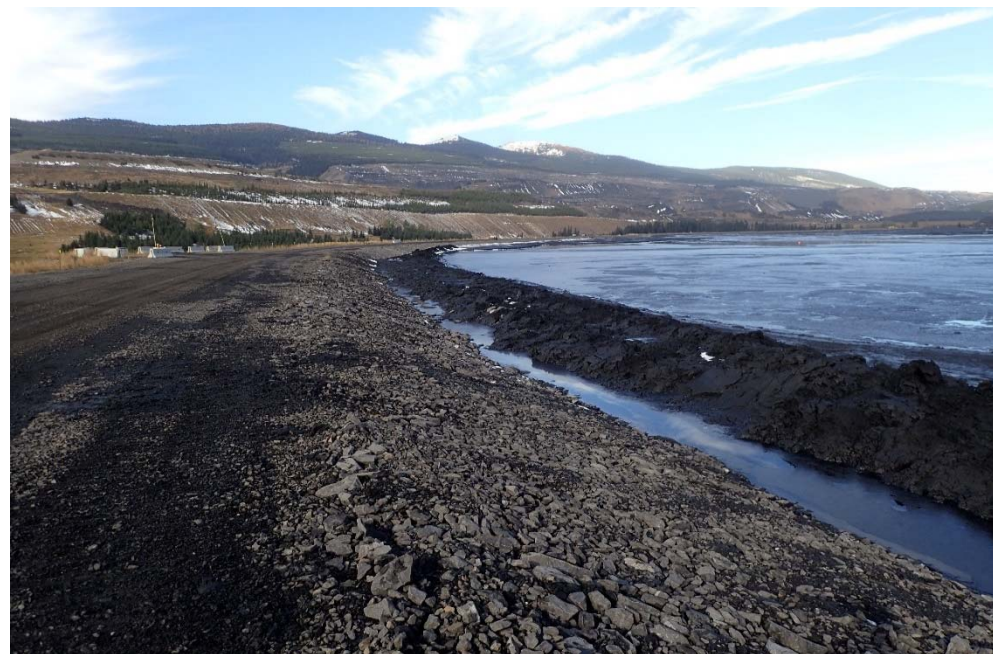
*Photograph 36: STP West Dam, upstream slope with new riprap, looking northwest.  
Note tailings were pushed into pond to place riprap. 4 October 2017.*

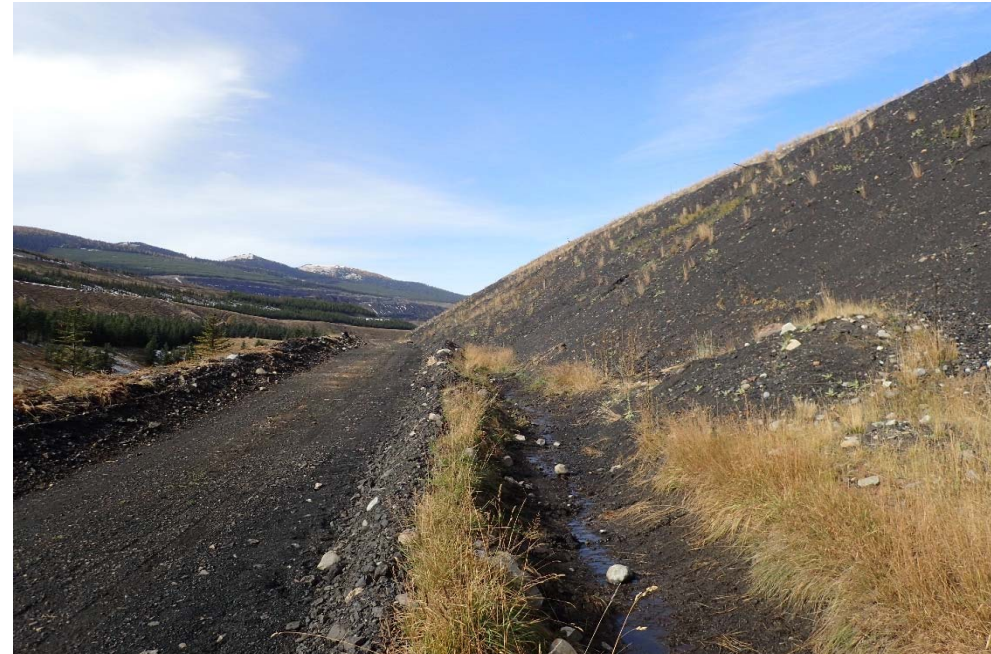
- External seepage water was observed to be clear.
- The ditch that captures runoff or seepage at the toe of the West Dam was reinstated (Appendix A, Photograph 37).

*Photograph 37: STP West Dam, access road used for riprap haulage, ditch re-established along bench, looking northwest.  
4 October 2017.*

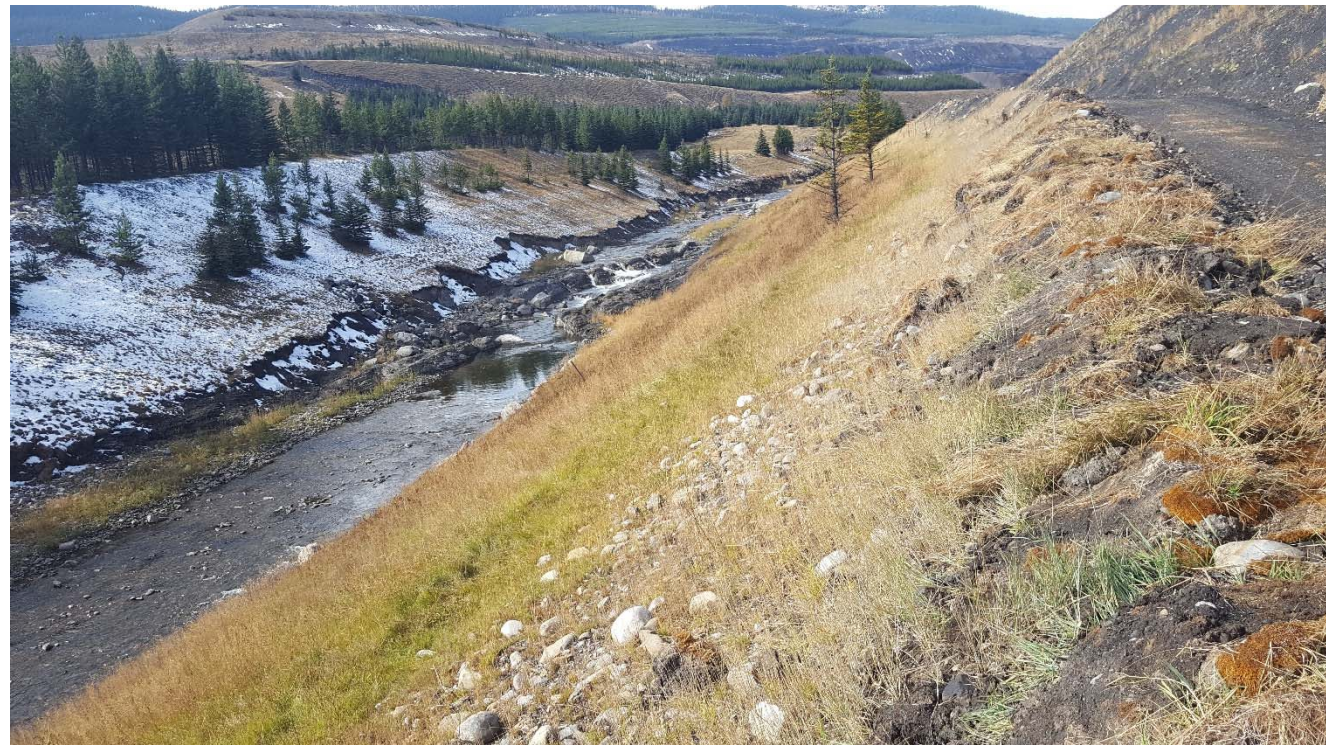
*Photograph 38: STP West Dam, downstream slope, looking northwest. 4 October 2017.*

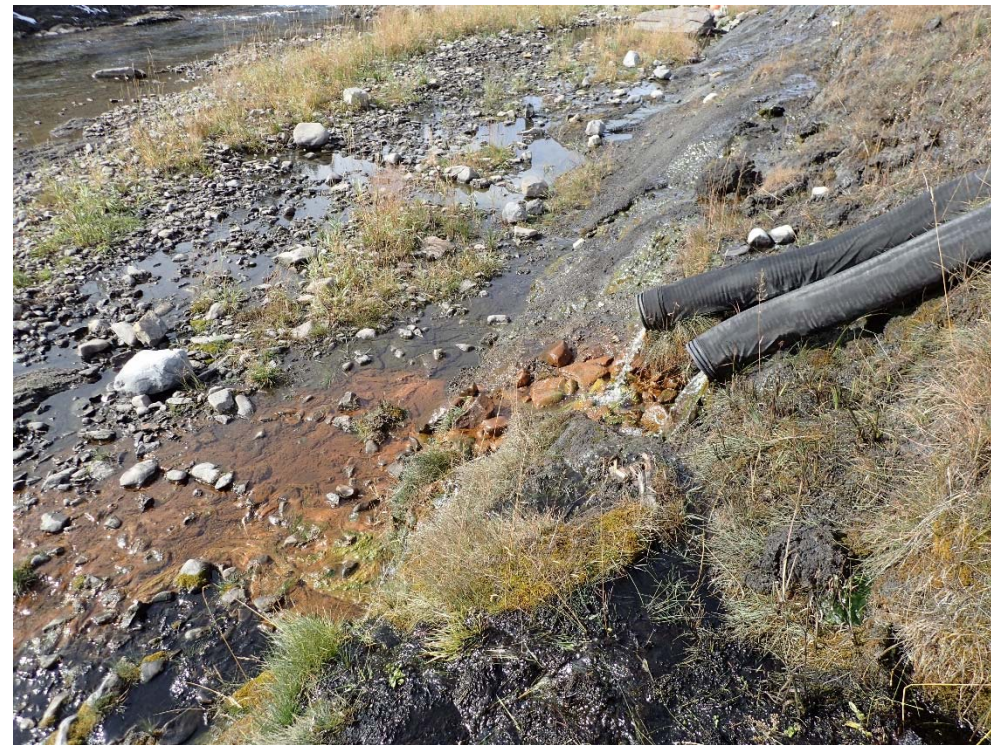
- Seepage continues along the presumed till/bedrock contact below the West Dam (Appendix A, Photograph 39). The seepage has pushed up mats of organics and created a hummocky, broken surface area. This is consistent with previous years. Seepage from the collection pipes at the time of the site visit was approximately 1.5 L/s from each the W Seep North and South pipes. Red staining was noted in some areas of seepage along the bedrock contact (Appendix A, Photograph 39).

*Photograph 39: STP West Dam, major seepage point at the downstream slope toe (Stn. 1+000). Seepage collection pipes monitor flow. Note discolouration. The flow rate at the time of inspection was approximately 3 L/sec from both pipes. Looking northwest. 4 October 2017.*

4.2 Signs of Erosion	None	22	
4.3 Signs of Turbidity in Seepage Water	None		
4.4 Discoloration/Staining	Yes (green, red)	39 40	<ul style="list-style-type: none"> <li>■ Green mineral (possible calcite) deposits from seepage water.</li> <li>■ Some minor areas with red colored staining in seepage from bedrock contact.</li> </ul>

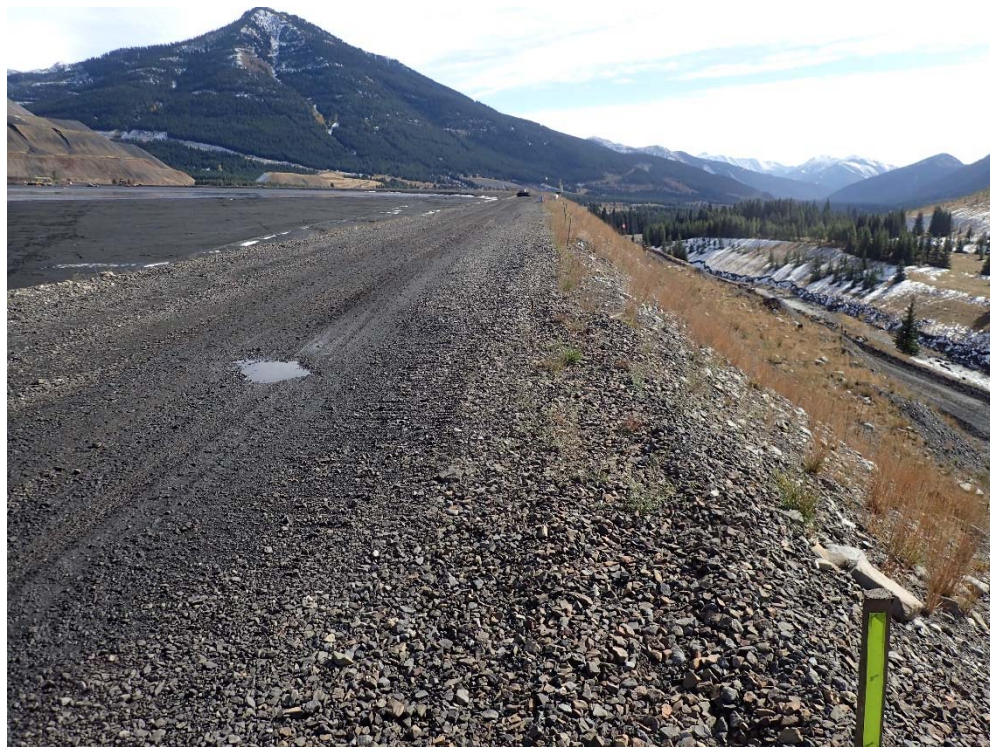
*Photograph 41: STP West Dam crest overview, looking southeast. Note crest regraded. 4 October 2017.*

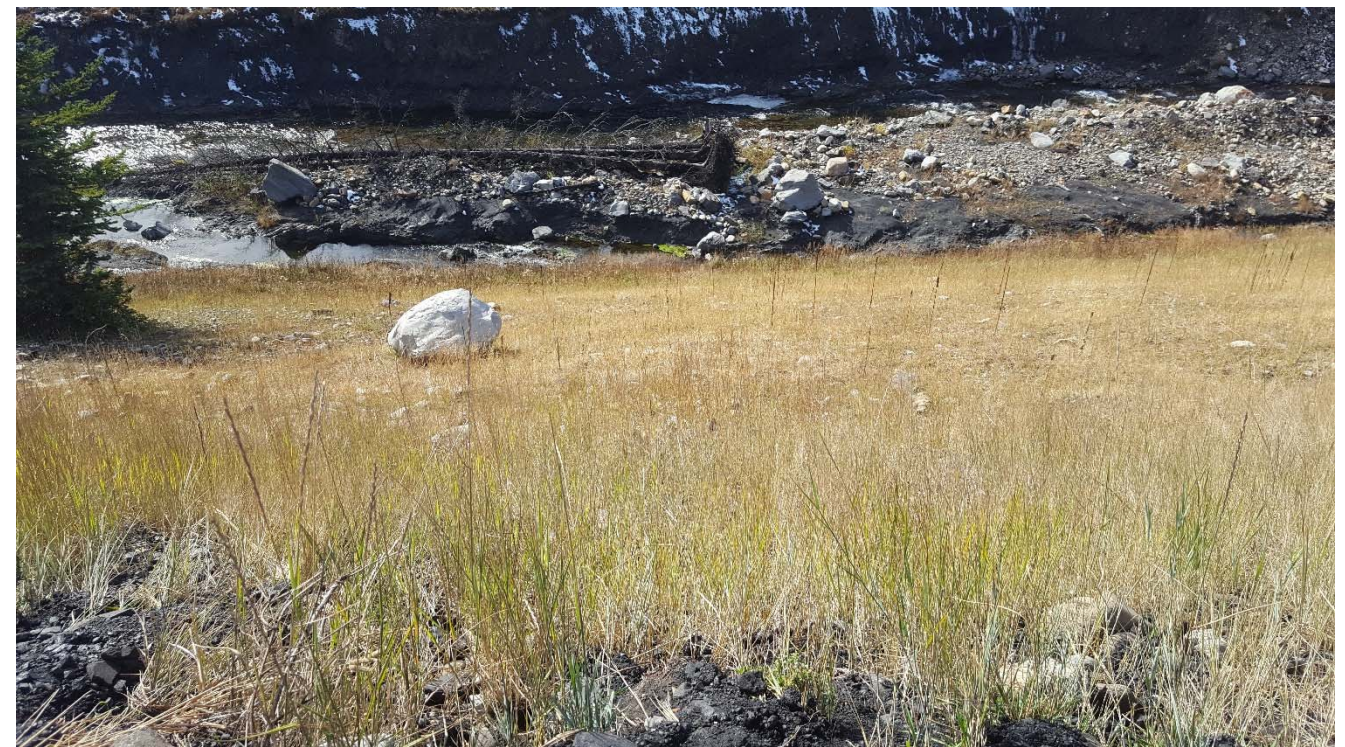
*Photograph 42: STP West Dam, downstream slope and Fording River, looking southwest. 4 October 2017.*

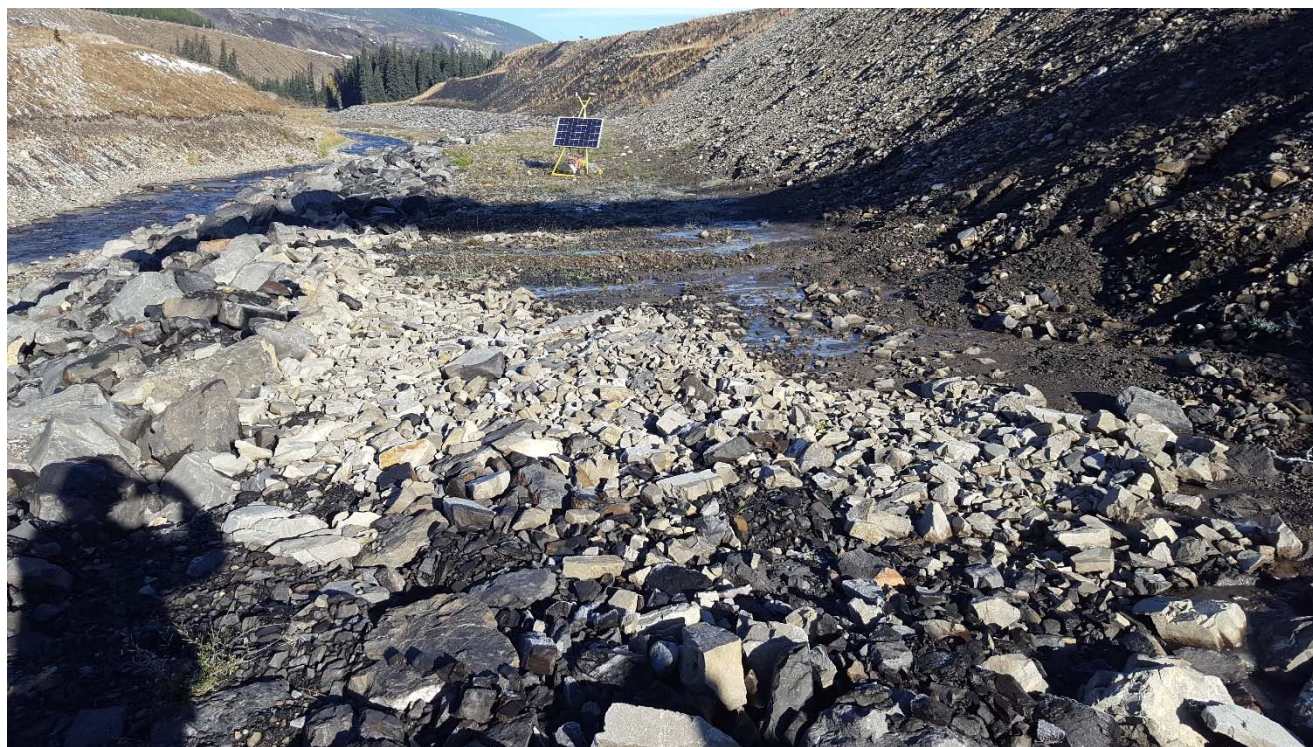
*Photograph 43: STP West Dam, seepage at riprap at downstream toe, looking northwest. 4 October 2017.*

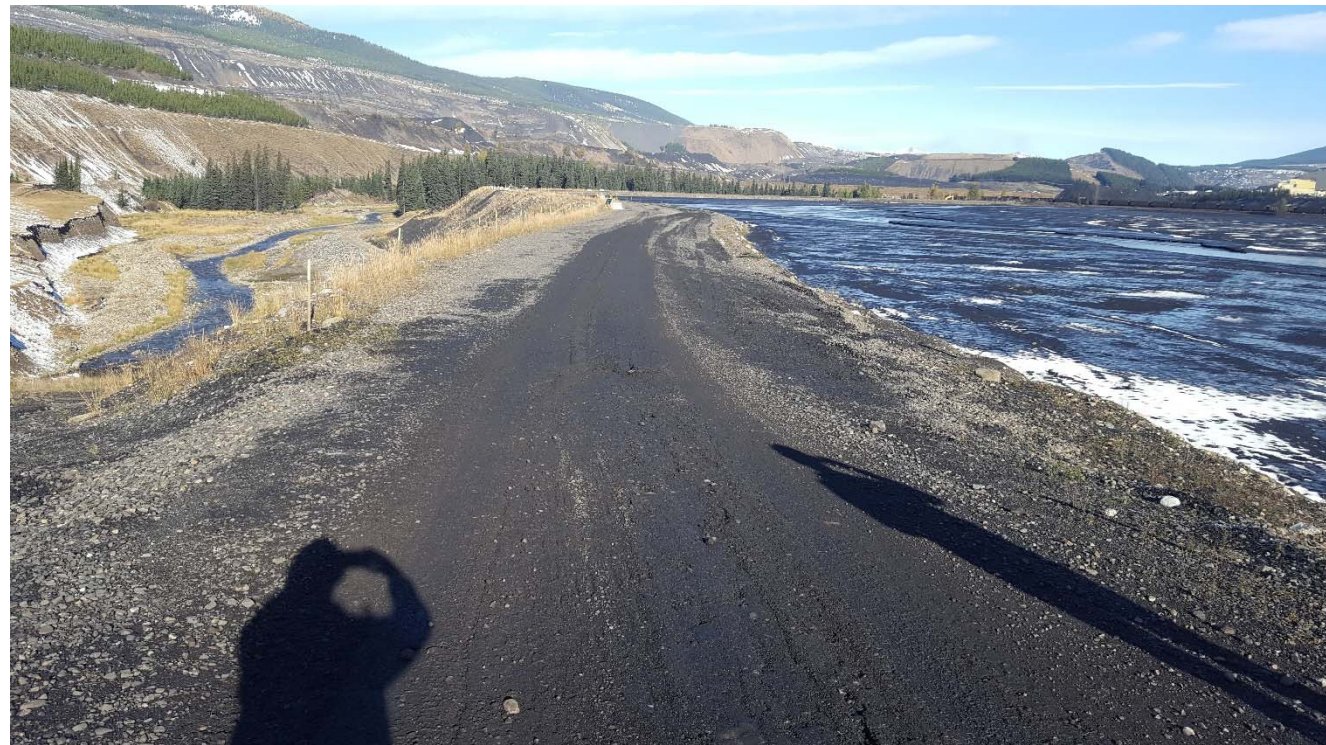
*Photograph 45: STP West Dam crest and tailings pond overview, looking northwest. 4 October 2017.*

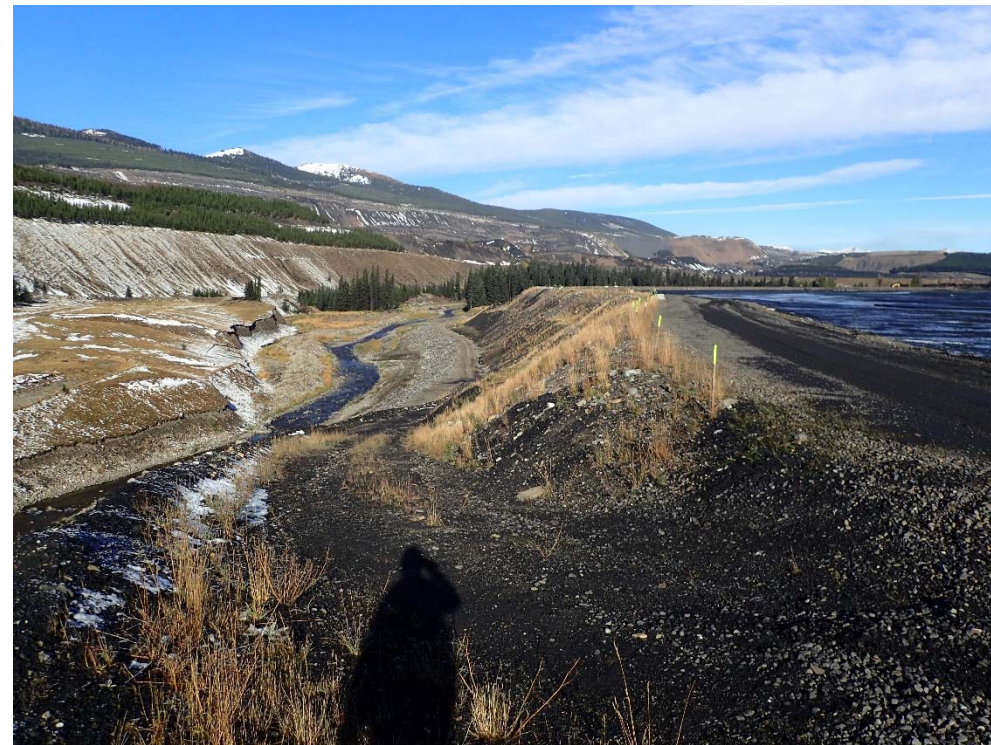
*Photograph 46: STP West Dam, downstream slope overview and Fording River, looking northwest. 4 October 2017.*

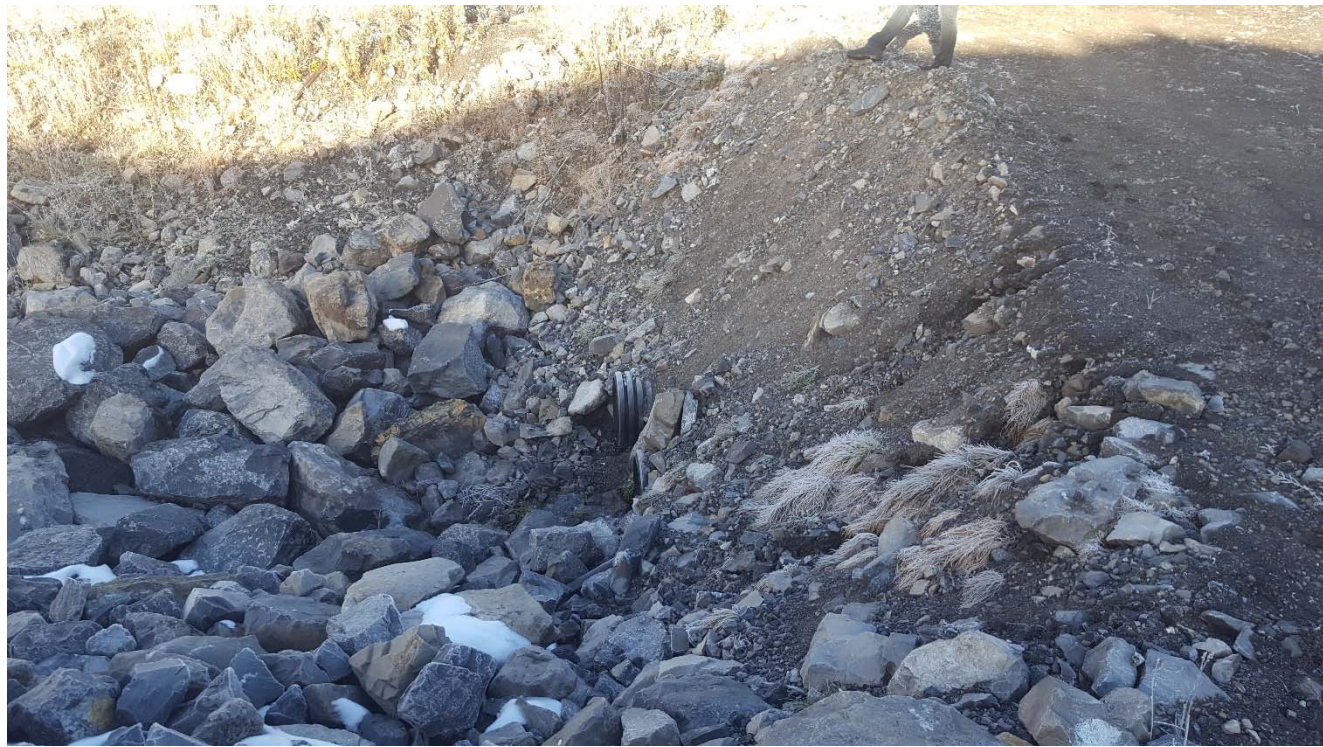
*Photograph 49: STP West Dam, twin culverts beneath access road at toe, looking east. 4 October 2017.*

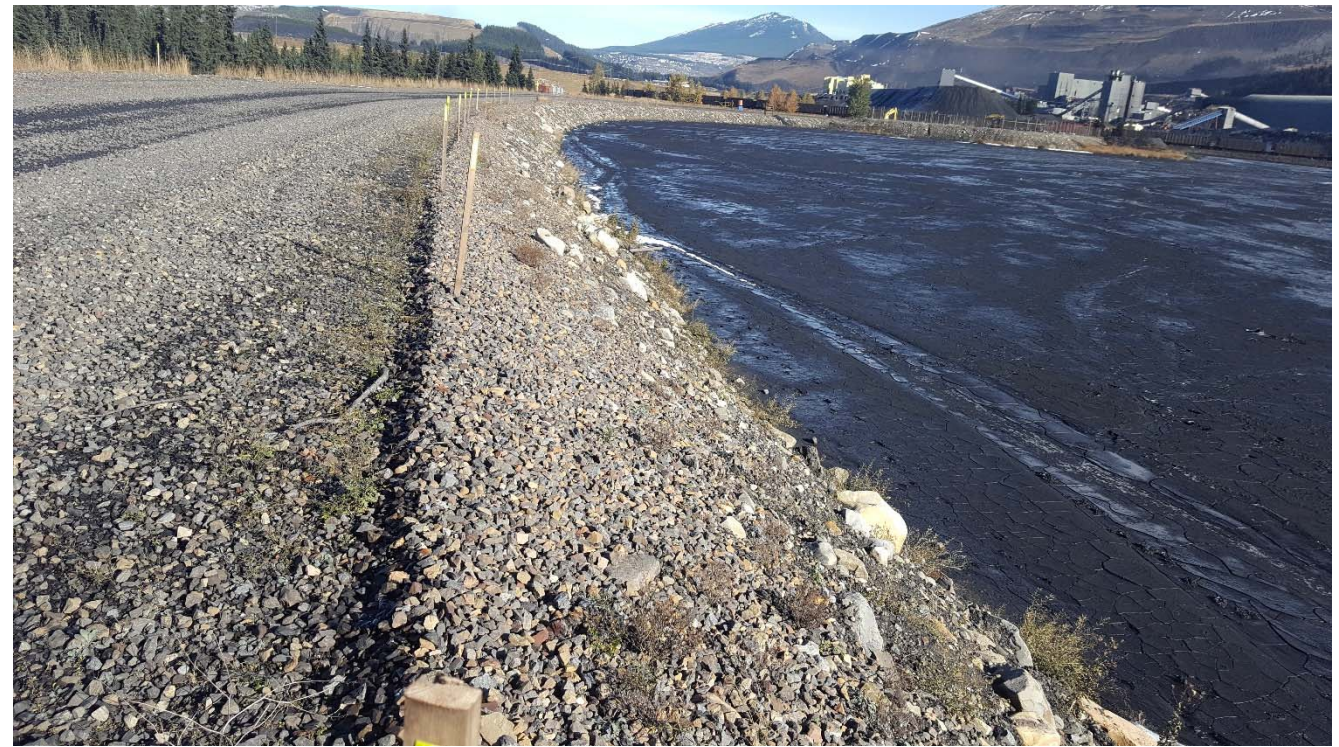
*Photograph 50: STP upstream slope and crest, looking north. 4 October 2017.*

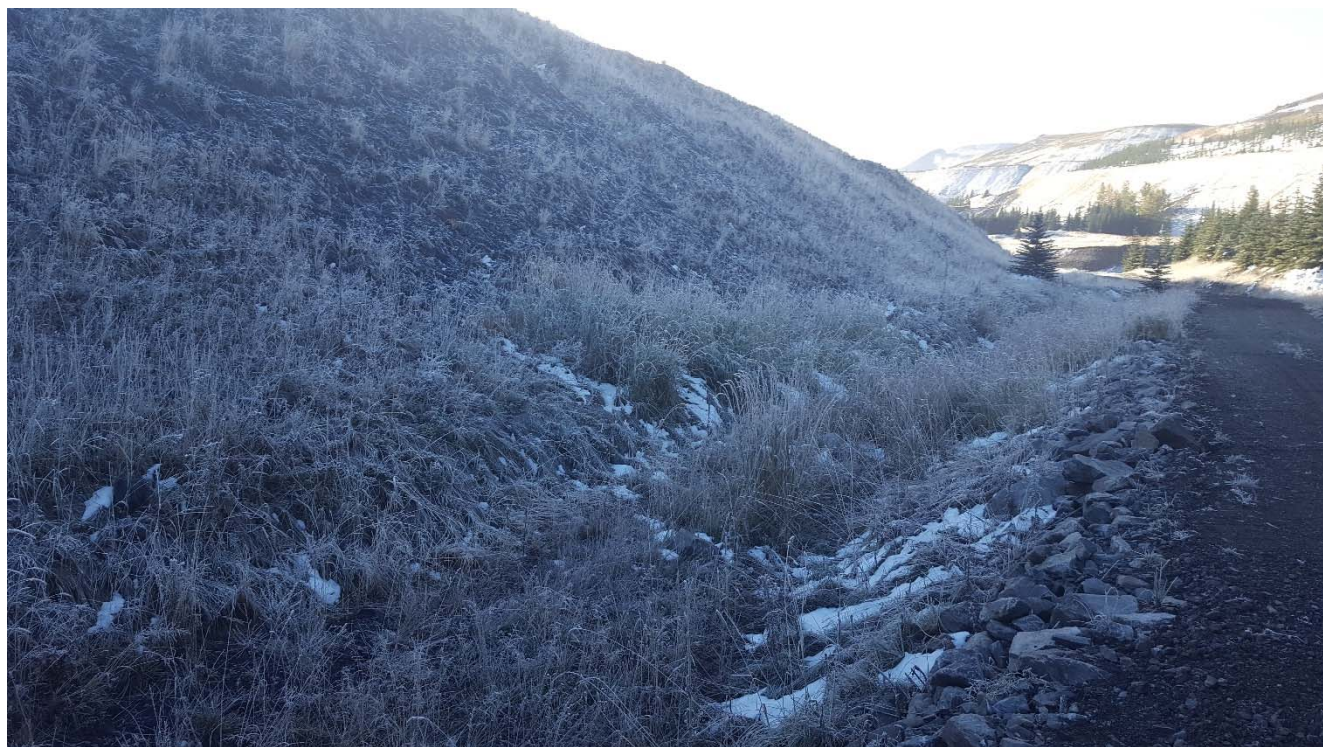
- Water flow has been seen in previous years in the ditch along the downstream toe of the north end of the West Dam (Golder 2017b). Due to the cold conditions during the site visit, very little water was observed; however, vegetation growth patterns at the toe of the West Dam indicate some seepage is exiting the dam (Appendix A, Photograph 51). Some of the water is presumed to be surface flow as well.

*Photograph 51: STP West Dam downstream slope with vegetation and ditch at downstream toe, looking south.  
4 October 2017.*

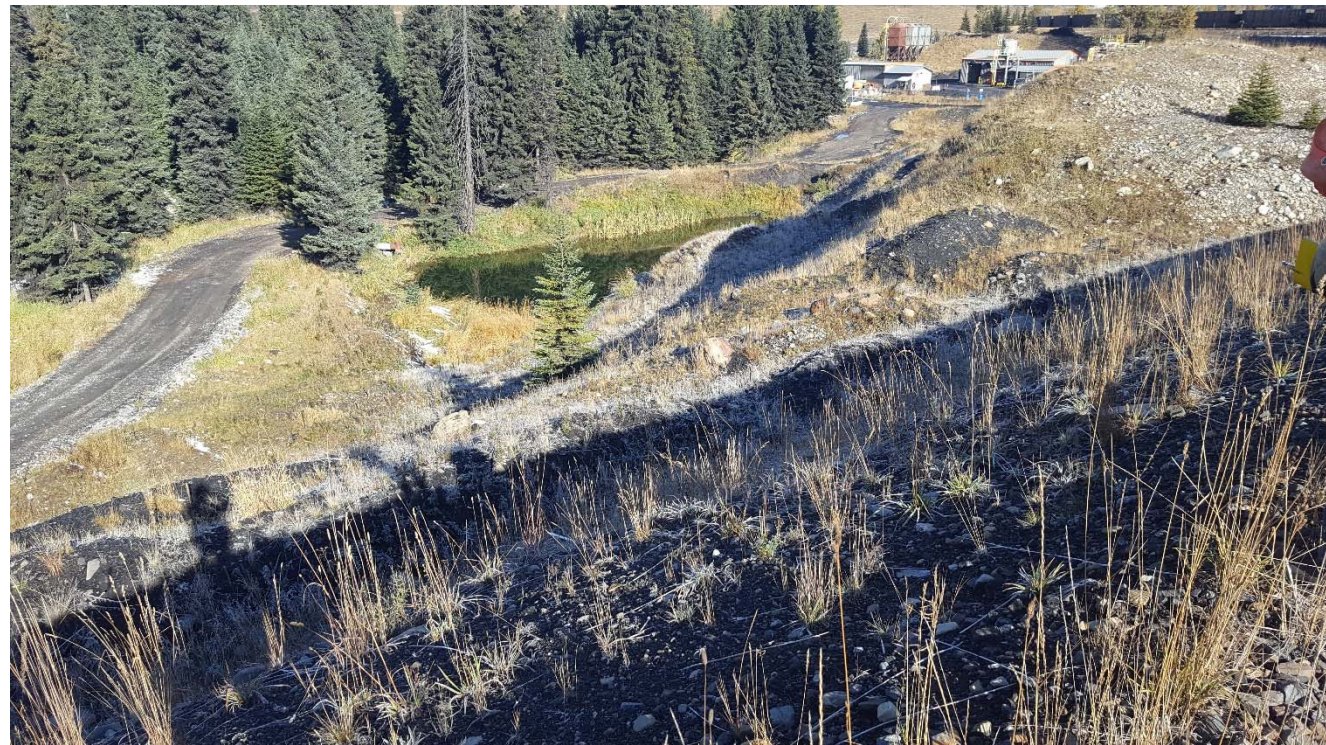
*Photograph 53: STP West Dam, pond at downstream toe near Stn.-0+050, looking northwest. 4 October 2017.*

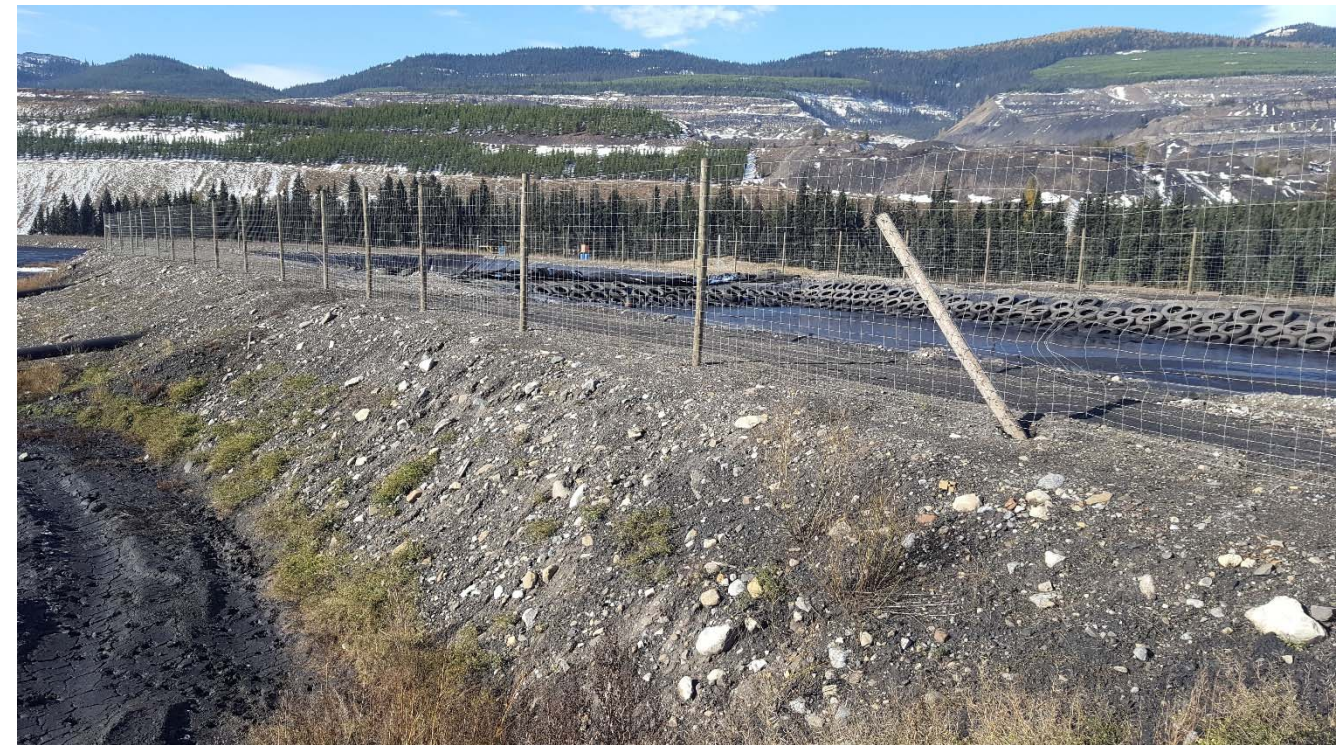
*Photograph 54: STP north abutment, waste water cells, looking southwest. 4 October 2017.*

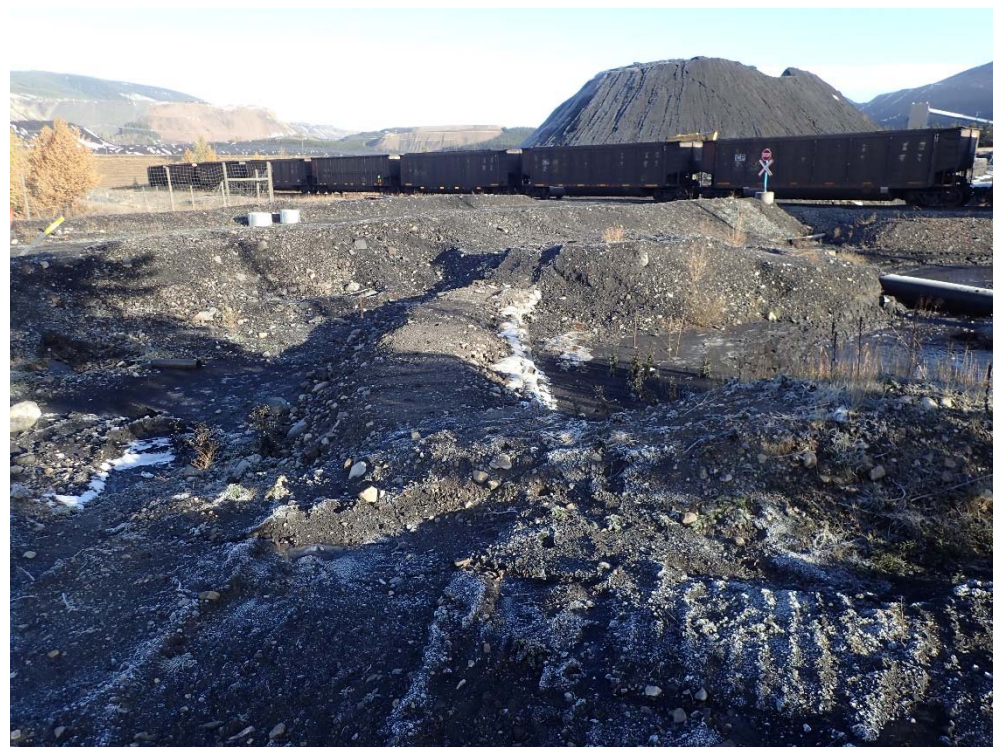
*Photograph 55: STP north abutment, recently constructed upstream till berm, looking northeast. 4 October 2017.*

Inspection Item	Observations/Data	Photo	Comments & Other Data
5.5 Other Unusual Conditions	Yes	55	<ul style="list-style-type: none"> <li>■ Gas main pipeline in north abutment area did not allow for abutment section of dam to tie into interim berm built.</li> <li>■ Till berm constructed near north abutment in 2017.</li> </ul>
<b>6.0 RESERVOIR</b>		22, 30

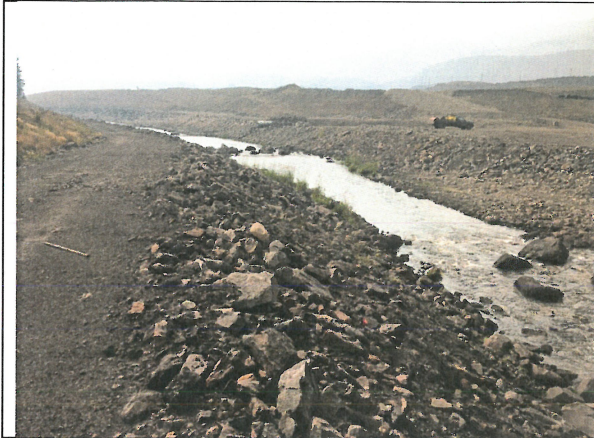
Photo 1: Looking downstream at NTP riprap (far bank) covered by gravel (approx. Sta. 0+100 to 0+200)

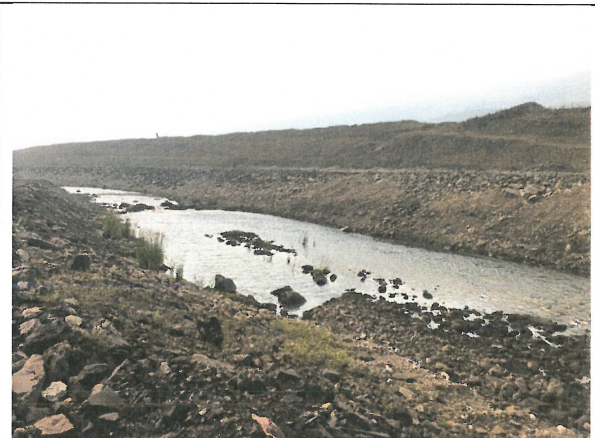
Photo 2: Looking downstream at NTP riprap (far bank) covered by gravel (approx. Sta. 0+200 to 0+320)

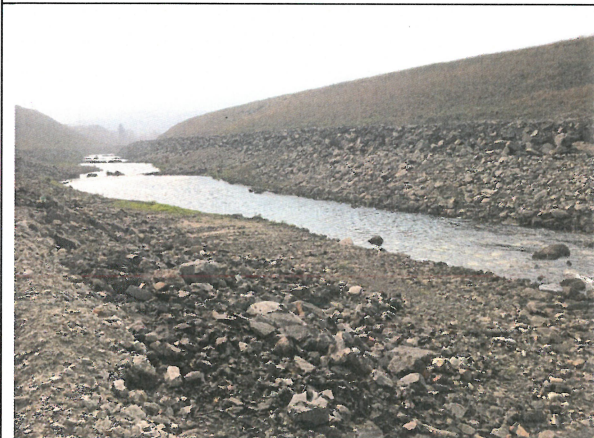
Photo 3: Looking downstream at NTP riprap (far bank) covered by gravel (approx. Sta. 0+340 to 0+450)
