**TECK COAL LIMITED  
FORDING RIVER OPERATIONS**

**2017 Dam Safety Inspection for  
North Tailings Pond and South  
Tailings Pond**

**Reference Number: 1784573-2017-129-R-Rev0-1000**

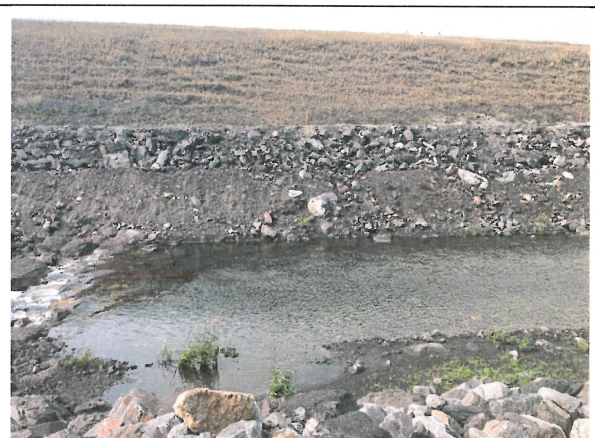
Riprap extends from upstream of the NTP to about Sta. 1+075 of the Golder NTP dam baseline as shown on Figure 1. Visual inspection of the lower riprap slope was impeded by gravel placed over the riprap during 2013 construction. The upper riprap slope placed during 2016/2017 was visible and appears to be well-interlocked. The exposed toe of the revetment was also observed and appears to be in good condition with no visual signs of scour or displacement. Riprap was visible on the entire slope in one short section approximately between Sta. 0+750 and Sta. 0+830. The exposed riprap is in good condition and appears to remain well interlocked. The slope of the exposed riprap is about 1.5H:1V.

Photo 4: NTP riprap (far bank) with 2013 riprap covered by gravel on lower slope and 2016 riprap exposed on upper slope (approx. Sta. 0+500)

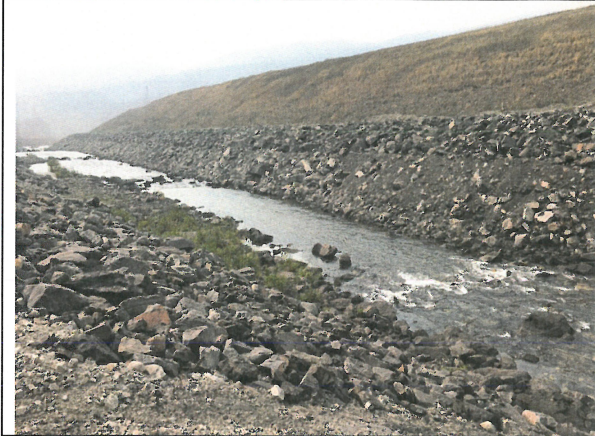
Photo 5: Looking downstream at NTP riprap (far bank) covered by gravel (approx. Sta. 0+620 to 0+800)

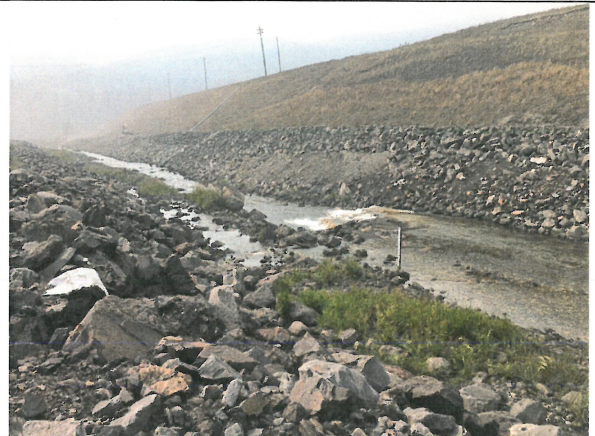
Photo 6: Looking downstream at NTP riprap (far bank) covered by gravel (approx. Sta. 0+840 to 0+940)

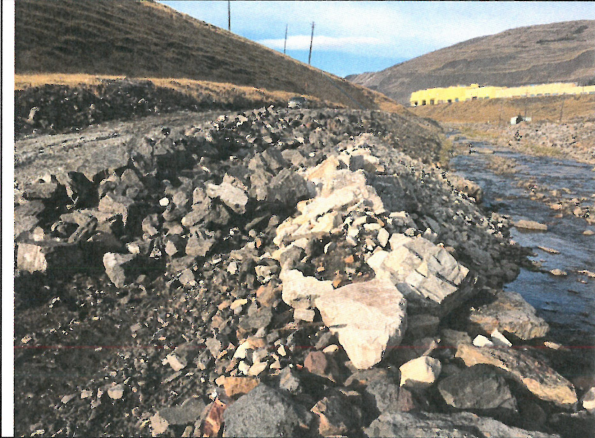
Photo 7: Looking upstream at NTP downstream tie-in of raised riprap (approx. Sta. 0+900 to 1+070)

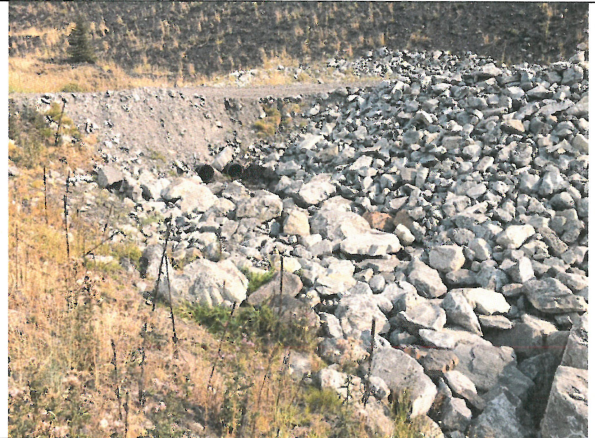
Photo 8: Looking upstream at STP riprap and drainage culverts along Maxam Creek (approx. Sta. 0+240 to 0+250)

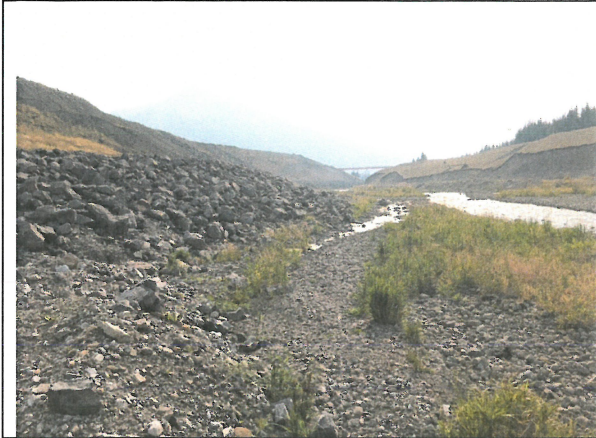
Photo 9: Looking downstream at STP riprap (approx. Sta. 0+280 to 0+360)

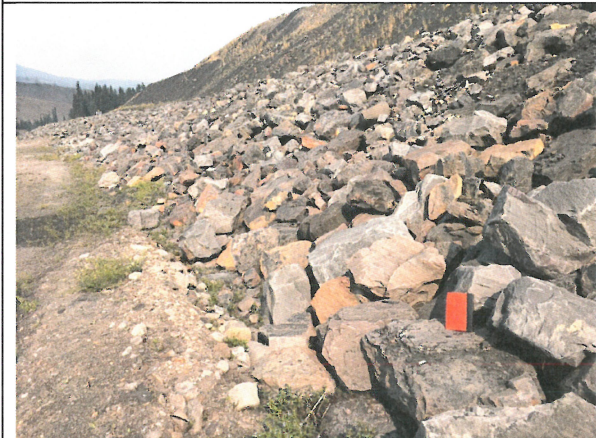
Photo 11: Looking upstream at STP riprap (approx. Sta. 0+360 to 0+460)

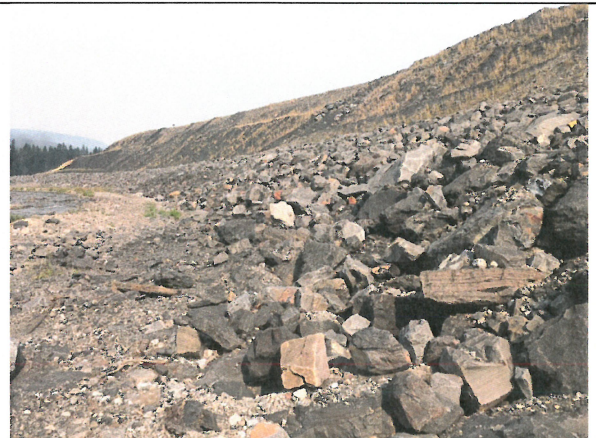
Photo 12: Looking upstream at STP riprap (approx. Sta. 0+360 to 0+580)

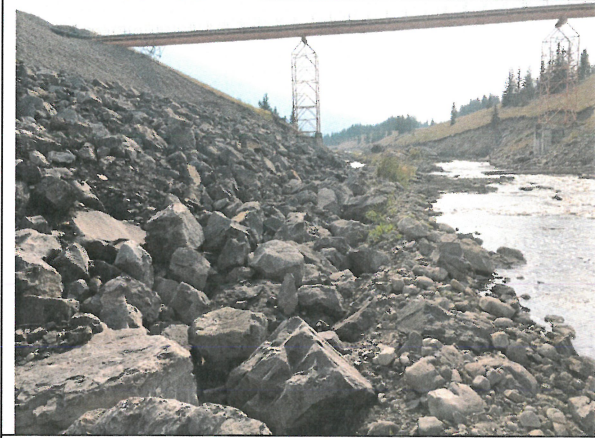
Photo 13: Looking downstream at STP riprap (approx. Sta. 0+580 to 0+680)

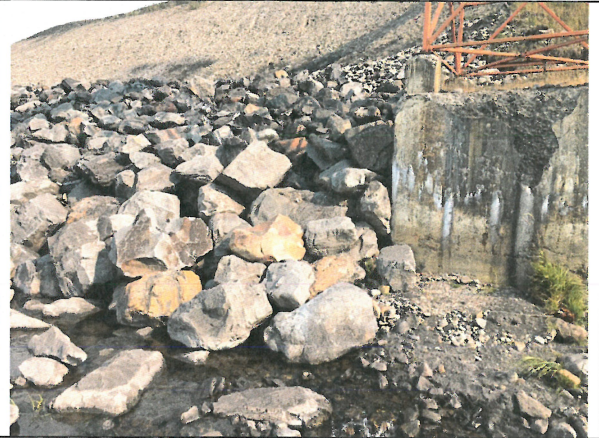
Photo 14: Looking at downstream extent of riprap (approx. Sta. 0+680)
