Teck Coal Limited

Elkview Operations

West Fork Tailings Facility and Lagoons A, B, C, and D

2022 Annual Facility Performance Report

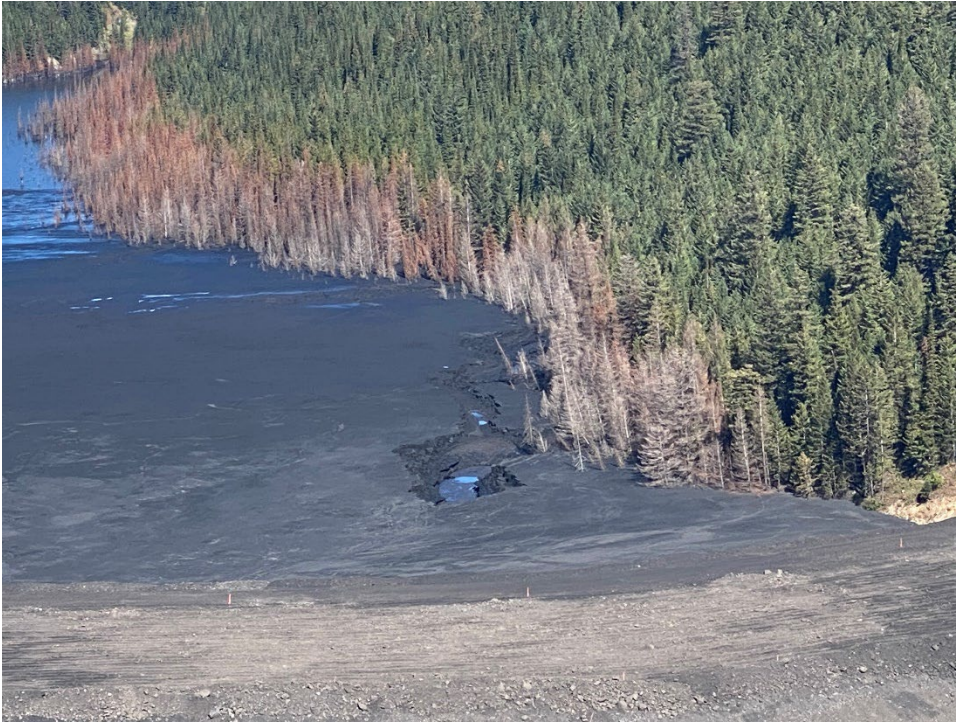
Photo IW-17 WFTF receding incised channel. (Looking north, from Sunshine Dump crest – Taken 21 September 2022)

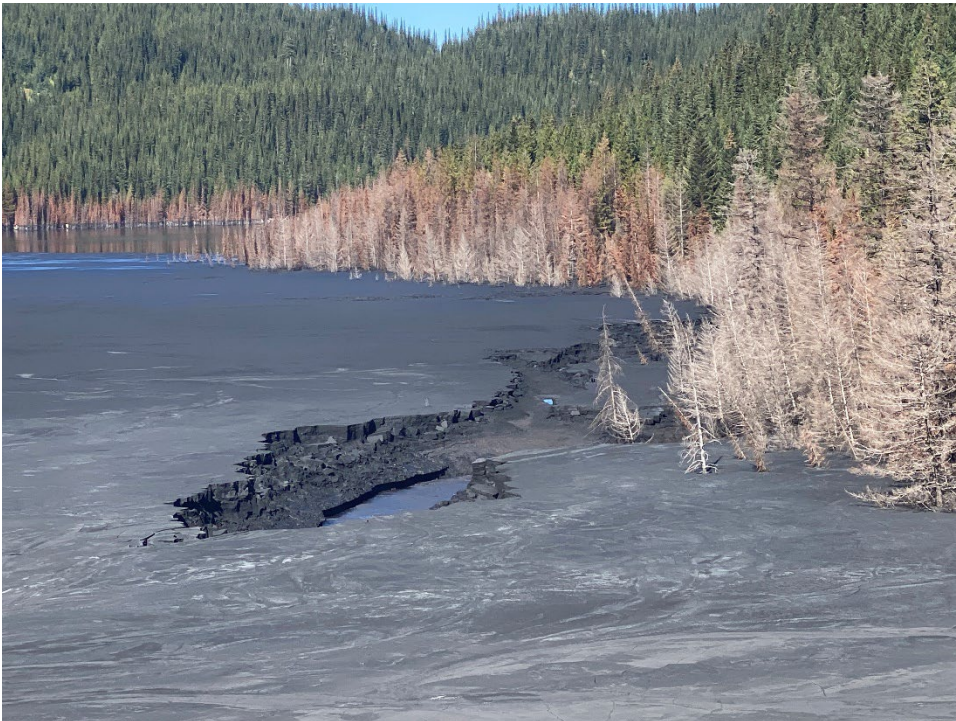
Photo IW-18 WFTF receding incised channel. (Looking north – Taken 21 September 2022)

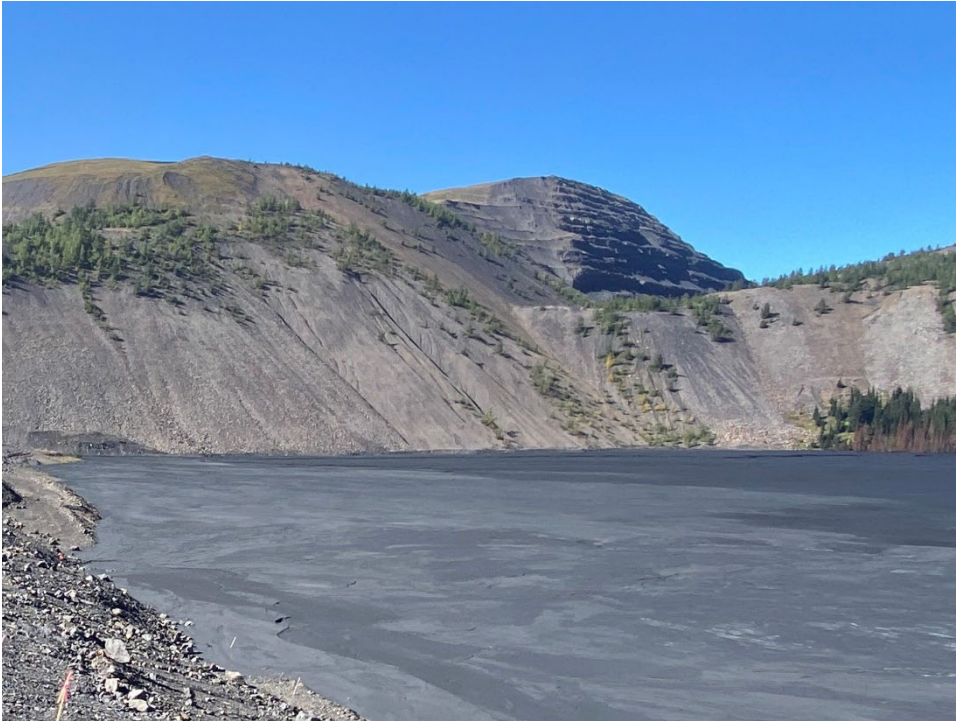
Photo IW-19 Adit Dump erosion above AFB. (Looking NW – Taken 21 September 2022)

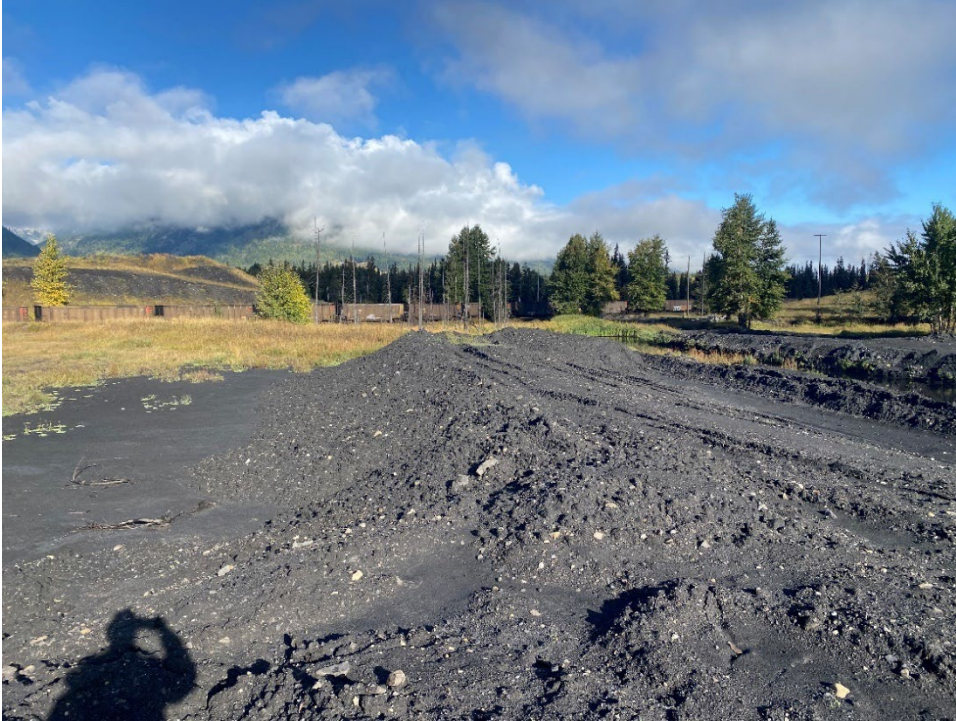
Photo IB-7 Lagoon B embankment resloping. (Looking NW – Taken 20 September 2022)

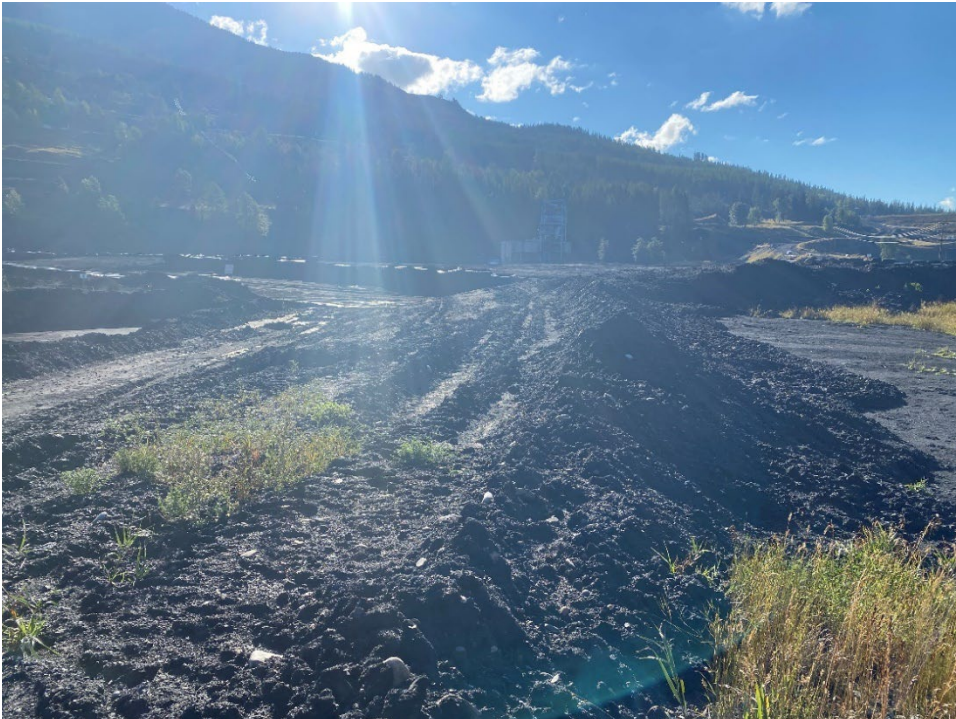
Photo IB-8 Lagoon B embankment resloping. (Looking SE – Taken 20 September 2022)

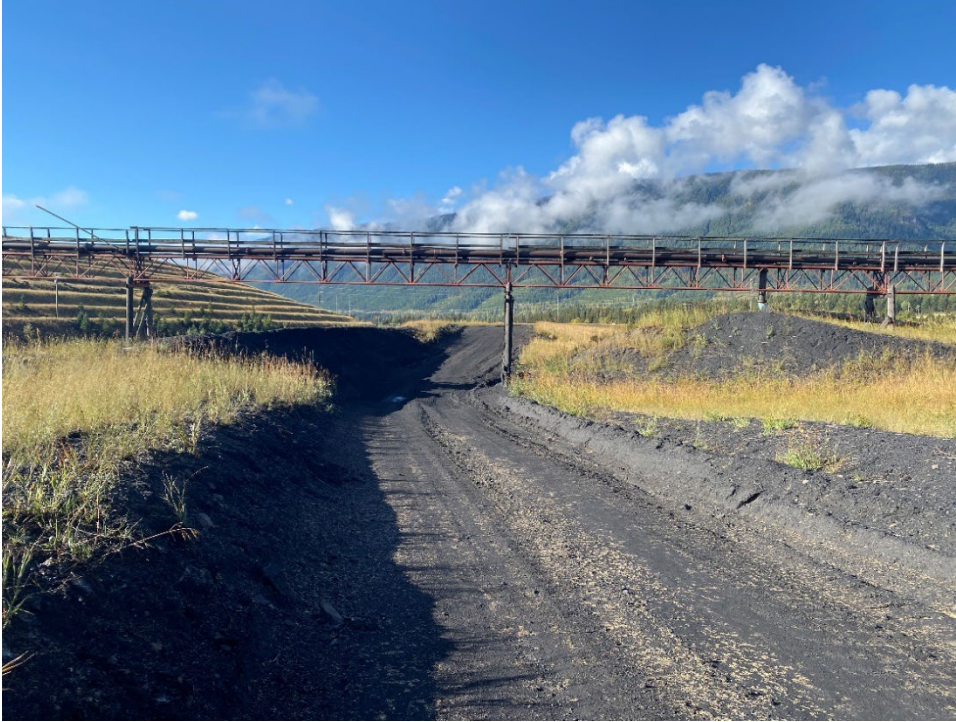
No.	Notable Observations	Change from 2021 AFPR?	Dam Safety Concern?	Photo Reference
Lagoon C				
LC-1	A local low spot on the crest near the trestle remains. Survey has previously confirmed the low spot elevation is El. 1126.6 m.	No	Yes	IC-9
LC-2	Erosion on the upstream side of the crest was observed at the north section of the Lagoon near the pumphouse. It is not expected that this erosion could propagate through the crest of the embankment and therefore is not an embankment safety concern.	No	No	IC-10
Lagoon D				
LD-1	Minor gully erosion of the downstream slope was observed at several locations along the Lagoon D embankment.	No	No	ID-15
LD-2	Minor erosion was observed along the south embankment crest, opposite the embankment crest road from tailings cell S-12. The erosion is likely from precipitation runoff.	Yes	No	ID-16

Lagoon C does not have a spillway but has sufficient capacity to store the 24-hr IDF; however, due to the low spot in the crest at the trestle, it has less than the recommended freeboard during this event and would overtop at the low spot during the 72-hour IDF (KCB 2021c). Ponded water infiltrates through the tailings to the natural ground.

Photo IC-9 Lagoon C crest low spot and trestle structure. (Looking SW – Taken 20 September 2022)

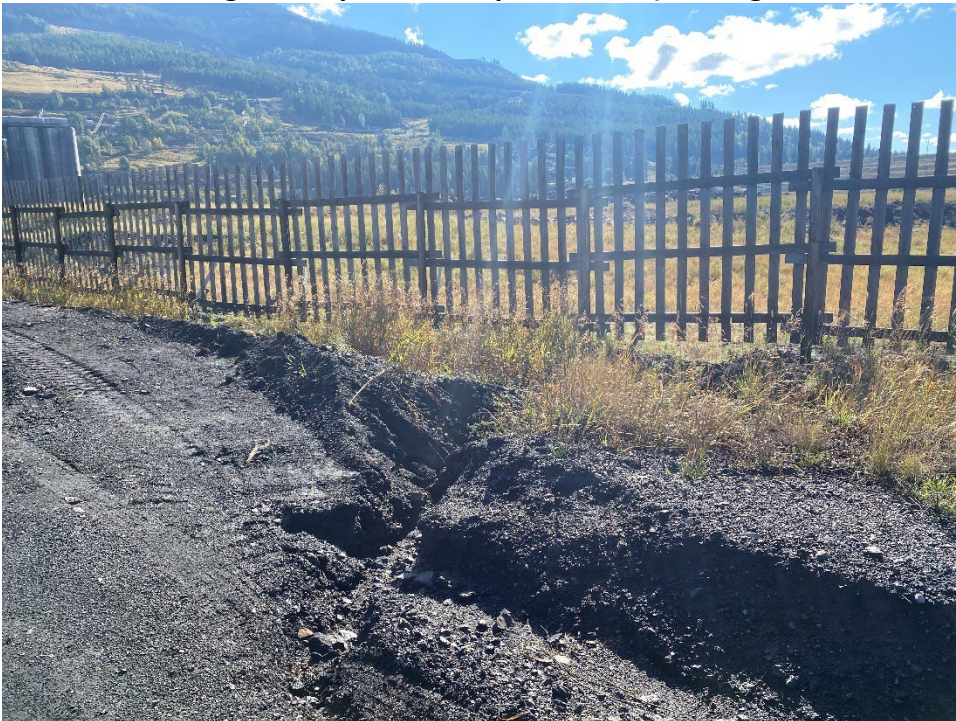
Photo IC-10 Lagoon C upstream slope erosion. (Looking SE – Taken 20 September 2022)

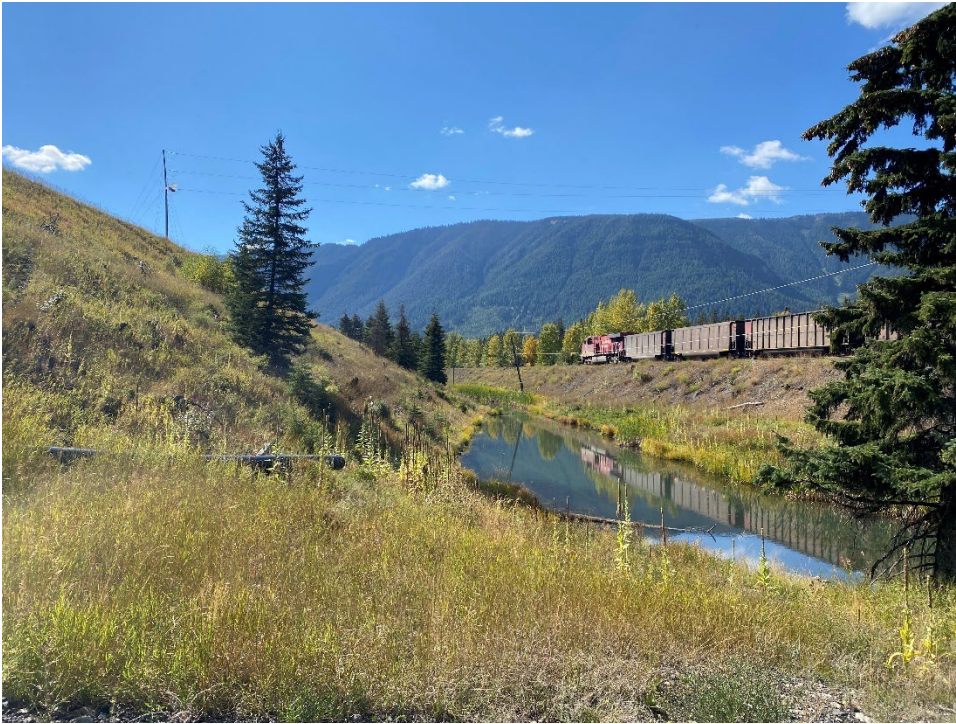
**Photo ID-5 Lagoon D ponding at the embankment toe (Otto Ponds) adjacent to the rail line.
(Looking SW – Taken 20 September 2022)**

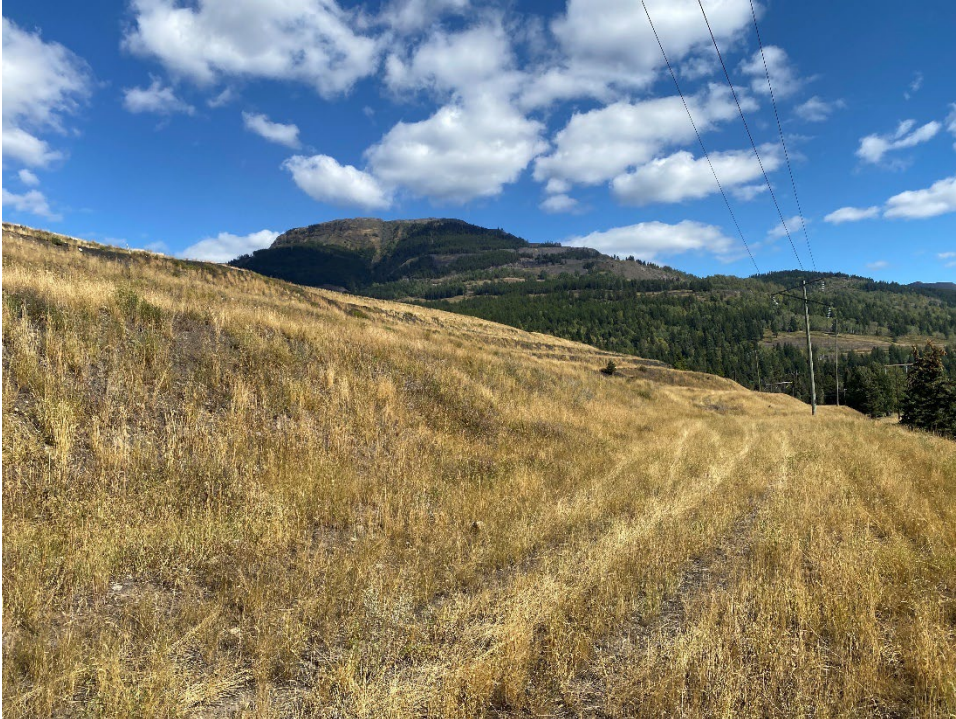
Photo ID-11 Lagoon D embankment. (Looking east – Taken 20 September 2022)

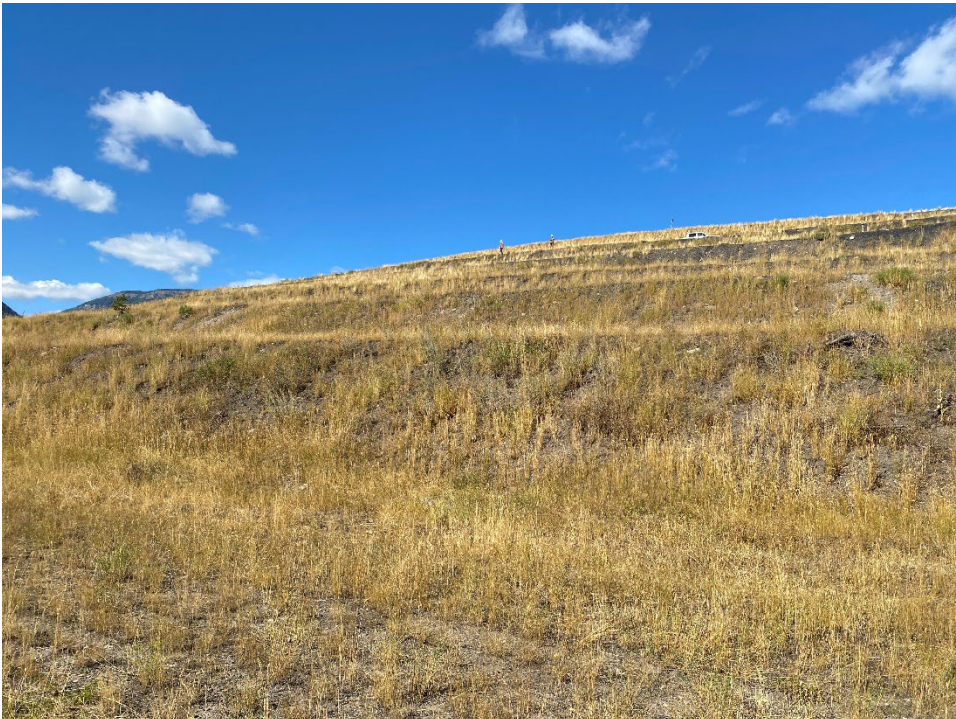
Photo ID-12 Lagoon D embankment. (Looking north – Taken 20 September 2022)

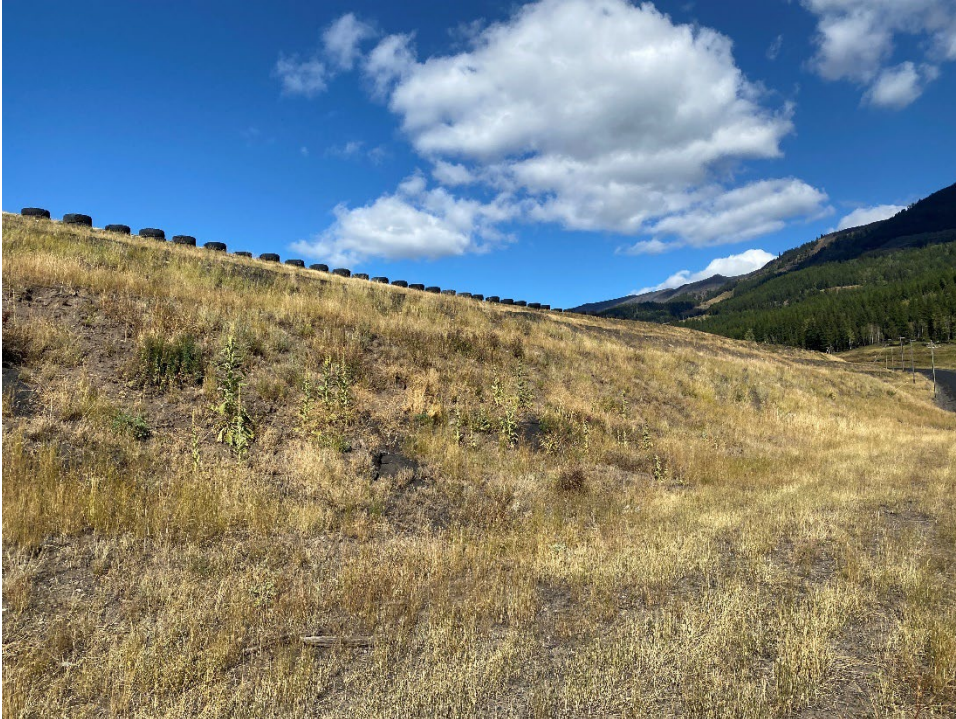
Photo ID-13 Lagoon D embankment. (Looking NE – Taken 20 September 2022)

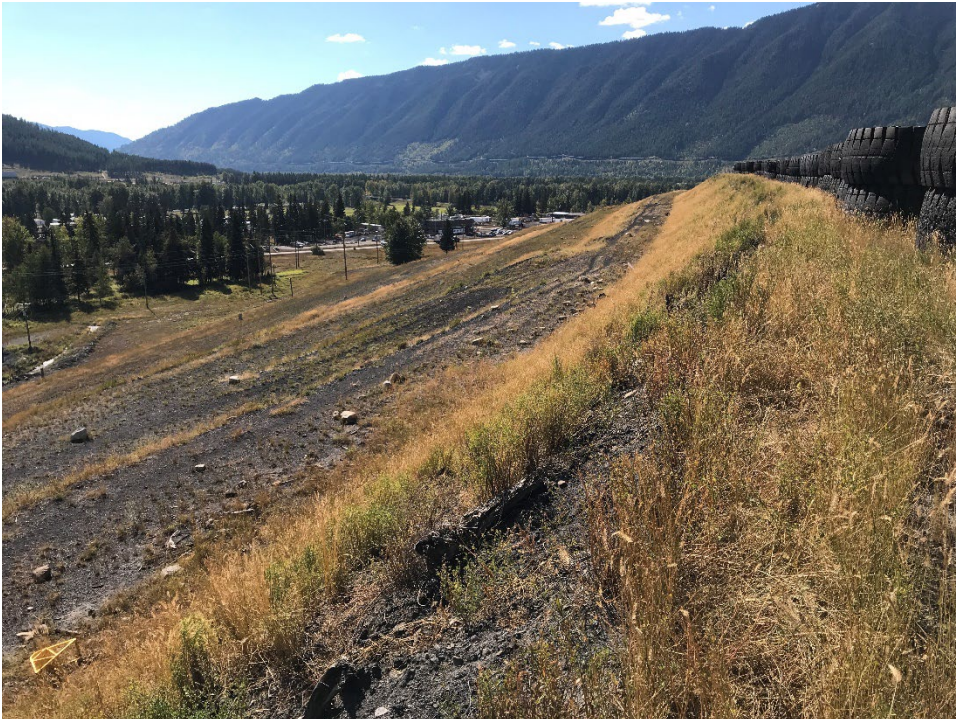
Photo ID-14 Lagoon D crest and embankment slope. (Looking SW – Taken 20 September 2022)

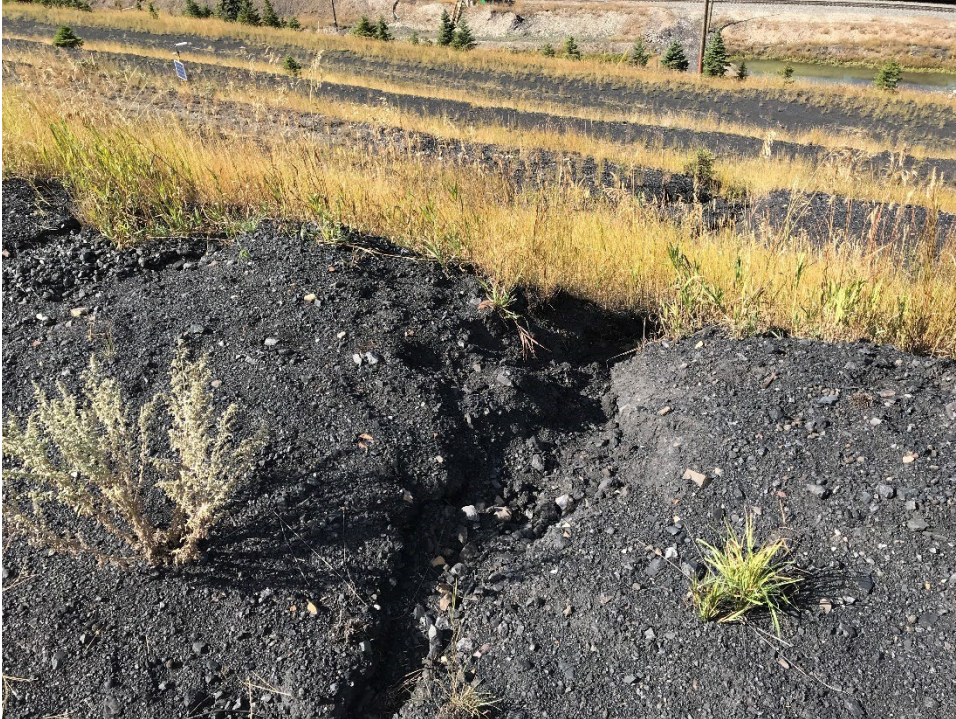
Photo ID-15 Lagoon D minor bench minor erosion. (Looking NW – Taken 20 September 2022)

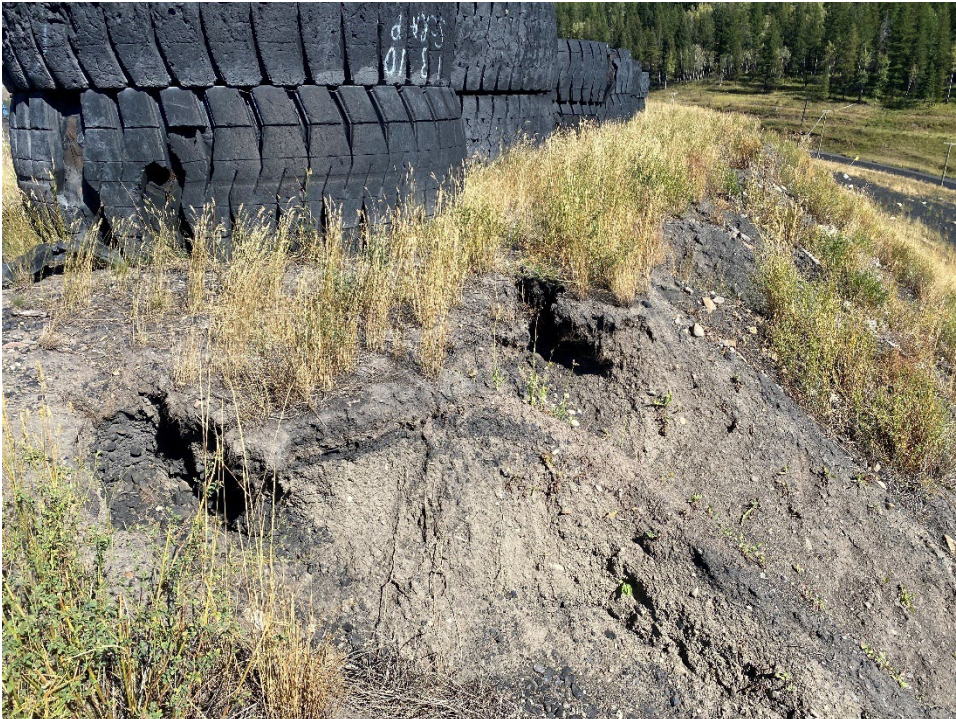
Photo ID-16 Lagoon D minor crest erosion. (Looking NE – Taken 20 September 2022)

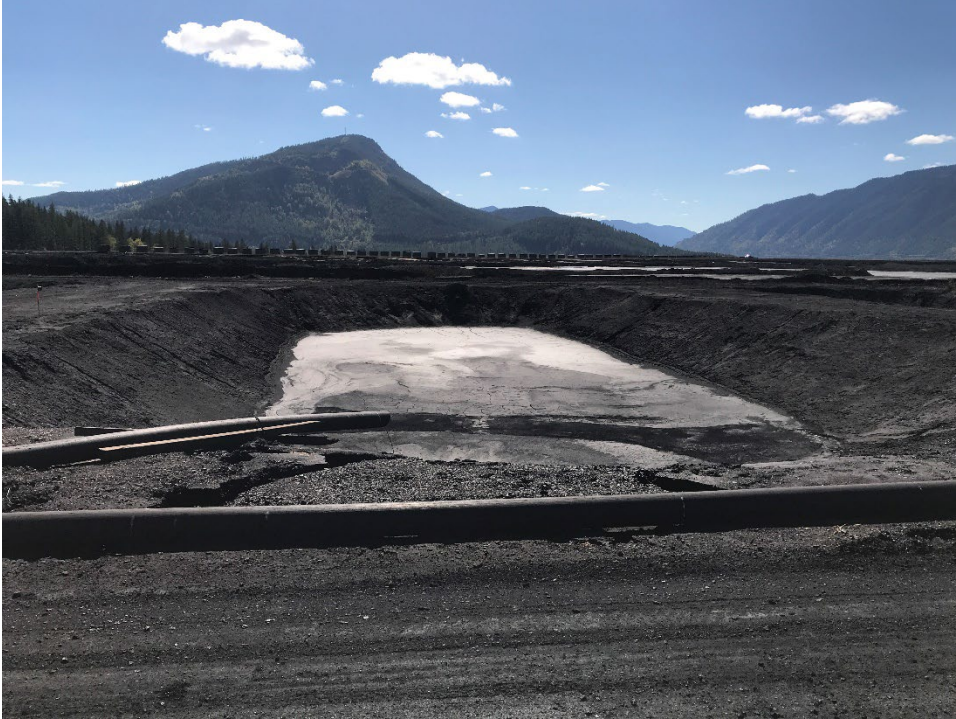
Photo ID-19 Lagoon D north tailings cells. (Looking south – Taken 20 September 2022)

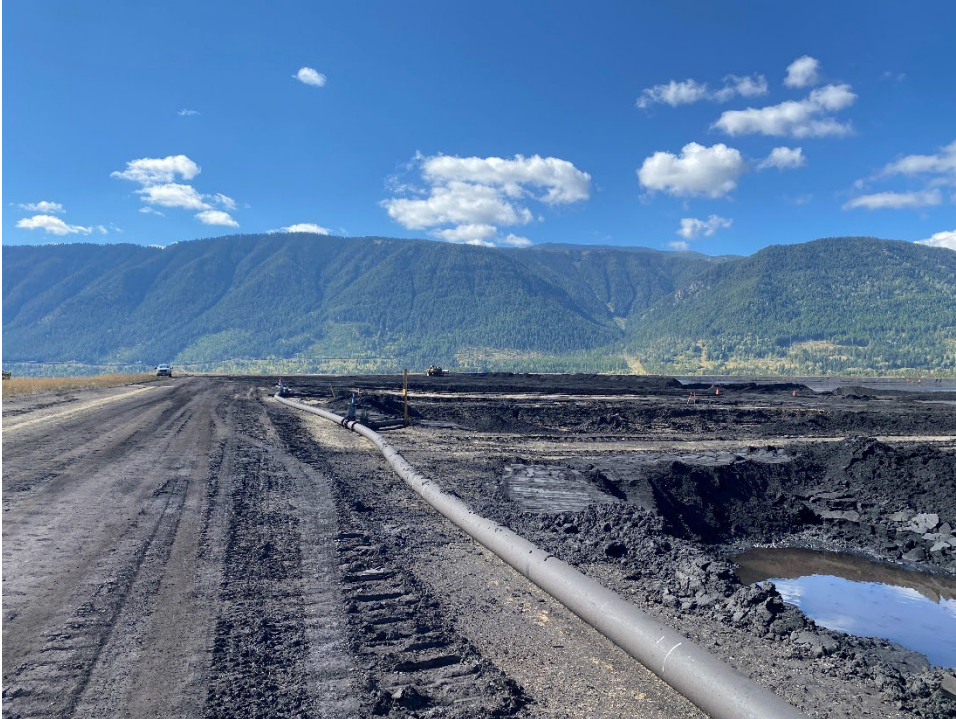
Photo ID-20 Lagoon D south tailings cells. (Looking west – Taken 20 September 2022)
